PERFORMANCE OF POWER, GAS AND WATER LIFELINES IN THE 2018 HOKKAIDO EARTHQUAKE

J. Eidinger⁽¹⁾

Abstract

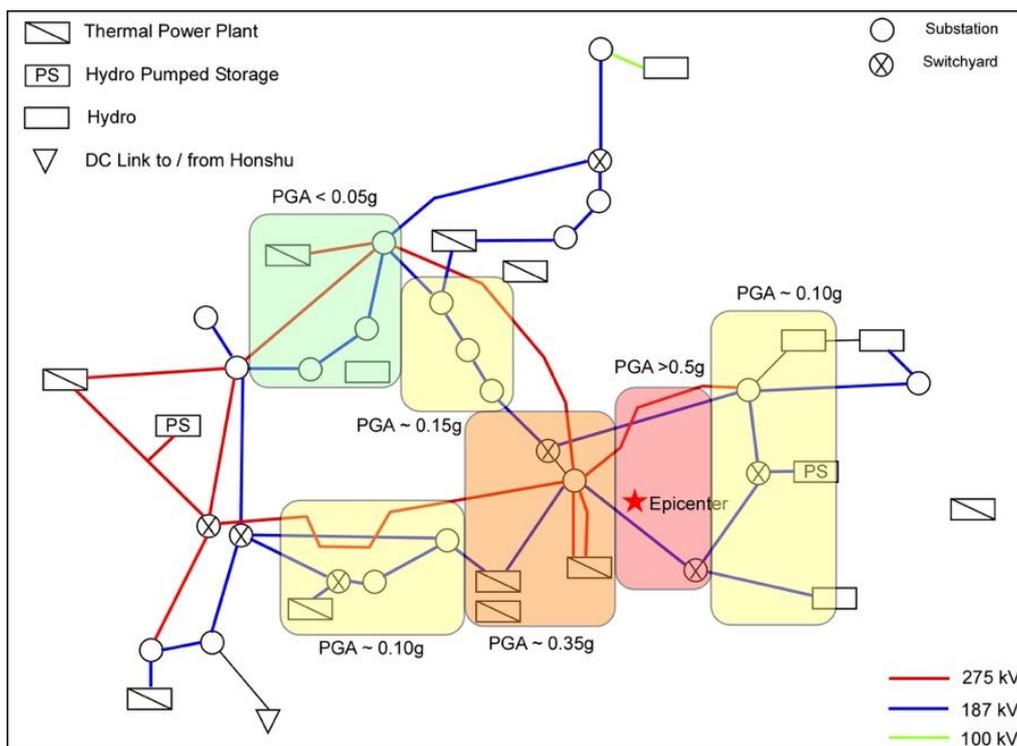
Fig. 6. Shaking Levels in the Transmission Grid

In the area highlighted in red, including the epicenter, the ground shaking was commonly over 0.5g. In this area, there were thousands of landslides. There were no high voltage (187 kV or higher) substations exposed in this area. There were some 66 kV substations exposed, generally without damage. In the area highlighted in orange, the ground shaking was commonly in the range of 0.30g to 0.40g. This included the Tomatoh-Atsuma power plant, and the Minami-Hayaki 275 – 187 – 66 kV substation. In the areas highlighted in yellow, the ground shaking was commonly in the range of 0.10g to 0.15g. This includes most of the City of

Sapporo. In the area highlighted in green (Otaru and Ishikari port areas), the ground shaking was commonly 0.03g to 0.05g. In the areas without color boxes, the ground shaking was commonly 0.01g to 0.03g. The bulk of the physical damage to the power grid occurred in the red and orange areas. This includes damage to the Tomatoh-Atsuma coal power plants, collapsed transmission towers, faulted transmission lines due to the "galloping" of jumpers that resulted in phase-to-ground faults, some damage to equipment within substations, and many collapsed distribution poles due to landslides. There was also some damage in the yellow zones due to landslide and liquefaction effects on distribution lines. Fig. 7 shows locations of damage at 8 transmission towers; 2 other transmission lines were faulted due to damage of equipment at substations. A portion of the single circuit 66 kV Iwashimishi line is shown, to highlight the relative locations of collapsed towers due to landslides. All the damaged towers are located in the red zone from Fig. 6. Five lines faulted due to high inertial loading on the conductors (20, 26, 29, 409, 135). Three towers were damaged due to landslides (52, 71, 107).
