1.0 Introduction

The Lushan earthquake occurred at 8:02 am local time, April 20, 2013. This earthquake is the result rupture on a nearby / adjacent fault segment from the great M 8.0 Wenchuan earthquake of May 12, 2008. The ruptured fault segment in 2013 was located south of the southern end of the rupture in the 2008 event. The distance between the Lushan EQ epicenter is about 83 km SSW of the Wenchuan EQ epicenter.

1.1 Key Findings

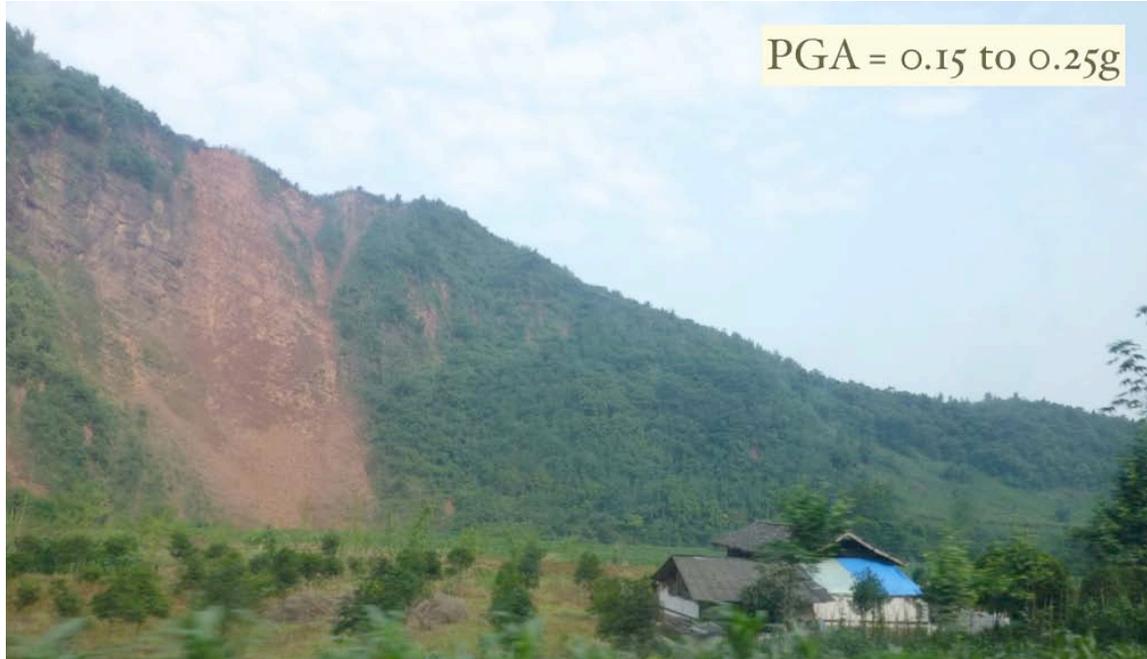
Figure 2-18. Landslide (Bare rock area of mountain)

Figures 2-18 and 2-19 show typical landslides (PGA values are estimated based on observations of nearby structures). In most cases, the buildings for human occupation

were located well set back from the base of the steep slopes, and there were few cases of landslide impacts to people. We suspect that this de-factor "zoning" was derived from a long history of intense-rainfall-caused landslides, resulting that only low occupancy activities (like farming) were allowed at the base of steep hills.

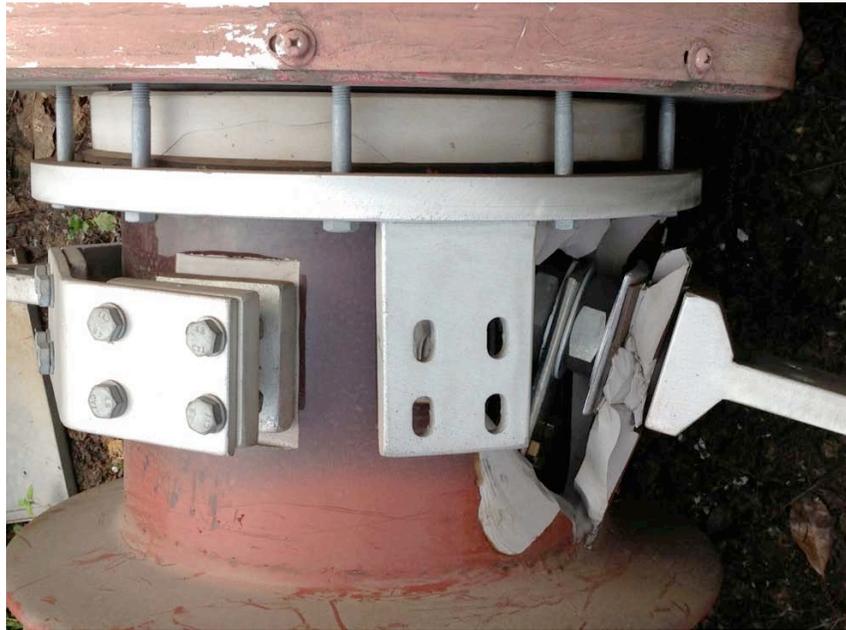
Twelve of the 110 kV current transformers were broken, Figure 4-7. When inspected, one damage mode was due to high tension forces applied to the terminations, leading to fracture of the porcelain, Figure 4-8. These high forces were likely due to inadequate cable slack between the current transformers and adjacent switches / circuit breakers, aggravated in large part by swinging wave traps.

Figure 4-8. 110 kV Broken Current Transformers

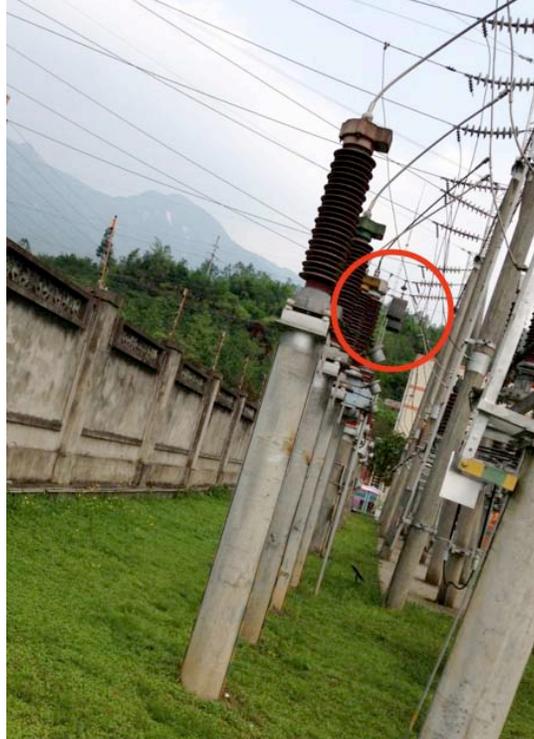
Figure 4-10 shows one end of the 110 kV yard, with the red circle highlighting two hanging wave traps. When the wave traps swing in the earthquake, they impose large displacements on the flexible bus, leading to high tension forces in the bus when the displacements exceed the available slack. These high forces are the primary reason for damage to the equipment in the yard. This problem can be readily mitigated in several ways: removal of the wave traps; support of the wave traps using posts; adding suitable cable slack; etc.

Figure 4-10. 110 kV Yard – After Repair – Wave Traps Highlighted in Red Circle

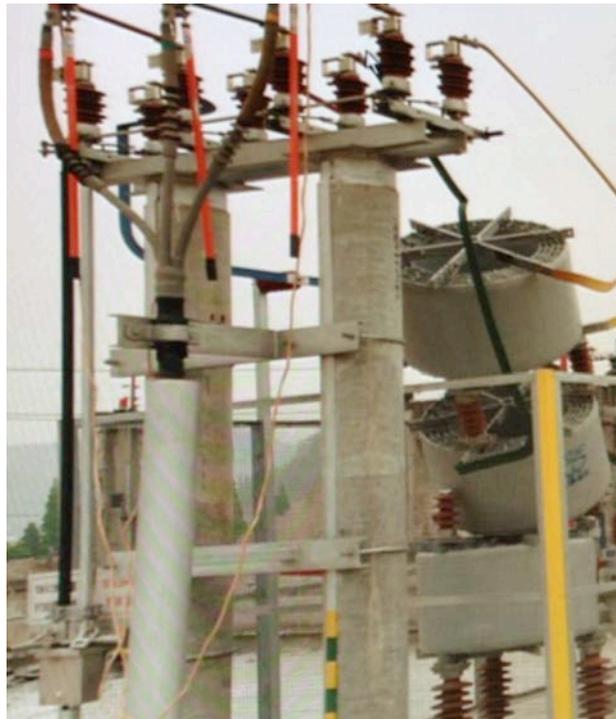
Figure 4-11 shows damaged air core reactors in the low voltage side of the yard. This failure mode occurred at three locations in the yard; two of the damaged reactors are seen in Figure 4-12.

Figure 4-11. Damaged Air Core Reactors

Normally, in the US one would not expect to see this type of damage to low voltage equipment, even at very high levels of ground shaking. For this yard, the cause of the damage appears to be that the adjacent equipment (either capacitors or station service transformers) rocked (all were unanchored), leading to high forces transferred to the air core reactors via the attached rigid bus (see Figure 4-11).

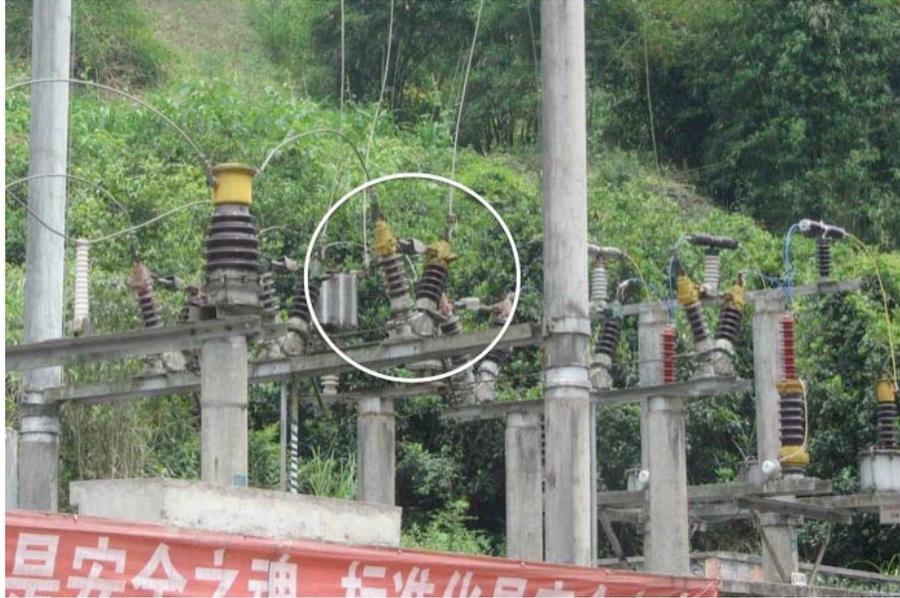
The only damage informed by the staff was one of the V-break disconnect switch that fell off its mount, Figure 4-18.

Figure 4-18 V-shape disconnect switch.

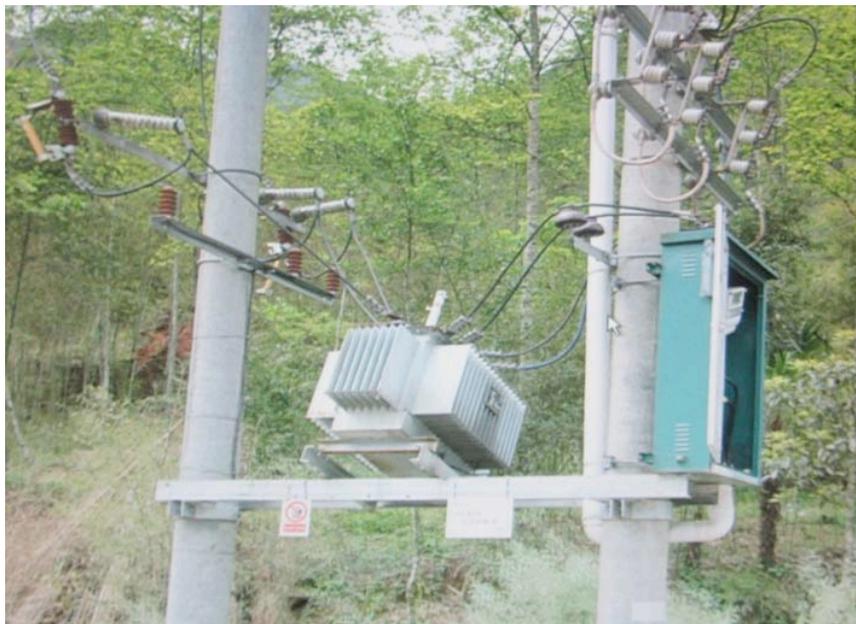
Fallen platform-mounted transformers occurred sporadically, Figure 4-22. This type of poor seismic installation was observed in California earthquakes of 1952 through 1971, but this failure mode has since been eliminated by use of proper anchorage.

Figure 4-22. Damaged Platform-Mounted Transformer

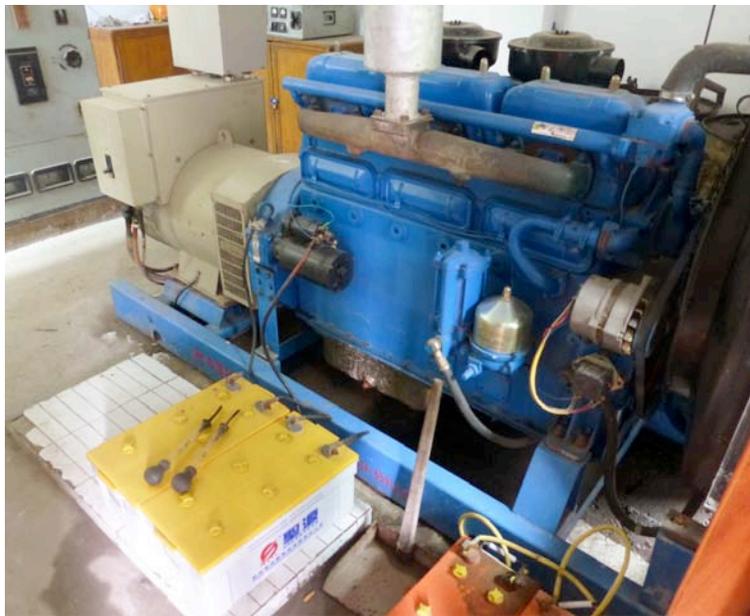
We visited one run-of-the-river concrete gravity dam, Figure 4-23, located immediately upstream of "bridge 1" (Figure 7-6). The operator of the dam reported that upon cessation of shaking, he immediately opened all radial and slide gates; all gates opened upon demand (no sticking). The dam included an emergency generator; we observed that the generator had an unanchored battery (Figure 4-24), and the dam operator confirmed that the generator failed to start on demand; but was quickly repaired.

Figure 4-24. Emergency Generator with Unrestrained Startup Batteries

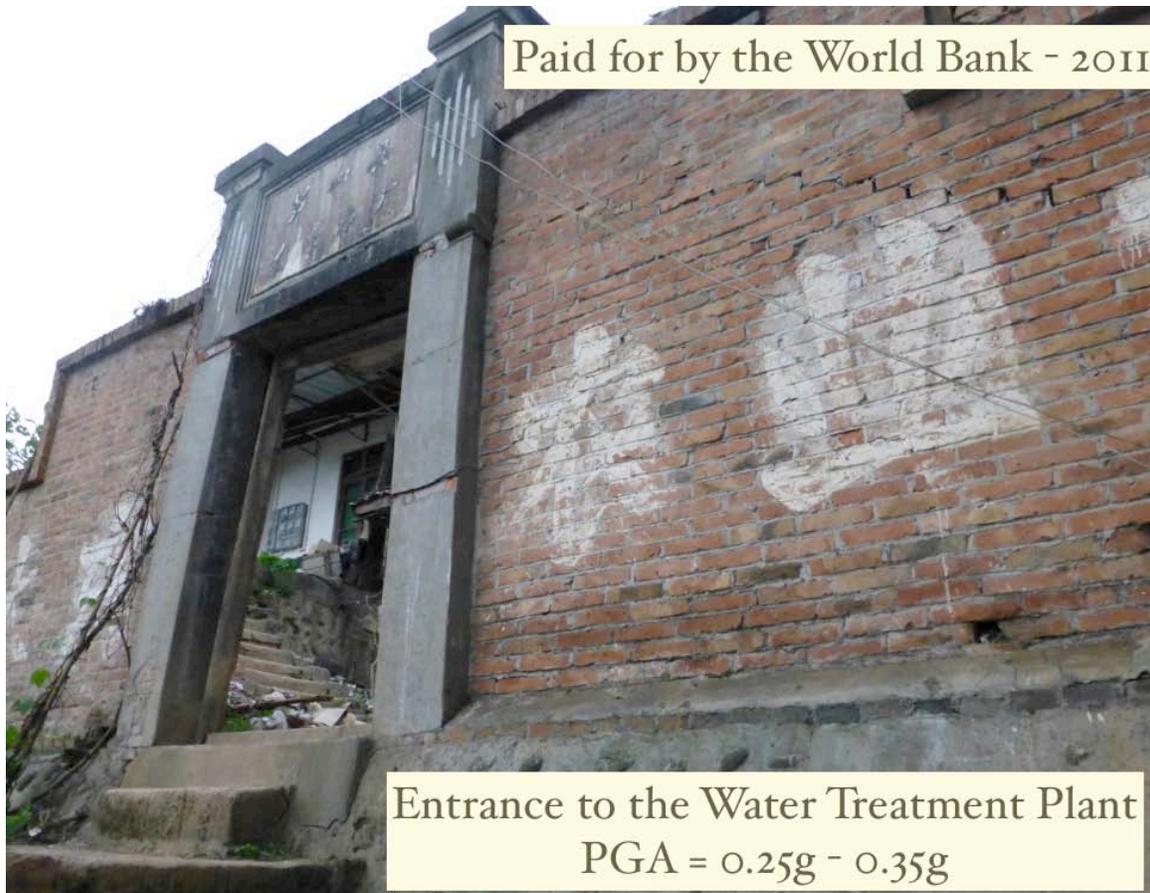
A new (2011 vintage) water treatment plant had just been completed prior to the 2013 earthquake, using funding from the World Bank. Figure 5-1 shows the entrance, using a URM wall (the wall was damaged, but this did not impact the plant's performance).

Figure 5-1. Entrance to Water Treatment Plant

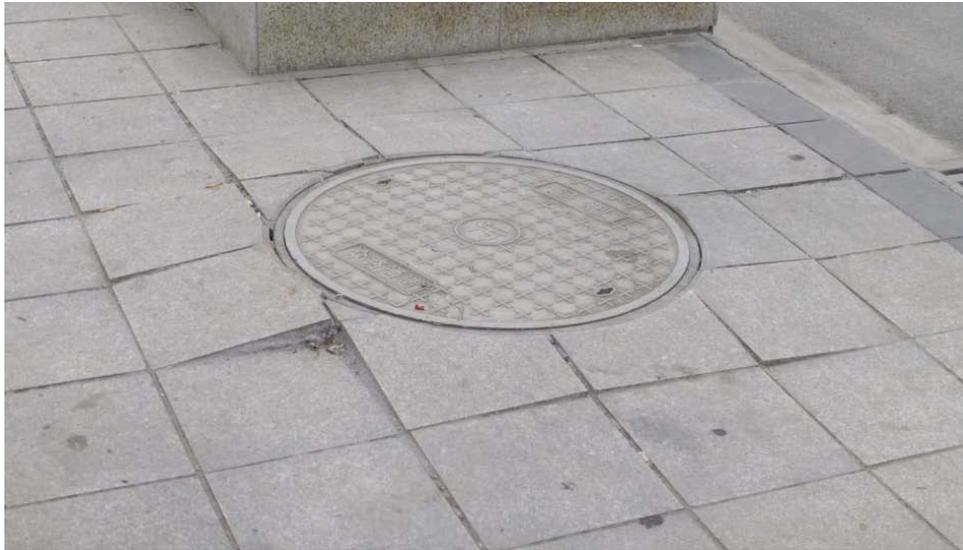
Several manholes that were raised ("floated") up to a few cm above the sidewalk level, in the eastern part of the city (so-called "New Town" area), Figure 6-1. At one location, a set of portable pumps and hole was being used to pump sewage between manholes, presumably due to a blockage.

Figure 6-1. Floated Manhole

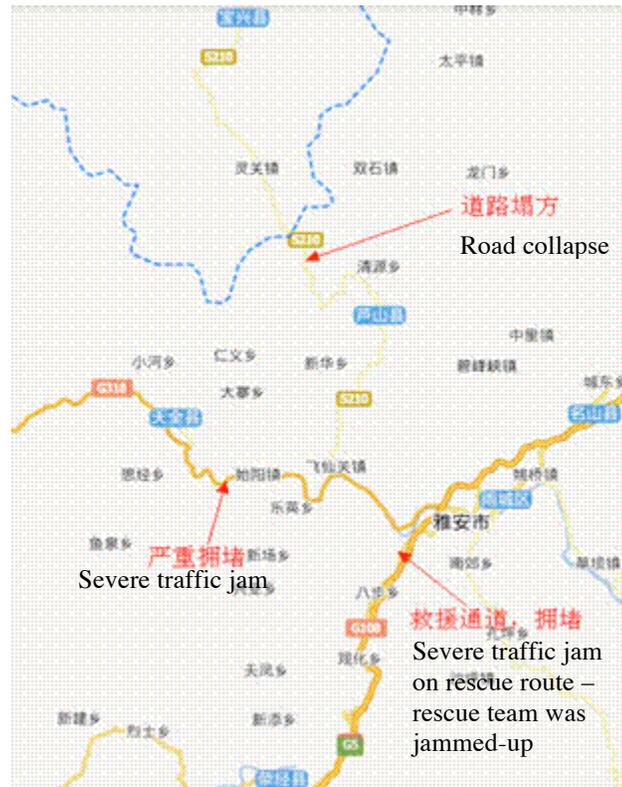
Figure 7-2 shows a map of important transportation routes in the Lushan earthquake affected area. Preliminary reports identified four Highways (G5, S8, S9, and G4201), two National and Provincial main lines (G318, S210) and six County Roads (X073, X074, Z001-Y004, XT26, XT27, XT06) that were damaged by either subgrade collapse, subsidence, landslides, or rock falls.

Figure 7-2. Map of roads and highways in Lushan earthquake damage area, some areas of severe problems noted for G318, G108, and S210

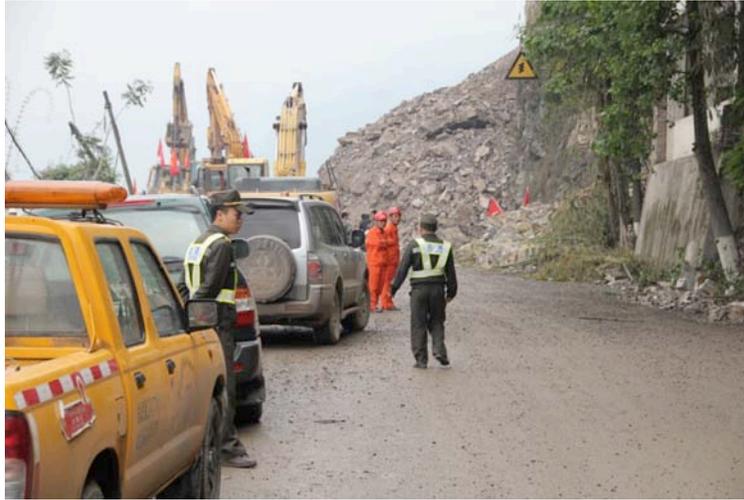
Figure 7-4 shows damage to S210 Ling Guan (灵关) Road from landslide debris sliding onto the roadway.

Figure 7-4. S210 Ling Guan Road damaged and blocked from landslide debris

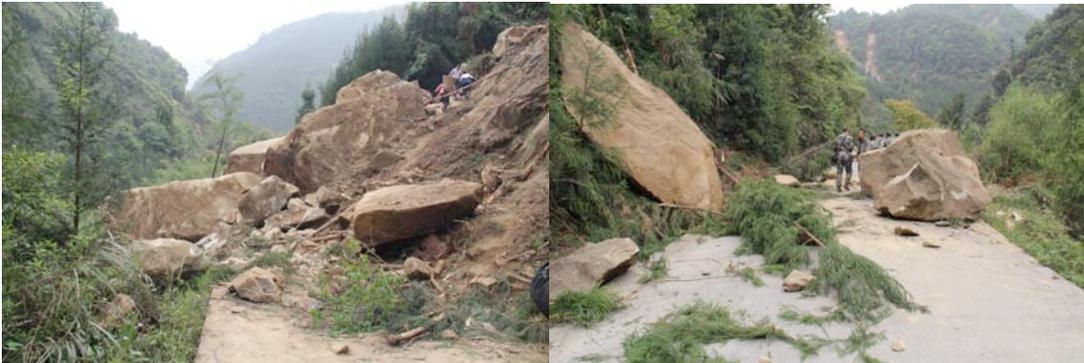
Figure 7-5 shows Lushan County roads blocked by falling rock debris.

Figure 7-5. Lushan County roads damaged and blocked by falling rock debris

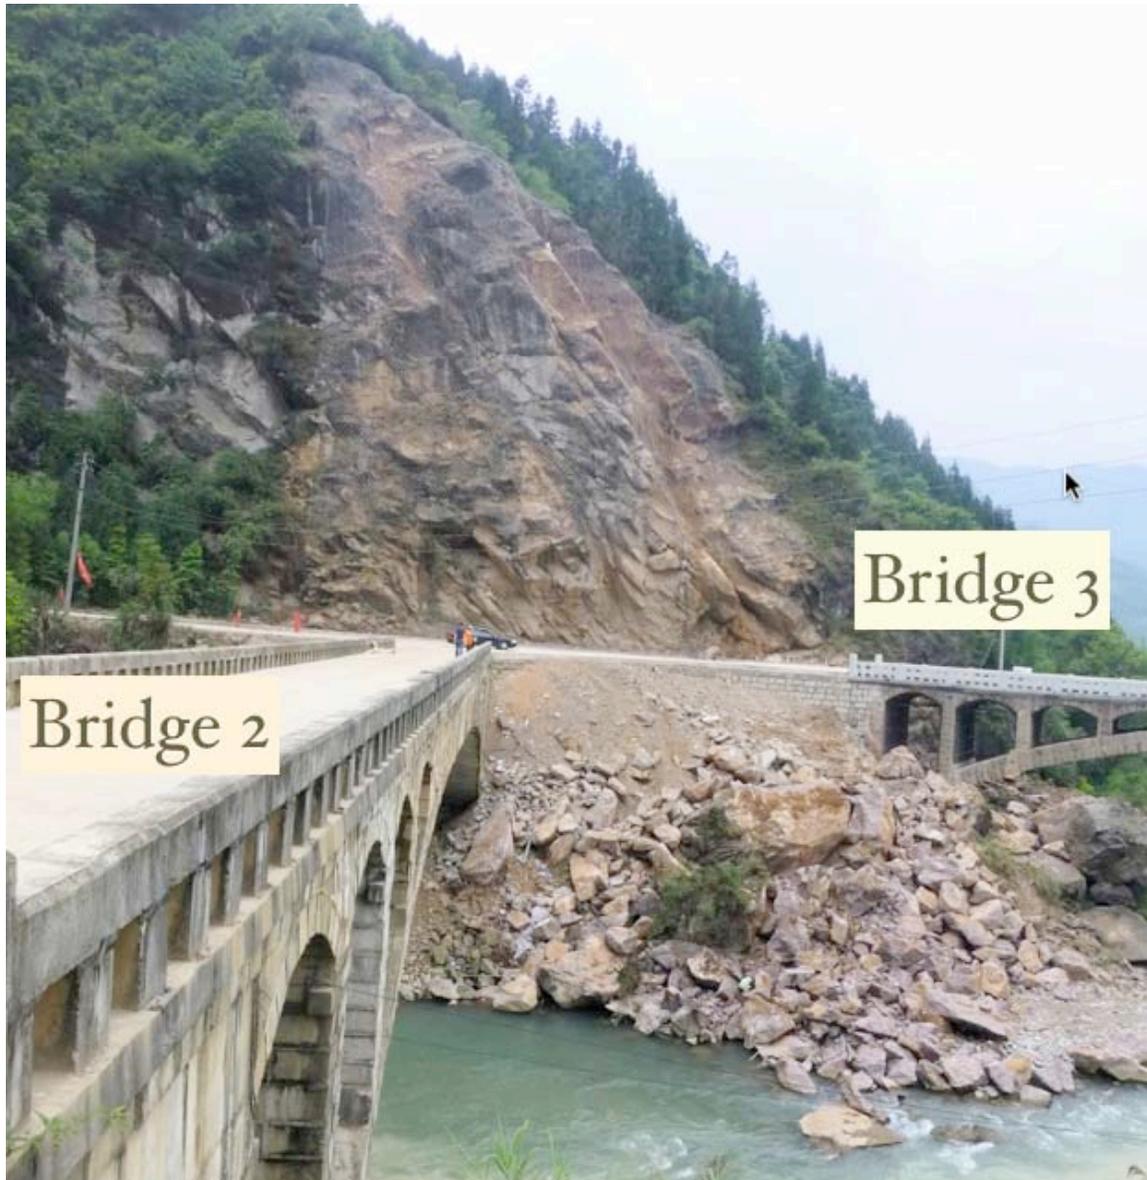
Figure 7-7 shows Bridges 2 and 3, both of essentially identical design as Bridge 1. Bridges 2 and 3 are located a few km northeast of Bridge 1. As with Bridge 1, we observed no damage to Bridges 2 and 3 due to inertial loading. However, the rockfall seen in Figure 7-7 substantially impacted Bridge 3, and struck just a glancing blow to Bridge 2.

Figure 7-7. Source Rockfall zone that Impacted Bridges 2 and 3 (photo date May 31, 2013)

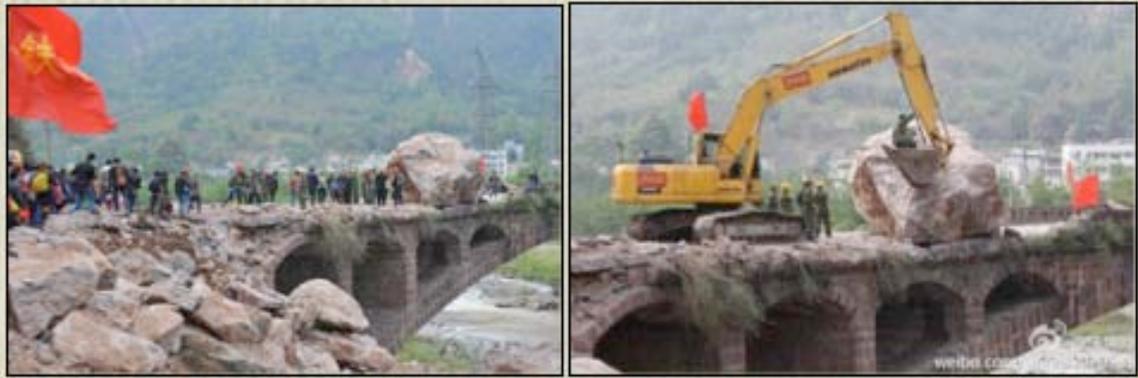
Figure 7-8 shows the status of Bridge 3 within a day after the earthquake. As can be seen, a portion of the URM railing was toppled over the bridge, and a large boulder came to rest on Bridge 3. This boulder was finally removed by blasting it, Figure 7-9.

Figure 7-8. Damage to stone arch Bridge 3 in Lushan County, Blossom Sector Road from large boulders. Left Image: Large boulder rolls onto bridge, destroys masonry rails. Right image: excavator attempts to remove large boulder.

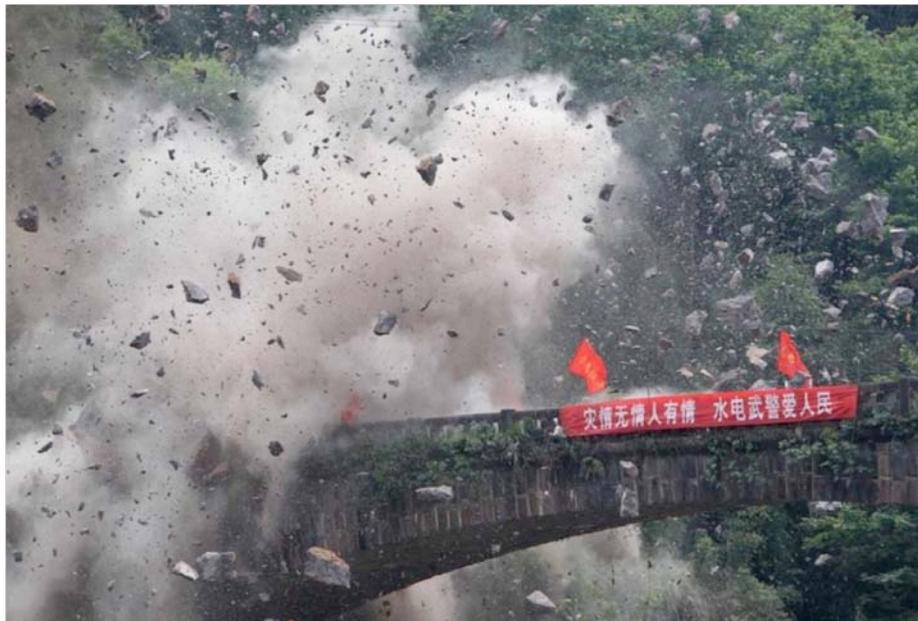
Figure 7-9. Blasting of large boulder to remove it from stone arch bridge

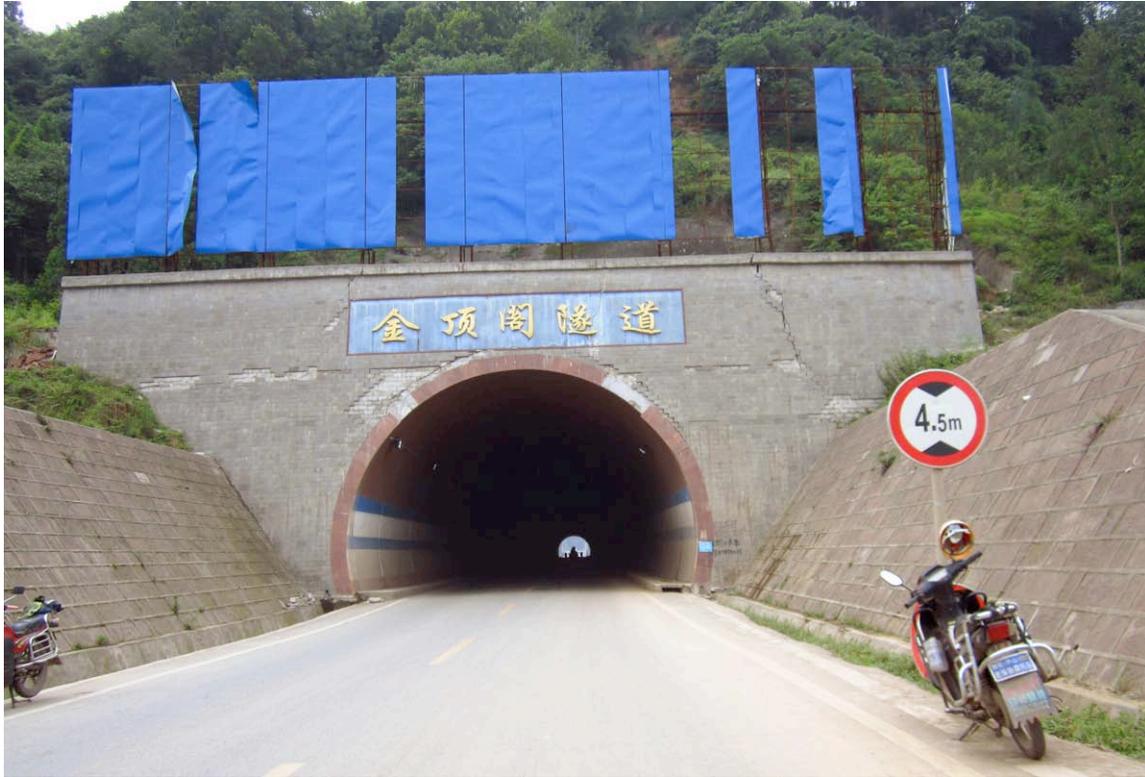
Figure 7-11 shows the headwall for a highway tunnel in Lushan (PGA ~ 0.30g). While the headwall shows damage (inertial loading only, evidence of racking), we observed no significant damage to the liner within the tunnel. This tunnel is the only major road tunnel observed in the epicentral area.

Figure 7-11. Highway Tunnel in Lushan

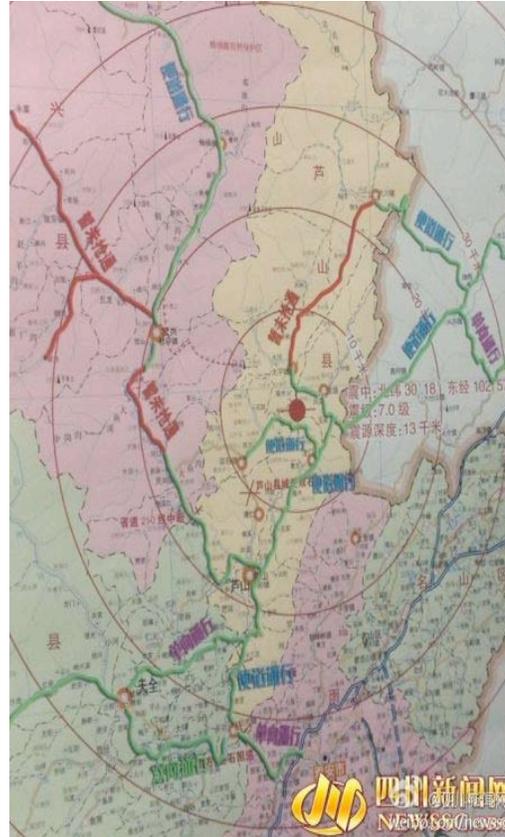
The damaged roads had a severe impact on emergency response and general transportation capabilities. Figure 7-12 shows the road map of Figure 7-2 overlain with preliminary seismic intensity contours and identifies road closures. As indicated in the Figure 7-2 map and photographs in Figures 7-3 to 7-6, critical roads were blocked forcing all in-bound and out-bound traffic onto a few narrow roads, most of which also suffered damages of some kind. The Chinese quickly mobilized a large rescue team, but transportation into the area to perform rescue and recovery activities was inhibited by damages to the transportation network. Figure 7-2 identifies a large traffic jam created by the rescue team during mobilization on Highway G108.

Figure 7-12. Road map overlain with seismic intensity contours, showing road closures

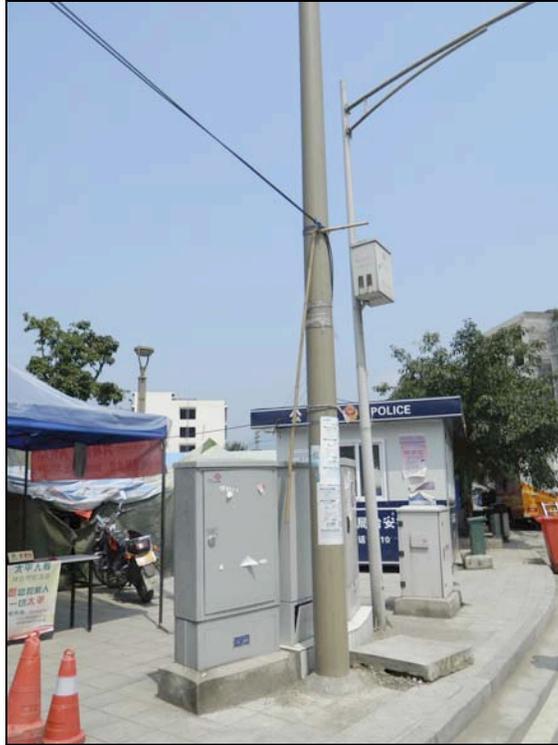
Temporary optical fiber cables were routed along sidewalks, wrapped around poles or trees to provide both landline services and Internet services, Figure 8-3.

Figure 8-3. This fiber optic cable provided temporary connection to the hospital. All three telecommunication service providers placed their cabinets close to the power termination box (the small cabinet to the right).

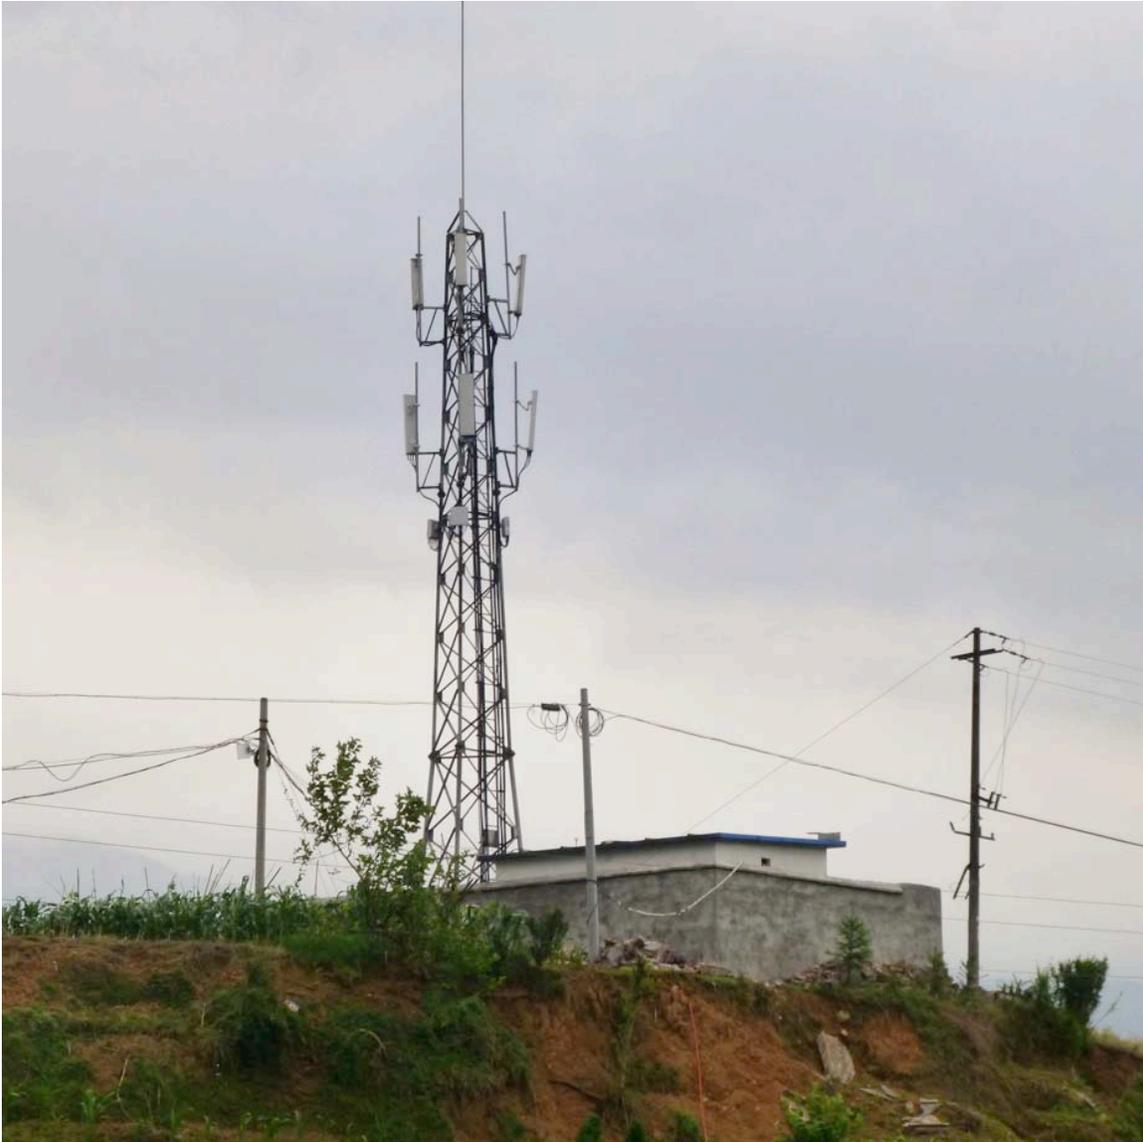
There were many cell sites on hill tops that did not have landslide or rock fall hazards were not damaged. Figure 8-6 shows one of these cell sites (with no damage) that was located on the hill next to the Lushan city water treatment plant. Ground motions at this site were likely around PGA = 0.25g to 0.35g.

Figure 8-6. This cell site did not show any sign of failure to the tower and to the building.

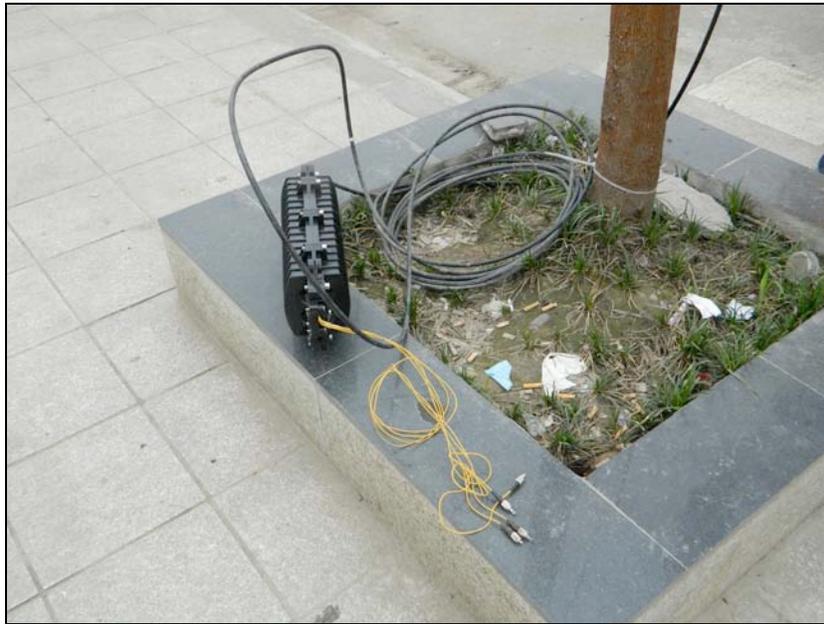
For landlines, China Telecom indicated that many aerial fiber optic cables were damaged due to collapsed poles along the main highway leading to Lushan (庐山) and Baoxing (宝兴). Temporary cables were routed along the same right of way to provide both voice and IT services. In Lushan, the ASCE team observed many fiber optic cables lying on the sidewalk or wrapped around light poles to provide connections to the network, Figure 8-7.

Figure 8-7. This temporary fiber optic cable was left here unattended after the network was restored.

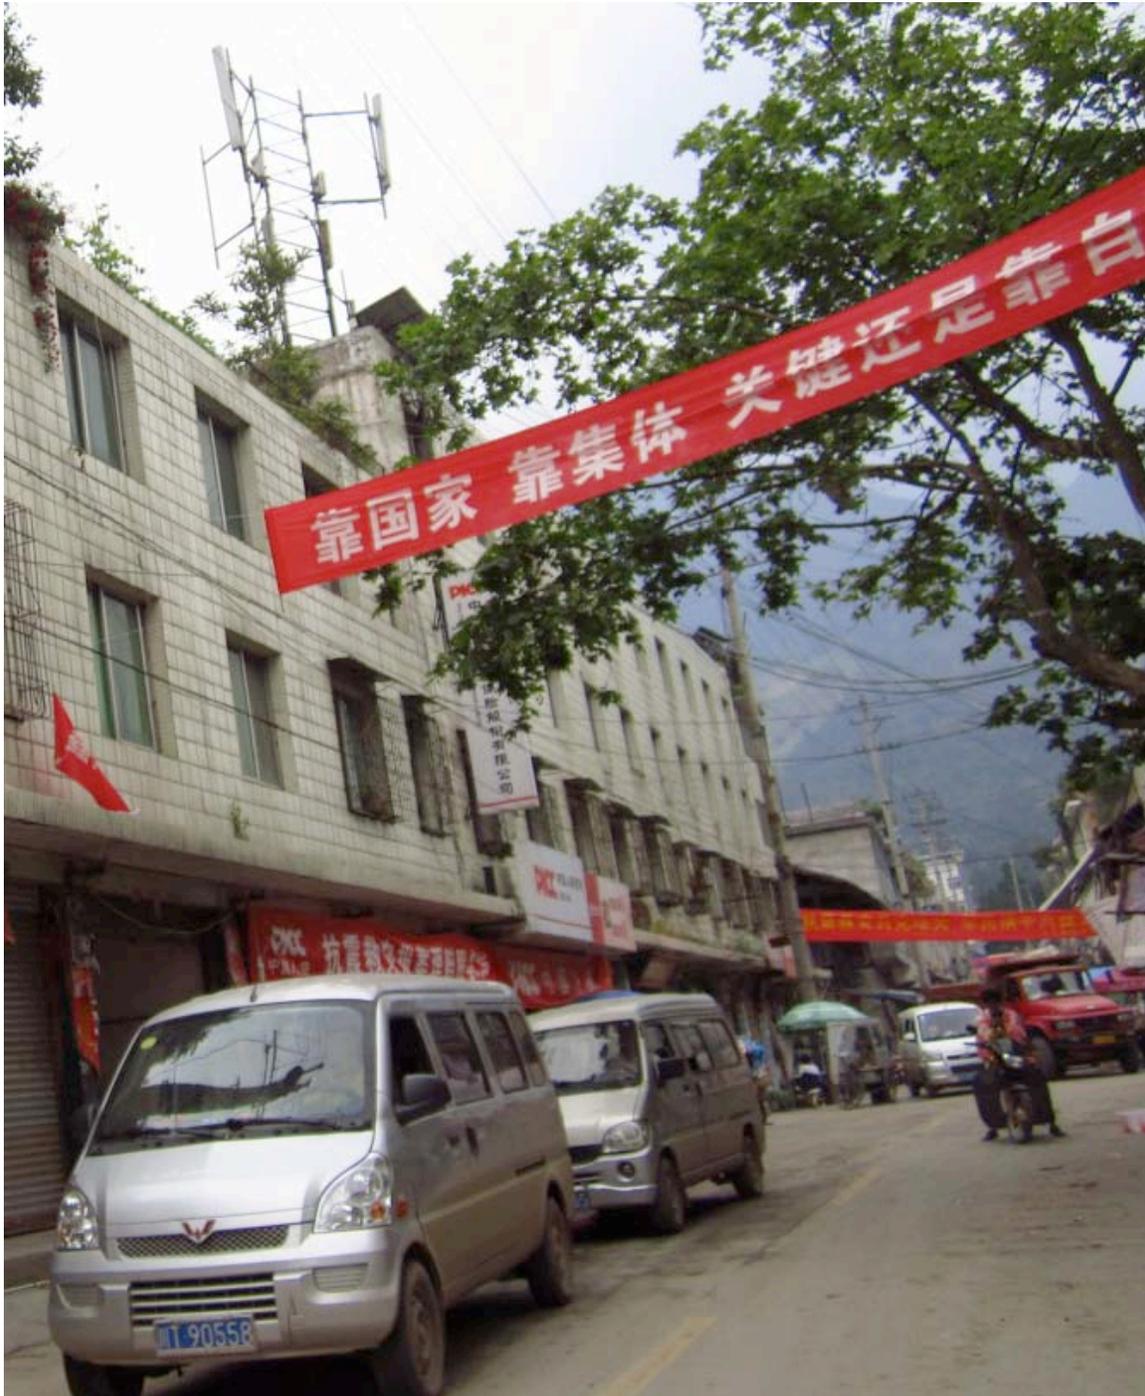
Cell towers in Taipingzhen (太平镇), which is within 10 km east of the epicenter were not damaged, Figure 8-8. The road leading to Shuangshizhen (双石镇), which is a town close (about 5 km south of epicenter) to the epicenter was an area where the wireless signal to be weak and missing, even as of May 26-31, 2013. In this mountainous region, damaged telecommunication cable poles (due to landslide and rock fall) were

Figure 8-8. Cell site in Taipingzhen was not damaged.

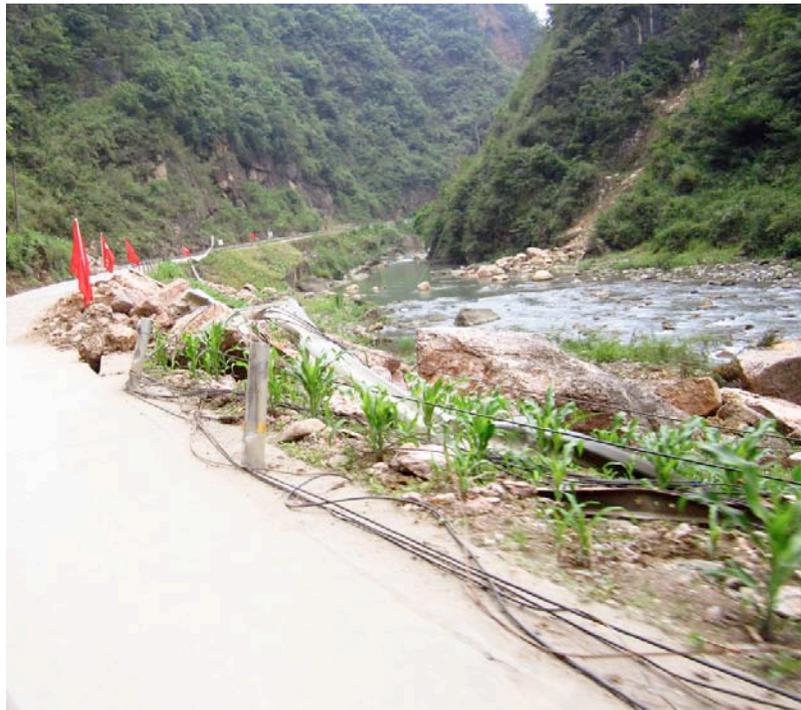
everywhere, as for example Figure 8-9. In these areas, we observed temporary repairs being made by laying new fiber optic directly on the ground (no poles), as for example see in Figure 8-10.

Figure 8-10. On the right side of the road, a bunch of fiber optic cables were placed on the ground without any protection. It is a temporary fix to provide connection to the network.

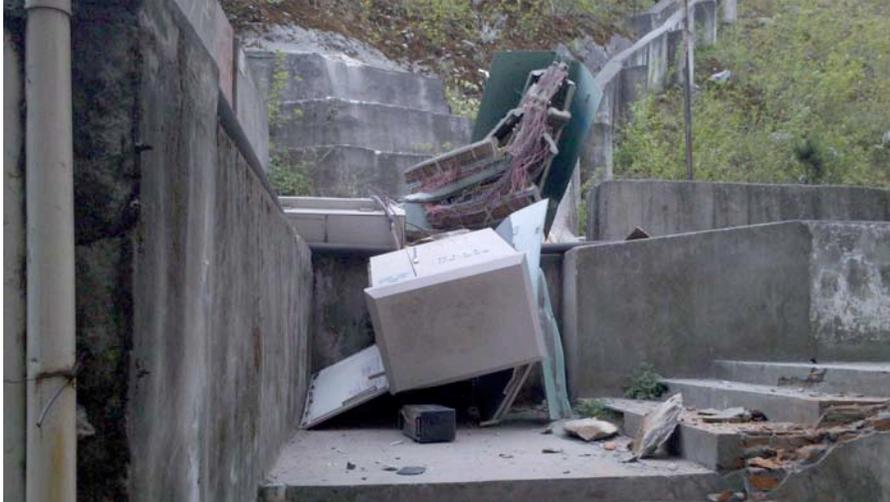
In Tianquan (天全) town, which is southwest of Lushan (庐山) one landline cross connect cabinet was destroyed by rock fall, Figure 8-11.

Figure 8-11. This cross connect cabinet in Tianquan (天全) town was destroyed by the rocks from above.

Cell sites that are deployed or to be deployed in the mountainous regions shall be protected again both landslide and rock fall. This means that more geologic and geotechnical support is needed in the initial cell site selection process, so that suitable advice and mitigation is taken initially to reduce these hazards. For existing cell phone sites in such areas, suitable geologic hazard investigations should be done to identify the vulnerabilities, and then suitable steps taken to mitigate them.

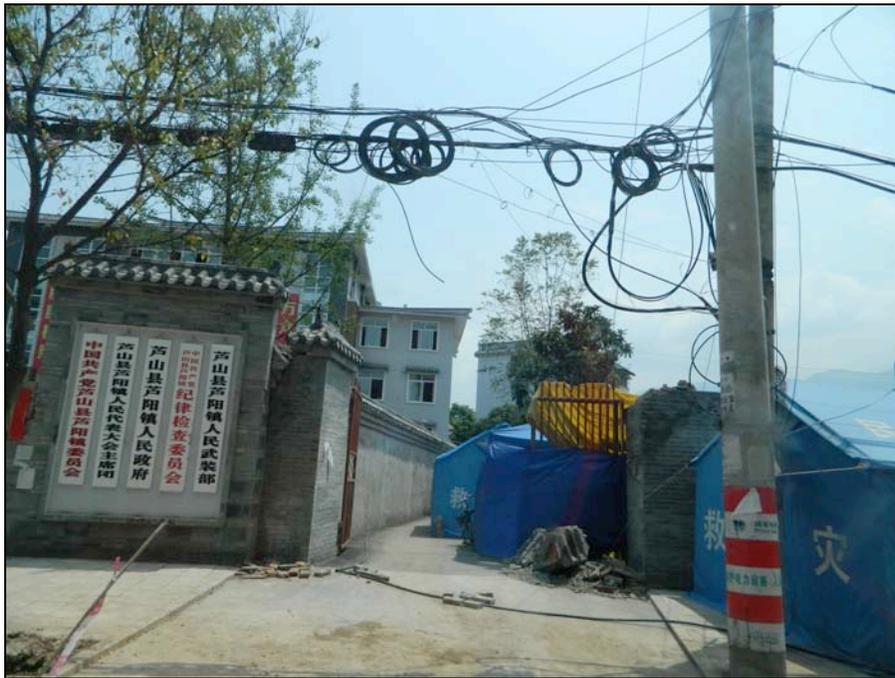
Poor cable management in routing aerial landlines is evident everywhere, Figure 8-12. Loops of excess cable length were hung on the poles, most of the time next to the splice case. It is a good practice to mine (remove) cables that are no longer used in order to reduce weight and that will help reduce time in restoration process.

Figure 8-12. Example of poor cable management in Lushan

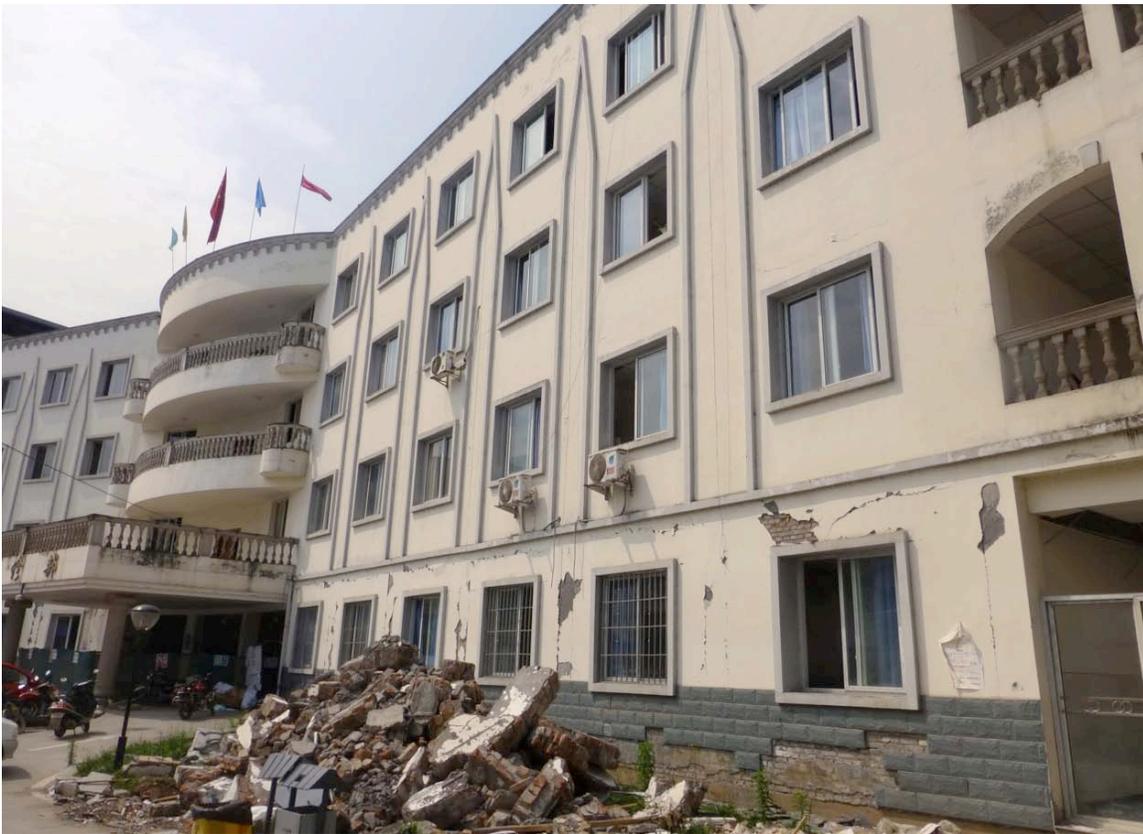
Two older (pre-2008) hospital buildings in Lushan were heavily damaged and "red-tagged", having sustained major structural (Figures 10-1, 10-2) and non-structural damage (see Chapter 12). All patients were evacuated from these conventional-designed buildings. These two damaged hospital buildings provided more than half the emergency care facilities for the region. While these buildings did not collapse out-right, they might have collapsed had the earthquake been higher magnitude or the hospital located a little closer to the epicenter. The style of construction was reinforced concrete frame with infill unreinforced masonry tiles. Close-up inspection of these buildings show major yielding in columns where they are connected to heavy horizontal reinforced concrete spandrel beams, and localized failure of infill walls.

Figure 10-1. Conventional Hospital in Lushan (PGA ~ 0.30g to 0.40g)

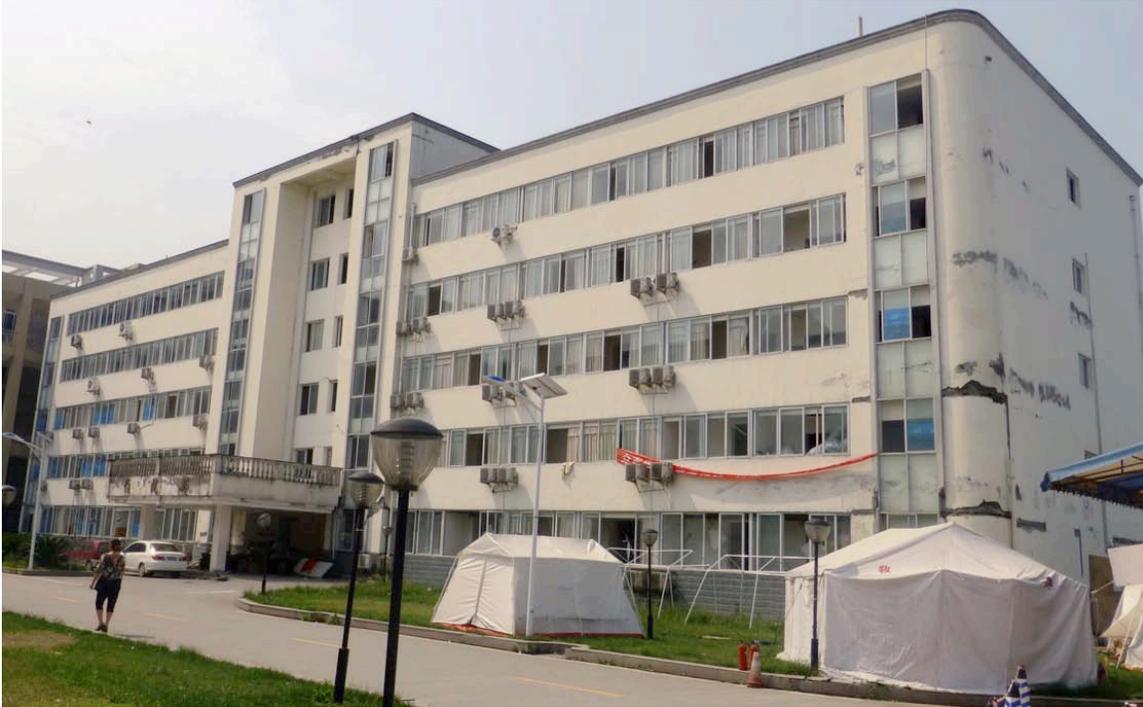
Figure 10-2. Conventional Hospital in Lushan (PGA ~ 0.30g to 0.40g)

Six weeks post-earthquake, these two conventional-designed hospital buildings remained red-tagged (no entrance). Unlike the practice adopted in Christchurch, New Zealand, local officials did not "red-tag" out the potential adjacent "drop zones" from these two damaged buildings.

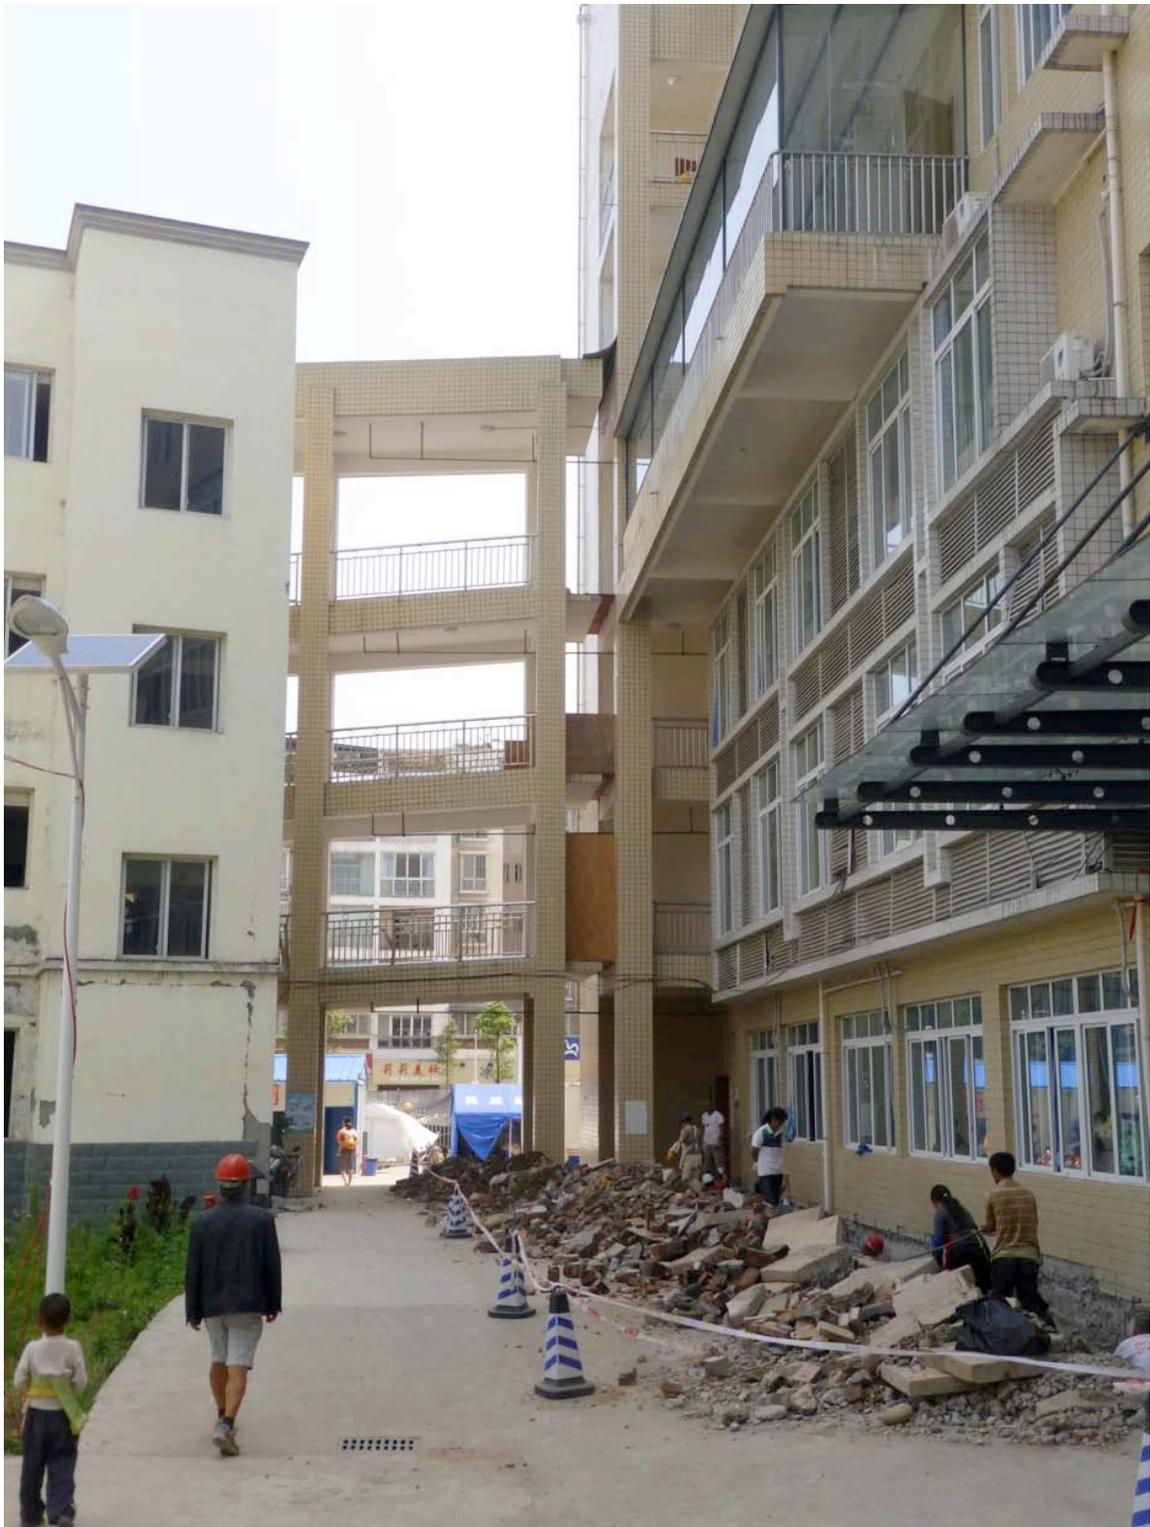
Immediately adjacent to the two older hospital buildings was a third new (post-2008) hospital building, Figure 10-3. This newer building was base-isolated using high-friction rubber bearings. The building was designed (and paid for?) by the generosity of the people of Macau, partially as an outcome of the 2008 earthquake. As seen in Figure 10-3, repairs are being made all around the base isolated building, as nearly all water / sewer / storm drain pipes broke at the interface from the isolated building to the non-isolated surrounding area.

Figure 10-3. Base Isolated Hospital Building (on Right) with Walkway to Conventional Building (on Left)

This building performed well, with the isolators displacing sideways about 10 inches or so. As the isolators moved sideways, the concrete floor slab of the isolated building bumped into the adjacent storm drains at many locations.
