1.0 Introduction

The Lushan earthquake occurred at 8:02 am local time, April 20, 2013. This earthquake is the result rupture on a nearby / adjacent fault segment from the great M 8.0 Wenchuan earthquake of May 12, 2008. The ruptured fault segment in 2013 was located south of the southern end of the rupture in the 2008 event. The distance between the Lushan EQ epicenter is about 83 km SSW of the Wenchuan EQ epicenter.

1.1 Key Findings

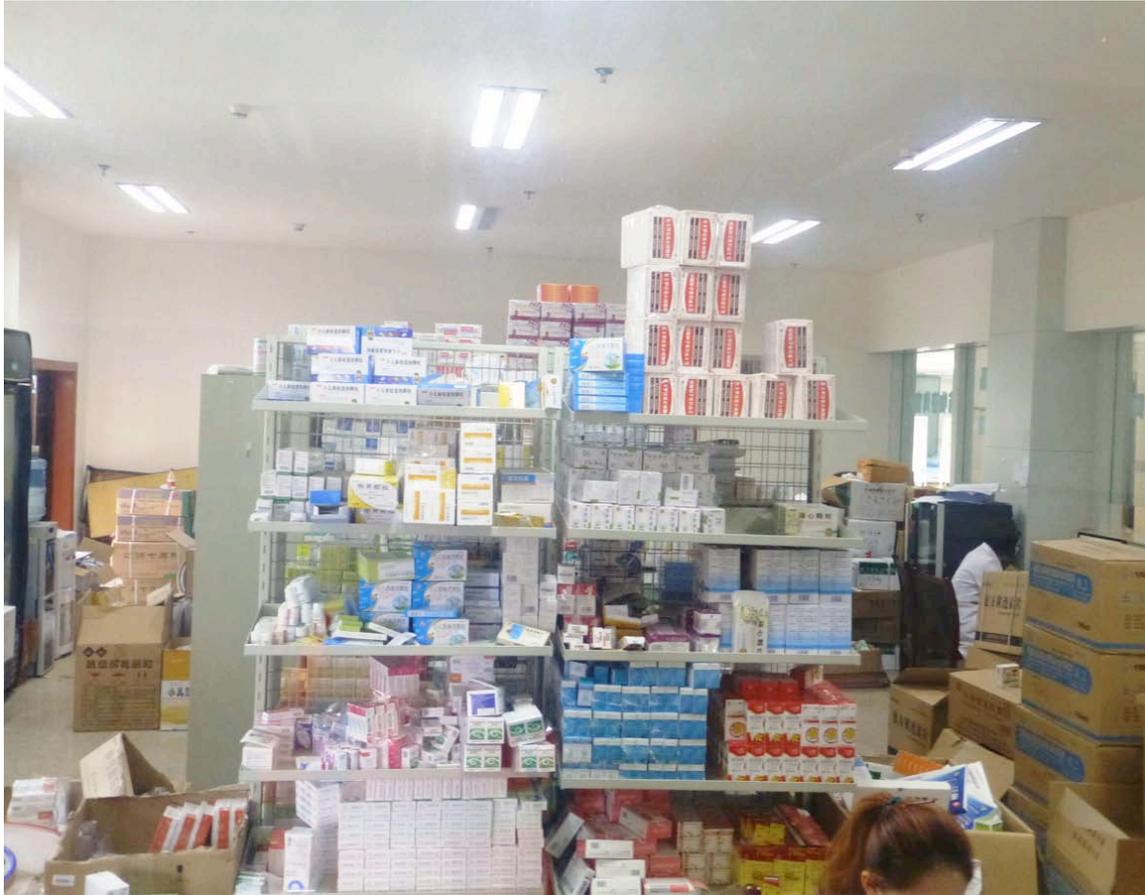
Figure 10-4 shows the dispensary within the base isolated building. We asked the nurses at the hospital whether any of the items in the shelves fell over in the earthquake: they replied "no". Note the fire sprinkler pipes in the suspended ceiling: they did not break.

Figure 10-4. Dispensary in the Base Isolated Hospital Building

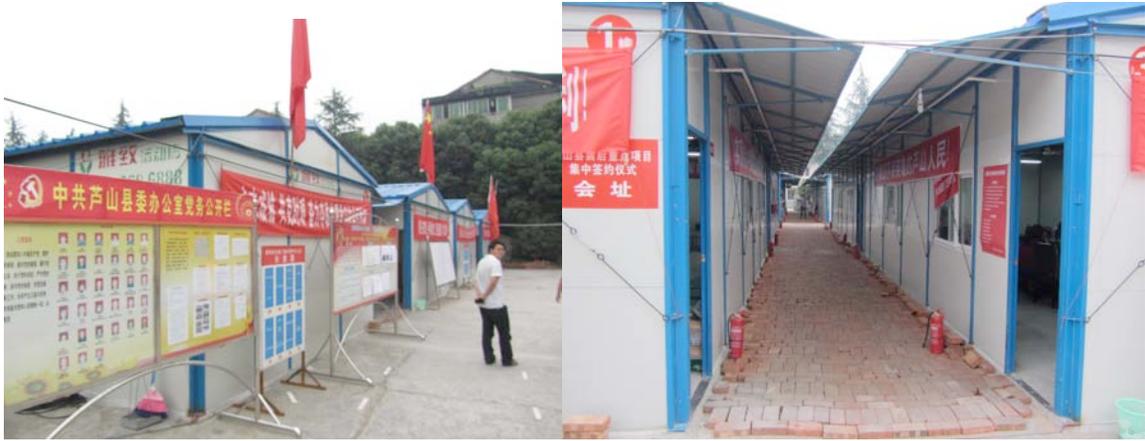
The city government offices were severely damaged and had to be essentially abandoned and relocated into temporary buildings. Figure 10-9 shows damage to city government offices. Figure 10-10 shows the temporary city buildings used to help provide services to city residents.

Figure 10-10. Temporary Lushan City Government Buildings

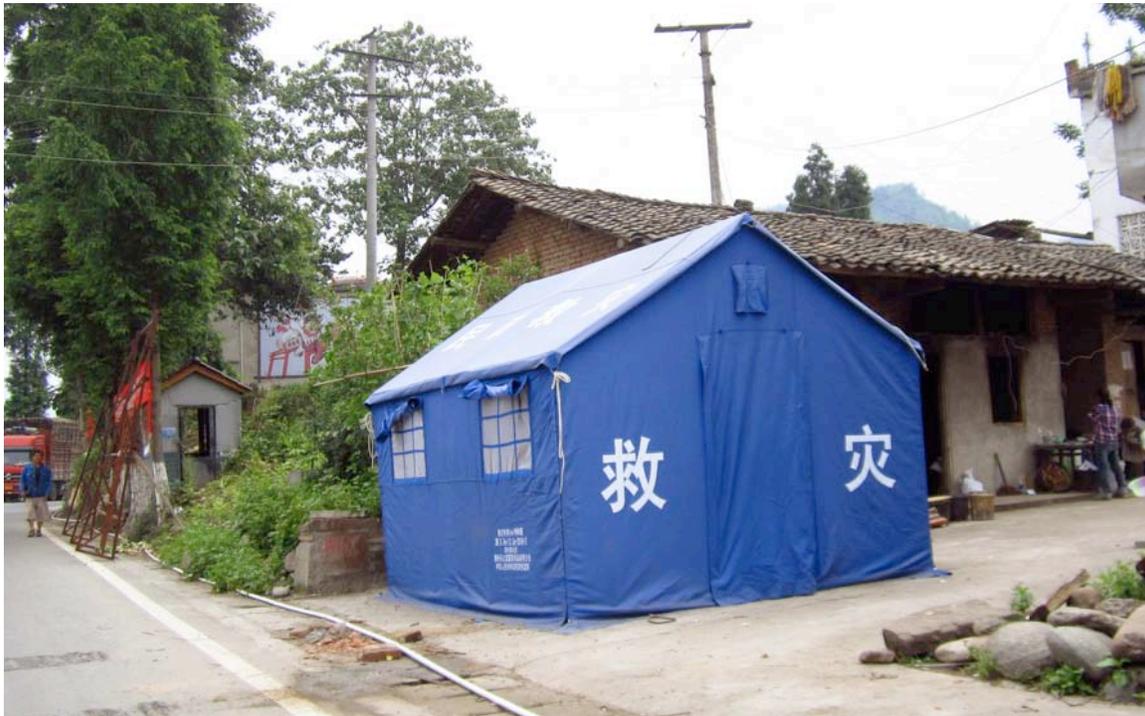
For many still standing buildings, a tent was set up, as many occupants no longer wanted to stay within their URM buildings, even if there was only slight damage, as for example, Figures 11-1 and 11-2. We observed hundreds of similar tent installations.

Figure 11-1. Example of Tent in front of Slightly Damaged Building (PGA ~ 0.35g)

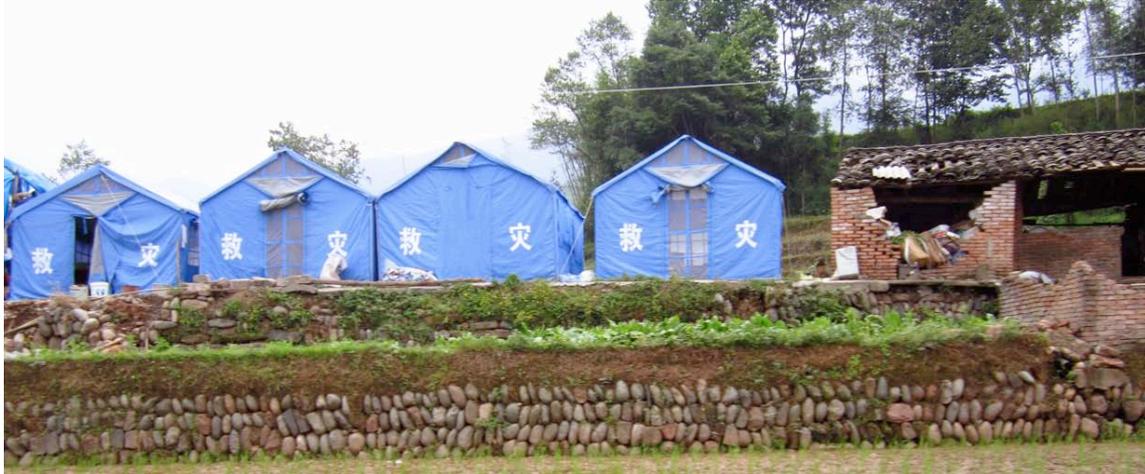
Figure 11-2. Example of Tents Adjacent to Damaged Building (PGA ~ 0.35g)

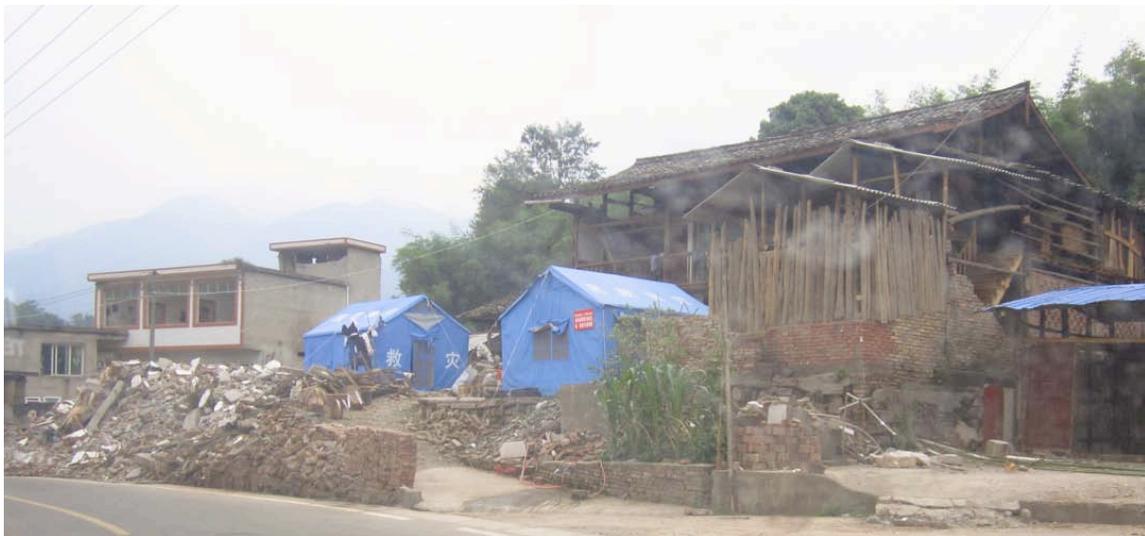
Figure 11-3 shows a typical situation in a small village north of Lushan: a few collapsed (or pulled down) structures with debris accumulation; tents in front of remaining slightly-to-moderately damaged buildings. The style of construction observed in this figure is common throughout Lushan and surrounding small farming communities.

Figure 11-3. Debris, Tents and Remaining Damaged Buildings (PGA ~ 0.35g)

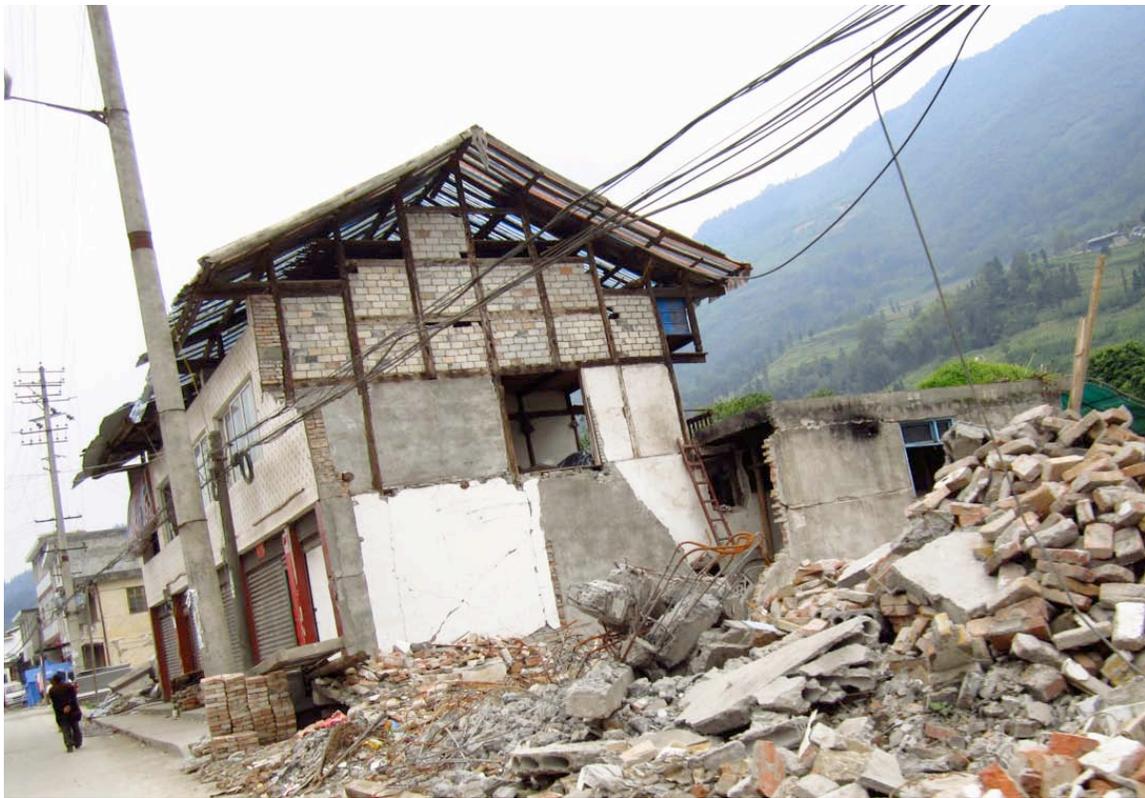
Figure 11-4 shows a common style of construction, using a combination of masonry (brick) load bearing walls, reinforced concrete columns and beams (with poor stirrup placement), lumber post and beams, infill clay tile bricks, roof using wood lathes with clay tiles (tiles having been removed in this photo), and soft story (store fronts). The structure in the foreground was seriously damaged and subsequently pulled down for debris removal; the structure in the background was considered good enough to remain in service.

Figure 11-4. Construction Style of Common Buildings (PGA ~ 0.35g)

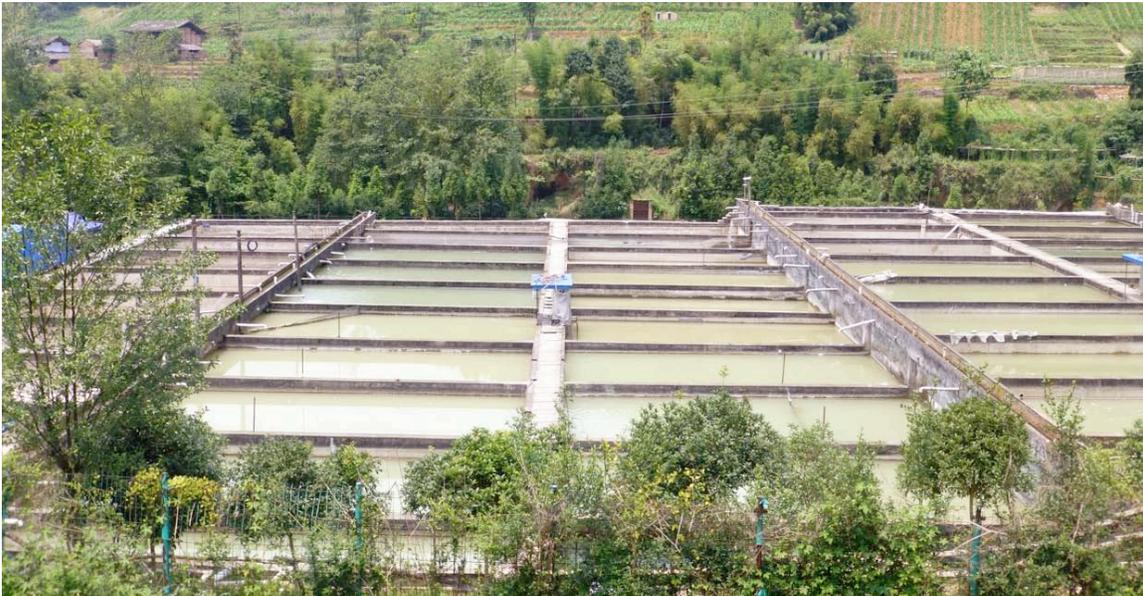
Water slosh heights at a fish-pond-farm (Figure 12-5, with more than 20 basins) were reportedly "under 30 cm high, and did not overtop the basin walls" per the local official who observed the sloshing (basin sizes typically 20 to 50 feet in plan dimension). It is hard to say if this observation was correct (the official might not have observed higher waves in the first few minutes post-earthquake), or if this indicates a lack of energy in the long-period portion of the spectral content of the ground motions.

Figure 12-5. Water Basins at Fish Farm (PGA = 0.25g to 0.35g)

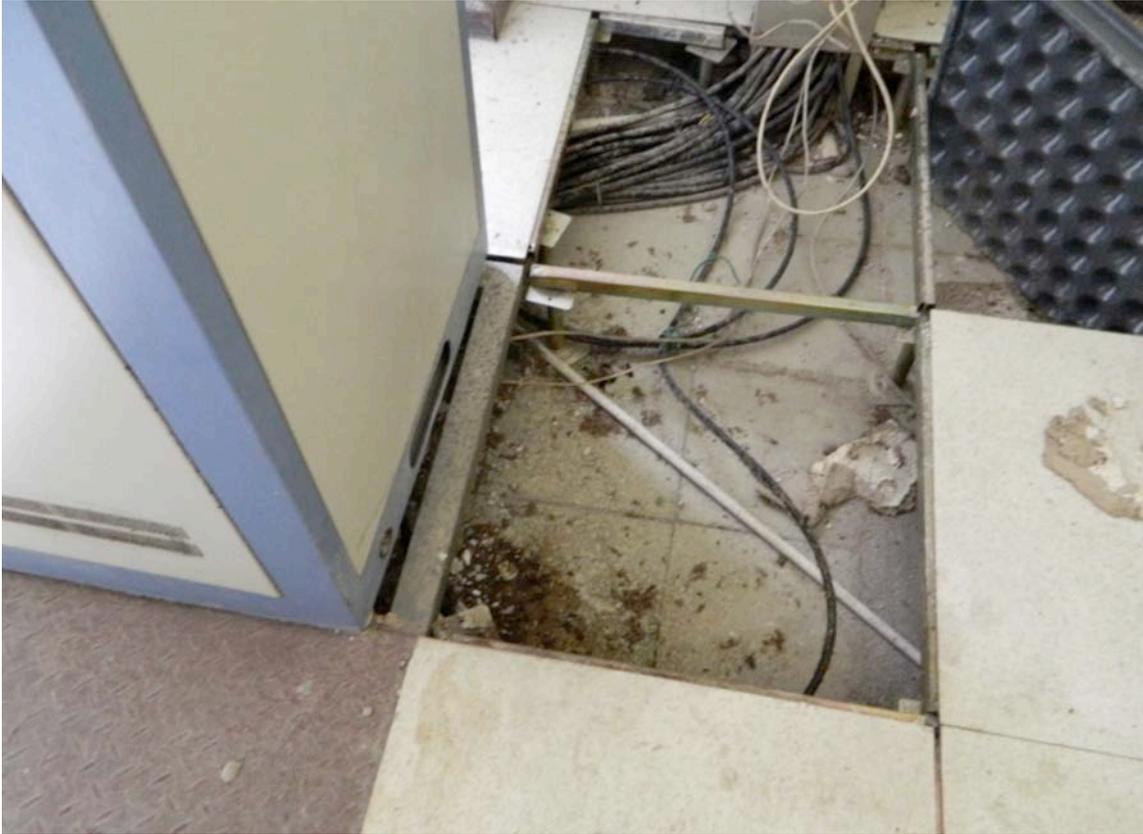
A raised computer floor at a power house (Figure 12-6) suffered some damage (panels popped off), and adjacent floor-supported (non-anchored) control cabinets "walked" towards the "holes" in the floor, but did not topple in.

Figure 12-6. Raised Floor at Power Plant
