The Performance of the Natural Gas System - Magna M 5.7 2020 Earthquake

The Council of Lifeline Earthquake Engineering
TCLÉE No. 6

April 7, 2021
Revision 0

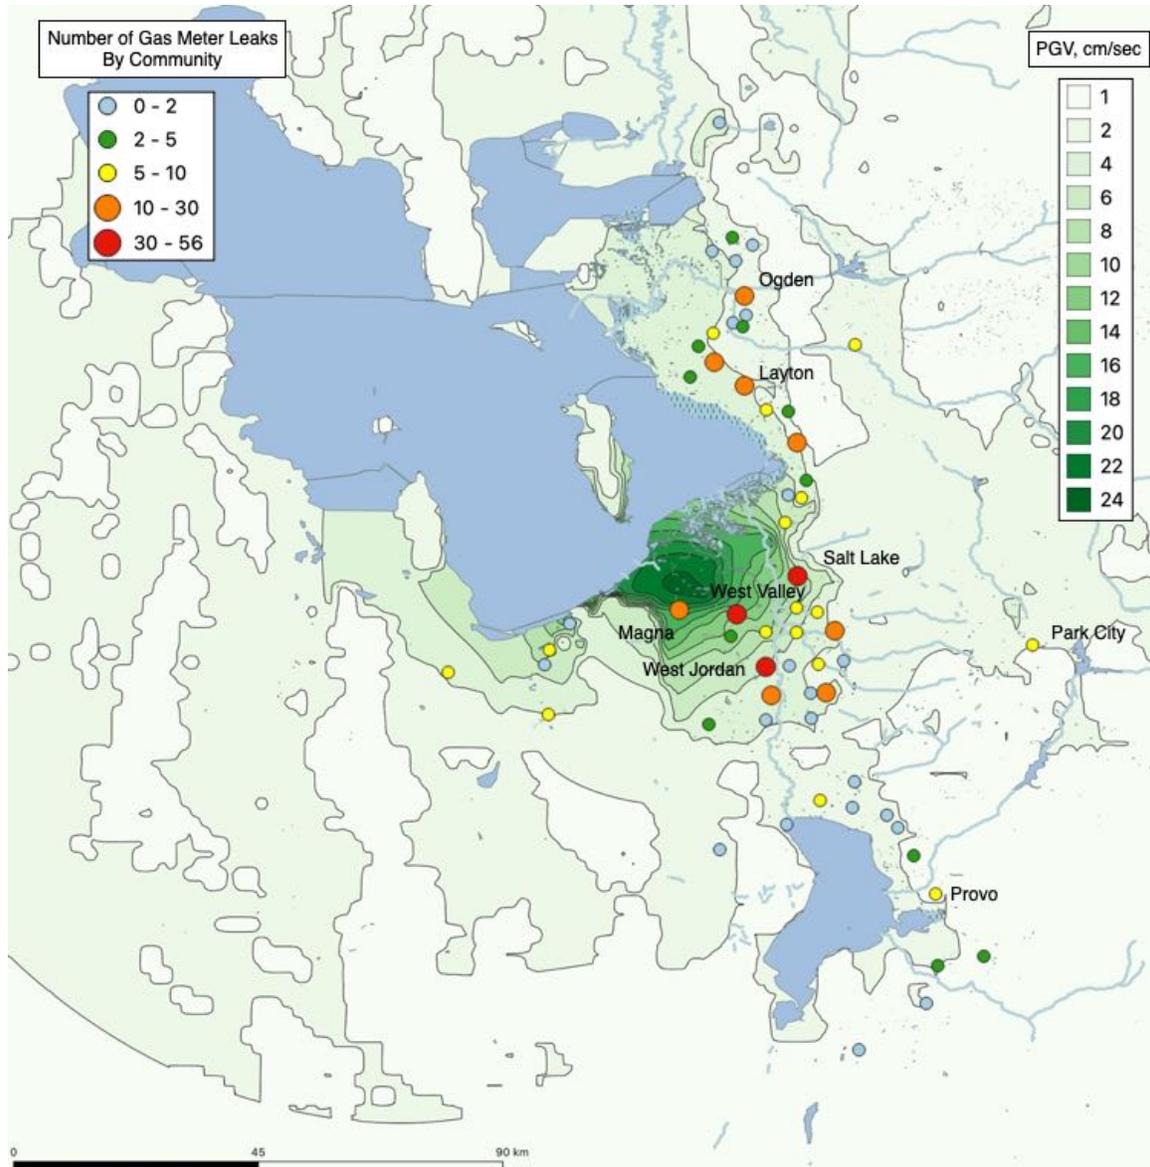
Figure 14. Number of Gas Meter Leaks, by Community

Figure 15 shows a plot of the number of meter leaks (468 total) versus the number of gas meters in each community. Figure 15 shows a generally increasing number of leaks in communities with a greater number of meters. Over the Greater Salt Lake City area, there was an average of one meter leak for every 1,730 meters.

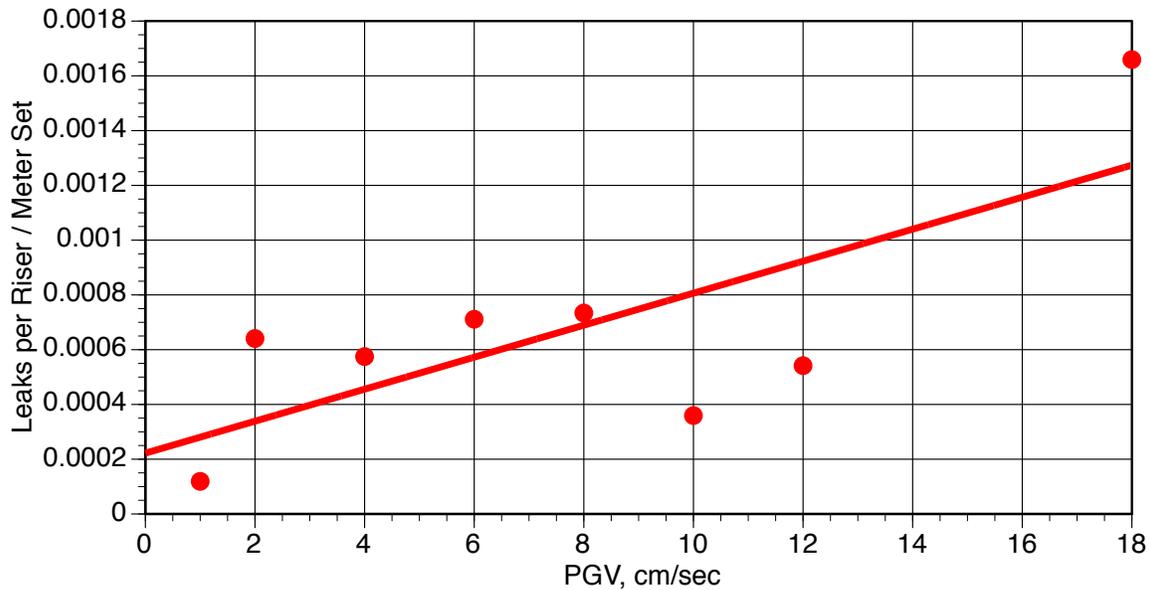
Figure 16. Leaks per Riser / Meter as a function of PGV

Figure 16, Risers and Meters. There were 468 leaks at gas meters. Figure 16 shows the correlation of gas meter leaks with PGV; the dots are the data and the plotted line is a linear best fit regression through the data. There is an increasing trend in the rate of leaks as PGV increases from 1 to 18 cm/sec. The data for the dots was computed by binning all the leaks by community (Figure 14), then assign the average PGV for that community, then assigning the number of gas meters in that community. Consistent with the findings in Maison and Eidinger (2021), we use PGV rather than PGA as the independent hazard variable. When using the data in Figure 16, it should only be used in a macro sense, meaning that it is an average leak rate for risers / meter sets, independent of the style of construction of the riser / meter set and the adjacent structure. Overall, at the highest PGV levels (18 cm/sec), about 1 in 600 risers / meters had a leak.

Figure 16 shows a trend in rising leak rate with rising PGV. In post-earthquake surveys of gas leaks, there is a question as to whether the recorded gas leak was pre-existing before the earthquake. For example, consider the gas leaks in the 2019 Ridgecrest earthquake; in that event, the field crews reported as to the proximate cause of the leak, and for about a tenth of all leaks, the reported cause with "earthquake / ground movement" or similar. This leads some to believe that the bulk of all reported leaks were pre-existing. However, when the leak data is plotted as a function of PGV (or PGA, etc.), there is an increasing leak rate as the level of hazard goes up, for both the Ridgecrest 2019 and Magna 2020 earthquakes. The engineering-based conclusion is that the extra forces (stresses) in the riser / meter sets caused by the earthquake do lead to increased rates of gas leak; quite possibly, had there been no earthquake, a smaller rate of gas leak might pre-exist the earthquake. The tentative conclusion is that the additional stresses imposed on the gas pipe riser / meter set does tend to open up more gas leaks at screwed joints, suggesting that if the riser / meter set was not leaking pre-earthquake, it might not leak; but if the riser / meter set was leaking pre-earthquake, the earthquake will tend to exacerbate the leak rate as the level of shaking increases.

Another interpretation of Figure 16 is that for PGVs between 1 and 12 cm/sec, there is possibly no (or little) increase in the rate of leaks per meter, averaging about 1 for every 1850 meters. It is only at the higher PGV levels (18 cm/sec) that there is a distinct increase in the rate of meter leaks (1 for every 600). But, the reader is cautioned that Figure 16 *does not differentiate* between meters that serve Mobile Homes versus meters that serve other types of structures. In Section 5, we examine the meters at one mobile home park (MHP). Statistically, the rate of riser / meter leaks was much higher at this MHP: on the order of 1 on 20 risers / meters at PGA = 22 cm/sec. This reflects that in the MHP, the sliding of structures impacted some meters; and the use of flex hose from the meter to the structure for all mobile homes, leads to a lower frequency of the riser / meter set (commonly around 1 Hz), leading to increased displacements, increased stresses in the

riser / screwed joints, leading to increased chance of a gas leak. The much higher rate of leaks at meters in the MHP (see more discussion in Section 5), strongly indicates that the lower frequency of meters in MHP (due to use of flex hose and thus lower fundamental frequency) leaks to increased earthquake-induced stresses, leading to more leaks at threaded fittings, etc.

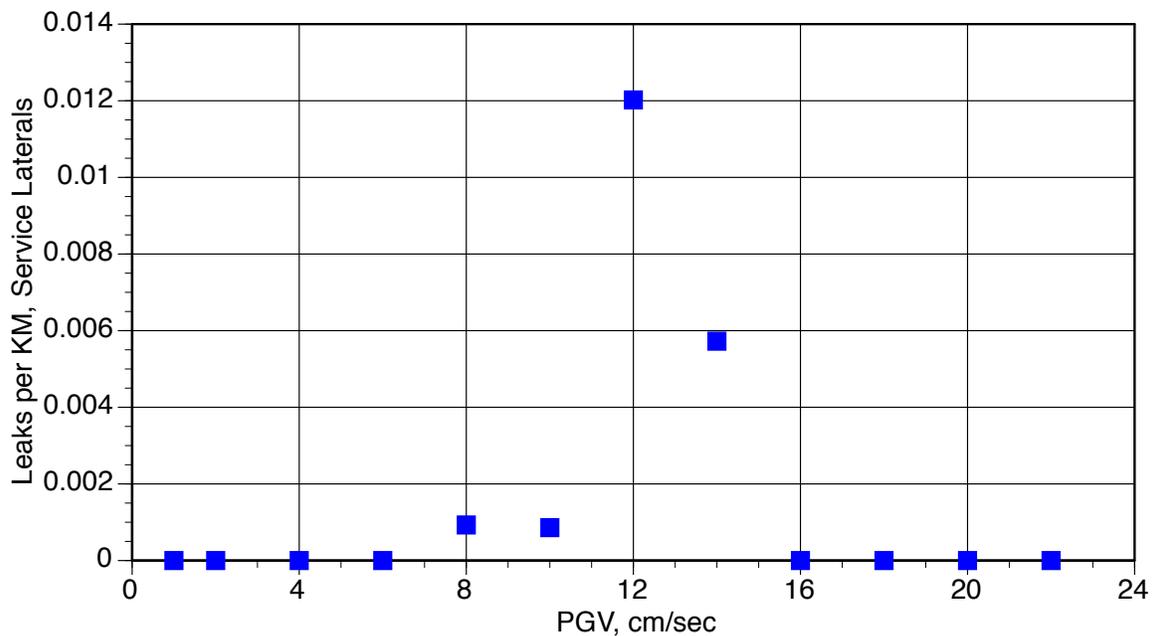
Figure 17. Leak Rate for Service Laterals per KM

Figure 17, Service Laterals. There were 11 leaks. The leak locations were assigned in 12 PGV bins, from 1 to 22 cm/sec. Figure 17 shows a distinct increase in the rate of leaks as PGV increases from 4 to 14 cm/sec. The repair rate for PGV = 16, 18, 20, 22 bins is shown zero; the length of service laterals in these four PGV bins (about 220 km) is cumulatively about 4% of that in the PGV = 4, 6, 8, 10, 12, 14 bins (about 5,500 km). The lack of observed damage in these higher PGV bins (16 to 22) (primarily in Magna and West Valley City) likely reflects the relatively small inventory; and the relatively modern construction in these areas (meaning service laterals are all installed to modern standards, most installed post 1985, and most PE and relatively few steel. Another caveat: the length of service laterals is approximate; and based on an average of about 15 meters per meter (some are shorter, some are longer).

For both Figures 16 and 17, the leaks are due to ground shaking hazard alone (in this case, quantified using PGV). In the Magna earthquake, only a very small length of gas pipe traversed zones with liquefaction-induced PGDs, and nearly no structures were exposed to PGDs. Additional damage would be expected if an earthquake triggers liquefaction, landslide or fault offset and there are gas infrastructure exposed to PGDs.
