South Napa M 6.0 Earthquake of August 24, 2014

Revision 1

March 17, 2015

This report describes the performance of lifelines systems due to the South Napa, M 6.0 earthquake of August 24, 2014.

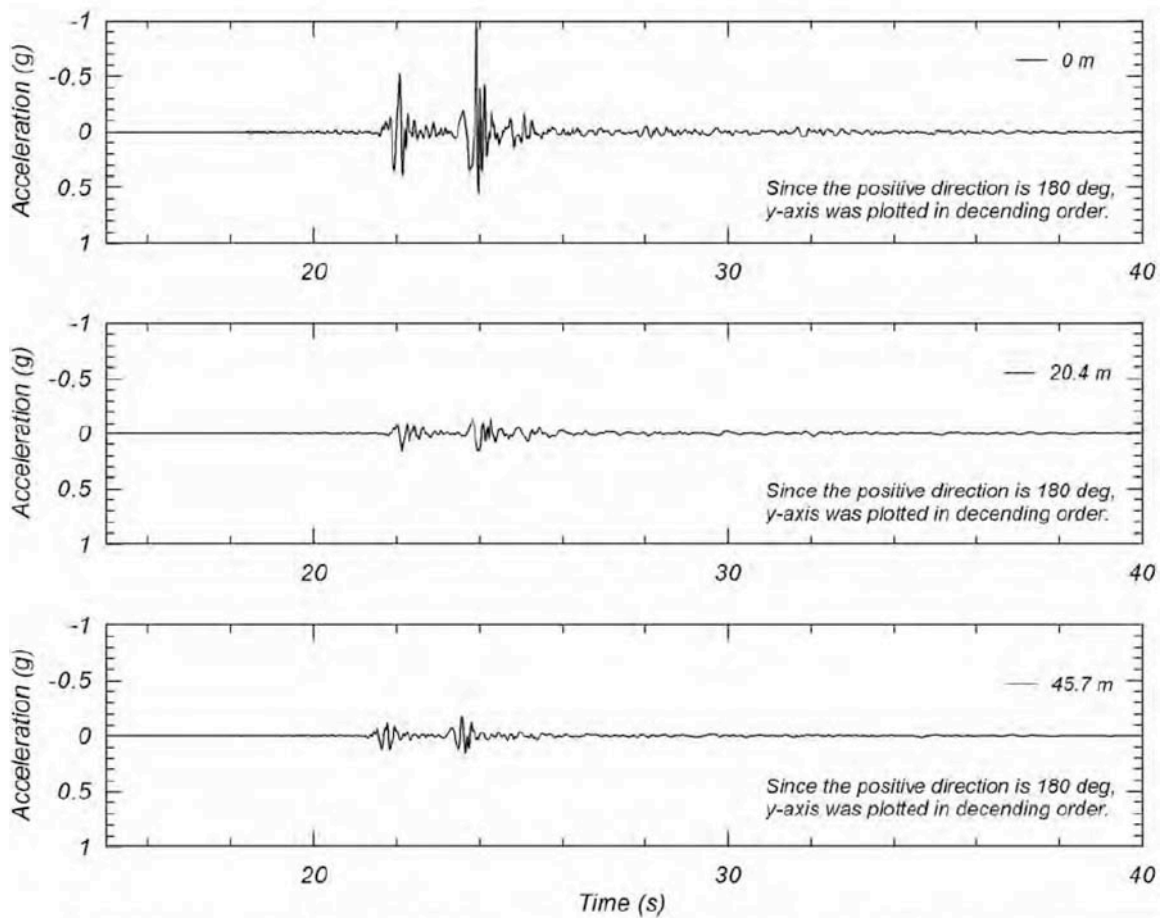
Figure 2-18 shows the time history for the NS-direction motion for instrument CE.68206. See Section 2.6 for further discussion of this instrument.

Figure 2-18. Instrument Time History (North-South Direction) (Carquinez Bridge)

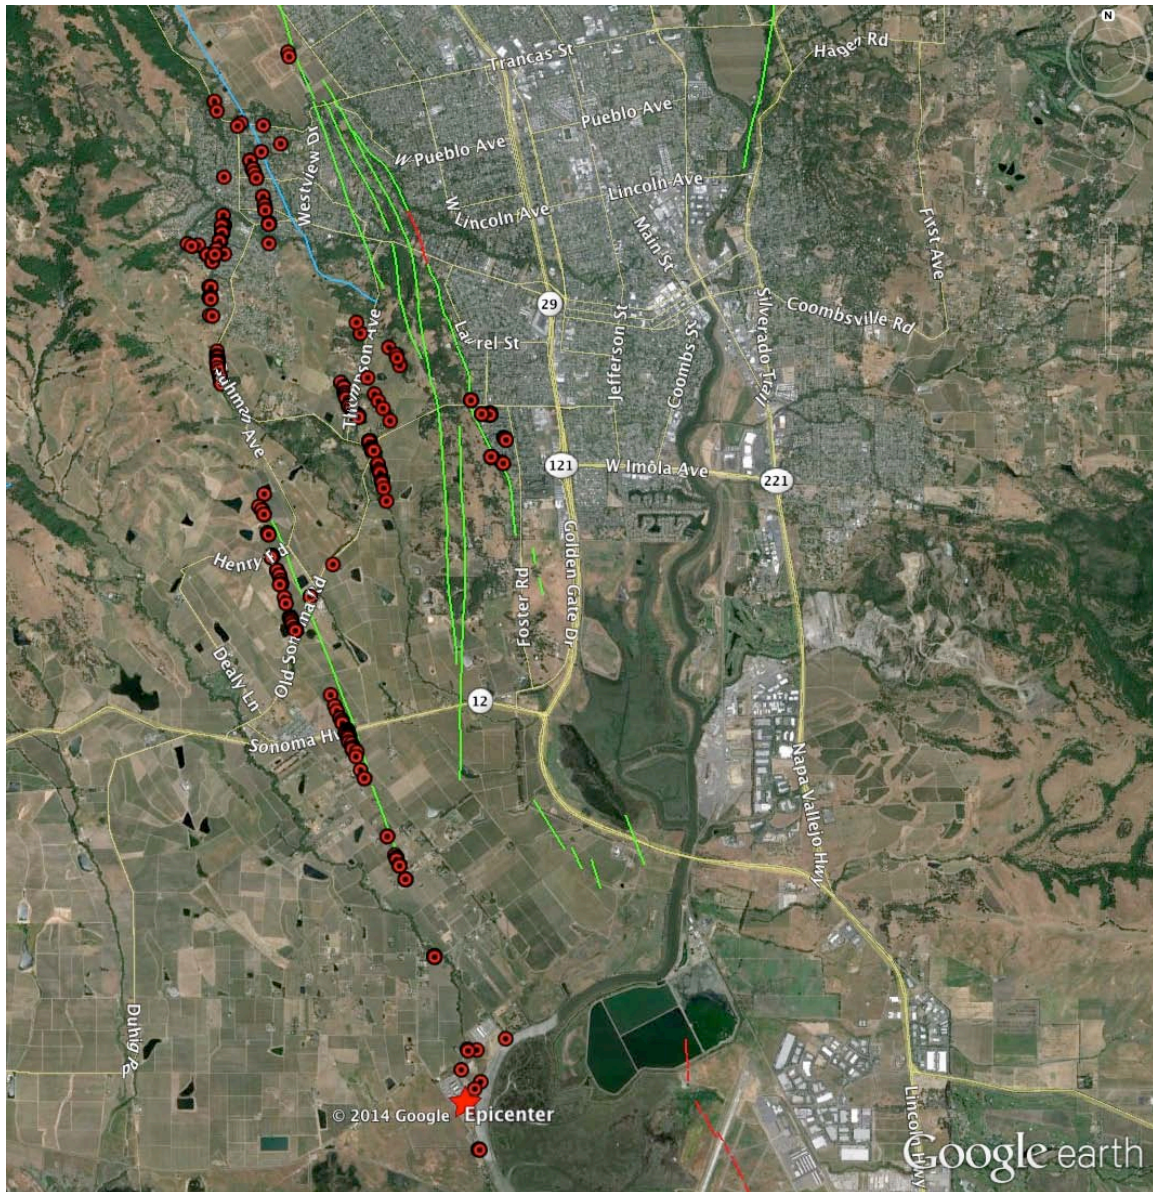
Surface faulting occurred at many locations to the west of downtown Napa. Figure 2-19 shows a map that highlights the prior mapped locations of lineaments in the West Napa fault zone (yellow and blue lines) and field observations of surface faulting (red dots). This map shows information available to the USGS by August 26 2014 (2 days post-earthquake).

David Schwartz of the USGS reports that the locations of surface faulting (red dots in Figure 2-19) do not correspond closely to the prior mapped locations of the West Napa fault (yellow lines in Figure 2-19).

Figure 2-19. Map of Surface Faulting Observations (Red Dots)

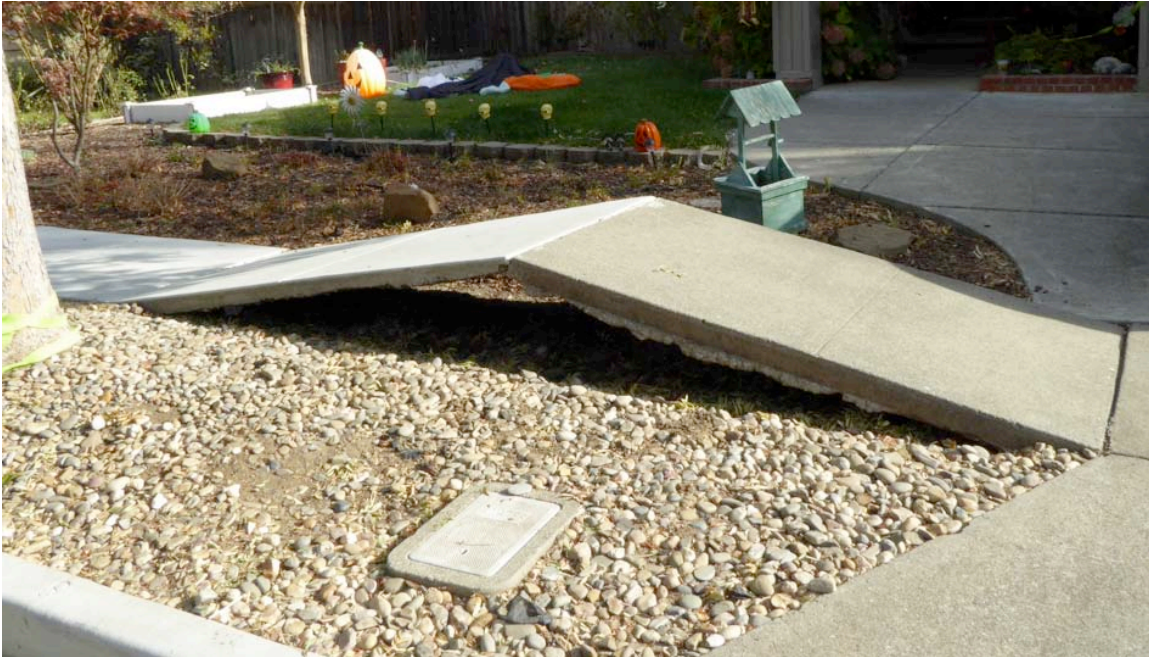
Figures 2-20 and 2-21 show buckled sidewalks at two of the fault crossing locations (red dots in Figure 2-19). These figures show two of many such sidewalk buckles in the west part of Napa near Meadowbrook Drive. In this area, there were about 8 streets, running nearly perpendicular to the strike of the fault. At each street, there was commonly one or two sidewalk buckles (one each side of the street), and if one maps the location of the buckles, one gets a more-or-less straight line of red dots, as shown in the top left part of Figure 2-19. Inspecting these buckles, one observes that there was some right lateral movement, as well as possibly some thrusting movement at the surface, resulting in net compression in the sidewalk slabs. This compression then results in the uplift of two adjacent concrete slabs as seen in Figures 2-20 and 2-21. Underneath the ground, the ground movements are also applied to buried water pipes, wastewater sewers, and natural gas pipes, and the impacts on these buried lifelines will be described later in this report.

Figure 2-20. Buckled Sidewalk at Fault Offset Location

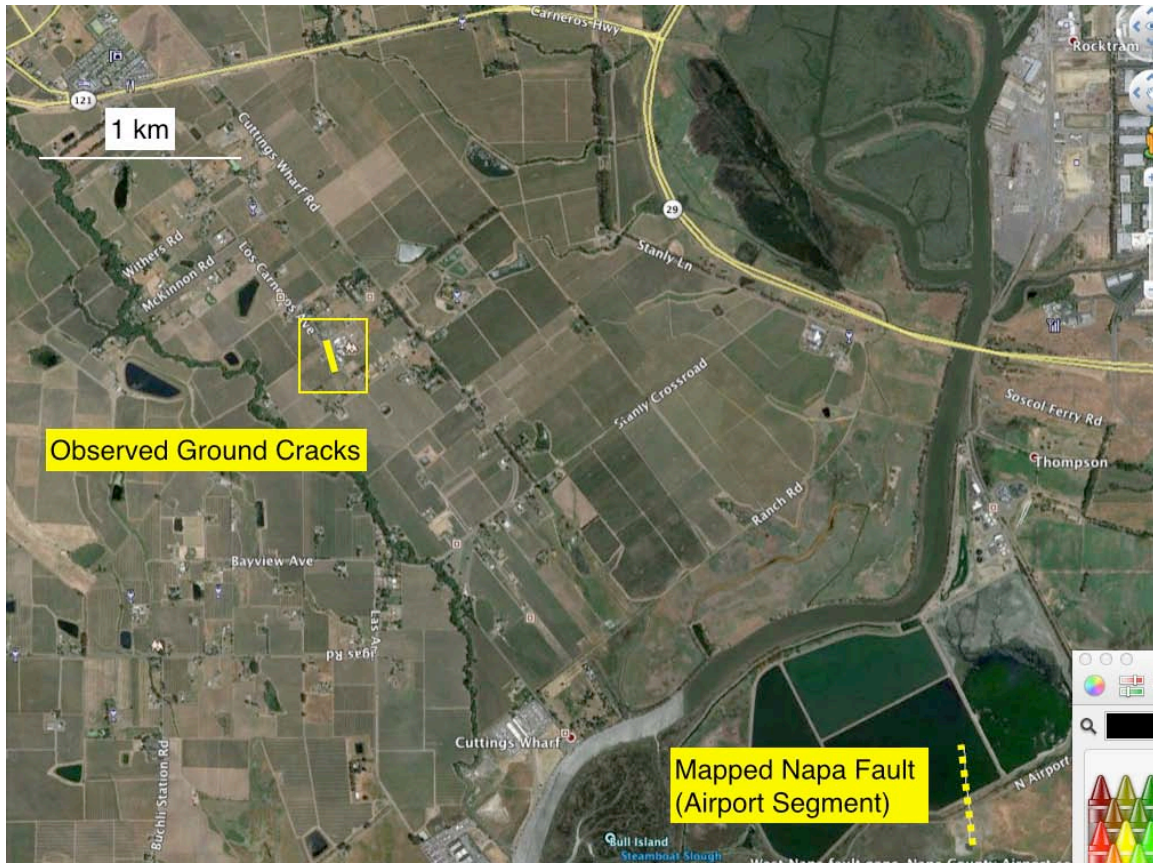
On August 26, 2014, some of the authors visited an area which shows ground failure, located by the solid yellow line in Figure 2-22. In Figure 2-22, the dashed yellow line shows the inferred location of the Napa fault zone, based on prior studies. In one projects this dashed line to the north, where it would connected up with the mapped Browns Valley segment of the West Napa fault zone, it is located about 2 km easterly of the solid yellow line, where (apparently) surface rupture was observed at this location.

The nature of the cracks suggest surface faulting, for the following reasons:

- It seems to be right lateral in nature
- The ground cracks are en echelon, oriented in a manner consistent with soil pull apart associated with right-lateral faulting
- The cracks, if projected north-northwesterly as suggested by the direction of the solid yellow line in Figure 2-19, would go over the epicenter. If we assume the West Napa fault zone has a 90 degree dip (purely vertical), then the rupture would correspond to the presently-observed fault location.
- The site with these ground failures is mapped as not likely to liquefy, using the geologic maps (mapped at border of Qoa and pre-Quaternary soils). A Moderate-high liquefaction zone is mapped a few hundred west of this site (along a creek);

as the entire area is nearly flat, it would seem unlikely that there could be a lateral spread towards the creek.

Figure 2-22. West Napa Fault Zone

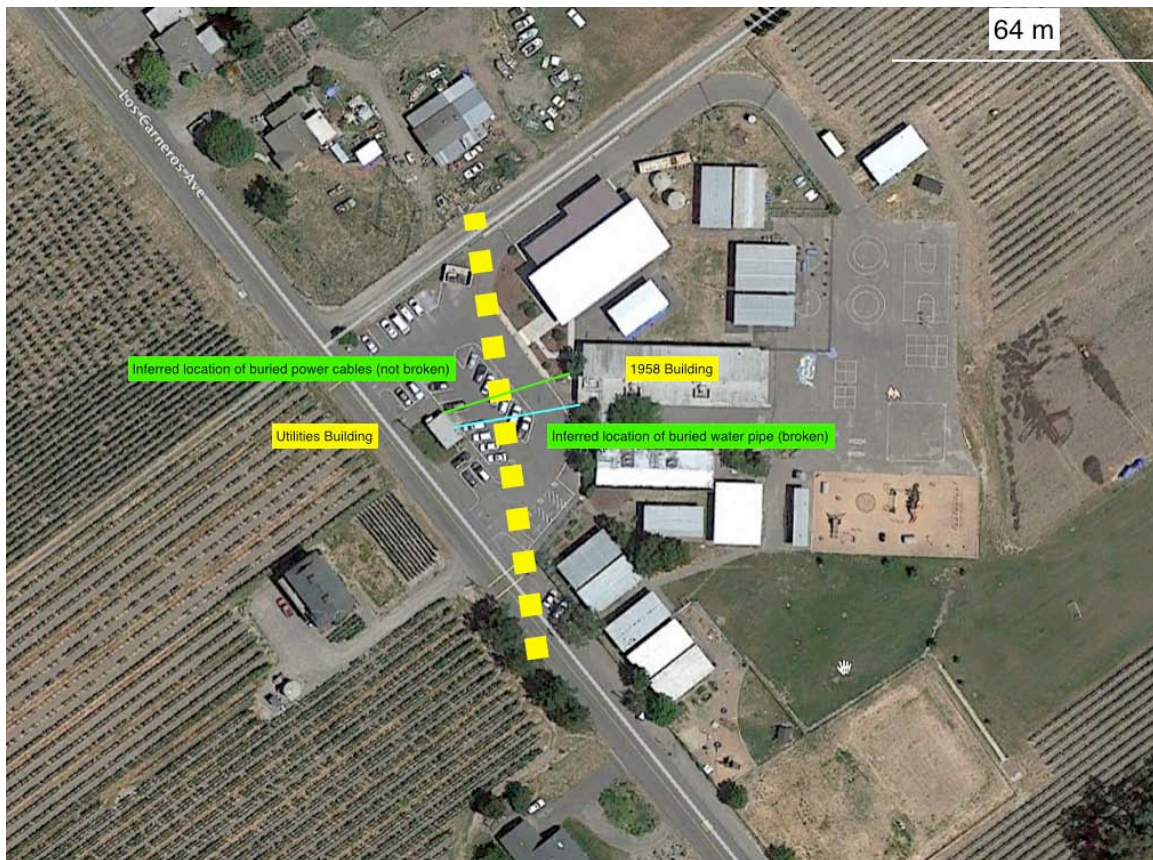
Figure 2-23 shows a close up aerial view of the area in the highlighted box in Figure 2-22. In Figure 2-23, the thick dashed yellow line represents the zone with surface faulting. The property is a K – 8th grade school. The building noted "1958" building is one of the primary classroom buildings, and the oldest at the site.

We measured the width of the fault zone with observed ground failure at about 35 feet wide. The thick dashed line represents the strike of the faulting, but the actual cracks were en-echelon in nature, with most of the larger cracks oriented somewhat clockwise from the strike of the thick yellow dashed line. The cracks are very clear in the road (Los Carneros Avenue) and in the asphalt-paved parking lot of the school. To the west is a small "utilities building" housing switchgear (from the overhead PG&E distribution line along Los Carneros Avenue) as well as water quality equipment to treat water from the school's well.

Figure 2-23. Aerial View of Fault Zone

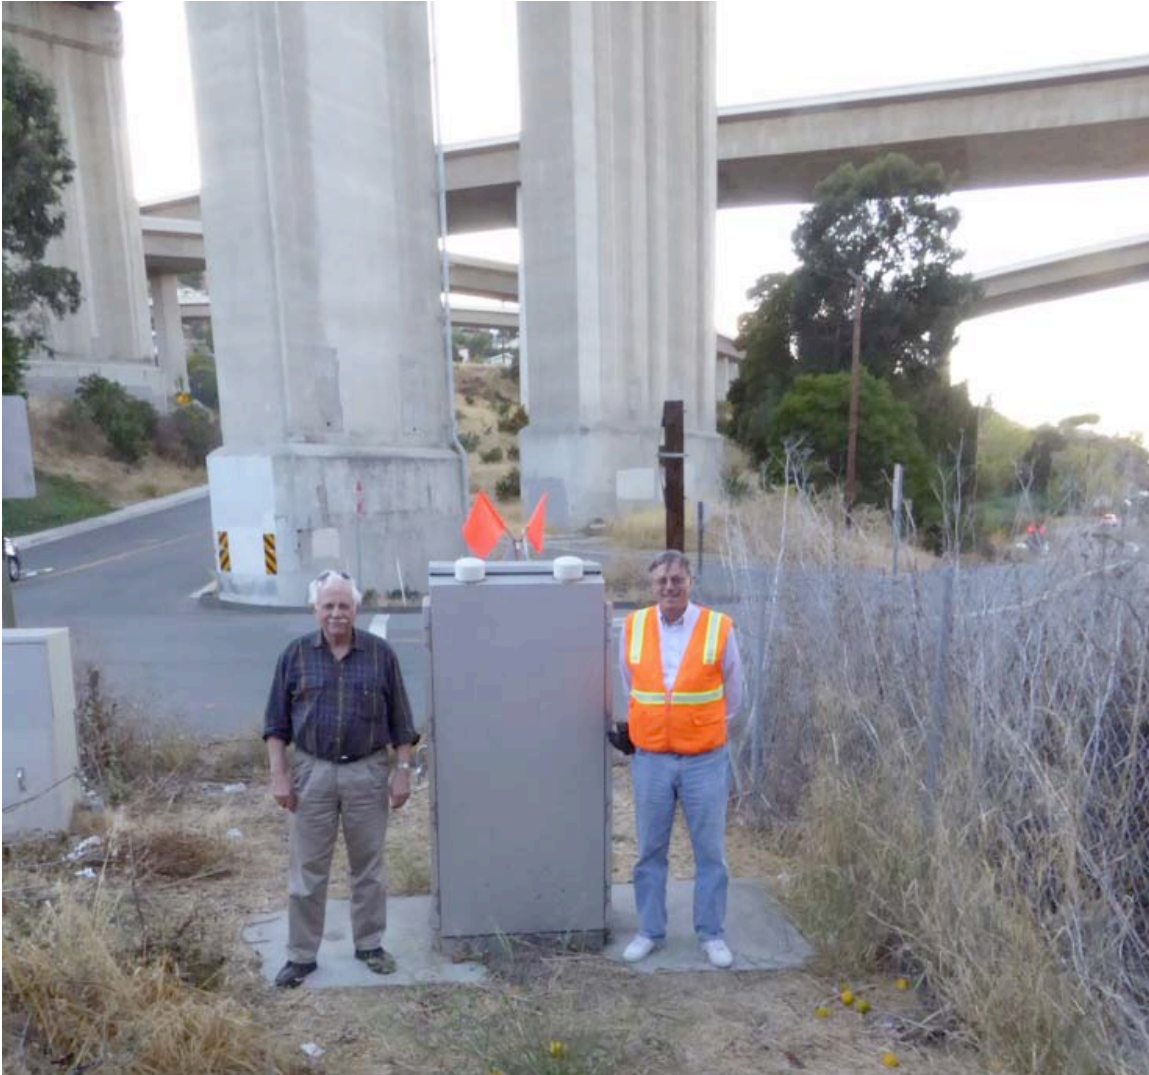
Figure 2-31. Instrument under old Carquinez Bridge with Scawthorn (left) and Eidinger (right)

Are these instruments Free Field? USGS assumes that these instruments are Free Field instruments, meaning that their recordings are not materially influenced by nearby structures. Examining Figures 2-30 and 2-31, this assumption is likely not valid. The massive bridge supports are very close to the instruments. As the bridges moved in the earthquake, they would impart into the ground very high reaction forces. It is possible that during the earthquake, that hinge-type connections in the bridges opened / closed, or similar phenomena, leading to some high frequency shocks. The very high recorded

Therefore, the PGA ShakeMap in Figure 2-2b is almost certainly much too high in the areas around Vallejo and points south.

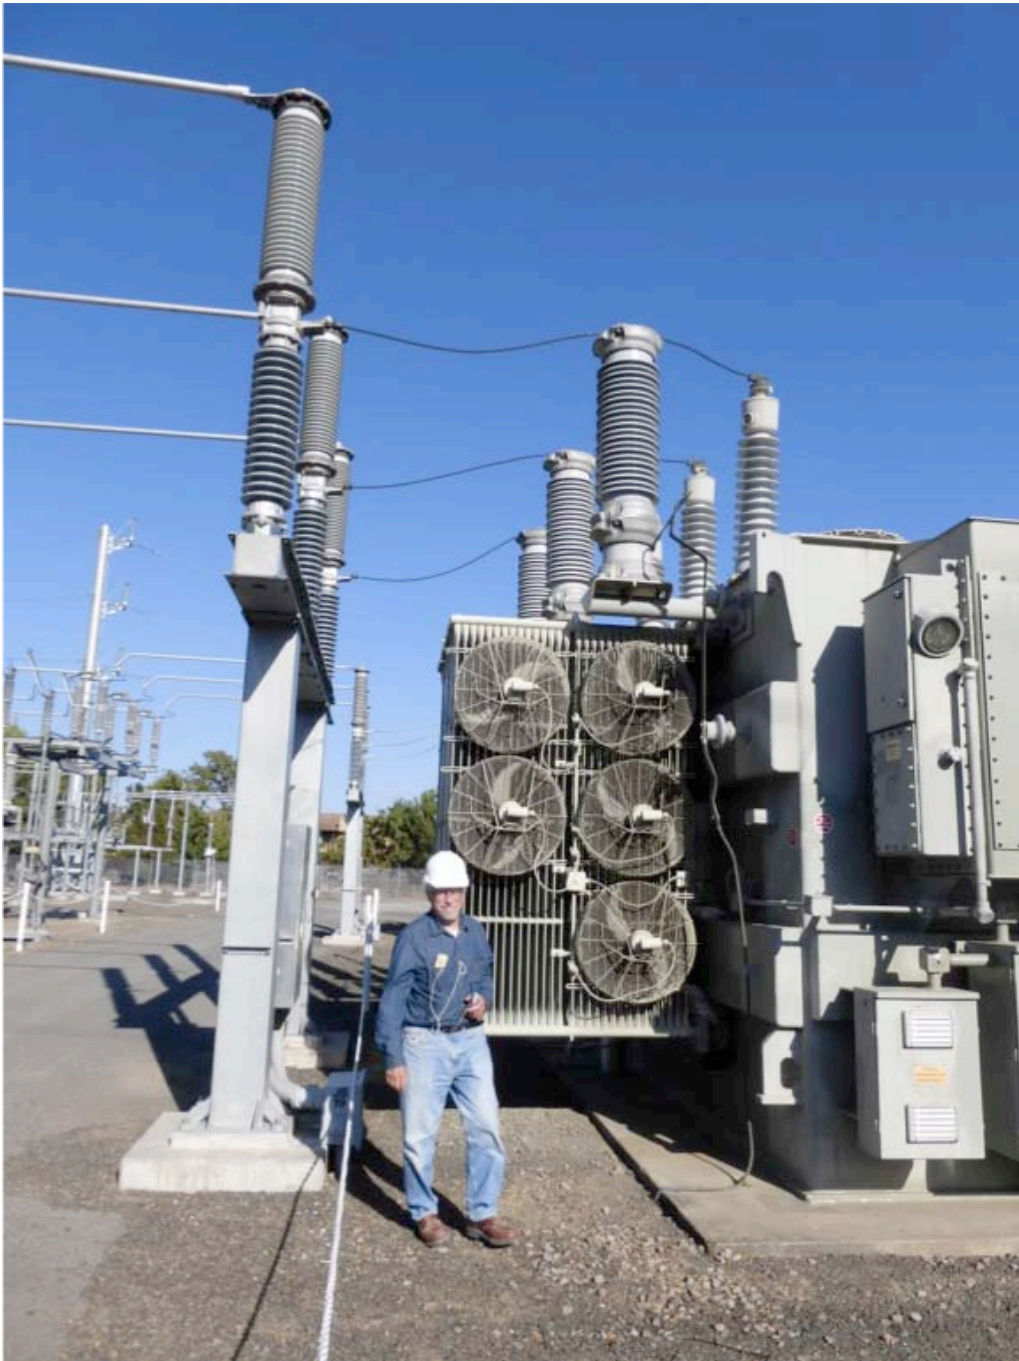
Figure 3-2 shows a 1977-vintage power transformer, with Prof Anshel Schiff in the foreground.

Figure 3-2. Power Transformer

There was evidence of oil leakage at this transformer, Figure 3-4.

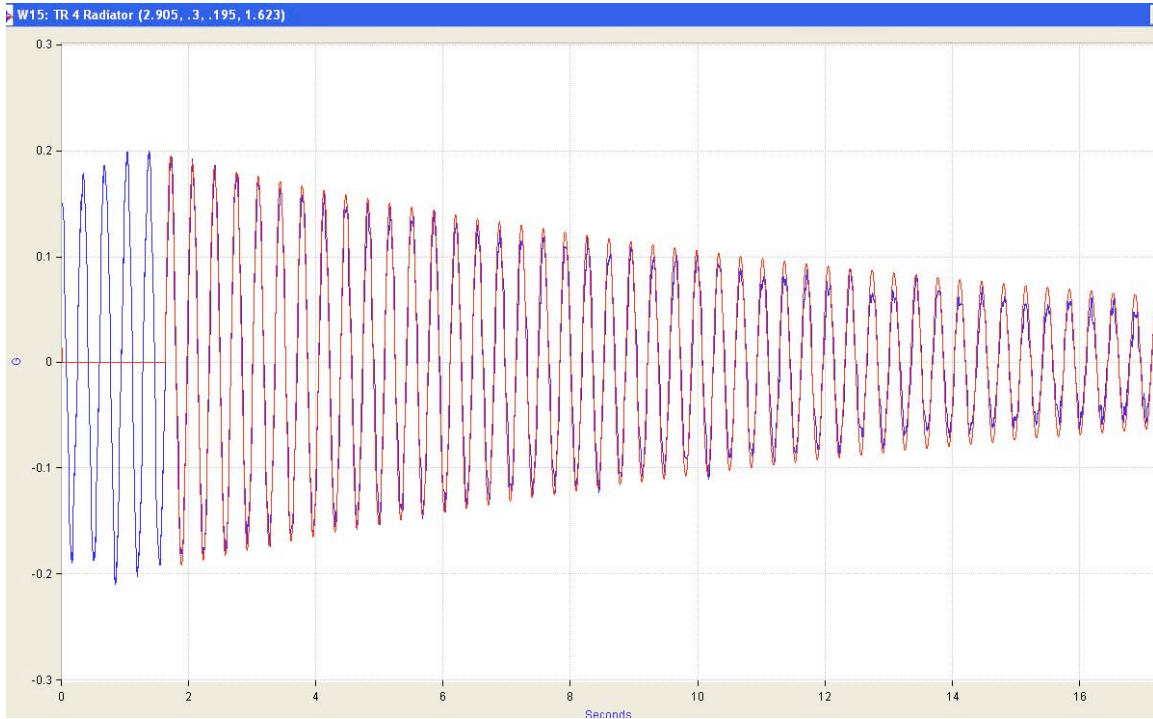
Figure 3-3 shows the time history of response of the radiator. The forced vibration response is seen on the left (increasing blue line) and the free vibration response is shown on the right (two lines, with the blue line being the recorded motion, and the second line being a fitted sine wave motion attempting to match the response). From the matched sine wave, the best-fit first mode frequency is 2.905 hertz with 0.3% damping.

Figure 3-3. In Situ Test Vibration Response of Radiator (A. Schiff)

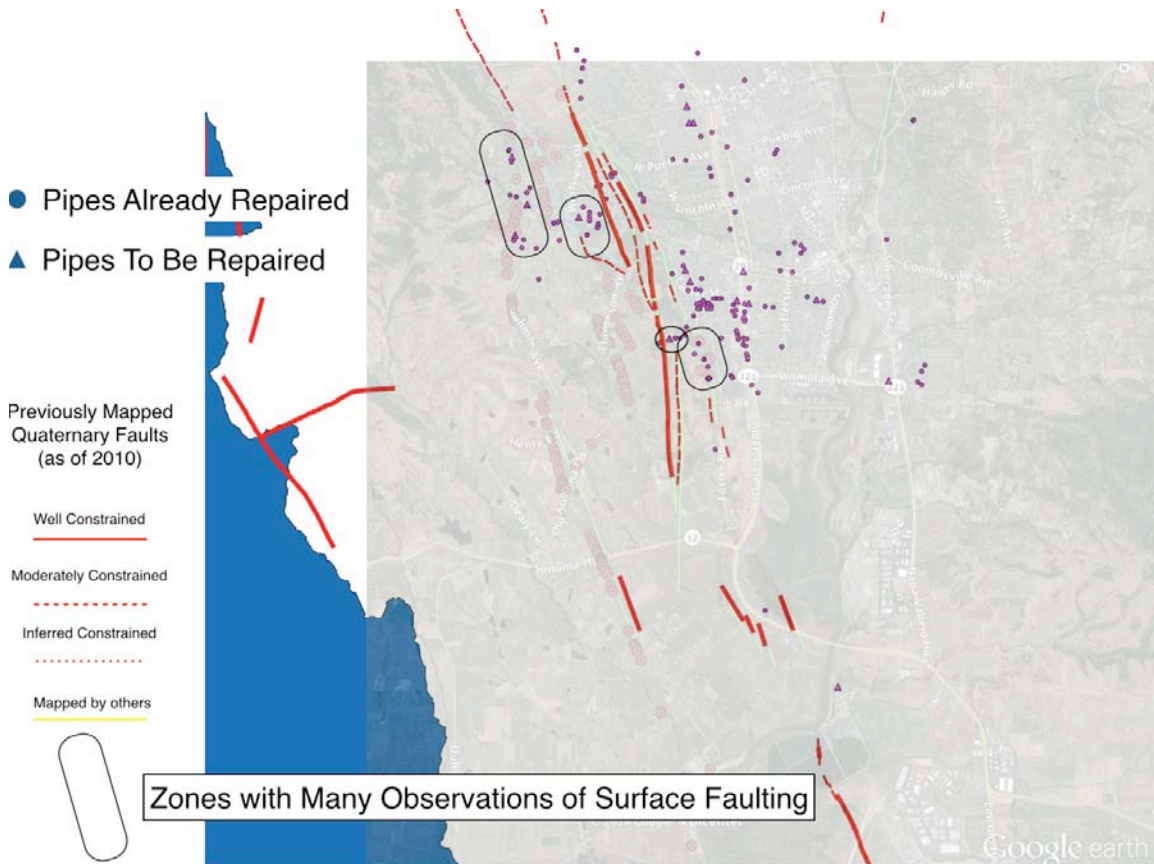
Figure 4-5 shows an overlay of pipe repairs (blue symbols) with the pre-earthquake location of mapped faults (red lines), along with zones subjected to surface faulting (black elongated zones). This map shows the pipe repair count as of September 2014, when it was 160.

Figure 4-5. Overlay of Water Pipe Repairs and Zones with Surface Faulting

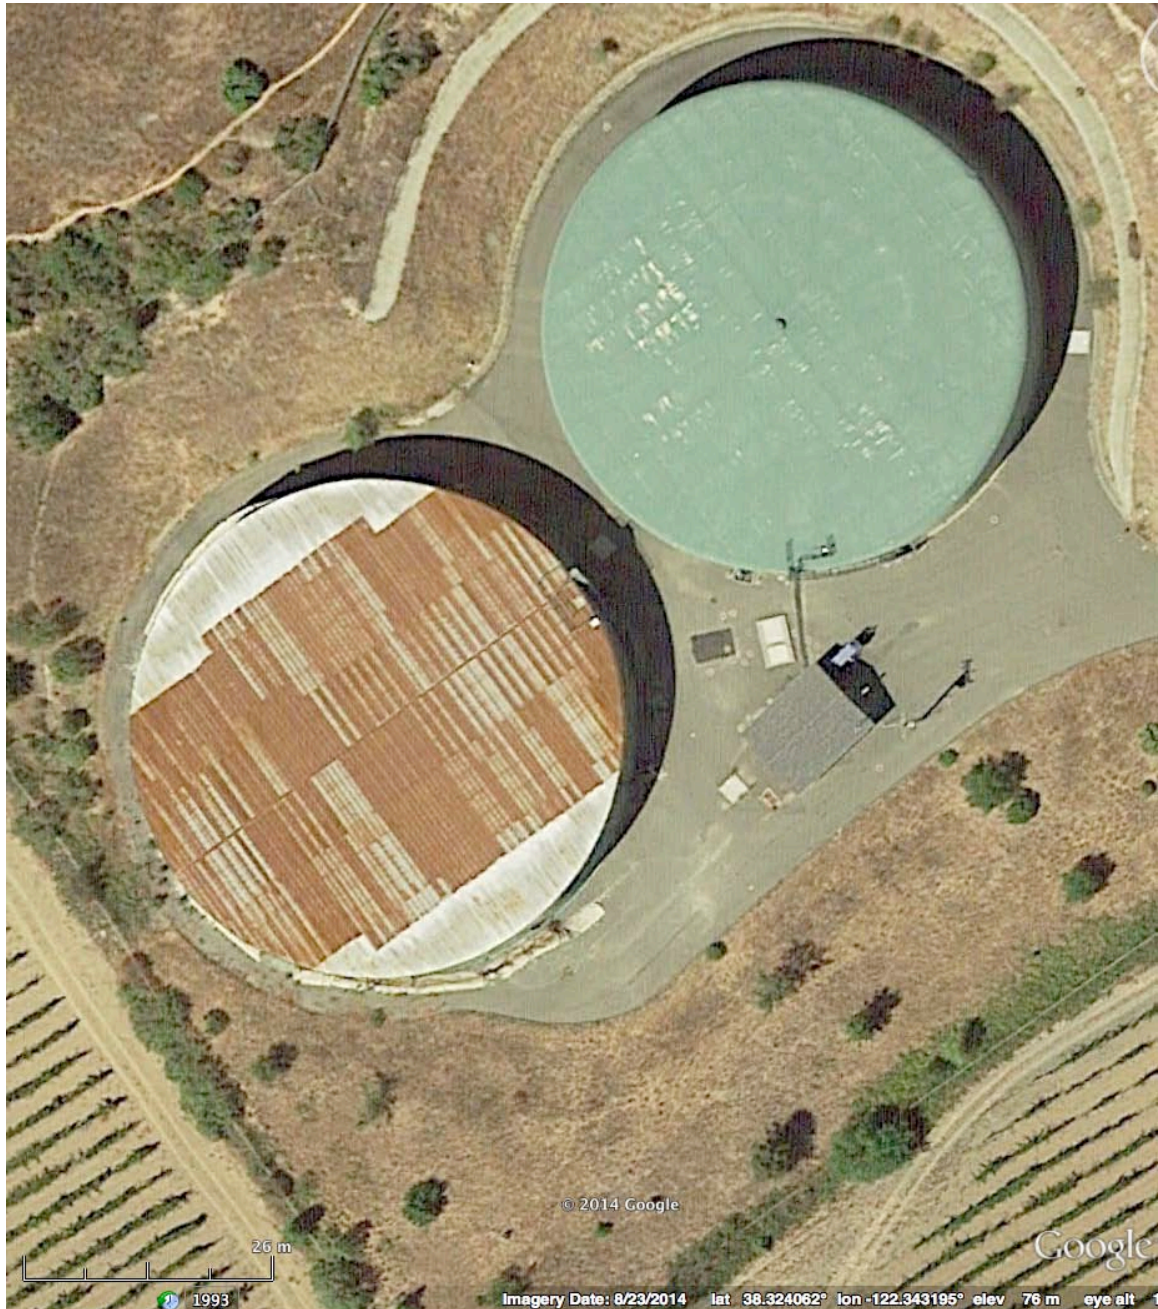
Figure 4-12. Two Tanks (38.2341, -122.3432)

Figure 4-12 shows two other steel tanks in the Napa water system, photo image dated August 23, 2014 (one day before the earthquake). These tanks are in the northwest part of the city, PGA ~0.3g to 0.4g. The tank in the lower left has a corrugated steel roof, but had been taken out of service some time before the earthquake, and thus had no water in it. The tank on the right was in service at the time of the earthquake, and initial exterior inspection suggests no damage.

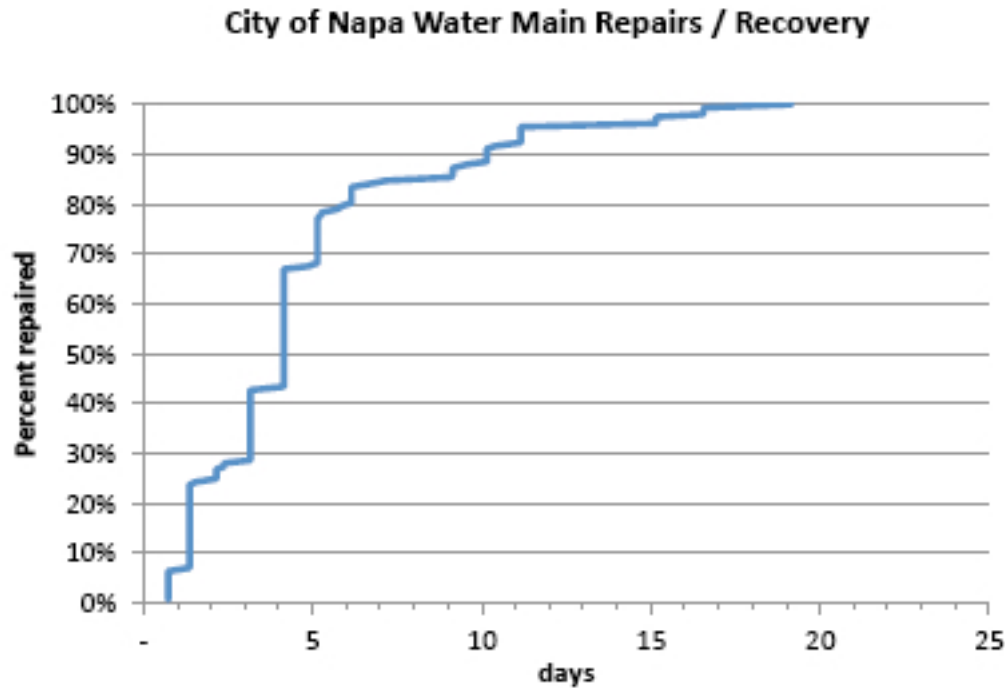
Figure 4-14. Napa Water Recovery

Figure 4-14 shows the restoration of water service after the earthquake.

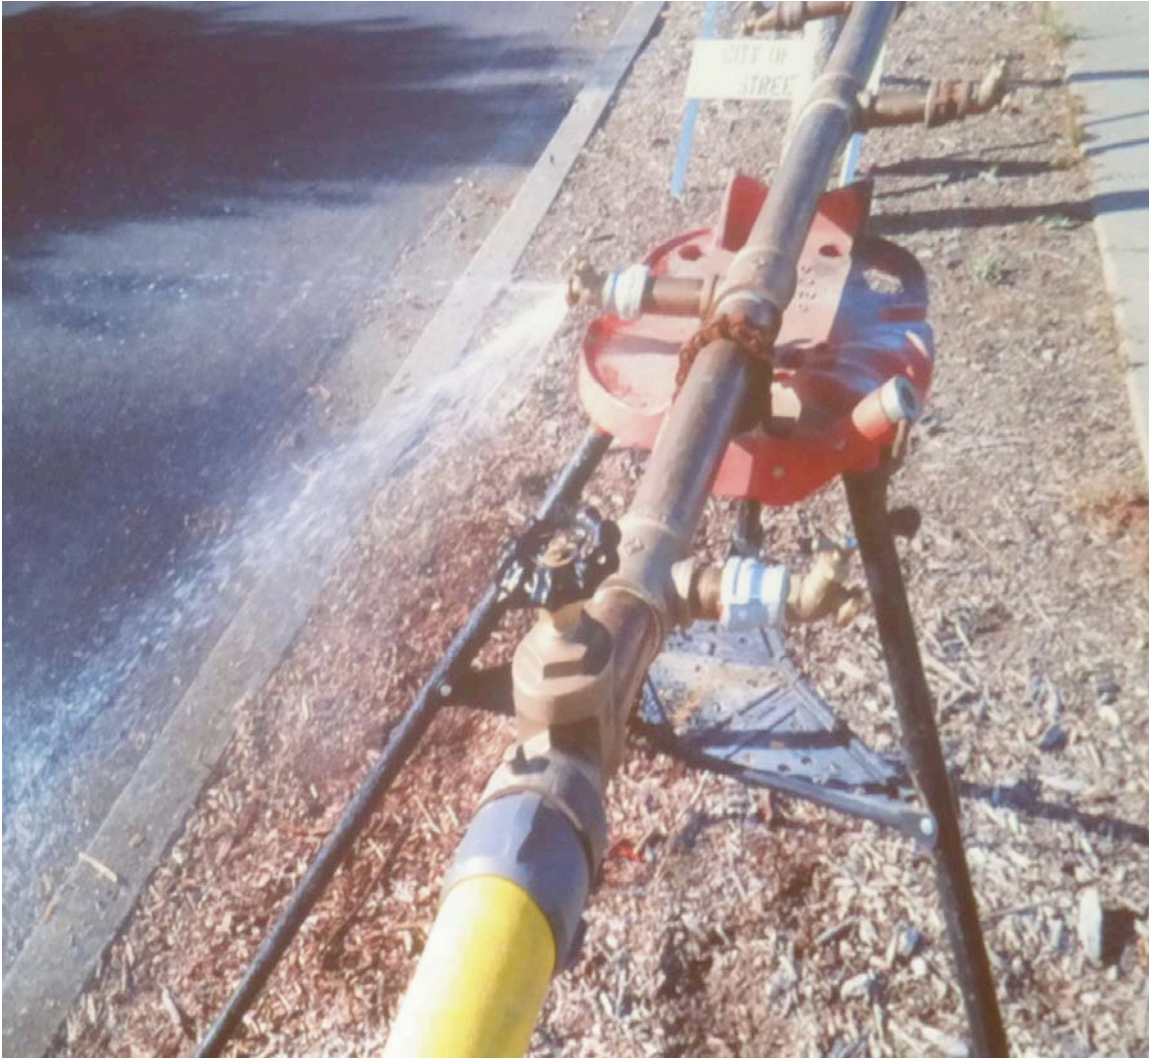
Figure 4-15. Hose Bib Used During Recovery

At some locations, the City of Napa installed hose bibs, Figure 4-15, at working fire hydrants with potable water, and alerted residents where they could go get potable water. These were located close to locations where there were water pipe breaks and with residents without piped potable water.

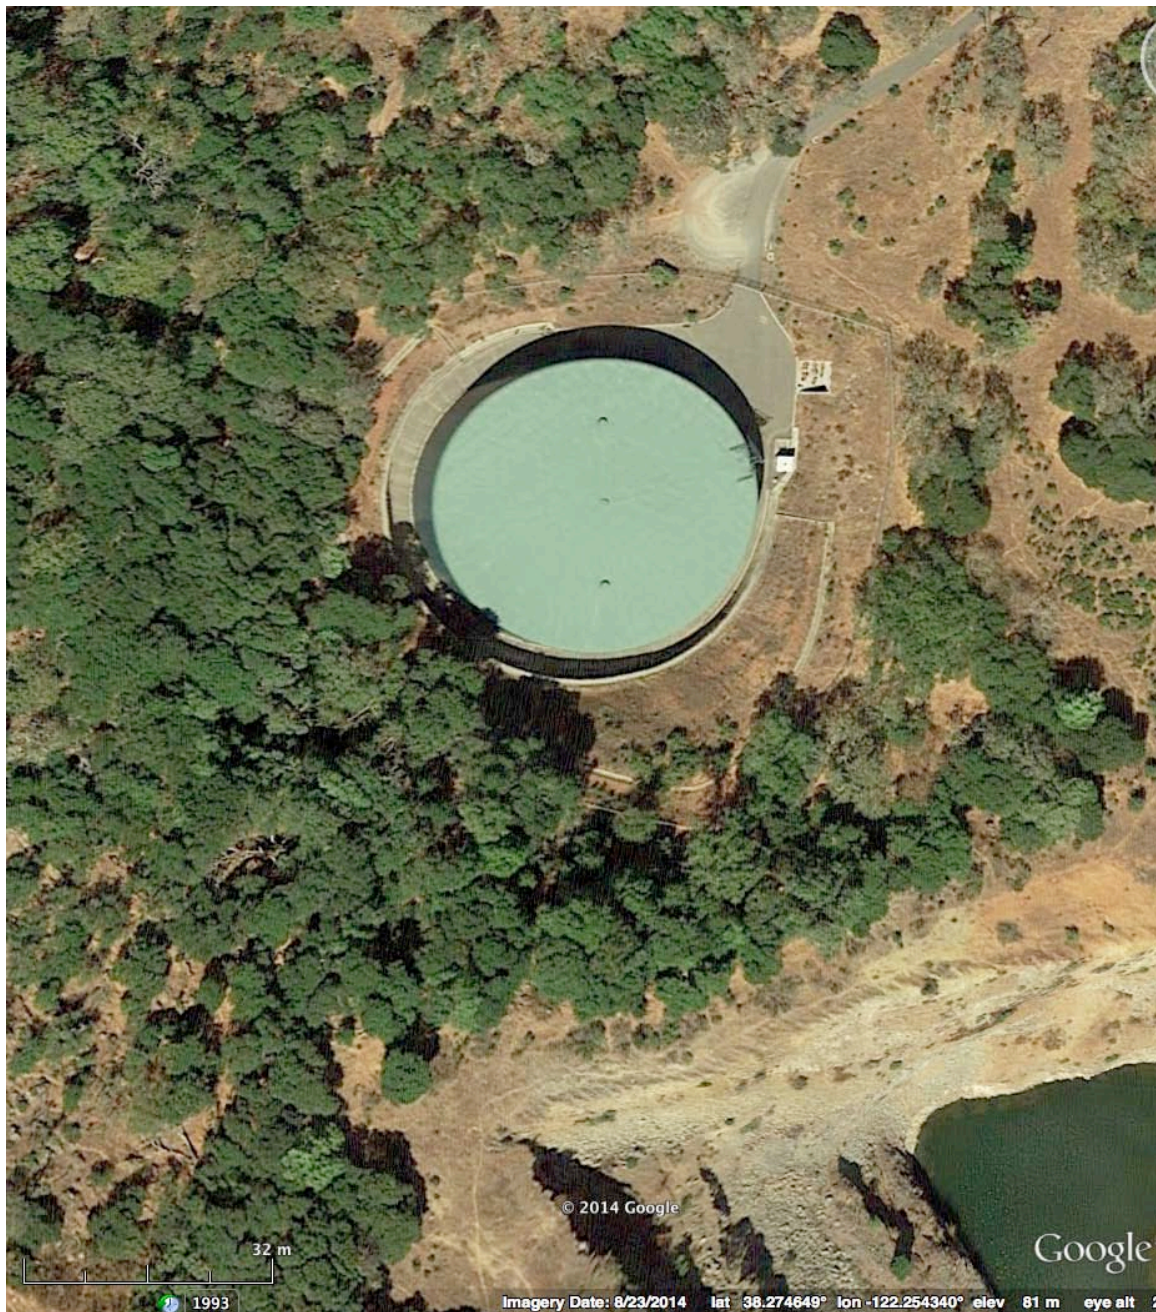
Figure 4-18. Recycled Storage Reservoir

Figure 4-18 shows the recycled water storage reservoir (PGA $\sim 0.15g$).

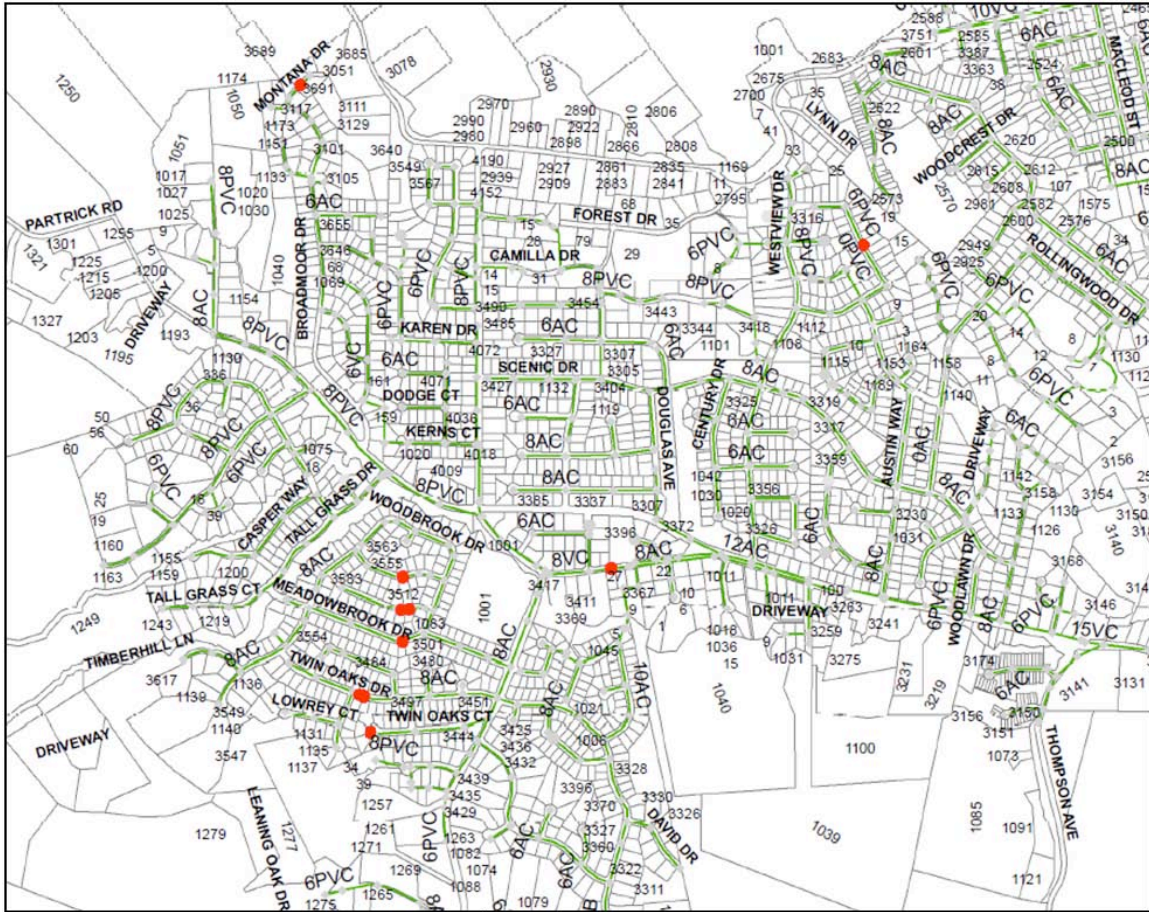
Figure 4-19. Location of Sewer Breaks

Figure 4-19 shows the locations of the sewer line breaks where repairs were made shortly after the earthquake (red dots). The red dots near Meadowbrook are all nearly coincident (within about 100 feet or so) with observed surface faulting.

Through September 15, 2015, NSD reported 11 breaks (possibly 13?) in sewer mains (all AC). Of these breaks, 9 were along the fault trace, and 2 were due to washouts from nearby water main breaks.

The typical repair strategy across the fault was to insert a PVC-type bladder within the broken pipe, then inflate and set the bladder. NSD reports that this effort was successful.

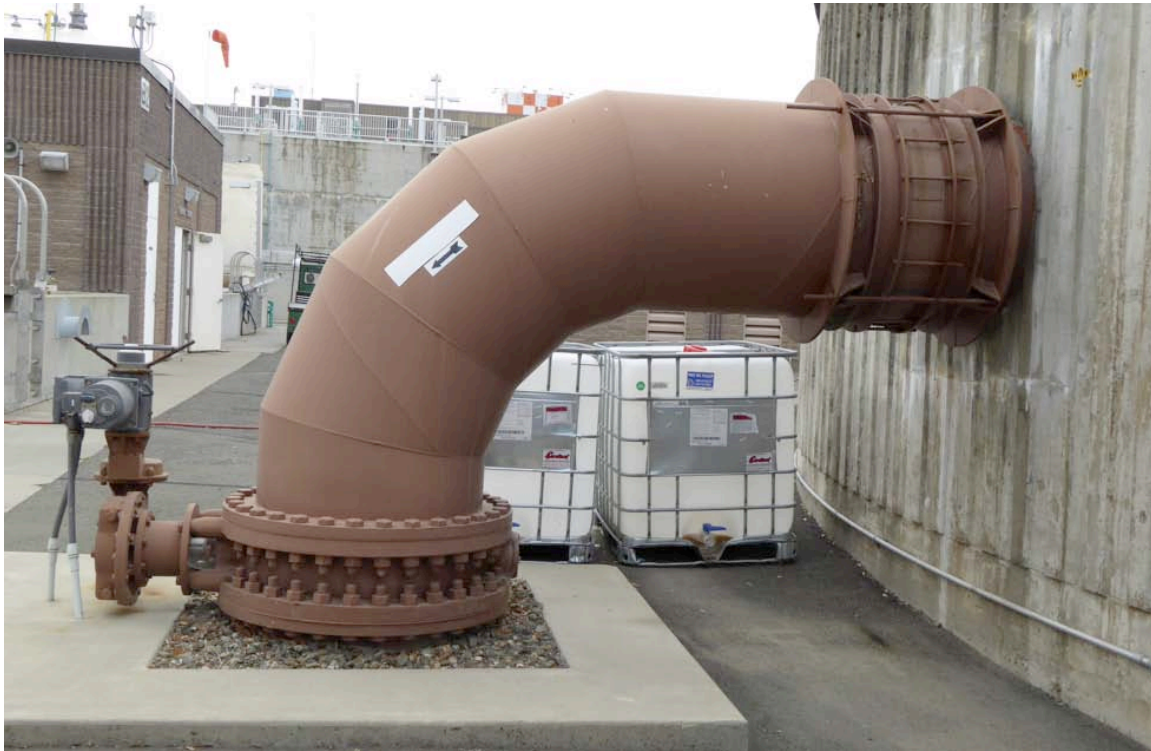
Figure 4-20. Steel Pipe with Dresser-Type Coupling

- At one location, a large pipe that enters a tank had a distressed Dresser-type coupler (slip joint). Figure 4-20 shows one of the two such pipes (the other pipe leaked); both have essentially the same details. This leak was attributed to high inertial ground shaking, rather than differential settlements. The shaking caused some movement at the slip joint. The leak was solved by re-tightening the bolts that make the connection (top right part in Figure 4-20).

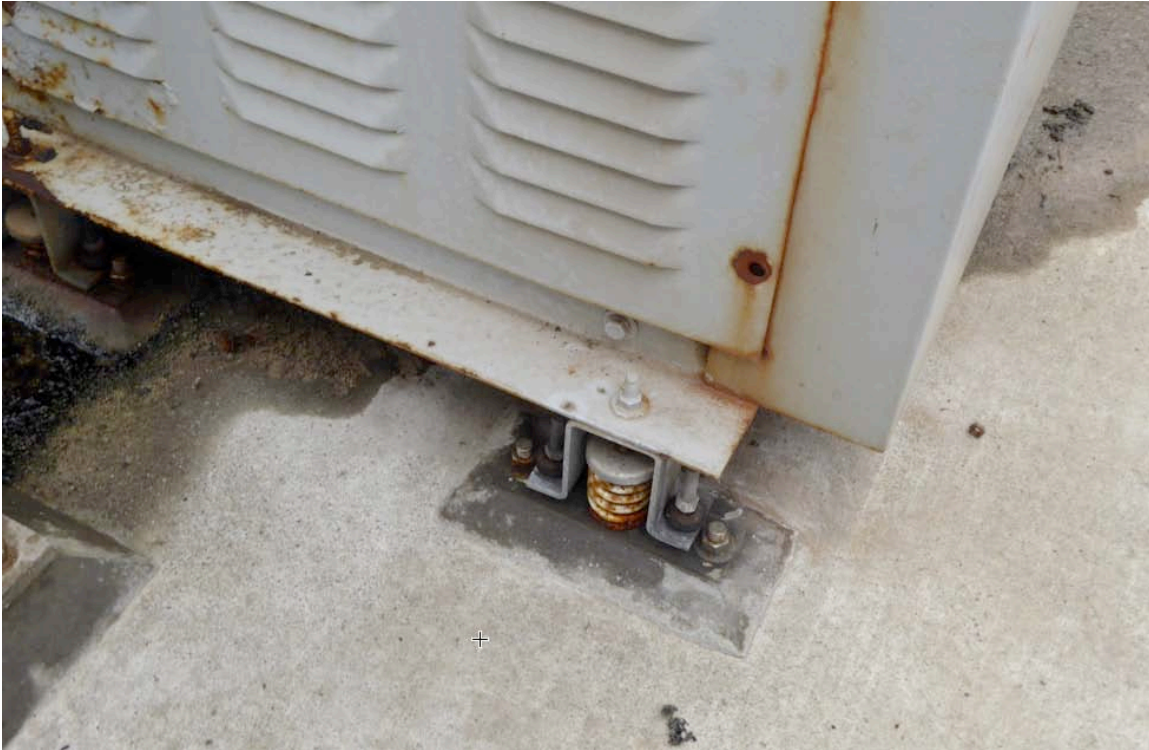
Figure 4-21. Spring-Mounted Motor Assembly

A spring-mounted motor system suffered some damage, Figure 4-21. This assembly is attached to an adjacent large diameter steel pipe. During normal operation, the spring mounts allow minor movements (commonly under 1/16th inch) of the motor assembly. To accommodate these movements, the attached pipe is supported on a concrete pedestal, and a rubber-type connector is used between the pipe and motor assembly. The earthquake broke the first pipe support. This pipe support had already sustained considerable damage due to corrosion, prior to the earthquake, and the incremental forces applied during the earthquake failed the support.

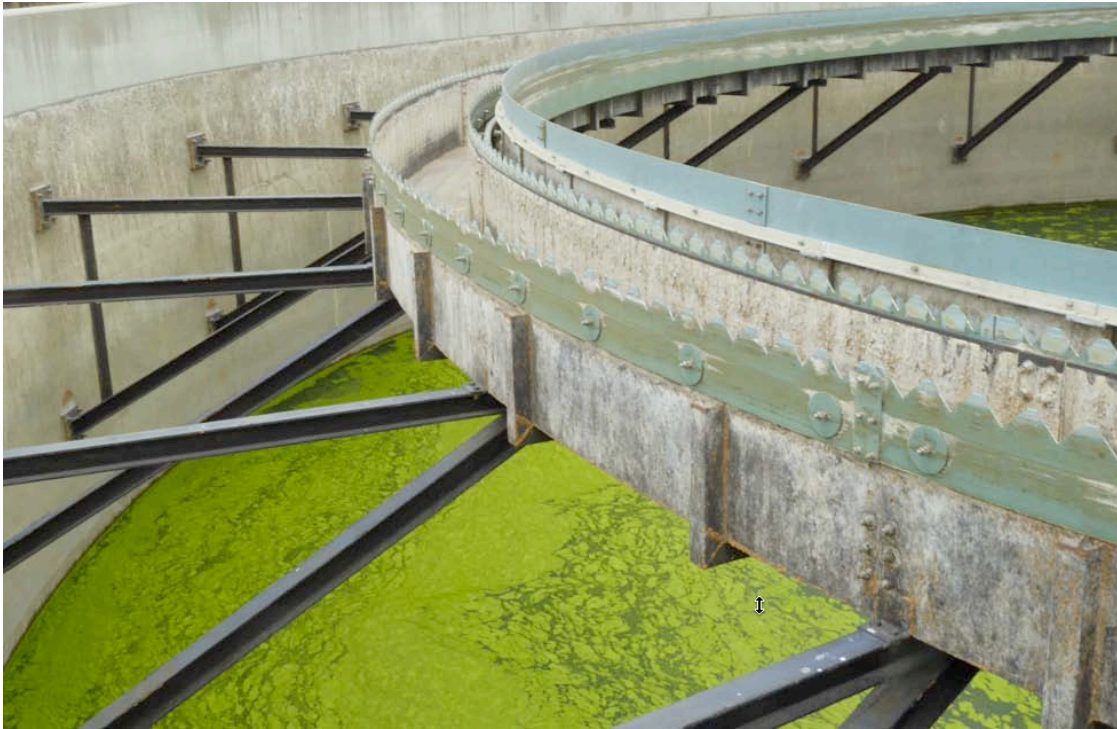
Figure 4-22. Empty Clarifier

In Figure 4-22, the heavy steel bracing for the water trough is seen. The water level in this clarifier at the time of the earthquake corresponds to the water (with algae, etc.) seen in this photo. A complete drain of this tank had not been done within 7 weeks of the earthquake; but as the water level was very low at the time of the earthquake, it is not expected that there would have been any damage to the central tower due to unbalanced water loading due to the sloshing effects.

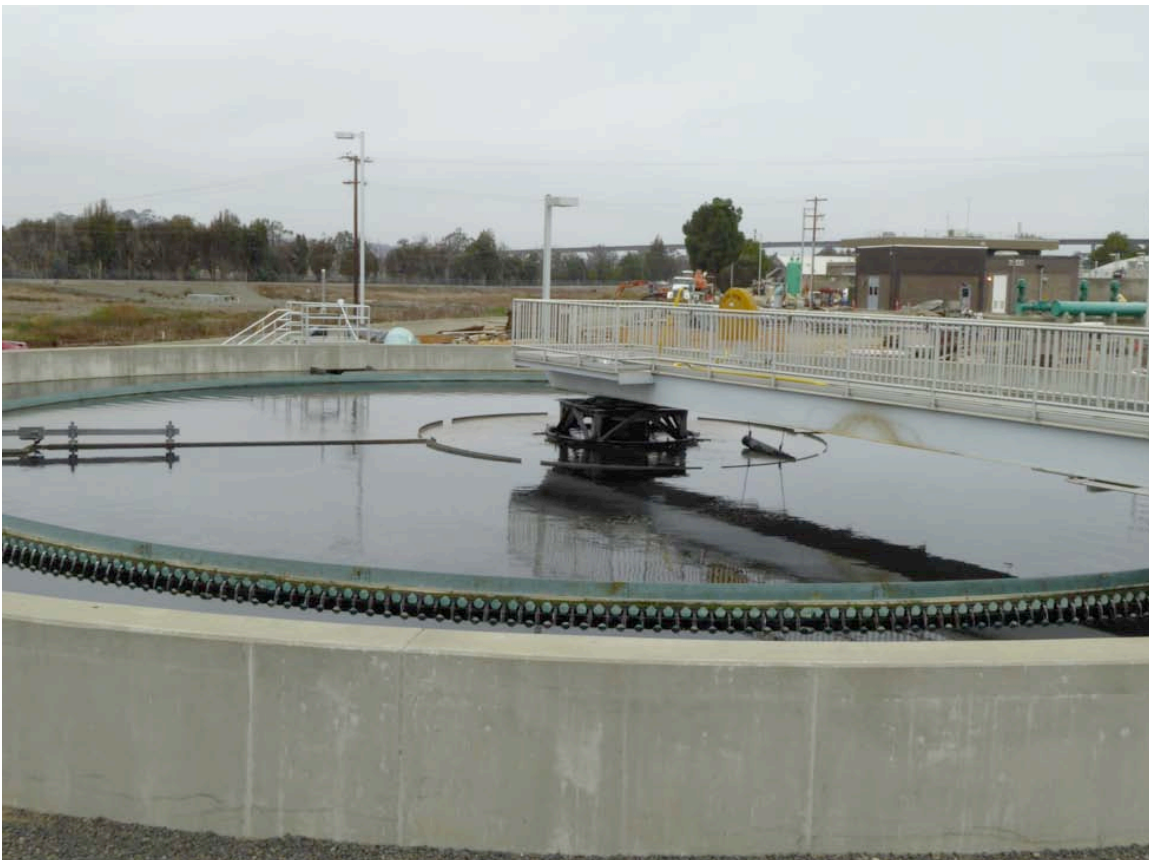
Figure 4-23. Full Clarifier

Discussion with plant staff indicate that there might have been some slight rocking of the central tower of the full clarifier in Figure 4-23, as the inside baffle (steel plate) seems to be slightly tilted; but as of 7 weeks post-earthquake, the clarifier had not been drained to verify the condition of the tower anchor system. While water sloshing as certain to have occurred, as the earthquake occurred during the night-time, there was no one there to observe the actual wave heights; there were no reported obvious solids on the ground adjacent to the clarifier.
