South Napa M 6.0 Earthquake of August 24, 2014

Revision 1

March 17, 2015

This report describes the performance of lifelines systems due to the South Napa, M 6.0 earthquake of August 24, 2014.

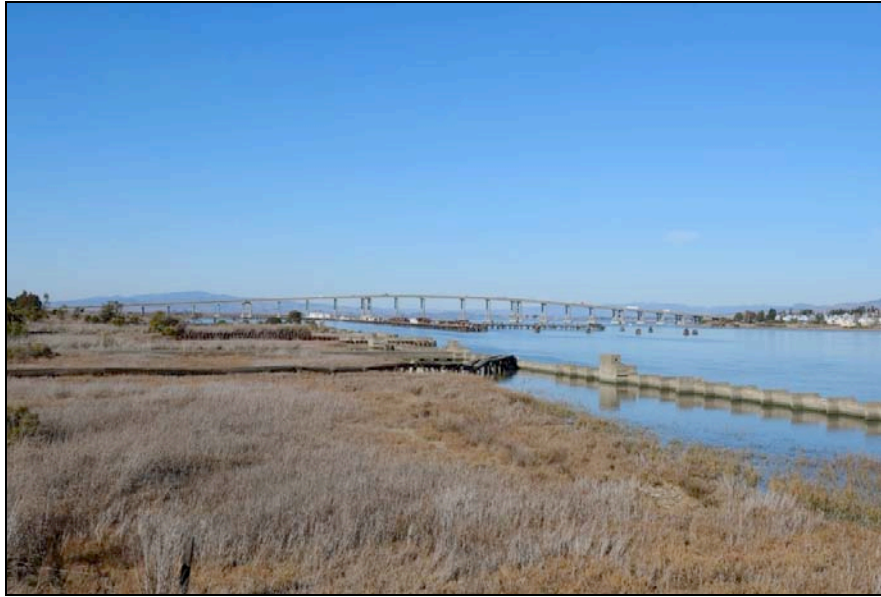
Figure 5-4. Napa River Bridge on Route 37 Br. #23 0064

Bridge 23-0064 is a 33 span precast girder bridge on flexible two column piers and stiff four column piers that was built in 1963. Like many river crossings it starts at ground level and then quickly rises to provide clearance over the river. A problem with many precast girder bridges is that they are not well designed for earthquakes. The girders need to be continuous to protect the superstructure and force plastic hinging into ductile columns. The girders on the Napa River Bridge were inadequately developed and they pulled out of the end diaphragms during the 1989 Loma Prieta earthquake. The bridge was repaired after the earthquake and got a very thorough seismic retrofit in 1996. The retrofit included bolsters around the end diaphragms to make the girders more continuous, also transverse prestressing, with additional seat width, and pipe seat restrainers at the hinges. The foundations were retrofit with additional piles and a bigger pile cap. All of the columns were encased in steel jackets. A downhole array³ was installed at the bridge, which recorded 0.2g acceleration, 19 cm/s velocity, and 2 cm displacement at the ground surface during the South Napa Earthquake. The bridge was also instrumented with Channels 1, 2, and 3 between piers 13 and 14 at the top of the bridge, which recorded 0.53g acceleration and 14.7 cm (about 6 inches transverse) of displacement. The ground motion and structural excitation were not high enough to cause serious damage to a well-designed or to a seismically retrofitted bridge. The only damage to the Napa River Bridge was that the expansion joints opened and closed enough to damage a few of the type B joint seals which had to be replaced. The hand railing at the

expansion joints opened up enough to cause the bridge crews who first inspected the bridge to close it as a precautionary measure.

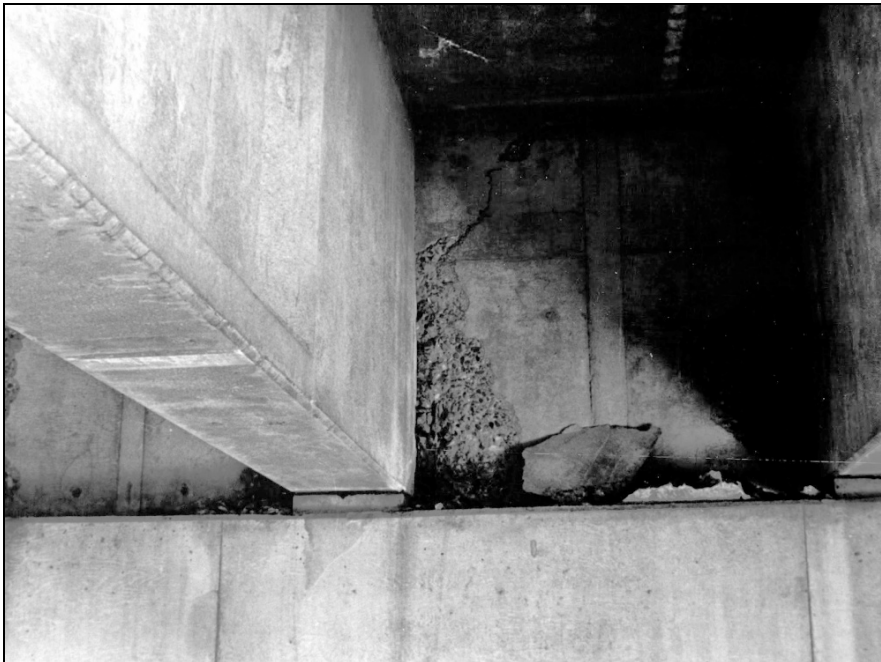
Figure 5-5. Damage to Napa River Bridge during the Loma Prieta 1989 Earthquake

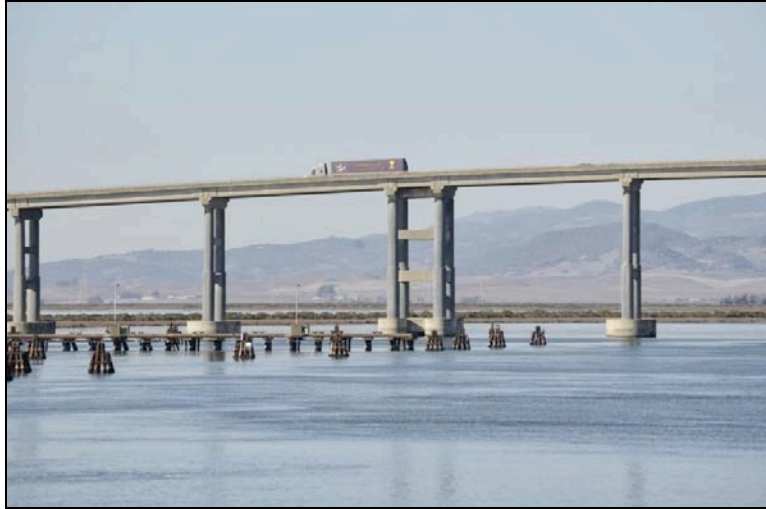
Figure 5-6. Retrofitted Napa River Bridge with Steel Column Casings and Enlarged Footings

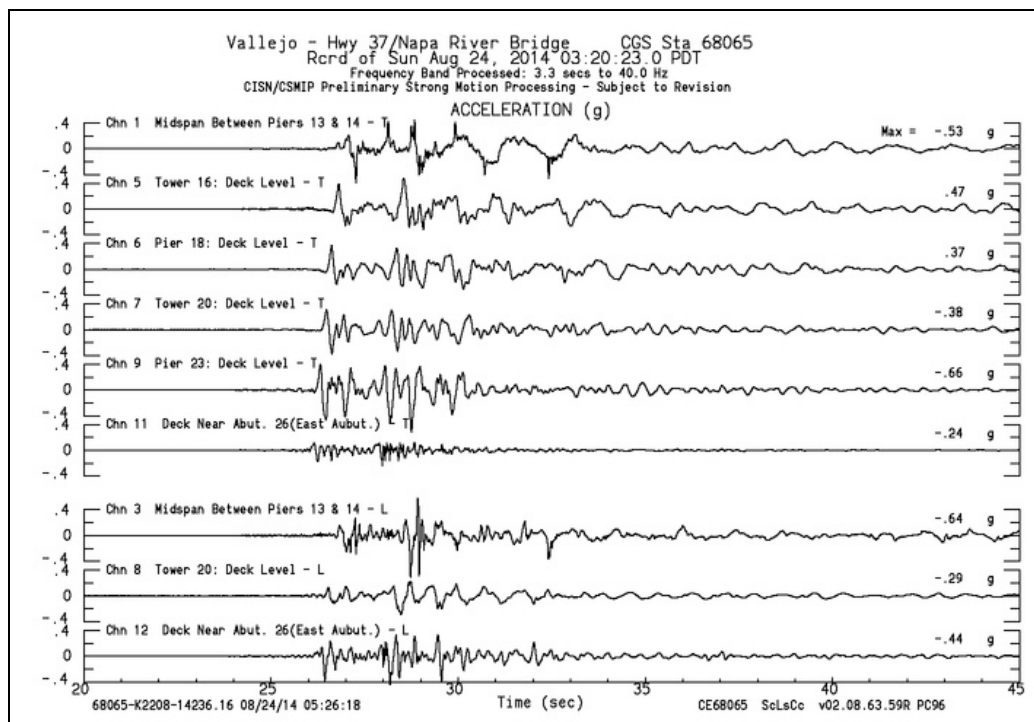
Figure 5-8. Acceleration Records on Napa River Bridge on Route 37

A strong motion instrument downhole array⁴ was installed at the bridge, which recorded 0.2g acceleration, 19 cm/s velocity, and 2 cm displacement at the ground surface. The bridge was also instrumented (see Figure 5-7) with accelerometers between piers 13 and 14 at the crest of the bridge, which recorded 0.53g acceleration and 14.7 cm (about 6 in transverse) of displacement (Figures 5-8 and 5-9).

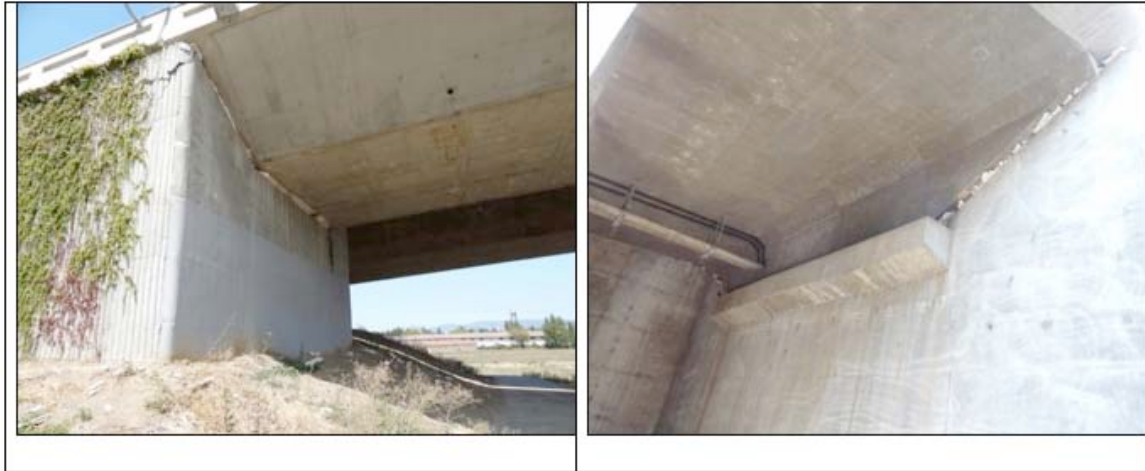
Figure 5-16. Outside and Inside of an abutment on the Napa River (West Imola Avenue) Bridges

This bridge is also very close to the Napa College station that recorded peak acceleration of 0.375g during the earthquake. The damage that occurred during the earthquake, cracks and spalls of the curtain walls at all the abutments, was the result of the ends of the superstructure banging against the slender curtain walls (Figures 5-16 and 5-17). More substantial abutments could have held the superstructure more securely in place. However, it is unlikely that the superstructure could unseat since the approach slab is securely attached to the end of the superstructure. Also, when Caltrans Office of Structures Maintenance and Investigations (OSMI) went inside the superstructure, they found the hinge restrainers had been poorly installed and were damaged at the swage connections or at the tension indicators (Figure 5-18). Restrainers must be carefully installed, which requires tightening them until the spiral washers close and then backing off to account for the variation in temperature. However, restrainers are a secondary system for earthquake protection and the hinges all had 36 inch seats.

This bridge had the most expensive repair (\$350,000) of all the bridges.

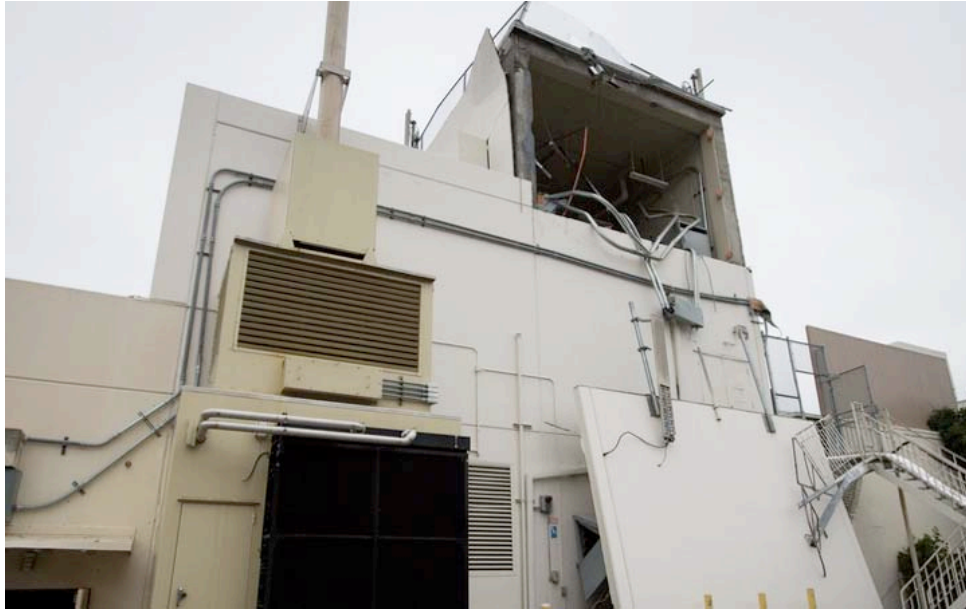
Figure 6-1. AT&T Building on Clay Street, Napa

The ATT building on Clay Street in downtown Napa was damaged, Figures 6-1, 6-2.

The concrete wall panel that has been displaced was apparently a "knock-out" type panel, to allow for future expansion of the facility. The panel was attached to the rest of the building using eight angles, bolted to the panel and to the building (Figure 6-4). Apparently, shaking of the building resulted in excessive forces on the bolts, and the connections failed, allowing the panel to fall.

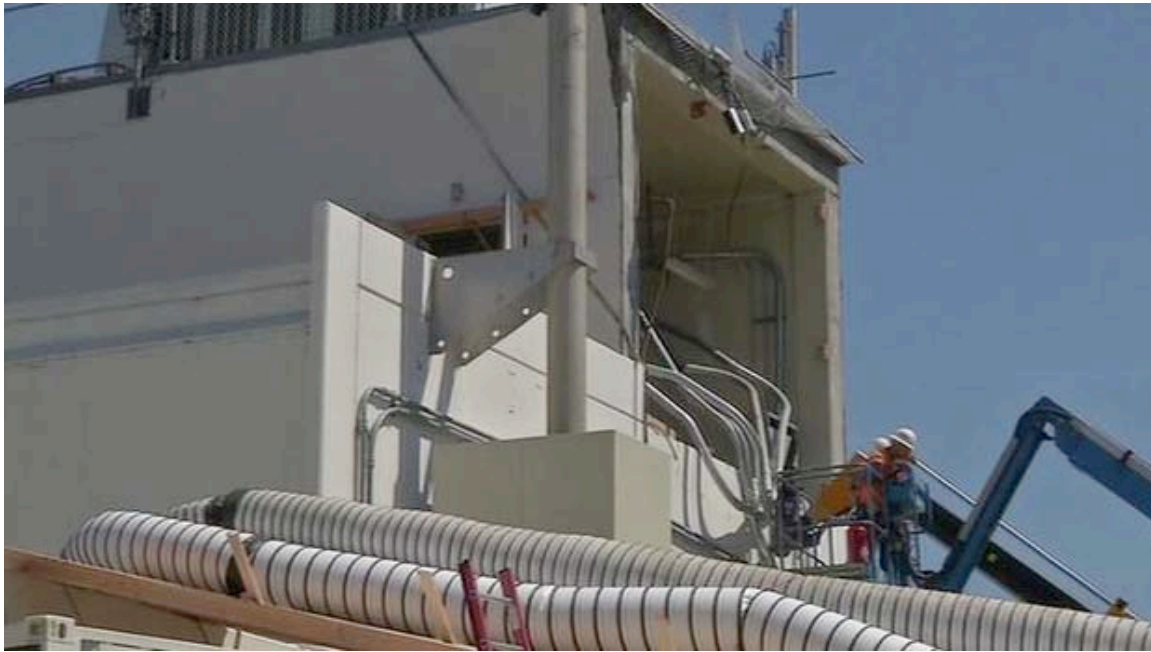
Figure 6-4. Providing External Services to AT&T Building

Cracks along at least two other walls of this penthouse (Figure 6-3) and damage to a corner next to the fallen wall seem to indicate that additional issues may have been present in this room. The fact that a large cooling unit that had been situated on the roof of this penthouse (see Figure 6-4) was removed shortly after the earthquake may also indicate that this room experienced other structural damage in addition to the fallen wall and that there could have been concerns that the earthquake weakened this room considerably.

When the panel fell, it damaged a water pump that is part of the HVAC system for the site, and severed the PG&E power supply into the facility. Additionally, the wall severed a fiber optic cable to a wireless base station located in this upper room causing it to lose service due isolation from its switching center. Also, the emergency generator seem to have experienced some issue and failed to work. Battery systems did work, and the batteries sustained the communication equipment and operations. However, as air conditioners are not connected to the DC bus, they cannot be powered by the batteries. This intrinsic system vulnerability in combination with damage to a water pump and other potential damage to ducts or other components of the HVAC required the deployment of an external emergency ventilation unit, shown in Figures 6-5 and 6-6, in order to keep the heat down in the building. Both figures also show a large portable generator deployed to this site. Images on a TV report produced by Dan Noyes and aired by KGO shows an air compressor outside the central office which likely was used to keep cables pressurized after the onsite pressurization system fail when the onsite generator

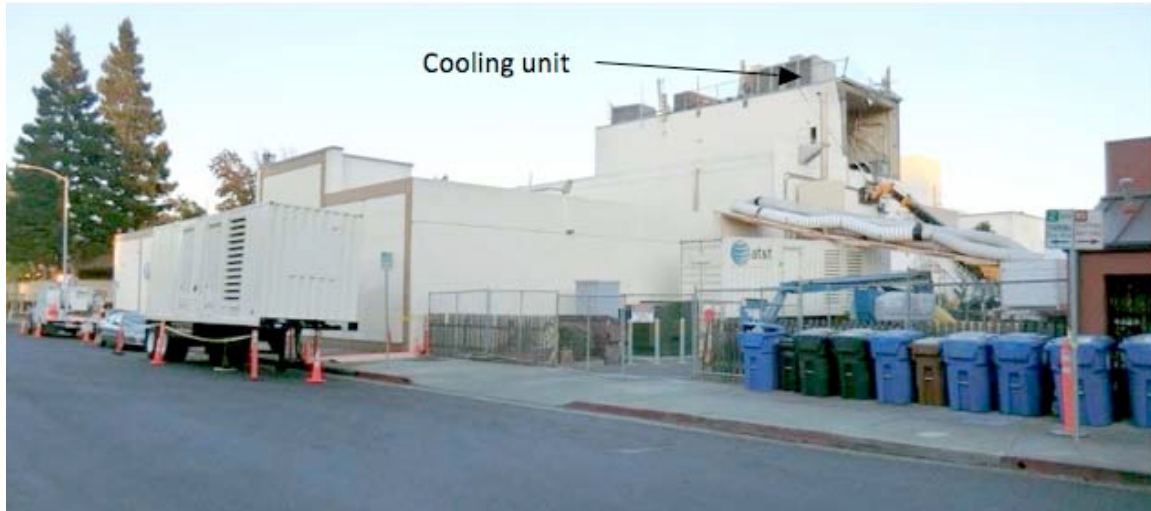
Figure 6-5. AT&T Building on August 25, 2014

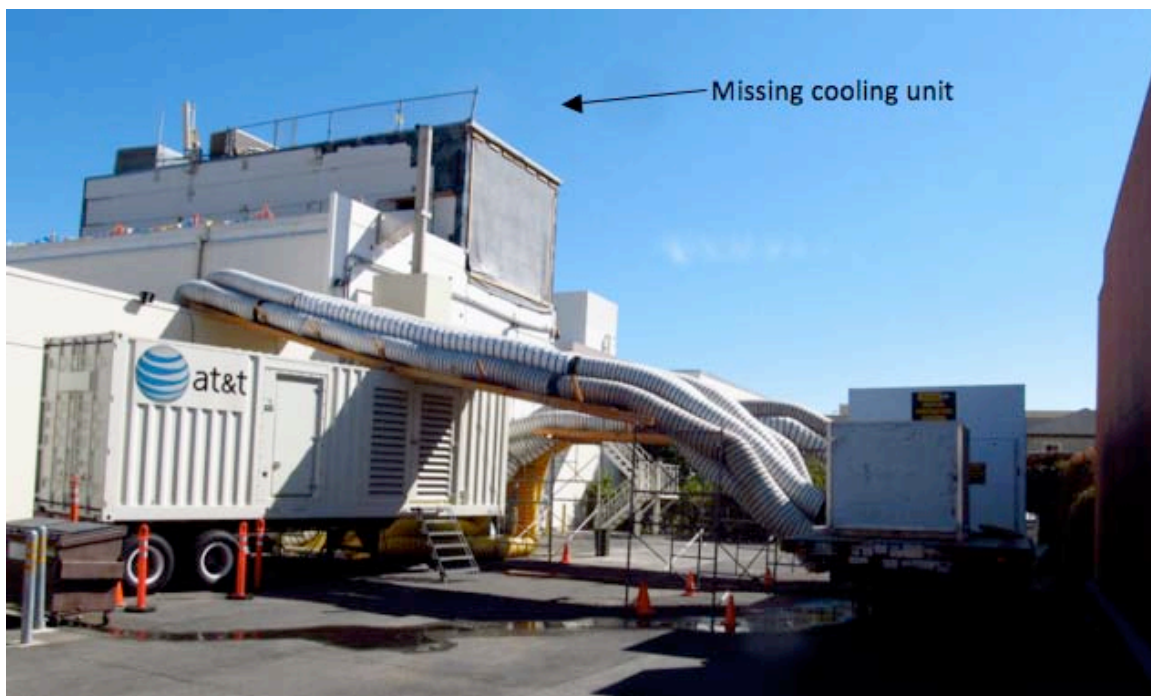
Figure 6-6. Parking Lot, with mobile generator on left and a mobile ventilation unit of the right. Photo taken on October 10, 2014

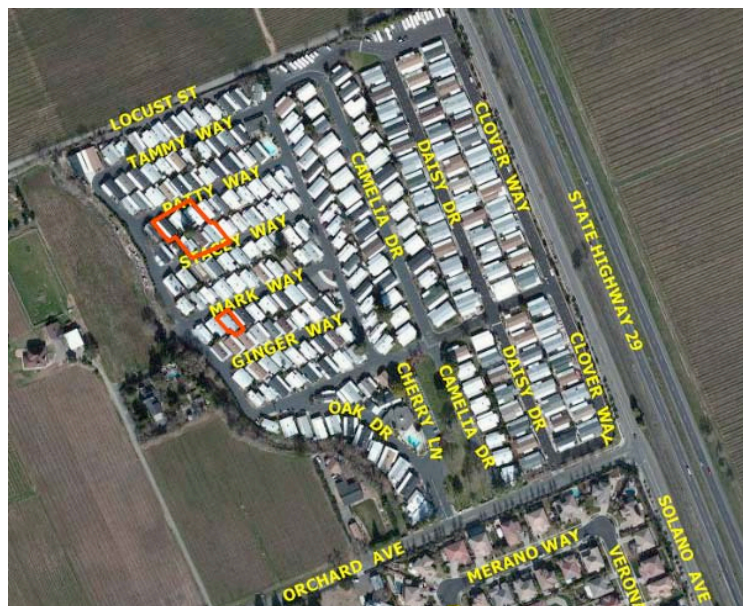
Orchard Ave Fire: This was the largest fire in the earthquake. First dispatch was of T1 to a report of gas odor but en route T1 observed a fire in the Napa Valley Mobile Home Park (NVMHP) off of Hwy 29 at Orchard Road, and diverted to this incident. T1 encountered a broken water main spewing water at the entrance to the NVMHP on Orchard Road, and proceeded to enter the NVMHP. T1 then encountered a single structure fire at 313 Mark Way – the structure was 50% involved; they also observed a second fire at 317 Patty Way, which was 100% involved and impinging on neighboring buildings, see Figure 7-2. Wind conditions were calm.

Figure 7-2. NVMHP Park and locations of fires, 24 Aug 2014 S. Napa M_w 6.0 Earthquake (damaged buildings outlined in red)

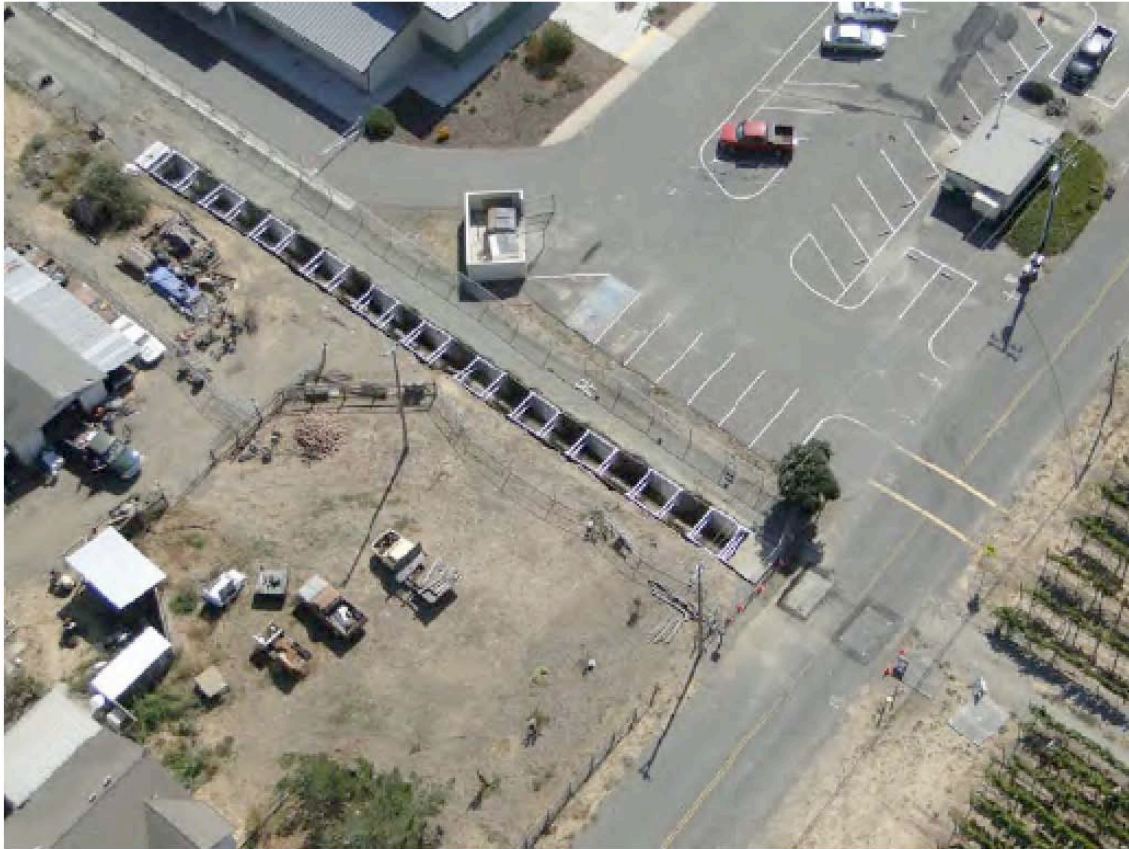
Figure 8-1. Location of PG&E Gas Pipe Trench Excavation

PG&E operates a 26-inch diameter buried gas transmission pipe (Figure 8-1, Line 021A, welded steel) that crossed the fault (across the dashed yellow line in Figure 2-20). The orientation of the pipe would place it into bending and compression due to the right lateral offset of a few inches (including post-event slip). The pipe remained operational (no leak).

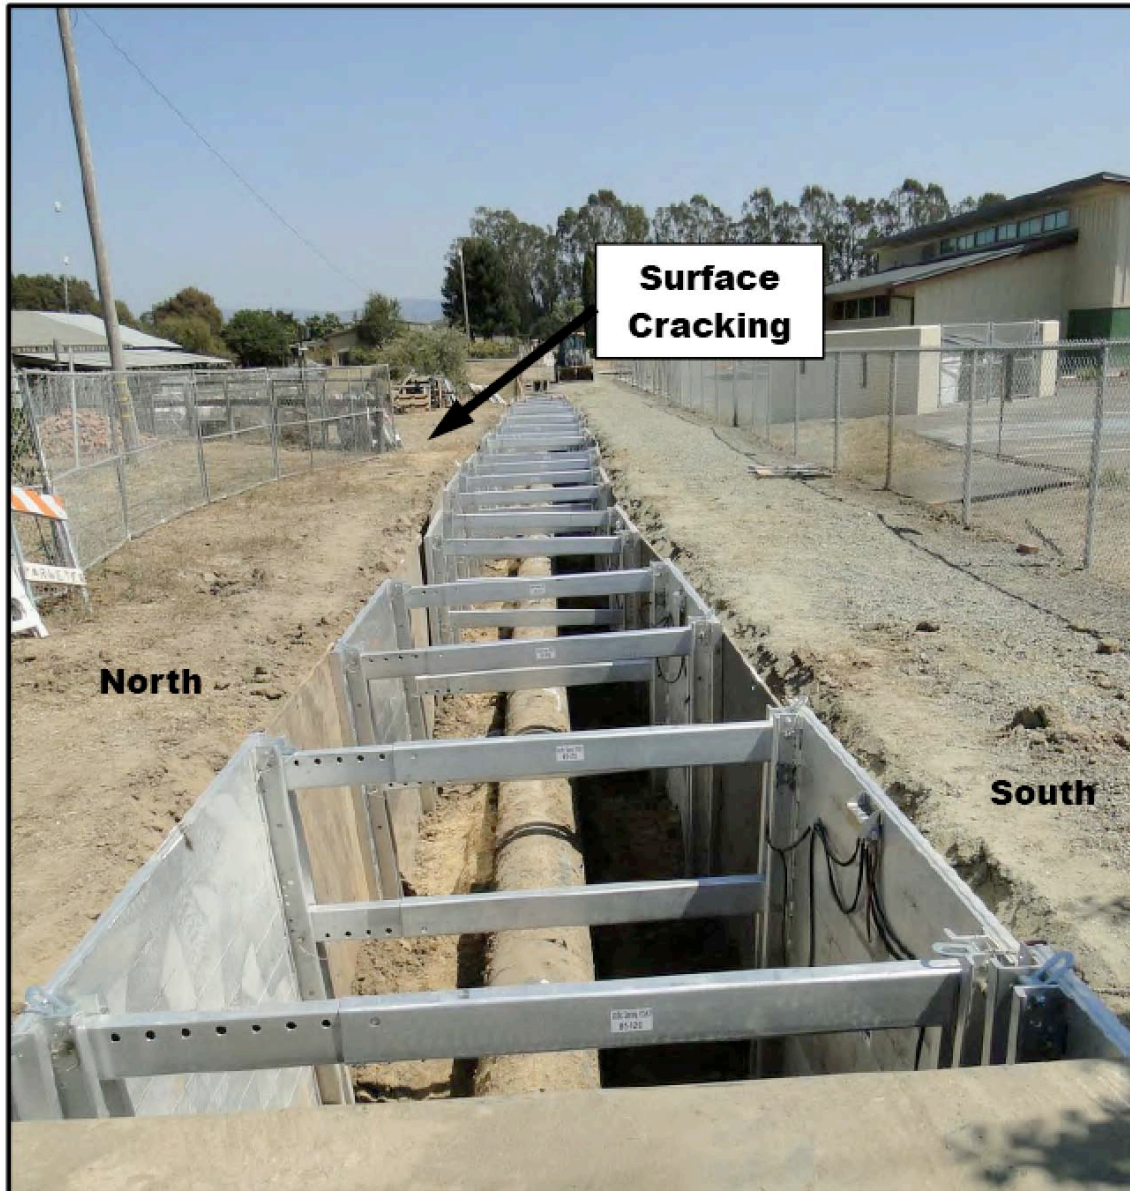
Figure 8-2. PG&E Gas Pipe Trench Excavation, Sept 1 2014, Looking East

By September 1 2014, PG&E uncovered and excavated the pipe through the fault zone, Figure 8-2. The excavated pipe (26 inch outside diameter, 0.297 inch wall thickness, Grade X60 steel, double submerged arc welded seam pipe built 1971, with a maximum allowable operating pressure of 450 psig) was uncovered and examined for indications of anomalies on the body and on the weld seam. No initial indications of pipe wrinkling were found to be present; however, the pipeline was cut out for further evaluation and testing. PG&E ultimately replaced about 200 feet of Line 021A through the fault crossing zone, with 26 inch outside diameter, 0.5 inch wall thickness, Grade X65, SAWL pipe.

No visually obvious damage was apparent, even after removing the exterior coating. The cut-out pipe was laser scanned for pipe ovality, and girth welds were radiographed and UT phase array inspected for anomalies. As of writing this report, preliminary results conclude that no major integrity concerns were identified such as wrinkling or bending of the pipe.

This replacement pipe is thought to be more robust than the original pipe, in that it has a lower D/t ratio making it more resistant to buckling due to future fault offset; and of course, is installed in a stress relieved state, whereas the 1971-vintage pipe was already loaded due to the fault offset in 2014.
