South Napa M 6.0 Earthquake of August 24, 2014

John Eidinger – G&E Engineering Systems

Revision 2

March 12, 2016

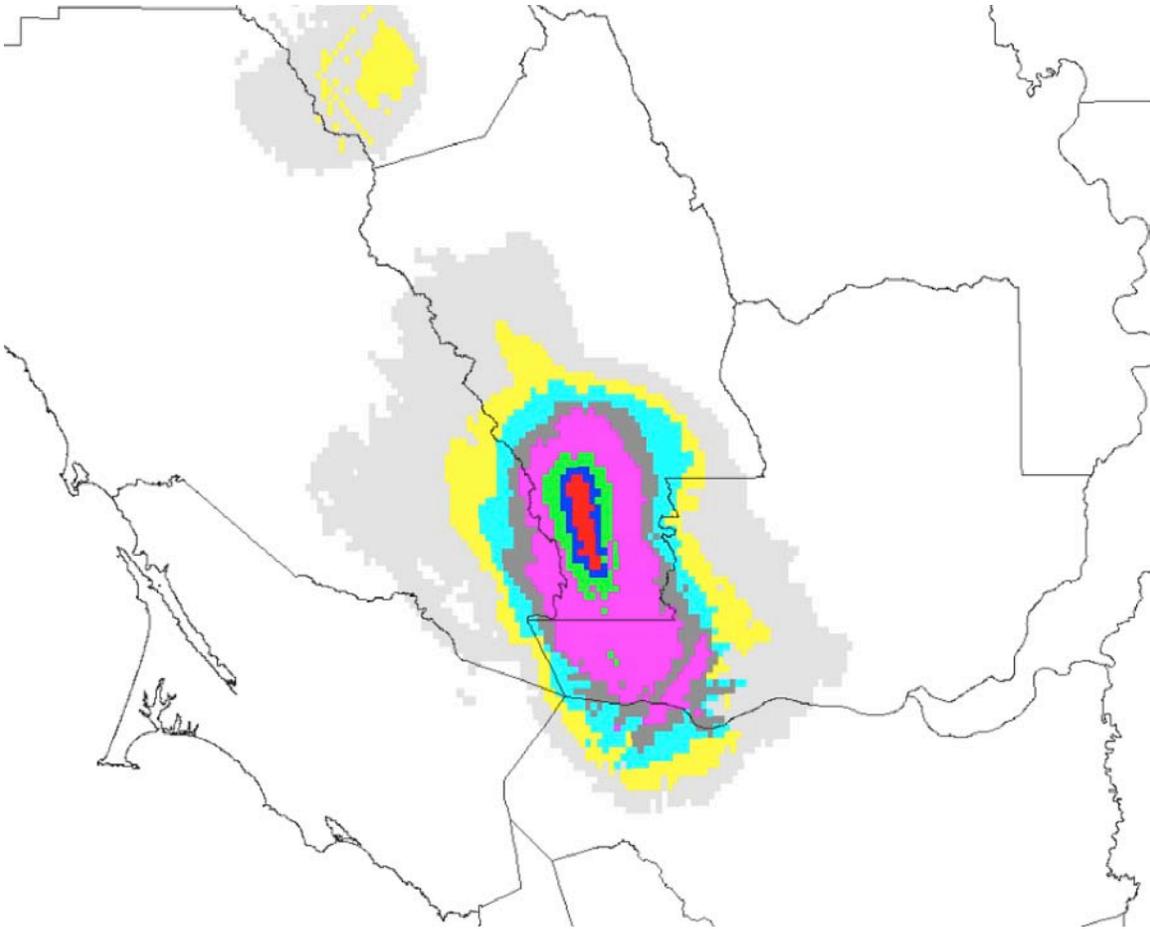
Figure 2-2b. Place Names and Populations, SERA ShakeMap-4 (PGA)

Comparing versions 3 and 4 maps, there is generally little differences. However, as noted before, one anomalous instrument value greatly distorts the true PGA map for Vallejo and points south.

Therefore, the PGA ShakeMap in Figure 2-2b is almost certainly much too high in the areas around Vallejo and points south.

It is recommended that future versions of ShakeMaps for important earthquakes (M 6 and larger near population centers) be peer reviewed, and anomalous instruments be removed from the production of the ShakeMaps.

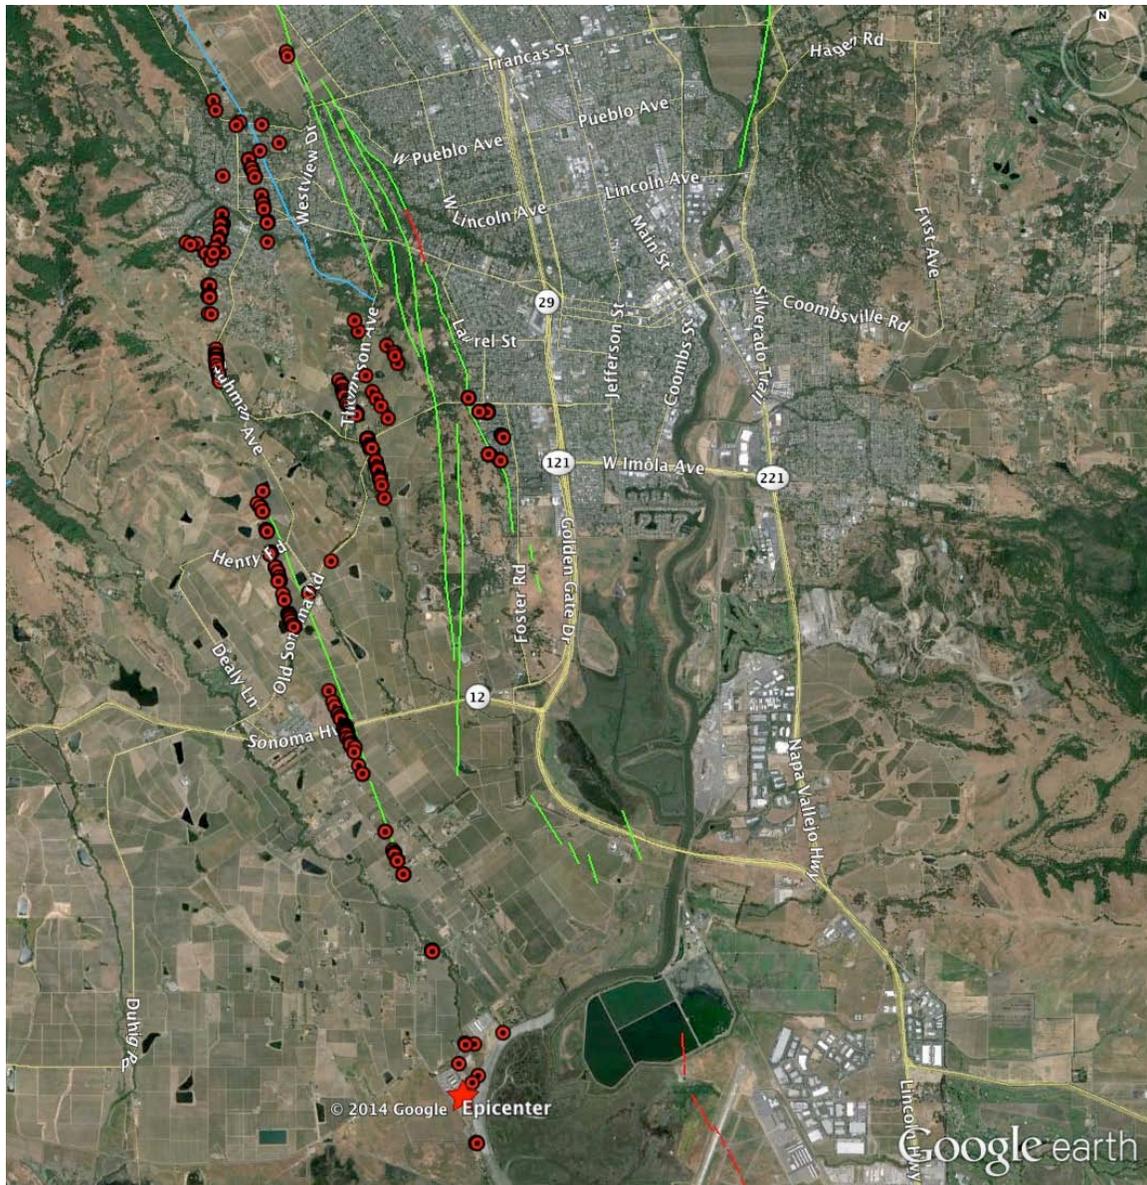
Surface faulting occurred at many locations to the west of downtown Napa. Figure 2-19 shows a map that highlights the prior mapped locations of lineaments in the West Napa fault zone (yellow and blue lines) and field observations of surface faulting (red dots). This map shows information available to the USGS by August 26 2014 (2 days post-earthquake).

David Schwartz of the USGS reports that the locations of surface faulting (red dots in Figure 2-19) do not correspond closely to the prior mapped locations of the West Napa fault (yellow lines in Figure 2-19).

Figure 2-19. Map of Surface Faulting Observations (Red Dots)

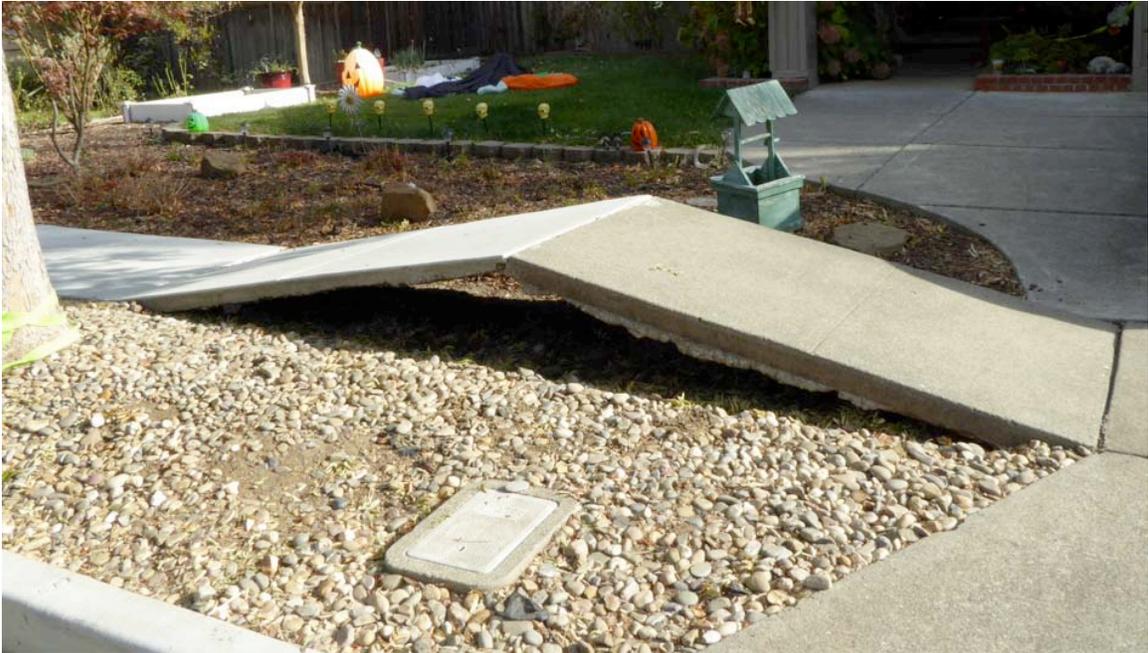
Figures 2-20 and 2-21 show buckled sidewalks at two of the fault crossing locations (red dots in Figure 2-19). These figures show two of many such sidewalk buckles in the west part of Napa near Meadowbrook Drive. In this area, there were about 8 streets, running nearly perpendicular to the strike of the fault. At each street, there was commonly one or two sidewalk buckles (one each side of the street), and if one maps the location of the buckles, one gets a more-or-less straight line of red dots, as shown in the top left part of Figure 2-19. Inspecting these buckles, one observes that there was some right lateral movement, as well as possibly some thrusting movement at the surface, resulting in net compression in the sidewalk slabs. This compression then results in the uplift of two adjacent concrete slabs as seen in Figures 2-20 and 2-21. Underneath the ground, the ground movements are also applied to buried water pipes, wastewater sewers, and natural gas pipes, and the impacts on these buried lifelines will be described later in this report.

Figure 2-20. Buckled Sidewalk at Fault Offset Location

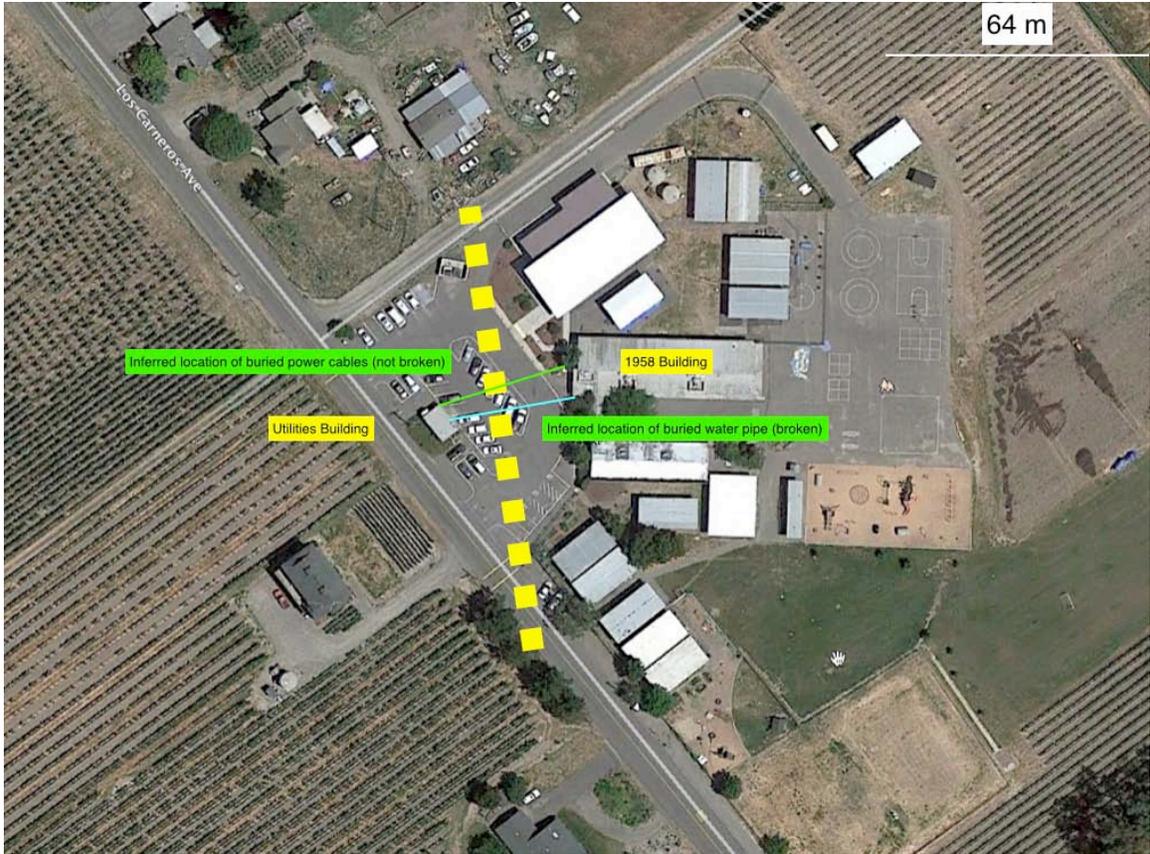
Figure 2-23 shows a close up aerial view of the area in the highlighted box in Figure 2-22. In Figure 2-23, the thick dashed yellow line represents the zone with surface faulting. The property is a K – 8th grade school. The building noted "1958" building is one of the primary classroom buildings, and the oldest at the site.

We measured the width of the fault zone with observed ground failure at about 35 feet wide. The thick dashed line represents the strike of the faulting, but the actual cracks were en-echelon in nature, with most of the larger cracks oriented somewhat clockwise from the strike of the thick yellow dashed line. The cracks are very clear in the road (Los Carneros Avenue) and in the asphalt-paved parking lot of the school. To the west is a small "utilities building" housing switchgear (from the overhead PG&E distribution line along Los Carneros Avenue) as well as water quality equipment to treat water from the school's well.

Figure 2-23. Aerial View of Fault Zone

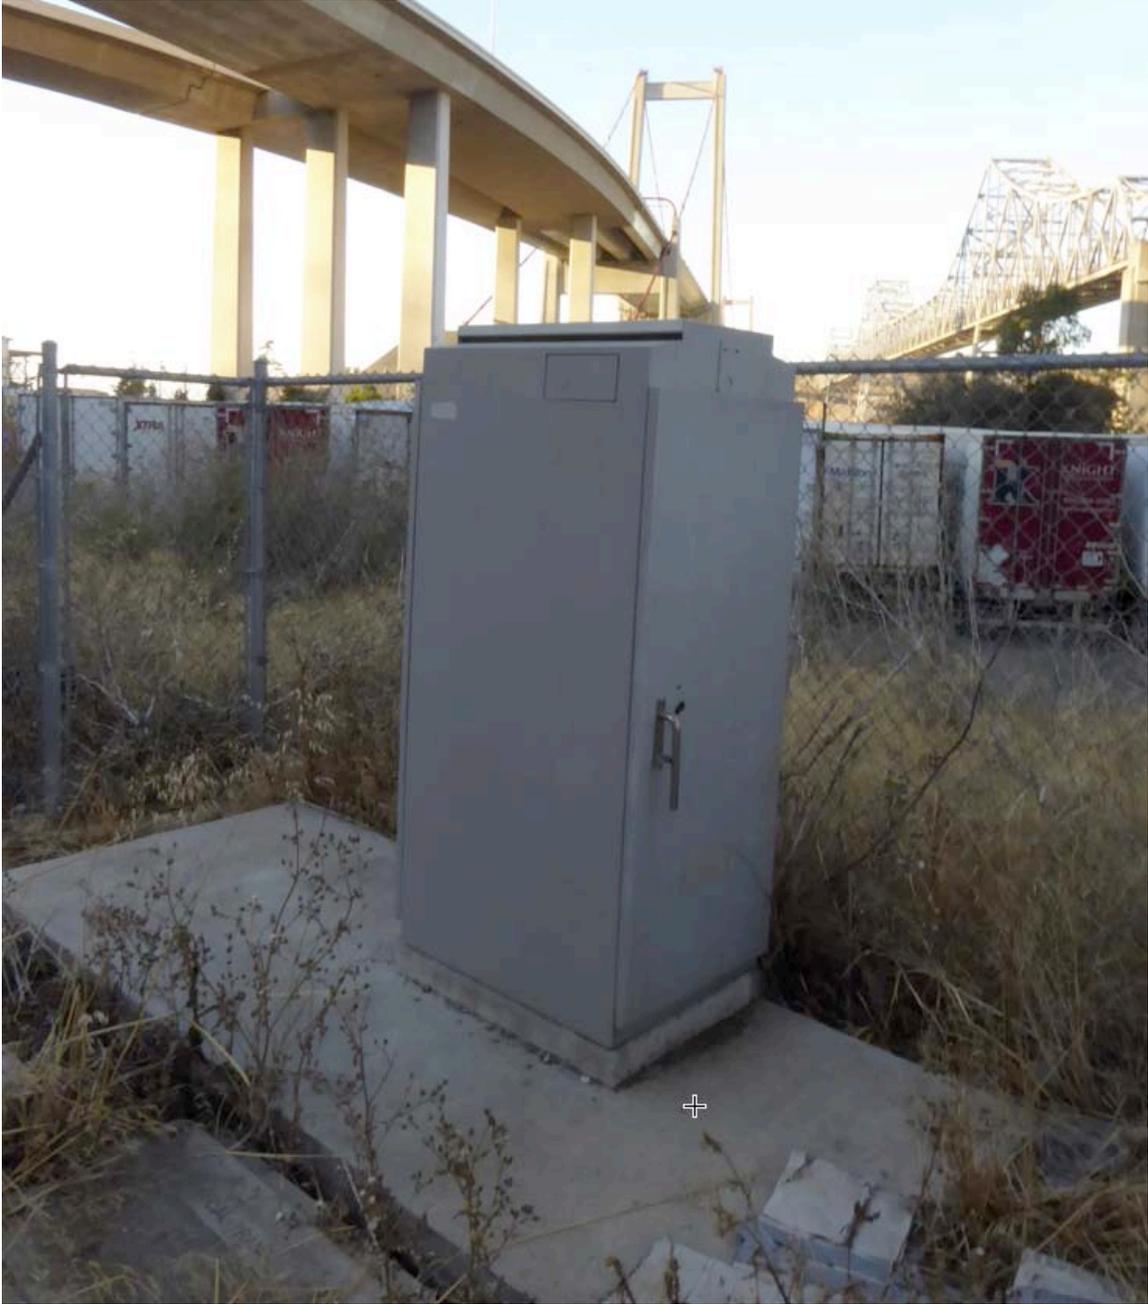
- Figure 2-30. This photo shows the instrument CE.68259 with the Carquinez bridge in the background. The photo is taken looking northwards, and the new Carquinez bridge (suspension bridge designed by Mark Ketchum) is on the left, and the older Carquinez bridge (cantilever truss type) is on the right.
- Figure 2-31. This photo shows instrument CE.68026, and Charles Scawthorn (left) and John Eidinger (right). The large reinforced concrete piers of the older highway bridge are in the immediate background. These piers are very tall, and support the bridge. The distance of the piers to the instrument is similar to the distance from the ground to the bridge deck.

Figure 2-30. Instrument with New (Left) and Old (Right) Carquinez Bridges in Background

Are these instruments Free Field? USGS assumes that these instruments are Free Field instruments, meaning that their recordings are not materially influenced by nearby structures. Examining Figures 2-30 and 2-31, this assumption is likely not valid. The massive bridge supports are very close to the instruments. As the bridges moved in the earthquake, they would impart into the ground very high reaction forces. It is possible that during the earthquake, that hinge-type connections in the bridges opened / closed, or similar phenomena, leading to some high frequency shocks. The very high recorded

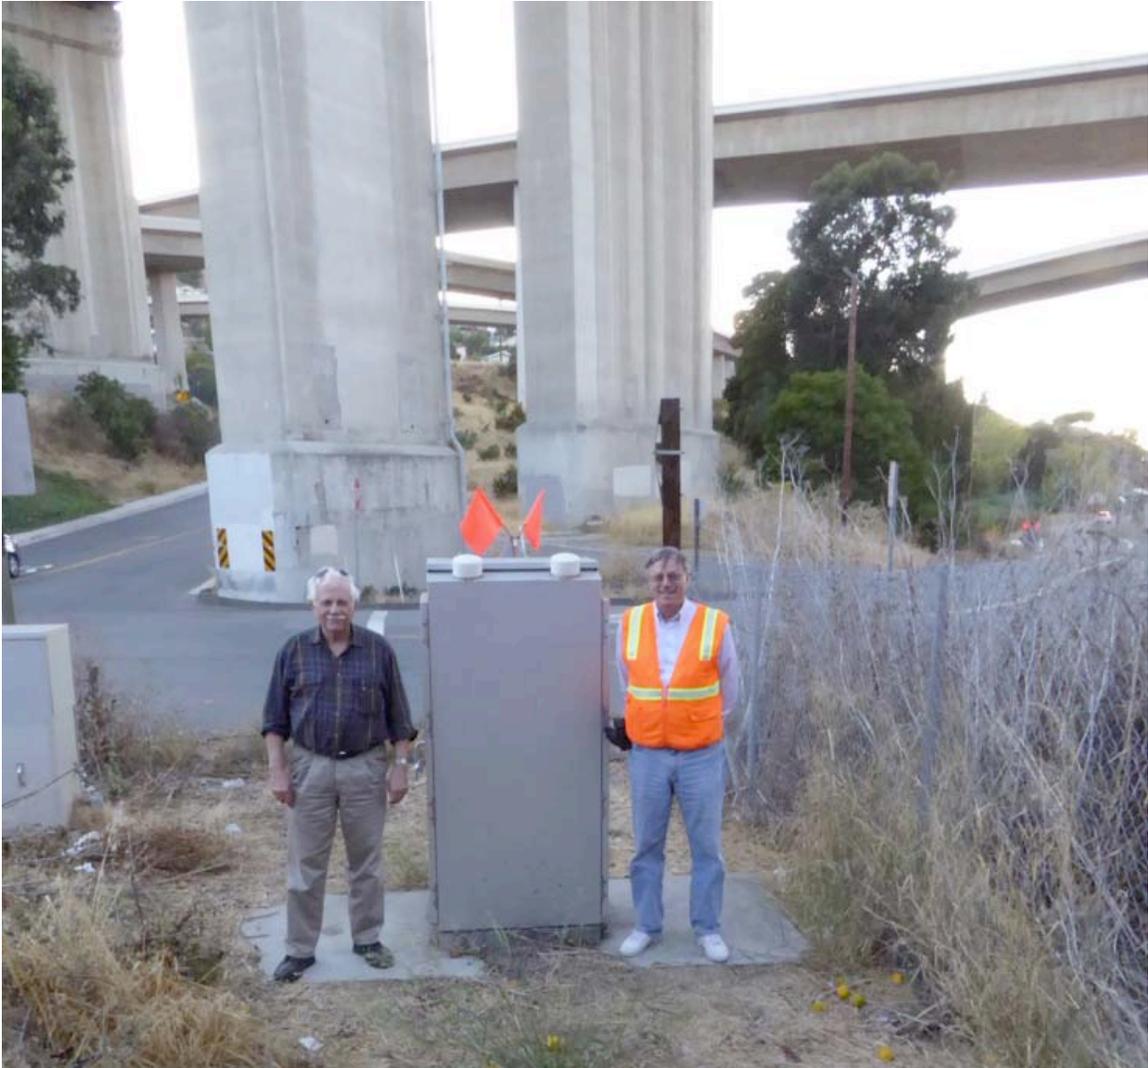
Figure 2-31. Instrument under old Carquinez Bridge with Scawthorn (left) and Eidinger (right)

motions at PGA / SA ($T=0.3\text{sec}$) are not reflected in the longer periods. This suggests that some type of "impact" forces in the bridge foundations are what the instruments are recording, and not the true free field motion. Further, if one uses commonly accepted attenuation models, the median PGA levels at these two instrument sites should have been about 0.1g or so; whereas one instrument recorded 0.97g (nearly 10 times higher than median expected). If one assumes sigma (total ground motion) of about 0.4 for PGA, then dispersion the 0.97g value is 5.7 standard deviations above the median. There is very little chance that this could have happened due to normal variations in free field ground motions.

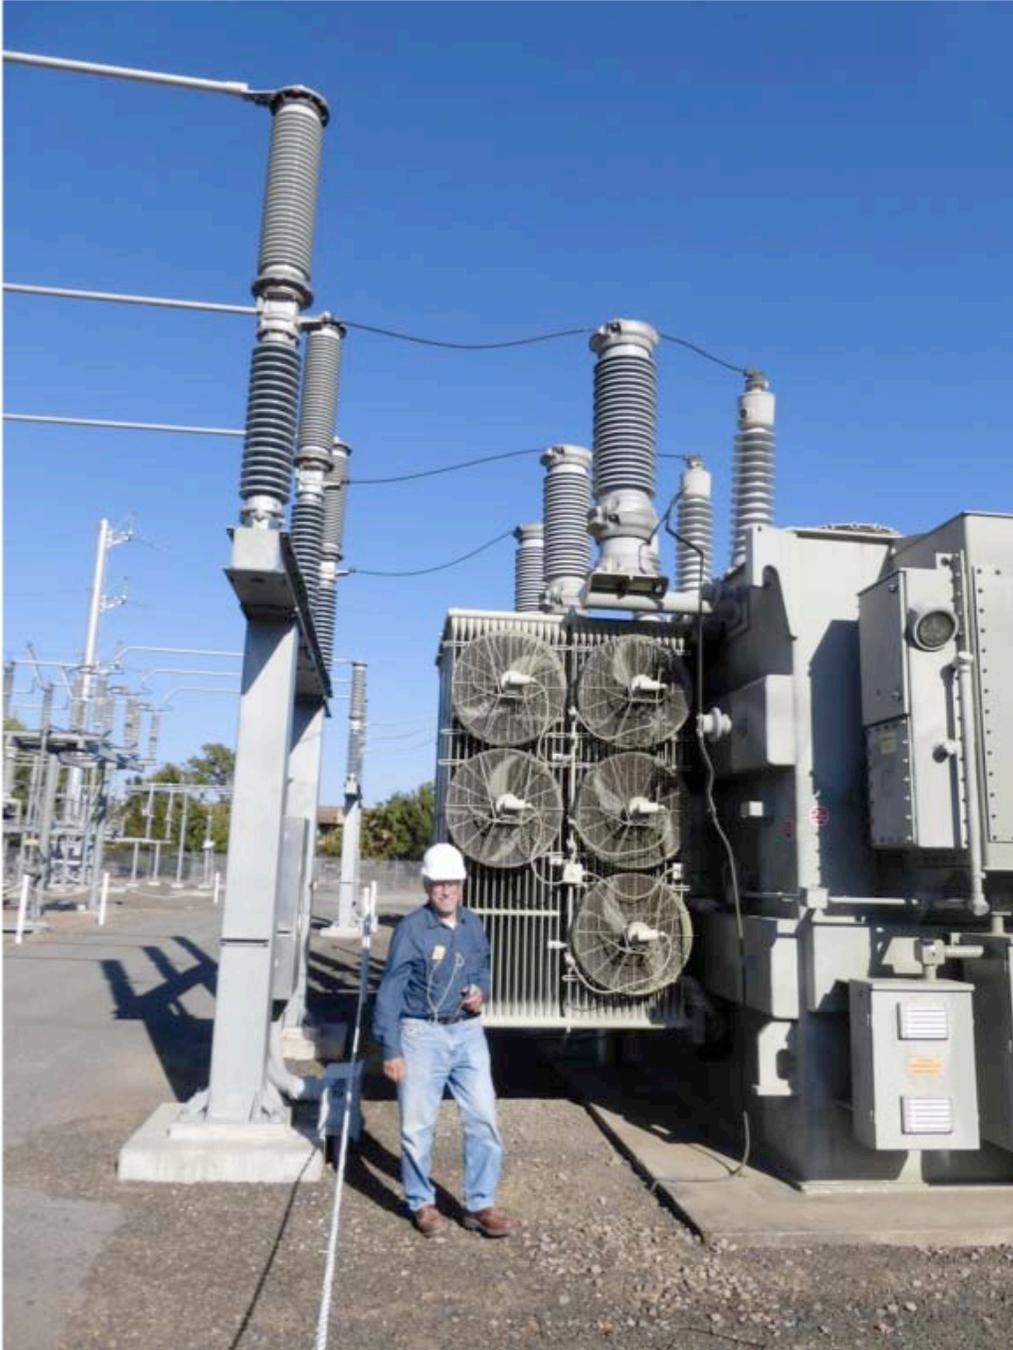
- Buildings. One precast concrete building suffered slight damage to the roof diaphragm. The building remained operational.
- Power transformers. 2 power transformers (installed pre-1980) had minor leaks of oil from radiators. Some of this leakage might have been pre-earthquake. The affected radiators were very flexible (first mode frequency from 2 to 3 hertz). All newly installed transformers had much stiffer radiators and no leaks. There was no damage to bushings (all porcelain) or surge arrestors (some porcelain, some composite).
- Circuit breakers, disconnect switches, circuit switchers. Nearly every component installed post-1990, with all 230 kV equipment having been seismically qualified to IEEE 693 (high seismic zone). No damage.

Figure 3-2 shows a 1977-vintage power transformer, with Prof Anshel Schiff in the foreground.

Figure 3-2. Power Transformer

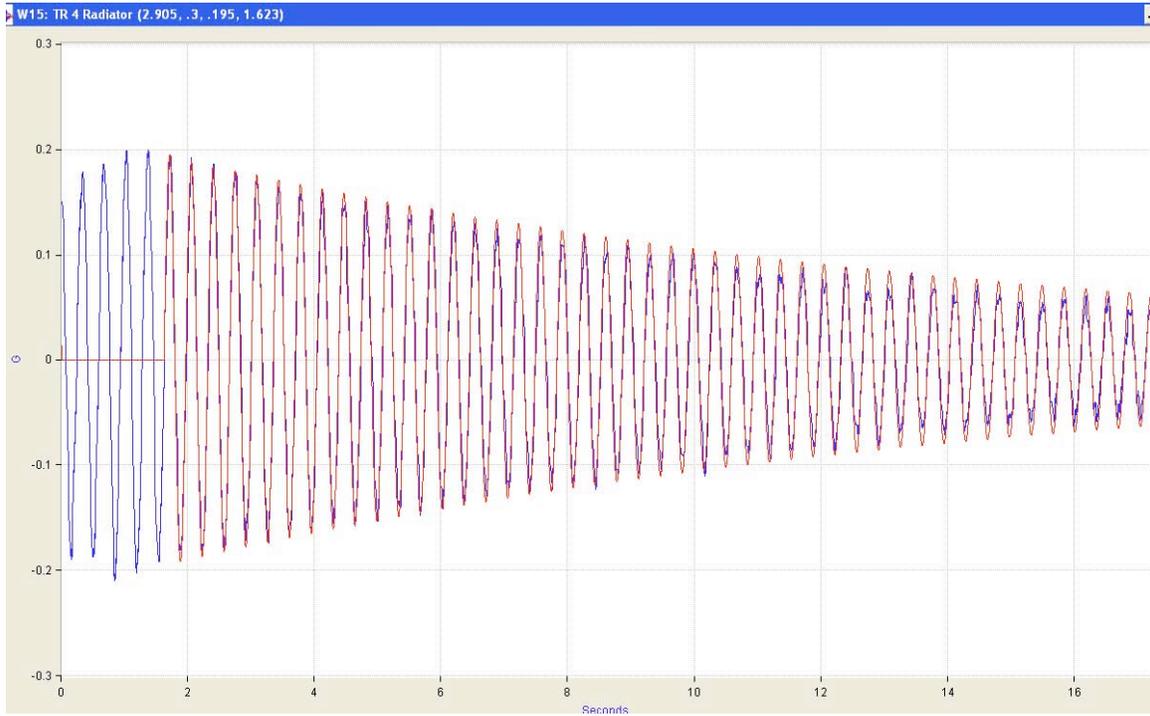
Figure 3-3 shows the time history of response of the radiator. The forced vibration response is seen on the left (increasing blue line) and the free vibration response is shown on the right (two lines, with the blue line being the recorded motion, and the second line being a fitted sine wave motion attempting to match the response). From the matched sine wave, the best-fit first mode frequency is 2.905 hertz with 0.3% damping.

Figure 3-3. In Situ Test Vibration Response of Radiator (A. Schiff)

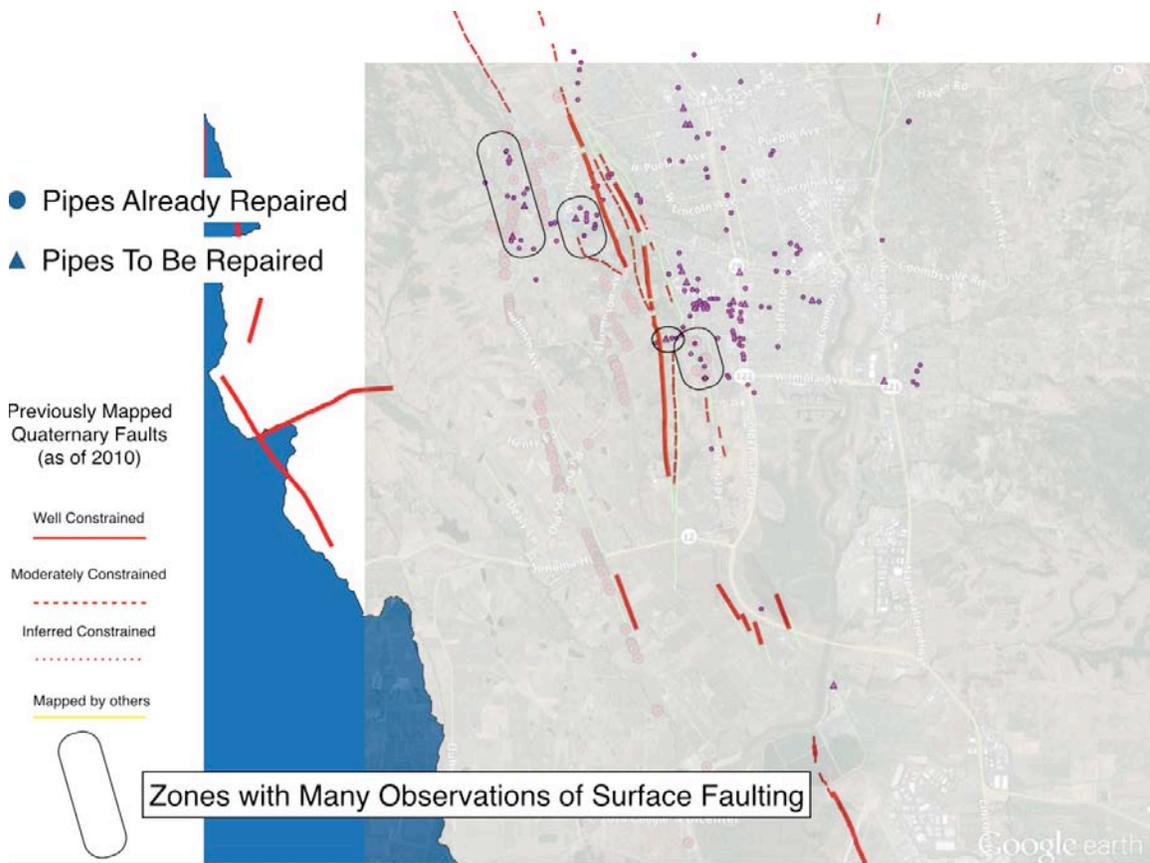
Figure 4-5 shows an overlay of pipe repairs (blue symbols) with the pre-earthquake location of mapped faults (red lines), along with zones subjected to surface faulting (black elongated zones). This map shows the pipe repair count as of September 2014, when it was 160.

Figure 4-5. Overlay of Water Pipe Repairs and Zones with Surface Faulting

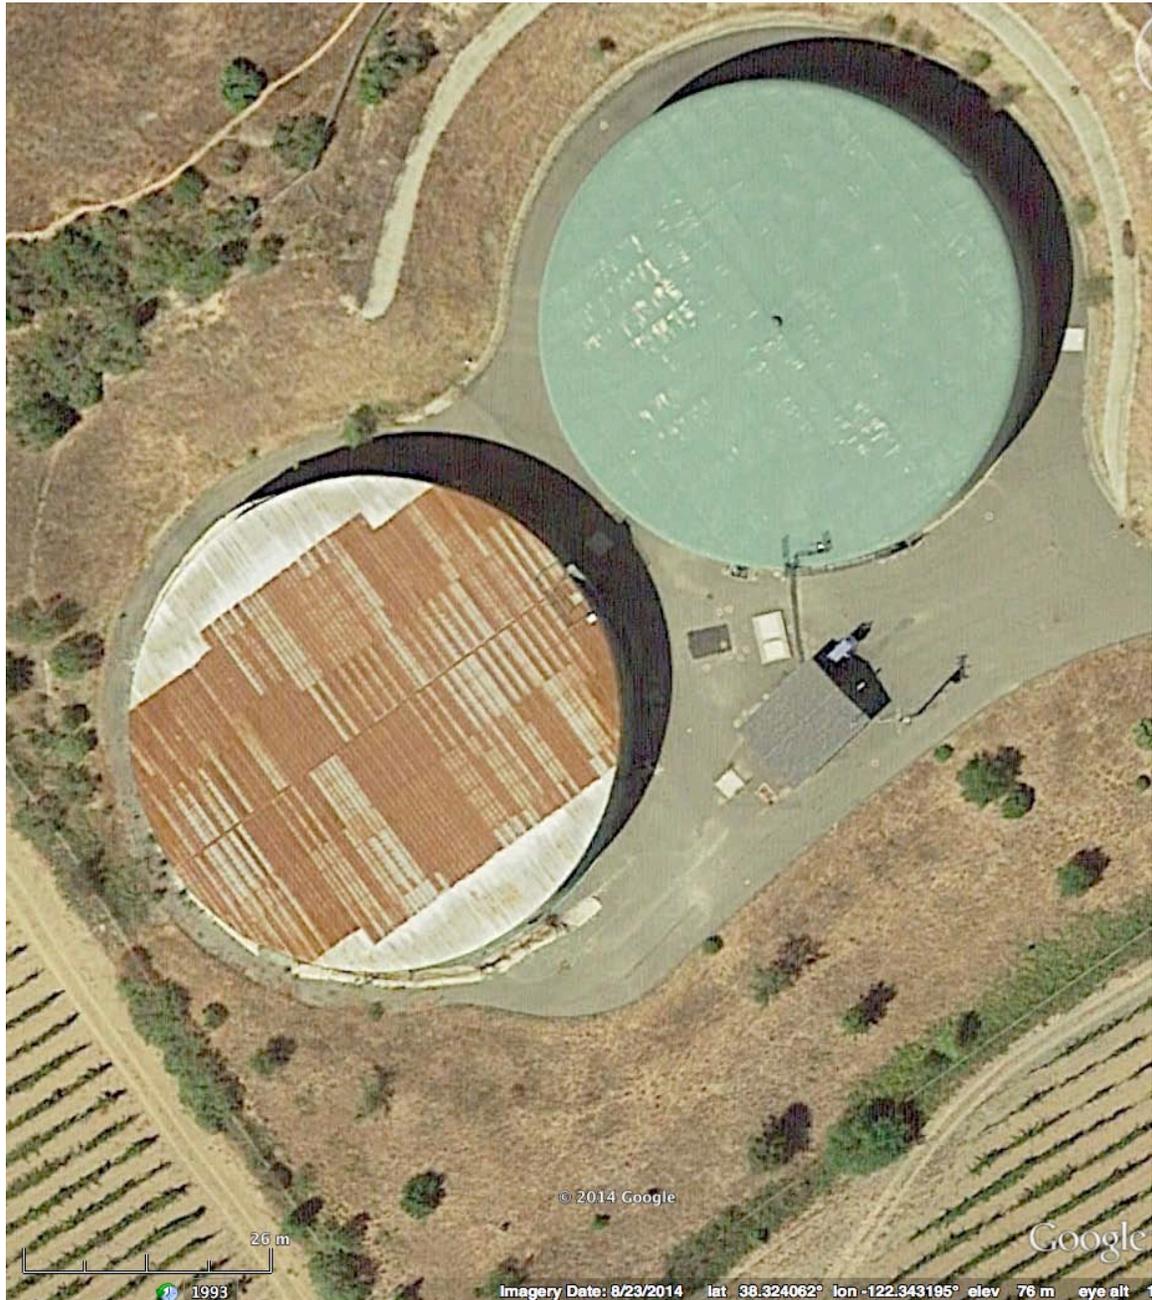
Figure 4-12 shows two other steel tanks in the Napa water system, photo image dated August 23, 2014 (one day before the earthquake). These tanks are in the northwest part of the city, PGA ~0.3g to 0.4g. The tank in the lower left has a corrugated steel roof, but had been taken out of service some time before the earthquake, and thus had no water in it. The tank on the right was in service at the time of the earthquake, and initial exterior inspection suggests no damage.

Figure 4-12. Two Tanks (38.2341, -122.3432)

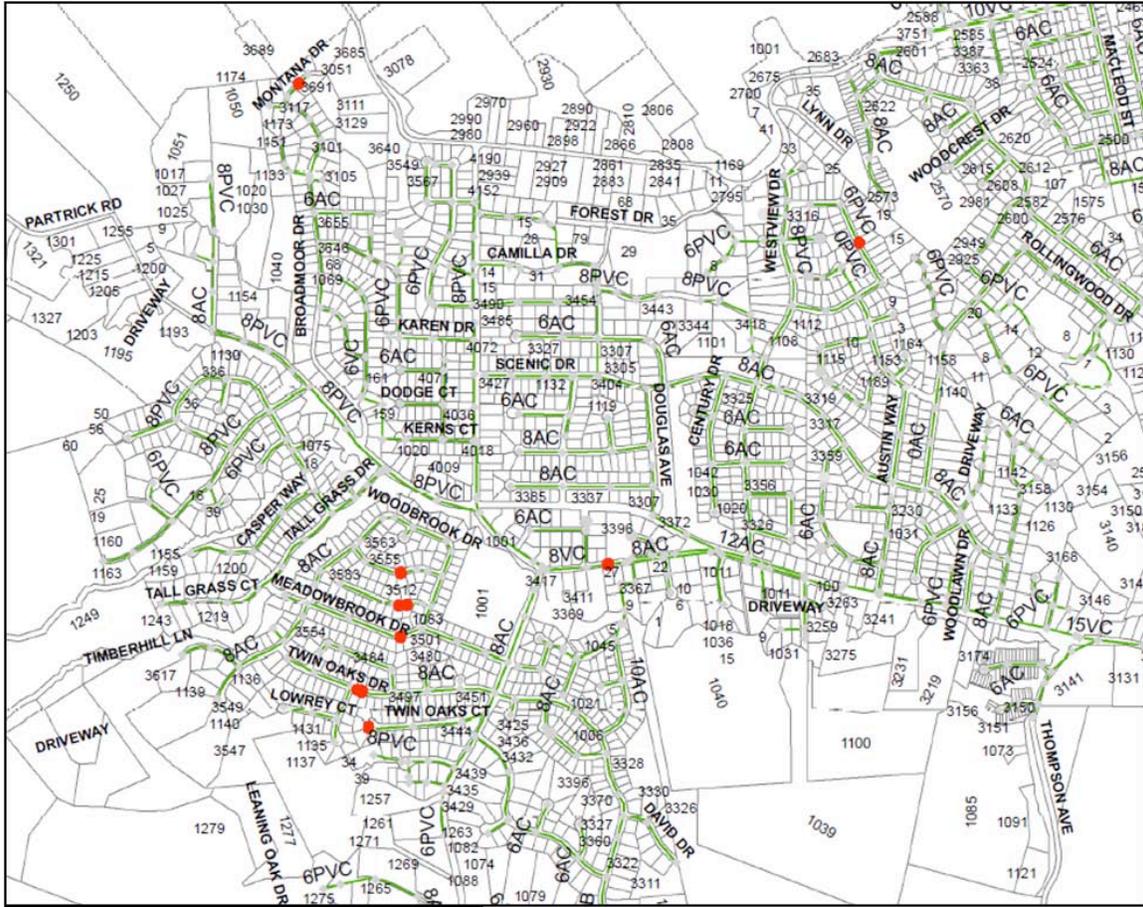
Figure 4-19 shows the locations of the sewer line breaks where repairs were made shortly after the earthquake (red dots). The red dots near Meadowbrook are all nearly coincident (within about 100 feet or so) with observed surface faulting.

Figure 4-19. Location of Sewer Breaks

Through September 15, 2015, NSD reported 11 breaks (possibly 13?) in sewer mains (all AC). Of these breaks, 9 were along the fault trace, and 2 were due to washouts from nearby water main breaks.

The typical repair strategy across the fault was to insert a PVC-type bladder within the broken pipe, then inflate and set the bladder. NSD reports that this effort was successful.

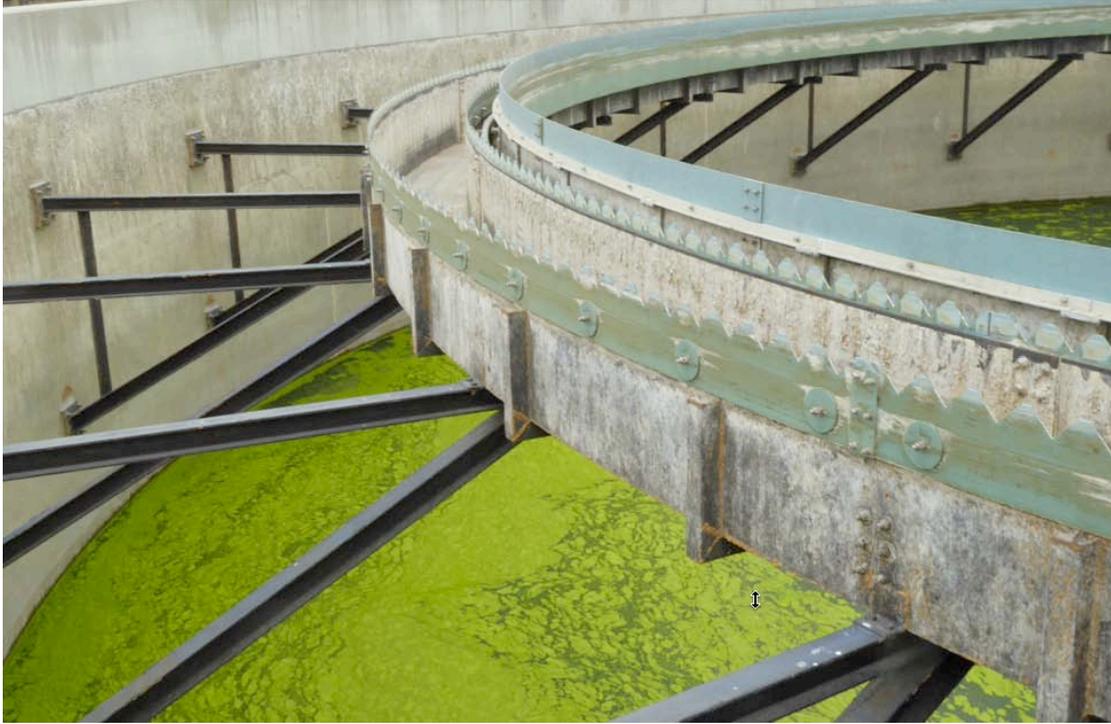
In Figure 4-22, the heavy steel bracing for the water trough is seen. The water level in this clarifier at the time of the earthquake corresponds to the water (with algae, etc.) seen in this photo. A complete drain of this tank had not been done within 7 weeks of the earthquake; but as the water level was very low at the time of the earthquake, it is not expected that there would have been any damage to the central tower due to unbalanced water loading due to the sloshing effects.

Figure 4-22. Empty Clarifier

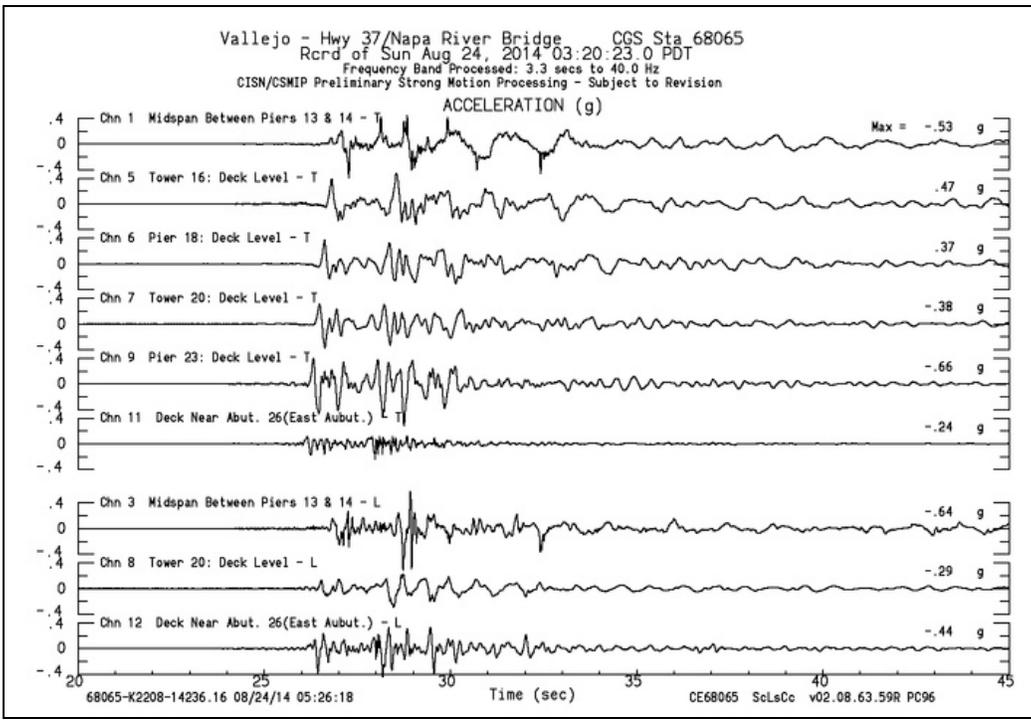
A strong motion instrument downhole array⁴ was installed at the bridge, which recorded 0.2g acceleration, 19 cm/s velocity, and 2 cm displacement at the ground surface. The bridge was also instrumented (see Figure 5-7) with accelerometers between piers 13 and 14 at the crest of the bridge, which recorded 0.53g acceleration and 14.7 cm (about 6 in transverse) of displacement (Figures 5-8 and 5-9).

Figure 5-8. Acceleration Records on Napa River Bridge on Route 37

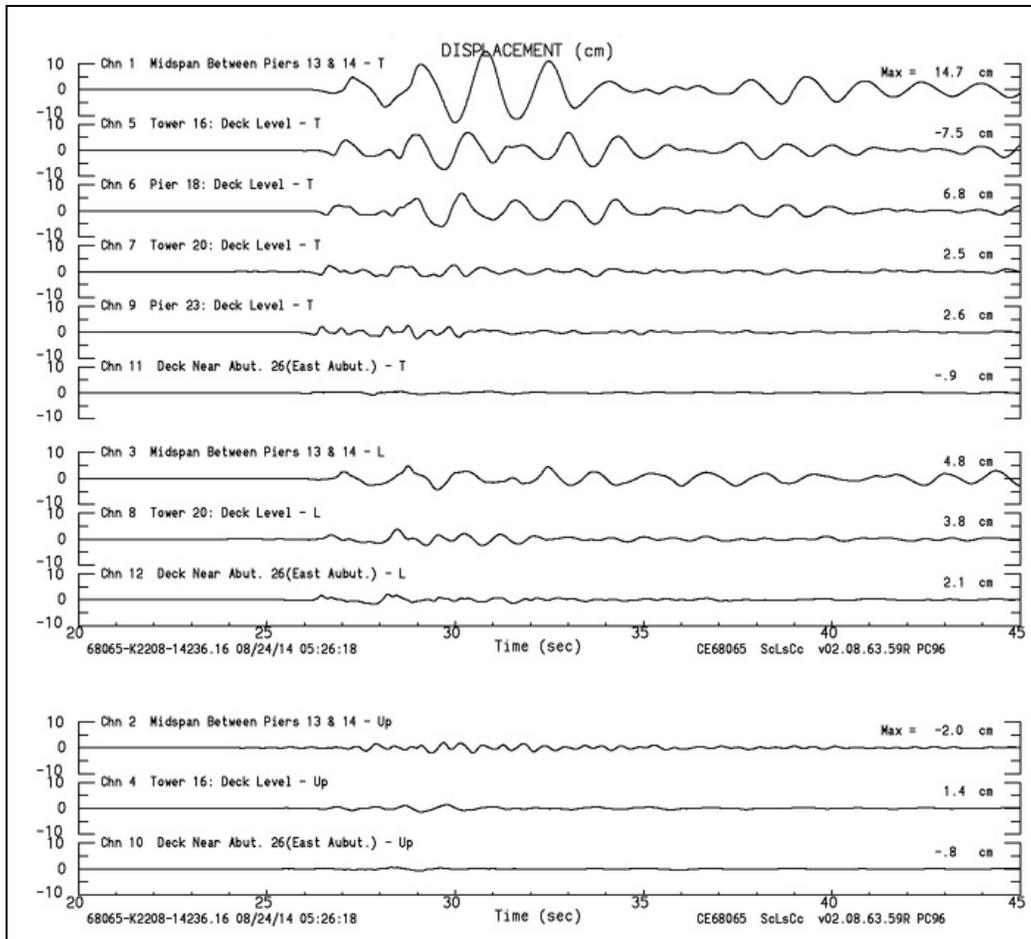
Figure 5-9. Displacement Records on Napa River Bridge on Route 37

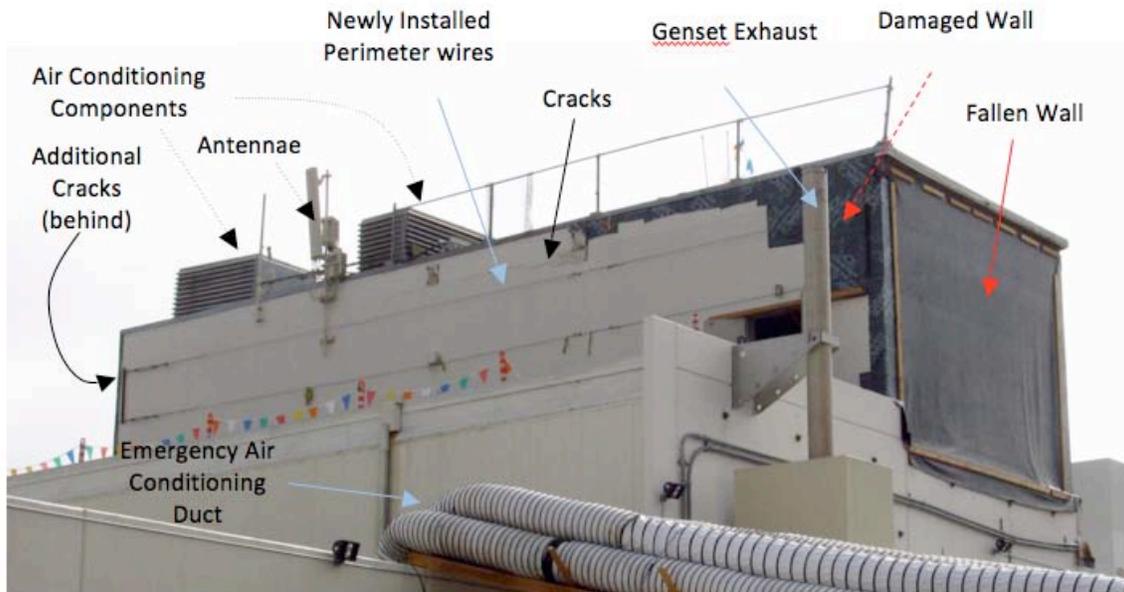
Figure 6-1. AT&T Building on Clay Street, Napa

Figure 6-2. AT&T Building on Clay Street, Napa

The ATT building on Clay Street in downtown Napa was damaged, Figures 6-1, 6-2.

The concrete wall panel that has been displaced was apparently a "knock-out" type panel, to allow for future expansion of the facility. The panel was attached to the rest of the building using eight angles, bolted to the panel and to the building (Figure 6-4). Apparently, shaking of the building resulted in excessive forces on the bolts, and the connections failed, allowing the panel to fall.

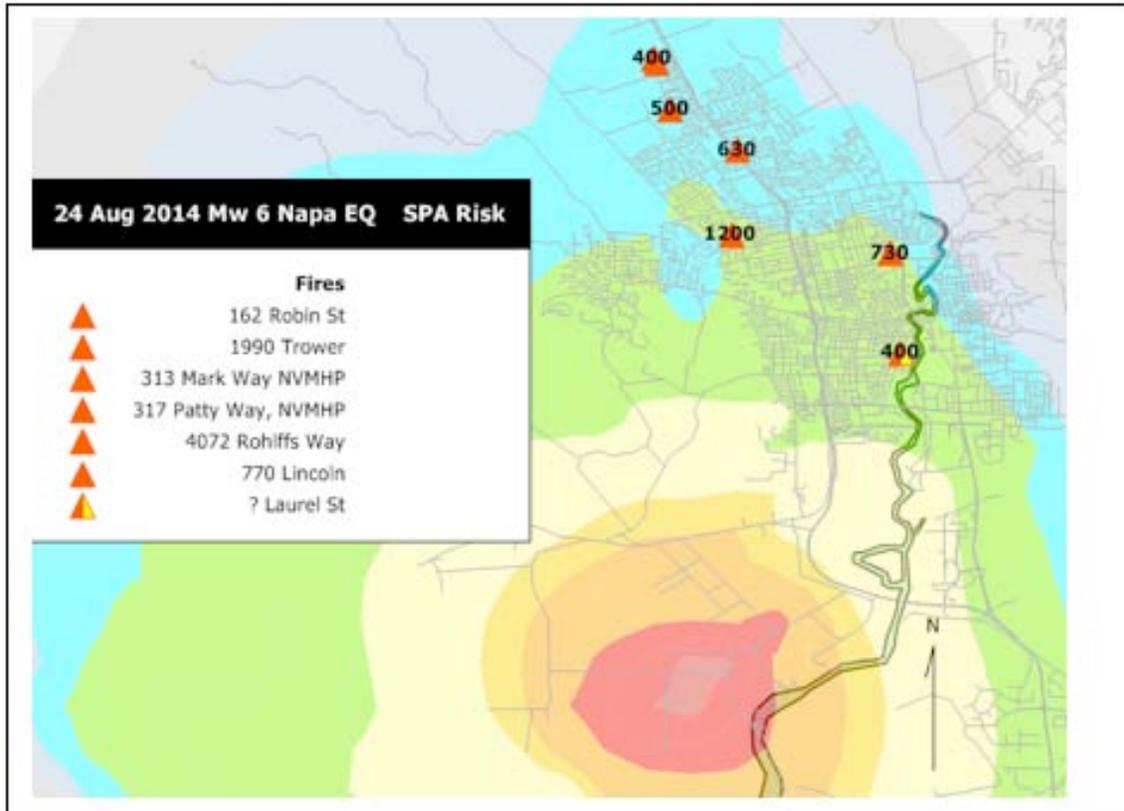
Figure 7-1. Location of Fires in Napa, with Overlay of ShakeMap (v1)

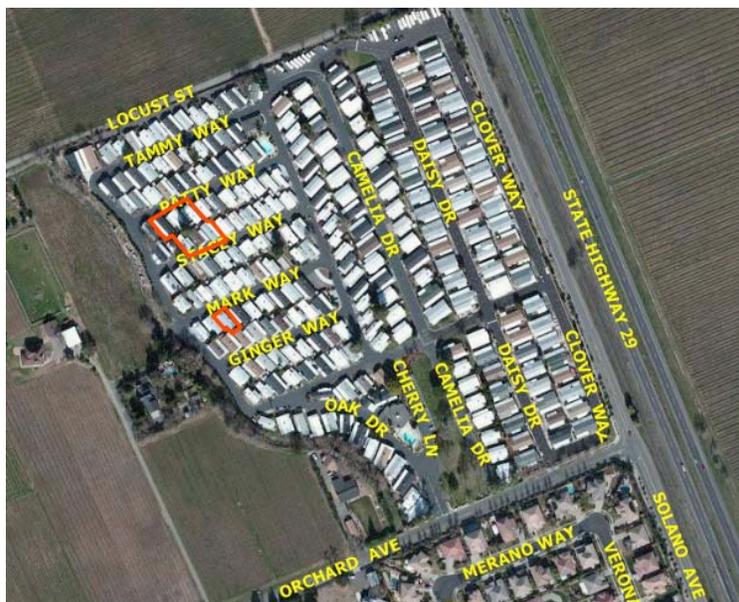
Orchard Ave Fire: This was the largest fire in the earthquake. First dispatch was of T1 to a report of gas odor but en route T1 observed a fire in the Napa Valley Mobile Home Park (NVMHP) off of Hwy 29 at Orchard Road, and diverted to this incident. T1 encountered a broken water main spewing water at the entrance to the NVMHP on Orchard Road, and proceeded to enter the NVMHP. T1 then encountered a single structure fire at 313 Mark Way – the structure was 50% involved; they also observed a second fire at 317 Patty Way, which was 100% involved and impinging on neighboring buildings, see Figure 7-2. Wind conditions were calm.

Figure 7-2. NVMHP Park and locations of fires, 24 Aug 2014 S. Napa M_w 6.0 Earthquake (damaged buildings outlined in red)

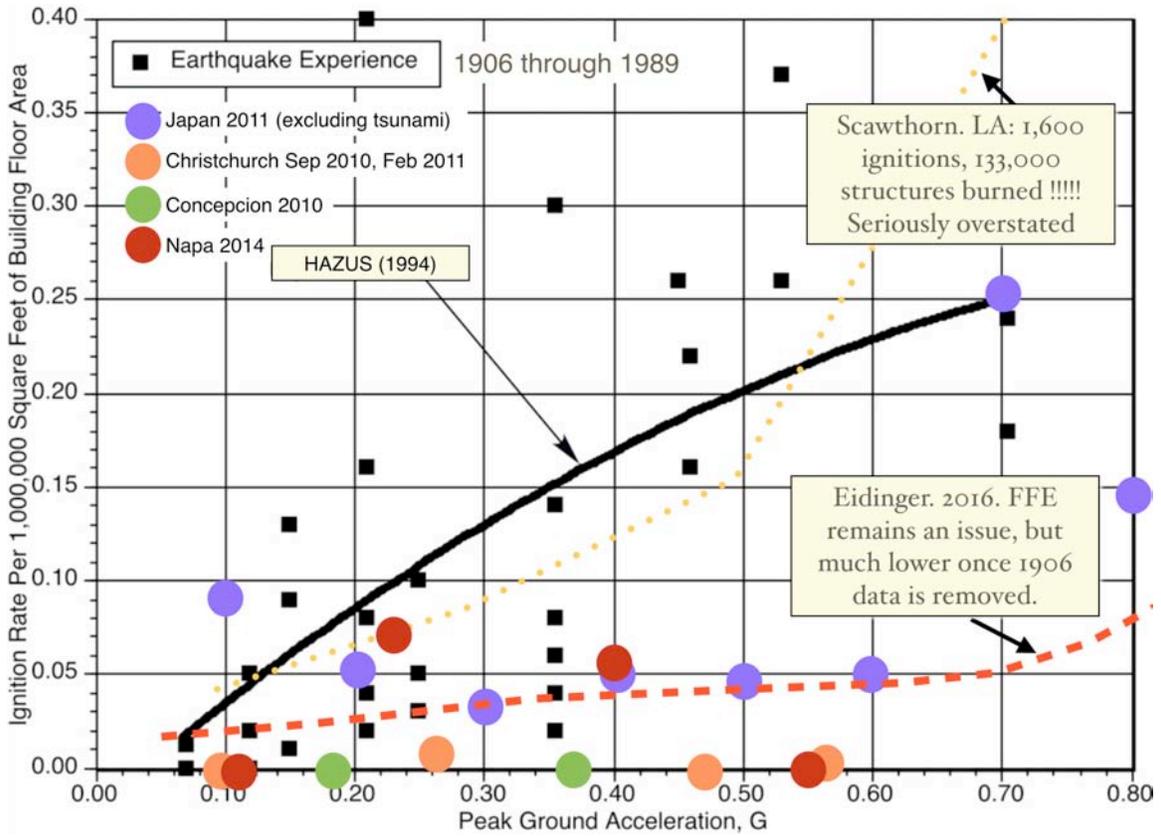
Figure 7-3 shows the fire ignition rate from the Napa earthquake along with fire ignition rate data from other recent earthquakes, and various models that correlate the ignition rate versus input PGA. It is apparent that the Scawthorn model, which relies heavily on the 1906 San Francisco earthquake ignition data, is no longer useful; this reflects that coal- and other fuel fired-cooking over open hearths in brick buildings, and vulnerable gas pipelines, is no longer the norm in most of California (or for that matter, in many other places in the world). If we exclude the data from prior earthquakes where building damage was primarily in unreinforced masonry buildings (1906 SF, 1983 Coalinga, Long Beach 1933, Santa Clara 1906 (four of the black squares located above the solid black line HAZUS model in Figure 7-3), which is included in the HAZUS model and the Scawthorn model), and include the data from recent 2010 – 2014 earthquakes, the lower ignition model (red dashed line) appears to better represent the modern world. The number of structures ultimately burned down is highly dependent on wind, the availability of water, and the availability of enough fire department engines and crews to control many simultaneous fires (Eidinger, 2004). It would appear that modern building (and cooking, etc.) practices have reduced the fire ignition rate, which is one factor to reduce the overall number of burned structures. It also appears that in Napa, the modern water system at the time of the 2014 earthquake) was not much better than the water system that served San Francisco in 1906 – the Napa water department (as of 2014) was still "in the dark ages" of no-seismic design for water pipes.

Figure 7-3. FFE Fire Ignition Rate Model

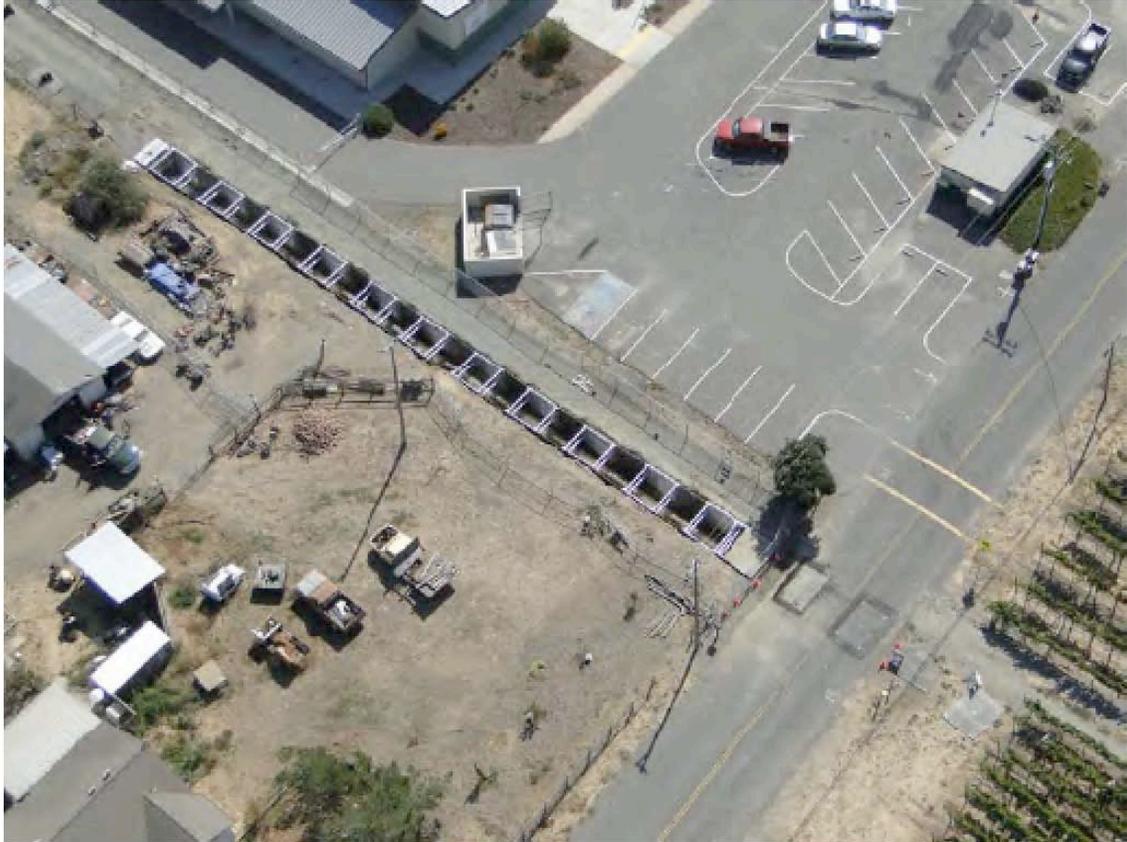
PG&E operates a 26-inch diameter buried gas transmission pipe (Figure 8-1, Line 021A, welded steel) that crossed the fault (across the dashed yellow line in Figure 2-20). The orientation of the pipe would place it into bending and compression due to the right lateral offset of a few inches (including post-event slip). The pipe remained operational (no leak).

Figure 8-1. Location of PG&E Gas Pipe Trench Excavation
