South Napa M 6.0 Earthquake of August 24, 2014

John Eidinger – G&E Engineering Systems

Revision 2

March 12, 2016

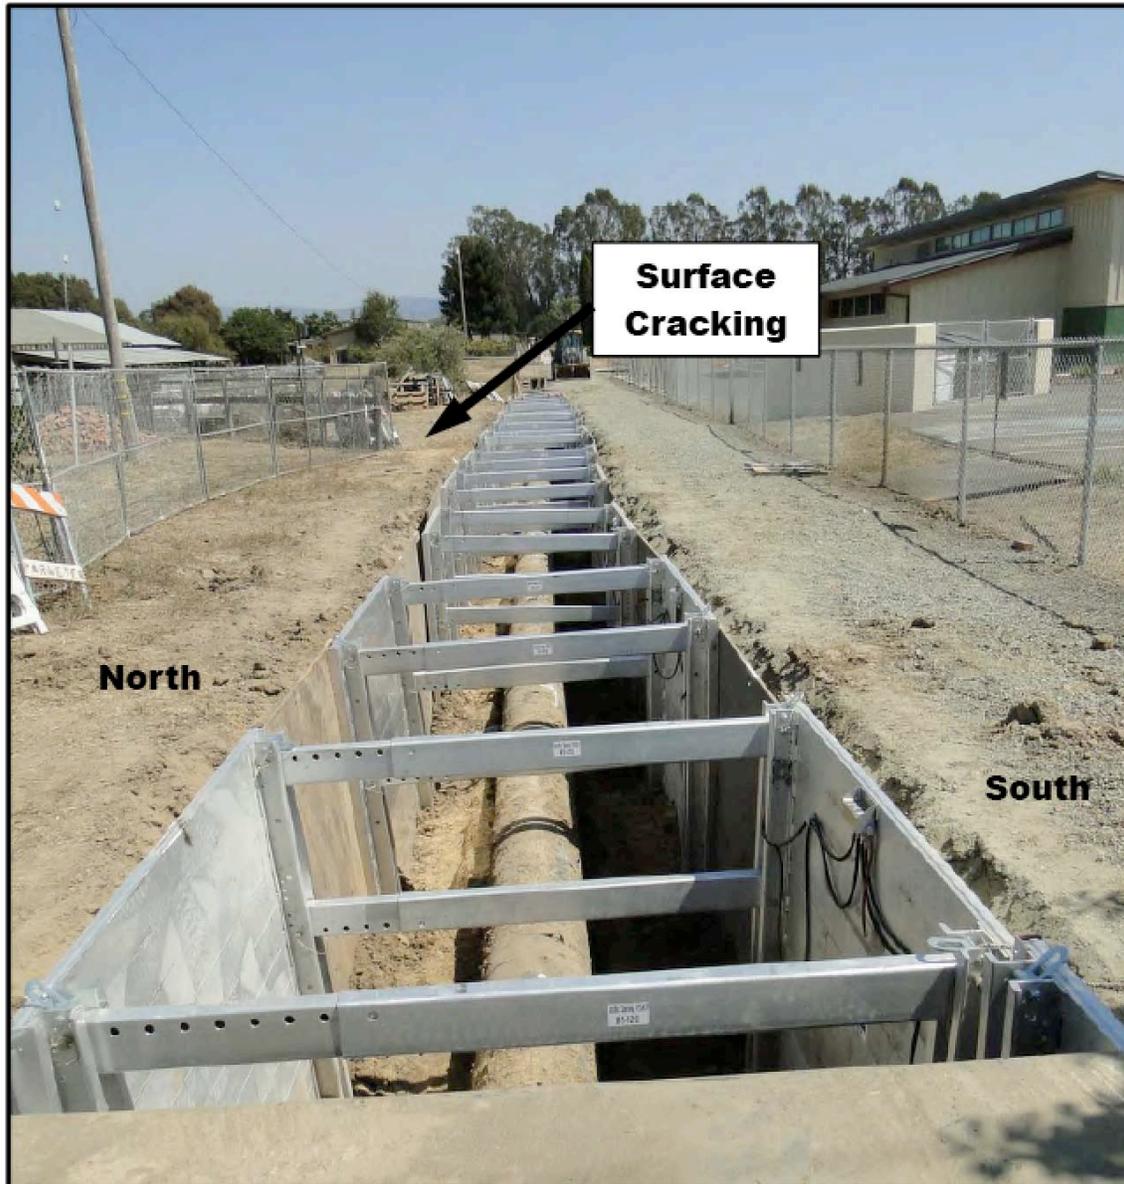
By September 1 2014, PG&E uncovered and excavated the pipe through the fault zone, Figure 8-2. The excavated pipe (26 inch outside diameter, 0.297 inch wall thickness, Grade X60 steel, double submerged arc welded seam pipe built 1971, with a maximum allowable operating pressure of 450 psig) was uncovered and examined for indications of anomalies on the body and on the weld seam. No initial indications of pipe wrinkling were found to be present; however, the pipeline was cut out for further evaluation and testing. PG&E ultimately replaced about 200 feet of Line 021A through the fault crossing zone, with 26 inch outside diameter, 0.5 inch wall thickness, Grade X65, SAWL pipe.

No visually obvious damage was apparent, even after removing the exterior coating. The cut-out pipe was laser scanned for pipe ovality, and girth welds were radiographed and UT phase array inspected for anomalies. As of writing this report, preliminary results conclude that no major integrity concerns were identified such as wrinkling or bending of the pipe.

Figure 8-2. PG&E Gas Pipe Trench Excavation, Sept 1 2014, Looking East

This replacement pipe is thought to be more robust than the original pipe, in that it has a lower D/t ration making it more resistant to buckling due to future fault offset; and of course, is installed in a stress relieved state, whereas the 1971-vintage pipe was already loaded due to the fault offset in 2014.
