South Napa M 6.0 Earthquake of August 24, 2014

John Eidinger – G&E Engineering Systems

TCLEE No. 1

March 2016, Updated April 2017

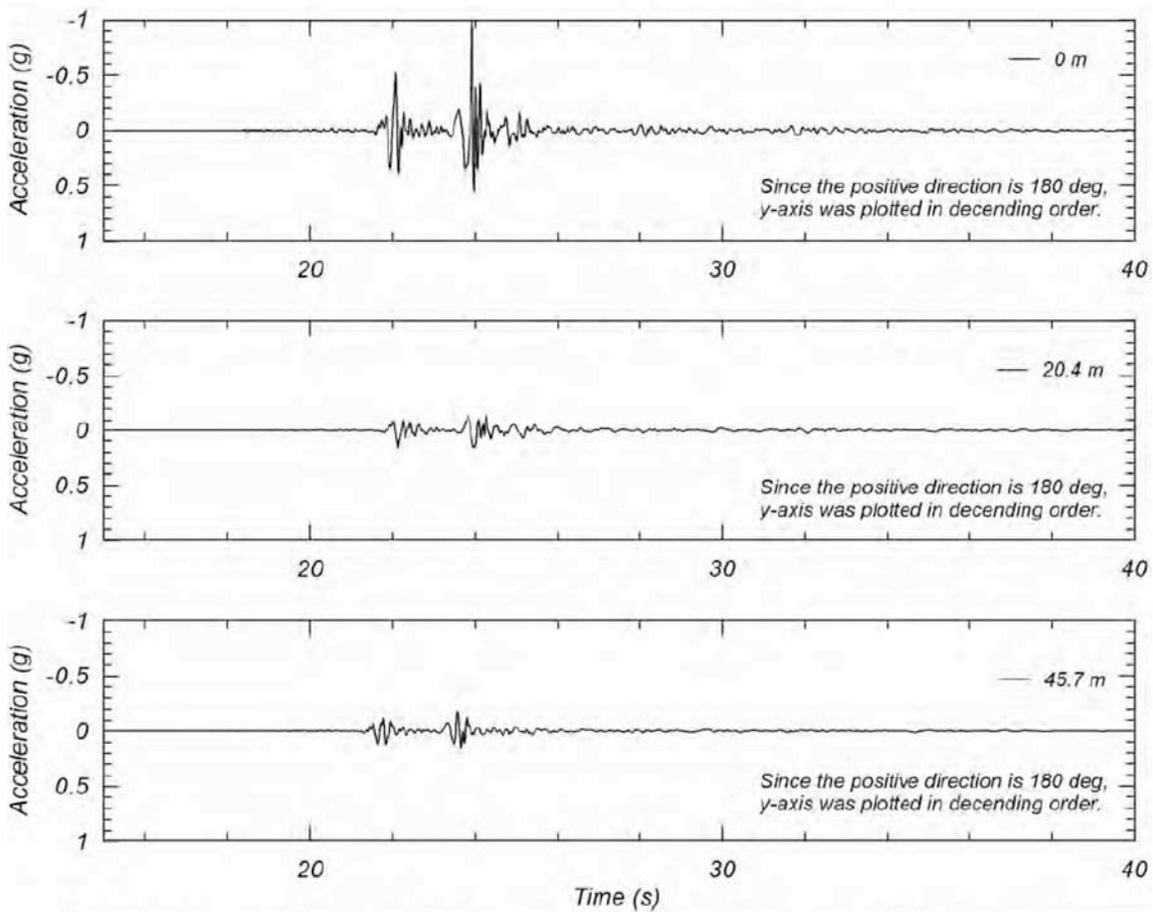
Figure 2-18. Instrument Time History (North-South Direction) (Carquinez Bridge)

Compare to the ShakeMap, where the inferred highest horizontal motion in the area is $PGA = 0.8532 \text{ g}$ (v3). As discussed earlier, the ShakeMap motions are different than the instrument motions due to the use of attenuation models, and various interpolation / soil computations, to backward infer the highest motions at the epicenter (fault rupture for v3). The estimated error at the instruments is likely under $\pm 2\%$; the estimated error at the vast majority of the ShakeMap locations is at least $\pm 50\%$. As the "grid" cell with the instrument that recorded 0.979 g also has another nearby instrument that recorded much lower motions, the resulting ShakeMap (v3) averages out the very high 0.979 g value to a lower value.

Figure 2-18 shows the time history for the NS-direction motion for instrument CE.68206. See Section 2.6 for further discussion of this instrument.

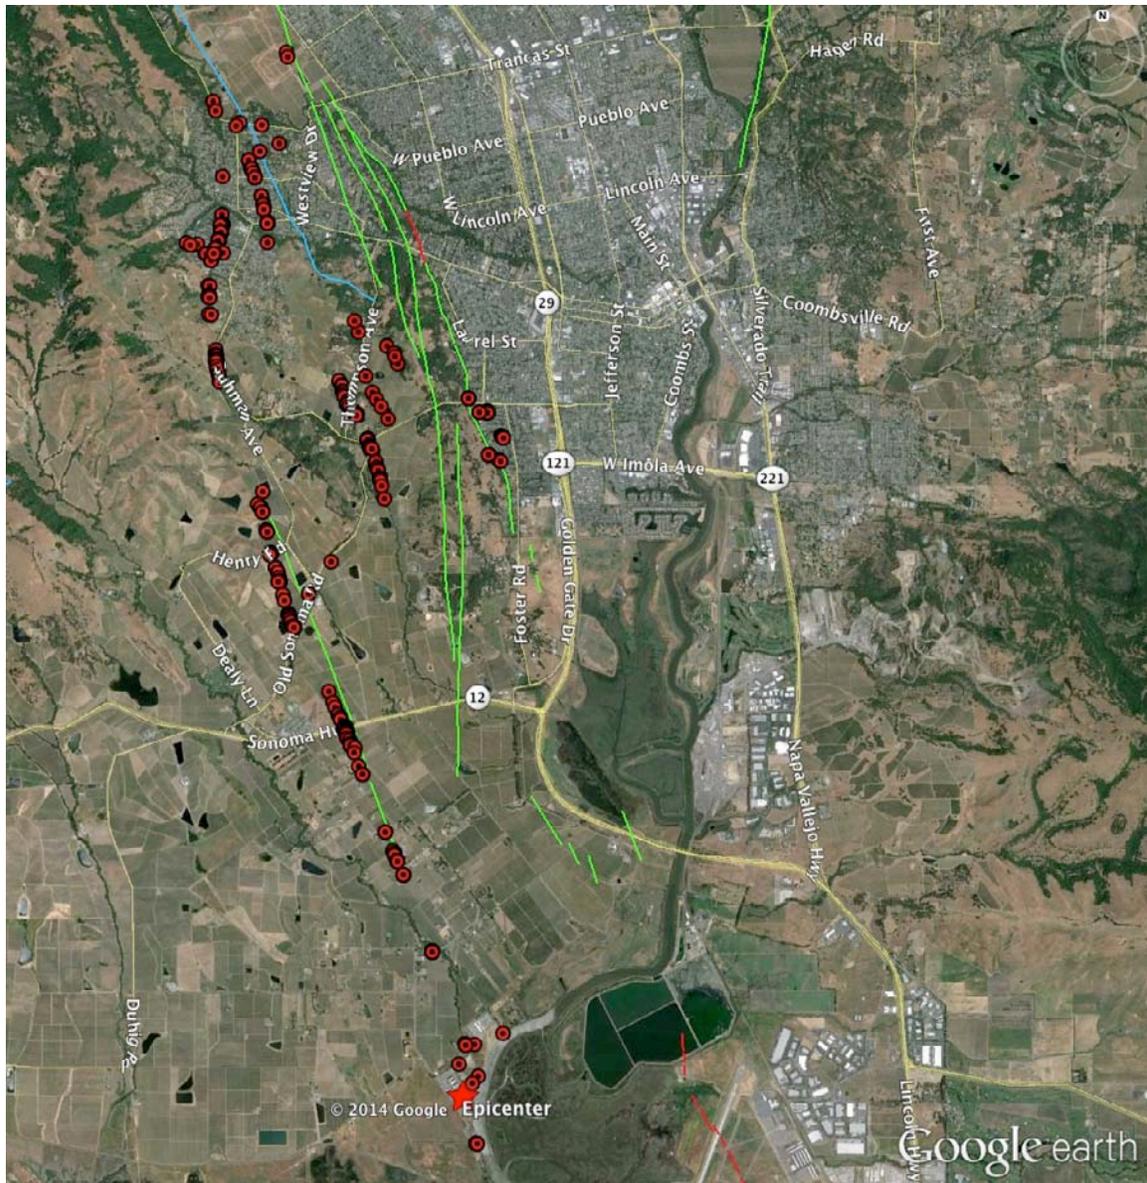
Figure 2-19. Map of Surface Faulting Observations (Red Dots)

Surface faulting occurred at many locations to the west of downtown Napa. Figure 2-19 shows a map that highlights the prior mapped locations of lineaments in the West Napa fault zone (yellow and blue lines) and field observations of surface faulting (red dots). This map shows information available to the USGS by August 26 2014 (2 days post-earthquake).

David Schwartz of the USGS reports that the locations of surface faulting (red dots in Figure 2-19) do not correspond closely to the prior mapped locations of the West Napa fault (yellow lines in Figure 2-19).

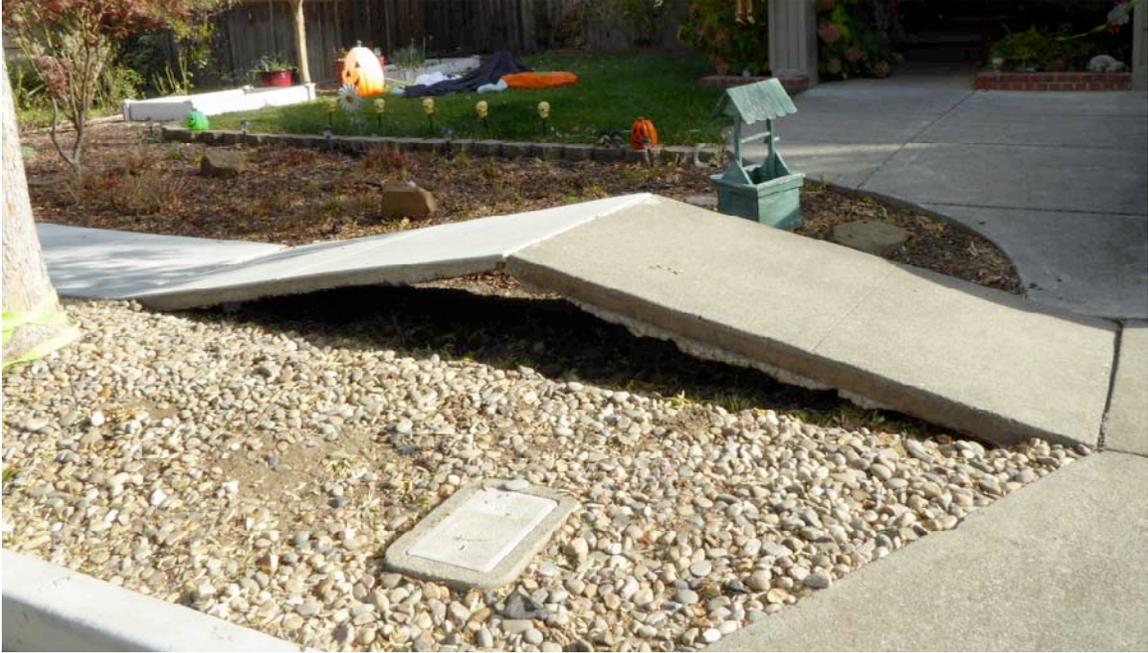
Figure 2-20. Buckled Sidewalk at Fault Offset Location

Figures 2-20 and 2-21 show buckled sidewalks at two of the fault crossing locations (red dots in Figure 2-19). These figures show two of many such sidewalk buckles in the west part of Napa near Meadowbrook Drive. In this area, there were about 8 streets, running nearly perpendicular to the strike of the fault. At each street, there was commonly one or two sidewalk buckles (one each side of the street), and if one maps the location of the buckles, one gets a more-or-less straight line of red dots, as shown in the top left part of Figure 2-19. Inspecting these buckles, one observes that there was some right lateral movement, as well as possibly some thrusting movement at the surface, resulting in net compression in the sidewalk slabs. This compression then results in the uplift of two adjacent concrete slabs as seen in Figures 2-20 and 2-21. Underneath the ground, the ground movements are also applied to buried water pipes, wastewater sewers, and natural gas pipes, and the impacts on these buried lifelines will be described later in this report.

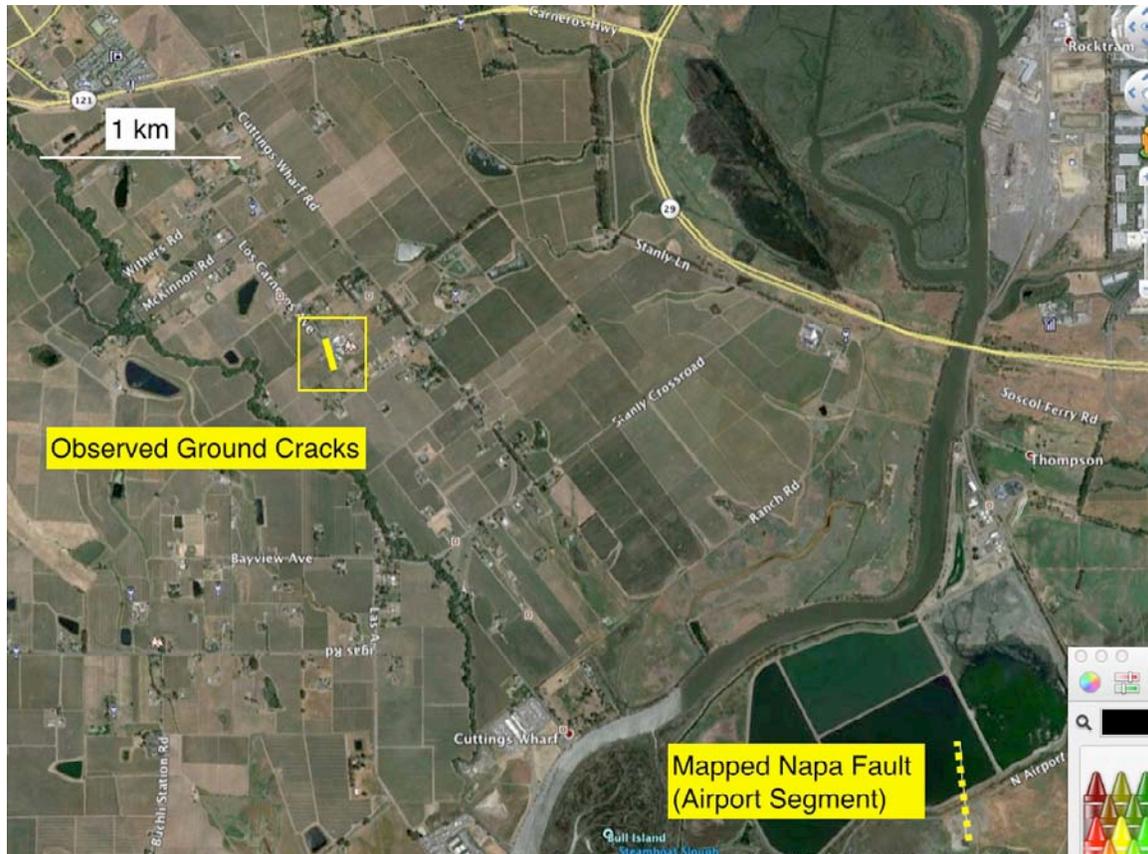
Figure 2-22. West Napa Fault Zone

On August 26, 2014, some of the authors visited an area which shows ground failure, located by the solid yellow line in Figure 2-22. In Figure 2-22, the dashed yellow line shows the inferred location of the Napa fault zone, based on prior studies. In one projects this dashed line to the north, where it would connected up with the mapped Browns Valley segment of the West Napa fault zone, it is located about 2 km easterly of the solid yellow line, where (apparently) surface rupture was observed at this location.

The nature of the cracks suggest surface faulting, for the following reasons:

- It seems to be right lateral in nature
- The ground cracks are en echelon, oriented in a manner consistent with soil pull apart associated with right-lateral faulting
- The cracks, if projected north-northwesterly as suggested by the direction of the solid yellow line in Figure 2-19, would go over the epicenter. If we assume the West Napa fault zone has a 90 degree dip (purely vertical), then the rupture would correspond to the presently-observed fault location.
- The site with these ground failures is mapped as not likely to liquefy, using the geologic maps (mapped at border of Qoa and pre-Quaternary soils). A Moderate-

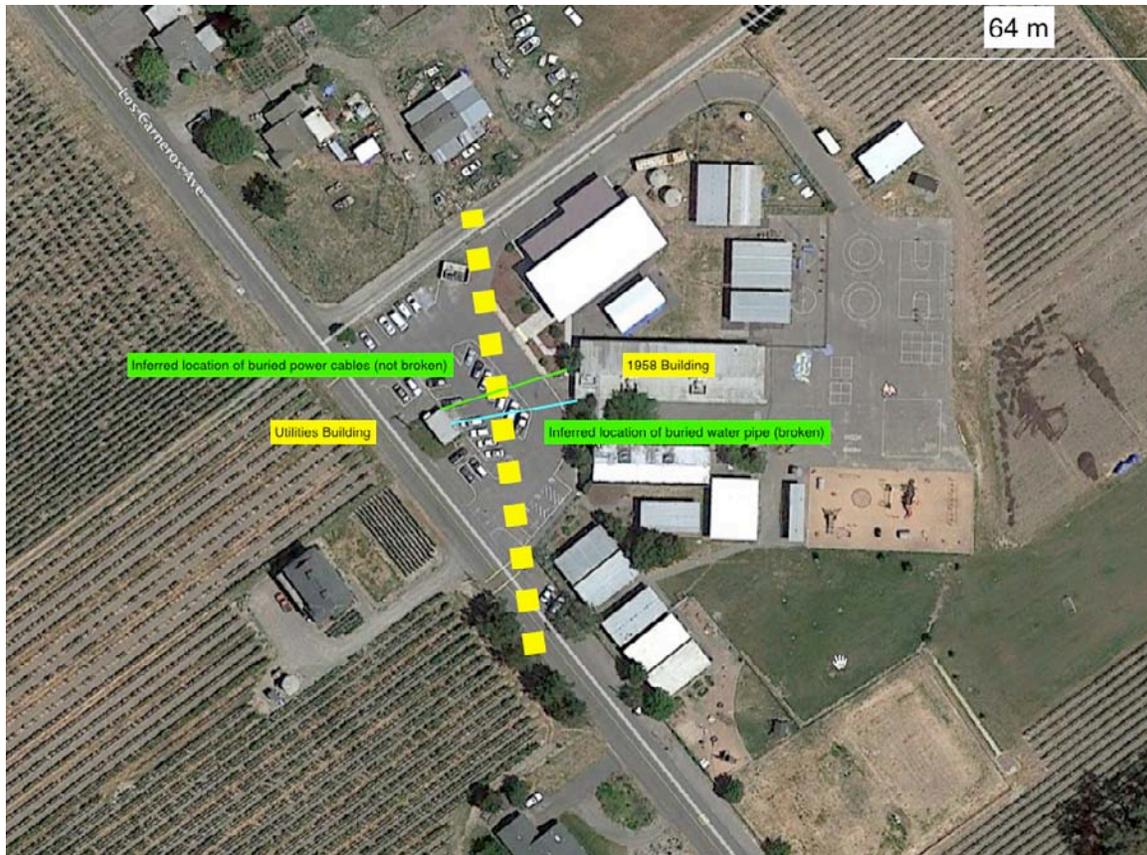
Figure 2-23. Aerial View of Fault Zone

Figure 2-23 shows a close up aerial view of the area in the highlighted box in Figure 2-22. In Figure 2-23, the thick dashed yellow line represents the zone with surface faulting. The property is a K – 8th grade school. The building noted "1958" building is one of the primary classroom buildings, and the oldest at the site.

We measured the width of the fault zone with observed ground failure at about 35 feet wide. The thick dashed line represents the strike of the faulting, but the actual cracks were en-echelon in nature, with most of the larger cracks oriented somewhat clockwise from the strike of the thick yellow dashed line. The cracks are very clear in the road (Los Carneros Avenue) and in the asphalt-paved parking lot of the school. To the west is a small "utilities building" housing switchgear (from the overhead PG&E distribution line along Los Carneros Avenue) as well as water quality equipment to treat water from the school's well.

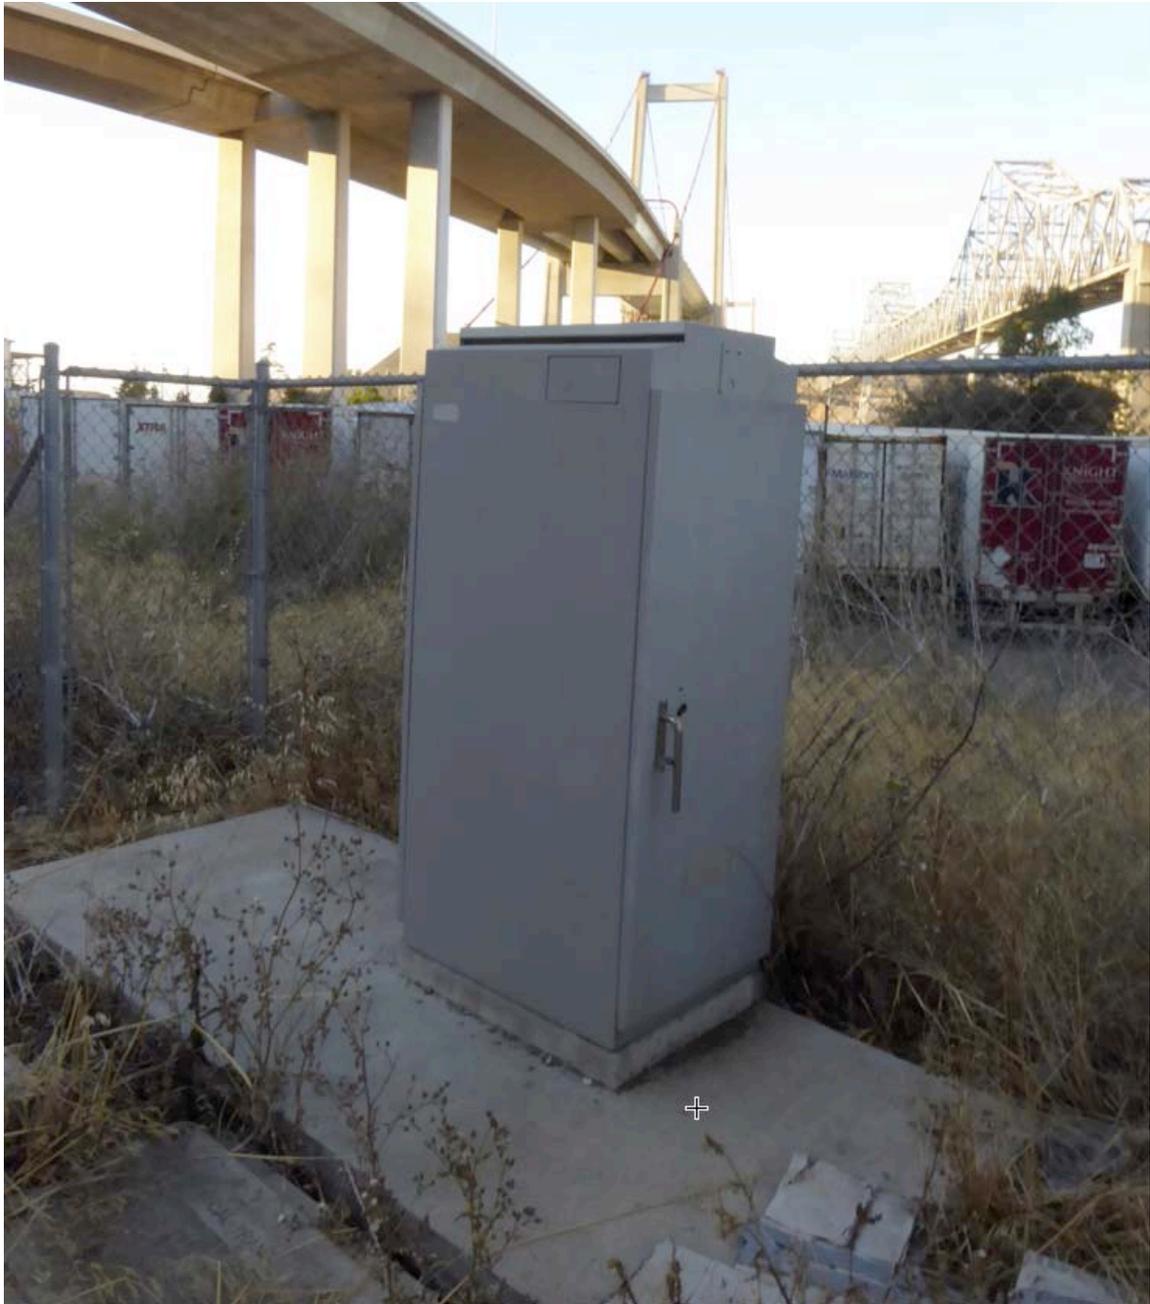
Figure 2-30. Instrument with New (Left) and Old (Right) Carquinez Bridges in Background

- Figure 2-30. This photo shows the instrument CE.68259 with the Carquinez bridge in the background. The photo is taken looking northwards, and the new Carquinez bridge (suspension bridge designed by Mark Ketchum) is on the left, and the older Carquinez bridge (cantilever truss type) is on the right.
- Figure 2-31. This photo shows instrument CE.68026, and Charles Scawthorn (left) and John Eidinger (right). The large reinforced concrete piers of the older highway bridge are in the immediate background. These piers are very tall, and support the bridge. The distance of the piers to the instrument is similar to the distance from the ground to the bridge deck.

Are these instruments Free Field? USGS assumes that these instruments are Free Field instruments, meaning that their recordings are not materially influenced by nearby structures. Examining Figures 2-30 and 2-31, this assumption is likely not valid. The massive bridge supports are very close to the instruments. As the bridges moved in the earthquake, they would impart into the ground very high reaction forces. It is possible that during the earthquake, that hinge-type connections in the bridges opened / closed, or similar phenomena, leading to some high frequency shocks. The very high recorded

motions at PGA / SA ($T=0.3\text{sec}$) are not reflected in the longer periods. This suggests that some type of "impact" forces in the bridge foundations are what the instruments are recording, and not the true free field motion. Further, if one uses commonly accepted attenuation models, the median PGA levels at these two instrument sites should have been about 0.1g or so; whereas one instrument recorded 0.97g (nearly 10 times higher than median expected). If one assumes sigma (total ground motion) of about 0.4 for PGA, then dispersion the 0.97g value is 5.7 standard deviations above the median. There is very little chance that this could have happened due to normal variations in free field ground motions.

It is recommended that future versions of ShakeMaps for important earthquakes (M 6 and larger near population centers) be peer reviewed, and anomalous instruments be removed from the production of the ShakeMaps.

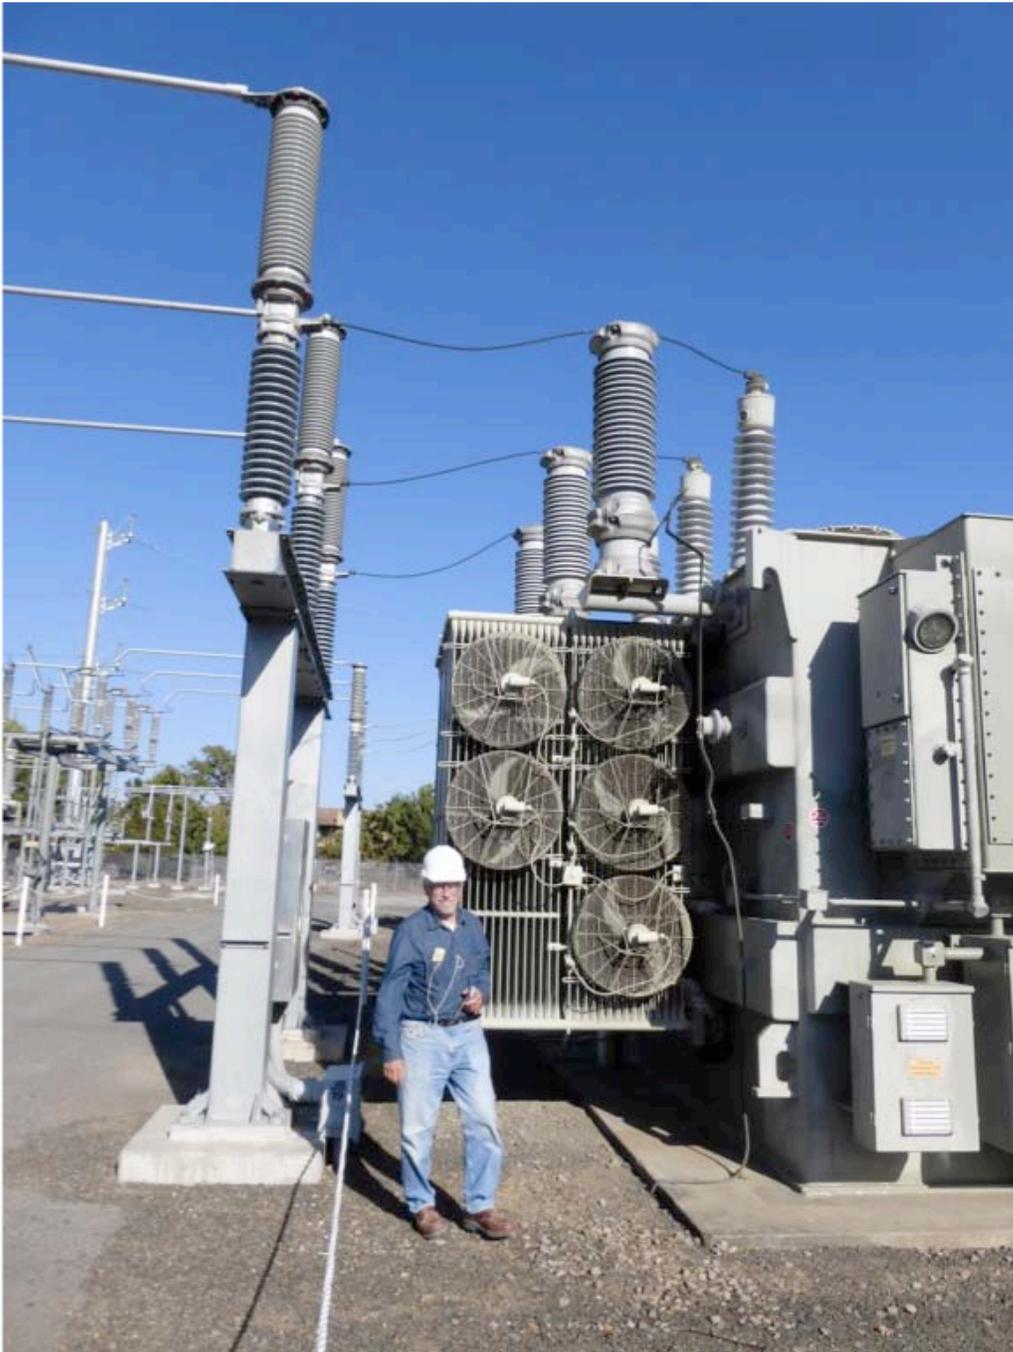
Figure 3-2. Power Transformer

- Buildings. One precast concrete building suffered slight damage to the roof diaphragm. The building remained operational.
- Power transformers. 2 power transformers (installed pre-1980) had minor leaks of oil from radiators. Some of this leakage might have been pre-earthquake. The affected radiators were very flexible (first mode frequency from 2 to 3 hertz). All newly installed transformers had much stiffer radiators and no leaks. There was no damage to bushings (all porcelain) or surge arrestors (some porcelain, some composite).
- Circuit breakers, disconnect switches, circuit switchers. Nearly every component installed post-1990, with all 230 kV equipment having been seismically qualified to IEEE 693 (high seismic zone). No damage.

Figure 3-2 shows a 1977-vintage power transformer, with Prof Anshel Schiff in the foreground.

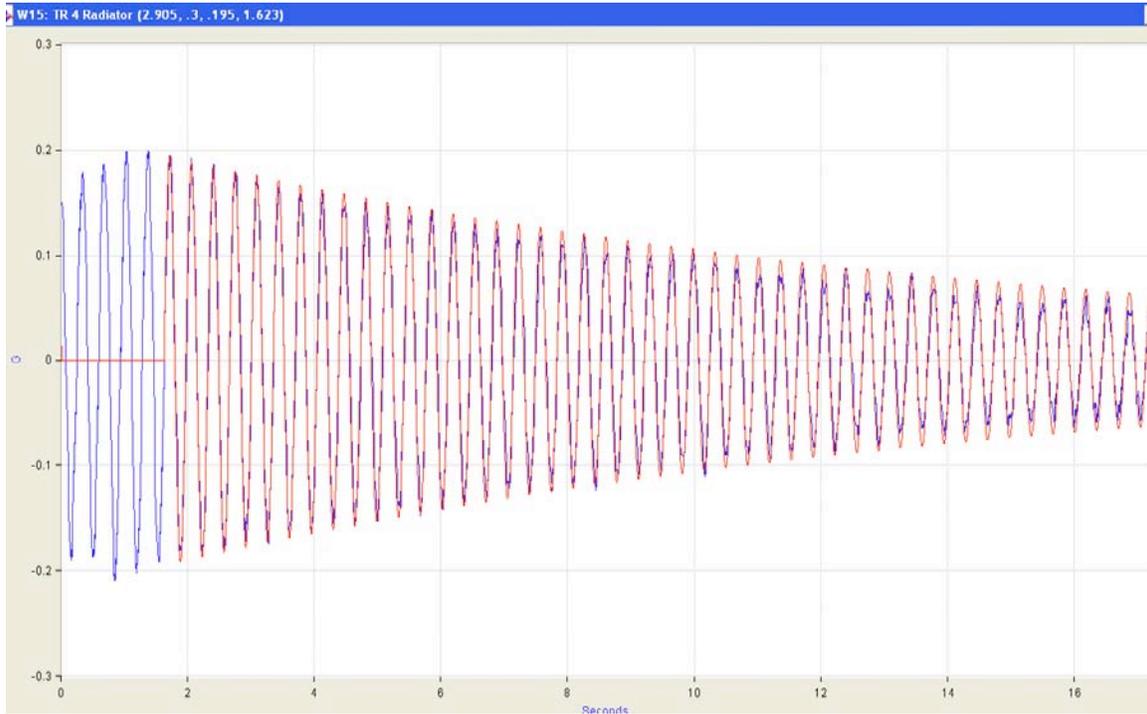
Figure 3-3. In Situ Test Vibration Response of Radiator (A. Schiff)

Figure 3-3 shows the time history of response of the radiator. The forced vibration response is seen on the left (increasing blue line) and the free vibration response is shown on the right (two lines, with the blue line being the recorded motion, and the second line being a fitted sine wave motion attempting to match the response). From the matched sine wave, the best-fit first mode frequency is 2.905 hertz with 0.3% damping.

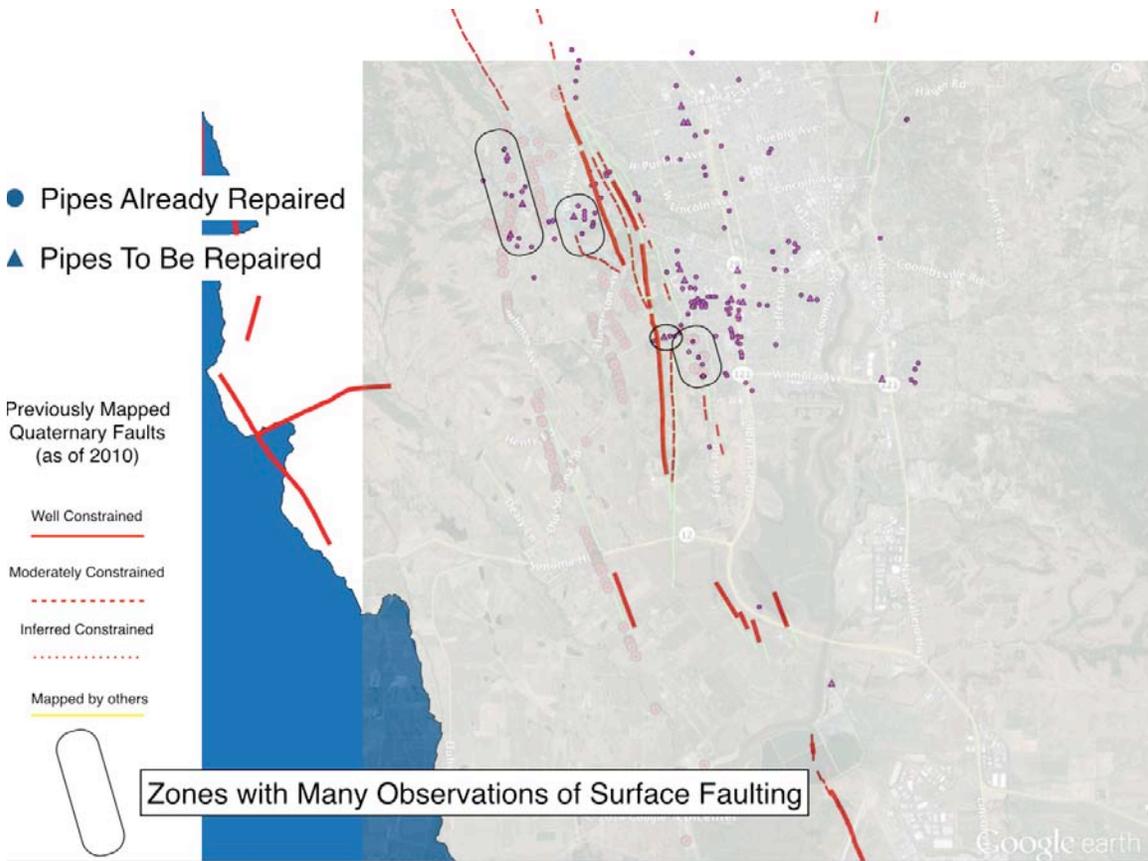
Figure 4-5. Overlay of Water Pipe Repairs and Zones with Surface Faulting

Figure 4-5 shows an overlay of pipe repairs (blue symbols) with the pre-earthquake location of mapped faults (red lines), along with zones subjected to surface faulting (black elongated zones). This map shows the pipe repair count as of September 2014, when it was 160.

If one assumes that the pipes outside the surface faulting zones were only subjected to ground shaking effects, and uses ALA (2001) pipe fragility models, and assumes that the average PGVs were: 30 inches per second (for cast iron pipe, a lot of which was located near the fault and areas thought to potentially have higher PGVs) and 20 inches per second (all other pipes), then Table 4-3 shows the projected number of pipe repairs versus actual.

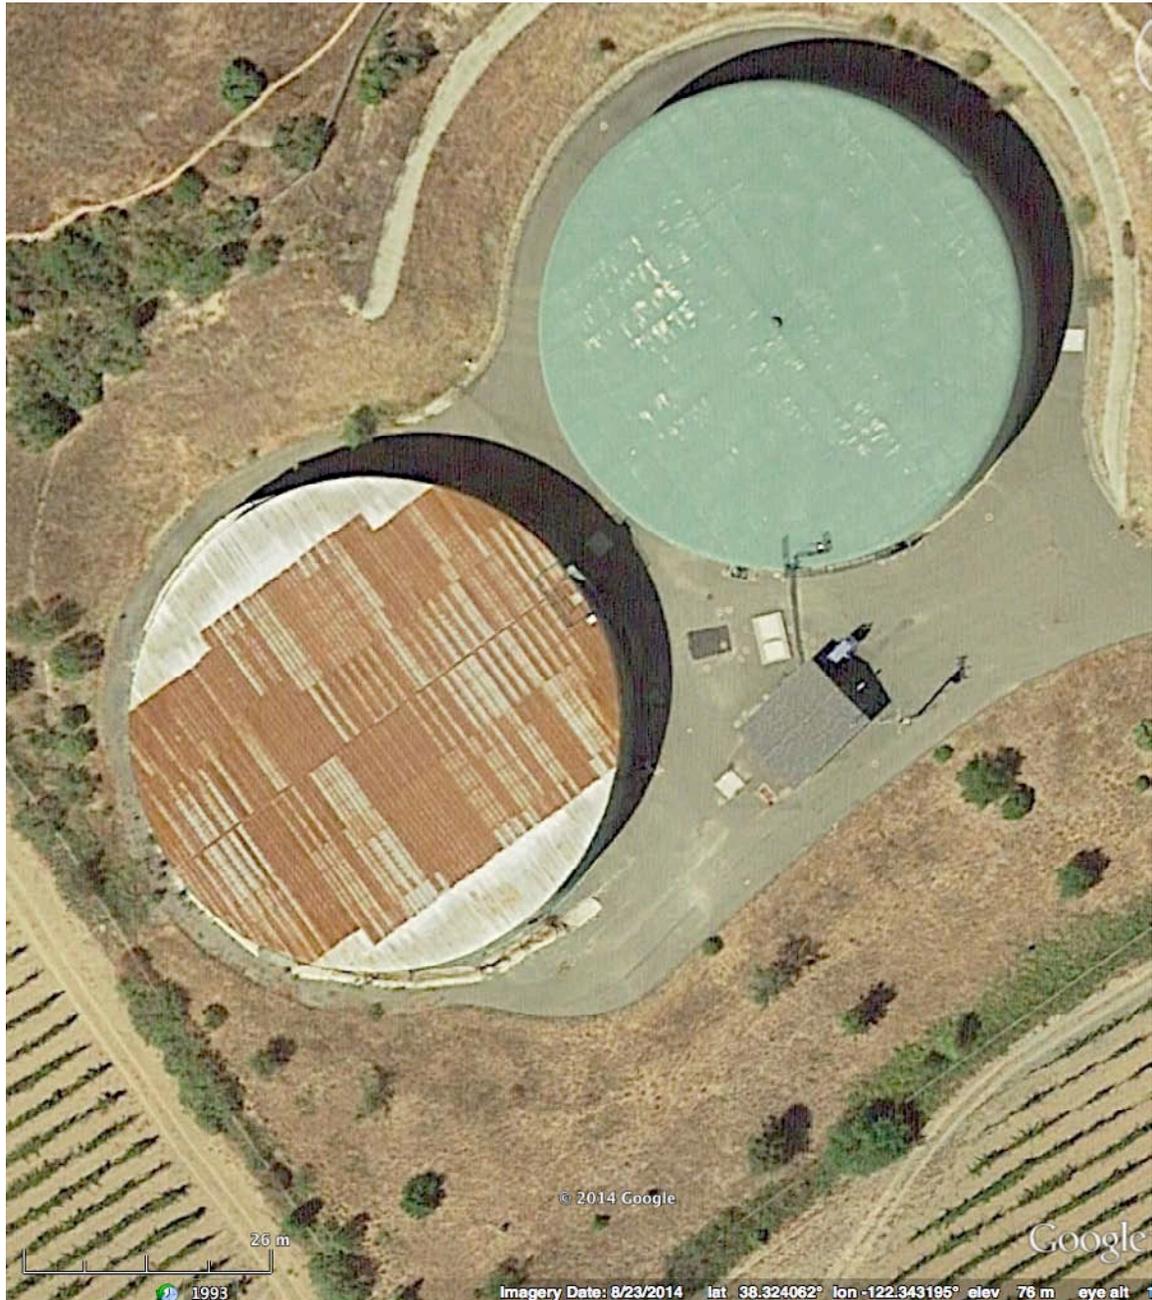
Figure 4-12. Two Tanks (38.2341, -122.3432)

Figure 4-12 shows two other steel tanks in the Napa water system, photo image dated August 23, 2014 (one day before the earthquake). These tanks are in the northwest part of the city, PGA ~0.3g to 0.4g. The tank in the lower left has a corrugated steel roof, but had been taken out of service some time before the earthquake, and thus had no water in it. The tank on the right was in service at the time of the earthquake, and initial exterior inspection suggests no damage.

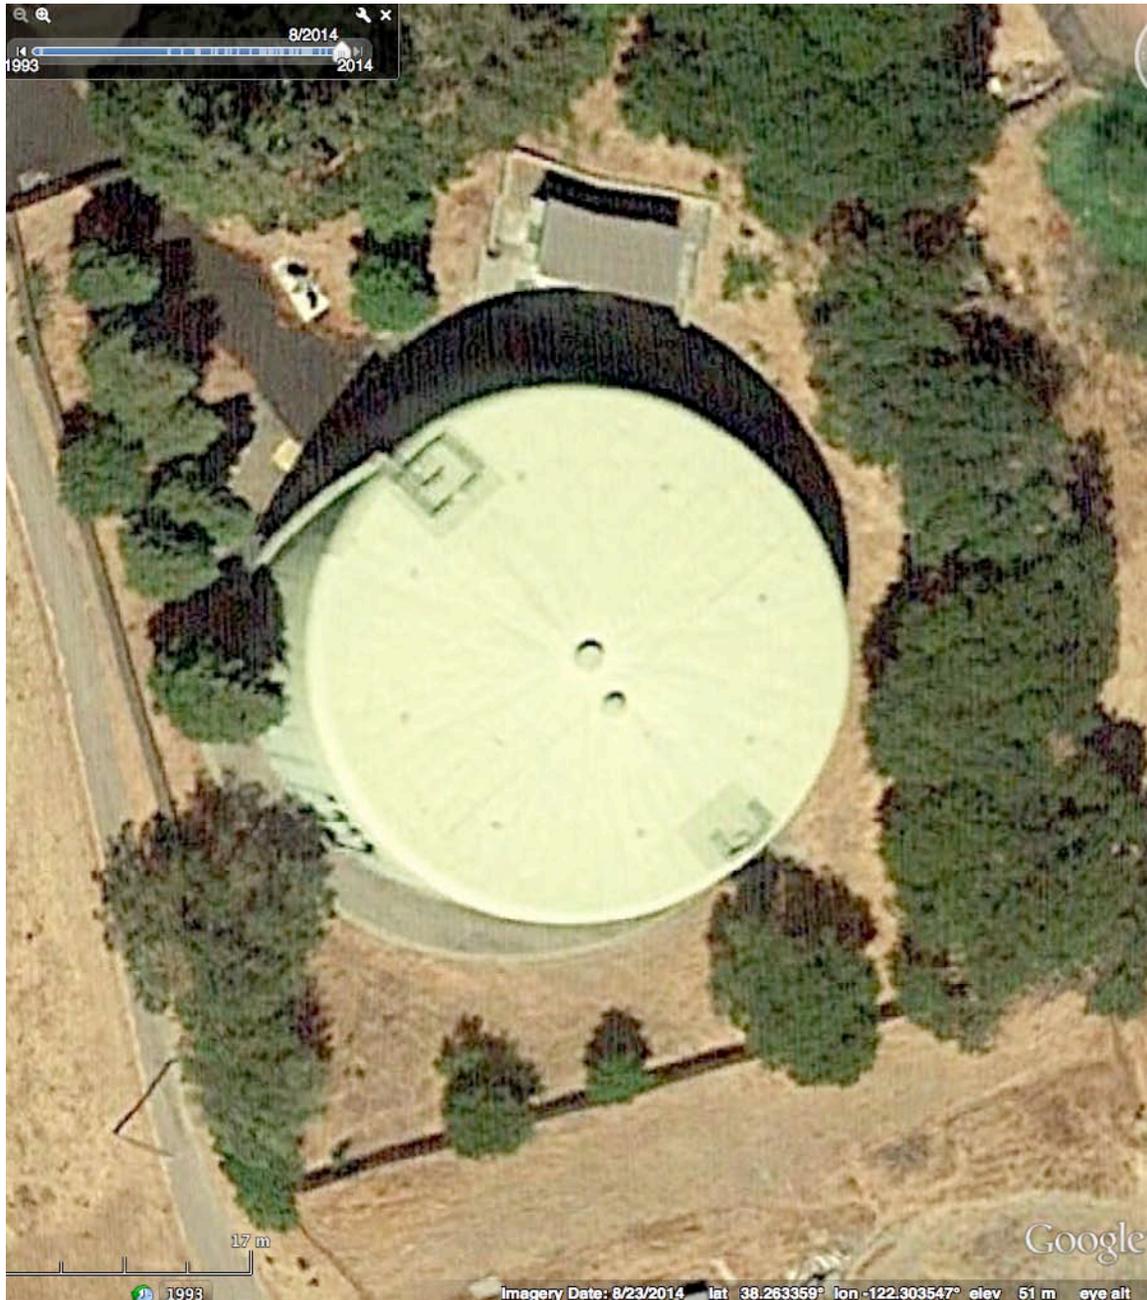
Figure 4-13. West Side Tank (38.2631, -122.3039)

Figure 4-13 shows a steel tank in the southwest part of Napa, built pre-1993. PGA at this location was likely around 0.4g. In mid-September 2014, it was reported that there was water observed near this tank, coming out of the ground; whether this water was from a leaking pipe, the tank, or some other source, remains unknown as of the time of writing this report.

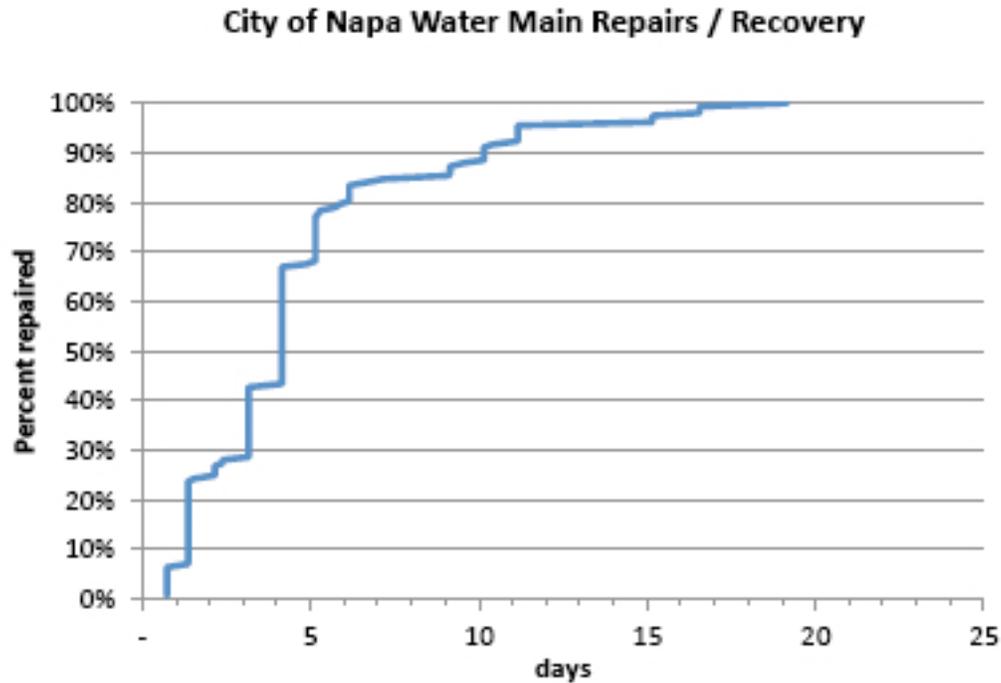
Figure 4-14. Napa Water Recovery

Figure 4-14 shows the restoration of water service after the earthquake.

Time	Water Flows from WTPs	Then Known Water Leaks
Day 1. Sunday Aug 24	32 MGD	60 leaks
Day 2. Monday	28 MGD	90 leaks
Day 3. Tuesday	24 MGD	100 leaks
Day 4. Wednesday	22 MGD	105 leaks
Day 5. Thursday	20 MGD	110 leaks
Day 6. Friday	19 MGD	120 leaks
Day 20. Sept 12		167 leaks
Day 37. Oct 1		179 leaks
Day 68. Nov 1		193 leaks
Day 99. Dec 2		220 leaks
Day 153. Jan 26 2015		241 leaks

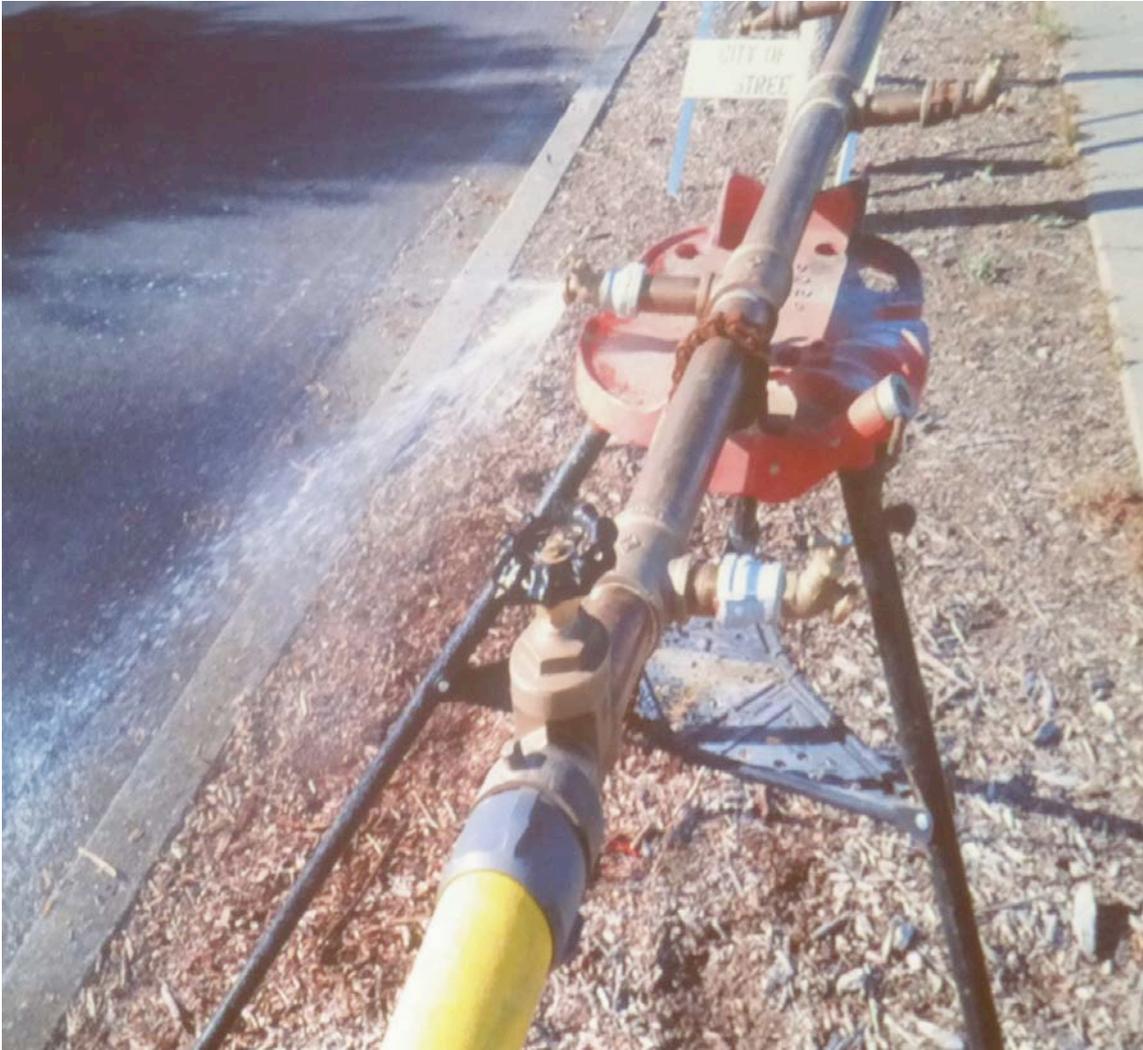
Figure 4-15. Hose Bib Used During Recovery

At some locations, the City of Napa installed hose bibs, Figure 4-15, at working fire hydrants with potable water, and alerted residents where they could go get potable water. These were located close to locations where there were water pipe breaks and with residents without piped potable water.

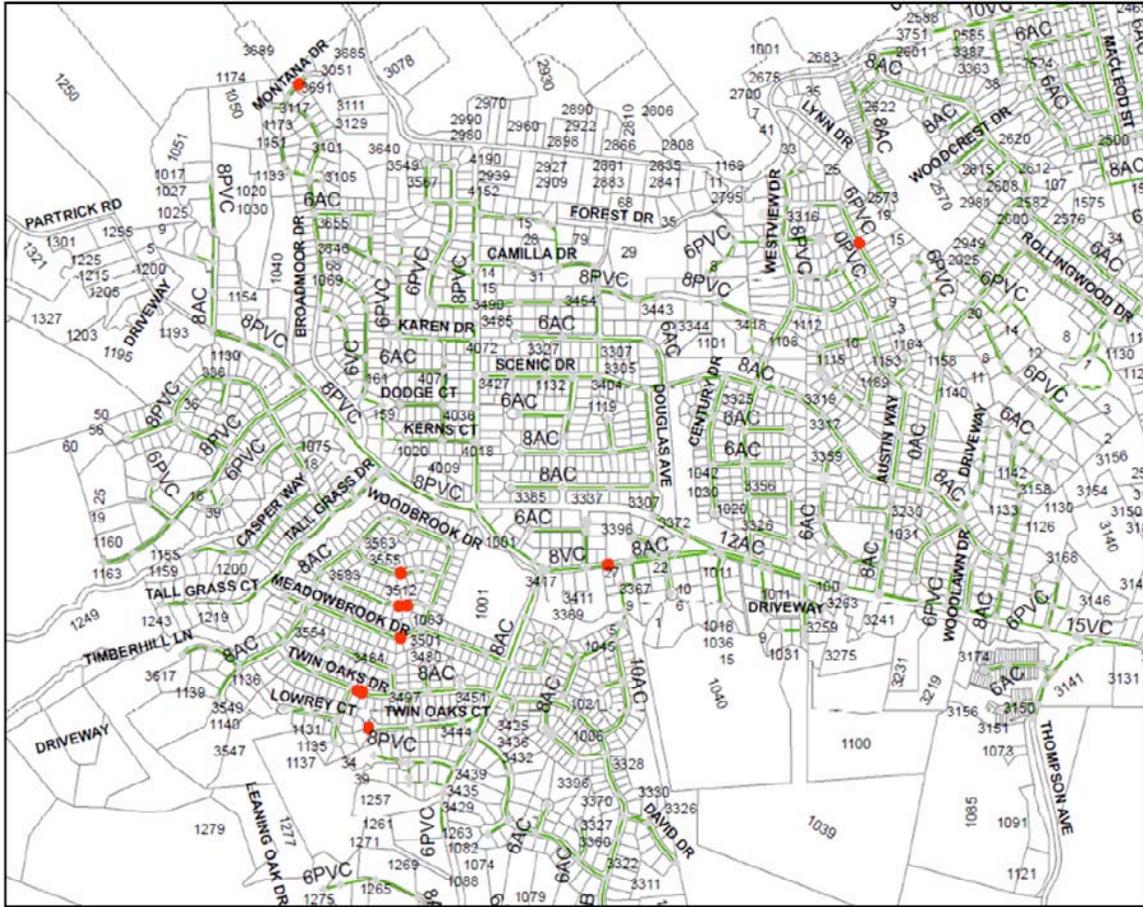
Figure 4-19. Location of Sewer Breaks

Figure 4-19 shows the locations of the sewer line breaks where repairs were made shortly after the earthquake (red dots). The red dots near Meadowbrook are all nearly coincident (within about 100 feet or so) with observed surface faulting.

Through September 15, 2015, NSD reported 11 breaks (possibly 13?) in sewer mains (all AC). Of these breaks, 9 were along the fault trace, and 2 were due to washouts from nearby water main breaks.

The typical repair strategy across the fault was to insert a PVC-type bladder within the broken pipe, then inflate and set the bladder. NSD reports that this effort was successful.

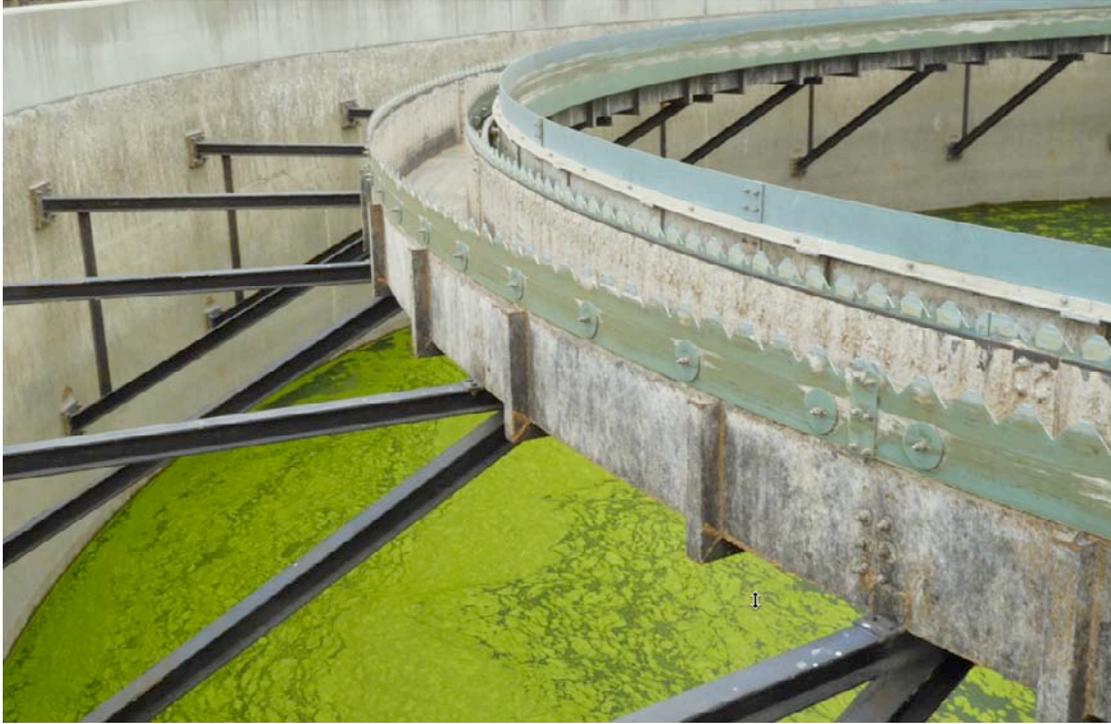
Figure 4-22. Empty Clarifier

In Figure 4-22, the heavy steel bracing for the water trough is seen. The water level in this clarifier at the time of the earthquake corresponds to the water (with algae, etc.) seen in this photo. A complete drain of this tank had not been done within 7 weeks of the earthquake; but as the water level was very low at the time of the earthquake, it is not expected that there would have been any damage to the central tower due to unbalanced water loading due to the sloshing effects.

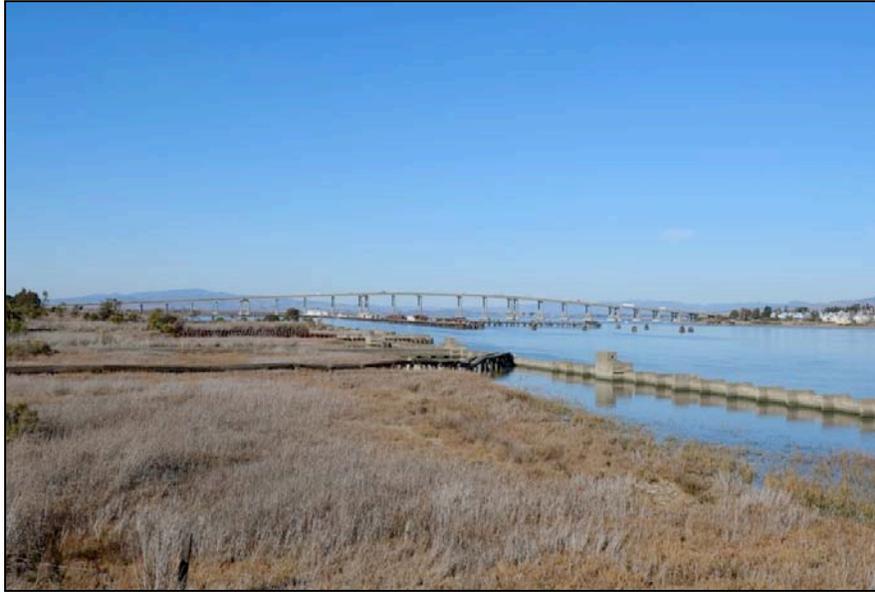
Figure 5-4. Napa River Bridge on Route 37 Br. #23 0064

Bridge 23-0064 is a 33 span precast girder bridge on flexible two column piers and stiff four column piers that was built in 1963. Like many river crossings it starts at ground level and then quickly rises to provide clearance over the river. A problem with many precast girder bridges is that they are not well designed for earthquakes. The girders need to be continuous to protect the superstructure and force plastic hinging into ductile columns. The girders on the Napa River Bridge were inadequately developed and they pulled out of the end diaphragms during the 1989 Loma Prieta earthquake. The bridge was repaired after the earthquake and got a very thorough seismic retrofit in 1996. The retrofit included bolsters around the end diaphragms to make the girders more continuous, also transverse prestressing, with additional seat width, and pipe seat restrainers at the hinges. The foundations were retrofit with additional piles and a bigger pile cap. All of the columns were encased in steel jackets. A downhole array³ was installed at the bridge, which recorded 0.2g acceleration, 19 cm/s velocity, and 2 cm displacement at the ground surface during the South Napa Earthquake. The bridge was also instrumented with Channels 1, 2, and 3 between piers 13 and 14 at the top of the bridge, which recorded 0.53g acceleration and 14.7 cm (about 6 inches transverse) of displacement. The ground motion and structural excitation were not high enough to cause serious damage to a well-designed or to a seismically retrofitted bridge. The only damage to the Napa River Bridge was that the expansion joints opened and closed enough to damage a few of the type B joint seals which had to be replaced. The hand railing at the

expansion joints opened up enough to cause the bridge crews who first inspected the bridge to close it as a precautionary measure.

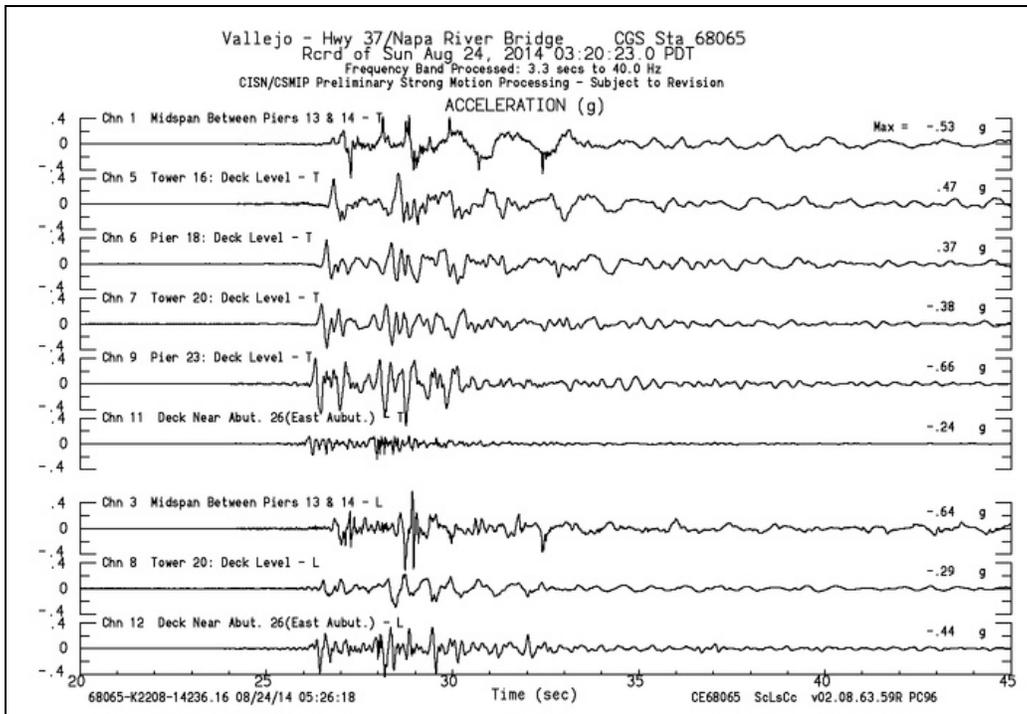
Figure 5-8. Acceleration Records on Napa River Bridge on Route 37

A strong motion instrument downhole array⁴ was installed at the bridge, which recorded 0.2g acceleration, 19 cm/s velocity, and 2 cm displacement at the ground surface. The bridge was also instrumented (see Figure 5-7) with accelerometers between piers 13 and 14 at the crest of the bridge, which recorded 0.53g acceleration and 14.7 cm (about 6 in transverse) of displacement (Figures 5-8 and 5-9).

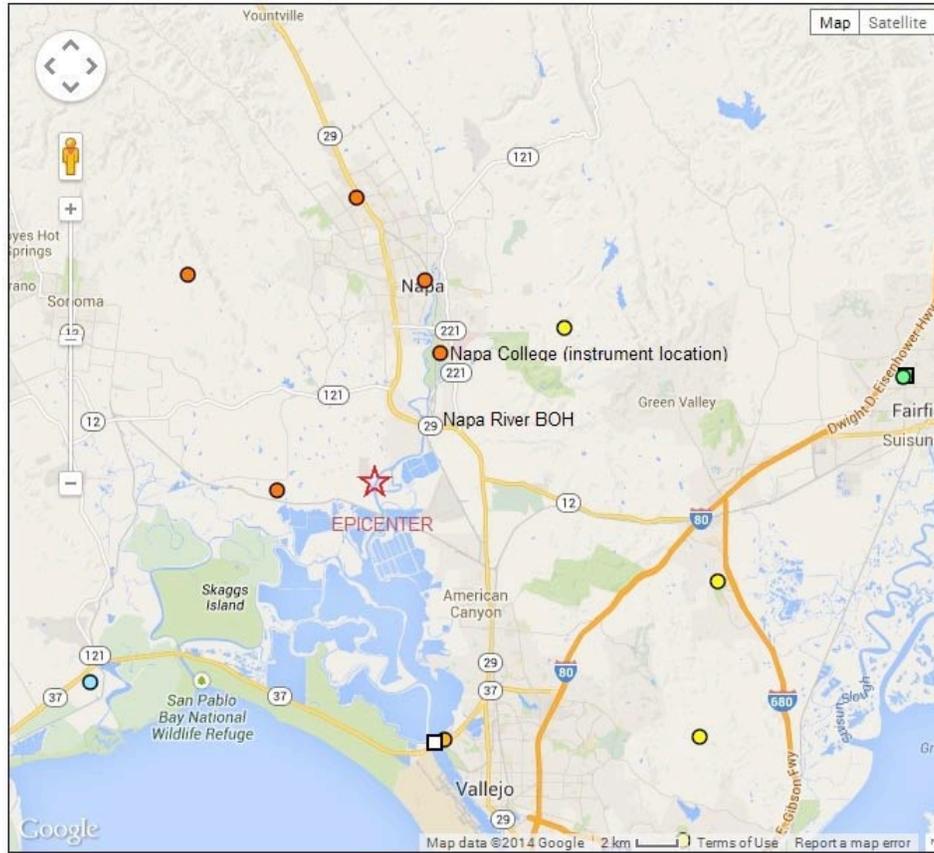
Figure 5-13. Map showing epicenter, bridge, and instrument locations

This was the closest bridge to the earthquake epicenter (about 2 miles). Although the bridge wasn't instrumented there was a station nearby at Napa College (red dot) that recorded peak ground motion of 0.375g (Figure 5-13).
