South Napa M 6.0 Earthquake of August 24, 2014

John Eidinger – G&E Engineering Systems

TCLEE No. 1

March 2016, Updated April 2017

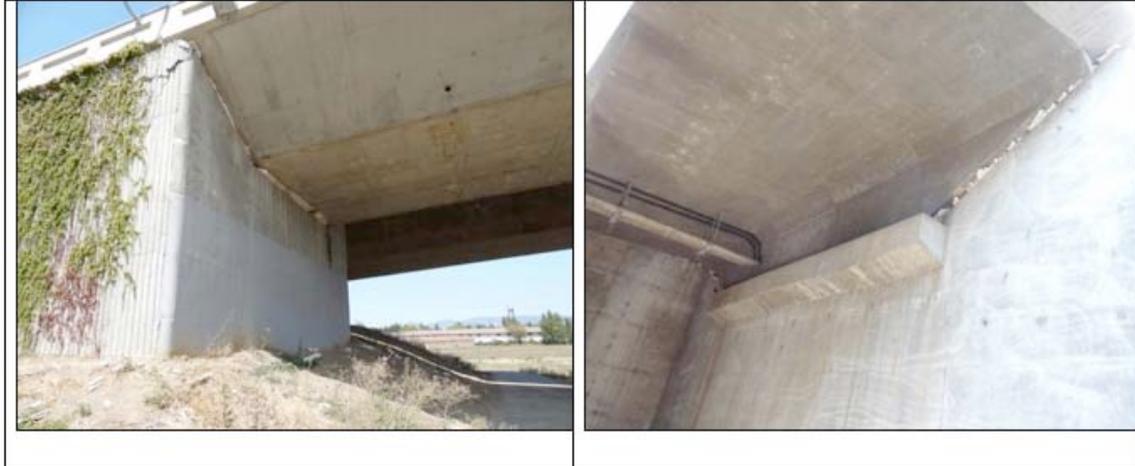
Figure 5-16. Outside and Inside of an abutment on the Napa River (West Imola Avenue) Bridges

When the investigation team first saw the abutments on the West Imola Avenue Bridges, it was assumed there was soil behind them that was held in place with mechanically stabilized earth (MSE) retaining walls. However, when they looked behind the abutment, it was seen that the approaches were actually slab bridges on pile extensions. What had been thought to be MSE Walls turned out to be curtain walls. Caltrans prefers to have soil behind the abutment to provide stiffness and damping during the earthquake. However, on such a long bridge a stiff abutment plays a much smaller role.

This bridge is also very close to the Napa College station that recorded peak acceleration of 0.375g during the earthquake. The damage that occurred during the earthquake, cracks and spalls of the curtain walls at all the abutments, was the result of the ends of the superstructure banging against the slender curtain walls (Figures 5-16 and 5-17). More substantial abutments could have held the superstructure more securely in place. However, it is unlikely that the superstructure could unseat since the approach slab is securely attached to the end of the superstructure. Also, when Caltrans Office of Structures Maintenance and Investigations (OSMI) went inside the superstructure, they found the hinge restrainers had been poorly installed and were damaged at the swage connections or at the tension indicators (Figure 5-18). Restrainers must be carefully installed, which requires tightening them until the spiral washers close and then backing off to account for the variation in temperature. However, restrainers are a secondary system for earthquake protection and the hinges all had 36 inch seats.

This bridge had the most expensive repair (\$350,000) of all the bridges.

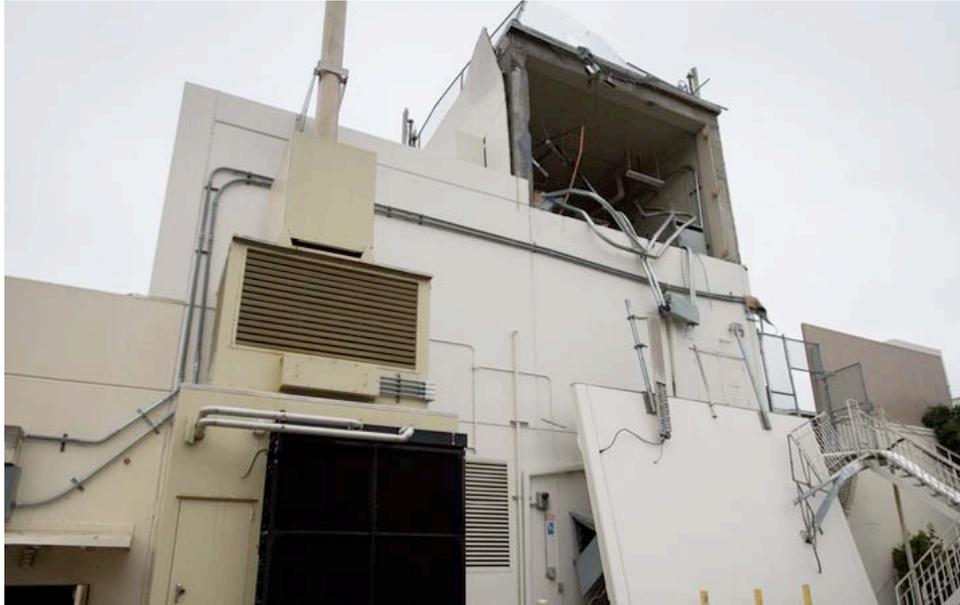
Figure 6-1. AT&T Building on Clay Street, Napa

The ATT building on Clay Street in downtown Napa was damaged, Figures 6-1, 6-2.

The concrete wall panel that has been displaced was apparently a "knock-out" type panel, to allow for future expansion of the facility. The panel was attached to the rest of the building using eight angles, bolted to the panel and to the building (Figure 6-4). Apparently, shaking of the building resulted in excessive forces on the bolts, and the connections failed, allowing the panel to fall.

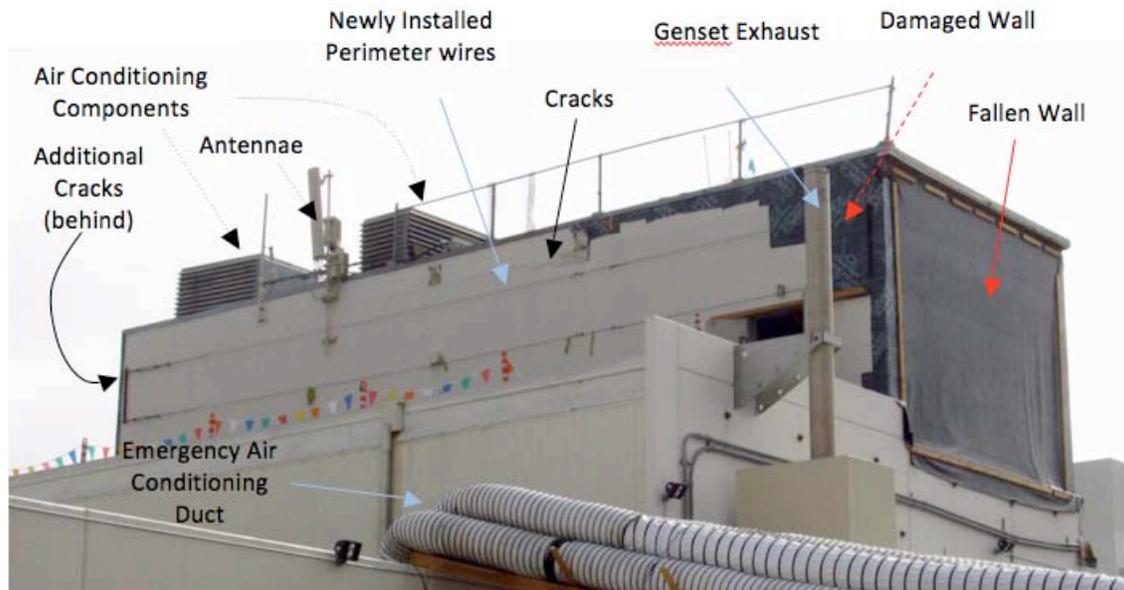
Figure 6-2. AT&T Building on Clay Street, Napa

When the panel fell, it damaged a water pump that is part of the HVAC system for the site, and severed the PG&E power supply into the facility. Additionally, the wall severed a fiber optic cable to a wireless base station located in this upper room causing it to lose service due isolation from its switching center. Also, the emergency generator seem to have experienced some issue and failed to work. Battery systems did work, and the batteries sustained the communication equipment and operations. However, as air conditioners are not connected to the DC bus, they cannot be powered by the batteries. This intrinsic system vulnerability in combination with damage to a water pump and other potential damage to ducts or other components of the HVAC required the deployment of an external emergency ventilation unit, shown in Figures 6-5 and 6-6, in order to keep the heat down in the building. Both figures also show a large portable generator deployed to this site. Images on a TV report produced by Dan Noyes and aired by KGO shows an air compressor outside the central office which likely was used to keep cables pressurized after the onsite pressurization system fail when the onsite generator

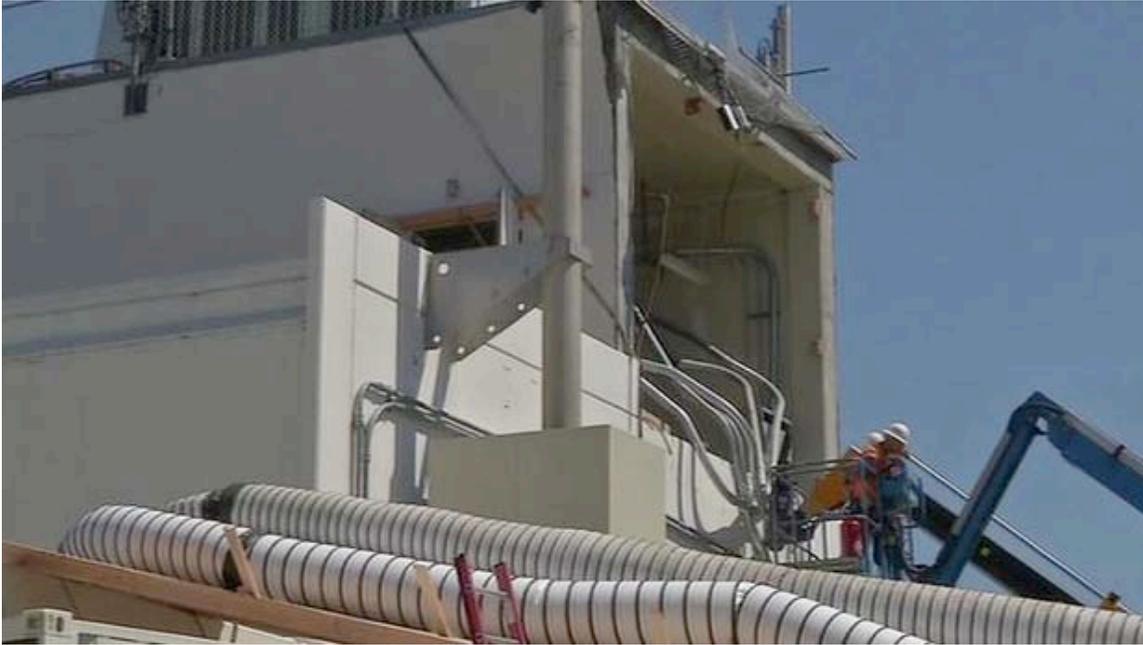
Cracks along at least two other walls of this penthouse (Figure 6-3) and damage to a corner next to the fallen wall seem to indicate that additional issues may have been present in this room. The fact that a large cooling unit that had been situated on the roof of this penthouse (see Figure 6-4) was removed shortly after the earthquake may also indicate that this room experienced other structural damage in addition to the fallen wall and that there could have been concerns that the earthquake weakened this room considerably.

Figure 6-4. Providing External Services to AT&T Building

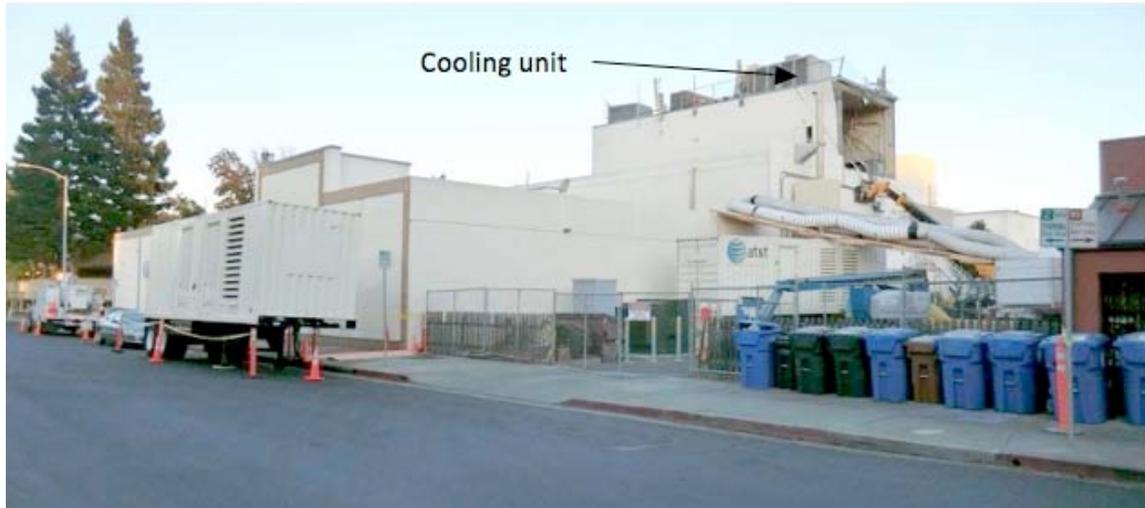
Figure 6-5. AT&T Building on August 25, 2014

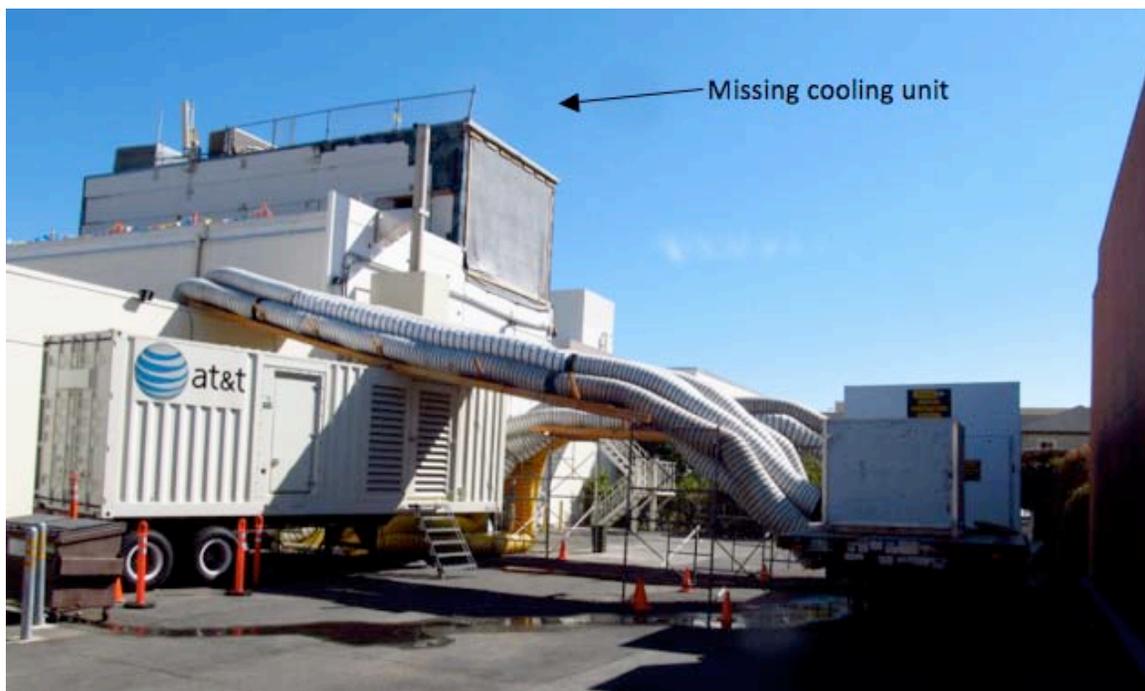
Figure 6-6. Parking Lot, with mobile generator on left and a mobile ventilation unit of the right. Photo taken on October 10, 2014

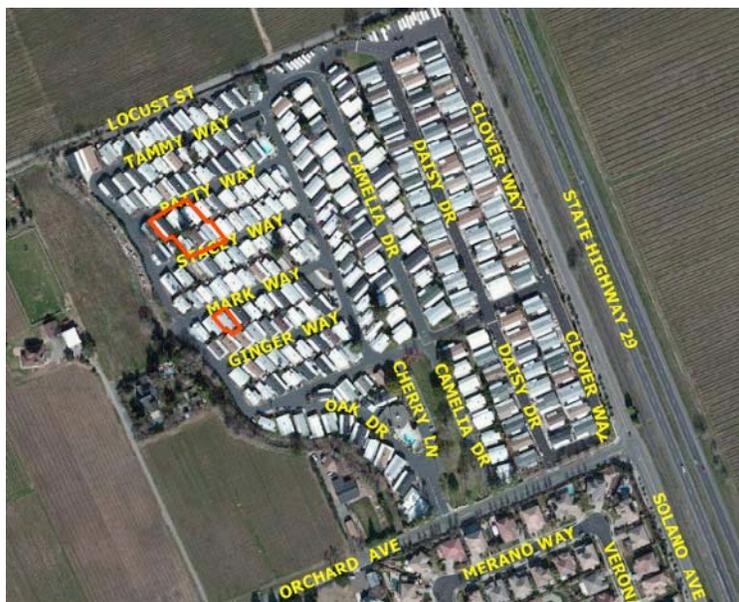
Orchard Ave Fire: This was the largest fire in the earthquake. First dispatch was of T1 to a report of gas odor but en route T1 observed a fire in the Napa Valley Mobile Home Park (NVMHP) off of Hwy 29 at Orchard Road, and diverted to this incident. T1 encountered a broken water main spewing water at the entrance to the NVMHP on Orchard Road, and proceeded to enter the NVMHP. T1 then encountered a single structure fire at 313 Mark Way – the structure was 50% involved; they also observed a second fire at 317 Patty Way, which was 100% involved and impinging on neighboring buildings, see Figure 7-2. Wind conditions were calm.

Figure 7-2. NVMHP Park and locations of fires, 24 Aug 2014 S. Napa M_w 6.0 Earthquake (damaged buildings outlined in red)

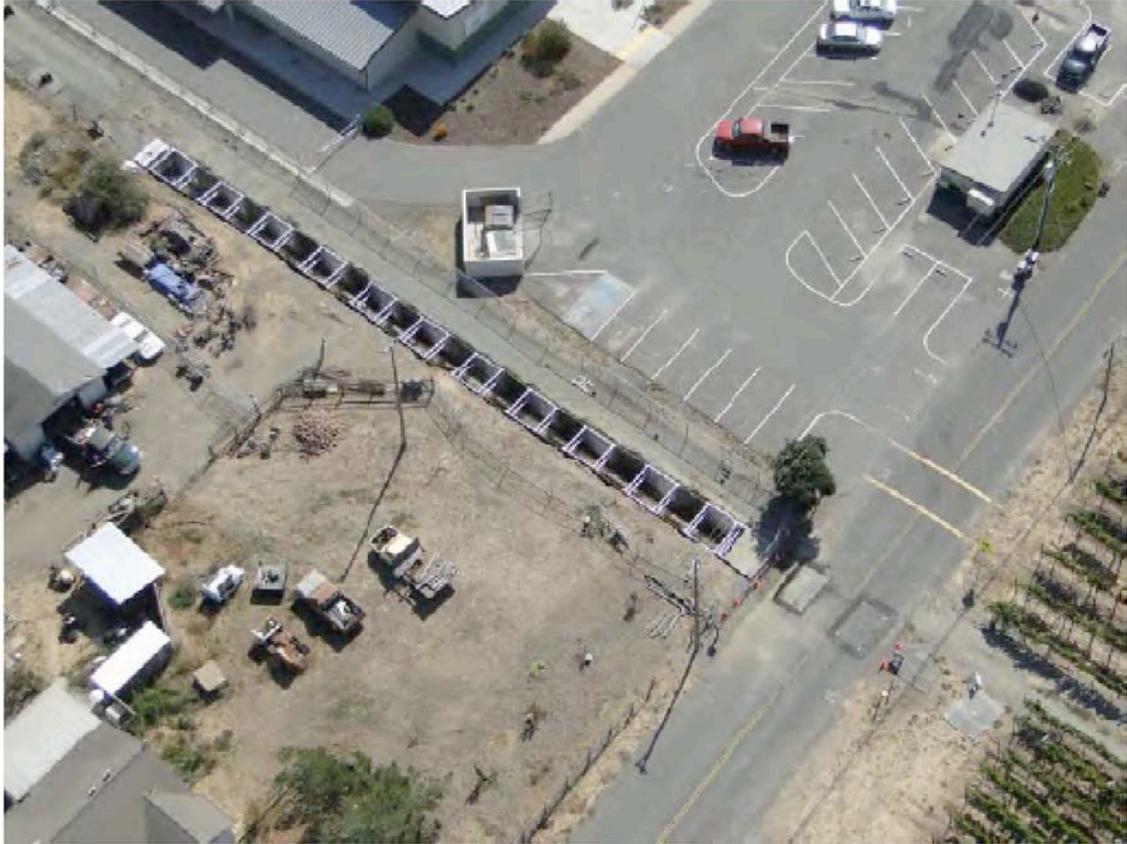
PG&E operates a 26-inch diameter buried gas transmission pipe (Figure 8-1, Line 021A, welded steel) that crossed the fault (across the dashed yellow line in Figure 2-20). The orientation of the pipe would place it into bending and compression due to the right lateral offset of a few inches (including post-event slip). The pipe remained operational (no leak).

Figure 8-1. Location of PG&E Gas Pipe Trench Excavation

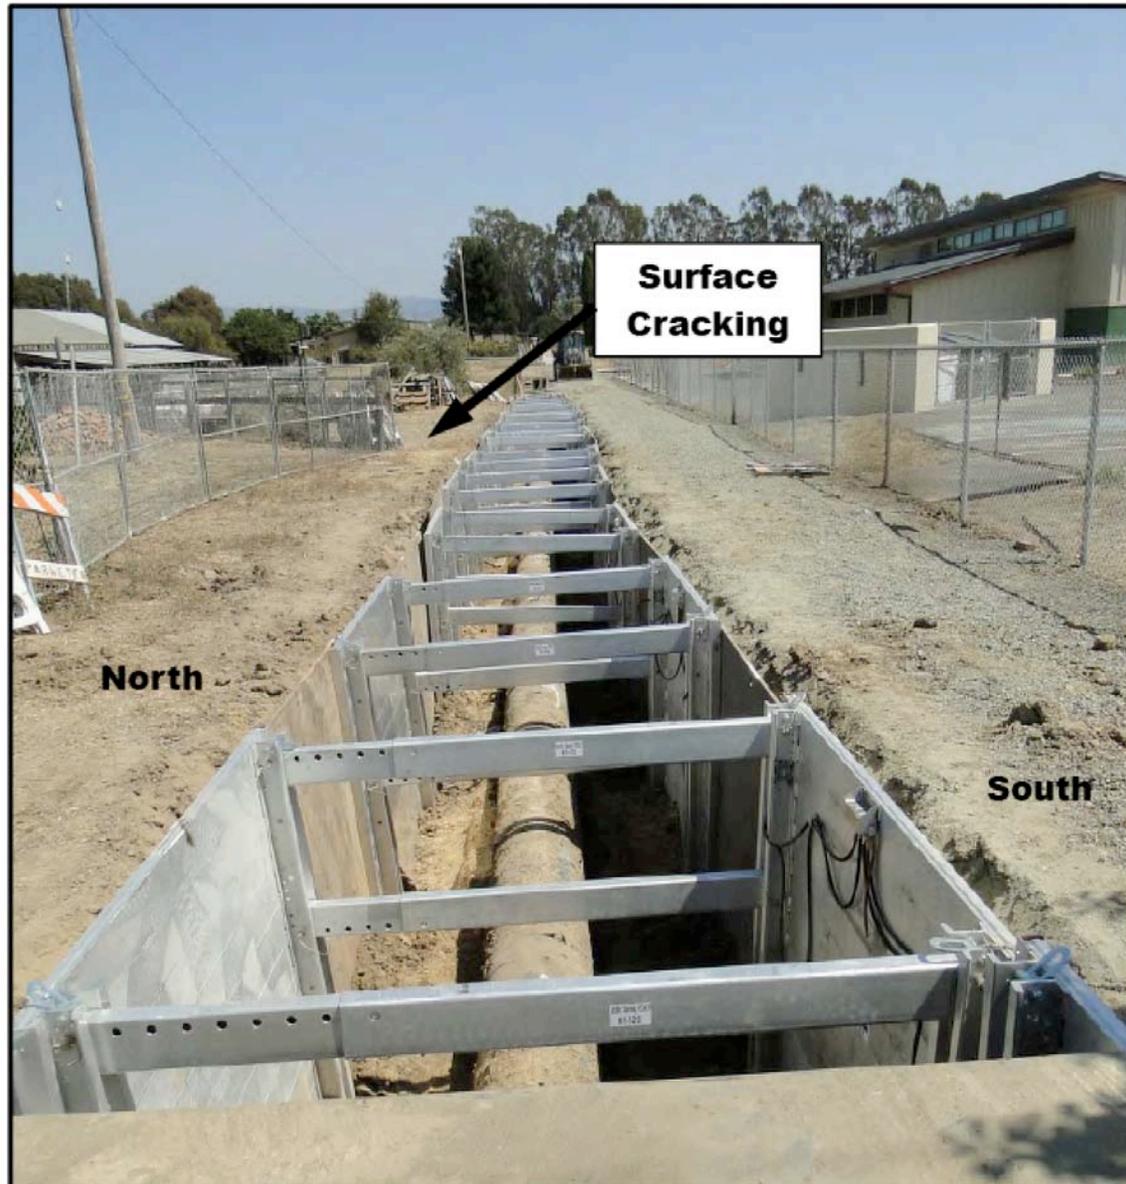
By September 1 2014, PG&E uncovered and excavated the pipe through the fault zone, Figure 8-2. The excavated pipe (26 inch outside diameter, 0.297 inch wall thickness, Grade X60 steel, double submerged arc welded seam pipe built 1971, with a maximum allowable operating pressure of 450 psig) was uncovered and examined for indications of anomalies on the body and on the weld seam. No initial indications of pipe wrinkling were found to be present; however, the pipeline was cut out for further evaluation and testing. PG&E ultimately replaced about 200 feet of Line 021A through the fault crossing zone, with 26 inch outside diameter, 0.5 inch wall thickness, Grade X65, SAWL pipe.

No visually obvious damage was apparent, even after removing the exterior coating. The cut-out pipe was laser scanned for pipe ovality, and girth welds were radiographed and UT phase array inspected for anomalies. As of writing this report, preliminary results conclude that no major integrity concerns were identified such as wrinkling or bending of the pipe.

Figure 8-2. PG&E Gas Pipe Trench Excavation, Sept 1 2014, Looking East

This replacement pipe is thought to be more robust than the original pipe, in that it has a lower D/t ration making it more resistant to buckling due to future fault offset; and of course, is installed in a stress relieved state, whereas the 1971-vintage pipe was already loaded due to the fault offset in 2014.
