Napa Earthquake of 8.24.2014 Performance of Lifelines

Water, Power, Gas, Fires

City and County Engineers Association of
San Mateo County

South Napa M 6.0 Earthquake of August 24, 2014

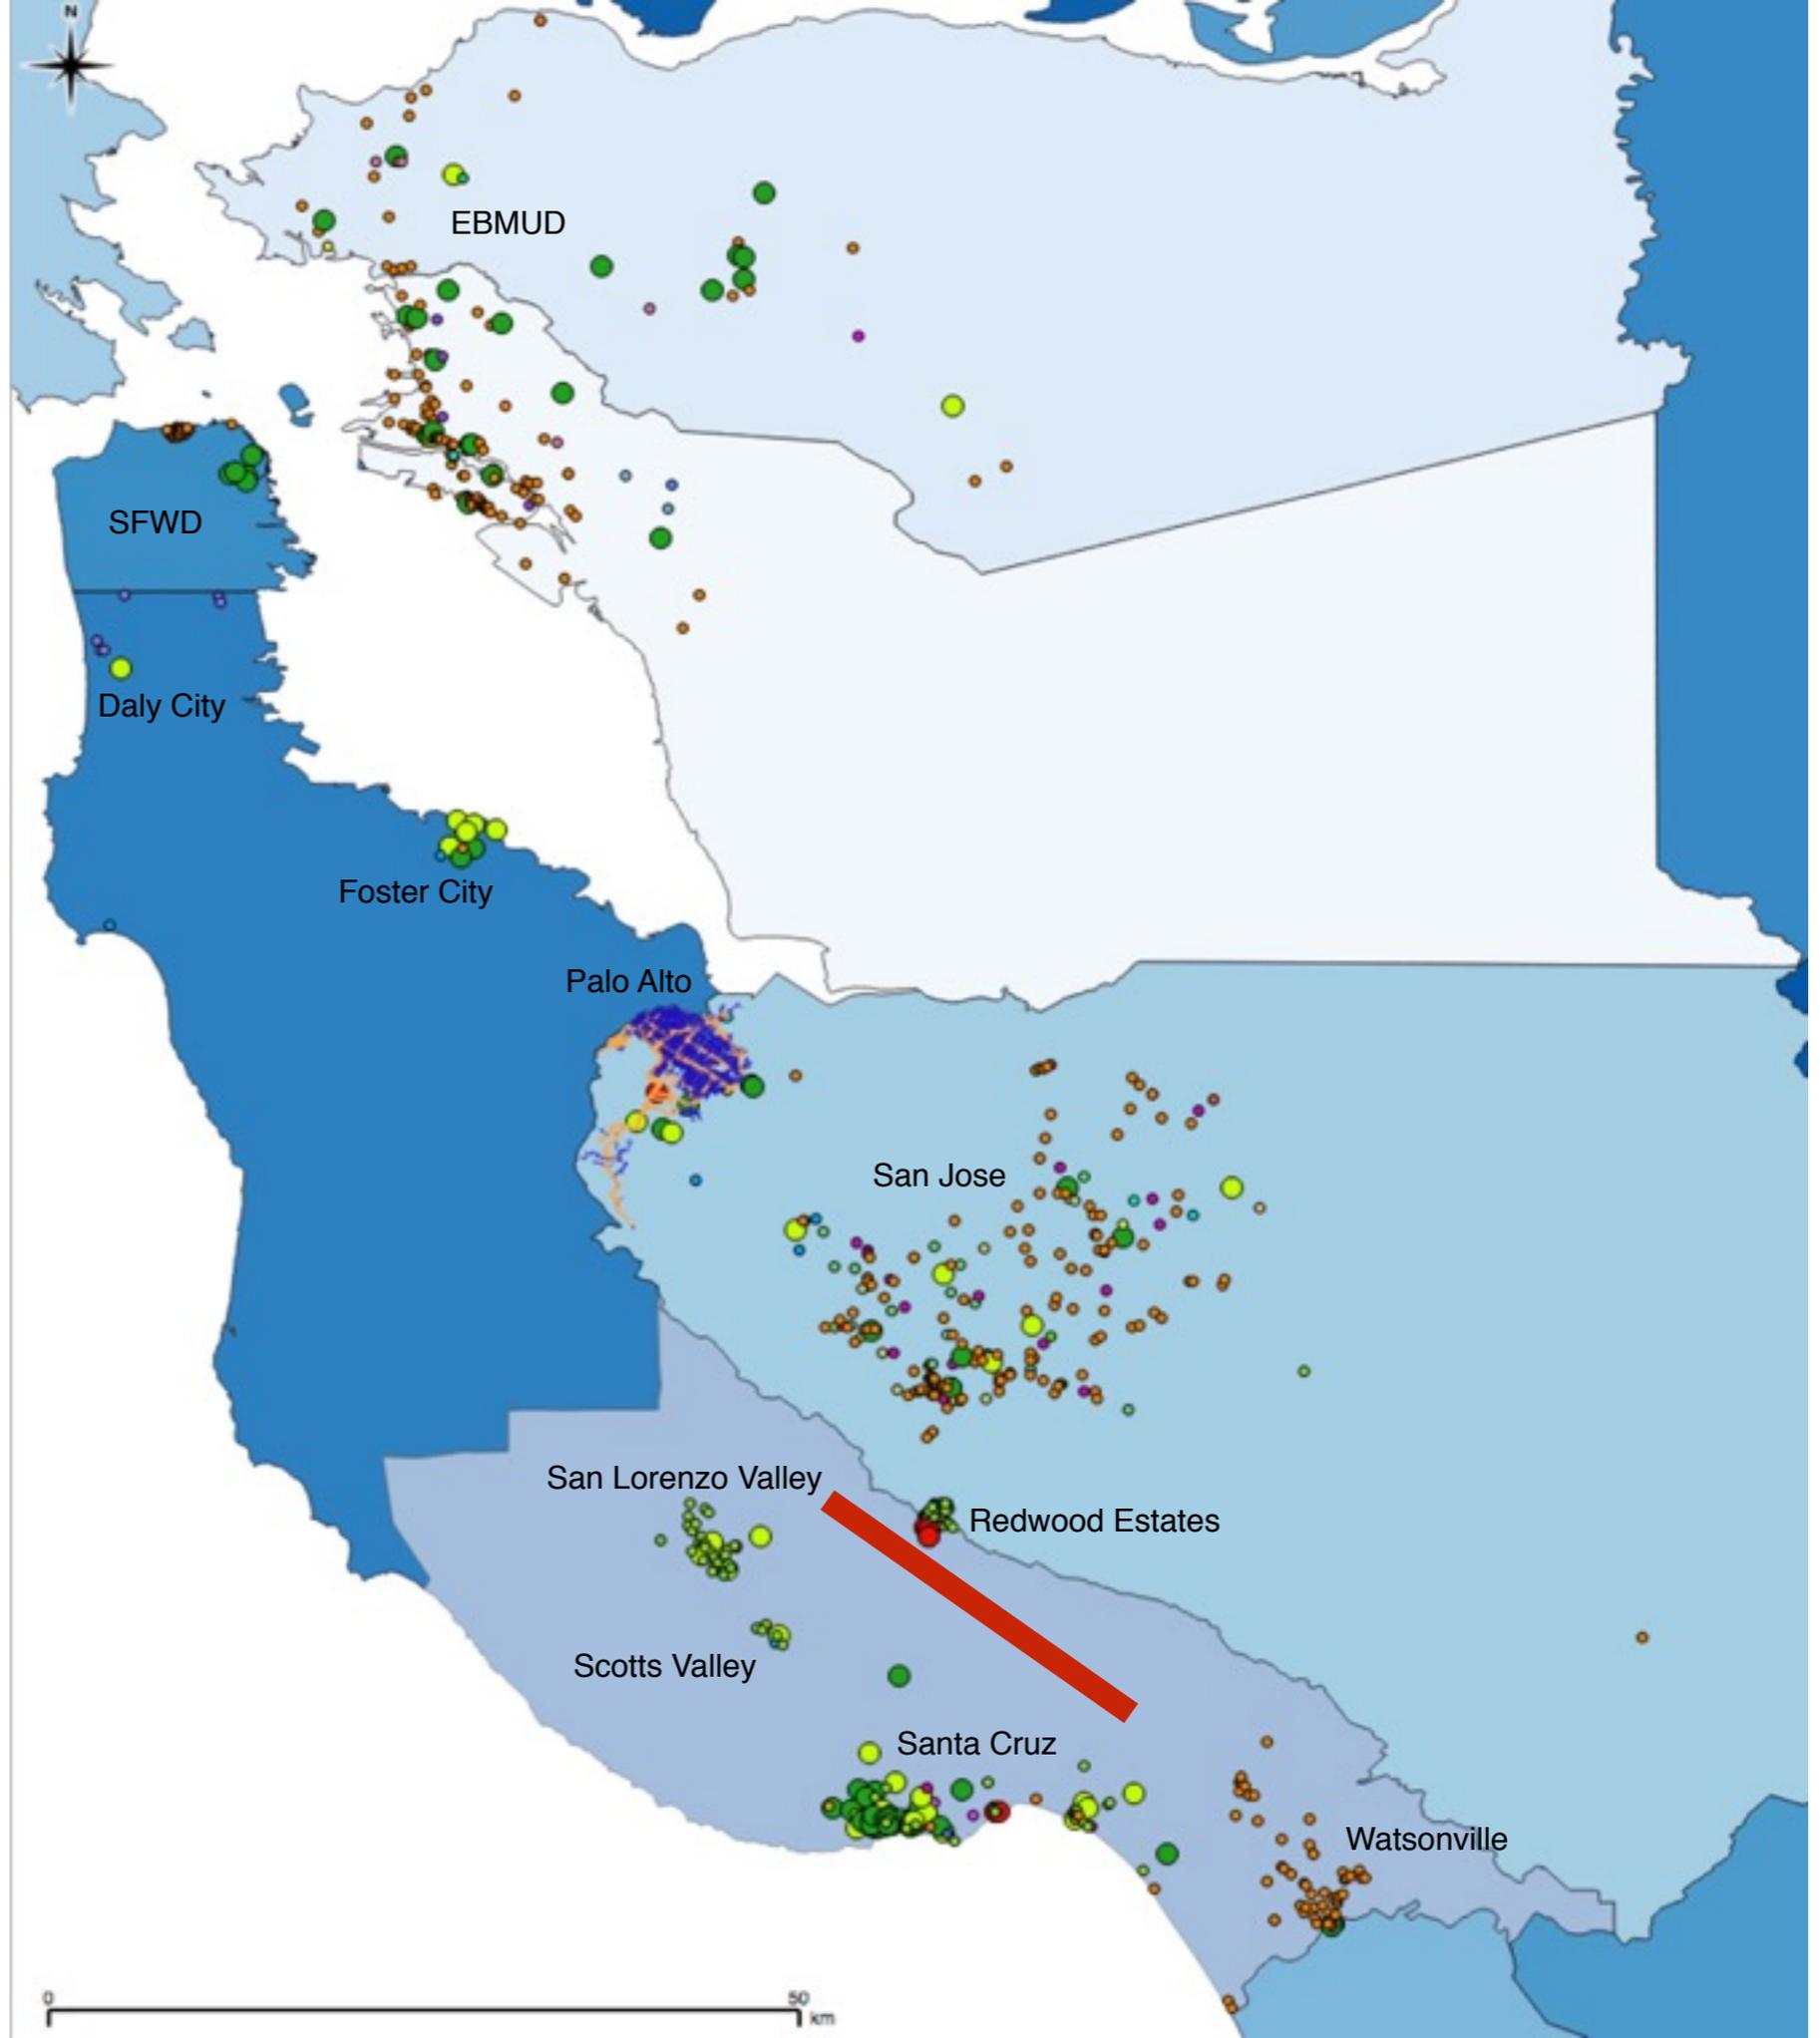
Damaged Pipes in the Loma Prieta 1989 Earthquake for Selected Water Systems

Note: not all pipe repairs shown.
City of Santa Clara pipe repairs not shown.

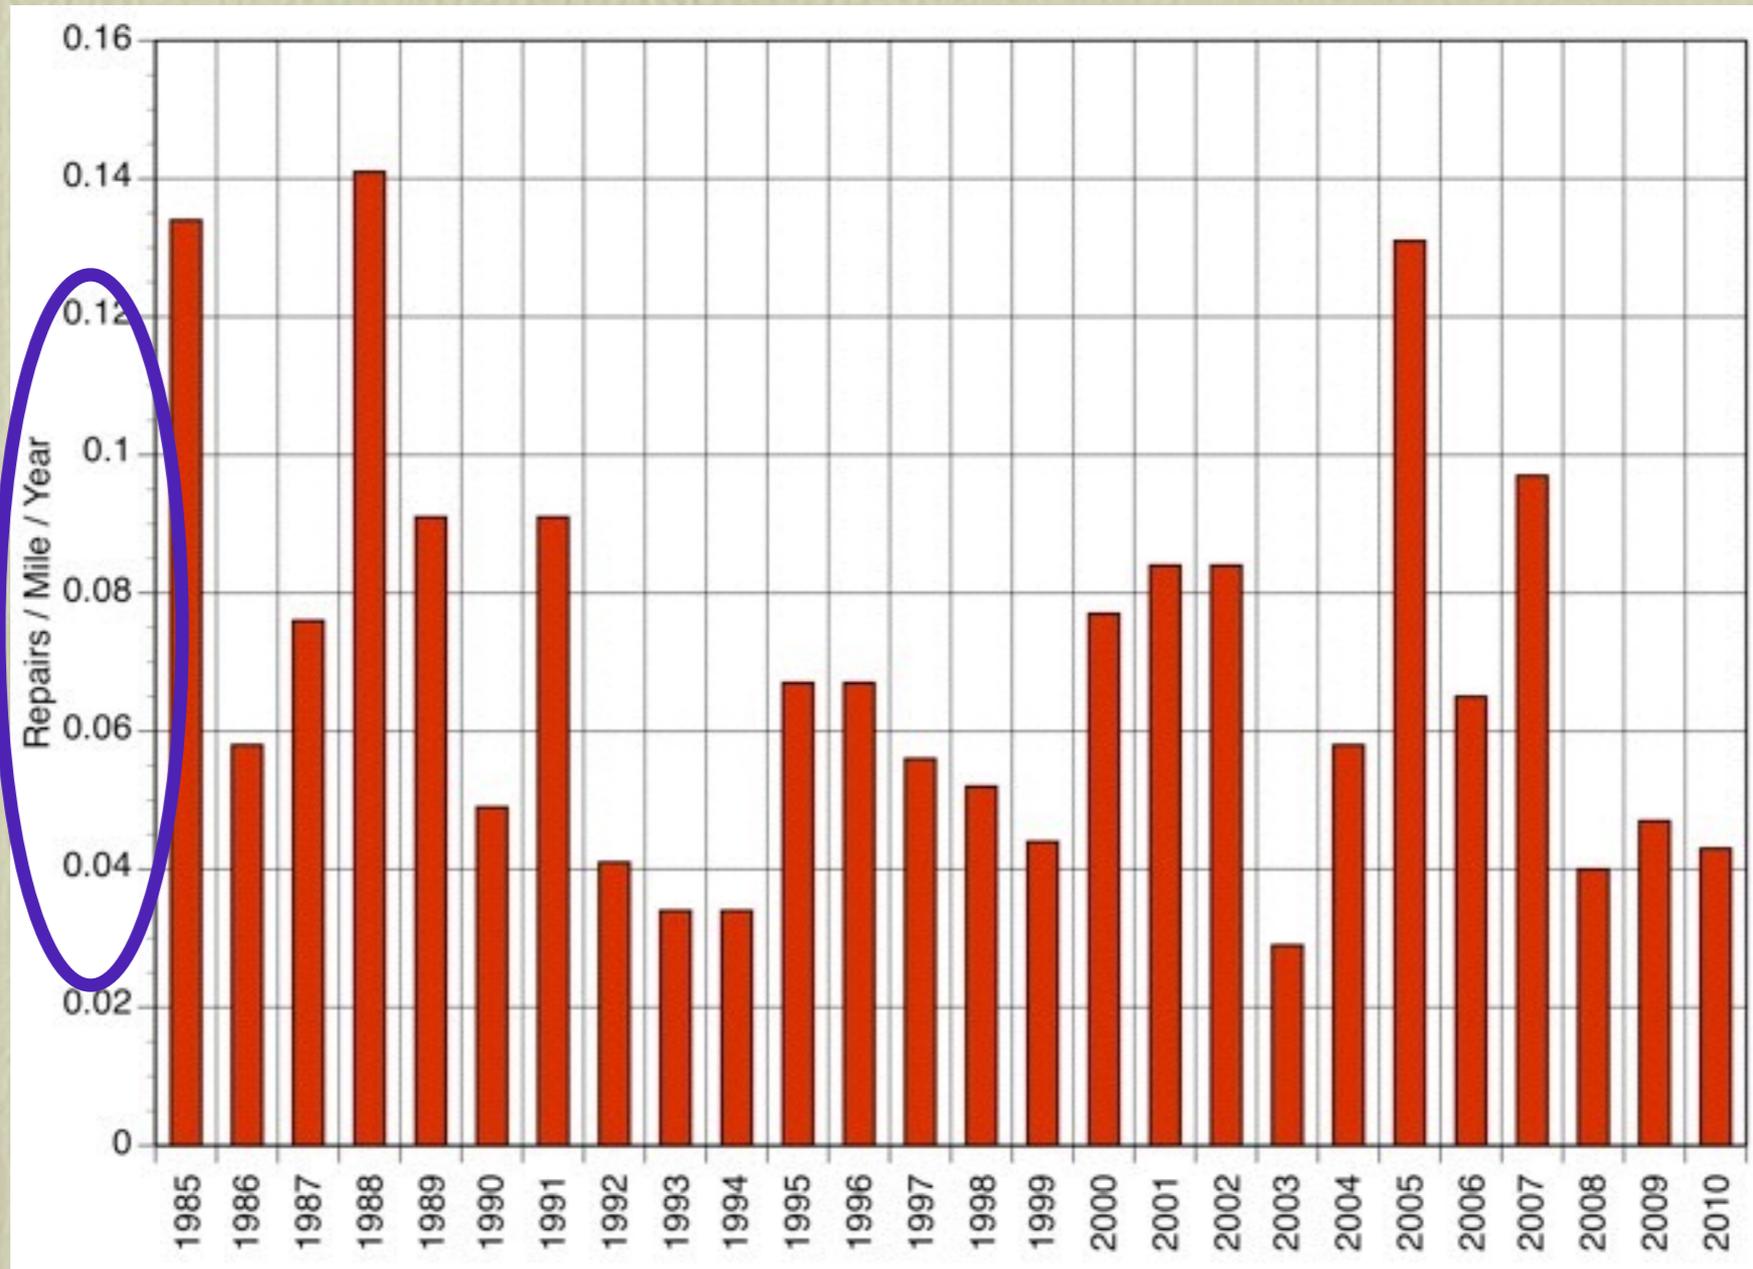
Burbank Leak History

Industry Average: 0.24 to 0.27

No trend for increasing leak rate in past 24.5 years

excludes leaks on service laterals

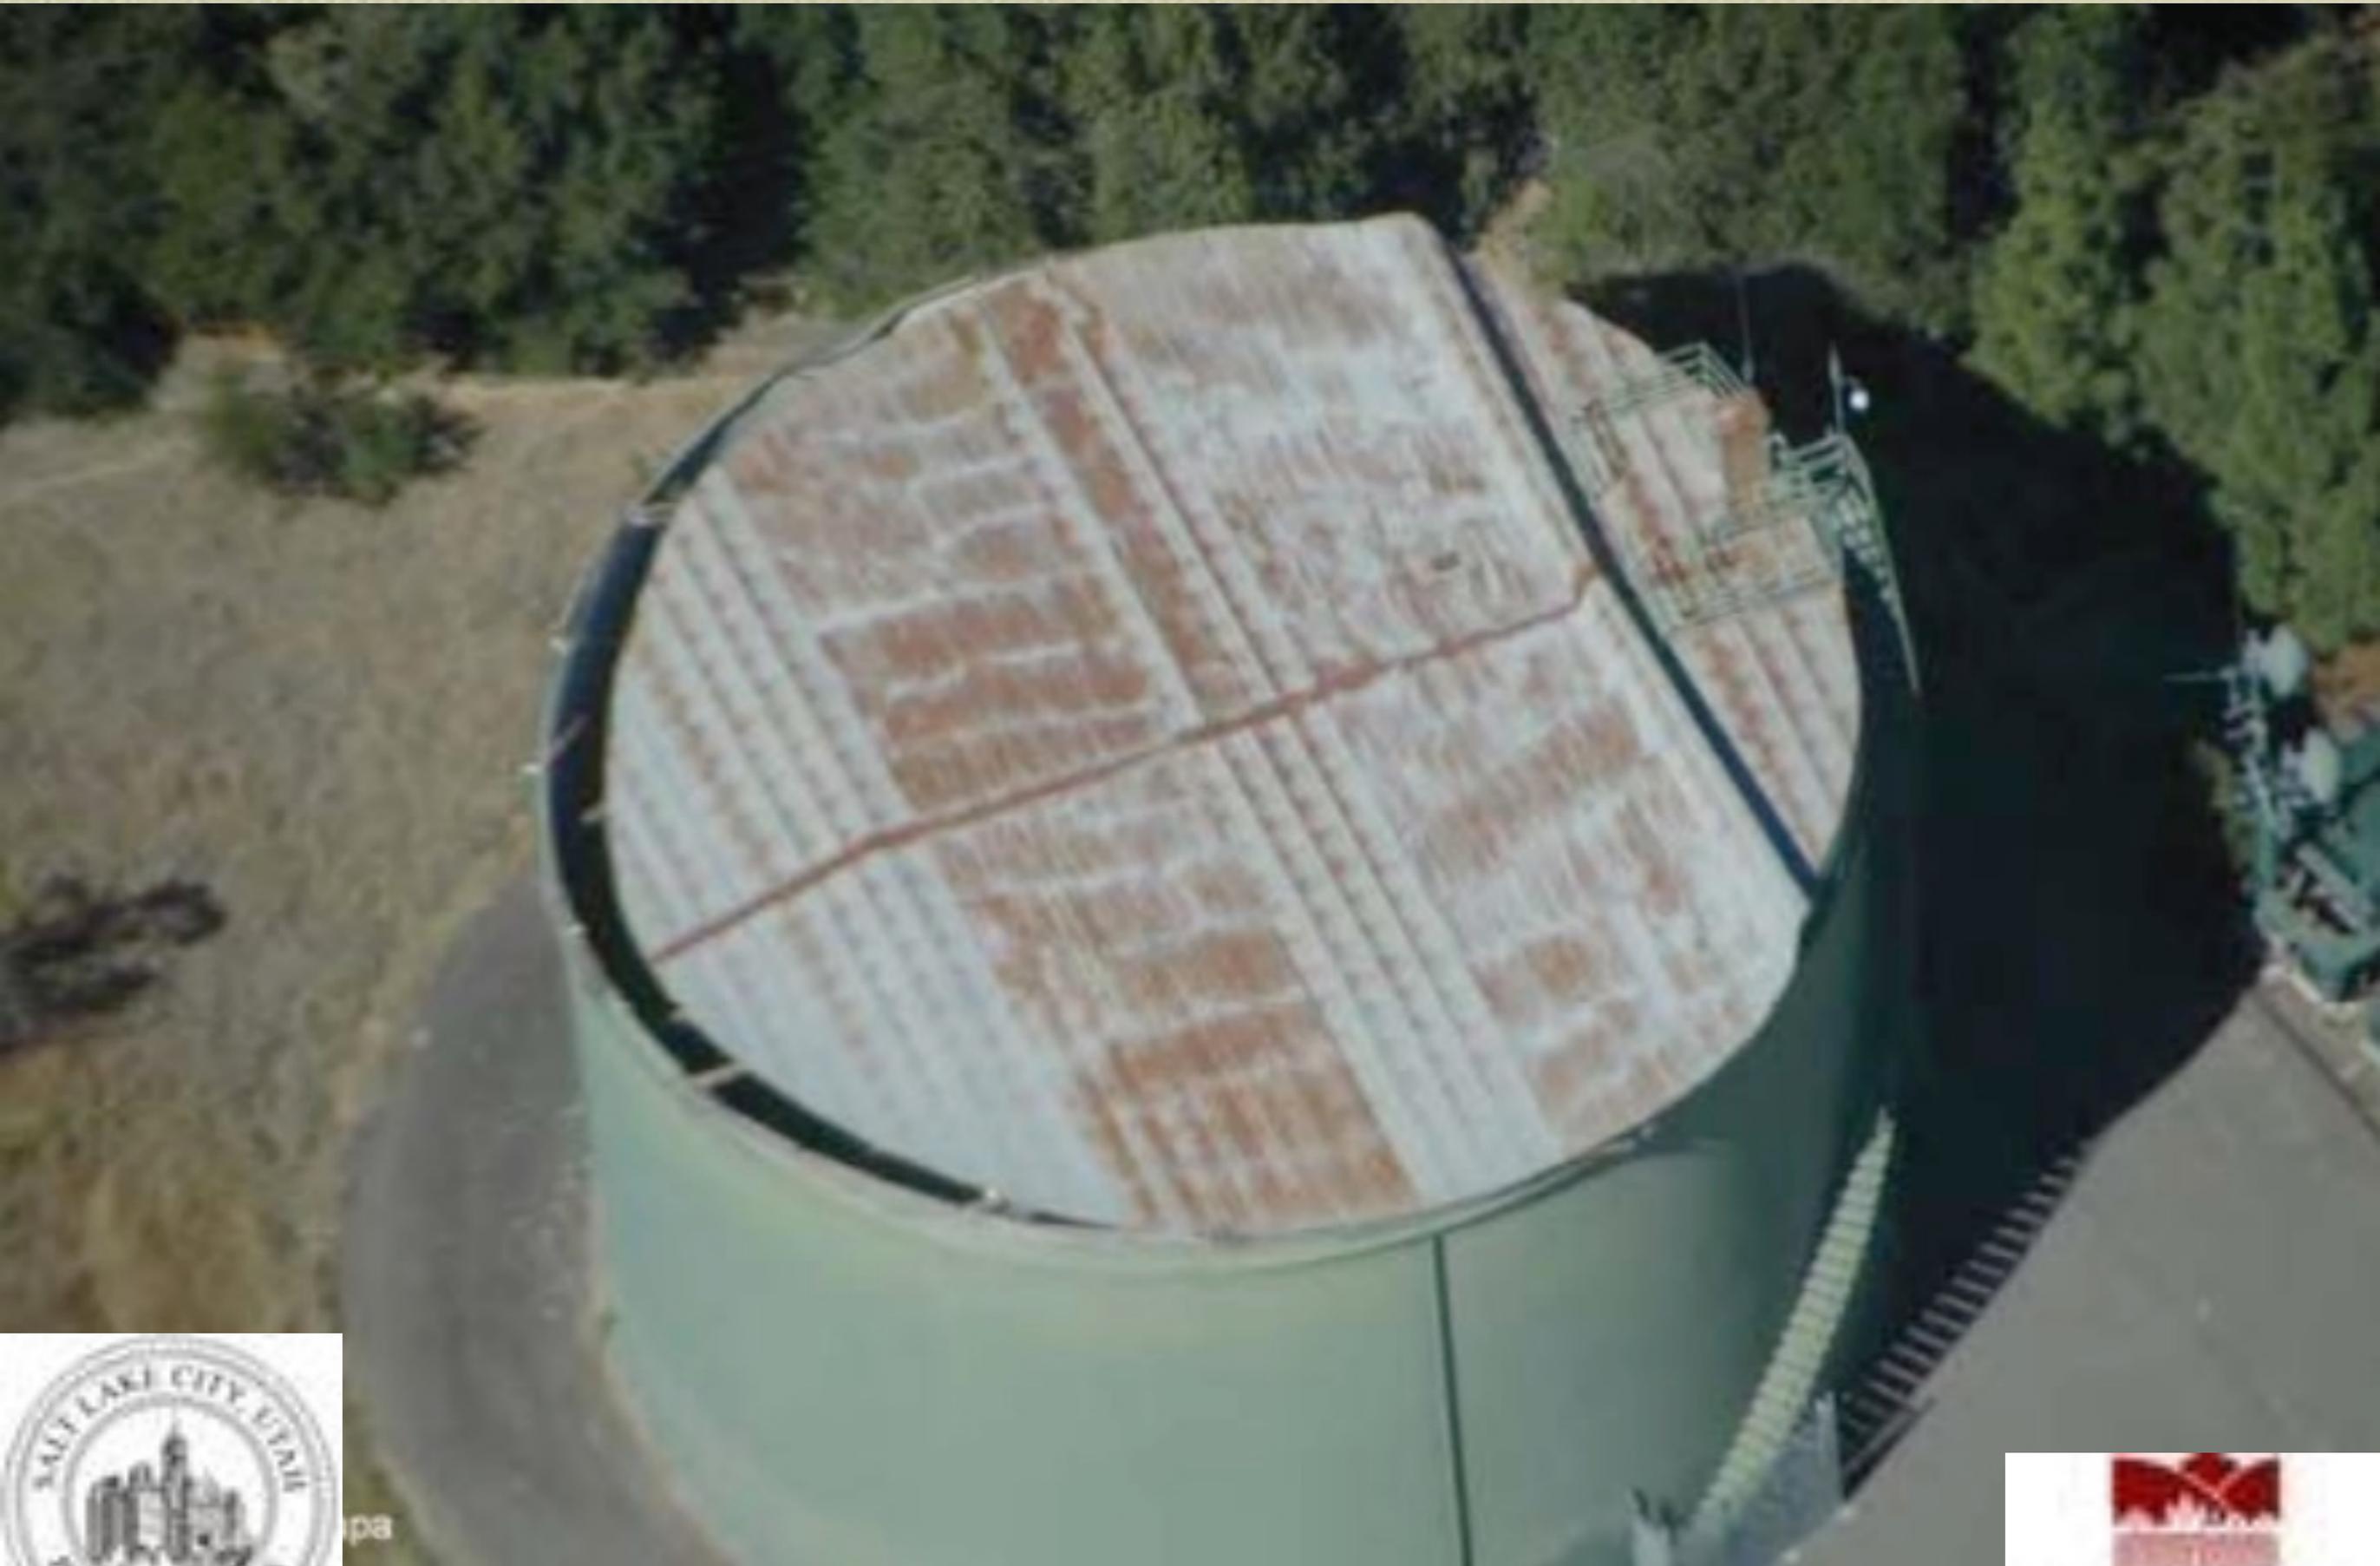
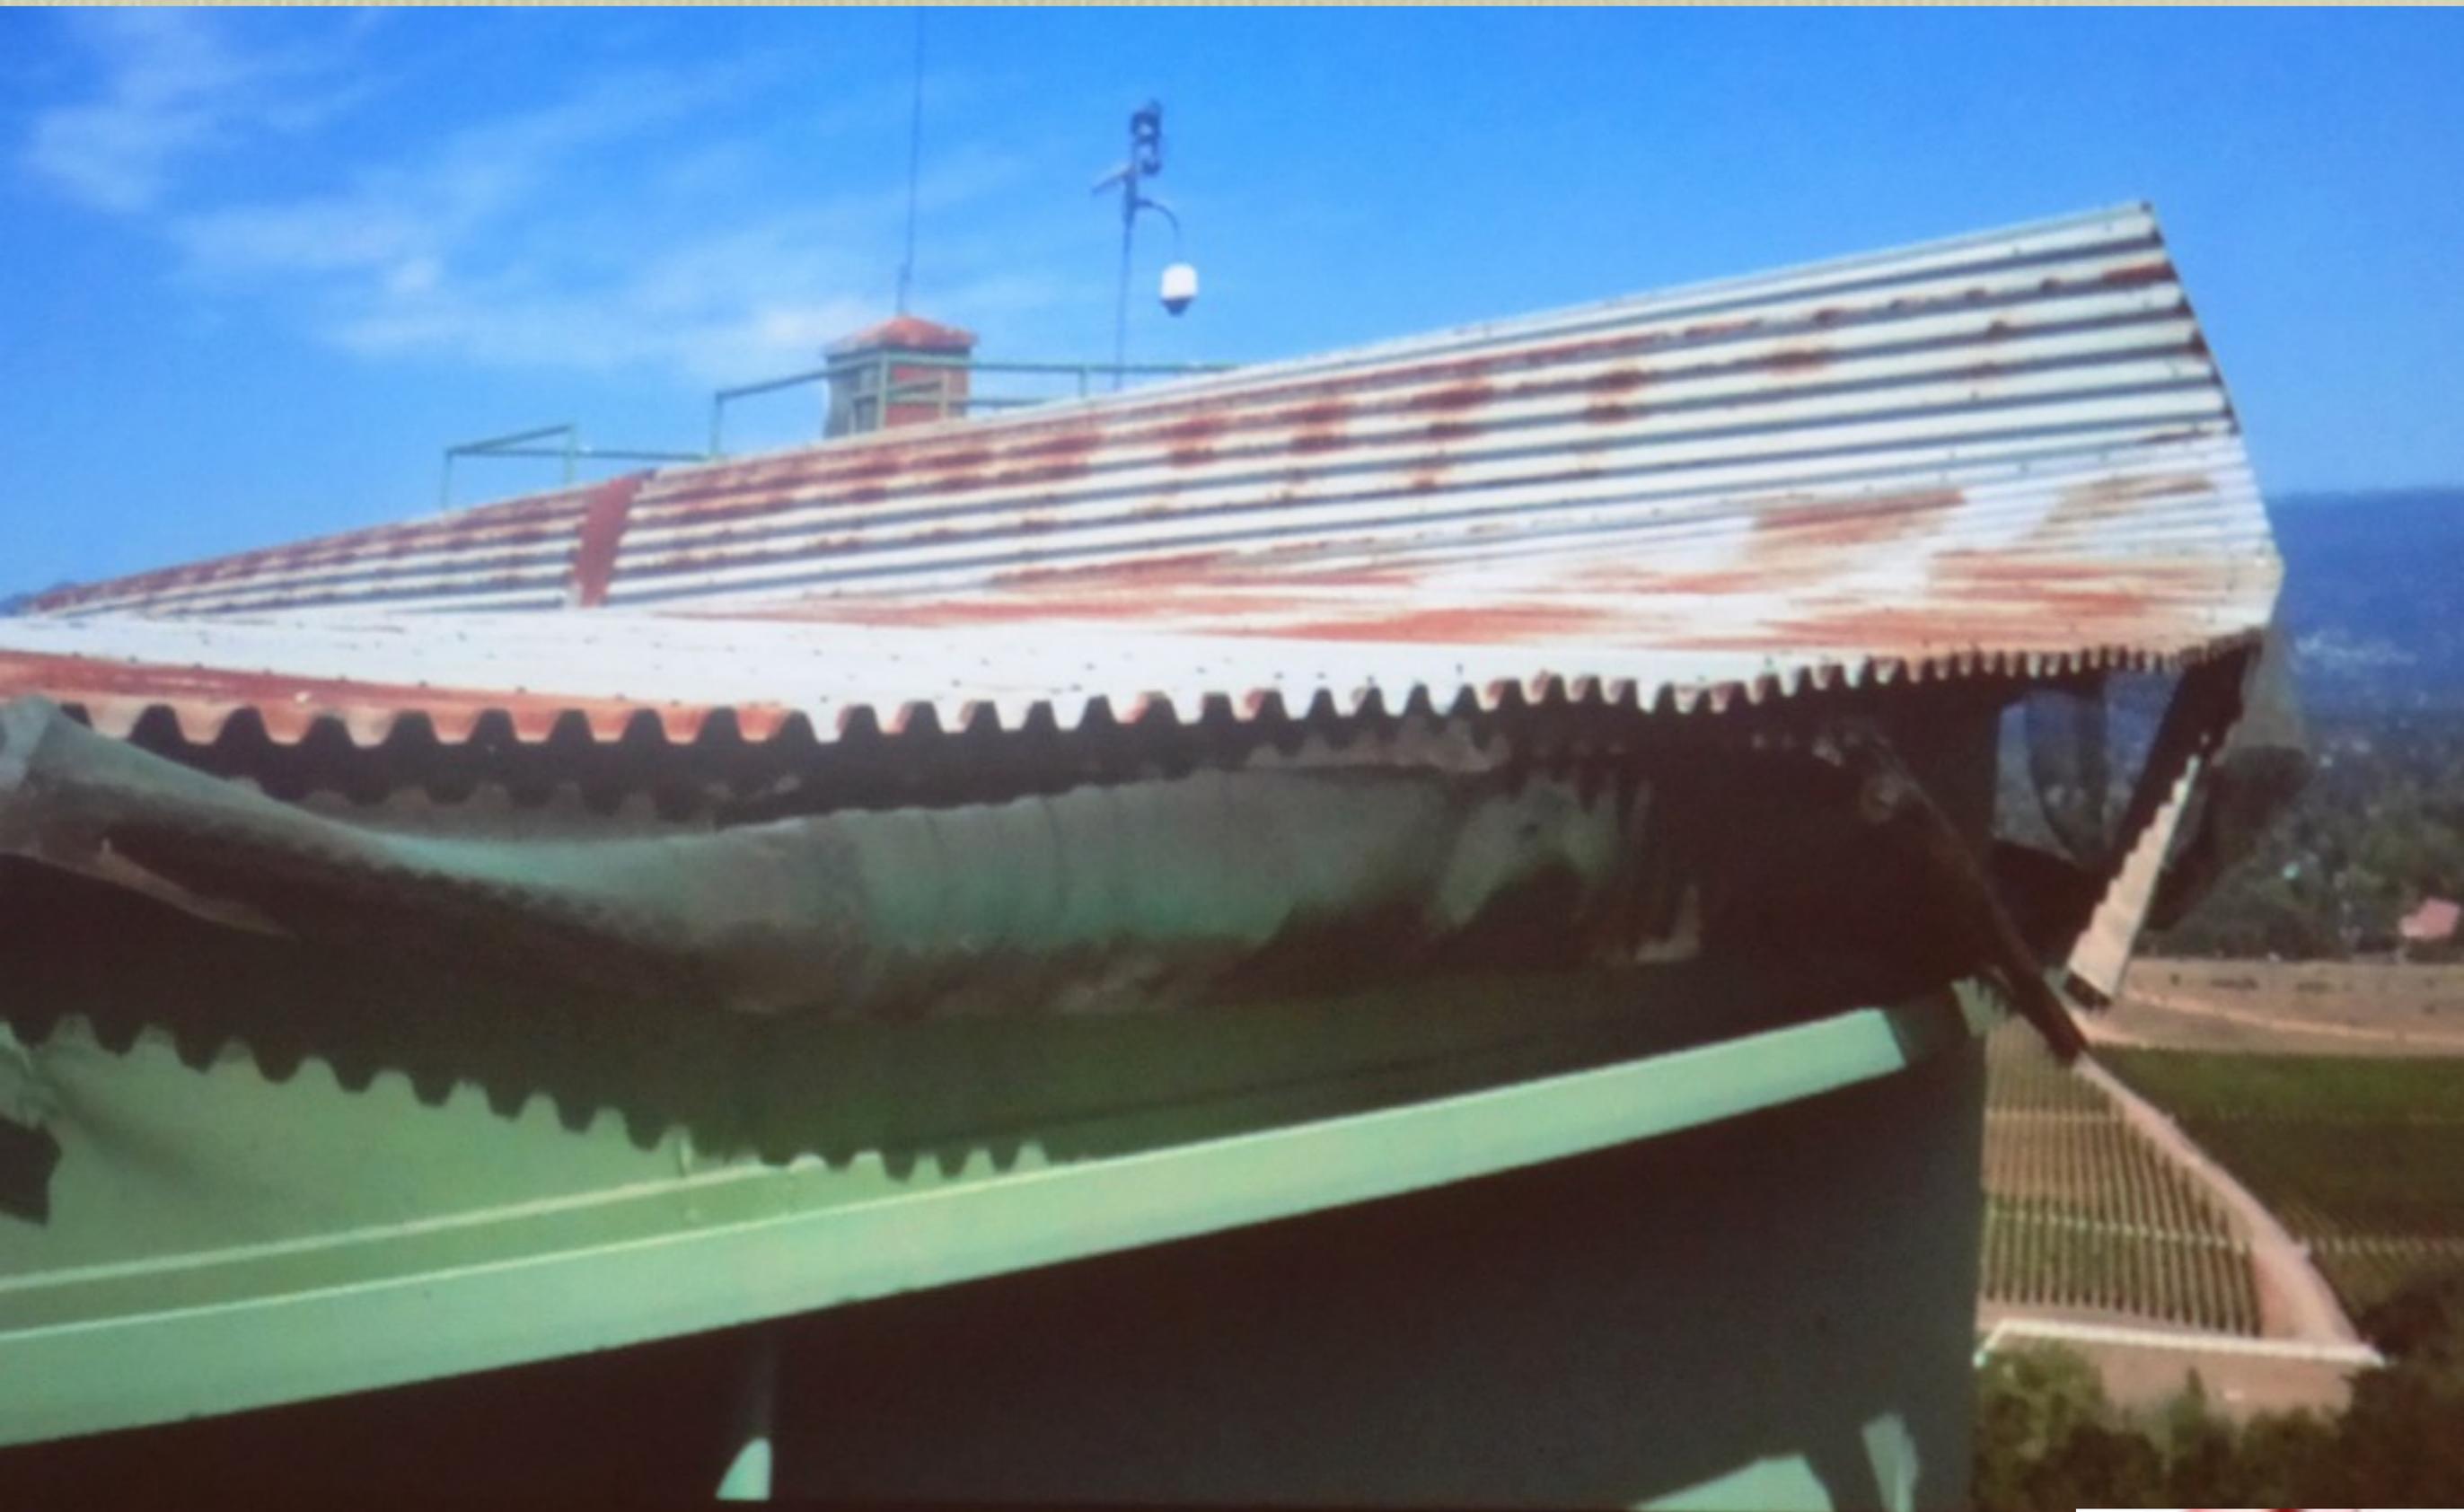
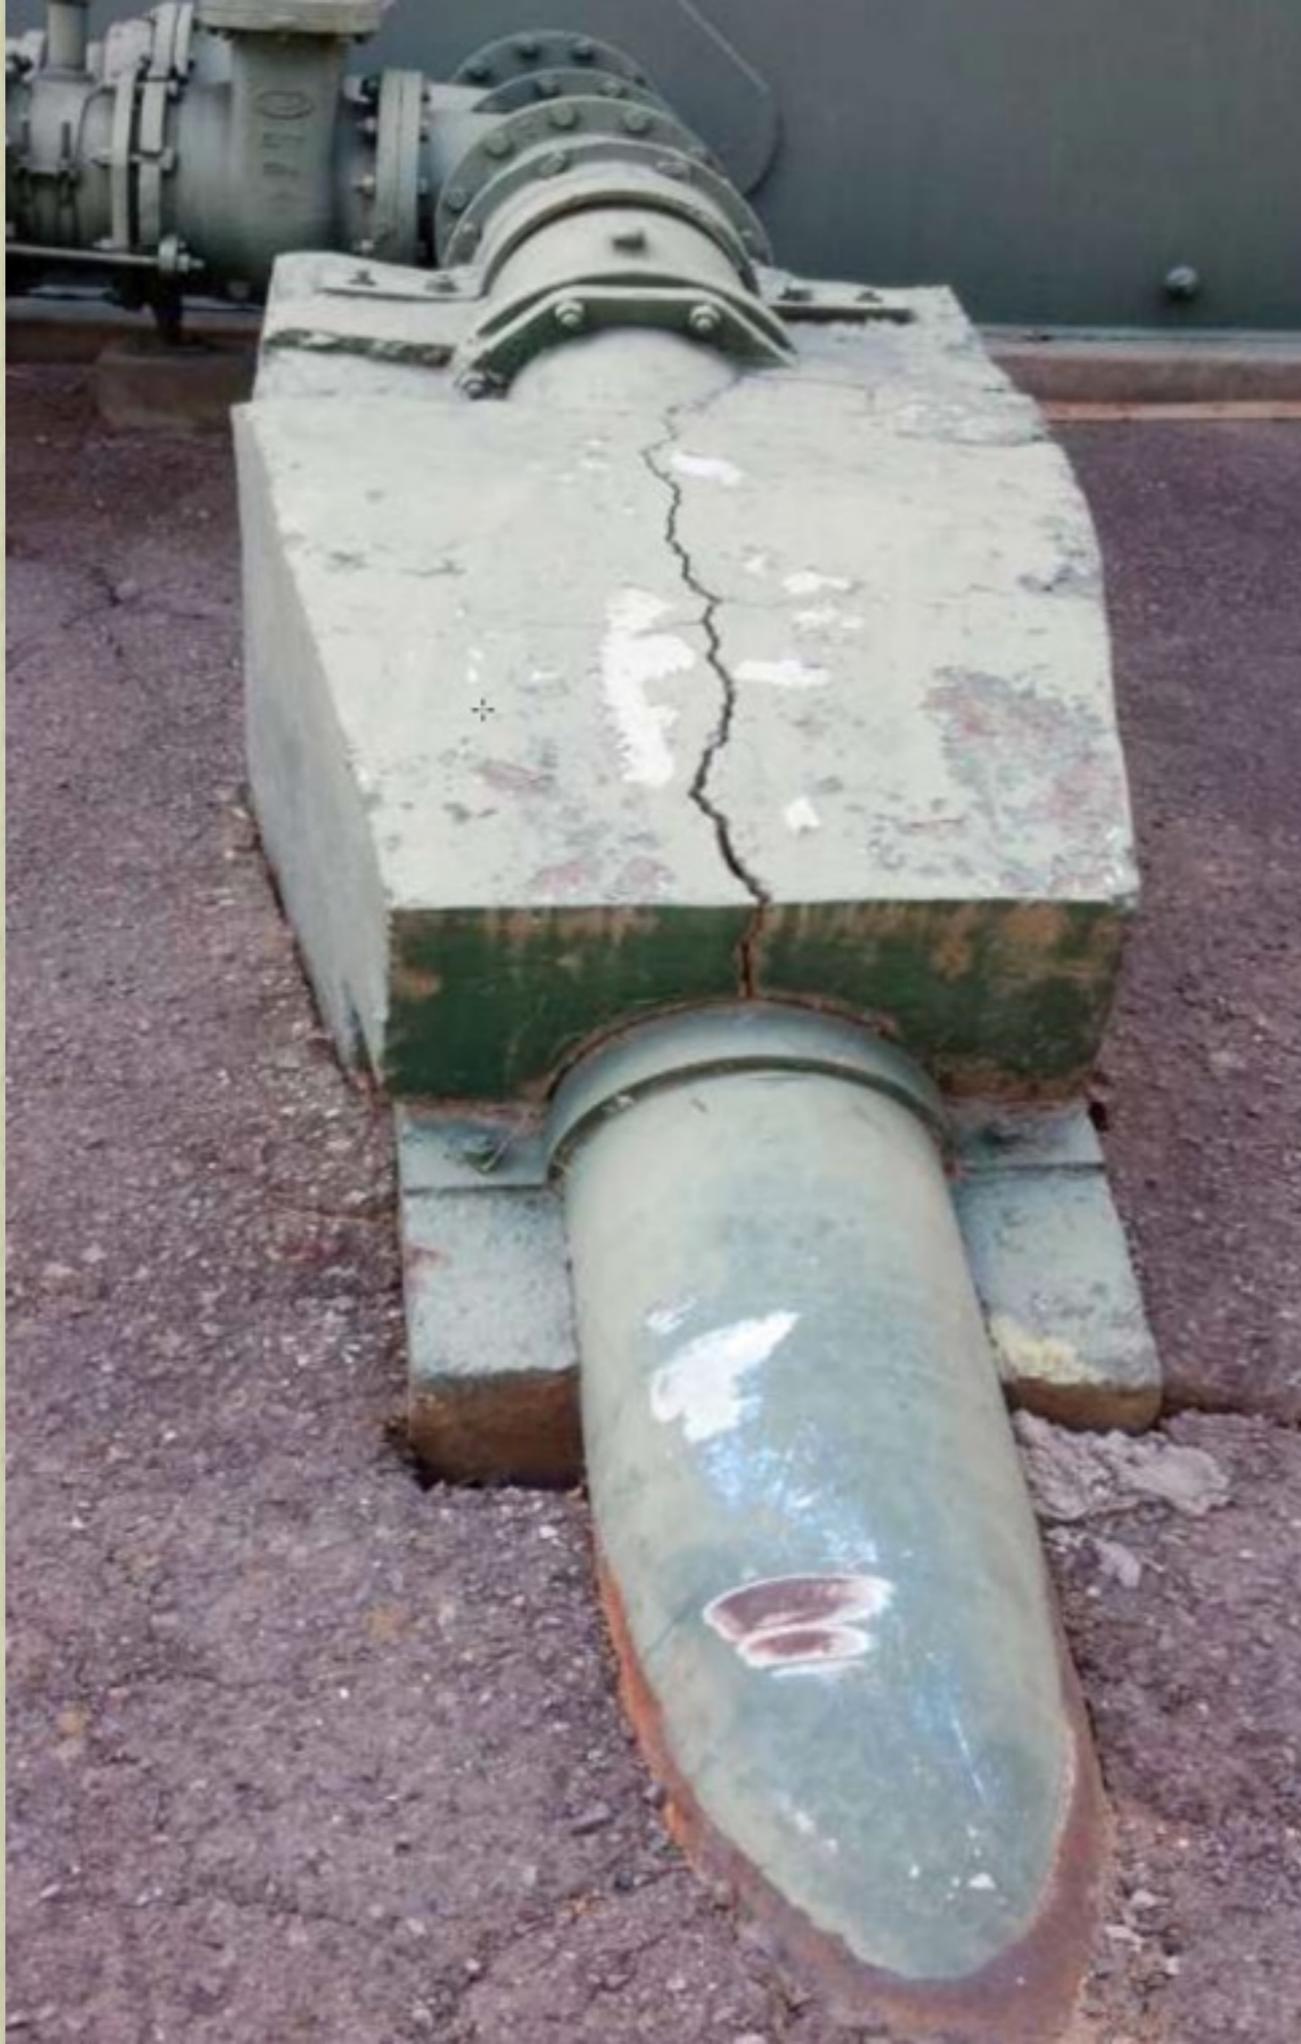
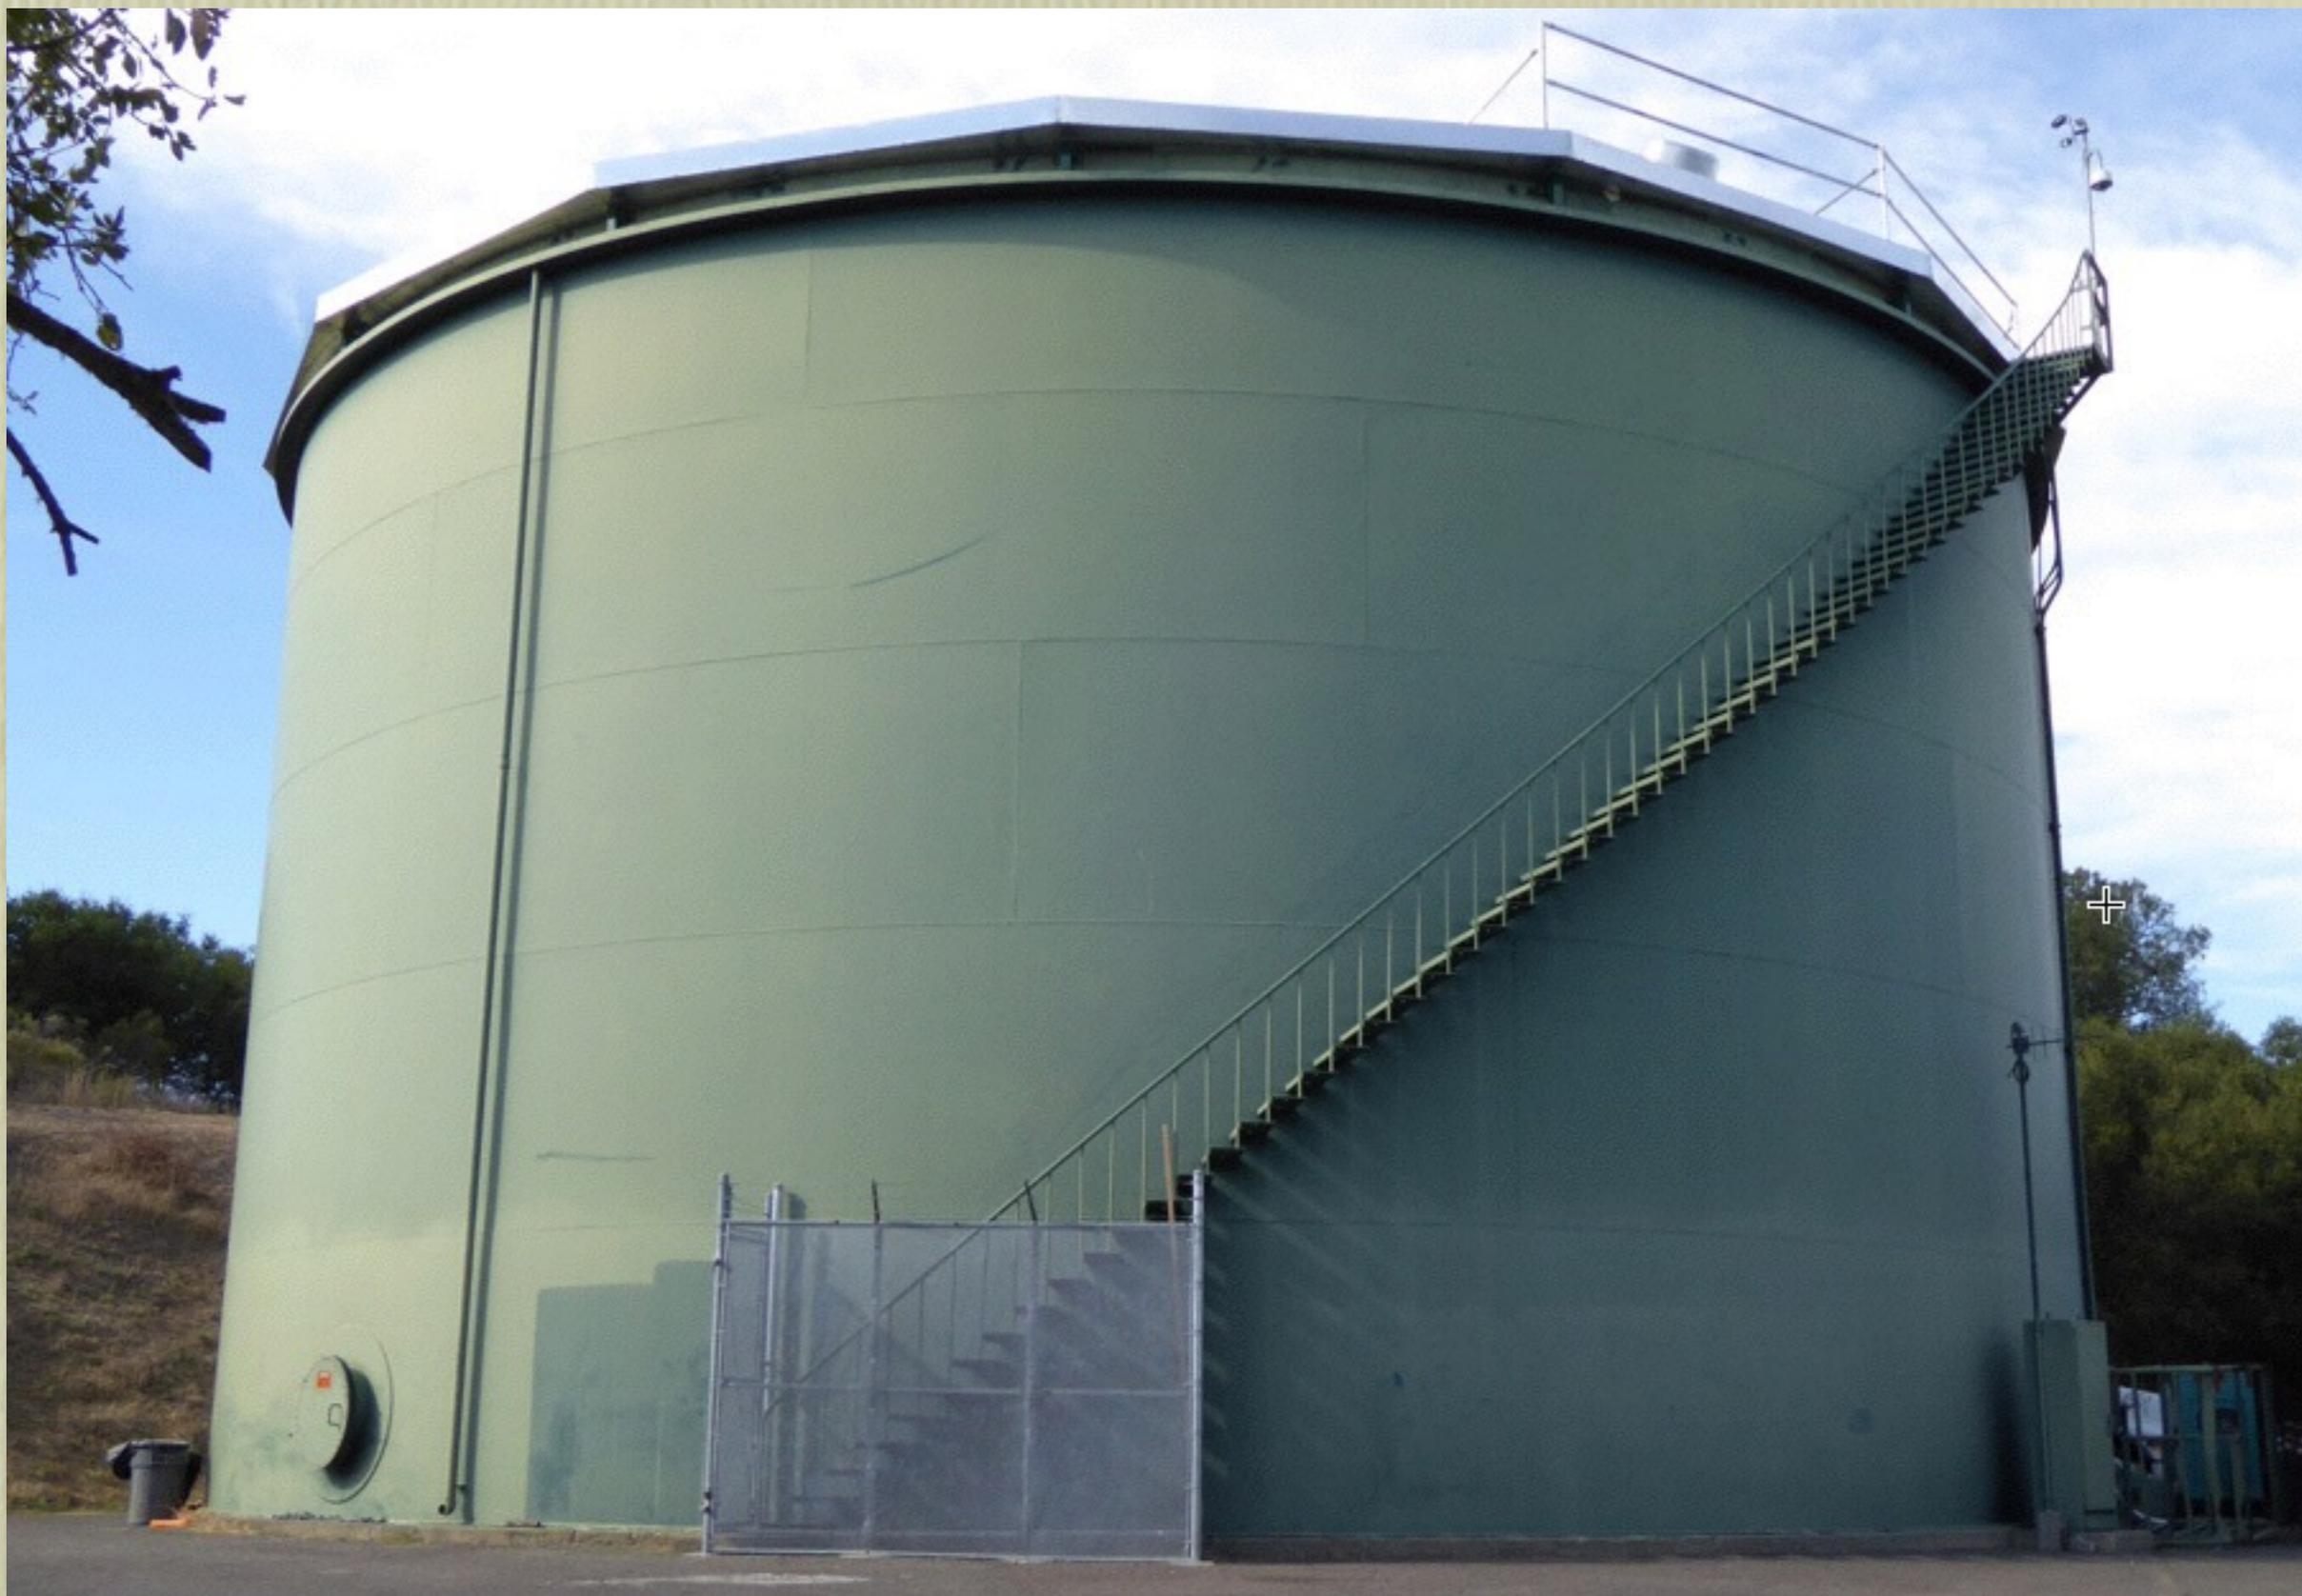
Tank "B"

The Roof was damaged due to water sloshing and tank wall uplift (who cares, FEMA pays)

Napa replaced the roof

Then, Napa wanted to "raise" the roof top prevent future roof damage (IMHO, a waste of \$\$)
