Napa Earthquake of 8.24.2014 Performance of Lifelines

Water, Power, Gas, Fires

City and County Engineers Association of
San Mateo County

South Napa M 6.0 Earthquake of August 24, 2014

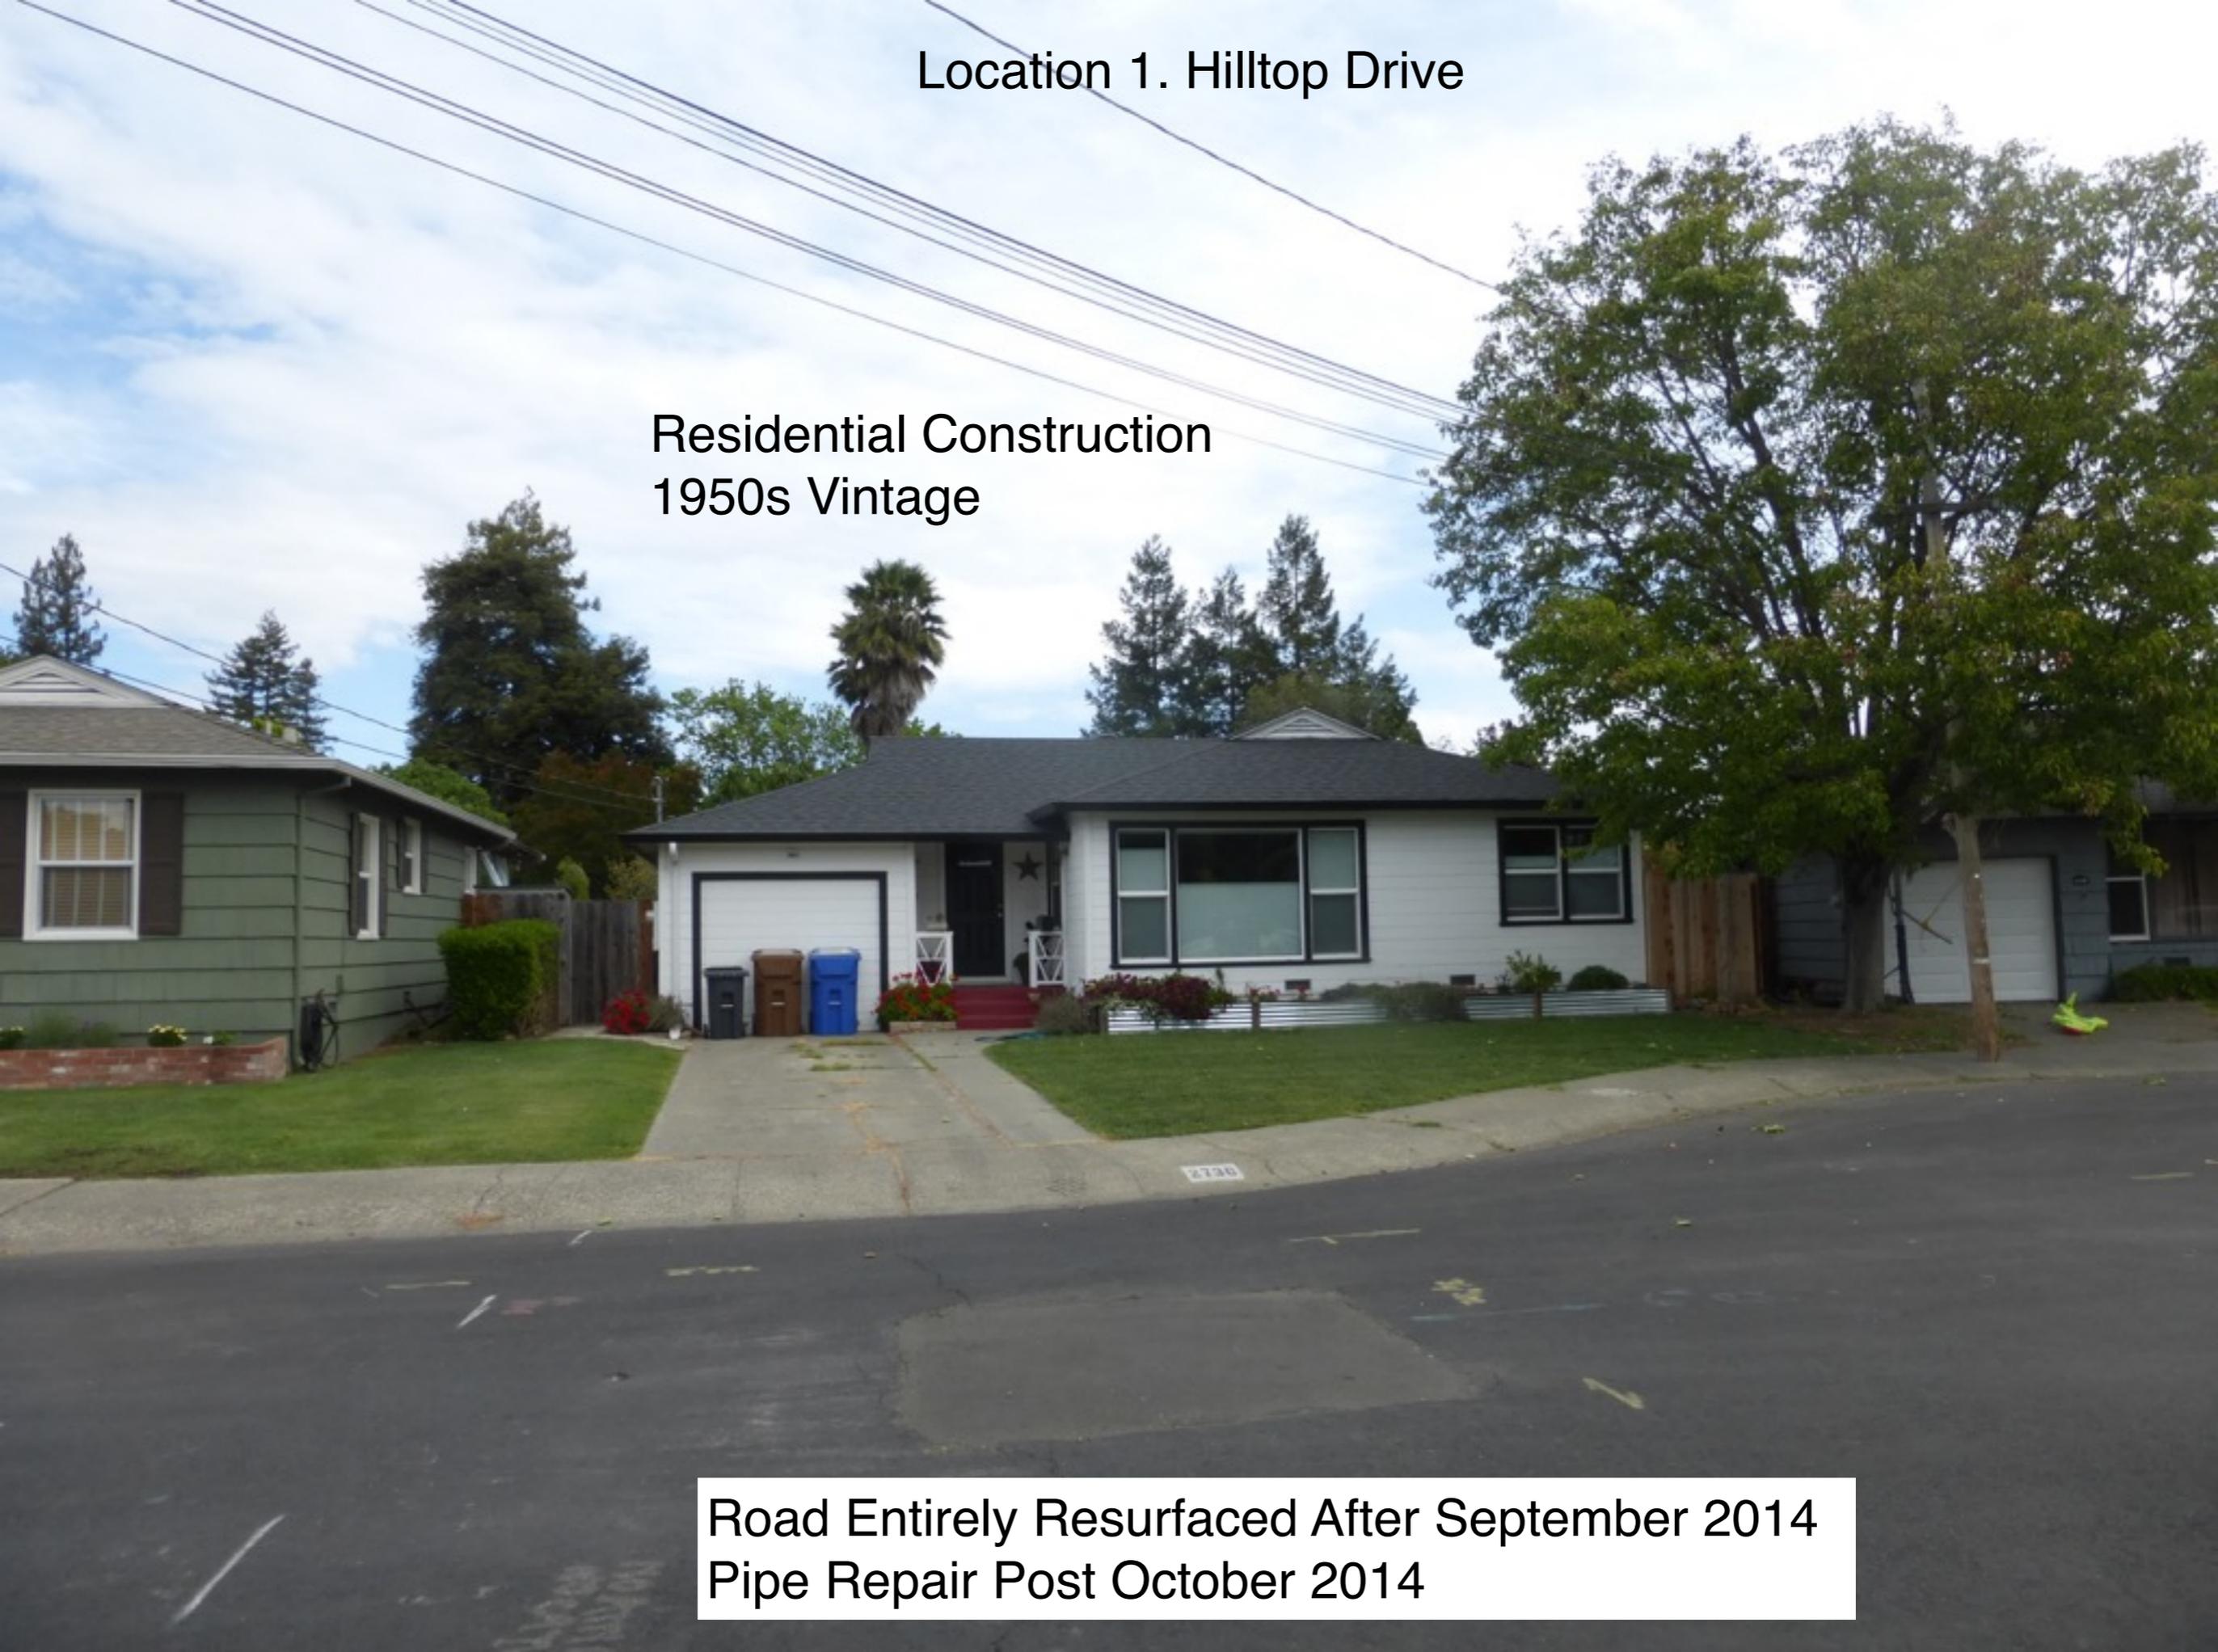
Location 1. Hilltop Drive

Residential Construction
1950s Vintage

Road Entirely Resurfaced After September 2014
Pipe Repair Post October 2014

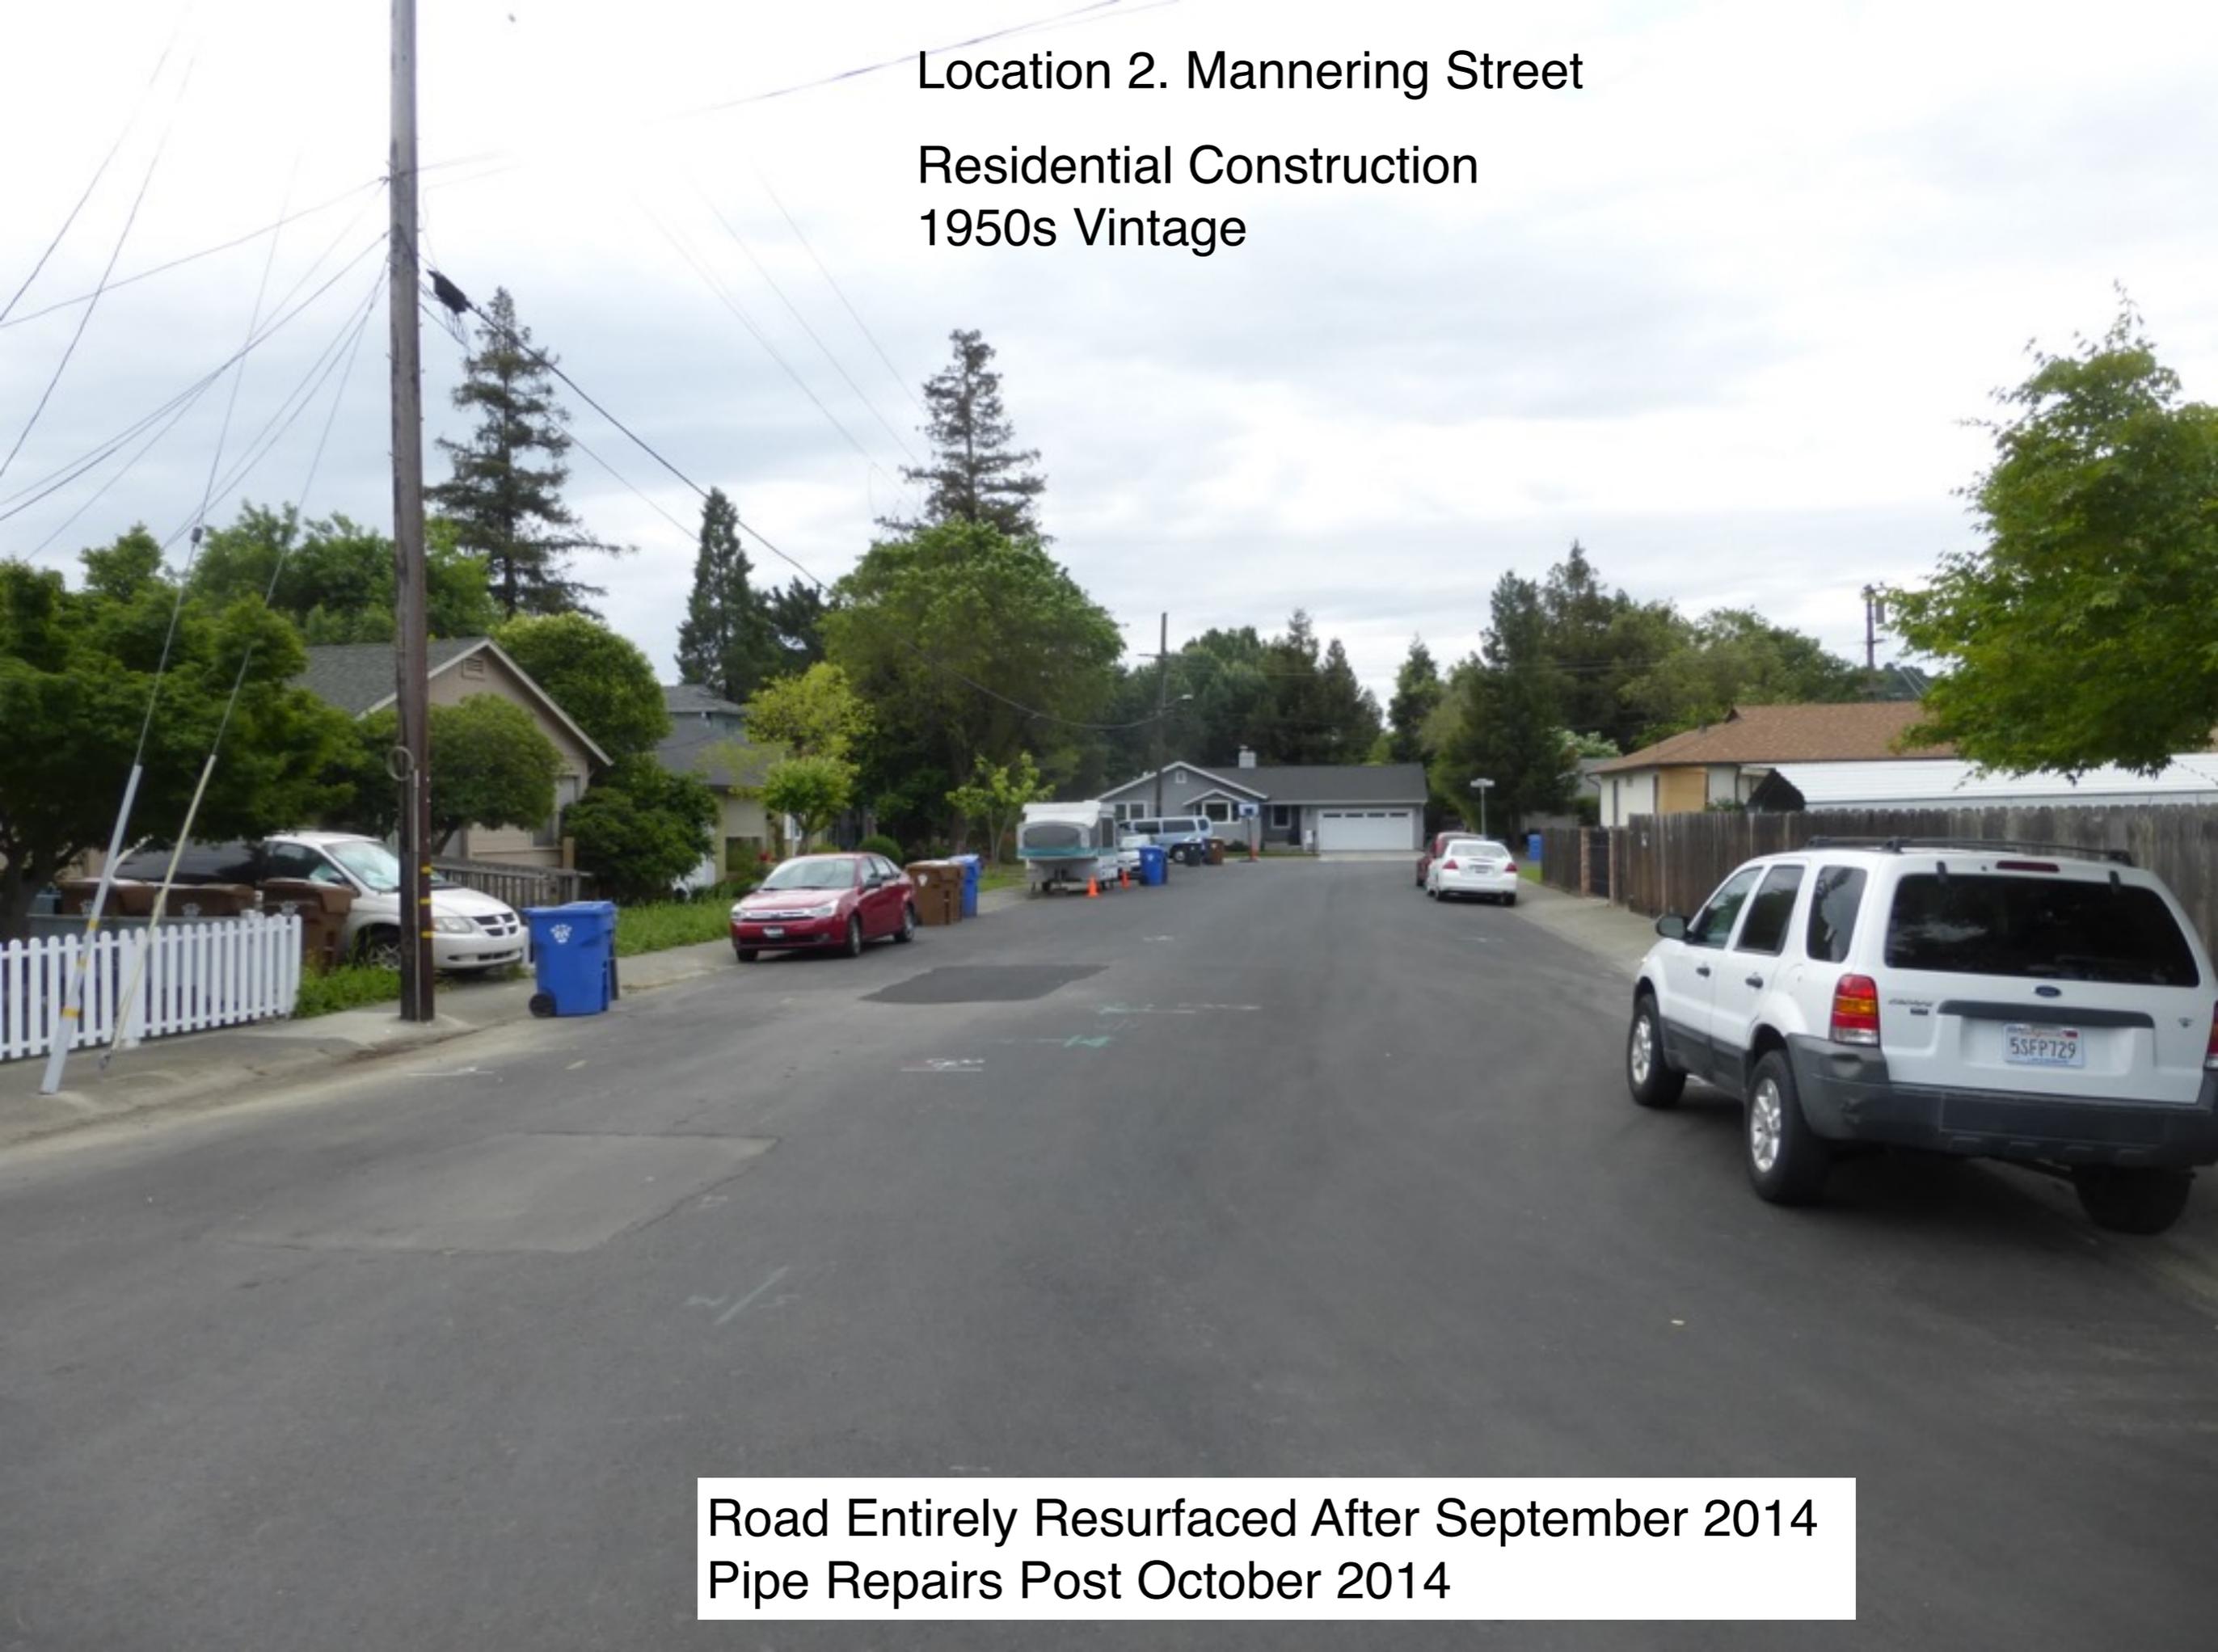
Location 2. Mannering Street

Residential Construction
1950s Vintage

Road Entirely Resurfaced After September 2014
Pipe Repairs Post October 2014

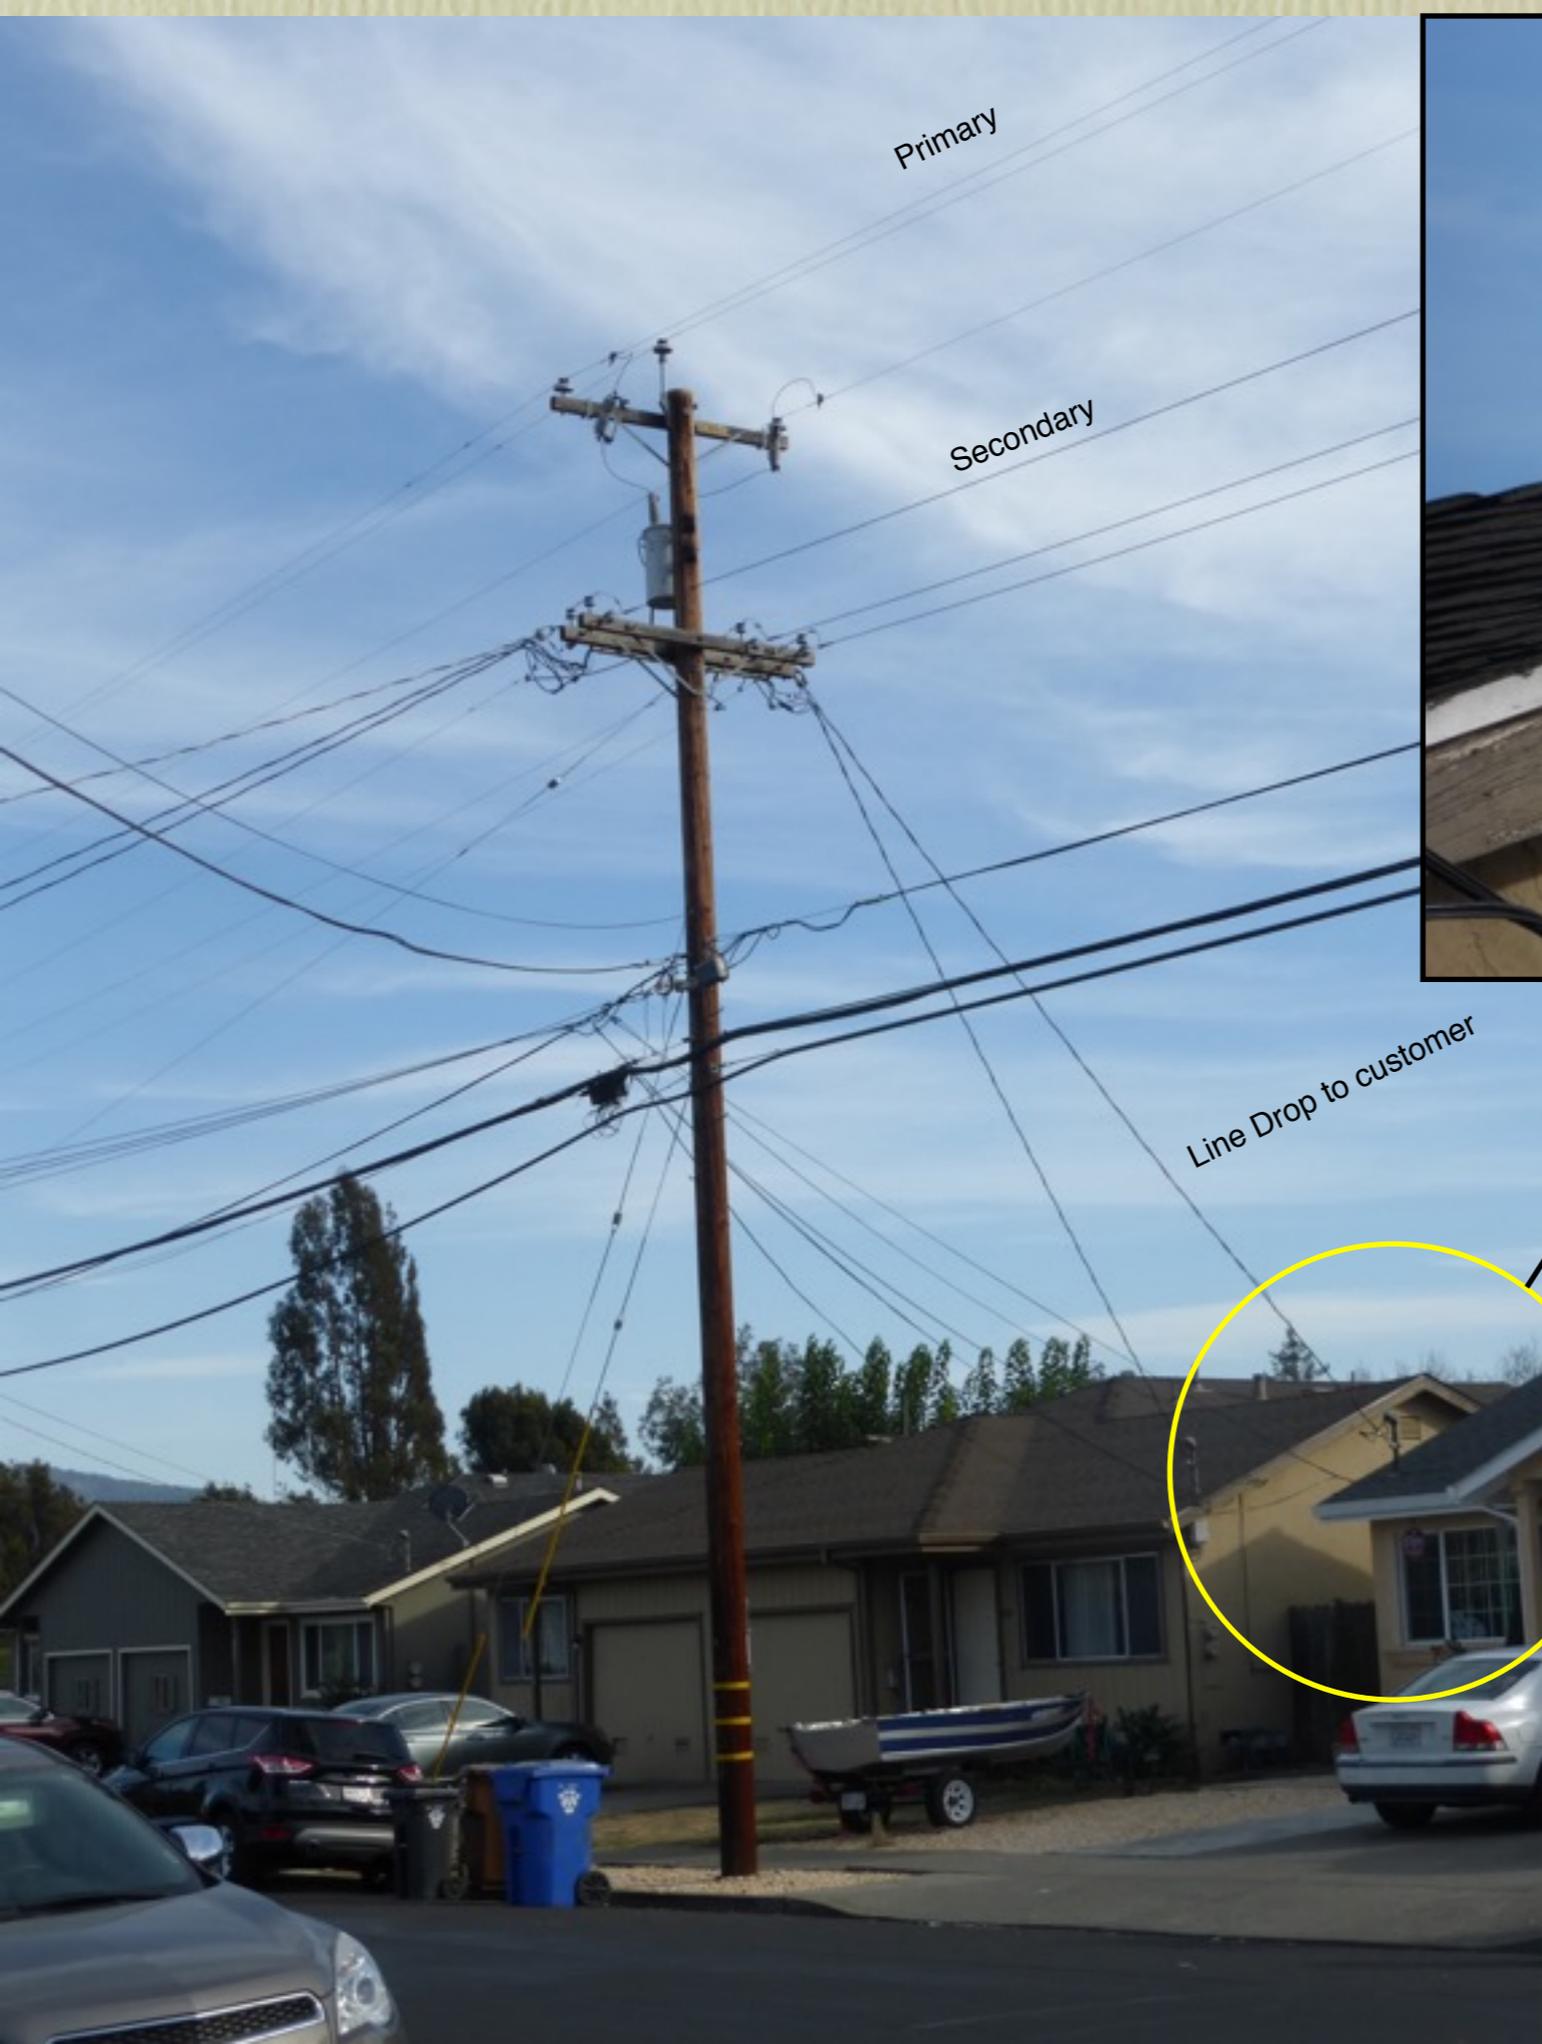
Swaying of pole and inadequate slack on secondary line drop to house led to failure of the insulator connection on the house.

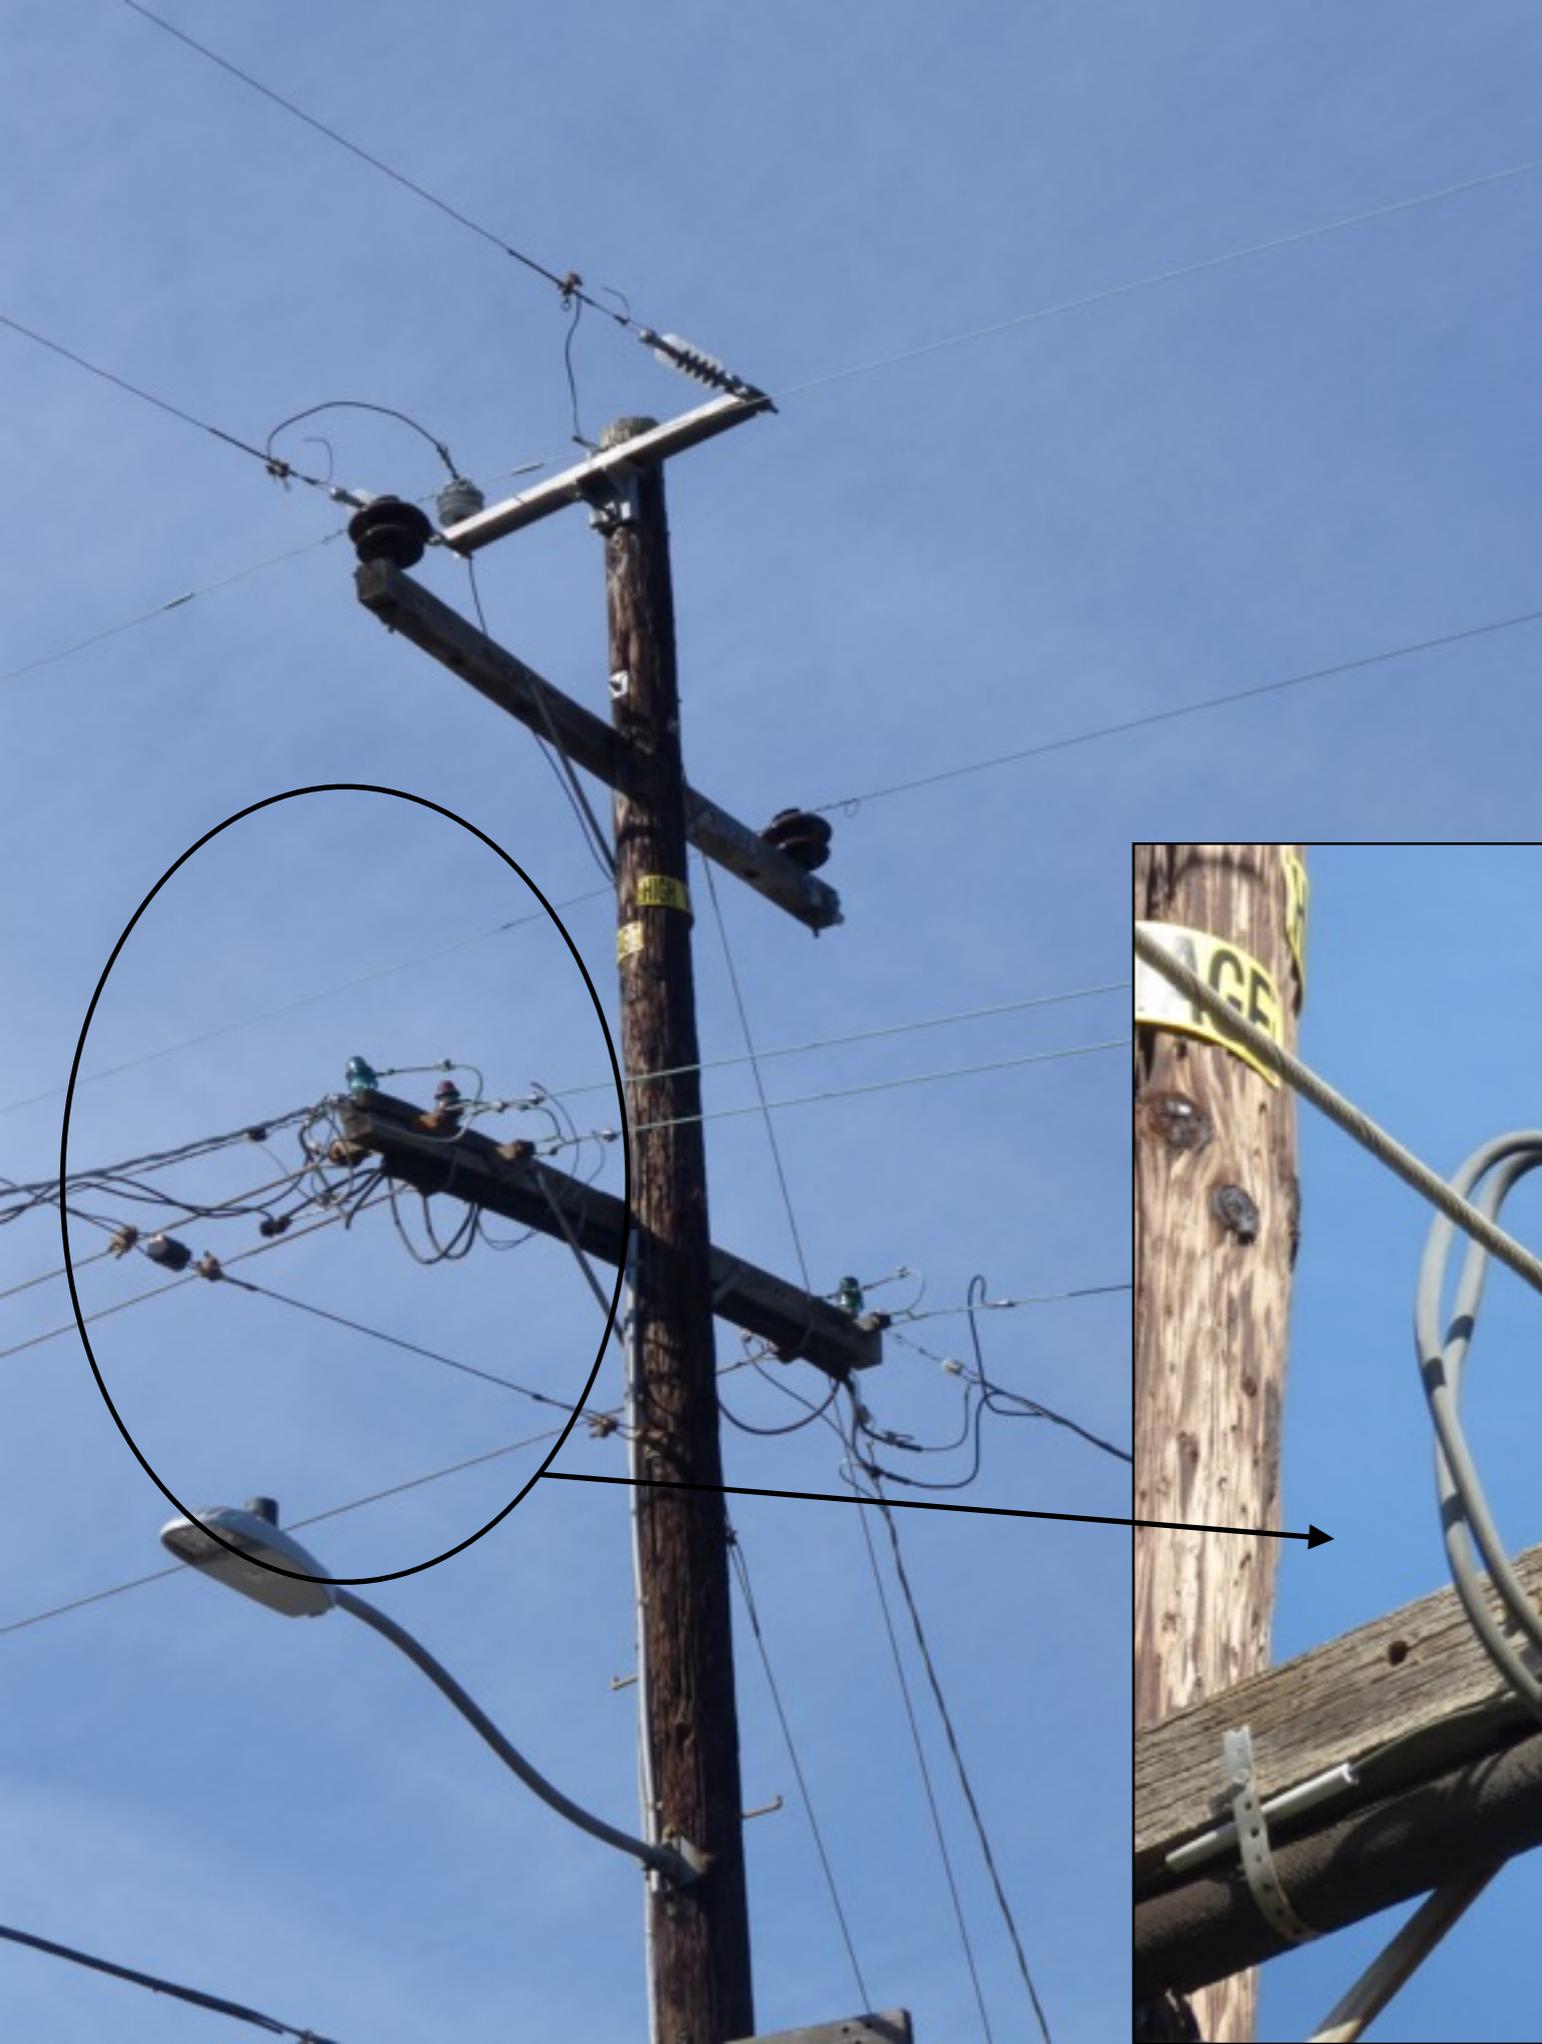
cross arm damaged due to unbalanced "snap" loads

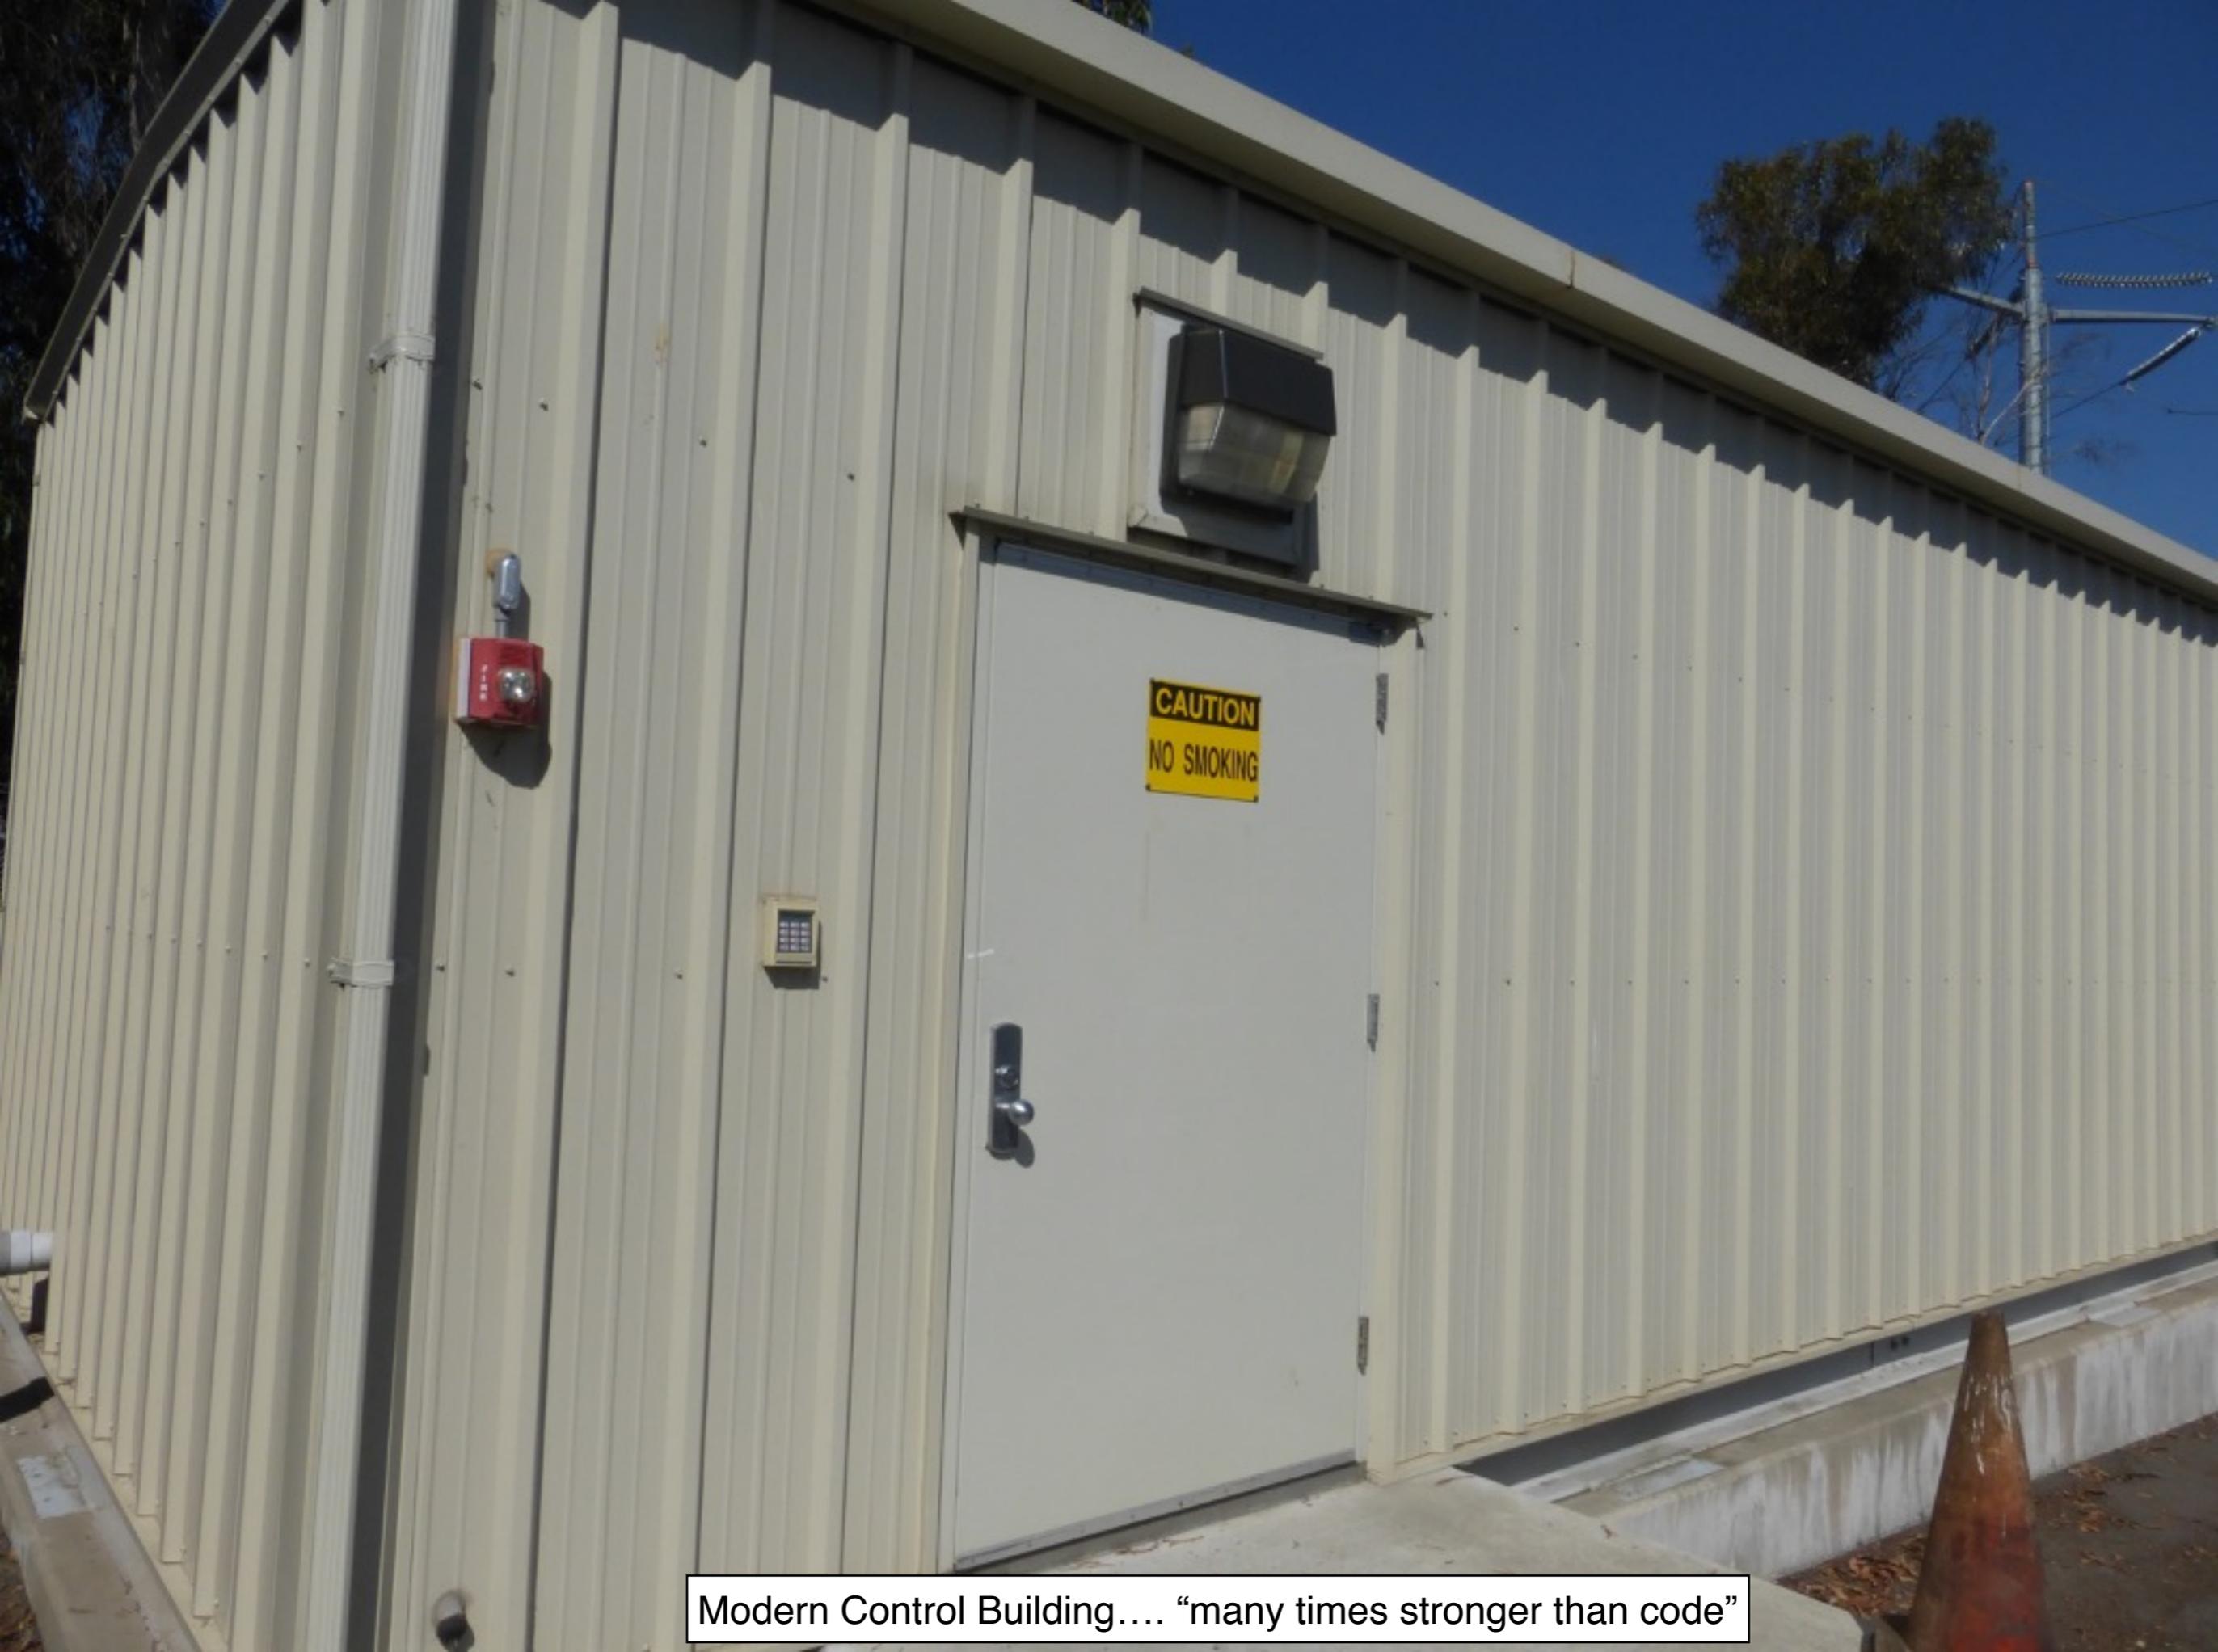
Modern Control Building.... "many times stronger than code"

Old Control Building (Behind). Why replace it if it still plenty strong?
and Battery Enclosure (Front). Why build a Tesla when a Prius will do?

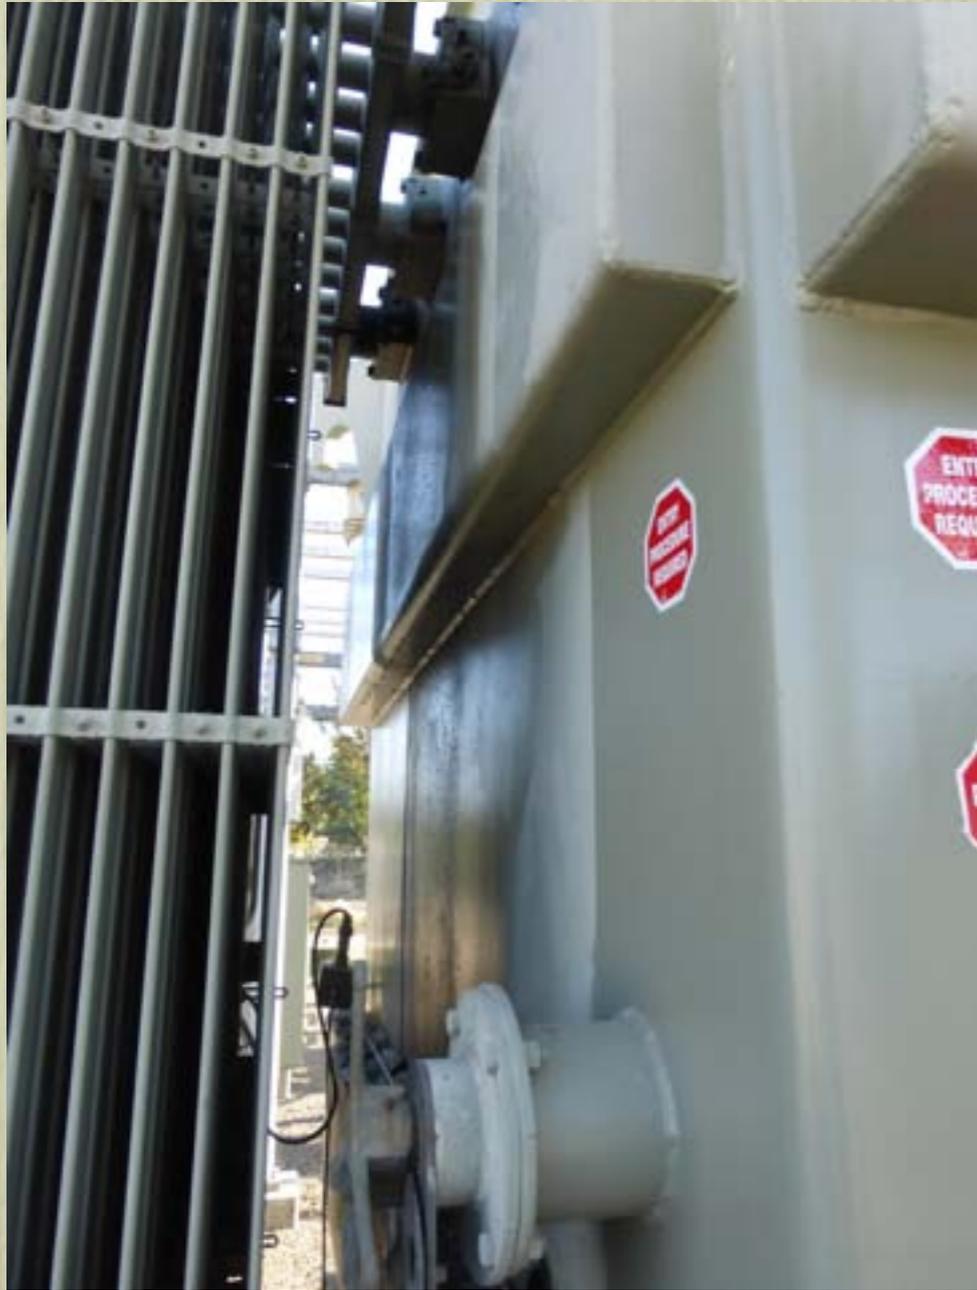
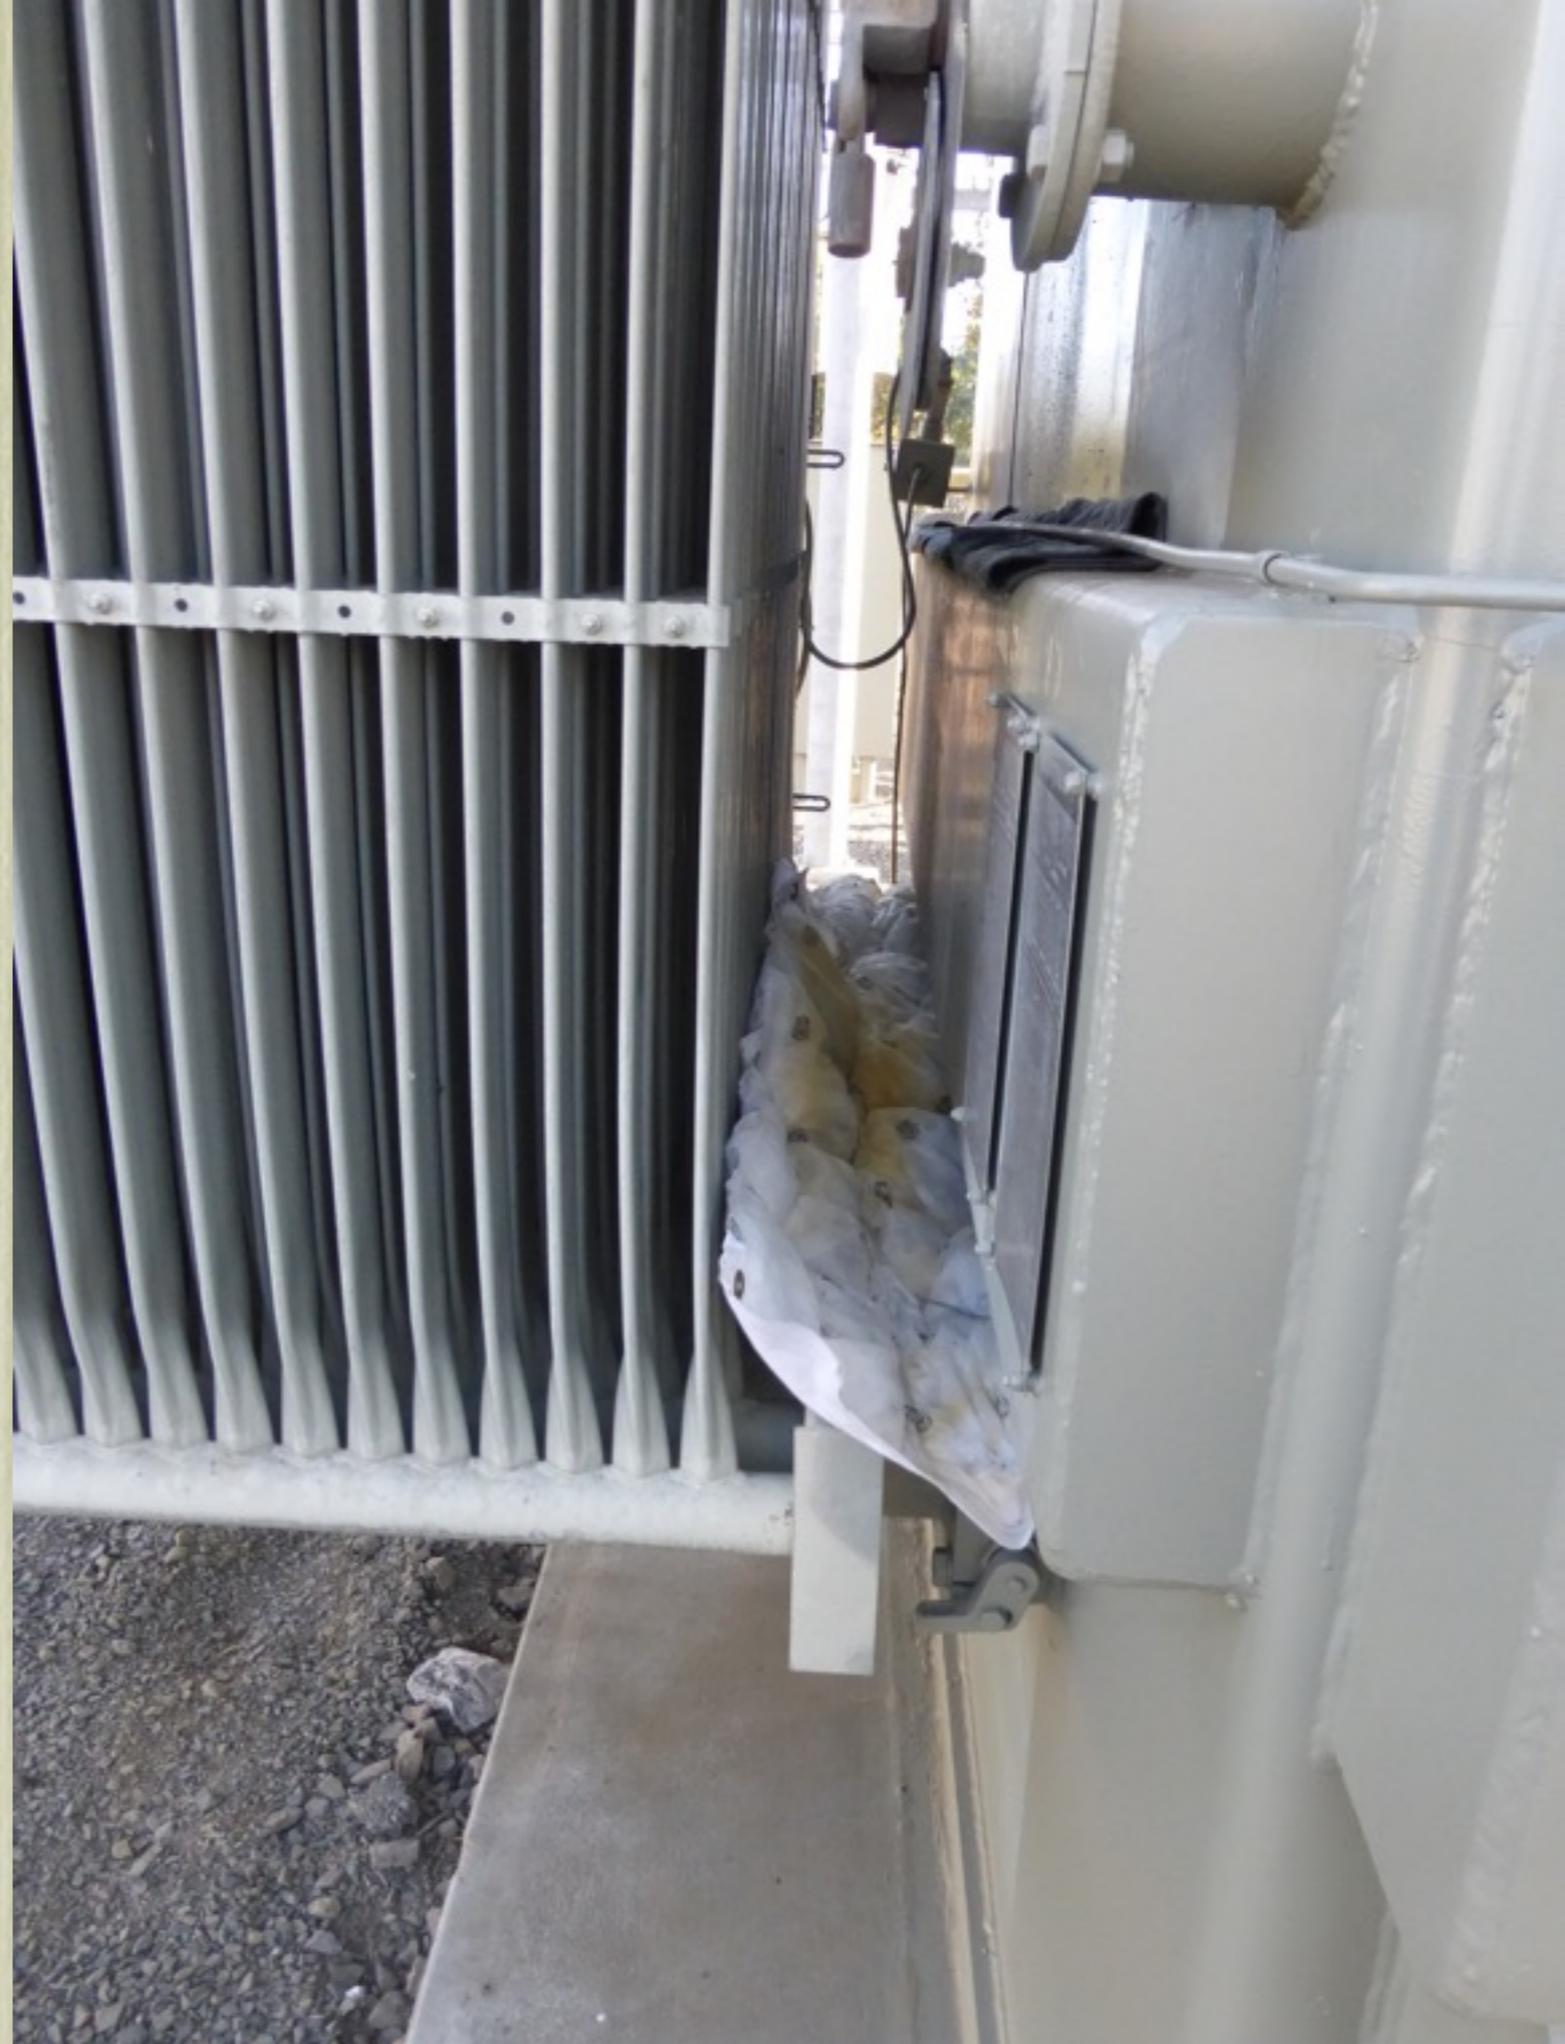
115 kV - 12 kV Bank 1

Oil leaks appears to be from top pipe connections (as expected / common)

Station Service Transformers. Heavy braced. No damage.
