Napa Earthquake of 8.24.2014 Performance of Lifelines

Water, Power, Gas, Fires

City and County Engineers Association of
San Mateo County

South Napa M 6.0 Earthquake of August 24, 2014

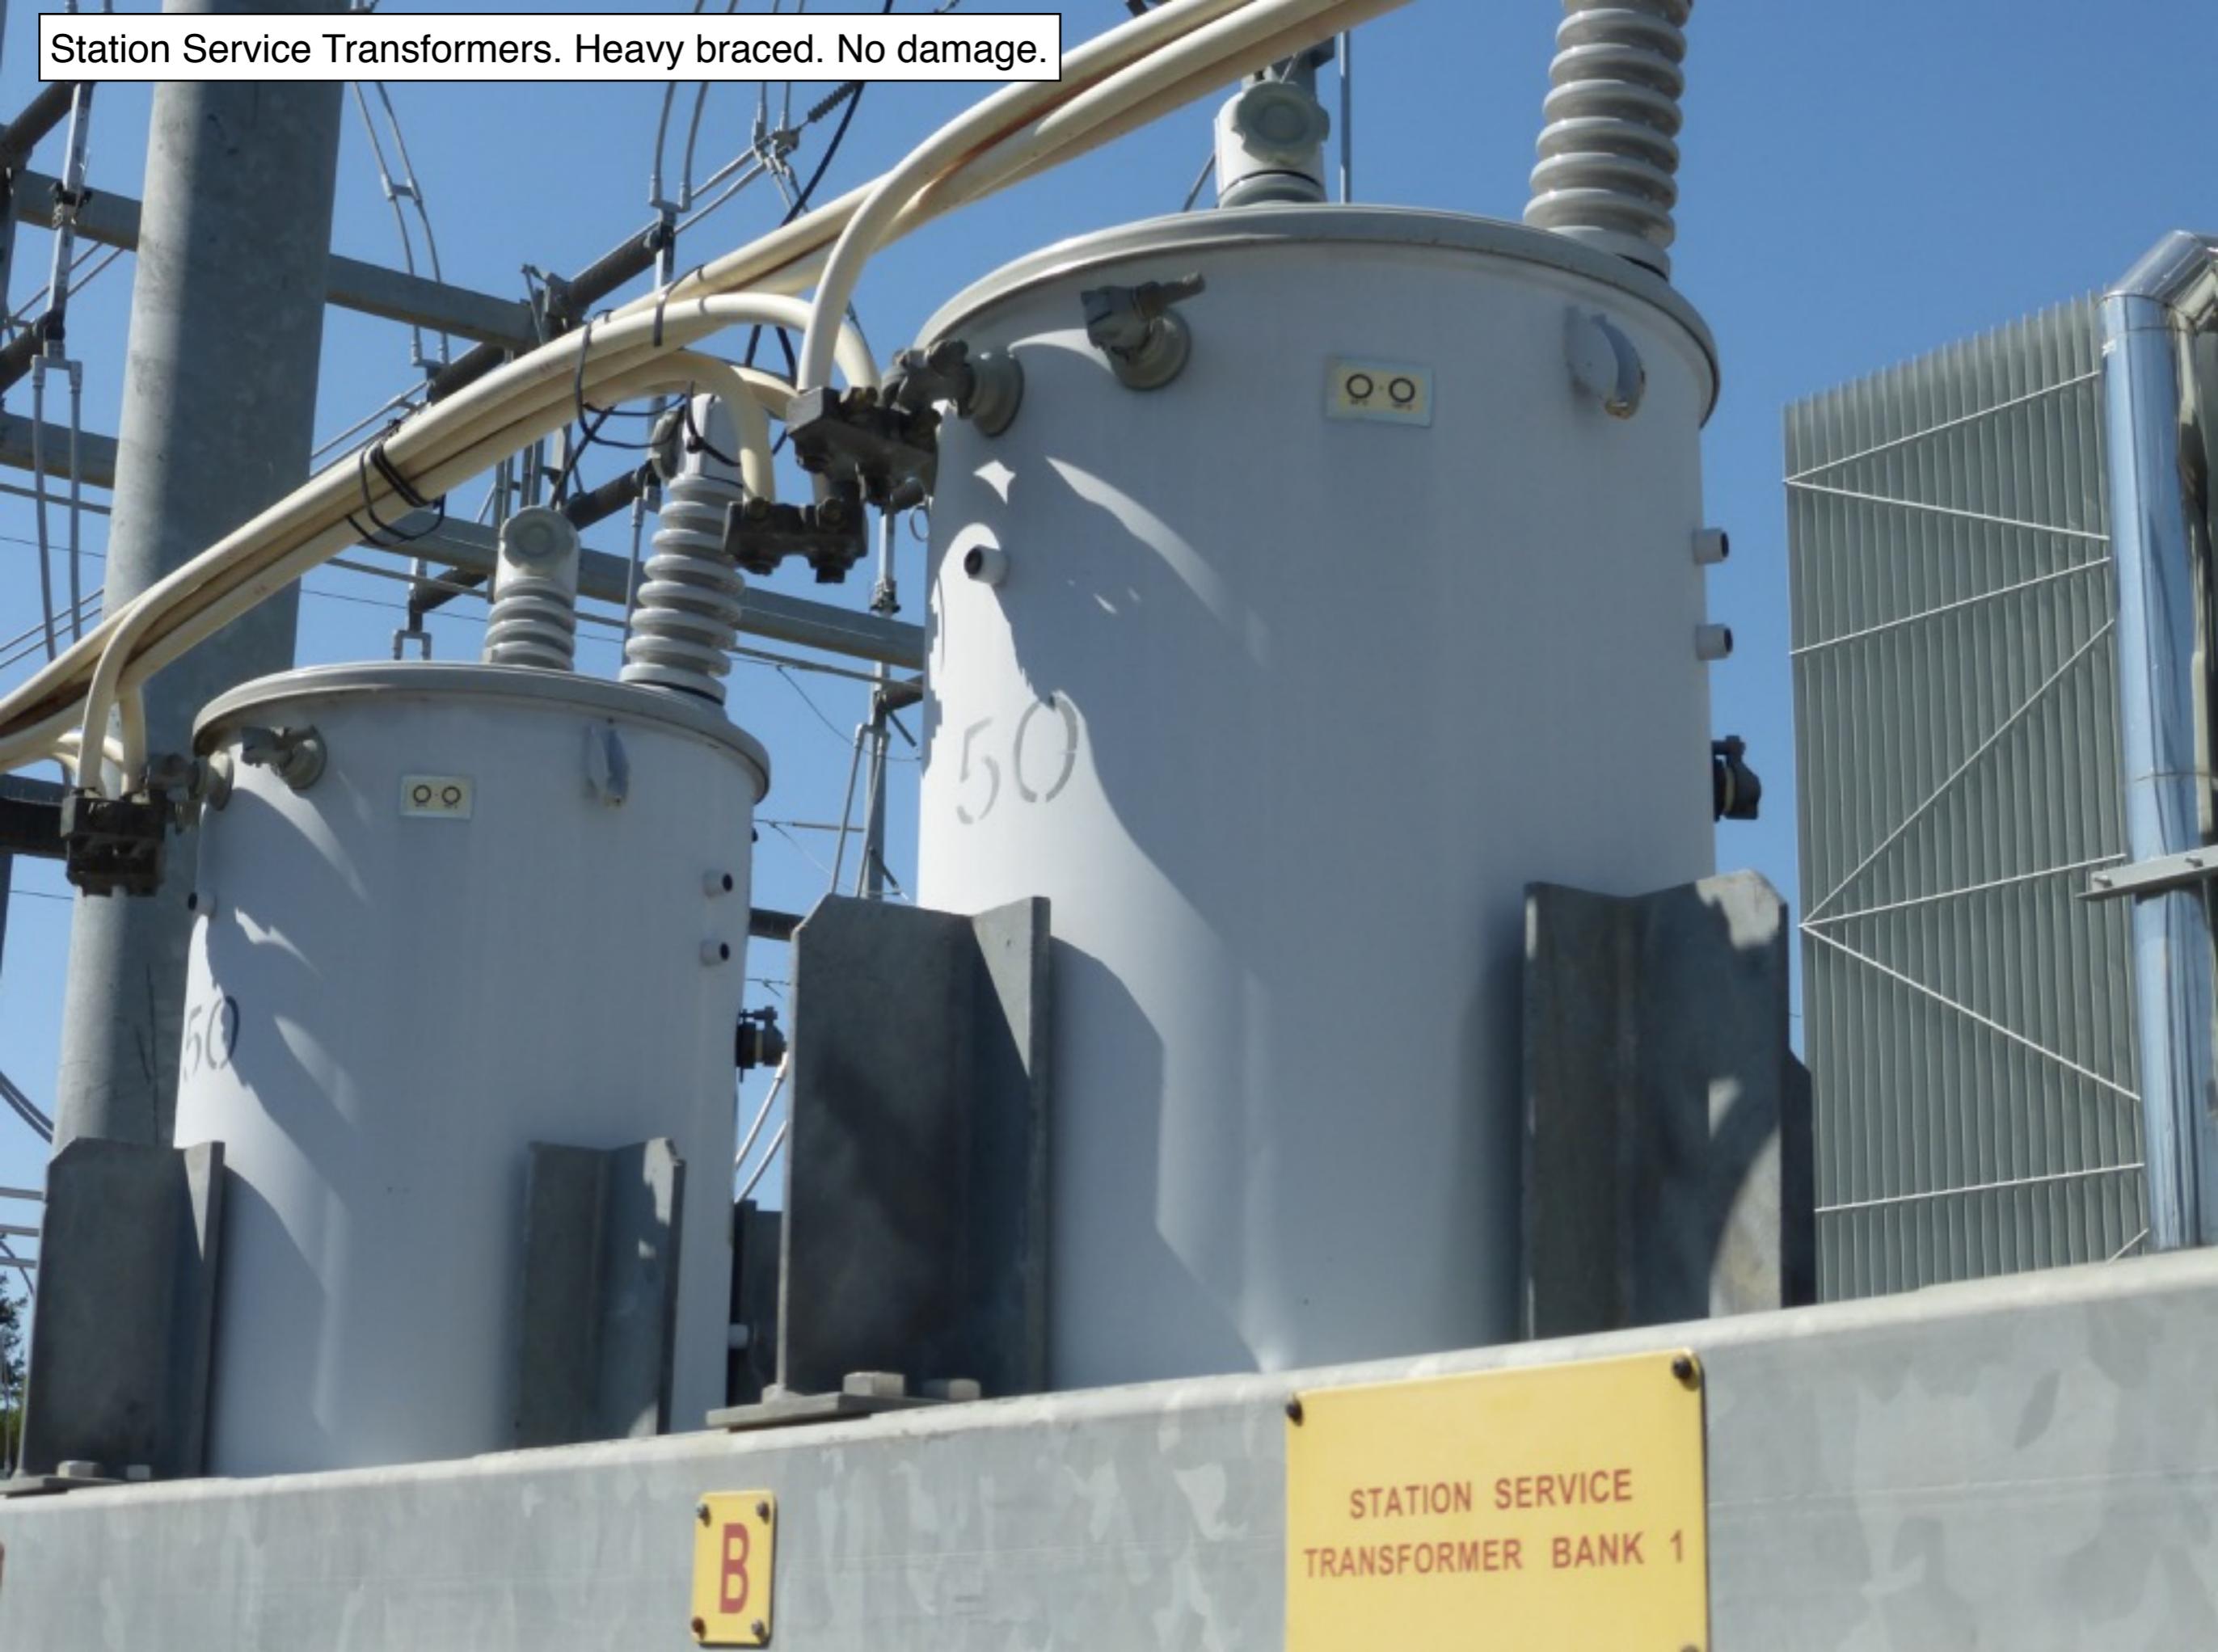
Vintage transformers. No damage at PGA $\sim 0.30g$. Well anchored.
A new parallel transformer bank was installed so these are somewhat "Redundant"

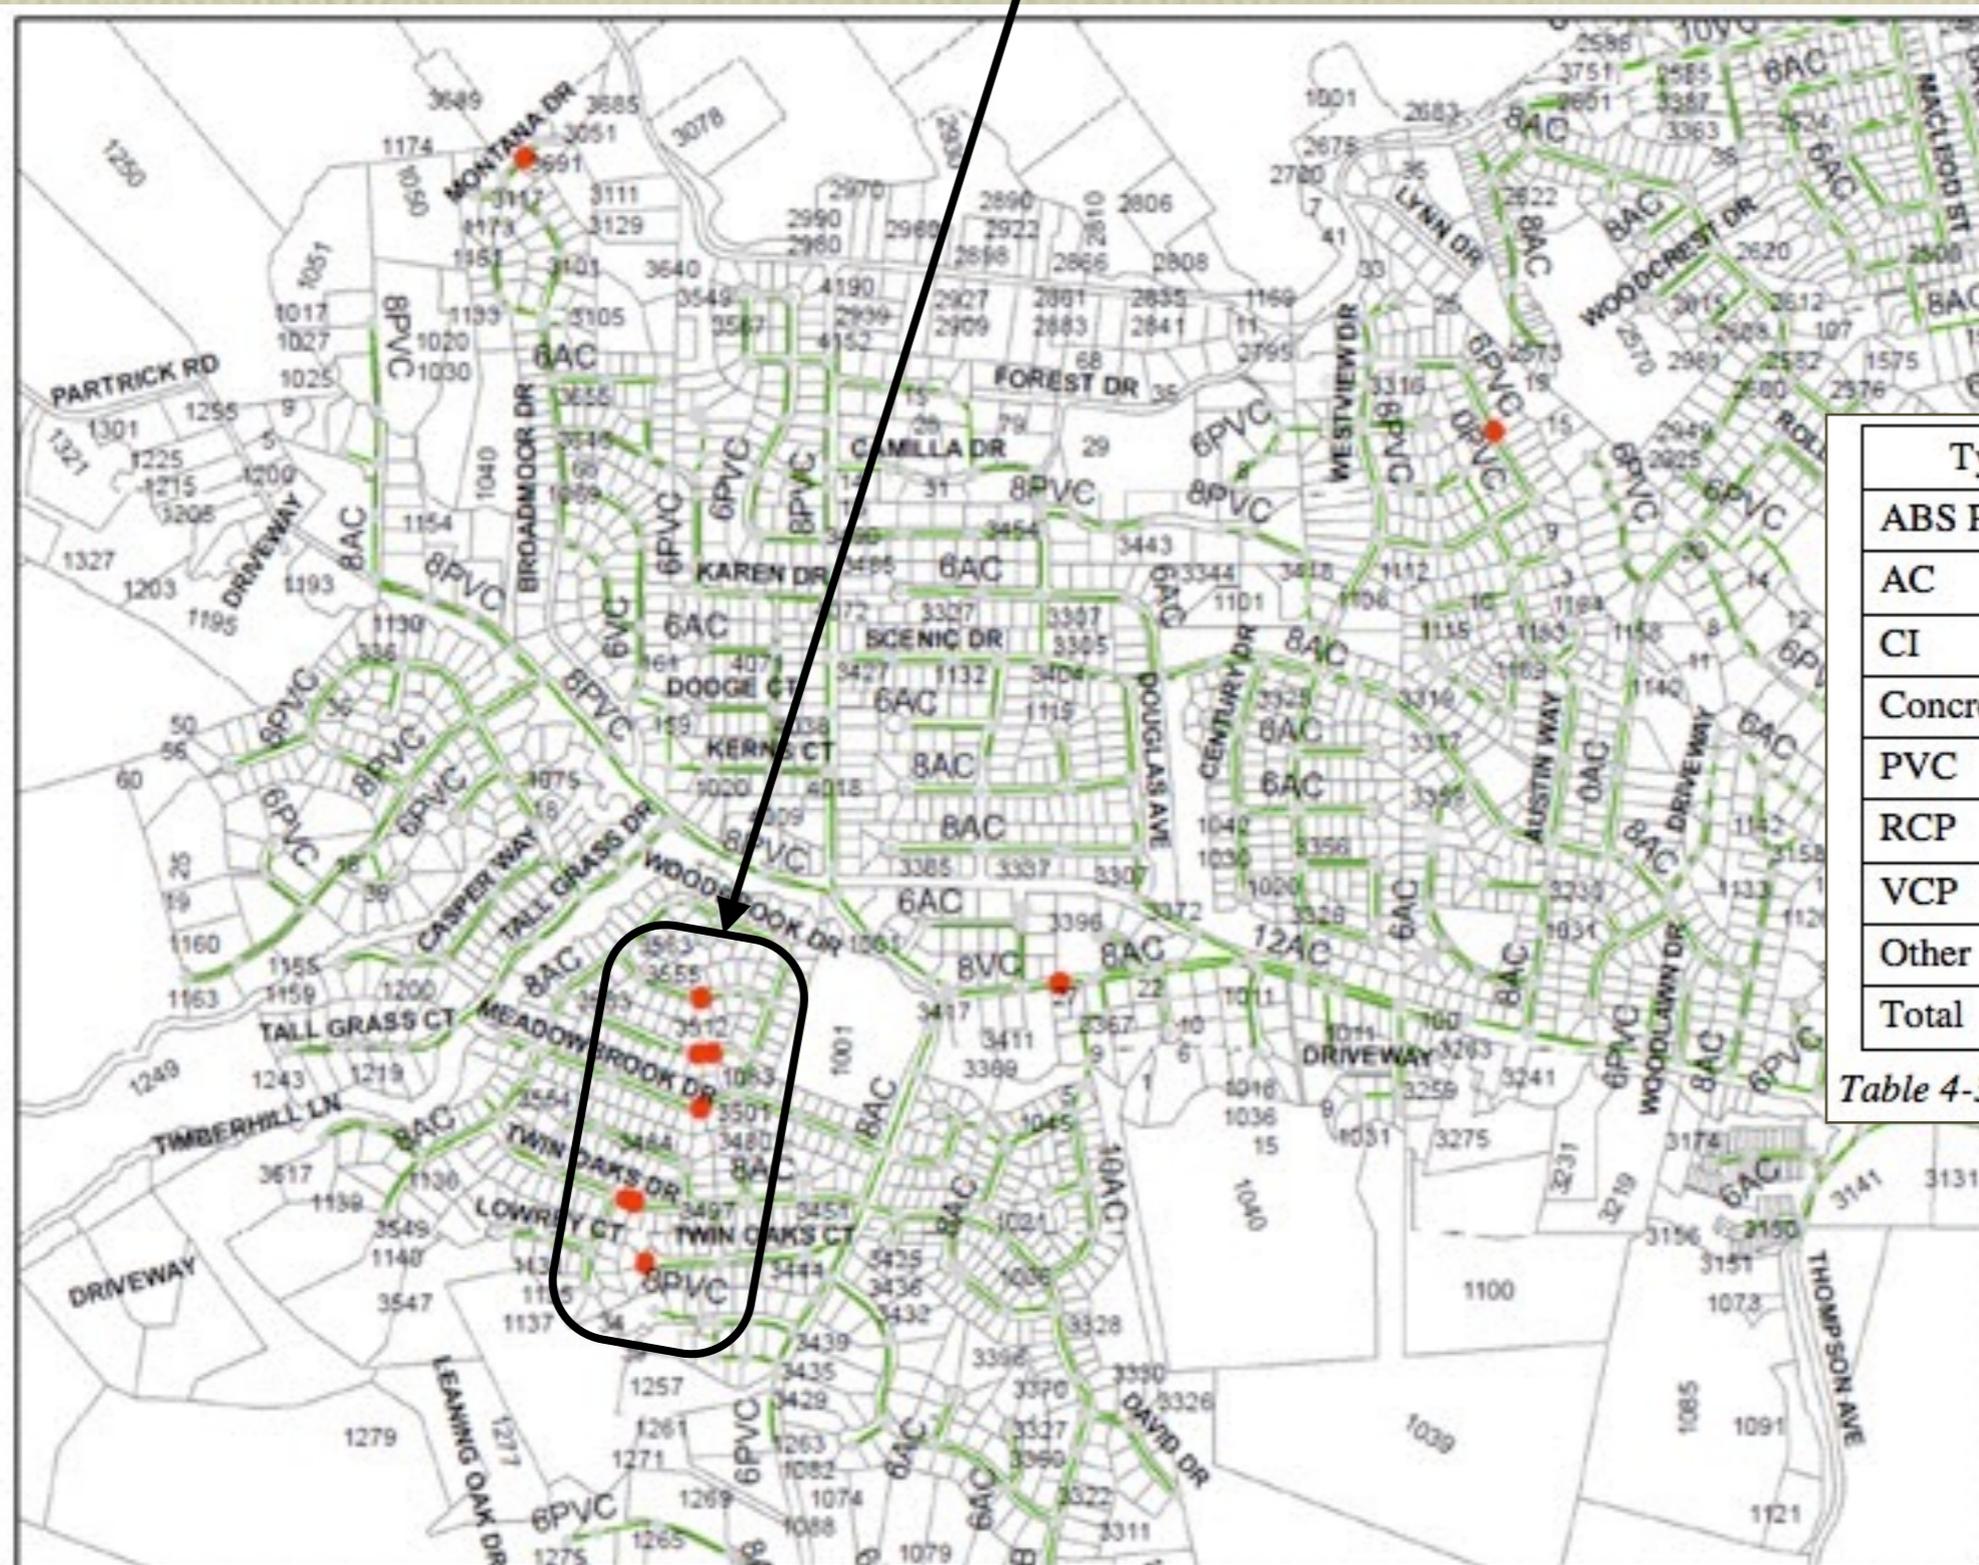
Figure 4-16. Location of Sewer Breaks

Sewer Pipes Broke
Repaired at fault
crossings
