# Napa M5.2 Earthquake of September 3, 2000

## Evaluation of Lifeline Performance

**John Eidinger<sup>1</sup>**  
**Mark Yashinsky<sup>2</sup>**  
**Anshel Schiff<sup>3</sup>**

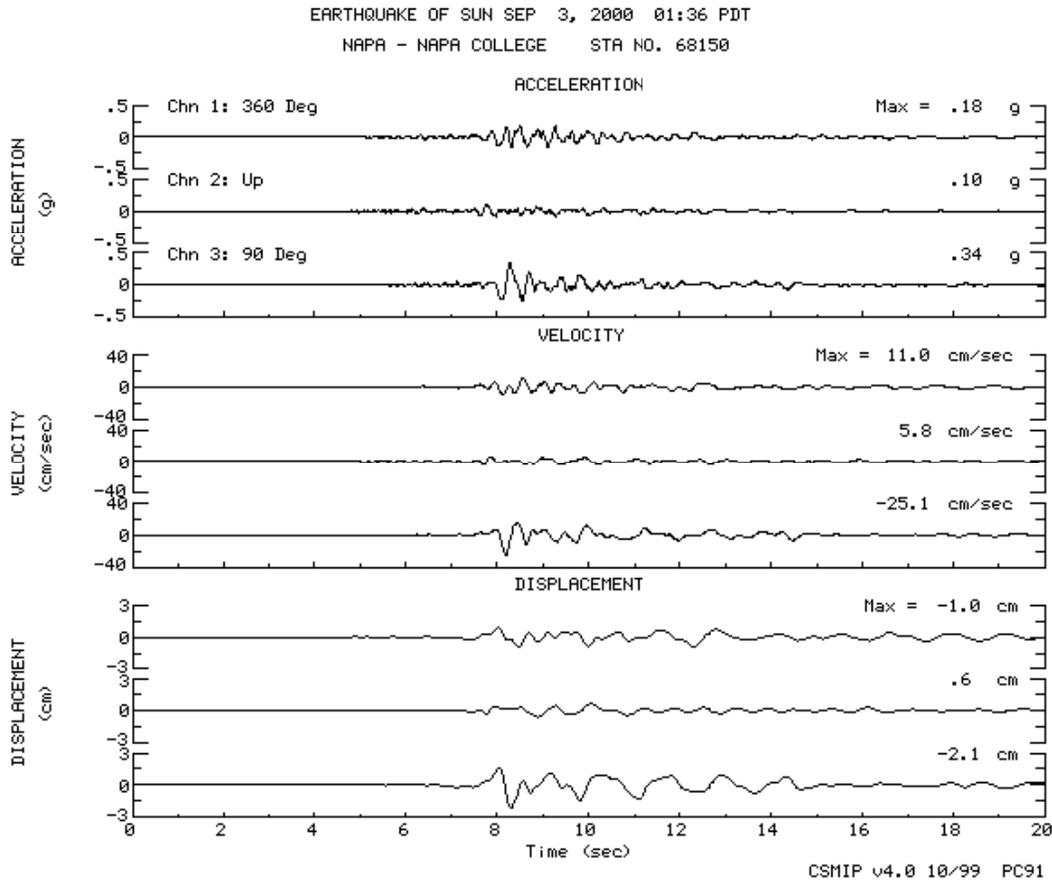
Figure 2. Recorded Ground Motions - CSMIP Station 68150

Figure 2 shows the ground motion time histories for instrument 68150. The motions suggest a site period of about 0.4 seconds, typical of a deep alluvial site. In fact, the instrument is located at Napa Junior College, just east of the Napa River.
