PERFORMANCE OF WATER SYSTEMS IN THE M_w 8.4 ATICO (PERU) EARTHQUAKE OF JUNE 23, 2001

John Eidinger¹

This report describes the performance of water systems in the Atico, Peru M_w 8.4 earthquake of June 23, 2001.

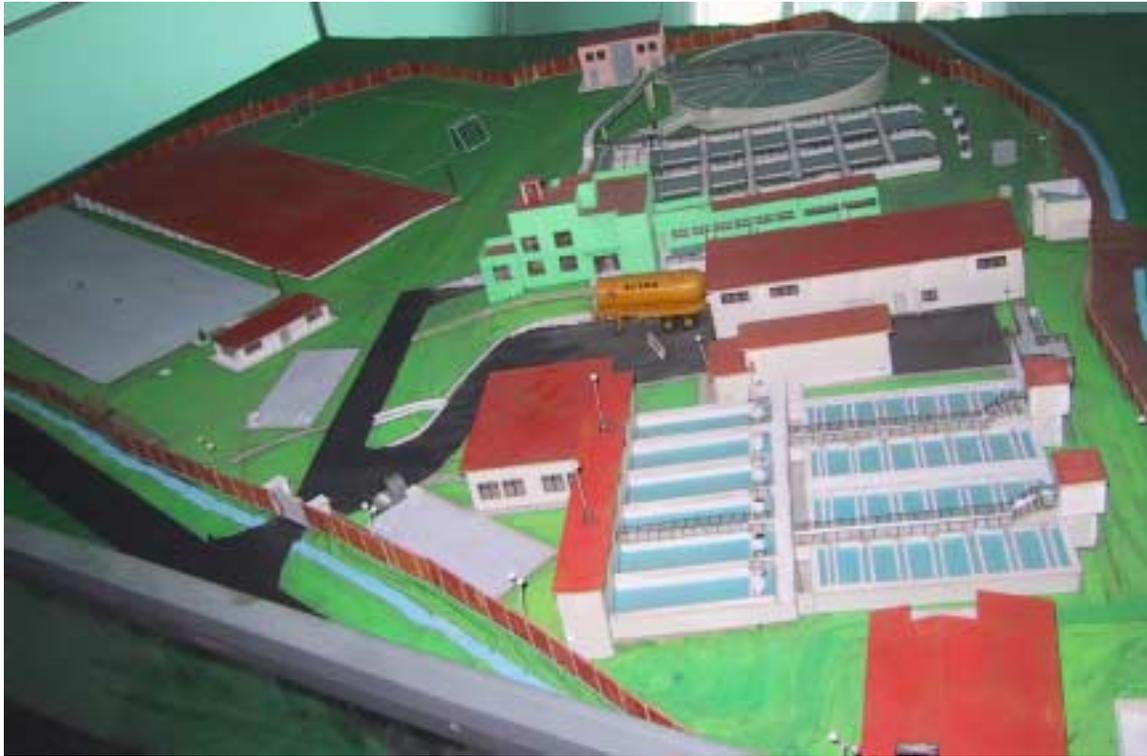
Figure 4-1. Arequipa Water Treatment Plant

As seen in Figure 4-1, the plant is divided into three main basins. In the foreground is a rectangular set of basins (floc / sedimentation on the right, filters on the left). The first large building is the chlorine building. The next large building is the main operations building. Then there is another rectangular set of basins (filters in the foreground, floc/sedimentation in the background). In the background is a circular clarifier. On the left are two rectangular covered clearwells. There is a pump station building next to the clearwells which pumps potable water to higher elevation pressure zones of Arequipa.

Raw water enters the plant from four parallel pipelines located to the right side of Figure 4-1. These raw water pipelines are about 2 km long; one of the 4 pipelines was damaged by the earthquake, and remained leaking and non-repaired as of 34 days after the earthquake. These raw water pipelines range from 14" to 24" in diameter (note that pipe sizes in Peru are commonly denoted in inches of diameter).

Upstream of these 4 raw water pipelines, the raw water is conveyed from the mountains via tunnels and canals. The canal was inundated by landslide debris in one location, and this caused a turbidity spike at the water treatment plant, forcing a 2 hour shutdown of the entire plant.

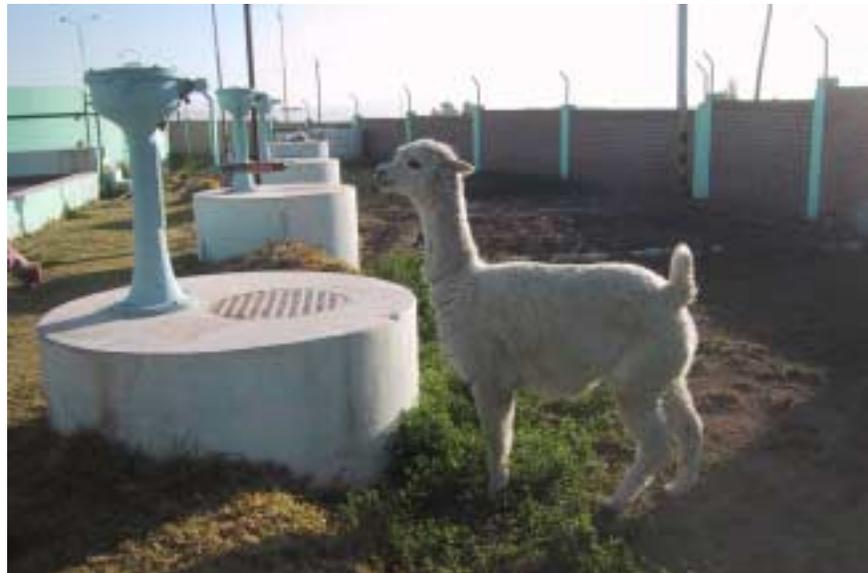
Figure 4-4. Alpaca at Arequipa WTP – Served as a Peruvian Canary

Figure 4-4 shows an Alpaca chained to the raw water gate valve for the plant; presumably, this pet alpaca served as a "canary" – however, it is not known if there were any injuries from the chlorine gas release. Not shown in these pictures are the "ton" chlorine cylinders which are located within the building; all these cylinders were resting on simple roller supports; none were reported to have rolled off their supports during the earthquake.

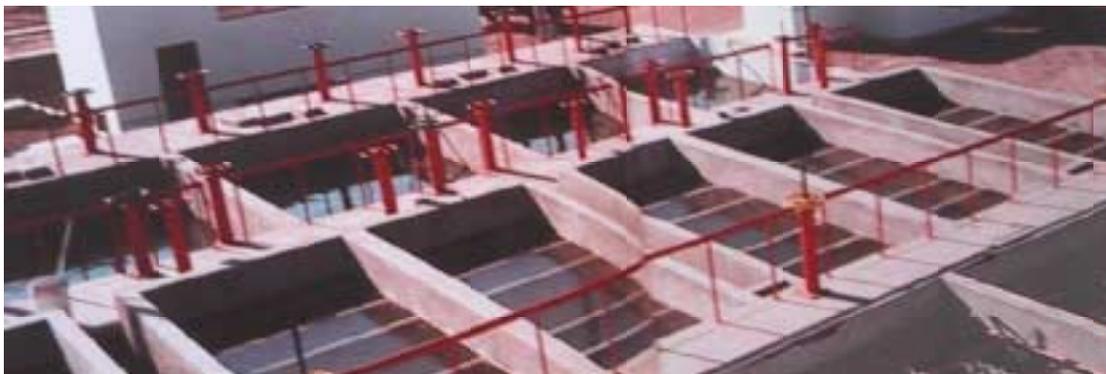
Figure 4-10. Moquegua Water Treatment Plant (Prior to Earthquake)

Figure 4-10 shows the Moquegua water treatment plant (WTP). This photo was taken prior to the earthquake. The three major stages of treatment are as follows:

- Bottom right of photo. Flocculation basins. Although difficult to discern in this photograph, each basin is subdivided by internal baffle walls. Each baffle wall is constructed from asbestos sheets, hung from lightweight steel channels. The baffle walls are oriented such that the incoming raw water must travel a long path before it leaves the flocculation basin, to give ample time for large particles to settle out of the water.
- Middle of the photo. Settling basins. There are five basins shown in this photo.
- Top of the photo. There are four filters shown in this photo.

to very firm soil. Based on the observed damage to the plant, the motions at this plant were likely at least 0.25g, and perhaps as high as 0.5g.
