Performance of Buried High Voltage Power Cables due to Earthquake Loads

SUMMARY

Buried high voltage power cables failed in many locations in the February 22, 2011 M 6.3 Christchurch earthquake, due to liquefaction. The empirical evidence of these failures is presented. The original design of the cables is considered, and what made the cables so vulnerable. The failure mechanism is described. Recommendations are made for the design of new buried cables in liquefaction zones.

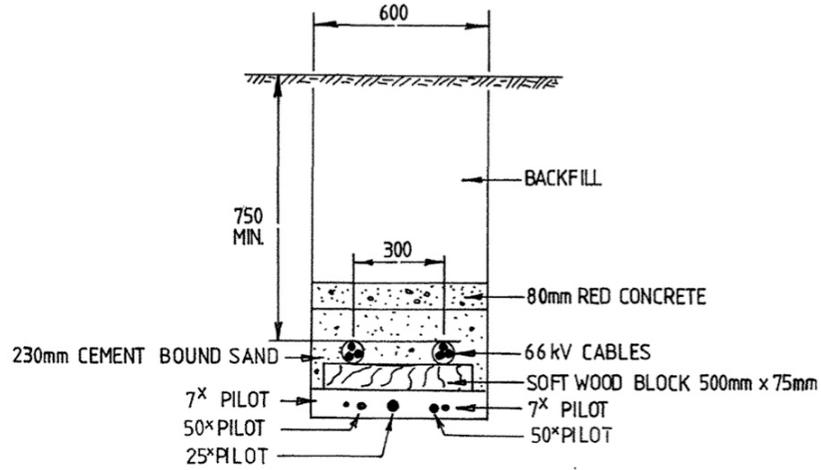
Figure 5. Trench Design 66 kV Oil-type Cable

Figure 4 shows failure Location 1. Figure 5 shows the cross section of the trench design used at Location 1, same as used at Locations 2 and 3. In the field, we observed the actual "230 mm cement-bound sand" and "80 mm red concrete cap" to have the consistency of a moderate strength concrete. Native soil in the top 3 meters, surrounding the cables, are typically moderate strength clays / silts, able to withstand a vertical-cut trench wall. Figure 6 shows the buckled cables, as crews dig them up after the earthquake. Figure 7 shows the cable cross section, comprised of three aluminum conductors (300 mm^2), paper wrapped, with three oil-ducts; all housed within a corrugated aluminum pipe and then with protective plastic outer sheath.

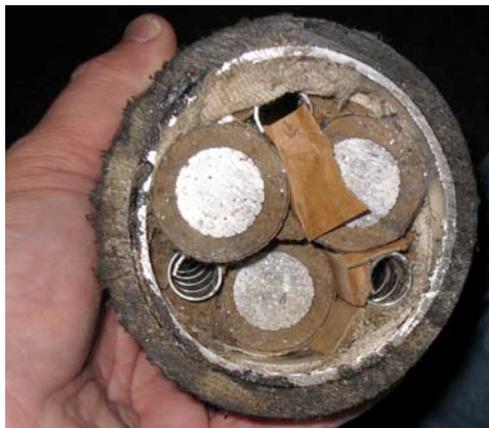
Figure 7. Oil-Type Cable Cross Section

The actual damage to the cable occurred due to high curvature on the exterior aluminum pipe, leading to local wrinkling of the corrugations, pushing inward on the oil tubes / paper wrap. The aluminum pipe tore, releasing the oil and allowing air into the cable. The actual aluminum cores did not appear worse-for-wear.

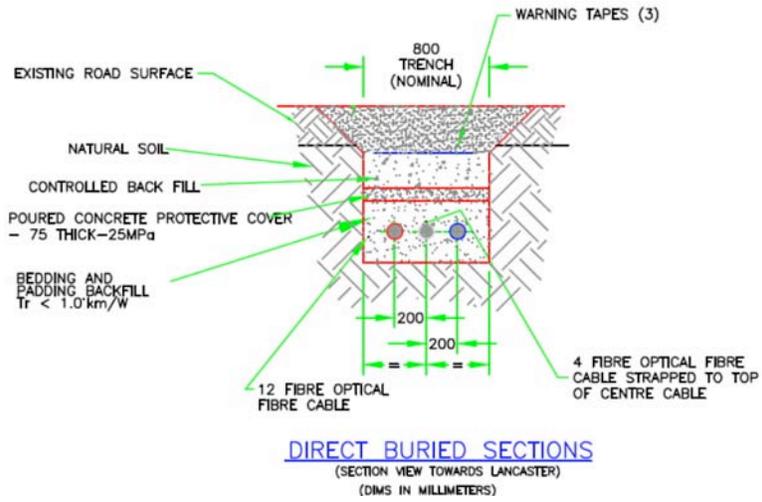
Figure 9. Trench Design 66 kV XLPE-type Cable

The cables used at Locations 4, 5 and 6 are XLPE-type. Cores are 1600 mm² copper. Figures 9 and 10 show the typical trench installation and cross section of the cable. Figure 11 shows work crews exposing the fault cable at Location 6.
