# Performance of Electric Power Systems in the 2010-2011 Christchurch New Zealand Earthquake Sequence

Alexis Kwasinski,<sup>a</sup> John Eiding,<sup>b</sup> M.EERI, Alex Tang,<sup>c</sup> M.EERI, and Christophe TUDO-Bornarel<sup>d</sup>

From late 2010 to mid 2011, Christchurch suffered a series of earthquakes and aftershocks that affected the city's power supply. The most relevant of these events occurred on September 4, 2010, February 22, 2011, and June 13, 2011. In all these events transmission level power restoration occurred rapidly—within one day. Except for the second event, similar relatively minor damage led to rapid restoration of distribution-level power outages. However, extensive damage to underground cables during the February 2011 earthquake caused some outages that lasted until early March. This damage seems to be amongst the only extensively-documented such failures to date. Despite recorded strong ground shakings, damage to other power infrastructure facilities was moderate to minor. This satisfactory performance of power infrastructure is attributed to a program implemented during the decade prior to this earthquake sequence to seismically upgrade almost all unr

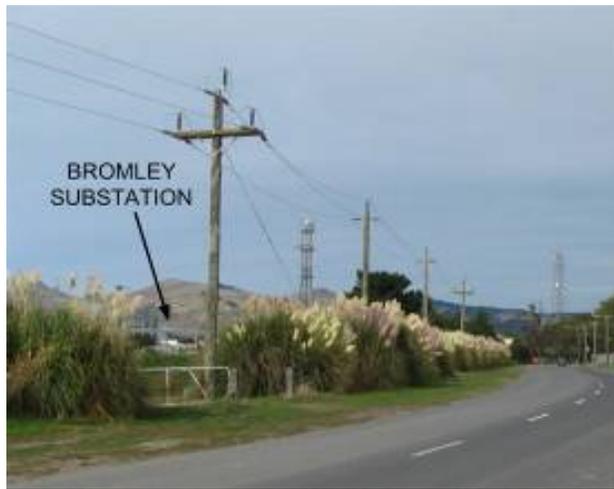
**Figure 10.** The temporary 66 kV line installed from Bromley substation to restore service in the Brighton-Dallington area.

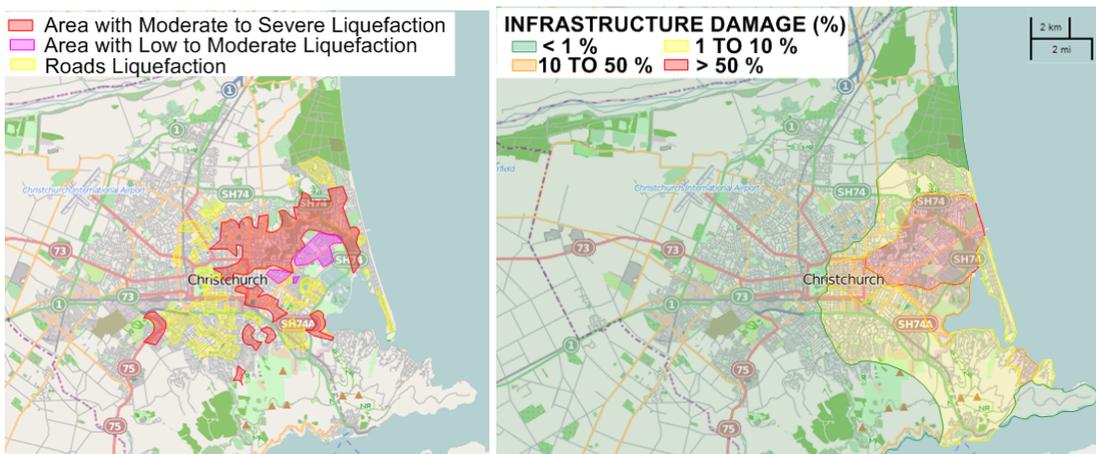
**Figure 12.** a) Left: Approximate soil liquefaction severity. Map prepared based on (Cubrinovski, 2012). b) Right: General areas with indicated power infrastructure damage severity.
