Ridgecrest M 7.1 Earthquake of July 5 2019 Performance of Gas Lifeline

March 2 2022
Jeff Bachhuber (PG&E)
John Eidinger (G&E)

Initial Inspections & Observed Damage for Ground Deformation

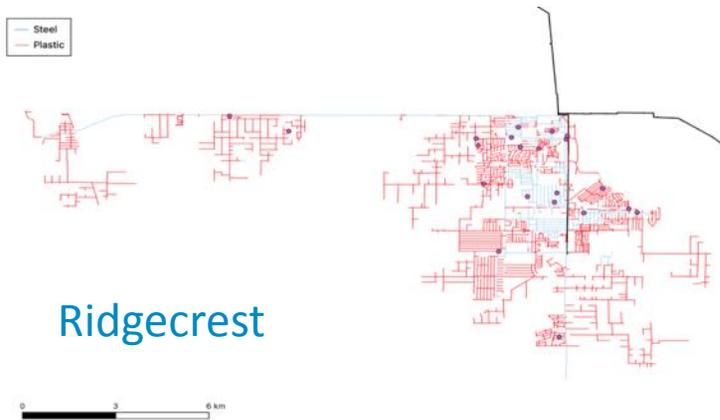
Ridgecrest

Distribution pipe
287 km plastic; 150 km steel

31 Gas Repairs (dots):
Steel: 16 (NP)
Plastic: 15 (P)
Liquefaction zones: blue boxes
324 leaks in services (not mapped)

- 31 repairs along mains. 324 leaks at service laterals / meter sets. 1 leak at a regulating station.

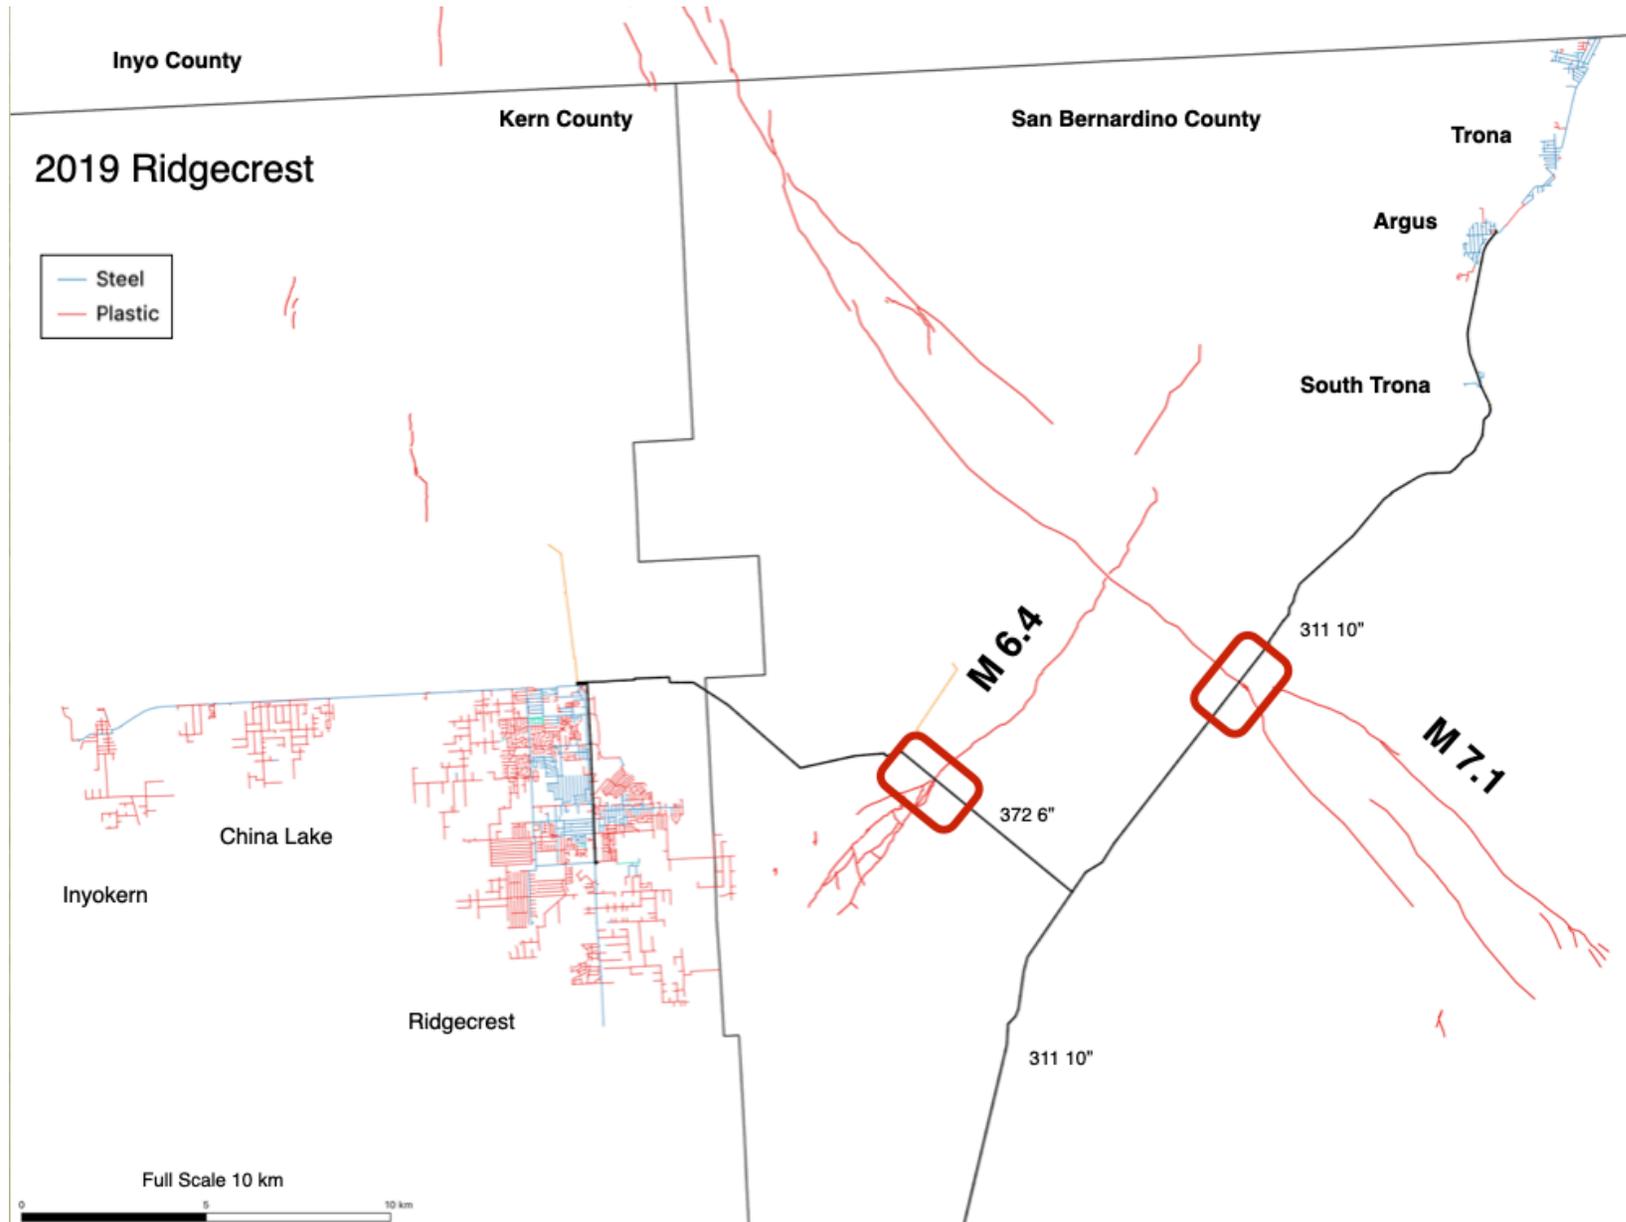
Damage to the Gas Transmission System (2 locations)

Surface rupture across pipeline alignment (pipeline alignment road at top of photo; southeast view); rupture is at a near-right angle to pipeline

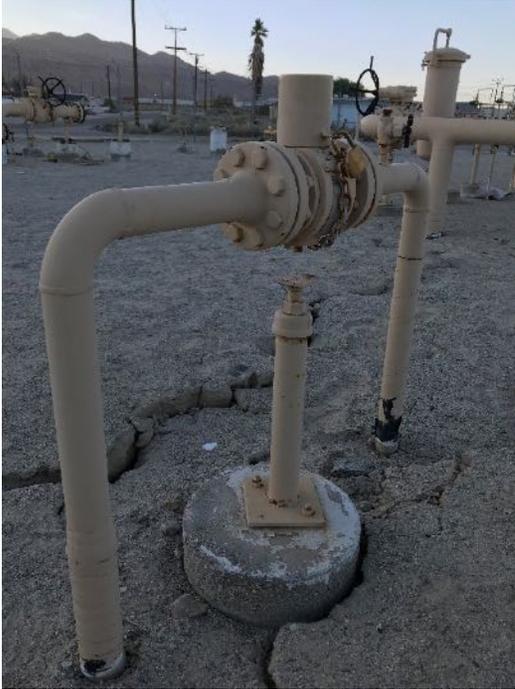
Settlement and lateral movements in station pad fills removed support for piping/valves. Settlement & lateral displacement is up to 0.5-1 foot.

Apparent settlement/lateral spread headscarp at northwest corner of station. Searles Lake is off the photo to the left (east), and crack patterns and direction of extension suggest lateral movements toward the lake.

General cracking is pervasive throughout station pad fill.
