The 1906 San Francisco Earthquake and its Impact on the Water System

John Eiding
G&E Engineering Systems Inc
October 28, 2004

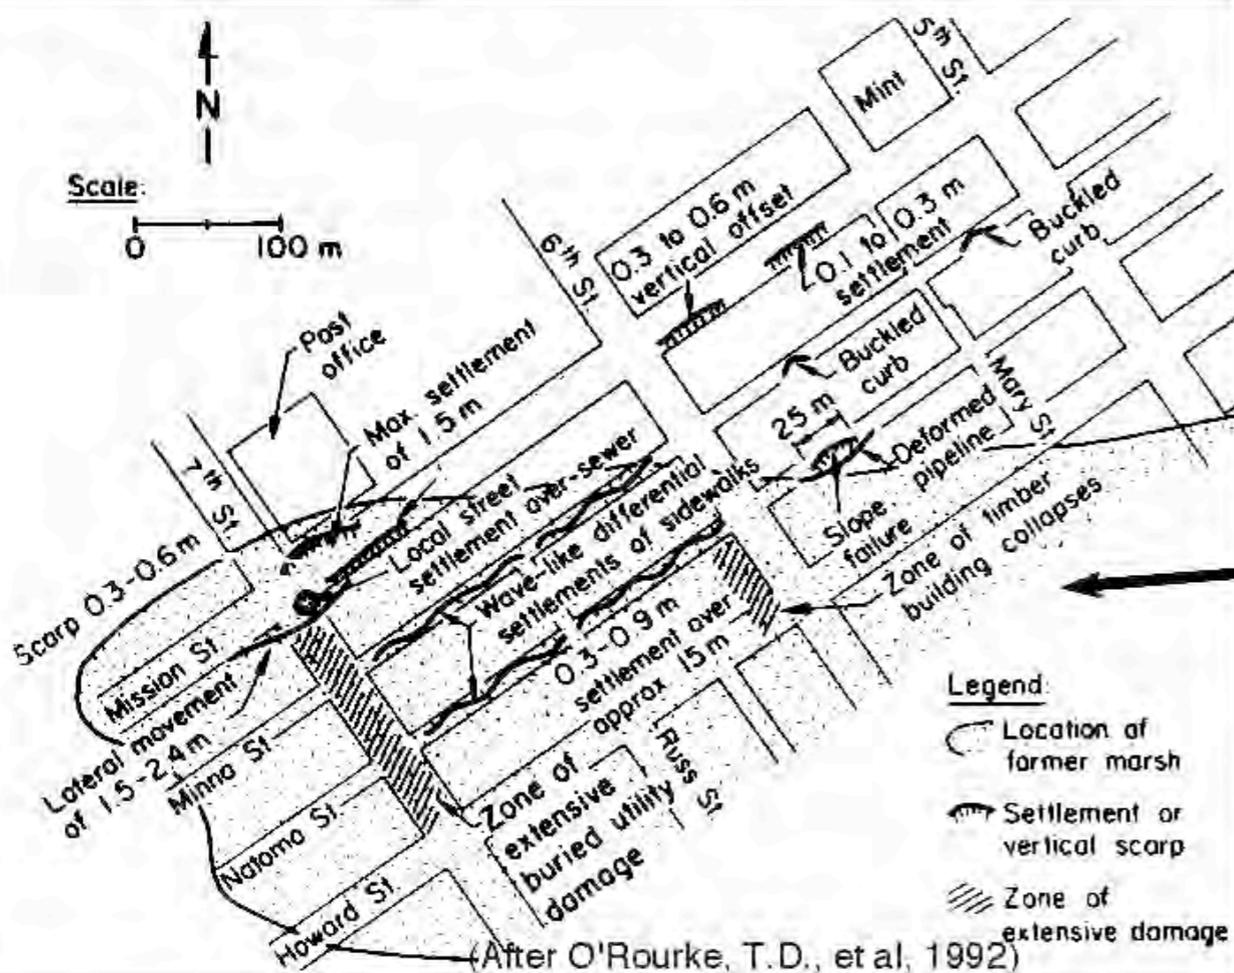
1906 Earthquake-Induced Ground Deformations

- Legend**
- Location of former marsh
 - Settlement or vertical scarp
 - Zone of extensive damage

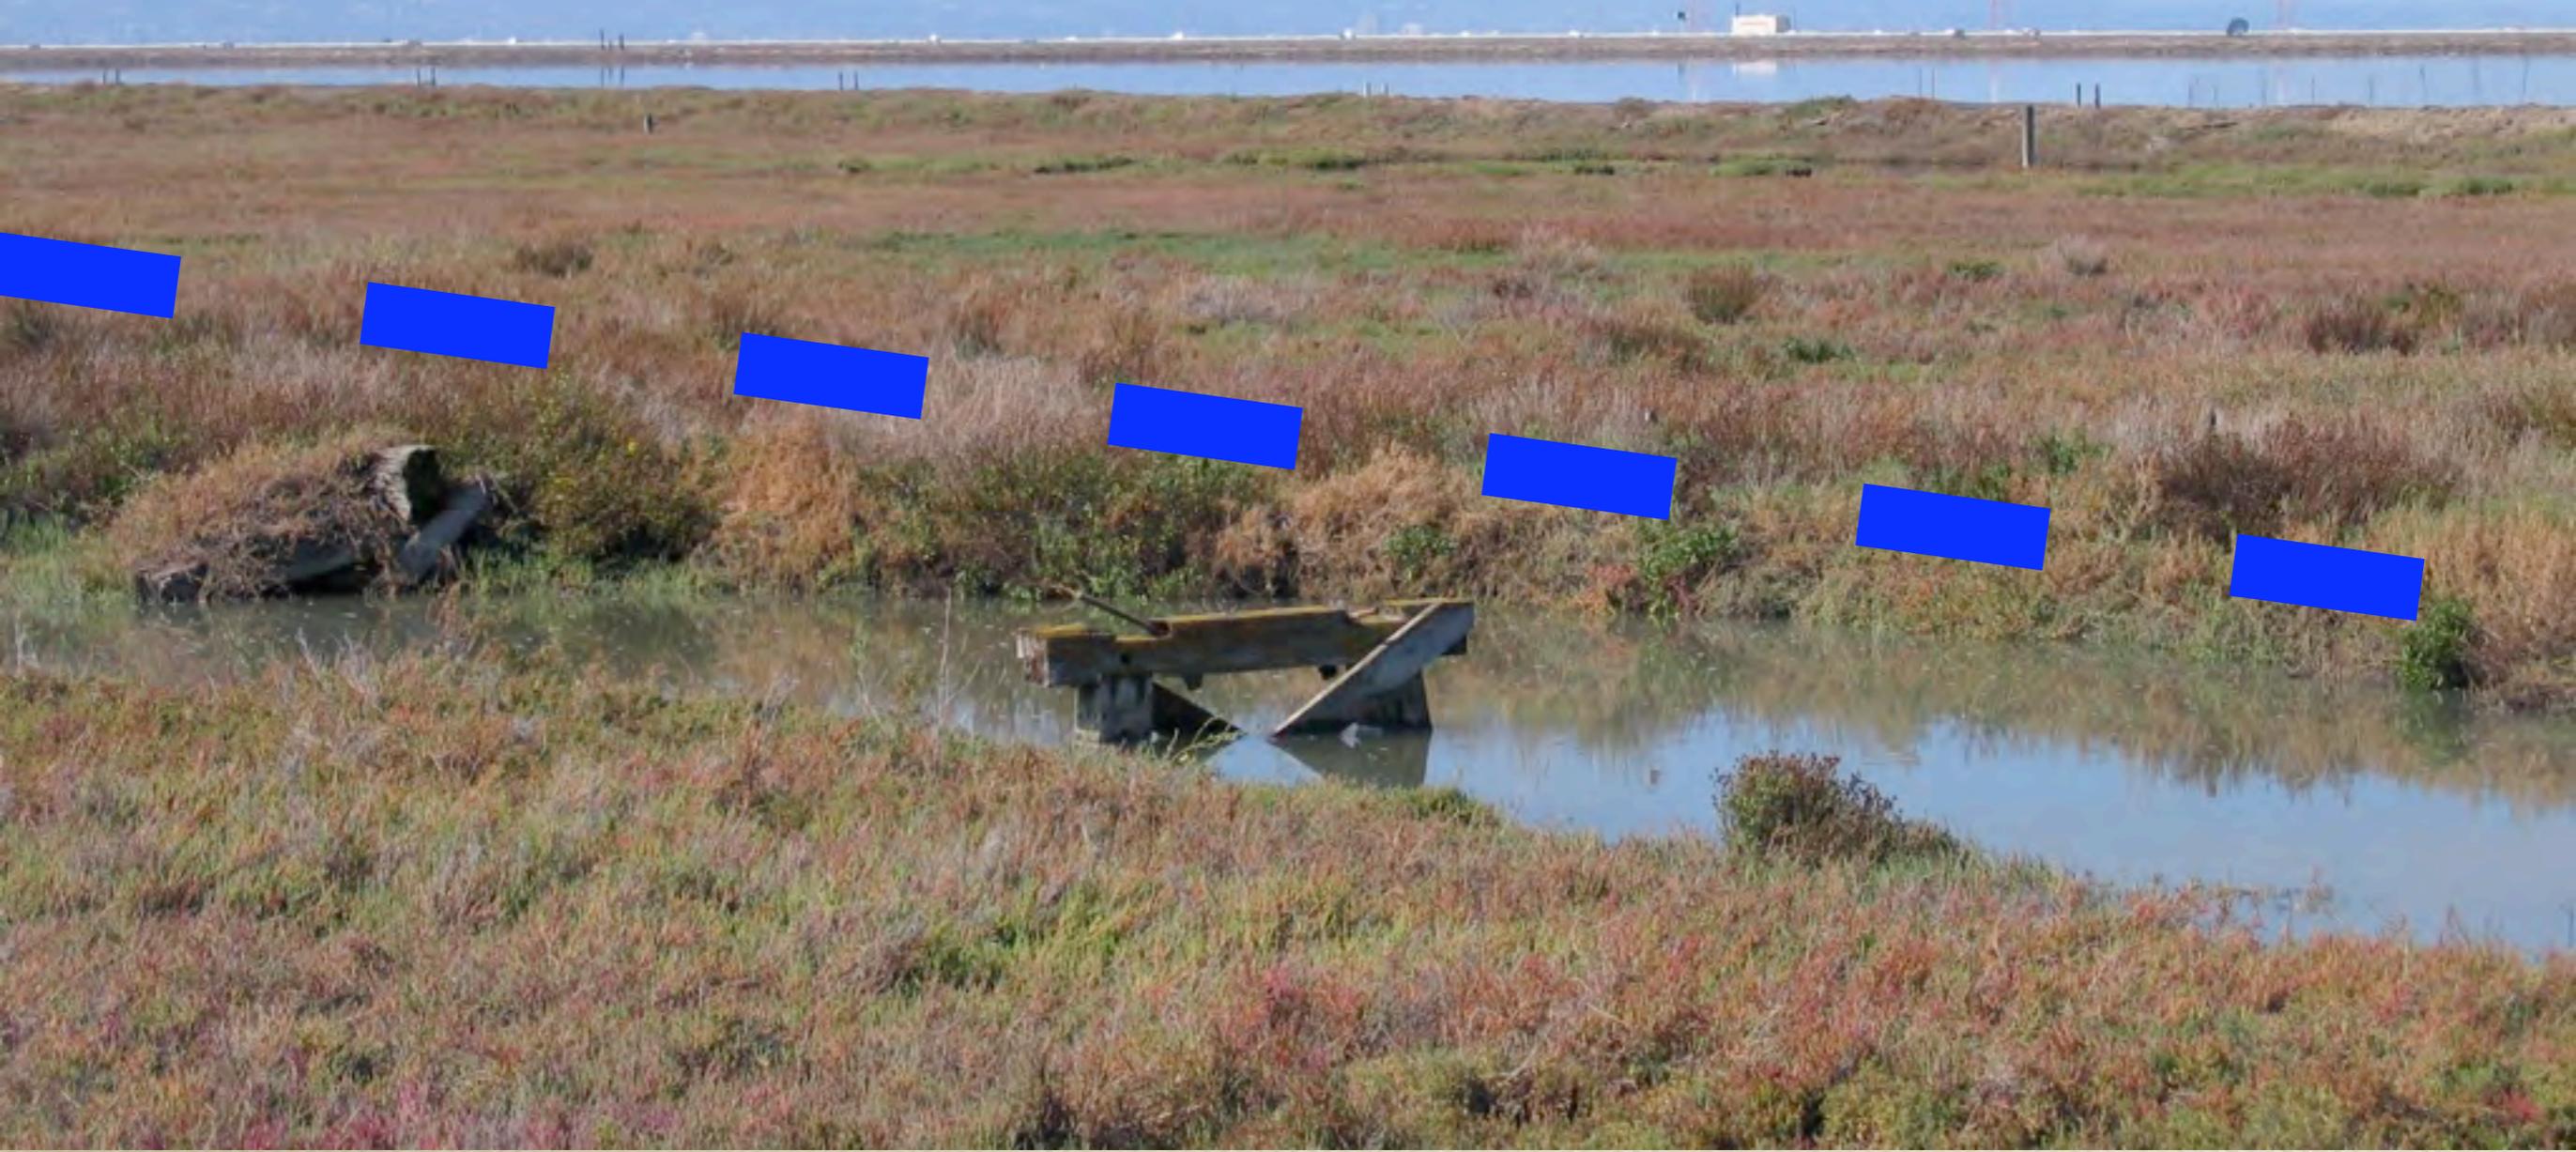
1906 36" Alameda Pipeline

Alameda 36" Pipeline
Brings Water to SF from Sunol
Crosses Bay Mud at Dumbarton
Minor damage - 2 minor leaks at 8" blowoffs,
1 slip joint pulled apart a few inches

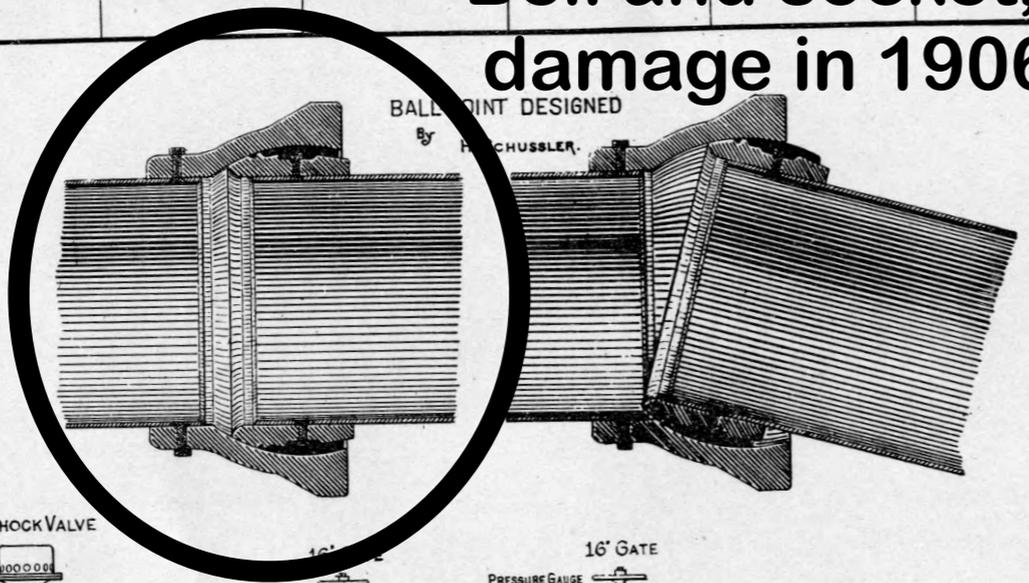
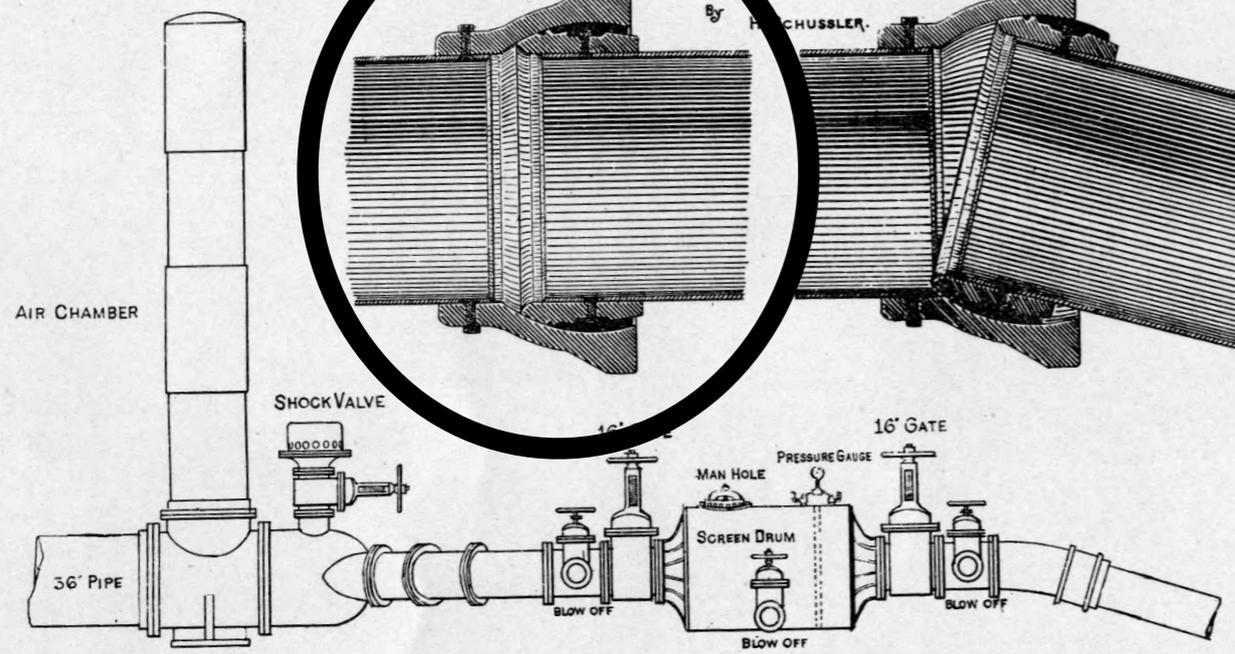
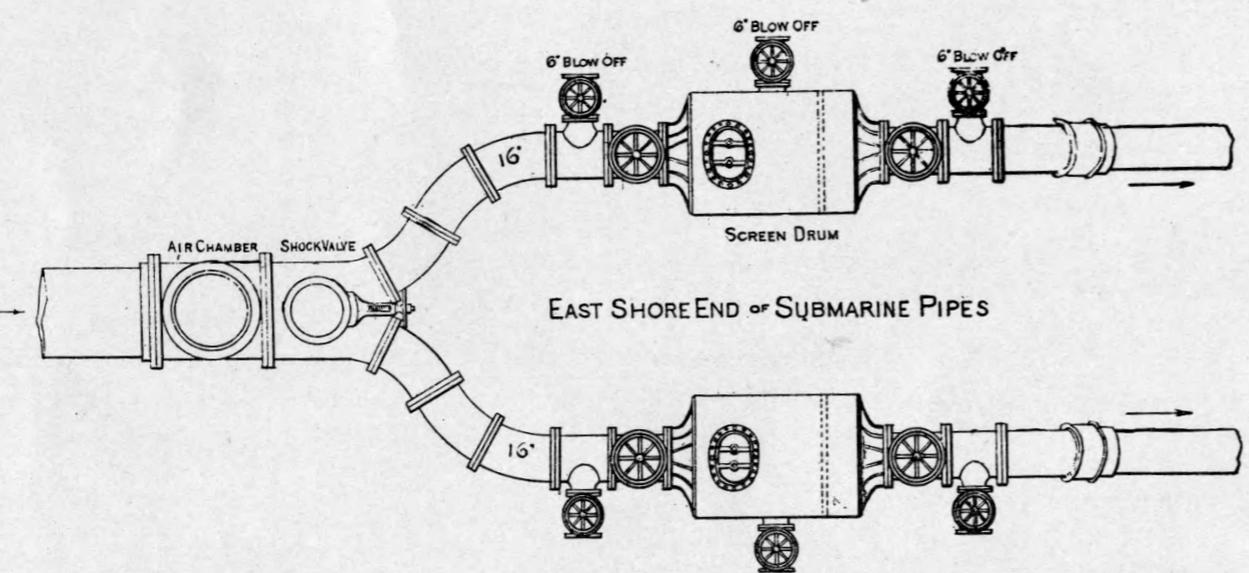
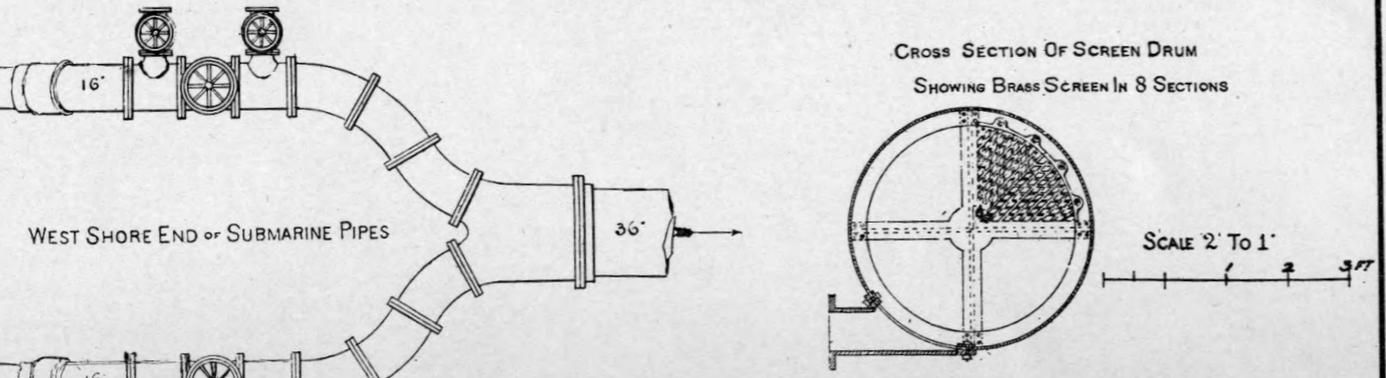
PROFILE AND DETAILS OF DOUBLE LINE OF 16" SUBMARINE PIPES, LAID BY S.V.W.W. ACROSS BAY OF SAN FRANCISCO, NOV. 1887. HERMANN SCHUSSLER, CHIEF ENGINEER

2 16-inch and 2 22-inch pipes Bell and socket, No damage in 1906

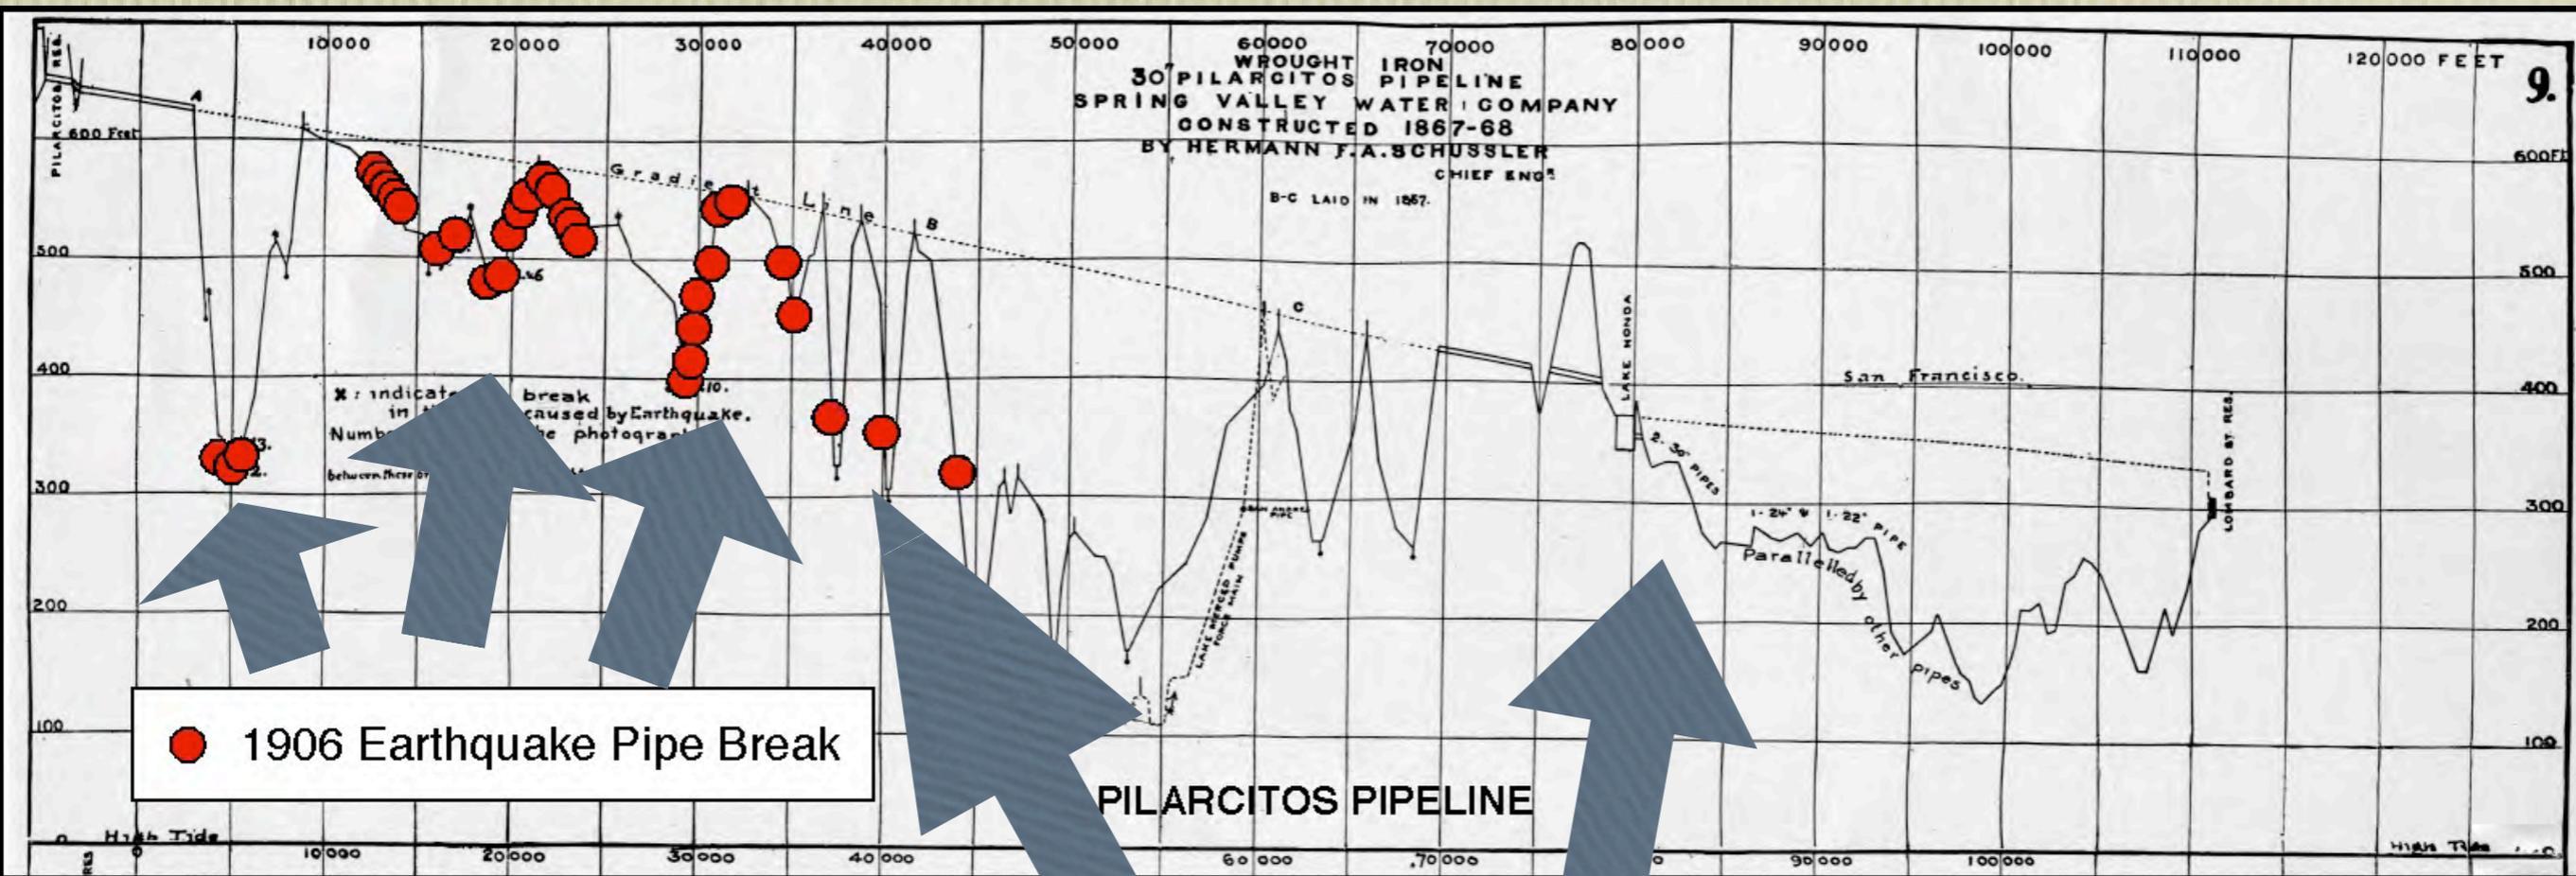
Pilarcitos Pipeline

Many fault crossings

Good Geology

Timber trestles over canyons

Normal supply from Pilarcitos Res to Lake Honda

This pipeline criss-crossed the San Andreas fault at many locations. It was also supported on wooden trestles across a few canyons, and suffered complete collapse. There was so much damage, the pipeline was abandoned south of Daly City. Today, Pilarcitos Reservoir dumps its water to San Andreas Reservoir.

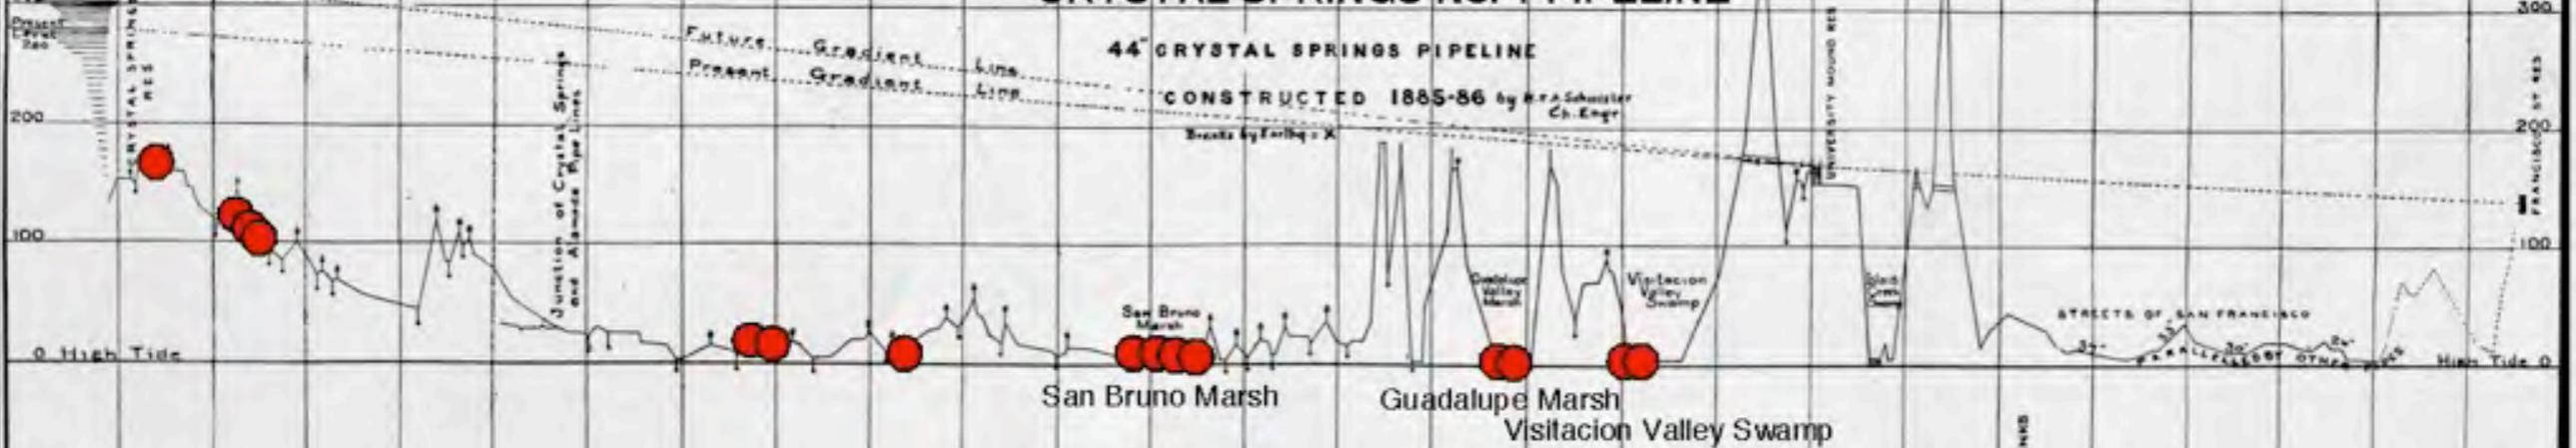
CRYSTAL SPRINGS No. 1 PIPELINE

500 feet of 44" pipe
thrown from trestle
onto the mud flats

It took 30 days to
fix this.

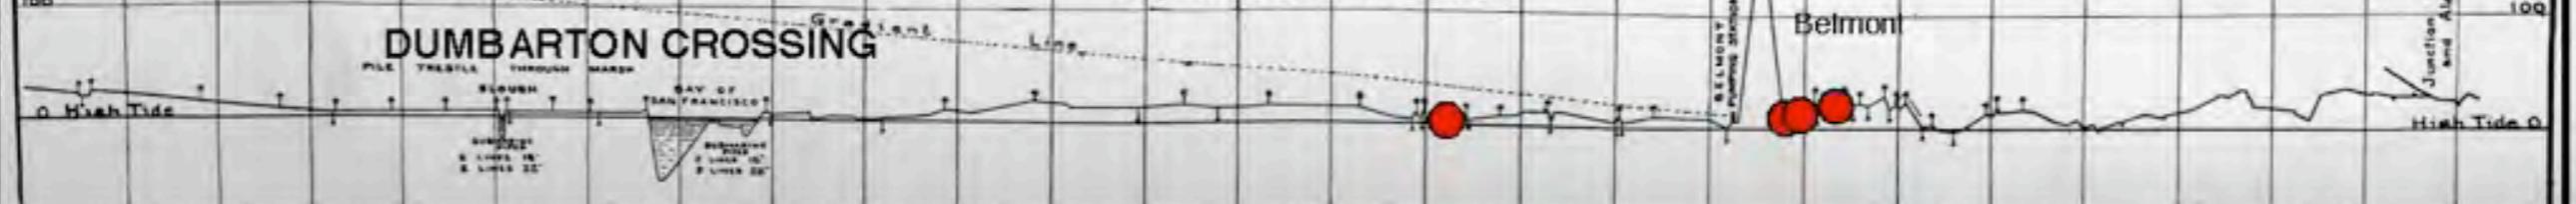
ALAMEDA PIPELINE

ALAMEDA 36" PIPE LINE constructed 1887-9 }
SUNOL AQUEDUCT constructed 1889-1900 }
AND }
NILES AQUEDUCT constructed 1887-8 }
S. V. W. CO. doublets substituted 1902-1 }
Breaks caused by Earthq. - X

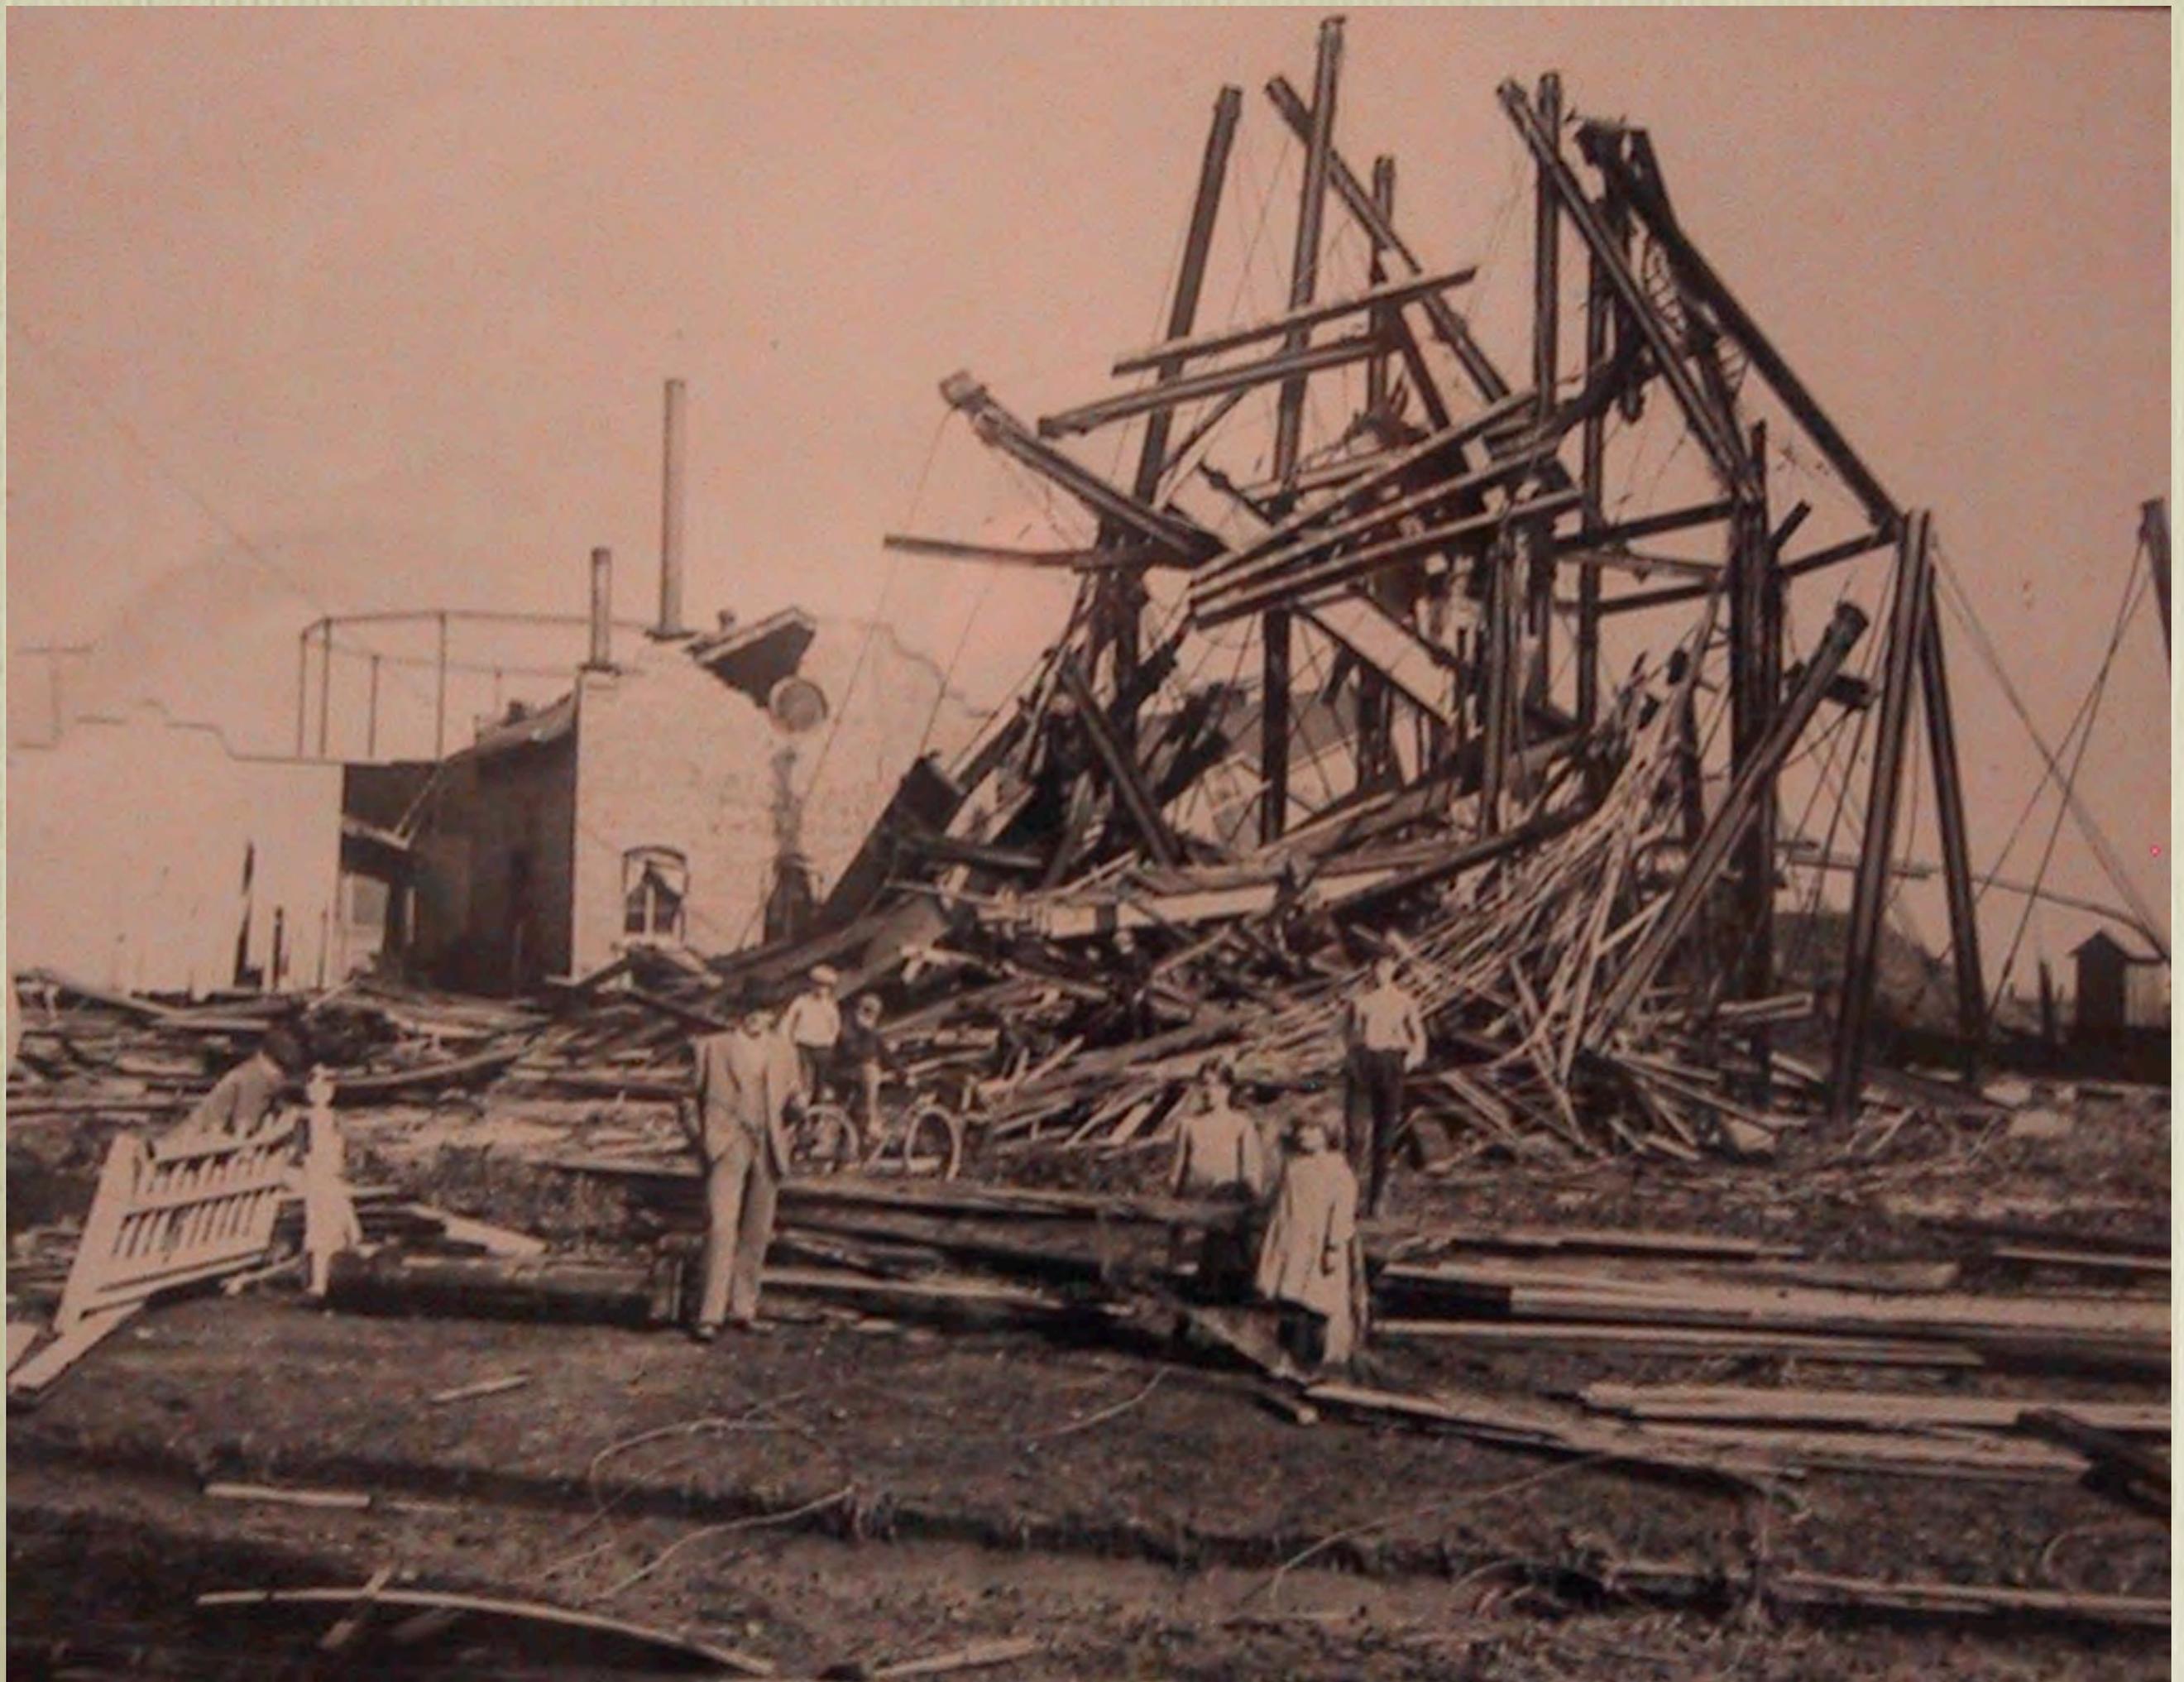
Water Tank

Inverness
