Tohoku Off Shore Earthquake & Tsunami, Japan
 $M_w=9.0$ 11 March 2011

Lifelines Performance Assessment
Preliminary Summary

(c) 2011, ASCE

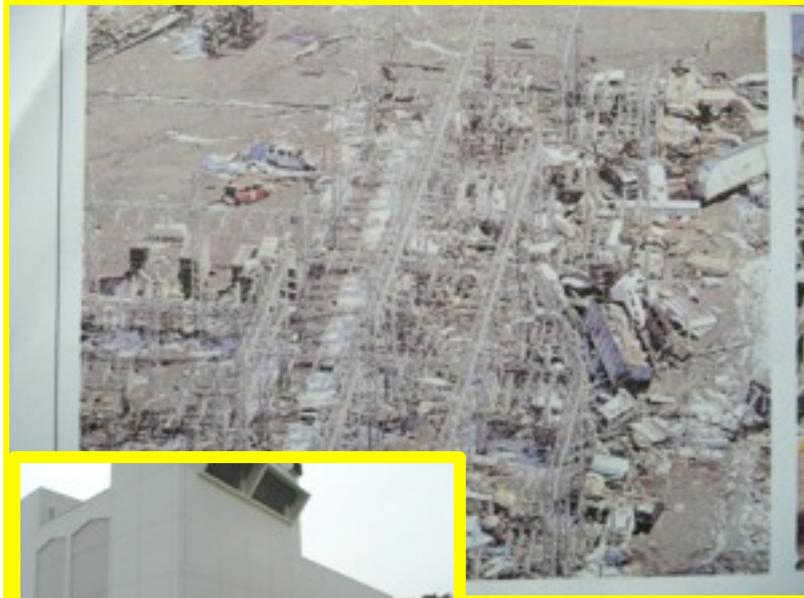
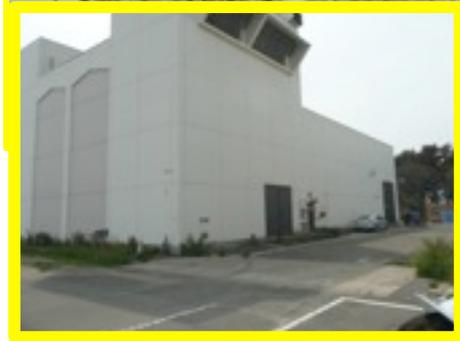
SUBSTATIONS

POWER TRANSFORMER FAILURES: Significant issue for transmission line system

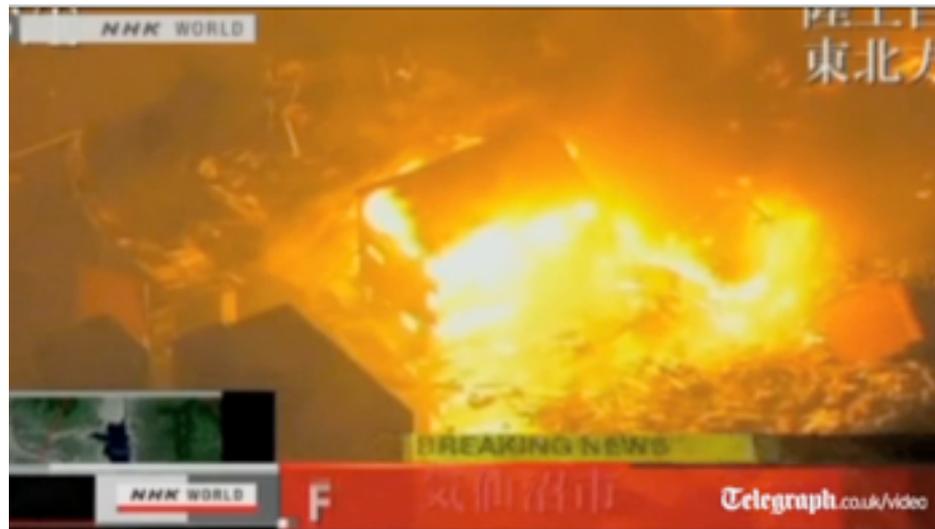
Kesennuma Fire

- Tsunami: little direct impact on water systems
- Liquefaction: much MORE will occur in future earthquakes.
- Power supply: loss of TEPCO and TOHOKU power to water treatment plants and pump stations had some impacts.
- Fire Following. 345 Fire Ignitions Reported. Failure of water supply might have led to conflagration in Kesennuma.

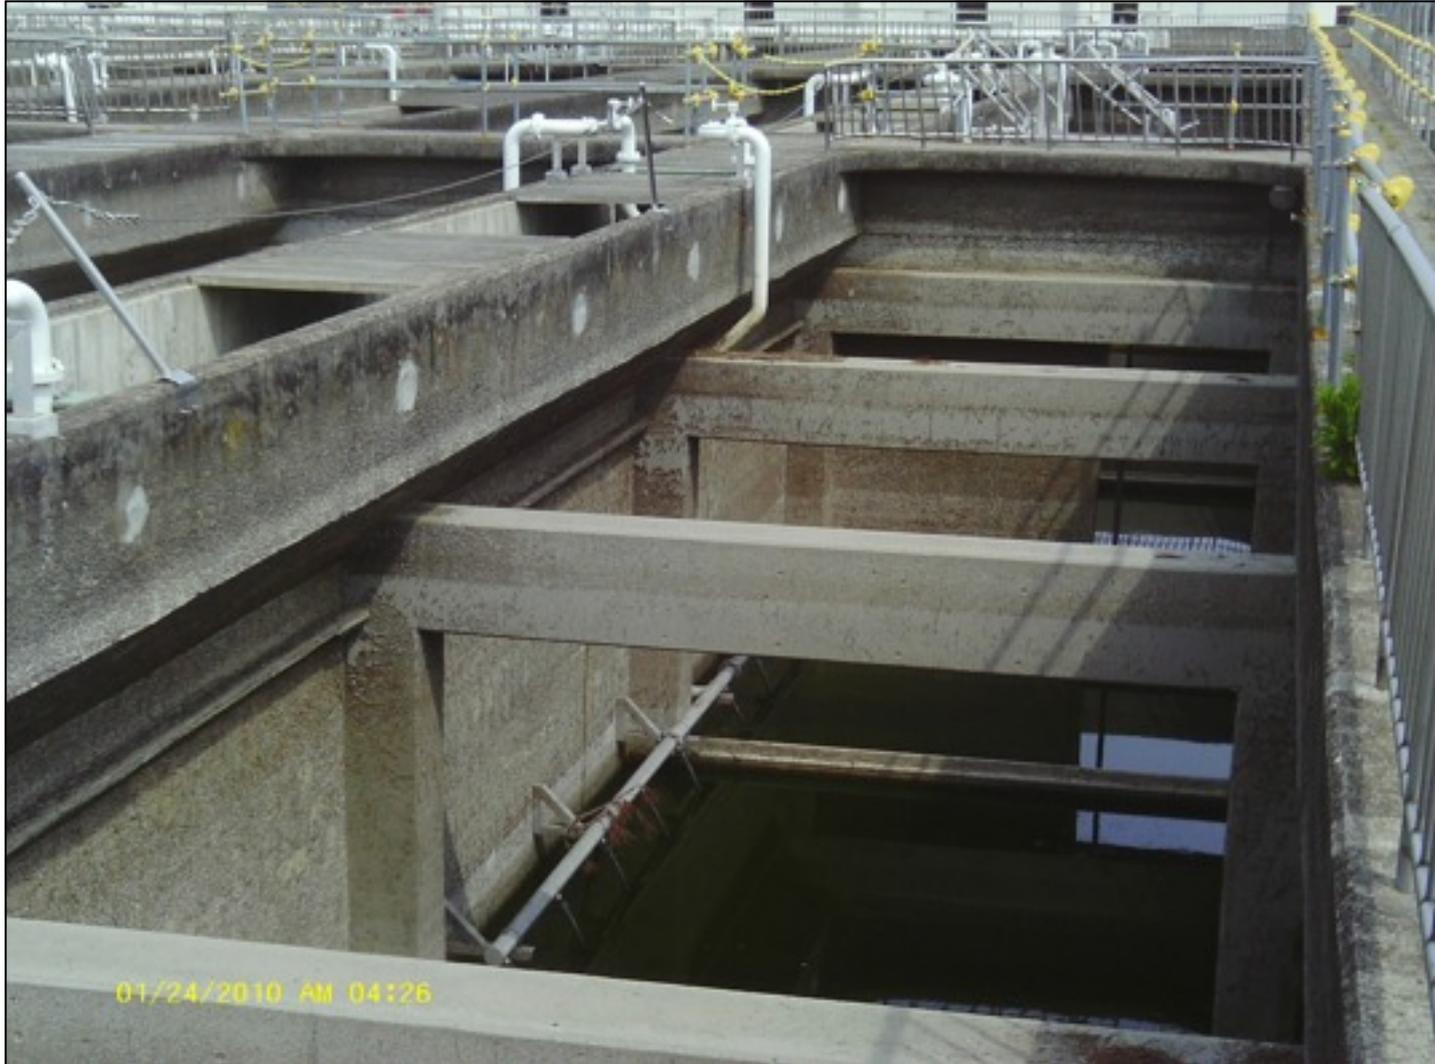
- Treatment plants in inundation zone
 - Impacted by flooding, debris, horizontal forces, electrical/control failures
 - Structural damage to buildings and equipment due to impact forces
 - Limited shaking damage inspection due to tsunami warning
 - Able to provide some levels of treatment with gravity settling and chlorination
