CHRISTCHURCH, NEW ZEALAND EARTHQUAKE SEQUENCE OF M_w 7.1 September 04, 2010 M_w 6.3 February 22, 2011 M_w 6.0 June 13, 2011: LIFELINE PERFORMANCE

**Technical Council on Lifeline Earthquake Engineering
Monograph No. 40
February 2012 – Revision 0
ASCE**

ABSTRACT

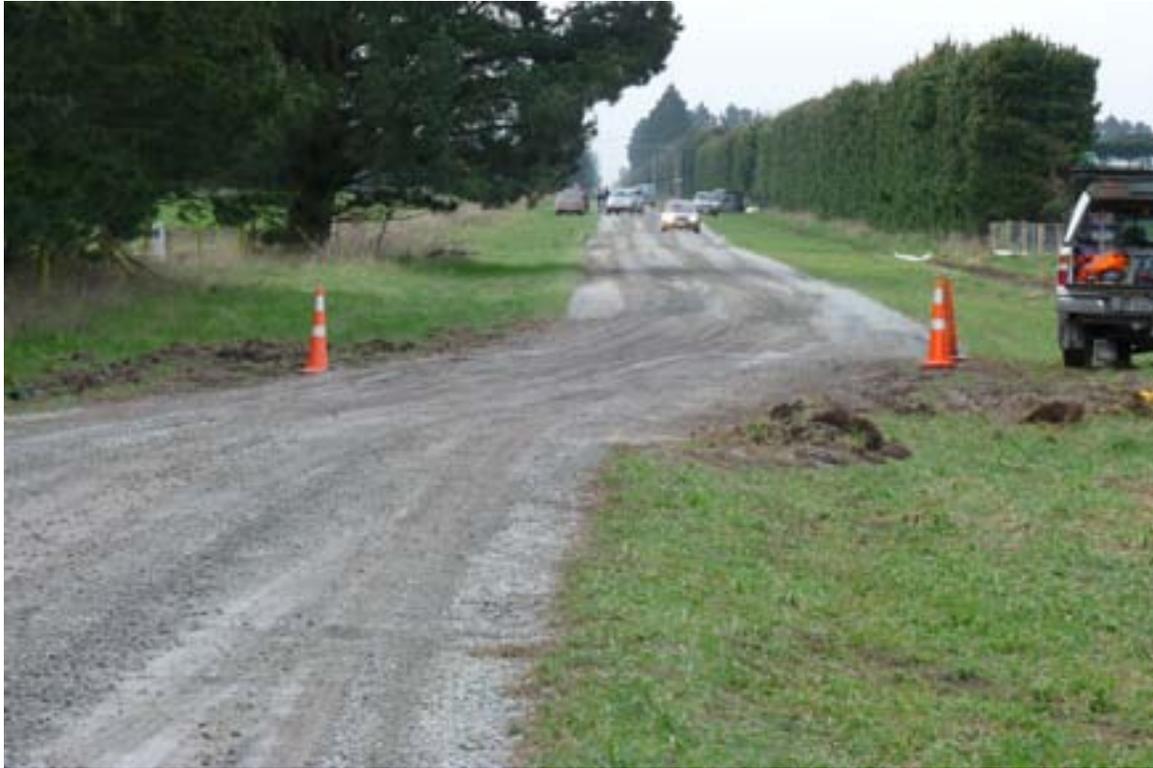
Figure 2-25 shows the right lateral offset of a country road. The road was straight prior to the earthquake. Figure 2-26 shows a paved road that crossed the fault; the right lateral offset of the fault appears to have forced the road to shorten, resulting in many pavement buckles.

Figure 2-25. Fault Offset Through a Road

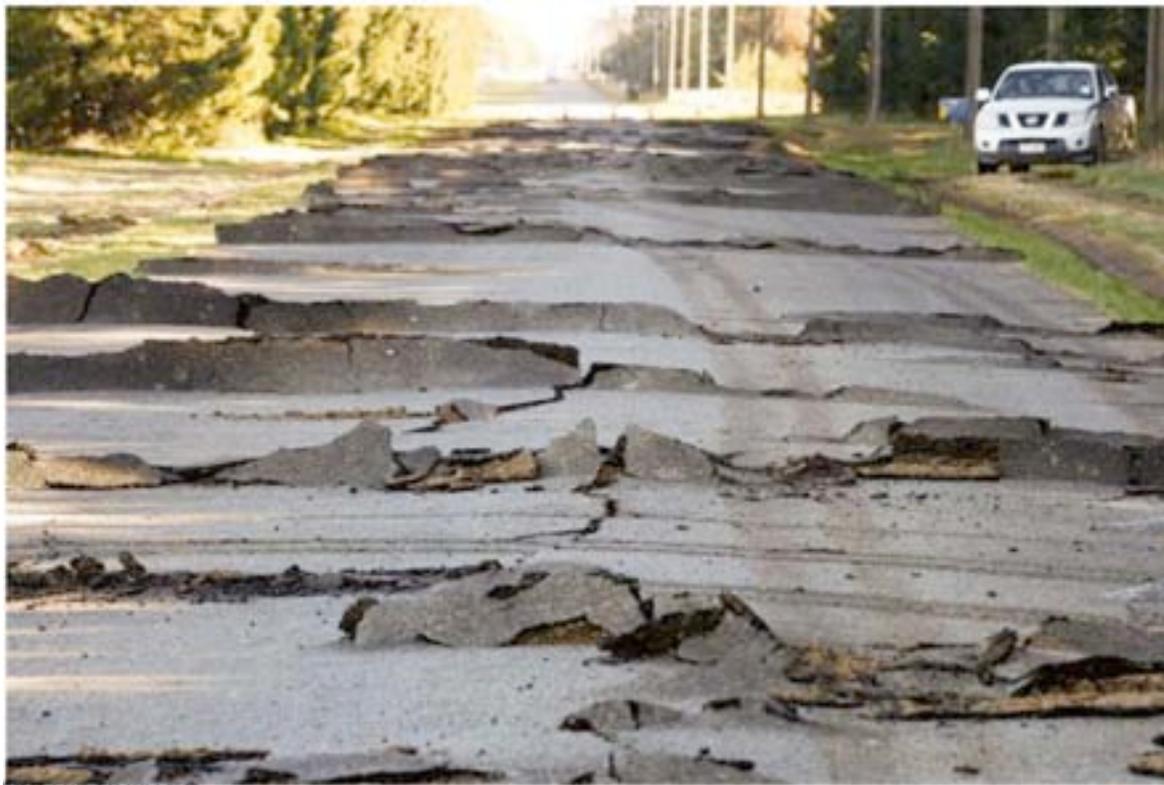
Figure 2-26. Fault Offset Through a Road, West of Rolleston

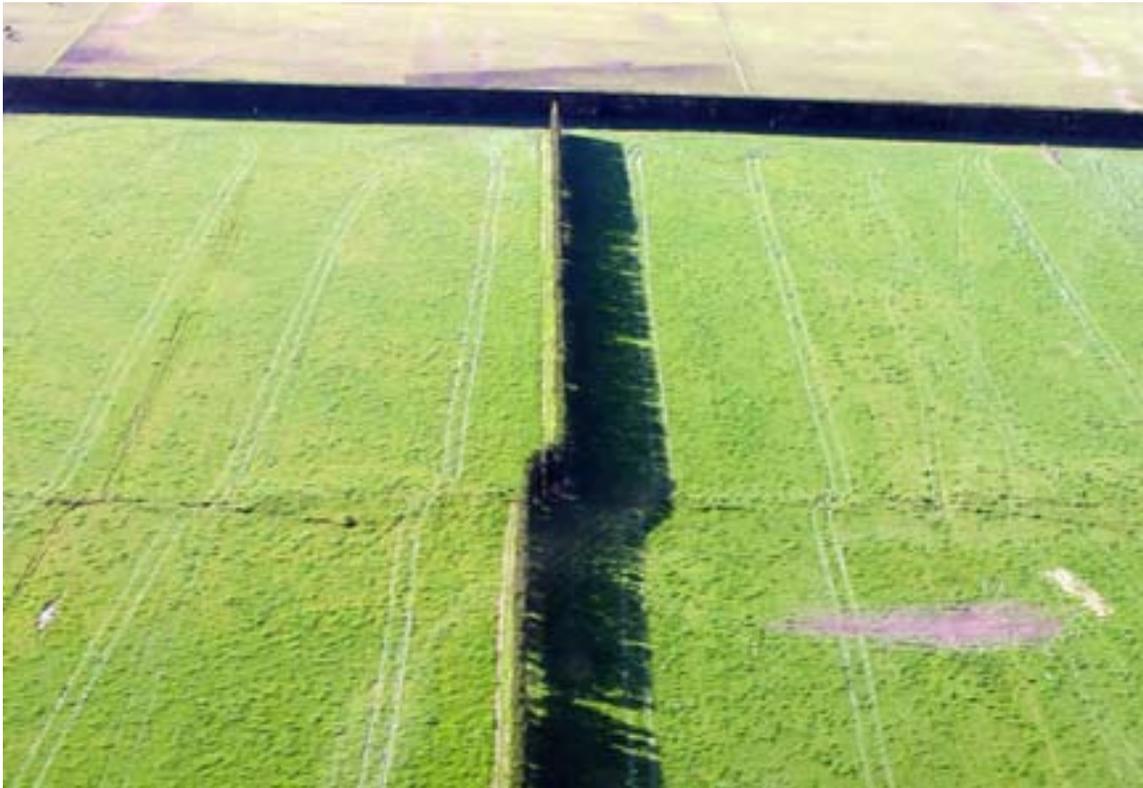
Figure 2-27 shows the right lateral offset through a straight hedge. These hedges are used as wind barriers and are believed to have been originally laid out in straight lines.

Figure 2-27. Right Lateral Fault Offset Through a Hedge

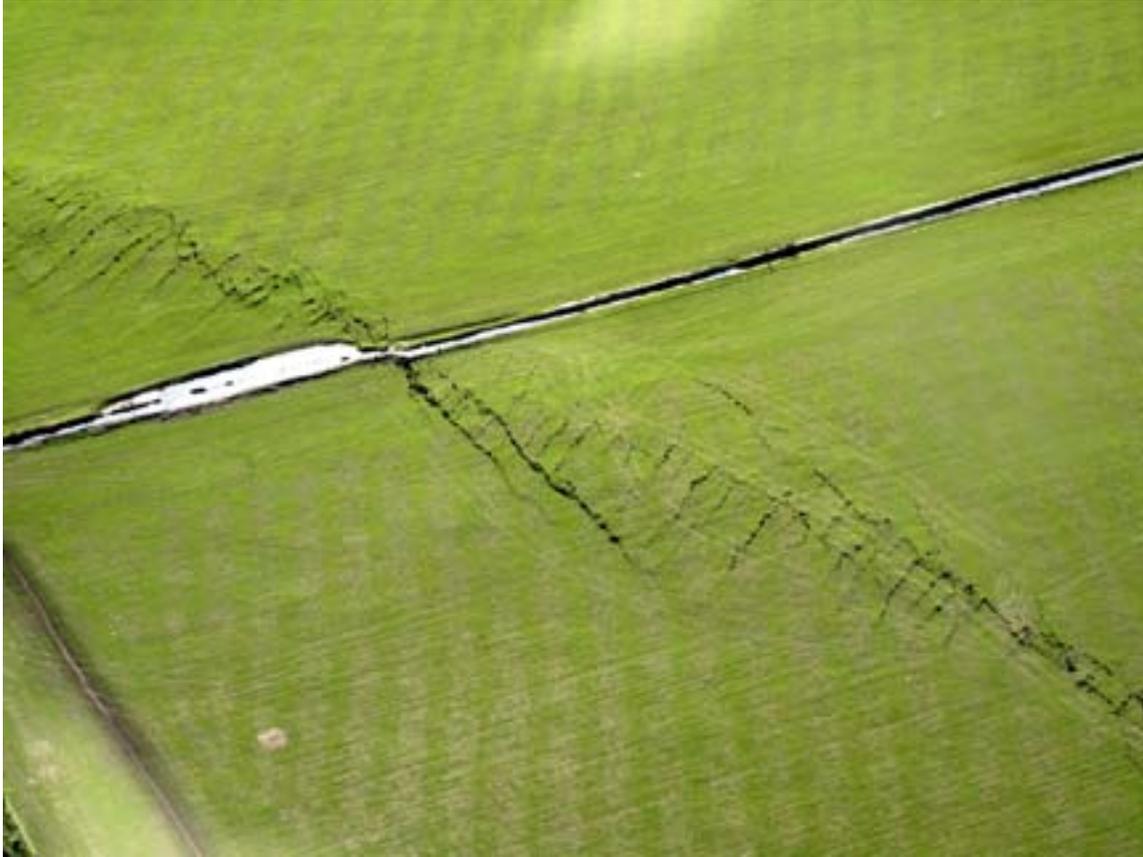
Figures 2-28 to 2-31 show fault offset patterns that were quite common. While the sense of fault offset was generally right lateral, we observe in these photos that the local zone of deformation were commonly about 10 meters wide, and the azimuth of ground cracking is commonly offset 20 to 30 degrees from the general east-west right lateral sense of movement.

Figure 2-28. Right Lateral Fault with En-Echelon Cracks

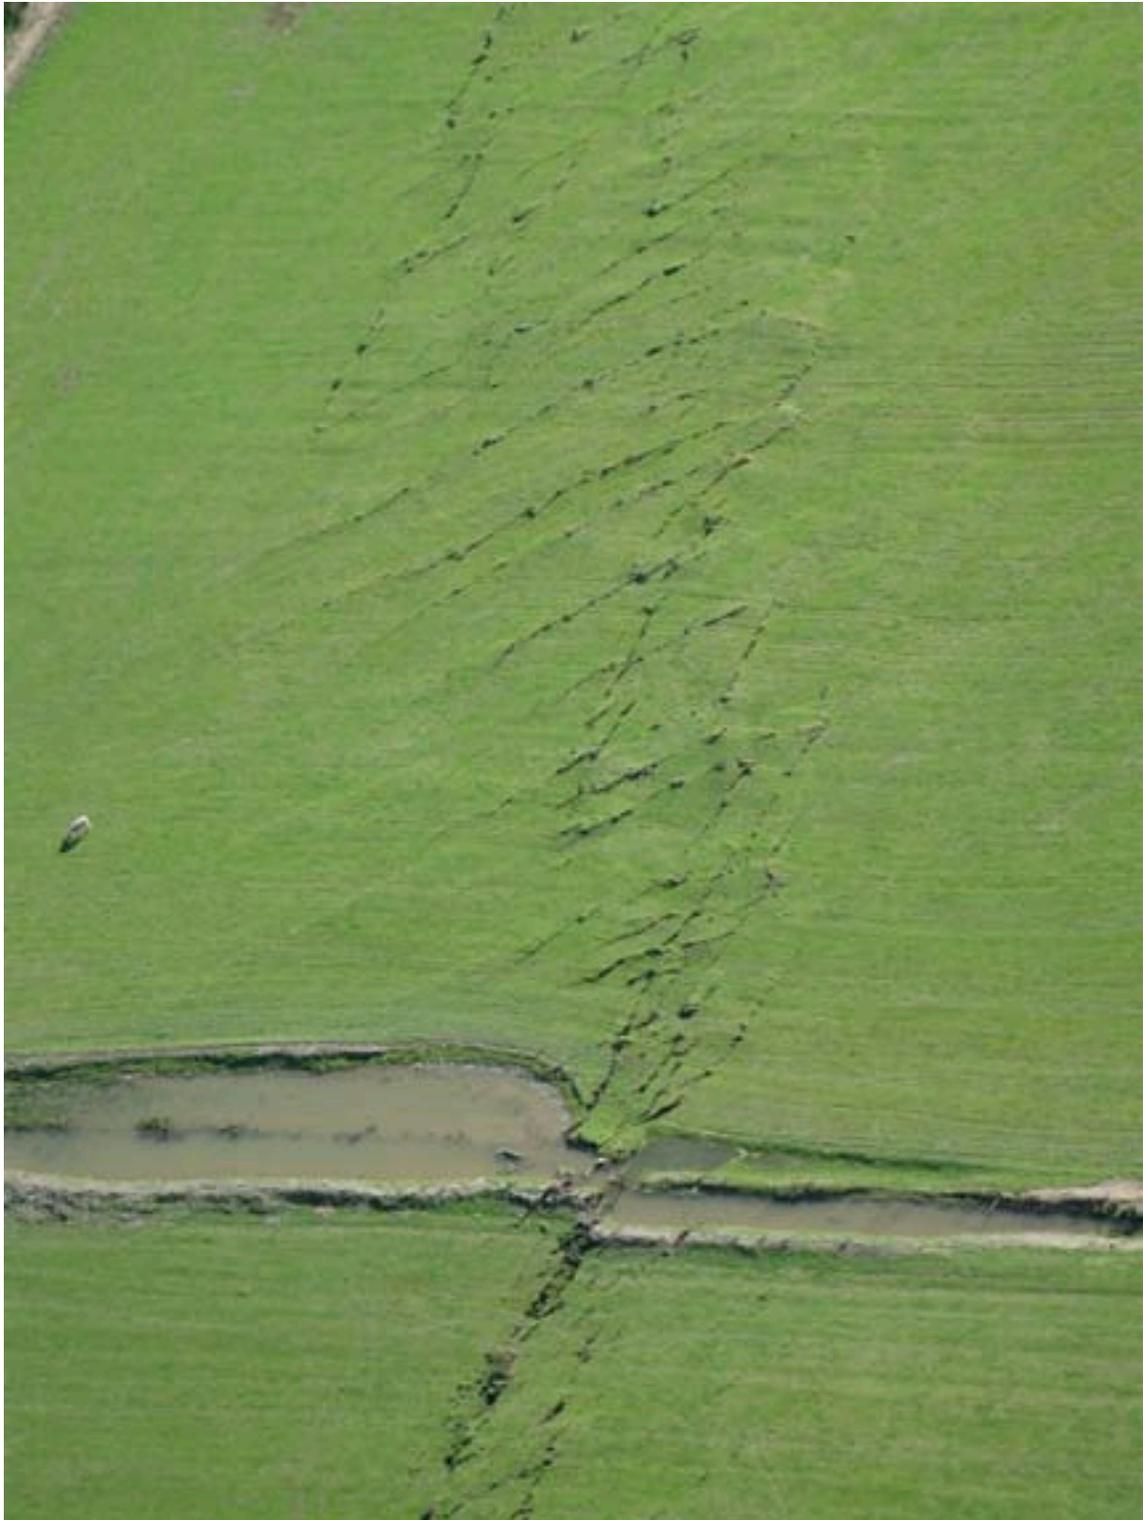
Figure 2-29. Right Lateral Fault with En-Echelon Cracks (Quigley, Univ. Canterbury)

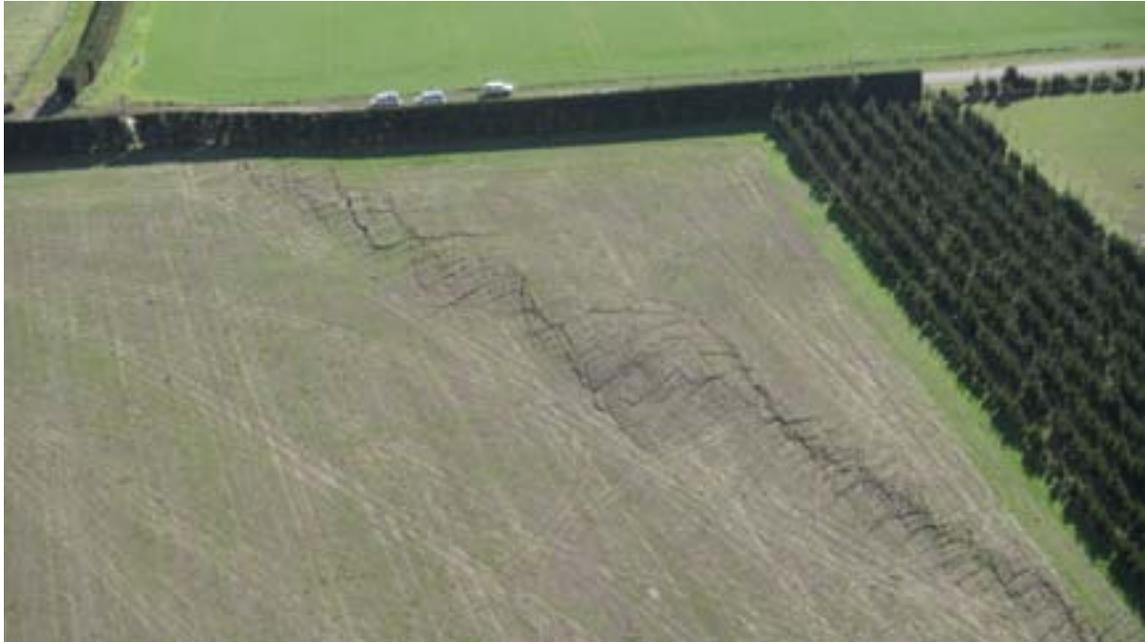
Figure 2-30. Right Lateral Fault with En-Echelon Cracks

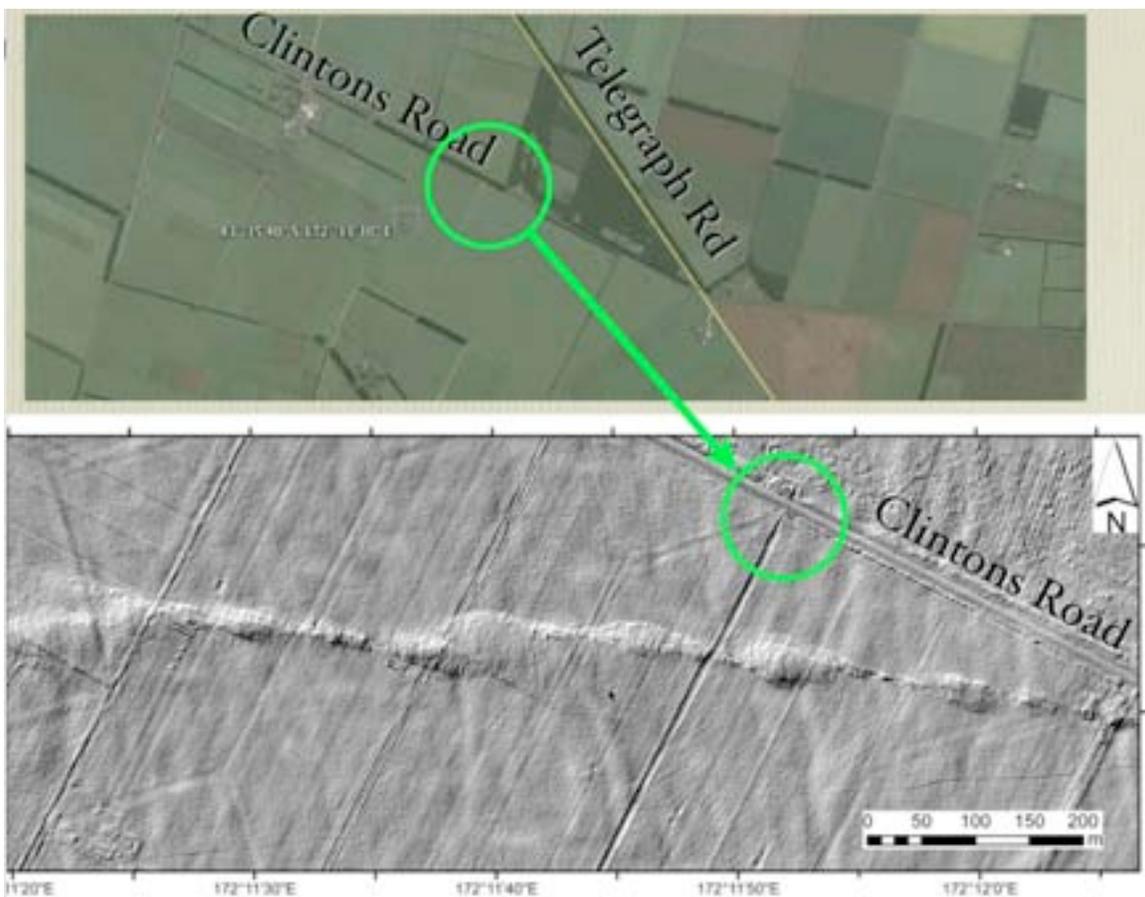
Figure 2-31 shows one section of the fault offset zone with a Lidar map. Generally, the sense of offset was right lateral, but about 10% of the fault zone also had some vertical offset, commonly about 1 meter rise on the south side of the fault; in a few locations there were small vertical elevation gains on the north side of the fault.

Figure 2-31. Location Map (Upper) and Lidar Map of Fault Offset Zone (Lower)

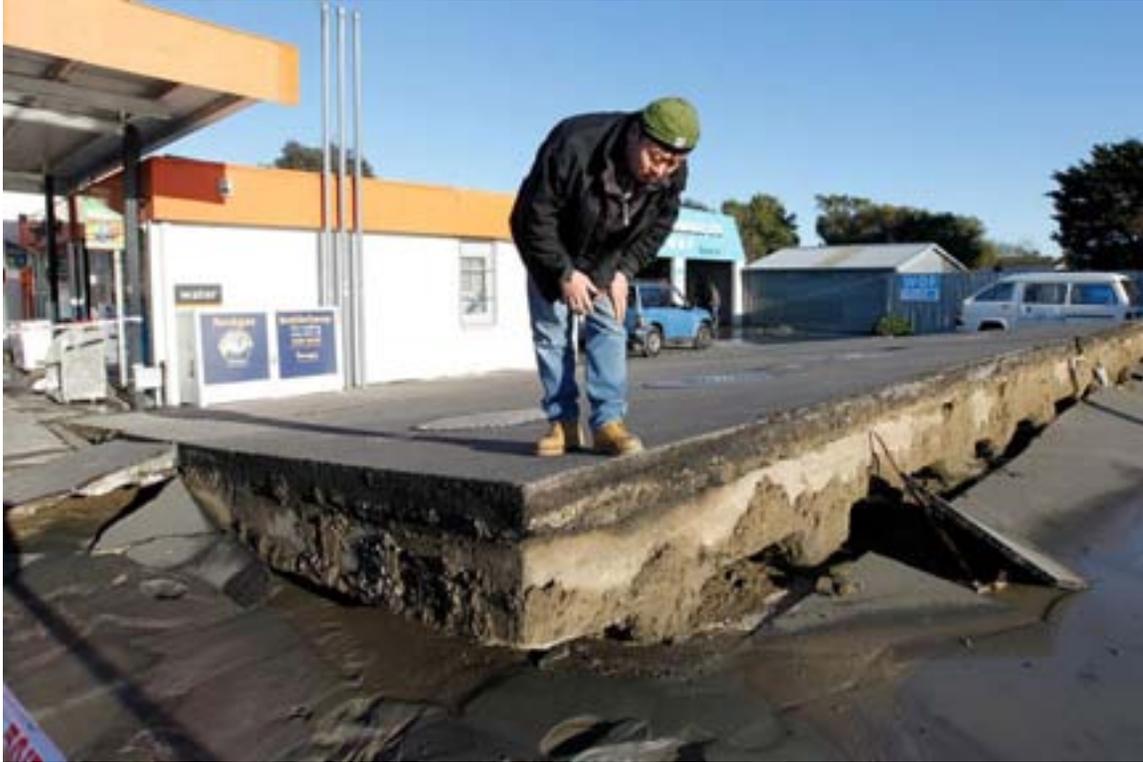
Figure 2-35 shows a gasoline (petrol) storage tank that floated. This tank was located in Bexley, an area of Christchurch with widespread liquefaction. Liquefaction is evidenced by the sand boils seen in the foreground of this photo, as well as evidence of sand boils at nearby locations. This gas station was out of service five weeks after the earthquake. Figure 2-36 shows sand boils typically observed in the liquefied areas.

Figure 2-35. Floated Gas Tank, Bexley

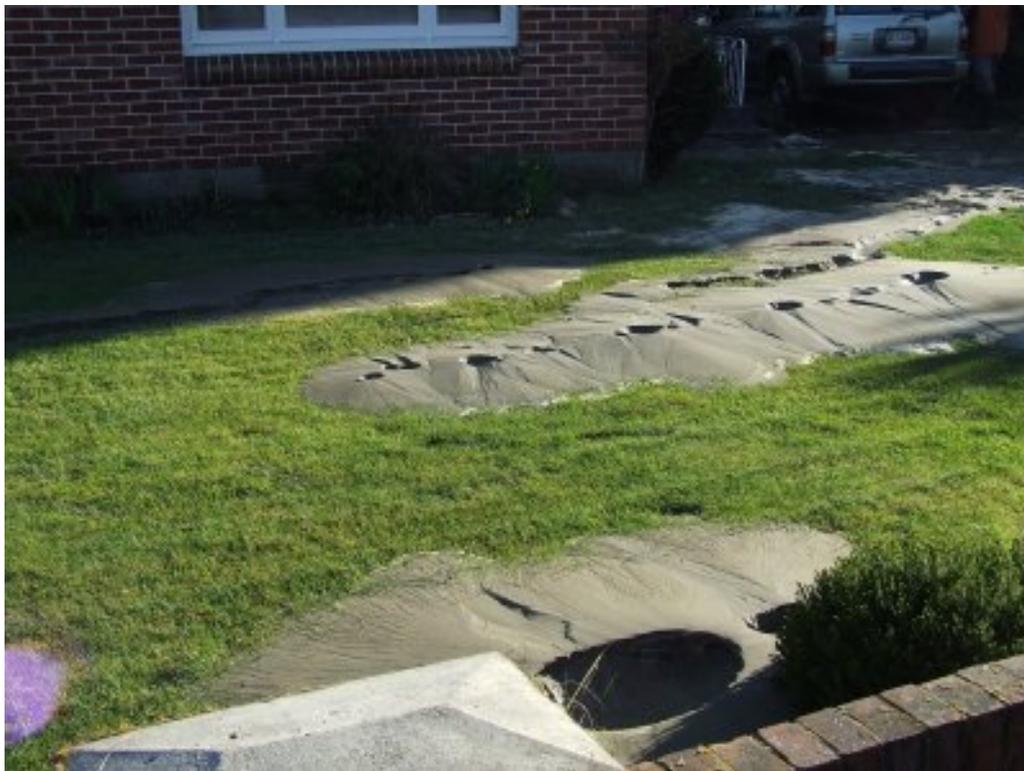
Figure 2-36. Sand Boils

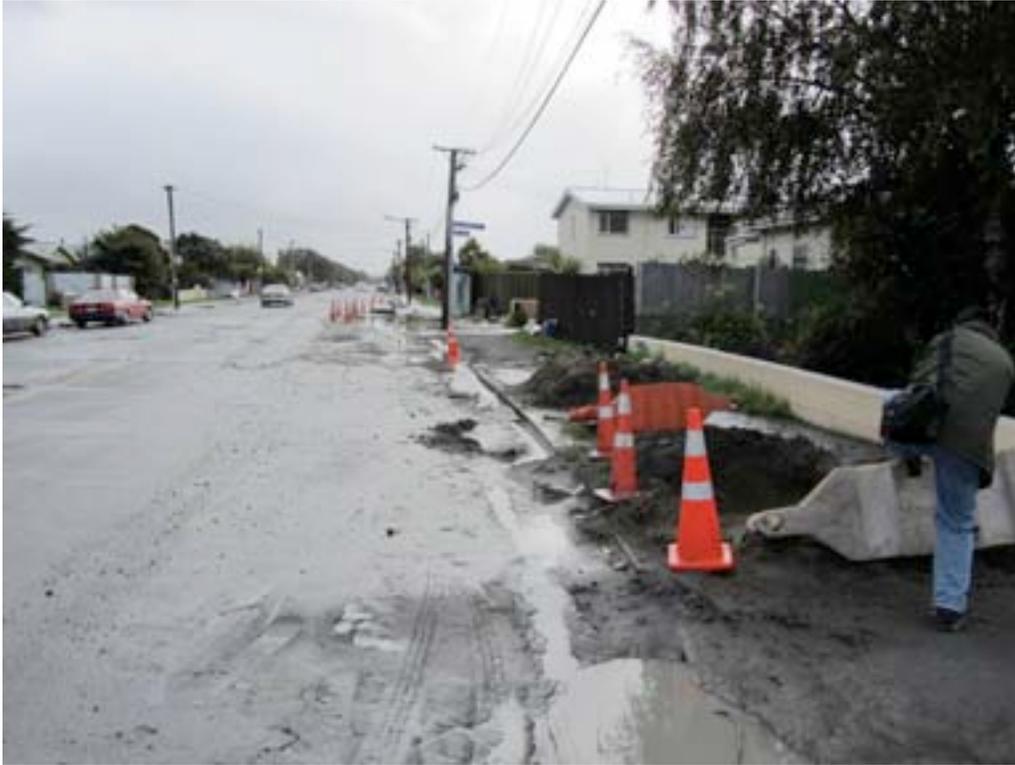
Liquefaction during the February 2011 earthquake extensive flooding of streets and large volumes of sand to be ejected on the ground surface. Liquefaction induced permanent ground deformations in the form of ground settlements and lateral spreading were prominent throughout the city. Figure 2-38 shows liquefaction induced deformations and sand deposits along Palmers Road. Clean up of the sand deposits was still underway in April 2011. Figure 2-39 shows liquefaction induced lateral ground movements causing the sidewalk brick work to deform in the Central Business District. Many of the same features of liquefaction described for the September 2010 earthquake apply to the February 2011 earthquake. However, the effects in February 2011 were generally more extensive, at least in Christchurch.

Figure 2-38. Liquefaction induced ground deformation on Palmers Road, Feb 22 2011

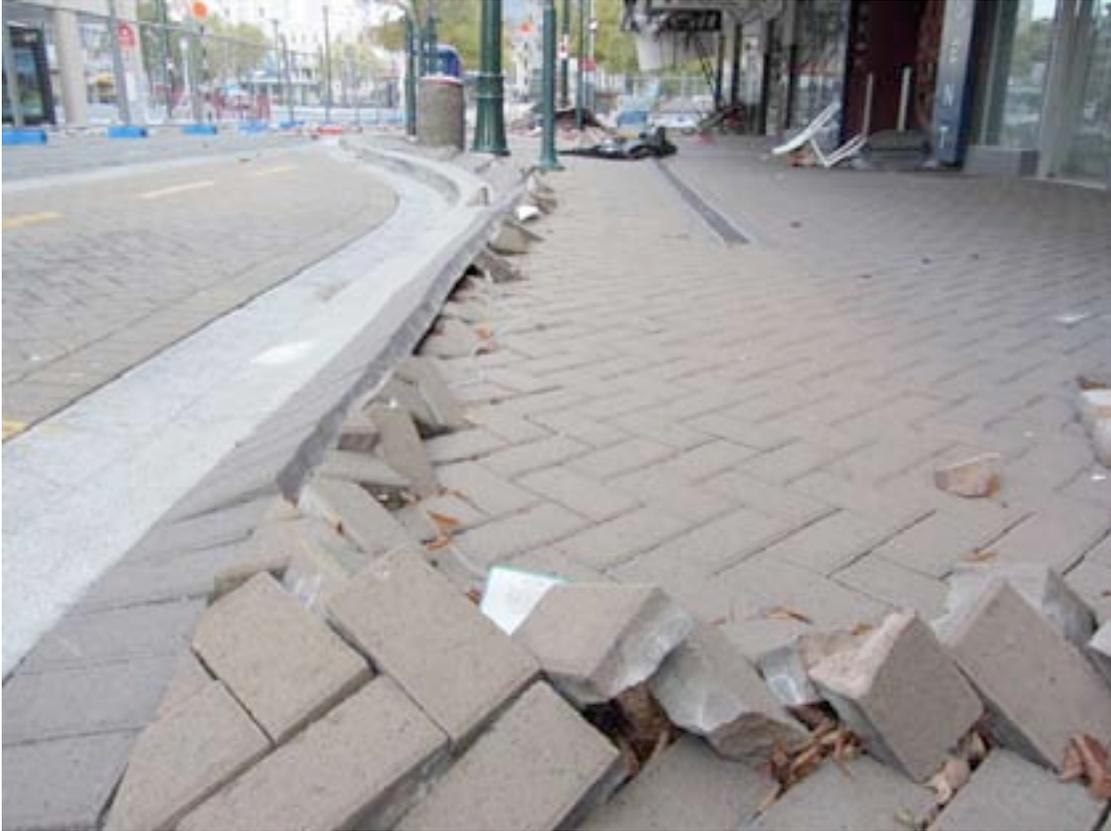
Figure 2-39. Liquefaction induced ground deformation in the Central Business District, February 22 2011

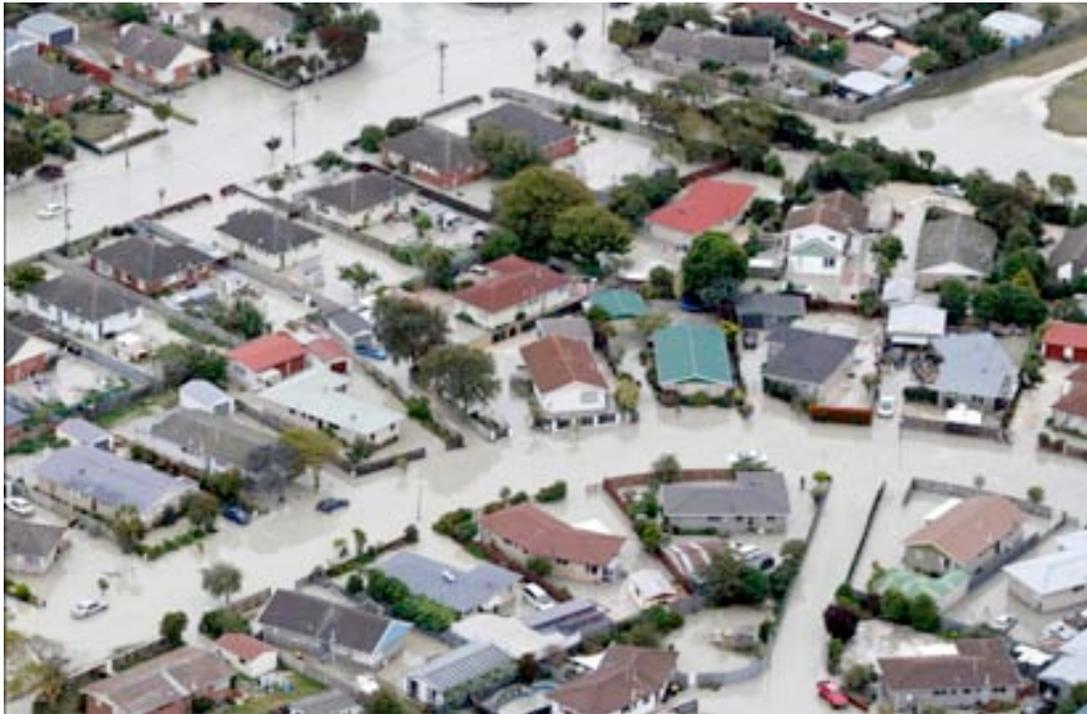
flooding. However, the liquefaction forced great volumes of water from the ground for very long periods of time and ultimately caused the flooding seen in Figure 2-33; this was repeated in the February 2011 earthquake, Figure 2-40.

Figure 2-40. Liquefaction, February 2011

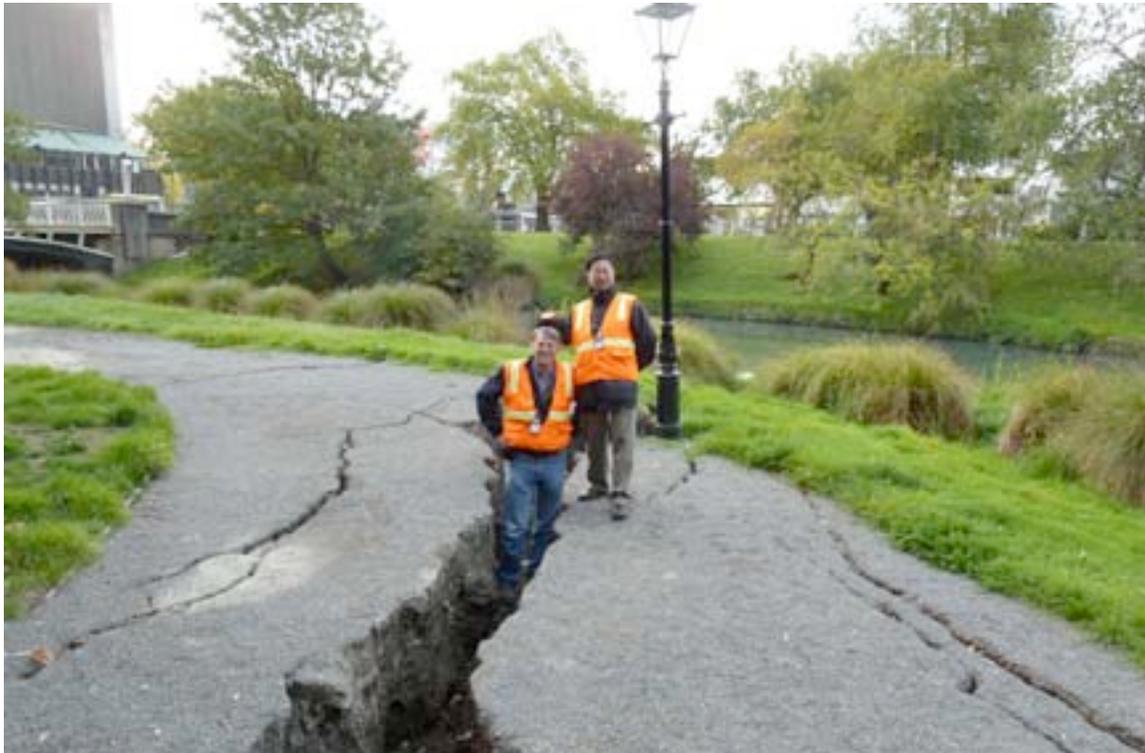
Figure 2-41 shows a graben and lateral spread adjacent to the Avon river in the CBD; as well as the editors of this report. The lateral movement of the banks towards the river resulted in buckling of the girder for the bridge in the background, Figure 2-42.

Figure 2-41. Liquefaction, Avon River Bank, CBD, February 2011

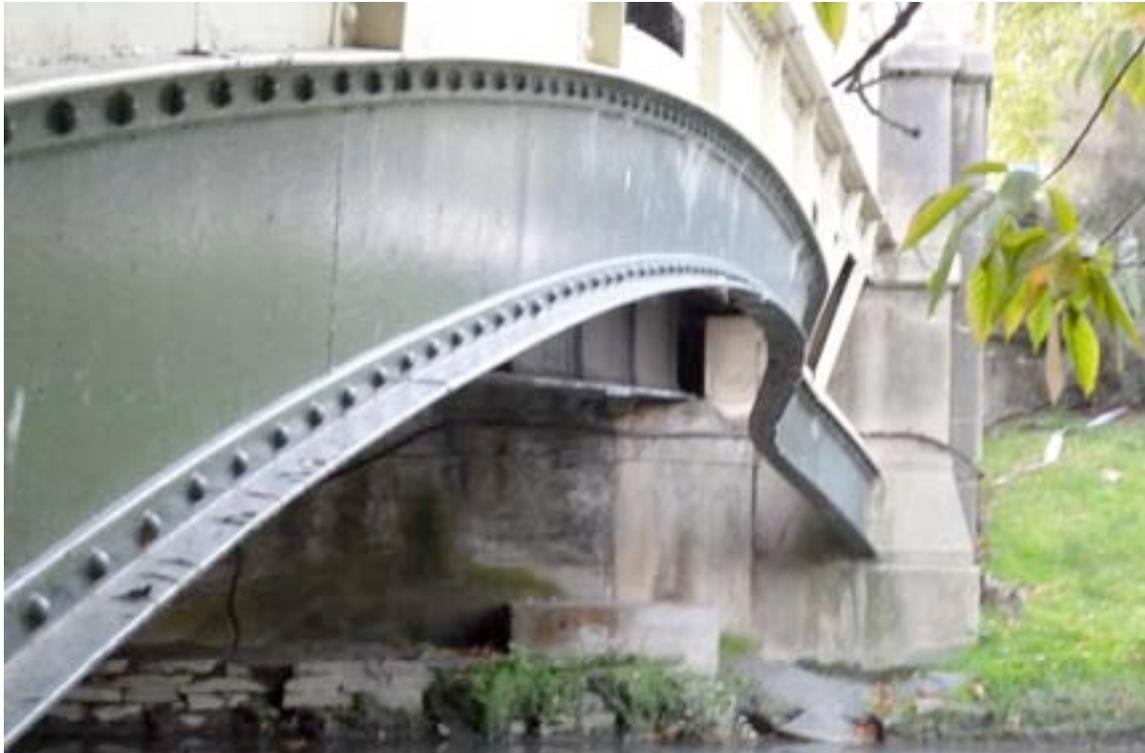
Figure 2-42. Damaged Bridge Girder due to Lateral Spread, CBD, February 2011

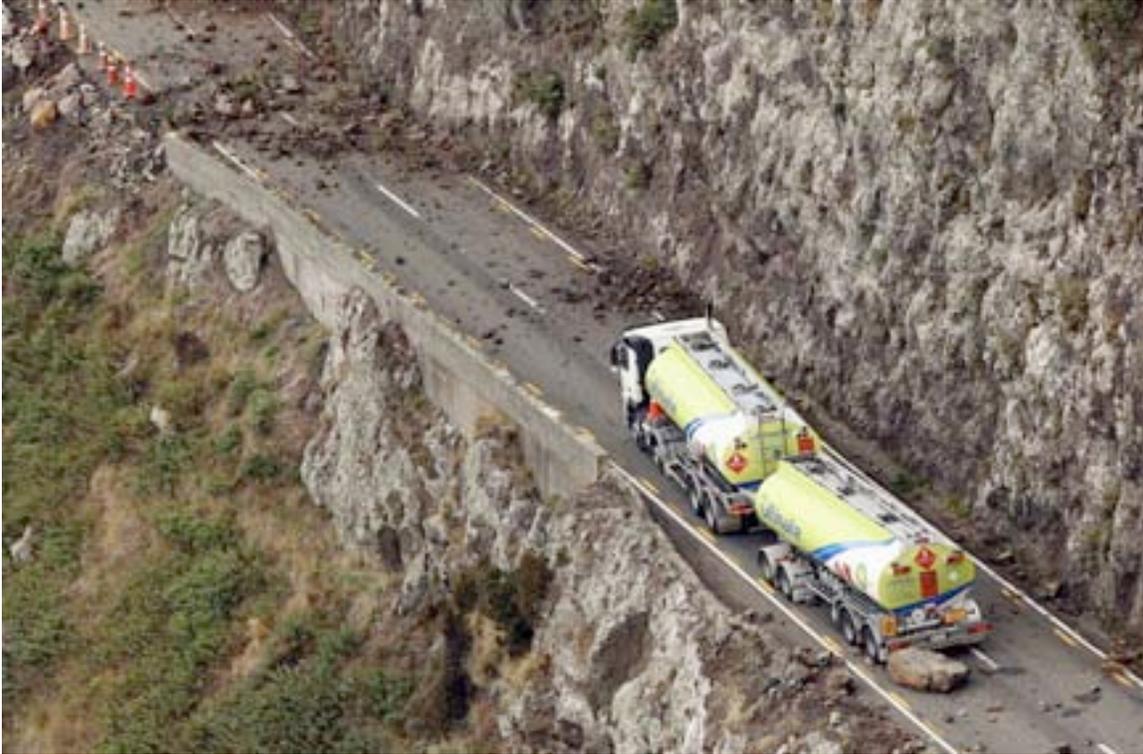
Figure 2-43. Rock Fall, Lyttleton Port Area, February 22 2011

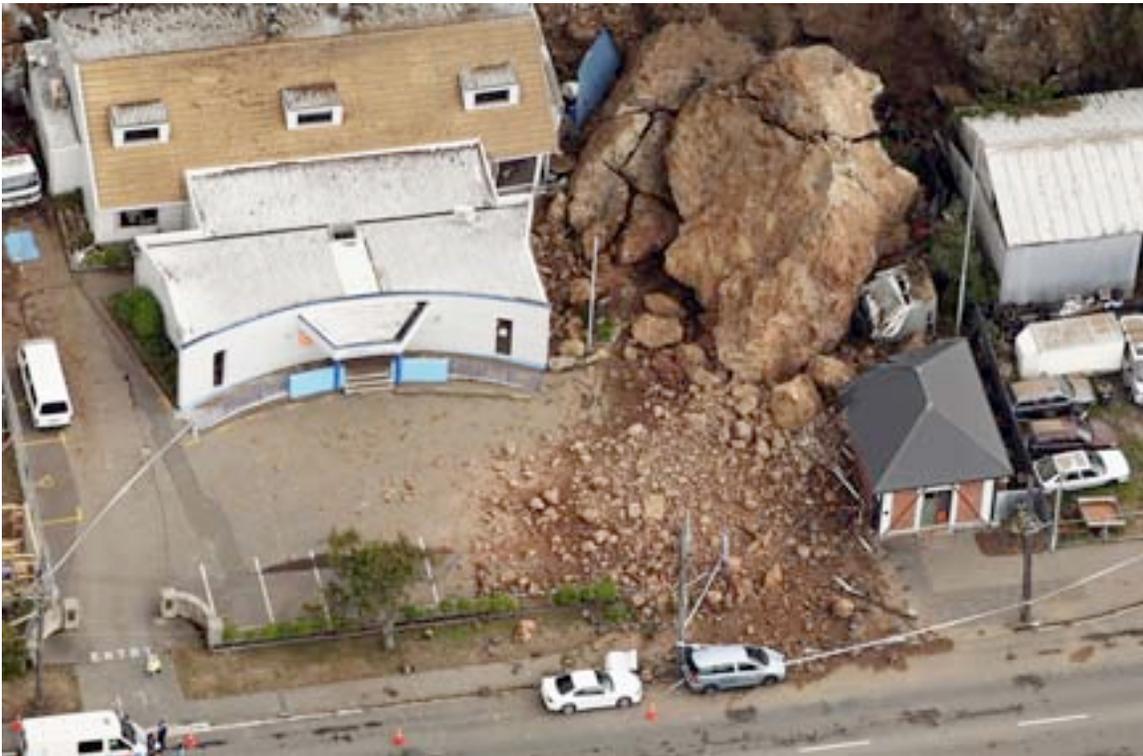
Figure 2-44. Rock Fall, Sumner Area, February 22 2011

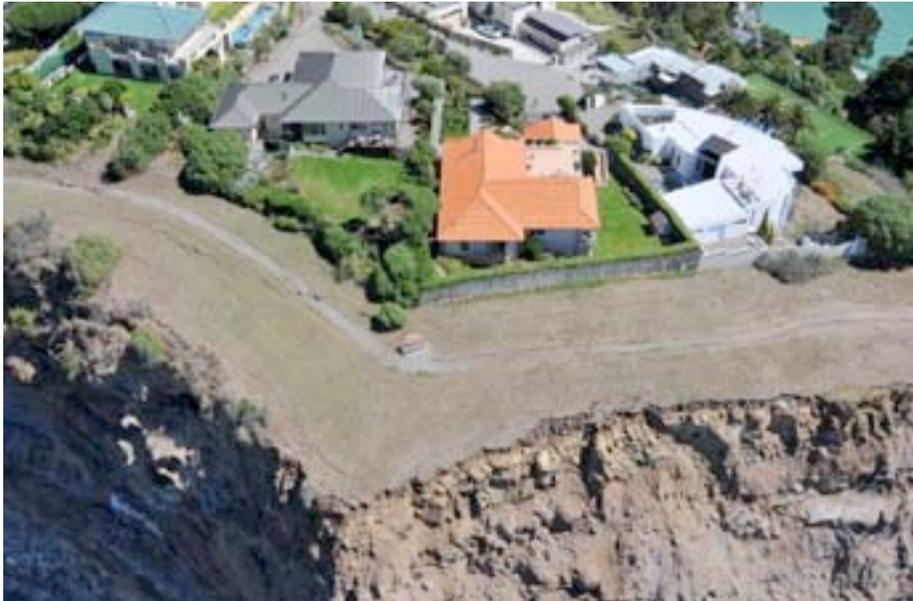
Figure 2-45 shows cracks at the edge of cliffs at Sumner Head (southeast Christchurch suburb). Many rocks rolled off the steep mountainsides and damaged/destroyed buildings at the foot of the hills. The June 11 2011 event also caused rock falls in this area. Chapter 6 describes some water tanks impacted by rock falls. Figure 2-46 shows extensive rock accumulation on Summit Road.

Figure 2-45. Cliff Edge Cracks, Sumner Head, February 22 2011

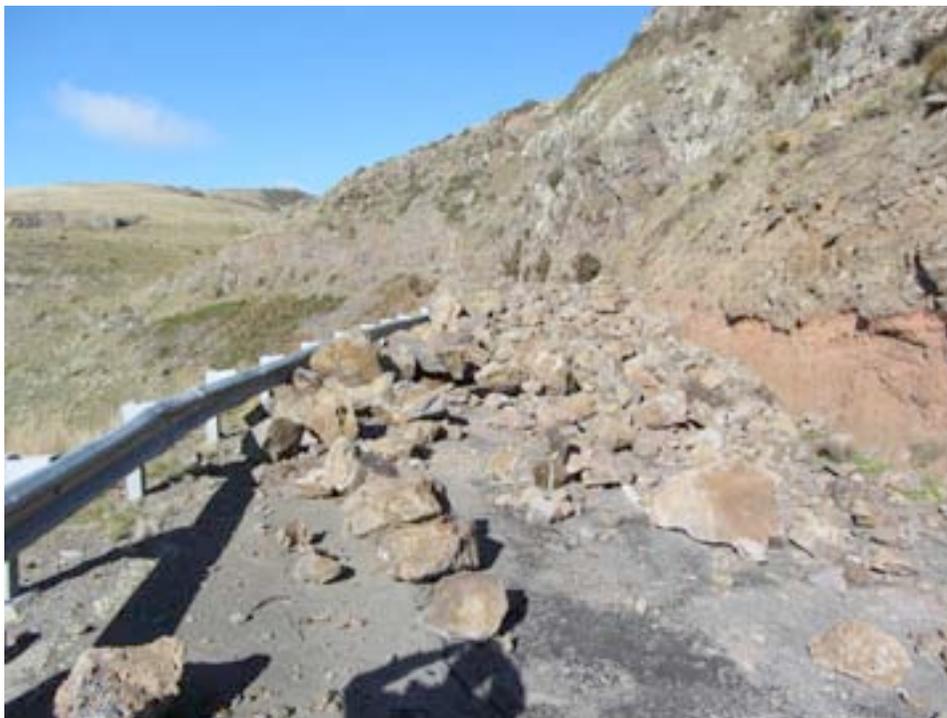
Figure 2-46. Rock falls accumulated on Summit Road, February 22 2011

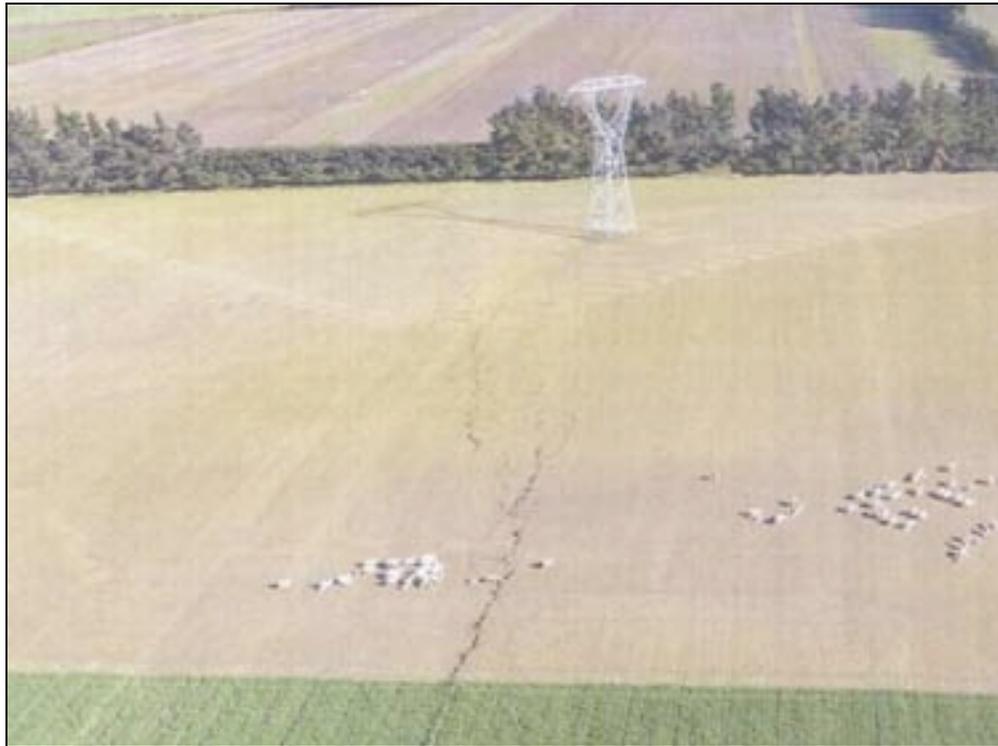
Two single-circuit 220 kV overhead transmission lines crossed the rupture zone of the September 2010 event. The fault rupture passed nearby the legs of the steel lattice towers, but not through them (Figures 4-3, 4-4). There was no observed damage to any towers

Figure 4-3. Surface Fault Offset Approaches the Tower in Figures 4-4, 4-5

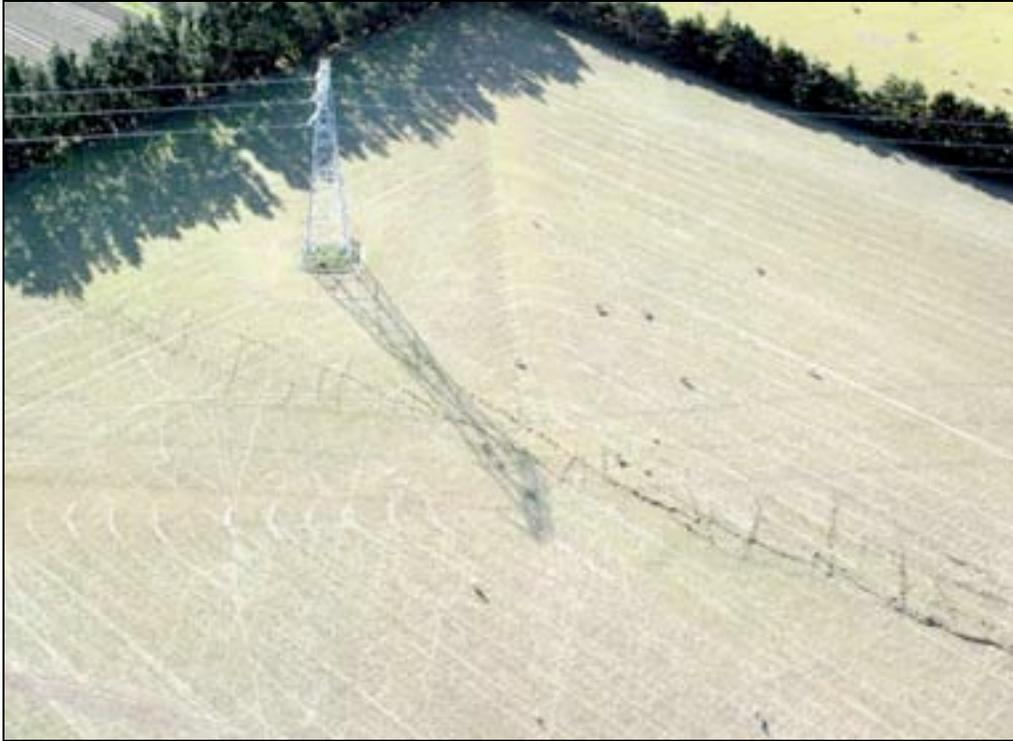
Figure 4-4. Surface Fault Offset Approaches the Tower in Figures 4-3, 4-5

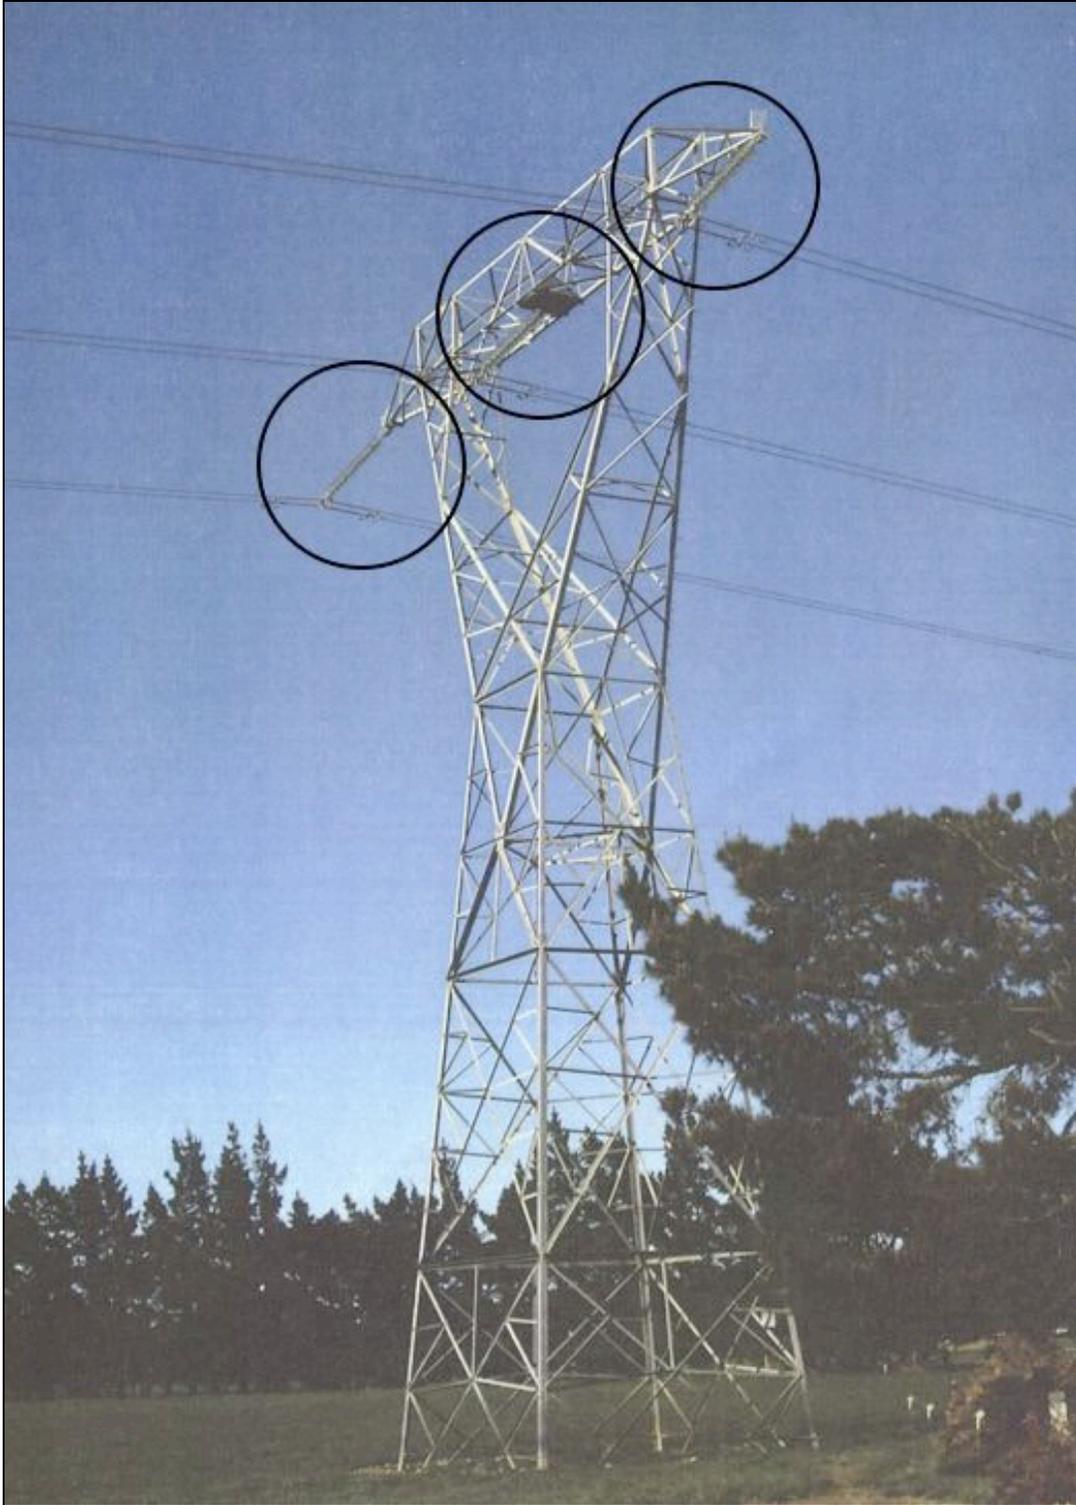
due to inertial shaking in any of the events. Due to the fault offset (September 2010 event), on the order of 4 meters, the conductor sags on either side of the fault became unbalanced. On the ROX-ISL-A line, the unbalanced sag is indicated by the diagonally-swung insulators (normally they would be straight down) in Figures 4-5, 4-6 this sag remains unbalanced 6 weeks after the September 2010 earthquake; Transpower reported that they would adjust the sag during some future outage; Transpower reported this was completed by February 2011. On the Benmore-Islington line, the September 2010 fault offset resulted in high tension loads in a ground wire, which bent the tower extension that supported the ground wire (Figure 4-7); again, this did not led to an outage, but could be repaired during a future outage.

Figure 4-5. Displaced Insulators on Suspension Tower Adjacent to Fault Offset

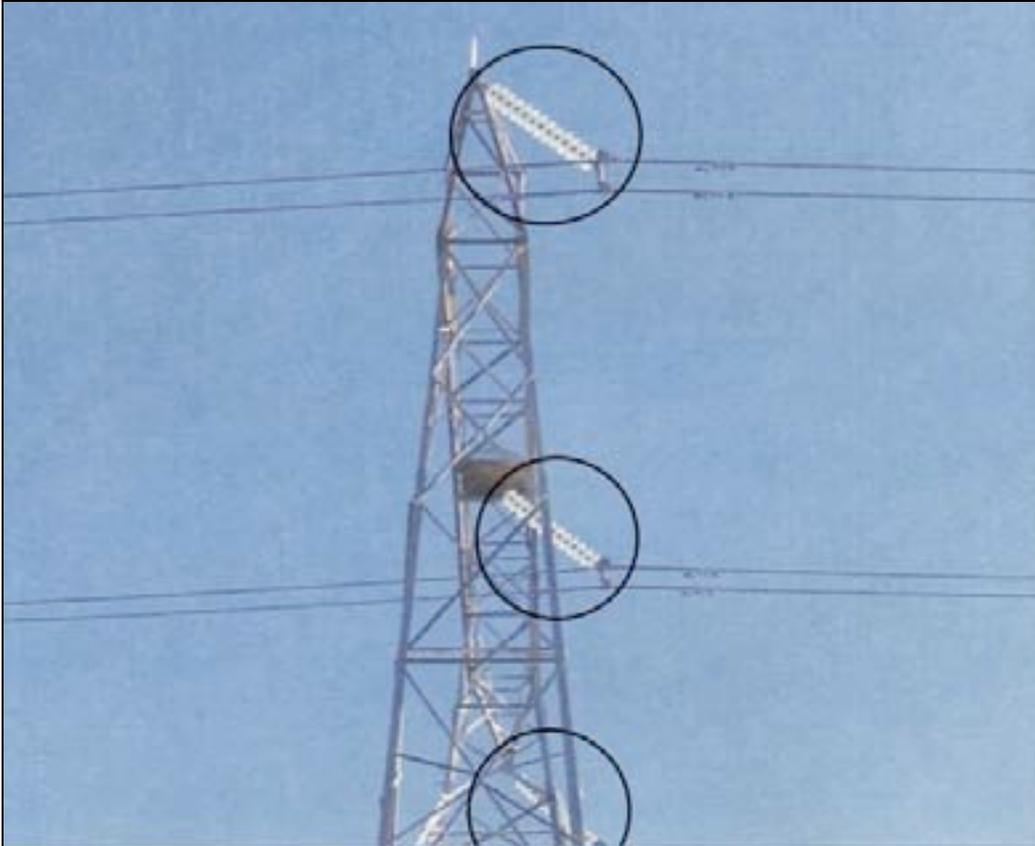
Figure 4-6. Displaced Insulators on Suspension Tower Adjacent to Fault Offset

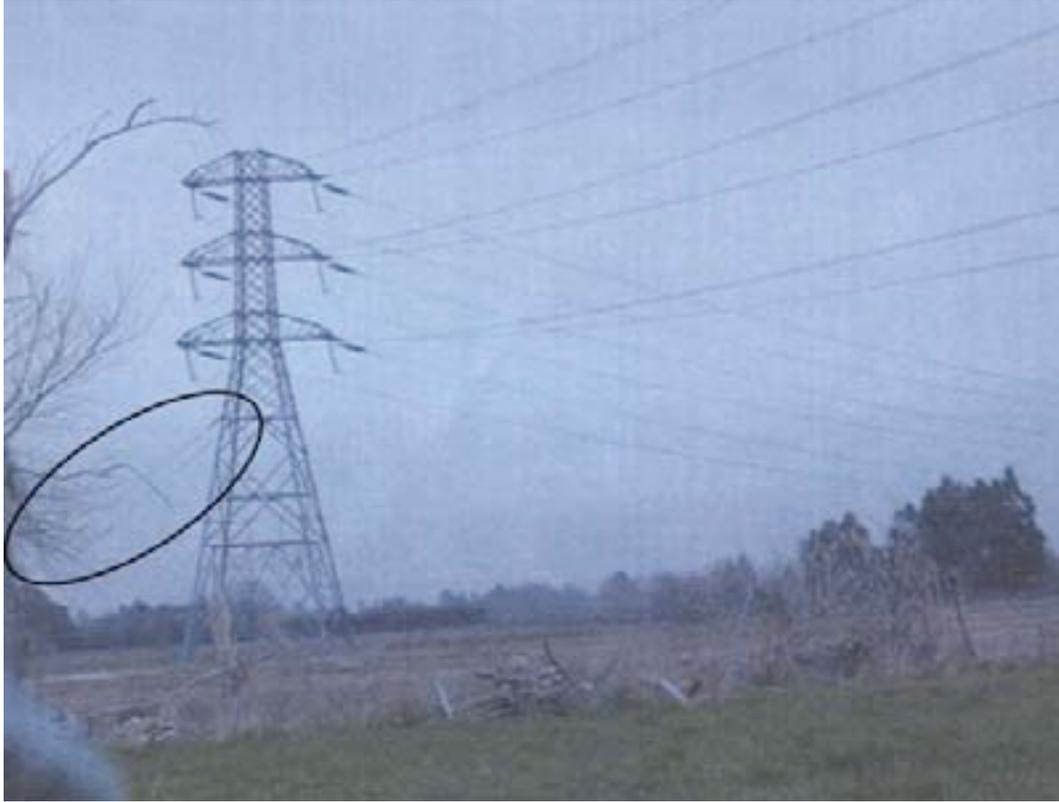
Figure 4-8. Angle Tower With Added Guy Wires

- Coleridge: 12:16 pm. One line tripped due to a feeder fault.
- Bromley: One 220 kV angle steel lattice tower on the Bromley to Islington transmission line was leaning (Figure 4-8), likely due to liquefaction (but, Transpower staff reported that they could not be completely sure the tower was not leaning before the earthquake). Repair was to install guy wires. Diagonal crack in a wall of the control building next to a door. A small amount of oil sloshed out of the tap changers of transformers T2, T3 and T4. Some 66kV wood bus poles had a slight lean. One disconnect switch (DS 894) was not properly closed. Note: This substation sustained substantial liquefaction and additional damage in the Feb 2011 earthquake.
