CHRISTCHURCH, NEW ZEALAND EARTHQUAKE SEQUENCE OF M_w 7.1 September 04, 2010 M_w 6.3 February 22, 2011 M_w 6.0 June 13, 2011: LIFELINE PERFORMANCE

**Technical Council on Lifeline Earthquake Engineering
Monograph No. 40
February 2012 – Revision 0
ASCE**

ABSTRACT

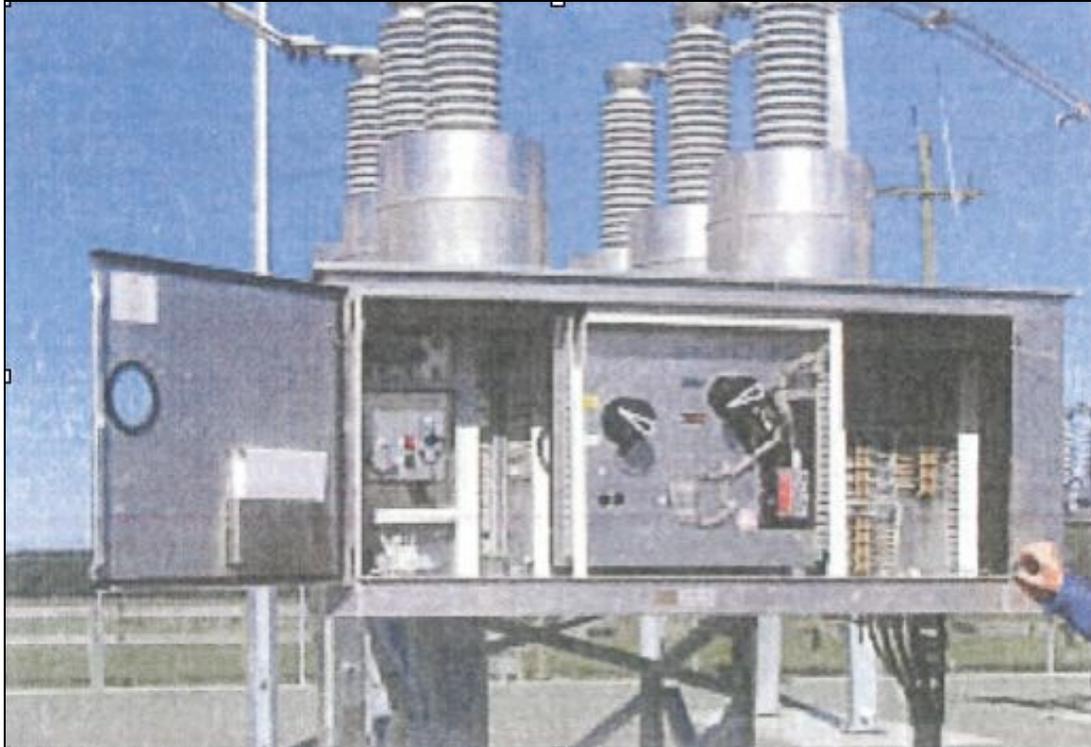
- Springston: 7:48 am. Two transformers tripped due to vibration causing false operation of mercury switches in high pressure protective devices. Loose items rattled off ledge of walls. One fuse holder fell out of the carrier. A cabinet door broke off a 66 kV circuit breaker 438, Figure 4-9. Two Orion 33 kV poles were leaning.

Figure 4-9. One of Two Cabinet Doors Broke Off, SF6 Circuit Breaker

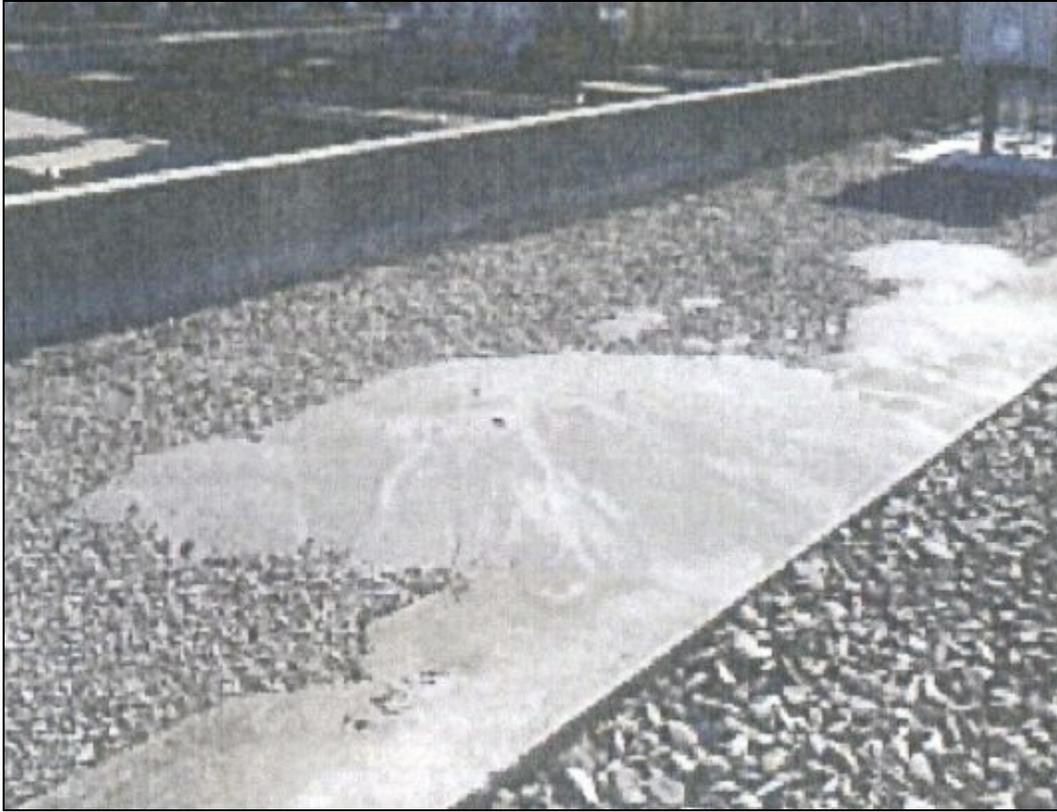
- Papanui: 8:28 am. The Islington-Papanui 66 kV overhead circuit broke at the terminal tower and fell down onto another phase. There was liquefaction at this substation, as evidenced by sand boils, Figure 4-11. Sand was ejected through the switchyard rock, and had to be removed. The gate at the entrance dropped. Oil containment tanks need to be inspected internally. Spill prevention containment walls around transformers were cracked, Figure 4-12. There was a broken window in the relay room. There were two cracks in the control building. Liquefaction did not adversely affect the upgraded transmission tower Figure 4-13.

Figure 4-11. Sand Boils, Papanui Substation

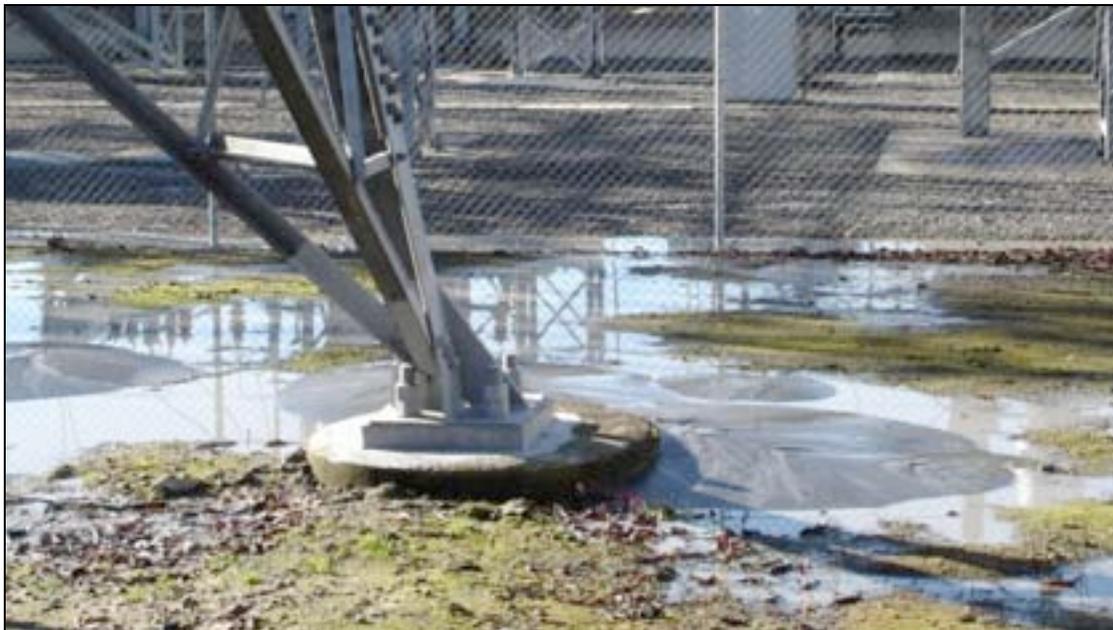
Figure 4-13. Sand Boil, Upgraded Tower, Papanui Substation

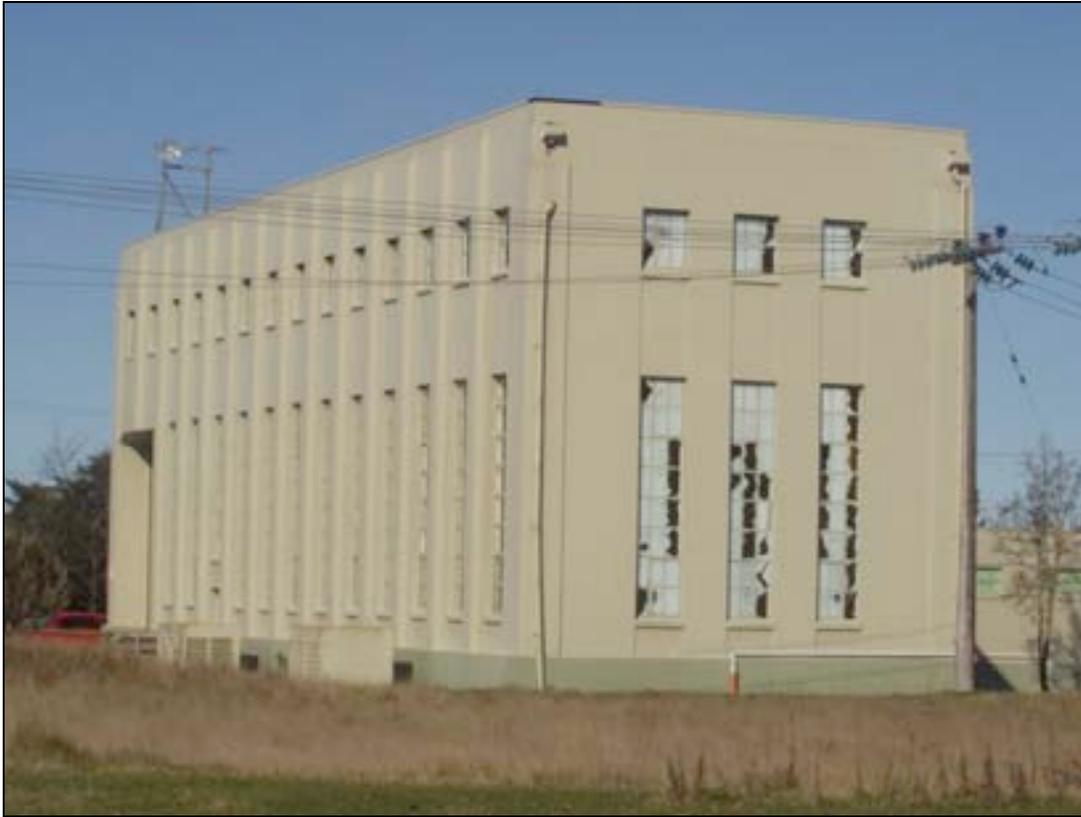
- Hororata: 8:23 am. Two transformers tripped due to vibration causing false operation of mercury switches in high pressure protective devices. (PGA between 0.3g and 0.7g). Older style multi-level reinforced concrete building had broken windows, Figure 4-14. Three spare (unanchored, in process of relocation) current transformers toppled, Figure 4-15. A desk collapsed. Florescent lights on chains, hanging from the ceiling, became loose; florescent tubes fell out. Some data cable tray tie rods ripped out of the ceiling. Lightning poles swayed and loosened their foundations.

Figure 4-14. Hororata Control Building

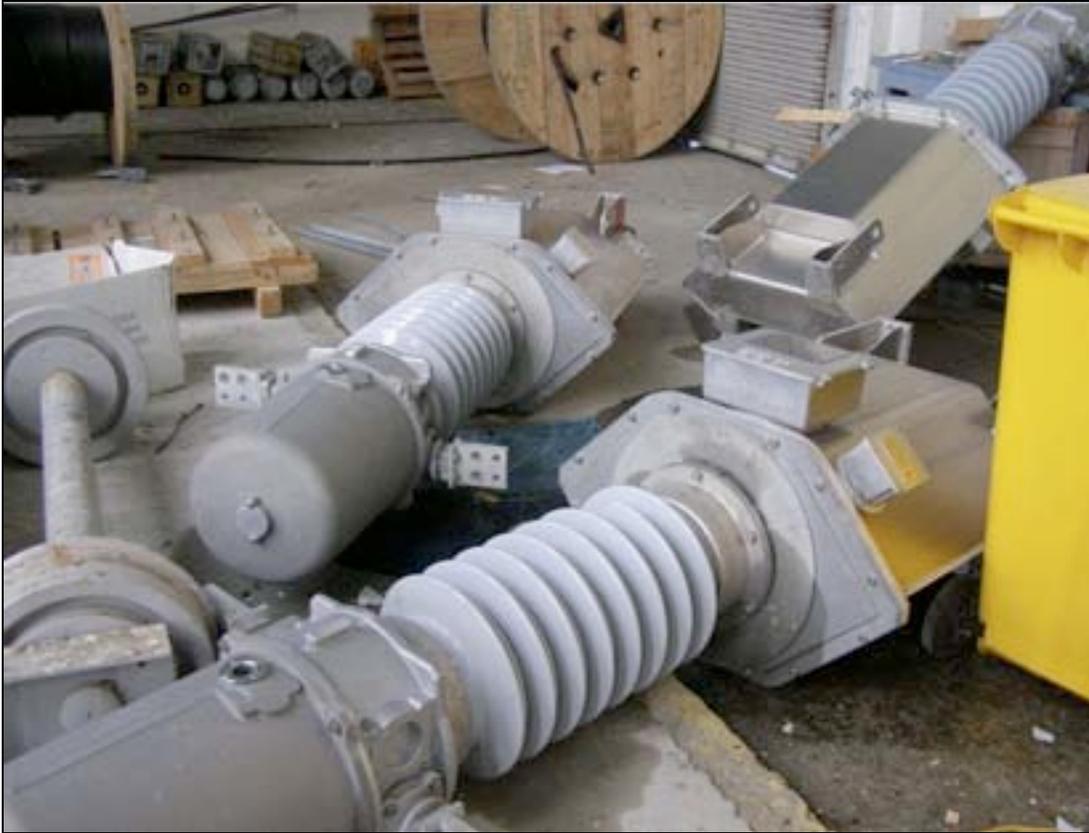
Figure 4-15. Hororata Toppled Current Transformers

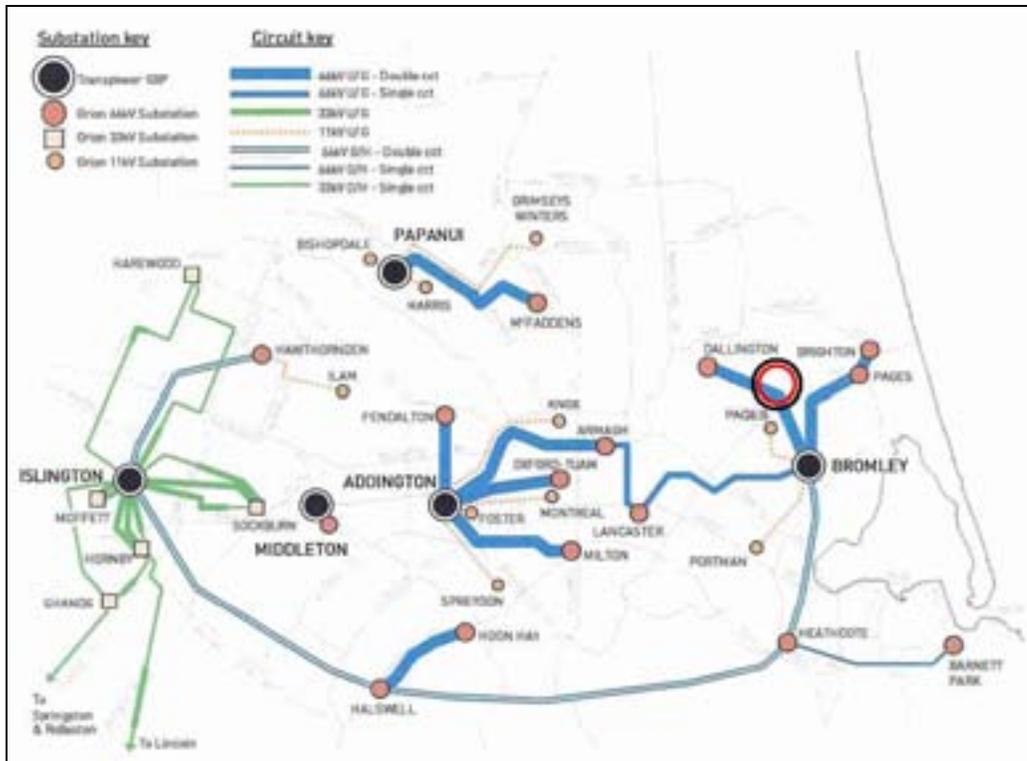
Figure 4-17 shows the main transmission lines of the Orion system. The circle shows the damage location on the Bromley-Dallington double circuit 66 kV lines (but they remained operable) due to settlement and lateral spread.

Figure 4-17. Orion System (Damage Location to 66 kV Circled, September 2010)

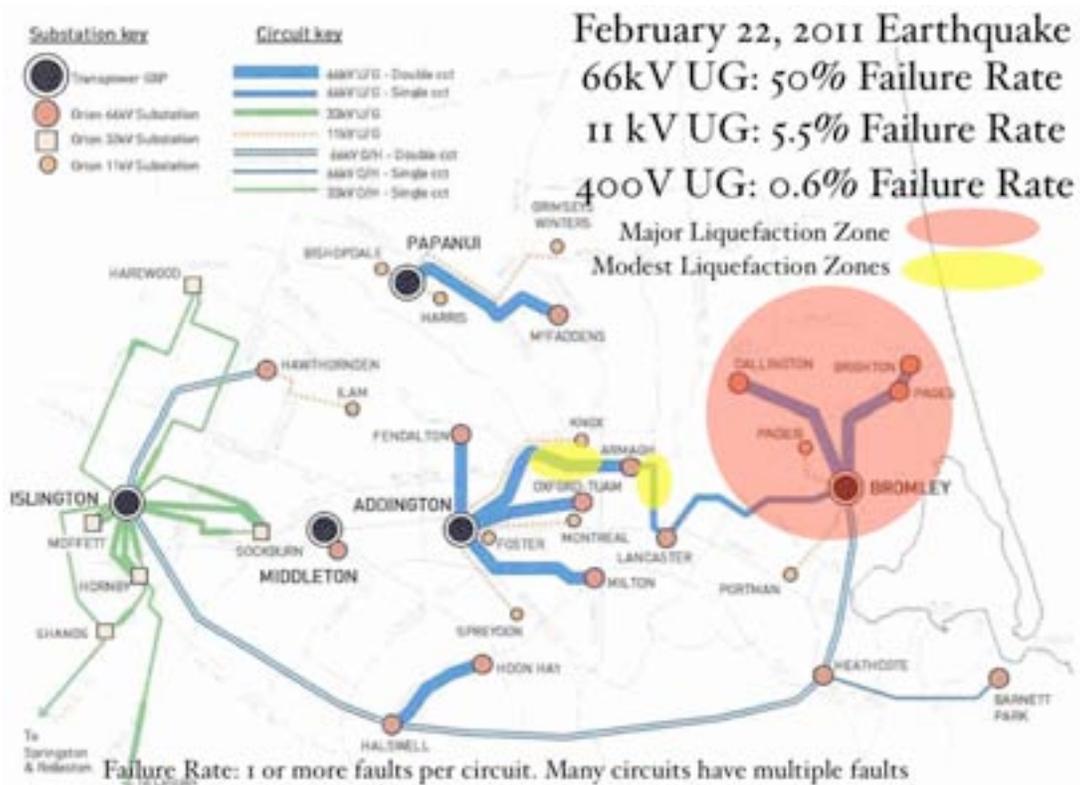
Figure 4-18 shows the damage trends for buried circuits due to the February 22 2011 earthquake. In the areas highlighted by the red circle (major liquefaction), the 66 kV buried circuits were abandoned as the buried cables were damaged at multiple locations. In the areas highlighted by the yellow circles (moderate liquefaction), the 66 kV buried circuits were repaired at six locations (Eidinger, 2012).

Figure 4-18. Orion System (Damage 66 kV Circuits, February 2011)

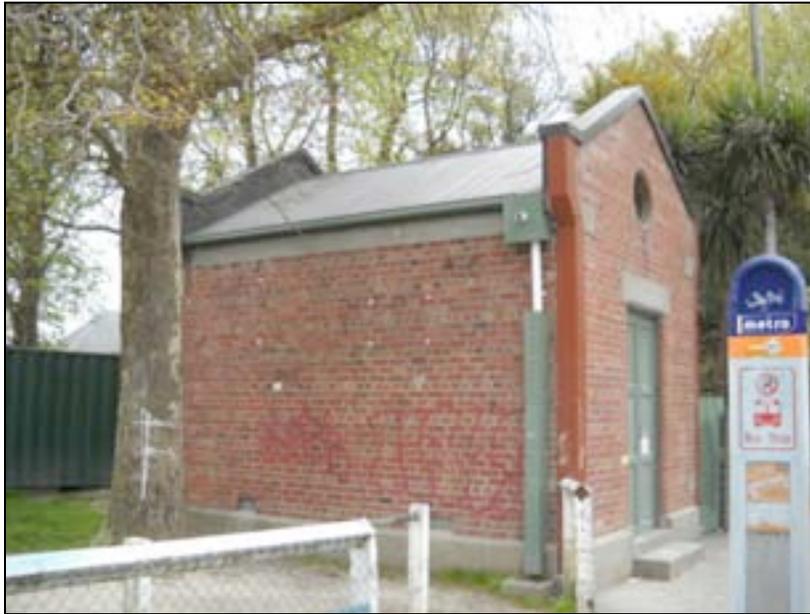
Figure 4-19 shows one of Orion's seismically upgraded small URM substations. Note the steel supports outside the building that had been installed as part of the seismic upgrades instituted over the prior years. Figure 4-20 shows another URM and non-retrofitted building; instead of upgrading this building, Orion abandoned it; the amount of damage observed is common to that observed at other URM buildings in Christchurch.

Figure 4-19. Orion URM Upgraded Small Substation

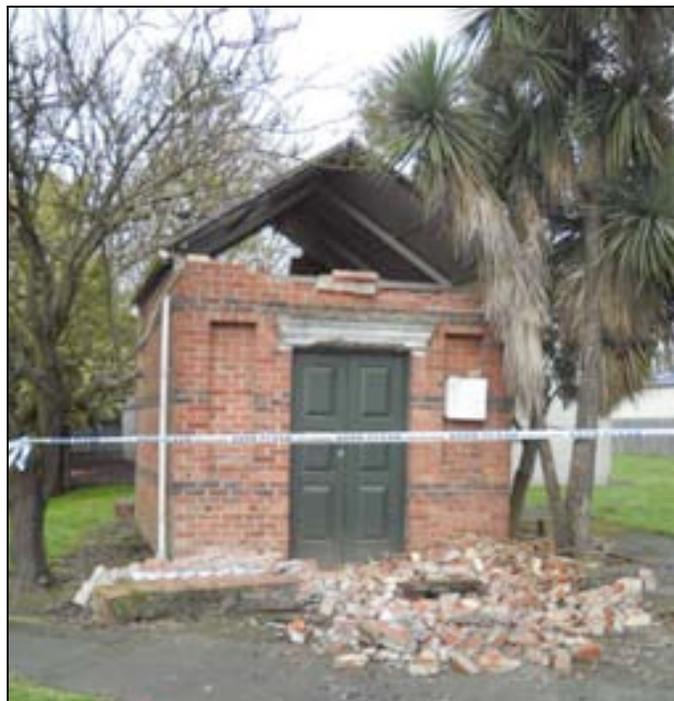
Figure 4-20. Orion URM Non-Upgraded Former Small Substation

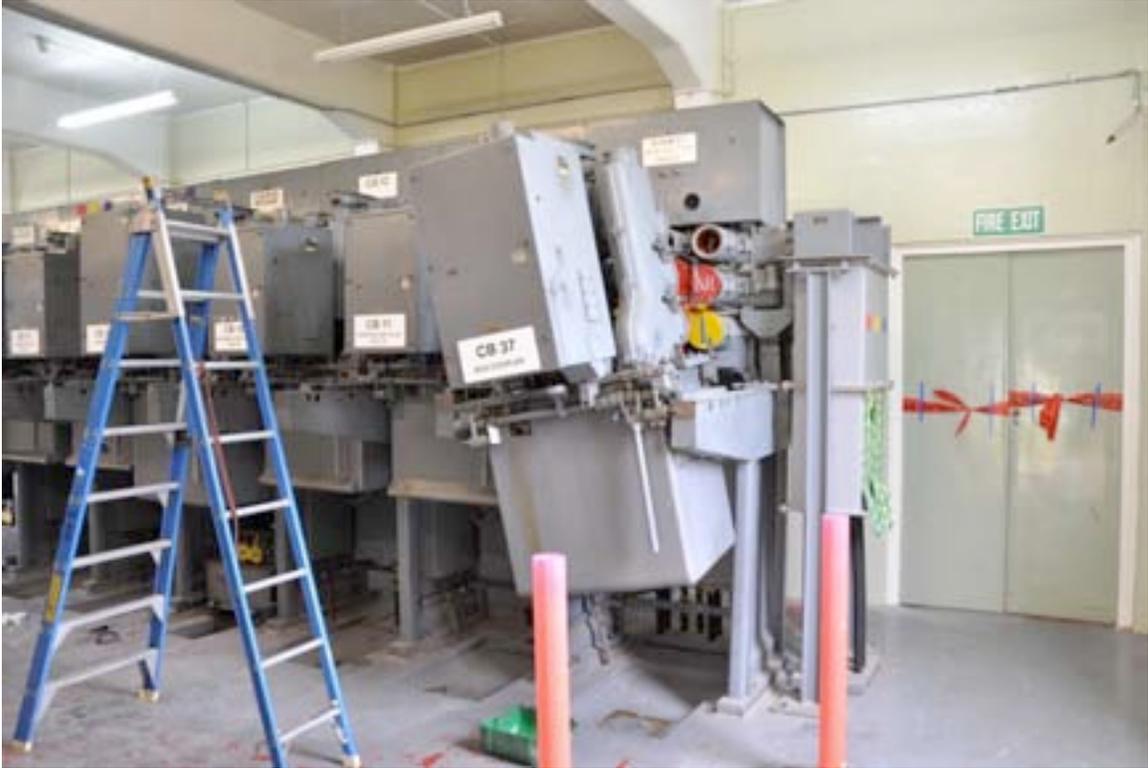
The control building contains low voltage switchgear. The circuit breaker (#37) for one position had been put into its "not-in-service" position prior to the earthquake. During the earthquake, its heavy eccentric mass caused it to partially topple (Figure 4-25). Figure 4-26 shows that the steel support frame for this breaker cracked; anchorage to the concrete floor for all units showed distress (concrete spalling). Transpower responded by installing supplementary bracing for all breakers; with the long term plan to replace all the breakers with modern equipment.

Figure 4-25. Toppled Circuit Breaker at Bromley Substation

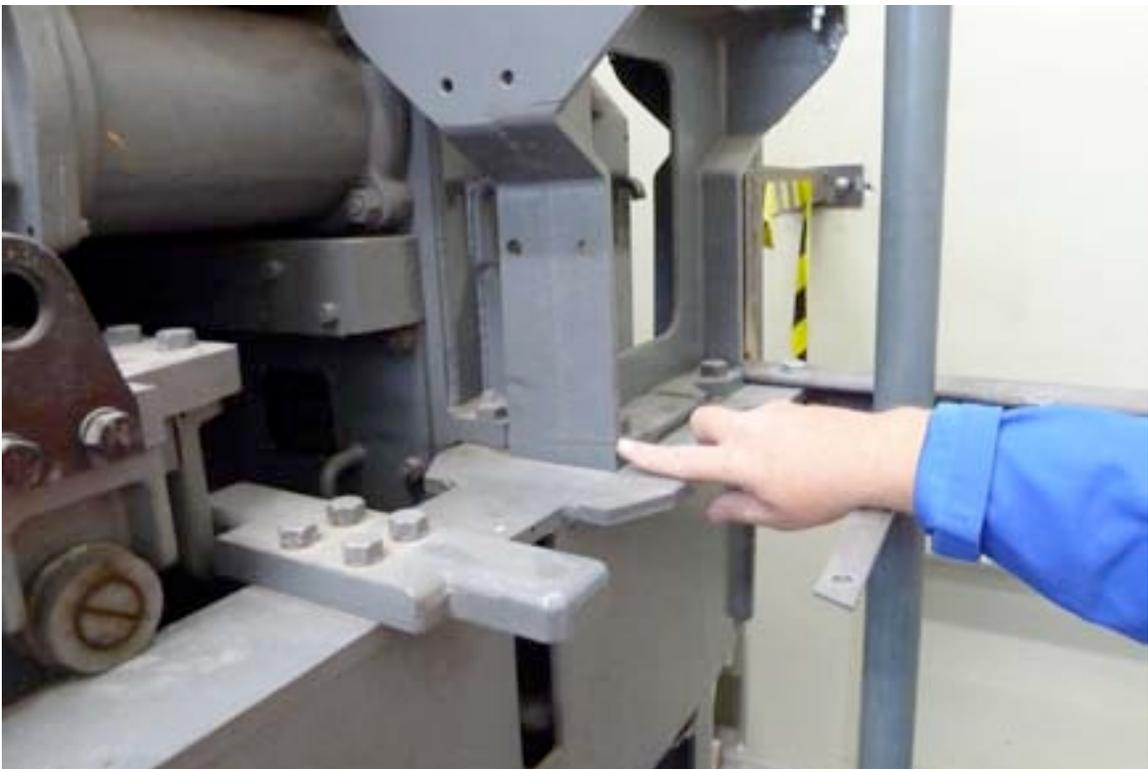
Figure 4-26. Cracked Steel Frame for Circuit Breaker 37, Bromley Substation

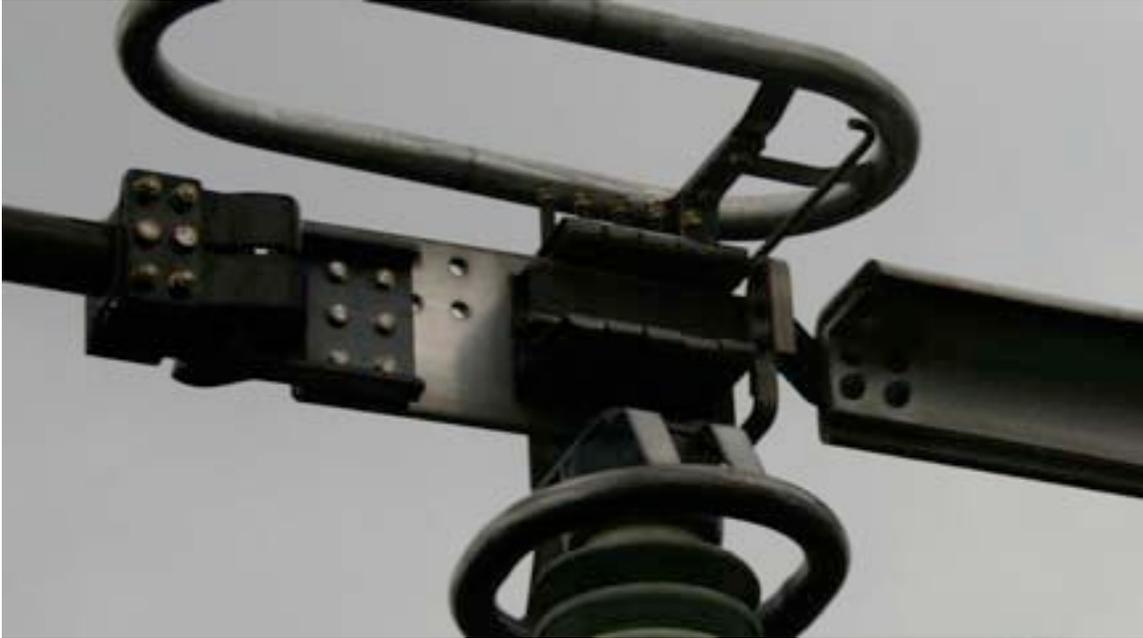
One of the disconnect switches (Figure 4-31) showed a 1 cm displacement in one of its contacts.

Figure 4-31. A disconnect switch with a 1cm offset in its contact.

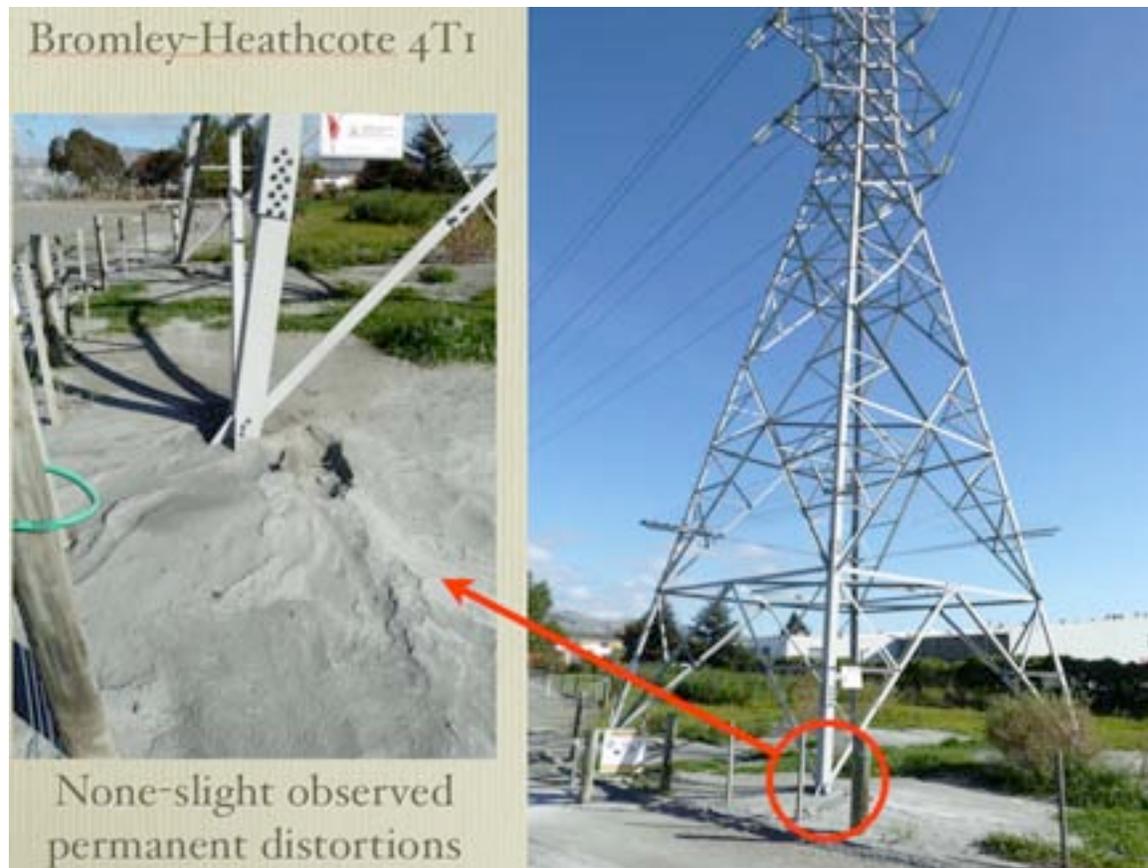
Many 220 kV towers were in zones with liquefaction (Figures 4-33, 4-34). While evidence of sand boils (commonly 4" to 12" deep) were observed on a variety of towers, it was reported that some (all?) of the 220 kV towers had been upgraded by tying-together their four foundations; there was no lateral spreading observed at these locations; the tower members appeared to remain elastic. On an adjacent 66 kV tower that did not have the foundations tied together, the liquefaction allowed relative movement of a leg, with attendant buckling of secondary members; but the tower remained in service.

Figure 4-34. Liquefaction at 66 kV Transmission Tower

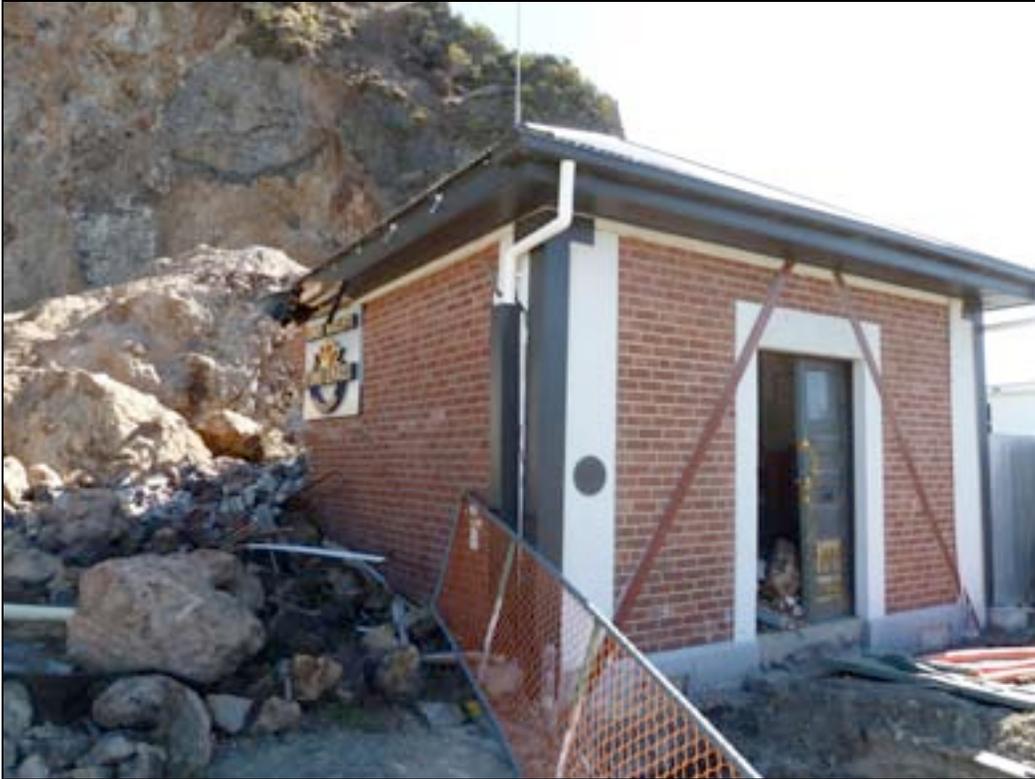
In Sumner (eastern Christchurch at the base of the Port Hills), there was a considerable amount of rock falls. One of the small distribution substation was directly impacted, resulting in the total loss of the substation, see Figures 4-35 and 4-36. This URM facility had been seismically upgraded prior to the earthquake, but evidently earthquake-triggered avalanche landslide was not considered as a hazard. Figure 4-37 shows the damaged switchgear within this substation.

Figure 4-36. Substation Impacted by Rock Fall (Sumner Redcliffs Area) Feb 22 2011

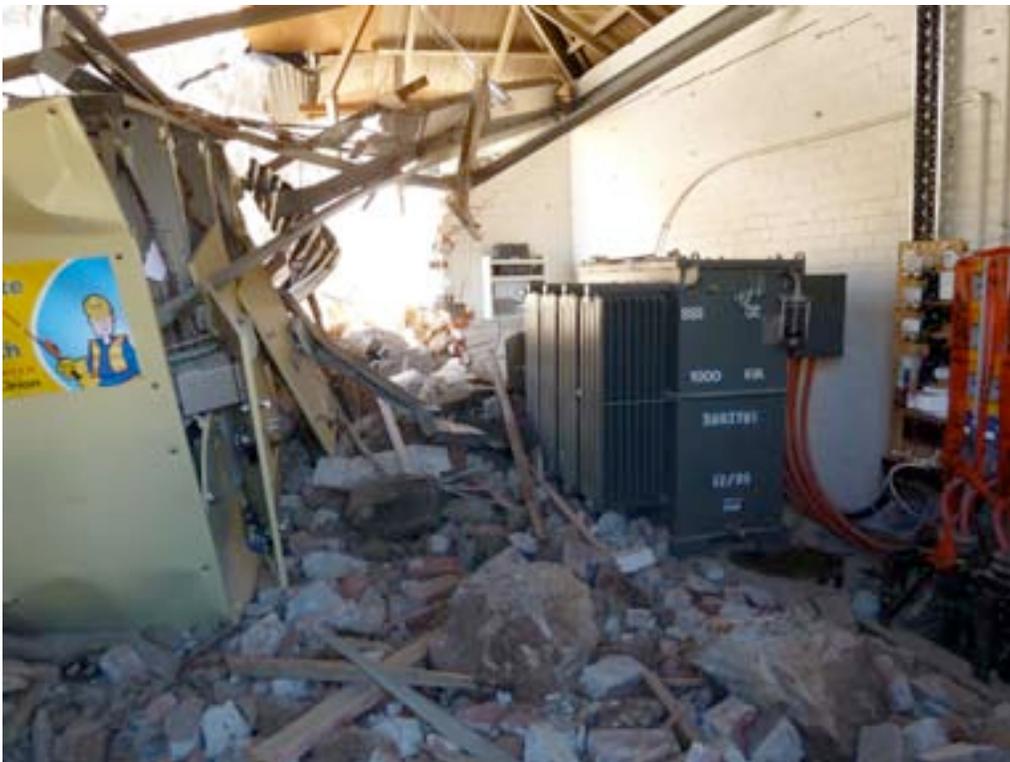
Figure 4-37. Damaged Switchgear Within Avalanche-Impacted Substation

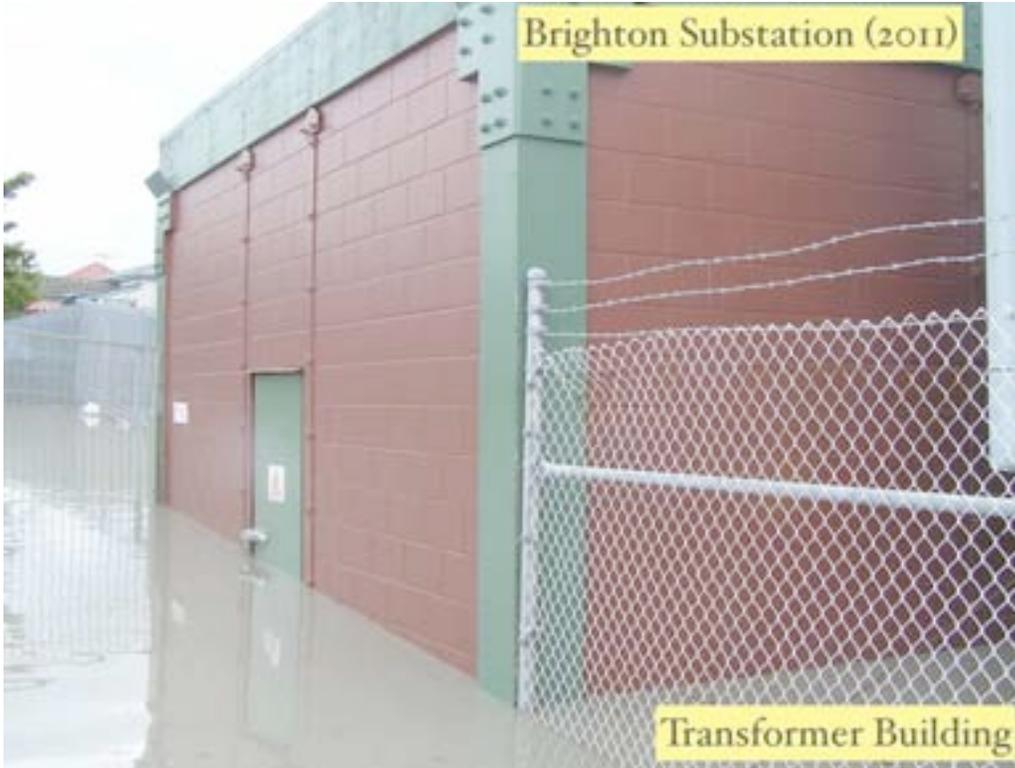
Figures 4-38 (September 2010) and 4-39 to 4-41 (February 2011) show the effects of liquefaction at the Brighton substation. While there are sand boils apparent in the 2010 event, facility remained functional. In the February 2011 event, the liquefaction was more severe, resulting in a loss of bearing capacity and several feet of settlement and tilting of the building. The water seen in Figure 4-39 is just a couple of inches deep; under the water are a few feet of silts and sands. Figures 4-40 and 4-41 show the transformer building and adjacent radiators after the water drained and the soils were dug out. While the door held leak tight, the tilting of the foundation led to complete functional failure, requiring a brand new substation to be built. Similar liquefaction-induced foundation failures and tilting of the building occurred at the New Brighton substation.

Figure 4-39. Liquefaction at Brighton Substation, Feb 22 2011

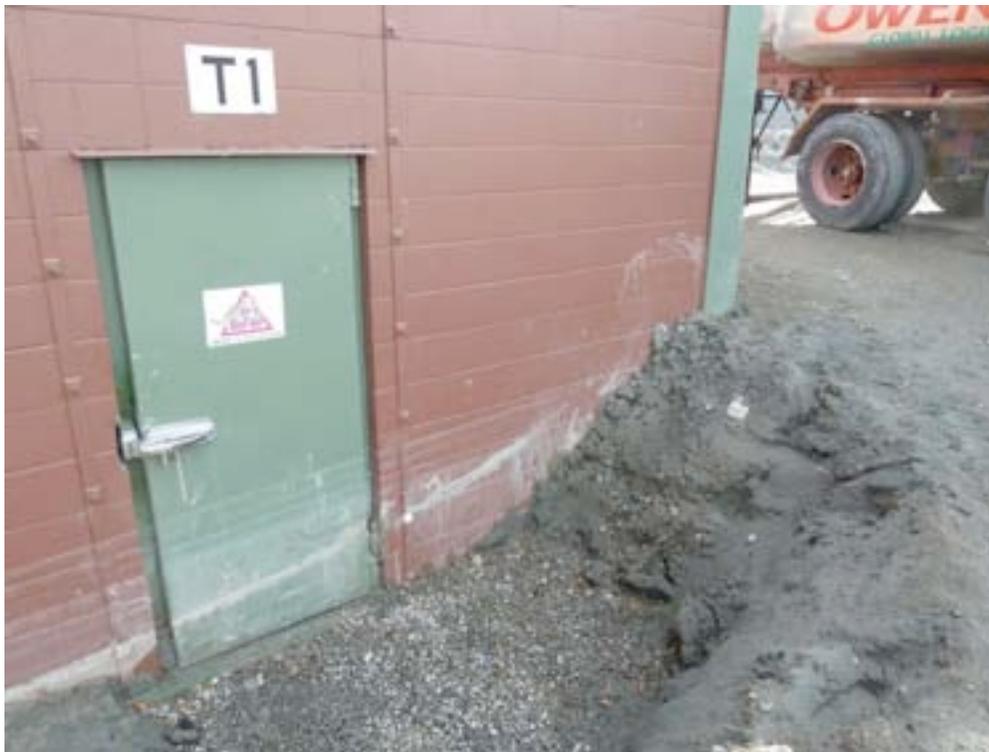
Figure 4-40. Liquefaction at Brighton Substation, Feb 22 2011

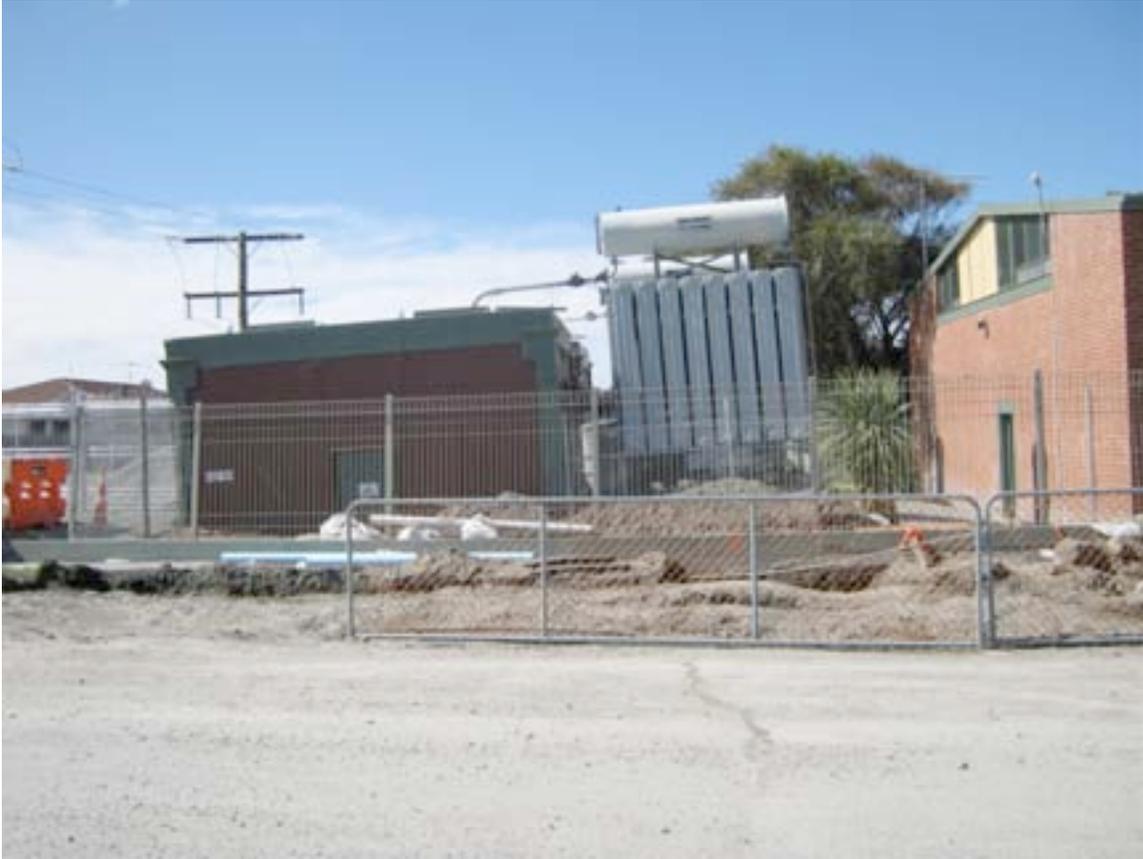
Figure 4-41. Liquefaction at New Brighton Substation, Feb 22 2011

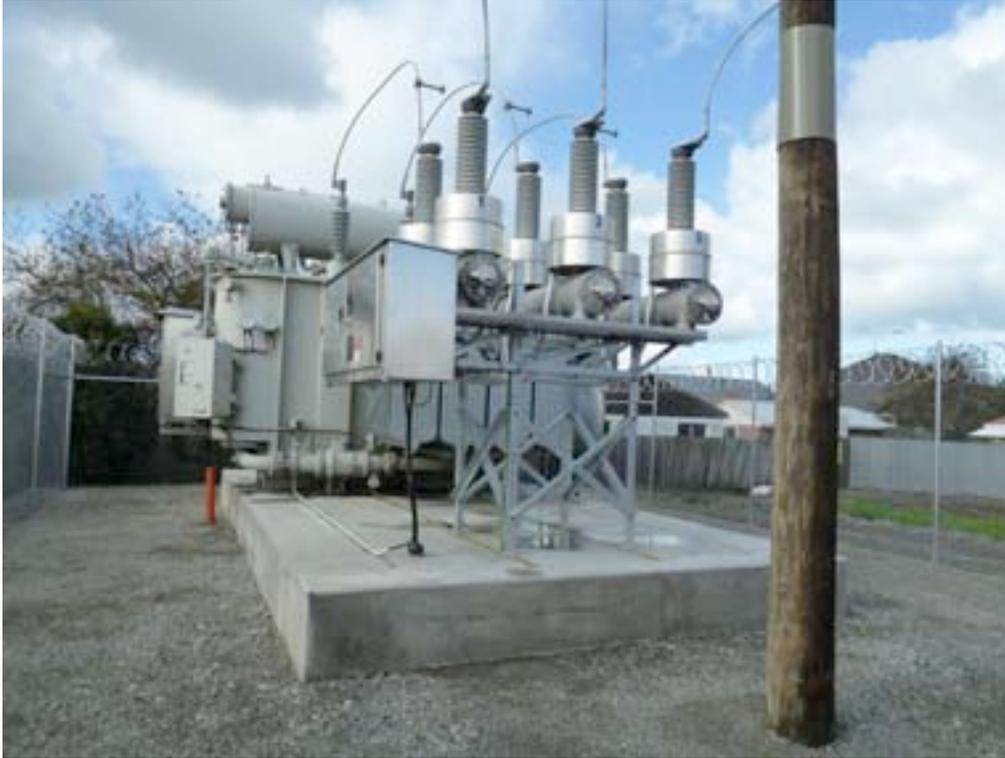
Figure 4-42. Temporary transformer installed after the Feb 22 2011 earthquake in order to restore service to the New Brighton Substation area.

A transformer and circuit breaker (Figure 4-42) were rapidly installed (about five days in a design-build effort) on site in order to restore service until the substation could be rebuilt. A new provisional 66 kV line running from Bromley Substation was also necessary to restore service. This line is shown in Figure 4-43 in the vicinity of Bromley Substation. This temporary installation settled about 50 mm in the June 2011 earthquake, but remained functional.

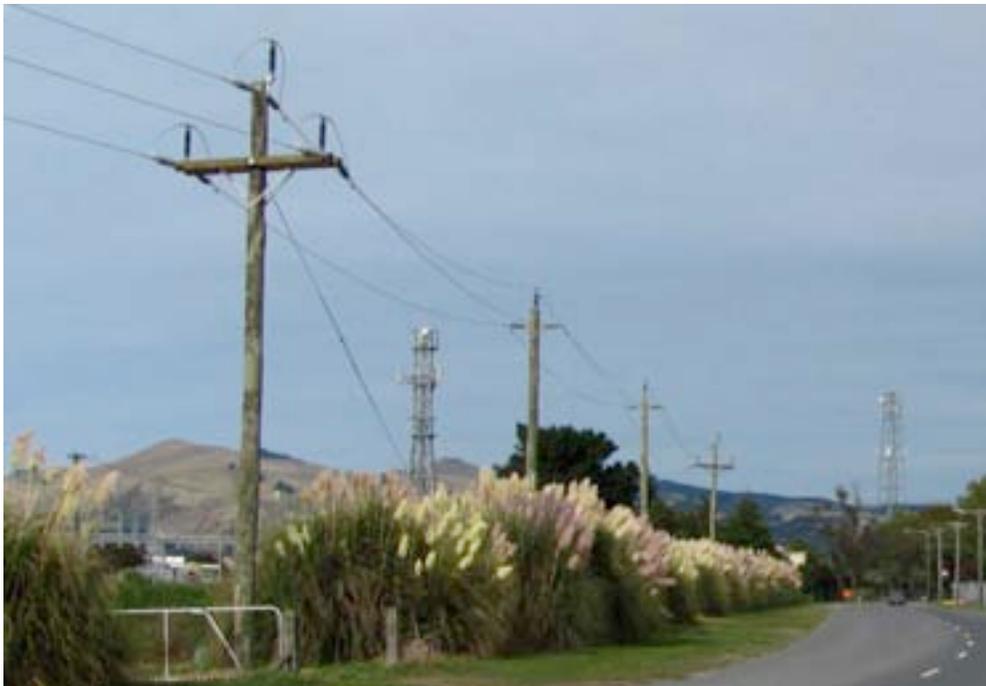
Figure 4-43. A temporary 66 kV line installed after the Feb 22 2011 and running from Bromley Substation (seen on the background behind the white gates on the left) and the temporary transformer shown in Figure 4-44.

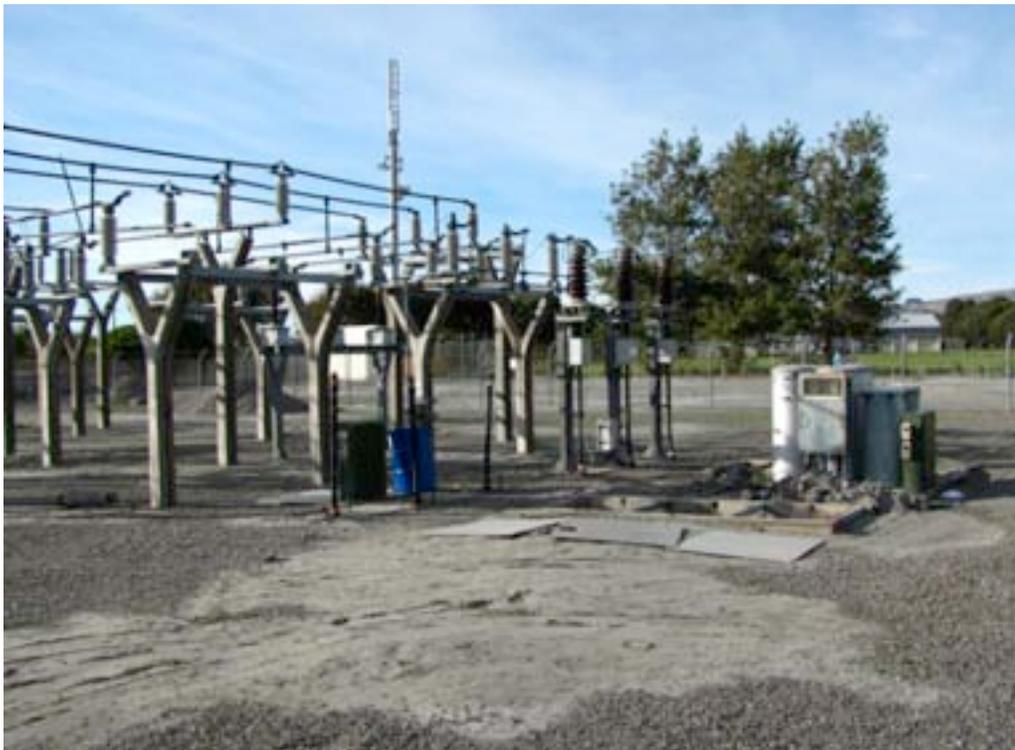
Figure 4-45. Pages Substation endings for the two 66 kV lines to Bromley Substation. A damaged bushing is observed on the left

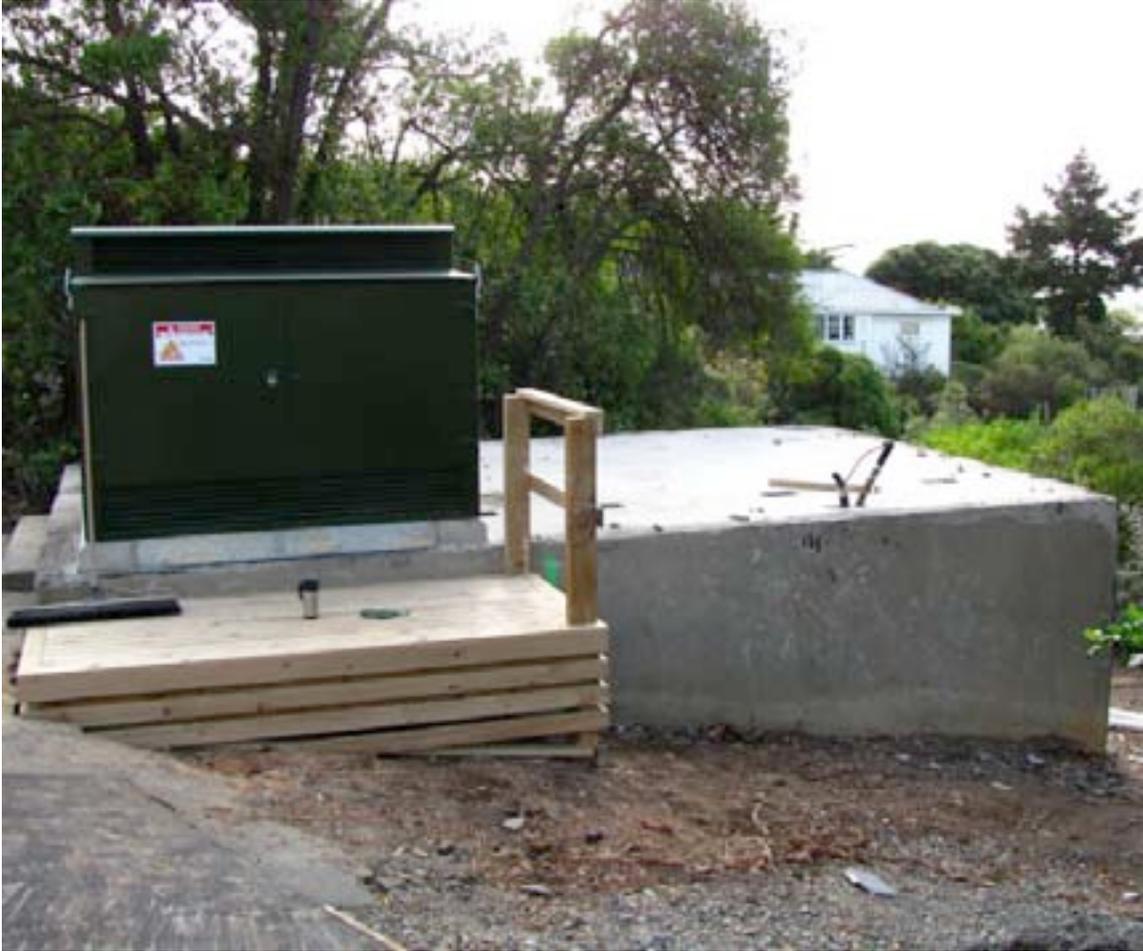
Figure 4-49. The pad-mounted transformer that replaced the one inside the substation in Figure 4-47.

Figure 4-47 shows one of the successfully-upgraded substation buildings in the Feb 2011 earthquake. Note the failure of the adjacent unreinforced masonry structure. One upgraded substation still failed due to inertial overload, Figure 4-48; ground motions at this site were likely well over $PGA = 0.5g$. This is the only URM substation (of 268) failure due to inertial overload in this event. Given that better than 99% of the similarly-upgraded URMs did withstand the inertial loadings, one might consider this an overall success, in that the cost savings of doing relatively modest URM upgrades were real; while the post-earthquake response needed to resolve one damaged (and normally unoccupied) URM was not too high. The building of the substation in Figure 4-48 was later demolished and the substation was replaced by the pad-mounted transformer in Figure 4-49.

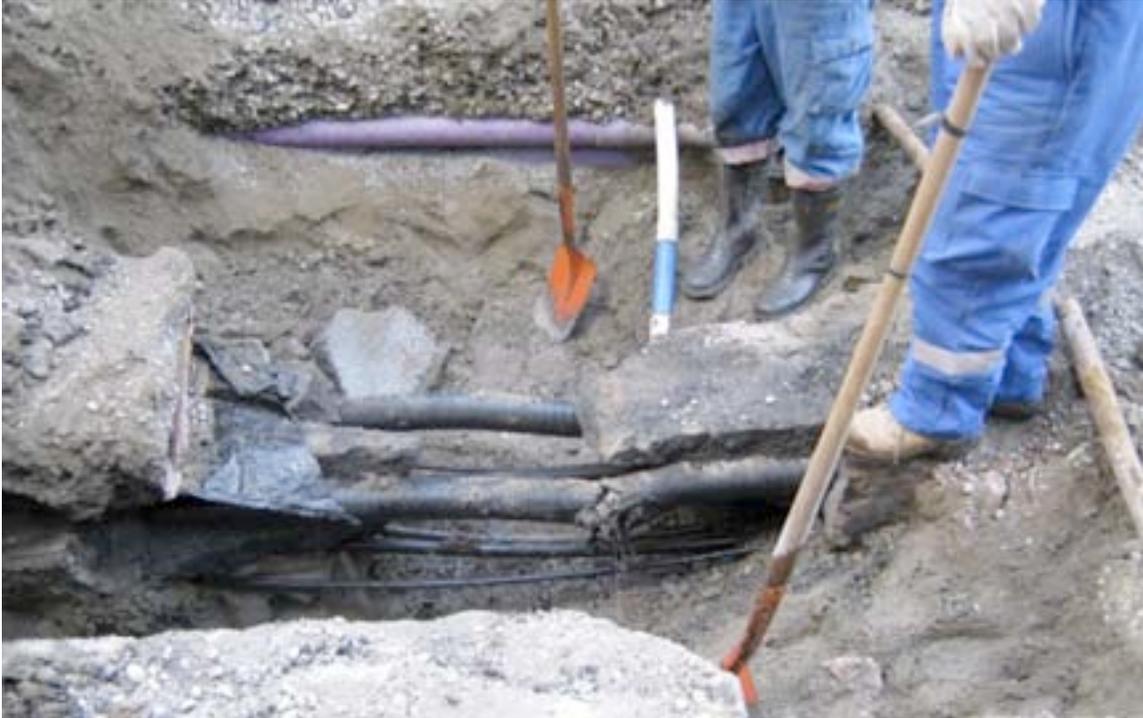
Figure 4-50 shows damage to a direct burial 11 kV cable. Figure 4-51 shows damage to two 66 kV pipe-type oil-filled cables in direct burial with thermal backfill. The lack of reinforcement allowed permanent ground deformations at this site to concentrate movement at a discontinuity of the thermal backfill; leading to high curvature and failure. Figure 4-52 shows damage to three 66 kV XLPE cables.

Figure 4-51. Failure of Two 66 kV Buried Oil-Filled Cables, Feb 22 2011

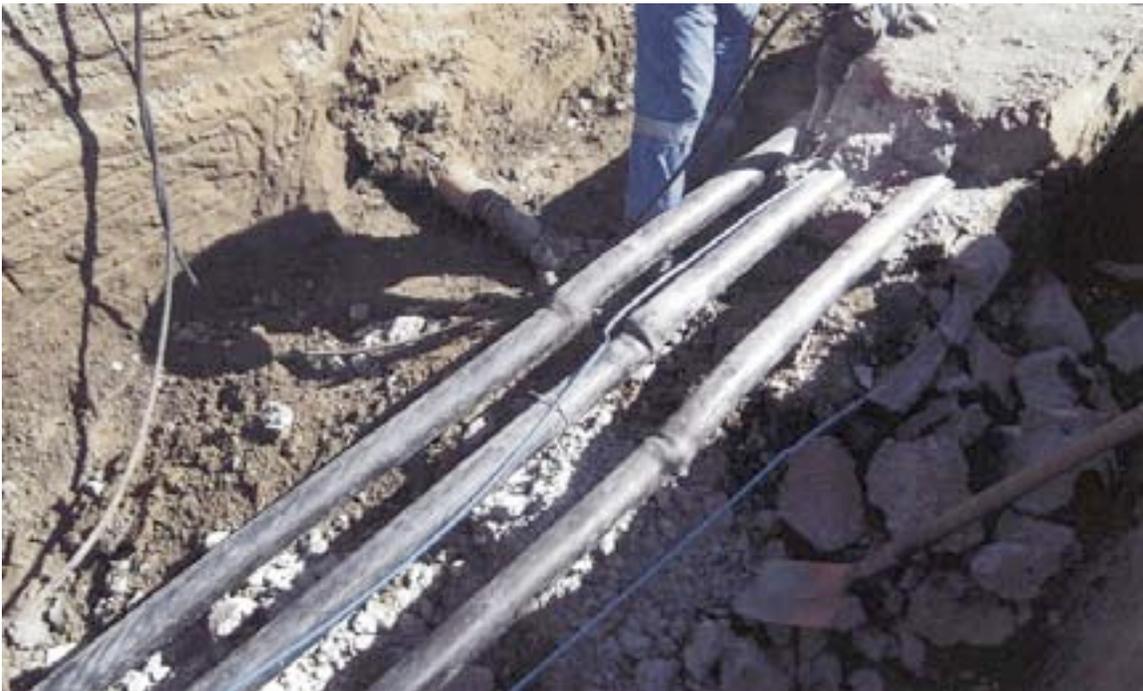
Figure 4-52. Failure of Three 66 kV Buried XLPE Cables, Feb 22 2011

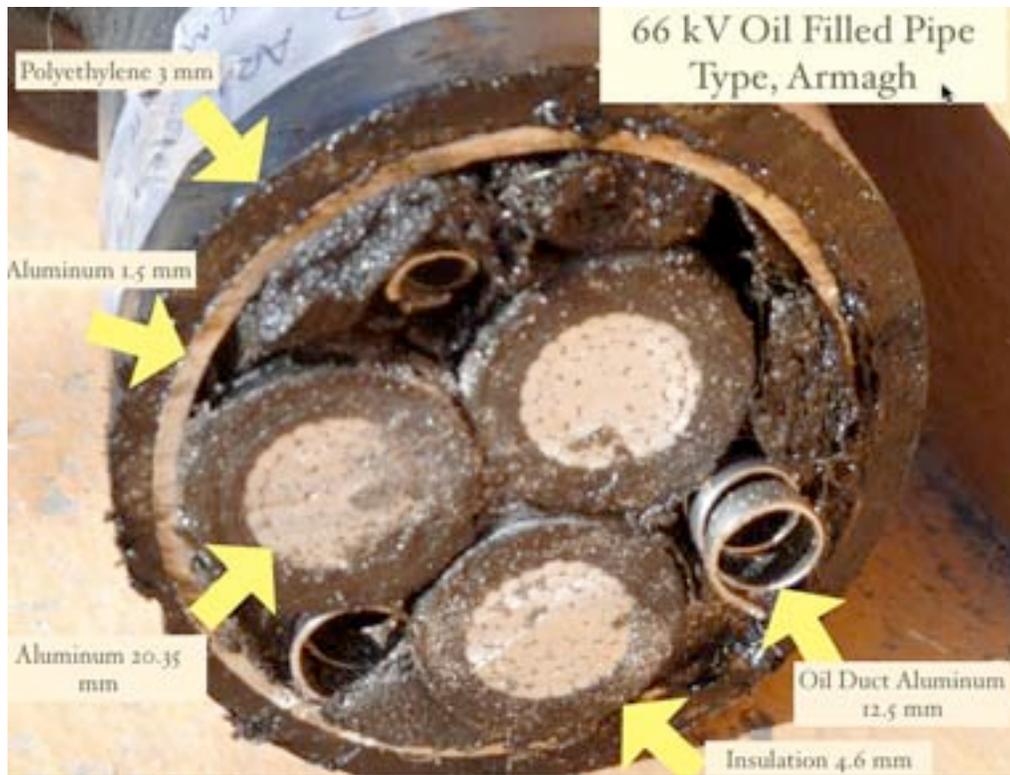
Figure 4-53 shows the cross section of the damaged 66 kV oil-filled pipe-type cable. Figure 4-54 shows the cross section of a damaged 66 kV XLPE-type cable.

Figure 4-53. Cross Section of 66 kV Buried Oil-Filled Cable
