CHRISTCHURCH, NEW ZEALAND EARTHQUAKE SEQUENCE OF M_w 7.1 September 04, 2010 M_w 6.3 February 22, 2011 M_w 6.0 June 13, 2011: LIFELINE PERFORMANCE

**Technical Council on Lifeline Earthquake Engineering
Monograph No. 40
February 2012 – Revision 0
ASCE**

ABSTRACT

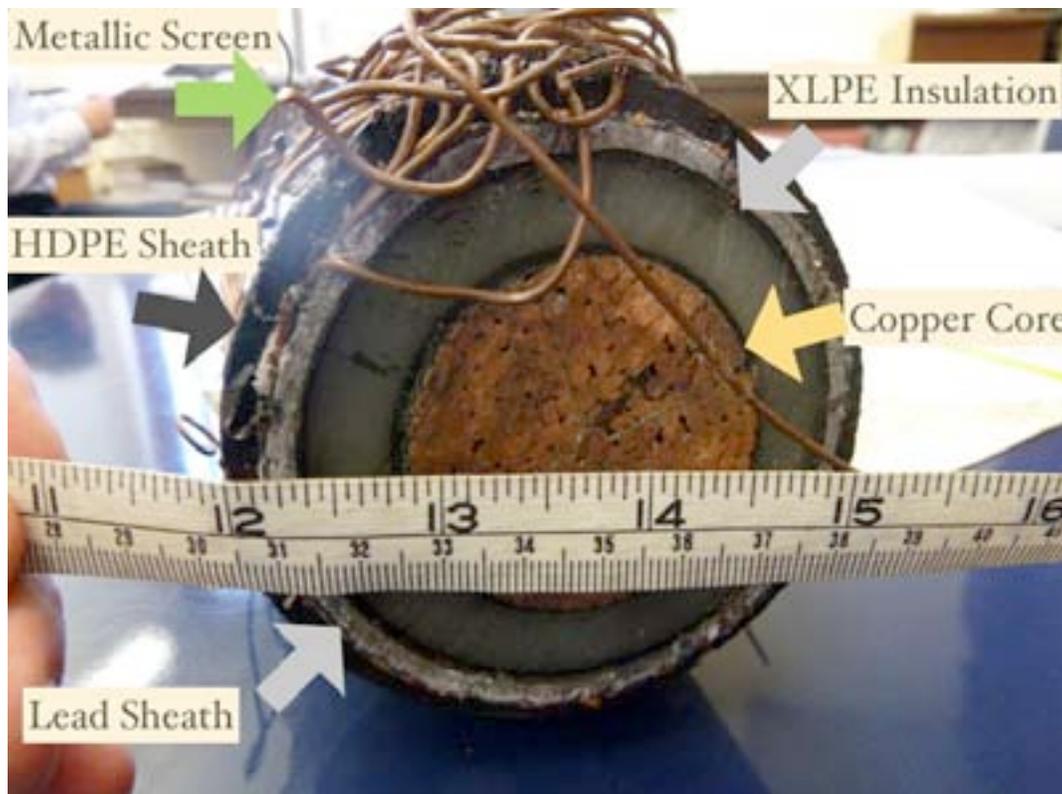
Figure 4-53 shows the cross section of the damaged 66 kV oil-filled pipe-type cable. Figure 4-54 shows the cross section of a damaged 66 kV XLPE-type cable.

Figure 4-54. Cross Section of 66 kV Buried XLPE Cable (Scale is inches / cm)

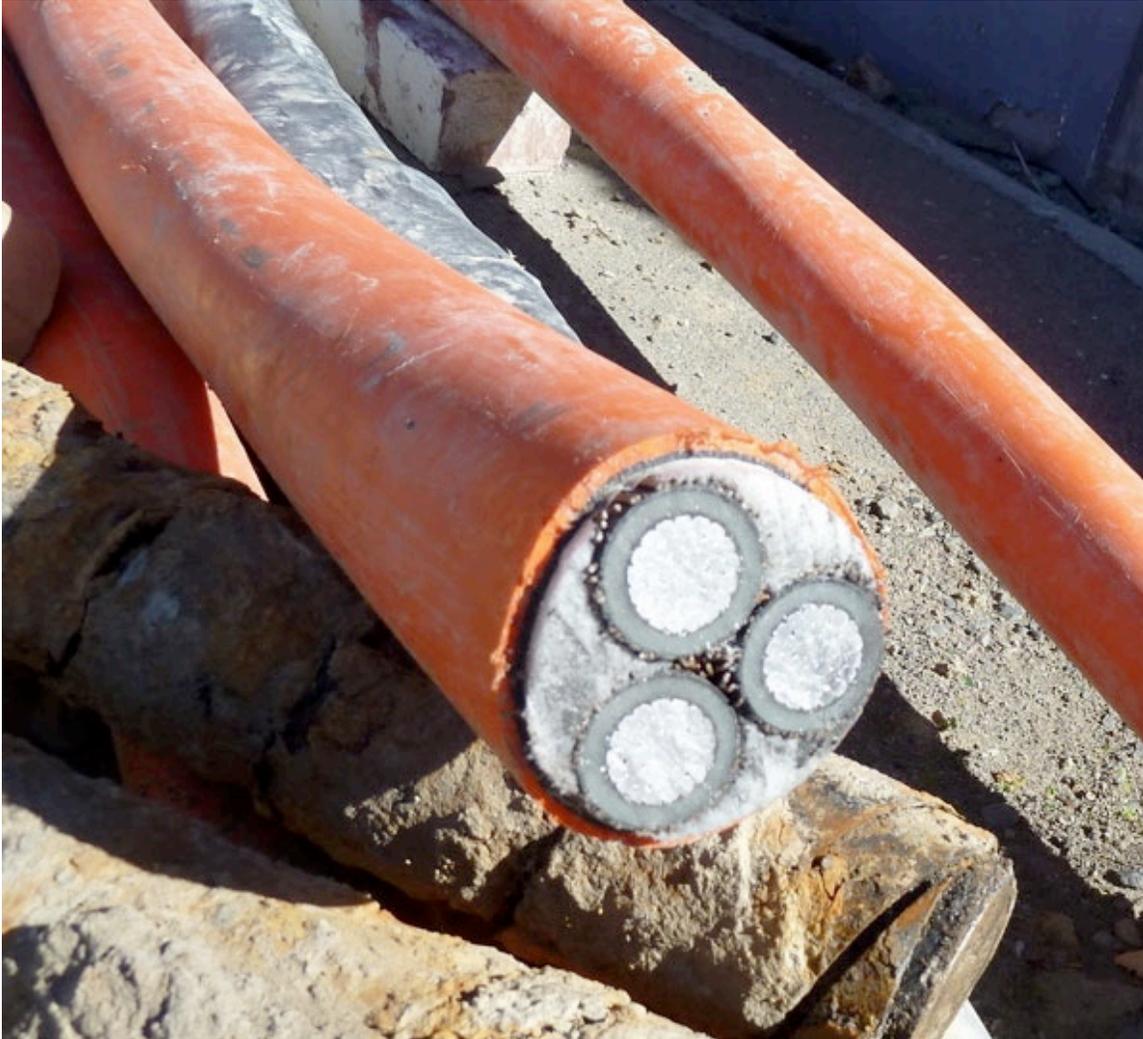
Figure 4-55. Cross Section of 11 kV Buried Cable

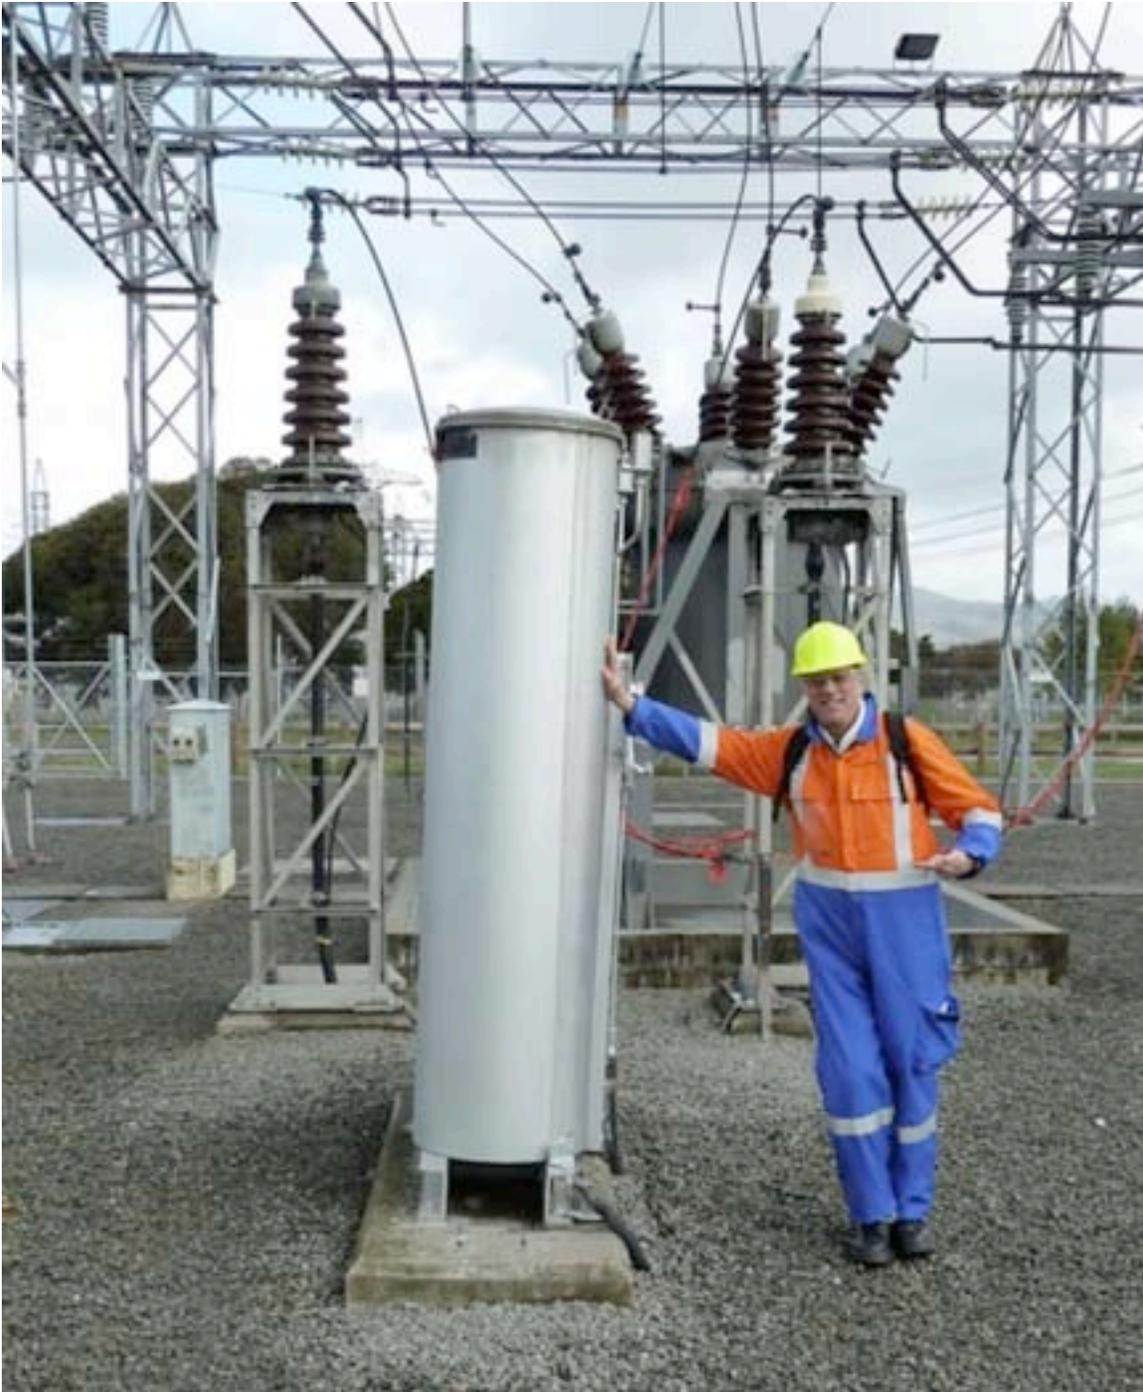
Figure 4-56 shows the oil tank for the Dallington No. 2 cable. The tilted tank is evidence of the liquefaction at the Bromley substation site; but more importantly, the tank pressure gage reads 0 psi (0 kPa), reflecting that the pipe-type cable has failed.

Figure 4-56. Oil Tank at Bromley Substation for Dallington No. 2 66 kV Cable.

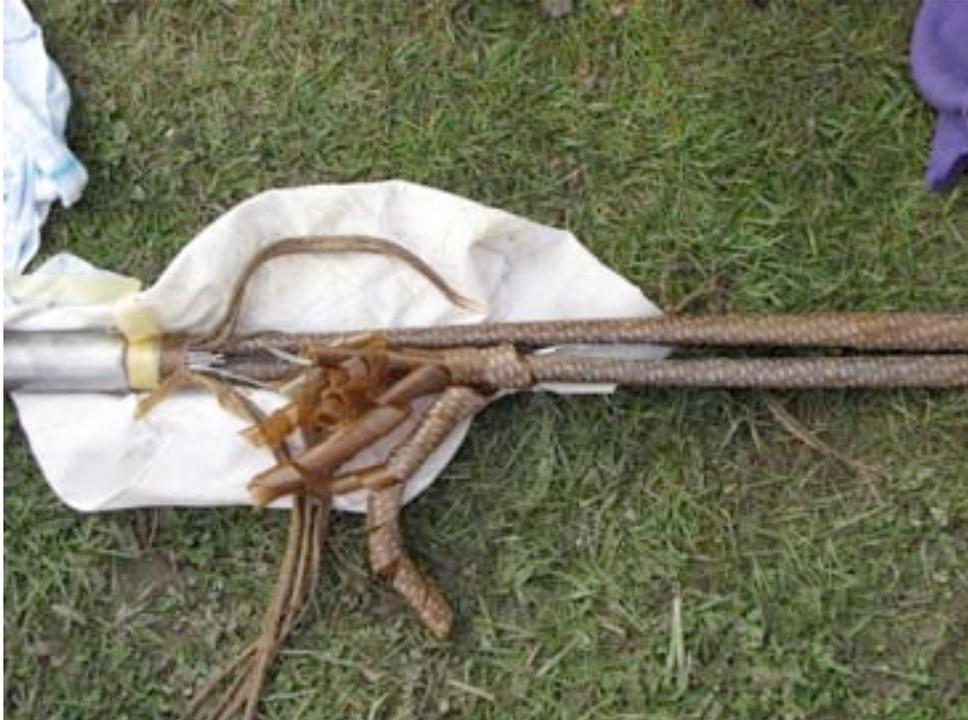
Figure 4-60 shows a damaged distribution cable in Kaiapoi. Figure 4-61 shows the buckling of power and other cables out of a cable tray that crosses a small creek in Kaiapoi; the banks of the creek showed a lateral spread.

Figure 4-60. Damaged Distribution Cable – Kaiapoi – Sept 2010

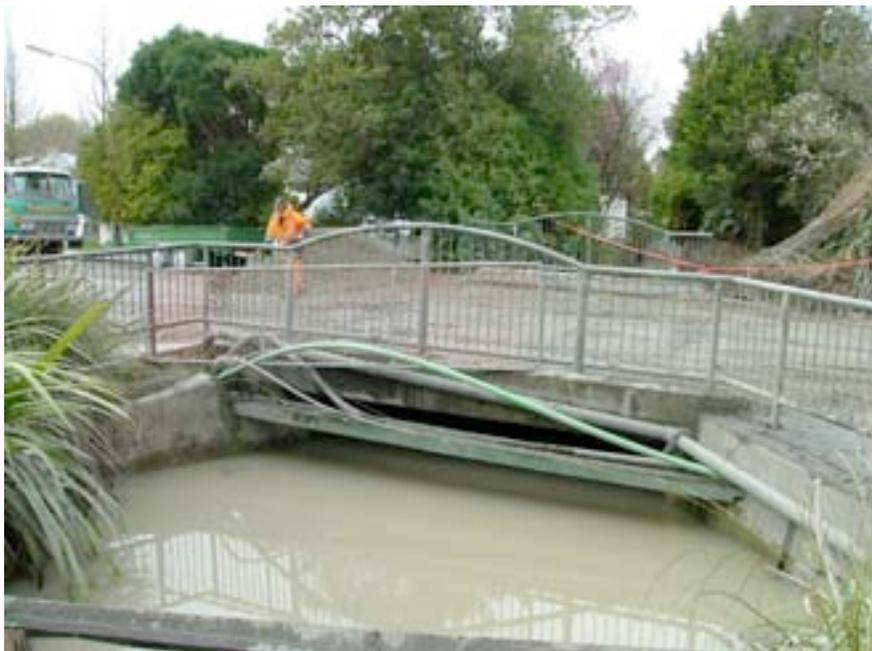
Figure 4-61. Buckled Distribution Cables – Kaiapoi – Sept 2010

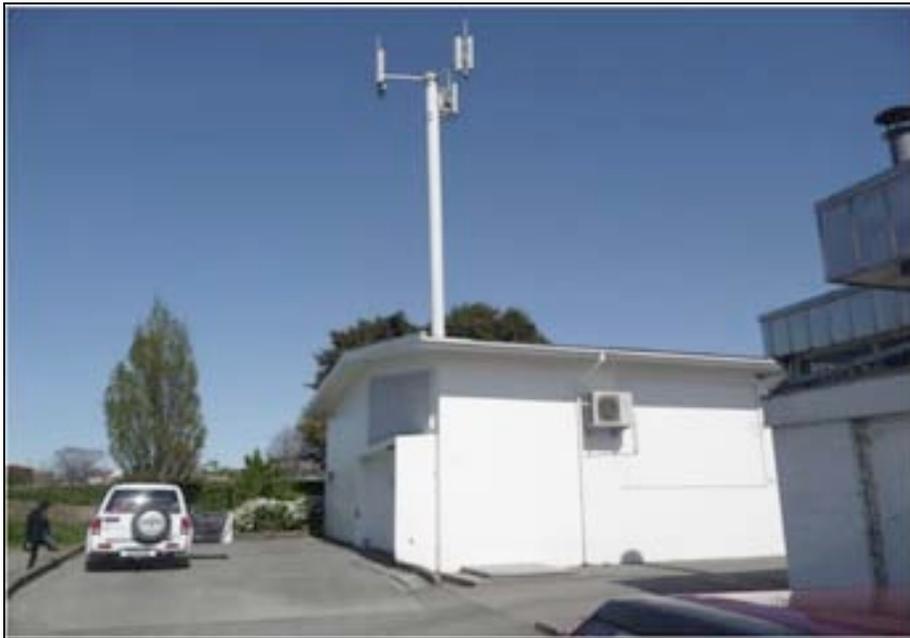
At Kaiapoi Exchange the antenna tower of the cellular network had a 1° to 2° slant from vertical due to ground slumping, Figure 5-1. Operation was not affected. The fix will be determined later. The antenna tower at Gailbraith Mobile site had 5° lean, Figure 5-2. Again, operations were not affected. Two cable guided antenna towers had slack guide cables, most likely the anchor points were affected by ground deformation. The towers were not in danger of collapsing and the sites remained operational.

Figure 5-1. Kaiapoi Exchange Antenna tower slant about 1° to 2° (Courtesy Telecom New Zealand)

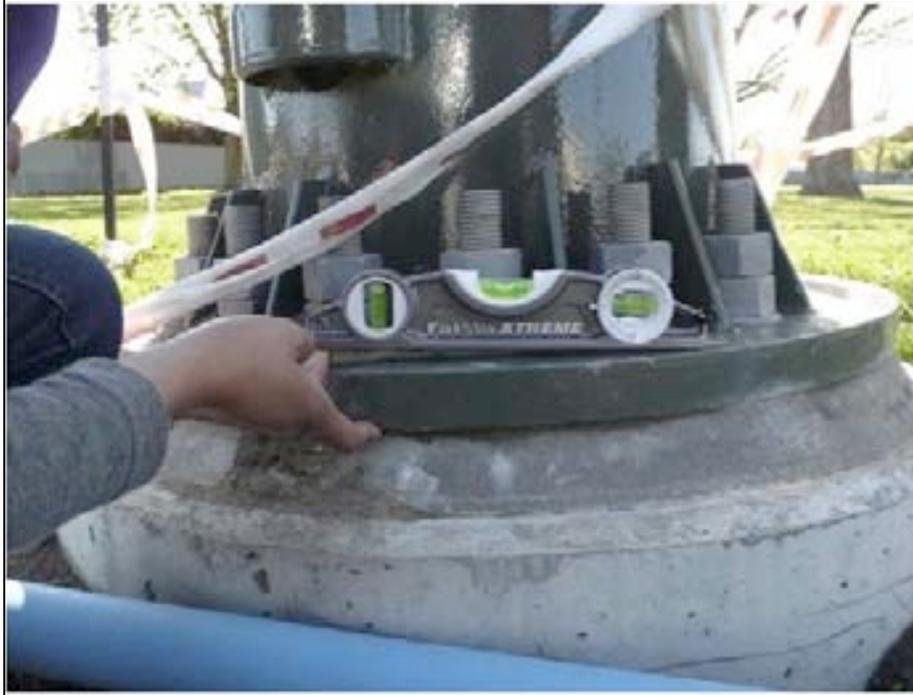
Figure 5-2. Antenna tower base at Gailbraith Exchange rotated 5° (Courtesy Telecom New Zealand)

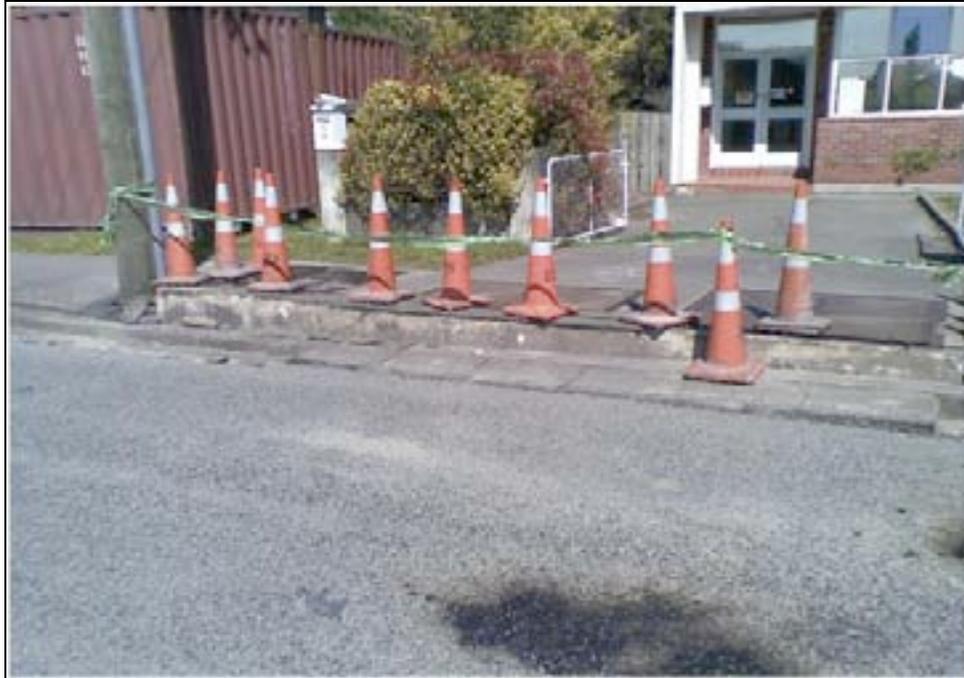
*Figure 5-6. Halswell Exchange, the underground fuel tank was raised due to liquefaction
(Courtesy of Telecom New Zealand)*

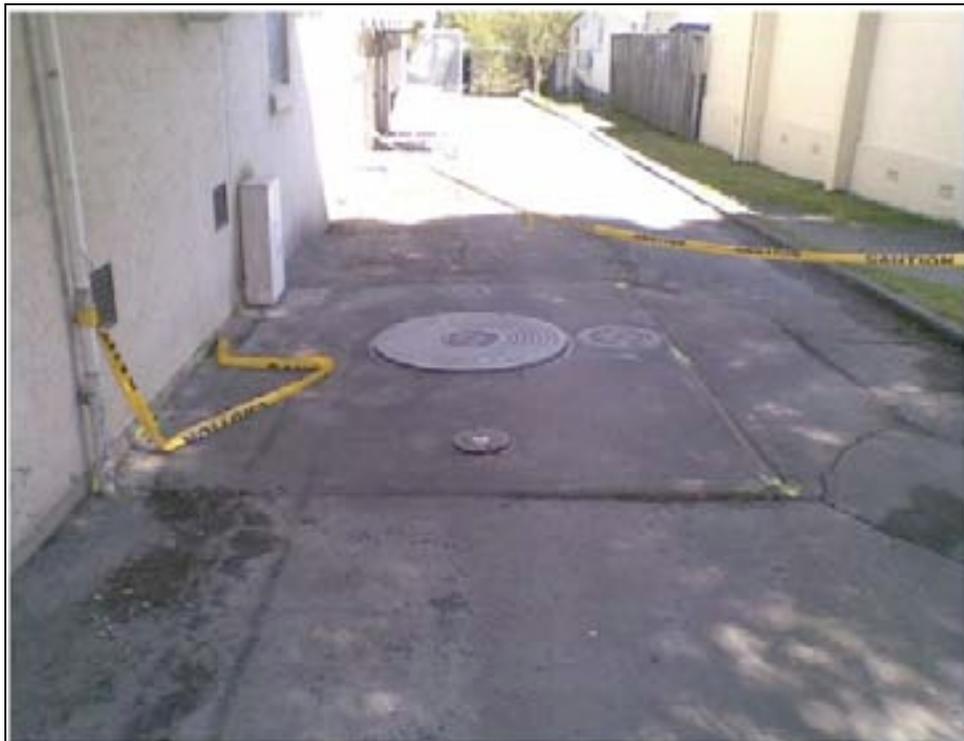
*Figure 5-7. The manhole outside Halswell Exchange was also raised due to liquefaction
(Courtesy of Telecom New Zealand)*

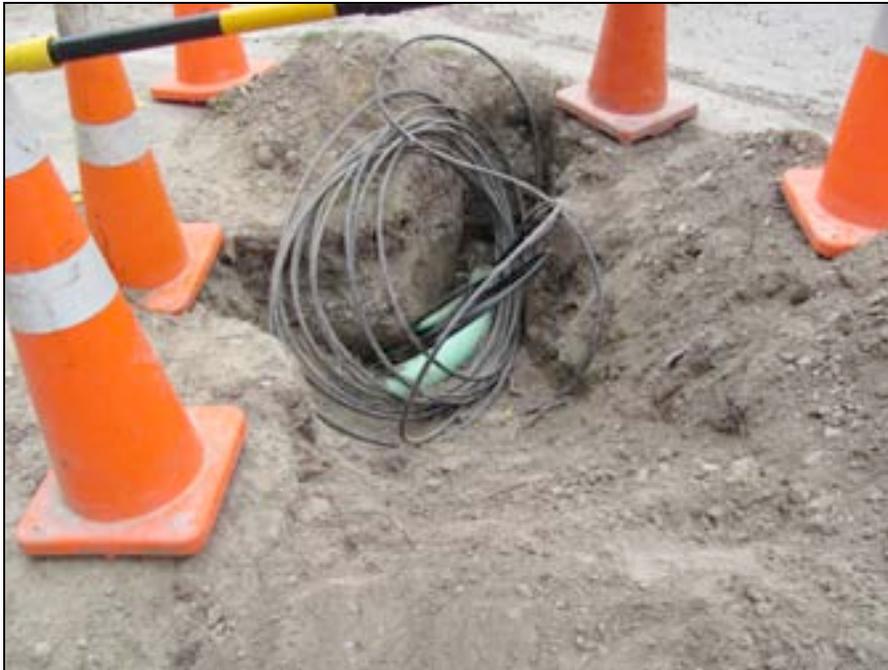
Cable fault level was back to normal within a week after the earthquake. However, underground cable upgrades in Christchurch and the vicinity were still on going as of October 2010, Figures 5-8 and 5-9. The underground cable repair shown in Figure 5-8 was located in Christchurch where significant liquefaction occurred. The cable repair shown in Figure 5-9 was located at the intersection of Charles St and Jones St in Kaiapoi. It is on the west side of Charles St, the coordinates are 43.3838°S, and 172.6603°W. This location is very close to the riverbank and liquefaction occurred in this area. In both cases the plastic conduits are used for routing optical fiber cables. Telecom is aware that more cable faults will be showing up.

Figure 5-8. In Christchurch, contractor was routing optical fiber cable to repair cable damage in this area.

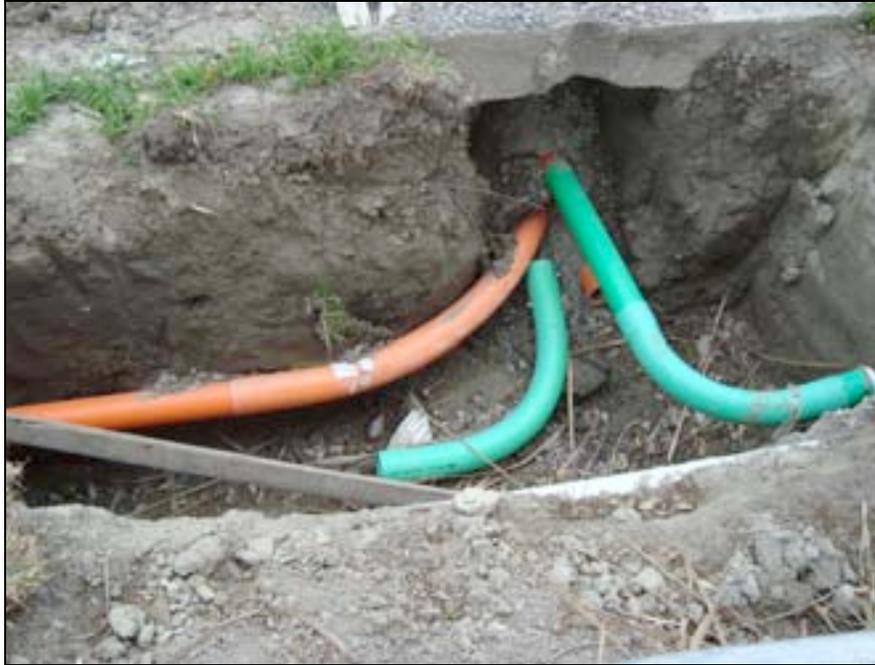
Figure 5-9. Under ground telecommunication cables repair, plastic ducts were used in this area northeast of Christchurch.

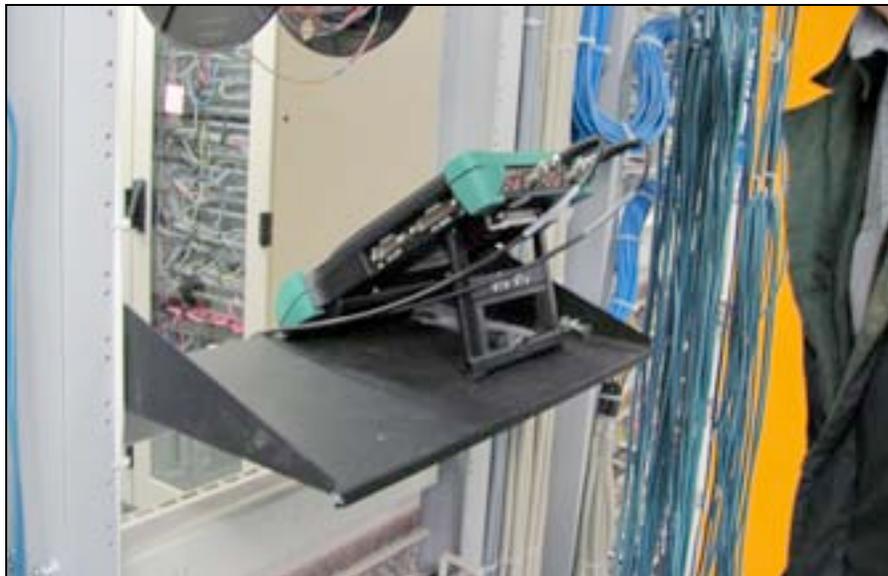
However, we observed a few items that require improvement. Figure 5-14 shows a piece of test equipment sitting on an open shelf without being tied down, and Figure 5-15 shows a cart with casters (the casters may have locking device) and not secured to the wall. The equipment mounted on the wall with a power adaptor plugged in the wall socket (Figure 5-16) should be hard wired or a device used to prevent the plug from being accidentally unplugged.

Figure 5-14. Test equipment shown was not secured to the shelf.

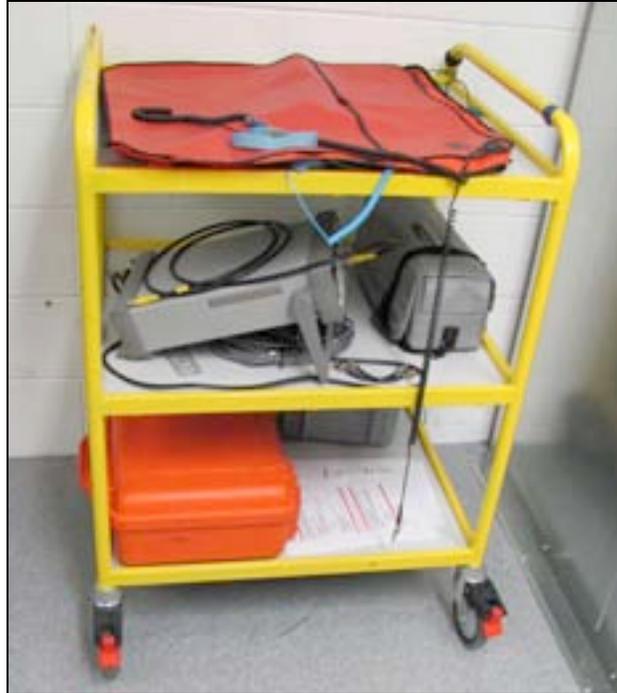
Figure 5-15. The cart shown was not secured to wall or to the floor. The wheels may be locked but the cart can topple or the equipment on it may fall.

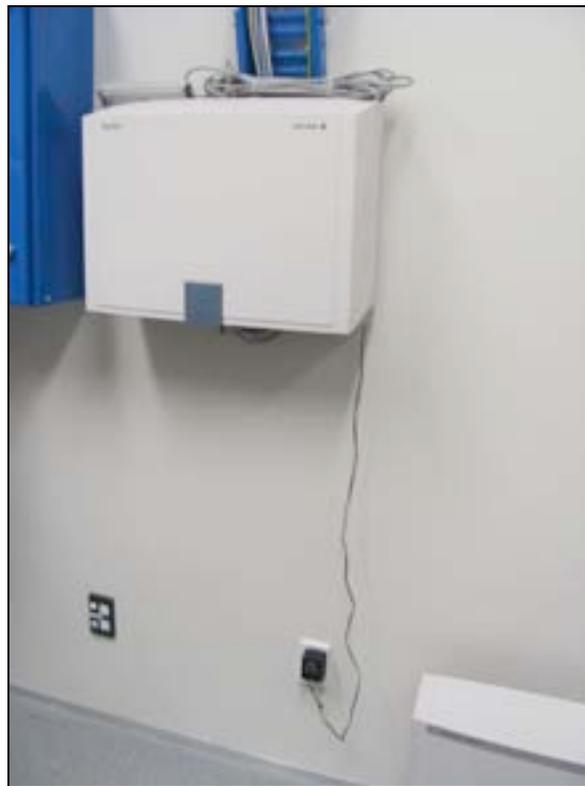
Figure 5-16. Power connection not protected from accidentally unplugged

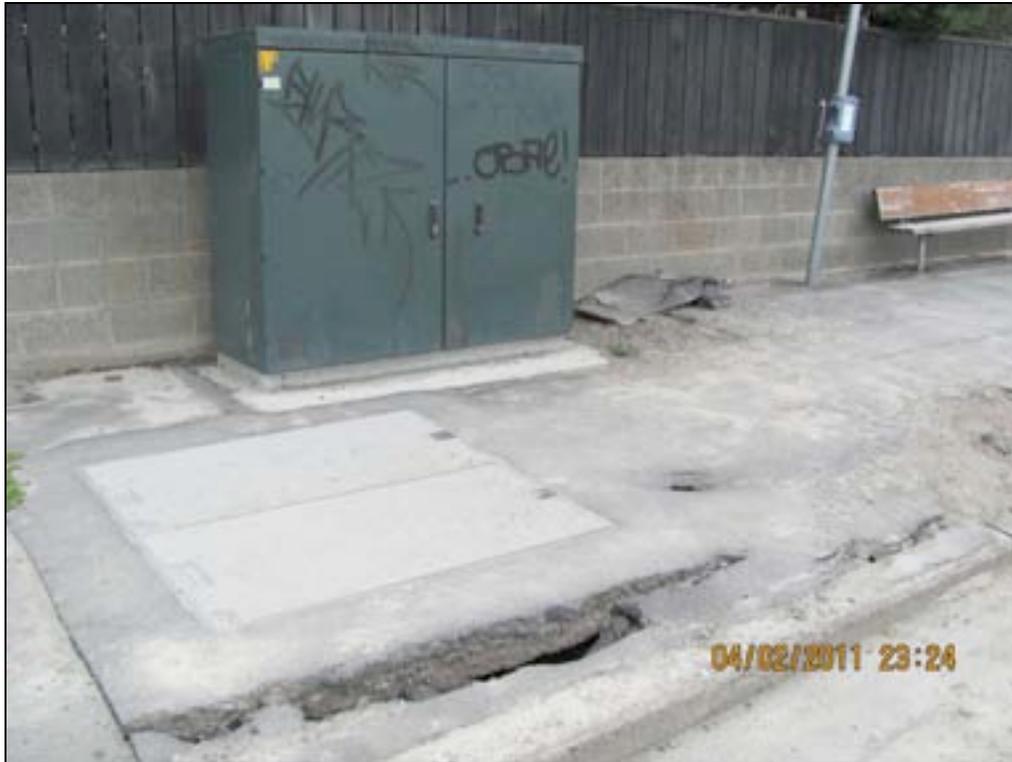
In liquefaction affected areas, particularly along the Avon River, buried cable damage was extensive. Modes of damage were: i) cracked sheaths, ii) water leak into cable, and iii) cable being pulled apart. The cable fault levels had taken about 6 weeks to come to normal. Street cabinet affected by liquefaction and cable was damaged, Figure 5-17.

Figure 5-17. Street Cabinet impacted by liquefaction, note the slight uplift of the manhole

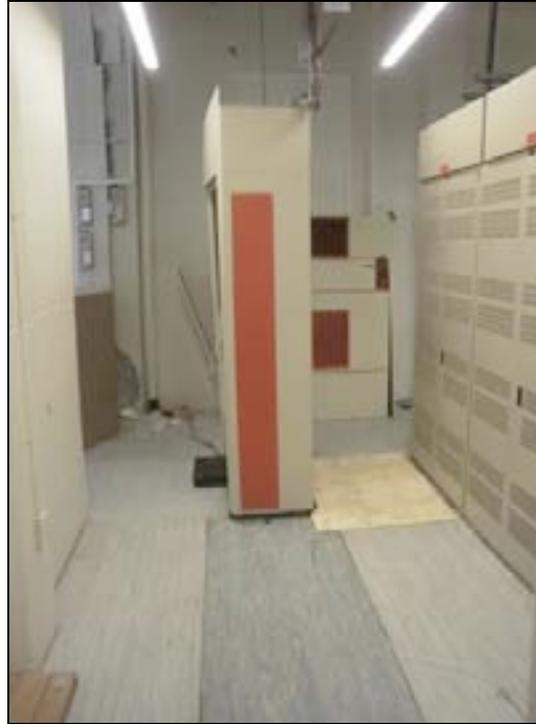
The Mt Pleasant Exchange sustained damage to its walls and floor. One equipment cabinet straddled across the crack was relocated. This building was yellow tagged originally.

Figure 5-18. This equipment was straddled across a crack along the floor. It was relocated. (Courtesy Telecom NZ)

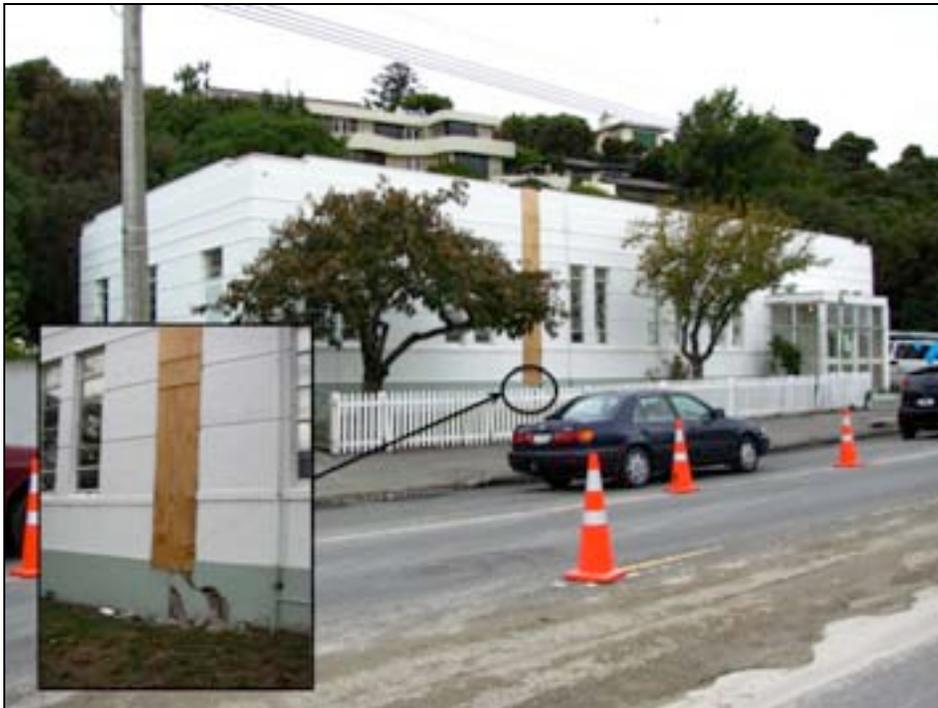
The Shirley Exchange suffered a crack across the building extension. A permanent fix needed to be designed and specified, Figures 5-18 and 5-19.

Figure 5-19. Weather seal was placed on the cracked expansion joint at Mt Pleasant Exchange.

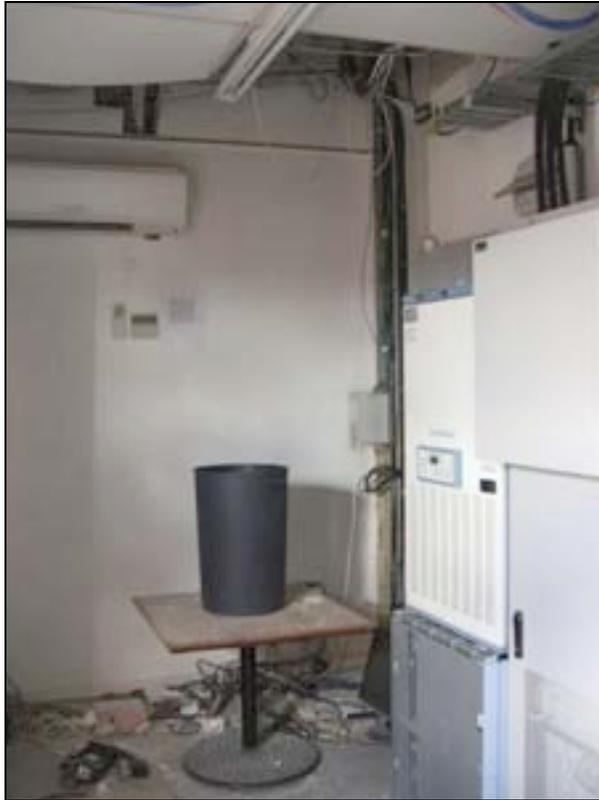
The Liwood Mall Cell Site had a bit dusty due to fallen ceiling tiles, Figure 5-20.

*Figure 5-20. Liwood Mall Cell Site, fallen ceiling tiles, the site was operational.
(Courtesy Telecom NZ)*

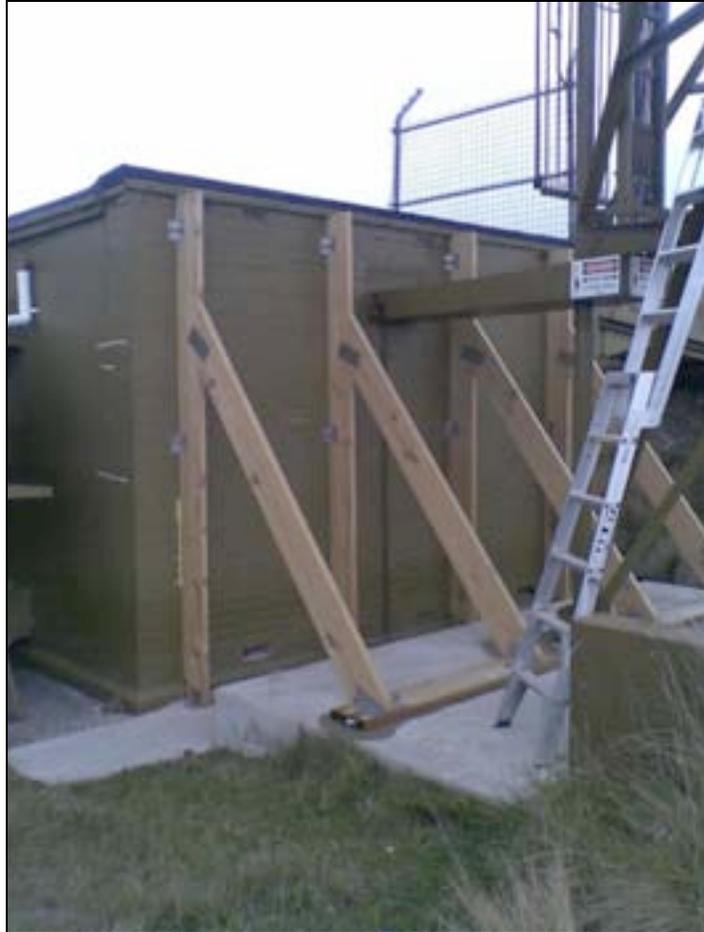
At the Mt Pleasant Radio site, the end wall where the cable tray entry was located pulled away but did not collapse. The wall was shored to prevent damage to cables and cable tray, Figure 5-21.

Figure 5-21. The URM wall was pulling on the cable tray at the MT Pleasant Radio site. (Courtesy Telecom NZ)

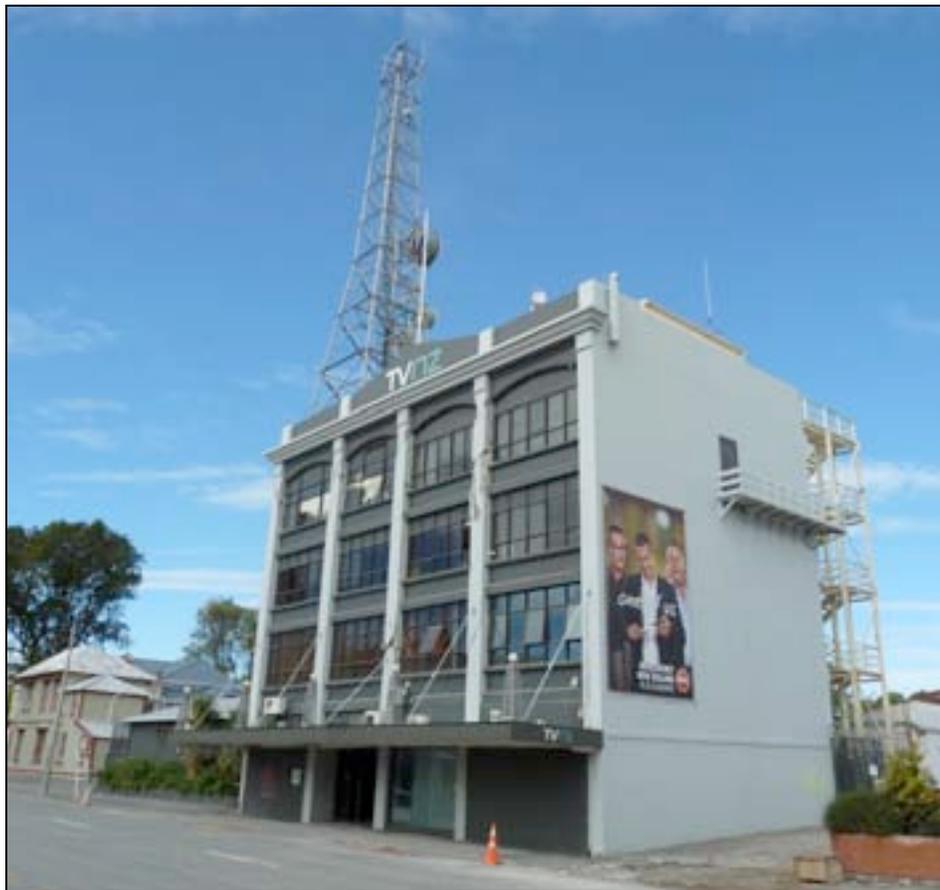
The worst impact was in the CBD area, where Vodafone has major operations for both network and business. The major problem was the building damage of the Television New Zealand Building hub site, Figures 5-22 to 5-25. As the building is within the cordoned area, no one is allowed to enter the building. Although the operation has 24 hours of reserve power, and a power generator with 120 hours of fuel supply, Vodafone had to work quickly to transfer the functions of this site to other locations. Routing a new fiber cable out of Christchurch took 3 days. The most recent information is that this building will be reconstructed.

Figure 5-22. The Television New Zealand Building that housed Vodafone hub site.

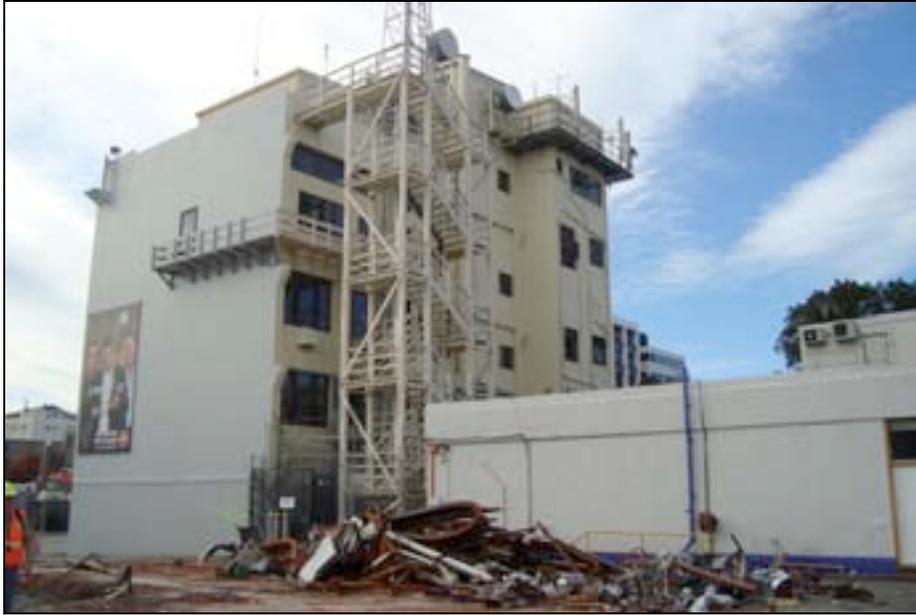
Figure 5-23. The rear of the building, note the microwave and cell site antenna.

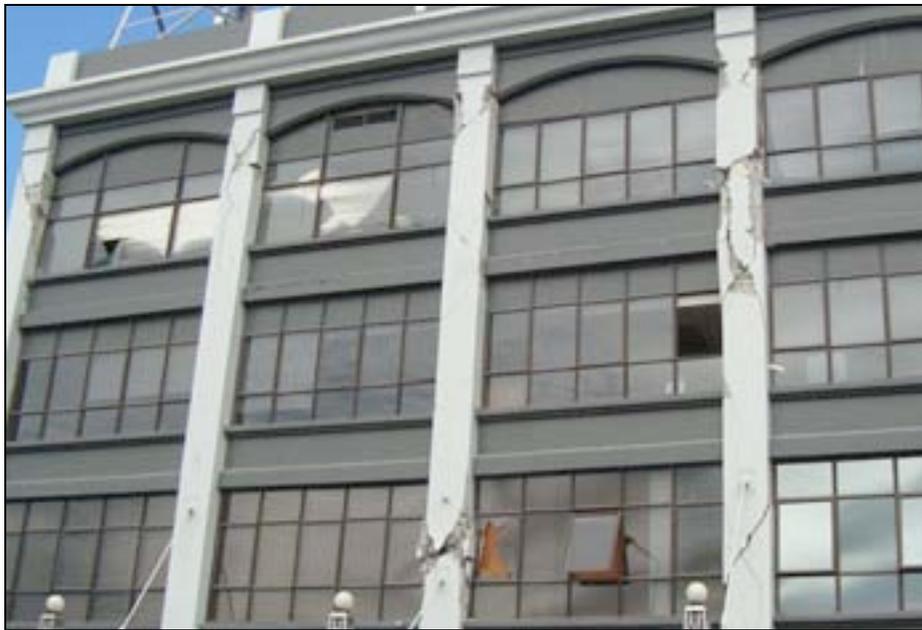
Figure 5-24. The front columns of the building sustained significant damage.

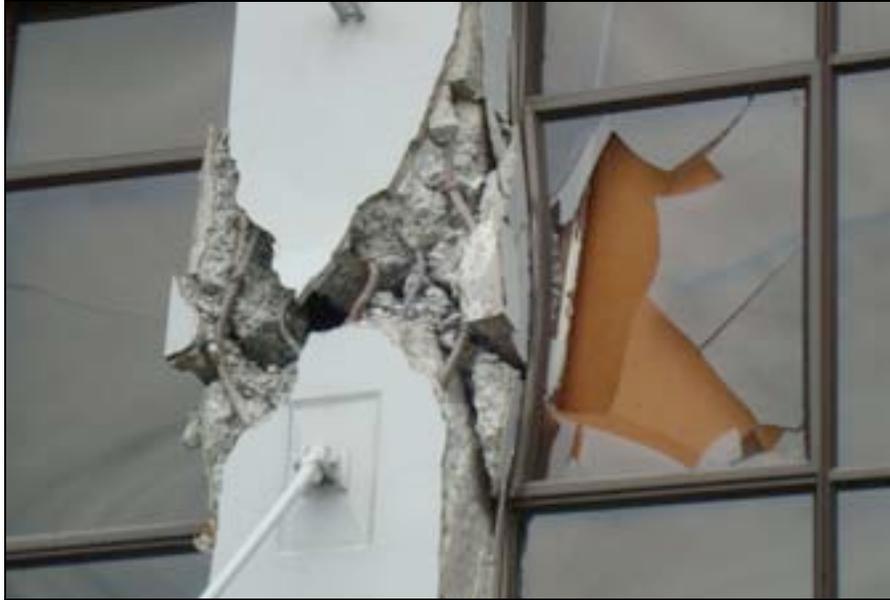
Figure 5-25. TVNZ Building - close up of one of the columns damaged.

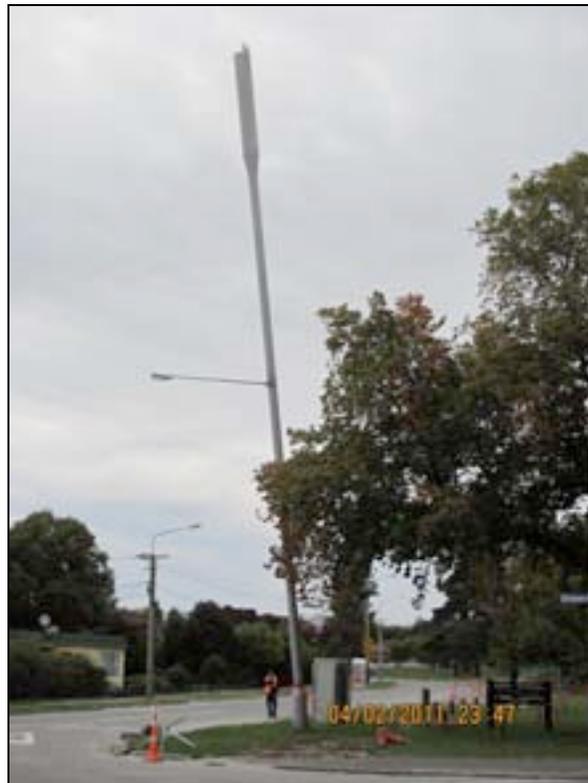
The cell sites on roof tops of buildings that were set to be demolished were out of service. The total number could be up to 9 cell sites. 12 cell sites required significant remedial work, this included broken poles, foundation damage, etc., Figure 5-26.

Figure 5-26. The cell site antenna pole tilted due to liquefaction in the Avon River area.

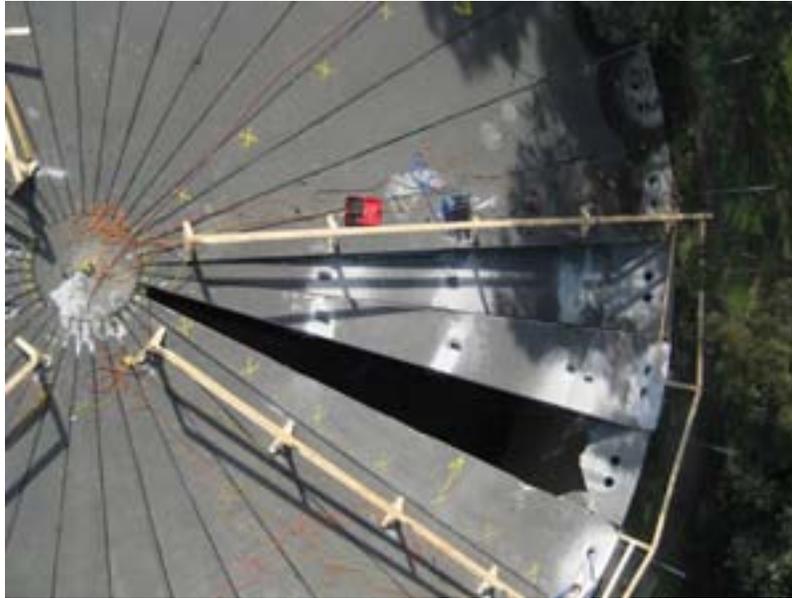
In the western edge of the CCC service area, one circular buried concrete tank with segmented concrete roof sustained damage to the roof, Figures 6-4, 6-5. It is thought that water sloshing uplift forces exceeded the capacity of the concrete segments, resulting in uplift, and then damage when the segments dropped back down. CCC was actively repairing this roof after the earthquake.

Figure 6-4. Damaged Segmented Concrete Roof, CCC (September 2010)

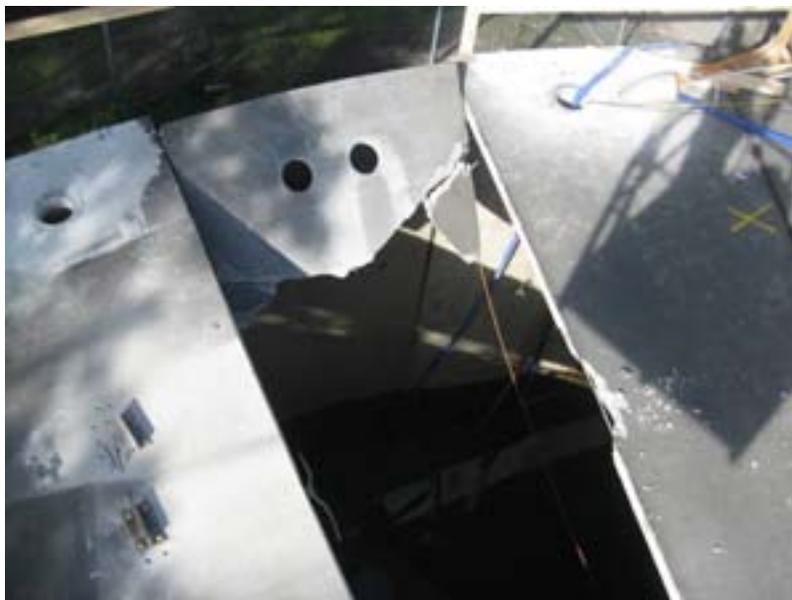
Figure 6-5. Damaged Segmented Concrete Roof, Detail, CCC (September 2010)

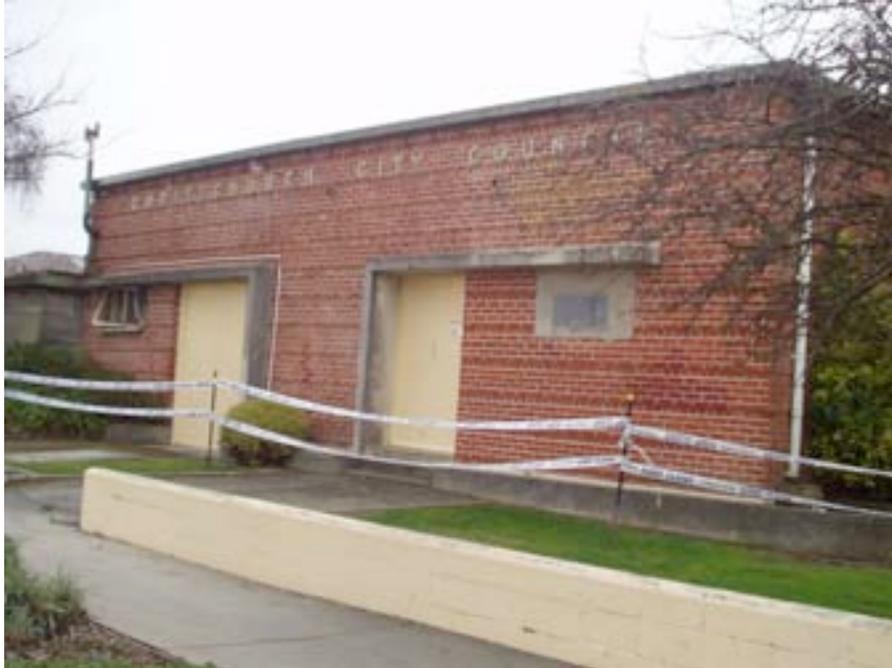
Figures 6-6 and 6-7 show a masonry pump station building damaged due to differential settlement due to liquefaction. This facility is located a New Brighton Road and Palmers Road.

Figure 6-6. CCC Pump Station Damaged due to Differential Settlement

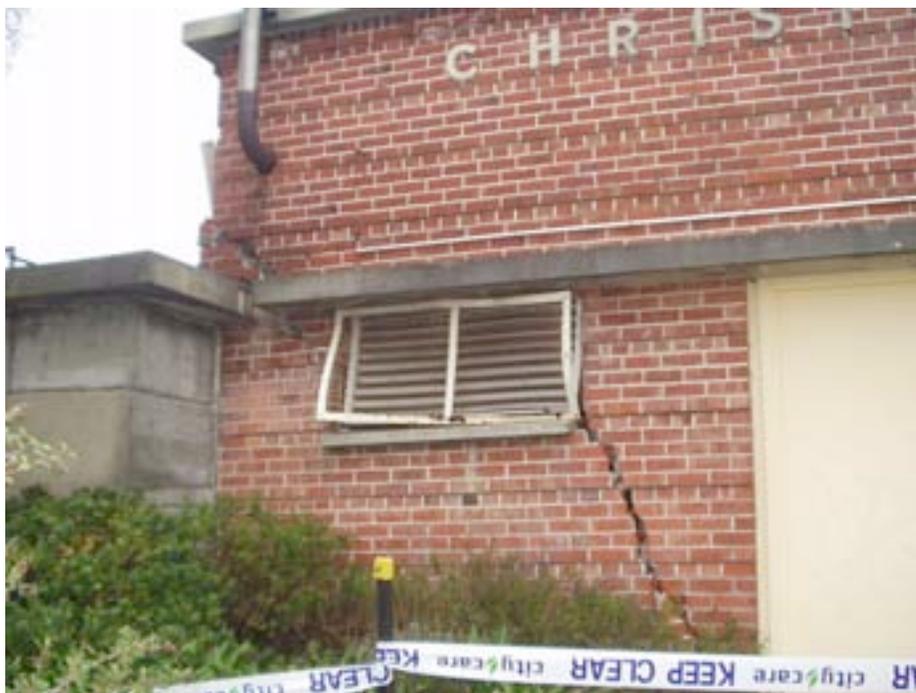
Figure 6-7. CCC Pump Station Damaged due to Differential Settlement

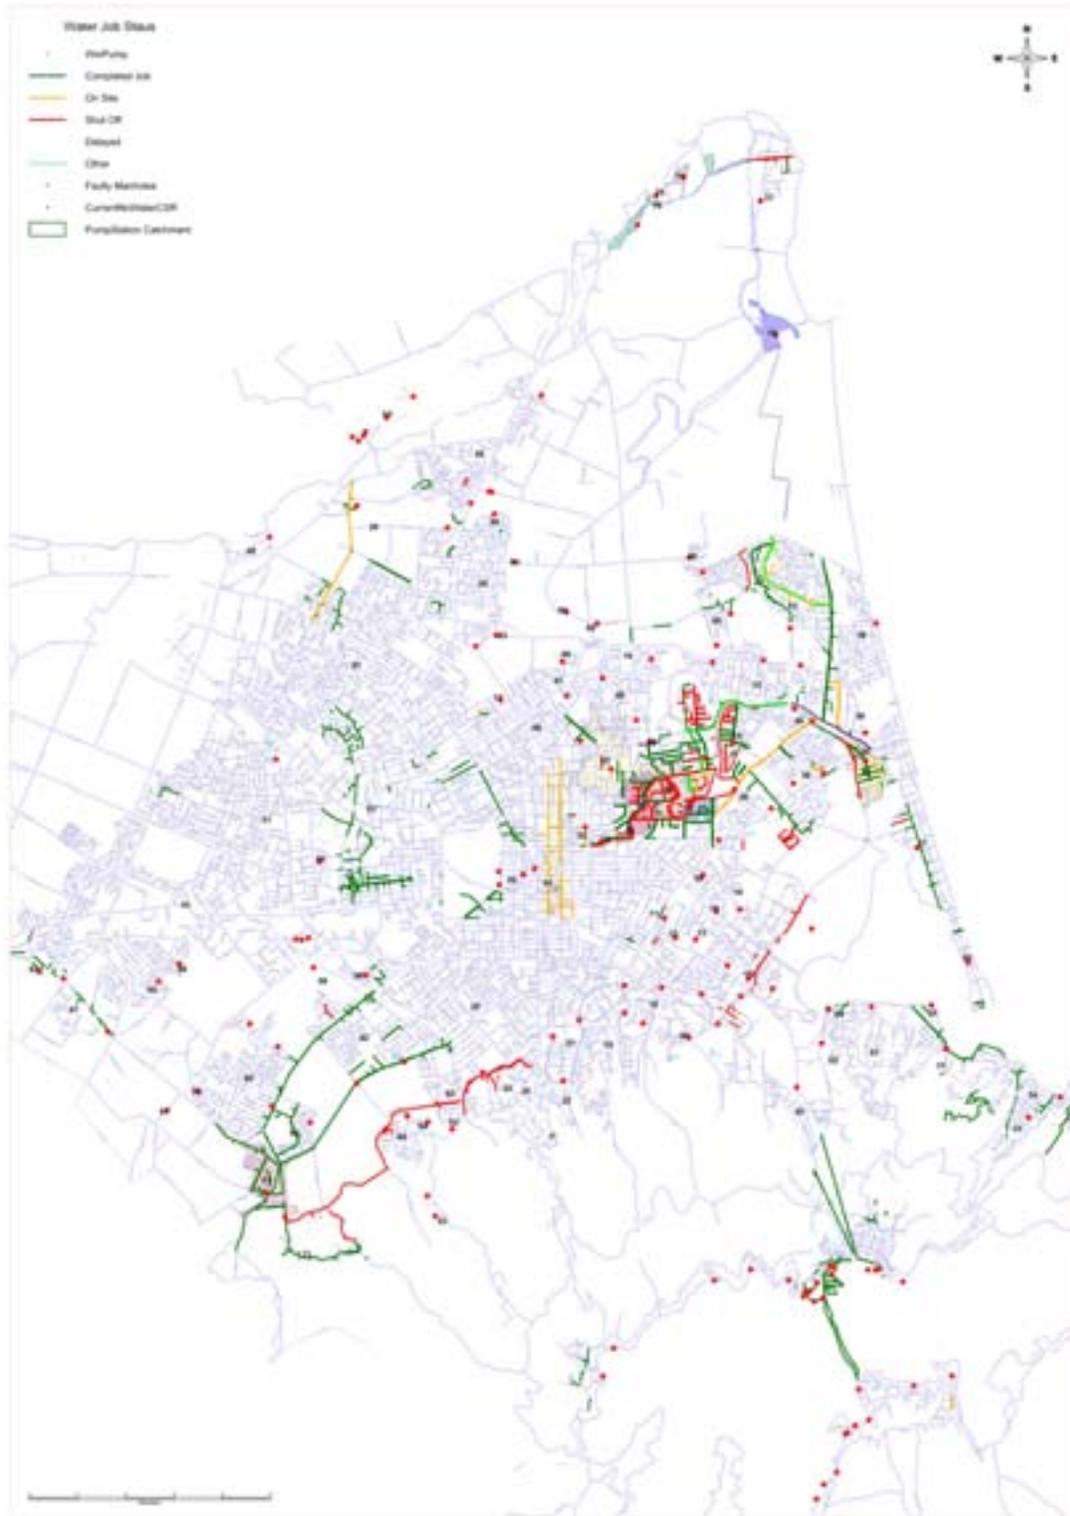
Figure 6-9. Map of Water Pipe Repairs, CCC, September 2010

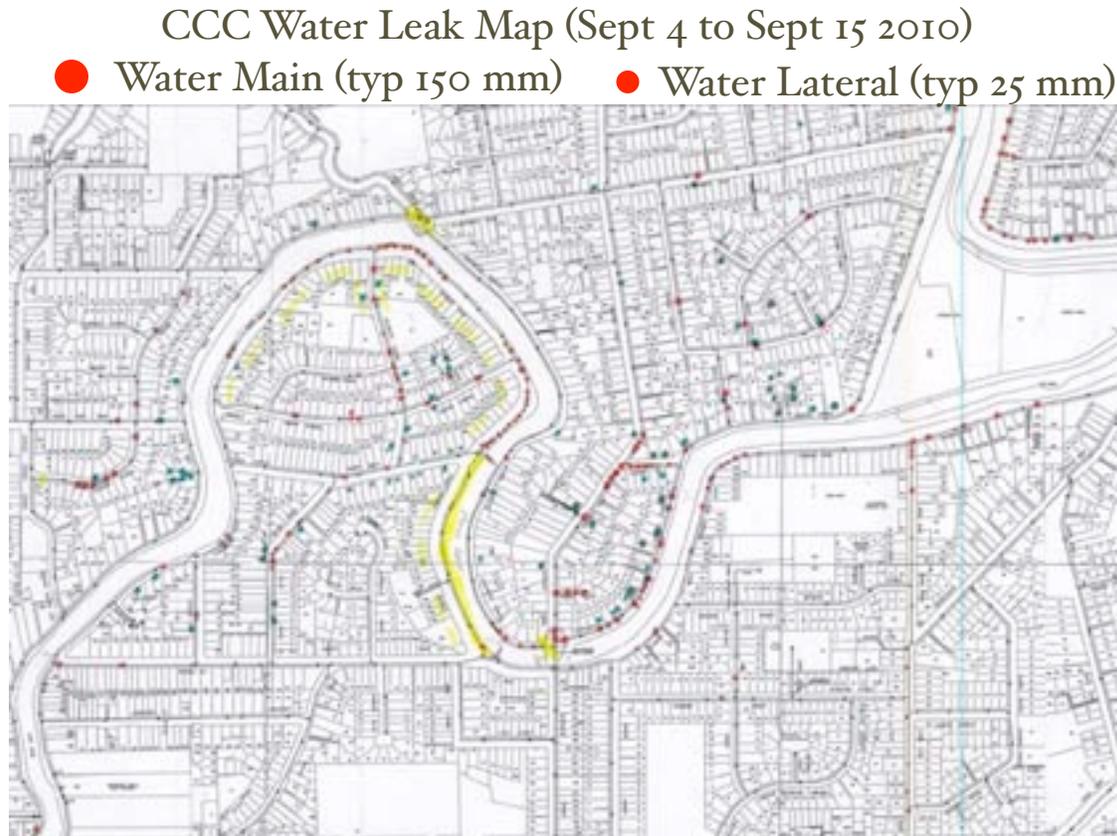
Figures 6-10, 6-11 and 6-12 highlight three heavily damaged portions of the CCC water system in the September 2010 event. The large dots represent locations with main trunk pipes repaired; the small dots show locations with repairs to sub-mains (laterals).

Figure 6-10. Map of Water Pipe Repairs, Christchurch City Council, as of September 15, 2010 (partial)
