CHRISTCHURCH, NEW ZEALAND EARTHQUAKE SEQUENCE OF M_w 7.1 September 04, 2010 M_w 6.3 February 22, 2011 M_w 6.0 June 13, 2011: LIFELINE PERFORMANCE

**Technical Council on Lifeline Earthquake Engineering
Monograph No. 40
February 2012 – Revision 0
ASCE**

ABSTRACT

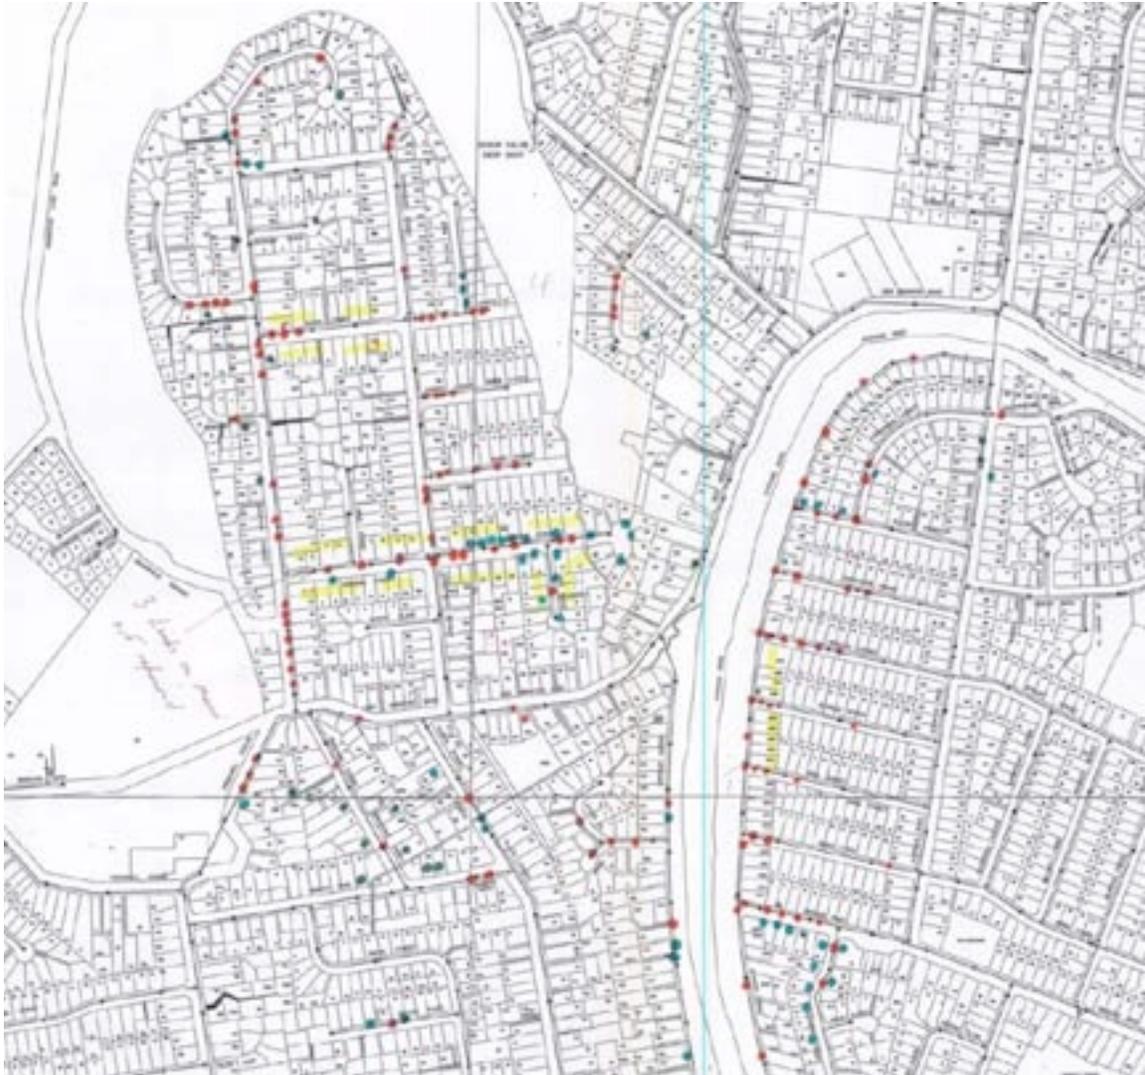
Figures 6-10, 6-11 and 6-12 highlight three heavily damaged portions of the CCC water system in the September 2010 event. The large dots represent locations with main trunk pipes repaired; the small dots show locations with repairs to sub-mains (laterals).

Figure 6-11. Map of Water Pipe Repairs, Christchurch City Council, as of September 15, 2010 (partial)

Horseshoe Lake (Figures 6-11, 6-31) suffered some of the greatest liquefaction-induced pipe damage in the September 2010 earthquake. In the time between the September 2010 and February 22 2011 events, CCC replaced some of the pipe in this area with HDPE pipe; some existing AC pipe was repaired. This area suffered more extensive liquefaction in the February 2011 event: no leaks were reported for any of the HDPE-installed replacement pipe in either the February 2011 or June 2011 events.

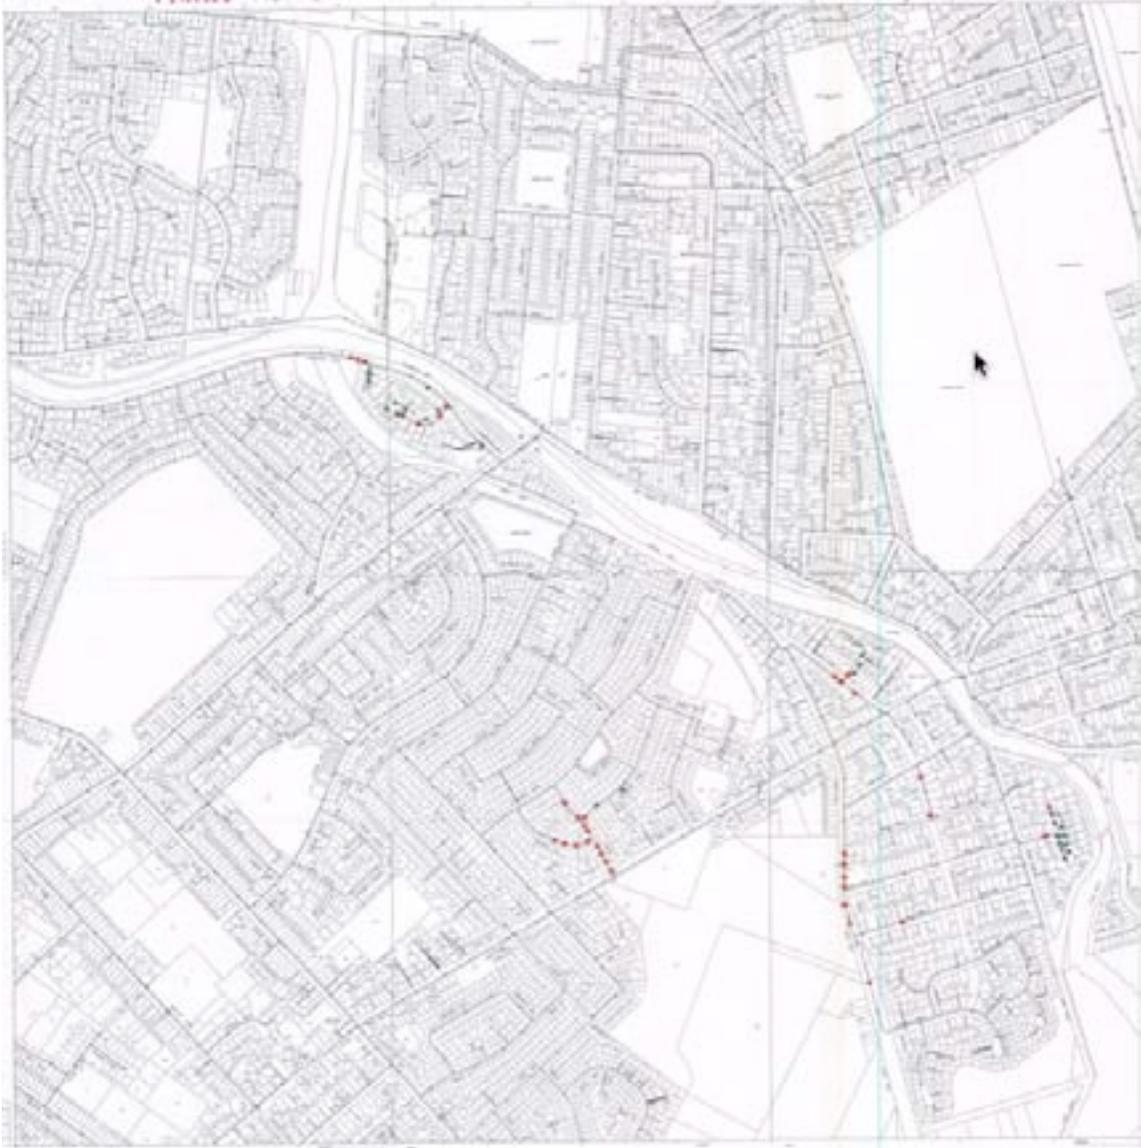
Figure 6-12. Map of Water Pipe Repairs, Christchurch City Council, as of September 15, 2010 (Bexley Area)

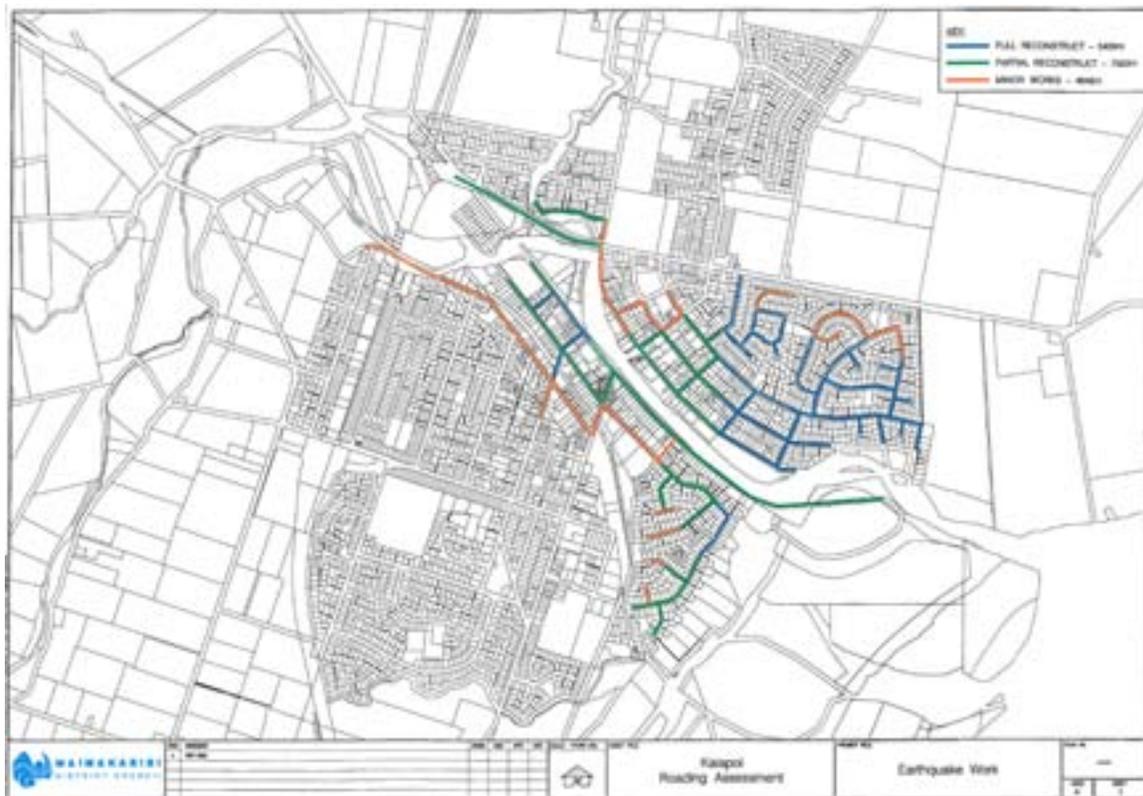
Figure 6-17. Road Assessments, Kaiapoi

Liquefaction was widespread in Kaiapoi, affecting about one-third of the streets. Figure 6-17 shows a map of Kaiapoi, highlighting damage to roads (also a good proxy for damage to buried water pipes):

- Blue lines: reconstruct roads entirely (5.409 km)
- Green lines: reconstruct roads partially (7.563 km)
- Orange lines: minor road works (4.848 km)

In this area alone, 31 km of sewer pipes, 32 km of water pipes, 12 km of drainage pipes, and 37 km of roads were damaged, with most (95%+) due to ground settlements or lateral spreads. Emergency repairs included 200+ potable water pipe repairs at a cost (through mid-October 2010) of \$1,800,000.

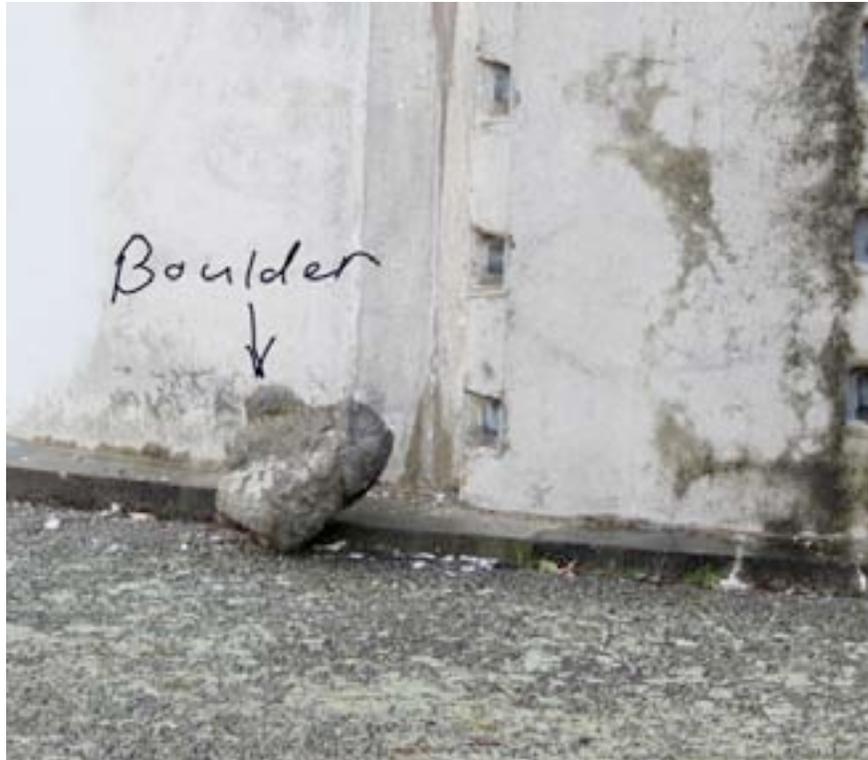
Figure 6-19. Boulder Impact McCormacks Bay Tank 1

Boulders impacted tank 1 (Figure 6-19), but this did not result in damage / leakage to the tank. However, an apparent landslide has impacted the fill-side (Figure 6-20) and the downslope of the site (Figure 6-21), resulting in a leak to tank 2.

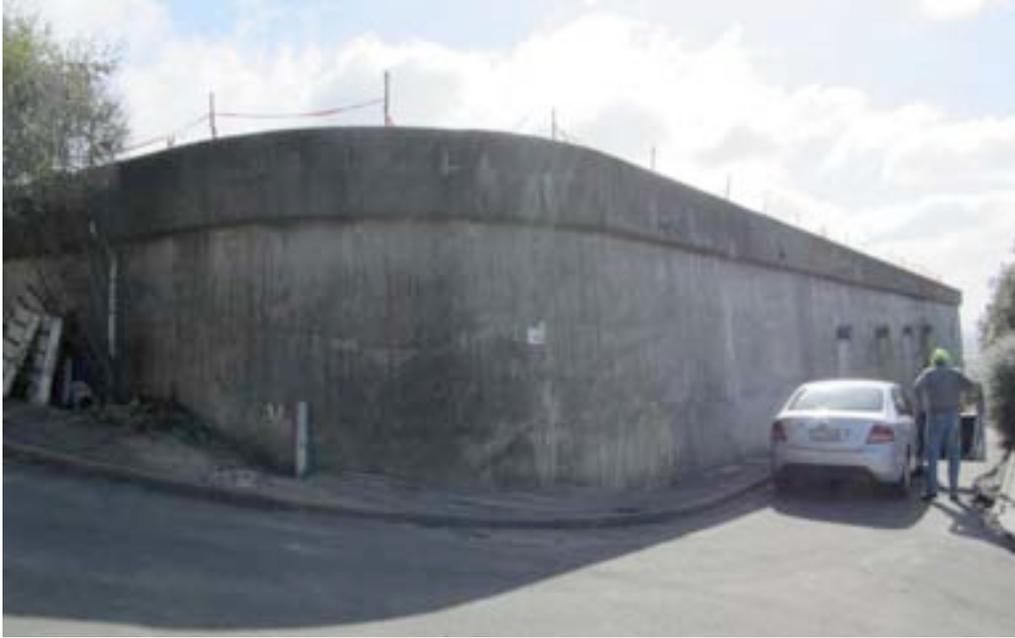
Figure 6-22. Huntsbury Concrete Reservoir (Southeast Corner)

The Huntsbury Reservoir is a 36,000,000 liter (10 million gallon) water reservoir, Figure 6-22. It is a rectangular reinforced concrete tank, with reinforced concrete floor slab, concrete interior columns, concrete roof with soil cover. It is located in the Port Hills. Figure 6-23 shows an aerial view of the reservoir; downslope slope movement was noted on the east side of the reservoir.

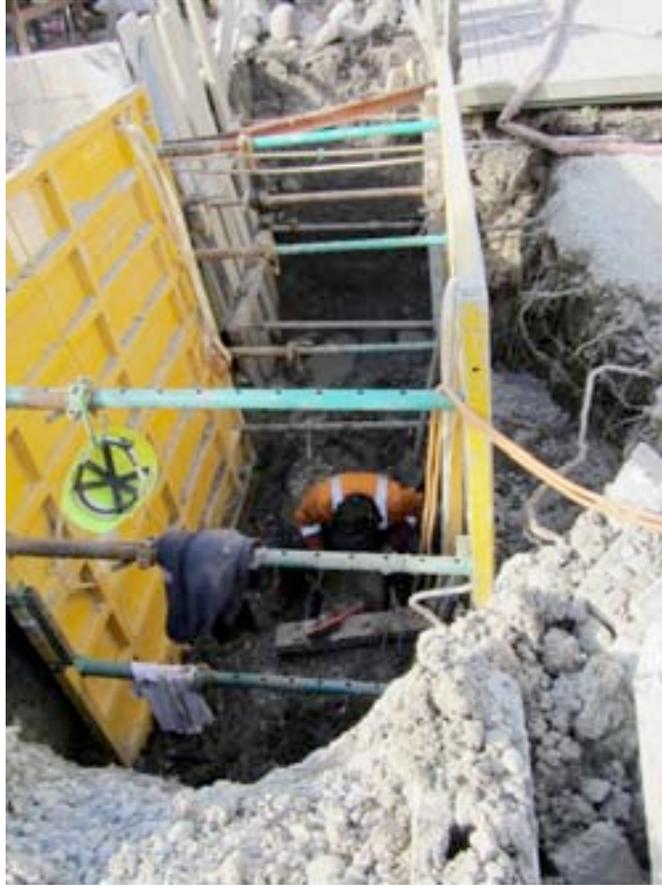
After the February 2011 earthquake, the tank was found to no longer hold water. Initially, this was thought to be caused by damage to the outlet pipe, located just downhill of the tank. We observed clear evidence of ground failure on the downslope side of the tank, as highlighted in damaged buildings. Figure 6-24 shows a 600 mm (24") steel pipe being repaired, located at the northeast corner of the reservoir; this repair was being made in early April, 2011. Figure 6-25 shows some of the surface movement at the southeast corner of the concrete reservoir.

Figure 6-24. Repair of Outlet Pipe, Huntsbury Concrete Reservoir

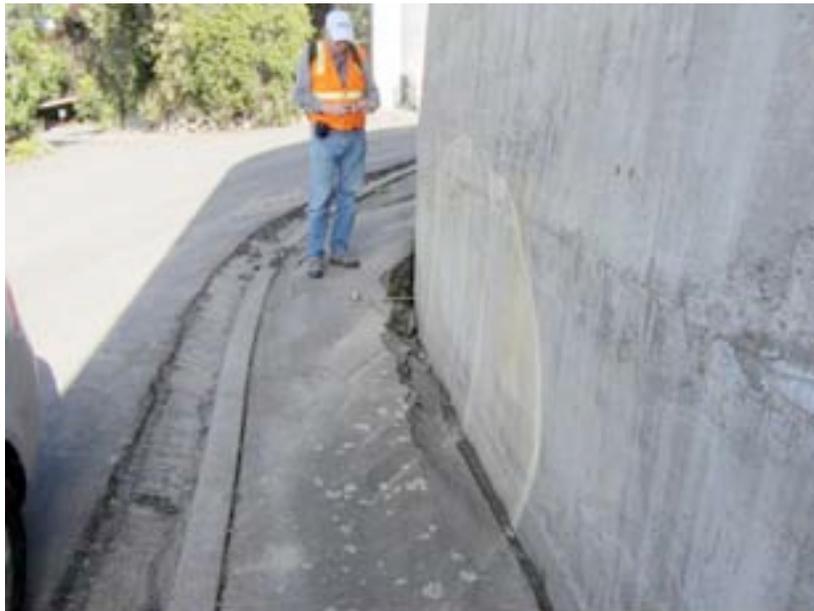
Figure 6-25. Evidence of Ground Failure, Southeast Corner of Huntsbury Concrete Reservoir

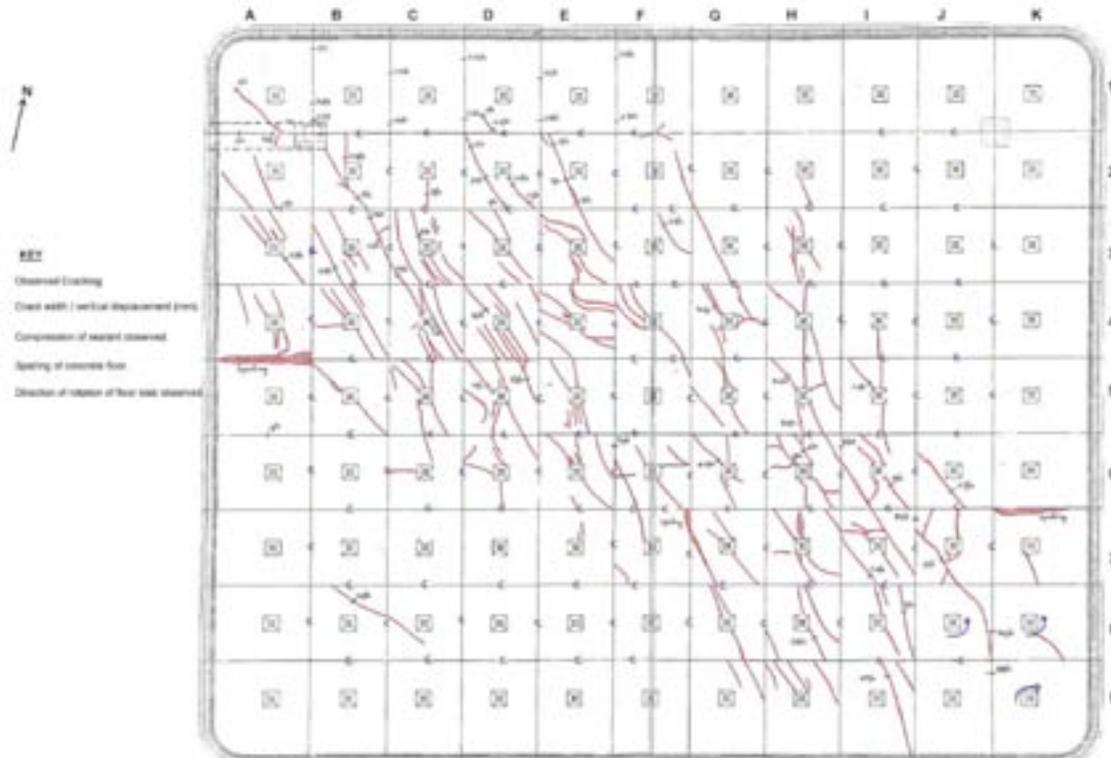
Figure 6-26. Interior Inspection of March 3 and 4, 2011

Further investigation has shown that a the interior concrete floor has suffered major cracking (1 inch wide in places), resulting is loss of the pressure boundary.

It has been speculated that the linear-type alignment of the cracks in the reservoir floor (Figure 6-26) might suggest surface fault offset. However, it might also reflect the formation of a scarp at the head of a landslide, as we observed clear evidence of building distortions downslope (eastward) of the reservoir. Possibly (?) a thin weak clay seam suffered large shears due to the very high levels of shaking at this site (PGA well over 0.5g, possibly as much as 0.9g or higher). Further investigation will be required to establish the cause(s) of the PGDs.

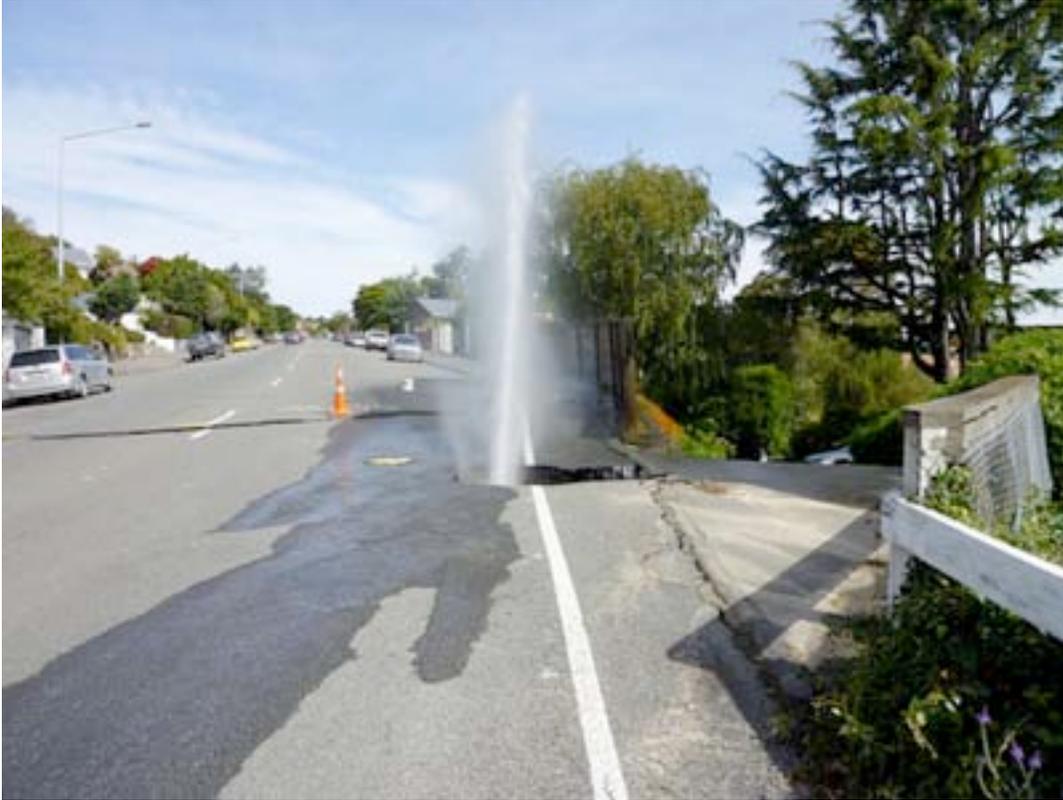
The February 2011 event resulted in 14,000 water pipe repair reports; of which 3,000 were pipe repairs. Figure 6-29 shows the results of a burst pipe. The effort included 300 pipe repair crews, including those from mutual aid. As the repair effort continued, the number of crews were reduced to 150. It took 6 weeks to complete the repairs.

Figure 6-29. Water Leak, February 2011 Earthquake

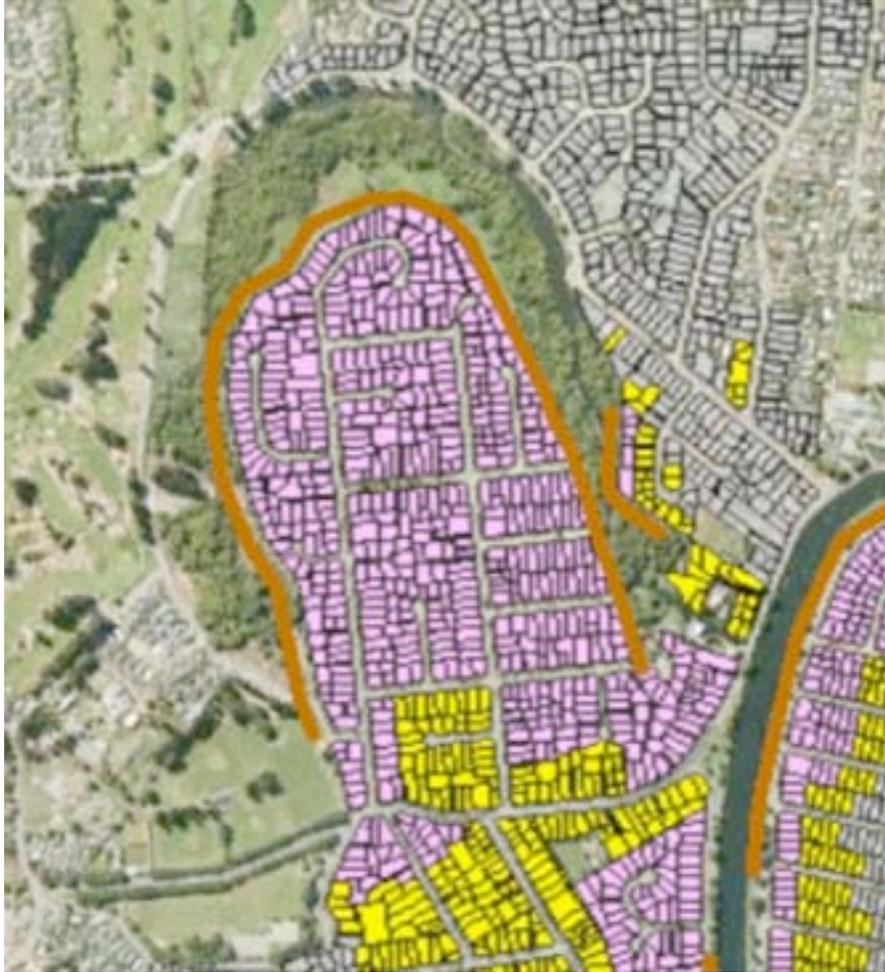
Figure 6-31. Horseshoe Lake Liquefaction, September 2010

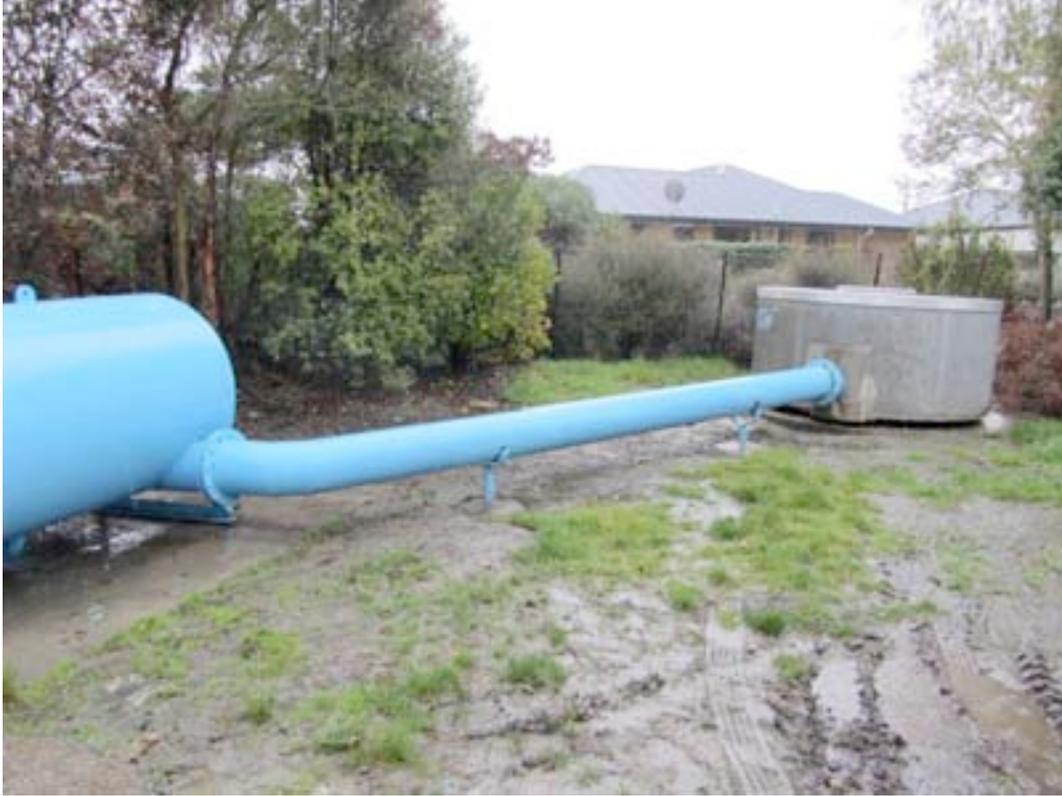
Figure 6-32. Bixley Water Well

Figure 6-32 shows one of the wells in CCC that was located in a major liquefaction zone. In this location, differential settlements have resulted in the discharge pipe lifting off its saddle support (Figure 6-33) and well head differential settlement (Figure 6-34).

At this well site, there is 6 meters of artesian head. The well had just been repaired from the effects of the September 2010 earthquake, when it was damaged (again) by the February 2011 earthquake. The damaged well released about 150,000 liters per hour into the nearby street.

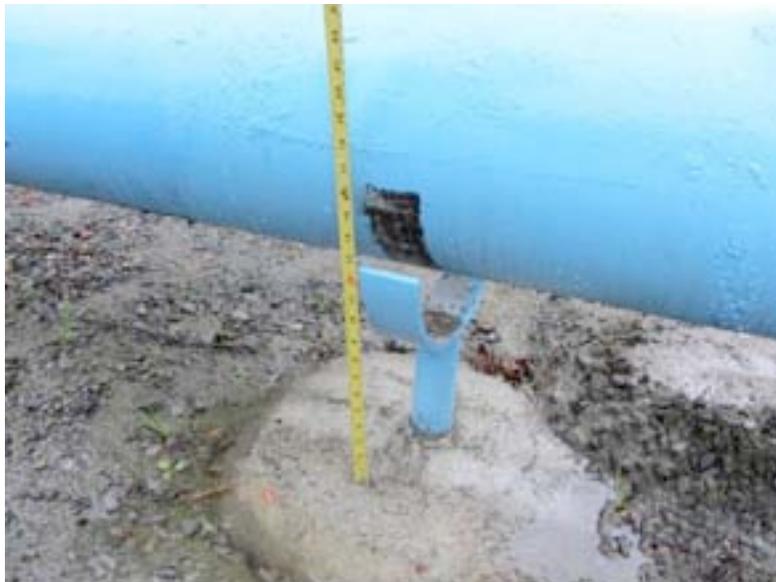
Figure 6-33. Pipe Support Settlement

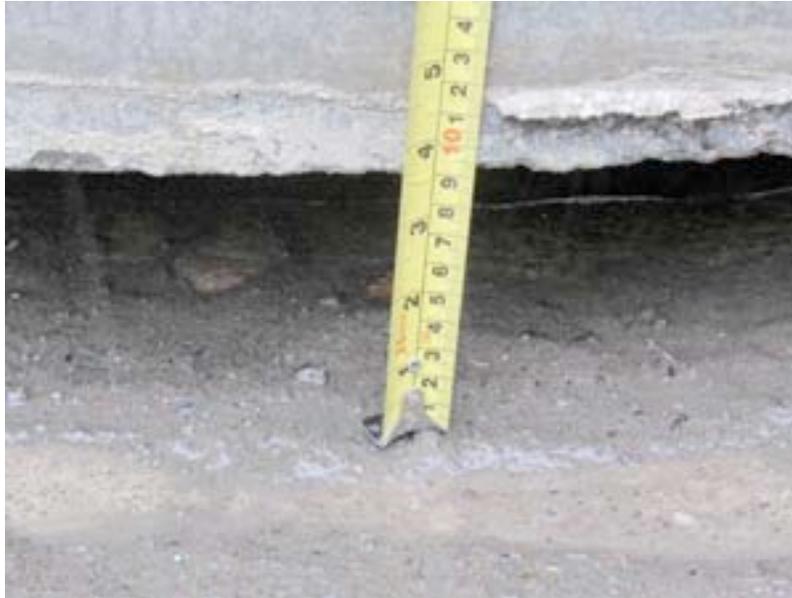
Figure 6-34. Well-head Differential Settlement

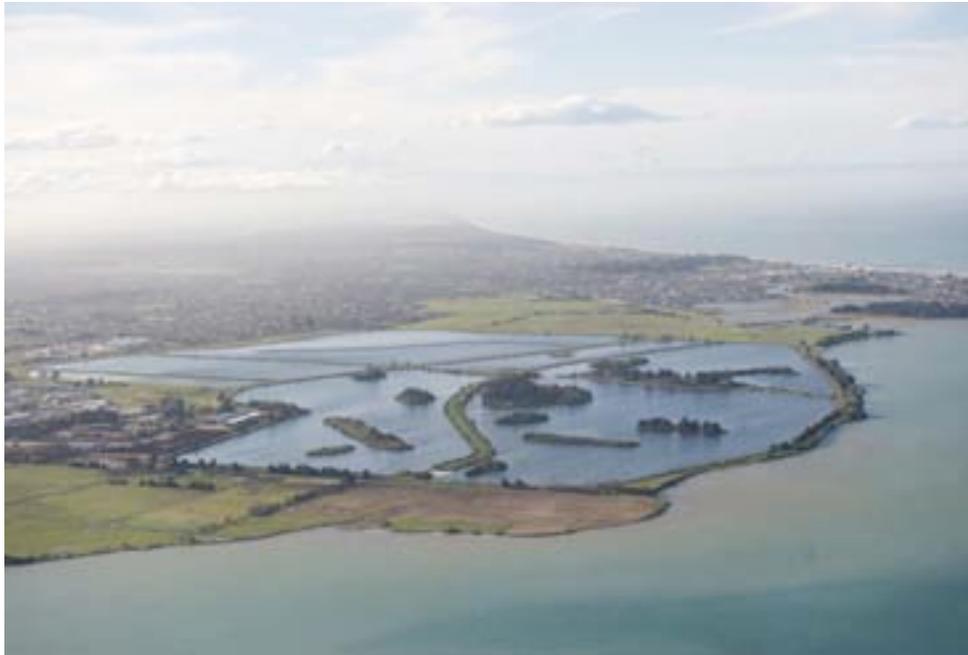
Figure 7-2. Christchurch WWTP at Bromley

The primary damage to the WWTP in the September 2010 earthquake was State Highway 71 between Ponds 2 and 4 (Figure 7-2) was closed due to 50 cm cracks. The pipe between oxidation ponds 2 and 4 had to be replaced. The levee between Ponds 1 and 2 cracked and slumped. There were sand boils in many places, with observed PGDs of 30 cm horizontal and 20 cm vertical.

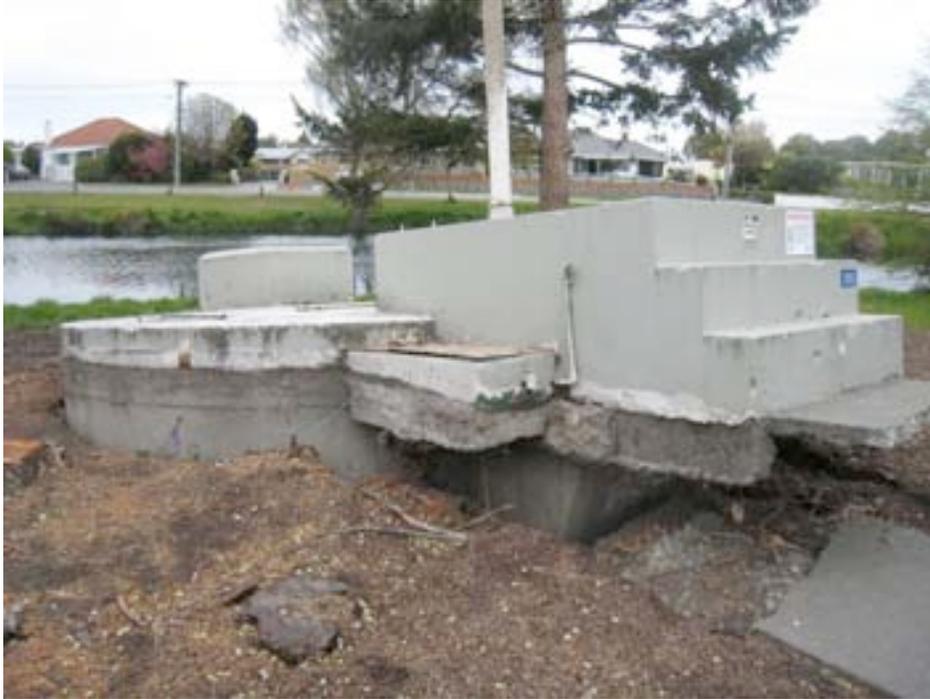
Two of CCC's wastewater dry well lift stations (Figures 7-4, 7-5) next to the Avon River were subjected to liquefaction and lateral spreads, and they floated and tilted. While the equipment within the lift stations may not have been damaged, the sewers leading to and from the lift stations were broken, and CCC bypassed these lift stations using portable pumps and flex hose.

Figure 7-4. Floated and Tilted Wastewater Life Station 26, Porritt Park, Avonside

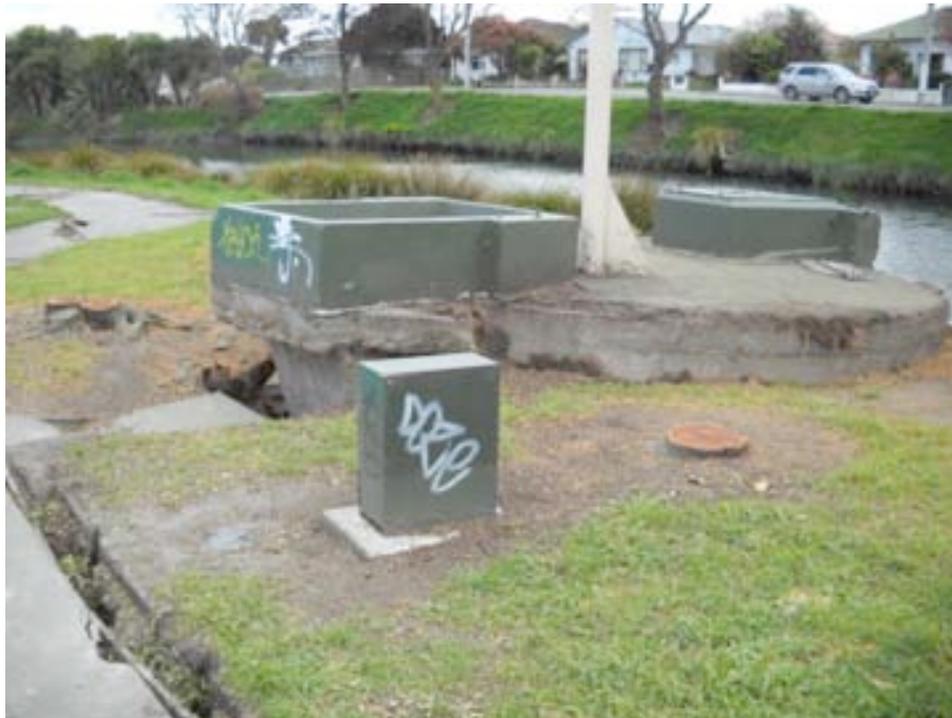
Figure 7-5. Floated and Tilted Wastewater Life Station 27, Avonside

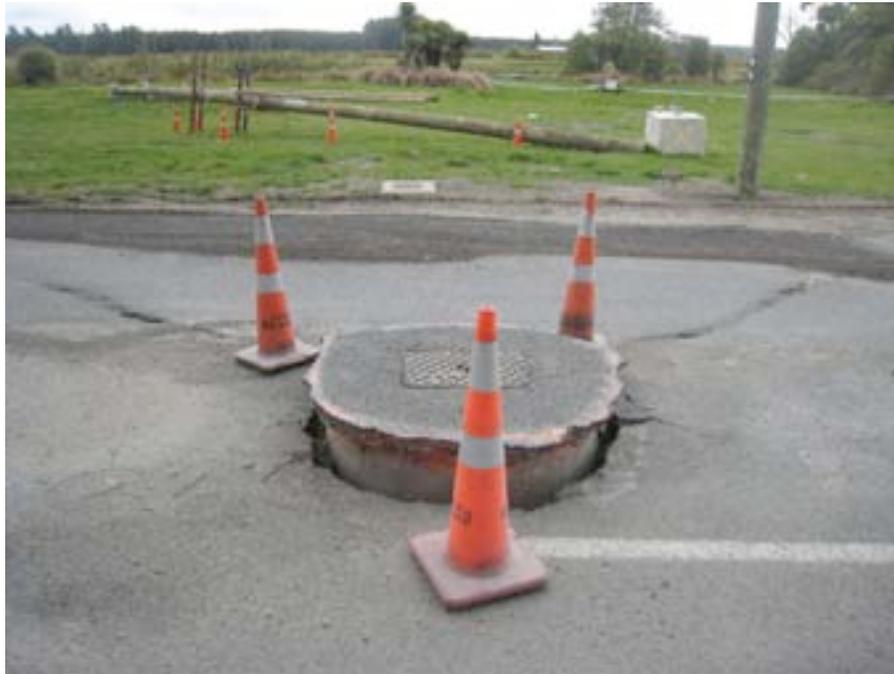
Damage to sanitary sewers (Figures 7-6 and 7-7) in many places led to direct discharge of untreated sewage into local rivers, leading to contamination warnings. Damage to the

Figure 7-6. Floated Sewer Manhole, Brooklands (one of fifteen)

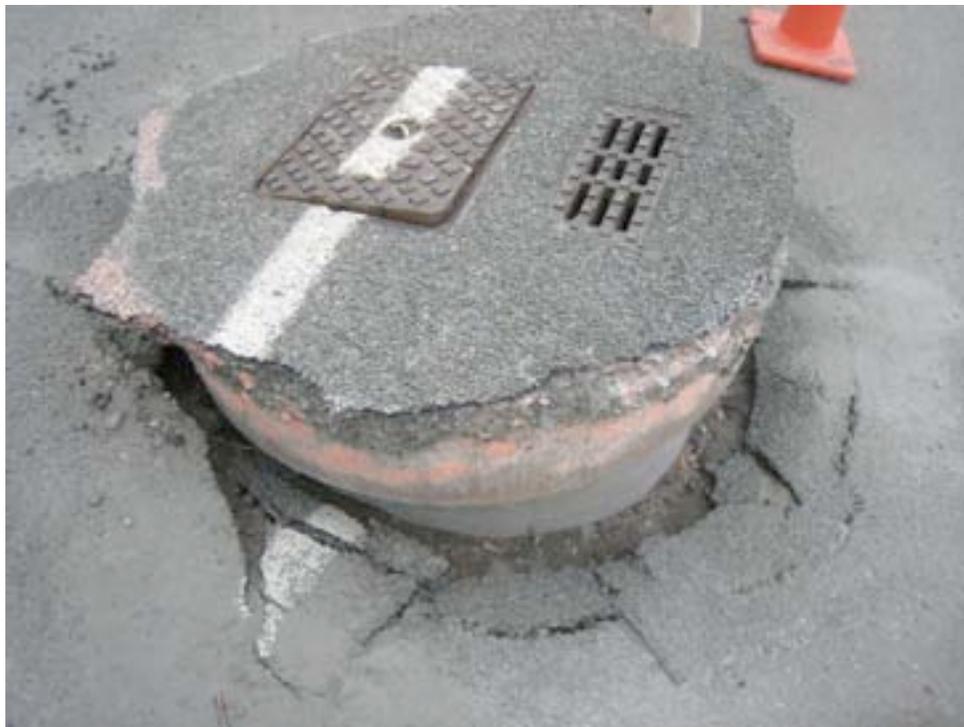
Figure 7-7. Floated Sewer Manhole, Brooklands (one of fifteen)

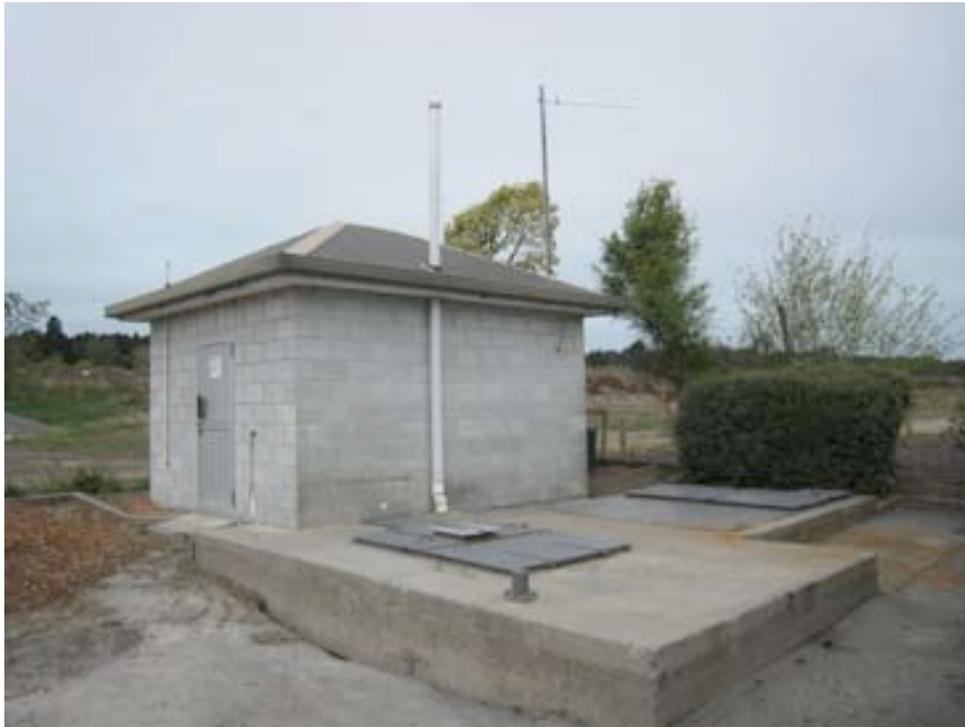
Figure 7-8 shows a lift station in the Brooklands area. It appears that there was as much as 6 to 10 inches of settlement around the concrete wet well.

Figure 7-8. Settlement due to Liquefaction, Lift Station in Brooklands

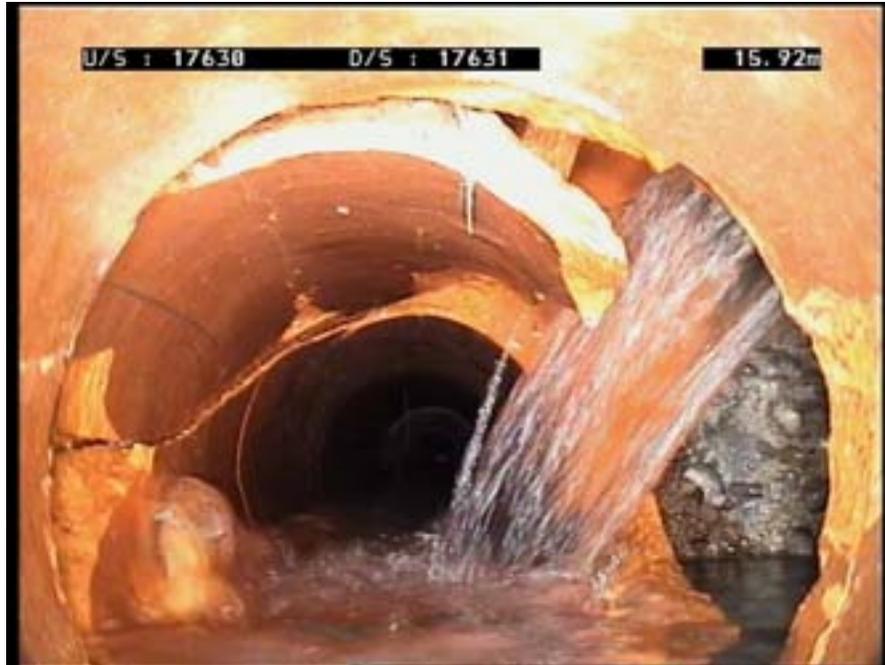
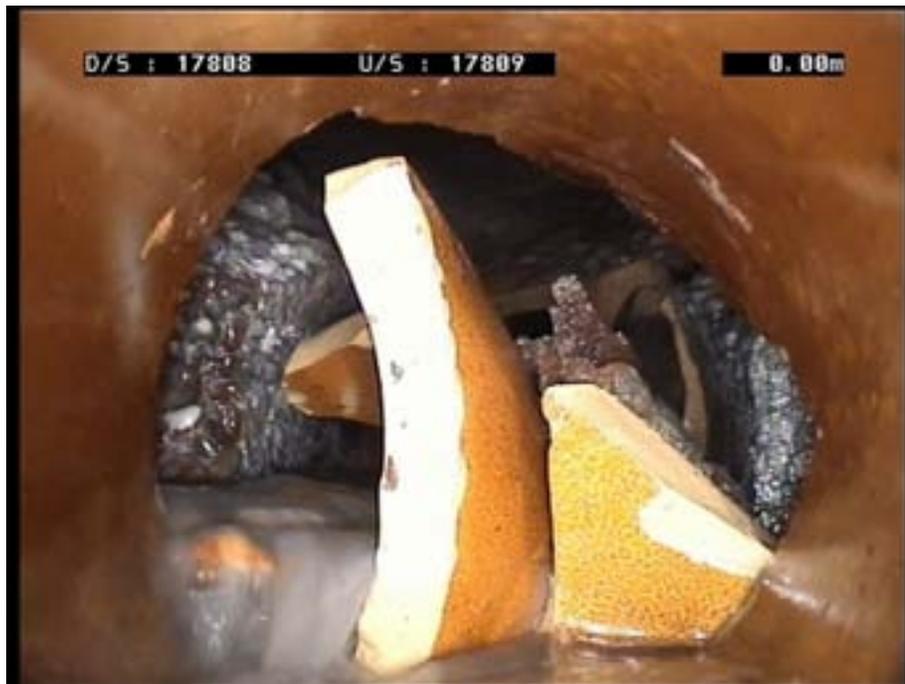
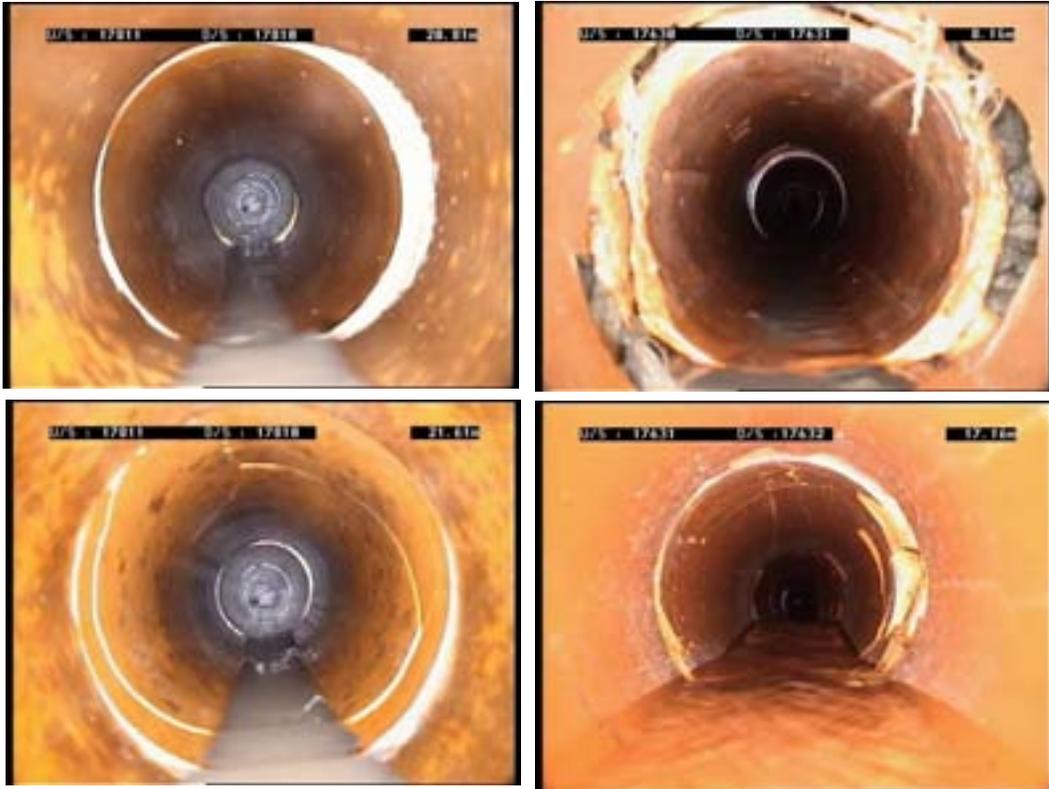
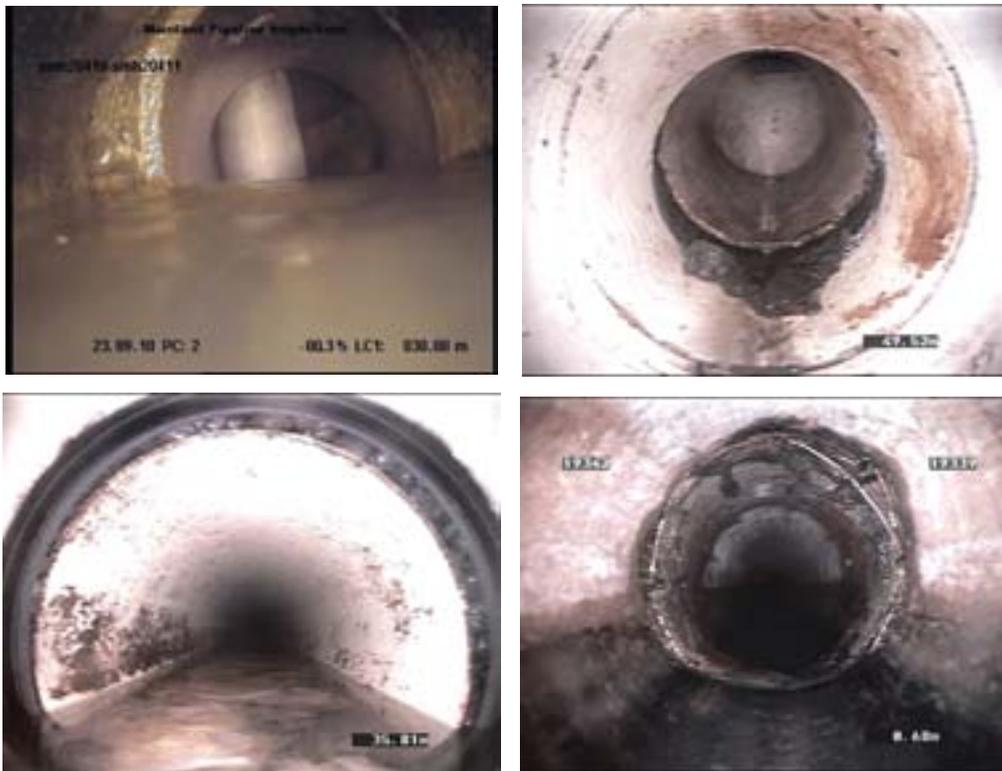
Figures 7-9 to 7-12 show typical images from CCTVs as to the type of damage within sewer pipes. The damage to brittle pipe is obvious. High volume infiltration of ground water, taking with it silts and sands of the streets, was problematical in the September 4 2010 earthquake, and an absolutely critical problem in the February 22 2011 earthquake.

Figure 7-9. CCTV picture of Broken Sewer, WDC

Figure 7-10. CCTV picture of Broken Sewer, WDC

Figure 7-11. CCTV picture of Broken Sewers, WDC

Figure 7-12. CCTV picture of Broken Sewers, WDC

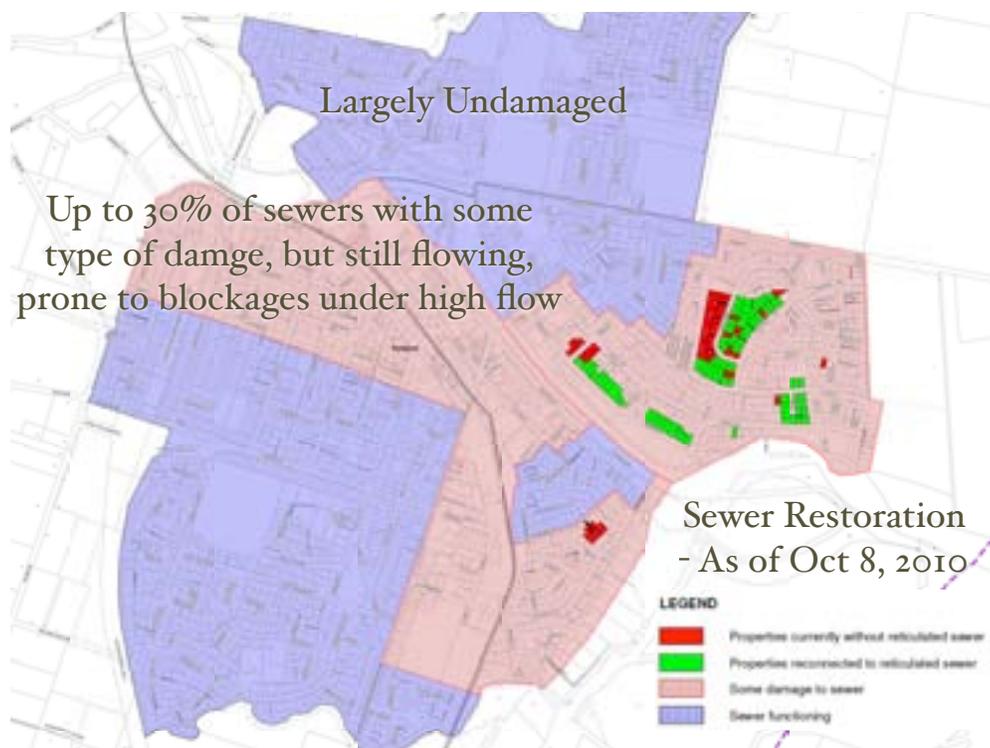
Figure 7-13. Map of Sewer Restoration, Kaiapoi, WDC, as of October 8, 2010

Figure 7-13 shows a map for Kaiapoi highlighting where the wastewater collection had failed and portable toilets were still in use 6 weeks after the earthquake; more than 200 structures were also so-affected in Christchurch. As of September 29, 2010, there were 150 customers in Kaiapoi and 50 in Pines Beach without any piped sewage service; with the remaining ~95% having piped sewage service.

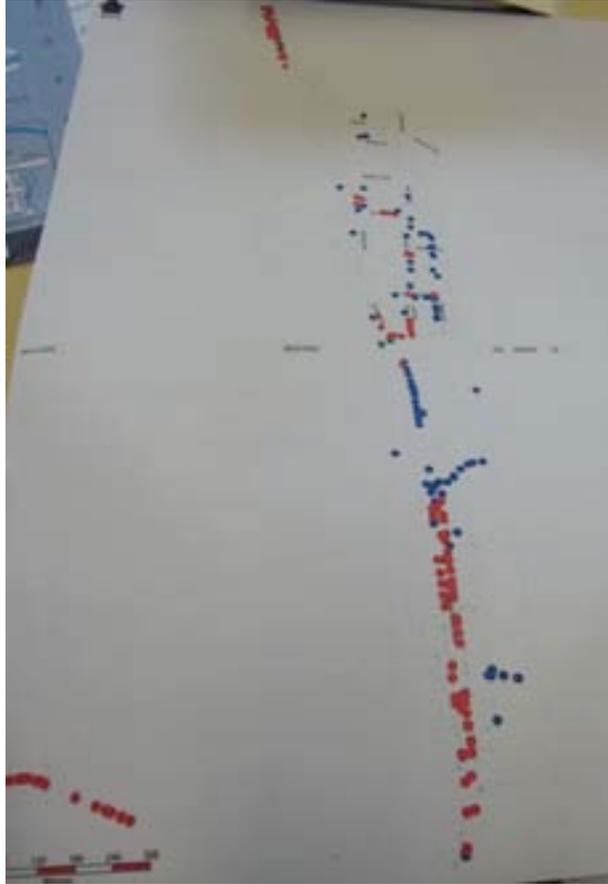
Figure 7-18. Pipe Repairs in Pine Beach

Figure 7-18 shows a map with the location of repairs made to water (blue dot), wastewater (red dot) or storm water (green dot) pipes in Pine Beach. It would appear that most of the Pines Beach community underwent some amount of liquefaction. Figure 7-19 shows a similar map for the main urban area of Kaiapoi.

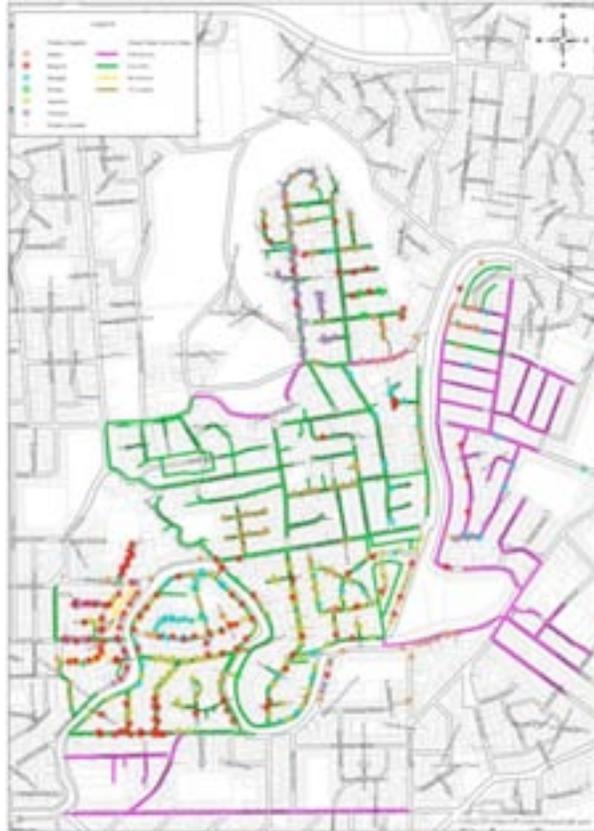
Figure 7-20. Portaloos in Service, October 11, 2010

Figure 7-20 shows the locations where portaloos were in use as of October 11, 2010, in the Dallington / Avonside / Burwood area of Christchurch. The colored dots reflect the agency that provided the portaloos (numbers indicate the number of portaloos at the site). The color road lines indicate roads where sewage service has been fully restored (blue), partially restored (green) or remained out of service (yellow). Figures 7-21 to 7-26 show similar information for the Bexley, Brooklands, Hallswell, South New Brighton / Southshore, Spencerville and Kainga areas. It would be reasonable to assume that all streets indicated by colored lines in these four maps suffered at least 1 inch, and in many cases several inches, or settlements at depths of the sewers (commonly 3 meters deep). Damage maps of the non-seismically-designed sewer pipes, coupled with those for non-seismically-designed water pipes, can be used to construct updated high resolution liquefaction hazard maps for Christchurch.

- Portable toilets were placed outside houses that lost sewer service, generally one portable for two houses (Figure 7-20).
- By October 15, small tanks were installed on berms or in front of properties without sewer service, where the sewer mains were so badly damaged that they cannot be repaired. These portable tanks were attached to the sewer from the house, to allow the households to use internal toilets, showers and washing machines. By October 15, 37 households had these tanks installed, and the goal was to install these tanks for all 235 households still out of service. Five crews worked on this effort

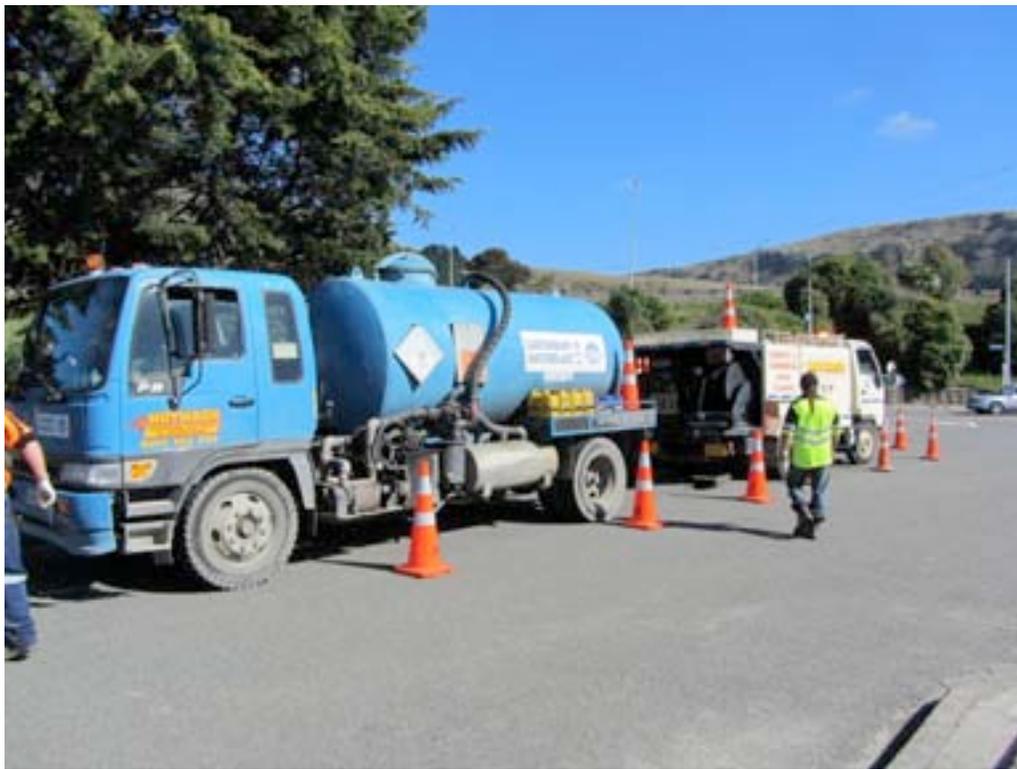
Figure 7-27. Crew flushing sewer pipes.

Six percent, or about 96 km of the collection pipes were not working, with a further 27%, or 474 km, working only slowly. As of early April, 2011, CCC had 92 trucks flushing sand out of the collection pipes, and 11 crews putting cameras through pipes to survey the damage. Figure 7-27 shows a crew working to flush sewer pipes with a water jetting method. The jetting cleans the pipes and cameras are deployed after the jetting process to inspect the pipes. Waste from this process is hauled in trucks and disposed at the WWTP. At locations where large sewer pipe breaks occurred, the jetting process sometimes effectively mined the sand from the ground surrounding the pipes and resulted in sink holes in the roadway above. Some cars have fallen into sink holes. The process was modified to reduce the possibility of creating sink holes by monitoring the rate of progress of the jetting holes, when the rate significantly slows the crews stop the jetting and report a location of potential significant damage.
