CHRISTCHURCH, NEW ZEALAND EARTHQUAKE SEQUENCE OF M_w 7.1 September 04, 2010 M_w 6.3 February 22, 2011 M_w 6.0 June 13, 2011: LIFELINE PERFORMANCE

**Technical Council on Lifeline Earthquake Engineering
Monograph No. 40
February 2012 – Revision 0
ASCE**

ABSTRACT

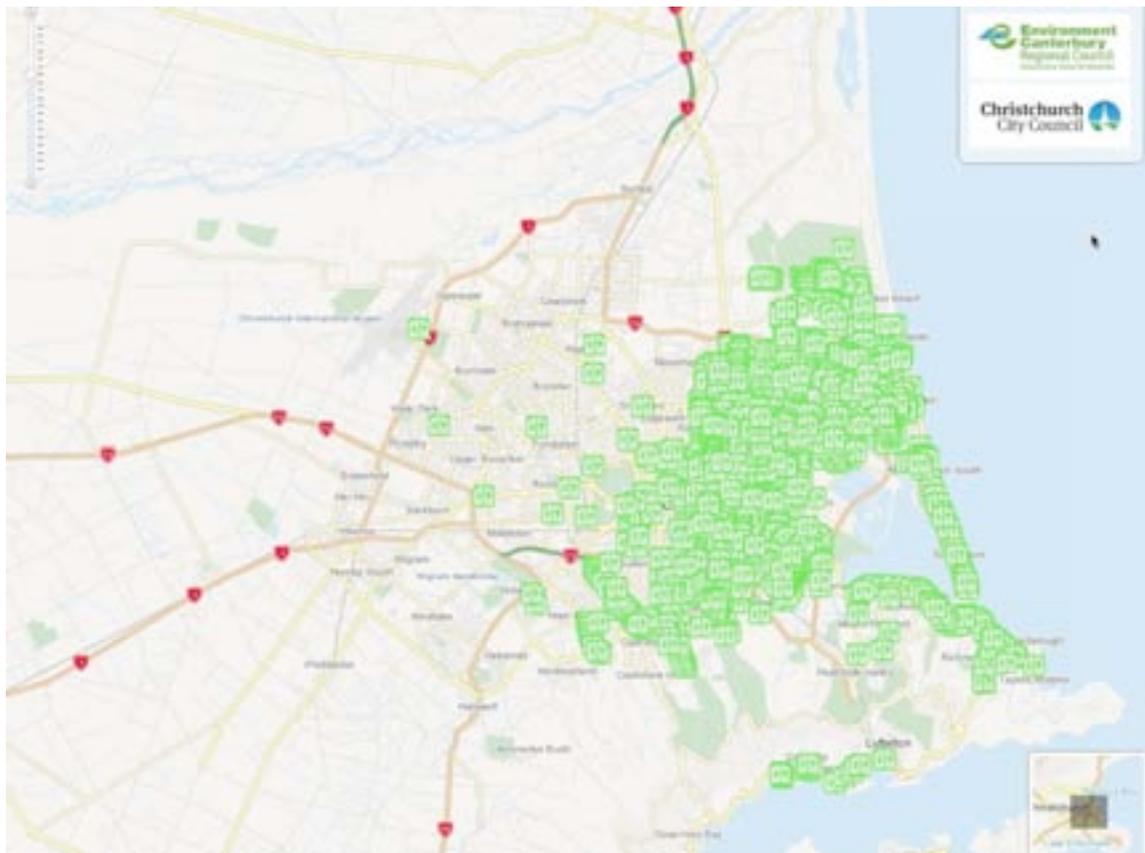
Figure 7-28. Portaloos in Service, March 2011

For residents in eastern Christchurch, the use of chemical toilets and portaloos was common as of April 3, 2011. Figure 7-28 shows the deployment of portaloos. Figure 7-29 shows deployed chemical toilets and portaloos. About 30,000 chemical toilets have been placed in homes and in excess of 10,000 Portaloos mobilized. At the time of the February 2011 earthquake, Kaiapoi still had portaloos being used since the Sept. 2010 earthquake; although very few, if any, portaloos remained in Christchurch as a result Sept. 2010 earthquake.

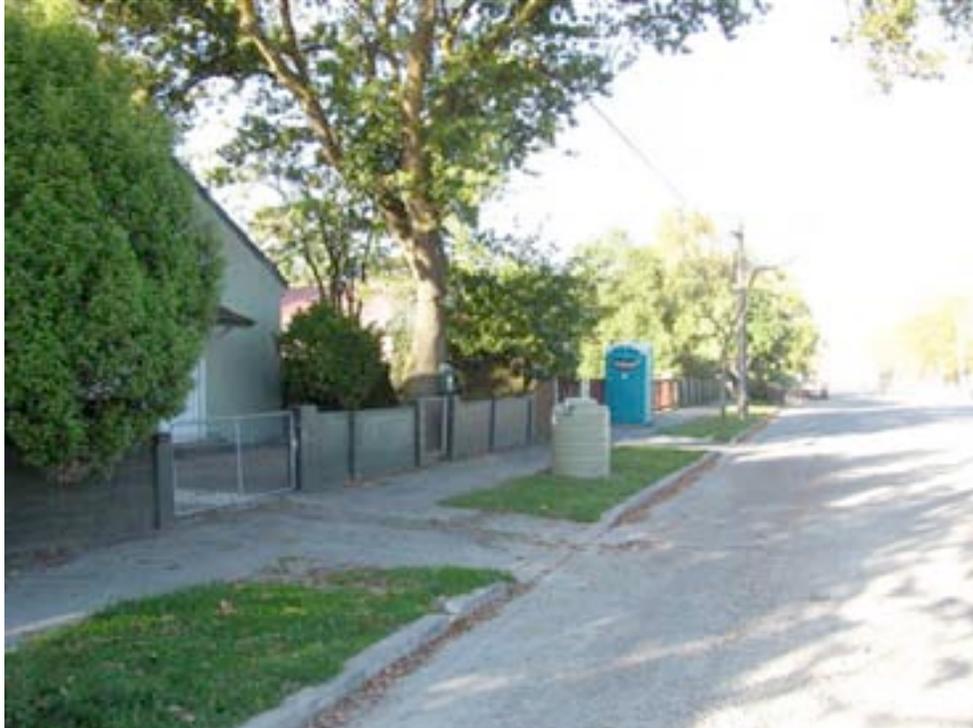
Figure 7-29. Portaloos and chemical toilet tank deployed in residential neighborhoods.

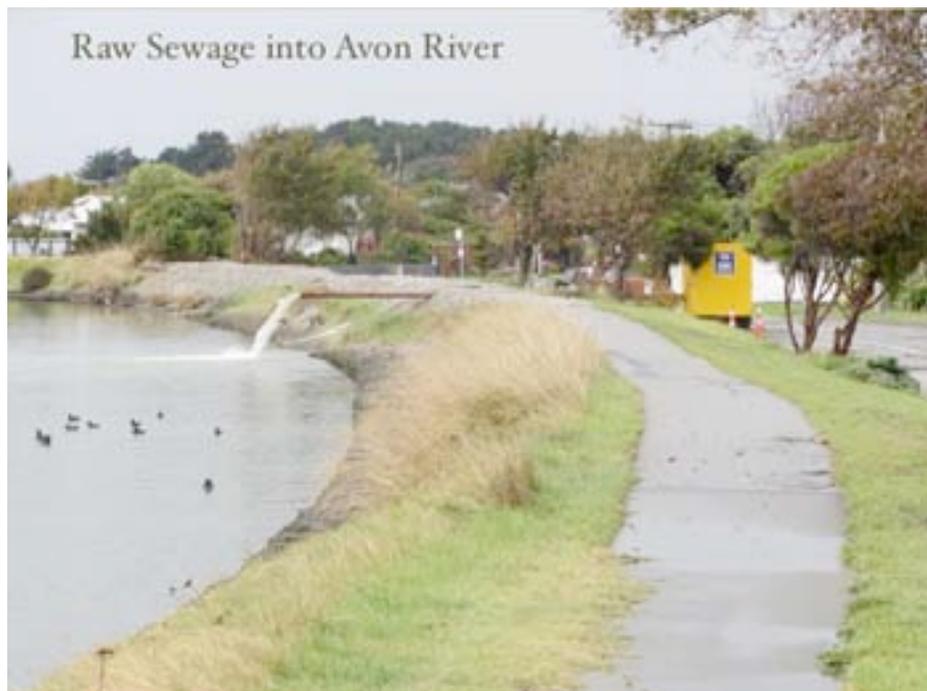
Figure 7-30. Raw Sewage in Local River, April 2011

Figure 7-30 shows raw sewage being spilled into the Avon River (note the ducks). The sight of solids floating on the river surface has been judiciously cut-out of the images in this report.

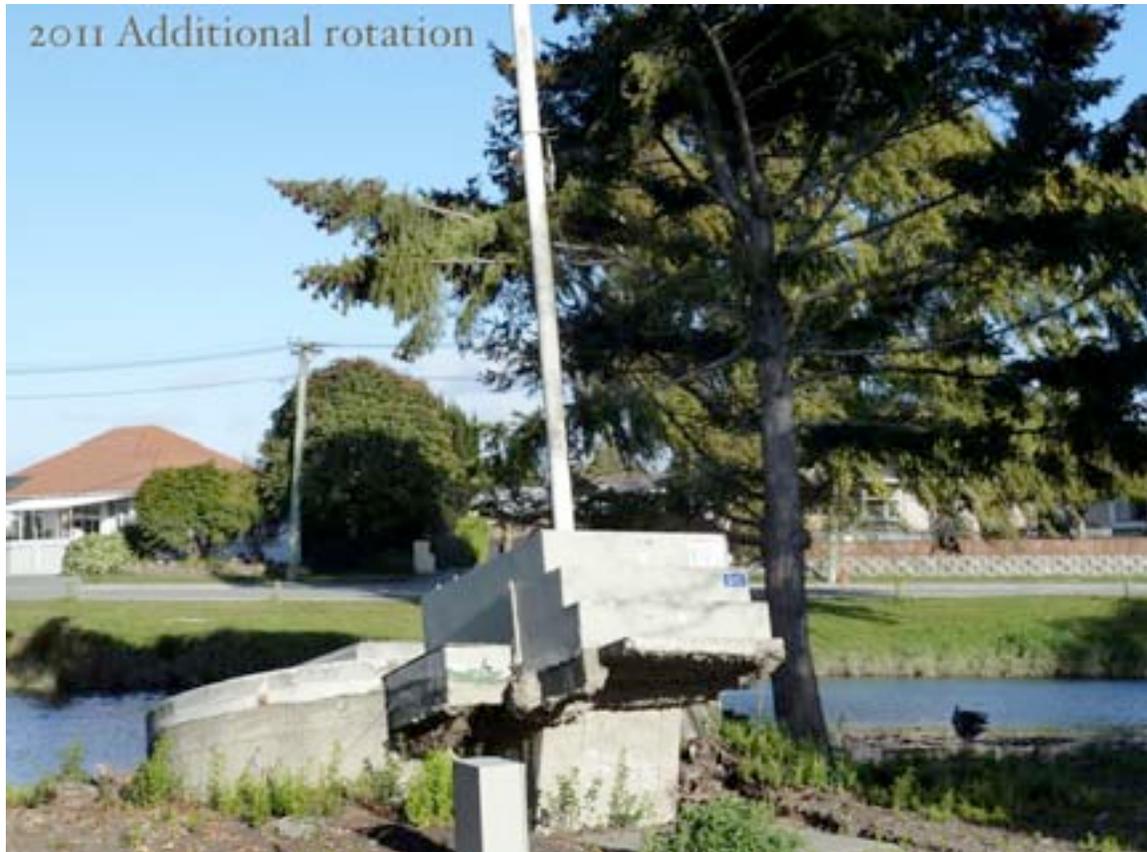
Figure 7-31 shows the additional movement of a sewer dry well lift station, due to the February 2011 earthquake. Compare this with the movement of the same lift station from the September 4 2010 earthquake, Figure 7-4.

Figure 7-31. Rotation and Sewer Lift Station, April 2011 (see Fig 7-4 for Comparison)

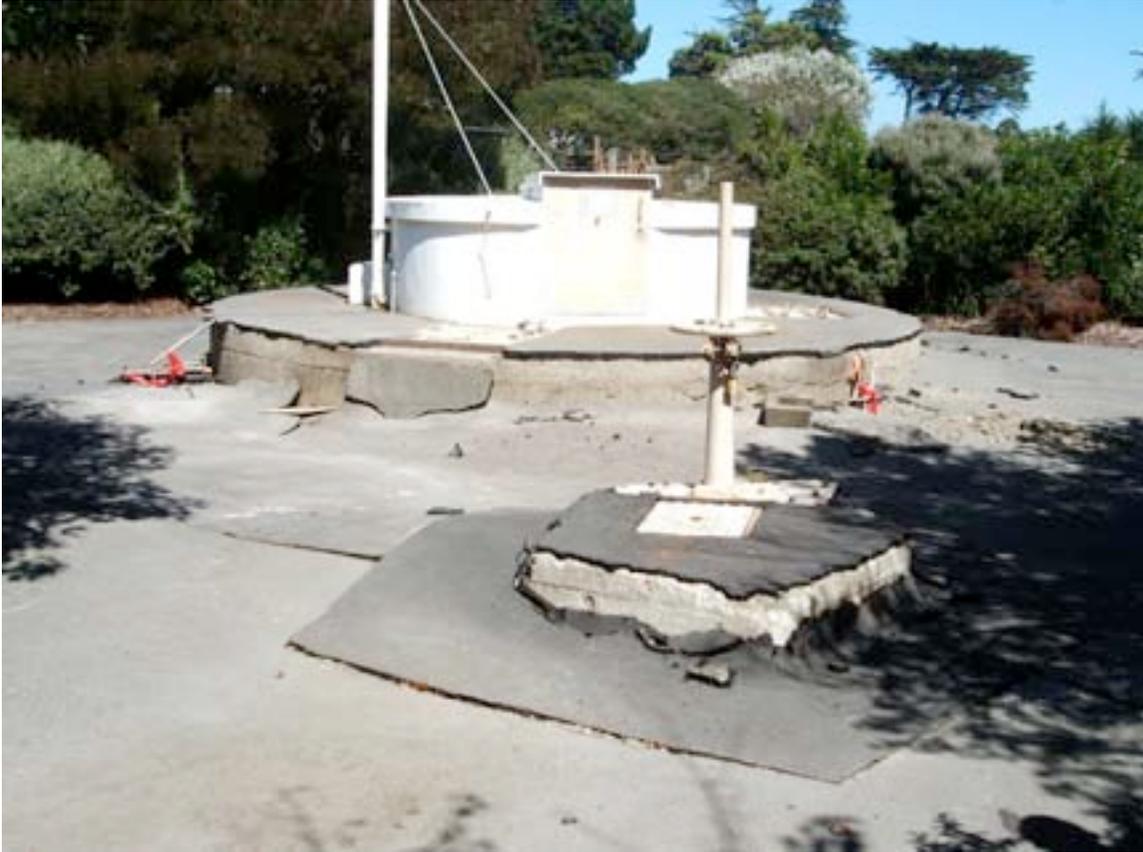
Figure 7-32 shows another dry well lift station that floated in the February 2011 earthquake. Several other dry well pumping stations floated during the February, 2011 earthquake due to the more extensive liquefaction. The total uplift between the two earthquakes at some stations was measured at about 0.6 m and could exceed a meter at other stations.

Figure 7-32. Flotation of Sewer Lift Station, April 2011

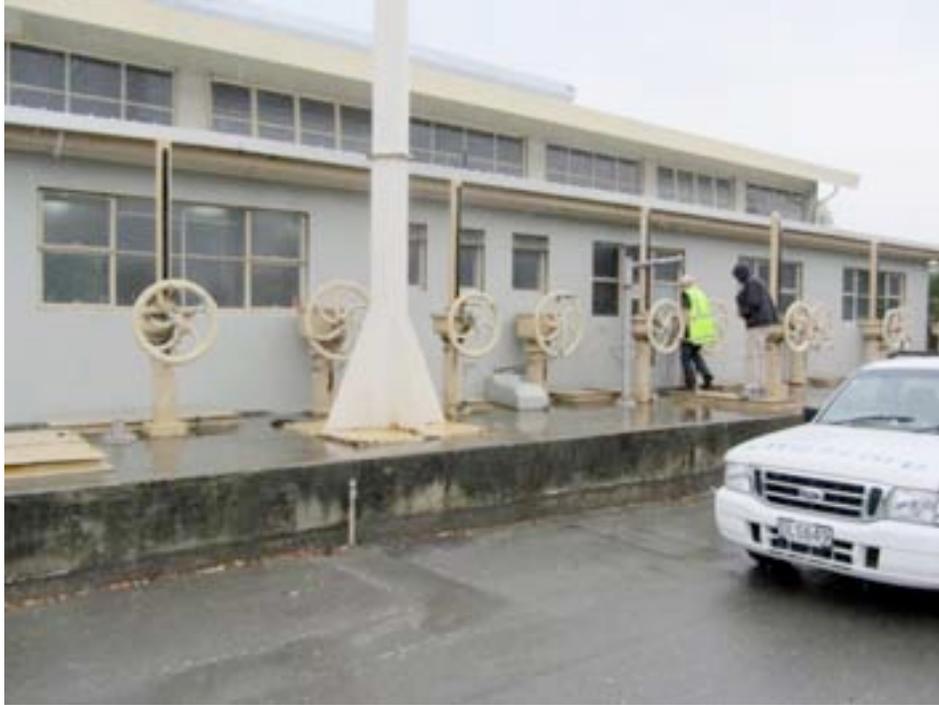
Figure 7-33. Pages Road Pumping Station.

Figure 7-33 shows the Pages Road Sewage Pumping Station. The pump station site suffered severe liquefaction. The suction well floated about 4" to 6" and connections with the sewage pipes broke outside the station, but the pumps and internal piping remained functional. Measurements on the outside indicated differential movements of 4" to 10" across the entire building. There were no flexible connections for piping at this station. Figure 7-34 shows the interior wall differential movement.

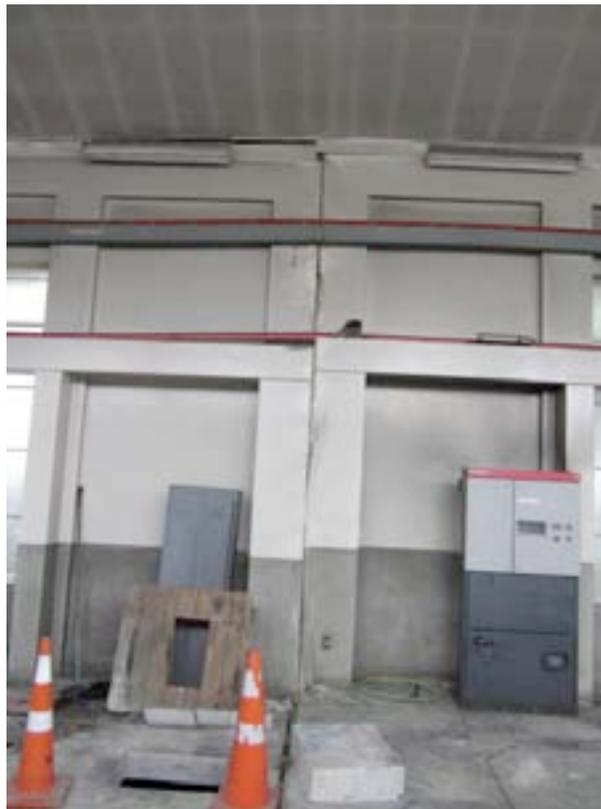
Figure 7-34. Pages Road Sewer Pumping Station differential movement.

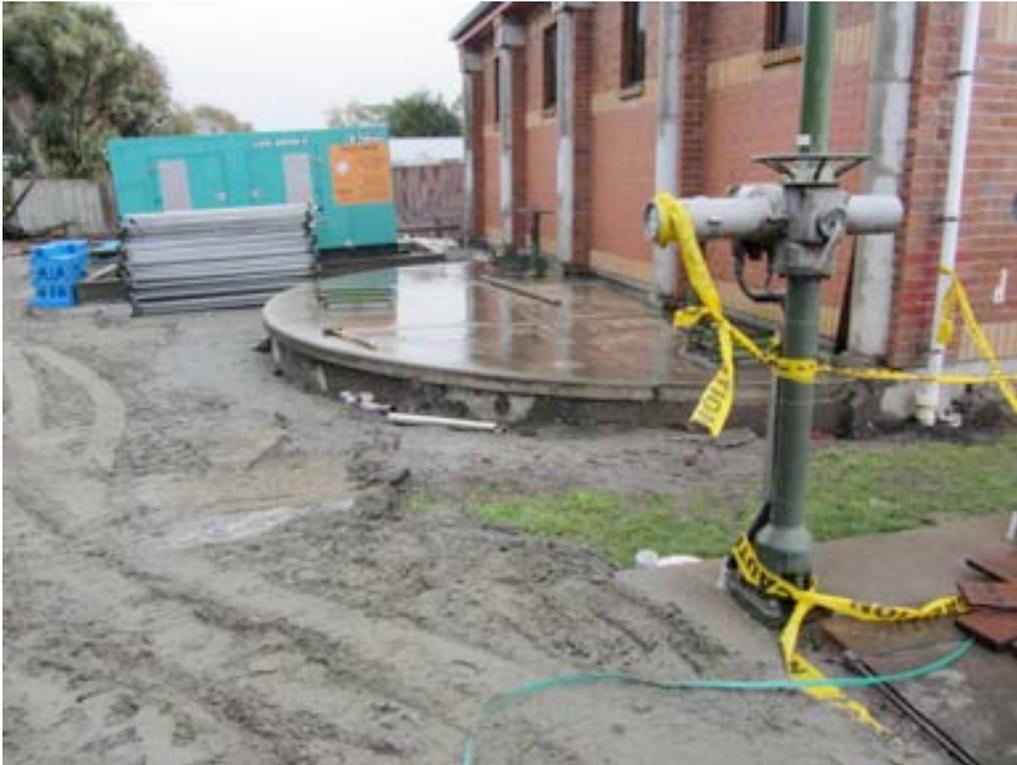
Figure 7-35. Sewer Pumping Station No. 36

Figure 7-35 shows uplift of the suction well at sewer Pumping Station No. 36. The concrete pumping station was not damaged by the earthquake, but liquefaction in the area damaged the inlet and outlet pipes and kept the station from functioning. CCC began sucking sewage from the wet well to dispose of the sewage in a truck. As they were sucking out the sewage the wet well began to float (should have been no surprise!)

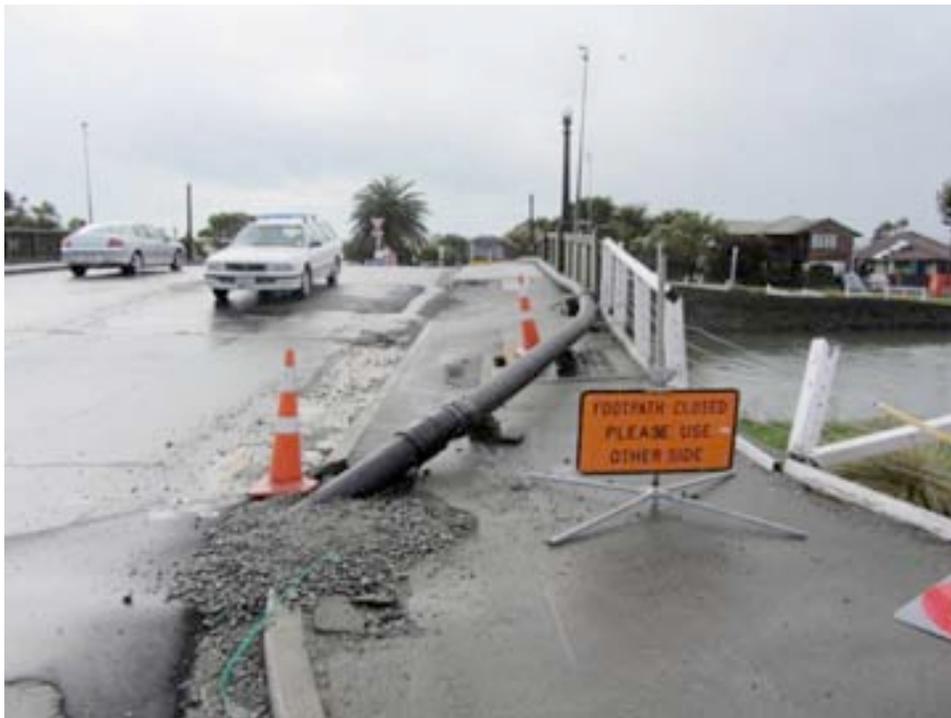
Sewer pipelines were damaged at bridge crossings where the bridge abutments were damaged by lateral spreading. Figure 7-36 shows a HDPE pipe used as a temporary bypass line placed overtop of the Brighton Bridge.

Figure 7-36. Sewer pipe bypass over the Avon River at Brighton Bridge.

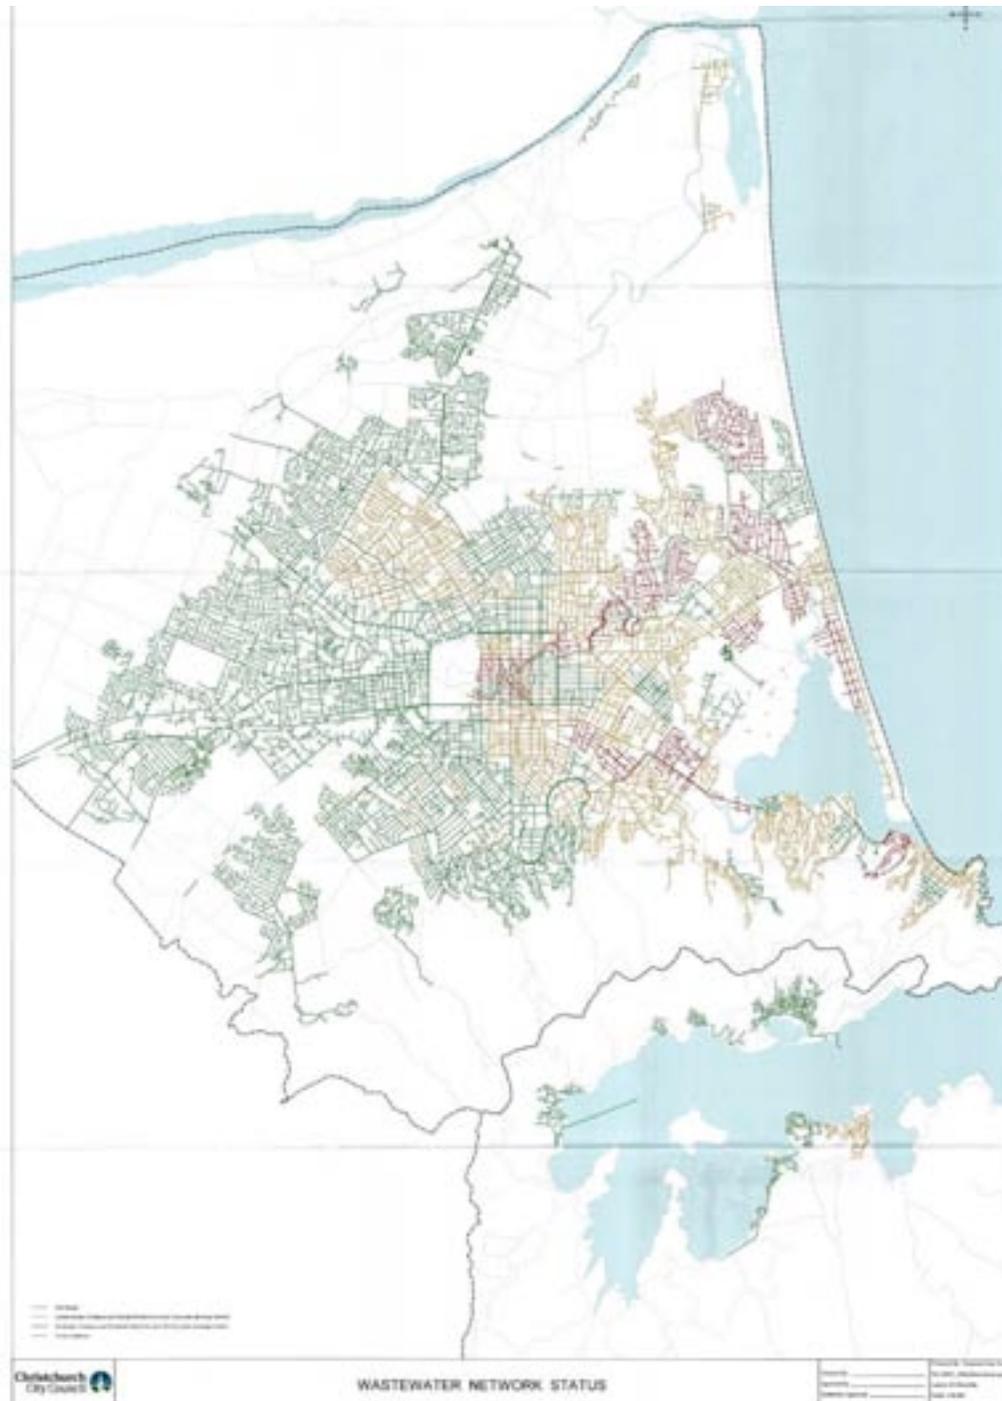
Figure 7-37. Wastewater pipe network status

Figure 7-37 shows the sewer system network status as of April 2, 2011. The green lines identify pipelines that are fully functional. Yellow lines indicate pipes that provide limited service. Red lines show areas having no service, and brown lines are locations needing confirmation of their status.

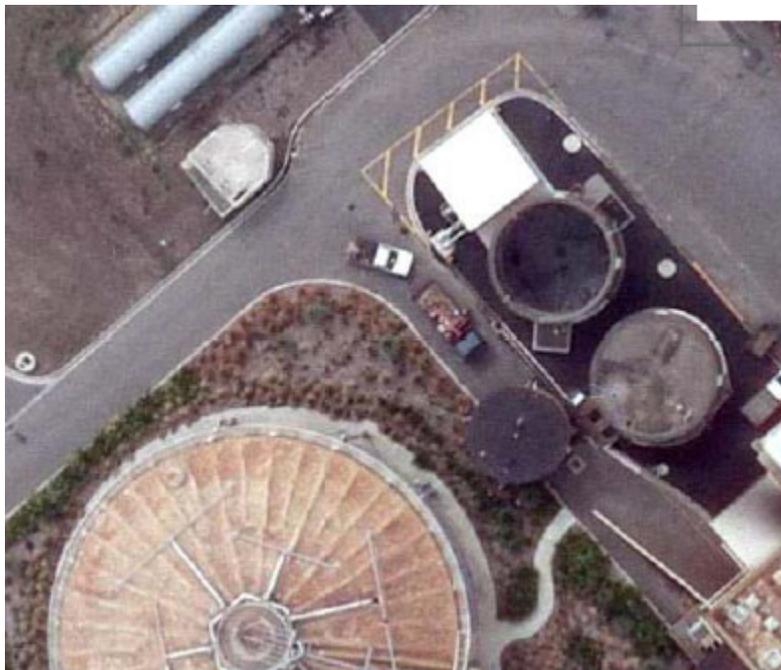
Figure 7-40. Aerial view of digester tanks at Bromley WWTP

Figure 7-38 shows the process flow diagram for the Bromley WWTP. Figure 7-39 shows an aerial view of the WWTP following the February 2011 earthquake. Figure 7-40 provides a close up from the aerial above the digester tanks showing how one of the two tanks had its roof thrown off during the earthquake.

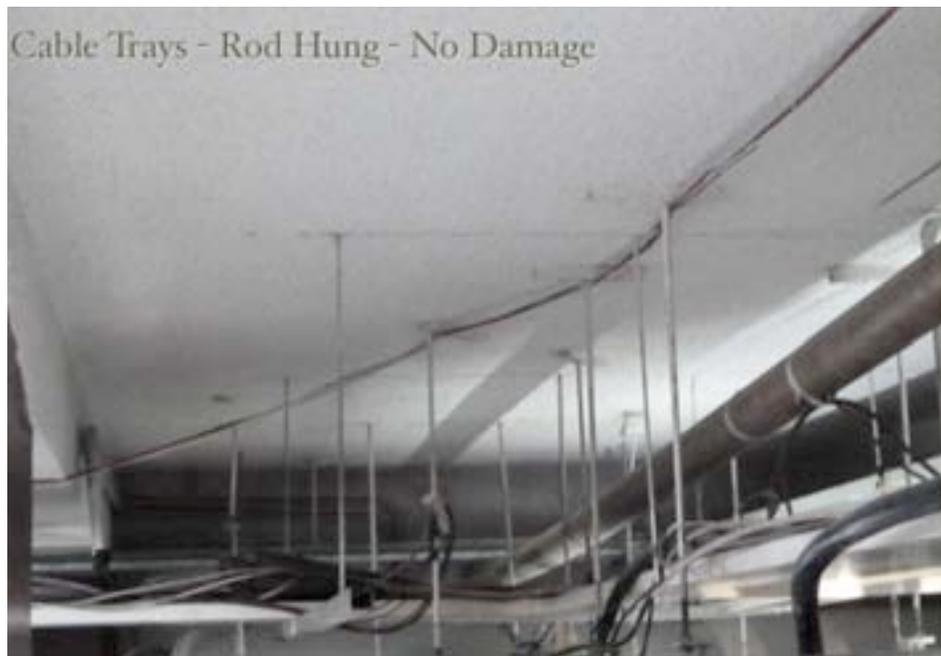
Figure 7-42 shows a cable spreading area at the Bromley WWTP. While the facility shook with $PGA = 0.5g$, there was no damage to these rod-supported trays and pipes; showing that intelligent New Zealand engineers have recognized the wastefulness of ASCE 7 2010 and related non-structural code that would require seismic lateral braces in such a situation.

Figure 7-42. No Damage to Rod-Hung Cable Trays, Bromley WWTP

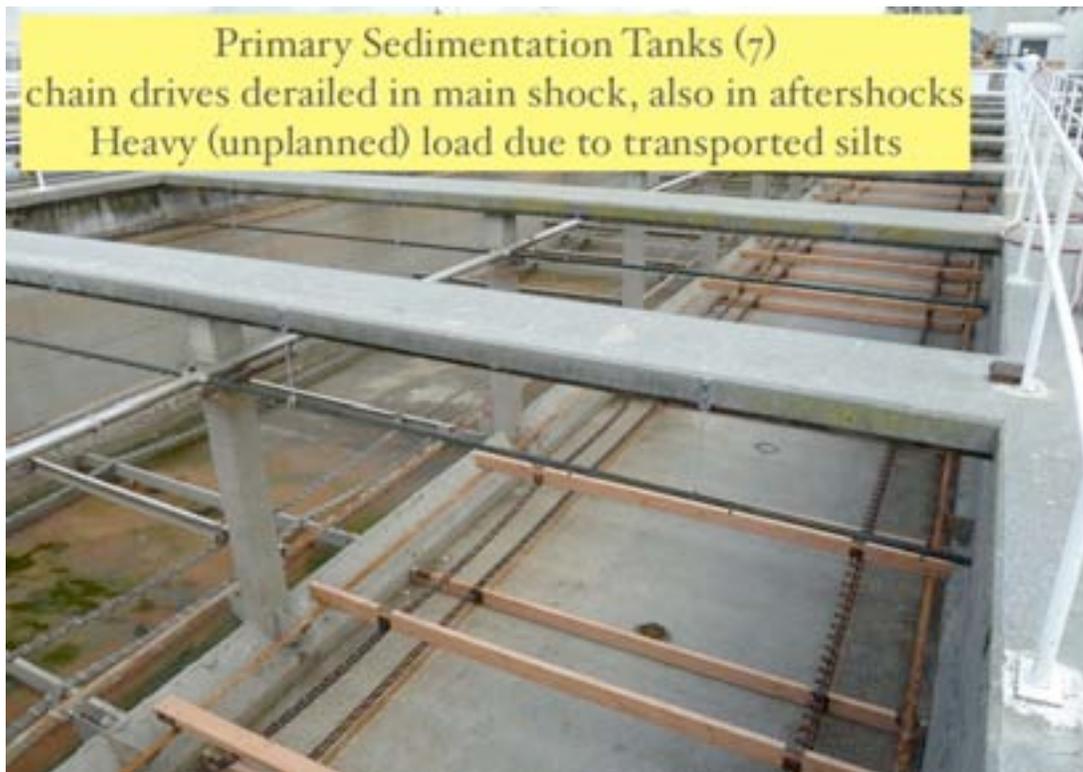
Figure 7-43. Scrapers, Bromley WWTP

Figure 7-43 shows damage to the scrapers in the primary sedimentation tanks. The tank on the right has wood scrapers, reflecting that the original metal channels have buckled and failed. This photo was taken in April 2011, while repairs were being made to these basins.

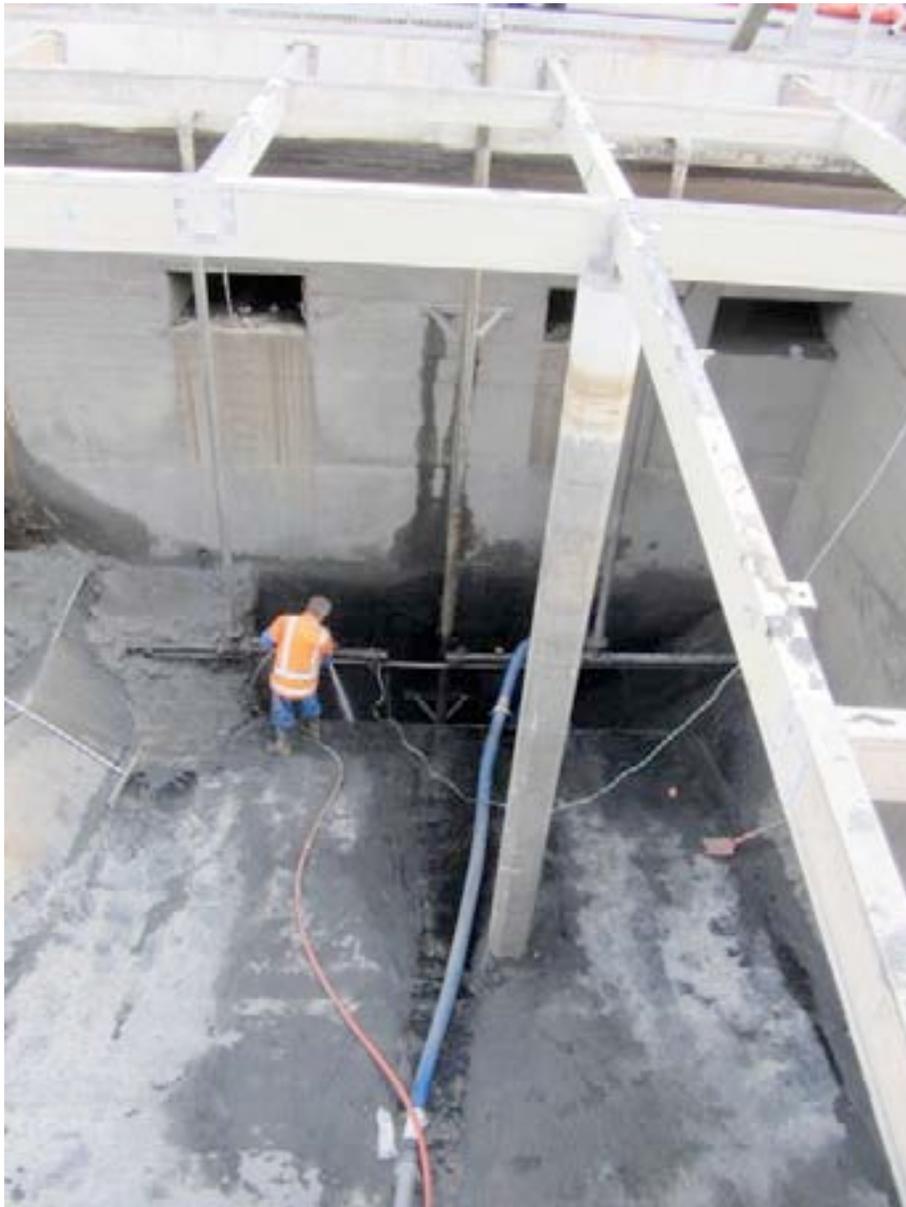
Figure 7-44. Grit Chamber cleaning, Bromley WWTP

Figures 7-44 and 7-45 show workers cleaning sand from the grit chambers and the primary settling basins, respectively. These basins were reportedly completely filled with

sand and were at the end of cleaning at the time of photos taken in early April 2011. The depth of sand reached about 6 m completely filling the grit chamber in Figure 7-44 to the top water mark notable near the top of column. One set of grit chambers and primary settling basins were restored within about 1.5 to 2 weeks after the earthquake. Since then the plant has been working at about 1/3 capacity and the different sets of grit chambers and primary settling basins have been rotated between cleaning of sands and treating of sewage.

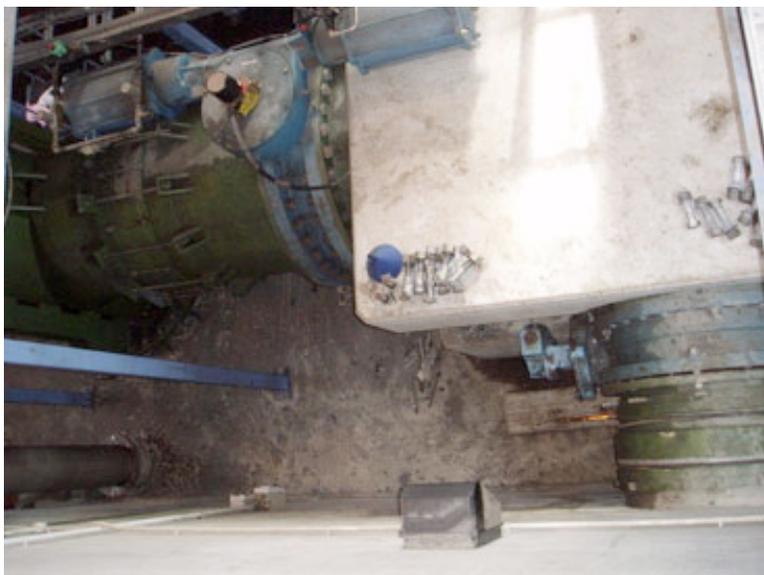
The Bromley WWTP has two pumping stations called Pumping Station A and Pumping Station B. There was no damage reported to pumping Station A. Pumping Station B had damage to a mechanical coupling shown in Figure 7-46 that allowed sewage to leak and fill up the station. The cause of damage to the coupling was not known as of April 2011, but is suspected to be from small differential movements, as observed during time of site visit.

Figure 7-46. Pumping Station B leak at mechanical coupling, Bromley WWTP

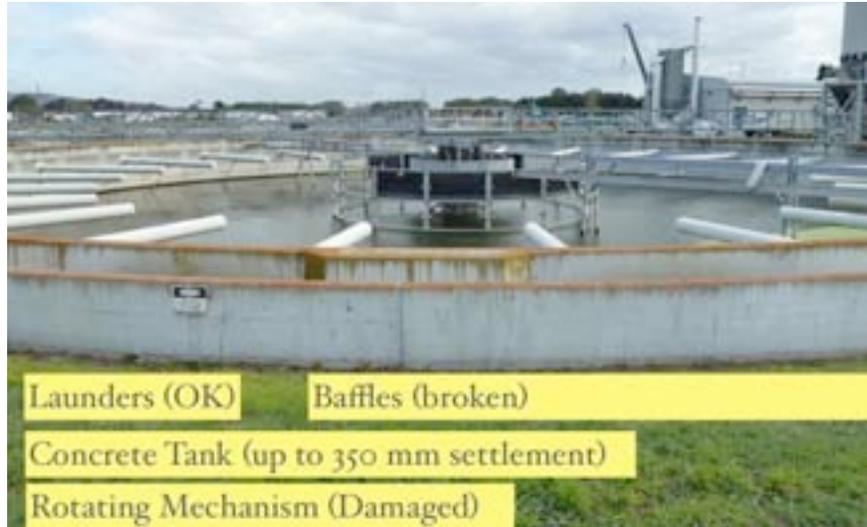
Figure 7-48 shows one of the four secondary clarifiers. Three of four clarifiers were heavily damaged, due to a combination of liquefaction and sloshing forces on the sludge mechanisms. CCC believes that some of the clarifier floors have experienced up heaving. Dewatering is necessary prior to emptying the tanks for inspections, thus significantly delaying ability to determine needed repairs/replacements. These will likely have to be rebuilt entirely.

Figure 7-48. Broken Secondary Clarifier, Bromley WWTP

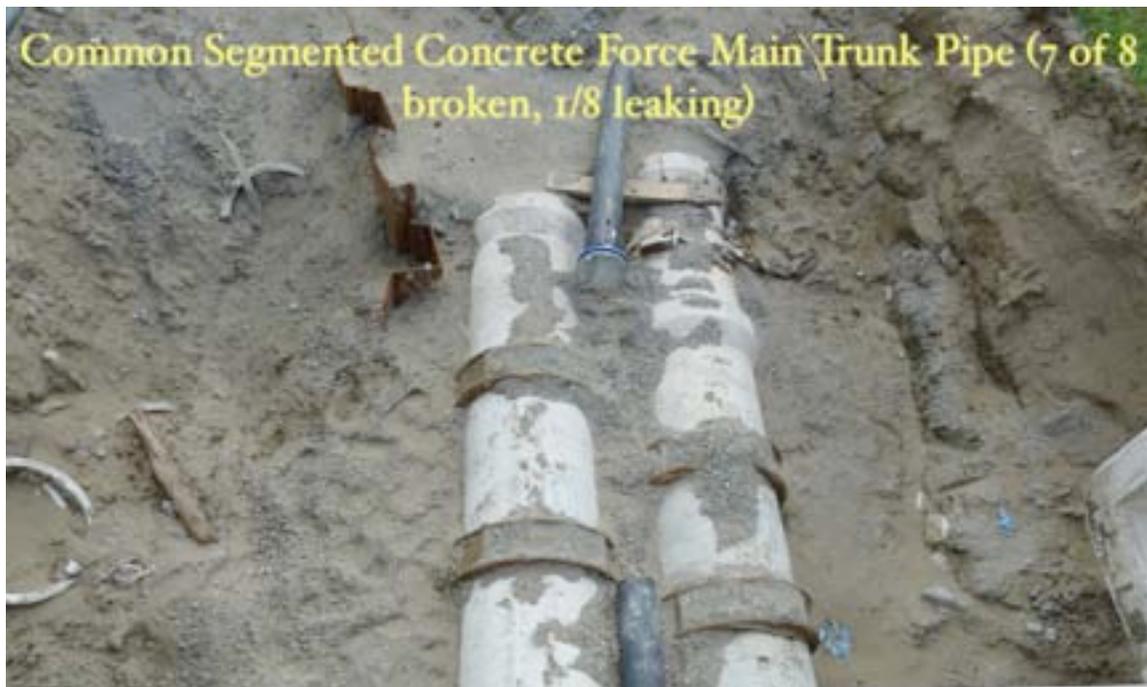
Figure 7-49. Broken Secondary Clarifier, Bromley WWTP

Figure 7-49 shows external clamps placed on leaking reinforced concrete pipes (3-foot diameter) at the WWTP.

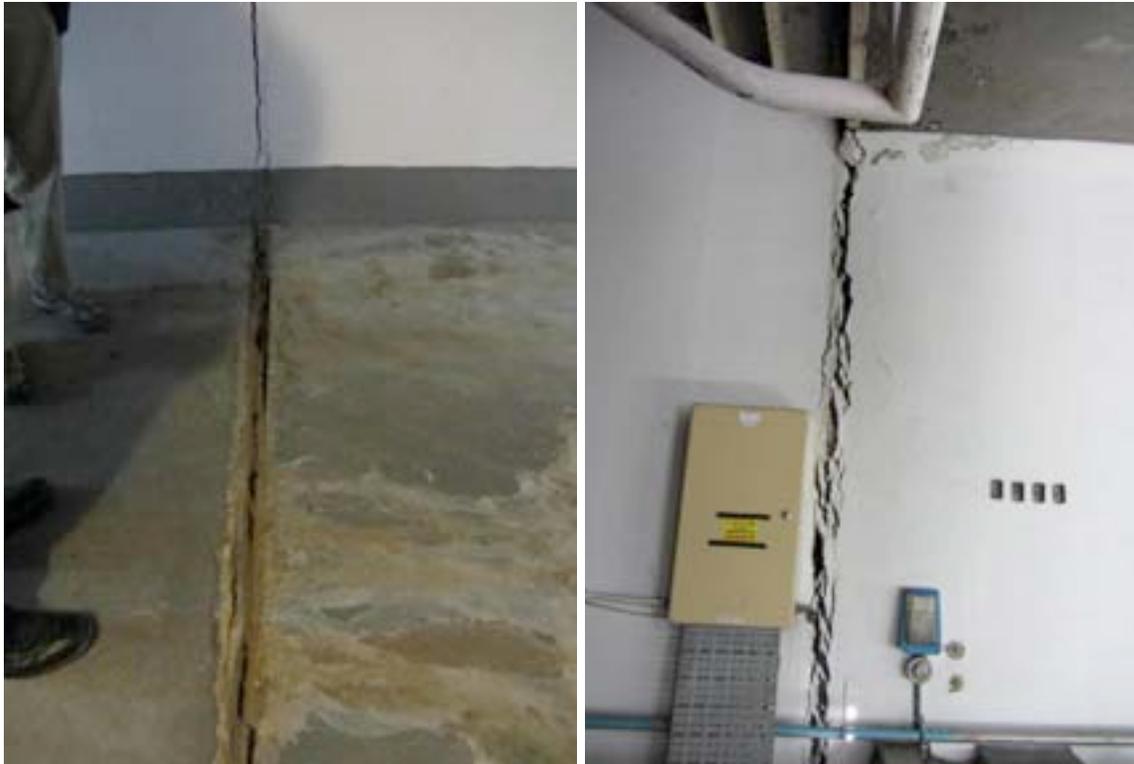
The Bromley WWTP has an underground corridor, called a gallery constructed of reinforced concrete, and used for housing piping and conduits. The gallery was damaged and separated at construction joints as shown in Figure 7-50. Water and sand flowed into the gallery through the drainage pipe system and the joint separations.

Figure 7-50. Gallery Damage, Bromley WWTP

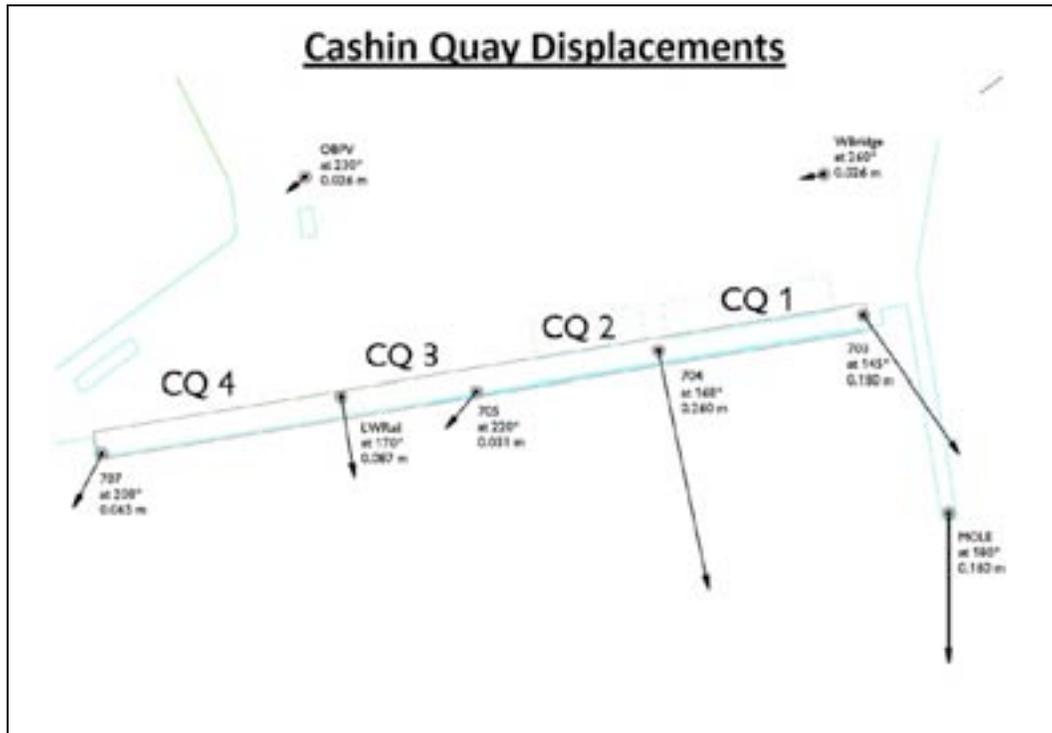
Figure 9-3. Cashin Quay Displacements

Quays 1, 2, 3 and 4 all underwent some permanent lateral movements, in the range of 5 cm to 18 cm, Figure 9-3. There is settlement behind these wharves. The moles sustained as much as 0.5 meters of settlement. There was slumping of the rubble mound sea wall at the oil berth.

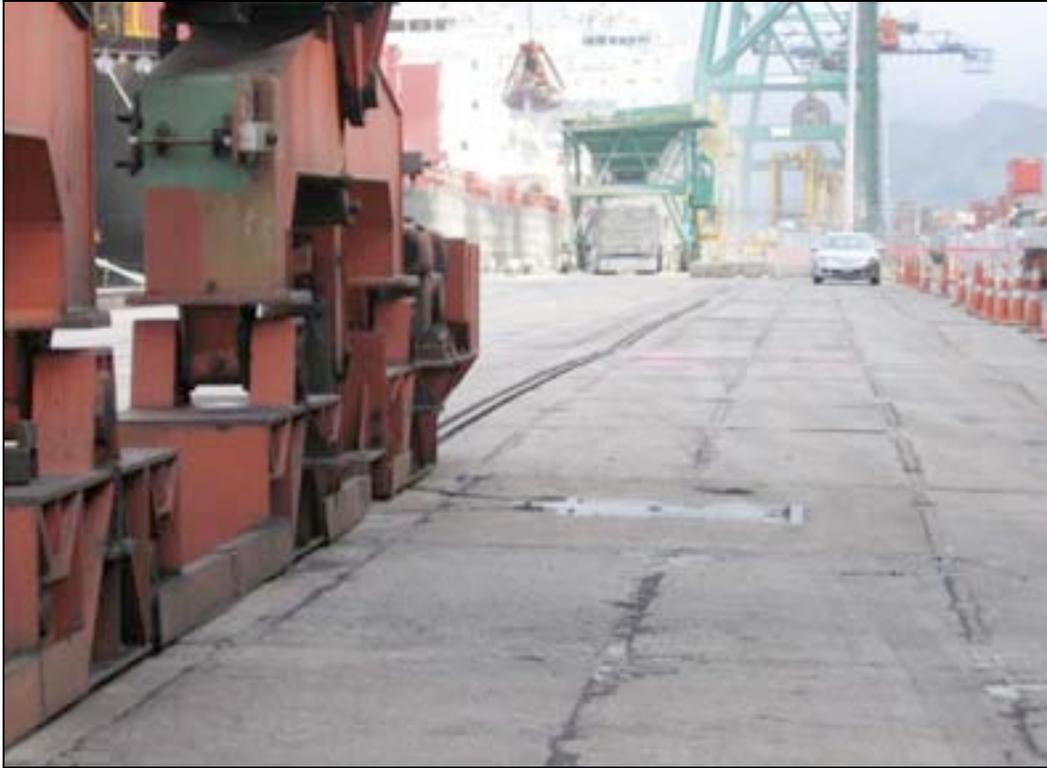
Figure 9-4. Cashin Quay 1 – Settlement of Deck

Figure 9-4 shows the settlements along the deck of Quay 1. This photo is taken looking towards the west, and the coal handling loader is in the left foreground. In the first few hours after the earthquake, in the spirit of precaution, coal loading onto adjacent boats was limited to avoid having to move the loading crane over the settled tracks; this did not adversely affect the ability to load the coal on September 4. By September 5, it was determined that it was feasible to move the coal loader over the displaced rails. The earthquake also damaged the coal conveyors, likely due to differential movement of the steel conveyor supports where they were supported on Quay 1 (with some PGDs, and on land (with no PGDs).

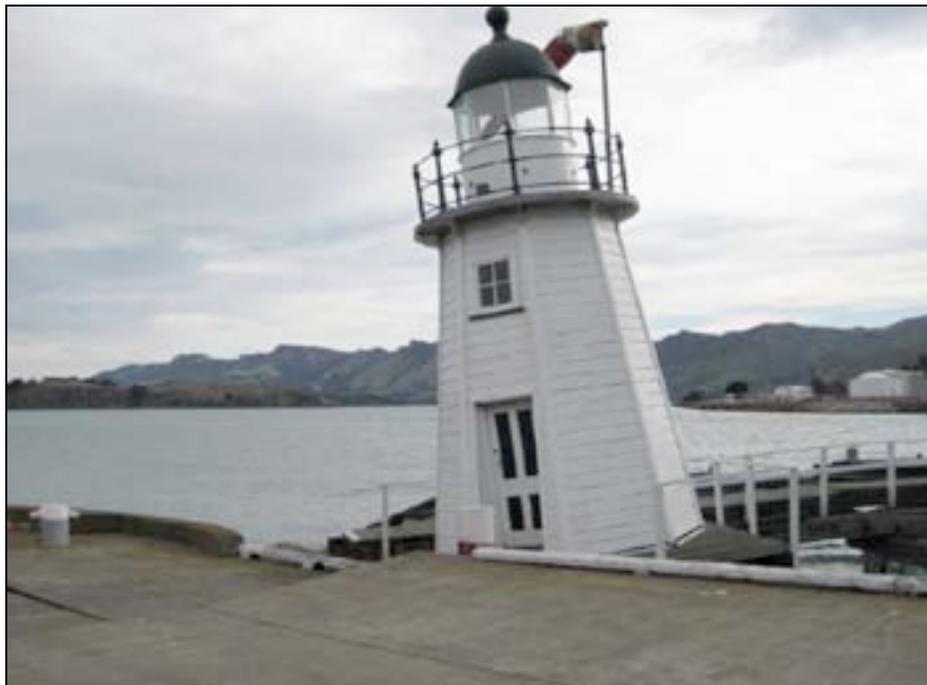
Figure 9-5. Lighthouse, Z Berth, Slumping of Eastern Mole

Figure 9-5 shows the lighthouse, tilted, at the end of the Z berth along the eastern mole.

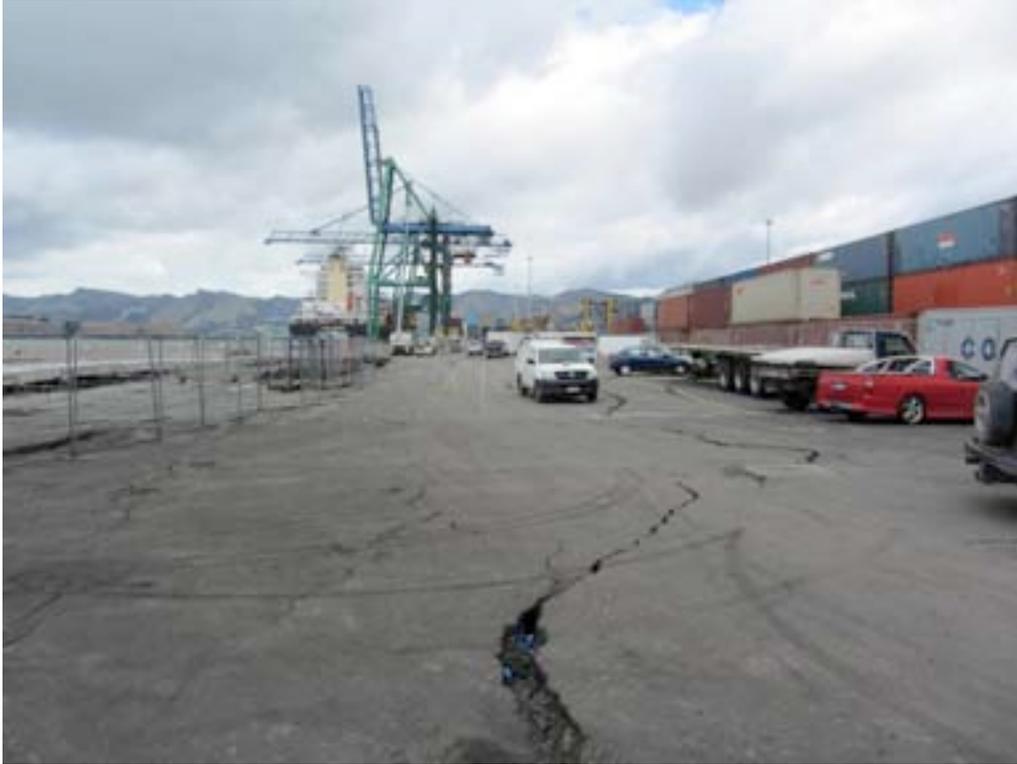
Figure 9-8 indicates CQ2 moved as much as 607 mm in both earthquakes (Sept. 2010 + Feb. 2011). Figure 9-11 shows the ground cracking that formed at CQ2. Figures 9-12 and 9-13 show damages to the piles and beams at CQ2.

Figure 9-11. Ground cracks at berth CQ2 (looking west).

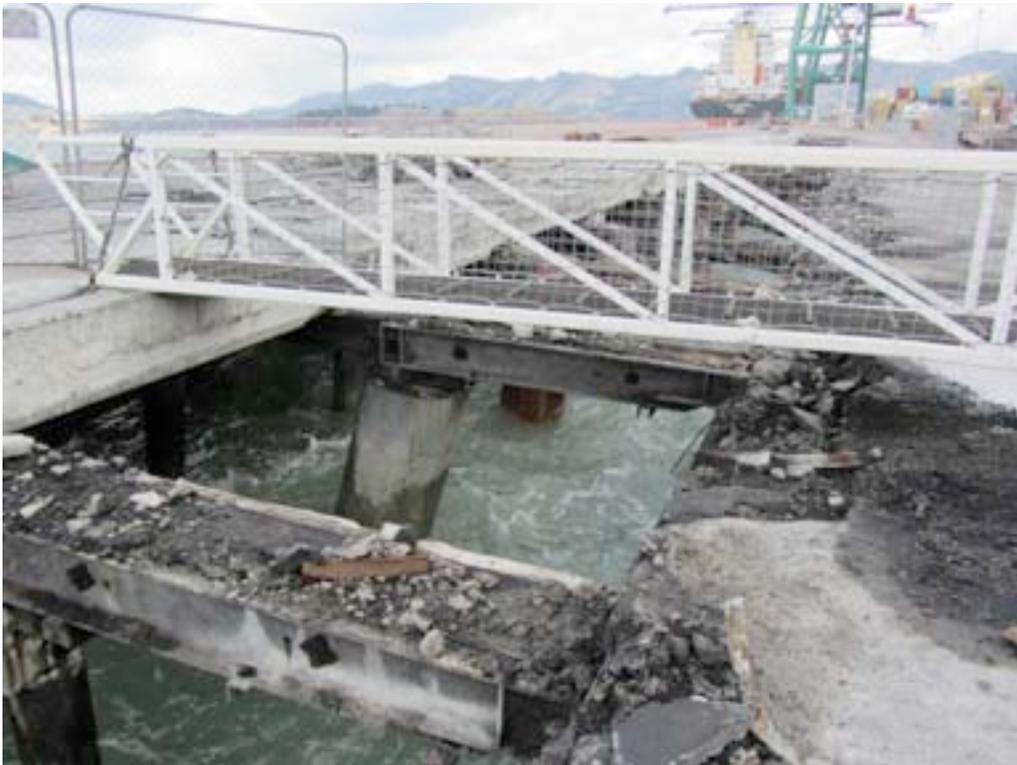
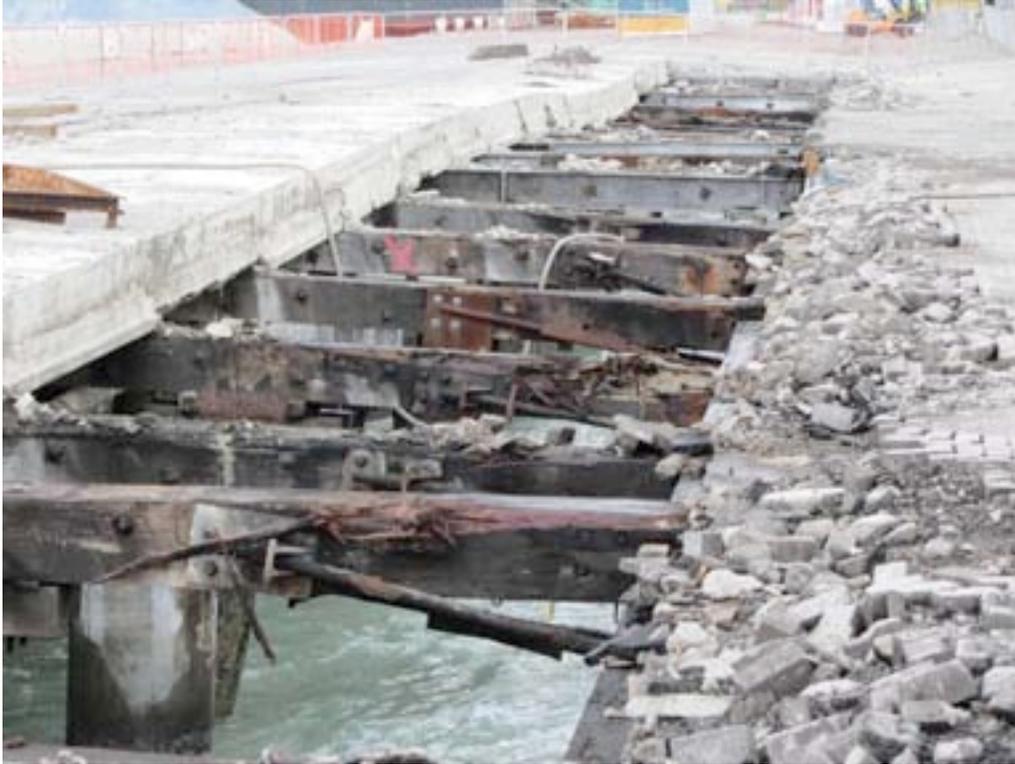
Figure 9-12. Damaged piles and beams at berth CQ2 (looking west).

Figure 9-13. Damaged piles and beams at berth CQ2 (looking west).

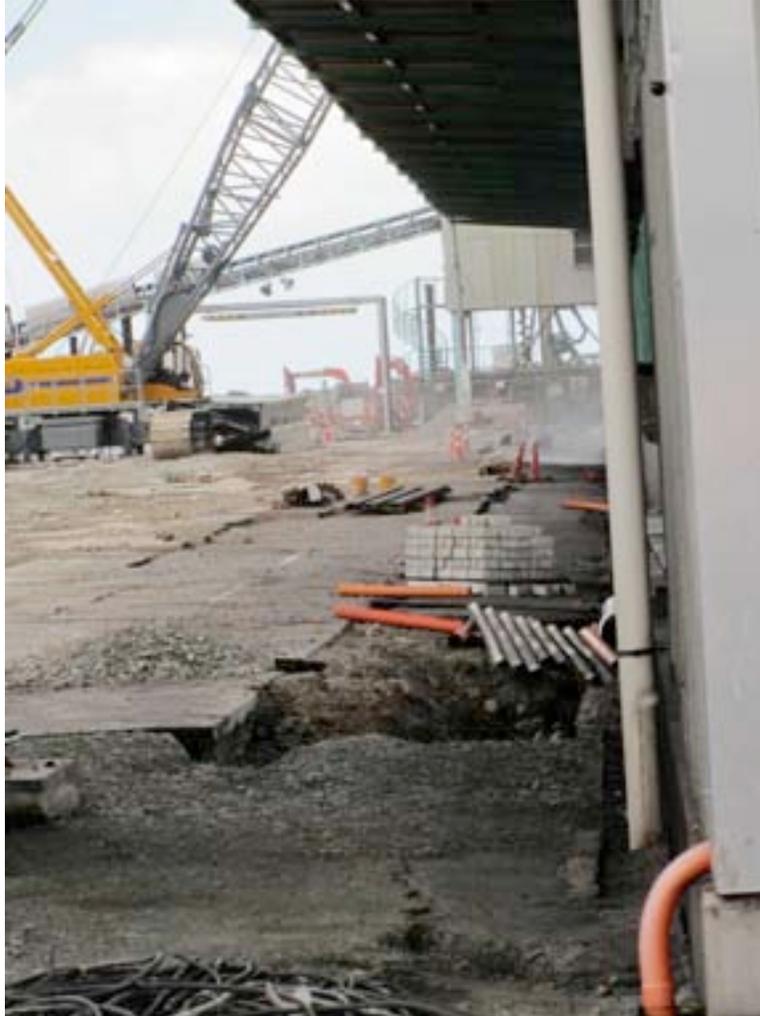
The coal gallery from CQ1 had a measureable permanent tilt. Figure 9-14 shows ground cracking, formed as part of the head scarp on the deep seated slide, on the north side of the coal gallery. Figure 9-15 shows damages to piles and beams at CQ1.

Figure 9-14. Ground cracks on north side of coal gallery at berth CQ1 (looking east).

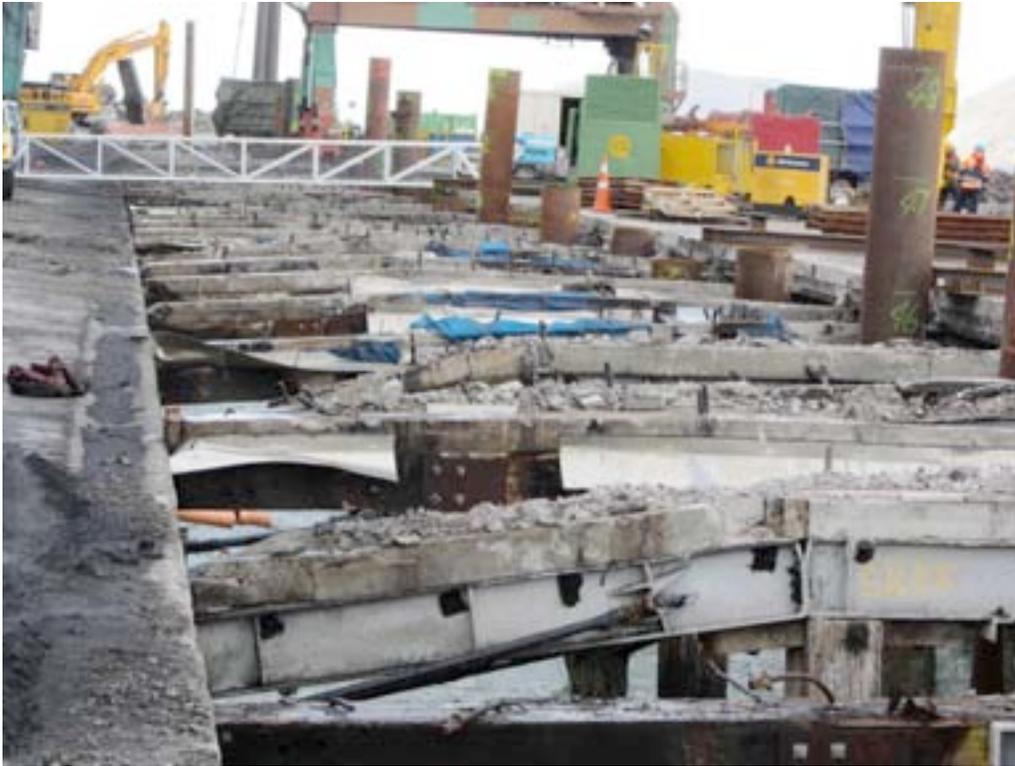
Figure 9-15. Damaged piles and beams at berth CQ1 (looking east).

The improvement work includes adding new 610 mm diameter steel pile tubes 50 m deep. The piles are being placed at 6 m on center. Improvements also include placing
