CHRISTCHURCH, NEW ZEALAND EARTHQUAKE SEQUENCE OF M_w 7.1 September 04, 2010 M_w 6.3 February 22, 2011 M_w 6.0 June 13, 2011: LIFELINE PERFORMANCE

**Technical Council on Lifeline Earthquake Engineering
Monograph No. 40
February 2012 – Revision 0
ASCE**

ABSTRACT

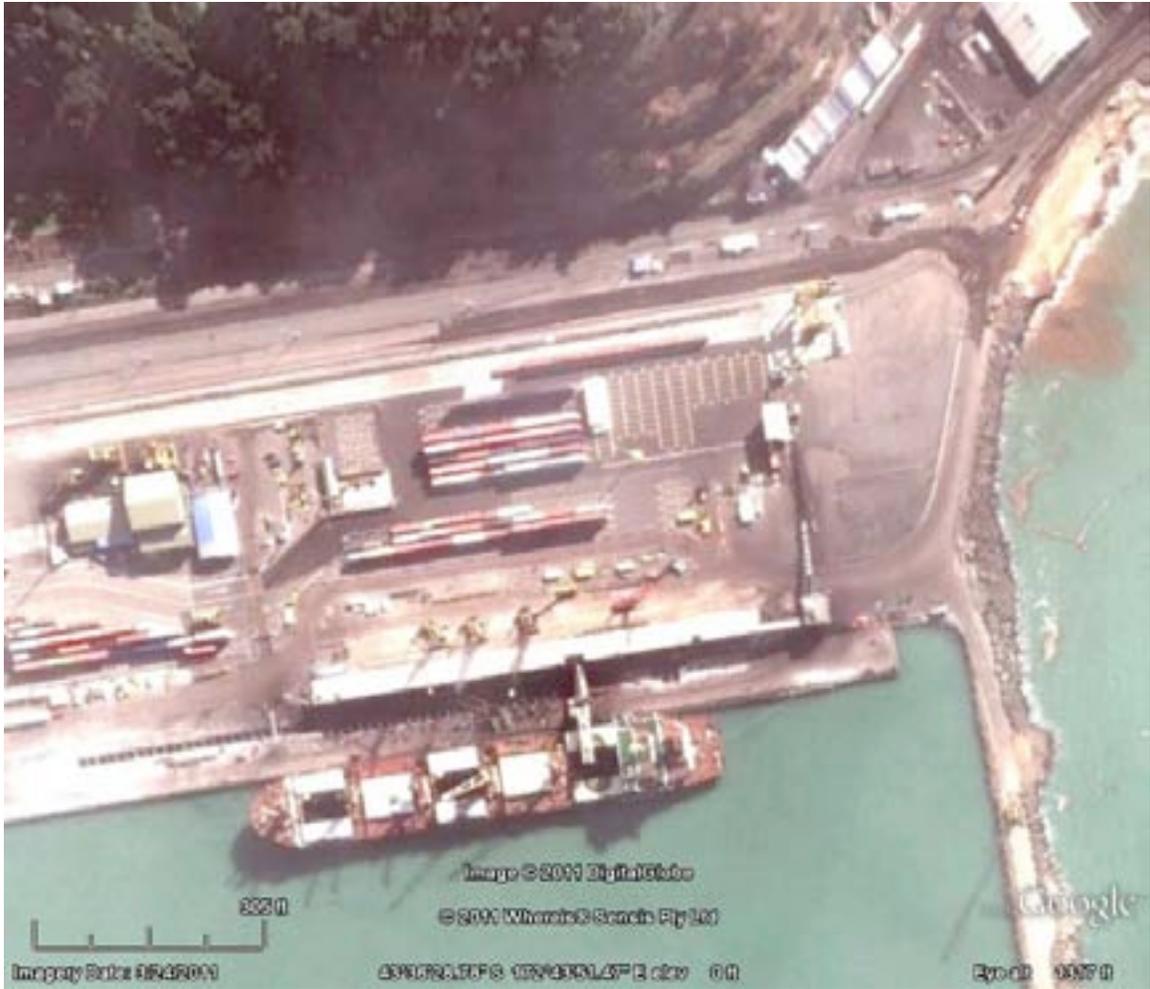
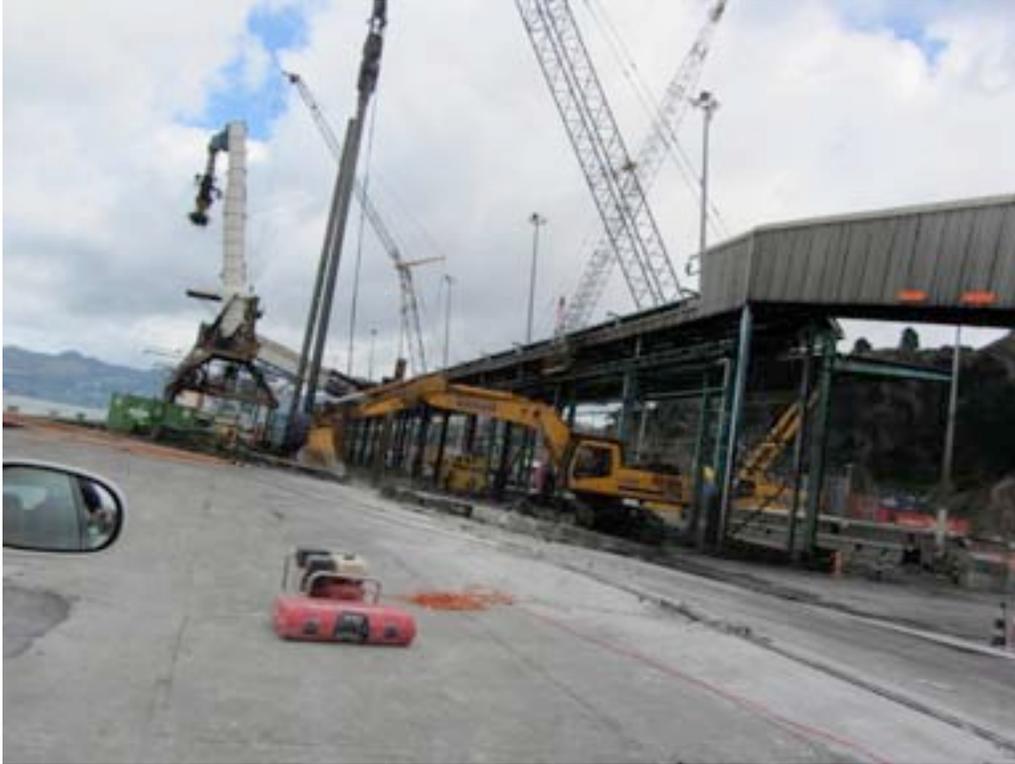
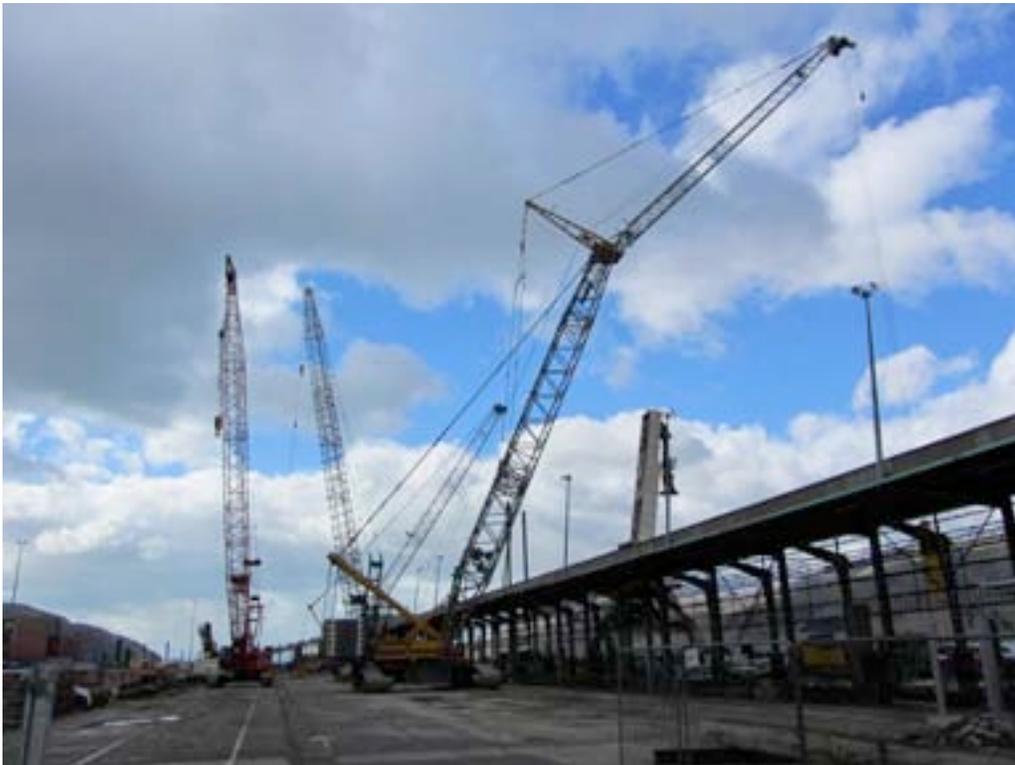
Figure 9-16. Satellite photograph showing construction underway at berth CQ1. Google Earth photo from 3/24/11.

Figure 9-17. Post-earthquake construction (April 2011) at berth CQ1.

Figure 9-18. Post-earthquake construction (April 2011) at berth CQ1.

The Lyttelton Port reports that after each earthquake event the critical Port services were restored within 96 hours. The wharf still works and is operable, but needs significant repairs and replacements. Figure 9-16 shows a satellite photograph taken shortly after the February 22, 2011 earthquake showing repairs and improvements underway at CQ1. As seen in Figure 9-17, many cranes are located at the port for post-earthquake construction activities. The port was able to mobilize these repairs and improvements nearly immediately after the February 22, 2011 earthquake because they had prepared an improvement plan following the observed damages from the September 4, 2010 earthquake. The damages sustained in February 2011 matched relatively well that expected from the evaluations performed after the September earthquake so the port mobilized to make the previously recommended improvements as soon as they could. This allowed them to acquire many of the large cranes in Christchurch, that were not being used at the time while others were determining what improvements and repairs were needed to infrastructure elsewhere in the area. Figures 9-17 and 9-18 show ongoing construction activities the first week of April 2011. Figure 9-16 shows that four large cranes were mobilized and in operation by March 23, 2011.

The improvement work includes adding new 610 mm diameter steel pile tubes 50 m deep. The piles are being placed at 6 m on center. Improvements also include placing

continuous flight augers (CFA) on back side of wharf to support cranes (shown in Figures 9-16 to 9-18) that are placing new piles. As indicated by the cranes being in place, these CFA were completed before March 24, 2011.

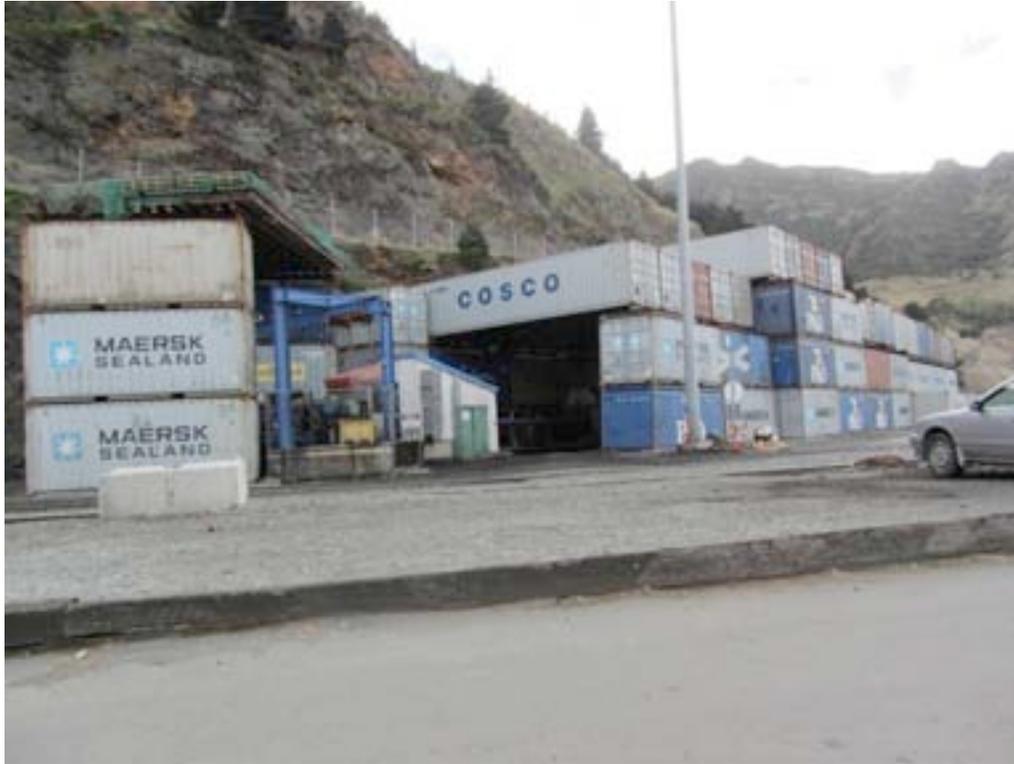
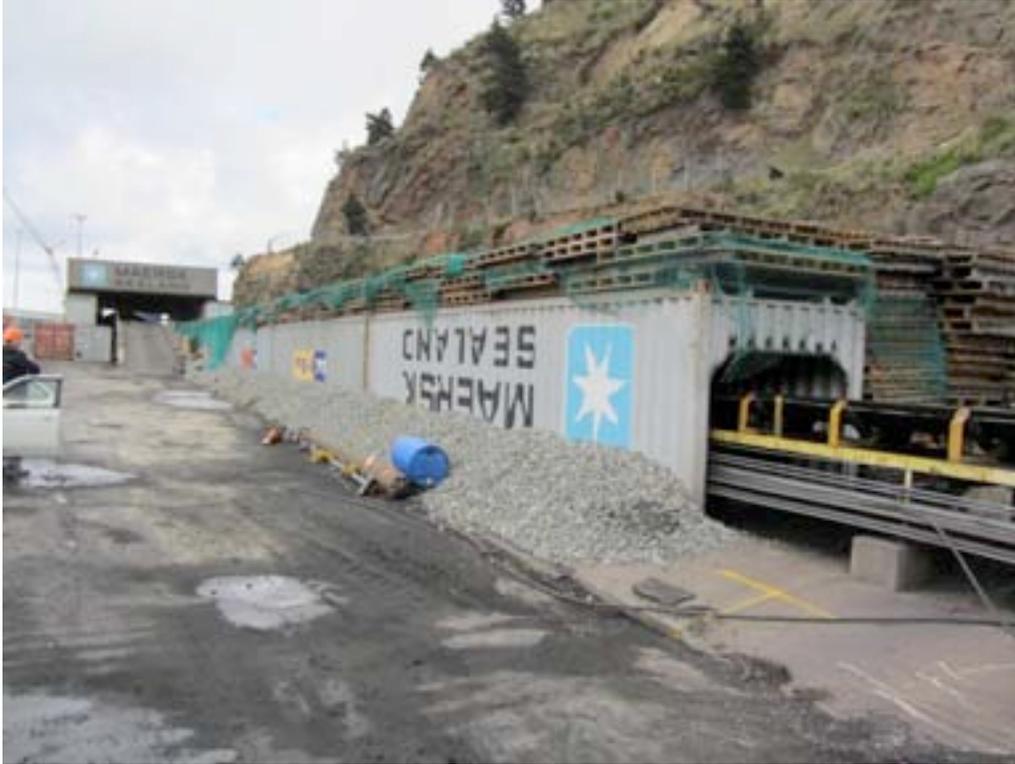
In addition to the damages to CQ1, the coal facility was impacted by a significant volume of rock falls from the hills on the north. Figures 9-19 and 9-20 show ballasted shipping containers stacked around and over a portion of the processing facility to protect against rock falls.

Figure 9-19. Ballasted shipping containers placed at the coal facility to protect against rock falls following the February 22, 2011 earthquake (looking east).

Figure 9-20. Ballasted shipping containers placed at the coal facility to protect against rock falls following the February 22, 2011 earthquake (looking west).

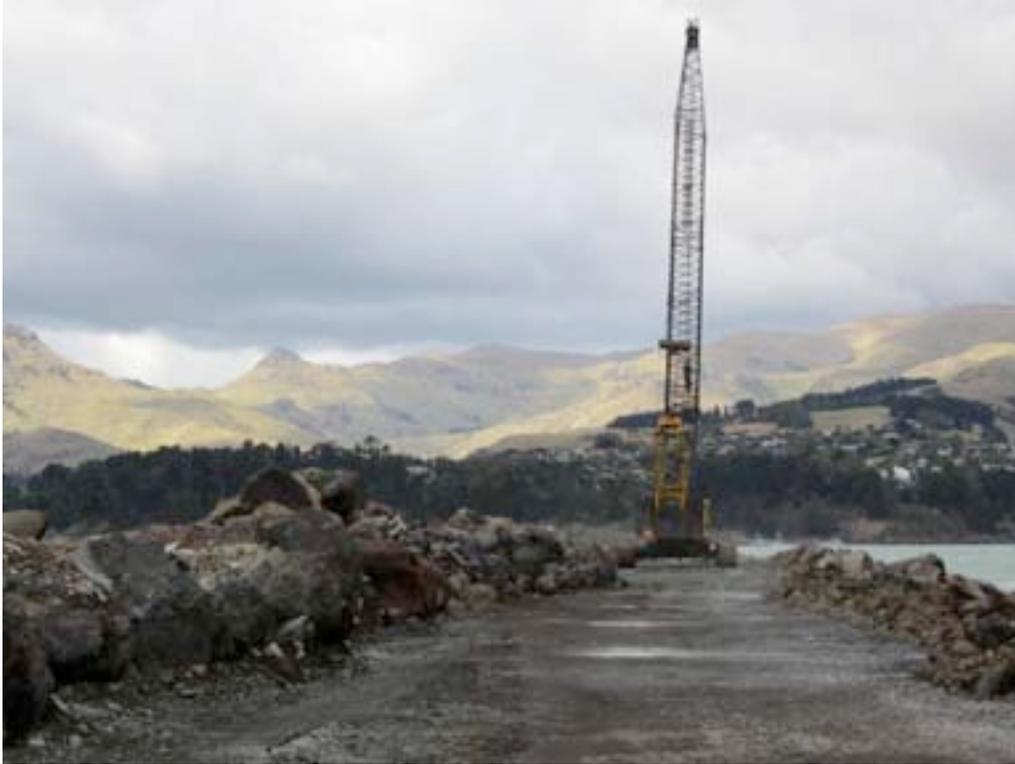
The breakwaters also sustained significant settlement, possibly a meter or so, making them less effective. Figure 9-21 shows the permanent deformations sustained to the eastern breakwater and a crane at work fortifying the breakwater to withstand wave attacks.

Figure 9-21. Breakwater east of harbor showing differential permanent deformations and ongoing repairs (looking south).

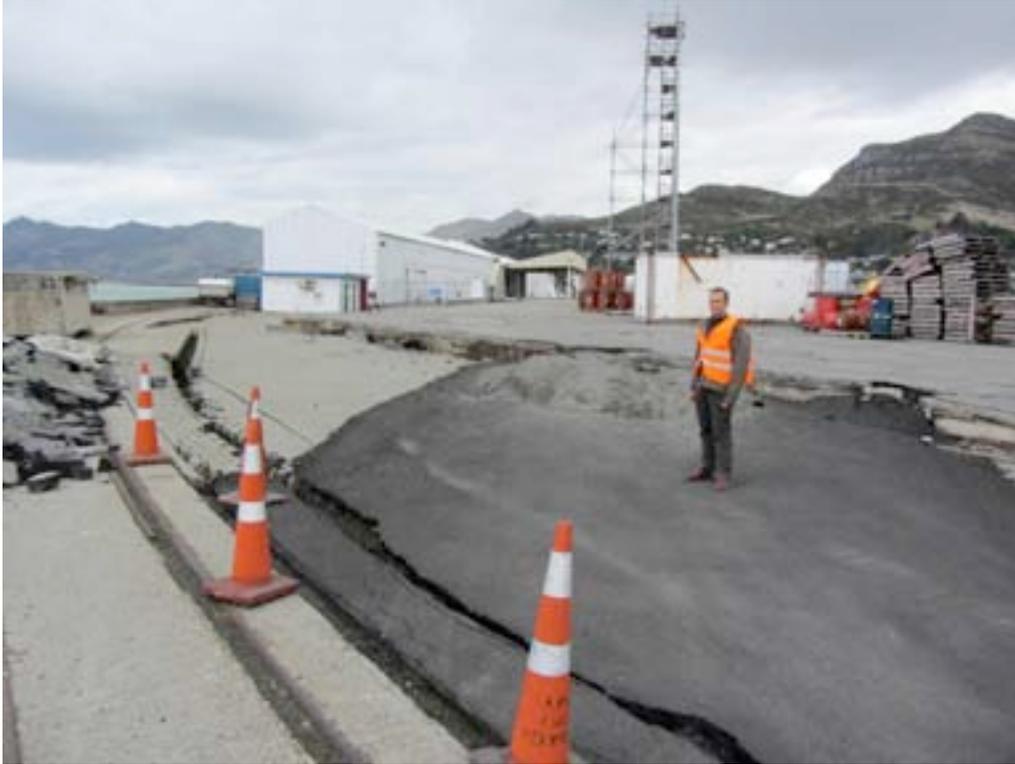
Figure 9-22 shows permanent deformations on the western edge of CQ4 at the transition to Z-Berth; the cool storage building is shown in the background. Z-Berth was badly damaged in the earthquakes and is no longer usable for cargo. Figure 9-23 shows settlements on the north side of the cool storage building; notice the large resulting slopes, down to the south, in the concrete slab. Figure 9-24 shows permanent deformations on the north side of the cool storage building. Figure 9-25 shows the large permanent deformations sustained on the west side of the cool storage building on Z berth, just west of the lighthouse shown in Figure 9-26. The lighthouse was left at a 15-degree lean as a result of deformations to the supporting timber structure. The Z Berth needs significant remediation. The cool storage has been demolished. The light structure has been temporarily relocated until the remediation is completed. The lighthouse has been at the port since 1878 and is intended to be replaced at its original location following completion of the Z Berth improvements. The loss of Z Berth and the cool storage has had a significant impact on the local fishing industry, and a number of fishing vessels have had to move to other ports. This has resulted in loss of business for the Port, and for local marine, engineering and supply businesses as well. Plans are underway for constructing a new cool storage building and fishing wharf just north of the oil berth.

Figure 9-22. Ground deformations on east end of CQ4 at transition toward Z berth (looking west).

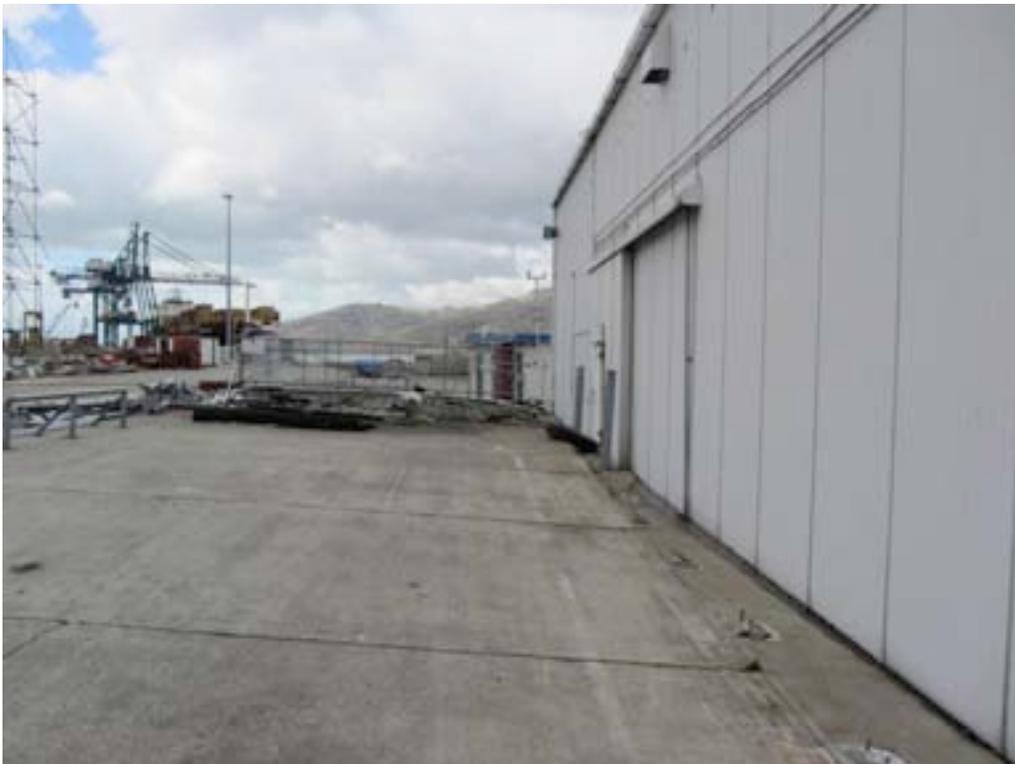
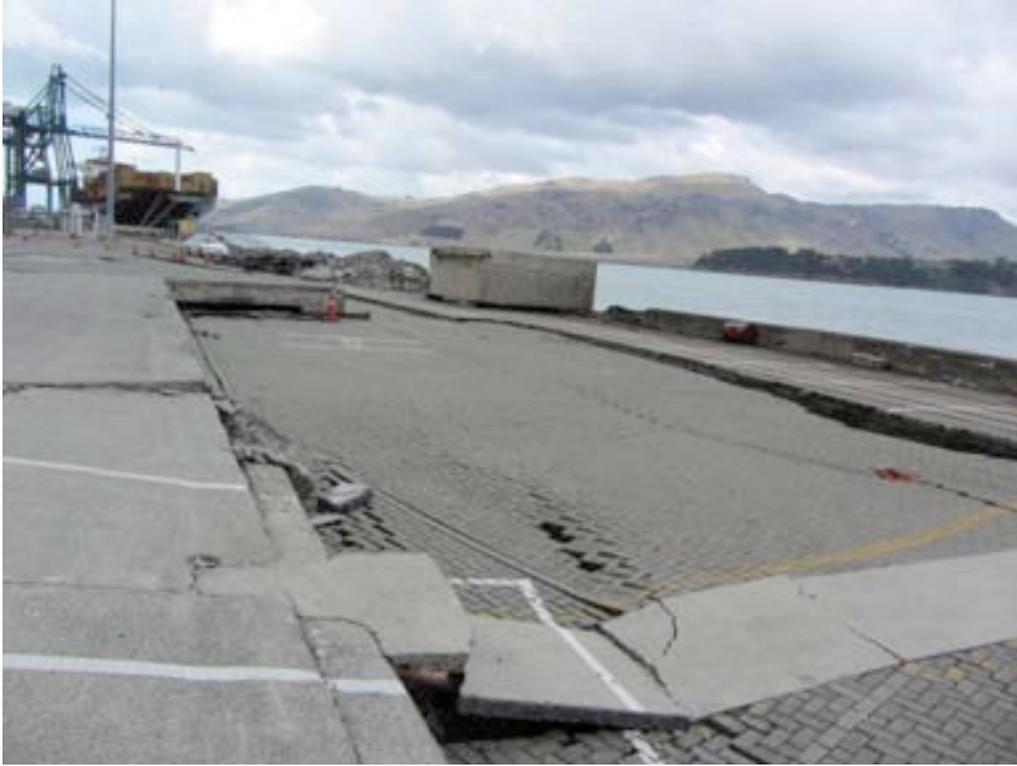
Figure 9-23. Ground settlements on north side of cool storage building (looking east).

Figure 9-24. Ground settlements on north side of cool storage building (looking west, north of Figure 9-25).

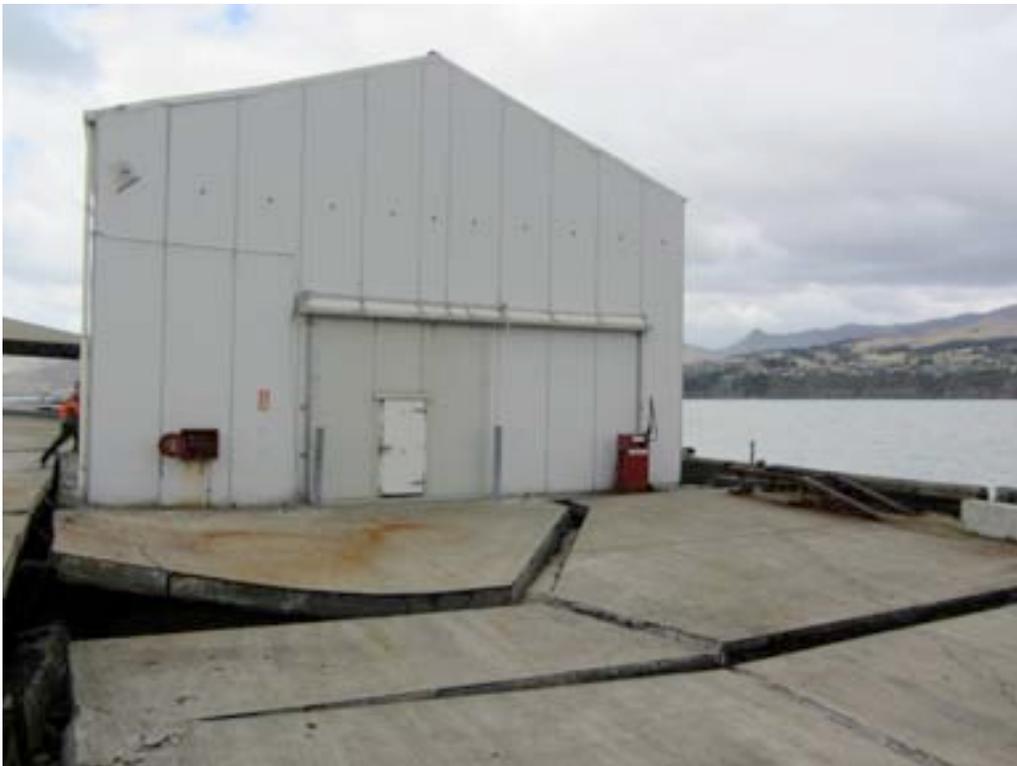
Figure 9-25. Deformations on west side of cool storage building (looking east).

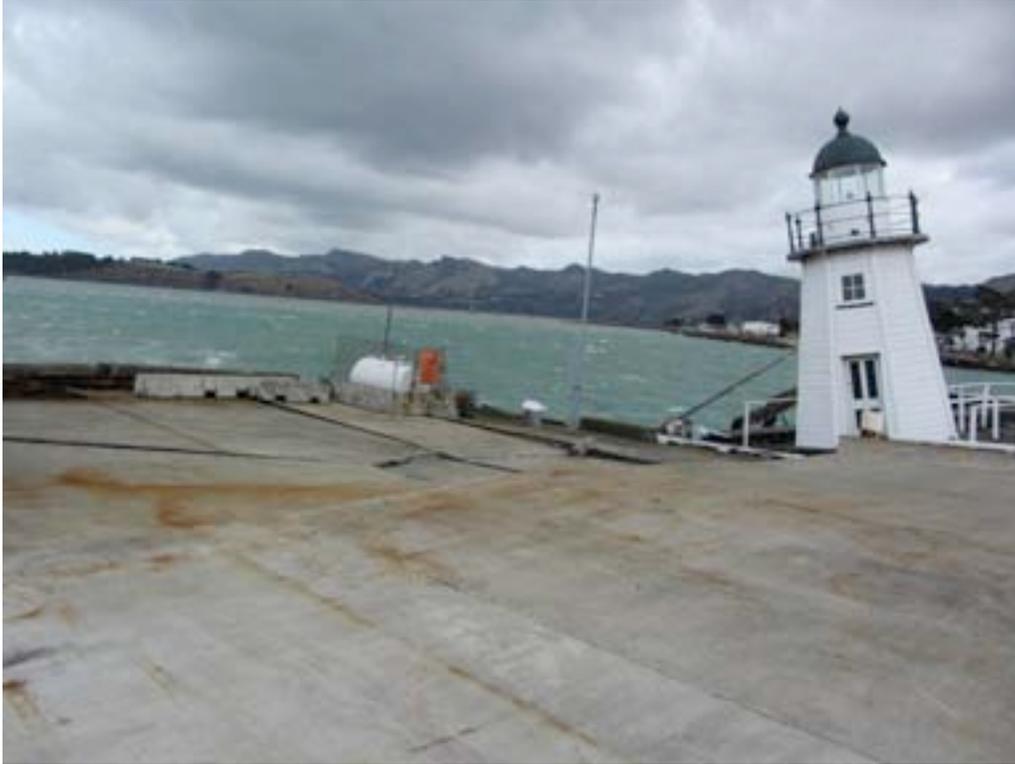
Figure 9-26. Lighthouse, Z Berth, Slumping of Eastern Mole following the February 22, 2011 earthquake (looking east).

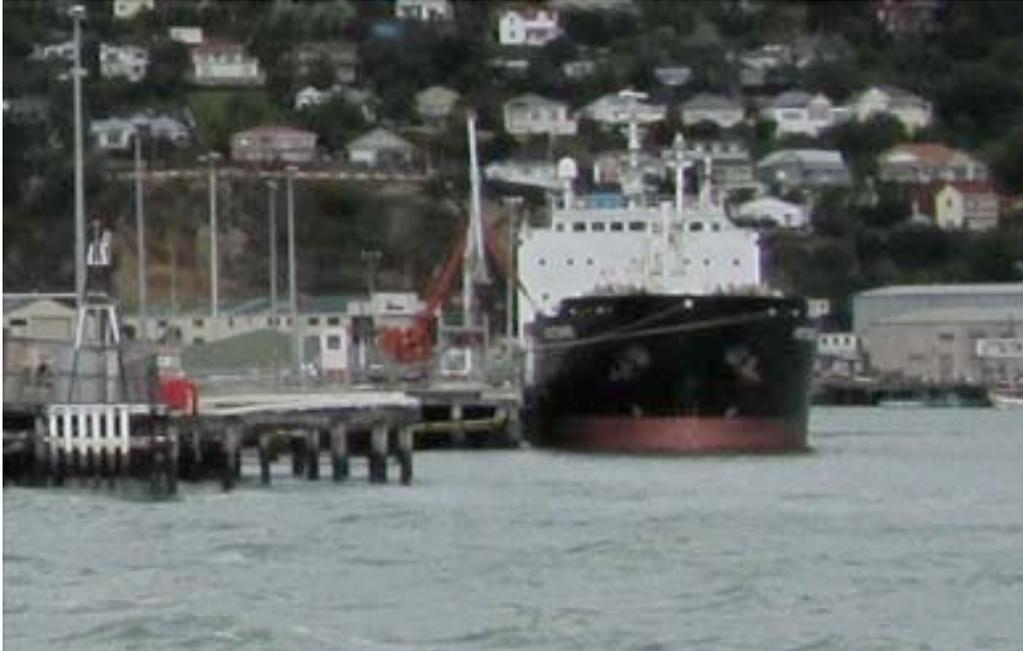
Figures 9-28 and 9-29 show a satellite view of the oil berth and a northeast-southwest cross section through the wharf at the oil berth. As seen in Figure 9-29 the oil tanks making up the tank farm are founded on hydraulic fill and the hydraulic fill overlies a weak silty mud. There is over 40 m of soil natural silt deposits and a few meters of fill below the tanks. The wharf is supported by 600 mm diameter piles that were constructed a few years ago to help stabilize the oil berth against a deep seated slide and allow the channel to be dredged deeper. This deep seated slide was mobilized during the February 22, 2011 earthquake. The ground movement displaced the wharf horizontally about 0.55 m and the ground behind the wharf dropped about 1 m. The slide continued to creep for some time following the earthquake. Figure 9-30 is a photograph of the wharf (looking northwest from Z berth) showing the backward rotation resulting from the deep seated slope movements.

Figure 9-30. Oil berth wharf (looking west) showing backward rotation resulting from deep slide movement.

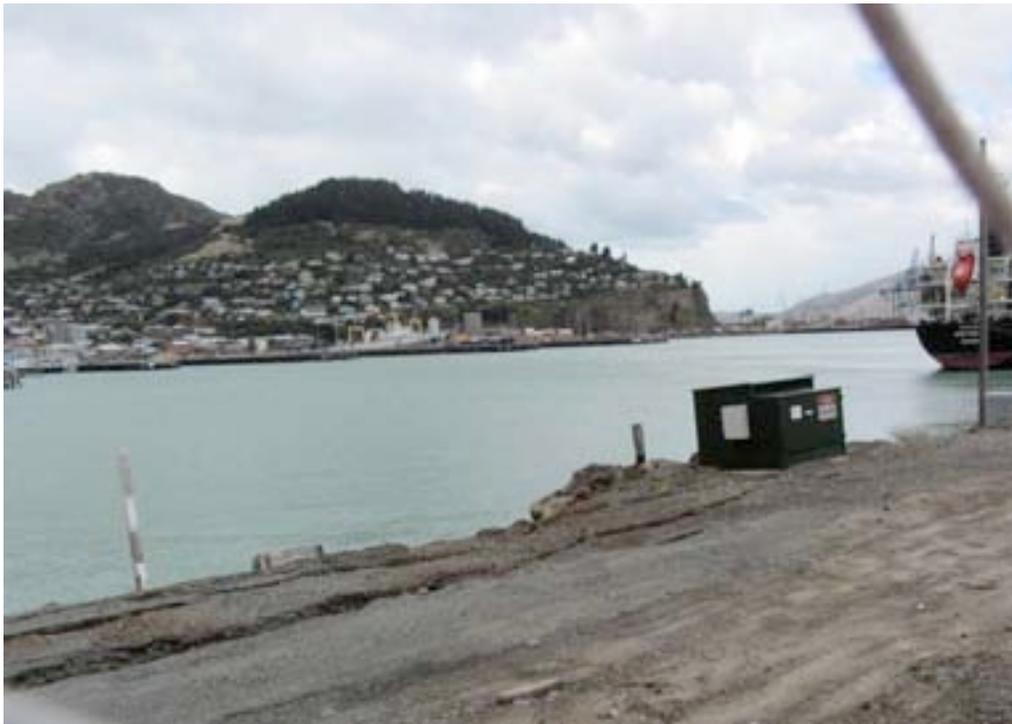
Figures 9-31 and 9-32 show lateral spreading and ground cracking at the oil berth. The lateral spreading shown in Figure 9-31 is located just northwest of the wharf shown in Figure 9-30.

Figure 9-31. Lateral spreading at the Lyttelton Port oil berth.

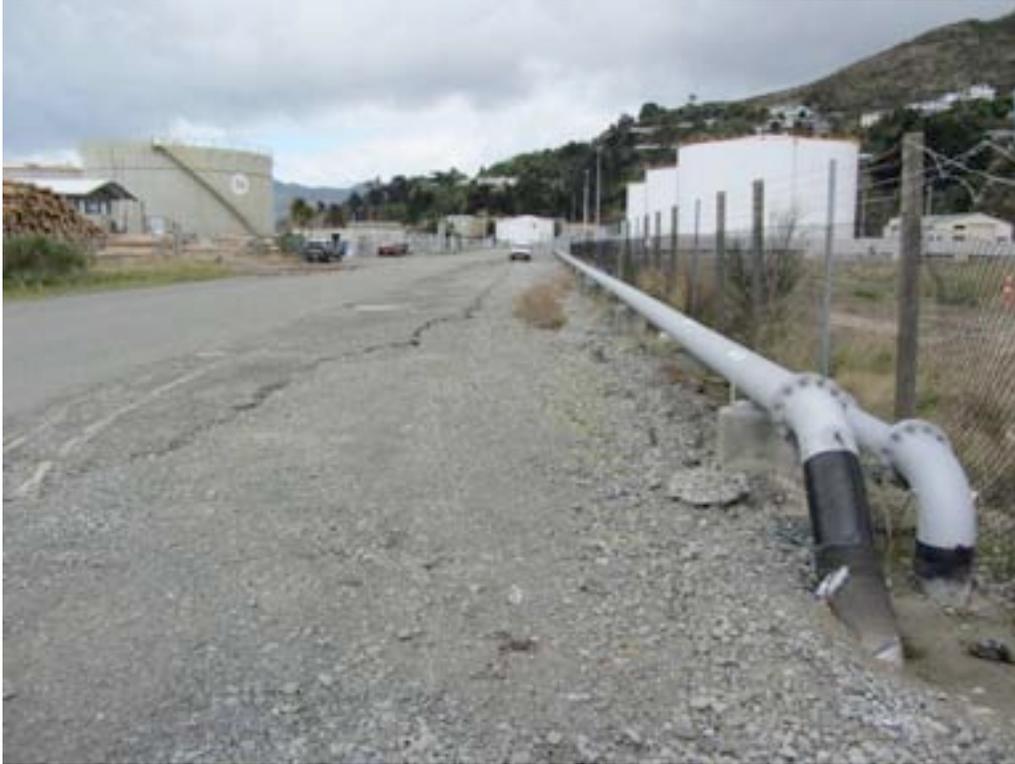
Figure 9-32. Ground cracking at the Lyttelton Port oil berth.

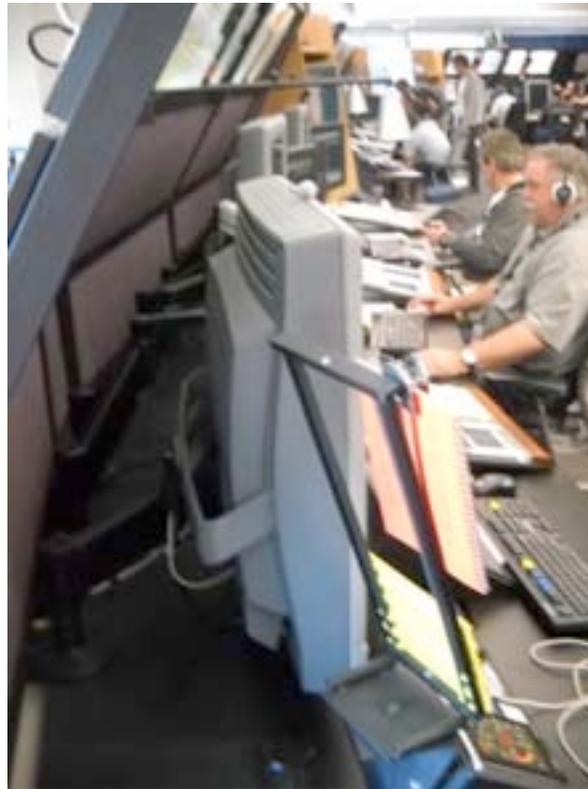
Figure 10-1. Air Traffic Control

A nearby air traffic control facility sustained limited structural damage, but with no material non-structural damage (Figure 10-1), it was in service shortly after the earthquake.

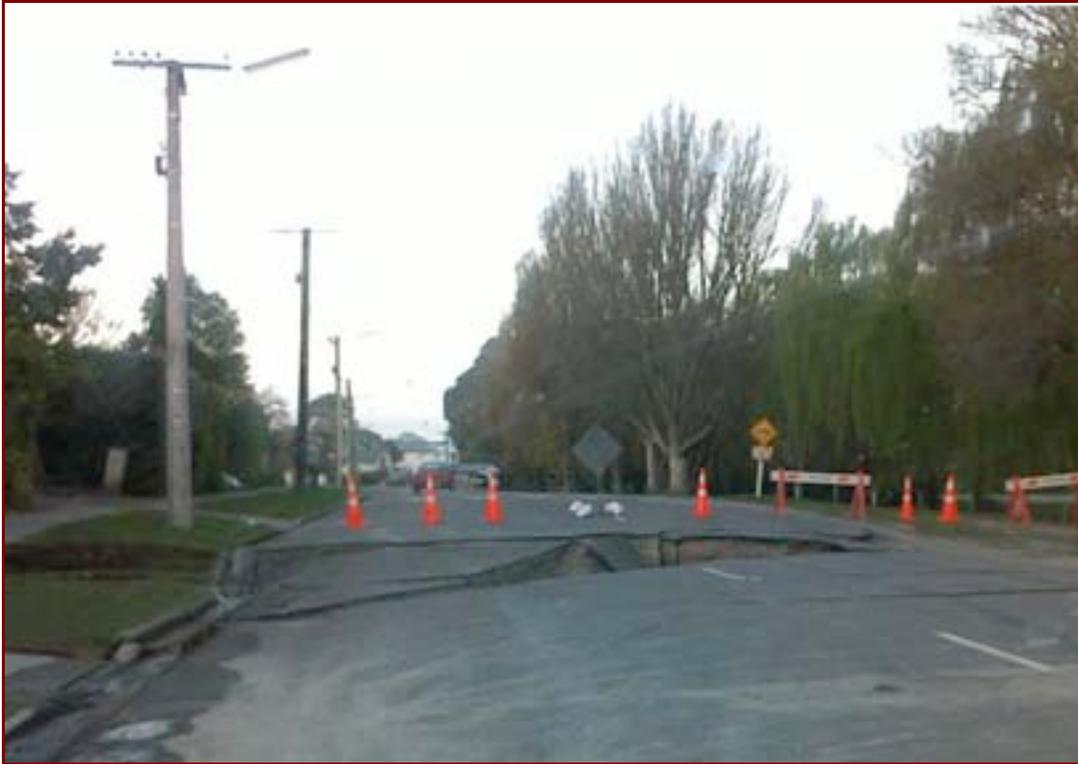
Fault offset resulted in damage to several surface roads. Figure 11-1 shows one such road with vertical uplift. Several roads that crossed the fault showed right lateral offsets of up to 4 meters, over a width of about 10 meters (Figures 2-20, 2-21). In almost all cases, the damage to the roads would have been passable by most passenger vehicles; in a few with uplift, most vehicles (including almost all four wheel drive vehicles) would have been able to cross, although perhaps with some difficulty.

Figure 11-1. Road surface up heaving due to permanent ground deformation

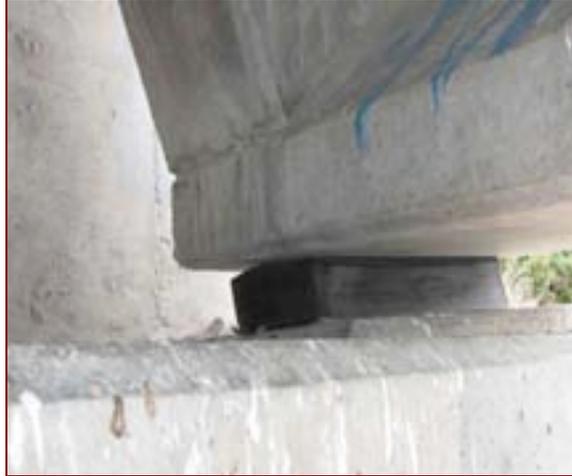
Most damage to bridges occurred at the abutments due to ground settlement and lateral spreading (Figures 11-2 and 11-3).

Figure 11-2. Rubber bearing deformed

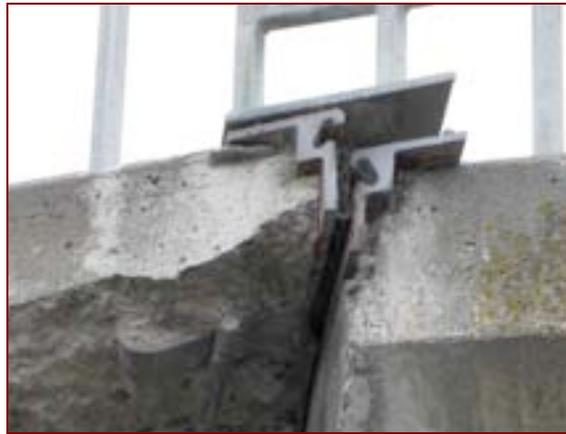
Figure 11-3. Deck and abutment impact damage

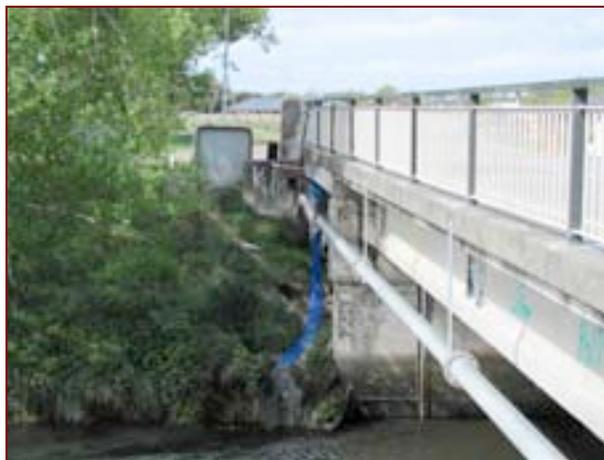
At most of the bridges that we visited that suffered abutment damage, if there were pipes hanging from the bridge, then the pipes were broken. Figures 11-4 and 11-5 show a broken sewer pipe crossing a bridge; the broken pipe remained in service and was discharging into the creek below.

Figure 11-4. Plastic hose connected to broke pipe to discharge wastewater to stream

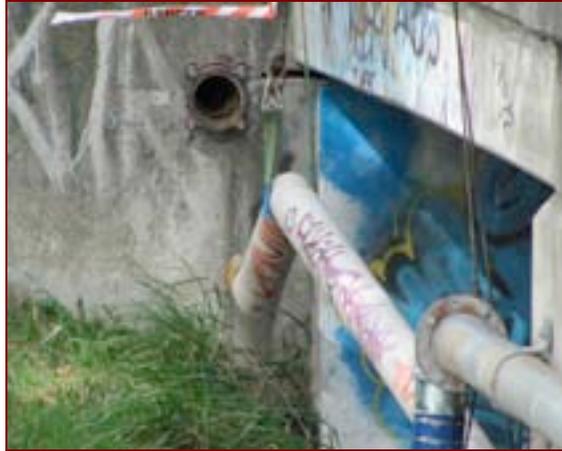
Figure 11-5. Close up of the damaged wastewater pipe

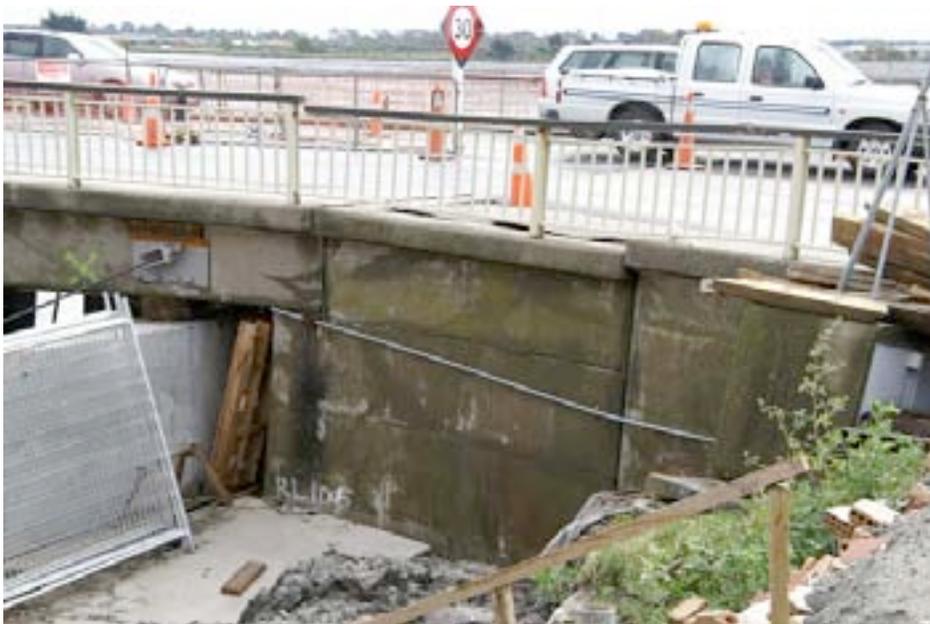
The Ferrymead Road Bridge (1967) is a continuous 3-span concrete bridge. It spans the Heathcoate River in the south-eastern part of Christchurch. The Ferrymead Road Bridge is classified a critical lifeline bridge, an important link in the transportation lifeline network. It also carries essential utility services. The Ferrymead Road Bridge was not damaged during the September 4, 2010 earthquake. Before the February 22 2011 earthquake, a new \$10 million NZD bridge was under construction at the same location to replace the existing bridge, as shown in Figure 11-6. During the February 22 earthquake, the existing bridge suffered serious damage due to rotation and lateral movements greater than 1 m at the abutments, as shown in Figure 11-7, and piles of bridge piers. The substructure of the bridge was damaged and had moved up by 80 mm. The utility service lines collocated with the bridge superstructure ruptured during the earthquake resulting in loss of utility services in surrounding communities. Emergency repairs at a cost greater than \$200,000 NZD, which include tie-backs for the bridge piers, as shown in Figure 11-8, and temporary supports of bridge spans, have been carried out. Rotation and lateral movement of the piers and abutments of the bridge are currently being monitored.

Figure 11-7. Rotation and lateral movement toward river of Ferrymead Road Bridge abutment and partial view of emergency tie-back measure to bridge pier/pile

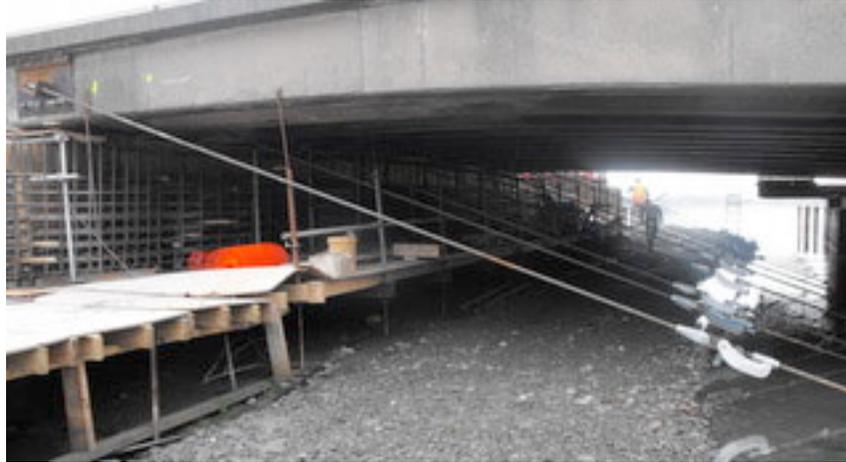
Figure 11-8. Temporary tie-back measure to arrest further lateral movement of pier/pile of Ferrymead Road Bridge (Photo: Lloyd Greenfield)

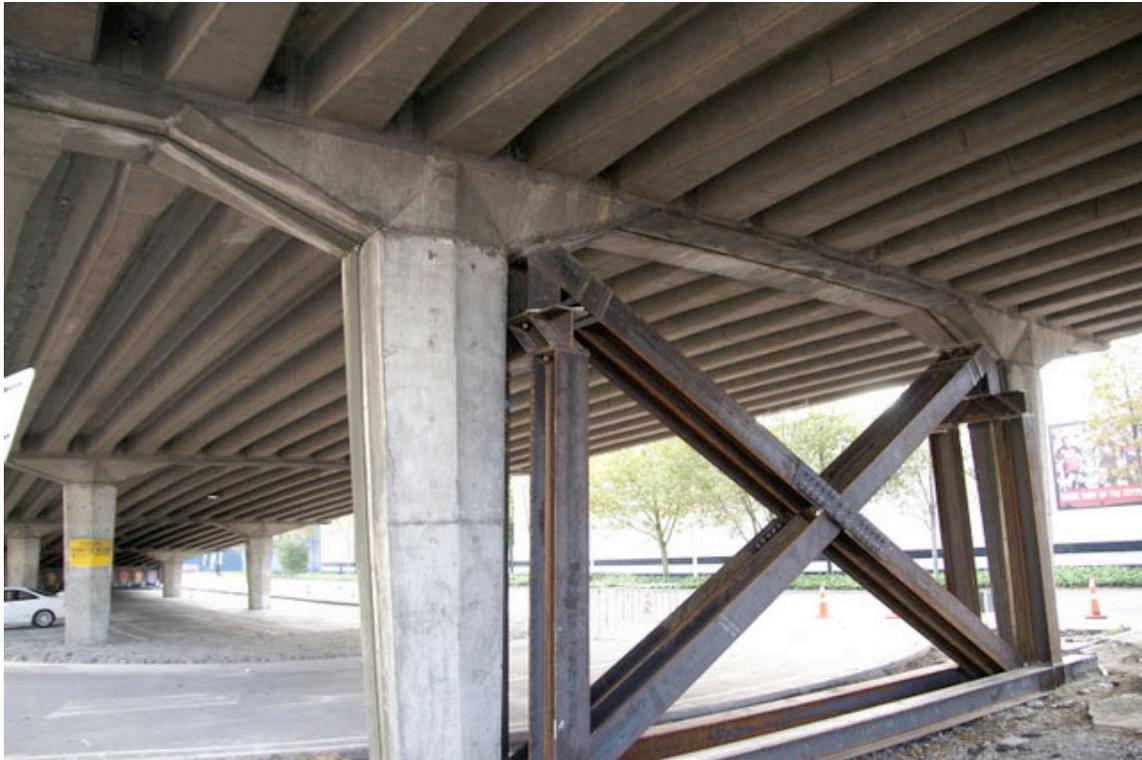
The columns have a hexagonal cross-section and are slightly tapered and flare at the top, as shown in Figure 11-10. The column has 1-1/8 in diameter smooth longitudinal rebars and smooth 5/8 in transverse ties at 12 in spacing. The Moorhouse Avenue Bridge suffered significant damage during the earthquake. The bridge has expansion joints at column bents 4 and 7 from the west abutment of the bridge. The presence of the expansion joint reduces the depth of the column cross-section to half of that in the other

columns. Thus, the columns at the expansion joint locations have a significantly smaller stiffness as compared to the other columns of the bridge. During the February 22, 2011 earthquake, the columns at the expansion joint locations suffered significant damage of shear failure at the column base and buckling of the longitudinal rebar, as shown in Figure 11-11 a, b. Evidence of liquefaction failure of the foundation soil was observed at the bridge site, as shown in Figure 11-12. After the earthquake, temporary repair measure of bracing of the damaged column bents at the expansion joints taken. The bridge was reopened to vehicle traffic.

Figure 11-10. Temporary bracing support of column bent with expansion joint of Moorhouse Ave Bridge at Colombo Street

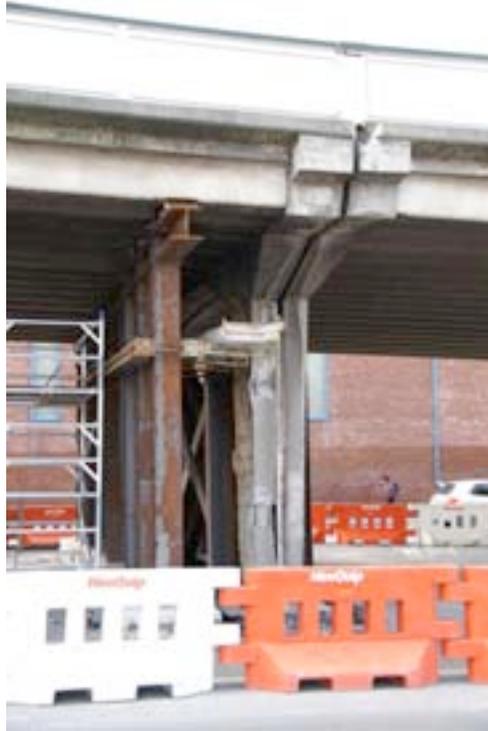
Figure 11-11a. Column bent with expansion joint

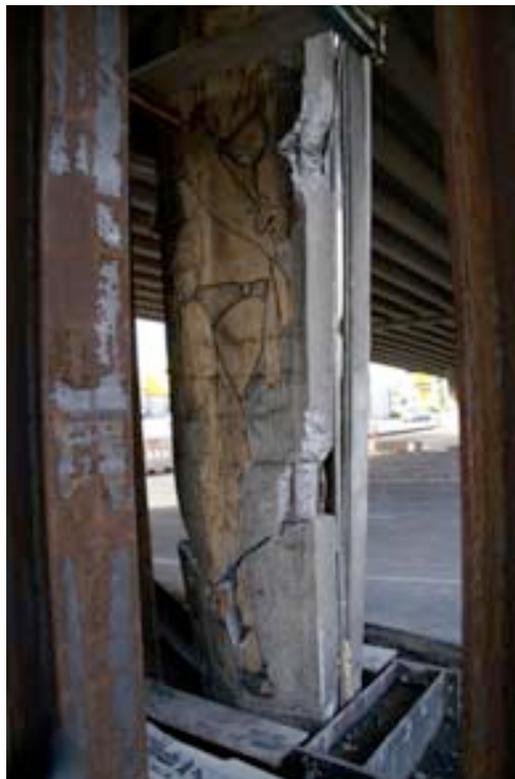
Figure 11-11(b). Shear failure and buckled smooth rebar of column of Moorhouse Avenue Bridge at Colombo Street

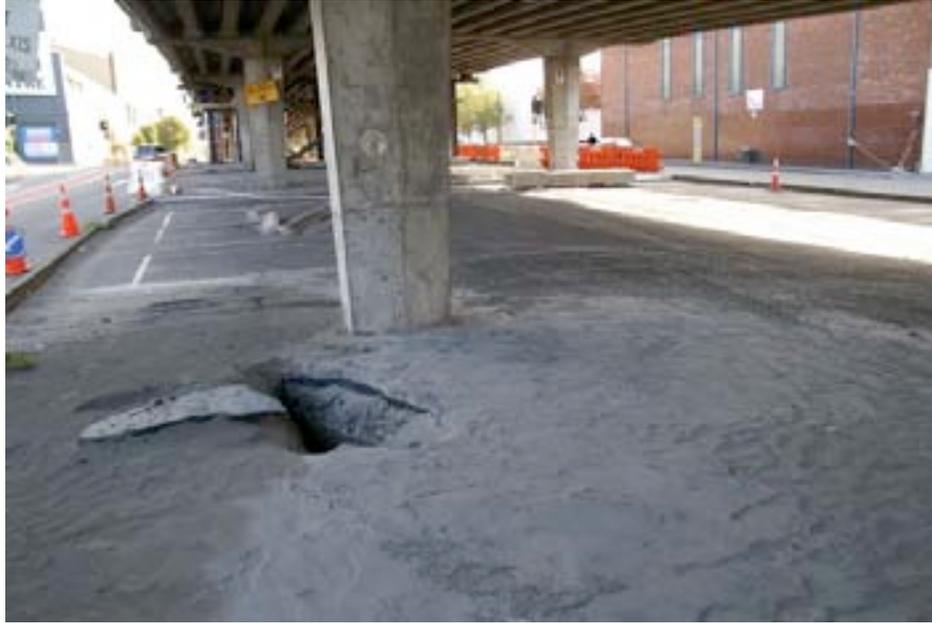
Figure 11-12. Liquefaction of foundation soil at Moorhouse Ave Bridge at Colombo St.

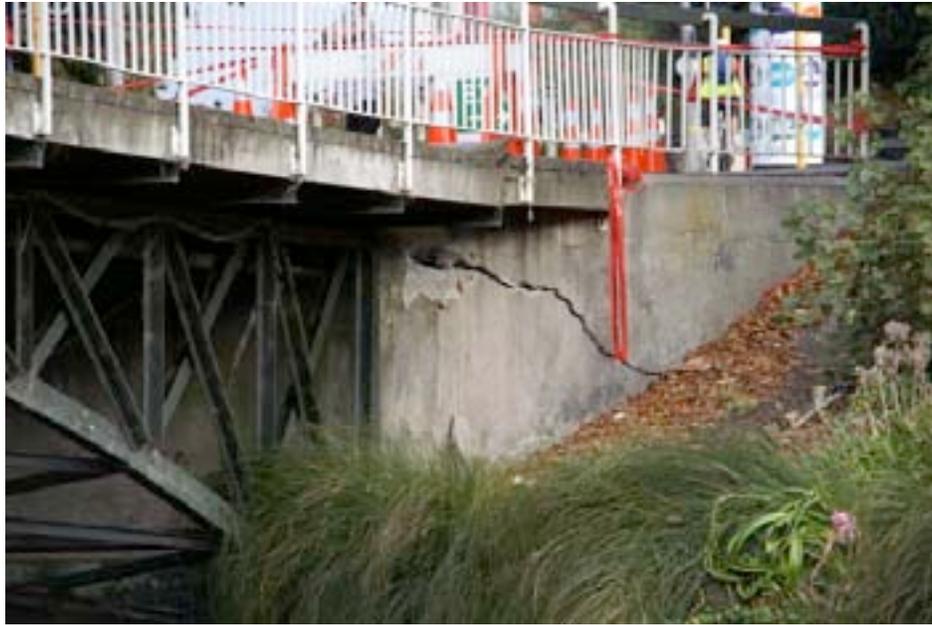
A 1920 single span steel truss arch pedestrian bridge with wooden walkway deck, as shown in Figure 11-13, near the Christchurch Hospital next to a boathouse over the Avon River was damaged during the February 22, 2011 earthquake. The abutments at both ends of the bridge had severe shear cracks due to lateral spreading movement of the river banks, as shown in Figure 11-14. The approach pavement near the joints with the bridge buckled due to pounding movement of the bridge deck superstructure.

Figure 11-14. Abutment failure of Boathouse Bridge.

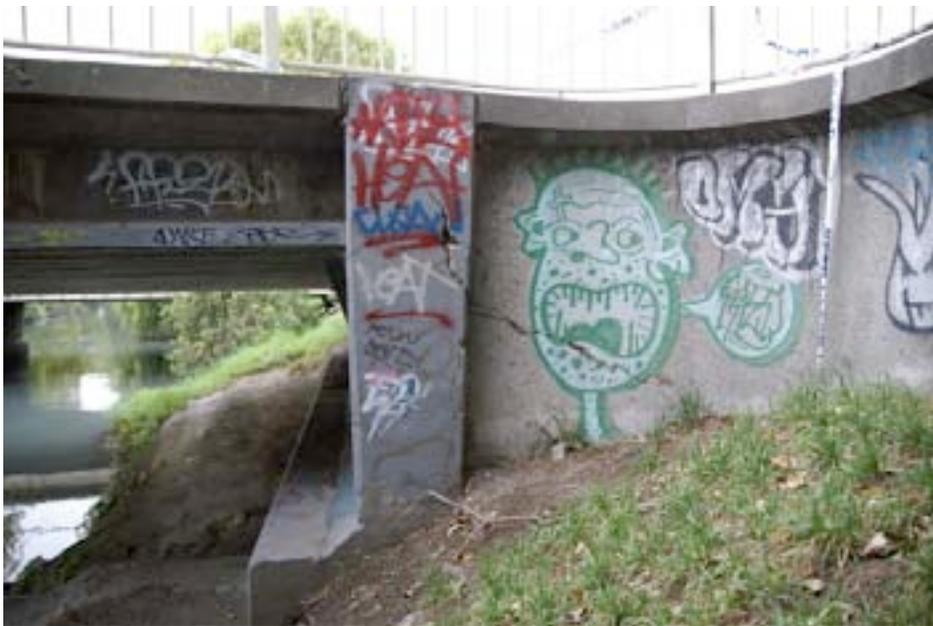
The Fitzgerald Avenue Bridge (1964) consists of two parallel concrete bridges, Figure 11-15. Each bridge is a 2-span girder on wall pier structure. During the February 22 earthquake, the abutments suffered shear cracks and rotation because of lateral spread movement of the river embankment soil, as shown in Figures 11-16 and 11-17, respectively. One of the bridge girders was damaged due to movement of the abutment. The approach and nearby roadways had significant lateral spread settlement after the earthquake. Before the Christchurch earthquake, the bridge had been retrofitted with steel seat width extender brackets at the abutments and wall piers.

Figure 11-16. Shear crack in abutment of Fitzgerald Ave Bridge

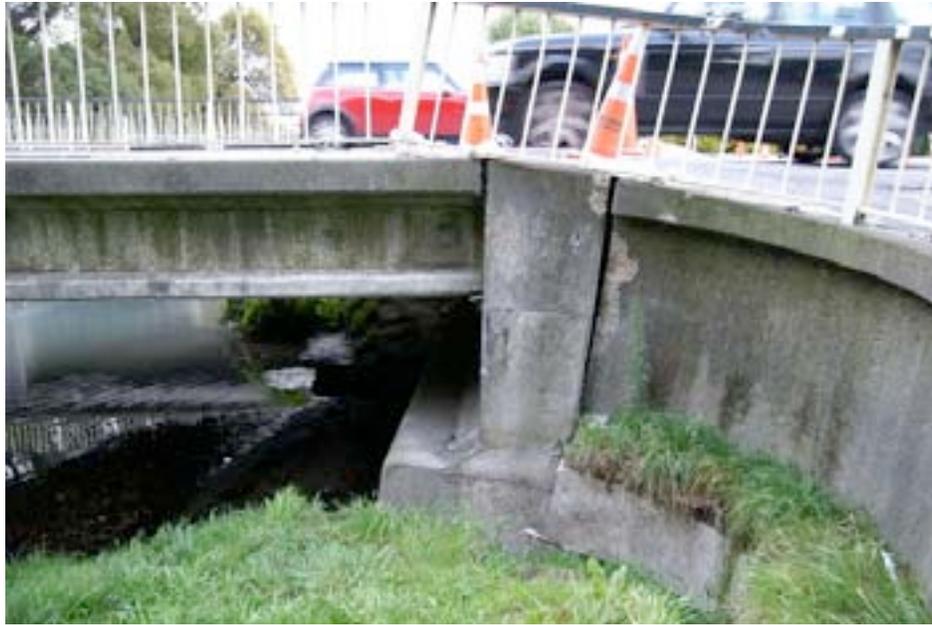
Figure 11-17. Rotation of abutment of Fitzgerald Ave Bridge

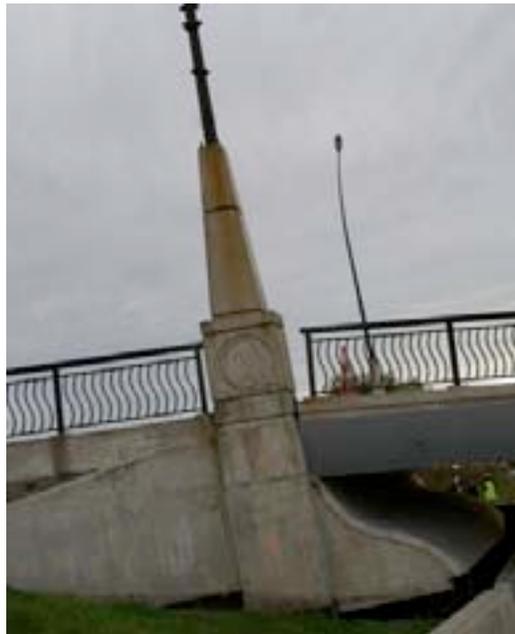
The Anzac Bridge (2000) is a concrete bridge of 3-span void slabs on 4-column bents over the Avon River, as shown in Figure 11-18 (Photo taken October 2010). During the February 22 Christchurch earthquake, the bridge sustained seismic forces and demands greater than design values. The abutment rotated (Figure 11-19) and moved laterally more than 2 m (design 0.5 m) toward the river. Liquefaction of foundation soil was estimated in depth significantly greater than the design assumption of 2 m. The pile supporting the abutment shown in Figure 11-20 was observed to have rotated after the earthquake. As a result of the lateral movement of abutments at both ends of the bridge, the bridge deck superstructure sustained compressive forces from the abutments. The

Figure 11-19. Rotation of left abutment of Anzac Drive Bridge (February 2011)

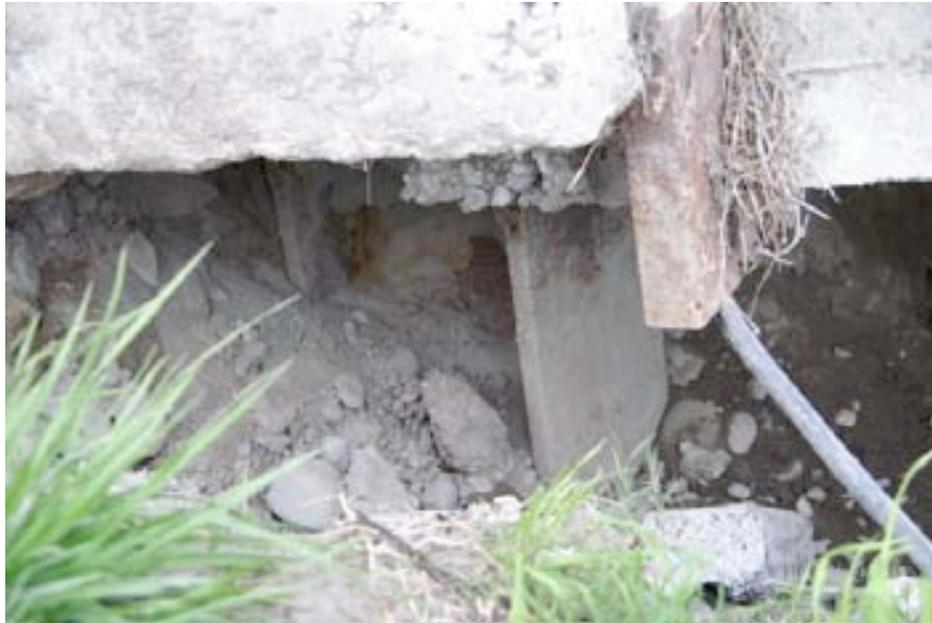
Figure 11-20. Damaged rotated pile at abutment of Anzac Drive Bridge
