CHRISTCHURCH, NEW ZEALAND EARTHQUAKE SEQUENCE OF M_w 7.1 September 04, 2010 M_w 6.3 February 22, 2011 M_w 6.0 June 13, 2011: LIFELINE PERFORMANCE

**Technical Council on Lifeline Earthquake Engineering
Monograph No. 40
February 2012 – Revision 0
ASCE**

ABSTRACT

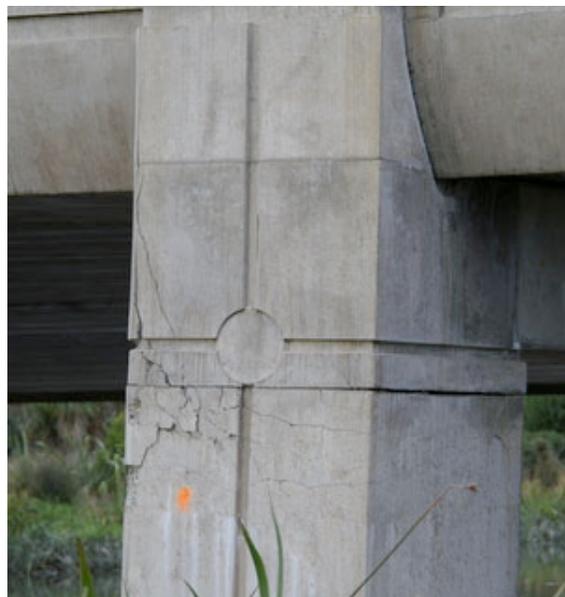
bridge piers had flexural and shear cracks, as shown in Figure 11-21, due to plastic hinging and lateral movement of the piers.

Figure 11-21. Flexural and shear cracks in column of Anzac Drive Bridge

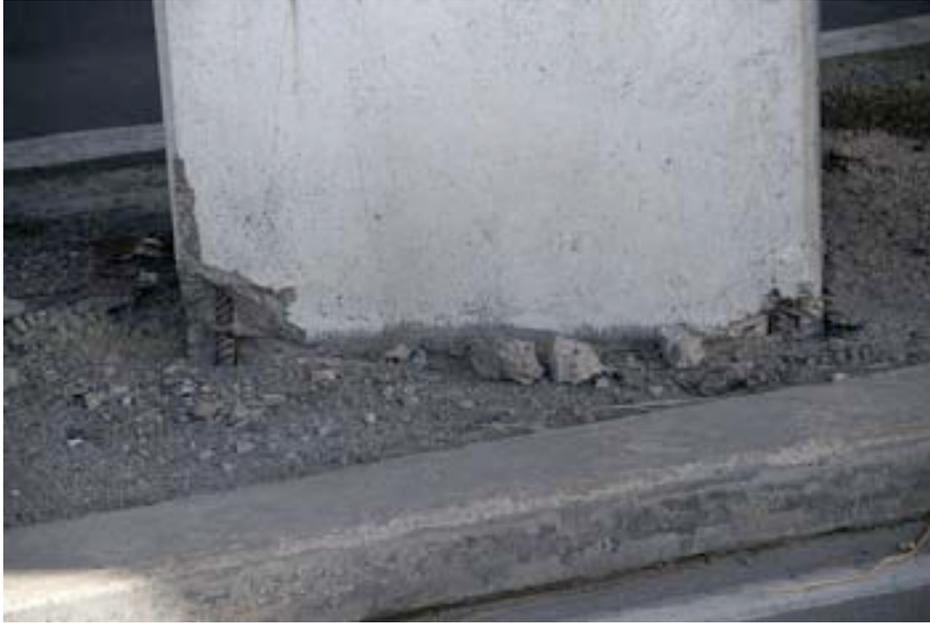
column sustained flexural crack and spalling of concrete, and buckling of the longitudinal rebar at the base, as shown in Figure 11-24.

Figure 11-24. Flexural crack and buckling of rebar in column of Port Hills Road Overbridge

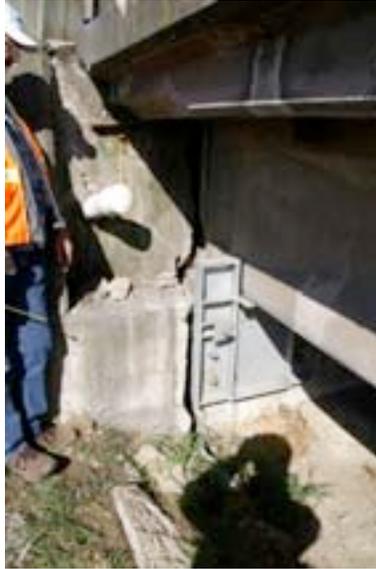
The Horotane Valley Road overbridge (1963) shown in Figure 11-25 is a 3-span T-girder concrete bridge. It was retrofitted with span tie-links and shear keys with seat width extension before the earthquake. After the February 22 earthquake, cracks were found at the abutments, as shown in Figure 11-26, and many bolts of the seat width extension brackets were sheared off, as shown in Figure 11-27.

Figure 11-26. Cracks in abutment of Horotane Valley Road Overbridge

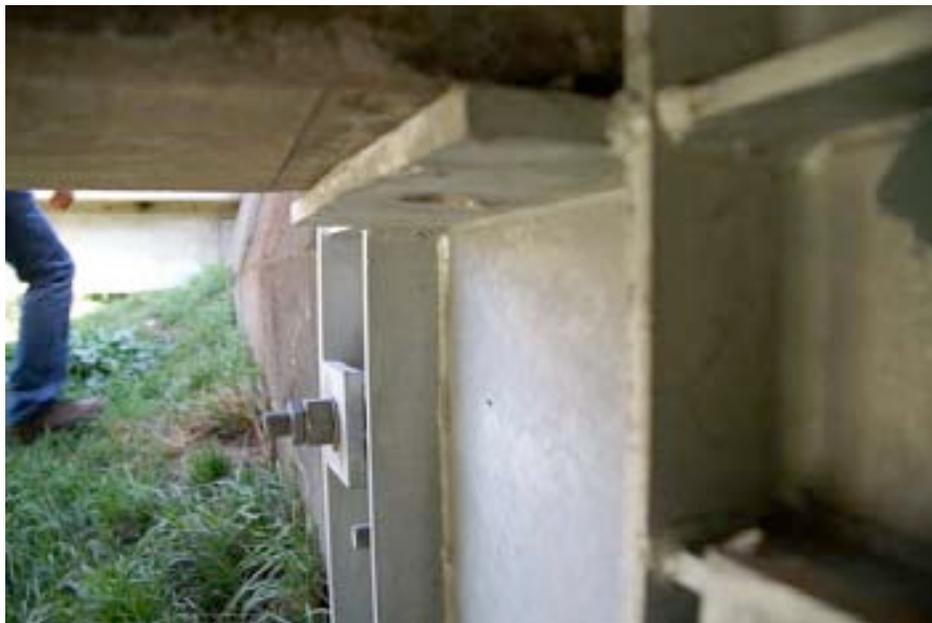
Figure 11-27. Shear-off of anchor bolt of seat width extension bracket of Horotane Valley Road Overbridge

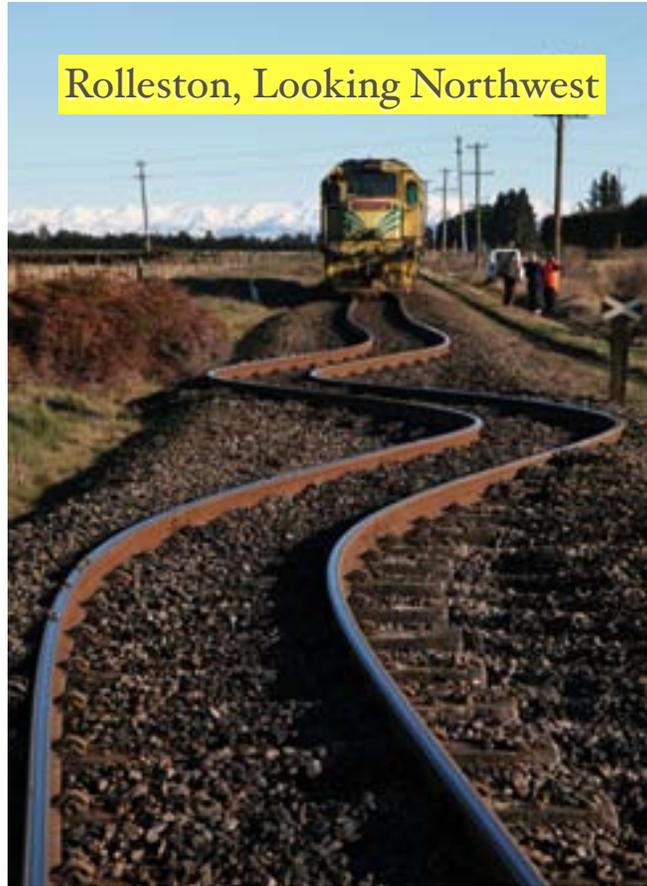
Figures 12-3 and 12-4 show the buckled rails where the right lateral fault (red line in Figure 12-2) crossed the Midland Line, northwest of Rolleston. The engineer in the locomotive seen in Figure 12-4 reported that the train was moving at about 80 kph when the earthquake occurred; he observed that the headlight was wavering, and that the front wheels "seemed to loose traction"; he then used emergency braking, and the locomotive stopped at the location seen in Figure 12-4, just a few meters before the buckled track section.

Figure 12-4. Buckling of Rails at Fault Offset Location (Baxter)

The track in Figures 12-3, 12-4 and 12-5 was repaired within 5 hours after the earthquake (Figures 12-6), 12-7. Ongoing fault creep required the track to be repaired a few times in the days and weeks following the earthquake.

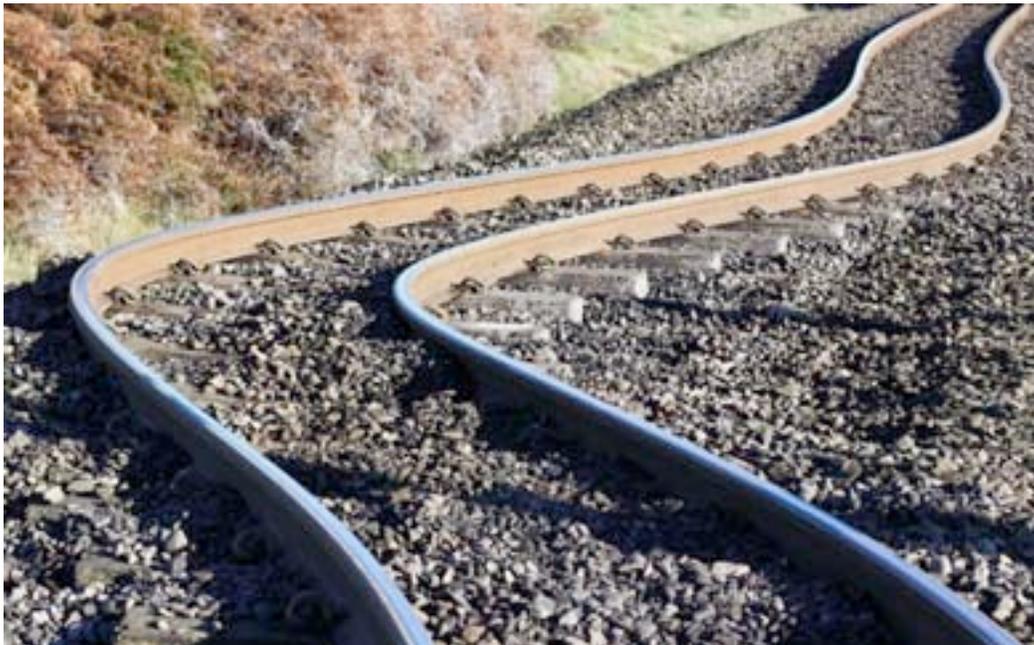
Figure 12-5. Buckling of Rails, Highlight of Figure 12-4 (Baxter)

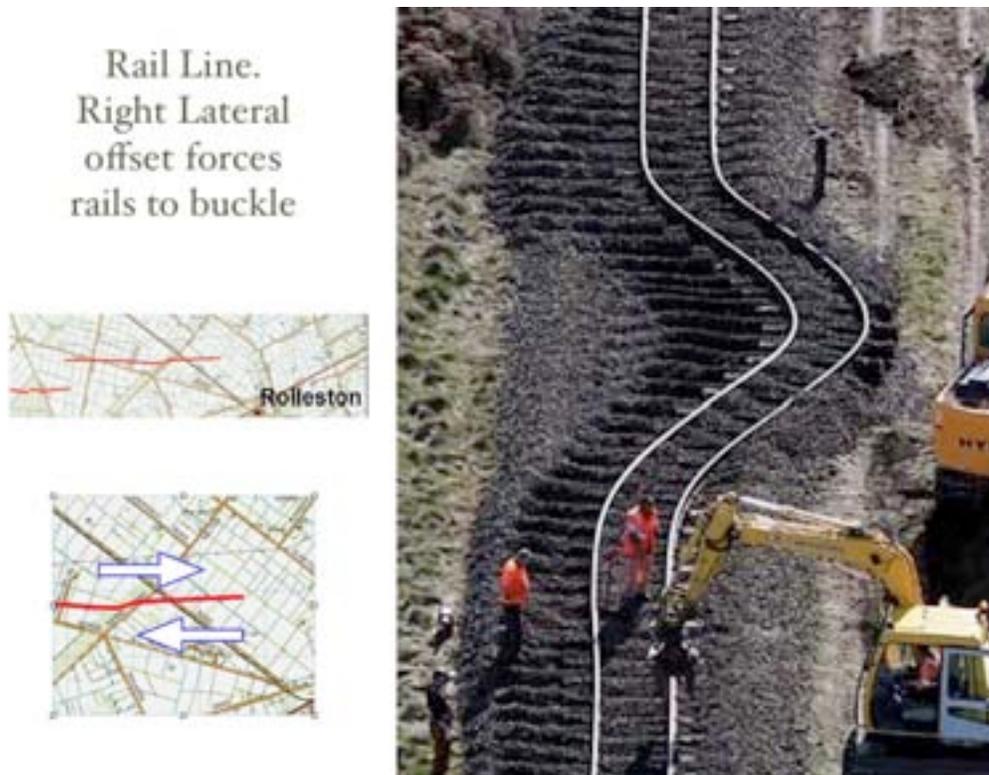
Figure 12-6. Rails Being Repaired

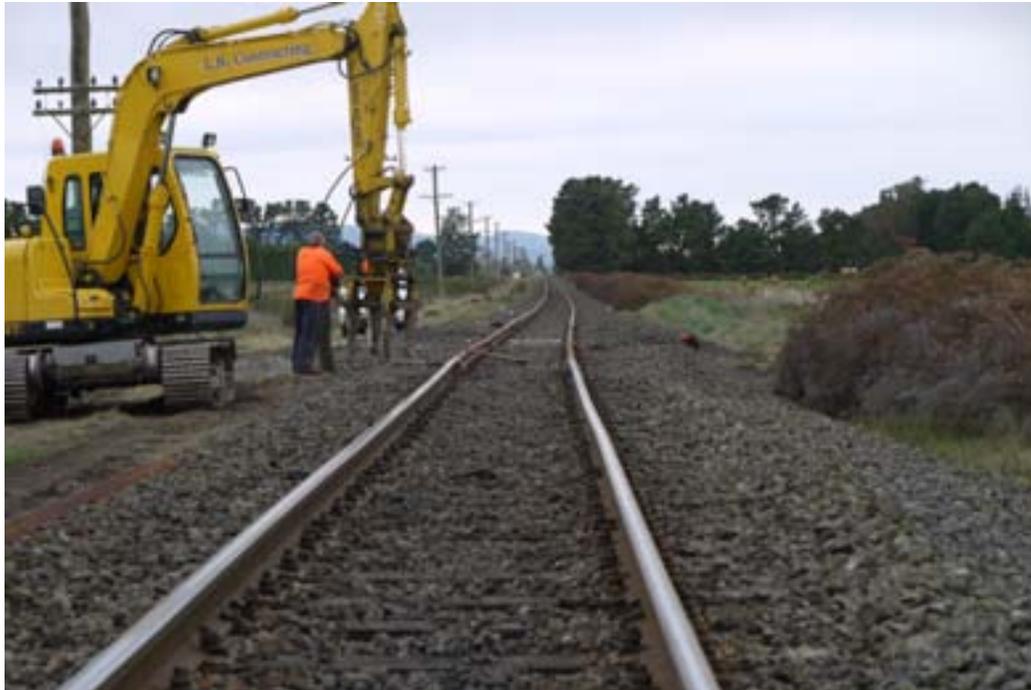
Figure 12-7. Rails Repaired, September 4, 2010

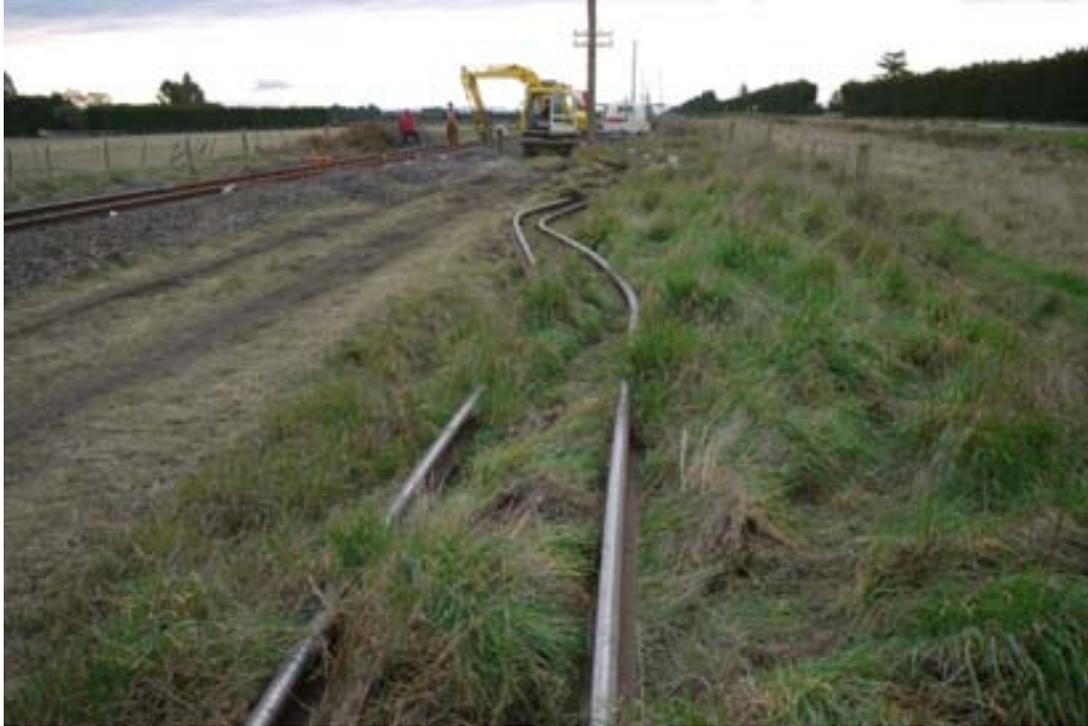
Figure 12-8 shows the removed sections of rail. This clearly shows that the rail buckling was largely inelastic (post-yield).

Figure 12-8. Removed Rail Segments

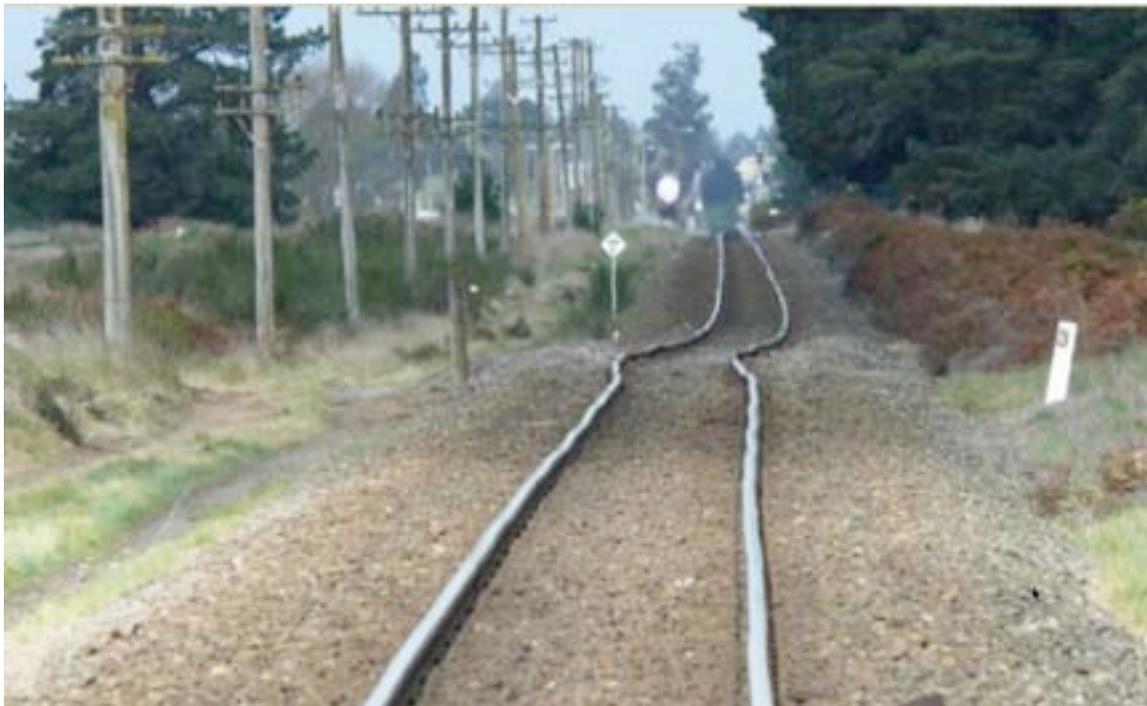
Figure 12-9 shows the repaired track some time after the earthquake. Additional wrinkles in the track can be clearly observed, suggesting the effects of post-earthquake fault creep.

Figure 12-9. Wrinkled Track

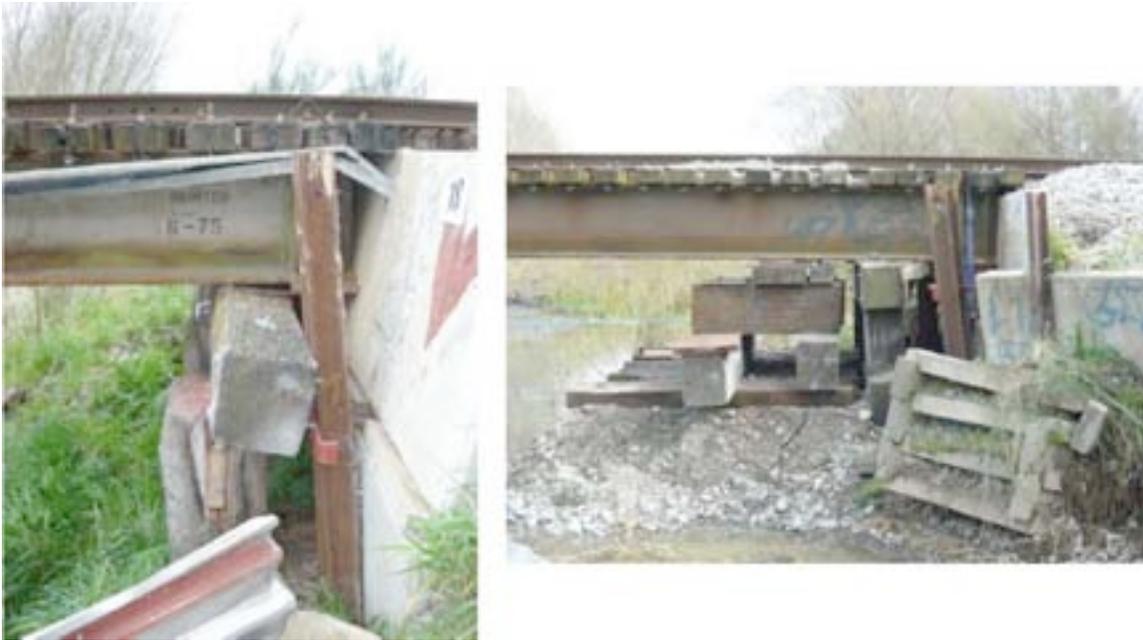
Figure 12-10 shows settlement of the approaches near the abutments of this bridge on the Main North Line. The photo also indicates lateral spreads that require the track to be re-ballasted. Figure 12-11 shows the two abutments for bridge 18 along the Main North Line. These abutments could not withstand the soil pressures imposed on them due to the earthquake.

Figure 12-11. Main North Line, Bridge 18

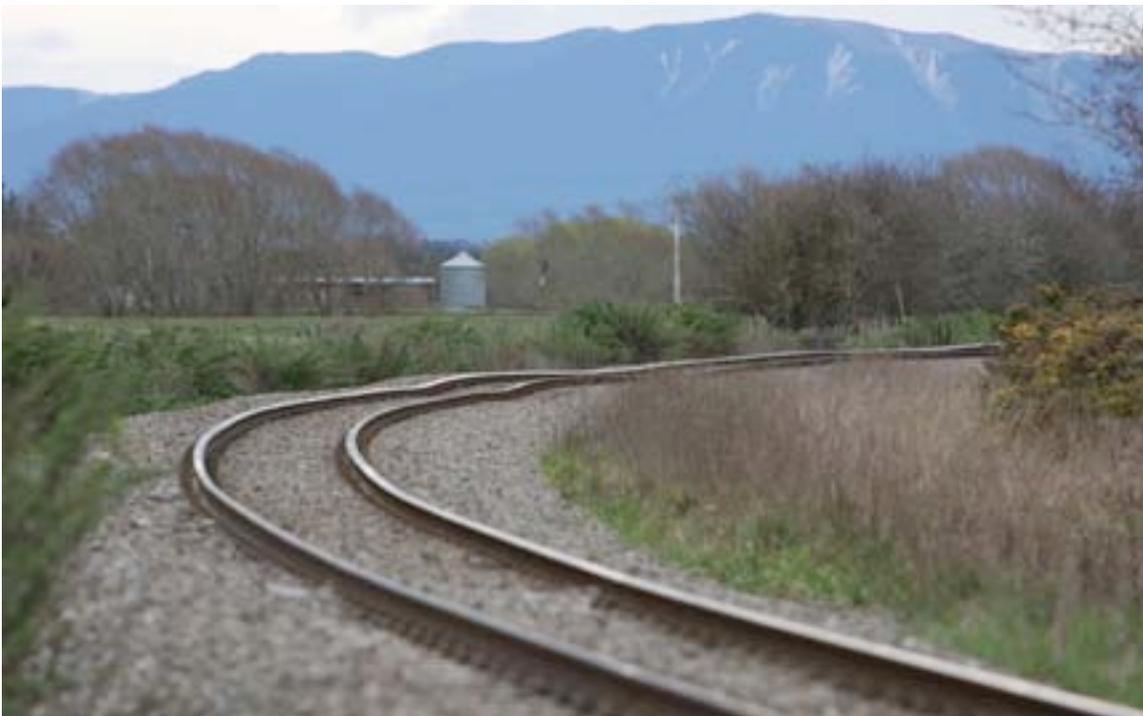
Figures 12-12 to 12-13 show the damage to a segment of track at a curve. Figure 12-14 shows the effects of liquefaction near Kaiapoi on the Main North Line located north of the Waimakariri River. This section of track required re-ballasting many times following the main shock on September 4, presumably because of re-liquefaction during aftershocks. Significant liquefaction and ground deformation also occurred at this location during the February 22, 2011 earthquake (see the discussion for the February 22, 2011 earthquake).

Figure 12-12. Kaiapoi, Looking towards Rangier (Baxter)

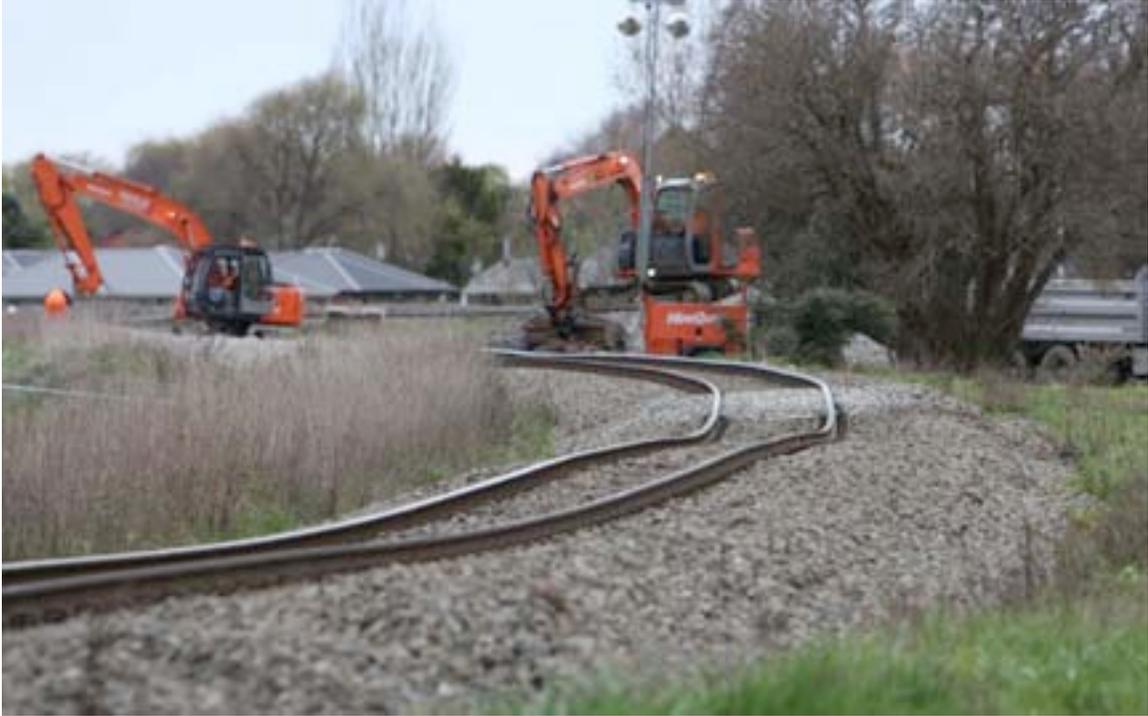
Figure 12-13. Kaiapoi, Looking towards Kaiapoi (Baxter)

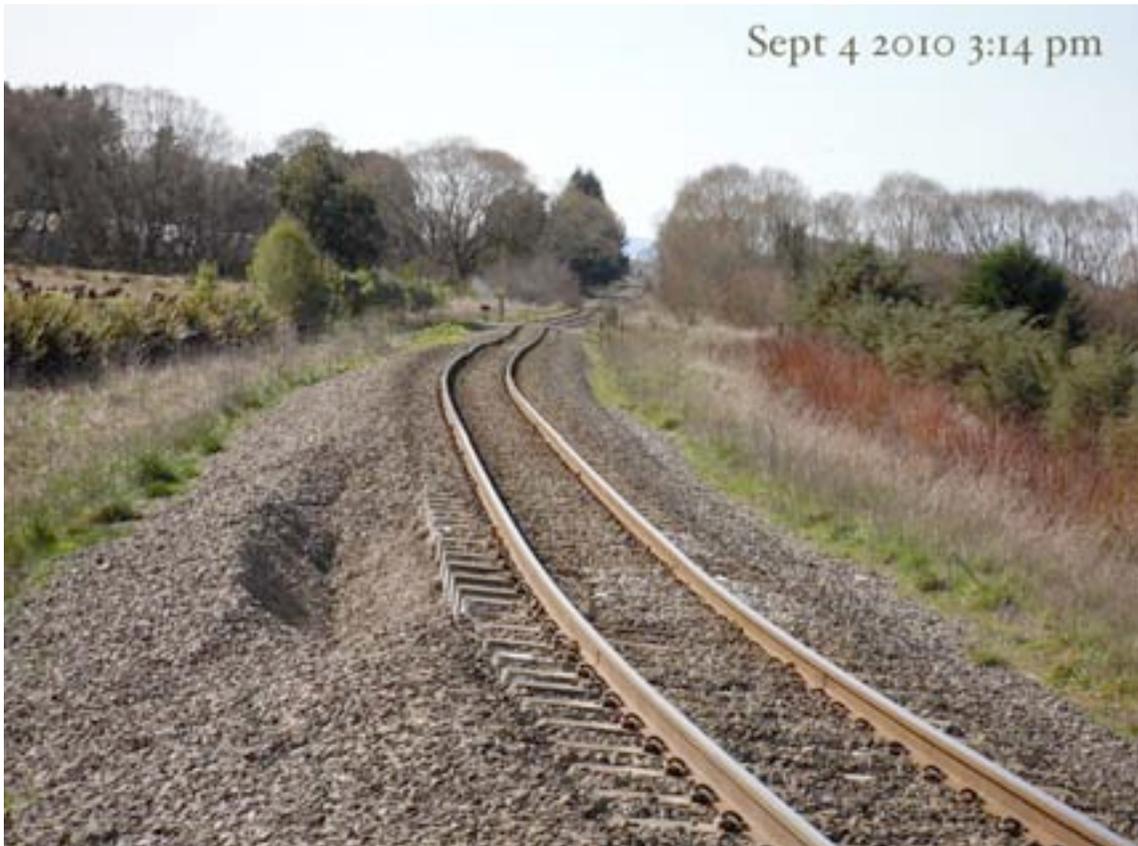
Figures 12-14 and 12-15 show the effects of liquefaction near Kaiapoi on the Main North Line located north of the Waimakariri River. Figure 12-14 shows the rail displacements just a few hours after the earthquake Figure 12-15 a few days later. This section required re-ballasting many times: see the discussion for the February 22 2011 earthquake.

Figure 12-14. Liquefaction along the Main North Line near Kaiapoi (Sept 4 2010)

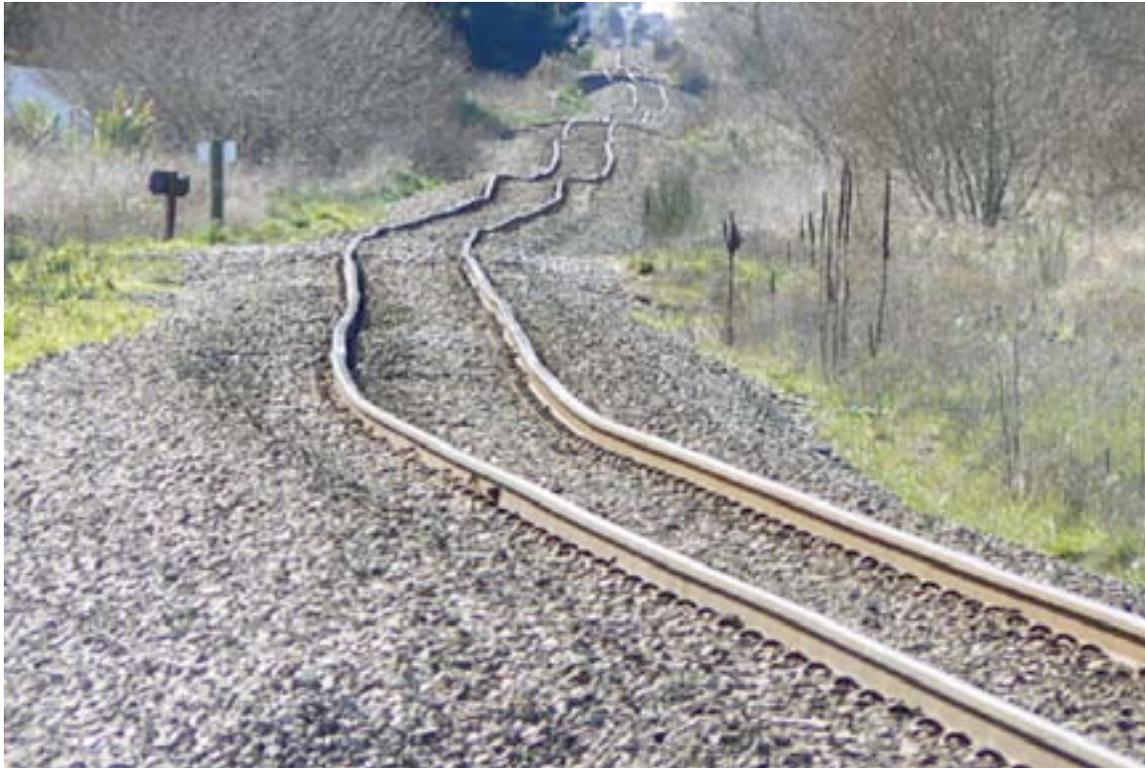
Figure 12-15. Ongoing Liquefaction along the Main North Line near Kaiapoi (mid-Sept 2010)

The embankment near Kaiapoi, shown previously in Figures 12-14 and 12-15, required periodic re-ballasting of the track to maintain alignment following the September 4 2010 earthquake. The frequency of maintenance had decreased to once every two weeks before the February 22 2011 earthquake struck. Figure 12-18 shows re-ballasting during the first week of April 2011. By this time, on-going displacement of the alluvial foundation soils had slowed the requirement for additional ballast to twice a week.

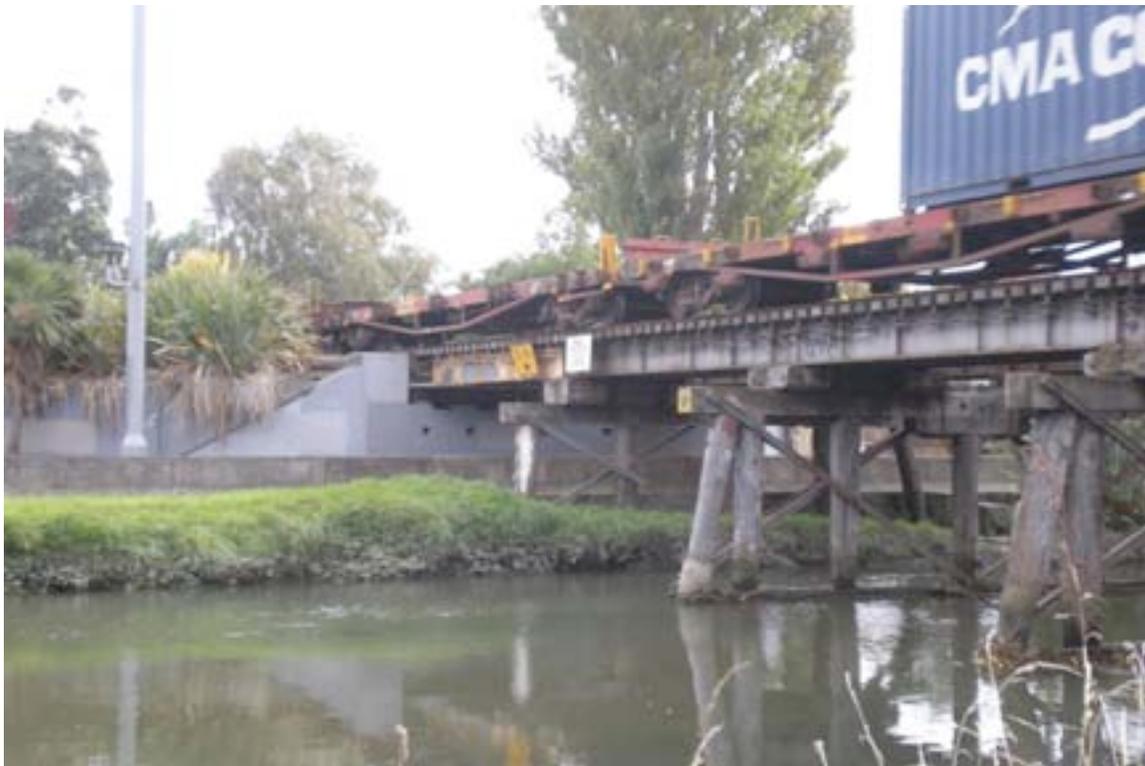
Most of the damage was due to settlement and lateral spreading of liquefied ground. Bridge 7 on the Main South Line over the Heathcoate River was a classic example, see Figure 12-16. Installation of temporary cribbing to repair the bridge reduced clearance for the roadway below to 2.4 m.

Figure 12-16. Timber cribbing

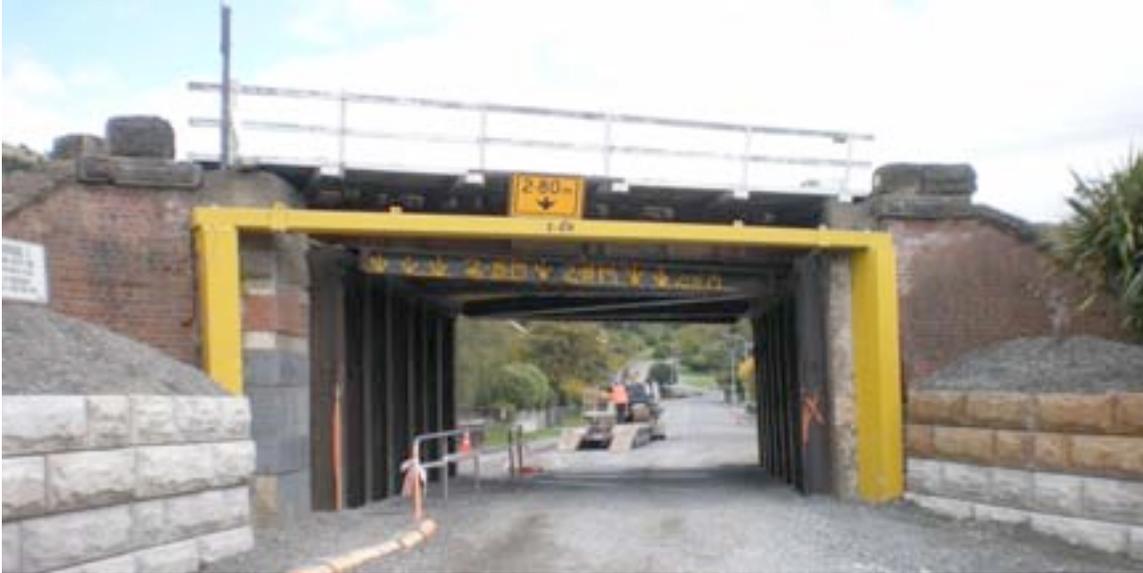
A temporary height restriction of 2.8 m was also placed on Bridge 3 of the same line over Martindales Road. Figure 12-17 shows the temporary bracing with steel supports to repair the damage at this location. The abutments moved and cracked during the extreme shaking and caused deformation in the track ballast and tracks. Stabilizing walls were also placed in front of the brick masonry wingwalls as a temporary repair.

Figure 12-17. Bracing with steel supports

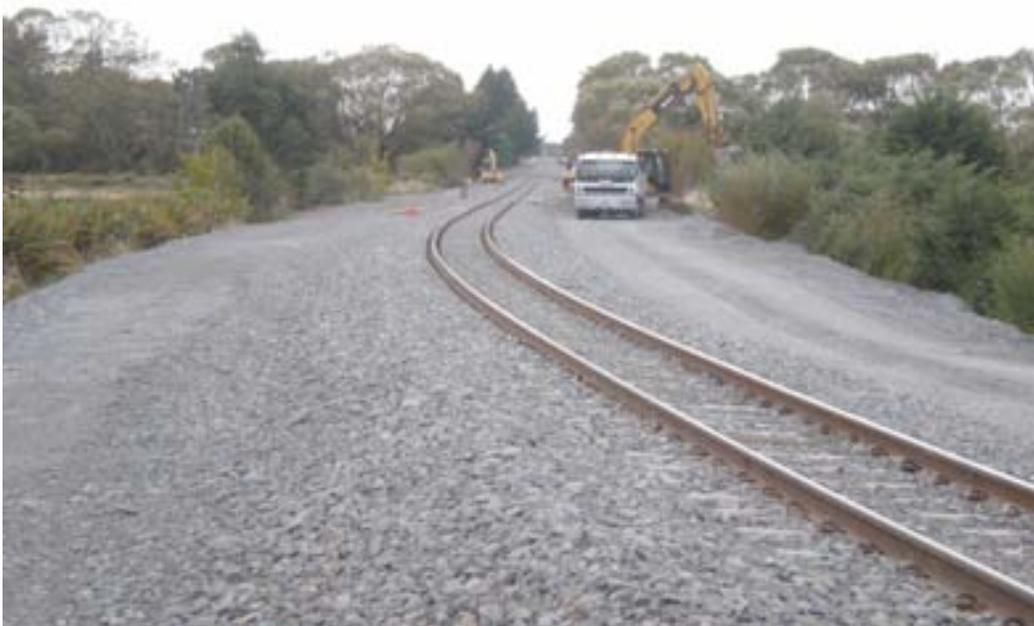
Figure 12-18. Re-ballasting the Main North Line (also, compare with Figures 12-14, 12-15)

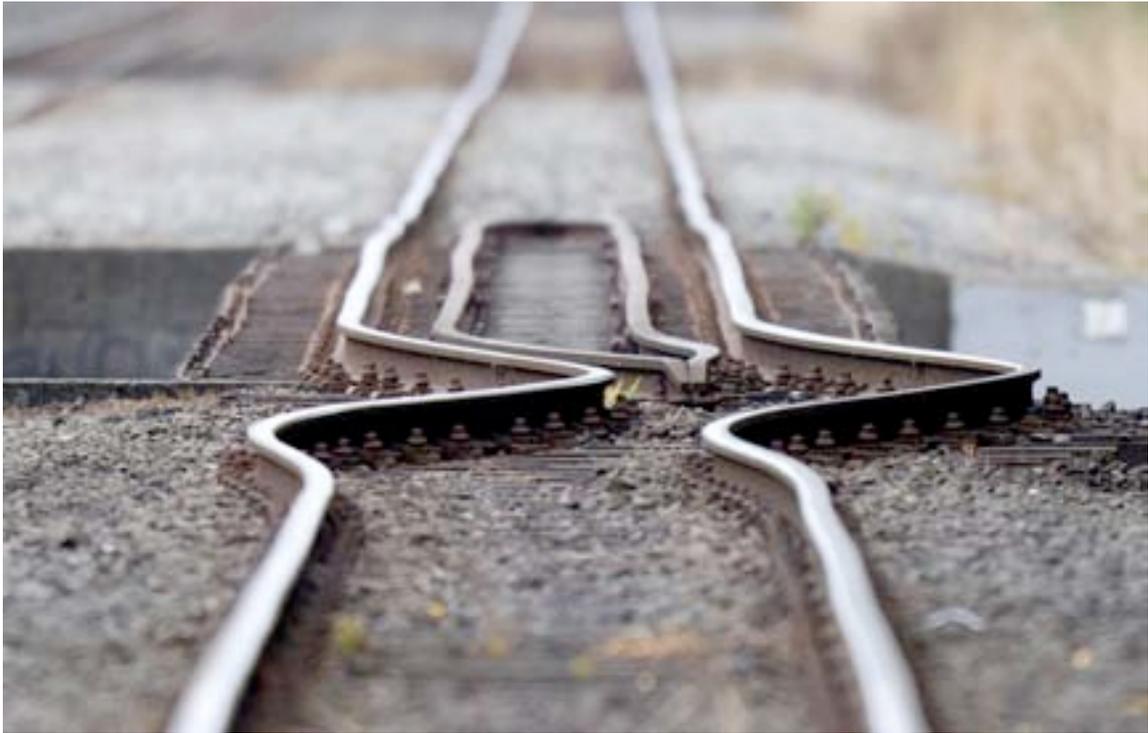
Figure 12-19 shows buckled tracks due to a lateral spread at a culvert.

Figure 12-19. Buckled Tracks

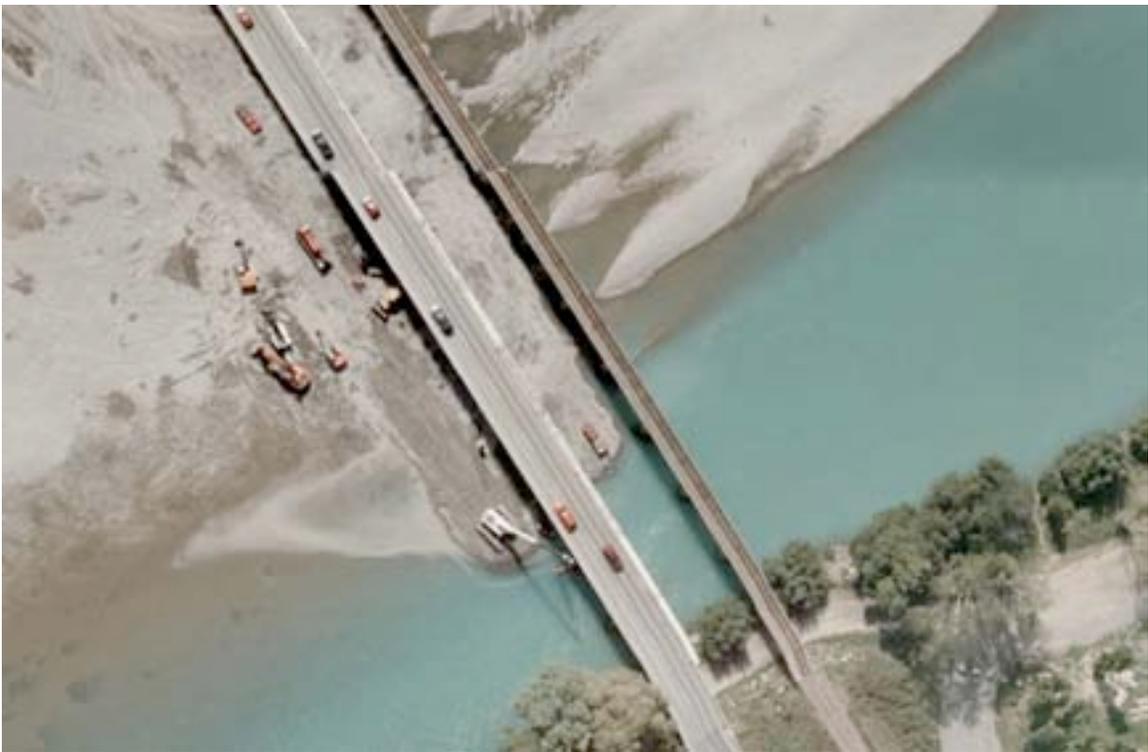
Figure 12-20. Damaged North Bridge

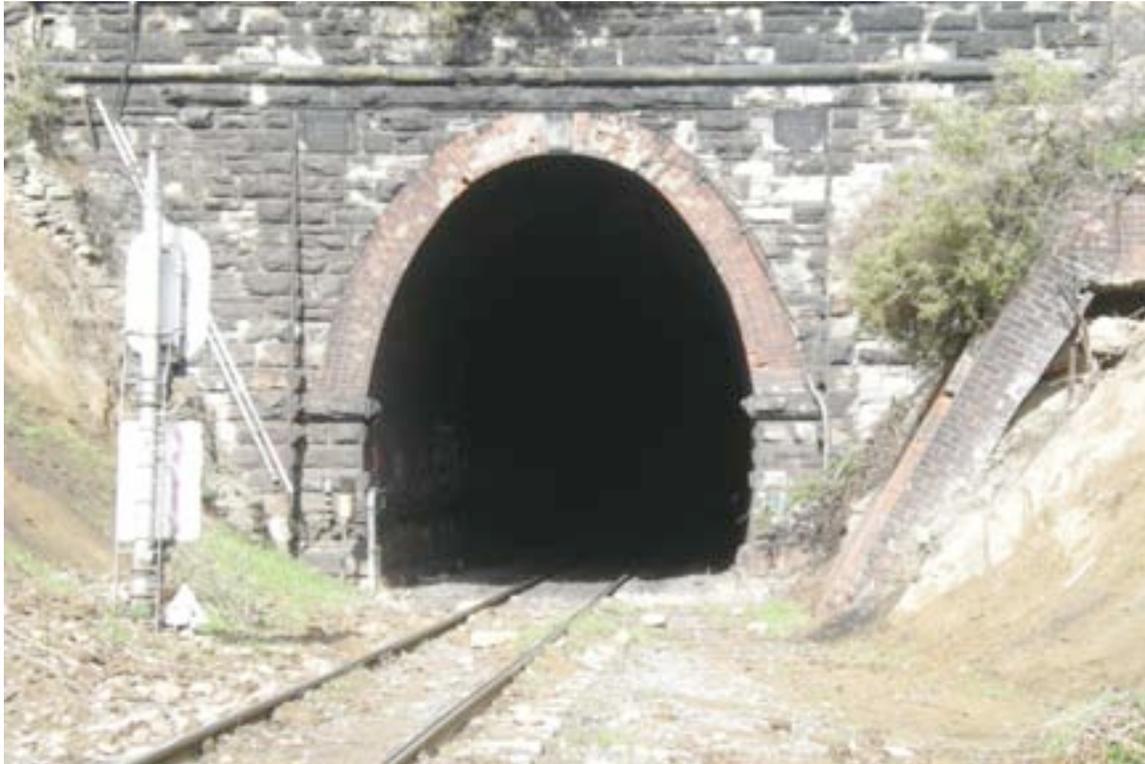
Rock falls in the Port Hills area led to closure of one of the two parallel rail lines that serviced the Port of Lyttelton. Rocks were also dislodged from the roof of the Lyttelton tunnel and additional groundwater springs have developed. Figure 12-21 shows the north portal of the Lyttelton tunnel where additional cracking was observed. Train engineers reported that the tunnel invert appears to be crowned more than it was before the February earthquake. Given the location of the tunnel, fault offset may have occurred (?? but not verified) at this location.

Figure 12-21. North Portal Lyttelton Tunnel

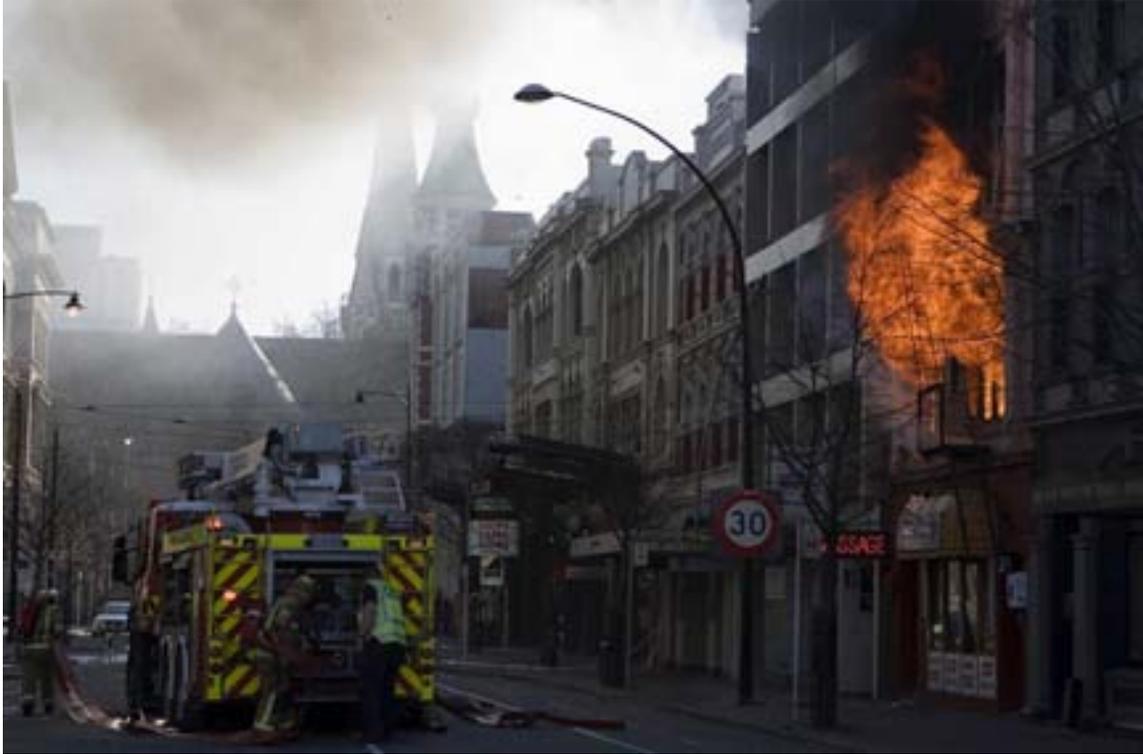
Figure 13-1. Fire in Downtown Christchurch

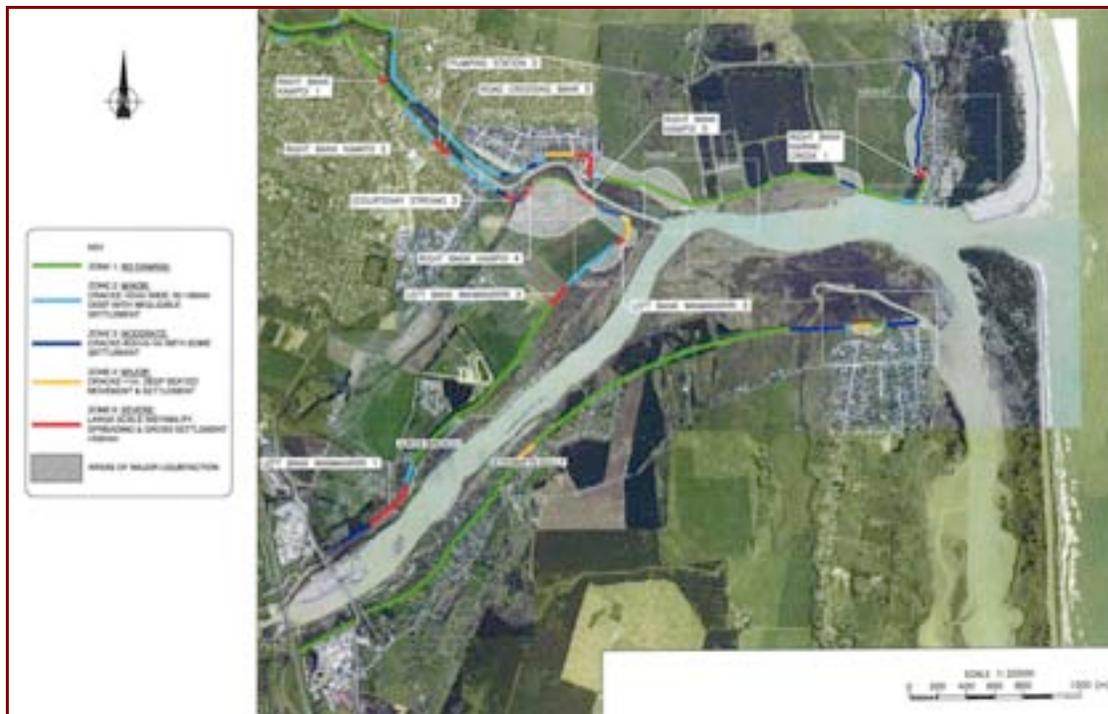
The stopbanks impacted by the earthquake are in the area close to river mouth of Waimakariri River and the junctions of Kaiapoi River and Kairaki River, Figure 12-1. Seven stretches of levees mapped in Figure 14-1 suffered severe damage, having large scale instability, spreading and gross settlement over 0.5m (red lines). Four stretches of levees suffered major damage, including cracks greater than 1 m in depth, with deep seated movement and settlement (yellow lines). Eleven stretches of levees suffered moderate damage, including cracks 0.4 meter to 1 meter in depth, with some settlement (dark blue lines). Fourteen stretches of levees suffered minor damage, including cracks less than 5 mm wide, 30-140 mm deep with negligible settlement (light blue lines). Levees with no observed damage are shown in green lines.

Figure 14-1. Stopbank damage surveyed by Riley Consultants

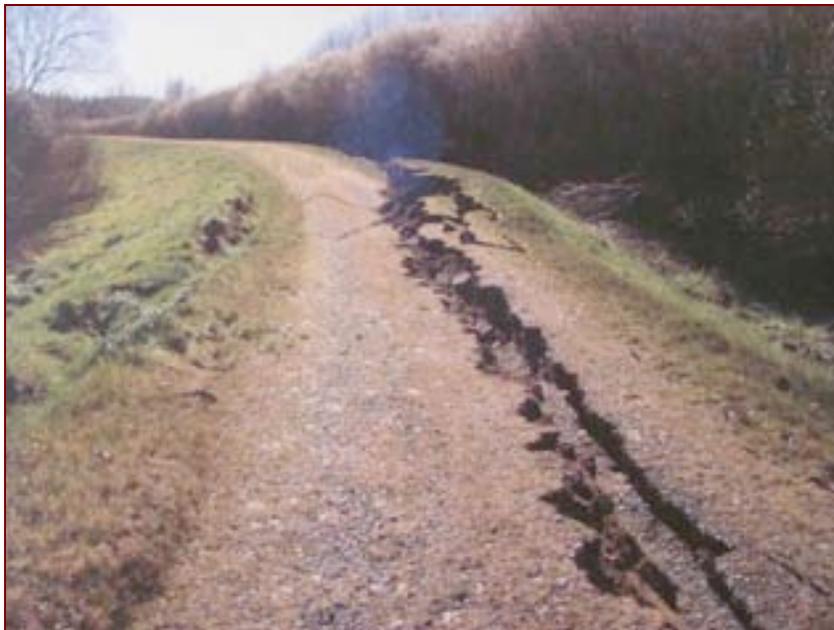
A survey reported by Riley Consultants indicated the following damage to stopbanks: 10 severe, 4 major, 11 moderate, and 14 minor damage: see Figures 14-3 to 14-5.

Figure 14-3. Severe Damage – Stopbank

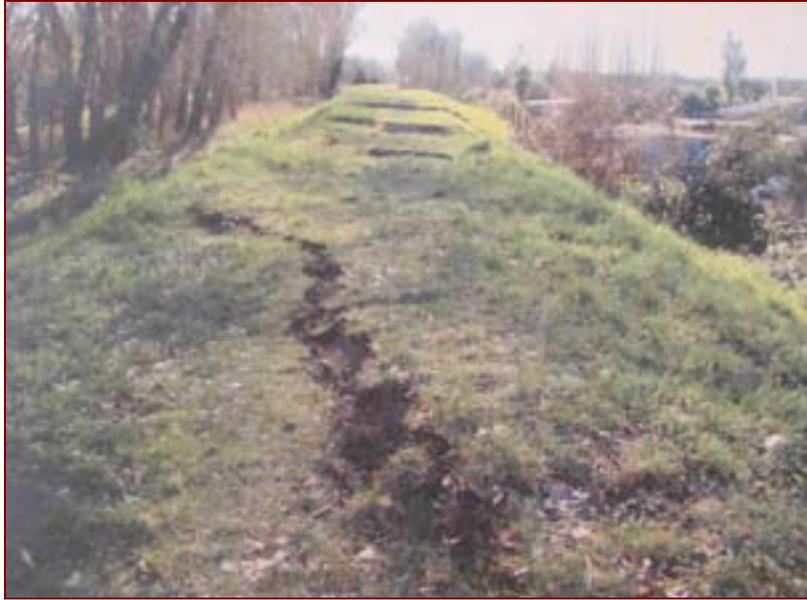
Figure 14-4. Major Damage – Stopbank

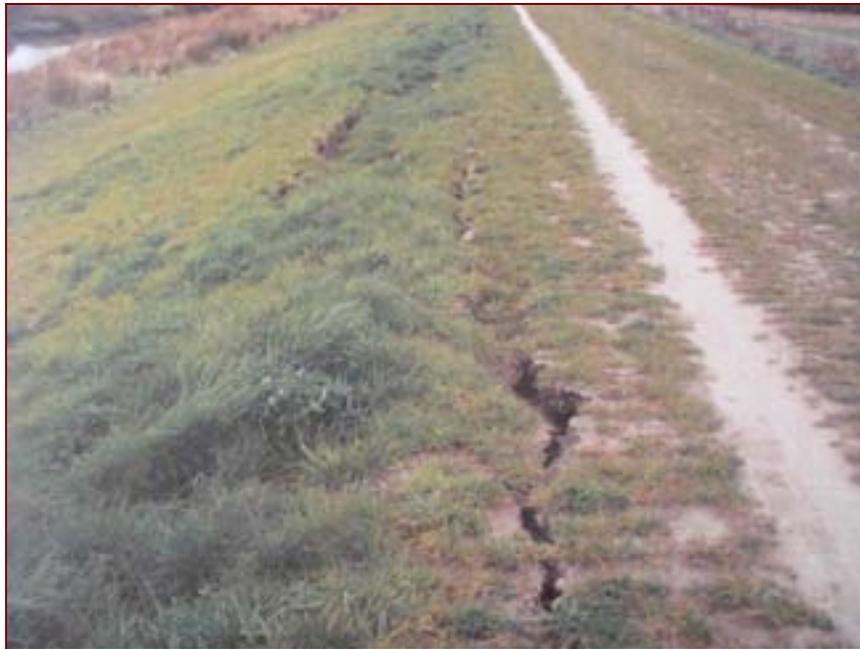
Figure 14-5. Moderate Damage – Stopbank

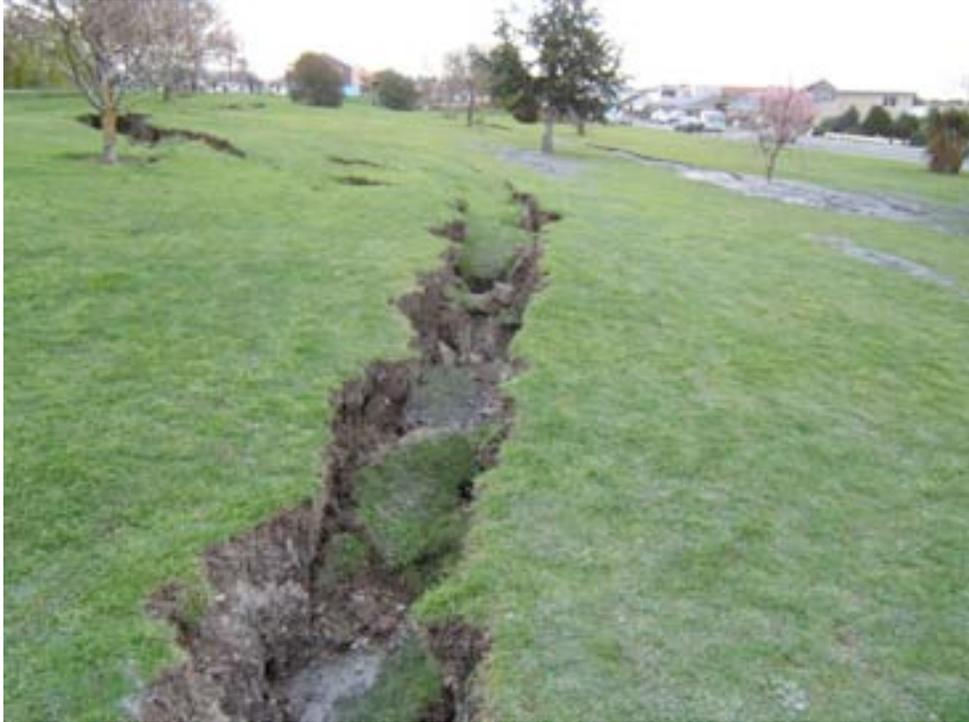
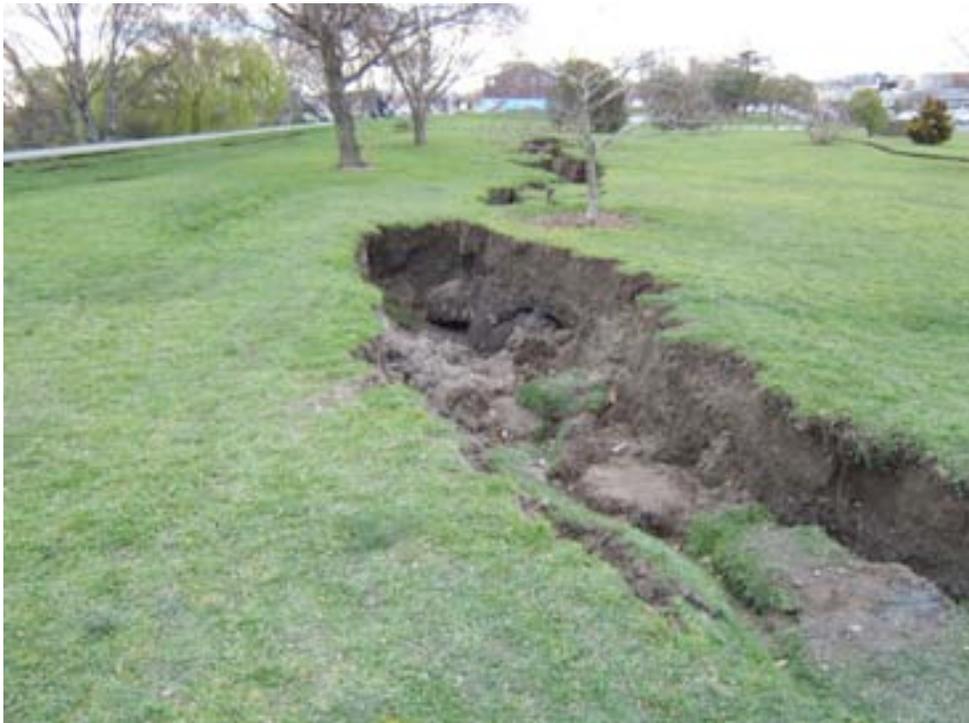
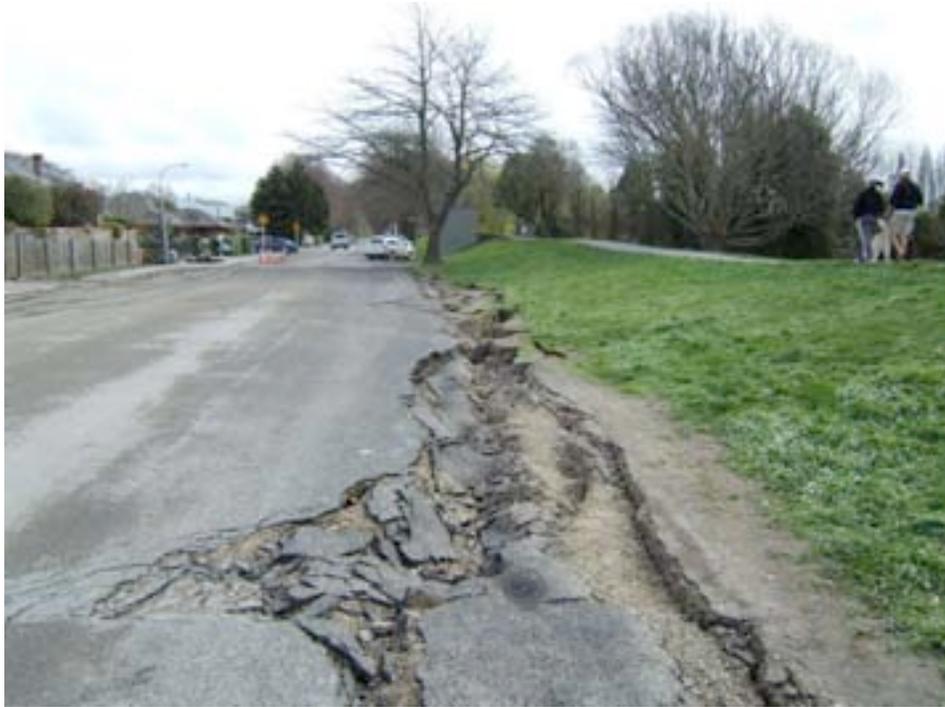
Figures 14-6 to 14-8 show slope failures along the levee in Kaiapoi.

Figure 14-6. Levee Damage - Kaiapoi (Sept 2010)
