CHRISTCHURCH, NEW ZEALAND EARTHQUAKE SEQUENCE OF M_w 7.1 September 04, 2010 M_w 6.3 February 22, 2011 M_w 6.0 June 13, 2011: LIFELINE PERFORMANCE

**Technical Council on Lifeline Earthquake Engineering
Monograph No. 40
February 2012 – Revision 0
ASCE**

ABSTRACT

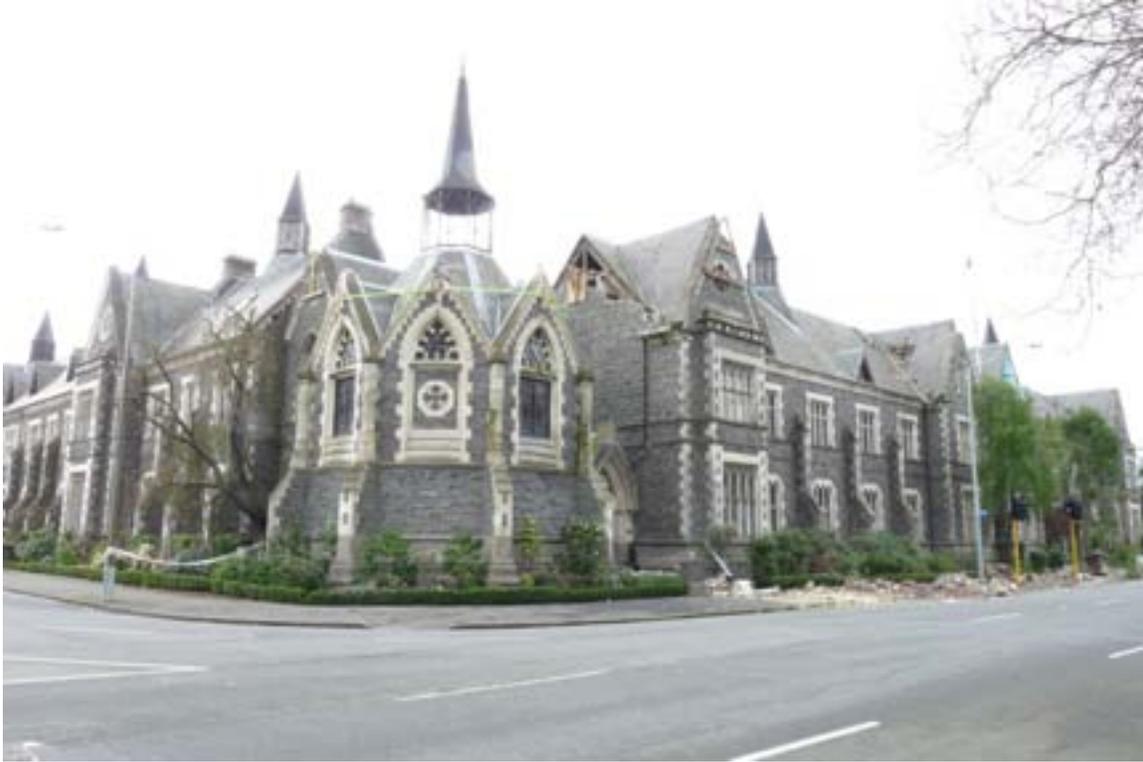
The URM buildings include several large, heritage buildings (Figure 16-1), Churches (Figures 16-2, 16-3), as well as many small commercial stores. The bulk of the URM buildings experienced ground motions from $PGA = 0.15g$ to $0.30g$, and most sustained minor damage (fallen parapets, etc.) (Figure 16-4); a few had major damage and outright collapses (Figure 16-5). Some small URM buildings with many walls and few windows showed no distress. Some of the more massively built URMs, including churches, the cathedral, etc. sustain only minor damage beyond loss of parapets. Some 1 and 2-story small URM commercial buildings had complete wall failures. The performance of the URM building stock was much worse in the February 2011 event.

Figure 16-1. Damage to Parapets and End Gables for this URM Heritage Building

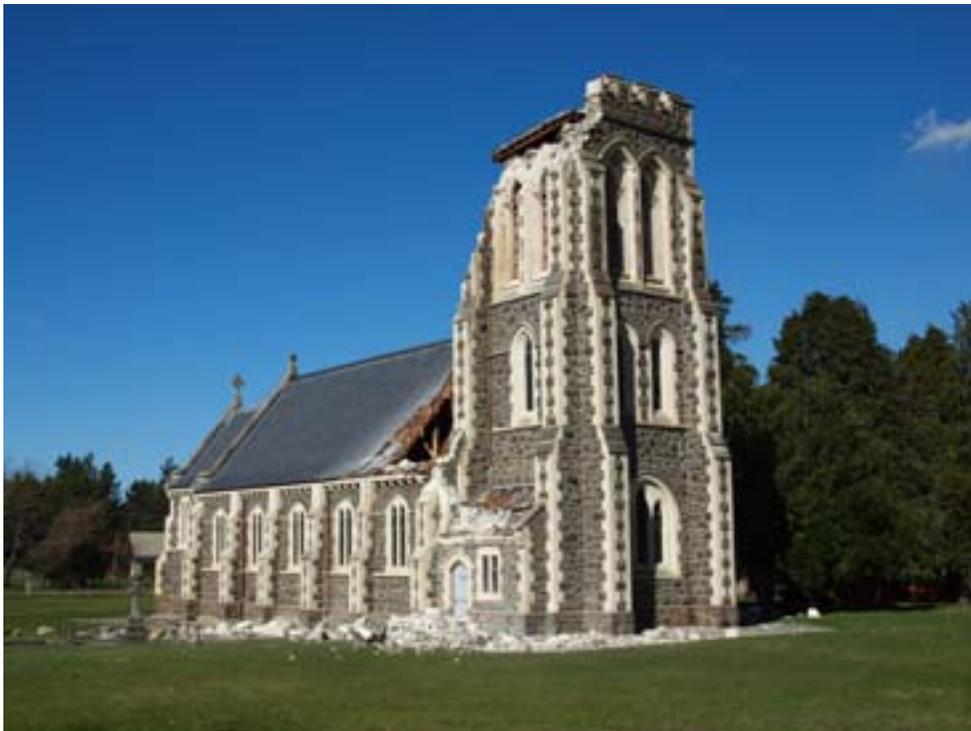
Figure 16-2. Damage (Parapets, Falling Debris Damaged Roof) to URM Church

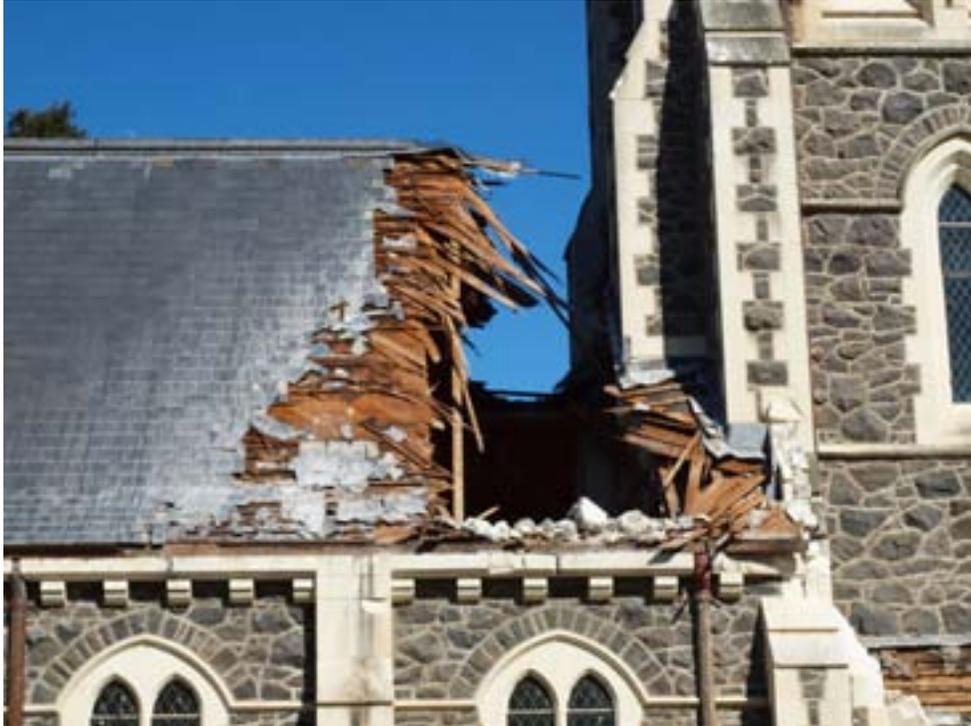
Figure 16-3. Fallen Debris Damaged Roof (Close Up from Figure 16-2)

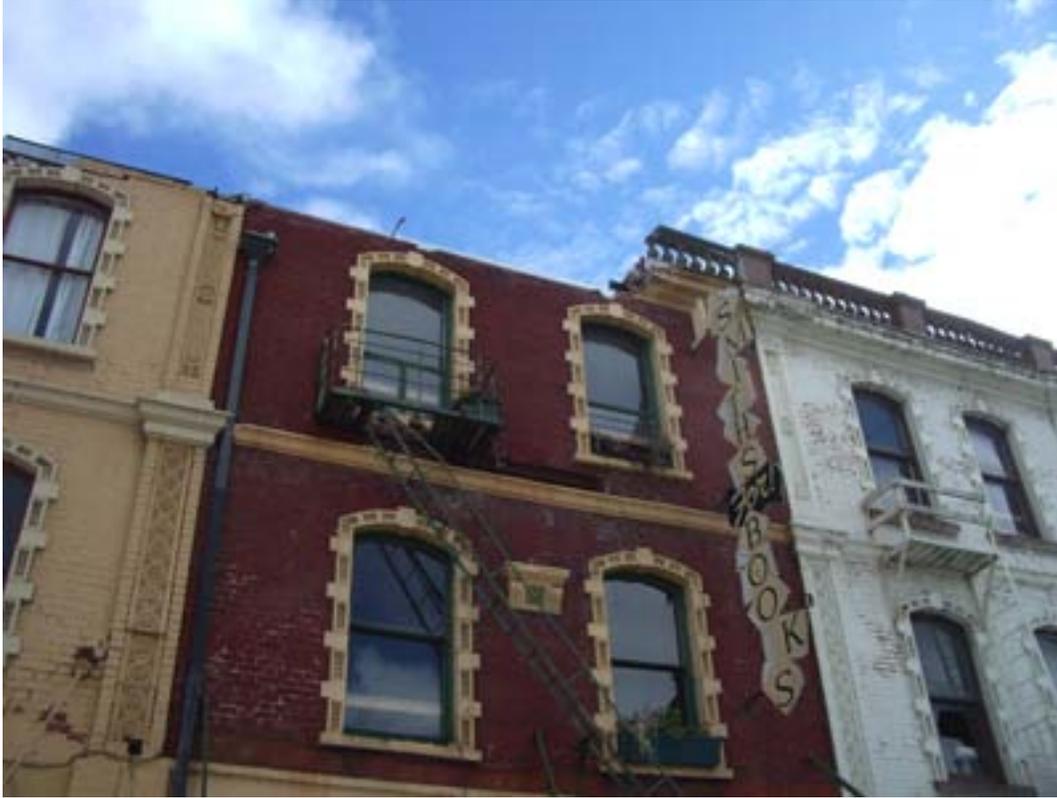
Figure 16-4. Damage to Parapets these URM Buildings

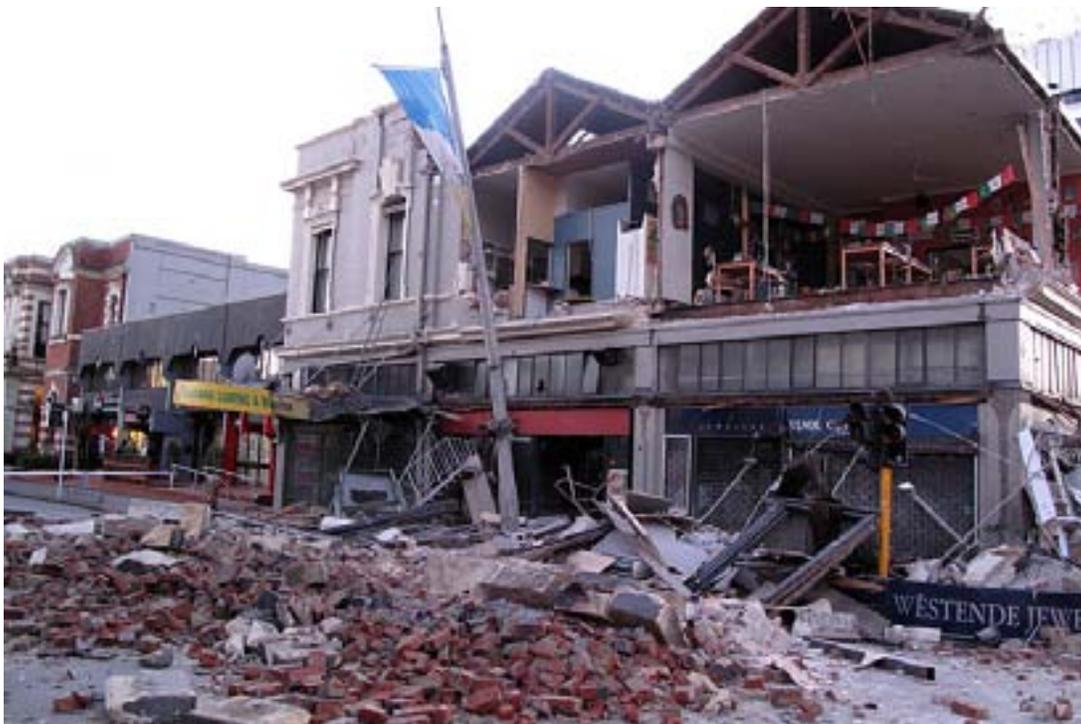
Figure 16-5. Damage to Walls for these URM Buildings

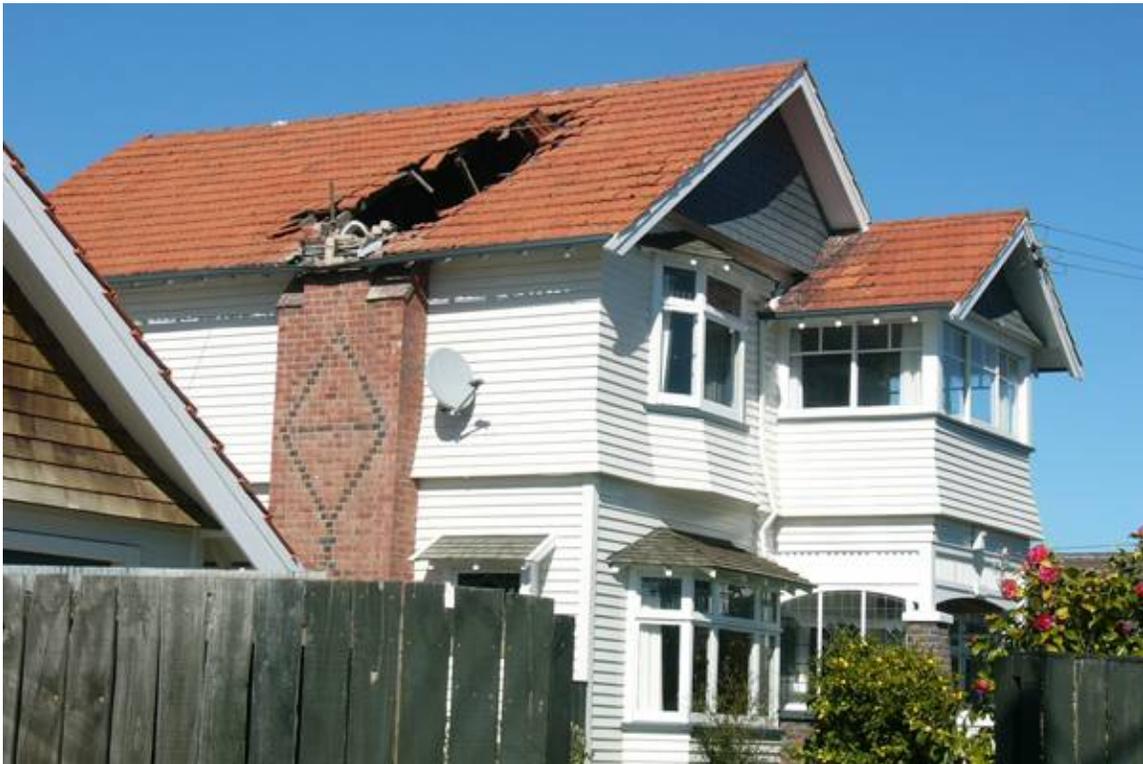
Residential single family buildings compose the largest inventory of buildings, using wood frame stud-wall / gypsum board type construction, not too different from that commonly used in the USA. There are no known collapses of these residential wood frame buildings, although up to about 3,000 of these types of buildings sustained various ranges of damage due to liquefaction. Brick chimneys for wood frame residential buildings are common throughout the area; perhaps 50% of these chimneys had some type of failure (Figure 16-6). There are no known injuries due to fallen chimneys.

Figure 16-6. Damage to URM Chimney

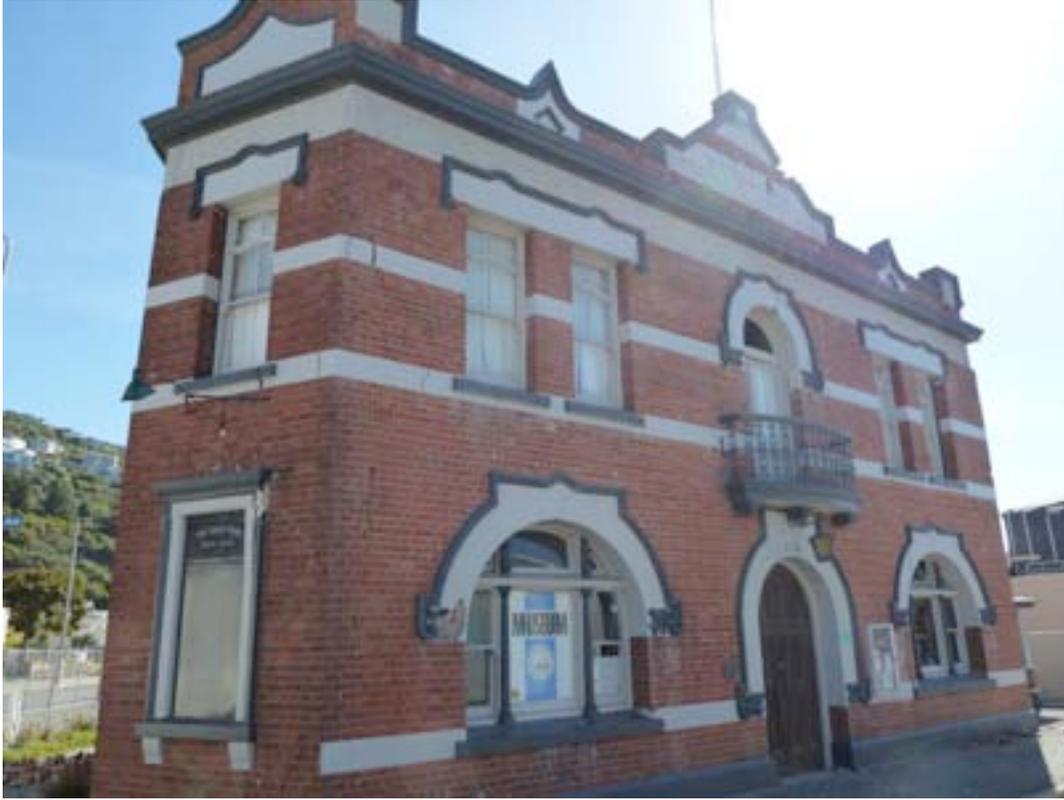
In the Sumner area, community center (URM) was heavily damaged and red-tagged.

Figure 16-8. Sumner District Council Building

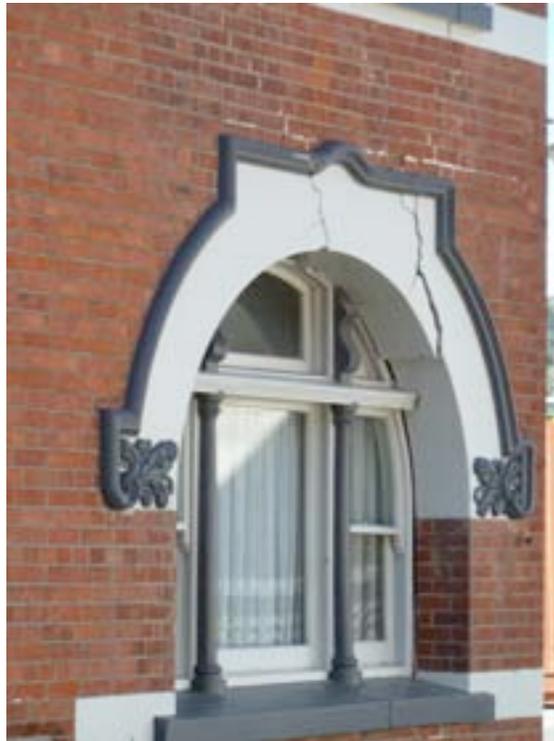
Figure 16-9. Sumner District Council Building (Failed Masonry Arch)

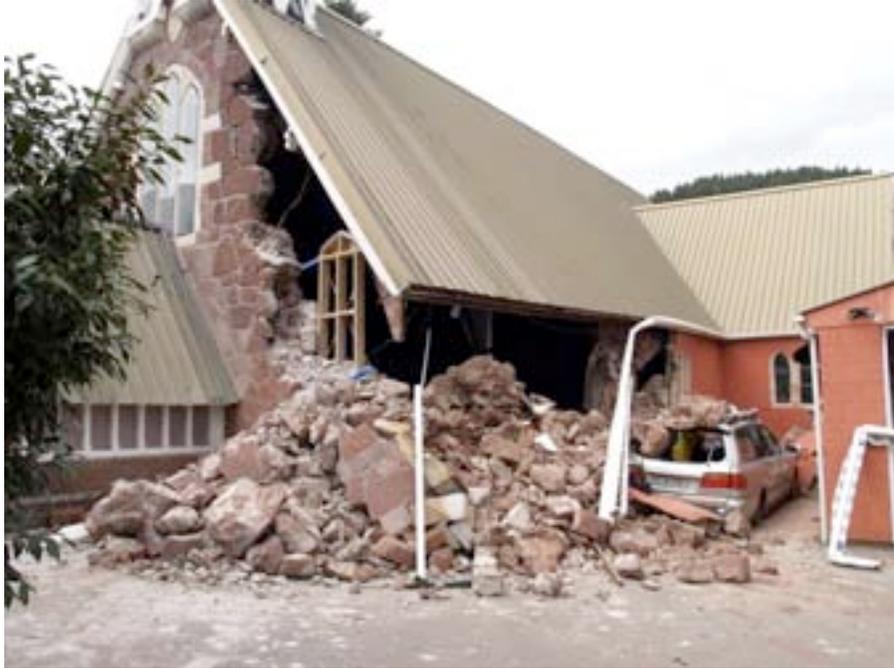
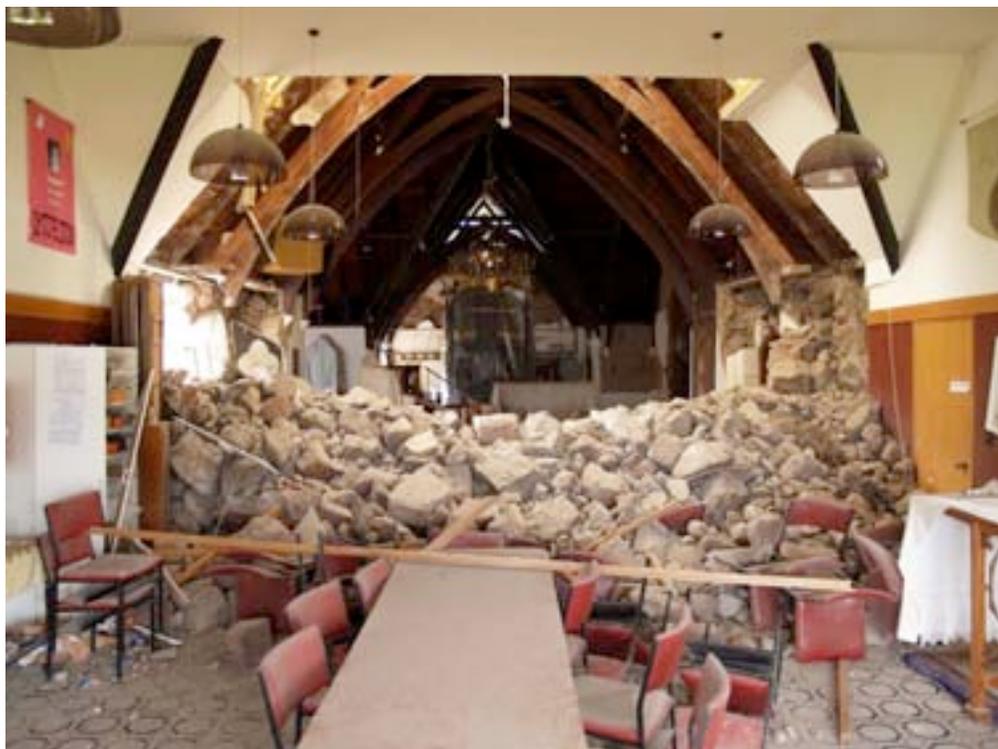
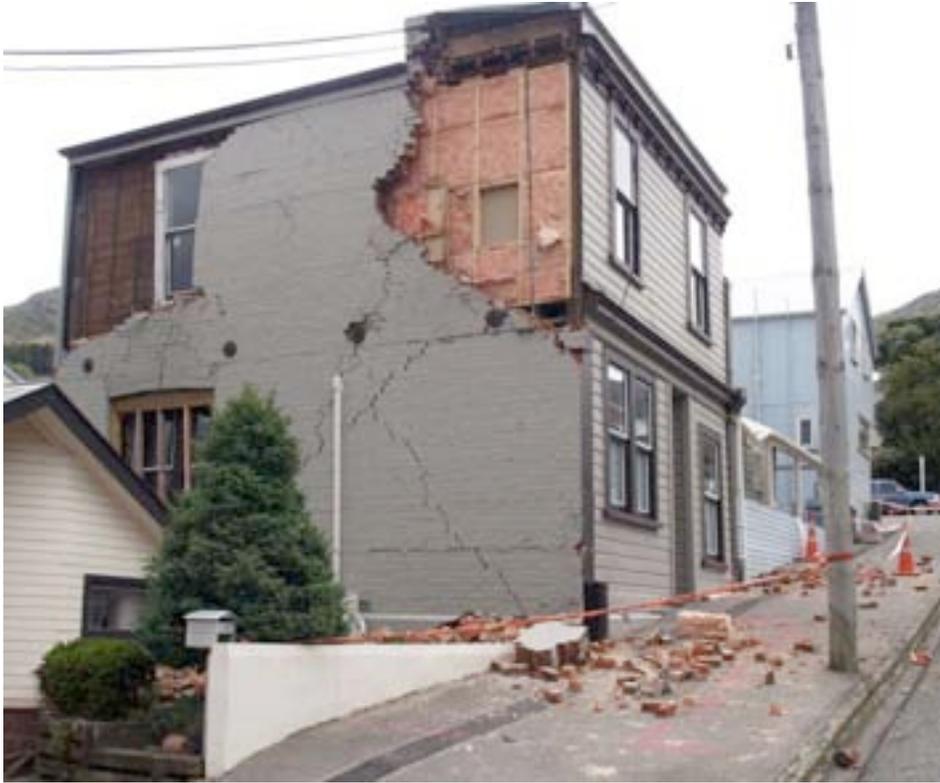
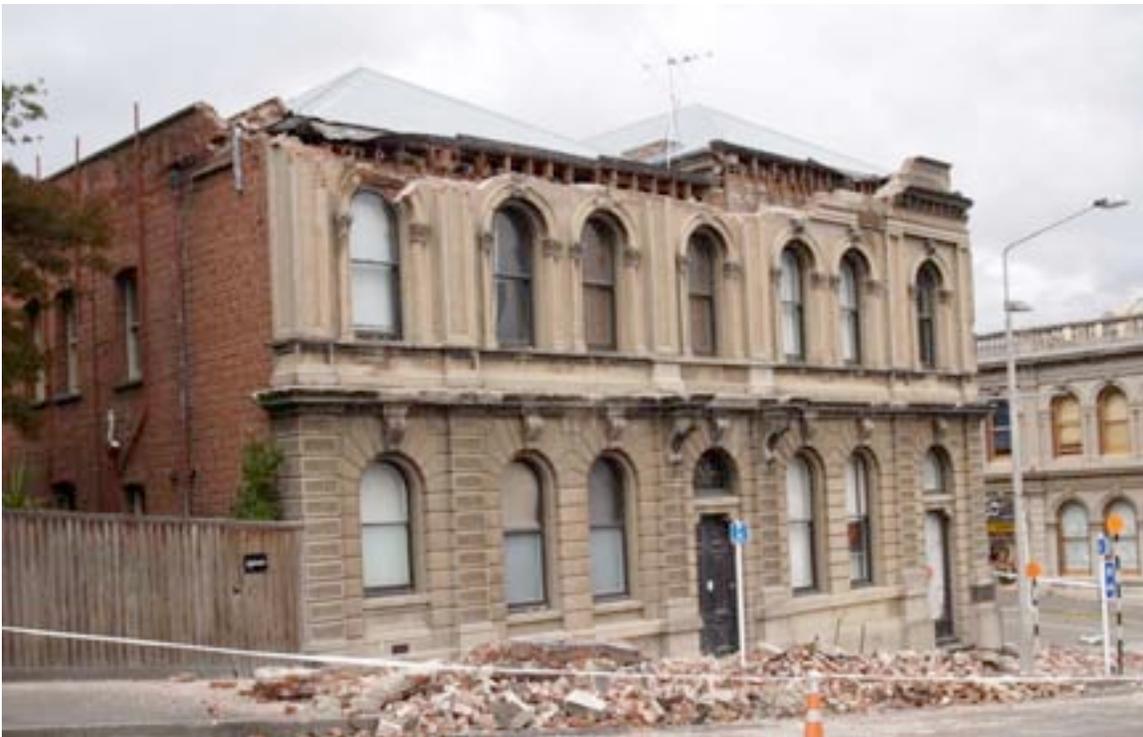
The Port of Lyttleton includes a small town. It is largely founded on bedrock. In the February 2011 earthquake, local ground motions were very high ($PGA > 0.5g$), and many of the masonry buildings were damaged, Figures 16-10.

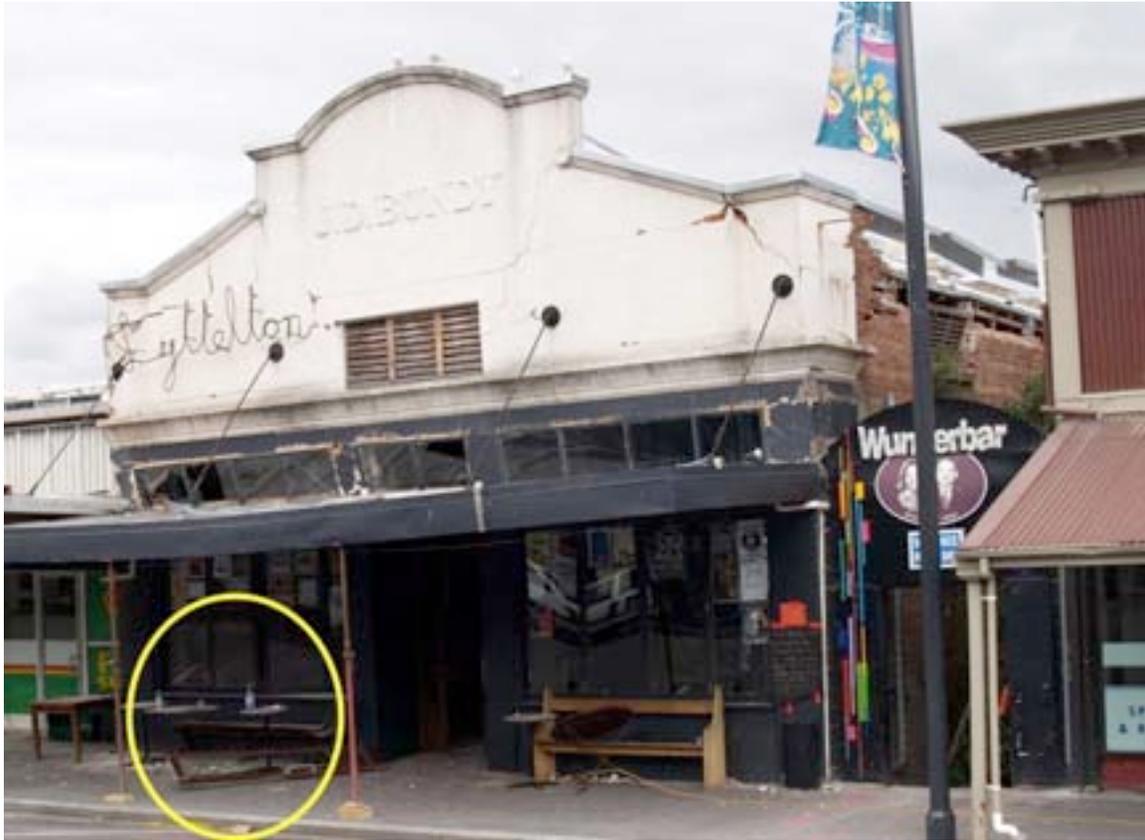
Figure 16-14 highlights outdoor tables where Prof. Tom O'Rourke and John Eidinge ate lunch in September 2010. It was remarked at the time that the building's parapets were dubious and potential life safety threats. Some other eateries and brew-houses visited by the TCLEE team in September 2010 (in conjunction with many Kiwi earthquake specialists) collapsed outright in the February 2011 earthquake.

Figure 16-14. Lyttelton Commercial Building (February 2011)

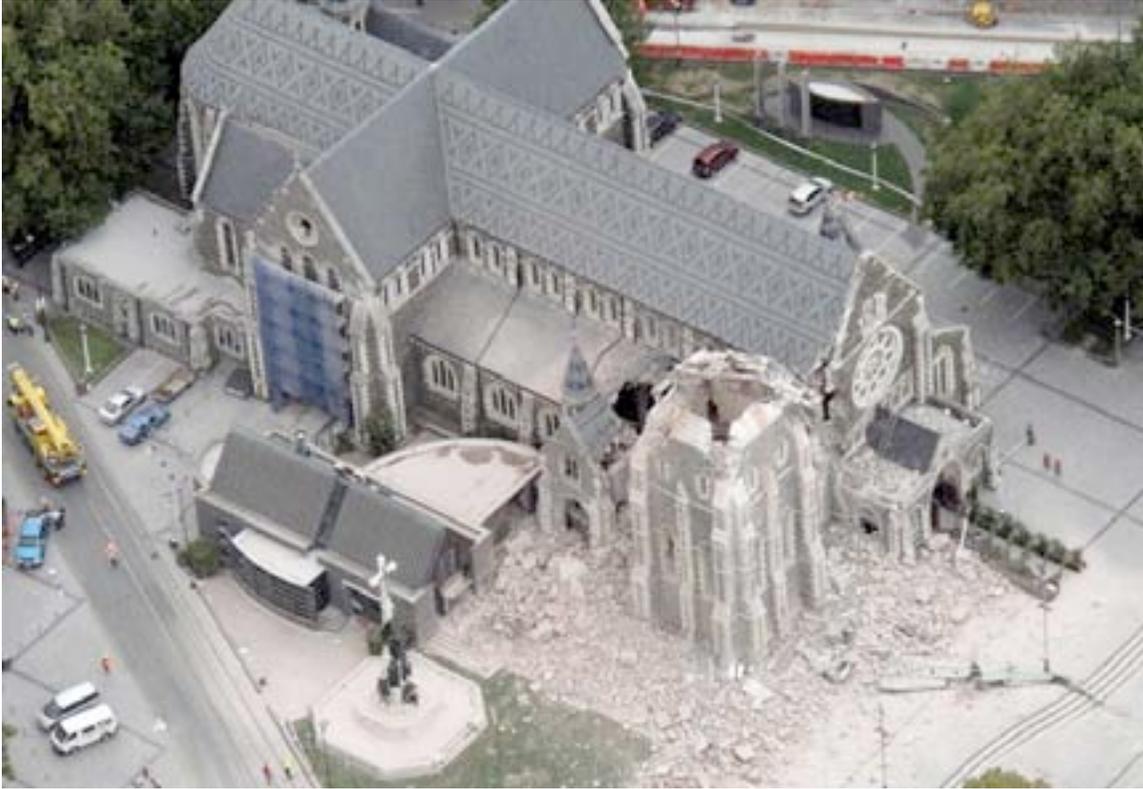
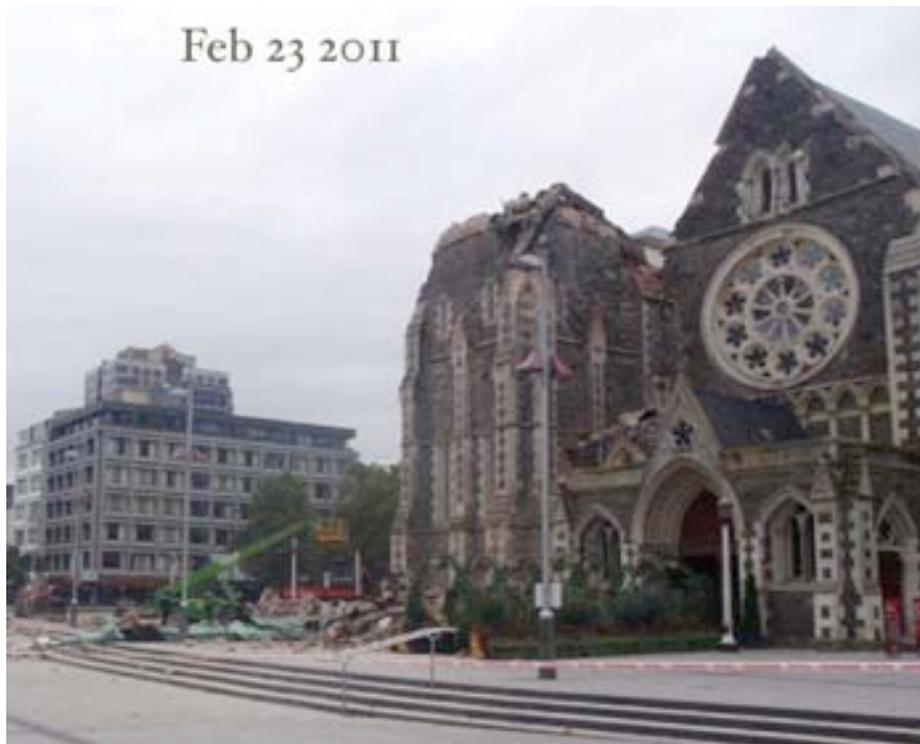
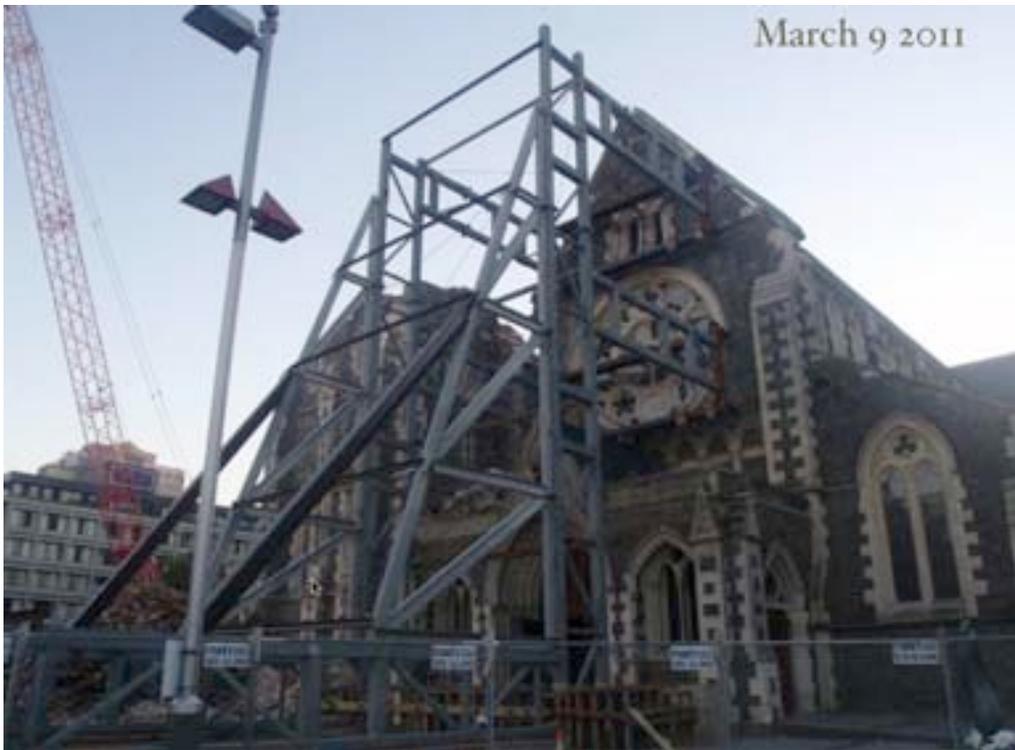
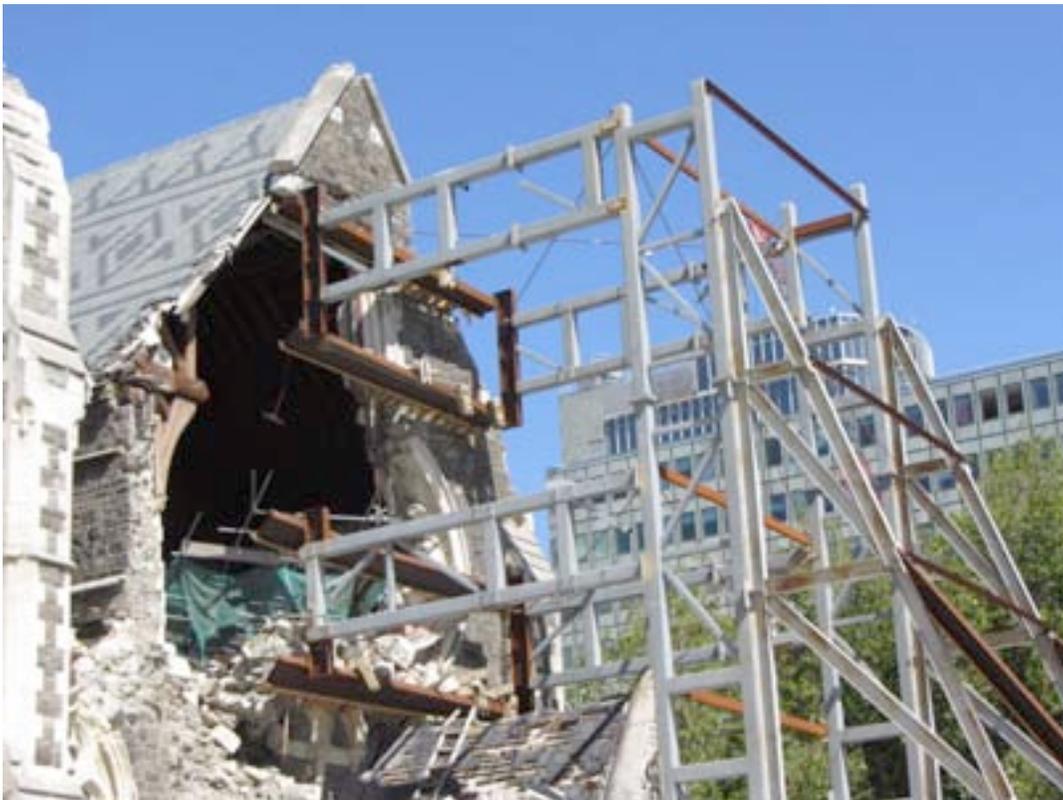
The Christchurch Cathedral occupies a central location in the central business district, and serves as a focal point in the history of Christchurch. Recognizing its importance, this building had undergone a seismic upgrade prior to the September 2010 earthquake; reportedly for about $PGA = 0.15g$ (about 2/3 of then current code). It partially collapsed in the February 22 2011 earthquake, Figures 16-15, 16-16. Shoring was installed, as seen in Figure 16-17, photo taken March 9, 2011. The façade shown in Figure 16-17 collapsed in the June 11, 2011 earthquake, Figure 16-18, photo taken December 12, 2011.

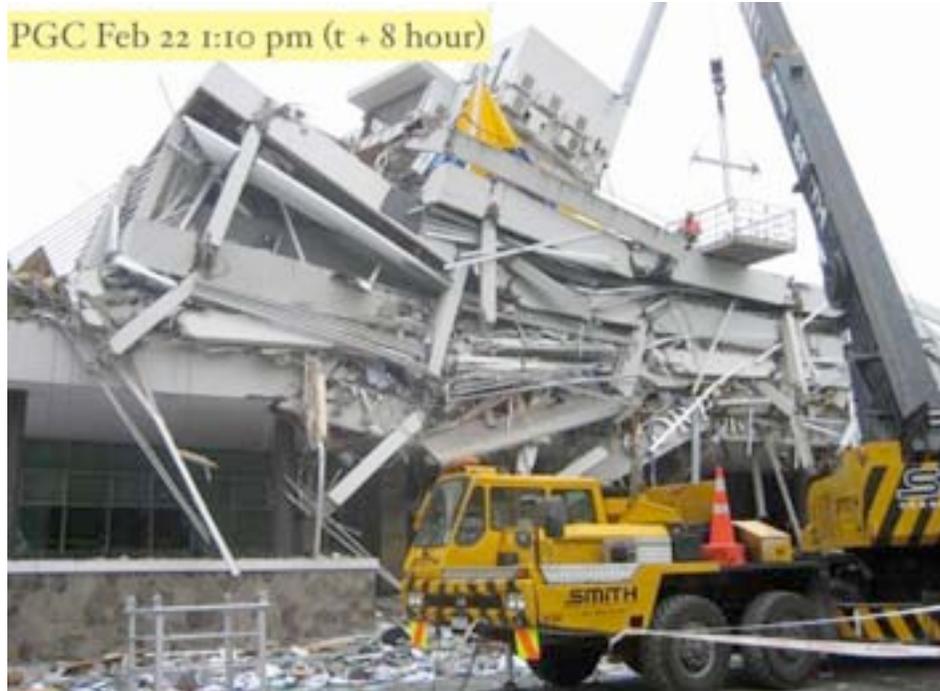
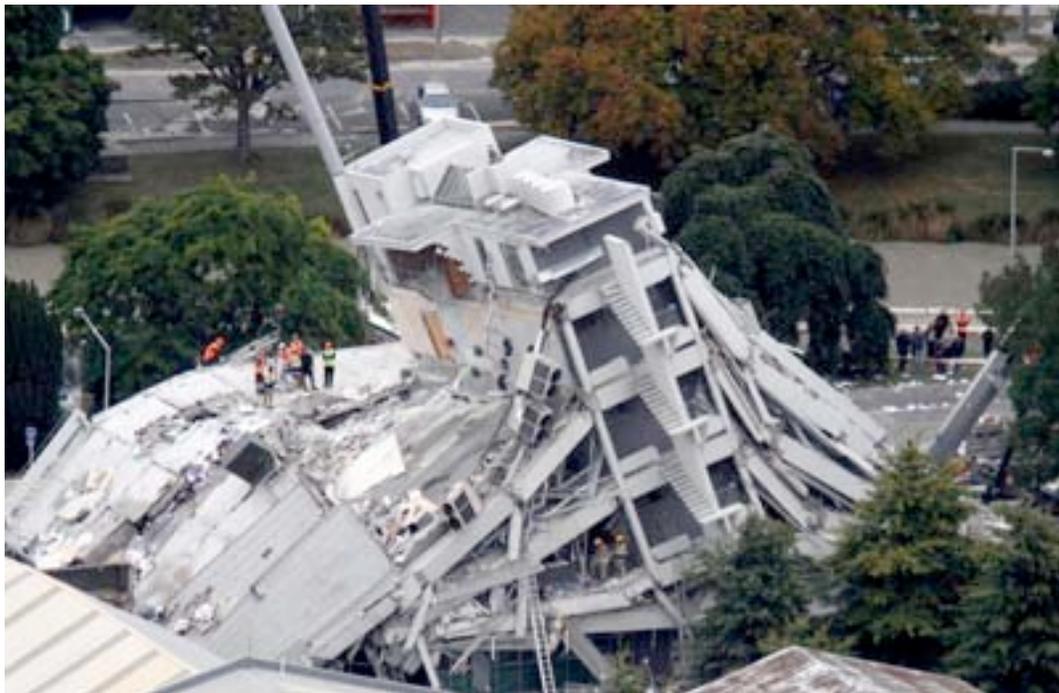
Figures 16-19, 16-20 (Pyne Gould Guinness Building), 16-21, 16-22 (CTV Building) show the two collapsed engineered buildings in which most of the loss of life occurred in the February 2011 earthquake.

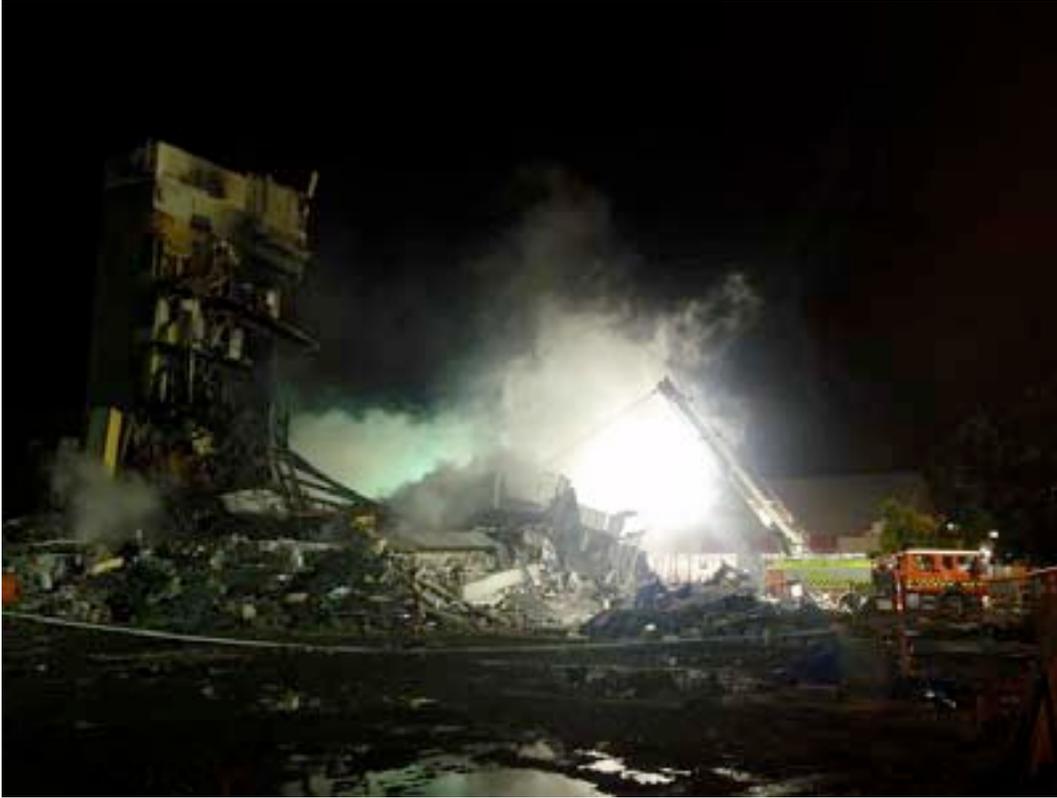
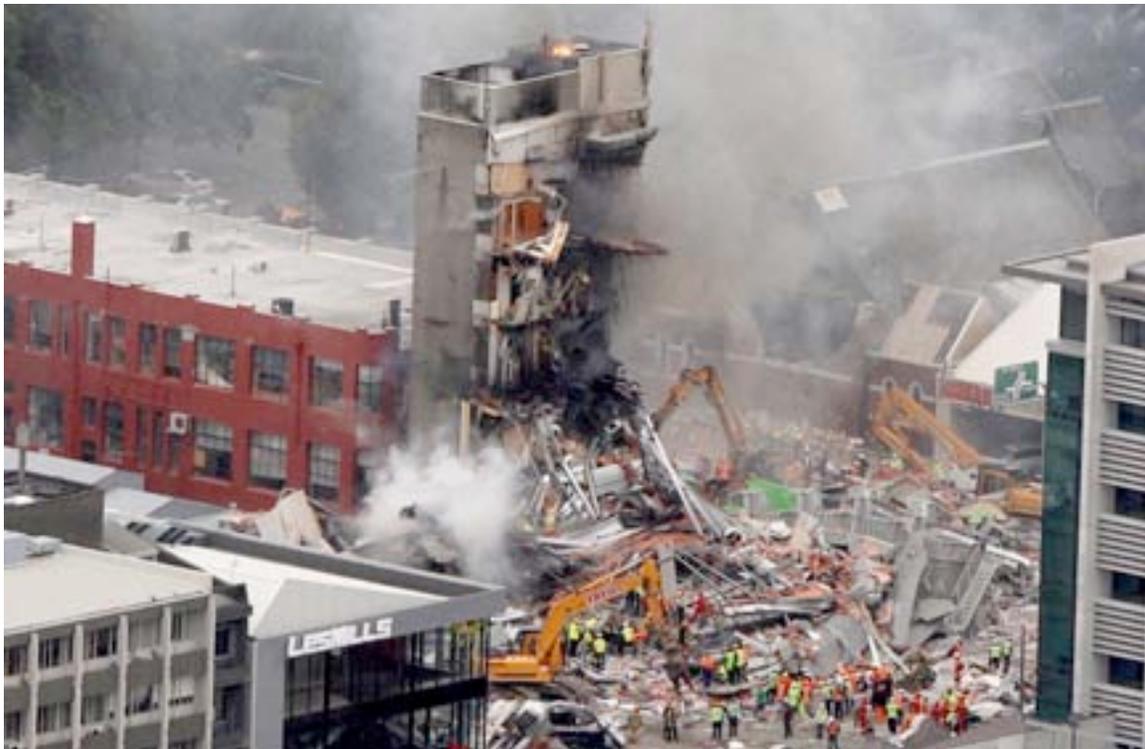
Only one significant structure fire occurred in the February 2011 earthquake, at the CTV building (Figure 16-18). The collapse of the building likely led to the ignition.

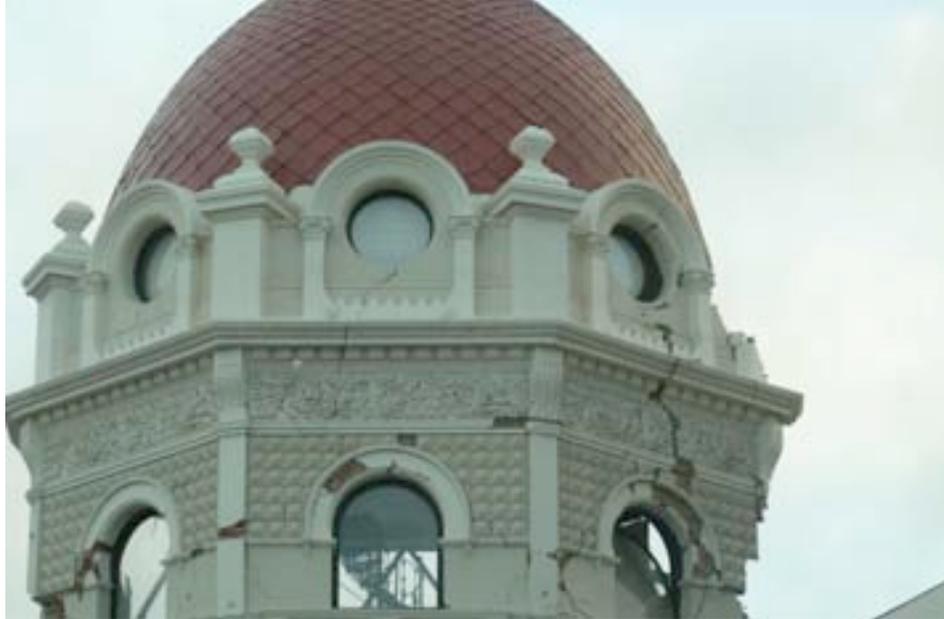
Figures 16-23 and 16-24 show the heavily damaged portion the tourism office located opposite the Christchurch Cathedral. This structure was originally a URM, and had previously been seismically upgraded (interior steel braced frames); but it was heavily damaged in the February 2011 event. It had been torn down by December 2011.

Figure 16-23. Damaged Tourism Building, February 2011

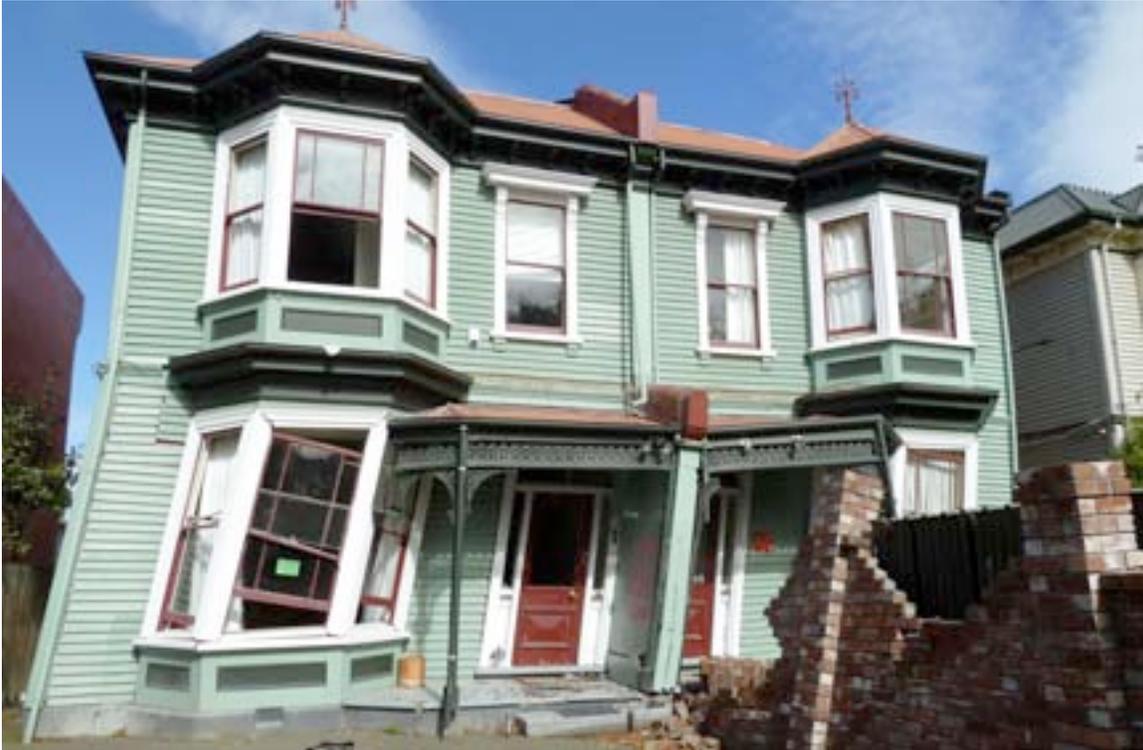
Figure 16-25. Racked Residential Building, February 2011

Figure 16-25 shows a severely racked residence located at the north edge of the CBD. A few residences on this street showed similar racking.

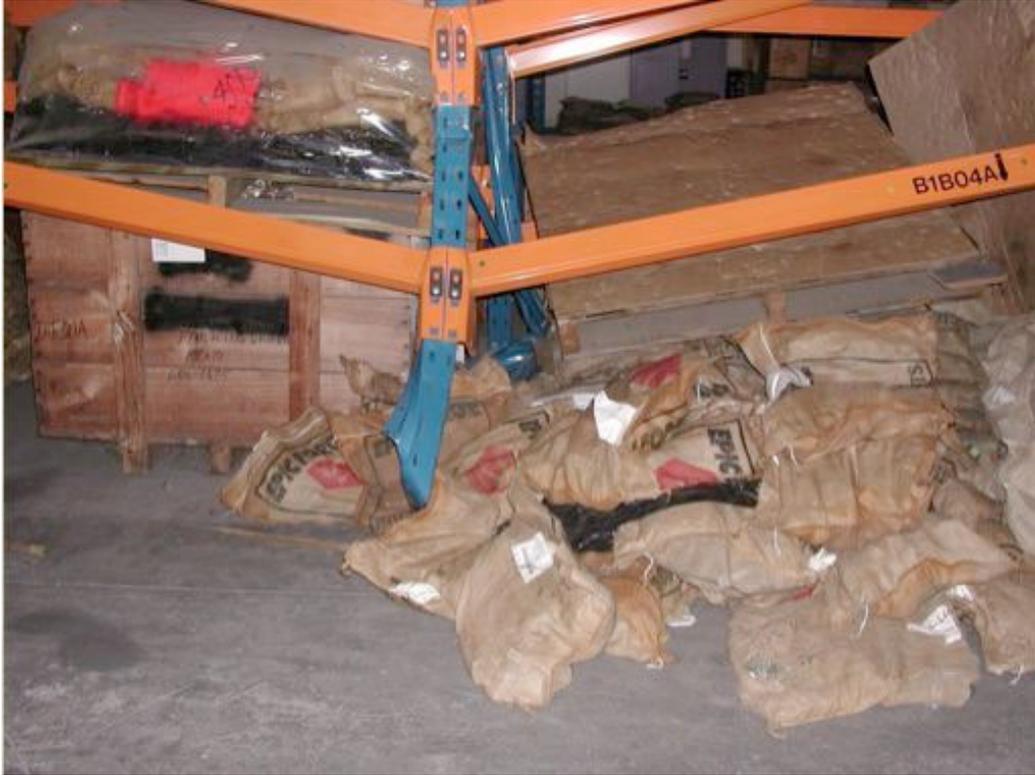
Figure 17-2. Damaged Column Leg, Addington Warehouse

Figure 17-1 shows a damaged storage rack at Transpower's Addington warehouse (PGA $\sim 0.25g$). This rack included two grossly buckled legs, Figures 17-2 and 17-3. Figures 17-4 and 17-5 show damage storage racks at other locations in Christchurch.

The seismic design standards for the existing steel storage racks will need to be reviewed, as the actual earthquake motions were generally within design levels, but the performance of heavily-loaded racks was poor. If the earthquake had occurred during working hours, no doubt the collapse of the racks would have led to many injuries or fatalities.

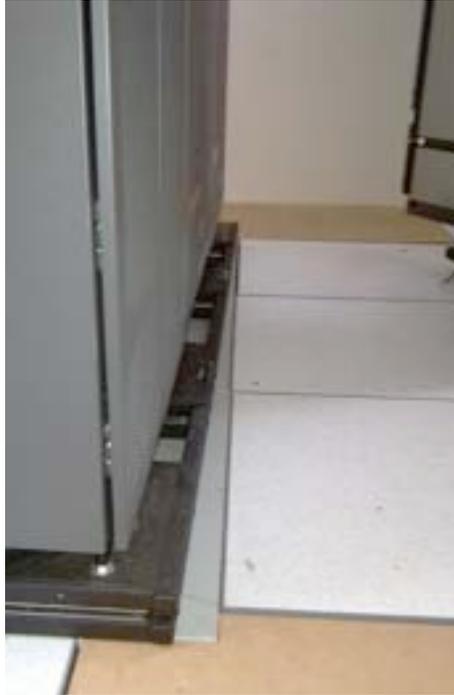
For three of the platforms, two cabinets each were installed above each platform; all the cabinets were bolted together and strapped to the platform below (Figure 17-6). For these three platforms, 3 of the 18 balls jumped out during the earthquake. The bottom platform moves sideways about 50 mm (2 inches). However, the racks remained as a block and were sitting on their base frame.

Figure 17-6. Triple Base Isolation Units – Slid 50 mm, Lost 3 of 18 Balls

The equipment in the rack in Figure 17-7 had to be shutdown after the earthquake in order to re-install the rack on its base isolation system. The photo in Figure 17-8 is believed to be taken during the re-installation process. RE-installation of the balls under the equipment in Figure 17-6 did not entail having to shut down the equipment.

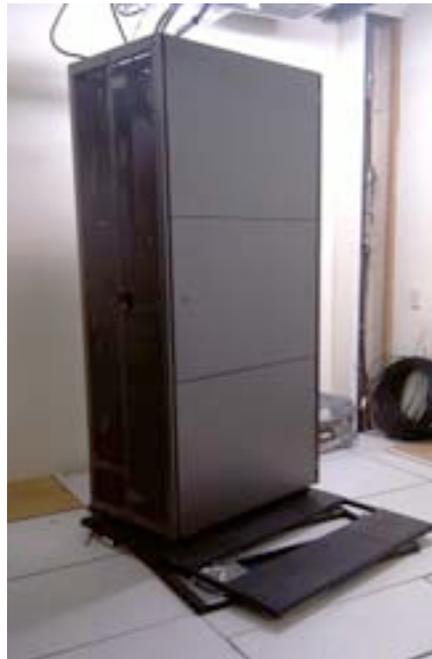
On the fourth platform, only one cabinet was installed on the platform, resulting in a torsional-eccentric arrangement. This cabinet and the platform below jumped off the isolation dishes, ending up rotated about 15 to 20 degrees from its original position, Figure 17-7. Figure 17-8 shows the disassembled system, to highlight the dishes below.

Figure 17-7. Base Isolation System as Found, Immediately Post-Earthquake

From an owner's point of view, the concept of base isolation is to reduce the input motions to the equipment so that they have a greater chance of remaining functional during and immediately after the design basis earthquake. Should the displacement limits of the base isolation unit be exceeded, higher mode effects (impacts) occur, quite likely negating any reductions provided by the first mode base isolation period. With today's solid state electronics, an owner should seriously consider direct anchorage of the

equipment to a competent floor slab below, as this is quite likely lower cost than the base isolation units, and can provide substantial margin in larger-than-planned-for earthquakes, and avoids dealing with the additional flexibility needed to all attached cables.

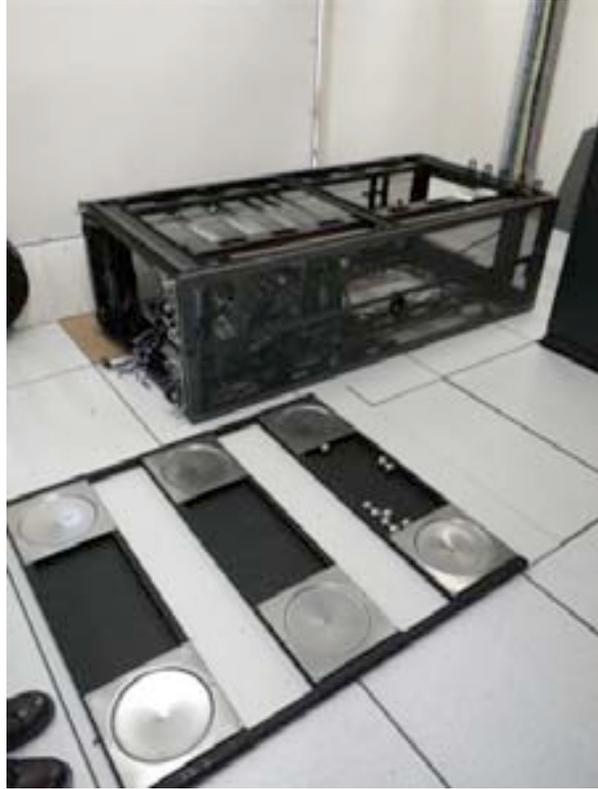
Figure 17-8. Base Isolation System, Disassembled

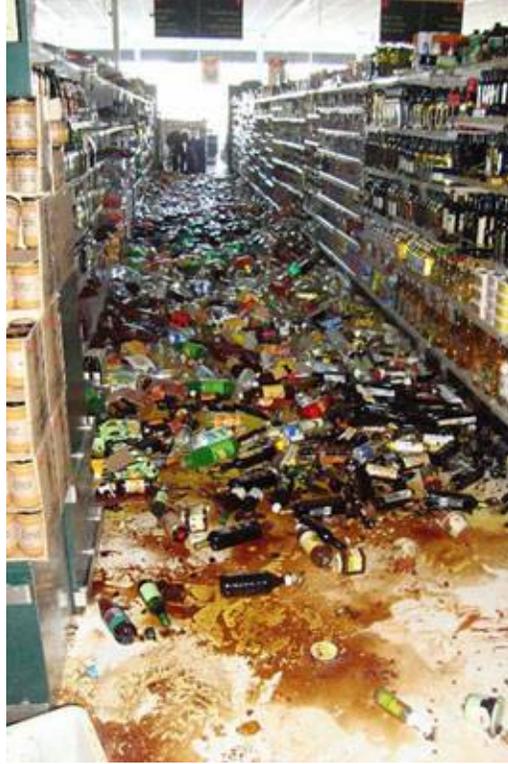
Figure 17-9 shows fallen bottles.

Figure 17-9. Toppled Bottles at Market

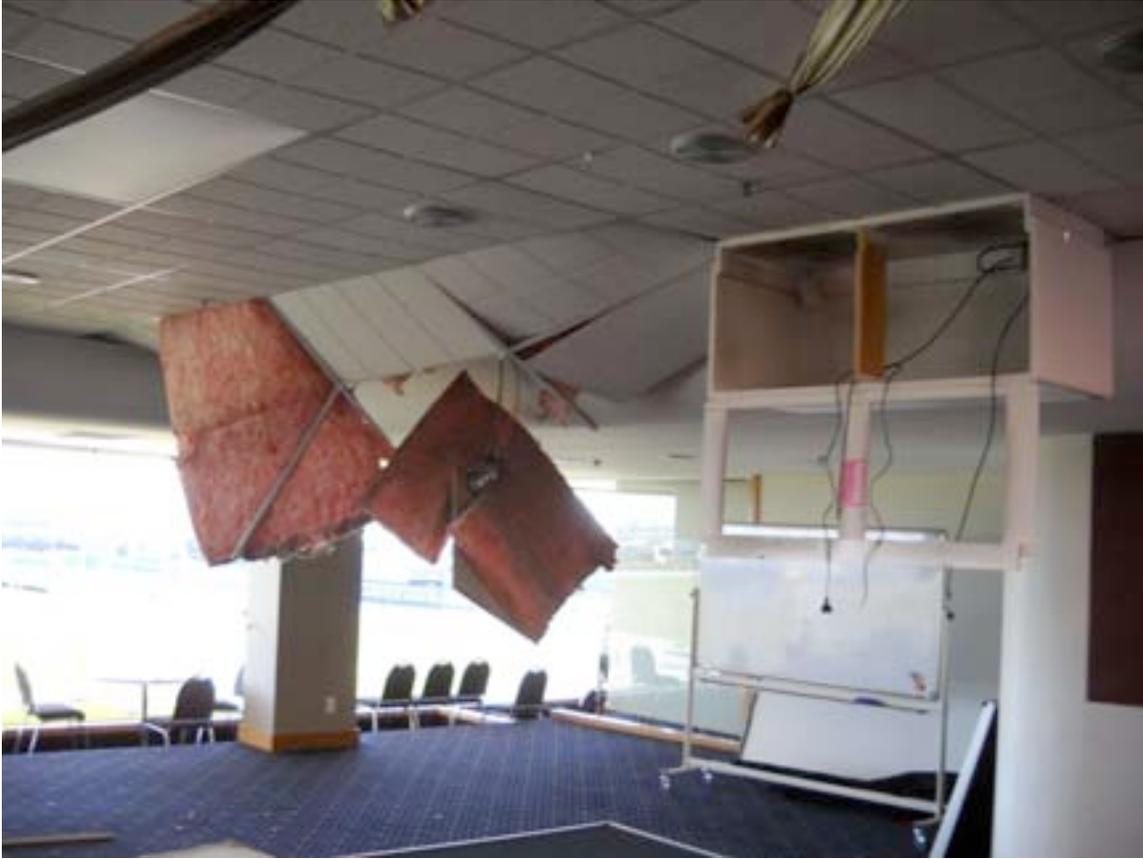
Figure 17-10 shows damage to a suspended ceiling; this damage was rather common at locations with $PGA > 0.3g$. No people were known to be seriously injured due to lightweight ceiling panel failures; there were no fatalities. Figure 17-11 shows the two television monitors that fell out of their enclosures in Figure 17-10.

Figure 17-10. Suspended Ceiling (credit John Mackenzie) September 2010
