CHRISTCHURCH, NEW ZEALAND EARTHQUAKE SEQUENCE OF M_w 7.1 September 04, 2010 M_w 6.3 February 22, 2011 M_w 6.0 June 13, 2011: LIFELINE PERFORMANCE

**Technical Council on Lifeline Earthquake Engineering
Monograph No. 40
February 2012 – Revision 0
ASCE**

ABSTRACT

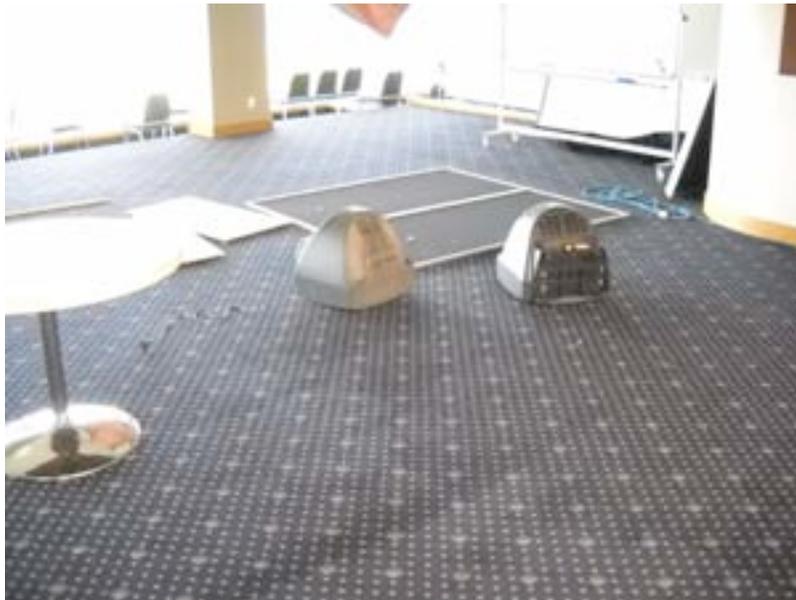
Figure 17-10 shows damage to a suspended ceiling; this damage was rather common at locations with $PGA > 0.3g$. No people were known to be seriously injured due to lightweight ceiling panel failures; there were no fatalities. Figure 17-11 shows the two television monitors that fell out of their enclosures in Figure 17-10.

Figure 17-11. Fallen Television Monitors (credit John Mackenzie) September 2010

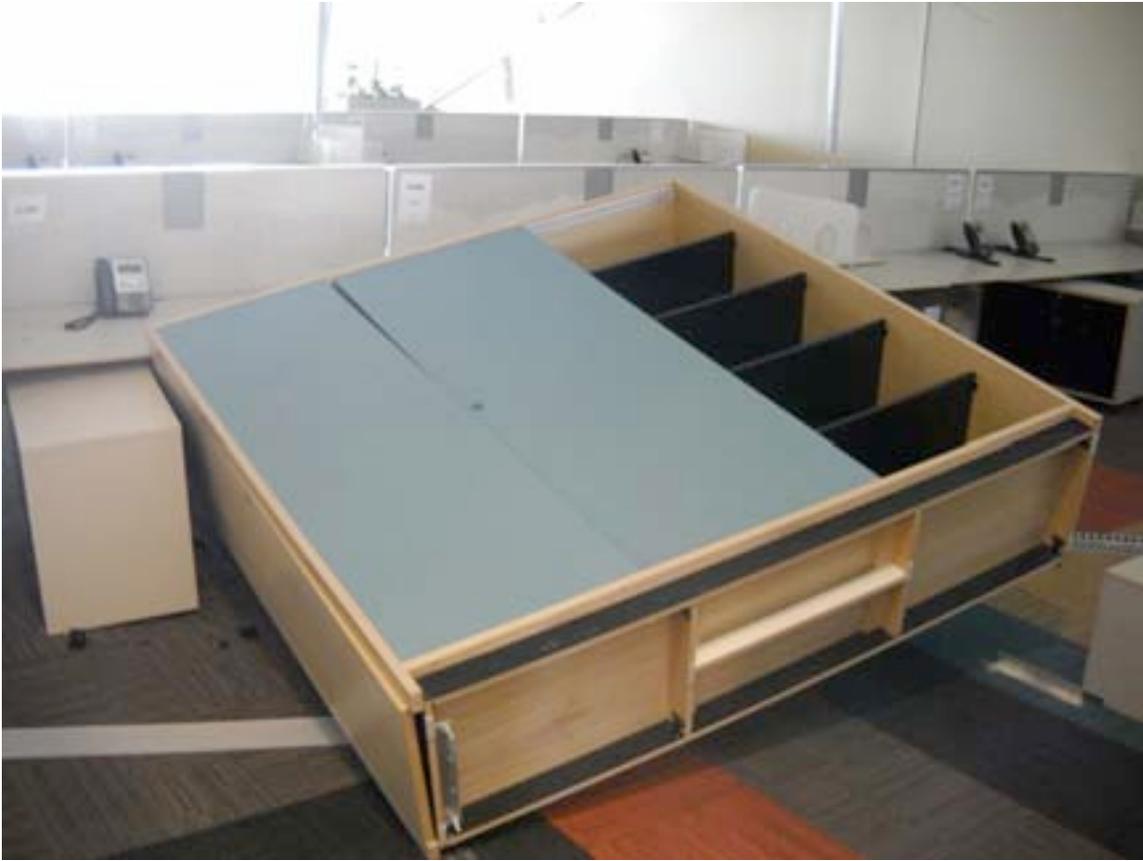
Figure 17-12 shows a toppled cabinet. This cabinet was lightly anchored. It was located at the top floor of a modern building.

Figure 17-12. Toppled Cabinet (credit John Mackenzie) September 2010

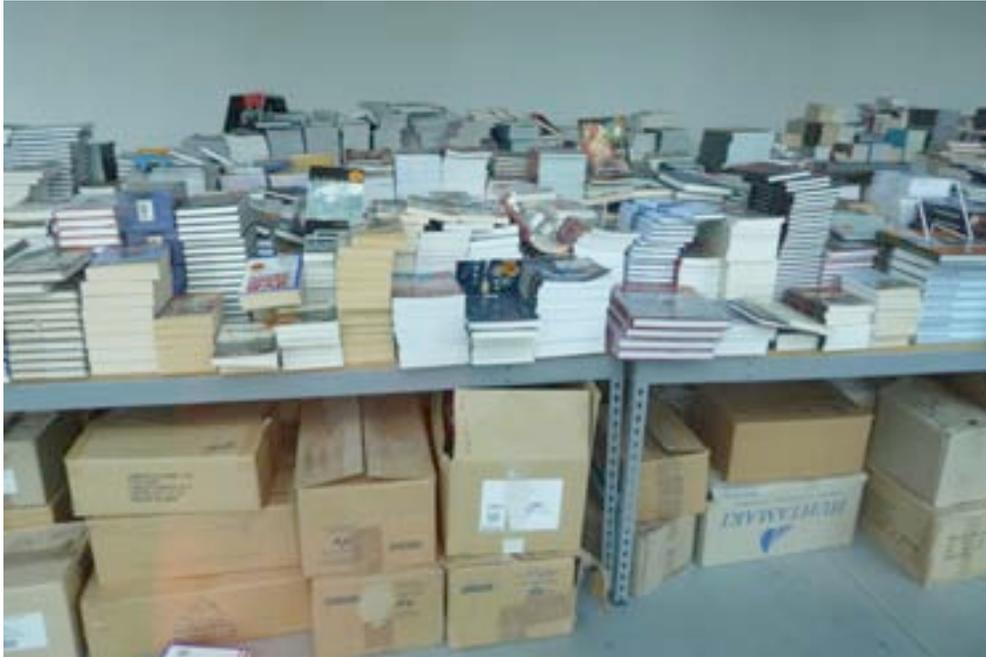
Figure 17-13. Stacks of Books, February 2011

Figure 17-13 shows stacks of books located in a shop in the CBD. Perhaps 1% of the books toppled / slid to the floor in the February 2011 event. Typical recorded ground motions in the CBD were on the order of horizontal PGA = 0.5g. Figure 17-14 shows buckling of two tables in this same shop, suggesting that the high vertical acceleration, coupled with the heavy loads, were too much for these two tables (out of perhaps 40 tables).

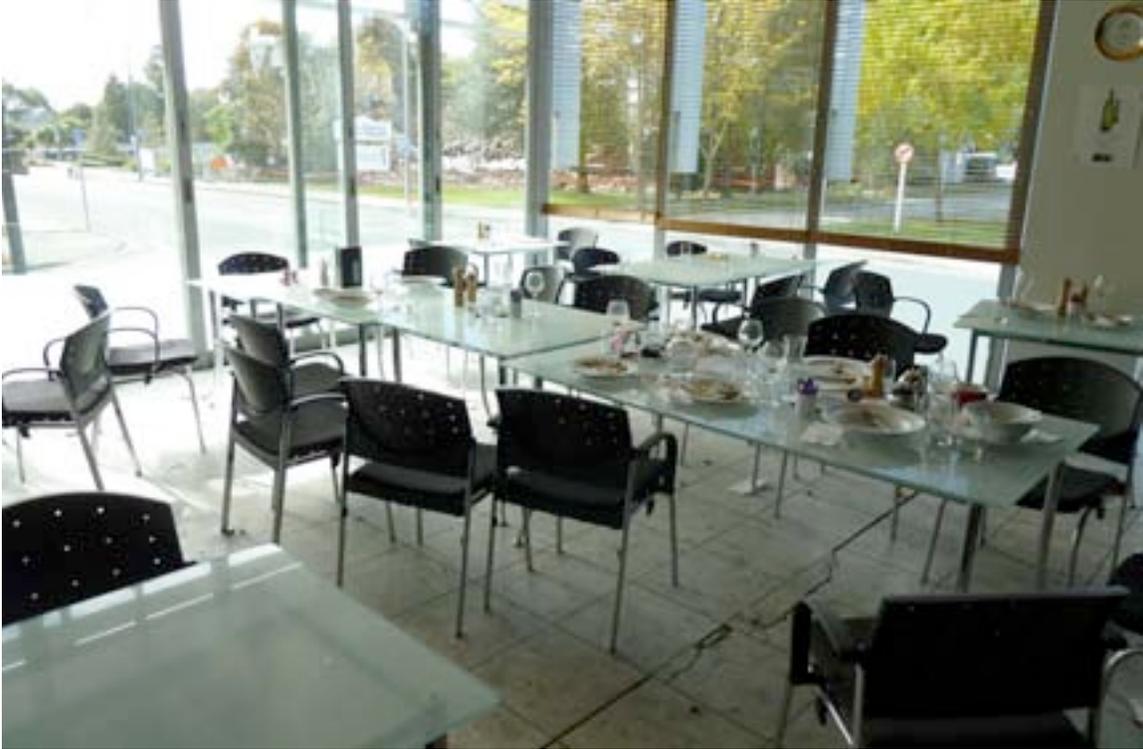
Figure 17-15 shows the state of dishes and glasses in a ground floor restaurant in the CBD. The dishes and glasses are as they were left on February 2011 event, apparently without attempt to clean up fallen items. This type of scene was repeated at many different locations throughout the CBD.

Figure 17-15. Tabletop Dishes and Glassware, CBD, February 2011

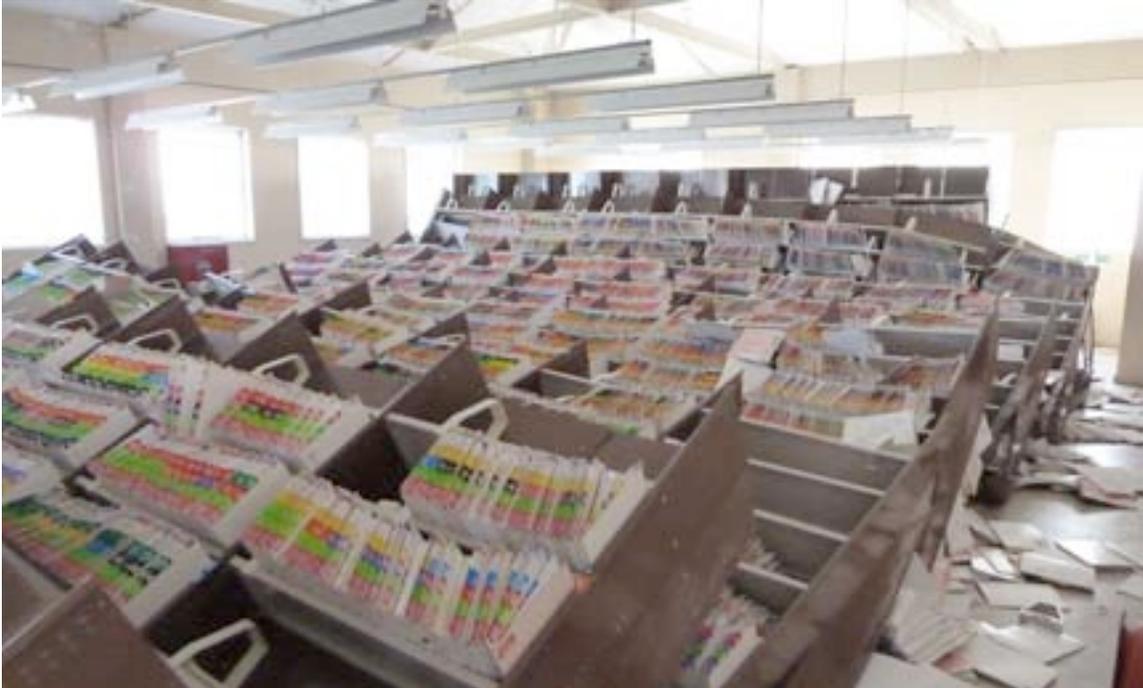
Figure 17-16 shows collapsed racks (no anchors, no bracing) with heavy paper records; these were located on the top floor of concrete building, at a site with $PGA = 0.5g$.

Figure 17-16. Collapsed Storage Racks, February 2011

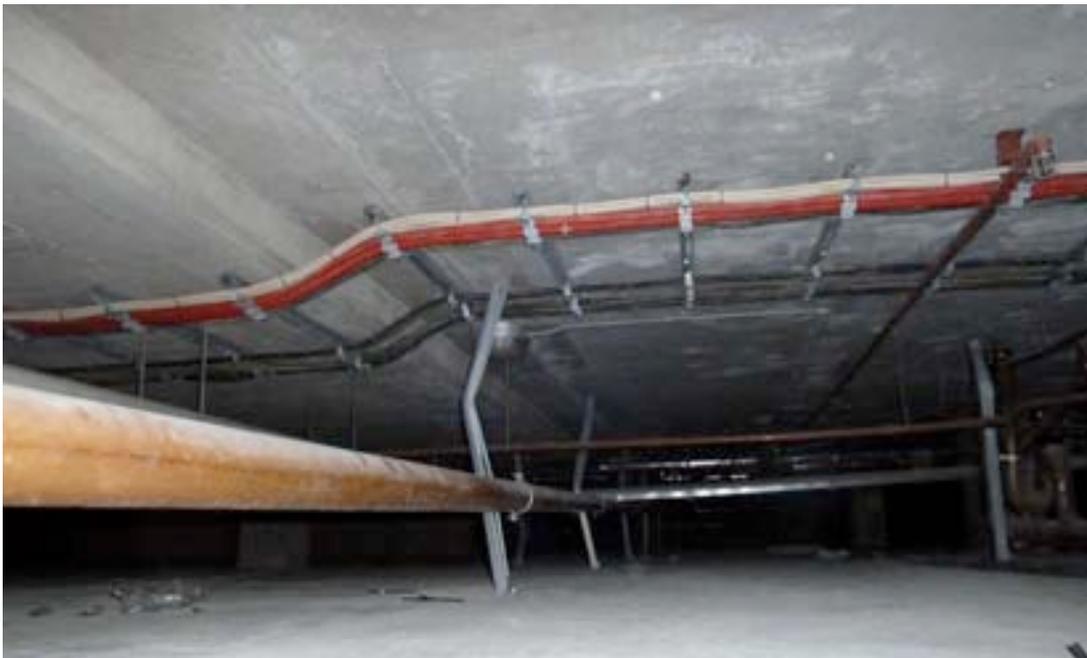
Figure 17-17 shows the buckled struts between the upper and lower concrete mats of the only base isolated building in Christchurch (women's Hospital). This damage did not impact the function of the utilities; but shows the need to think through the vertical movement that does occur (often ignored by building codes) in steel-laminate-type rubber bearing isolation systems.

Figure 17-17. Damaged Vertical Struts, February 2011

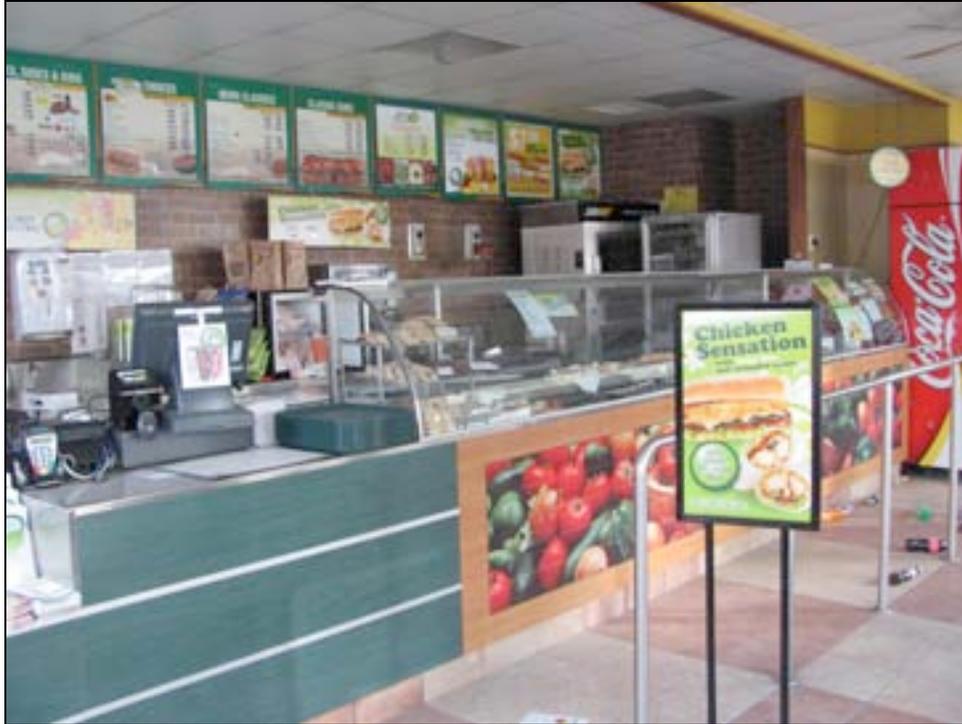
Figure 18-5. Spoiled food in eateries – food items that were exposed for a long time. Many restaurants within the cordoned area of CBD had the same problem.

Handling of perishable goods such as milk, meat, etc. was one of the hazardous materials and a special process was required to prevent any environmental impact.
