The Great San Francisco 1906 Earthquake: Why Did the Water Transmission Pipes Break at 49 Locations?

John Eiding and N. Timothy Hall

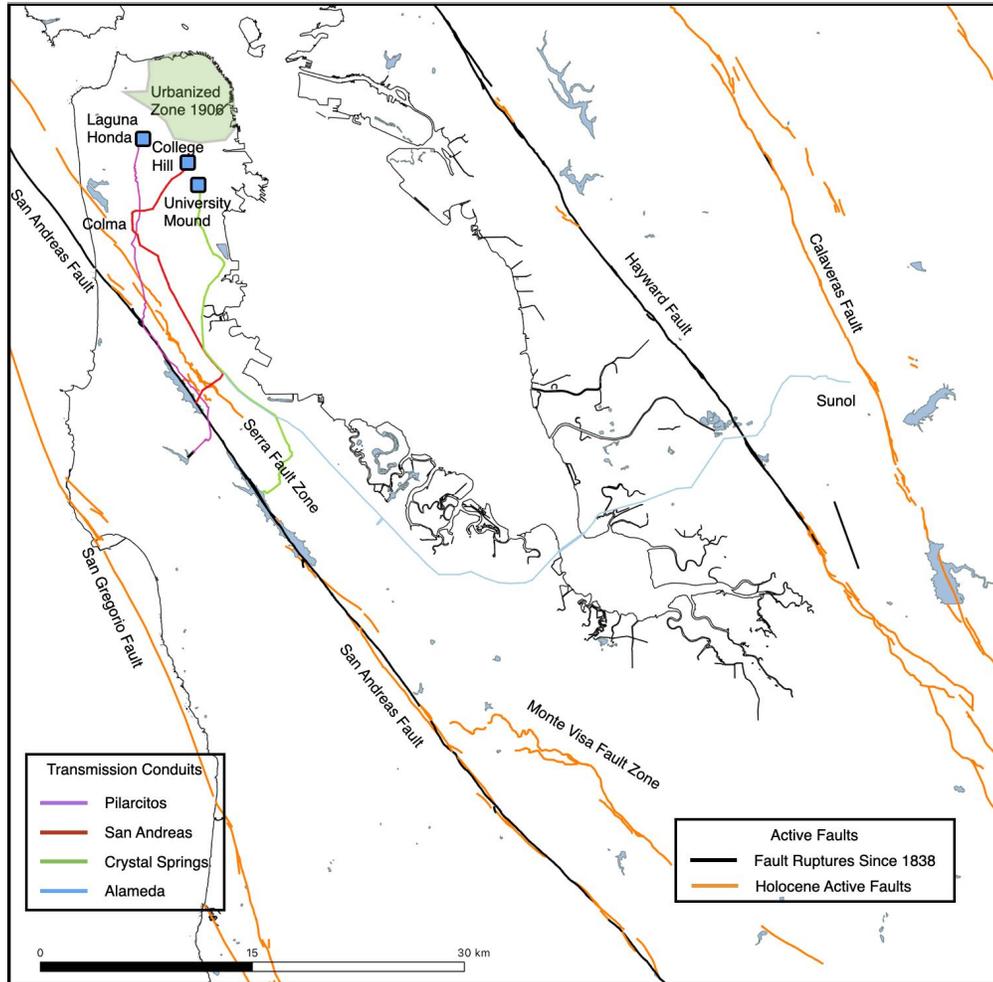
Figure 1. SVWC Regional Water Supply System, 1906

Figures 1, 2 and 3 show the regional and San Francisco distribution water system at the time of the 1906 earthquake. There were six sources of water into San Francisco (year built, name):

When Schussler designed and built San Andreas Dam and all the pipelines shown in Figure 1, he was probably unaware of the presence and location San Andreas fault, which was not officially recognized until 1895. When built in 1865, the Pilarcitos pipeline was aligned to cross the primary trace of the fault five times; a modern designer would not zig-zag an important pipe over the fault multiple times. The outlet works of the San Andreas reservoir are bisected by the fault; not a good design. The term "liquefaction" had not yet been invented, although Schussler was aware of ongoing settlement and pipeline failures at Mission Creek, because he laid pipe through these zones on buried wooden planks; and in 1893, he proposed to bypass that area entirely with a new 20 MG Market Street reservoir and pipeline system. Design for inertial forces from earthquakes was not done. There were no codes or guidelines for seismic design for buildings, and certainly no guidance for the seismic design of pipelines. The prevailing practice from 1860s to 1906 was to design above ground structures for a lateral wind pressure of 30 psf, and this was then considered to be adequate to address the impacts of earthquakes (not!).

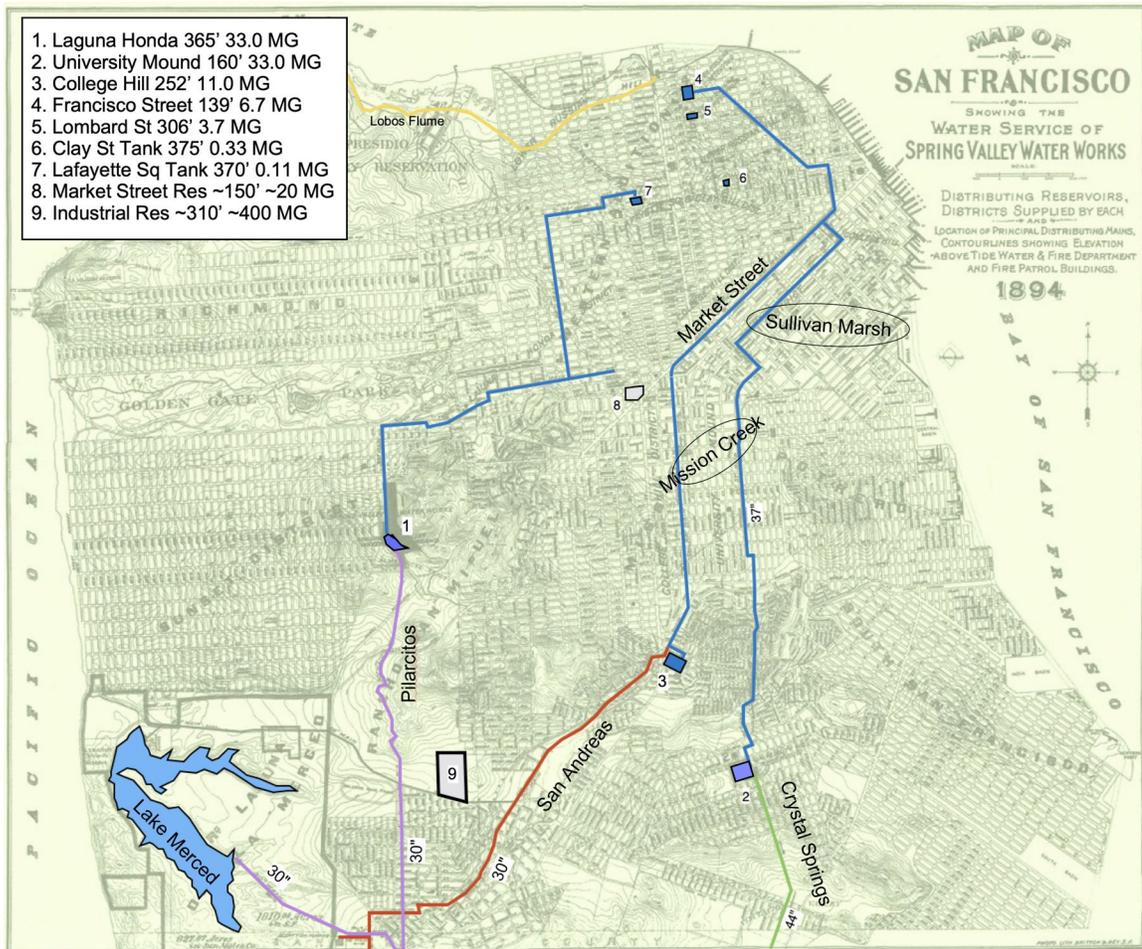
Figure 2. SVWC Water System – Main Pipes of the Distribution System - 1894

Figure 2 shows the main pipelines in the City system, as of 1894. Figure 2 also shows the Market Street (No. 8) and Industrial (No 9) reservoir sites. By the early-1890s, Mr. Hermann Schussler, the Chief Engineer of the SVWC, intended for them to be constructed as part of a much-improved fire-fighting water system, along with large diameter pipes that would avoid the liquefaction zones of Mission Creek and Sullivan Marsh areas. In 1893, the San Francisco Board of Supervisors turned down SVWC's request to build these reservoirs. Critically, reservoirs No. 8 and 9, along with pipes along Market Street studded with hydrants, could have prevented the conflagration that destroyed most of San Francisco in the 1906 earthquake.

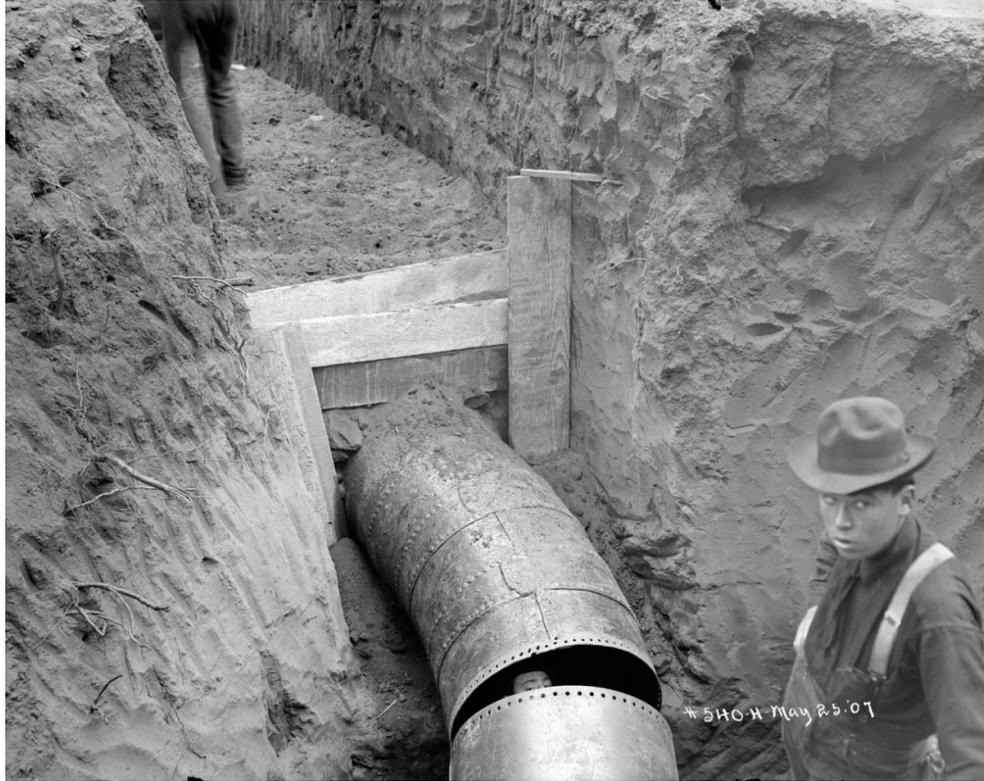
Figure 6. 30-inch Pilarcitos Pipe Preparation of a Riveted Joint (1907)

After the 1906 earthquake, the southern reach of the Pilarcitos pipeline was abandoned, and the pipe was excavated and re-used to build portions of the Baden-Merced pipe constructed in 1907. Figure 5 shows the 30-inch pipe atop a trestle at creek crossing: the 15 wooden "steeples" are to support wood planking (not yet placed) to enclose the pipe against effects of external corrosion. Figure 6 shows the common buried pipe installation in the sandstone-like Merced formation (note the person inside the pipe). The de-facto seismic design concept of these pipes was that should they fail, the terminal storage in reservoirs (Figure 2) would be sufficient to continuously meet demand while repairs are made.
