Chapter 3. Water and Wastewater System Performance in the August 17, 1999 Izmit (Kocaeli), Turkey Earthquake

Abstract

This chapter describes damage to several water and wastewater systems that were affected by the M_w 7.4 earthquake of August 17, 1999, with epicenter near Izmit, Turkey. Figure 1 shows the main locations covered in this chapter.

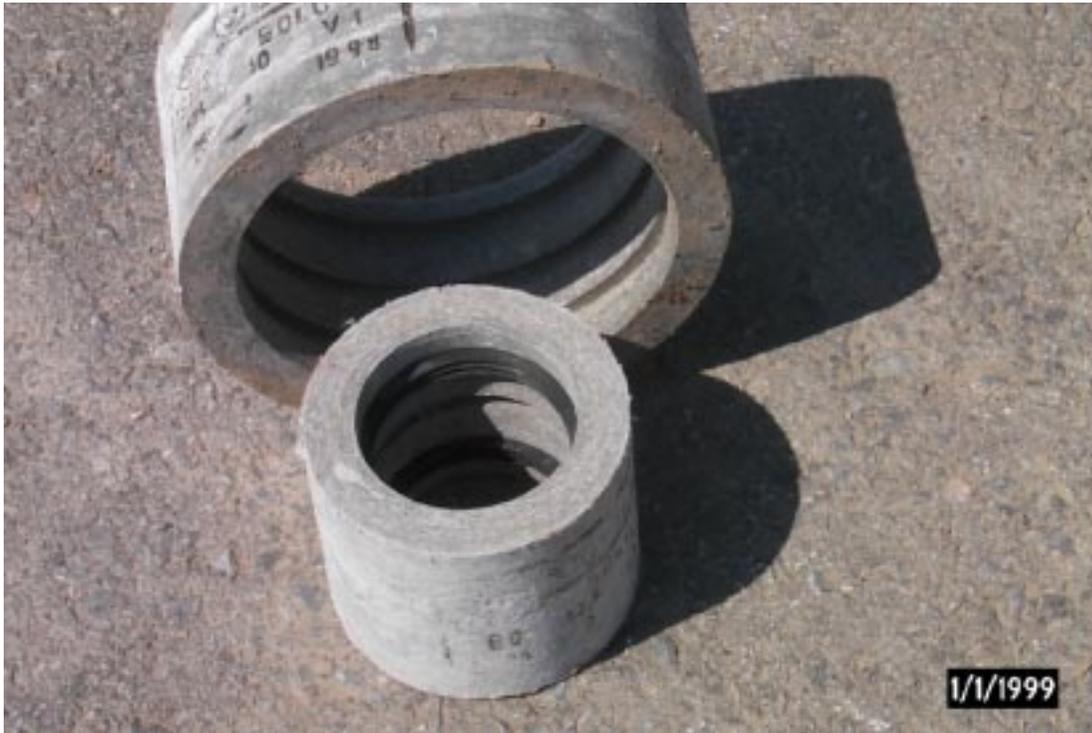
Adapazari Water Distribution System. For the City of Adapazari, there are 500 km of buried distribution pipelines. About 75% of these pipelines are made from Asbestos Cement pipe (AC pipe), 25% from PVC pipe and a small amount of butt welded steel pipeline (3 to 4 km). Typical AC pipe joinery was with rubber gasketed joints. Typical steel pipes use butt welded joints.

Figure 10. Typical Rubber Gasket Joint Fitting for AC Pipe, Common to All Water Systems in the Area

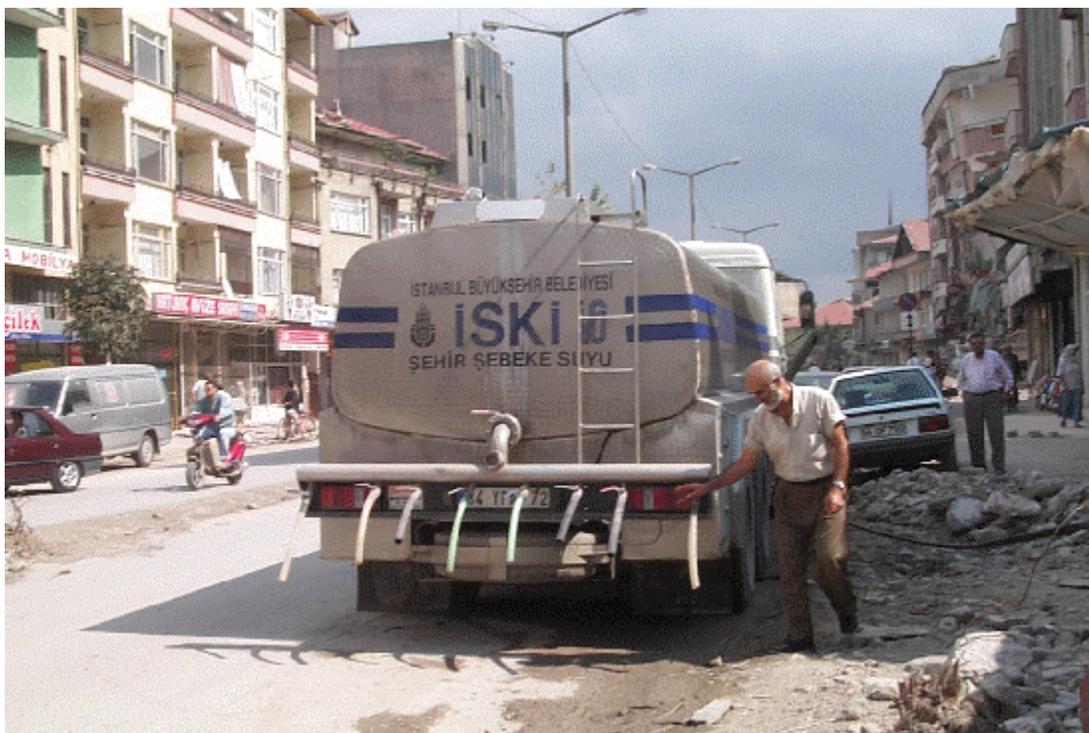
Figure 20. Water Trucks Bringing Potable Water to Urban Areas

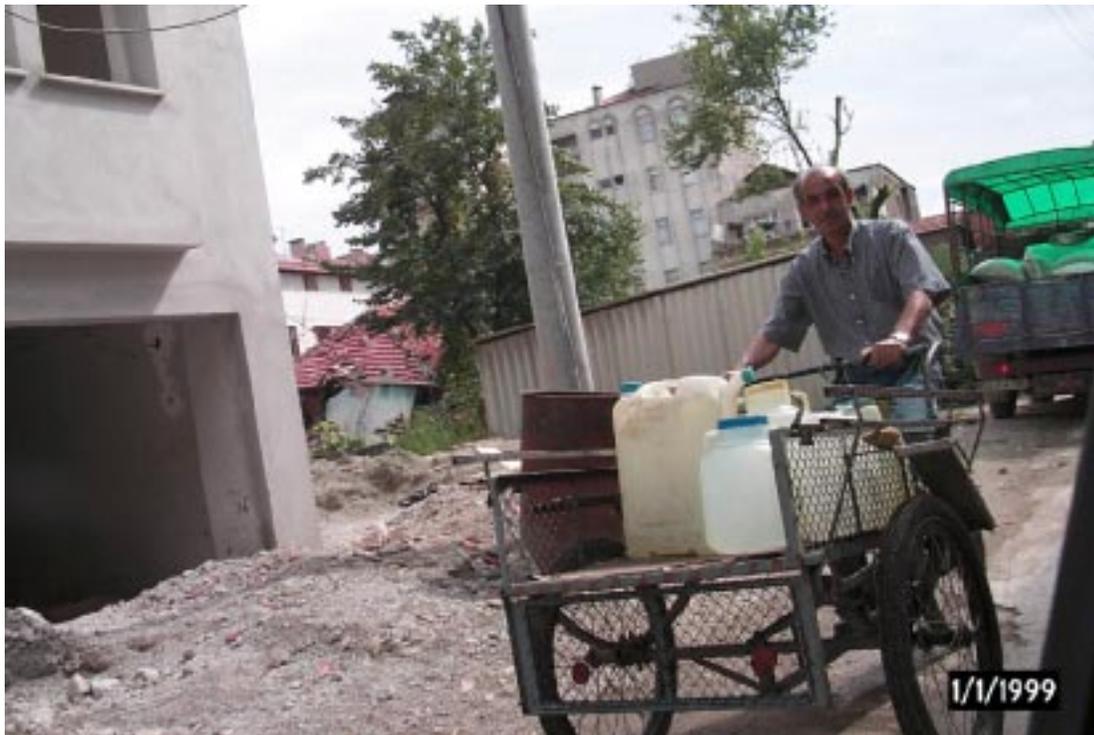
Figure 21. Small Potable Water Containers Being Delivered

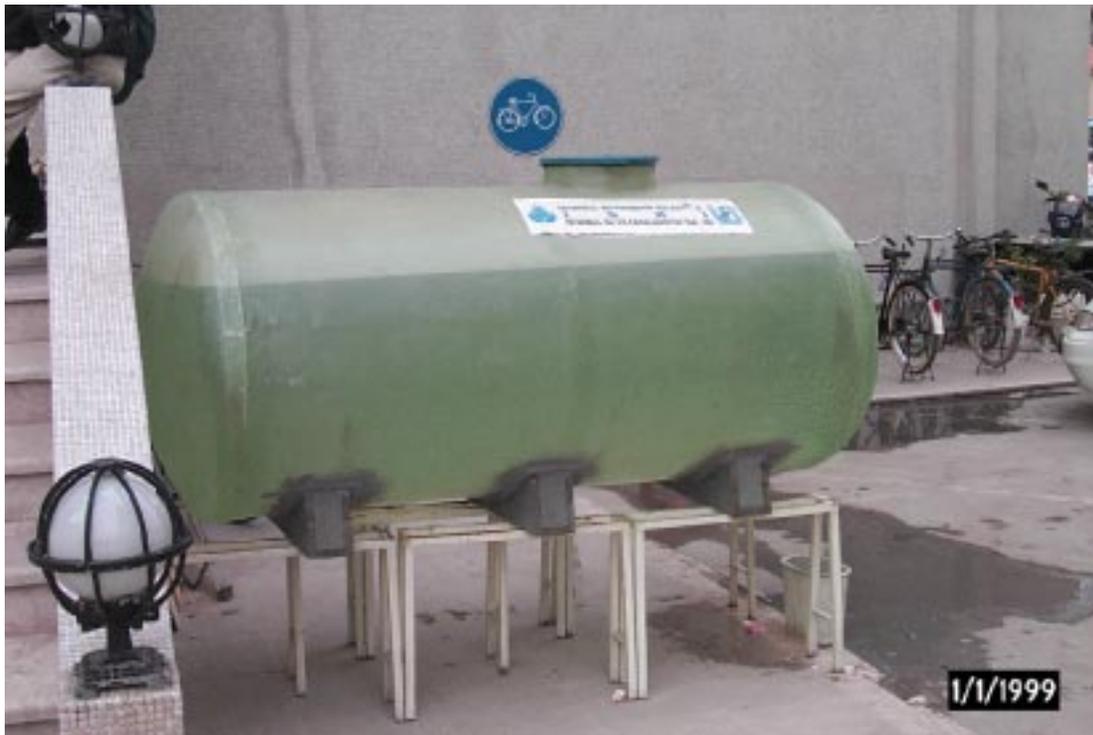
In some ways, this might be fortunate, in that there has been a robust system to produce, distribute and sell potable water in bottles and in small to medium size storage tanks. After the earthquake, almost 2,000 different water distribution points were set up, using 500 liter to 2,000 liter water storage tanks. Figures 19 to 21 show a few examples of water being distributed using these tanks.

Figure 22. Potable Water Tank (2,000 liters) in Downtown Adapazari
