# Puebla M 7.1 Earthquake of Sept 19 2017 Impact to Water and Power

John Eiding, Bruce Maison  
[eiding@geEngineeringSystems.com](mailto:eiding@geEngineeringSystems.com)  
[maison@netscape.com](mailto:maison@netscape.com)

Updated 9.14.2018

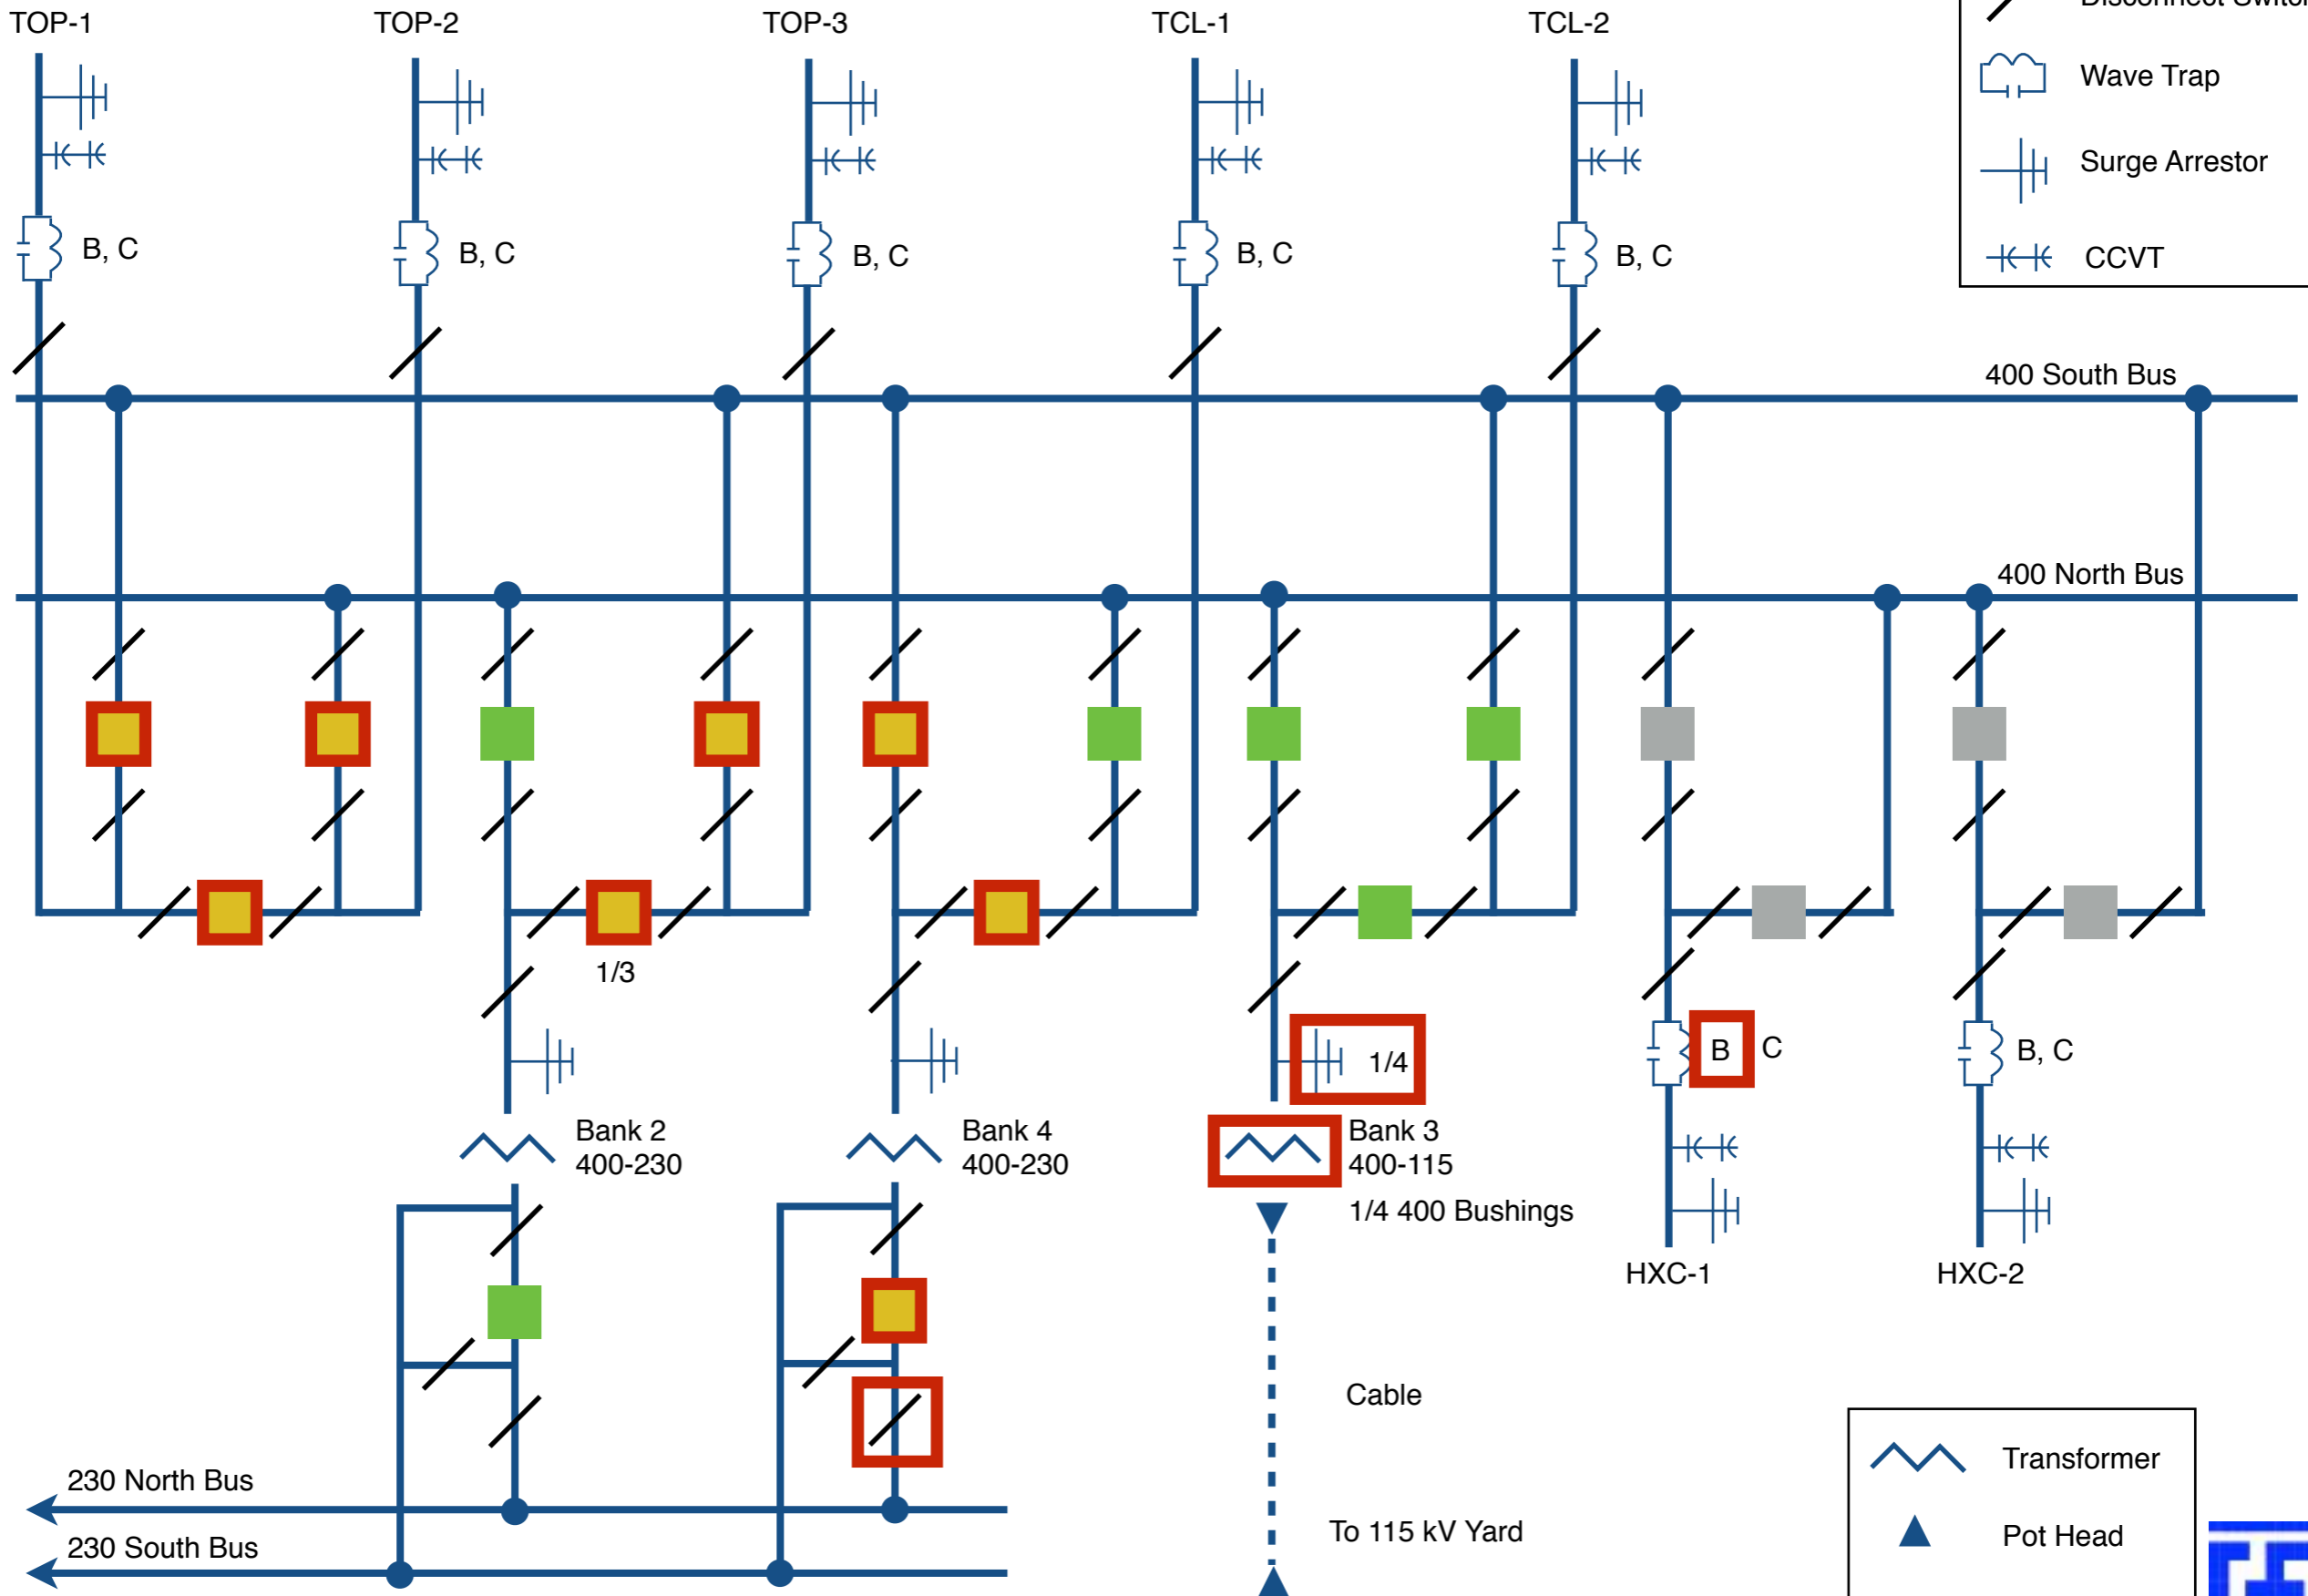
Item Damaged by Earthquake - Replaced

# Damage at YTP (Most Heavily Damaged Substation)

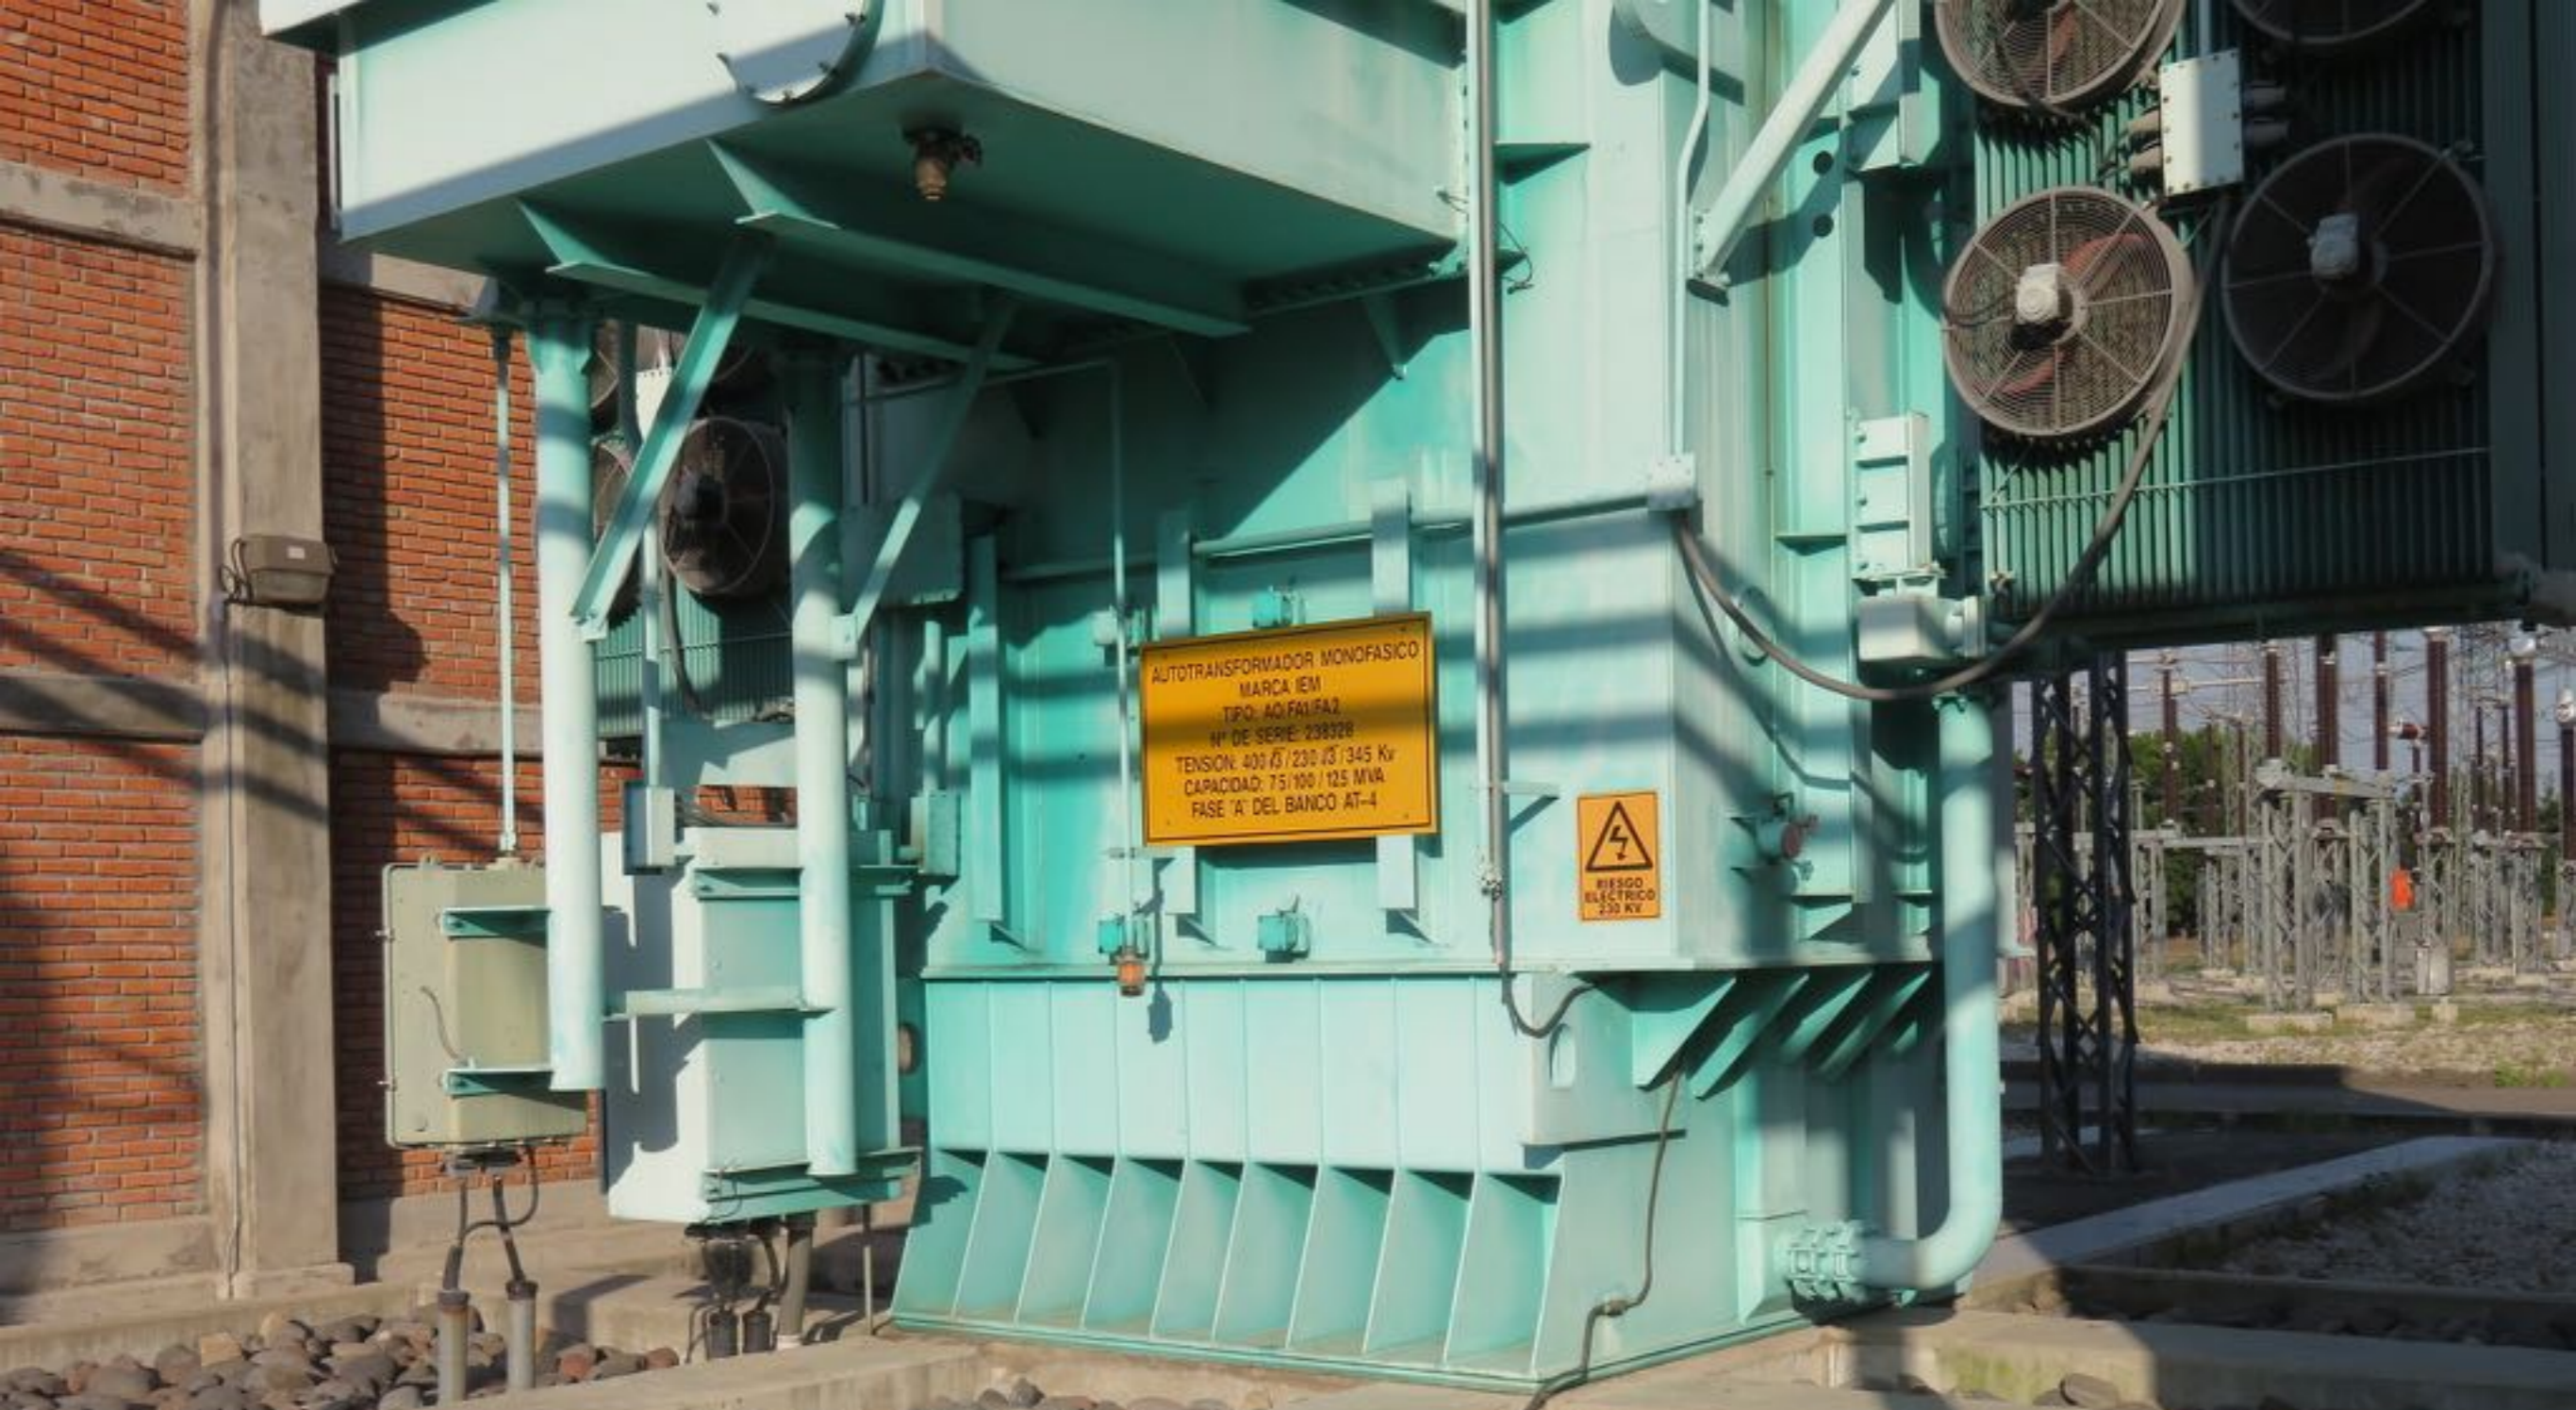
400 kV Transformers (11) (4 x 400-115; 7 x 400-230)

All unanchored

1 slid ~7 inches

1 slid ~2 inches

9 showed ~0 to 1 inch sliding

Many control cables deformed, none reported damaged

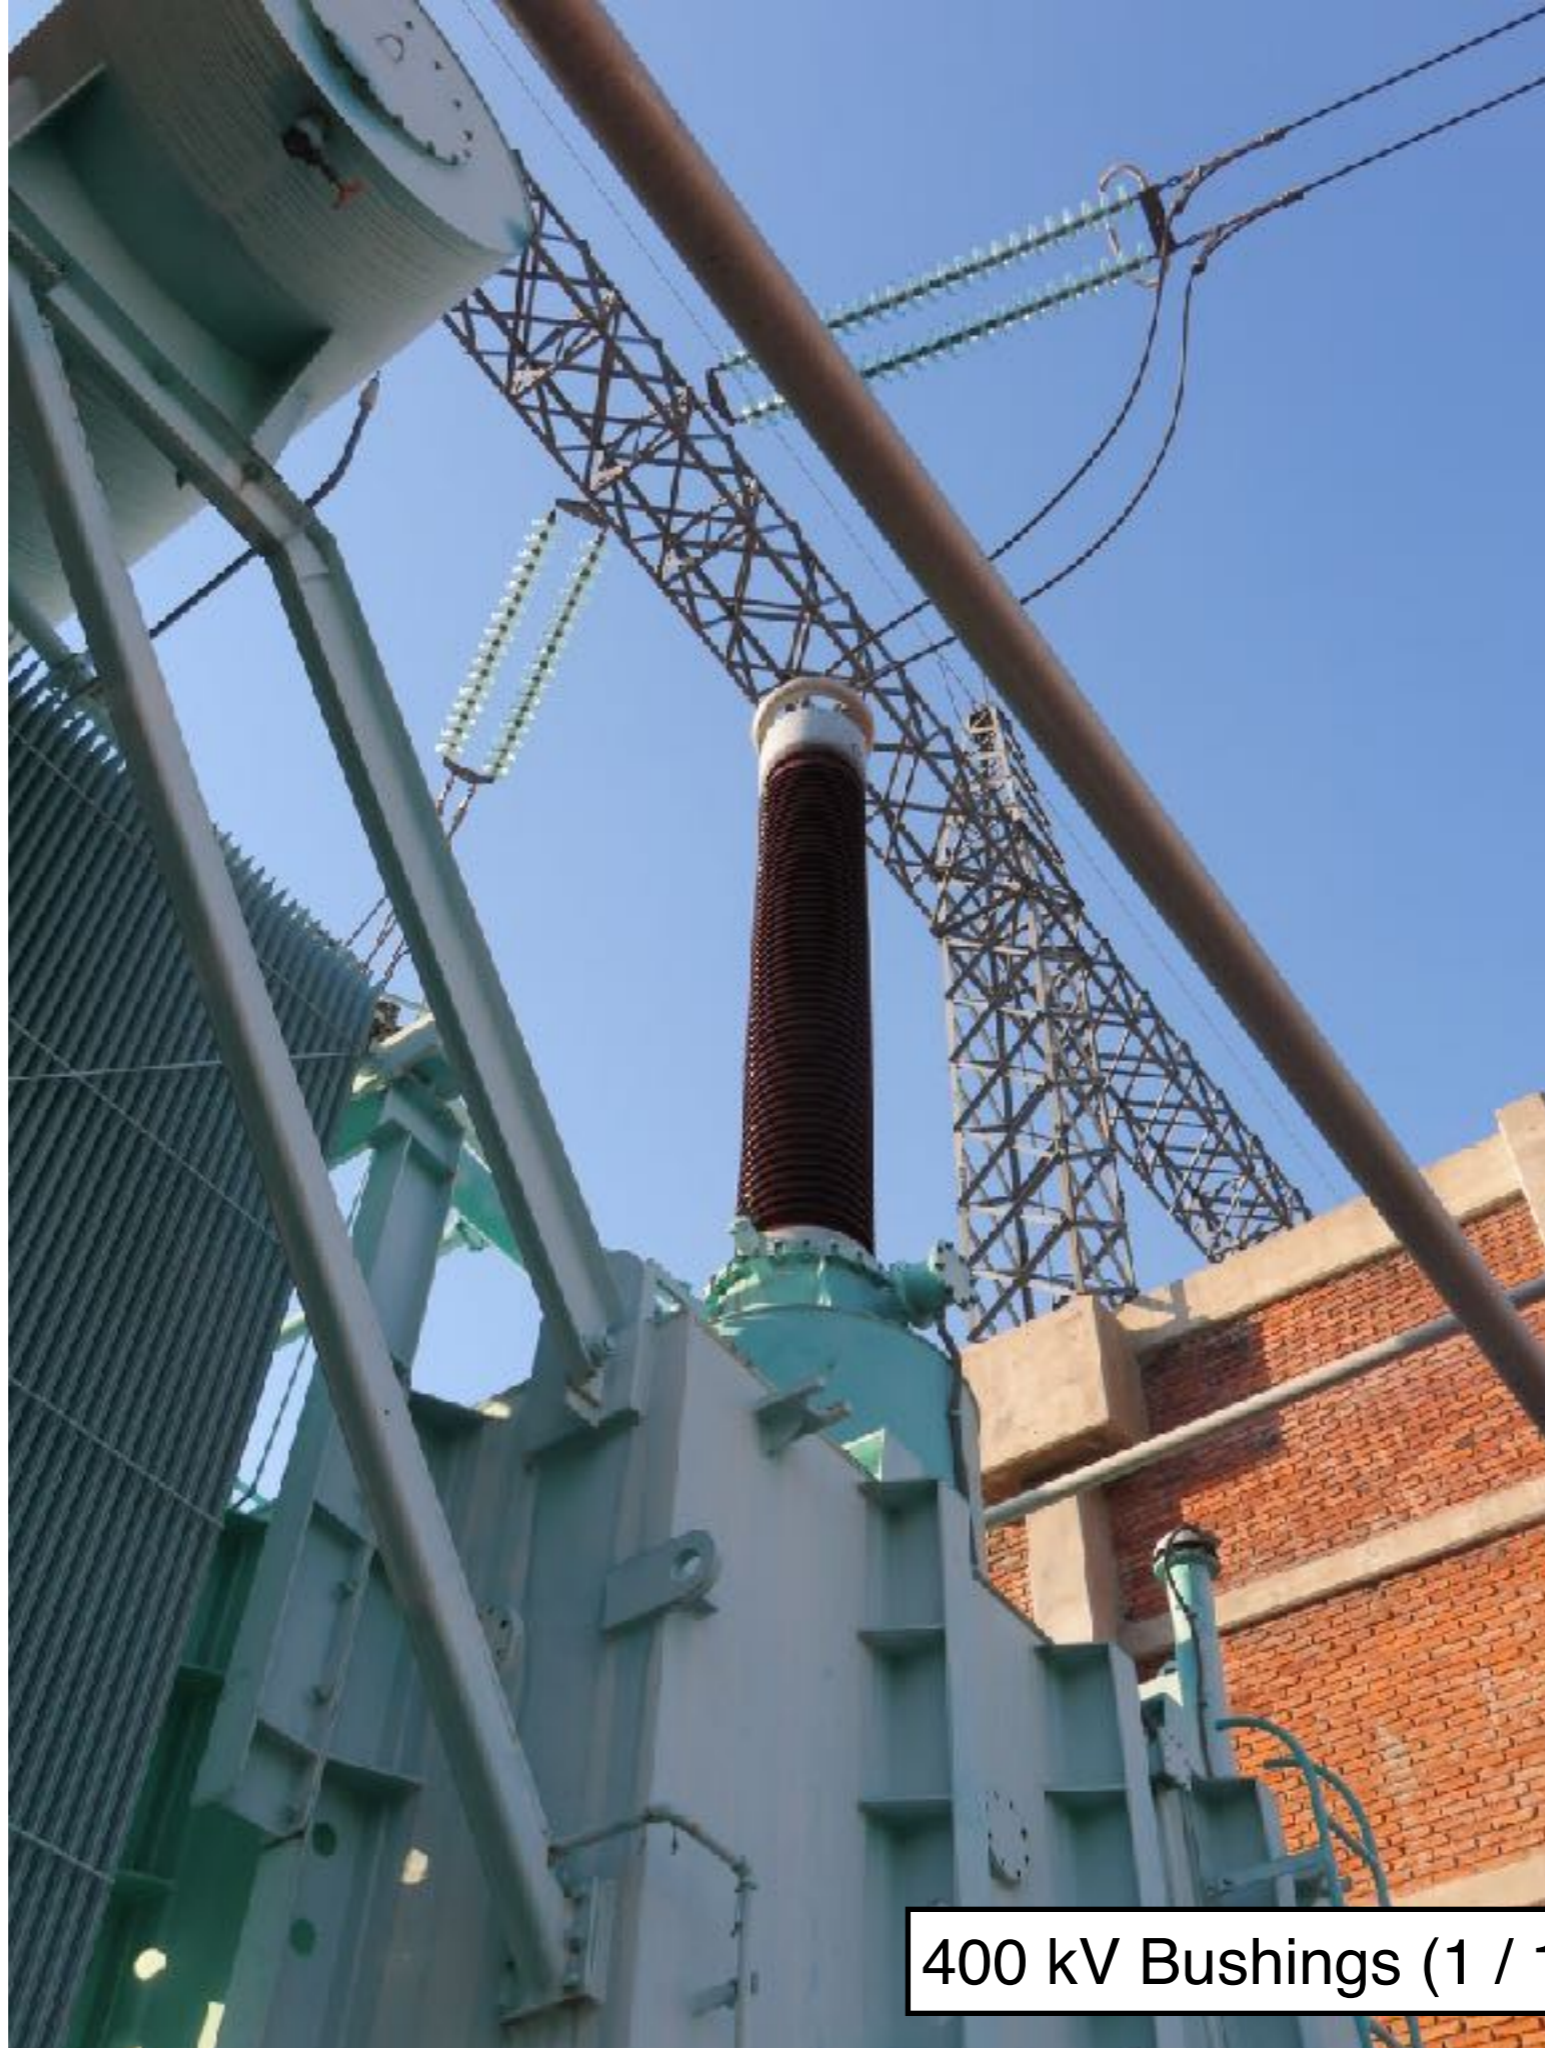
Broken 400 kV Surge Arrestor

Broken 400 kV bushing

400 kV Bushings (1 / 10 with damage)

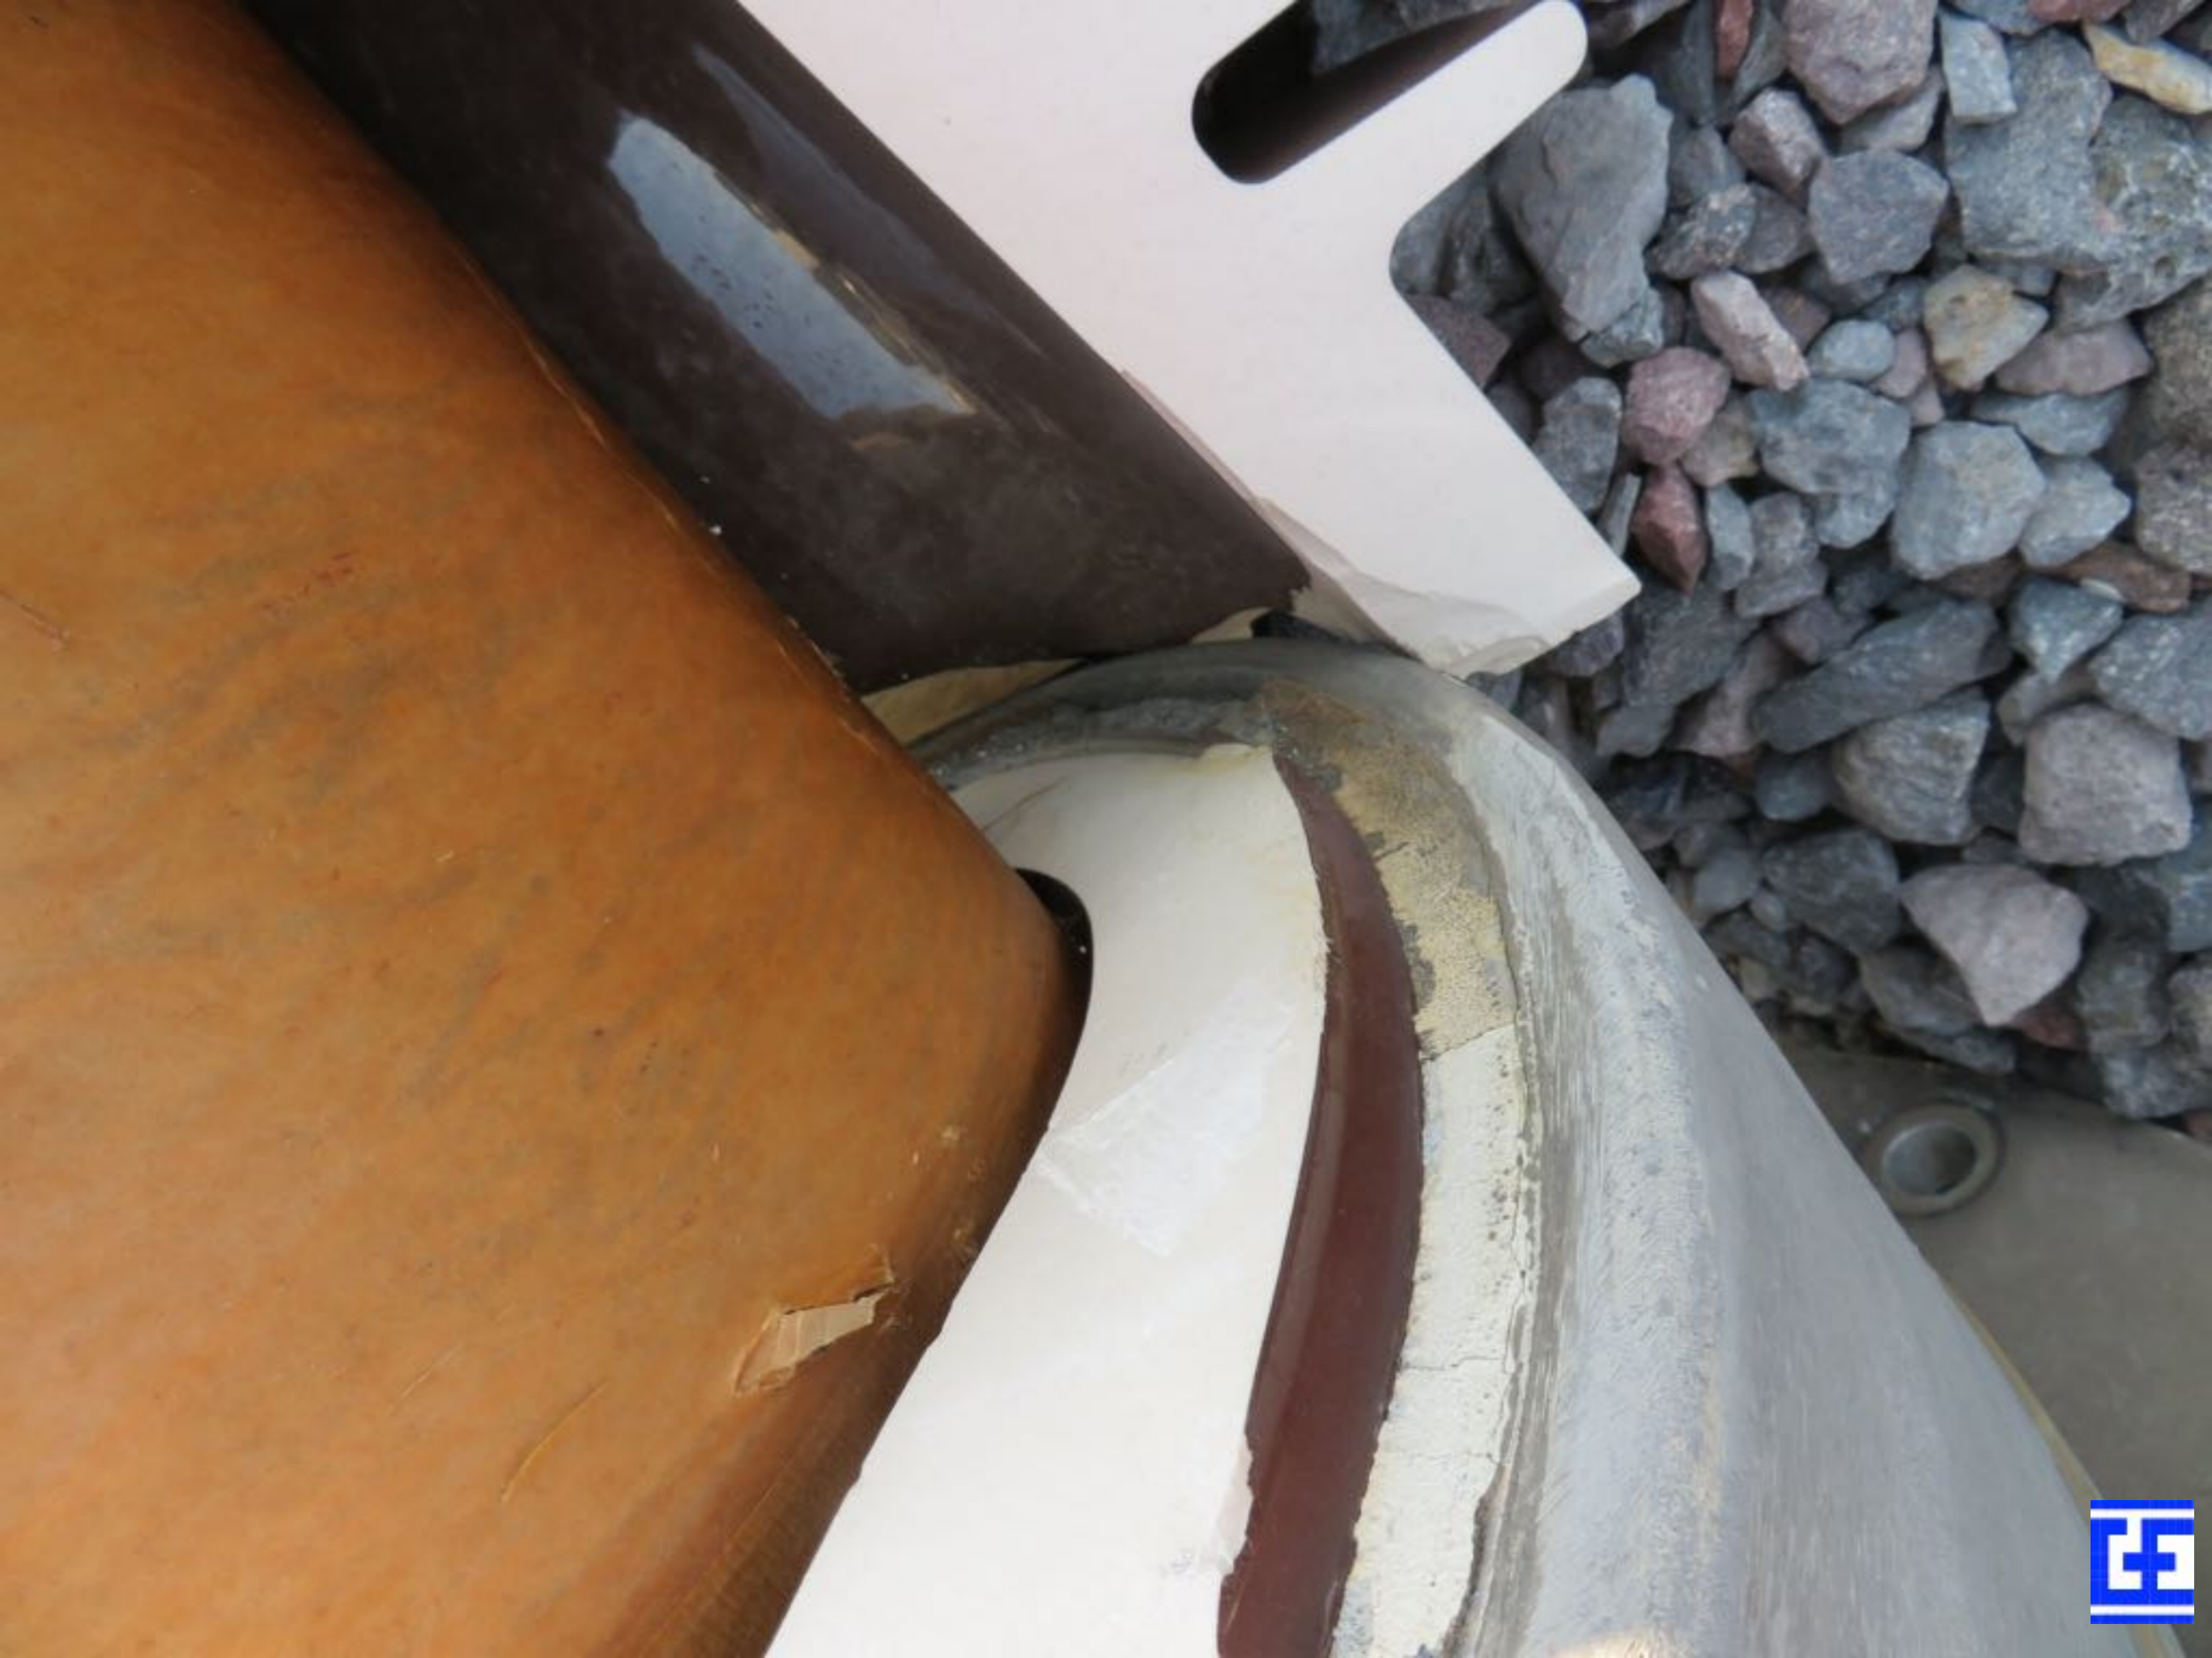
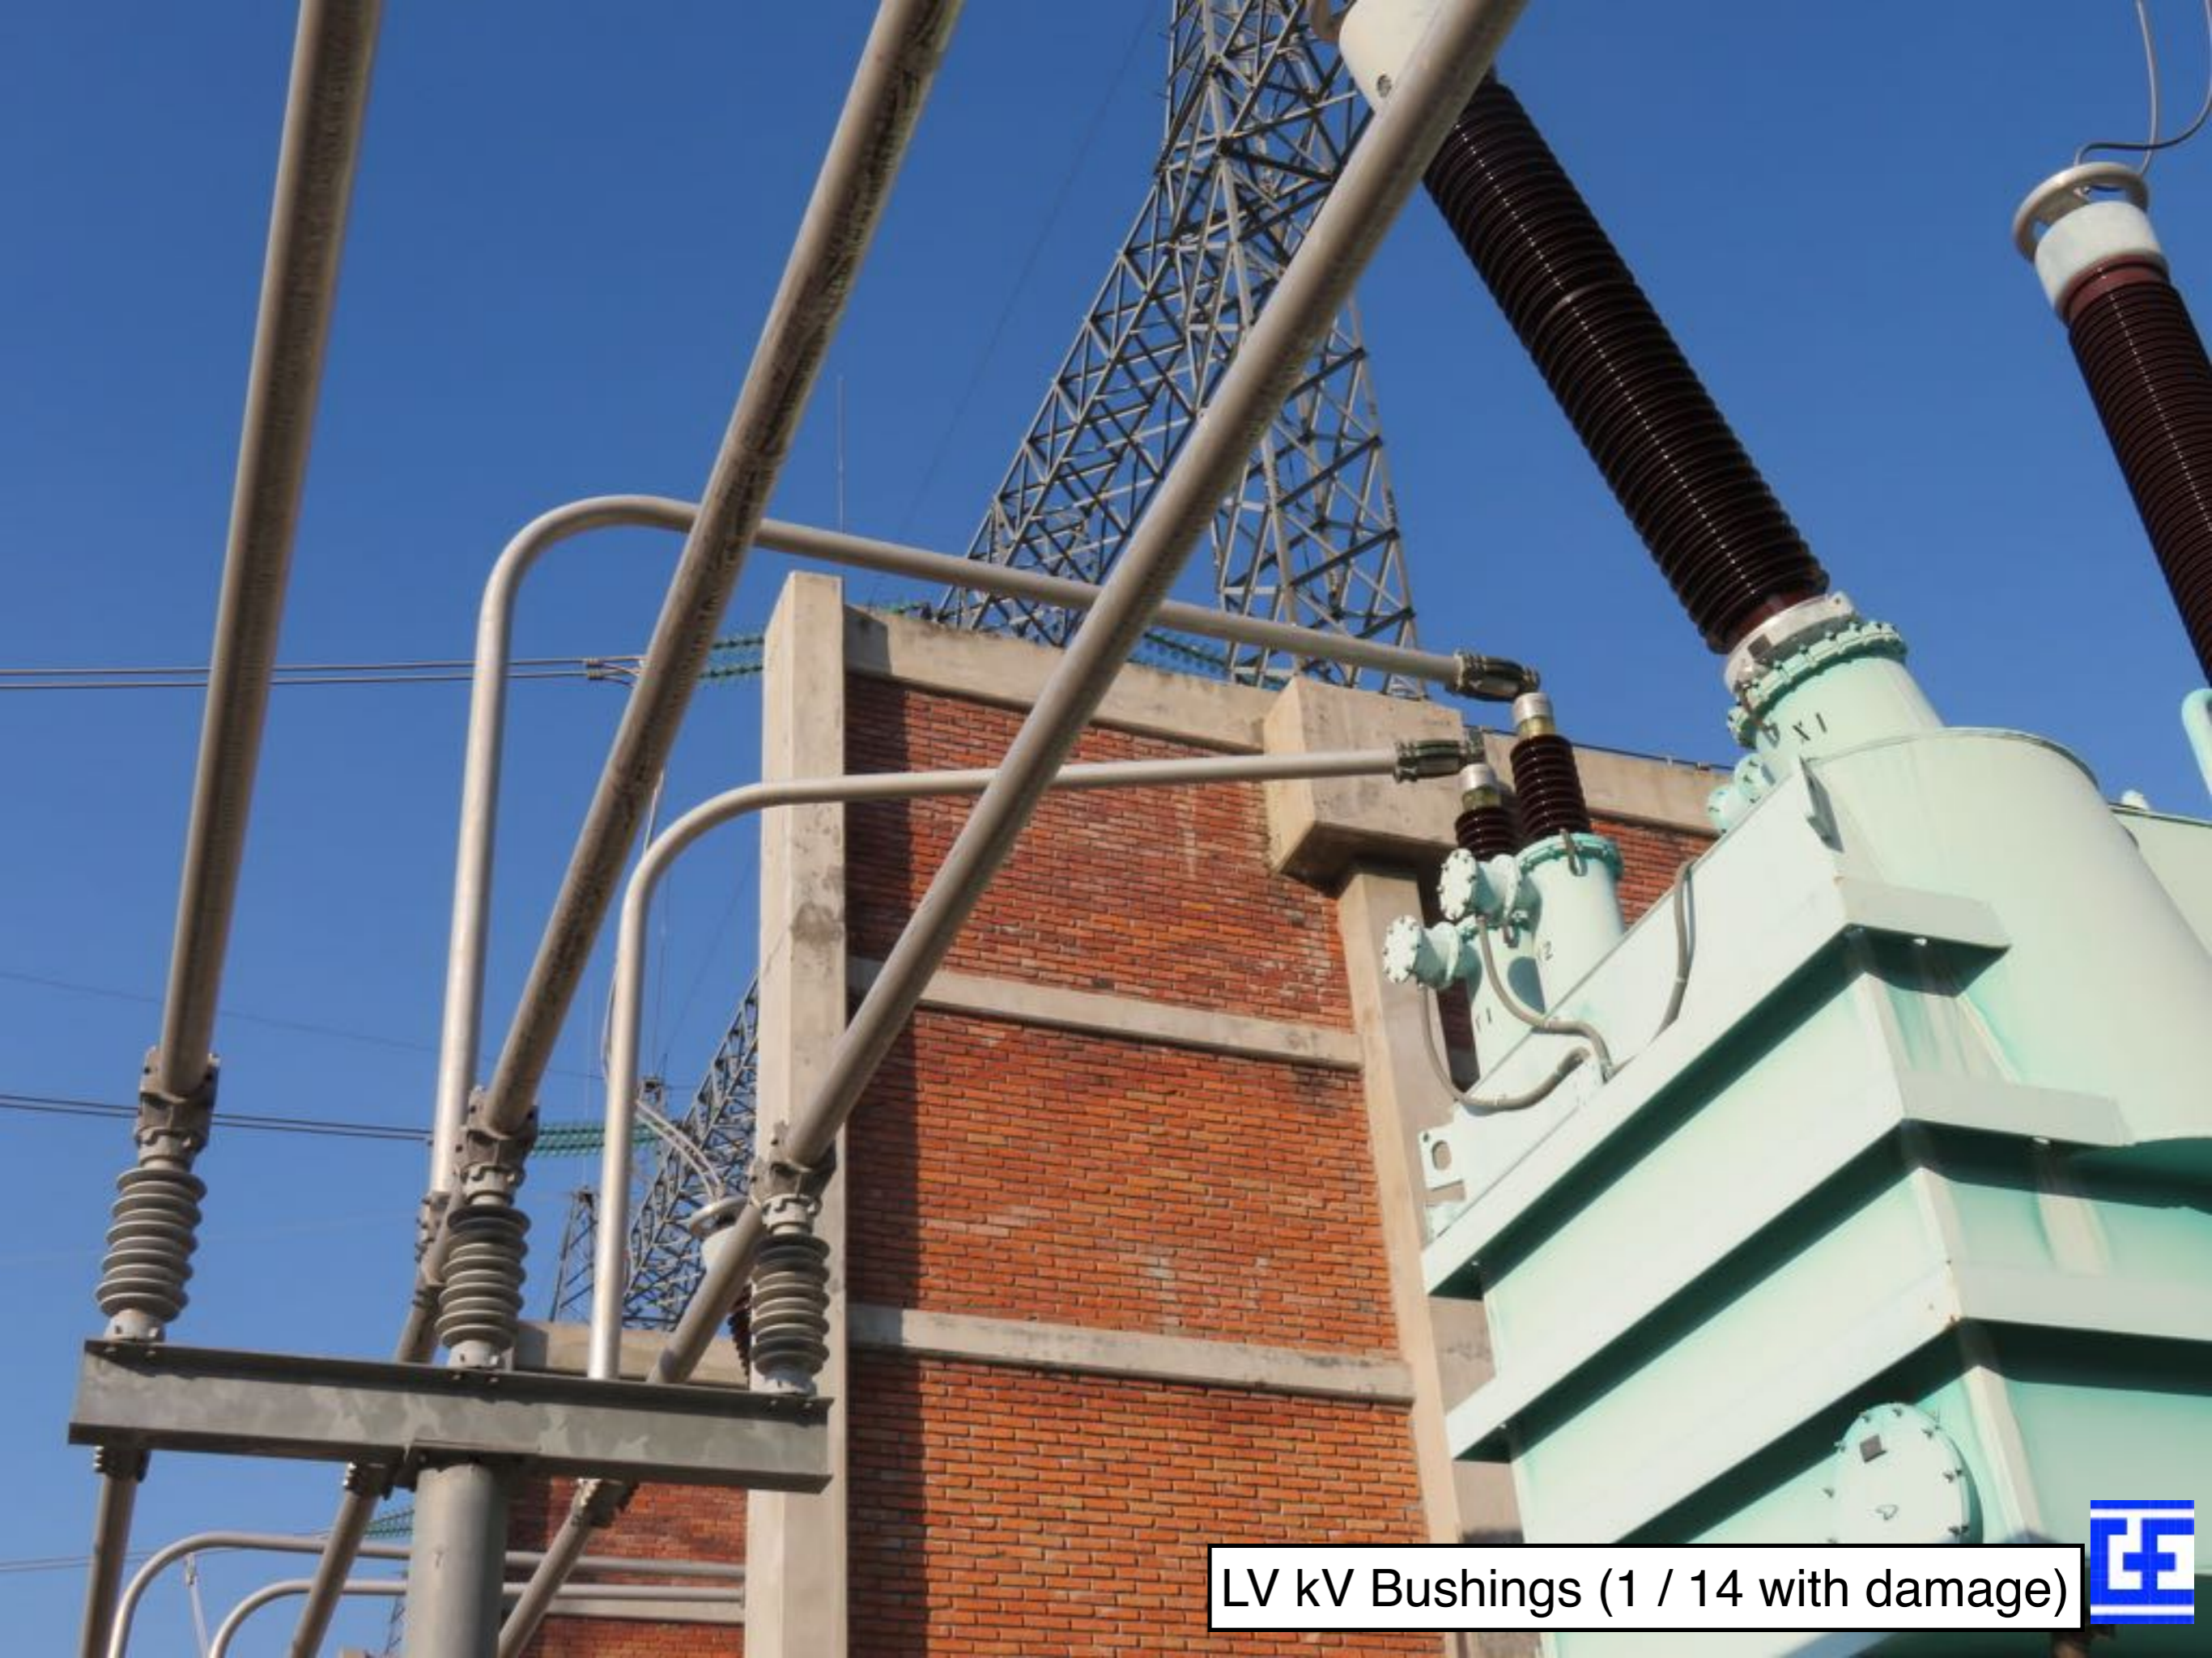
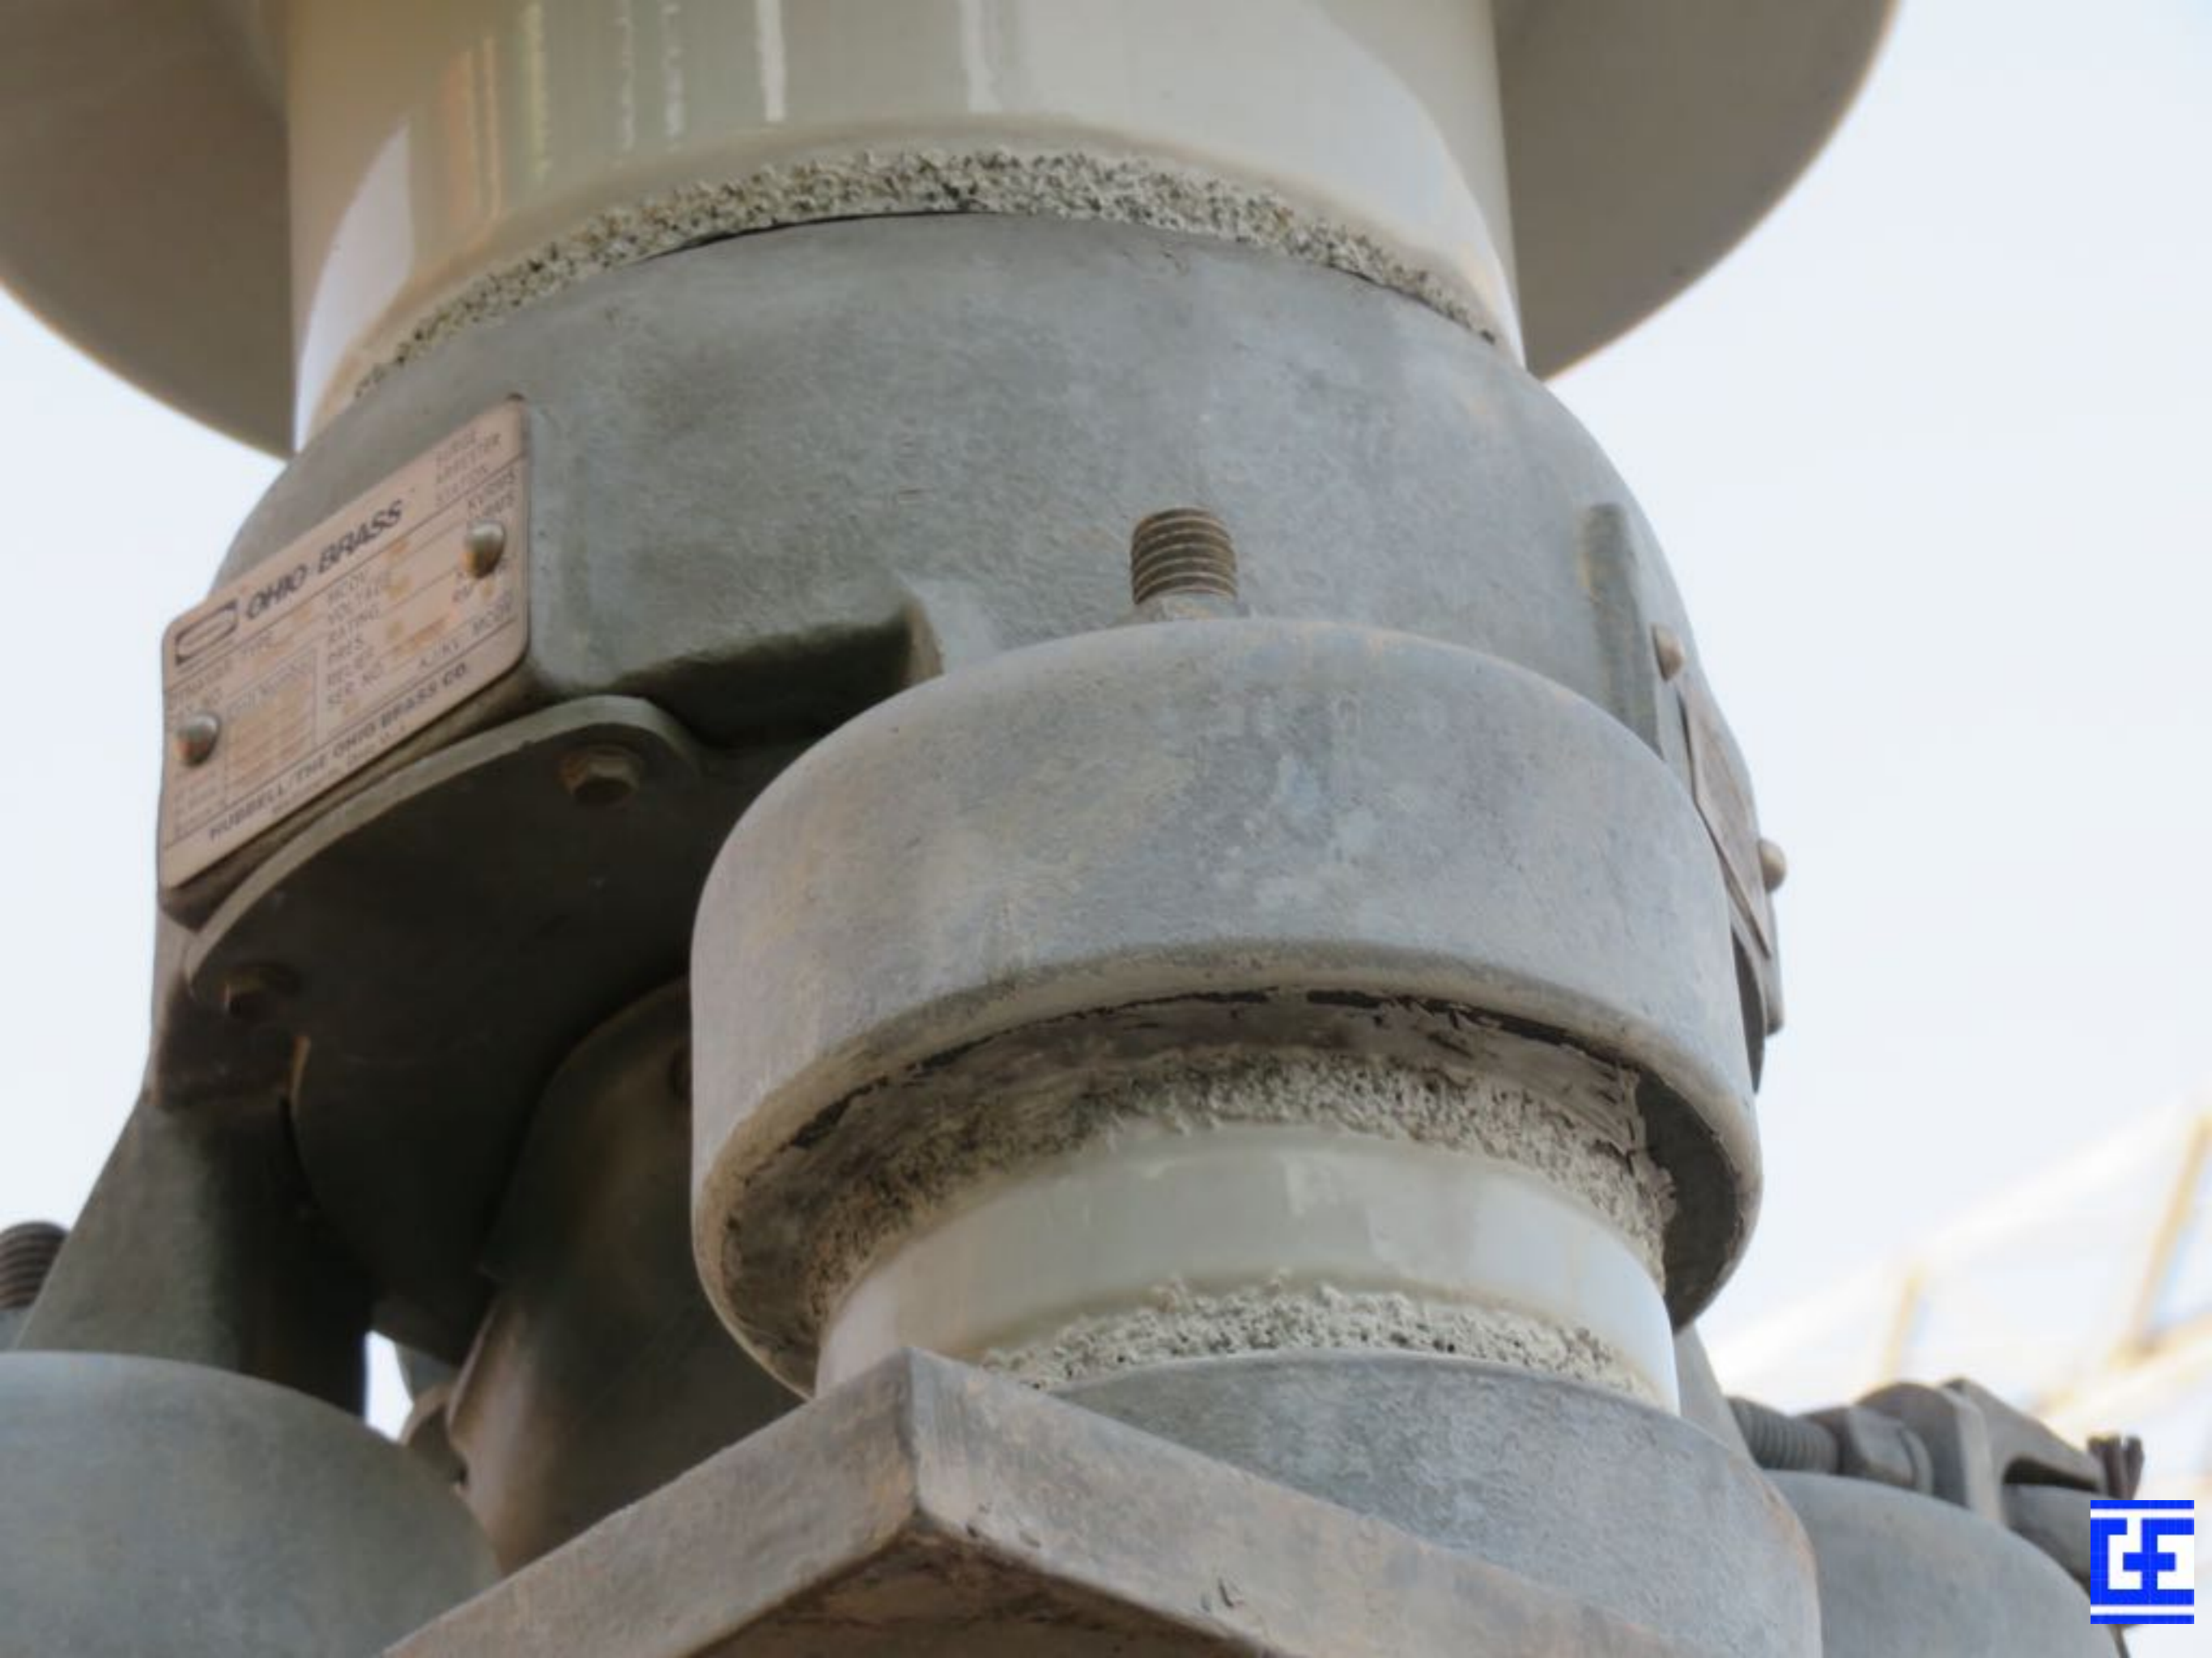
LV kV Bushings (1 / 14 with damage)
