# Puebla M 7.1 Earthquake of Sept 19 2017 Impact to Water and Power

John Eiding, Bruce Maison  
[eiding@geEngineeringSystems.com](mailto:eiding@geEngineeringSystems.com)  
[maison@netscape.com](mailto:maison@netscape.com)

Updated 9.14.2018

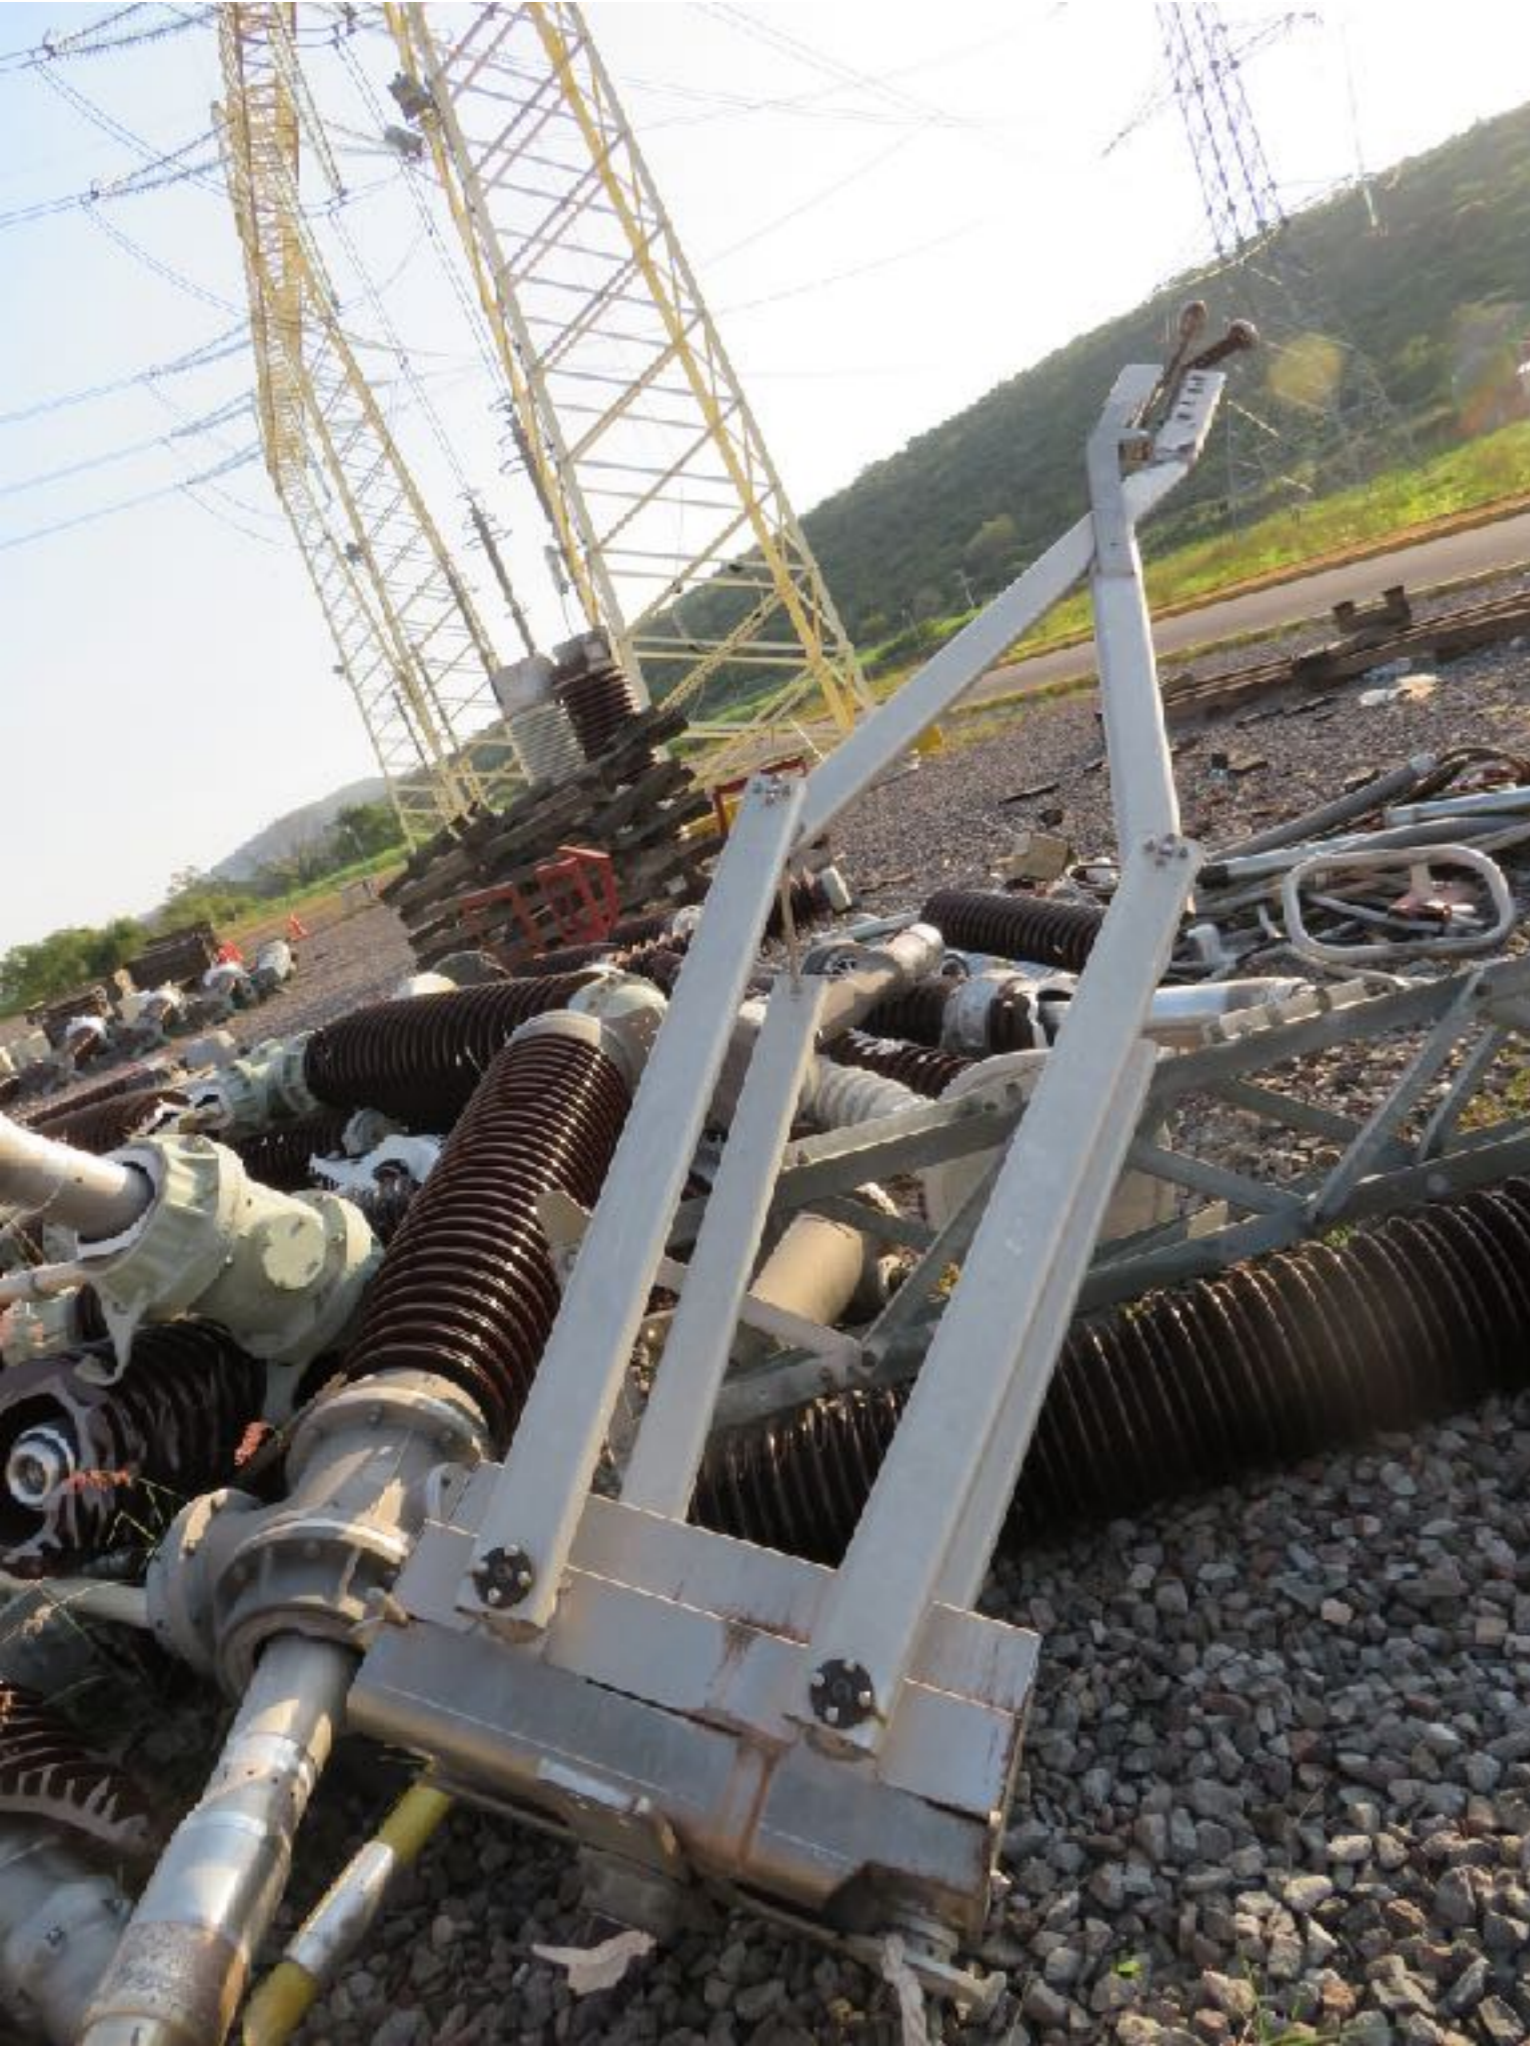
Older 230 kV DS (Scissor Switch) (6) - 3 / 6 collapsed

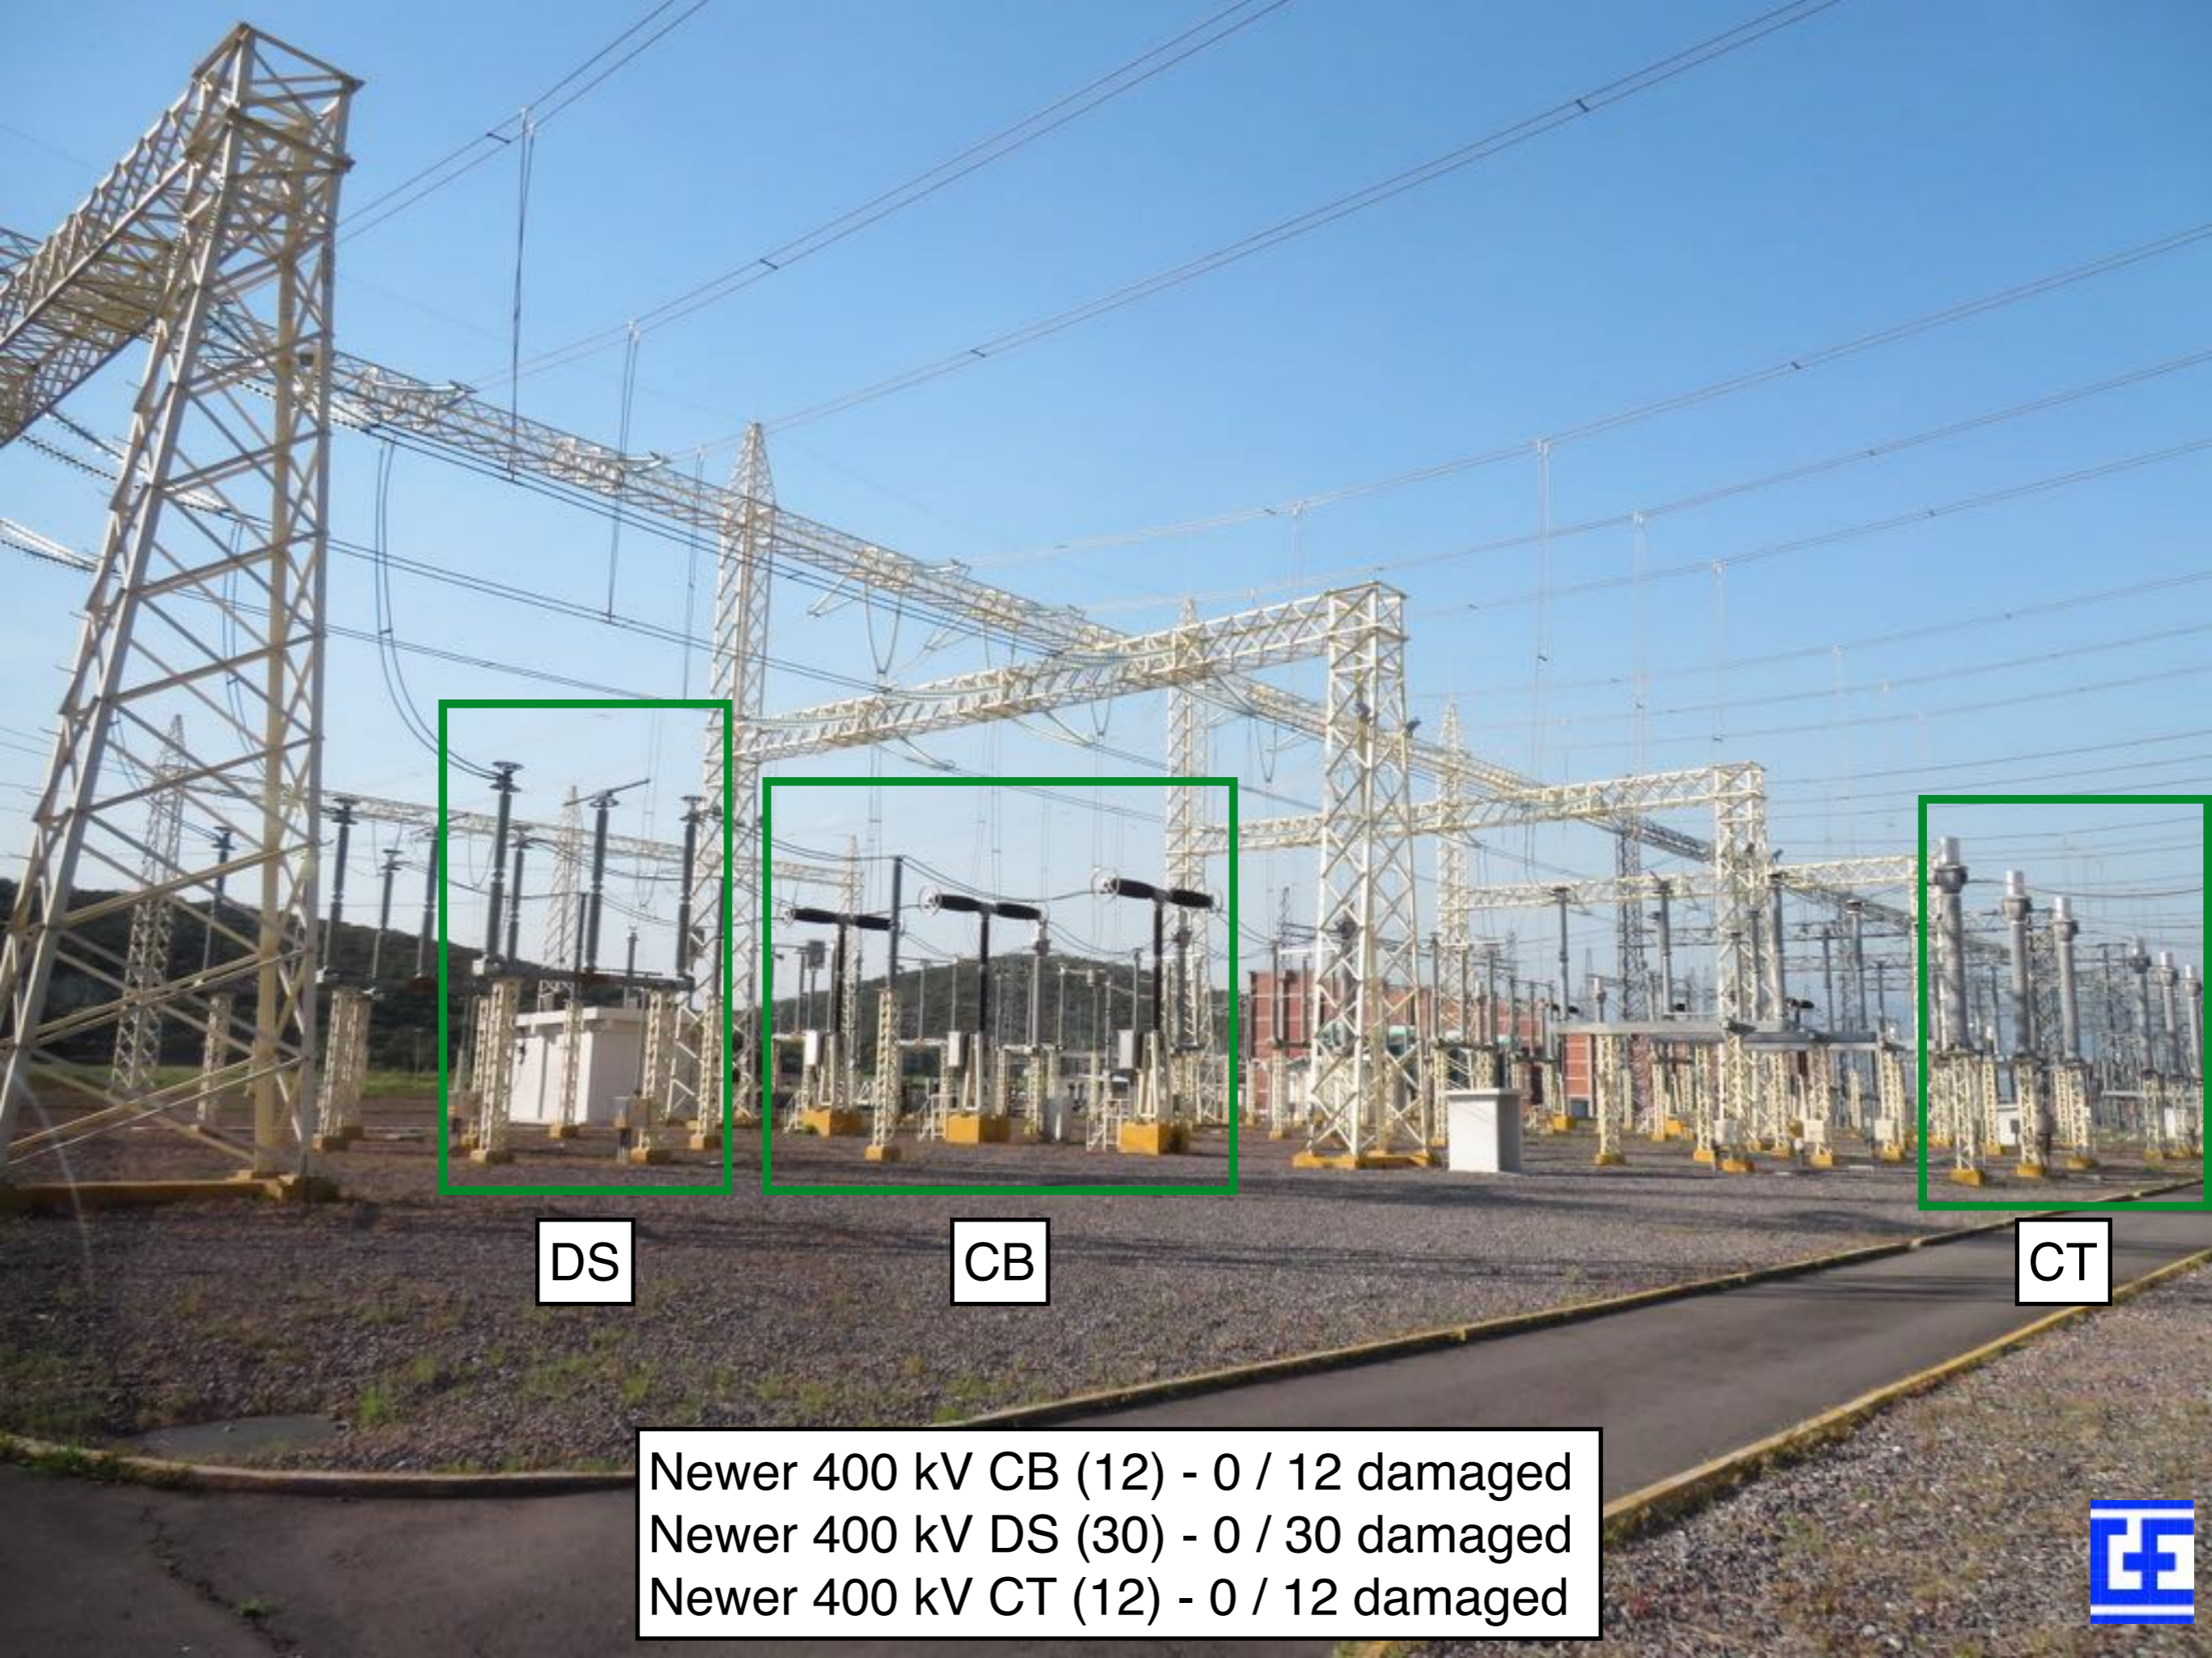
230 kV CBs 3 / 6 collapsed. May have been aggravated by collapse of adjacent Scissor Switches, note the tight slack

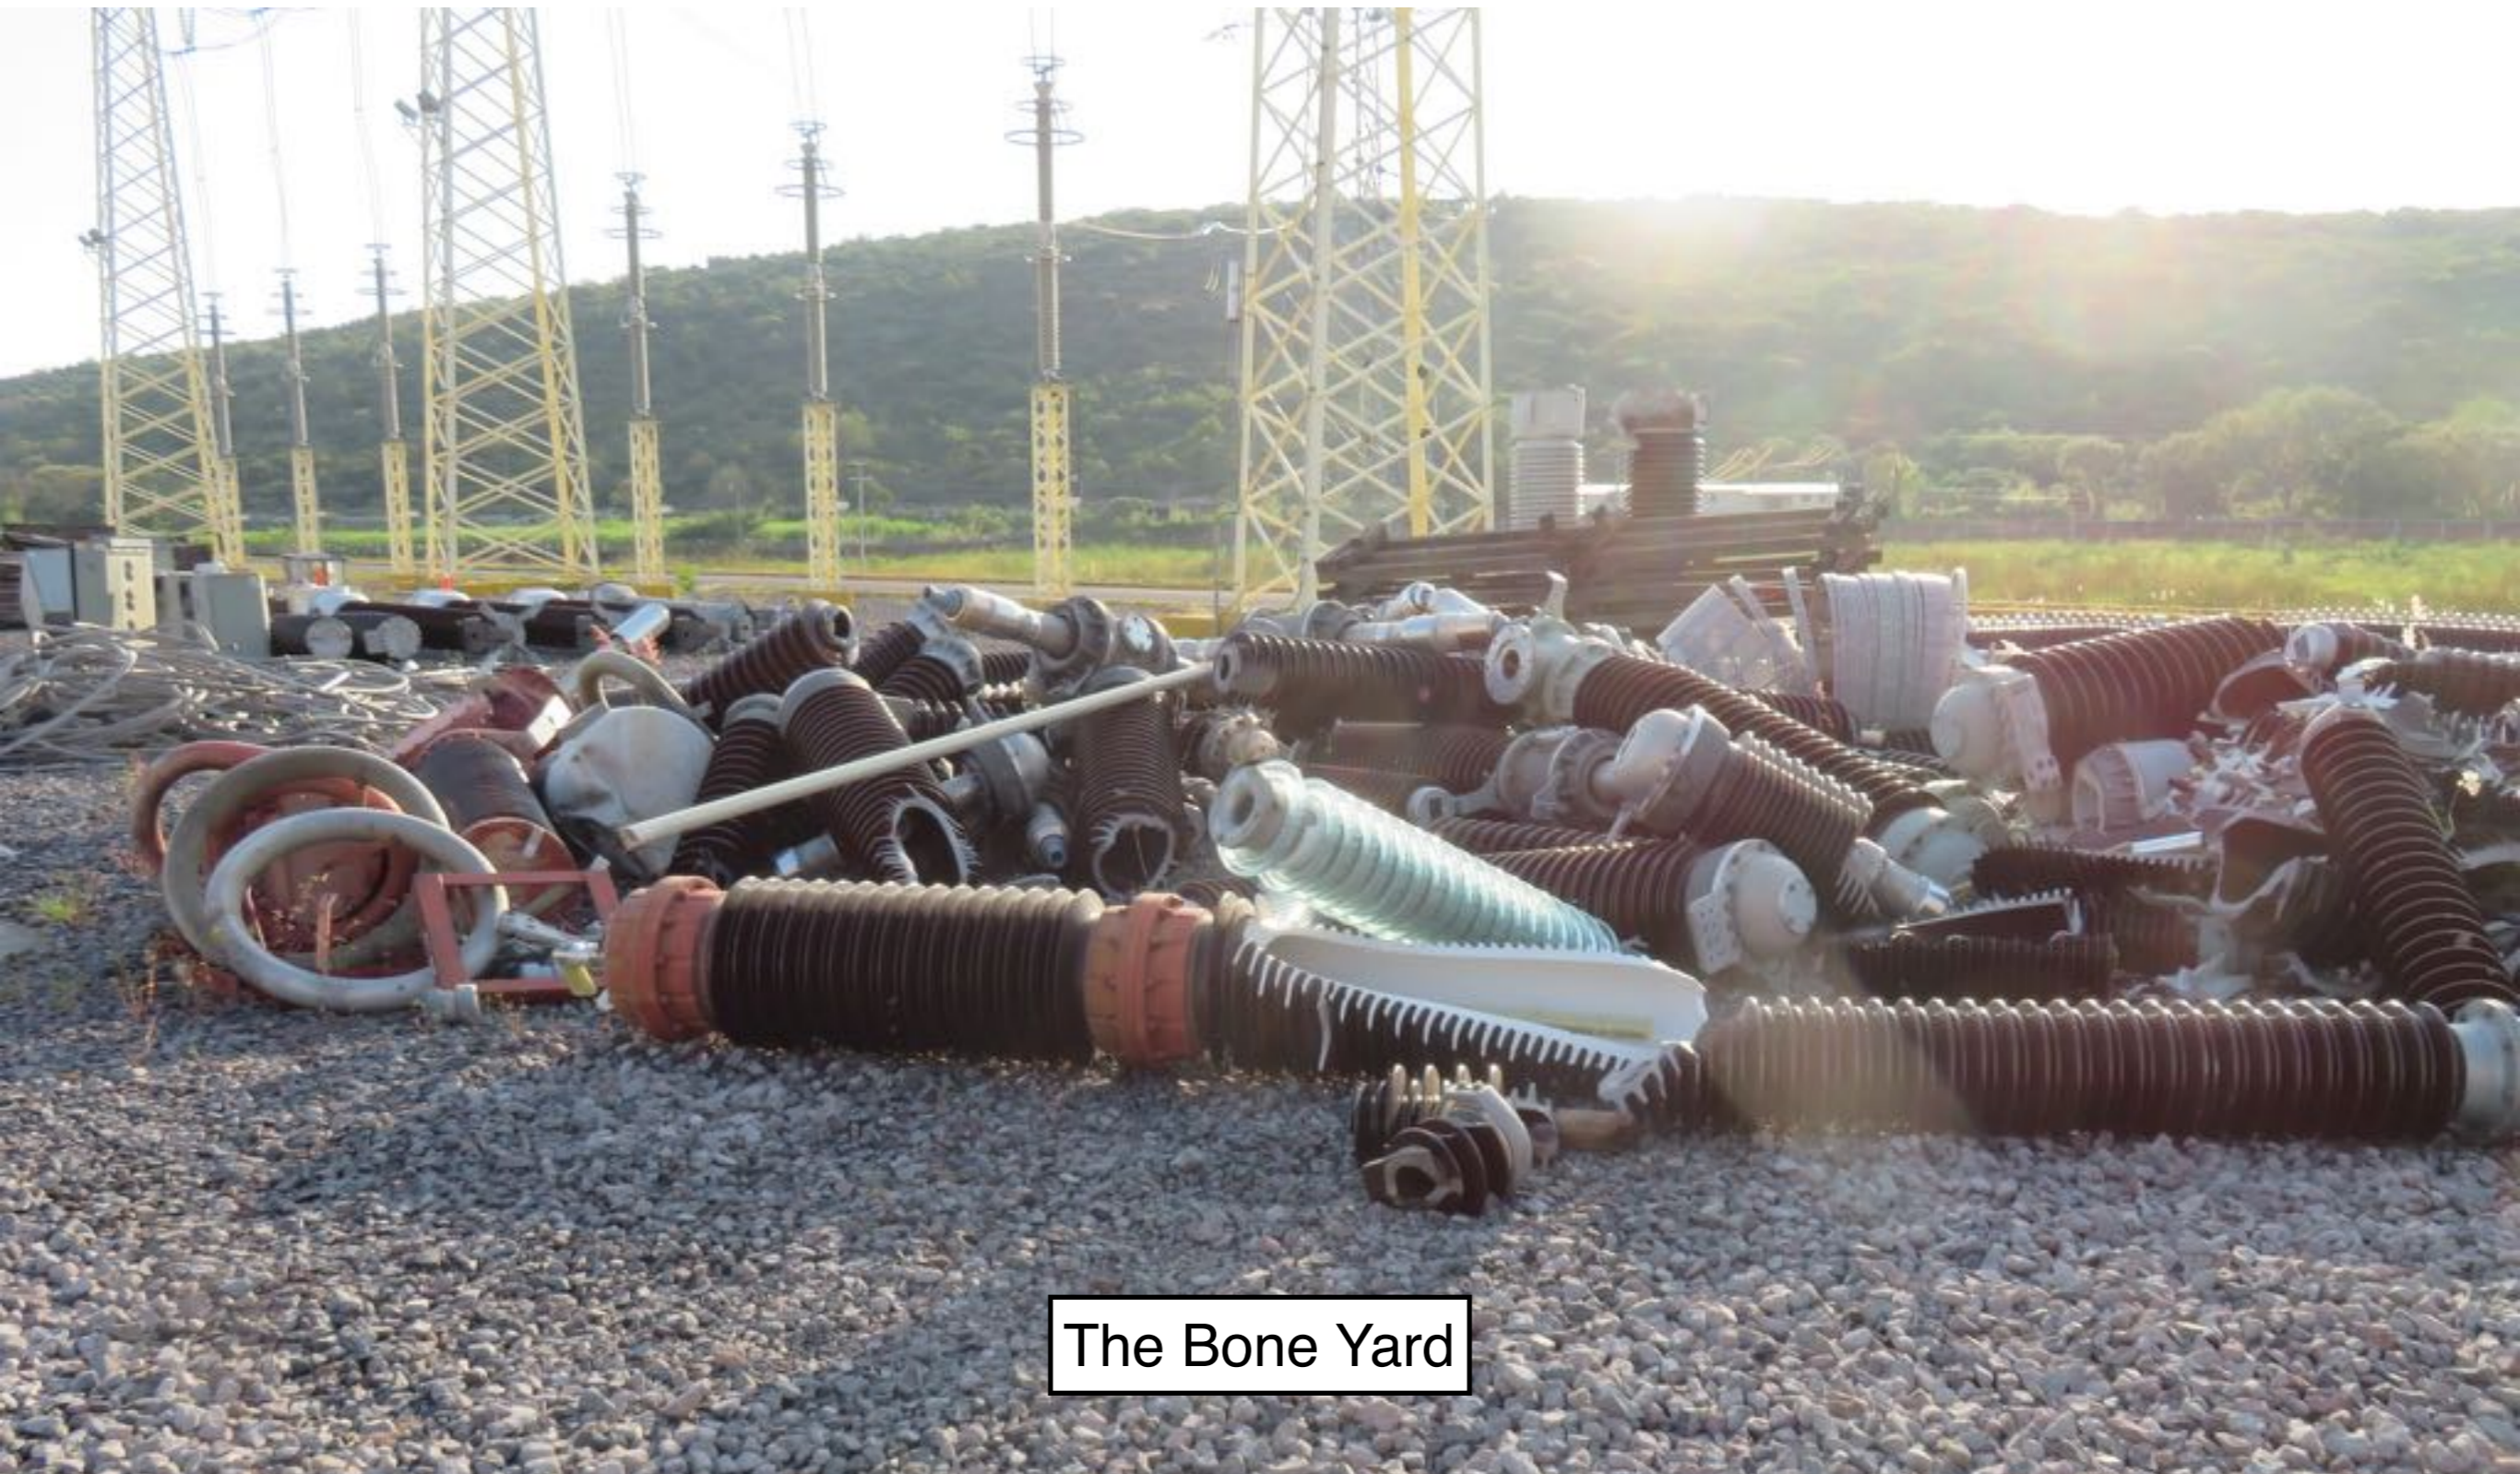
Newer 400 kV CB (12) - 0 / 12 damaged  
Newer 400 kV DS (30) - 0 / 30 damaged  
Newer 400 kV CT (12) - 0 / 12 damaged

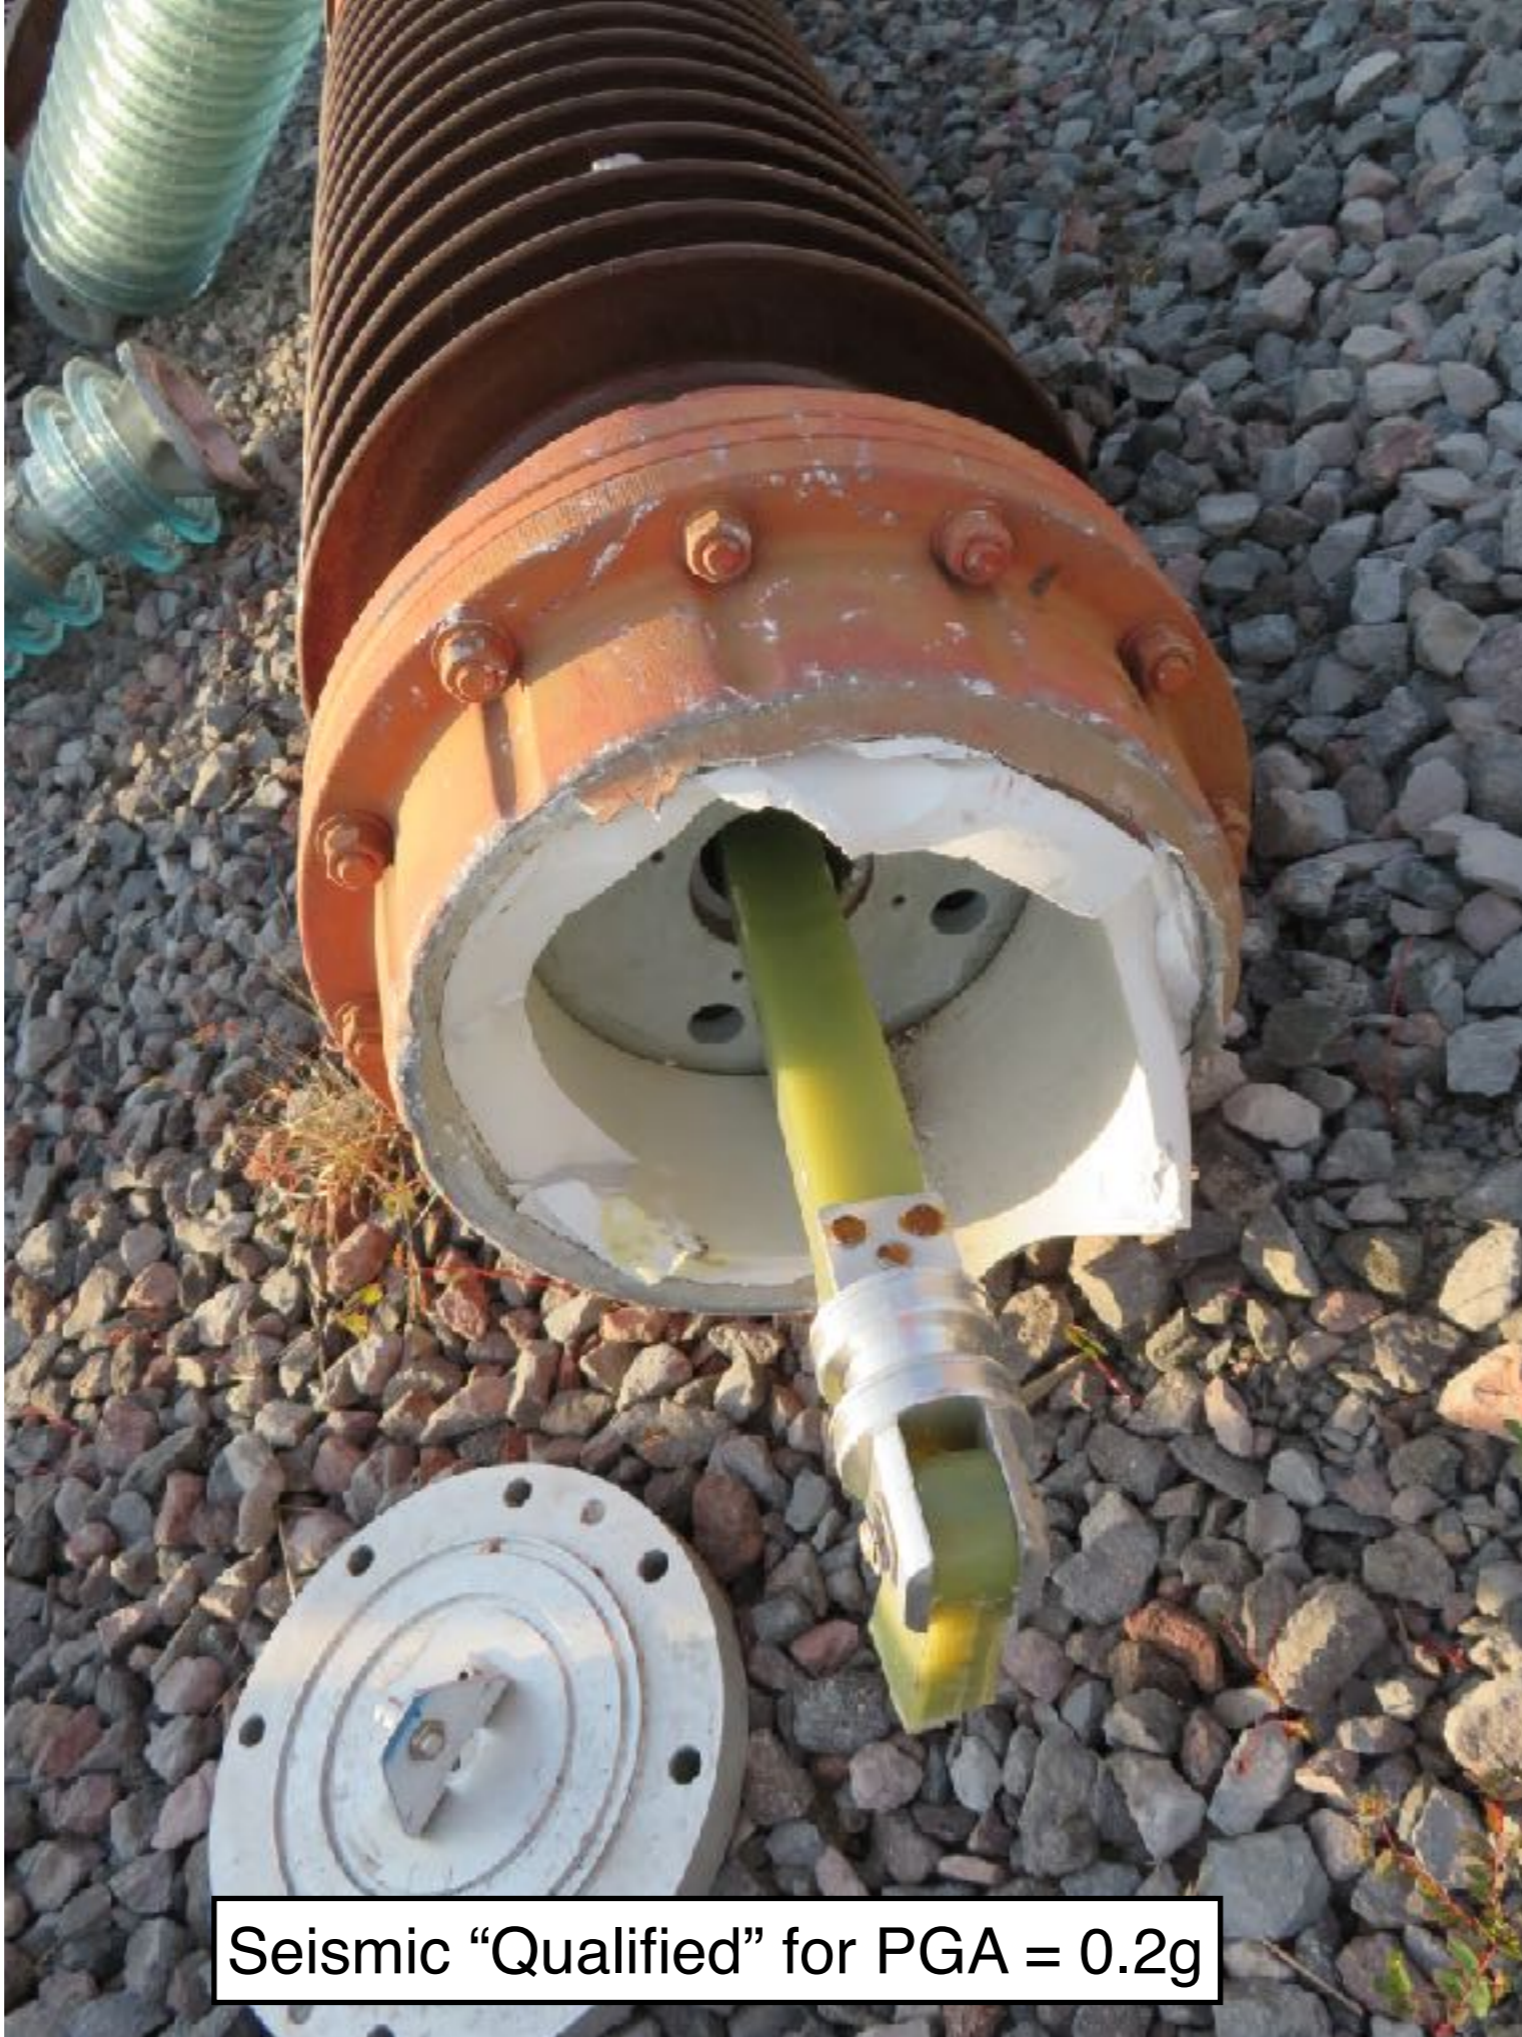
400 kV CB

Seismic "Qualified" for PGA = 0.2g

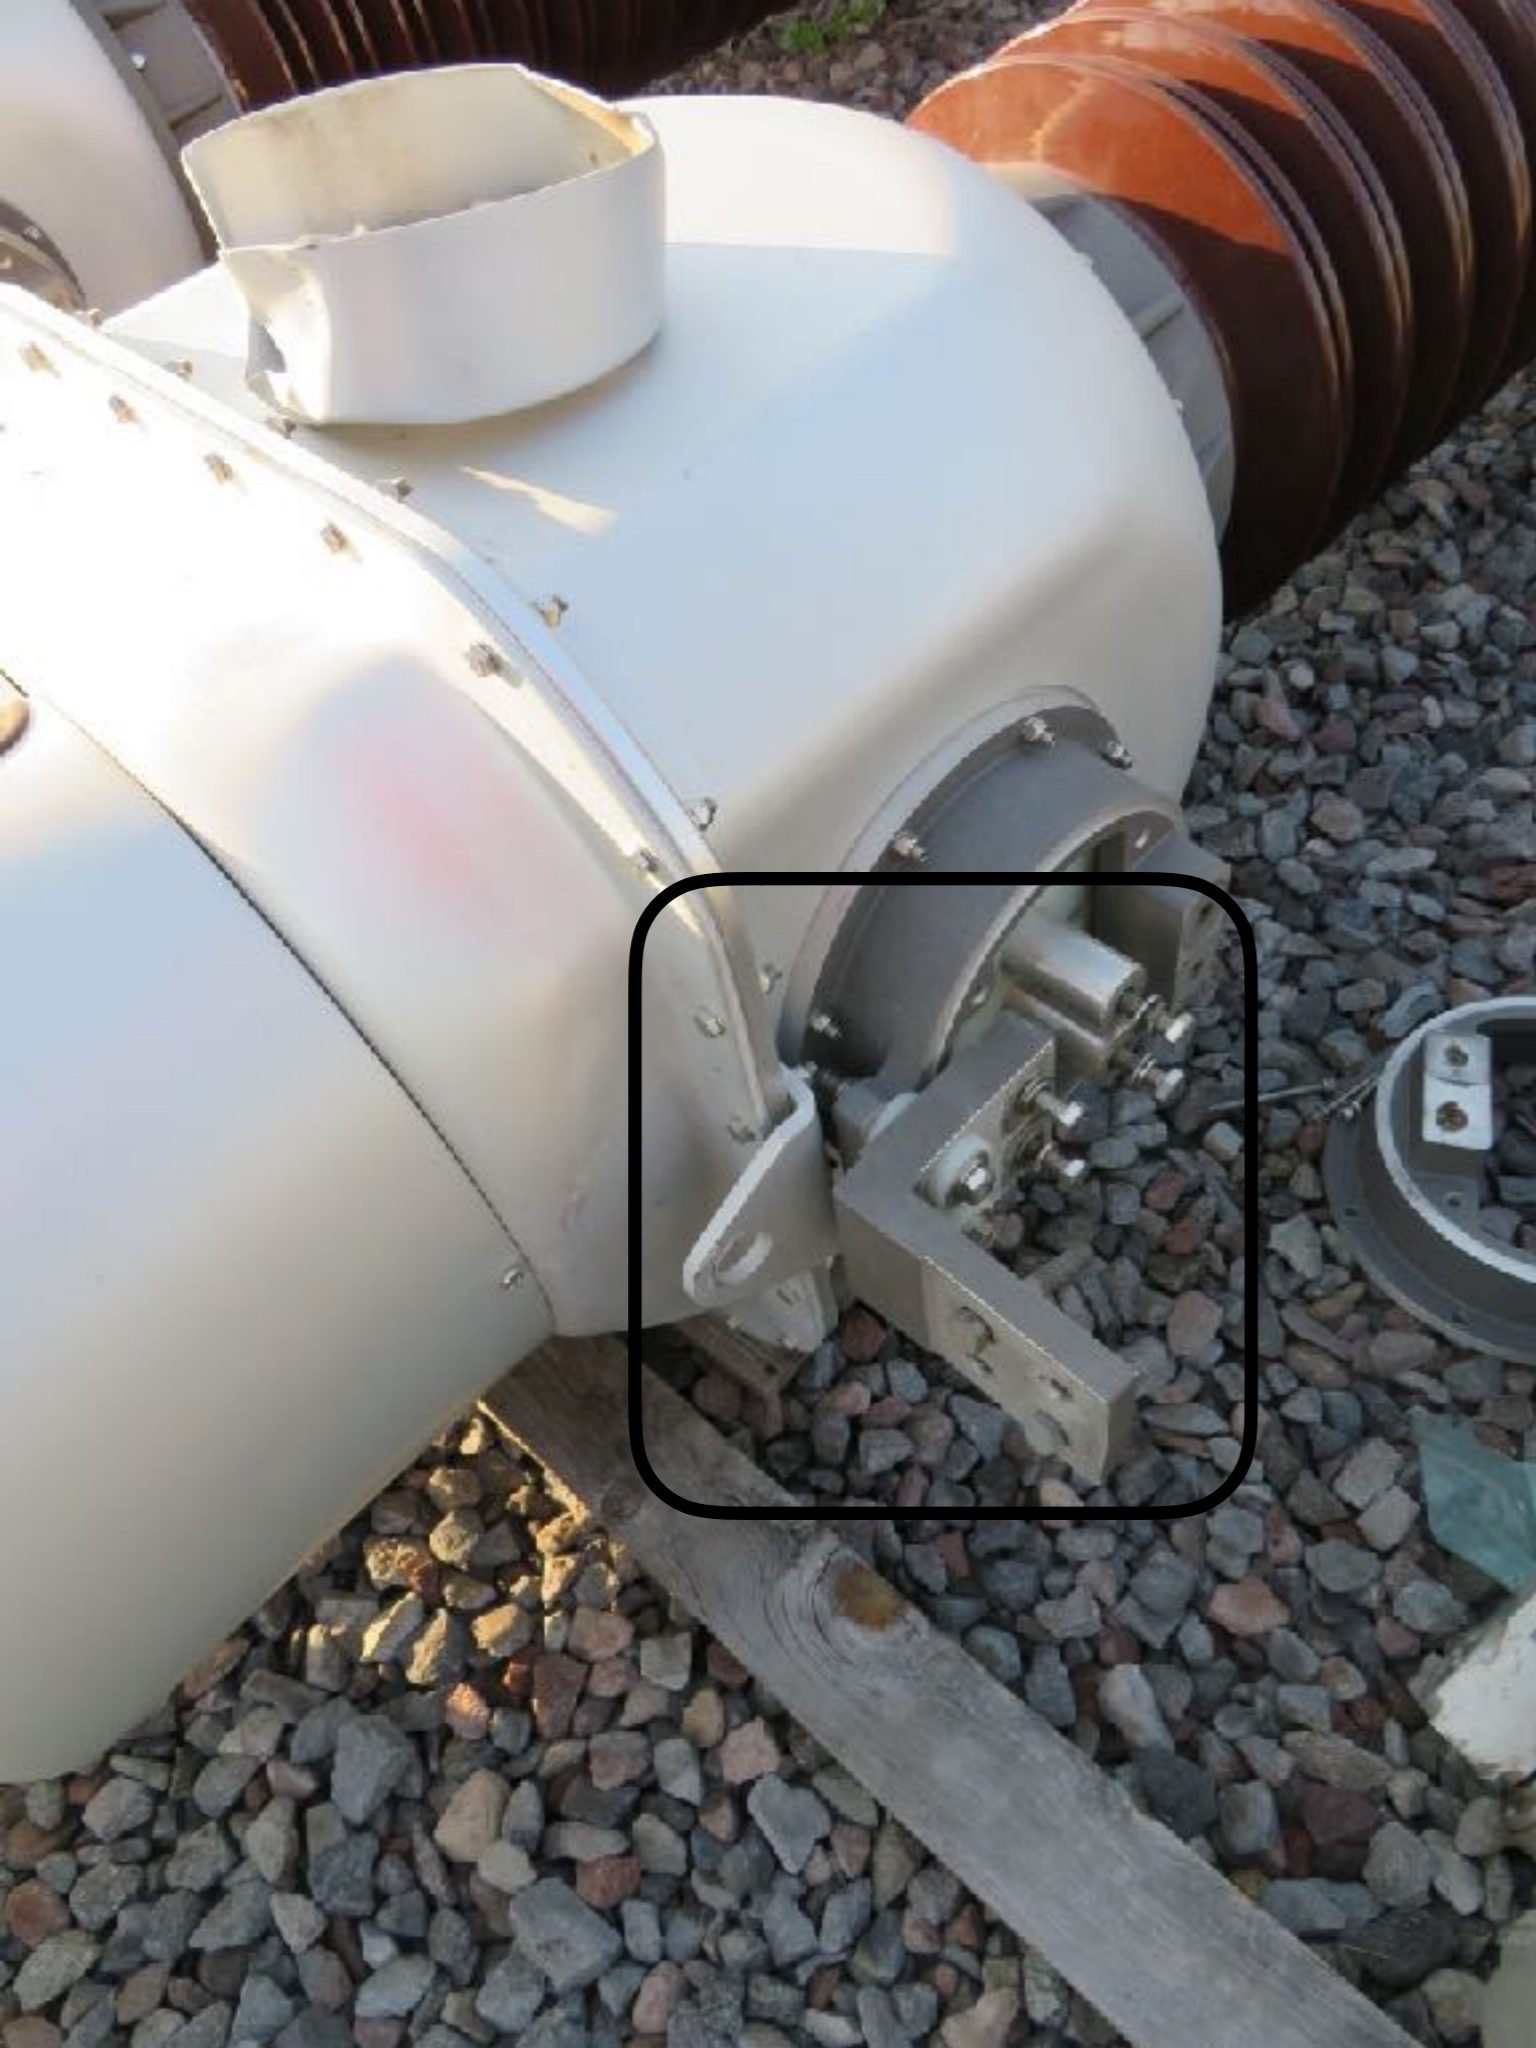
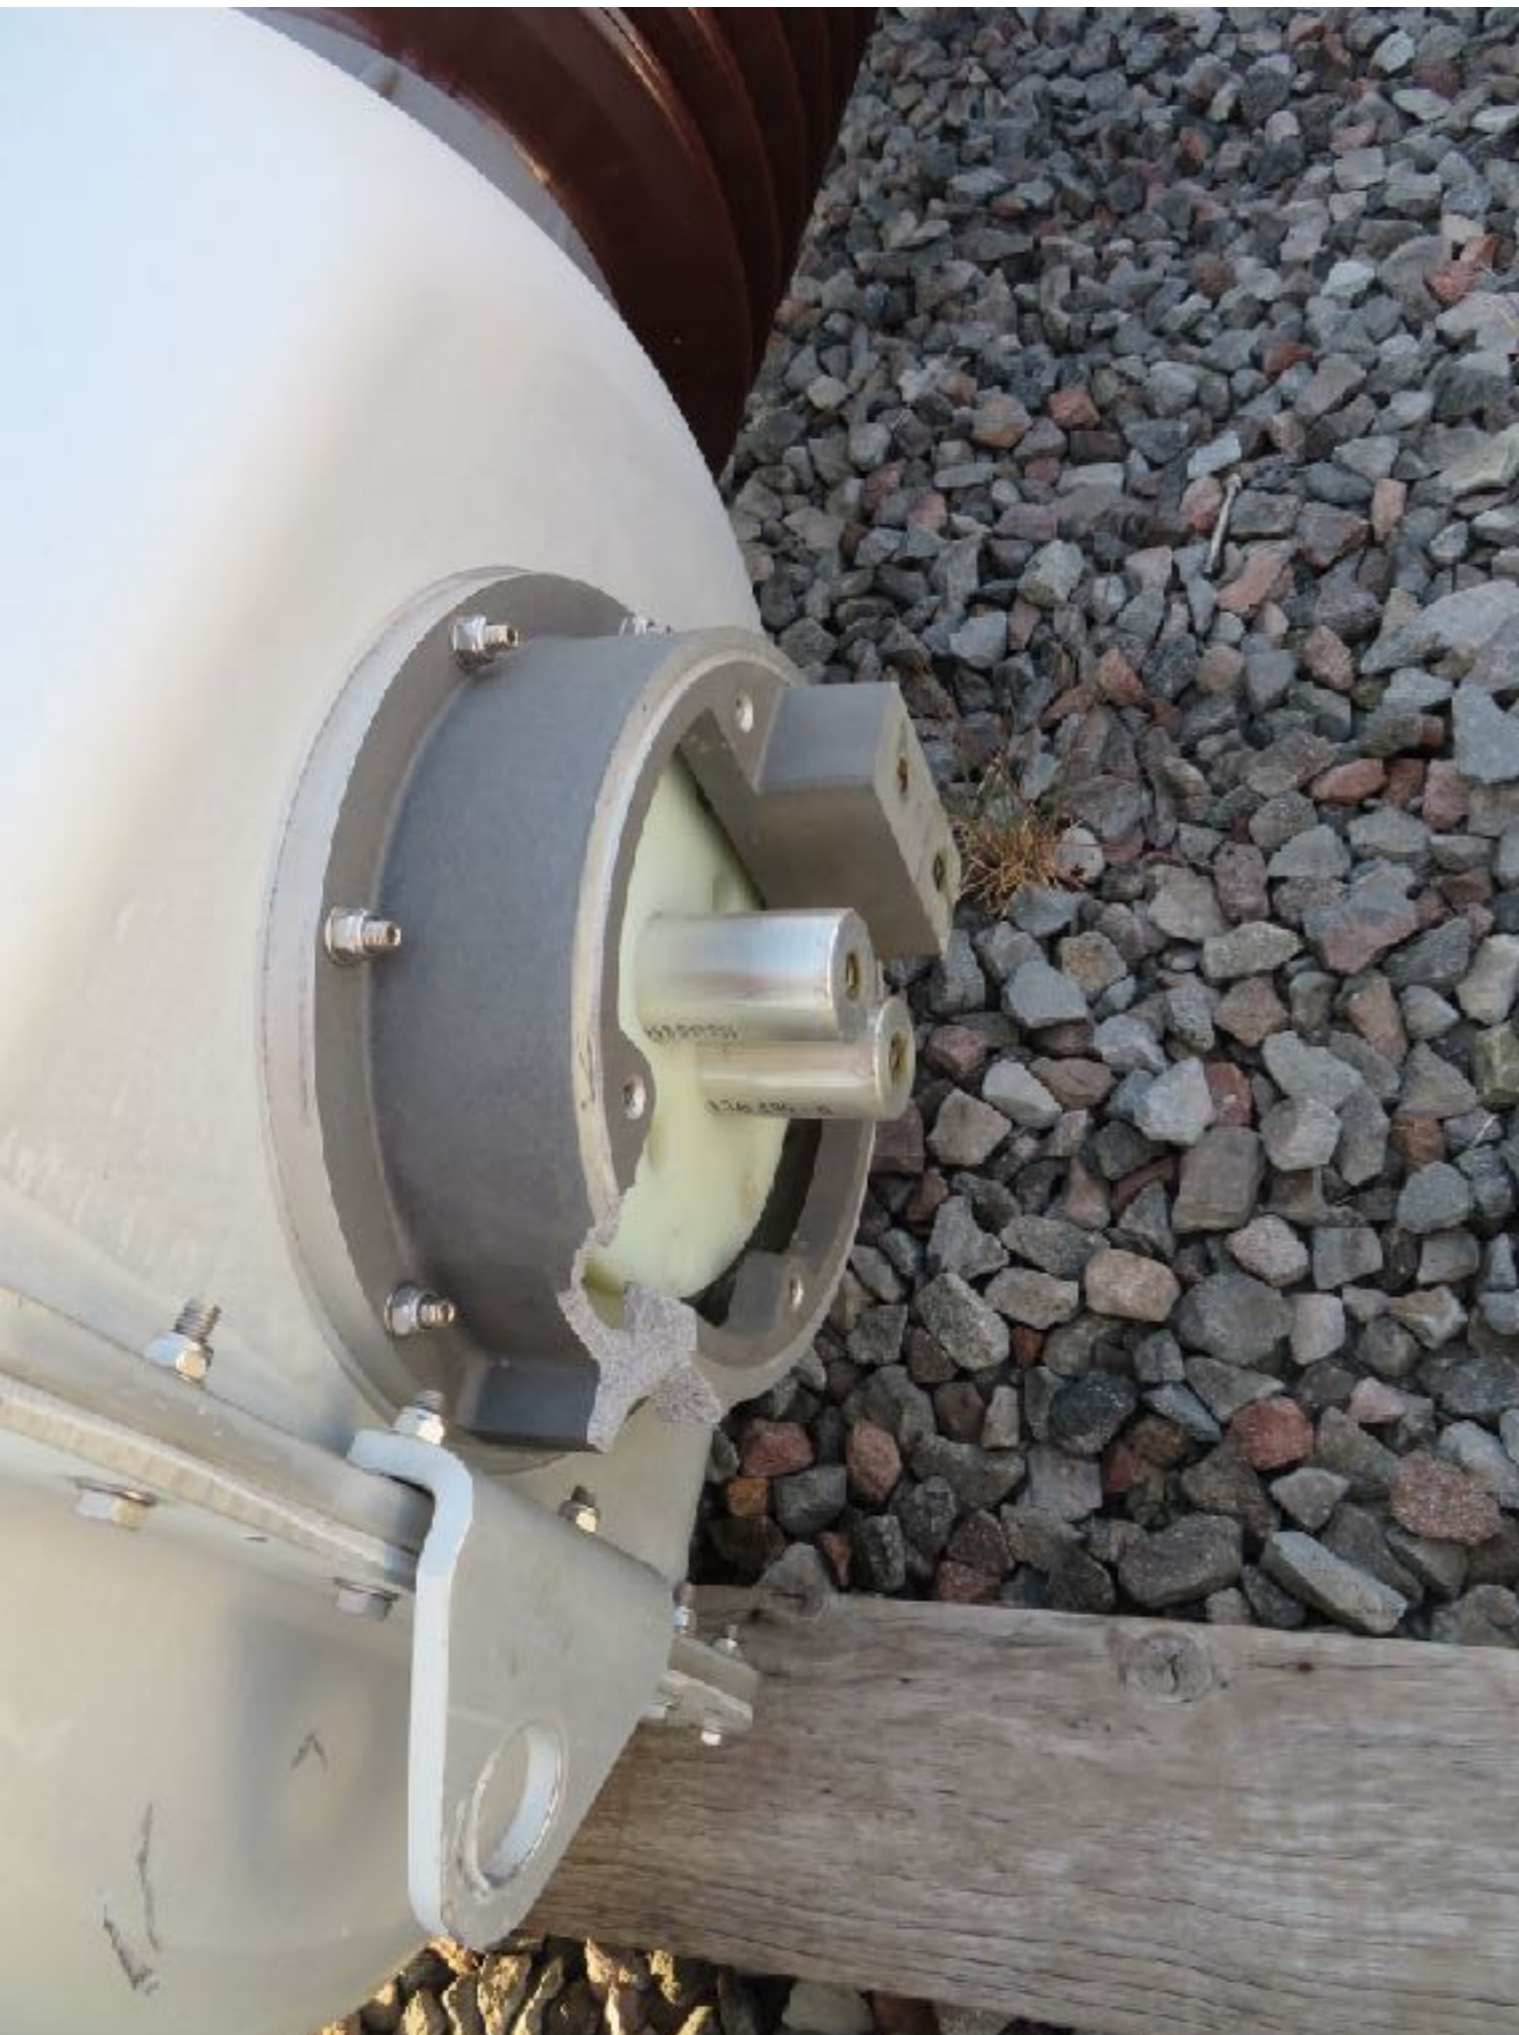
400 kV CT  
Failure is non-ductile failure of  
cast aluminum bracket.  
Likely due to insufficient slack

400 kV CT  
Non-ductile failure of  
cast aluminum bracket.  
Likely due to insufficient slack
