# Puebla M 7.1 Earthquake of Sept 19 2017 Impact to Water and Power

John Eiding, Bruce Maison  
[eiding@geEngineeringSystems.com](mailto:eiding@geEngineeringSystems.com)  
[maison@netscape.com](mailto:maison@netscape.com)

Updated 9.14.2018

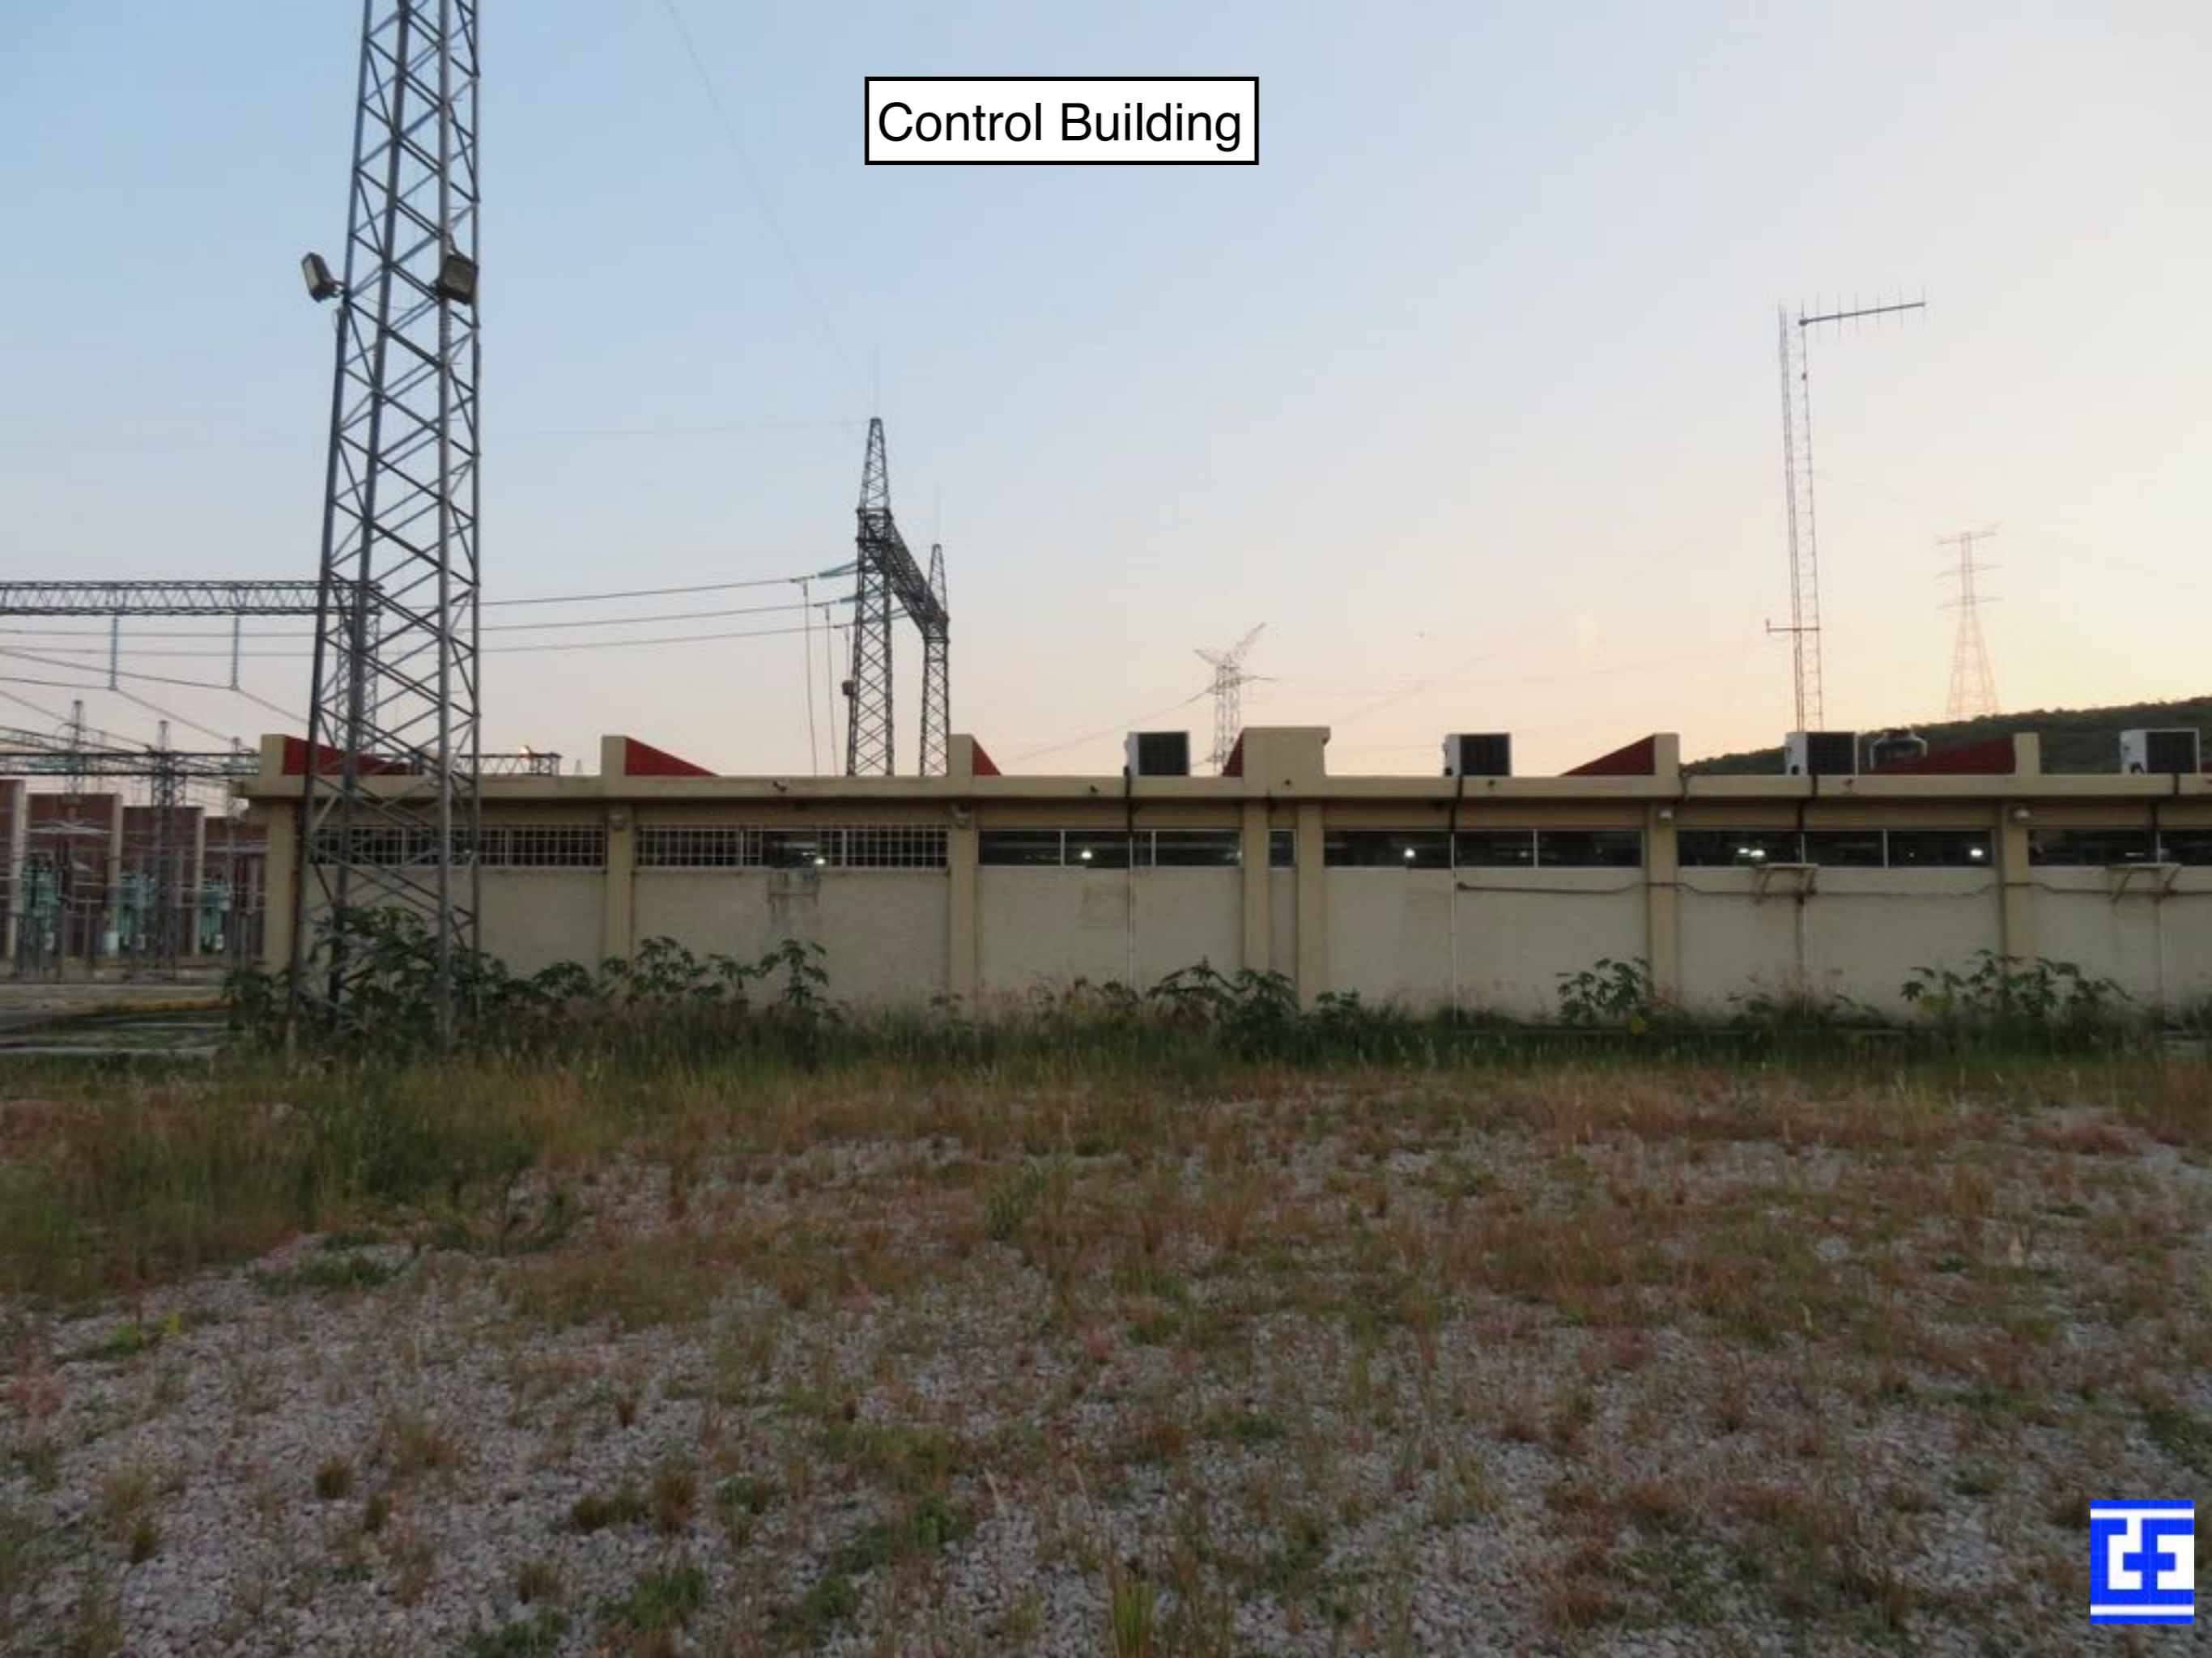
Batteries

No seismic design!  
(how can this be?)

Rocking starts at  $PGA > 0.1g$ .

1 cell toppled.

Remaining cells  
manually moved.

Evidence suggests  
that  $PGA$  was likely  $< 0.3g$ .

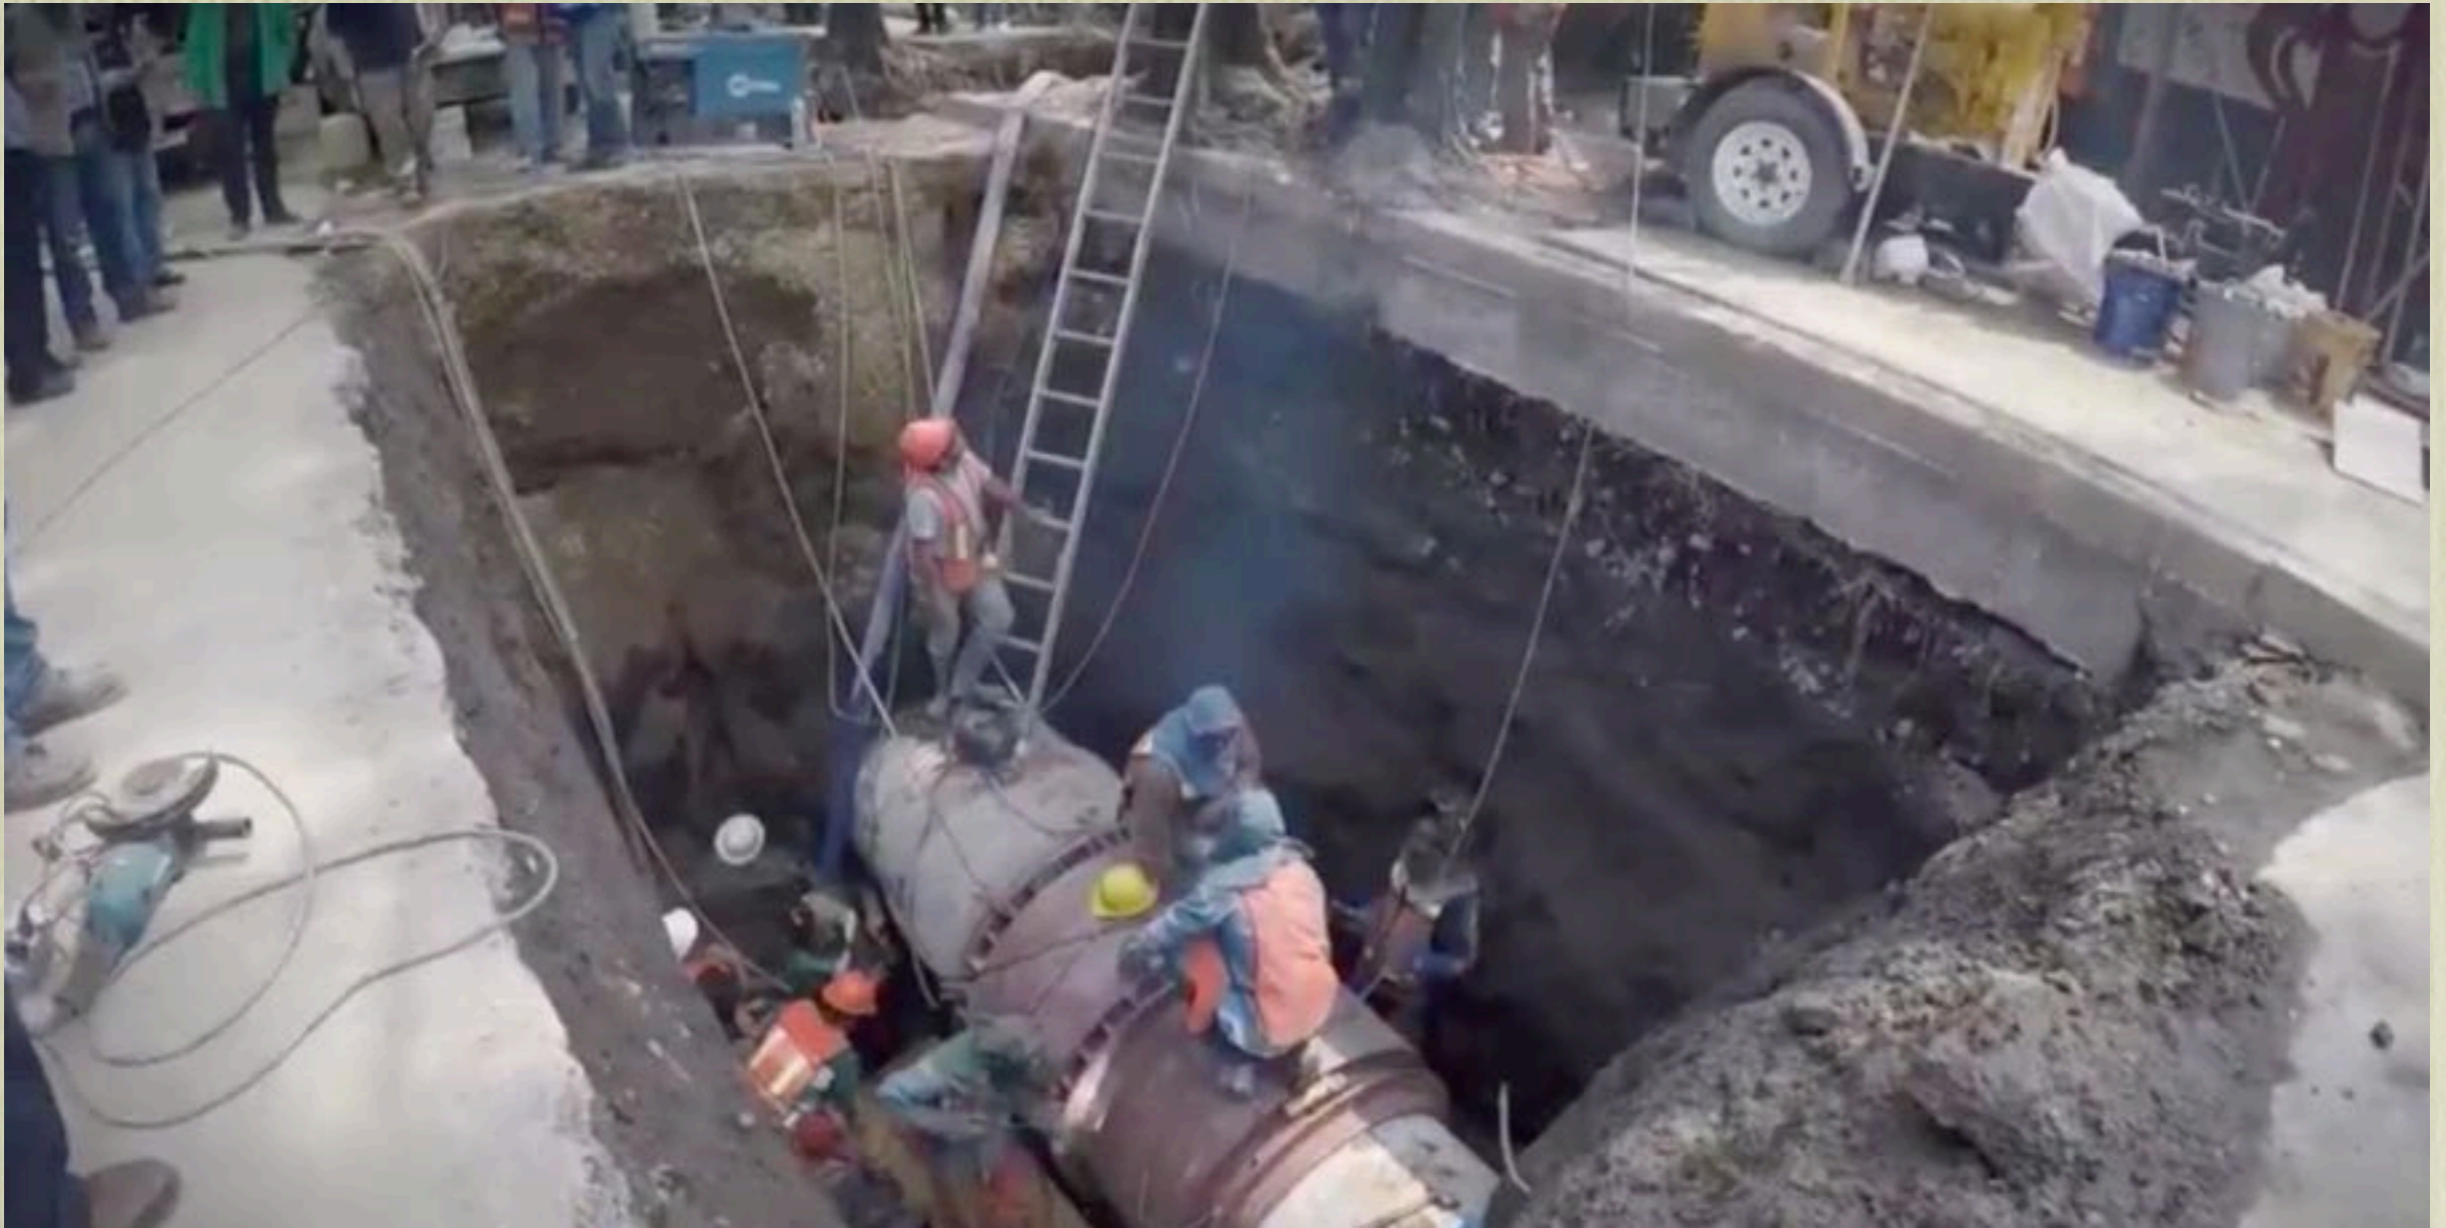
Santa Catarina

48" diameter

26 leaks in 22 km

Replaced 192 meters of pipe that were so badly damaged that they could not be quickly repaired

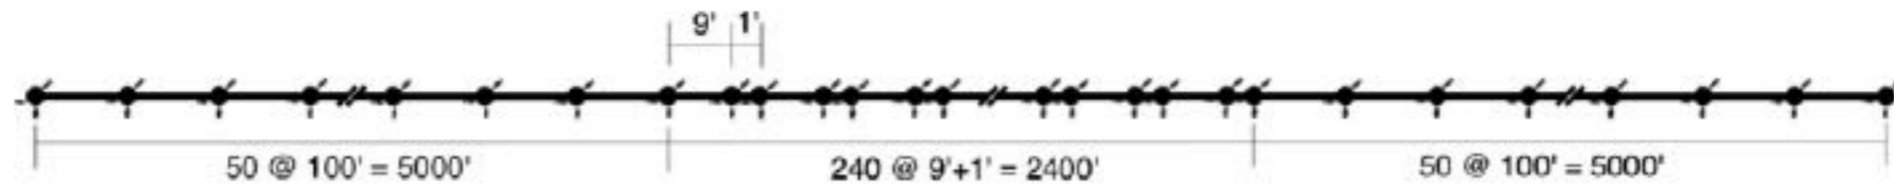
Case A

Case	Pipe M (kip-inch)	Joint Force (kips)	Joint opening (inch)
A	1260	~0	0 (restrained)
B	2980	2,040	1.35" peak

S Wave

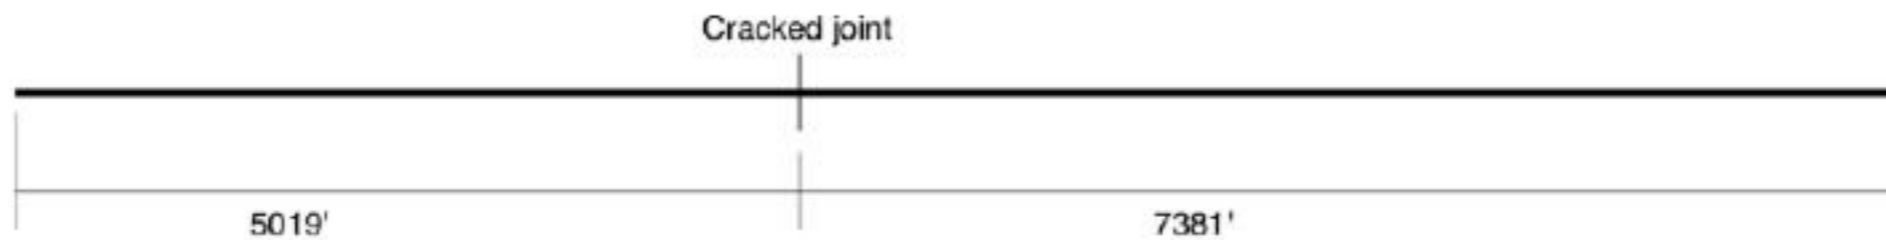
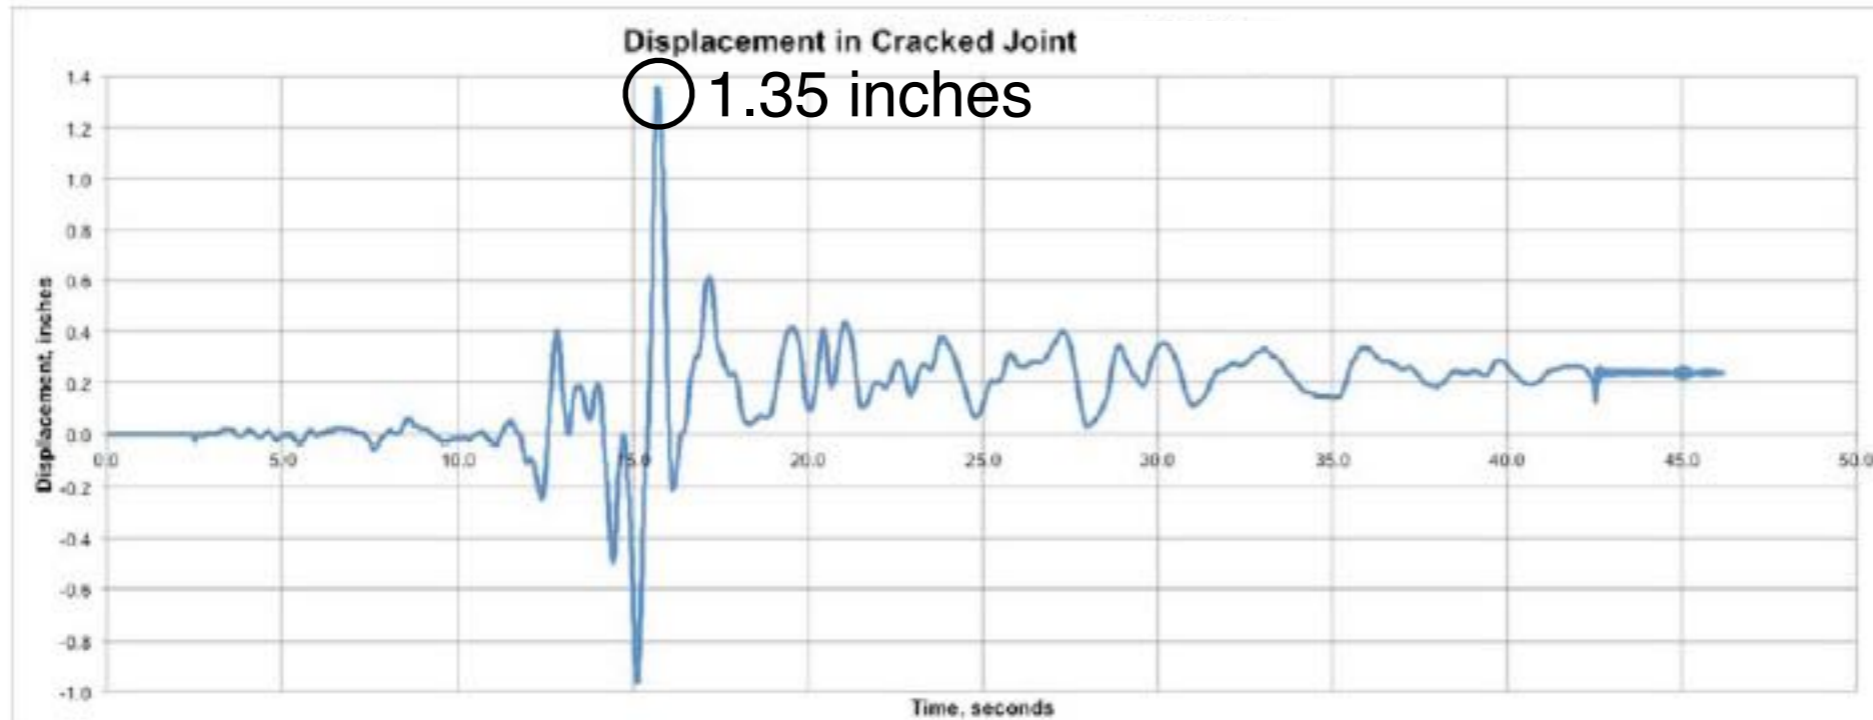
R Wave

Case B  
R Wave

Joint Opening Capacity ~ 1.0 inches

Increase surface wave speed to 10,000 feet/sec. Result: joint opening 0.29 inches

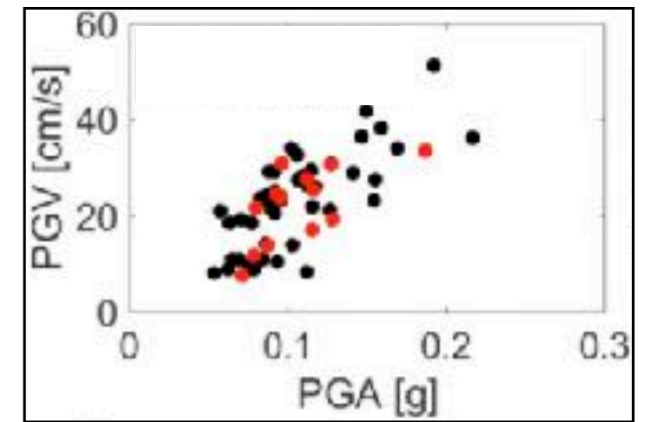
# Distribution Repairs

- Ground Motions. Mexico City “rock”. PGA = 0.05 to 0.10g. PGV = 10 cm / second. (1/5 of inventory)
- Ground Motions. Mexico City “lake and transition”. PGA = 0.07 to 0.2g, PGV = 28 cm / second. (4/5 of inventory)
- About 20,000 km of pipe (all types)
- Very few PGD zones (handfull, perhaps dozens of repairs)
- $RR = k_I * 0.00187 * PGV$  (RR in repairs / 1000 feet, PGV in inches / second,  $k_I$  varies based on pipe type) (see ALA 2001, Eidinger, Maison et al, for derivation of this pipe damage model)

- Total pipeline inventory might be about 20,000 km for 22 million people.  
“average” PGV = 24.5 cm/sec = 9.6 inch/sec
- Forecast repairs =  $0.00187 * 9.6 * (20,000 * 3.30)$  (assuming  $k_I = 1.0$ )
- Forecast repairs ~ 1,185
- Actual repairs ~ 1,500
- Pipeline inventory is known to have severe leakage (pre-earthquake losses ~30% or more), is aged, much might be in hot soils, PGV might be > 24.5 cm/sec for oldest and weakest pipes, many pipes have undergone distortions due to 1 to 3 inches of subsidence per year over 100 year time frame, length of pipe might be more or less than 20,000 km.
- Considering these issues, the first-order prediction (1,185), with further adjustments, might be within ballpark of actual (1,500). Or, Mexico  $k = 1.27$ .
