**M 9.0 Tohoku Earthquake  
March 11 2011  
Performance of Water and Power  
Systems**

*G&E Engineering Systems Inc.  
6315 Swainland Rd  
Oakland, CA 94611  
(510) 595-9453 (510) 595-9454 (fax)  
eidinger@earthlink.net*

*June 25, 2012*

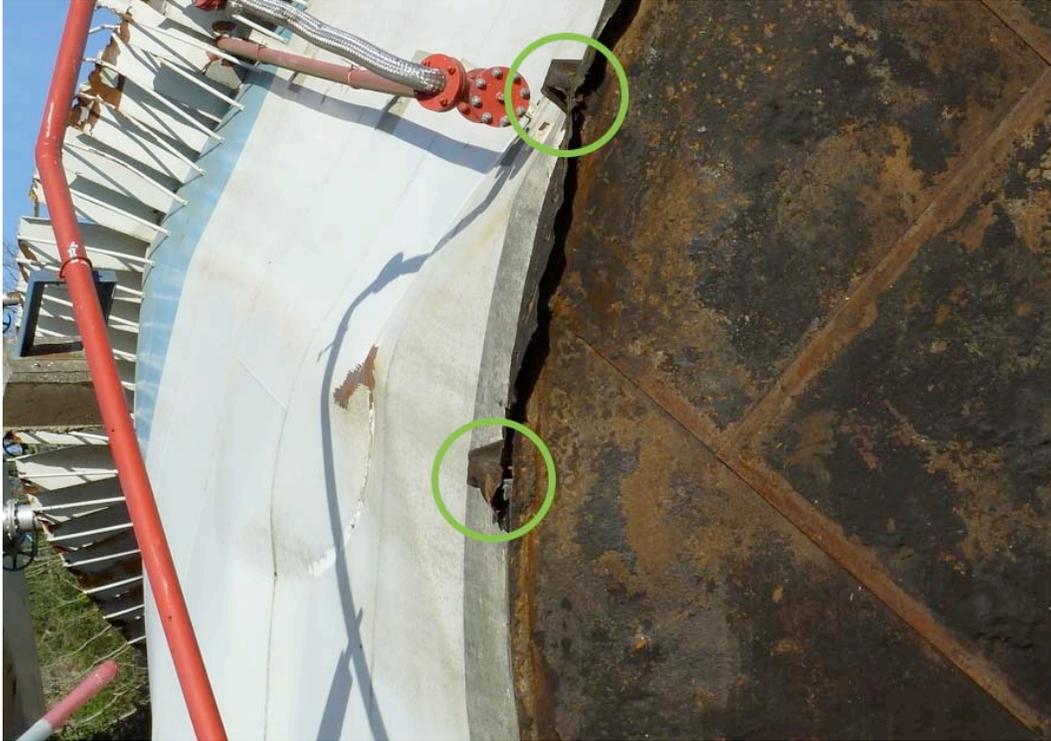
We observed more than 20 floated steel tanks in the tsunami zones. Figure 2-12 shows three oil tanks in Onegawa. The tsunami floated two of the tanks that were at about 20 feet above sea level; but the third tank, at about 50 feet above sea level, was placed high enough on a hill to avoid the tsunami. All three tanks were anchored; the anchors on the two lower tanks broke in the anchor bolts, Figure 2-13. The anchored upper tank appears to have survived the strong ground shaking effects without damage.

*Figure2-13. Failed Anchors on one of Two Floated Tank (Onegawa)*

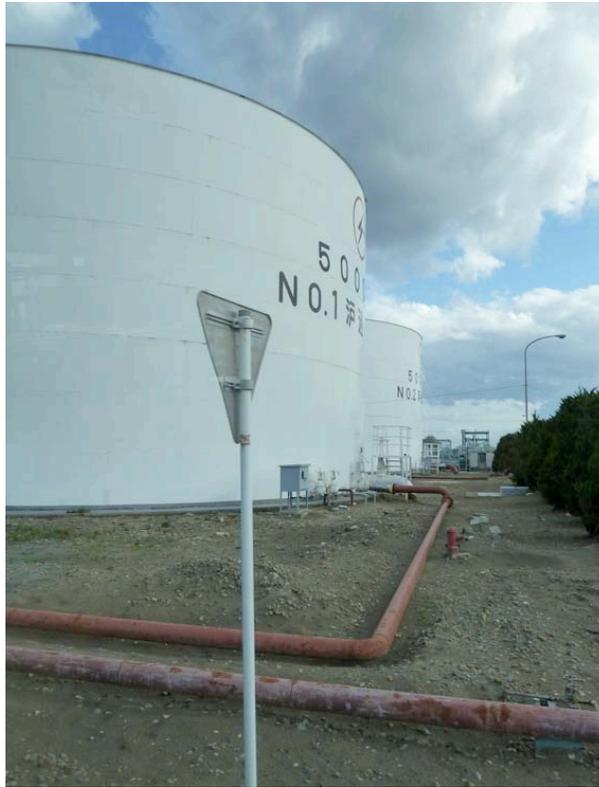
At the Port of Sendai, there are two identical 5,000,000 liter fire water tanks at the Shin Sendai power plant, Figure 2-14. Water heights from the tsunami were about 8 feet above local grade at these locations. Both tanks are welded steel, unanchored, resting within a concrete containment ring, Figure 2-15. Observations of Tank 1 show that it started to float / and or rock due to the tsunami; but the adjacent Tank 2 showed no distress at all. The performance of these tanks is further described later in this report.

*Figure 2-14. Two Water Tanks that were Inundated*

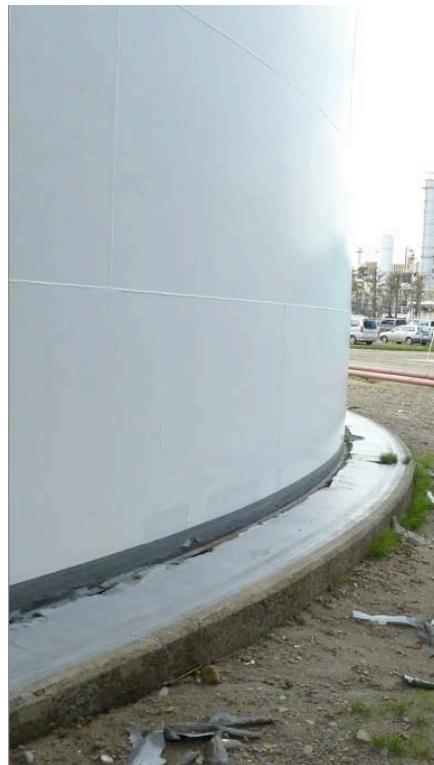
*Figure 2-15. Tank 1, Showing Evidence of Distress / Uplift*

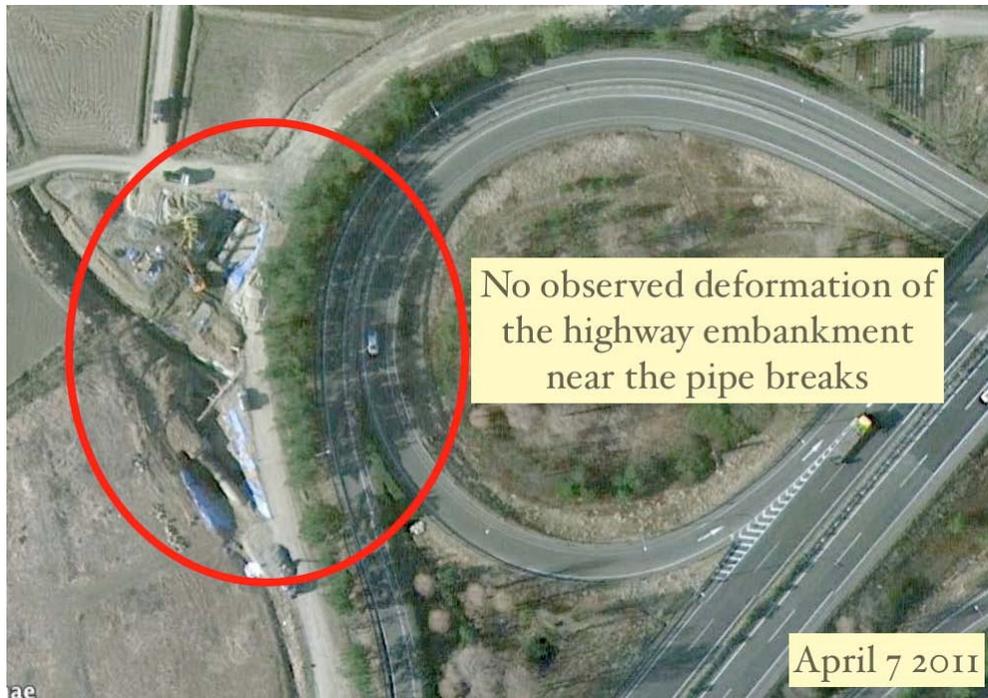
Figure 3-1 shows a map of this system. In total, this water transmission system was damaged in 53 locations. The large red arrow indicates probably the most critical of these damage locations, where a 96" (2400 mm) diameter pipe suffered breaks in two locations. Figure 3-2 shows an aerial view, taken on April 7 2011 (26 days after the earthquake). The pipe can be seen exposed in two locations within the red circle. At this location, the pipe was originally designed and routed to go around the freeway on/off ramps, as well as go under a drainage creek. As seen in Figure 3-3, the pipe also makes a sharp turn under the creek, to match the alignment around the freeway ramps.

Figure 3-2. Location of Pipe Damage

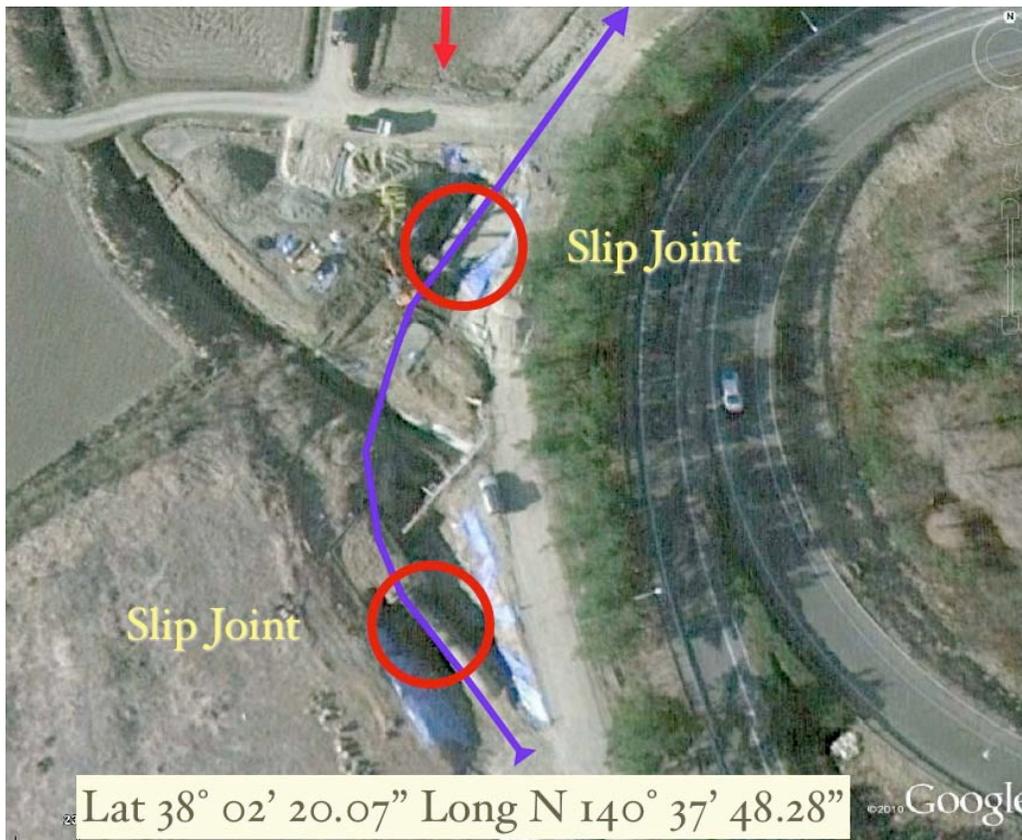
The pipe alignment and damage locations are shown in Figure 3-3. Figure 3-4 shows the damage to the pipe (at the lower left highlighted location in Figure 3-3), with the photo taken 30 minutes after the earthquake. The water being released (Figure 3-5) rapidly eroded the backfill and some surrounding soils, and undermined the concrete encasement in spots; but nearly all the water was routed into the storm drainage channel, so there was no flooding of the nearby highway. The water being released was then isolated by closing suitable valves in the system.

Most of the damage at the other 50+ locations along this pipe was also to the opening of slip joints. Site inspection of the nearby highway embankment could not reveal evidence of any permanent ground deformations for the site in Figure 3-3. The level of shaking at this site would be about  $PGA = 0.20g$  to  $0.25g$  range based on common attenuation models. Possible explanations as to why the encased section moved and caused the slip joints to pull apart are as follows:

Figure 3-3. Location of Pipe and Damage Points

- ALA (2005) provides some guidance as to how to estimate these hydrodynamic forces. In most situations, there would be little additional construction cost to restrain these forces, even assuming a weaker soil resistance at the bend.

- Lacking computation of such hydrodynamic forces, a simple approach would be to avoid placing slip joints into pipelines at any location near bends over  $5^\circ$  or so, or next to closed isolation valves, unless the pipe is provided with anchors or sufficient soil strength (including earthquake effects) to resist maximum hydrostatic forces with at *least* a factor of safety of 3.

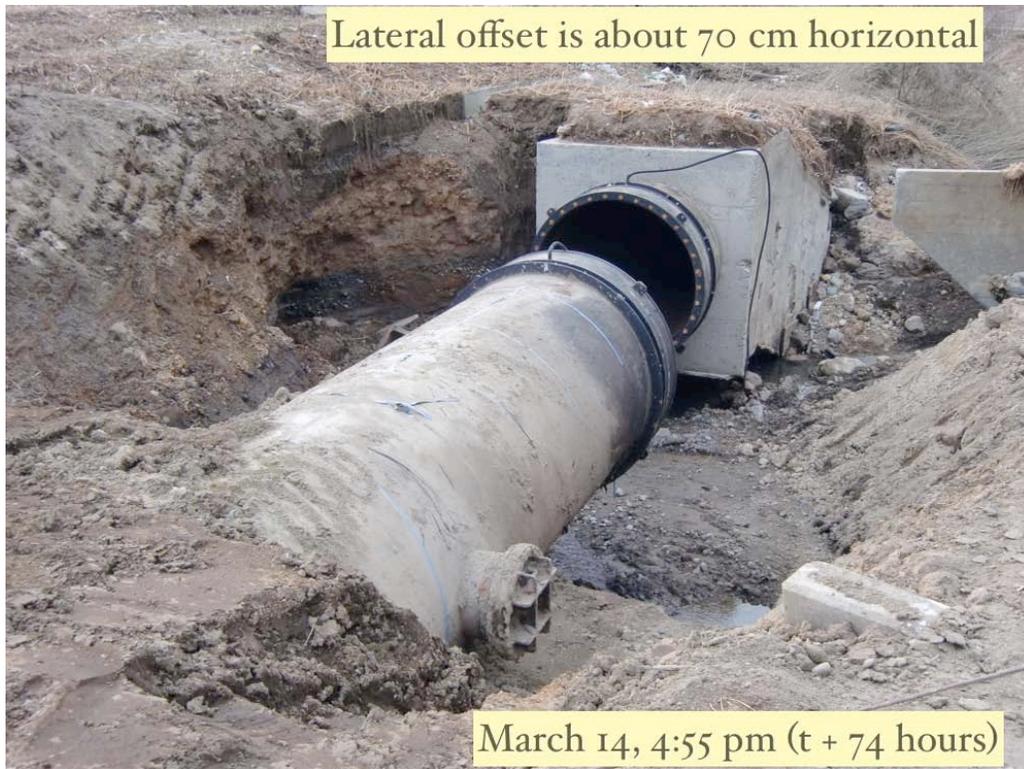
Repair of this pipe so that this section could be re-pressurized (there were still many other places on the pipe that remained to be repaired) took about 8 days, Figures 3-6, 3-7. Three days after the earthquake, the site was prepped for construction work (the failed slip joint sections were removed). On March 17, new steel pipe sections were brought to the site, and then welded into the places where the slip joints had been. By the end of the day on March 18, the pipe was welded closed. Figure 3-8 shows the repaired pipe as of

Figure 3-6. Offset at Slip Joint

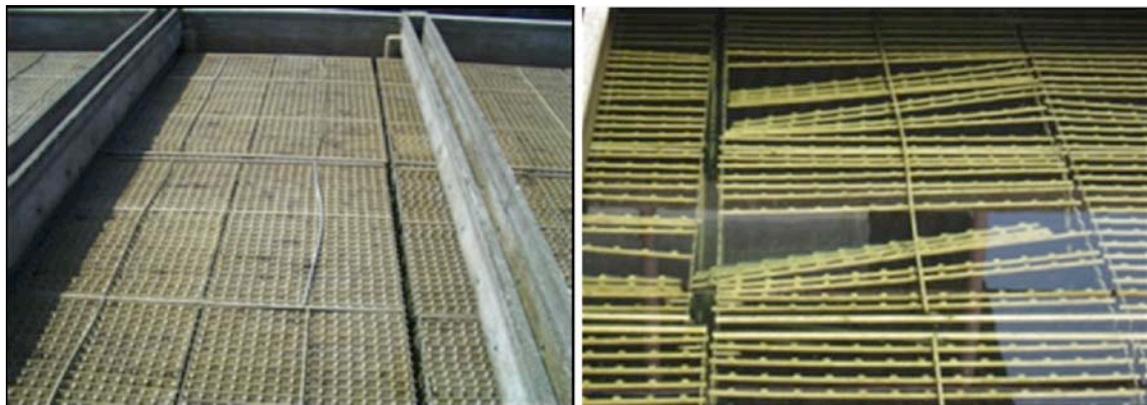
Generally speaking, there was no large scale damage to any of the WTPs. At the Moniwa WTP, inclined basin plates and baffle boards in the sedimentation tanks were displaced, Figures 3-11 and 3-12; these were readily repaired.

Figure 3-11. Inclined Basin Plates, Moniwa WTP (Left: before; Right: after)

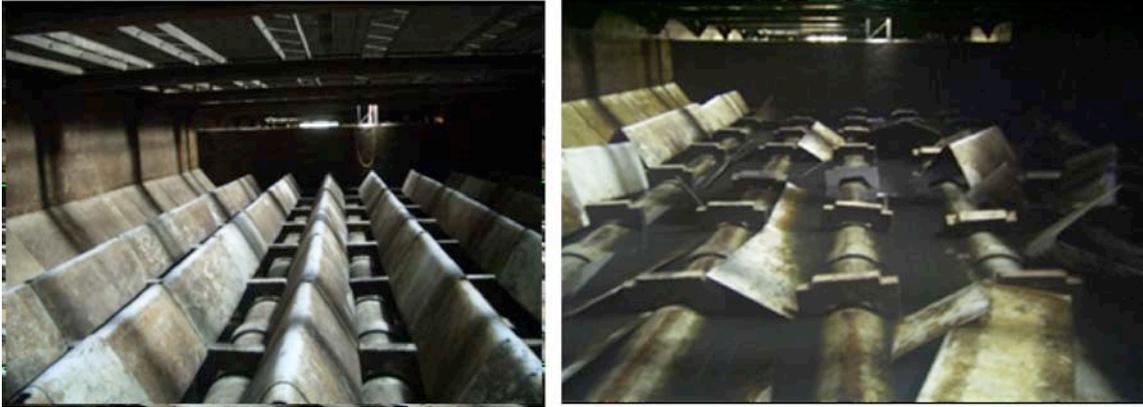
*Figure 3-12. Baffle Boards, Moniwa WTP (Left: before; Right: after)*

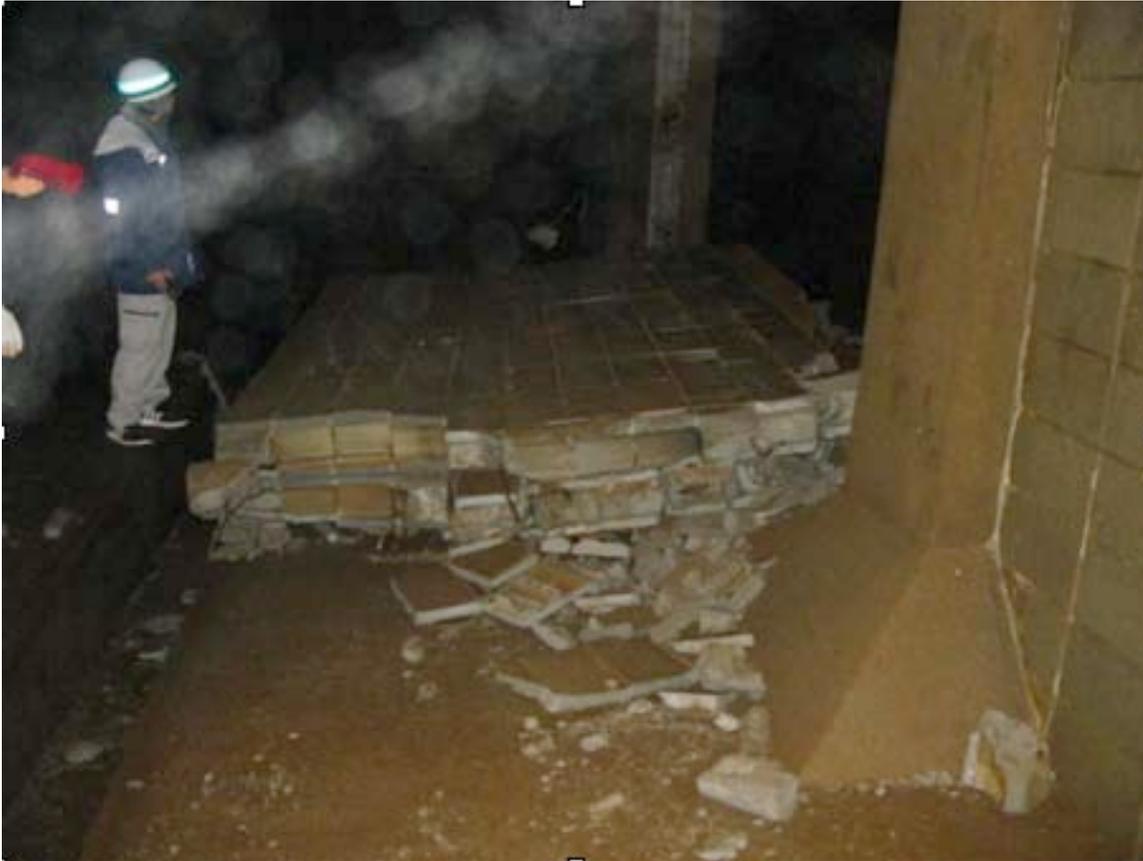
At one distribution tank (Anyoji), an internal unreinforced masonry baffle wall collapsed, Figure 3-13.

*Figure 3-13. Baffle Wall, Anyoji Reservoir*

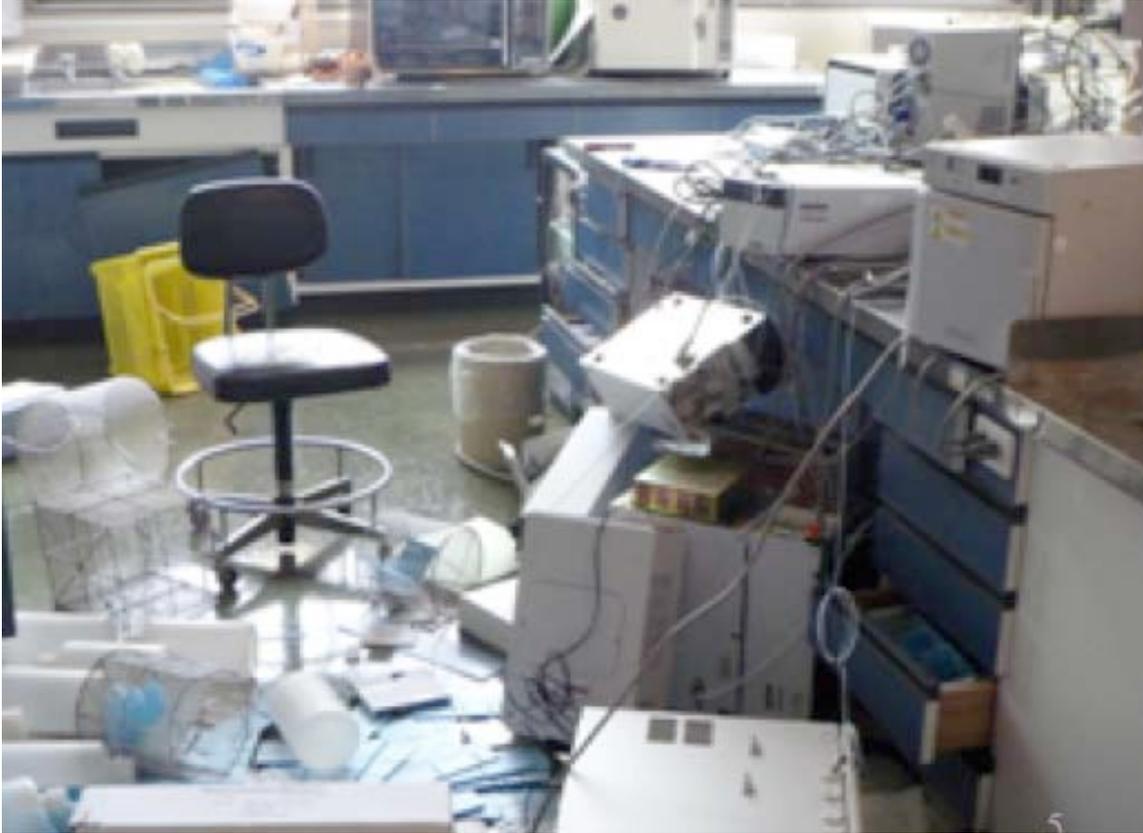
Unanchored lab equipment fell over to the floor at the Fukuoka WTP, Figure 3-14.

*Figure 3-14. Unanchored Laboratory Equipment Toppled, Fukuoka WTP*

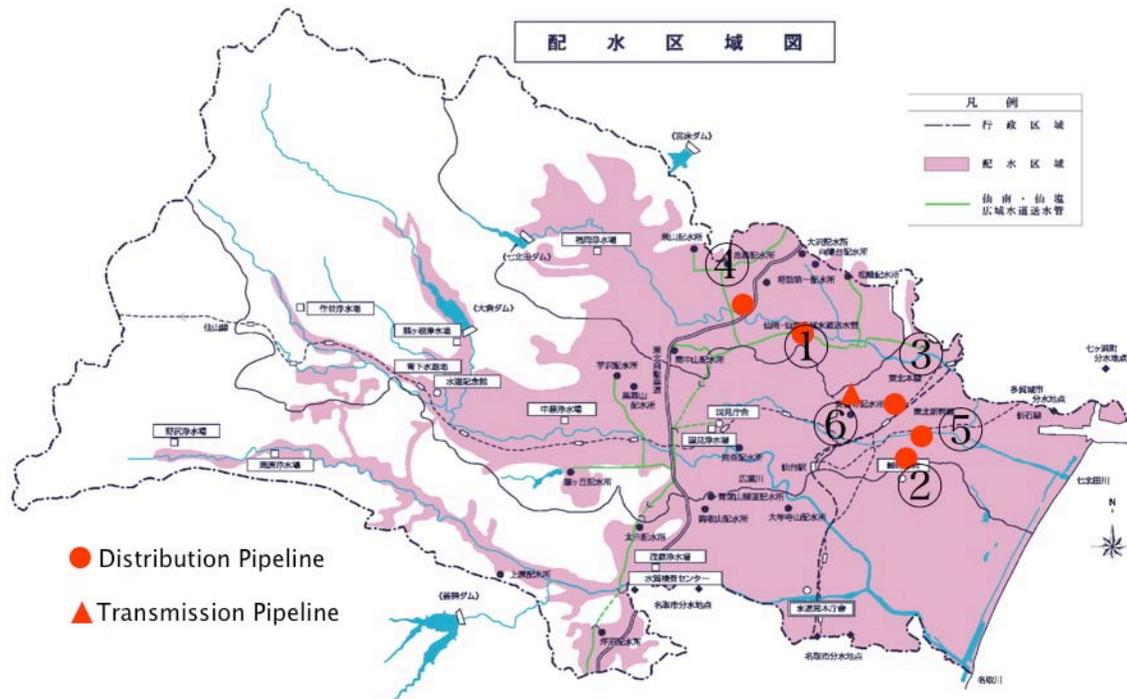
Pipeline damage included the following (see locations in Figure 3-15):

Figure 3-15. Damage to Large Diameter Pipes, Sendai

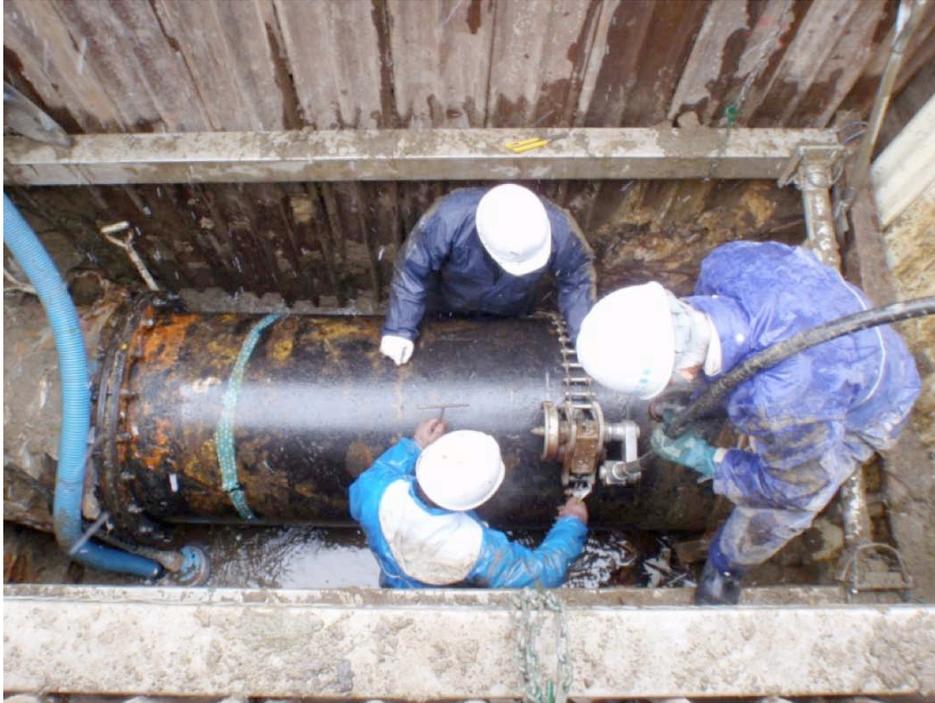
- 1. 800 mm (32") Kunimi No. 2 pipe broke. Installed 1988, DIP (K joints), Figure 3-16. "K type" joints in Japan are similar to Mechanical Joints used in the USA, whereby a bolted joint is made from a ductile iron gland and an internal rubber gasket.
- 2. 600 mm, installed 1973, DIP (K)
- 3. 500 mm, installed 1977, DIP (K)
- 4. 400 mm, installed 1972, DIP (K)
- 5. 400 mm, installed 1977, DIP (K)
- 6. 600 mm, installed 1974, Steel, subsidence, Figure 3-17.
- 41 cases of damage to appurtenances (for example, fire hydrants, air valves, gate valves) on large diameter (400 mm or larger) pipes.
- Many damaged distribution pipes, Figures 3-18, 3-19.
- There was no damage to any "seismically designed" pipes of the type that uses chained joints (see Section 3.X).

*Figure 3-16. 800 mm Kunumi 2, DIP, Sendai*

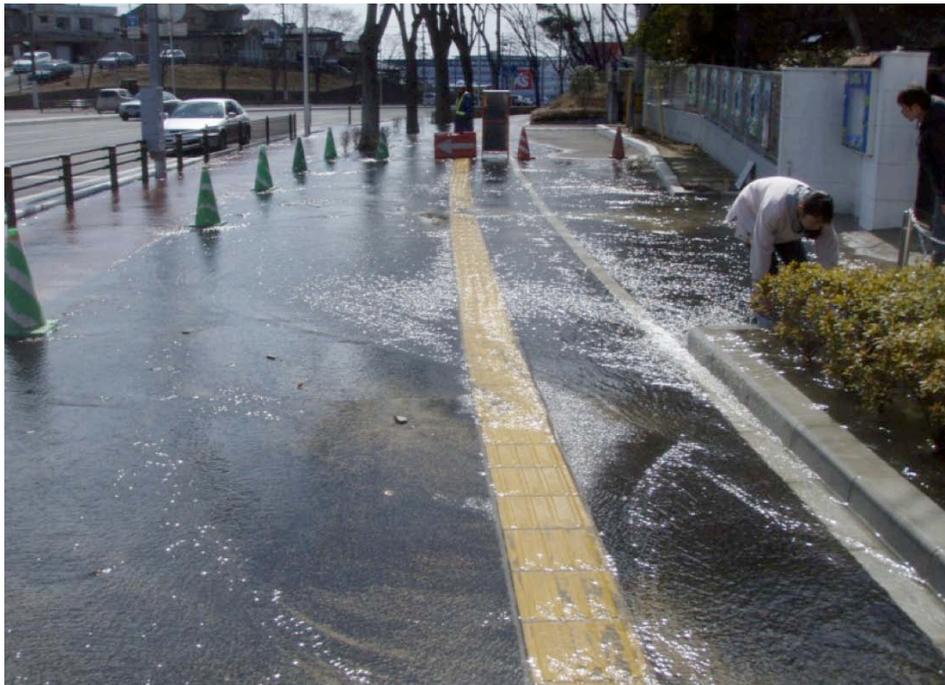
*Figure 3-17. 600 mm Masue 2, Steel, Sendai*

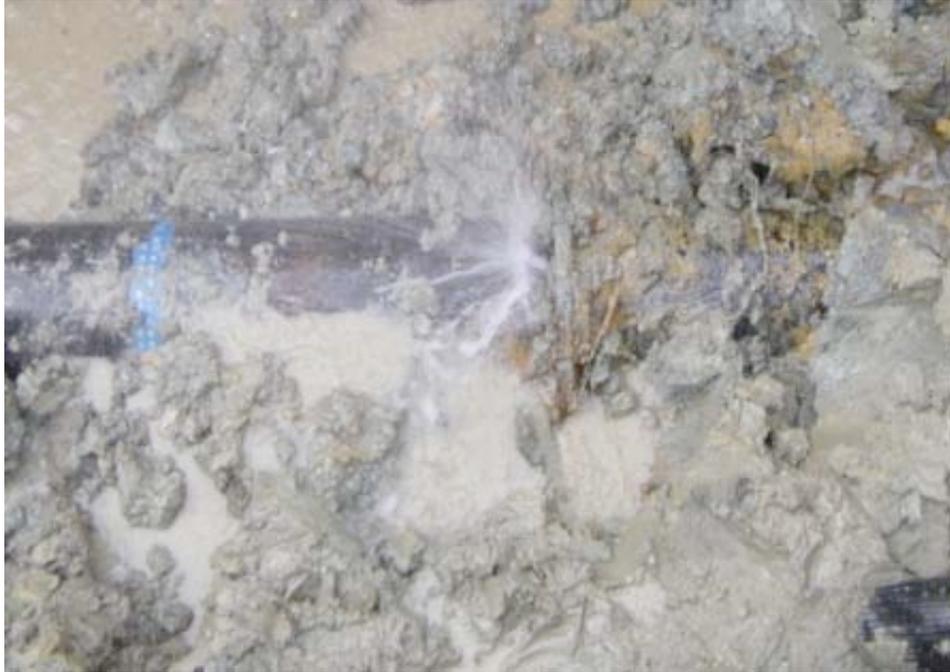
*Figure 3-18. Leaking Pipe, Sendai*

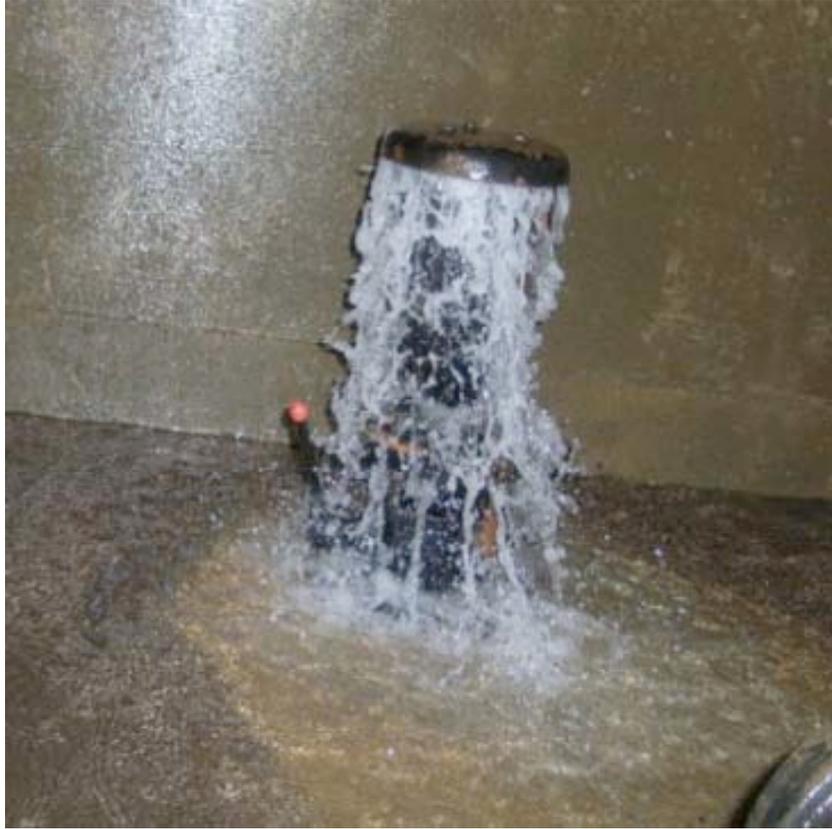
System-wide, 30 air release valves collapsed (Figure 3-20), indicating the importance of system over-pressurization in some locations (hydrodynamic loads) or rapid depressurization and negative pressures (due to pipe breaks).

*Figure 3-20. Leaking Air Valve, Sendai*

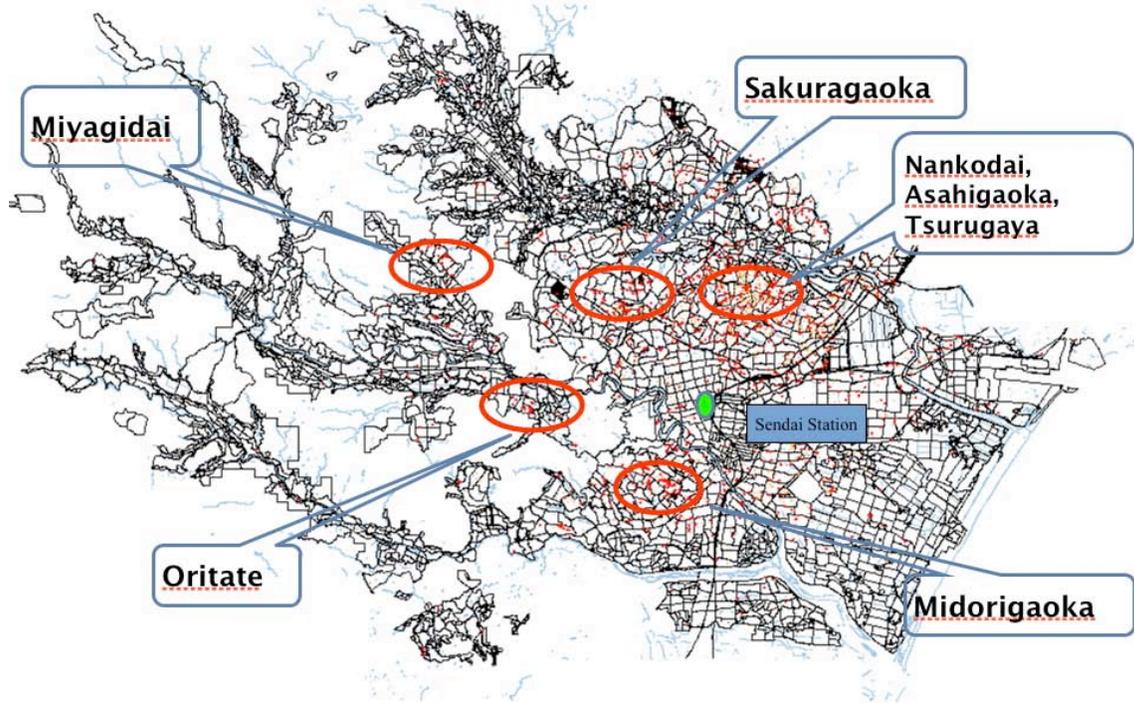
Figure 3-21 shows a map with the concentrated areas of smaller diameter pipeline damage in Sendai. A significant portion of the pipeline damage occurred in the western hilly areas of Sendai. The level of ground shaking in these areas would have been commonly  $PGA = 0.15g$  to  $0.25g$ ; although no doubt there was some local amplifications much above these values. Many of these hilly areas had been constructed using cut-and-fill methods, including the roads. There were many road-fill slumps. Where the roads were damaged (commonly a few inches to a foot or so), or where houses near the roads suffered settlements (slides), (Figures 3-22, 3-23) the buried water pipes were also damaged. It would seem that there was no seismic design considered for the roads, nor for the pipes within these roads to counter the effects of road-fill slumps.

Figure 3-21. Areas of Concentrated Damage to Pipe, Distribution System, Sendai

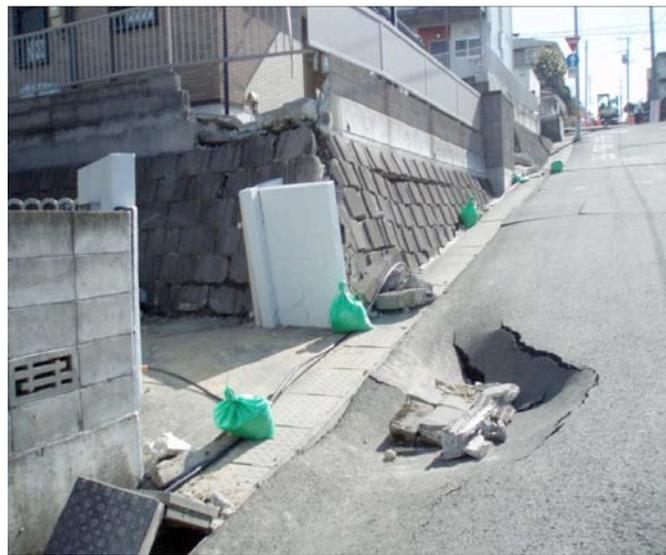
Figure 3-22. Damage to Road – Hillside Area, Nakayama, Sendai

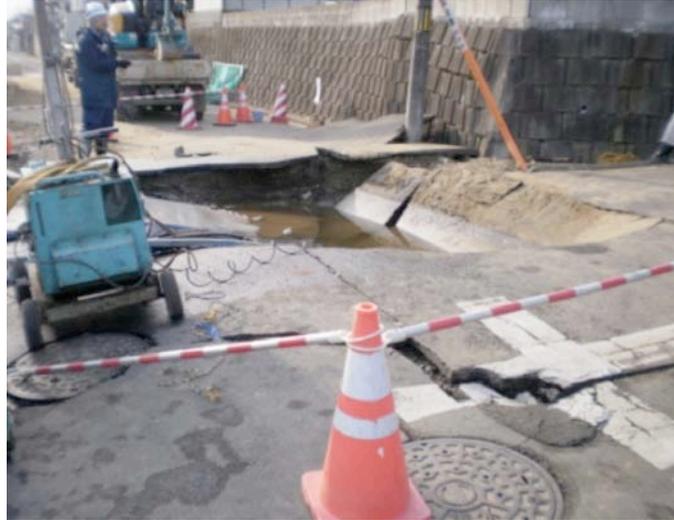
Figure 3-23. Damage to Road – Hillside Area, Nakayama, Sendai

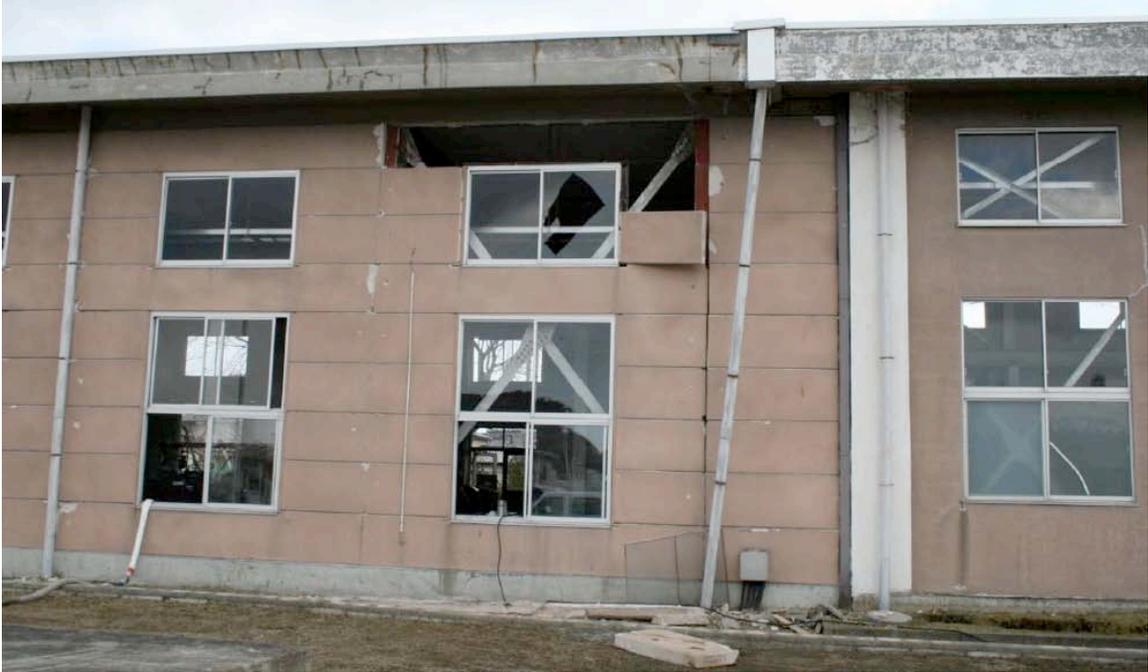
Inertial loading failed some of the walls at the pump station at the Abuta water treatment plant in Ishinomaki City, Figure 3-30. Liquefaction is apparent at the site, Figures 3-31 and 3-32.

*Figure 3-30. Pump Station, Abuta WTP, Ishinomaki City*

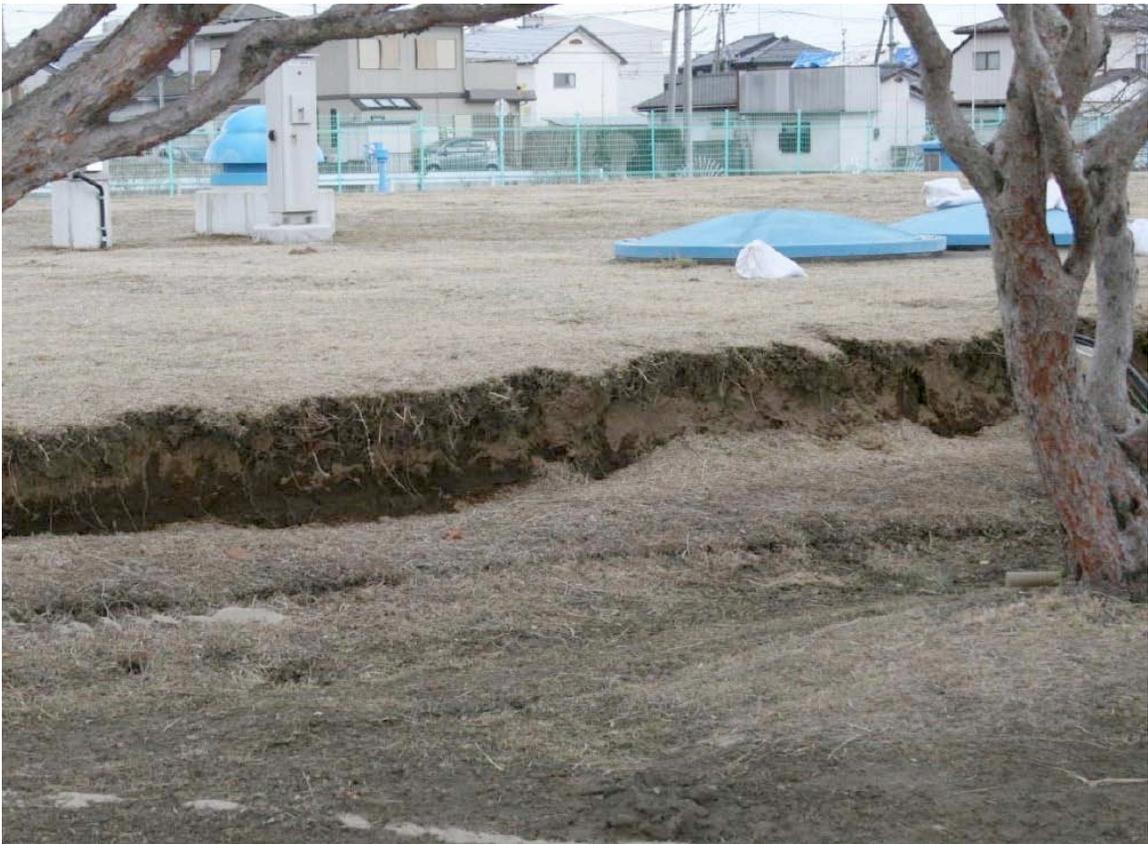
*Figure 3-31. Ground Deformation, Abuta WTP, Ishinomaki City*

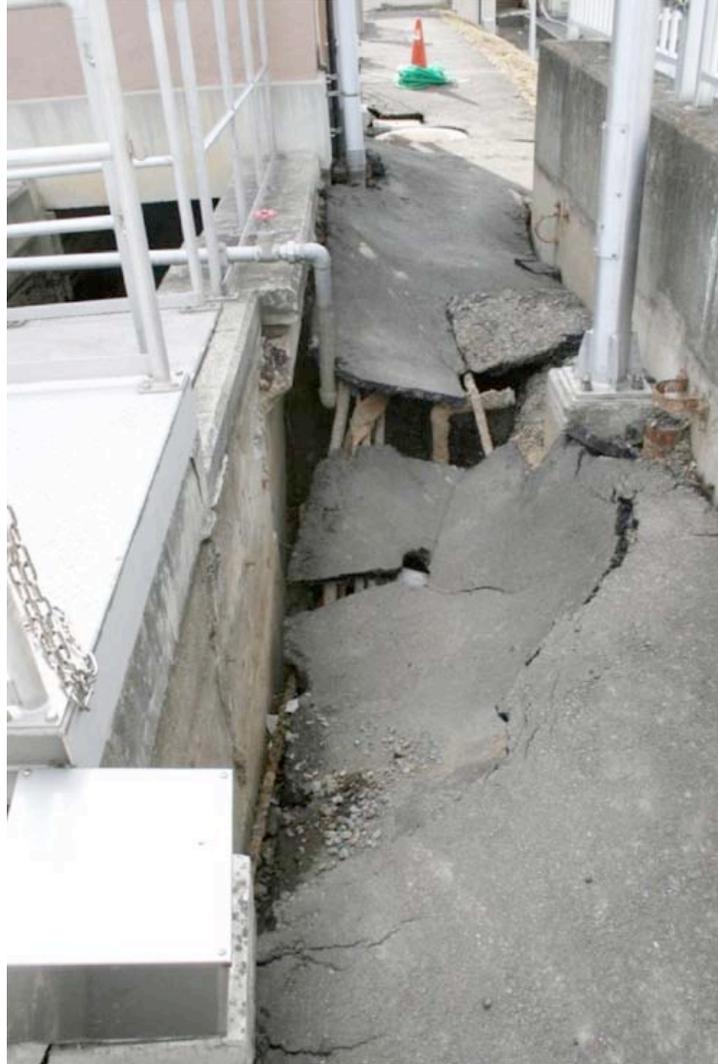
*Figure 3-32. Settlement Next to Sedimentation Basin, Abuta WTP, Ishinomaki City*

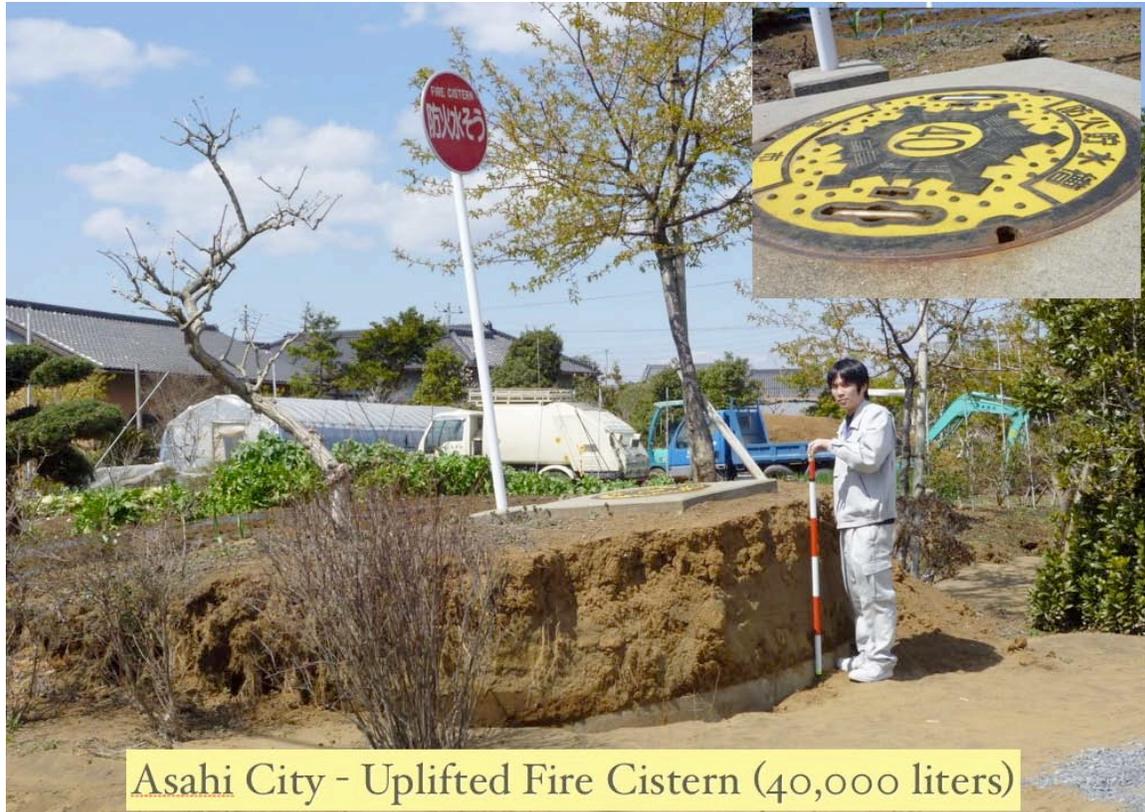
Figure 3-34 shows an uplifted cistern located in Asahi City. Asahi city is located in northeastern Chiba Prefecture, about 100 km from Tokyo, and near the Pacific Ocean. This area has ground motions on the order of  $PGA = 0.20g$  or so. There were many areas in this region that suffered liquefaction.

Figure 3-34. Ashaki City Cistern (photo: Kuwata)

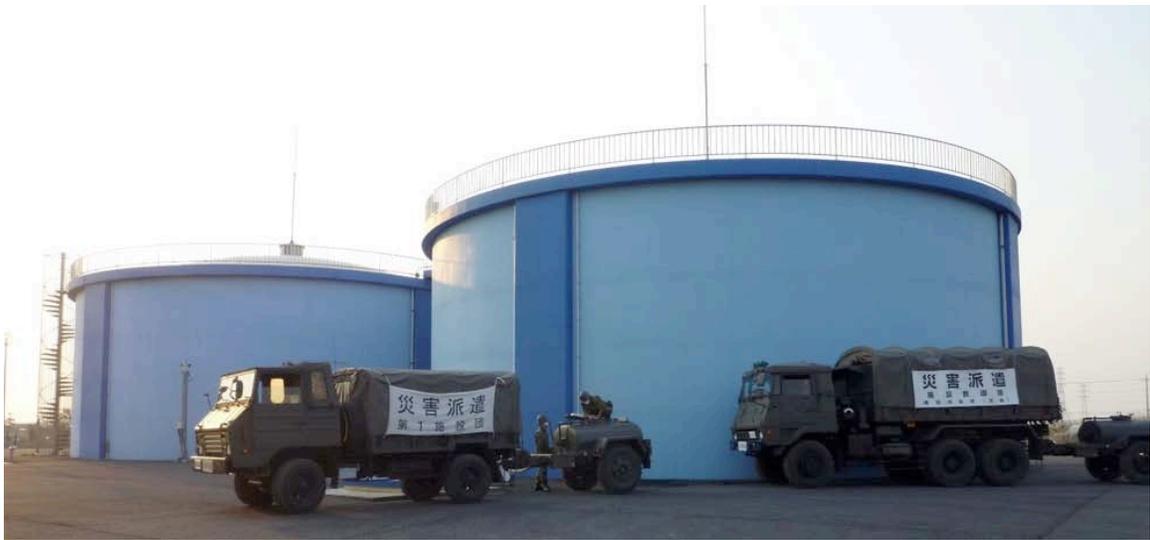
About 1 km from the Wanagawa WTP are two at-grade circular prestressed concrete tanks, Figure 3-39. This area is characterized as almost flat. Much of this area liquefied. Figure 3-40 shows the inlet-outlet pipe for this tank that has been excavated. One of the joints on this 300 mm DI pipe cracked.

*Figure 3-39. Concrete Tank Site*

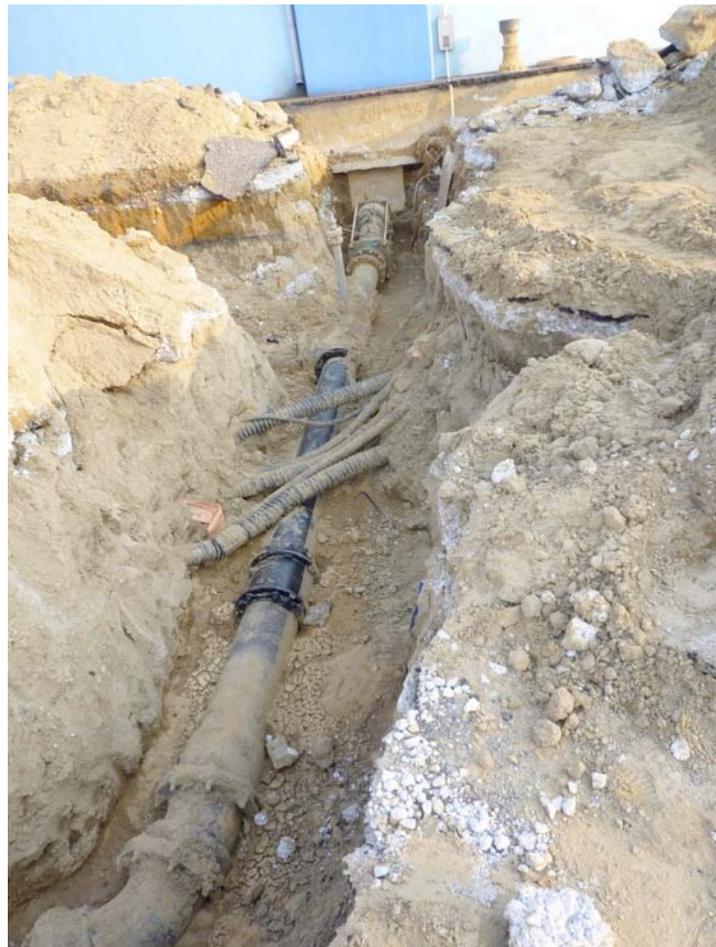
*Figure 3-40. Damaged 300 mm Pipe*

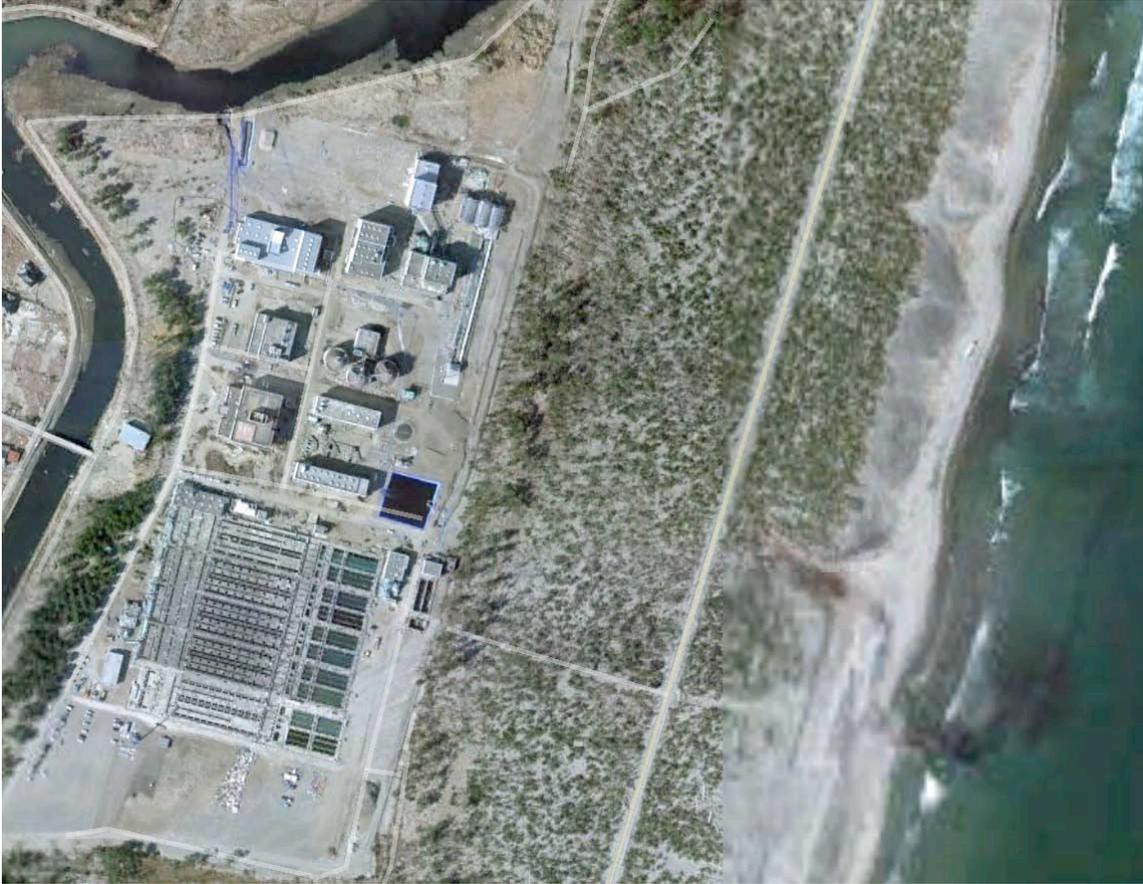
Figure 3-44 shows an aerial view of the WWTP. This plan is located about 5 km south of the Sendai airport. It was inundated by the tsunami.

*Figure 3-44. WWTP*

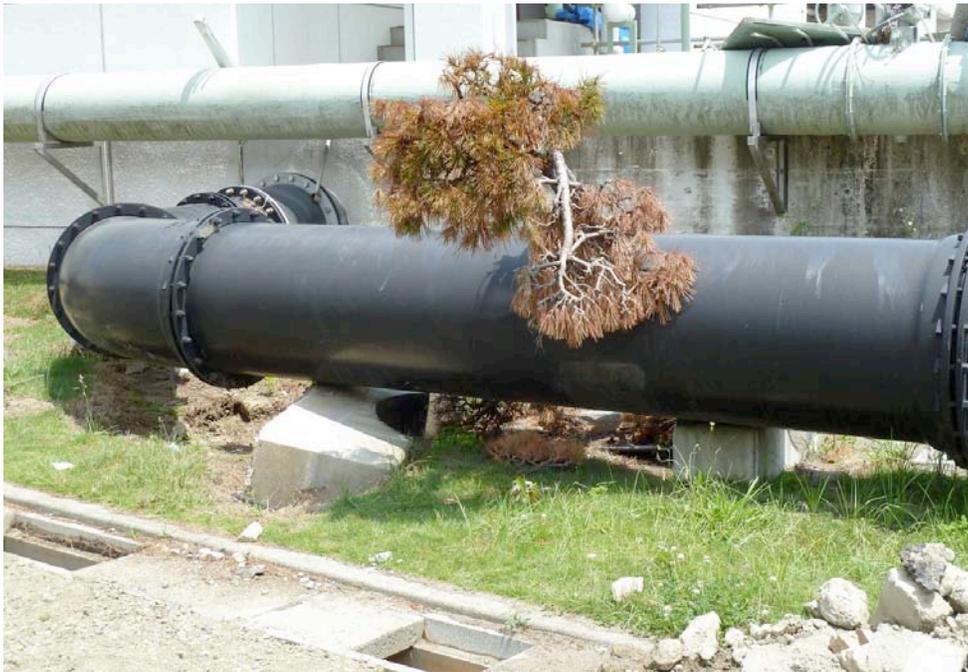
The concrete saddles under the pipe in Figure 3-49 were displaced by the tsunami.

*Figure 3-49. Movement of Pipe Concrete Saddle Supports due to Tsunami Velocity Effects*

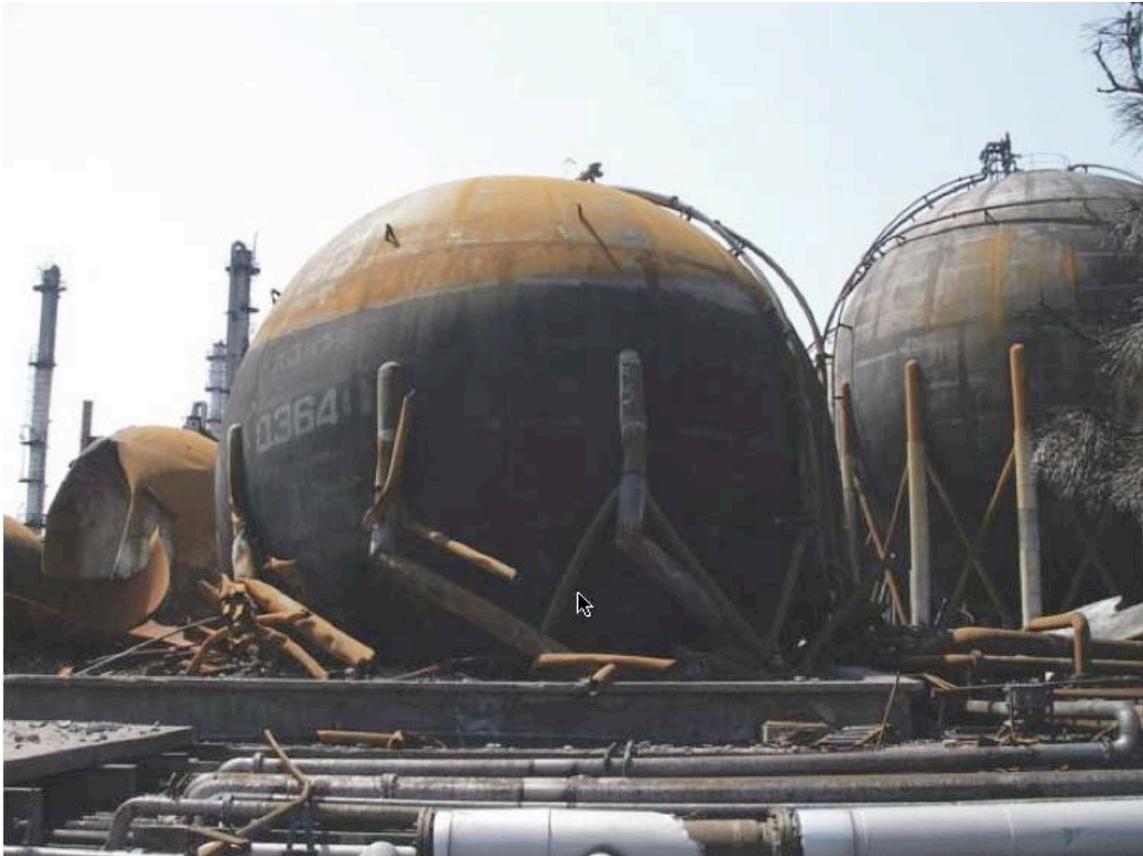
Figure 3-55 shows a fire at the tank yard at the Cosmos Refinery, Chiba Prefecture. The seismic cross bracing for one of the gas holder tanks was damaged by the main shock of the M 9.0 earthquake; 30 minutes later, a M 7.2 aftershock collapsed the tank, leading to the ignition. Figure 3-56 shows the collapsed tank after the fire; power outages after the M 9.0 earthquake had prevented closure of isolation valves.

*Figure 3-56. Collapsed tank, after fire*

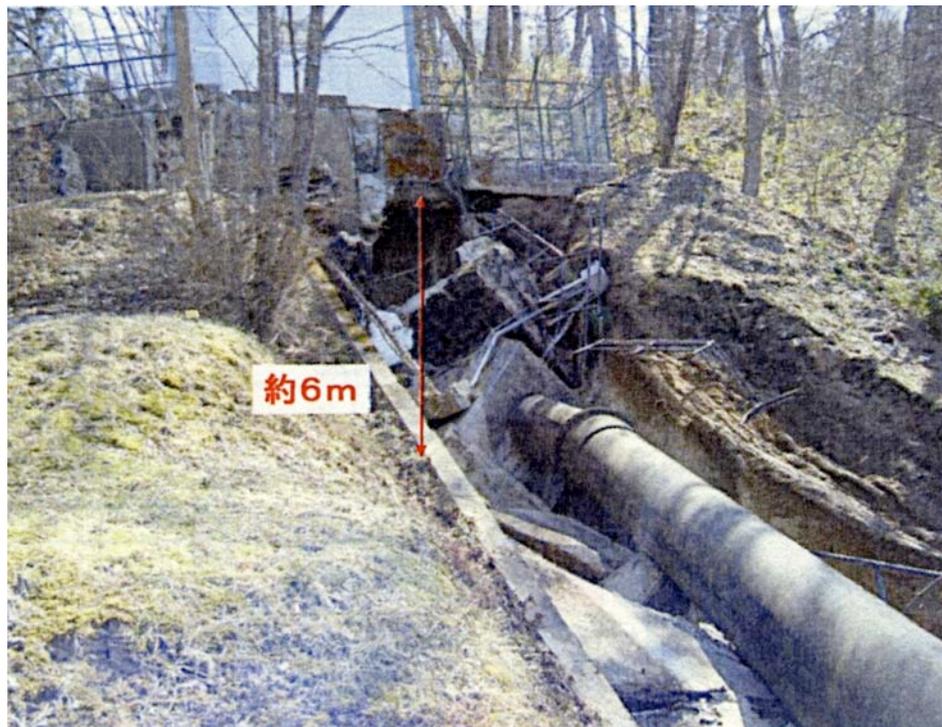
Figure 4-9 shows damage to the penstock and forebay at one of Tohoku EPCO's hydroelectric power plants (Kushma, southwest of Sendai). The failure mode appears to have been initiated by a landslide, undermining the top concrete support, followed by erosion from the failed forebay.

*Figure 4-9 Damaged Penstock and Forebay – Tohoku EPCo*
