**M 9.0 Tohoku Earthquake  
March 11 2011  
Performance of Water and Power  
Systems**

*G&E Engineering Systems Inc.  
6315 Swainland Rd  
Oakland, CA 94611  
(510) 595-9453 (510) 595-9454 (fax)  
eidinger@earthlink.net*

*June 25, 2012*

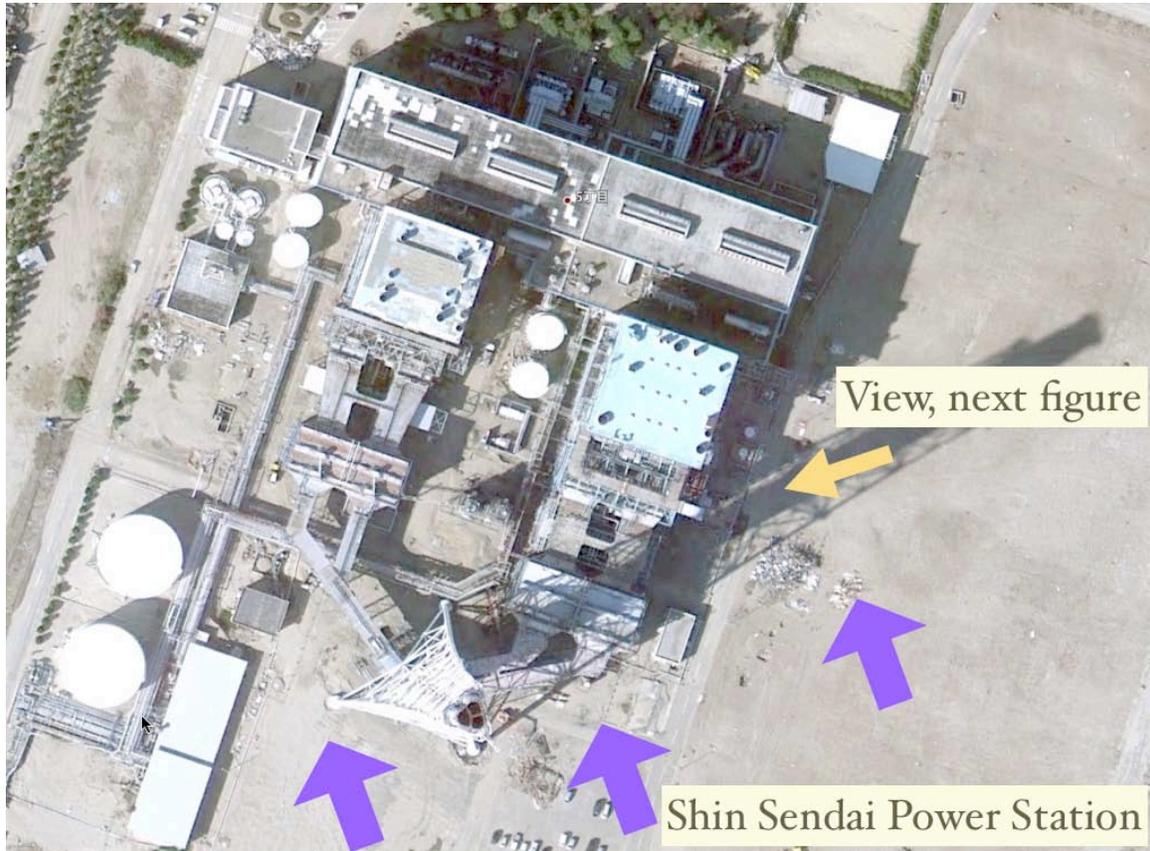
Figure 4-11. Shin Sendai Power Station – Tohoku EPCo

Figure 4-11 shows an aerial view of the Shin Sendai power station. The blue arrows show the general direction of the tsunami inundation. The yellow arrow indicates the ground level view in Figure 4-12.

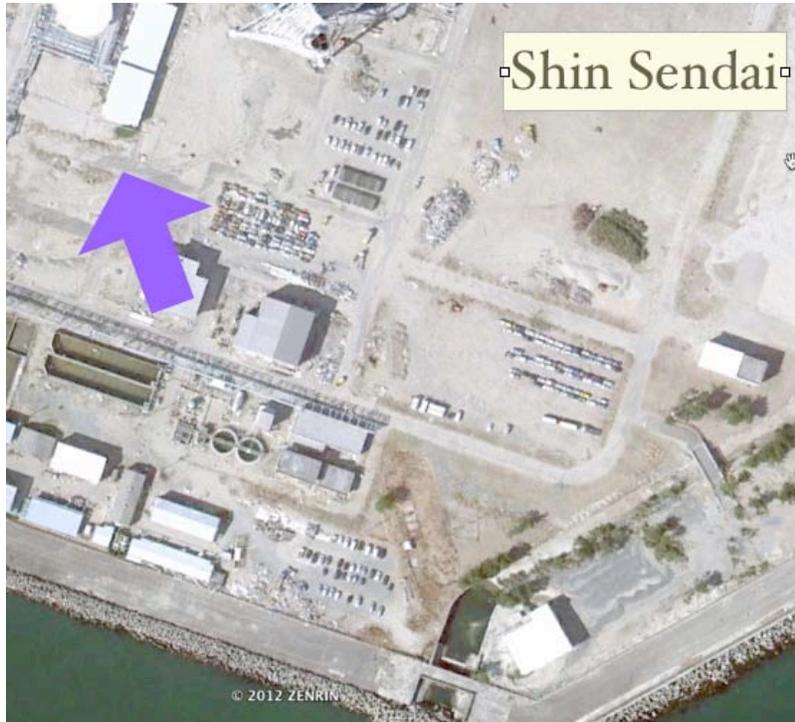
*Figure 4-13. Shin Sendai Power Station (see Fig 4.22 for view of building)*

Figure 4-13 shows the direction of the high velocity tsunami impact on one of the maintenance buildings at the Shin Sendai power plant. Figure 4-14 shows the damage to the wall of that building due to the tsunami impact. Note the large soil erosion around the corners of the building, caused by the tsunami.

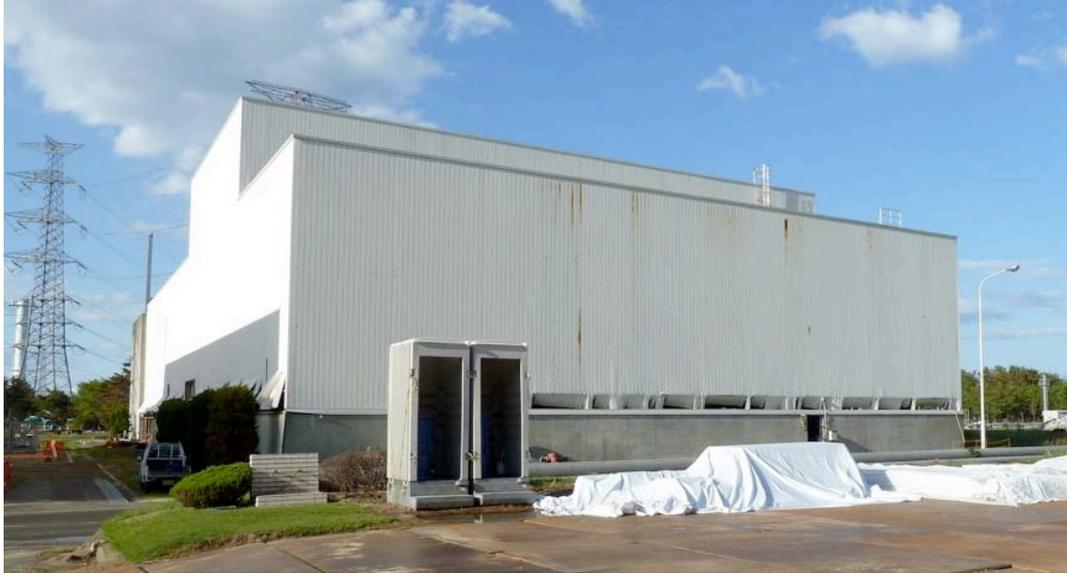
Figure 4-15 shows the building that surrounds the transformers at the Shin Sendai substation. Note the damaged metal wall cladding, that led to inundation of the transformers for this power station.

*Figure 4-15. Shin Sendai Power Station – Inundated Transformer Building*

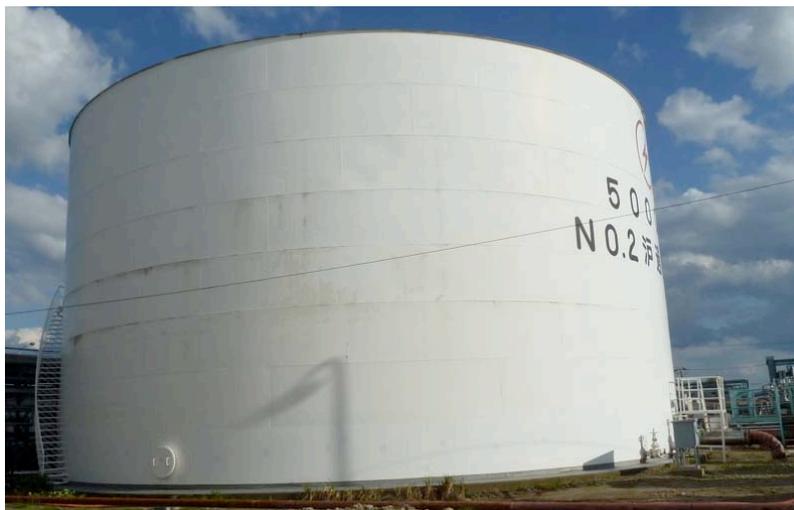
*Figure 4-16. Shin Sendai Power Station – Water Tank*

At the Port of Sendai, there are two identical 5,000,000 liter fire water tanks at the Shin Sendai power plant, Figure 2-14. Water heights from the tsunami were about 8 feet above local grade at these locations. Both tanks are welded steel, unanchored, resting within a concrete containment ring, Figure 2-15. Observations of Tank 1 show that it started to float / and or rock due to the tsunami; but the adjacent Tank 2 showed no distress at all. The performance of these tanks is further described later in this report.

Figure 4-16 shows one of two identical 5,000,000 liter (1.32 MG) steel tanks at the Shin Sendai power plant site (two tanks in lower left of Figure 4-11, see also Figure 2-14). Each tank has the following characteristics: at-grade, unanchored; 1.32 million gallon capacity; 76 feet diameter; 40 feet high, 8 courses, each 5 feet high; concrete ring girder; all attached pipes had flexible connections to allow for tank wall uplift. Tank No. 1 showed clear signs of uplift all around the tank (Figure 2-15); Tank 2 showed no sign of any uplift. Both tanks would have been flooded by about 8 feet of water. This suggests that Tank 1 (northernmost) was nearly empty at the time of the earthquake, while Tank 2 had at least 8 feet of water.

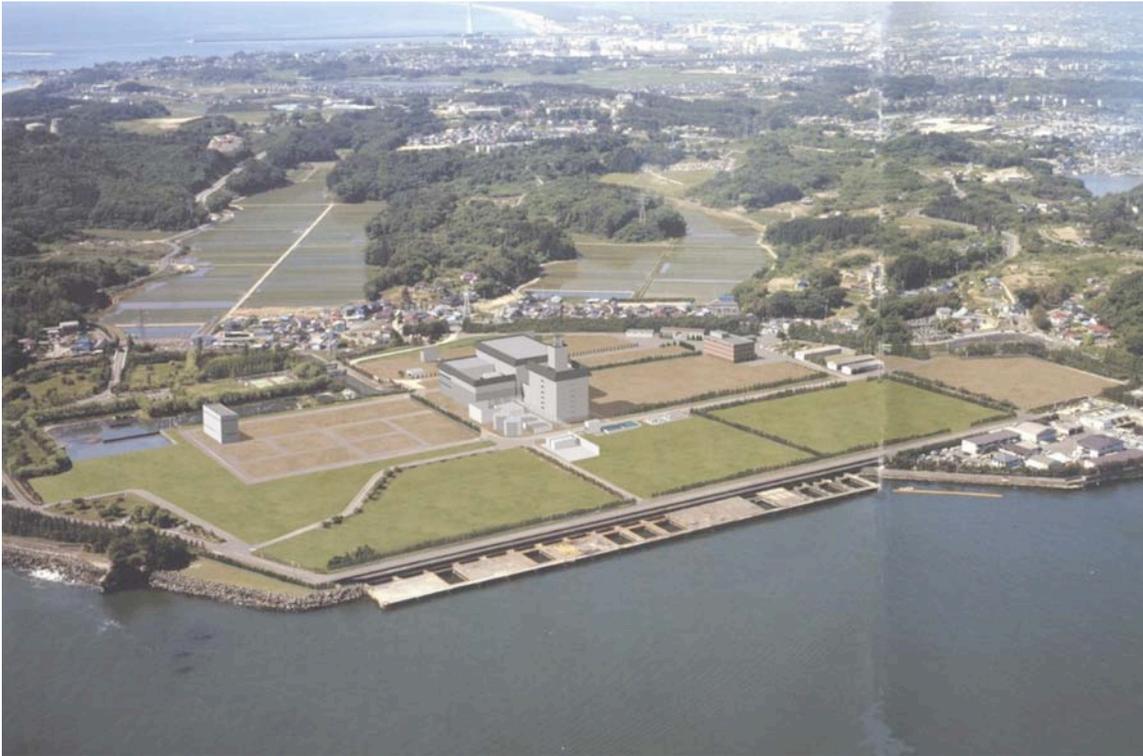
*Figure 4-19. Sendai Power Station*

The Sendai thermal power plant, Figure 4-19, was heavily damaged by the tsunami. This LNG-fired power plant was designed in 2007, and put into initial operation in 2010. As such, it is the newest power plant along the Pacific coast that was affected by the tsunami. The main features of the plant are as follows:

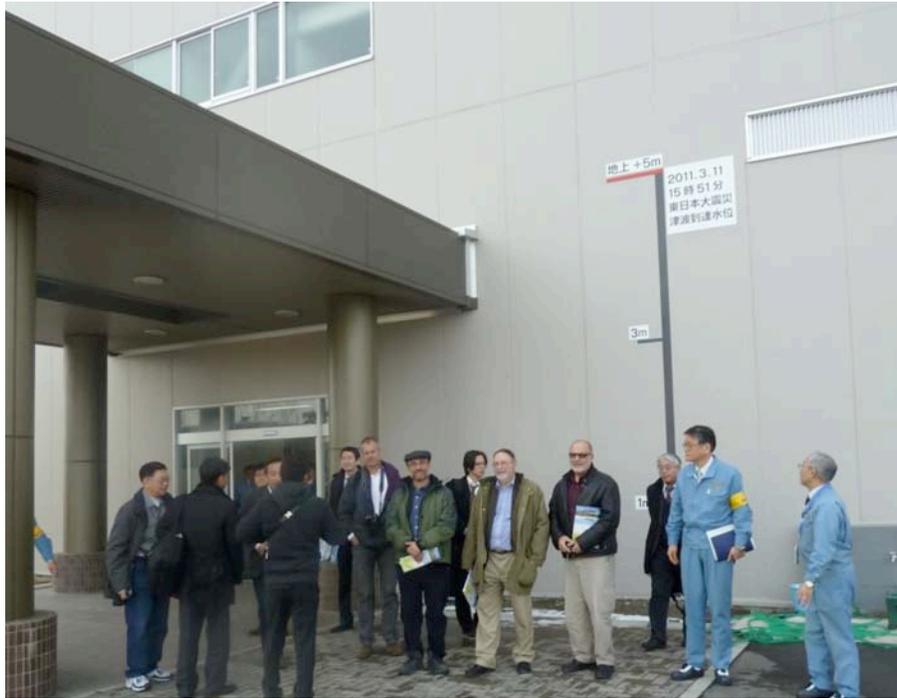
In the March 2011 earthquake, the actual tsunami at this site was about 8 meters high. A nearby instrument recorded 6 meters, before going off scale. Figure 4-20 shows the plant

entrance (on March 2, 2012), showing the maximum run-up height of +5 meters above grade at the front door entrance to the power plant building. The people in the photo include Alex Tang (ASCE team, far left), Mr. Noba (Plant Manager, far right), Mr. Mike Salmon (LANL) and Ruben Boroshek (Chilean expert for subduction zone ground motions).

*Figure 4-20. High Water Mark (+5m), Sendai Power Plant (photo taken March 2 2012)*

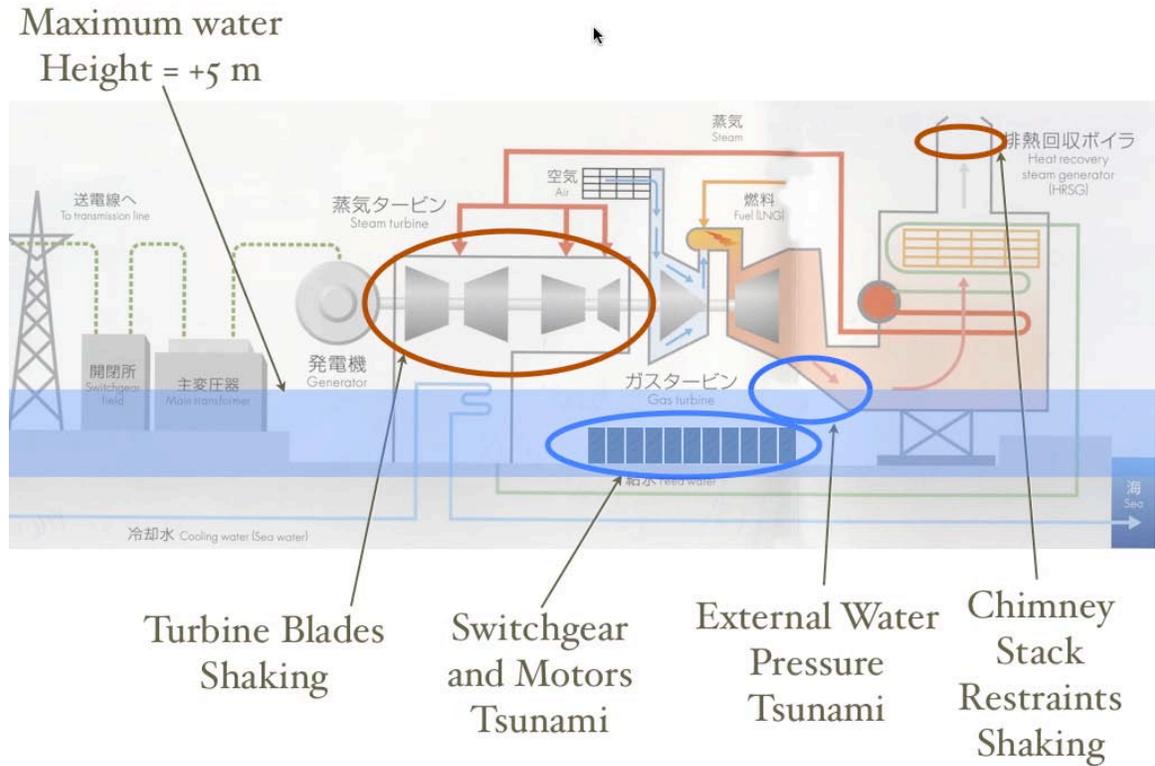
Figure 4-21. Main Damage Locations at the Sendai Power Plant

The earthquake-related damage (excluding tsunami effects) at the station included the following (highlights in Figure 4-21):

- Some broken pipe supports, but no broken pipe
- The turbine had slight damage. this turbine had reportedly been qualified for  $PGA = 0.5g$ .
- There were damaged supports at the top end of the chimney.
- The wheels on one of the overhead gantry cranes broke, when the crane was moved after the earthquake. This was reportedly due to the crane rails being out of alignment.
- Soft drink machines fell over in the lunch room.
- The tsunami-related damage at the station included the following (highlights in Figure 4-21):
  - Air compressor

- Boiler feed water pump set
- Bearing cooling water pump set
- Condensate pump set
- Main transformer (yard equipment)
- Starting transformer (yard equipment)
- Ground floor electrical facilities were destroyed
- Circuit breakers
- Emergency generator failed to start

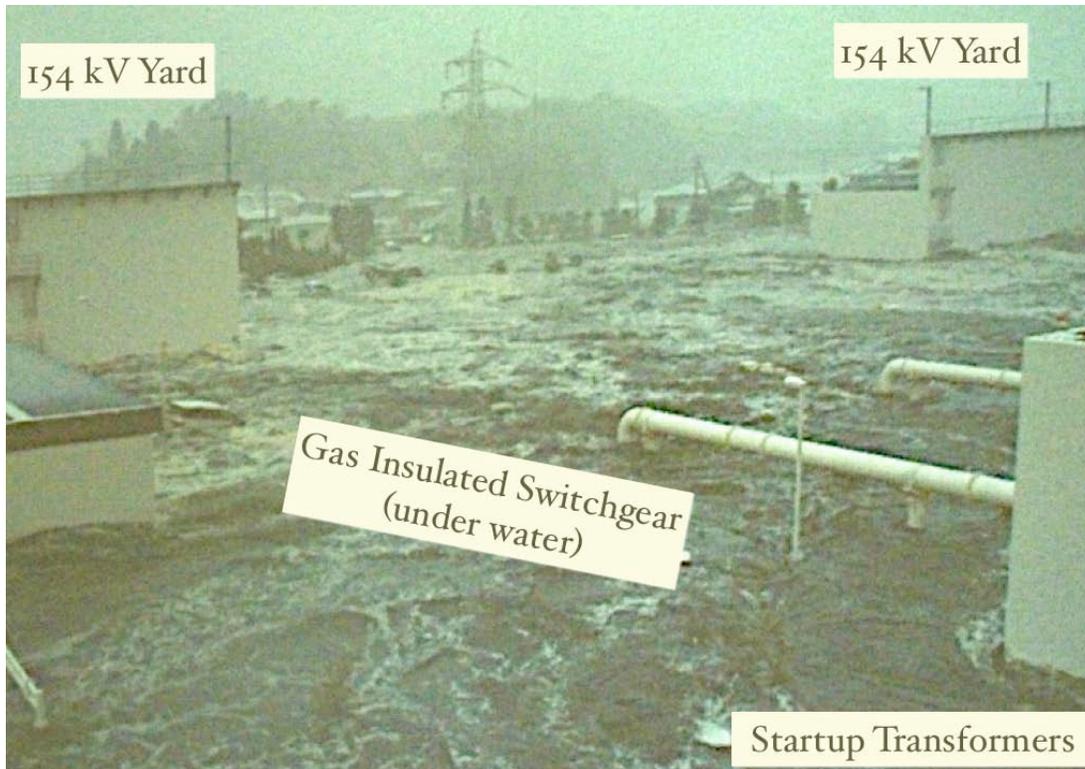
Figure 4-22 shows a photo, taken about 66 minutes after the earthquake, showing the tsunami water rushing into the plant switchyard and inundating the gas-insulated switchgear. Figure 4-23 shows the same switchyard after retreat of the water.

*Figure 4-22. Tsunami Inundating the Switchyard*

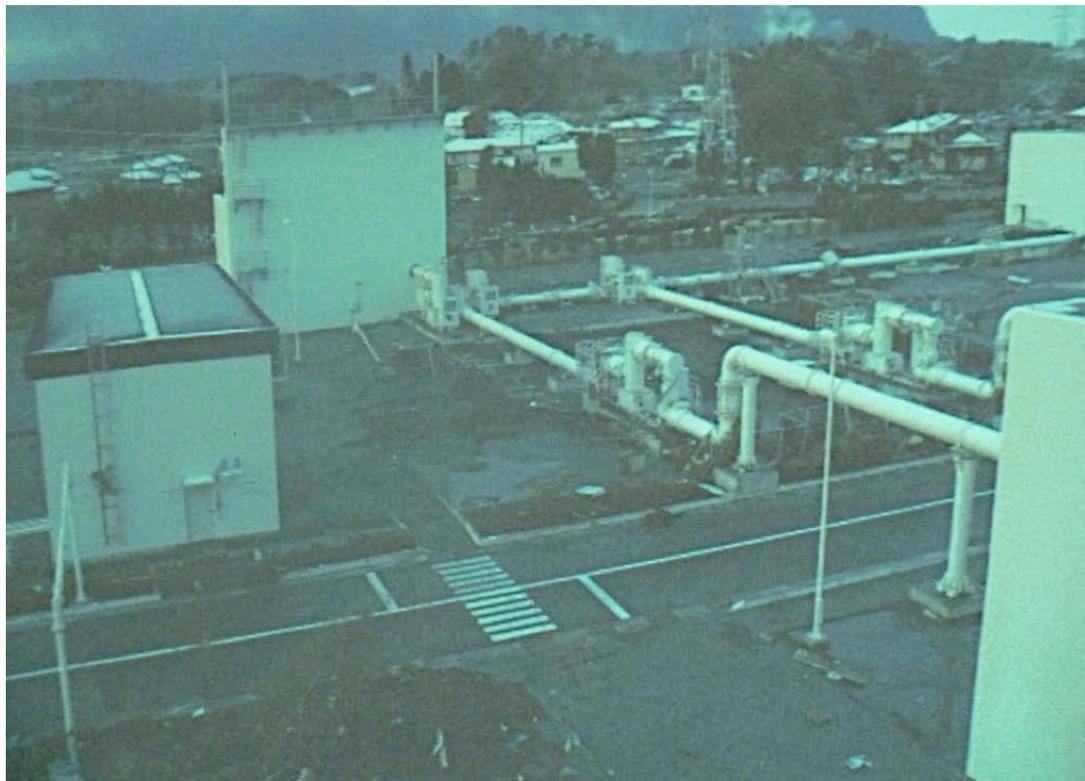
*Figure 4-23. The Switchyard after the Tsunami Retreated*

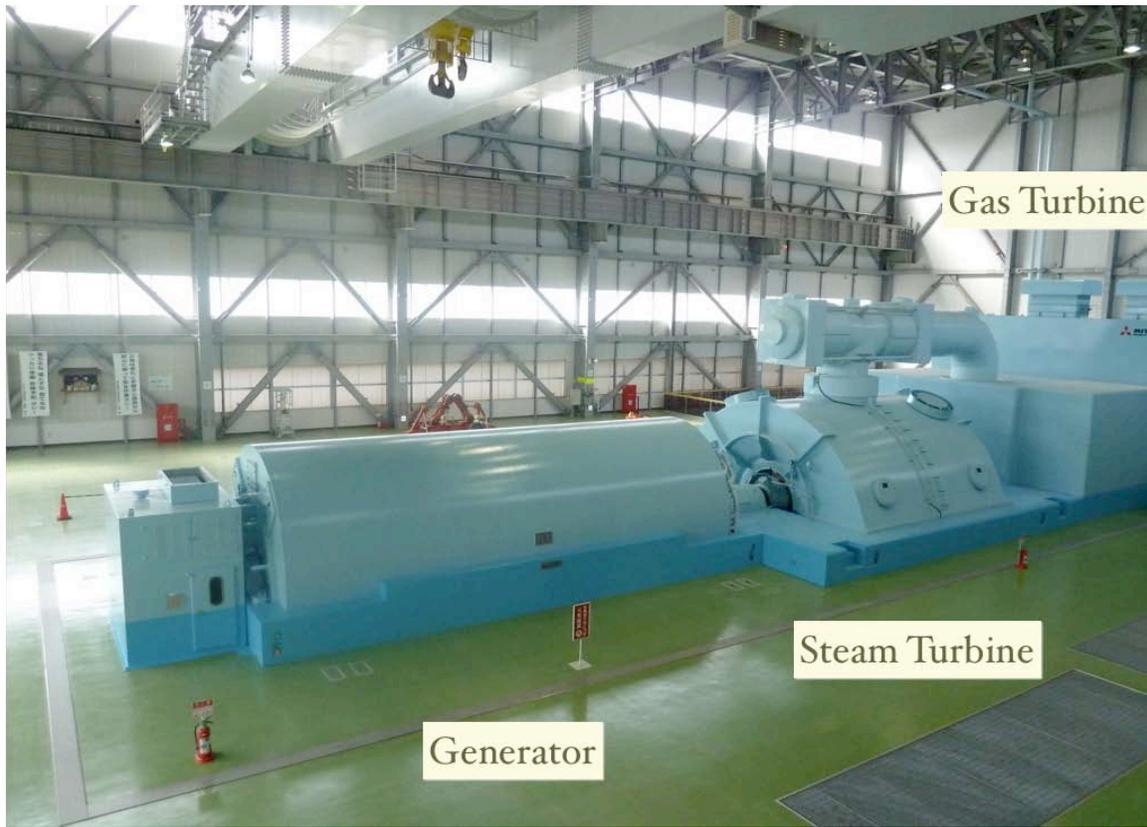
*Figure 4-24. Operating Floor with Main Equipment*

Figure 4-24 shows the operating deck of the power plant, with the generator, steam turbine and gas turbine. The operating deck is located above the high water mark, so this room was not inundated. Note that every bay is braced with K-type braces (restrained against buckling), indicating a much higher lateral design force used for design than used in the USA for high seismic zones, even with "I=1.5" type factors are used. We examined the plant carefully, and could see no obvious signs that any of the braces yielded (no permanent deformations, no chipped paint).

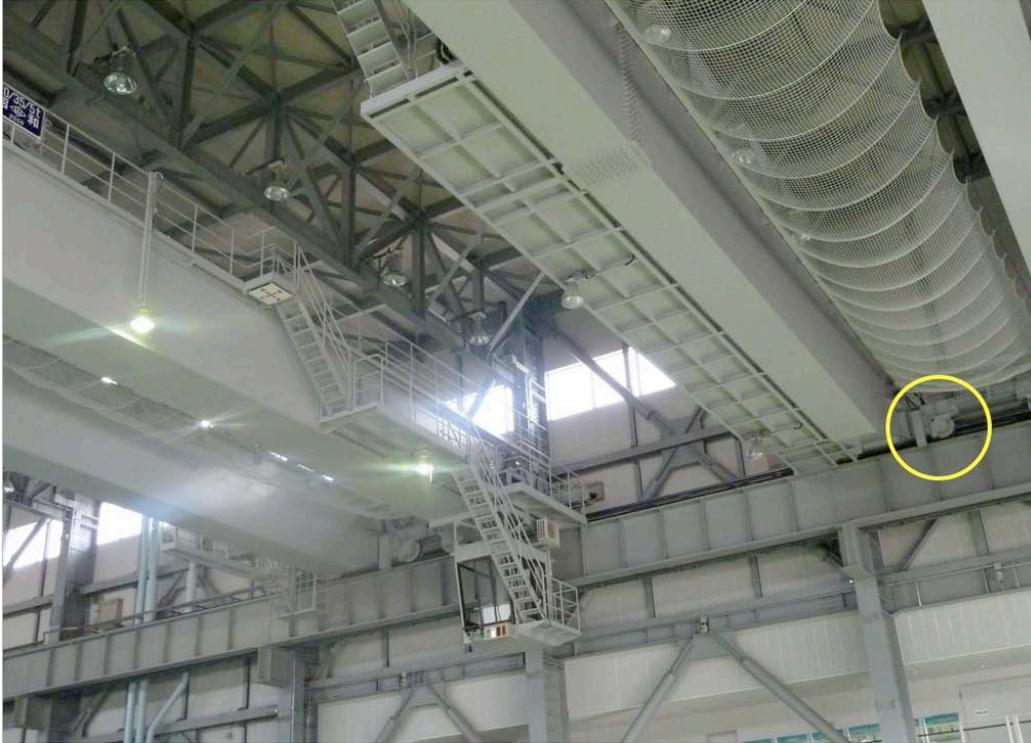
*Figure 4-25. Crane Rail*

Figure 4-25 shows the overhead gantry cranes. One of the crane rails broke when the crane was attempted to be moved after the earthquake. Apparently, the crane rail was out of alignment.

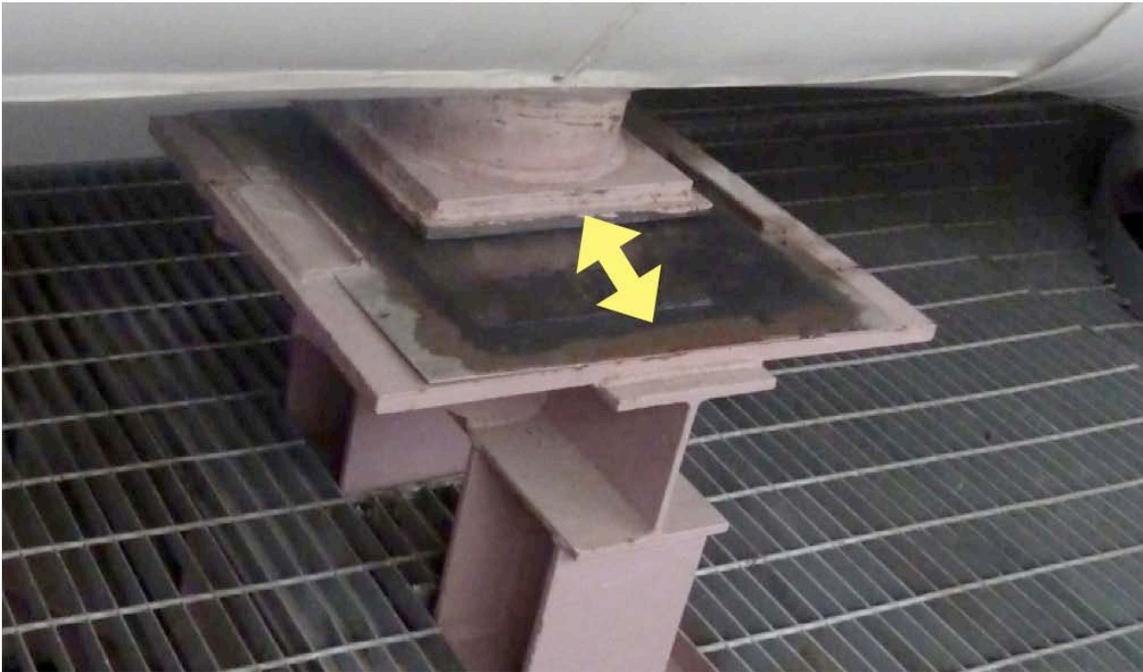
*Figure 4-27. Sliding Movement on pipe Support*

Figure 4-27 shows one of the sliding pipe supports in the plant. This particular support uses a graphite-type running surface to allow for thermal (and seismic) movements. At

this location, scratch marks show the pipe slide sideways up to about 6 inches. As noted earlier, there was no damage to any pipes in the plant, although there were some damaged pipe supports. this type of "good pipe" and "damaged pipe support" has been observed at other power plants around the world, and the reader is cautioned that the "design by rule" requirement in many modern US codes (including ASCE 7-2010, IBC 2009, SMACNA, NFPA) to place lateral seismic supports about every 10 feet, is largely based on warrantless assumptions and without regard to empirical observation that nearly all large bore (4 inches diameter and larger) power plant pipes perform extremely well in past earthquakes; over-constraint of pipes will lead to higher pipe stresses, more fatigue, and increase chance of pipe failure; the authors recommends that any power plant piping be designed to the stress rules of ASME B31.1 (or similar) codes; should the owner wish to assure good post-earthquake performance, the pipes should be designed to remain nearly elastic (perhaps 20% over yield) under the design basis earthquake motion and pipe supports designed accordingly; if screwed pipe connections are used, they should have elastically computed stresses no more than about 60% of nominal pipe yield; if welded pipe connections are used, suitable stress intensification factors should be considered.

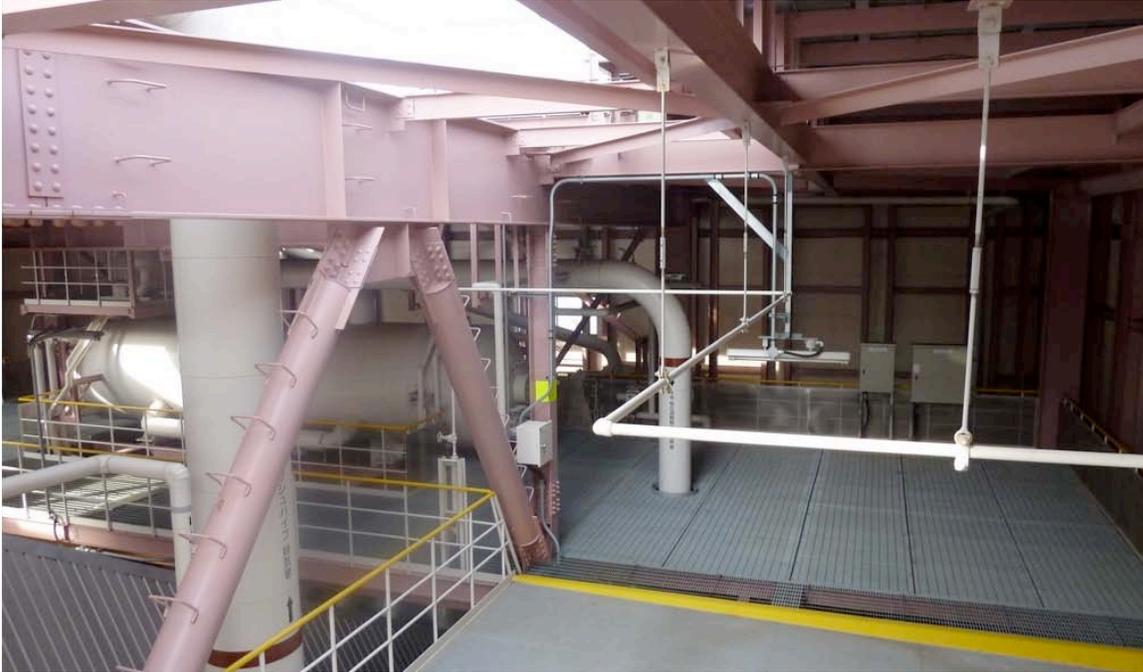
Figure 4-28 shows a rod-hung small bore pipe, located near the roof level of the plant (floor level motions in excess of 1 g). There was no damage to this pipe, even though it does not have lateral supports at 10-foot spans as required by modern US codes such as ASCE 7, IBC 2009, NEC, SMACNA, NFPA. Clearly, the non-structural provisions in these codes for seismic supports on commodities (pipes, cable trays, conduits) need to be revised, as these installations appear to be a waste of money, and may actually degrade day-to-day performance of the commodities.

*Figure 4-28. Small Bore Pipe with Rod Hanger Supports had Good Performance*

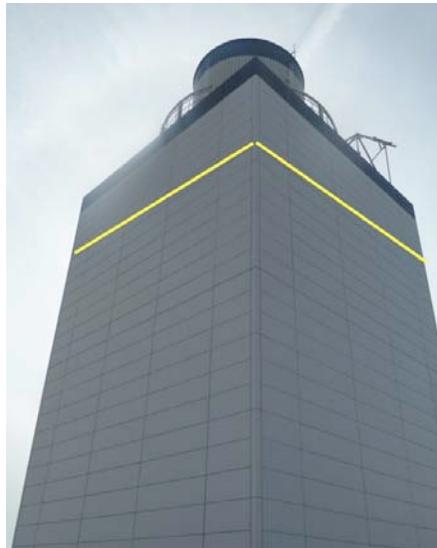
*Figure 4-29. Enclosure Around Chimney Stack. Yellow Lines Indicate Lateral Braces for Chimney Within*

Figure 4-29 shows the outside of the chimney stack, highlighting (yellow lines) the approximate elevation where the chimney within damaged its restraints (Figure 4.38).

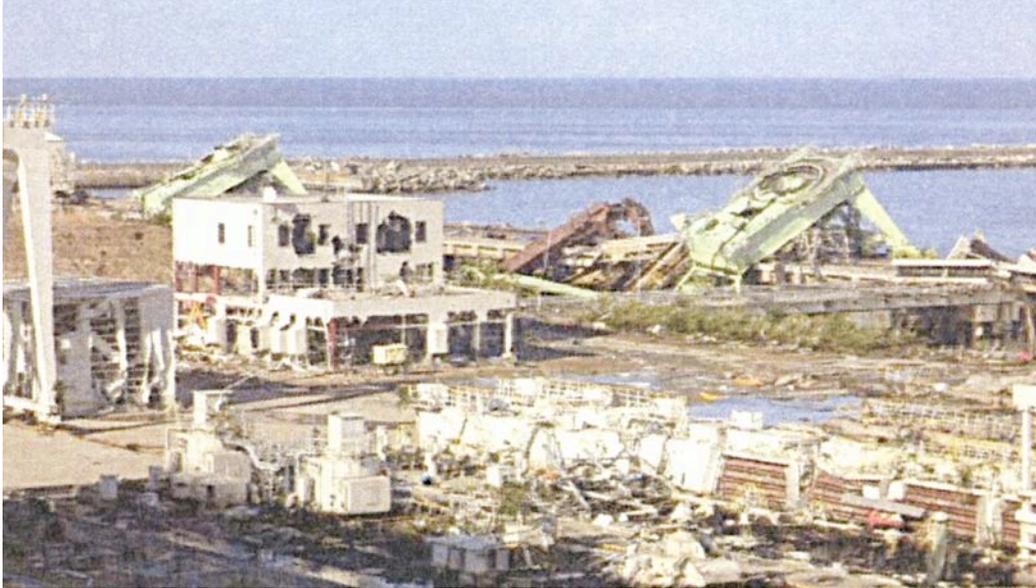
Figure 4-32 shows the collapsed coal unloader at the Haramchi power plant. The conveyor belts at Haramachi were damaged. Inundation damaged most of the equipment on the turbine floor, Figure 4-33. By December 2012, the plant had been returned to about 50% of capacity.

*Figure 4-32. Haramachi Power Station – Damaged Coal Unloader*

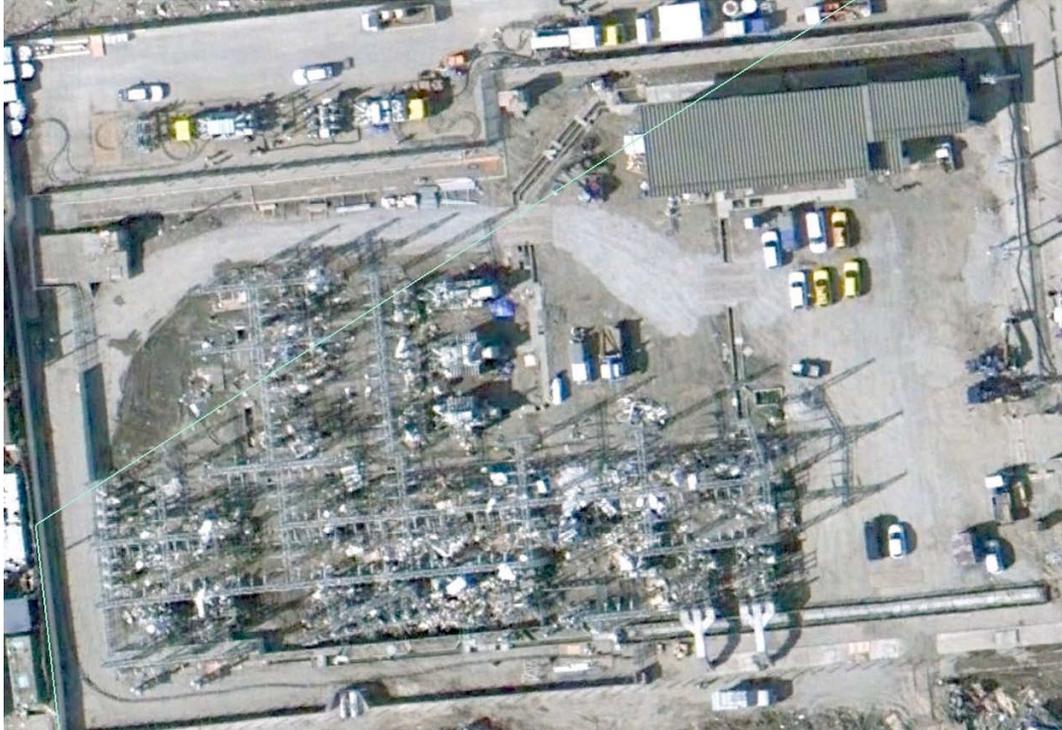
*Figure 4-35. Tagajyo Substation Post-Earthquake*

The 64.5 kV Tagajyo substation (38.2789, 141.0176) was inundated by the tsunami. This substation is close to the Sendai port area, located about 10 feet above sea level. The large quantity of floating debris caused most of the damage in the yard; salt water damaged the electric equipment in the control building.

Figure 4-34 shows the yard in March 2009. Figure 4-35 shows the yard on April 6, 2011, before debris has been removed from the yard.

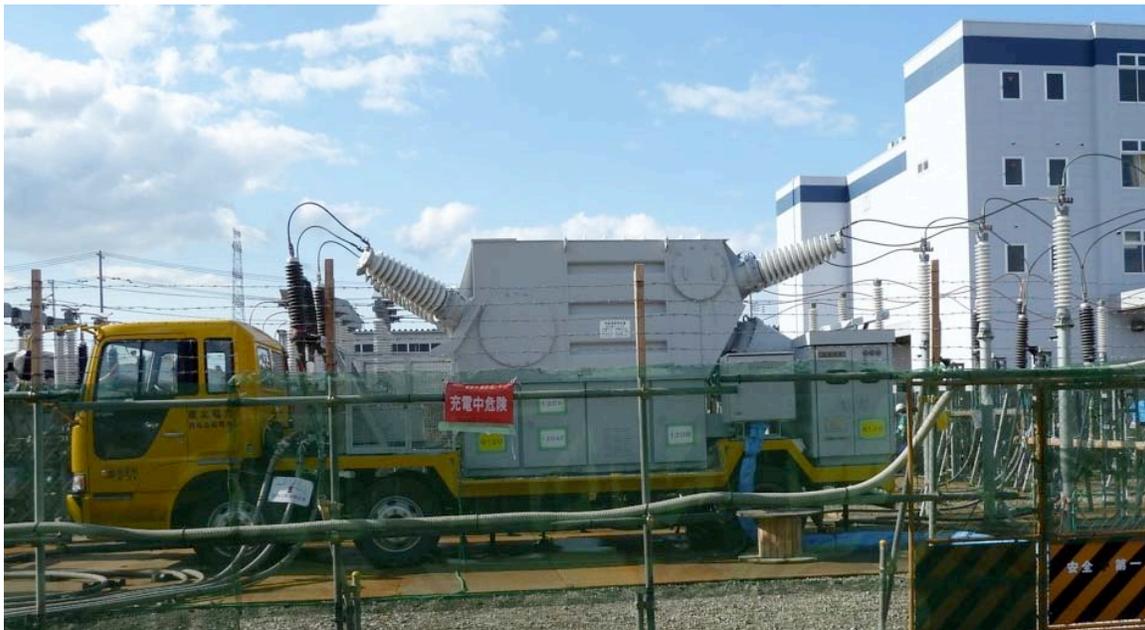
*Figure 4-36. Portable Transformer at Tagajyo Substation, June 14, 2011*

In Figure 4-35, one can see the portable 66 kV substation (truck-mounted) just outside the yard to the north. This portable truck-mounted transformer is seen in Figure 4-36, along with the newly-constructed temporary yard equipment (as of June 14, 2011).

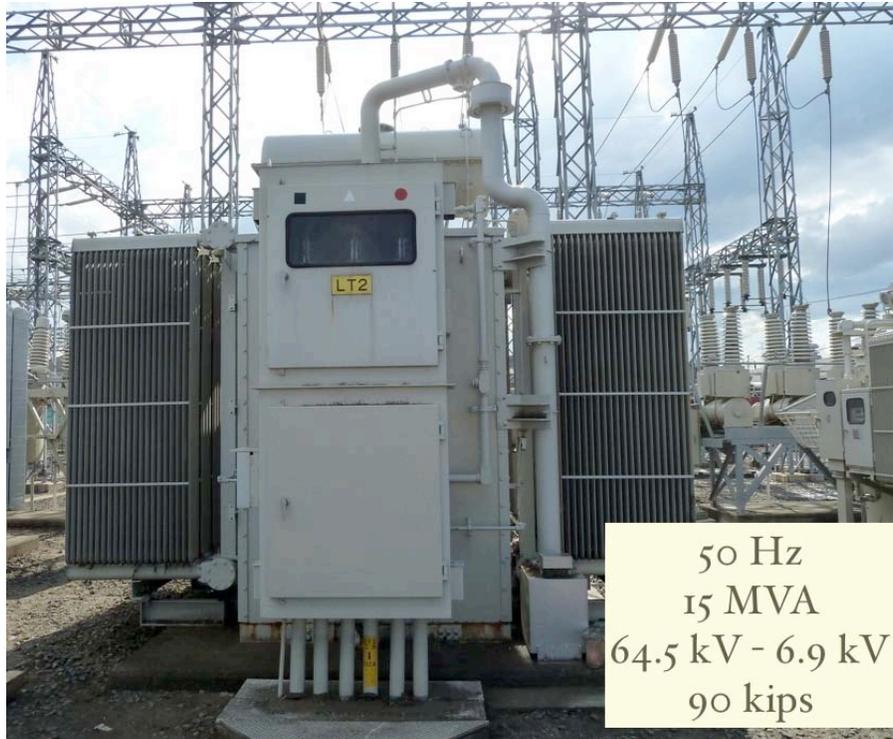
*Figure 4-38. Transformer at Tagajyo Substation, June 14, 2011*

Figure 4-38 shows one of the 15 MVA 64.5 kV-6.9 kV transformers. Based on high water marks on the control room building, the inundation level was about 11 feet above grade at this location. There is no sign of flotation of this transformer; we also did not see any flotation of bulk oil circuit breakers, or any other yard equipment). The transformer was anchored to a concrete slab below (Figure 4.47, showing soil residue left by the receding water). We did not observe any material scour at this substation site.

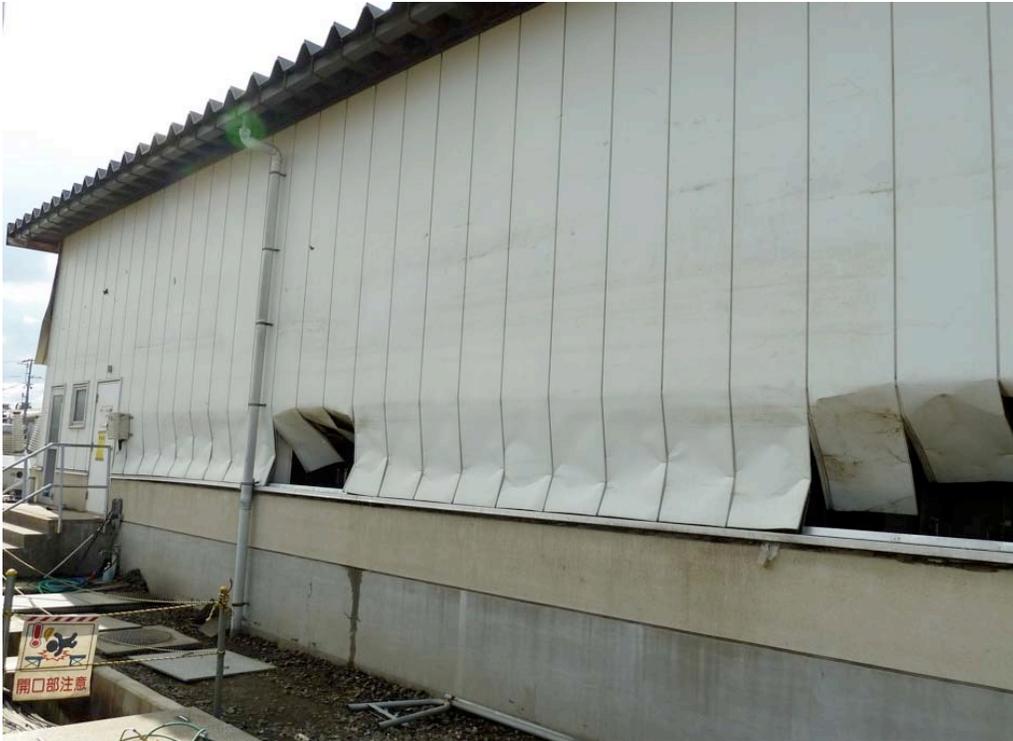
*Figure 4-41. Control Building at Tagajyo Substation*

Figure 4-41 shows the control building, with broken steel skin due to water inundation pressure. Figure 4-42 shows the panel boards within the control building, along with the broken z-lock skin sheathing. Battery racks were anchored, but all the lead-acid batteries were submerged.

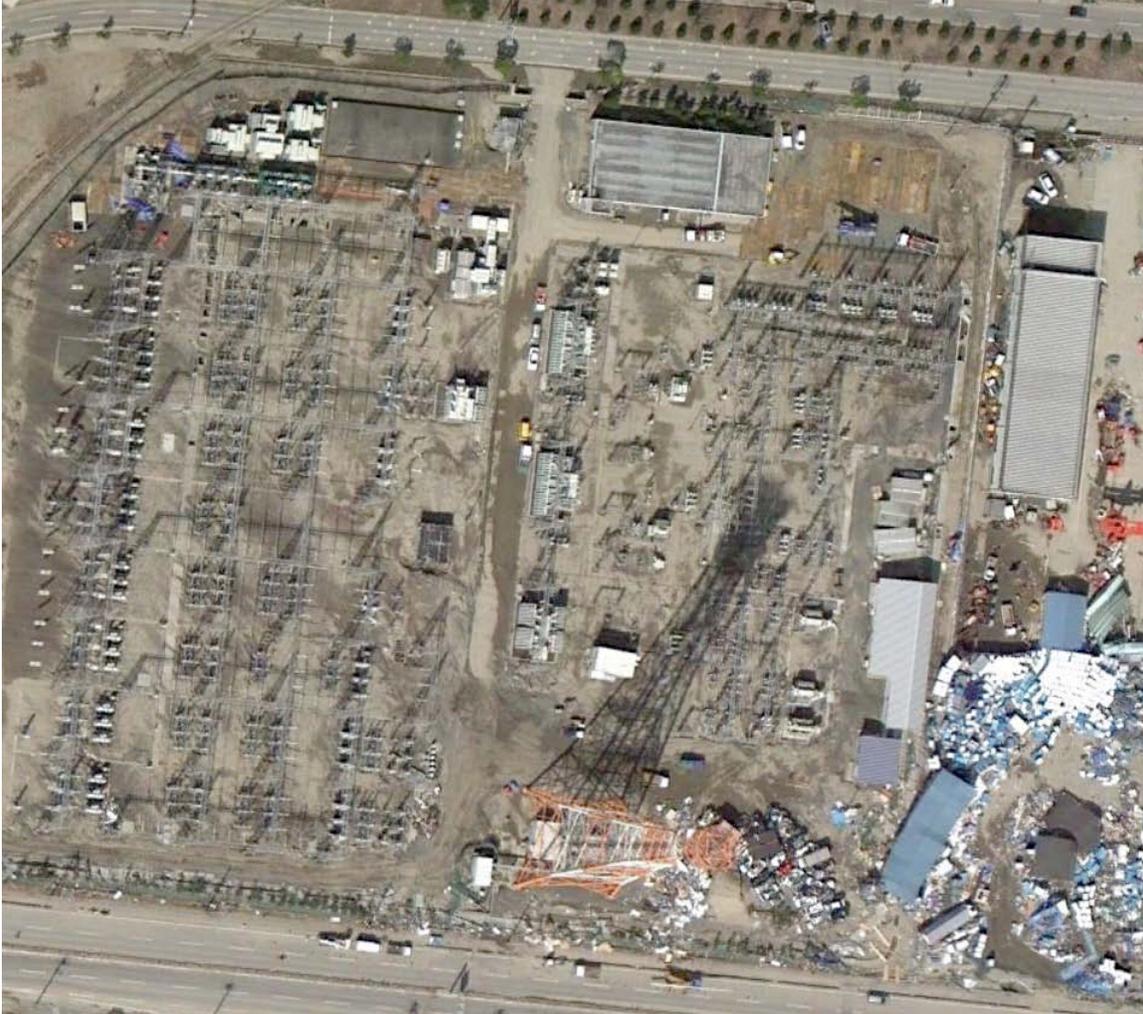
*Figure 4-43. Sendai Substation*

The Sendai substation (38.2766, 140.9946 Figure 4-43) is located about 1 mile from the Tagajyo substation, at the western end of the Sendai Port. Its ground elevation is about 15 feet above sea level, but it was still inundated from the southeast corner of the substation; debris entered the yard and covered about 10% of the yard (southeast corner).

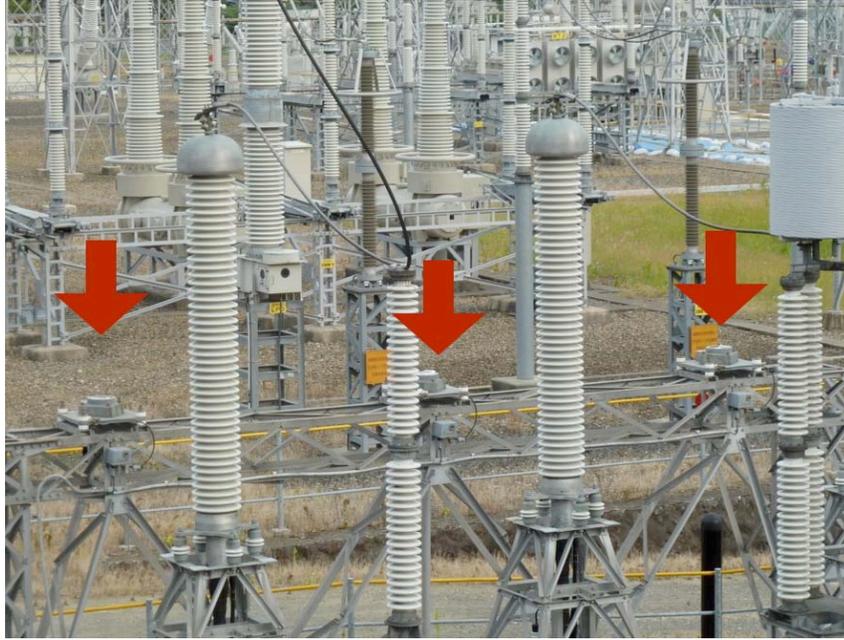
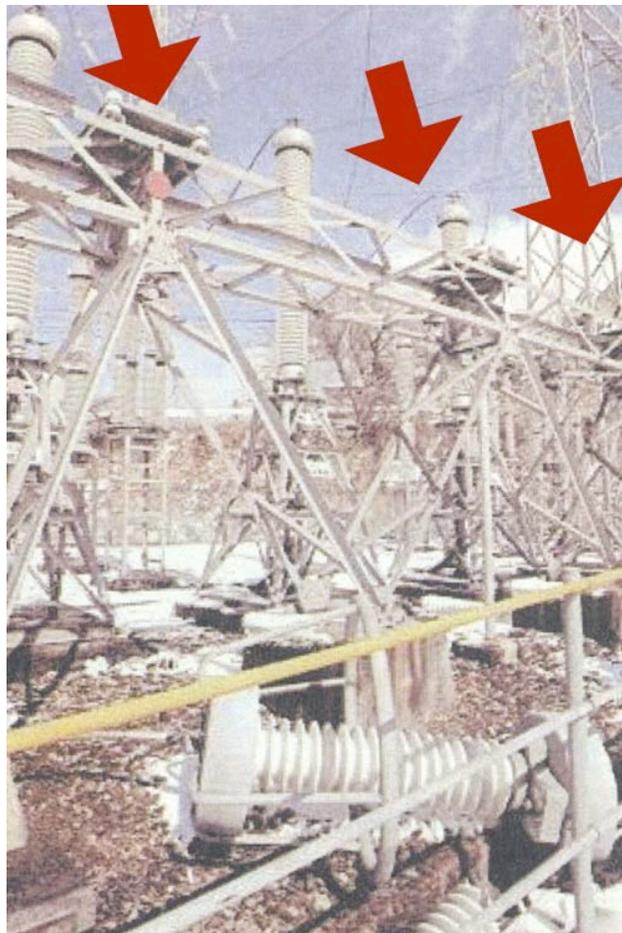
275 kV CVTs next to pot heads were damaged (Figures 4-46 and 4-47).

*Figure 4-46. 275 kV CVT Damage, Sendai Substation*

*Figure 4-47. 275 kV CVT Damage, Sendai Substation*

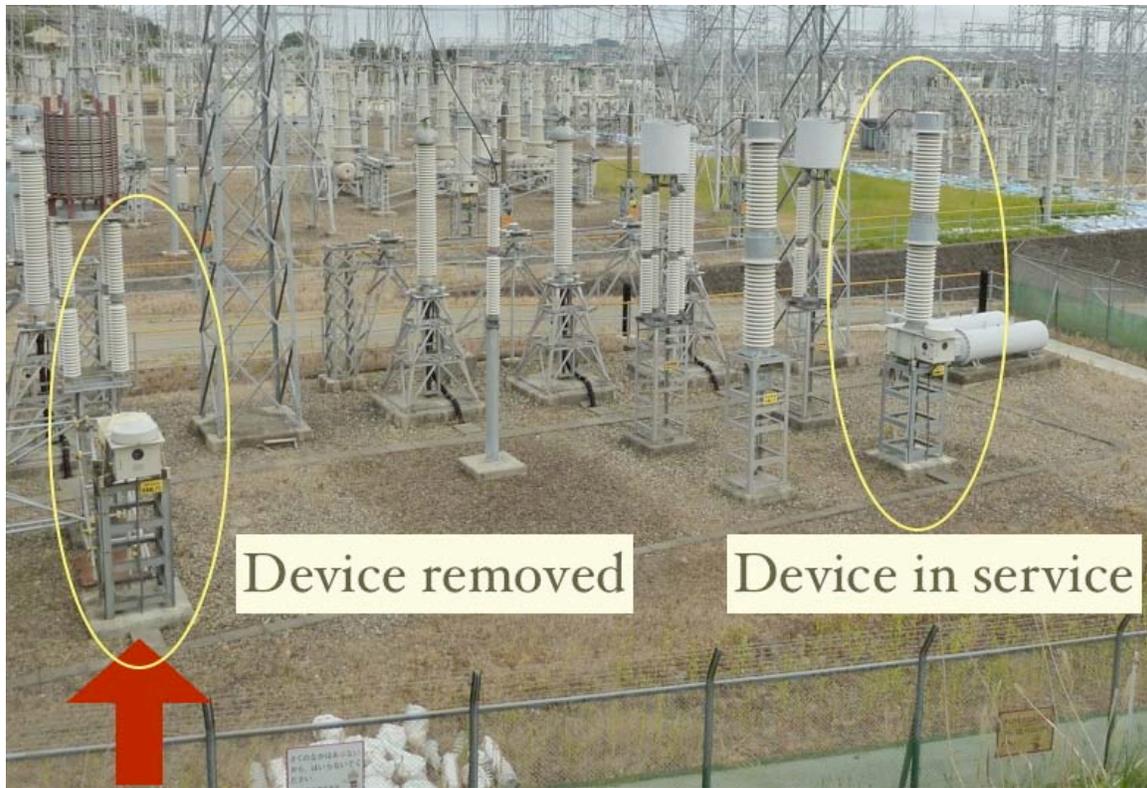
*Figure 4-49. 275 kV Instrument Transformer , Sendai Substation*

A 275 kV instrument transformer (left side of Figure 4-49) failed; a similar one to the right side of this photo remained intact, as also did the post-mounted wave traps. The device may have broken due to inertial overload on the porcelain; or perhaps cable slack interaction with the adjacent wave trap.

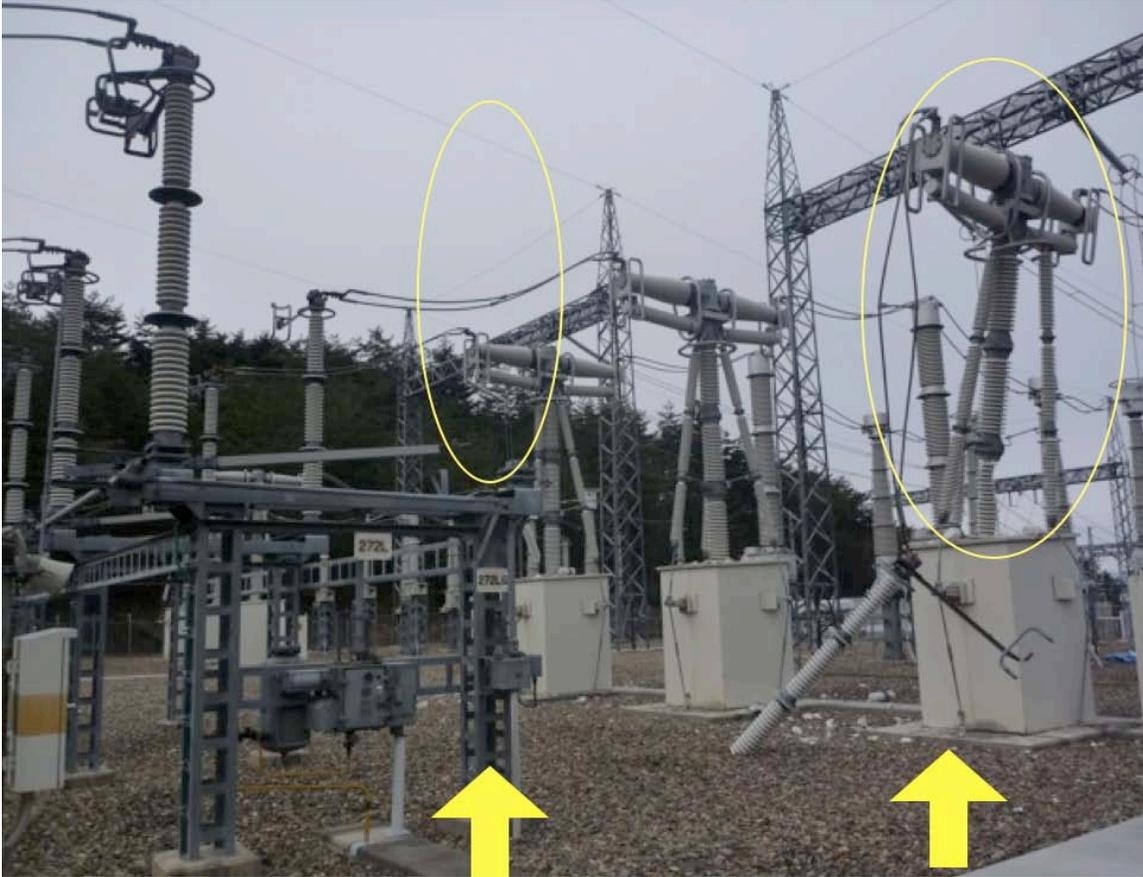
*Figure 4-50. 275 kV Live Tank Circuit Breaker*

At another substation, a 275 kV live tank circuit breaker (braced) collapsed, likely leading to pull down of the adjacent disconnect switch, Figure 4-50.

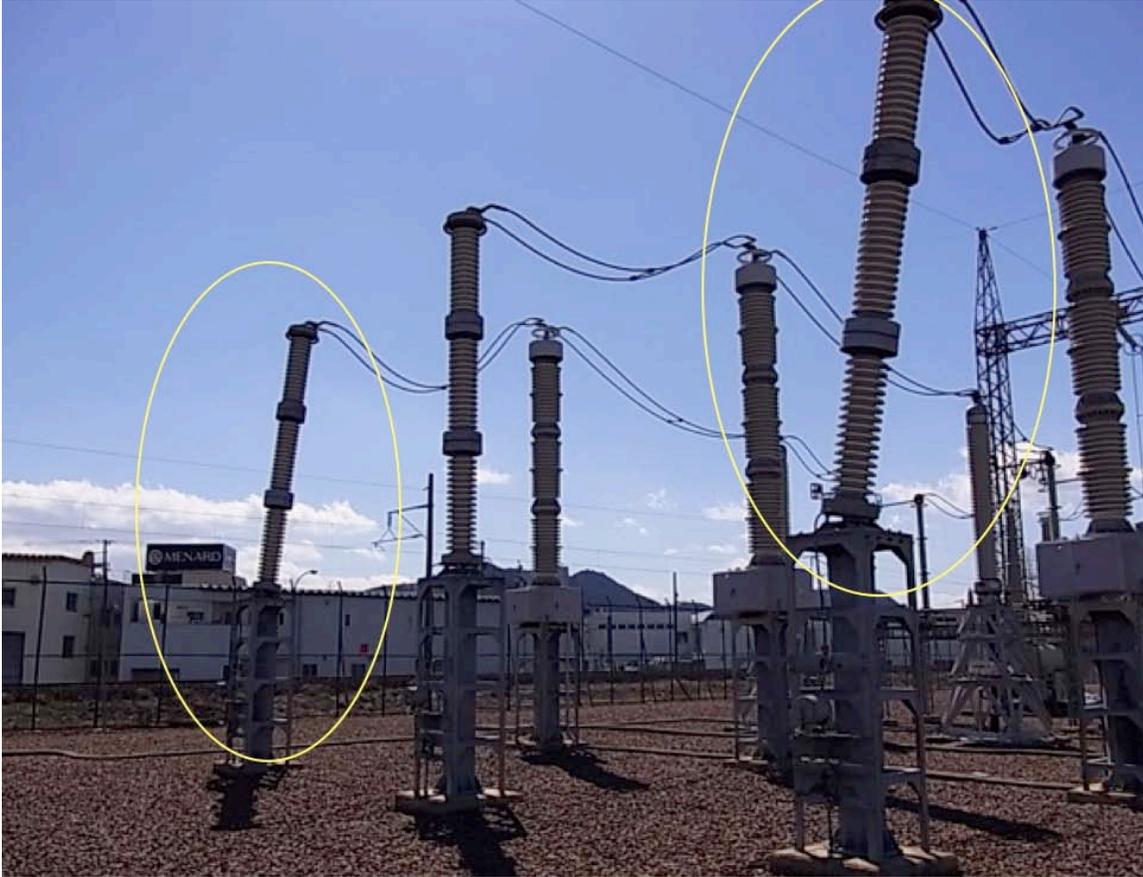
*Figure 4-51. 275 kV Surge Arrestors*

At another substation, two 275 kV surge arrestors failed, Figure 4-51.

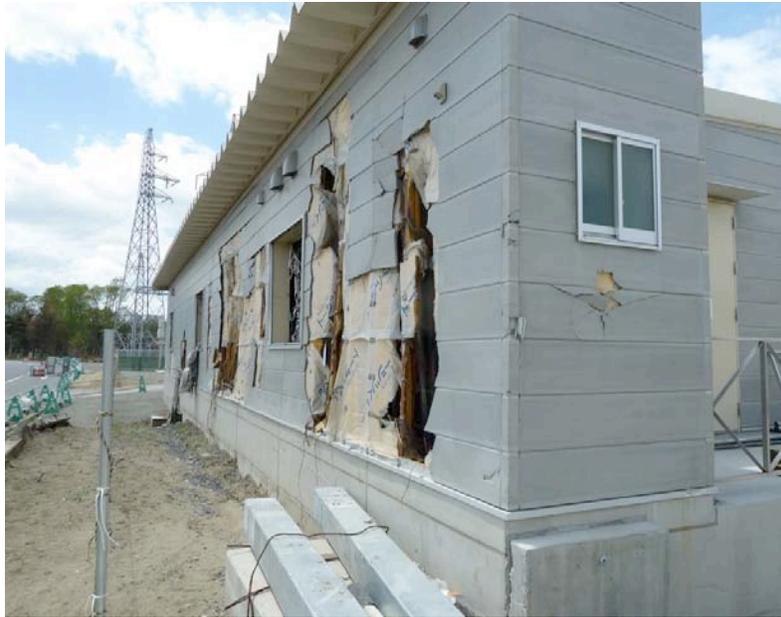
Figure 4-55 shows a control building damaged by tsunami inundation, near Ishinomaki. Figure 4-56 shows one of the transformers just adjacent to this control building, having about 4 feet of scour under its pile-supported concrete pad foundation; this transformer has since been removed from the system.

*Figure 4-55. Control Building Failed due to Inundation, Ishinomaki*
