**M 9.0 Tohoku Earthquake  
March 11 2011  
Performance of Water and Power  
Systems**

*G&E Engineering Systems Inc.  
6315 Swainland Rd  
Oakland, CA 94611  
(510) 595-9453 (510) 595-9454 (fax)  
eidinger@earthlink.net*

*June 25, 2012*

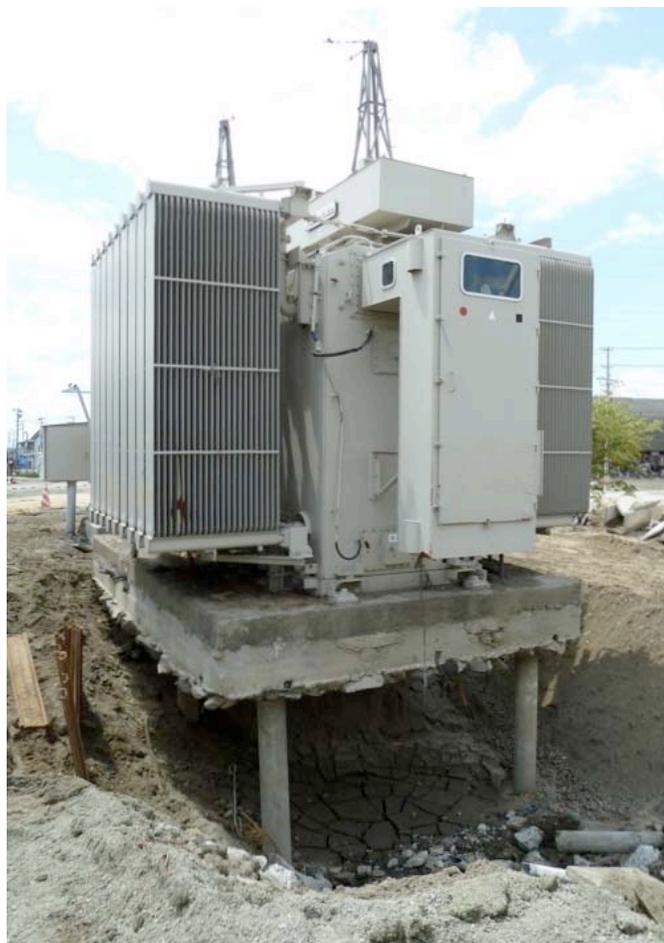
Figure 4-55 shows a control building damaged by tsunami inundation, near Ishinomaki. Figure 4-56 shows one of the transformers just adjacent to this control building, having about 4 feet of scour under its pile-supported concrete pad foundation; this transformer has since been removed from the system.

*Figure 4-56. Transformer Undermined by Scour, Ishinomaki*

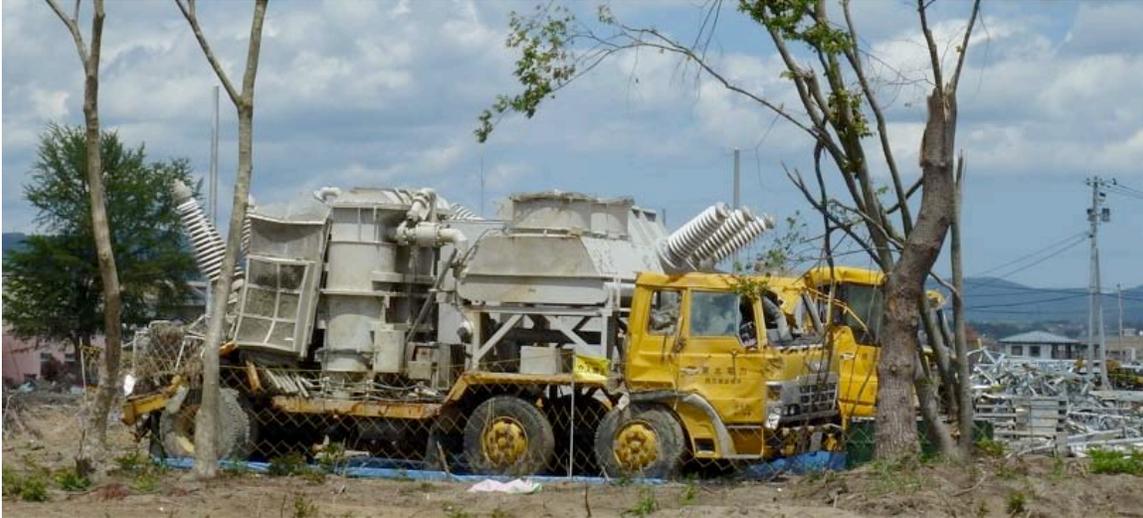
Figure 4-57 shows a portable truck-mounted 66 kV transformer. This truck was located about 200 meters from the waterfront in Ishinomaki. The tsunami waves hit this location perhaps 1 hour after the earthquake; however, no one had the time to drive these critical pieces of equipment away from the tsunami inundation area in the interim. Clearly, it would have been better to keep these pieces of equipment parked at locations outside any possible tsunami run-up zone. Figures 4-58 and 4-59 show three others with similar damage, stored nearby.

*Figure 4-58. Portable 66 kV Transformers Damaged by Inundation, Ishinomaki*

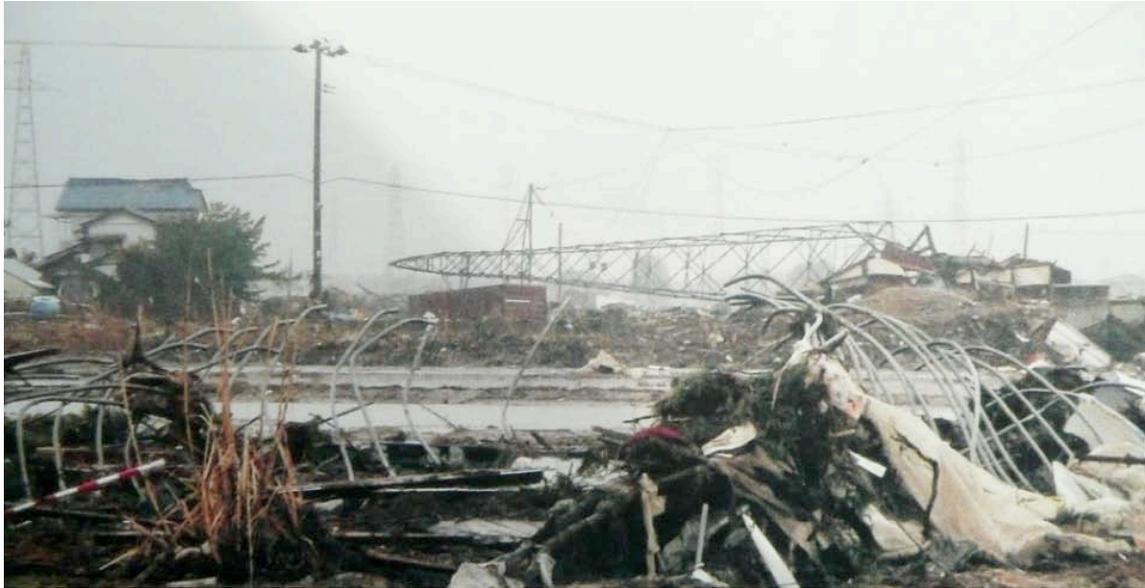
High voltage steel lattice tower-type transmission towers suffered damage in the earthquake. Of the 42 steel lattice towers that were damaged, 40 were due to tsunami inundation, and 2 from landslide. Figures 4-60, 4-61, 4-62 show some of the damaged towers. We observed several of the damaged towers, and we believe that the collapse of

these towers was not due to water forces (or scour); instead, the primary reason for collapse was due to the towers being hit by tsunami-floated cars, containers and other types of debris. From a mitigation point of view, for towers that must be placed in potential tsunami run-up zones with floating debris, the tower legs can be readily protected at modest cost by installed suitable bollard-type structures, all around the tower (downstream and upstream). Scour protection in these area would also be useful. While we did not survey all towers in tsunami run-up zones, we estimate that perhaps 85% to 90% of all inundated towers did survive the inundation without material damage.

*Figure 4-60. Collapsed Transmission Tower – Tsunami Debris*

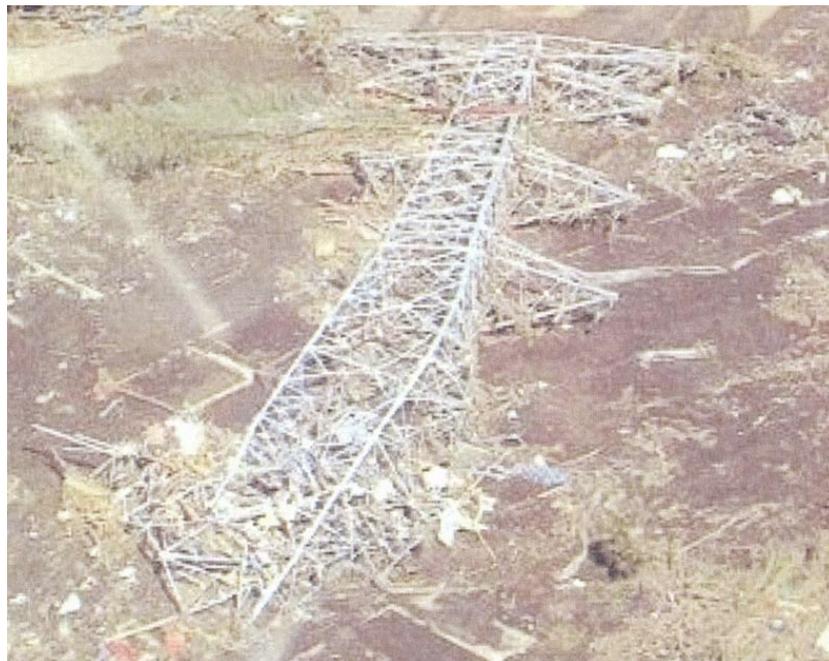
*Figure 4-61. Collapsed Transmission Tower – Tsunami Debris*

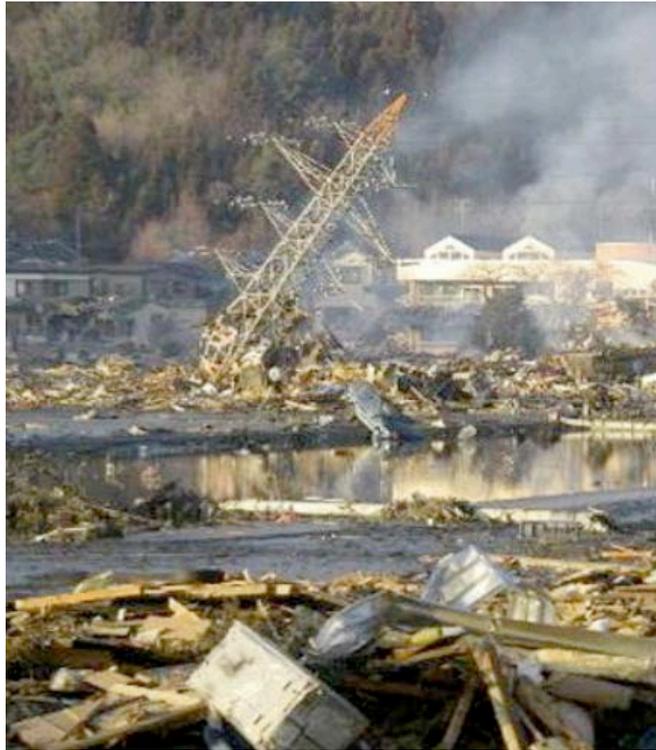
*Figure 4-62. Collapsed Transmission Tower – Tsunami Debris*

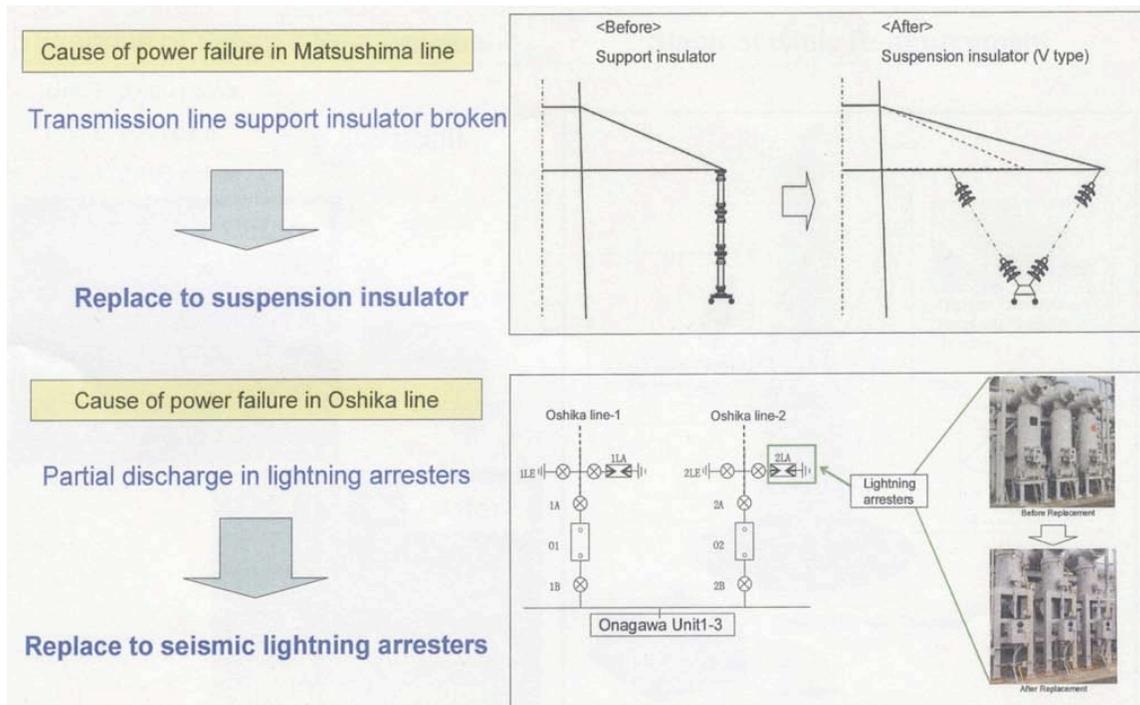
Figure 4-66. Transmission Lines Seismic Upgrades – Onegawa

Figure 4-66 shows the modifications made to the transmission lines after the earthquake, to seismically-strengthen these lines. The two Oshika 275-kV lines faulted due to partial discharge of the lightning arrestors, possibly because under strong ground shaking the air gaps became too small, and the lines faulted due to discharge on lightning arrestors at the termination at Onegawa; the seismic upgrade was to further brace the supports, so that at higher frequency, there would be less displacement. One of the two Matsushima lines faulted when one of the phases swung sideways enough to fault; the seismic upgrade was to replace the hanging-type insulator with a v-type arrangement, to limit the potential for side-to-side swinging under strong ground shaking.

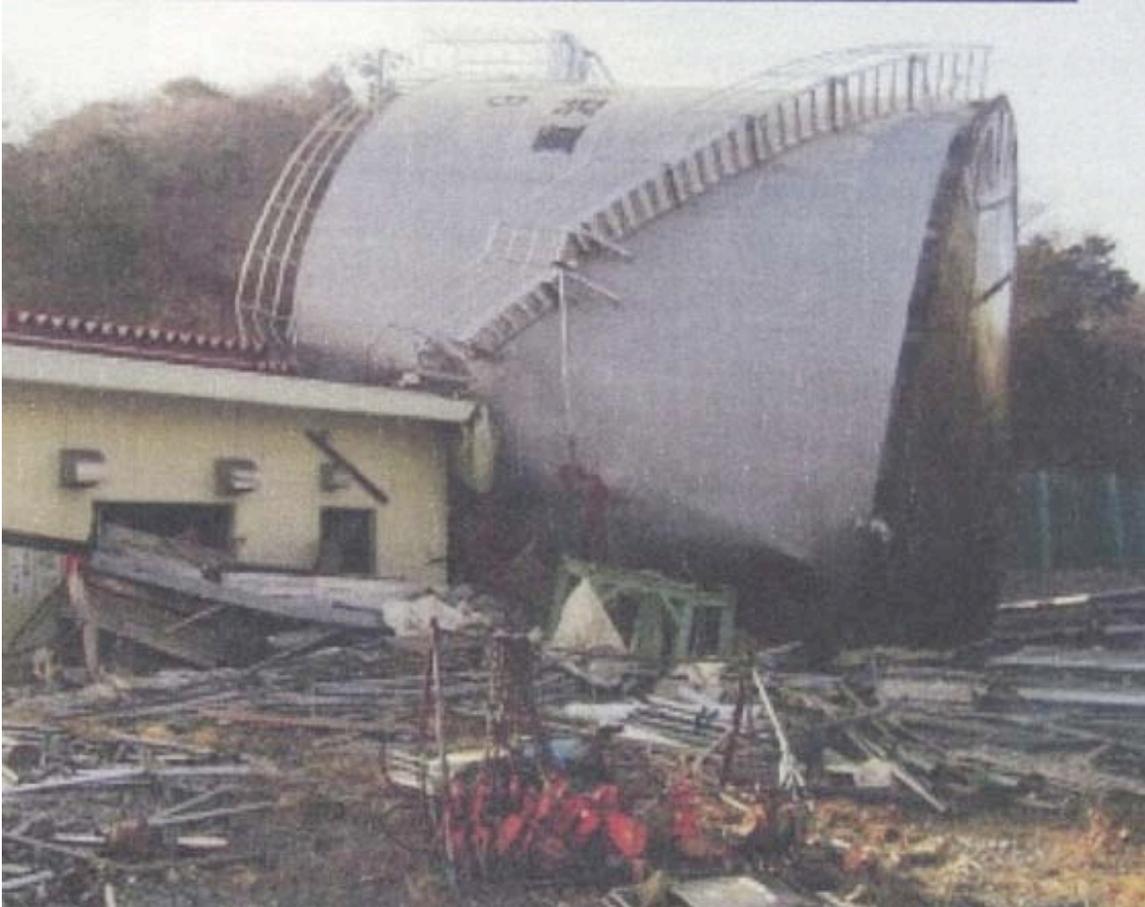
*Figure 4-67. Oil Tank for Unit 1 (Non Safety Related) – Onegawa*

The heavy oil storage tank for Unit 1 floated and failed, Figure 4-67. This tank was located blow the sea wall, denoted by the large red circle in Figure 4-63. The tsunami came in and floated the tank. This tank provide fuel for HVAC and liquid radioactive waste treatment processed, and was not considered "safety related" ... its location was outside the tsunami sea wall. The steel tank capacity was 960,000 liters, diameter 33 feet, height 36 feet; and was had about 600,000 liters at the time of the earthquake.

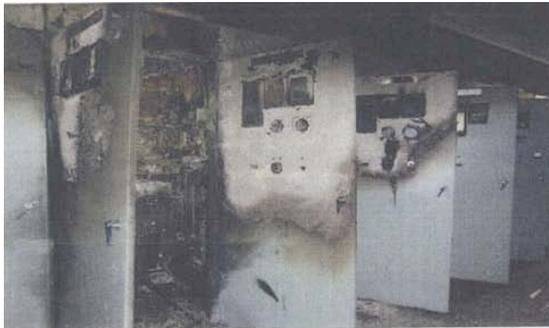
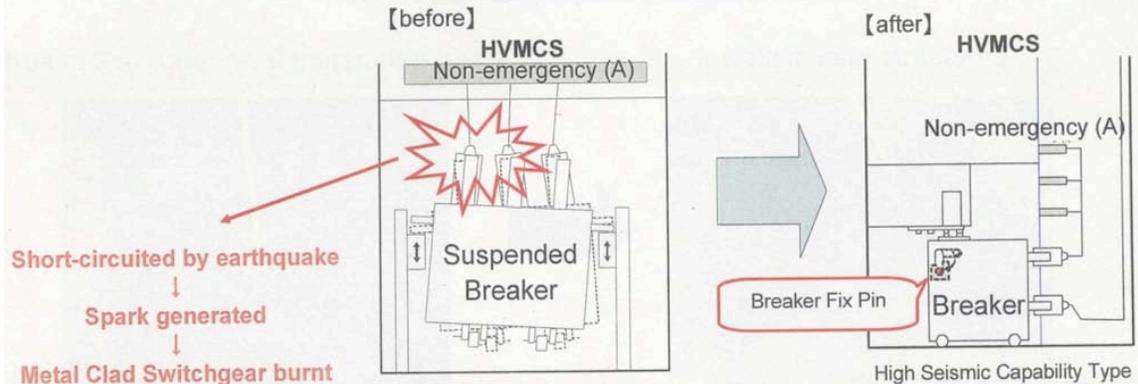
Figure 4-69. High Voltage Metal Clad Switchgear Failure and Upgrade – Onegawa

One train of high voltage metal clad switchgear, Train A, failed in Unit 1. The unit rocked, the phases faulted, and this started a fire. Train B and C worked properly. Figure 4-68 outlines the power system. Figure 4-69 outlines the likely cause of the failure.

- Probable Cause:**
- Breakers shaken by earthquake in HVMCS
  - Short circuit with surrounding structure
  - Spark melted cable covers and generated smoke

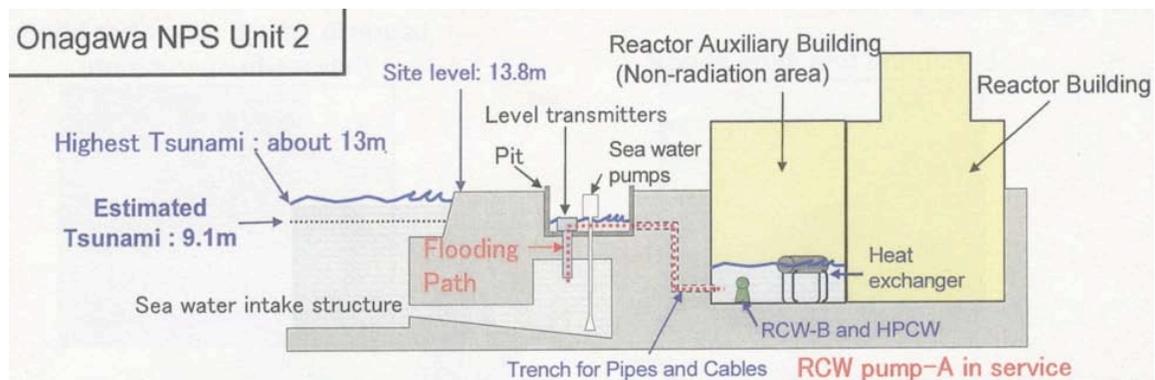
Figure 4-70. Path for Seawater to Flood Aux Building – Onegawa Unit 2

Seawater from the tsunami managed to enter into the basement of the Unit 2 Reactor Auxiliary building, flooding out the Reactor Cooling Water-B and High Pressure Cooling Water pumps. Thus, two of the three heat removal systems failed for Unit 2. Fortunately, Unit 2 was just in the process of start up, and the third cooling system worked to rapidly bring Unit 2 back to cold shutdown. Figure 4-70 shows a schematic cross section of Unit 2, and the path that allowed sea water to enter the basement of the Auxiliary building.

Note that in Figure 4.78 that the site tsunami wall (14.8 meters tall, reduced by 1 meter by tectonic subsidence) was tall enough to keep out the 13 meter tsunami; and the sea water pumps were fortunately high enough not to be flooded out by sea water. all the same, water pressure in the sea water wet well was high enough to cause pressure on the pressure transmitter tube cover, and this broke (Figure 4.79), allowing sea water into the concrete pit that housed the sea water pumps. This water then flowed via an open trench into the basement of the Auxiliary building, filling the basement to a height of 2.5 meters.

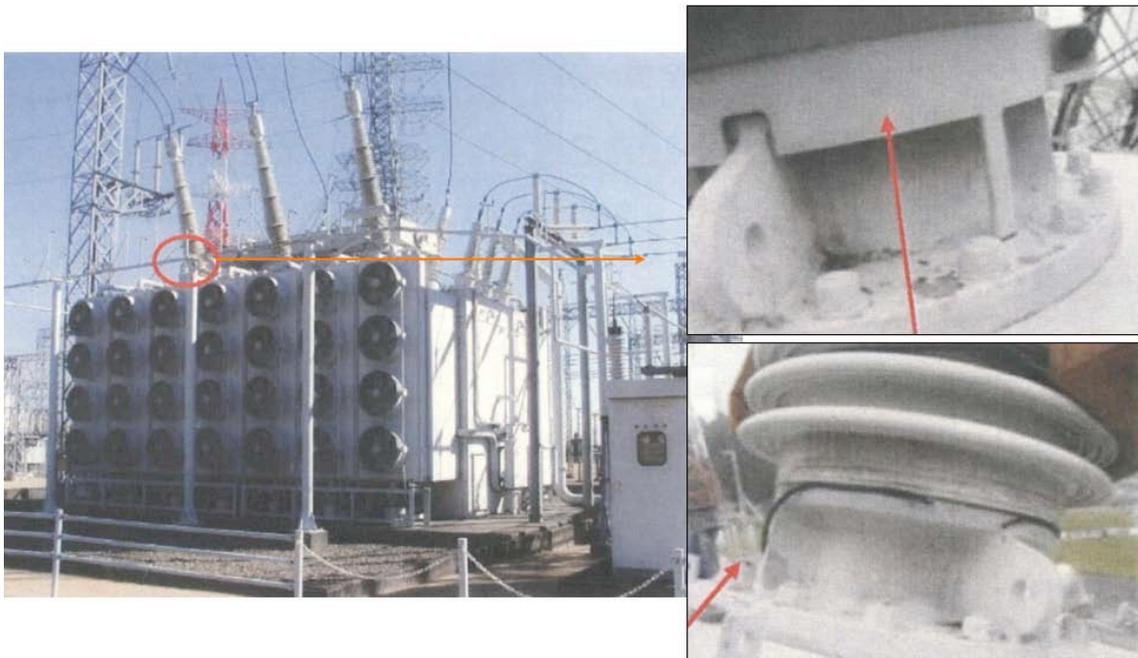
*Figure 4-79. Damage to a 275 kV Bushing*

Figure 4-79 shows damage to a 275 kV bushing. The gasket has been extruded where the porcelain bushing is attached to the forged metal support. This failure mode has been commonly observed in past earthquakes. This type of damage can lead to oil leaks, and while the utility can choose to continue to operate the transformer, there is heightened risk of fire.

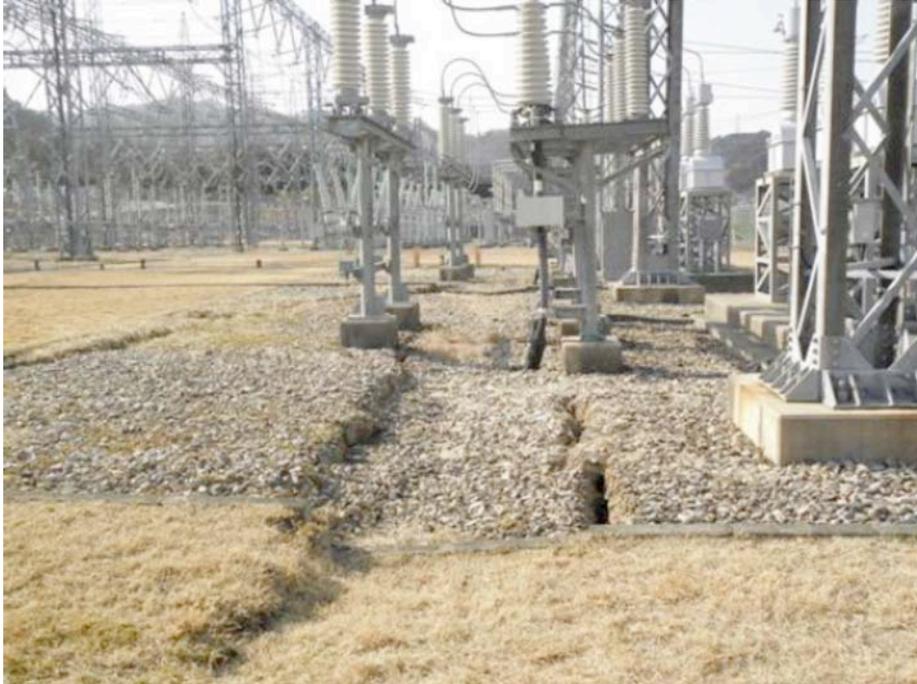
*Figure 4-80. Ground Deformations Near a 154 kV Pothead*

Figure 4-80 shows ground settlement adjacent to a 154 kV cable termination device (pothead). It is unknown if the settlement damaged the buried cables.

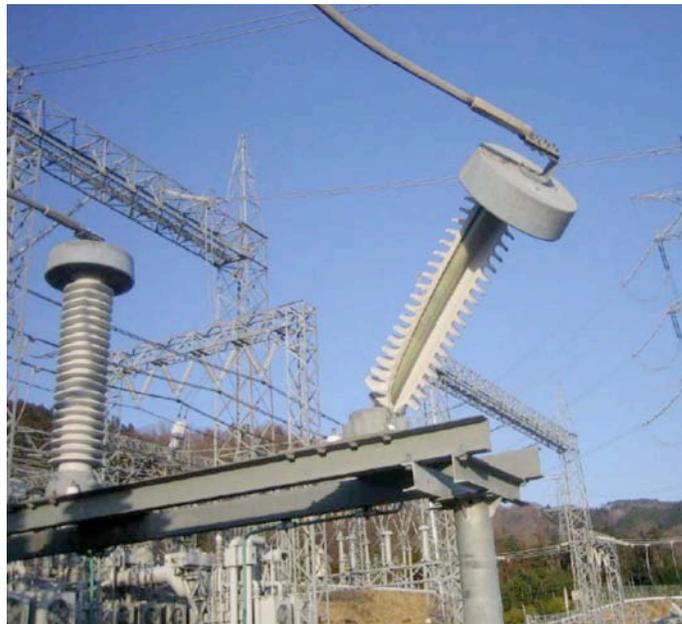
*Figure 4-81. Damaged 154 kV Instrument Transformer*

Figure 4-81 shows damage to an instrument transformer.

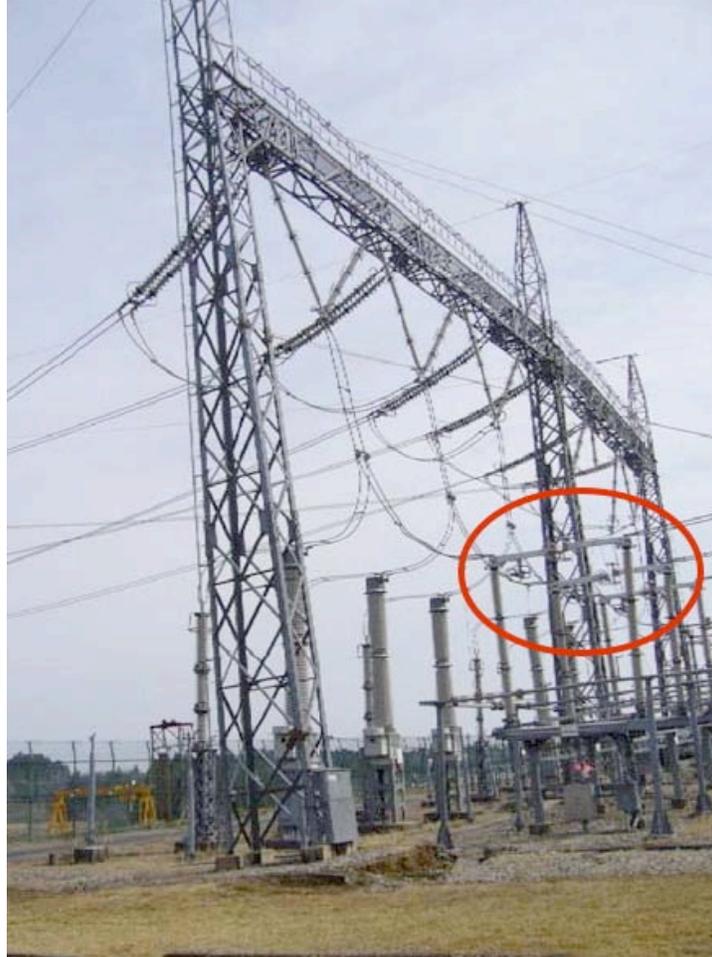
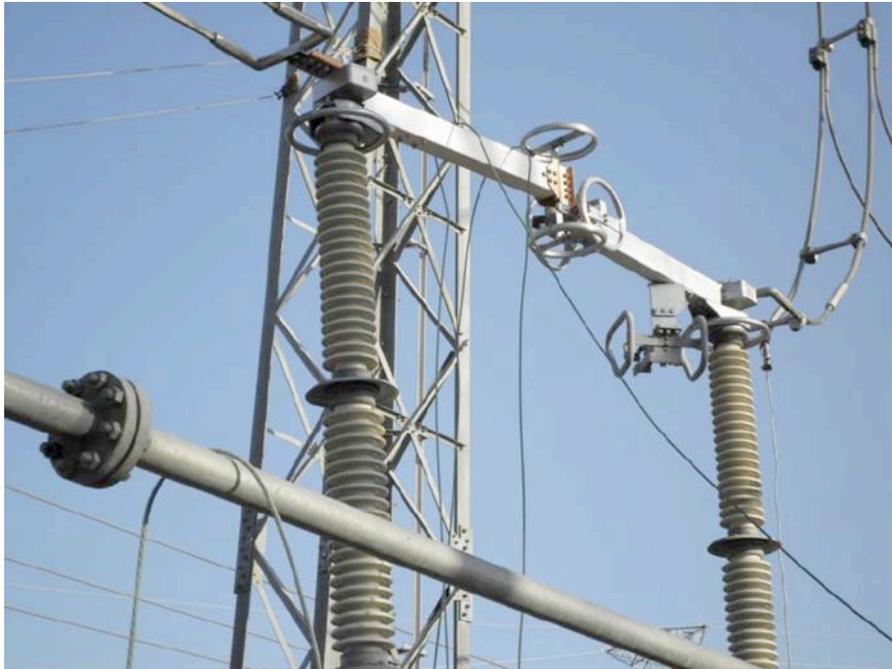
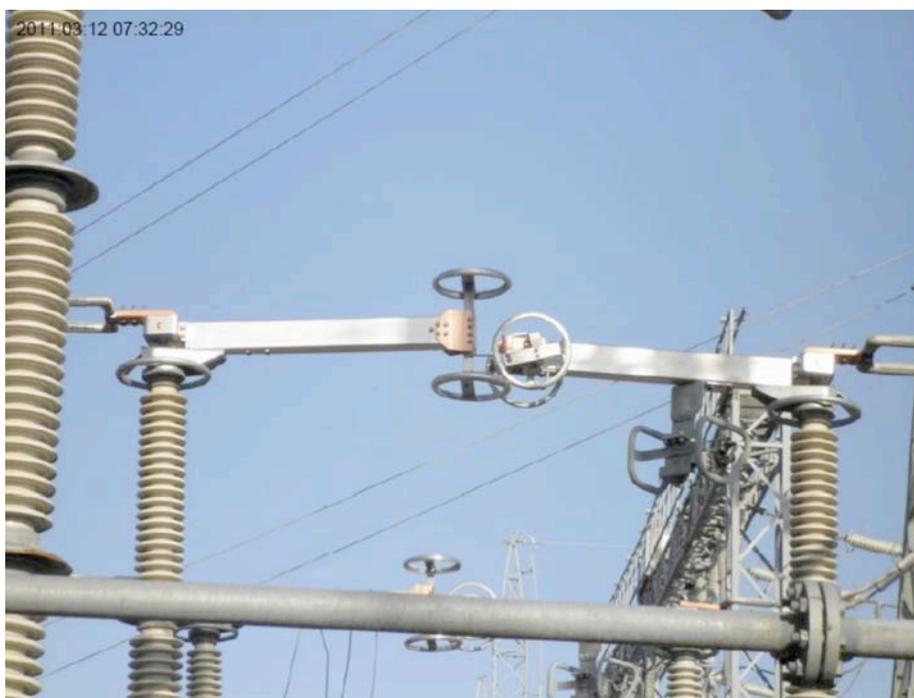
Figure 4-82 shows damage to a 275 kV disconnect switch, at the Shin Fukushima substation, located about 7 km west of the Fukushima Daiichi nuclear power plant. Possibly, the damage is due to the rocking of the dead end tower, leading to cable pull on the switch, Figures 4-83, 4-84.

*Figure 4-82. Damaged 275 kV Disconnect Switch*

*Figure 4-83. Damaged 275 kV Disconnect Switch*

*Figure 4-84. Damaged 275 kV Disconnect Switch*

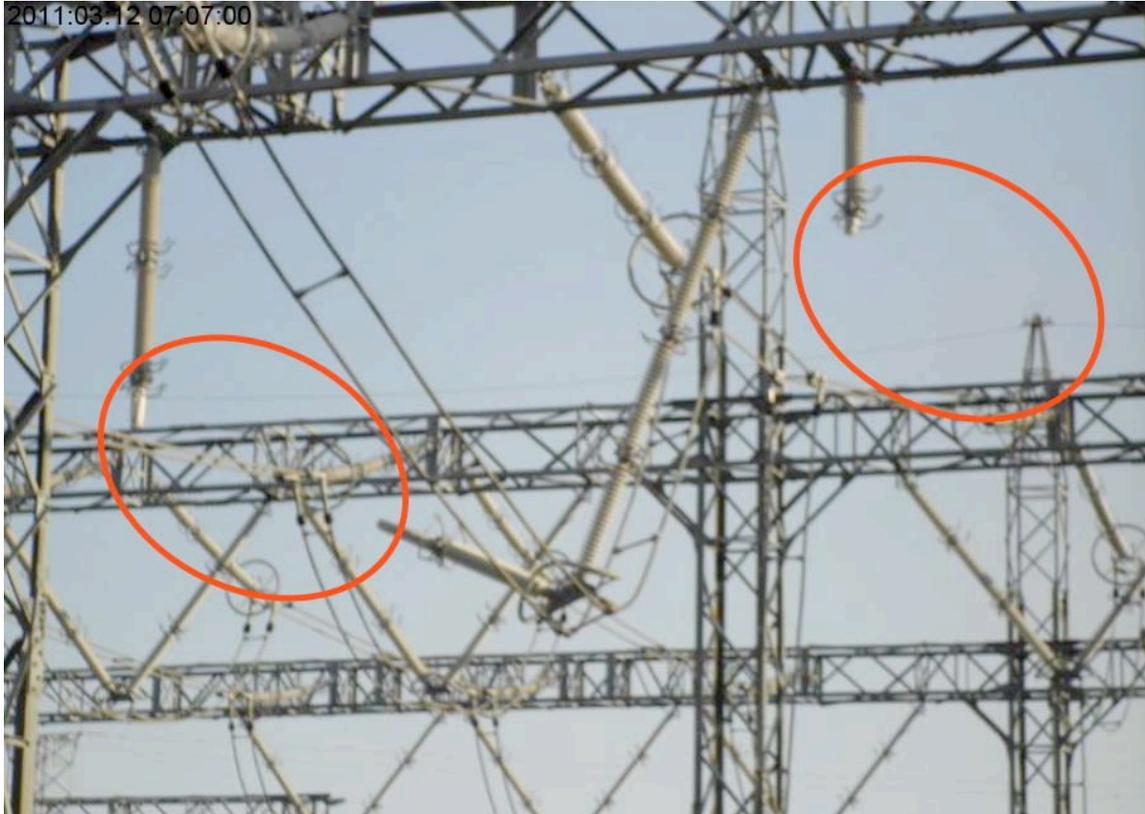
*Figure 4-85. V-Type Insulator*

Figure 4-85 shows damage to V-type insulations supporting a double conductor circuit. These insulators are composed of four post segments, and the failure mode appears to have occurred due to high bending along the assembly. The effect of cable dynamics, coupled with amplified motions at the top of the towers, should be investigated.

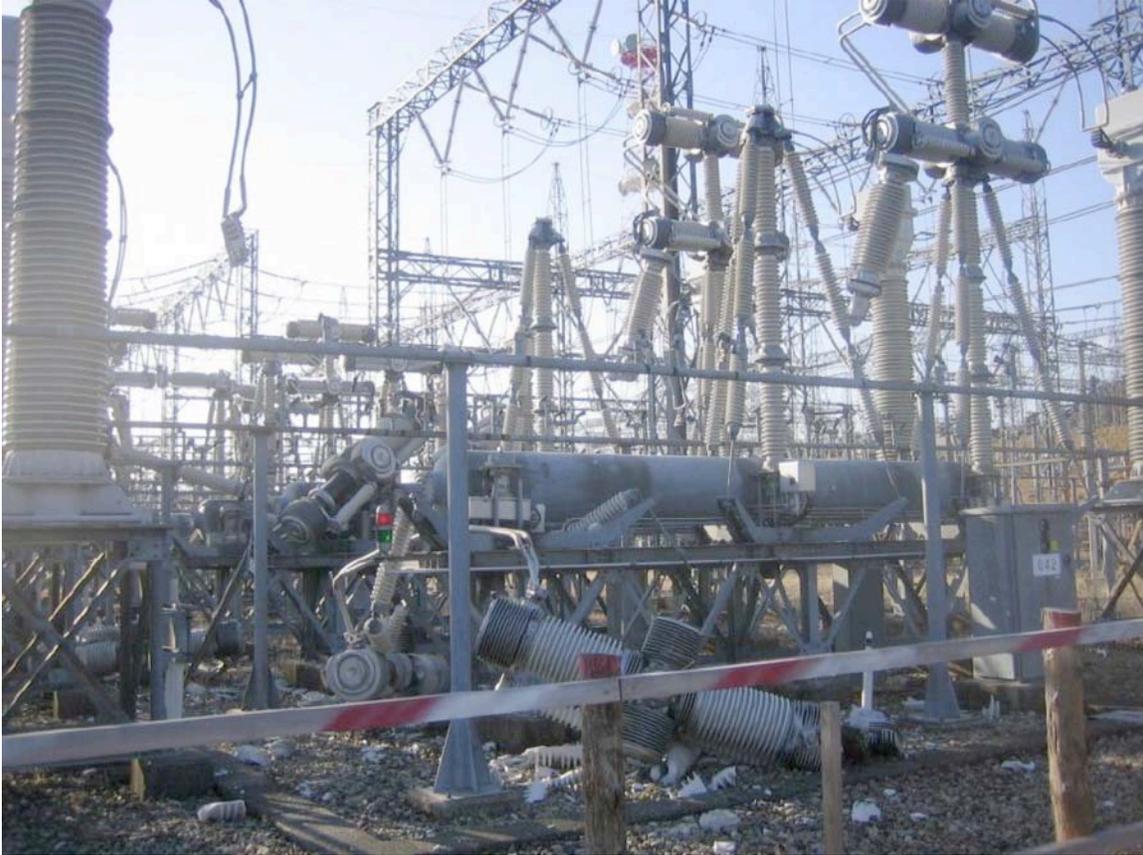
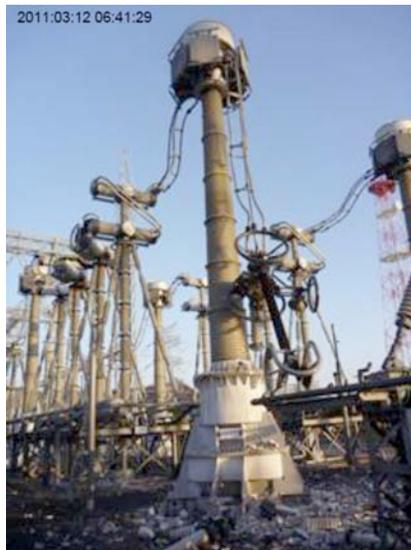
Figures 4-86 and 4-87 show damaged 275 kV live tank circuit breakers at the Shin Fukushima substation. These breakers had reportedly been seismically qualified, but failed to possible higher-than-assumed ground shaking at this substation.

*Figure 4-86. 275 kV Live Tank Circuit Breakers*

*Figure 4-87. 275 kV Current Transformers and Live Tank Circuit Breakers*

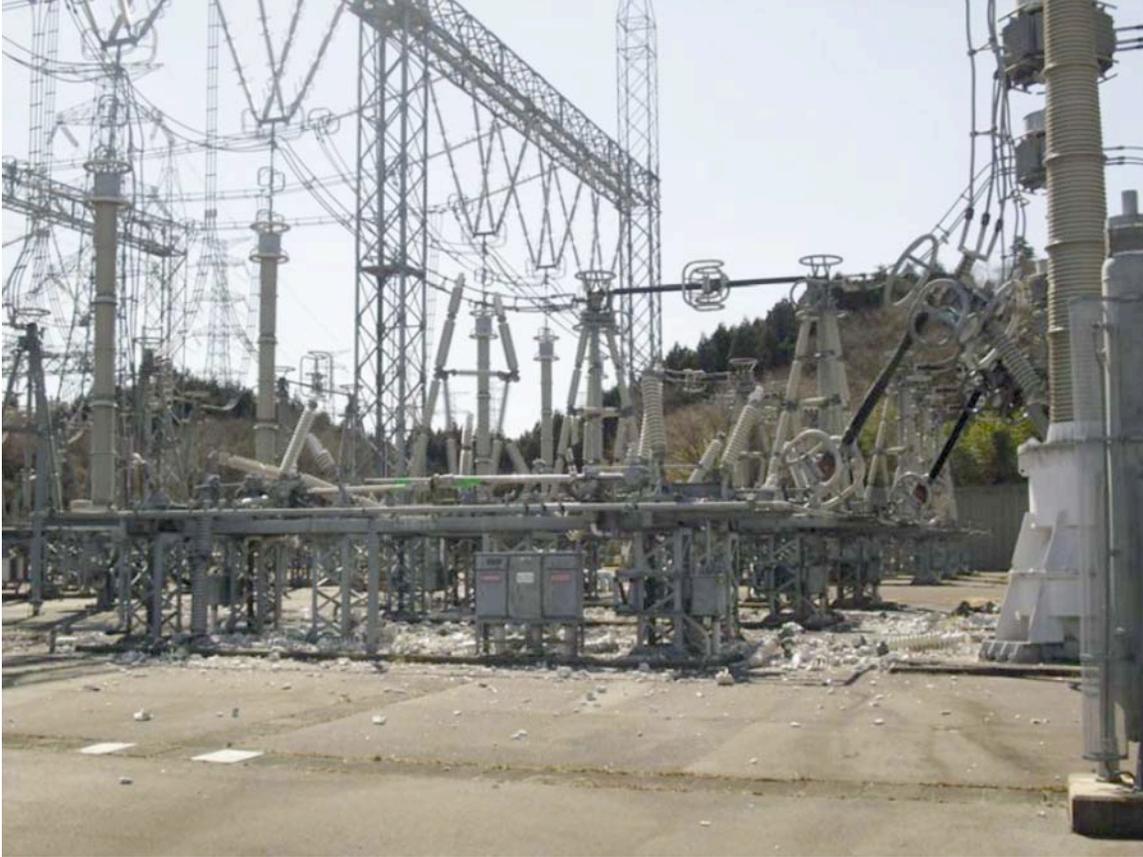
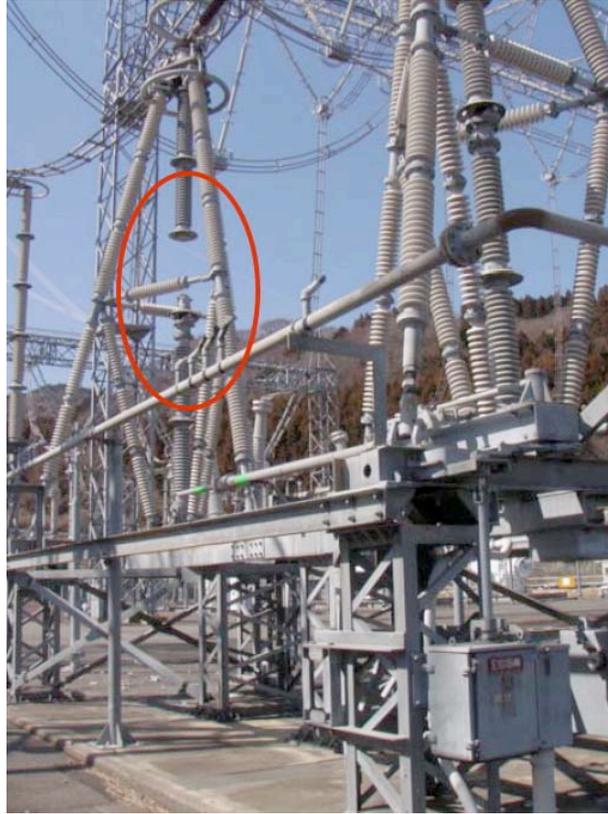
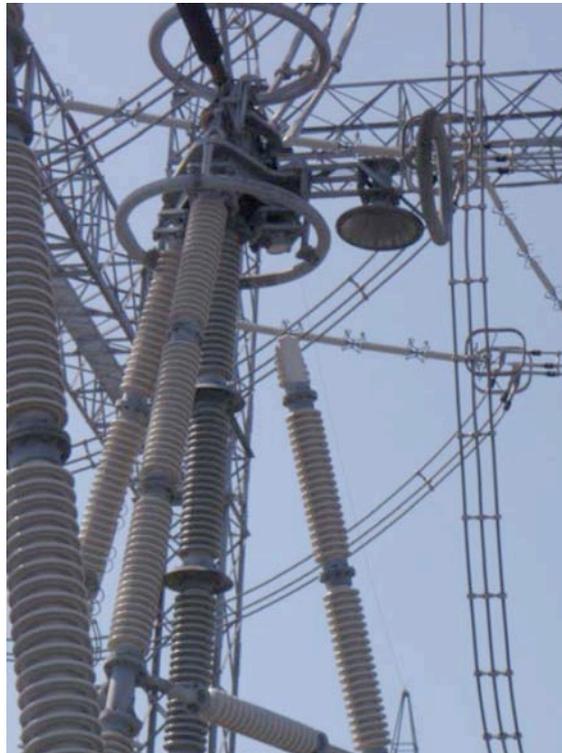
Figures 4-88, 4-89, 4-90 show failed 500 kV disconnect switches at the Shin Fukushima substation. Figure 4-89 shows the failure of the switch post, even though the three "tripod" lateral supports remain intact. Figure 4-90 shows the failure of the one of the tripod legs, even though the central switch post remains intact.

*Figure 4-88. 500 kV Disconnect Switch*

*Figure 4-89. 500 kV Disconnect Switch*

*Figure 4-90. 500 kV Disconnect Switch*

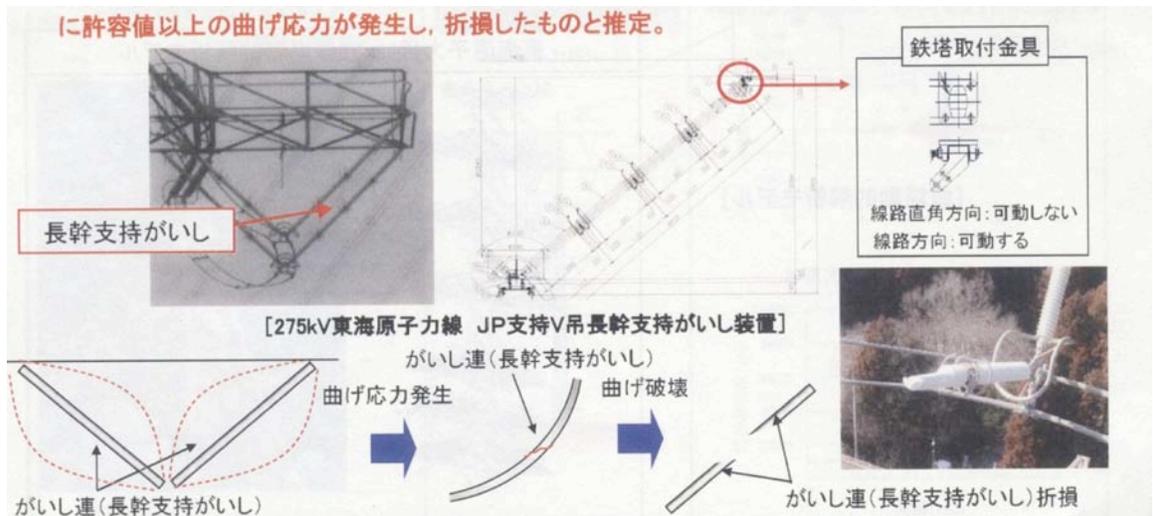
Figure 4-92. Possible Failure Modes to 275 kV Transmission Line

There was damage to the insulator strings at several towers along a 275 kV transmission line, Figure 4-91. Figure 4-92 suggests the possible failure modes.

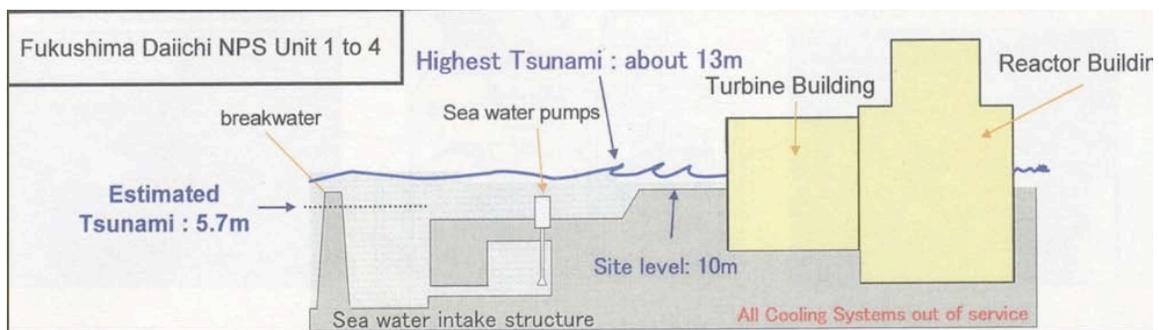
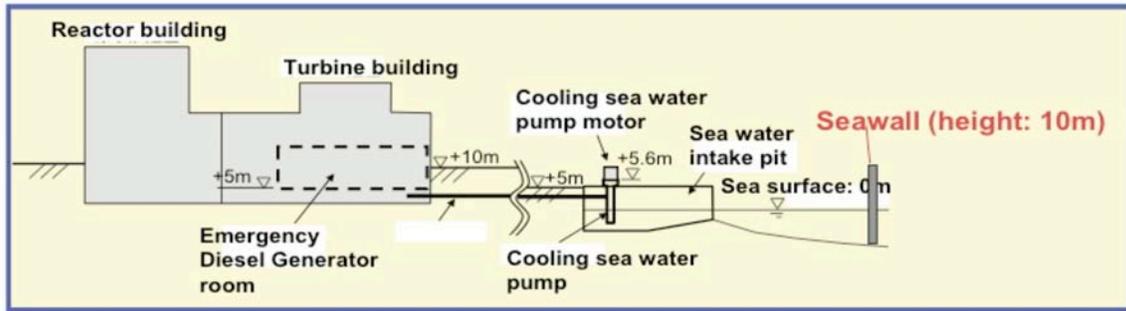
Figure 4-95 shows a schematic of the tsunami inundation of Fukushima Daiichi, Units 1 to 4. The site elevation for Units 1-4 is 10 meters above sea level; for Units 5-6 is 13 meters above sea level. The assumed tsunami height had been 5.7 meters in 2002. In the 2011 event, the first big wave (41 minutes after the earthquake) was at 4 meter height; 8 minutes later, the gages broke, but the height of the follow-on wave was estimated at 10 meters. This second wave went over the top of the breakwater and flooded the sea water pumps, making them useless, and then flooded the emergency generators located in the turbine buildings (elevation 0 to +5.8 meters), making all but one of them useless, Figure 4-96 (one emergency generator for Unit 6 was above the inundation level, and worked). The actual water run-up level was 14 meters.

Figure 4-95. Fukushima Daiichi Tsunami Inundation

Figure 4-96. Fukushima Daiichi Tsunami Inundation
