# **Fragility Models that Reflect Pipe Damage in the 2014 Napa M 6.0 Earthquake**

John M. Eidinger\*

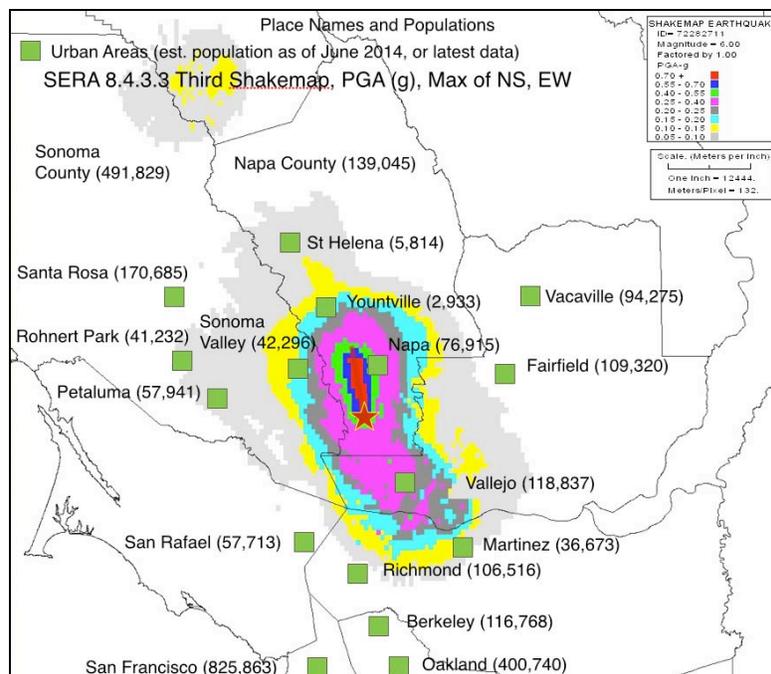
Figure 2. Ground shaking levels (PGA) on the Napa 2014 M 6.0 earthquake

Figure 2 shows the level of ground shaking in the earthquake (in PGA, g), along with names of major cities and towns, and latest census populations shown in (brackets). The star shows the epicenter, with the rupture going northwards. Red areas show  $PGA > 0.7g$ . White areas show  $PGA < 0.05g$ . Black lines show boundaries of counties.
