Berkeley Davis Hall Water System Earthquake Issues

John Eiding

EERI

April 15 2024

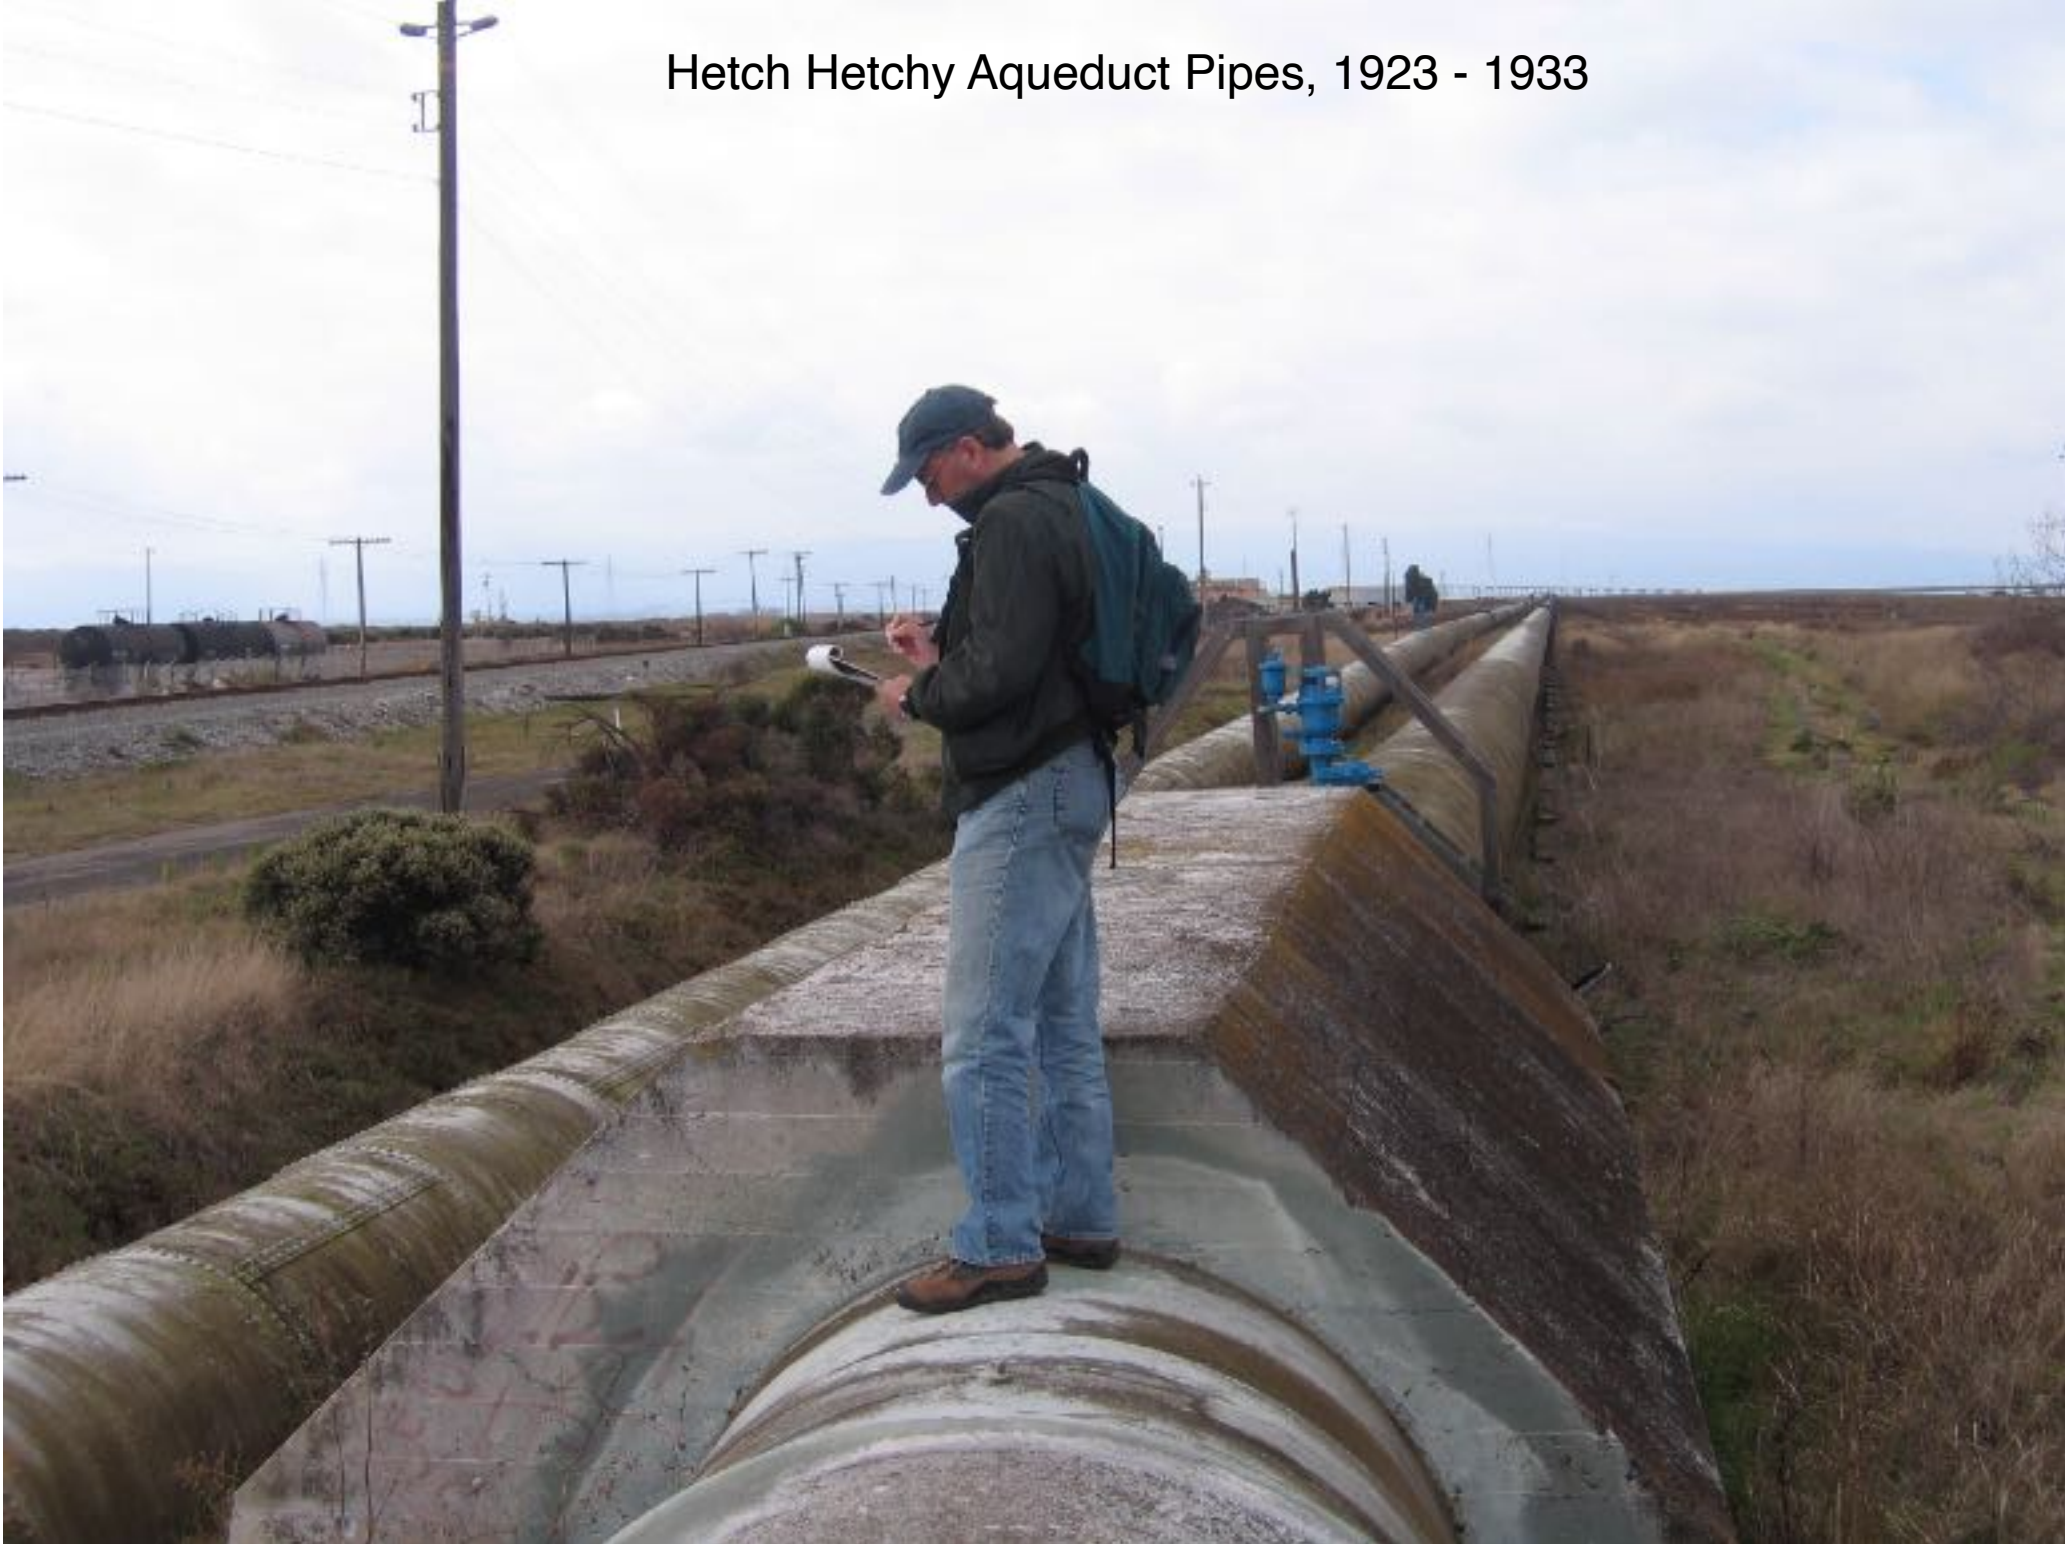
The Biggest Hetch Hetchy Aqueduct Pipe, 1965

BDPL 4 Slip Joints at the Hayward Fault

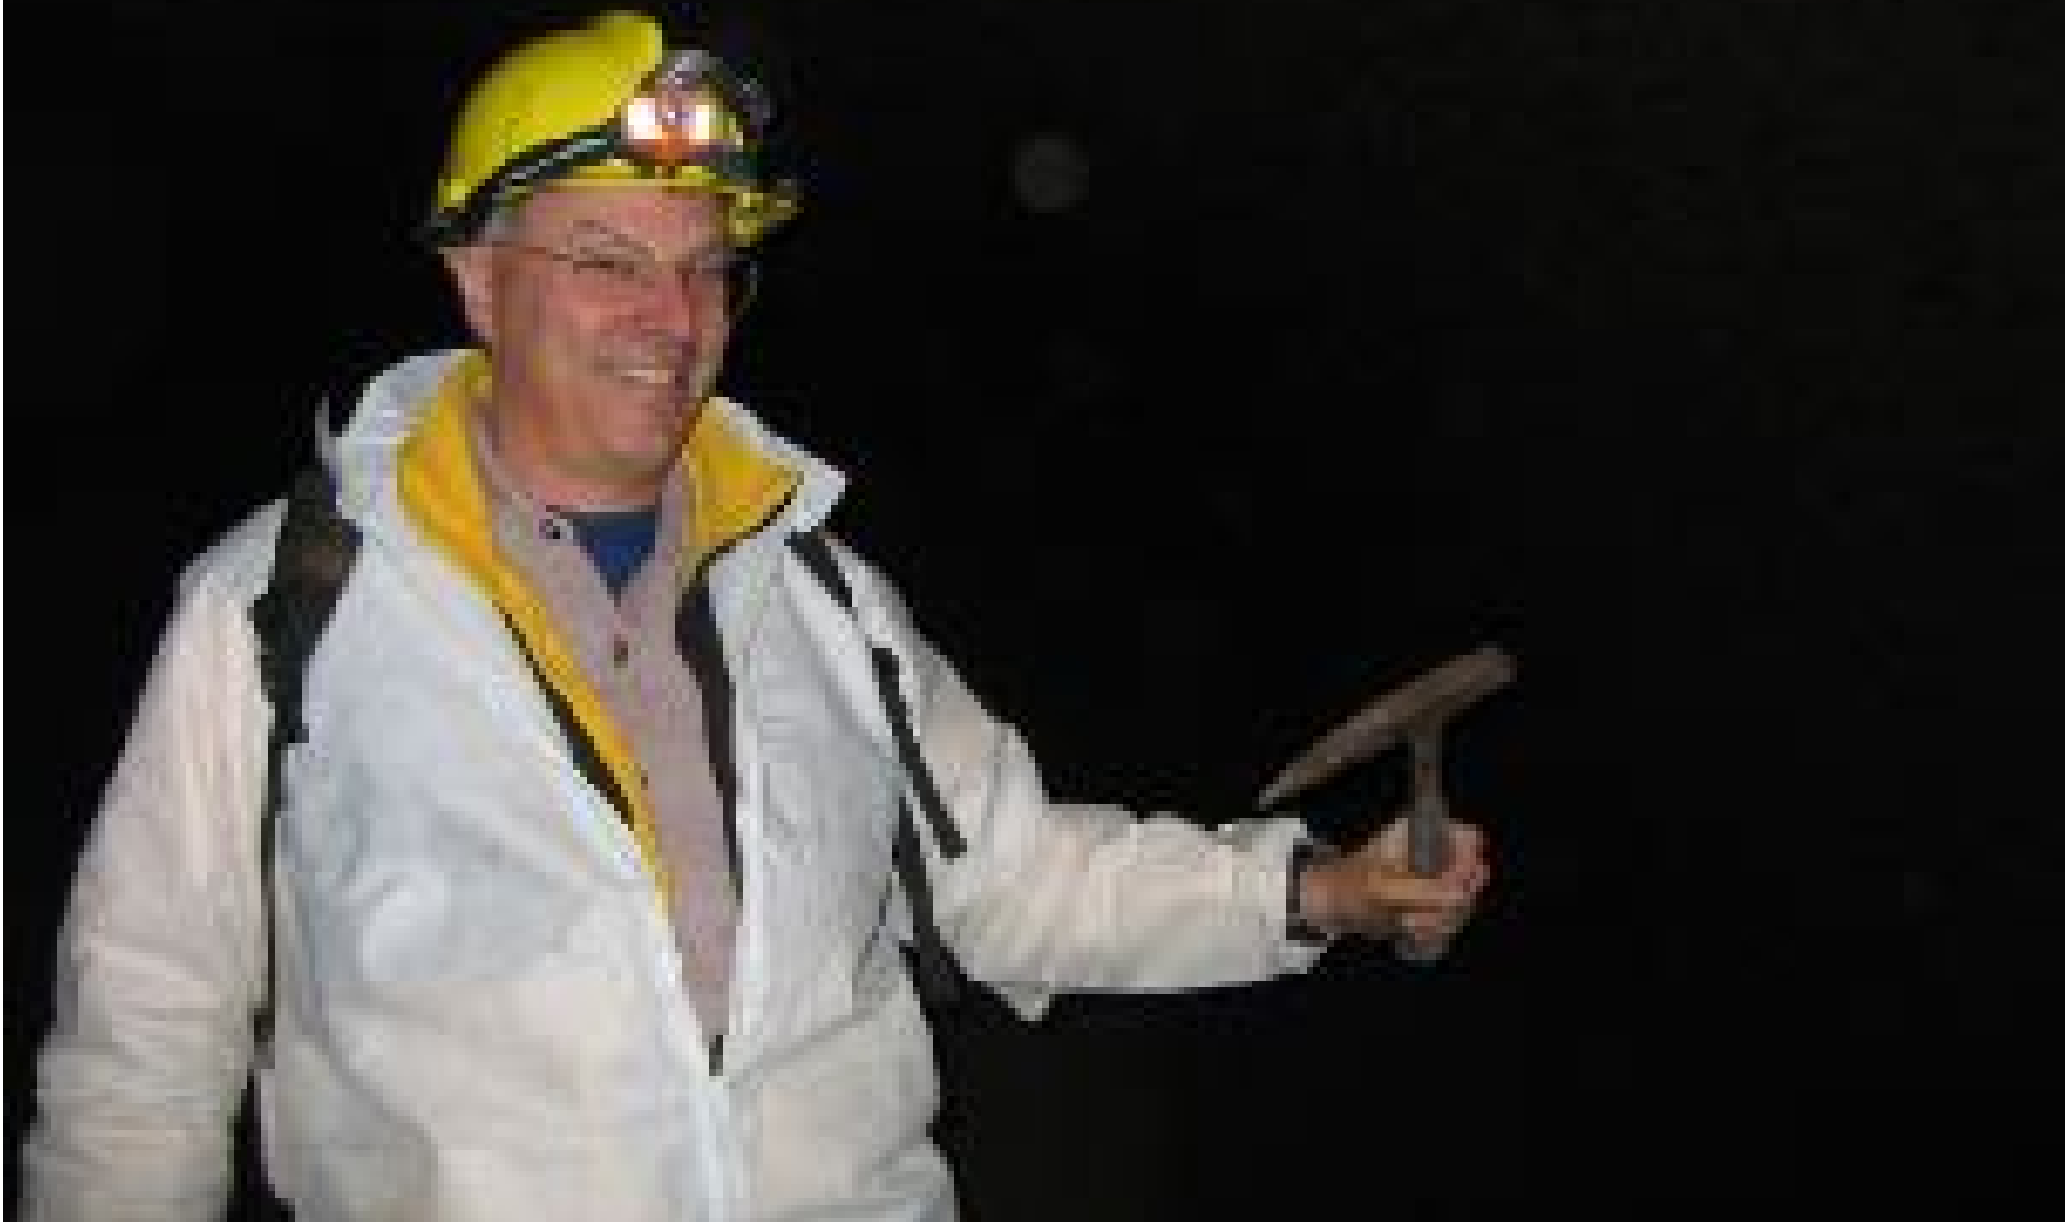
Inside BDPL 4 Inspecting Slip Joints at the Hayward Fault

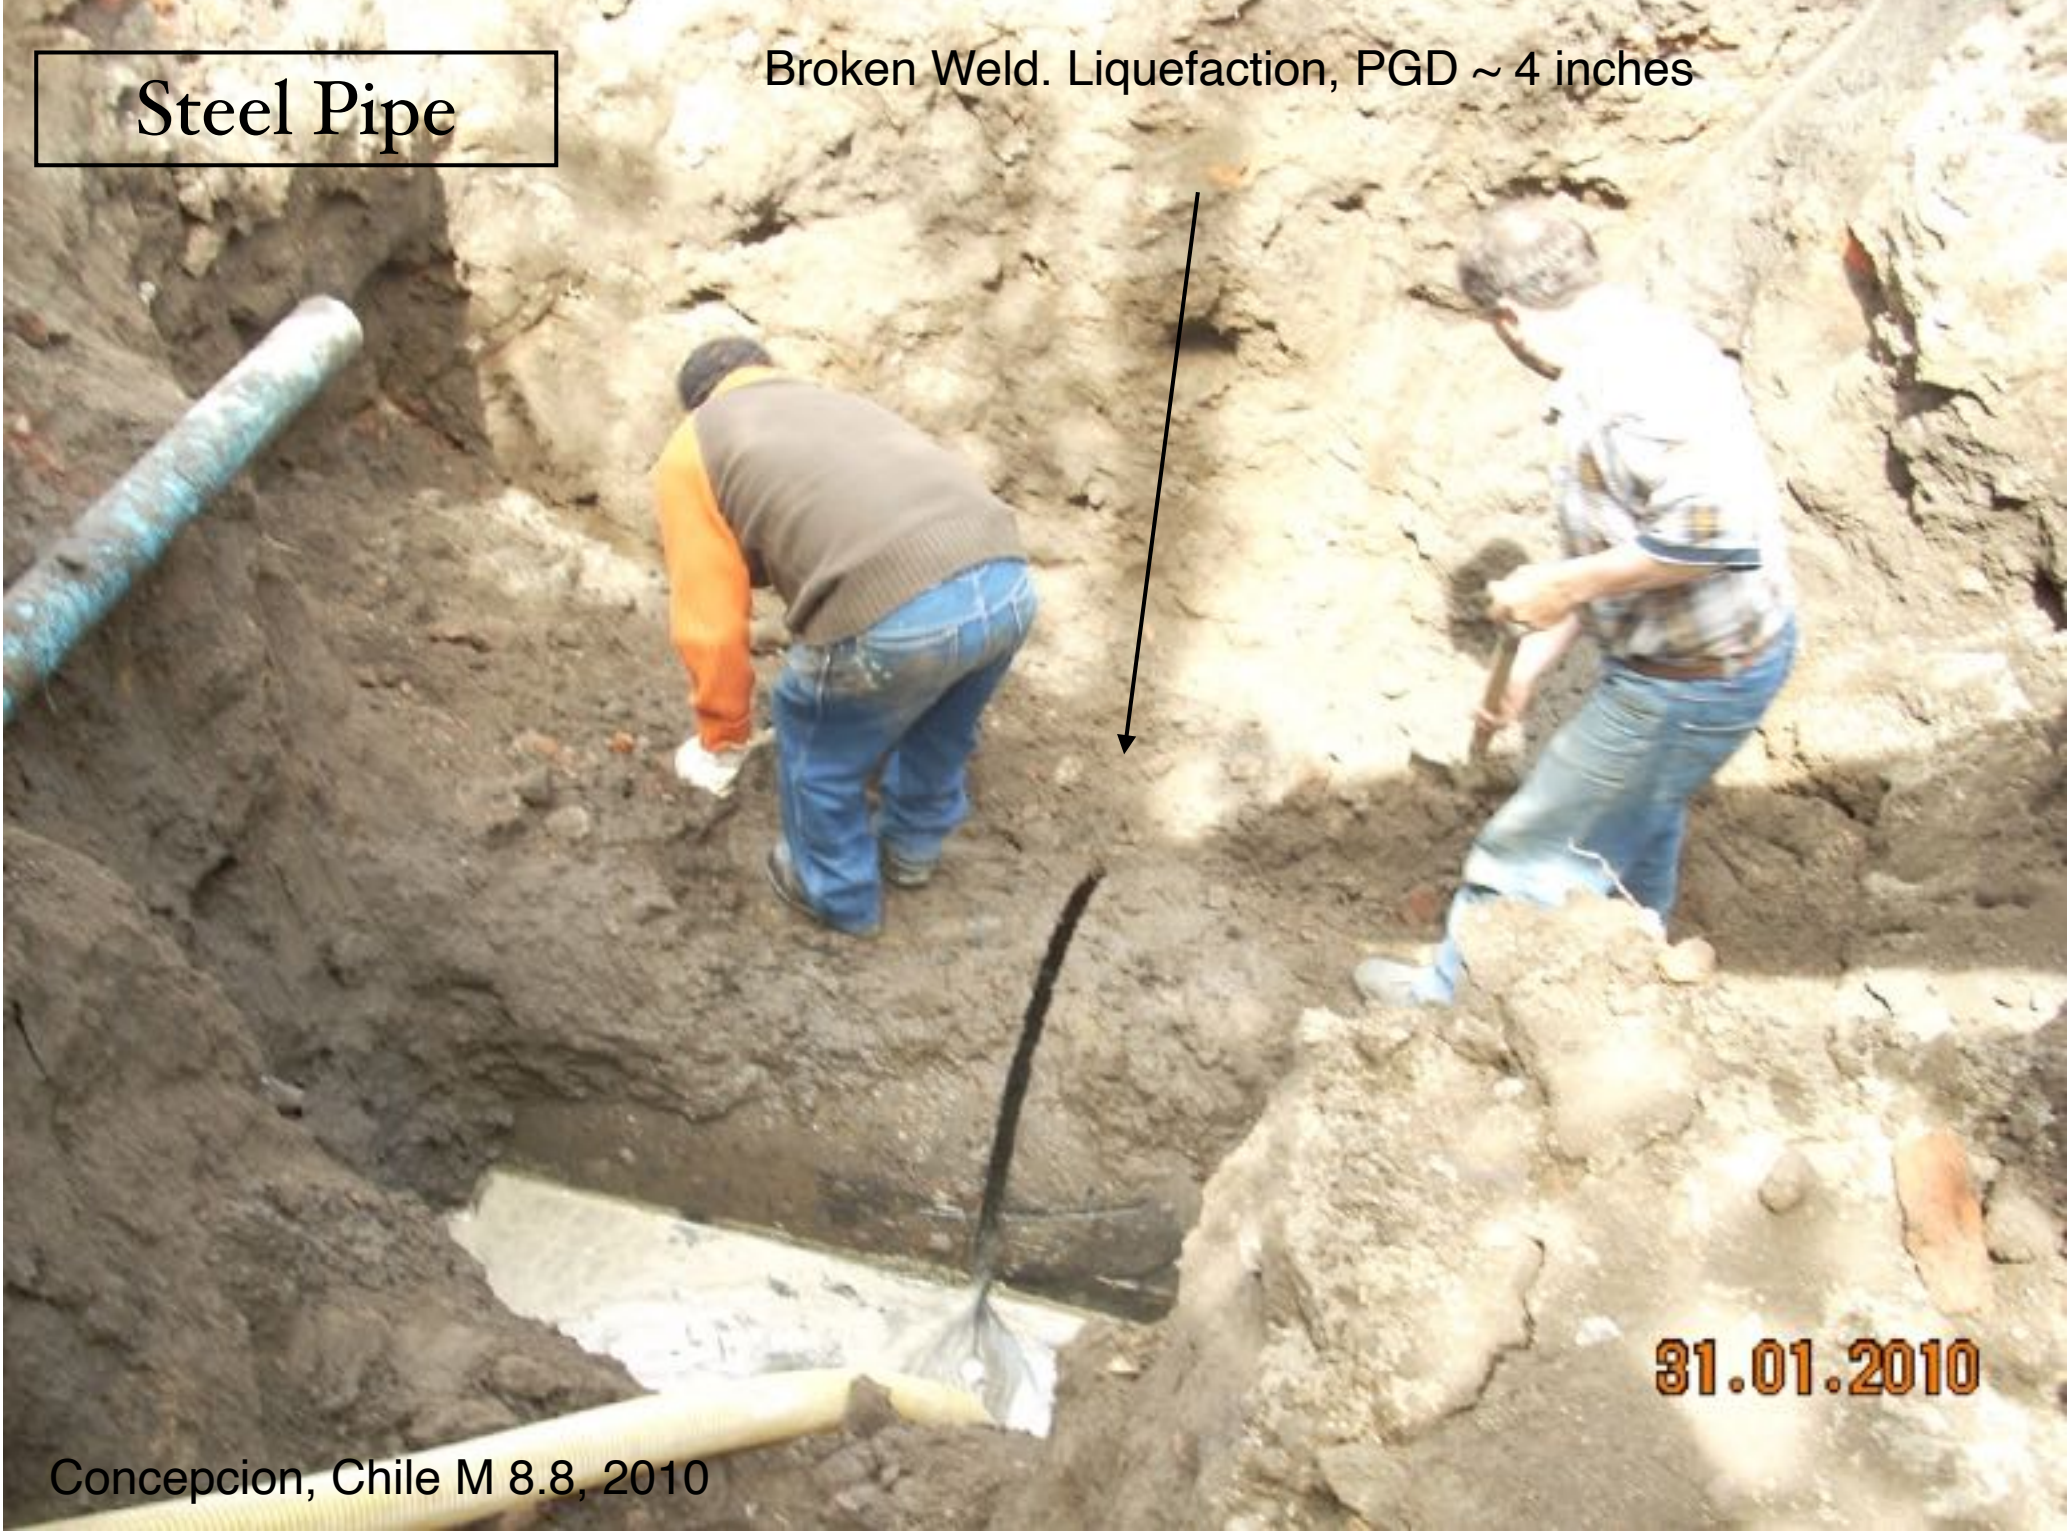
Steel Pipe

Broken Weld. Liquefaction, PGD ~ 4 inches

Concepcion, Chile M 8.8, 2010

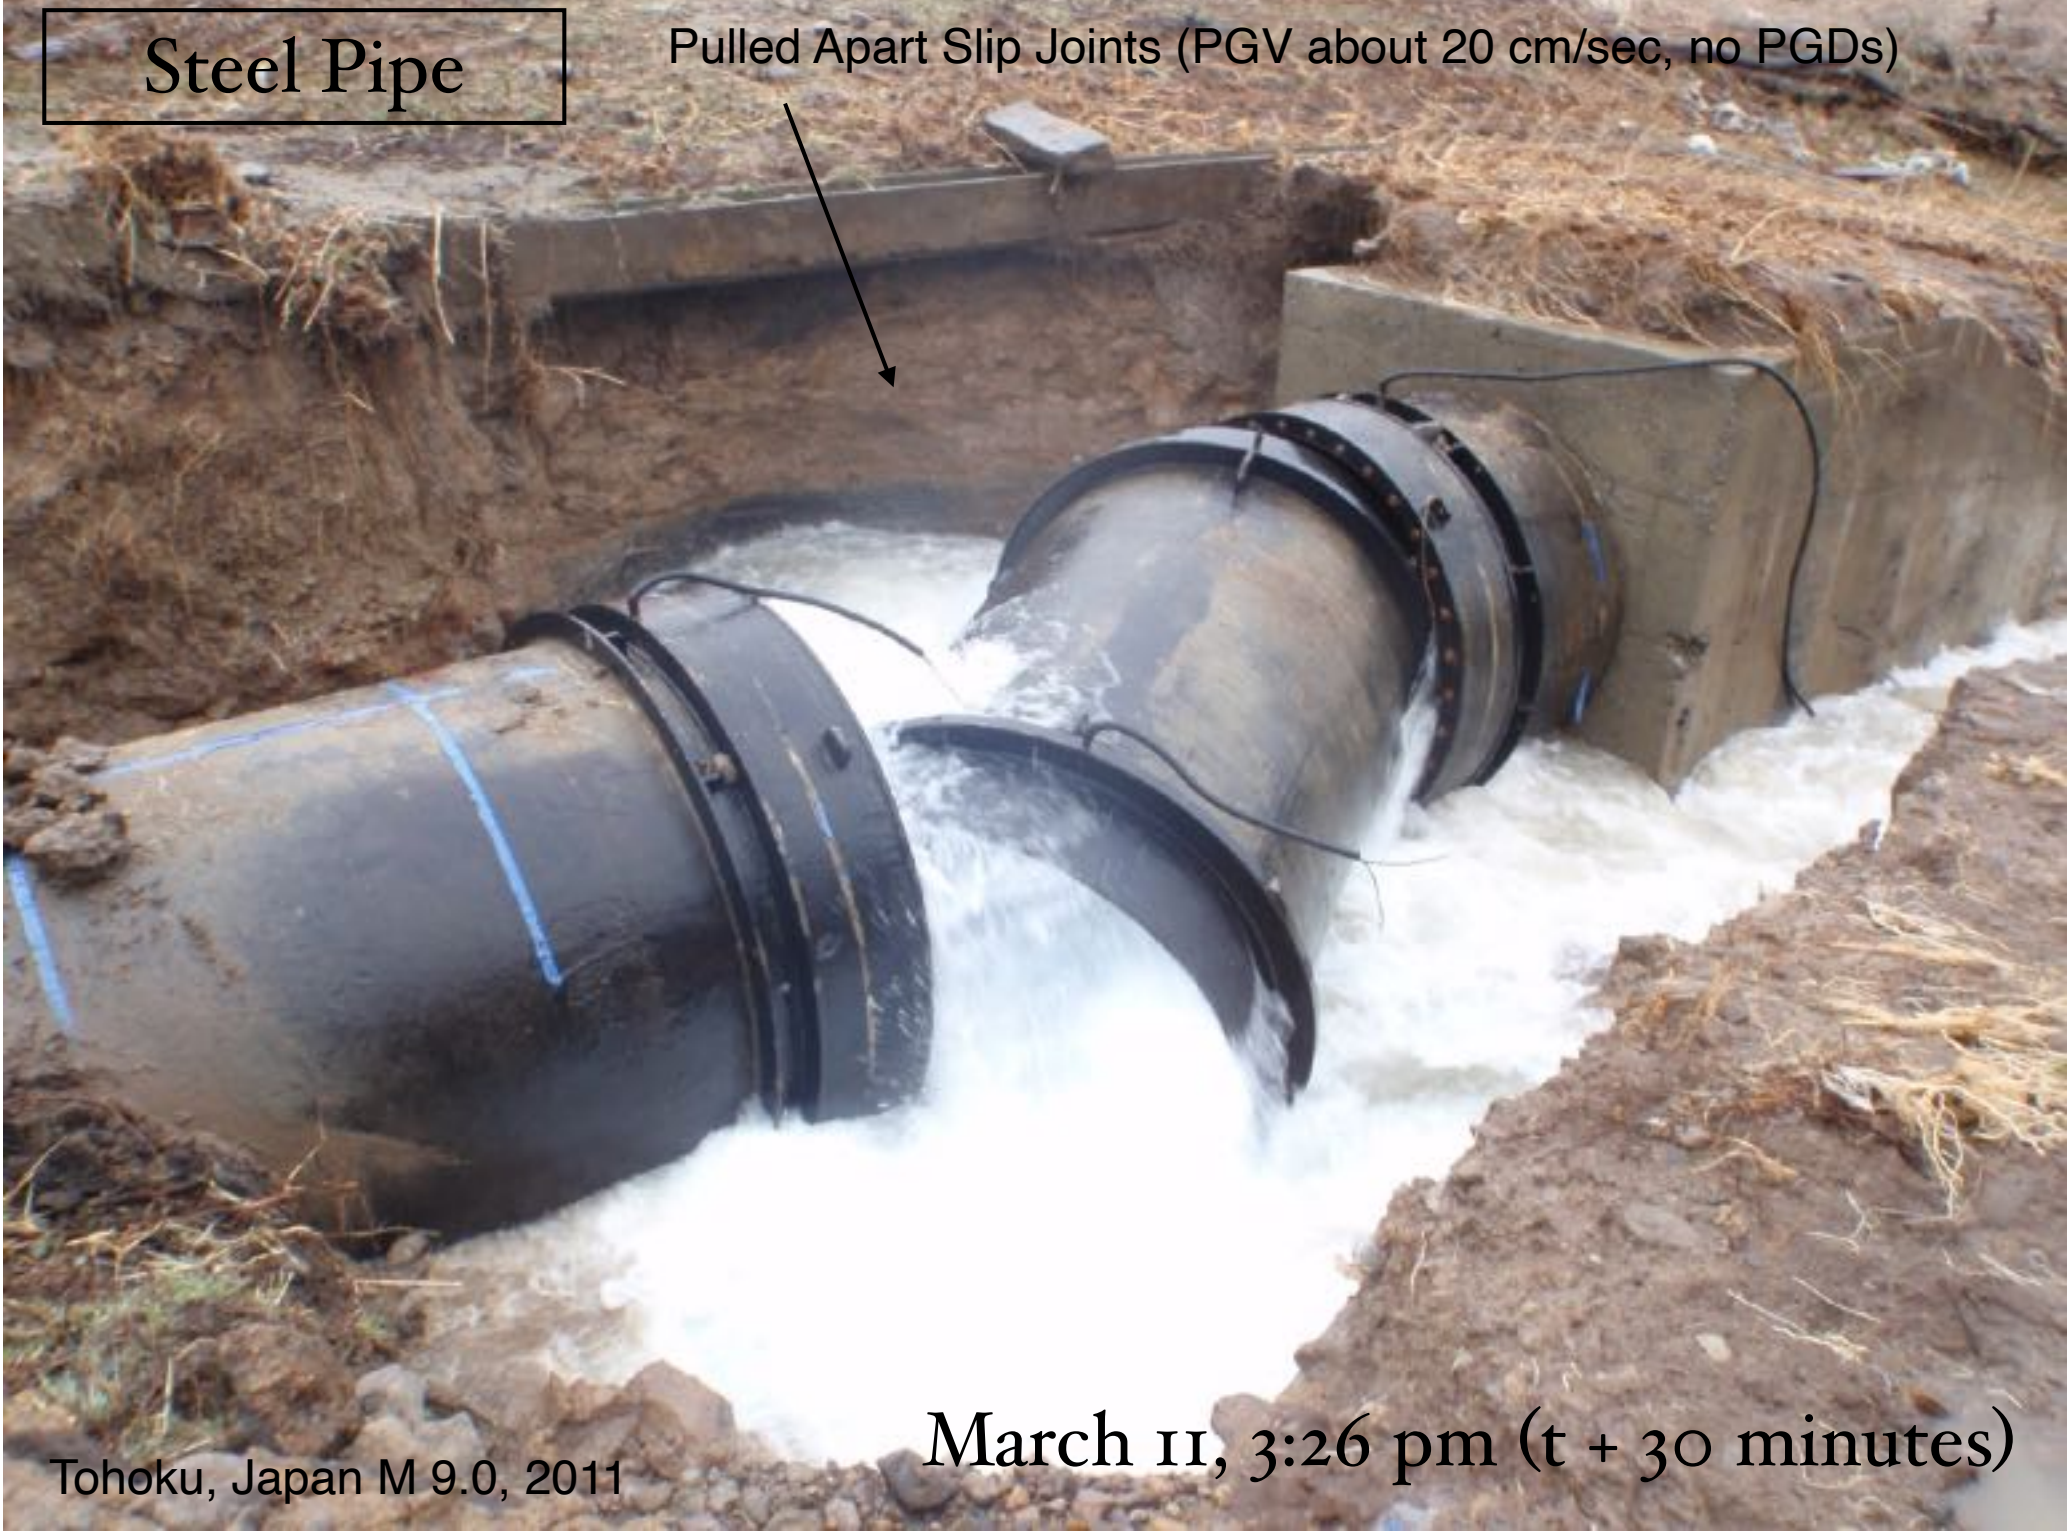
Steel Pipe

Pulled Apart Slip Joints (PGV about 20 cm/sec, no PGDs)

Tohoku, Japan M 9.0, 2011

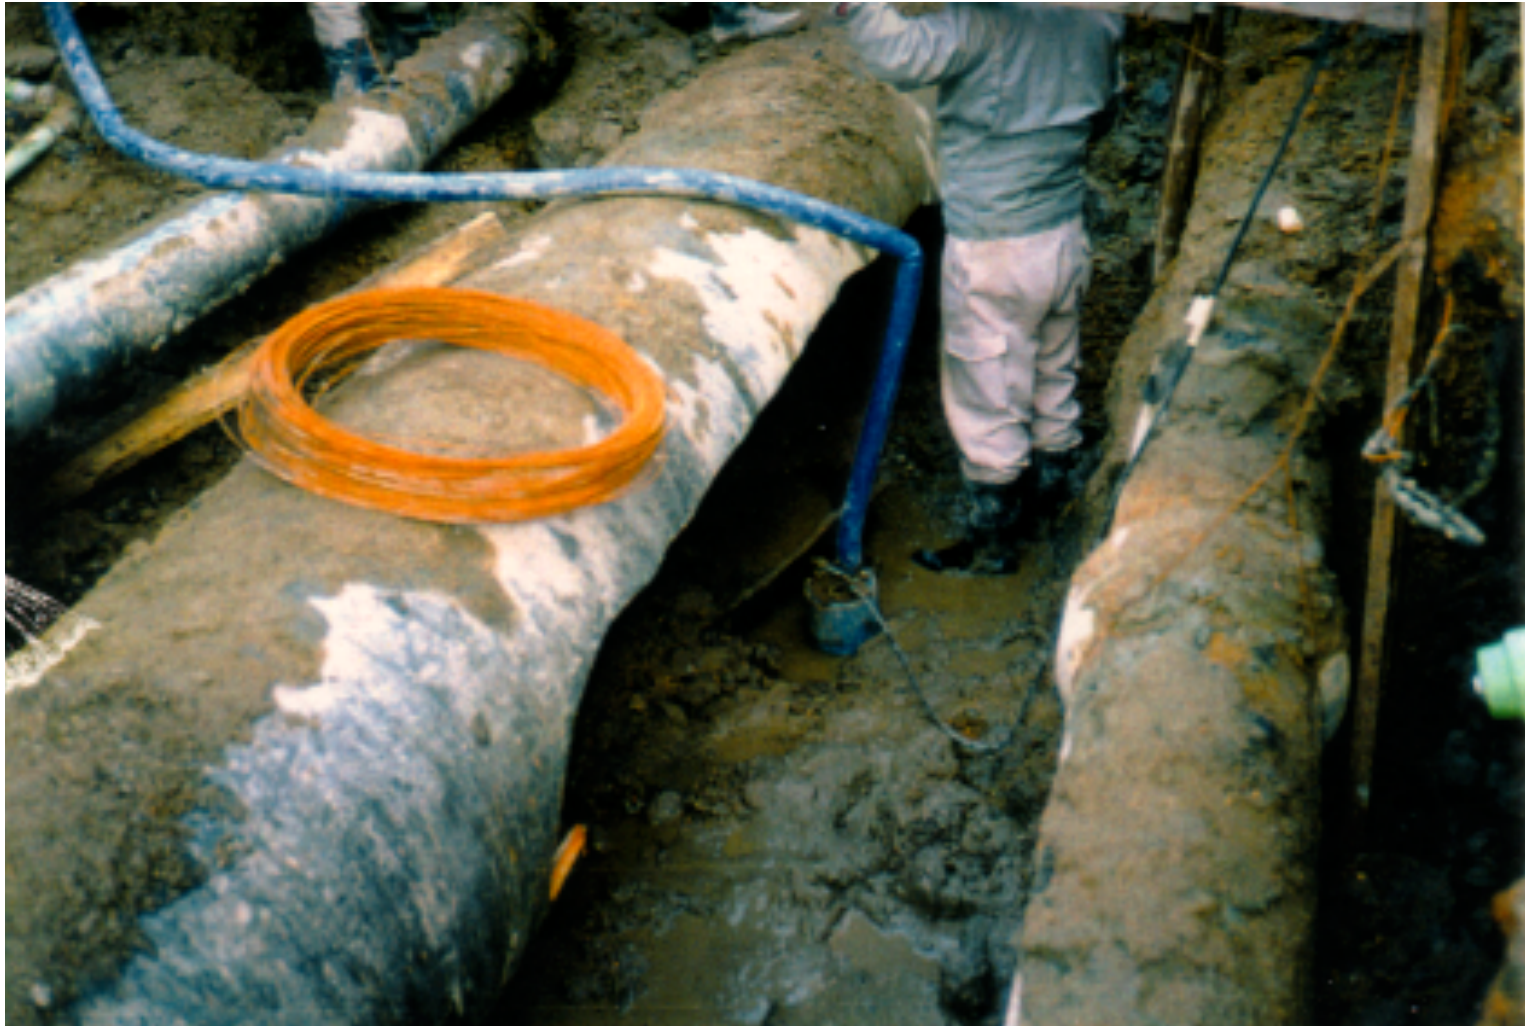
Cast Iron Pipe

Kobe, Japan M 6.9, 1995

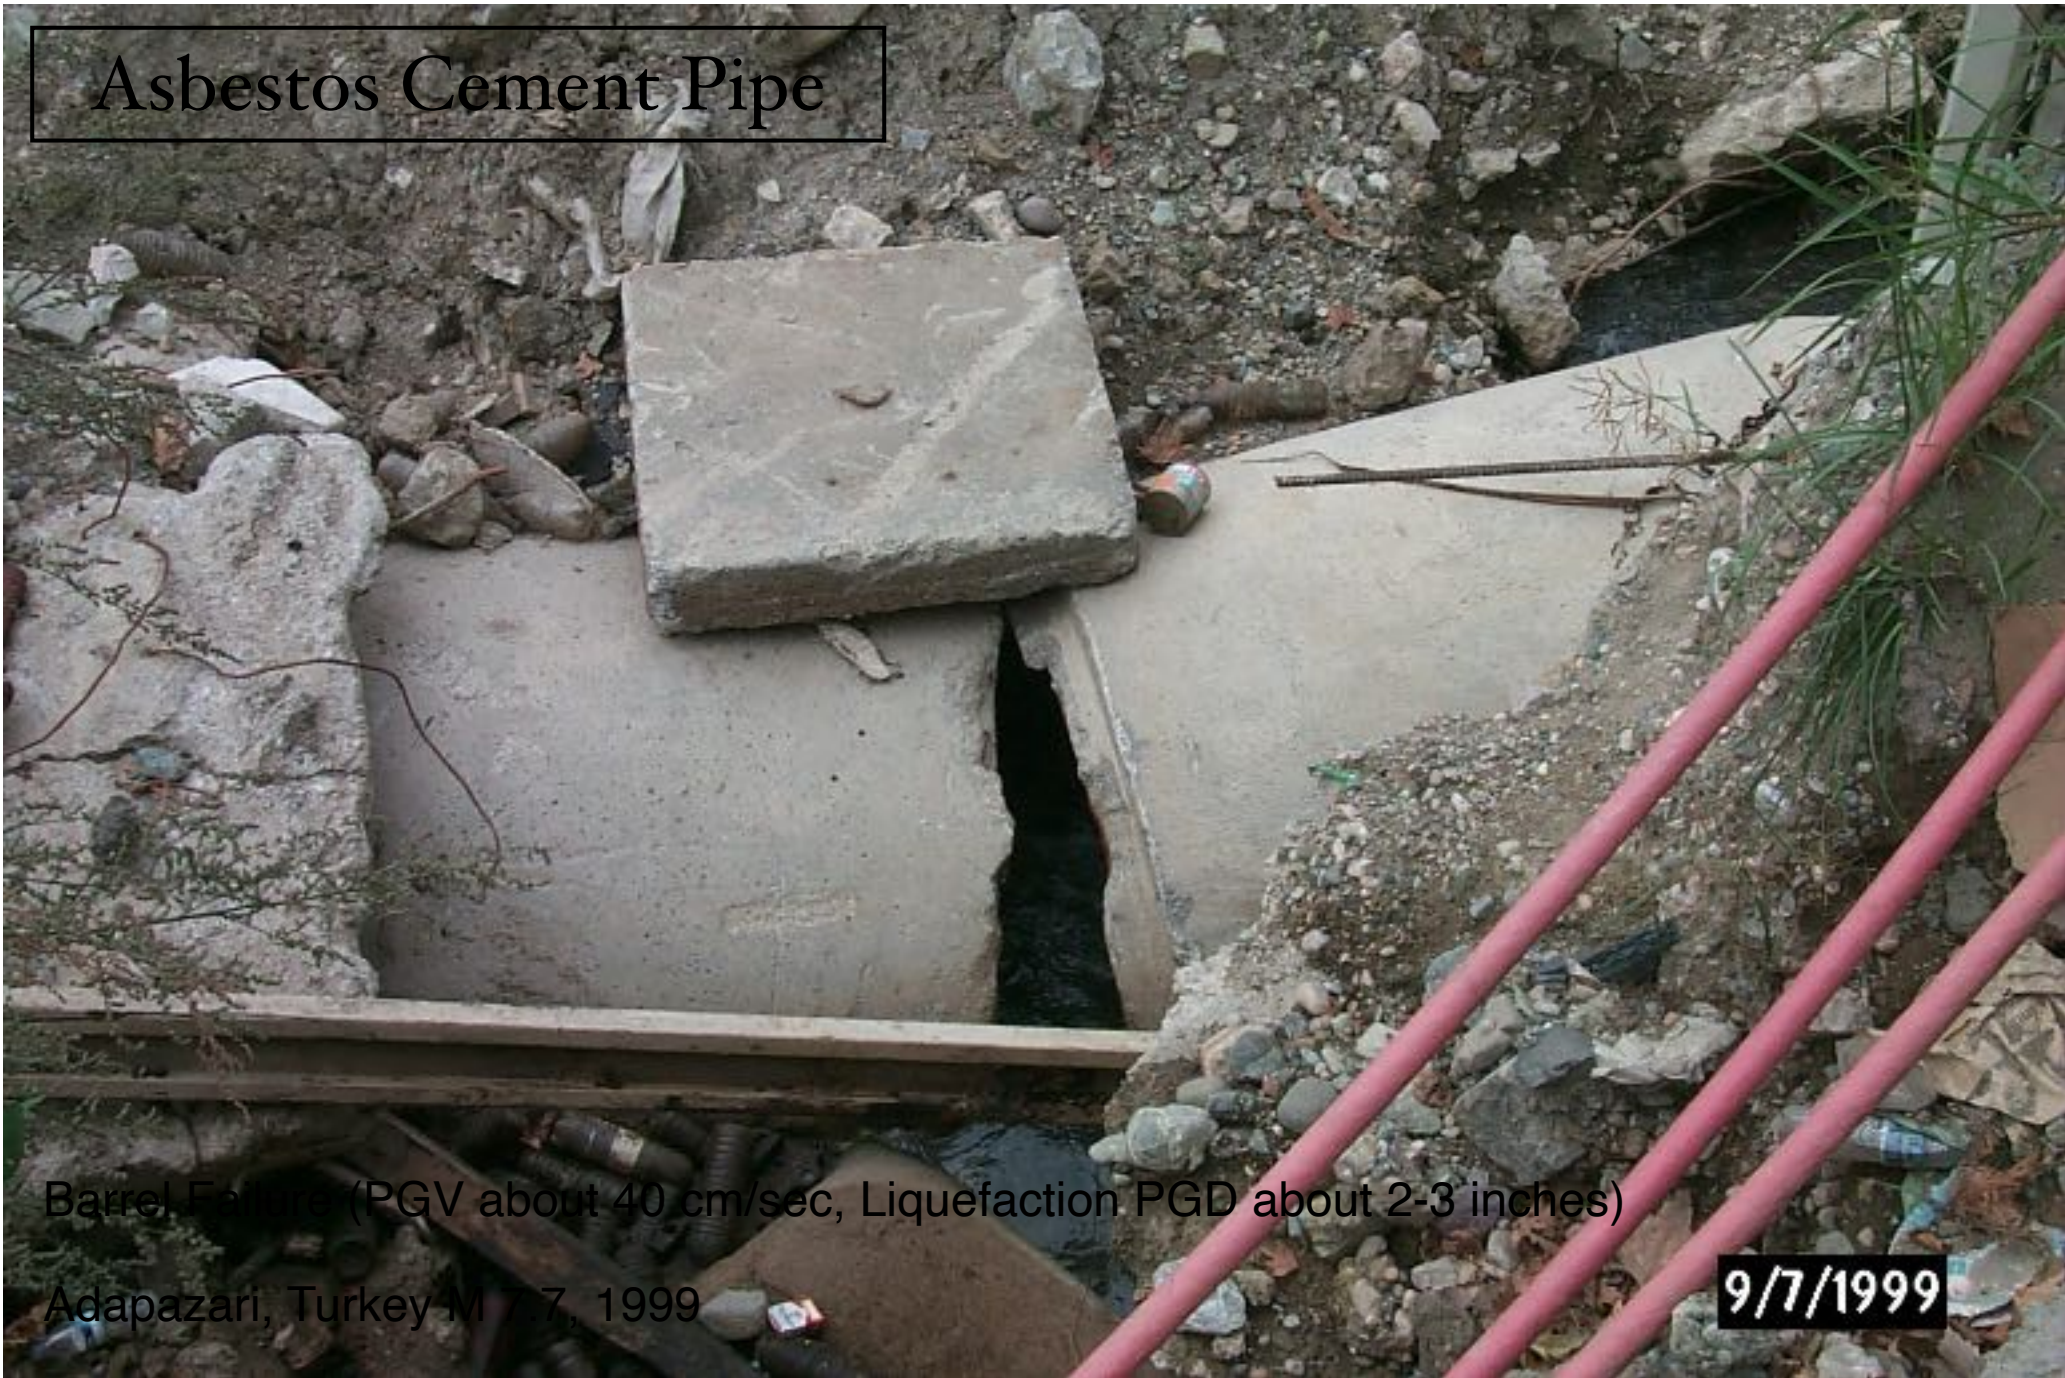
Asbestos Cement Pipe

Barrel Failure (PGV about 40 cm/sec, Liquefaction PGD about 2-3 inches)

Adapazari, Turkey M 7.7, 1999

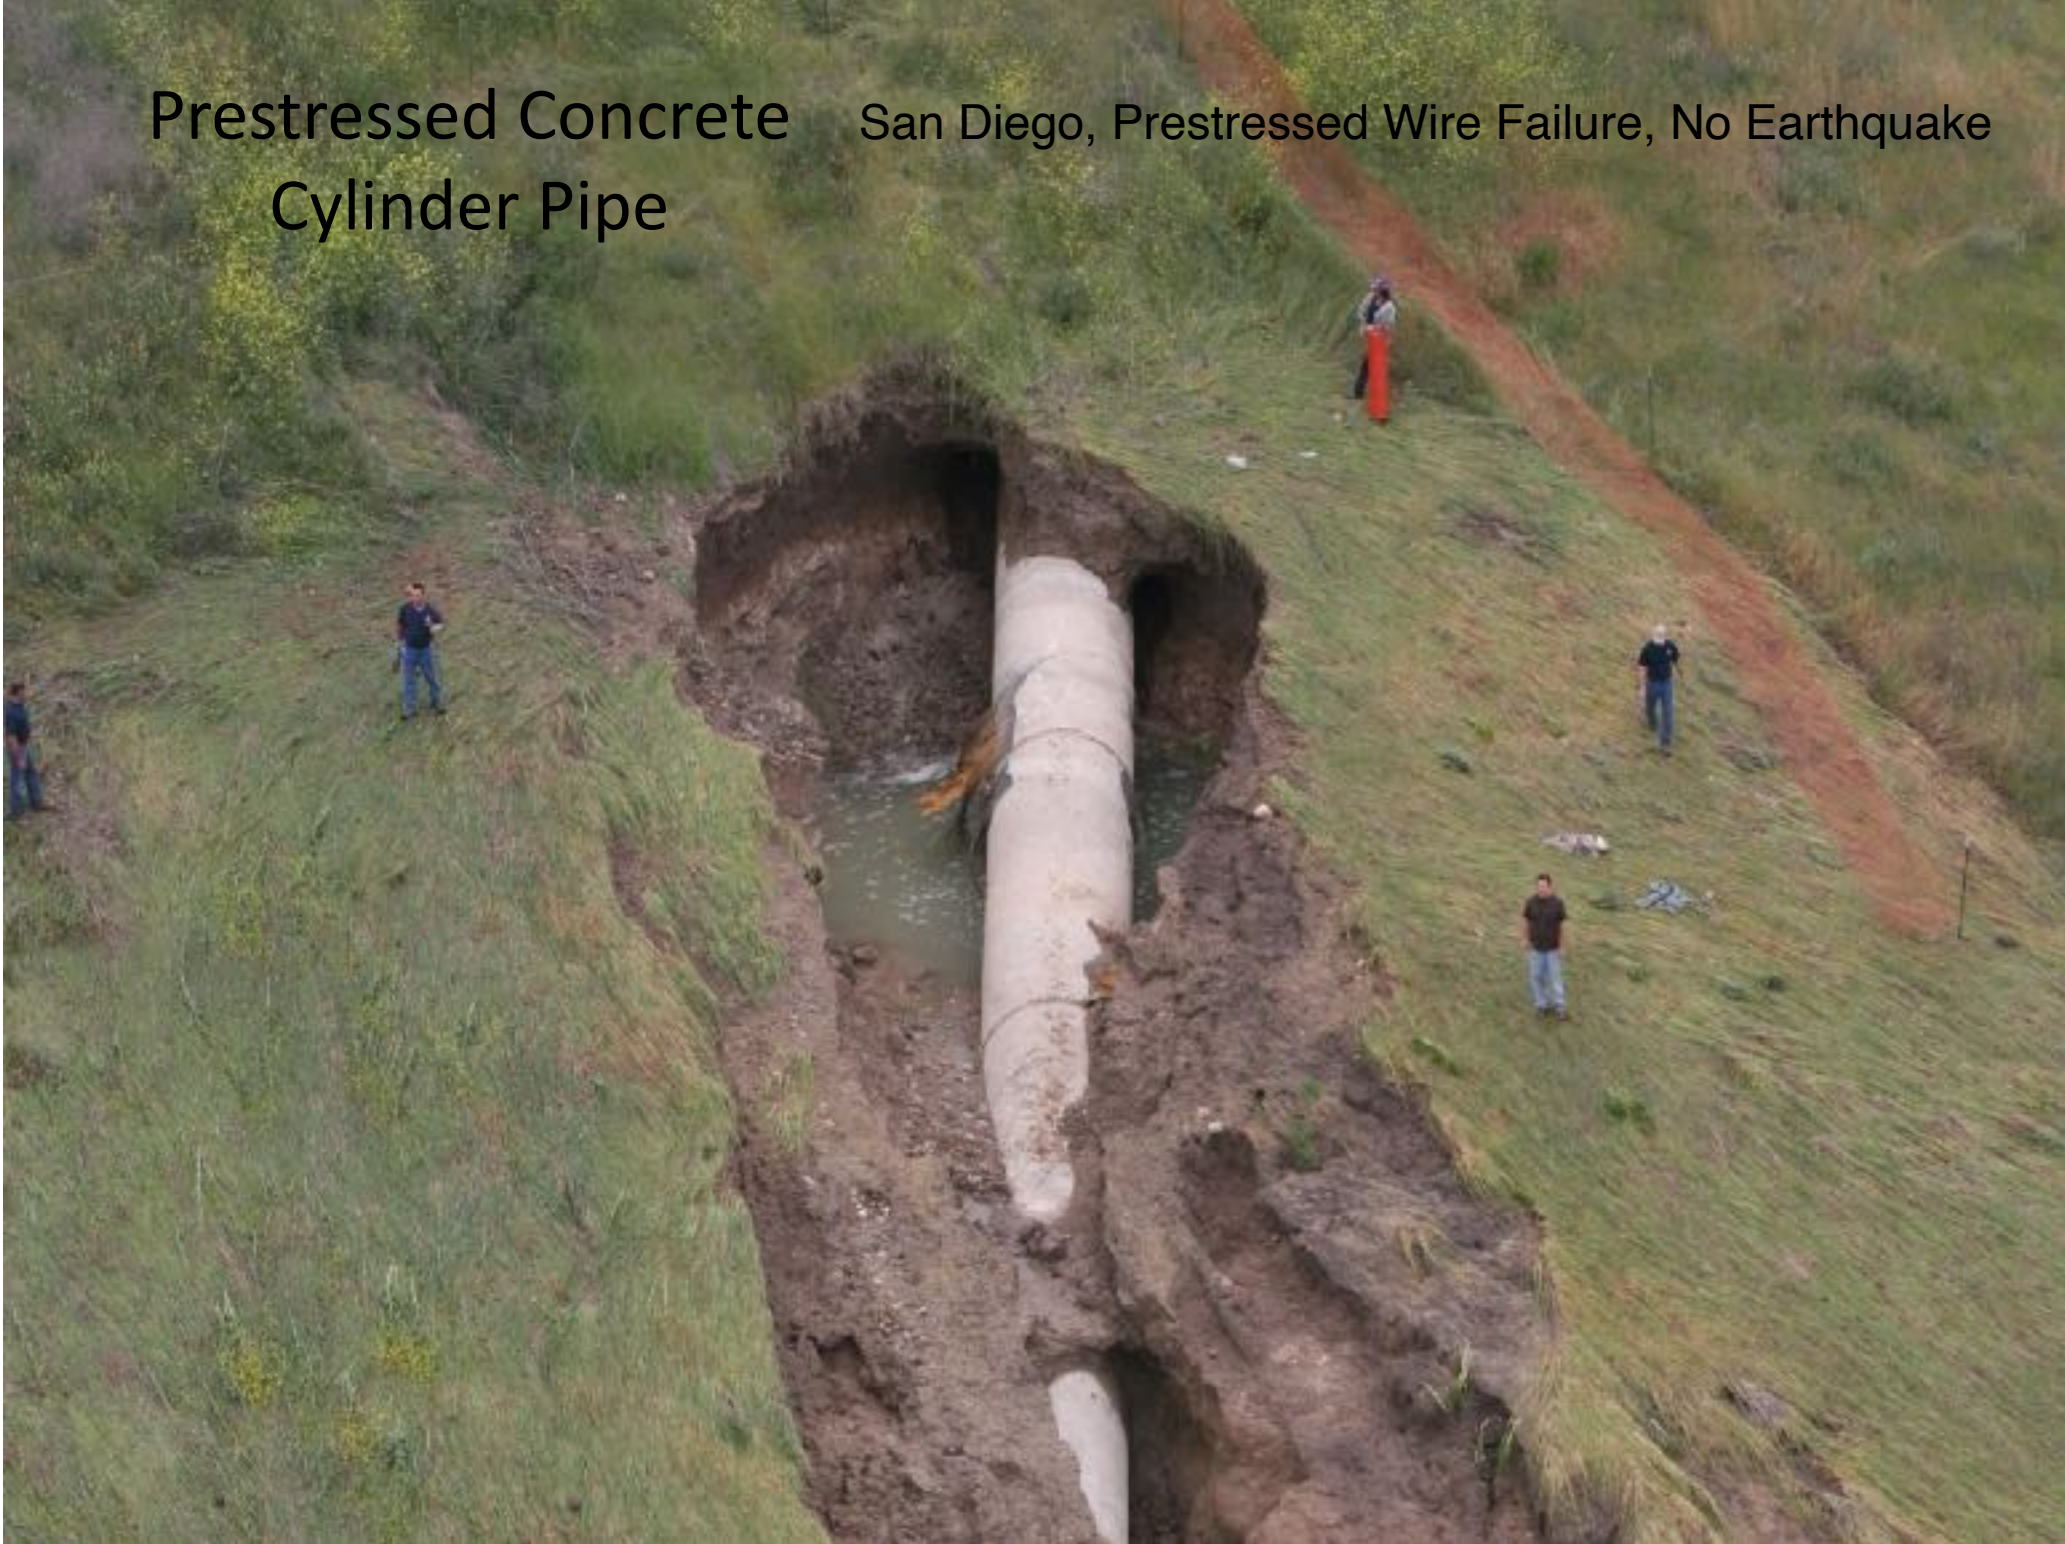
Prestressed Concrete Cylinder Pipe

San Diego, Prestressed Wire Failure, No Earthquake

- Hoop Stress: = $pressure * radius / thickness$
- Longitudinal Stress: = Hoop Stress / 2
- Why divide by 2? Because almost all water pipe codes (AWWA) ignore seismic loads
- This is a HUGE ERROR for seismic design

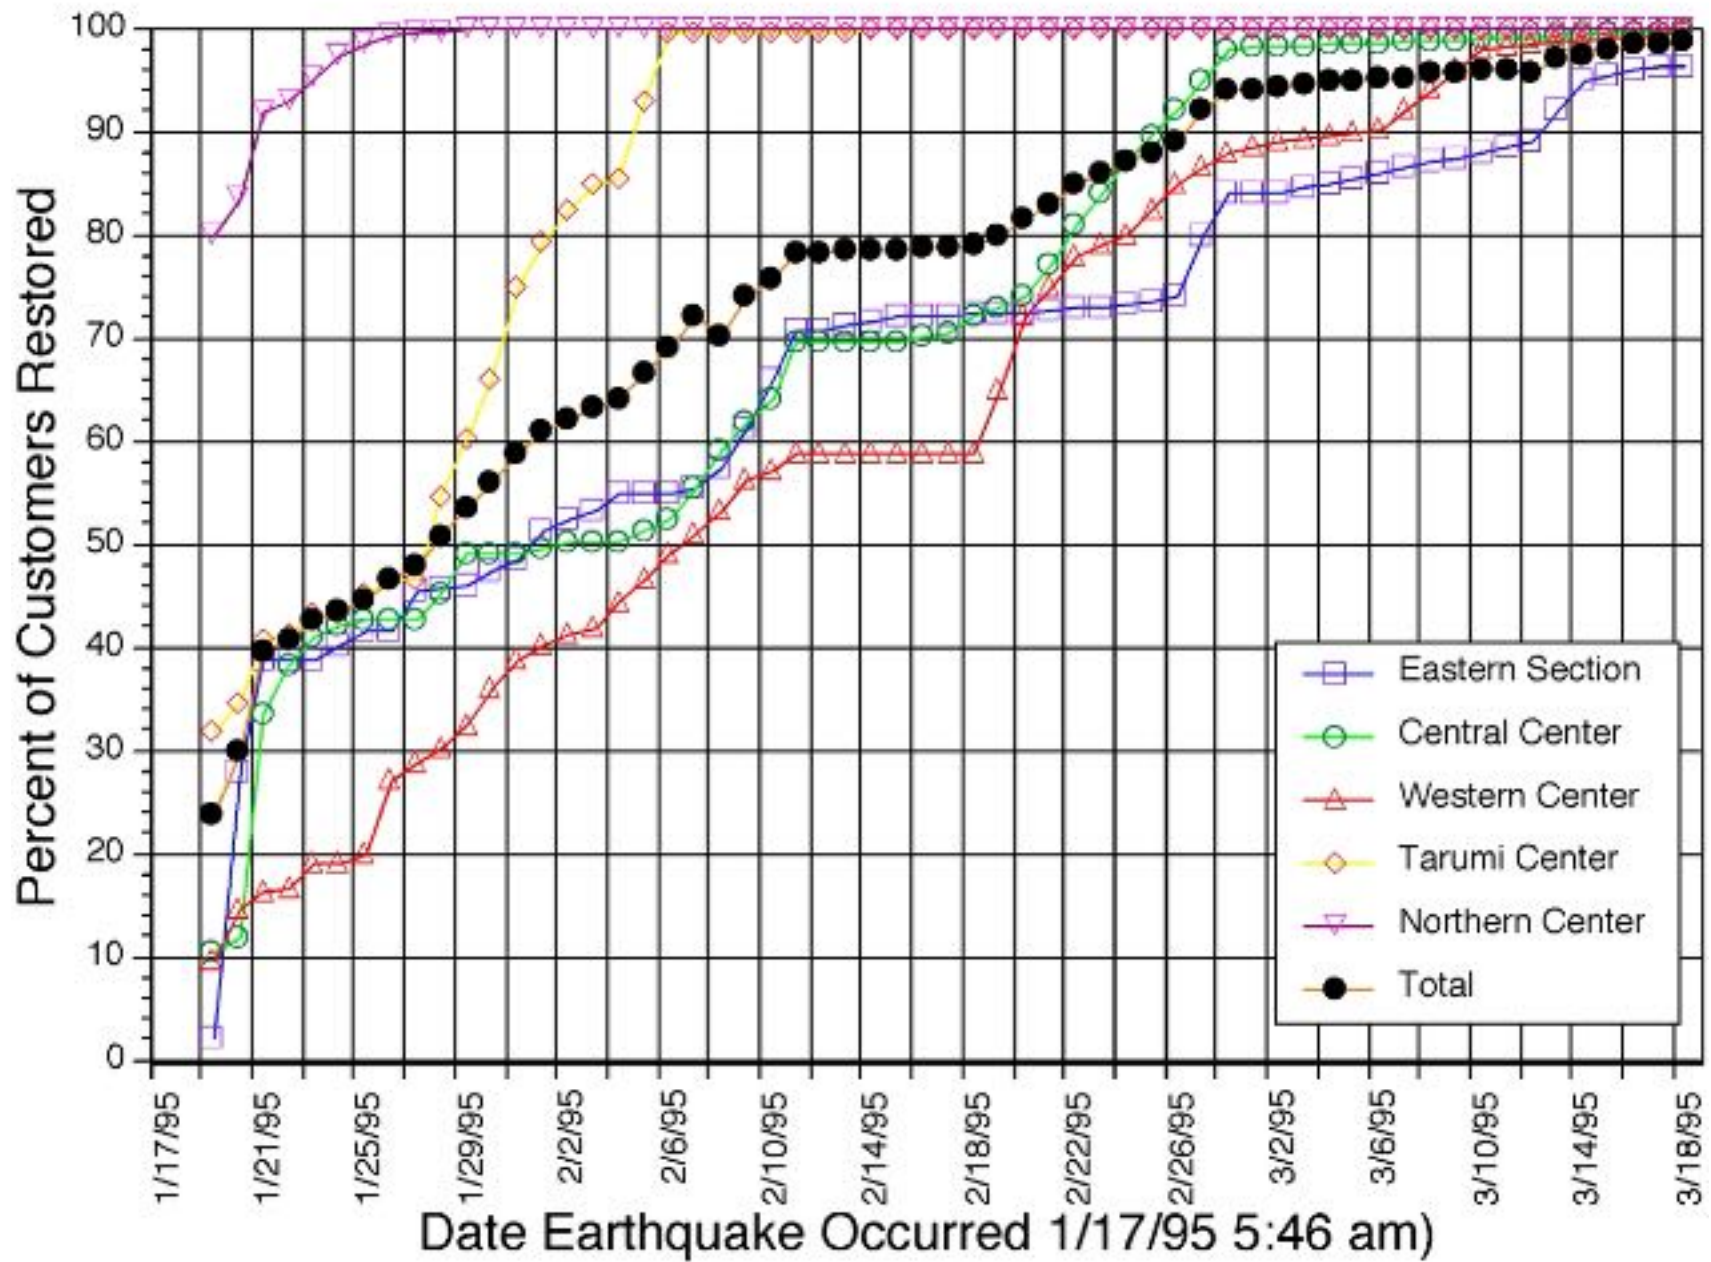
City of Kobe Water System Service Restoration
