Berkeley Davis Hall Water System Earthquake Issues

John Eiding

EERI

April 15 2024

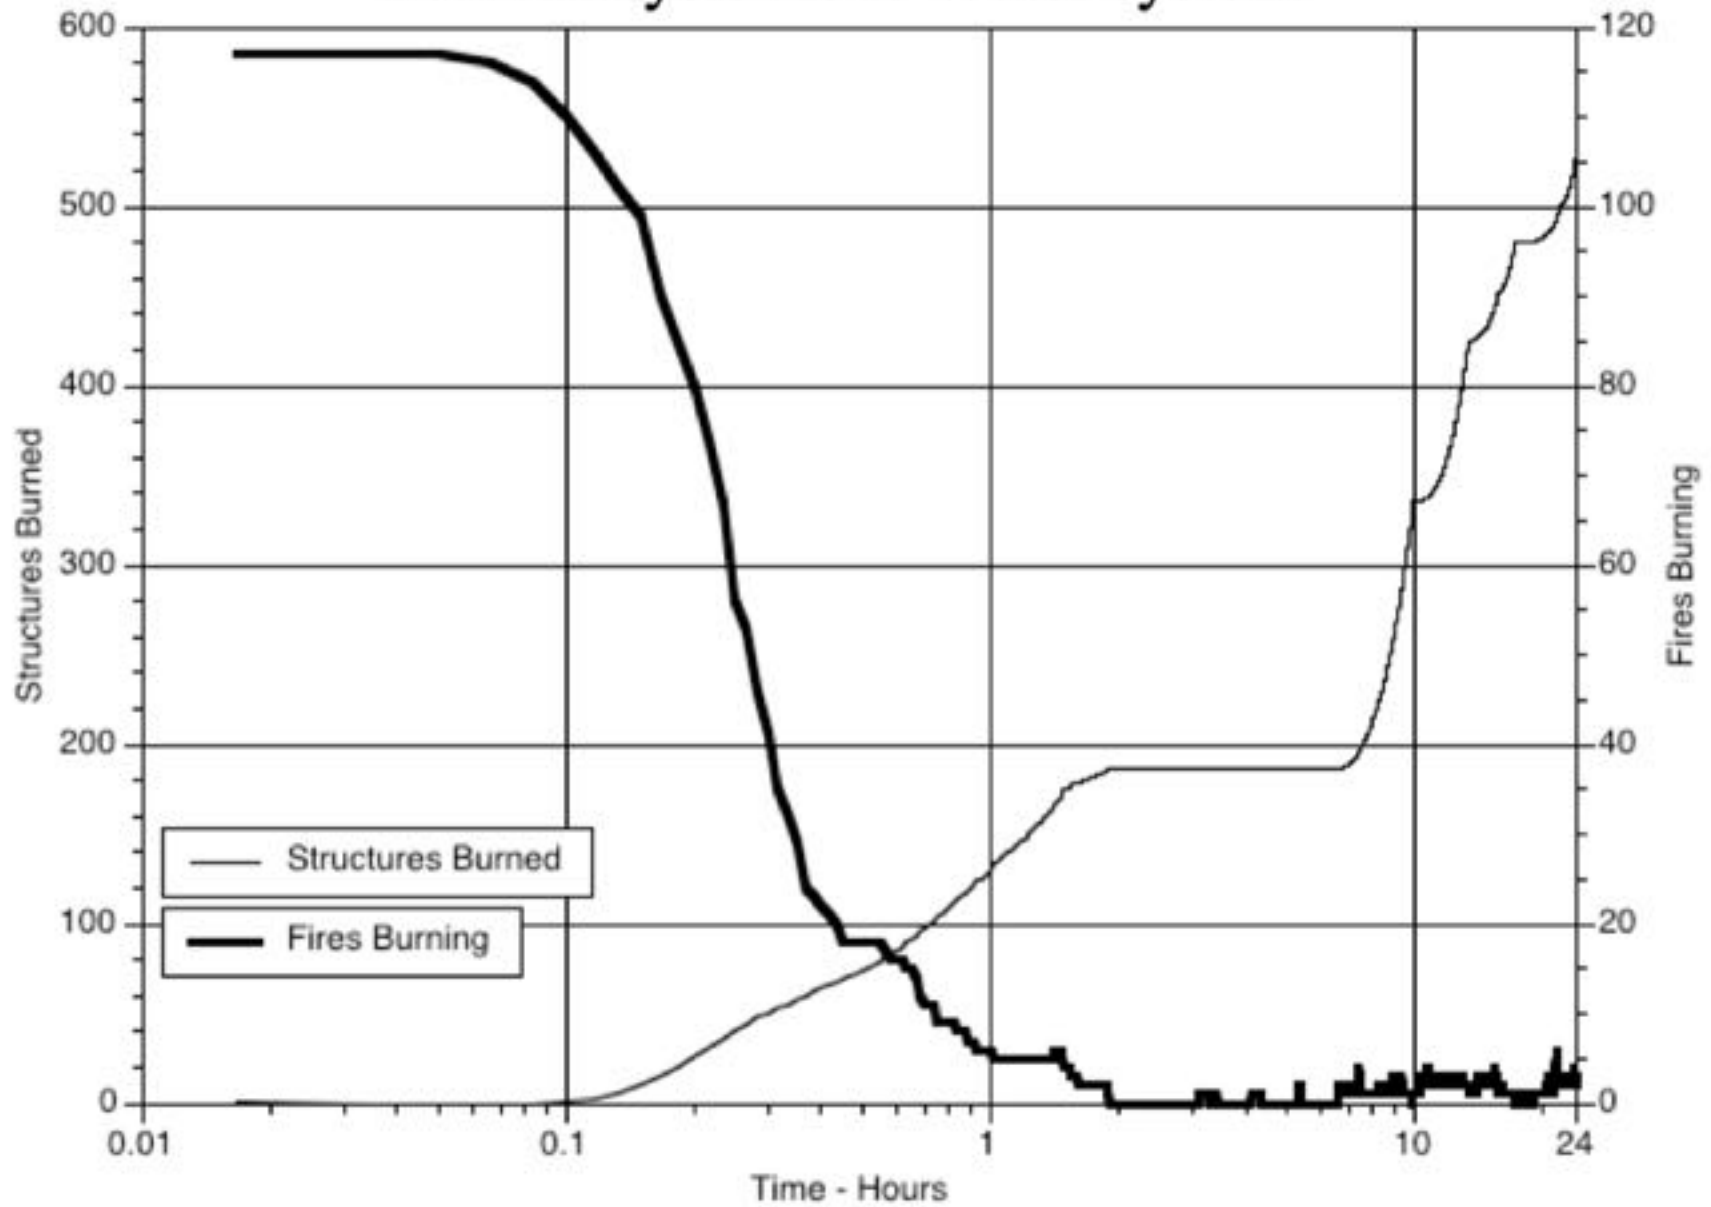
Fire Following Earthquake Full Analysis As Is Water system

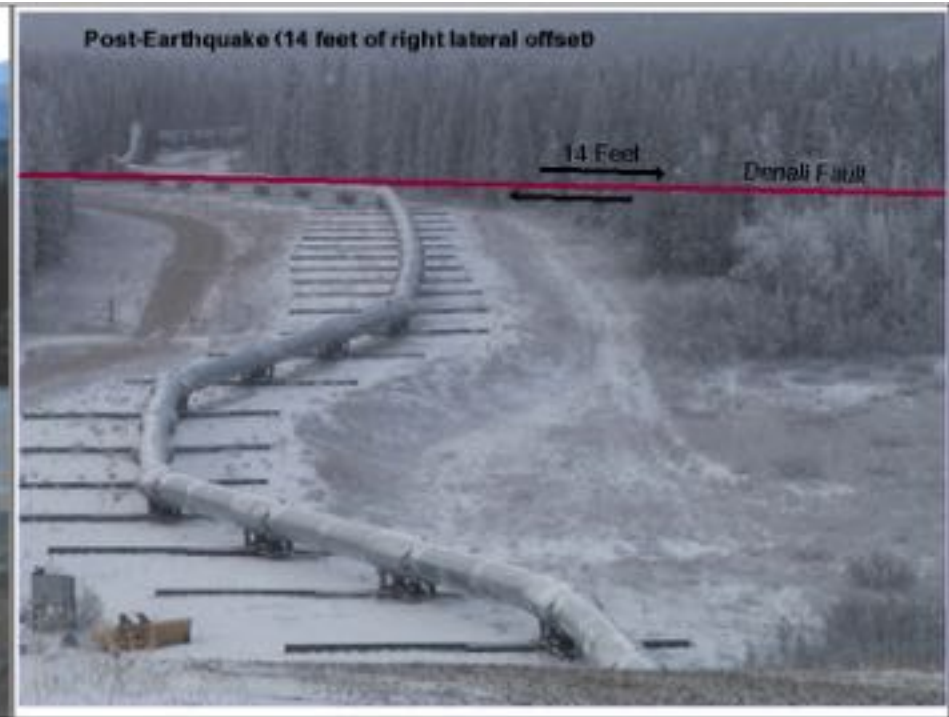
Seismic Design by Ed Keith c. 1970. Designed for 20 feet of right lateral offset. Designed to remain elastic assuming using El Centro 1940 motion (PGA = 0.33g)

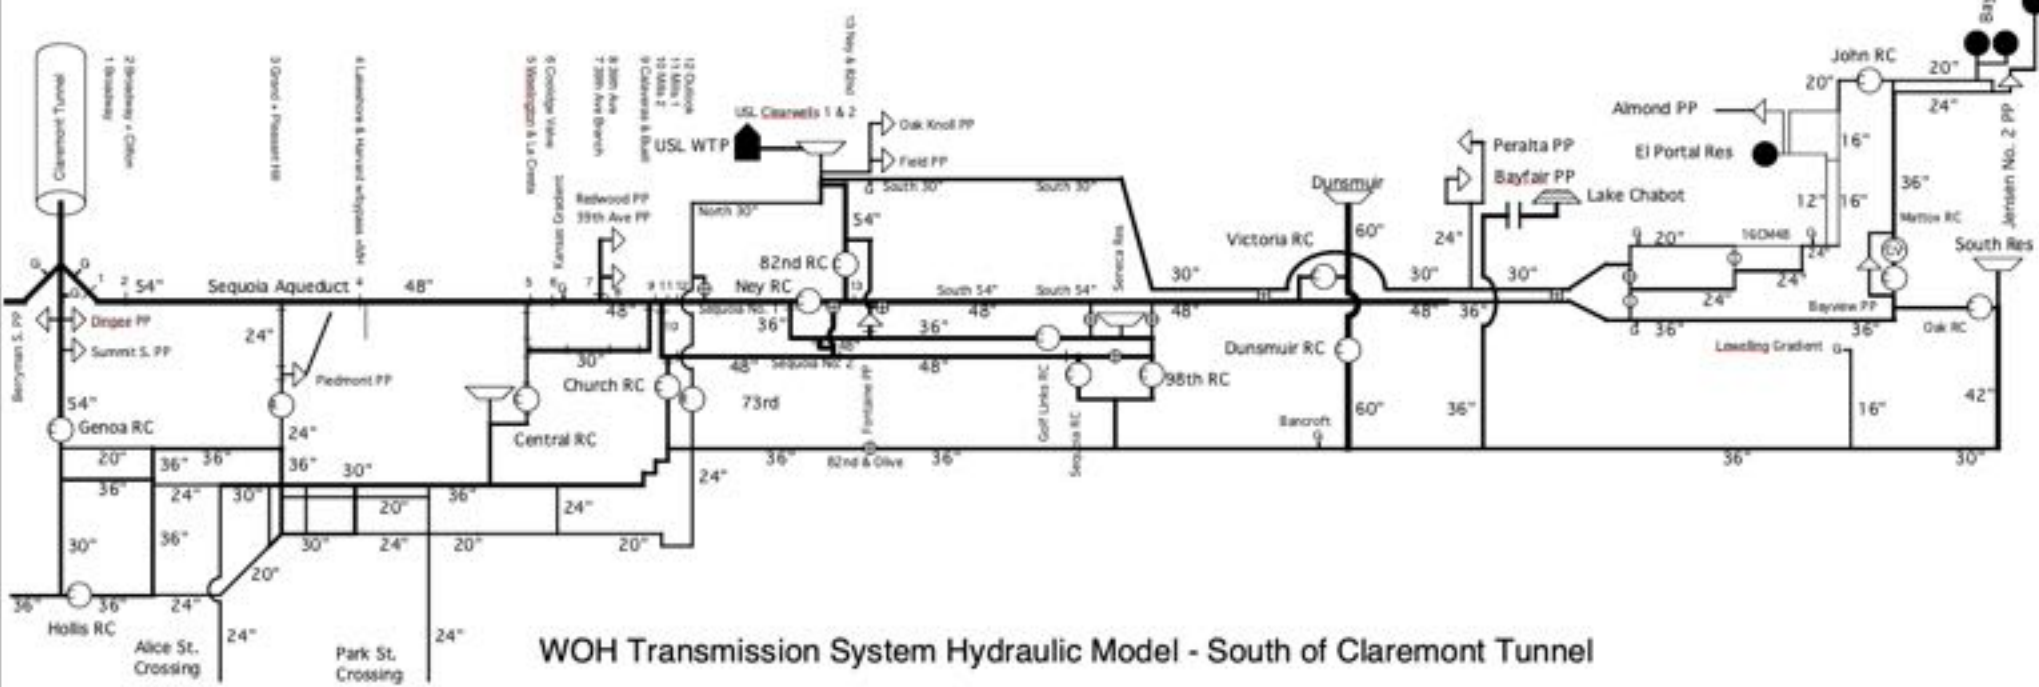
WOH Transmission System Hydraulic Model - South of Claremont Tunnel

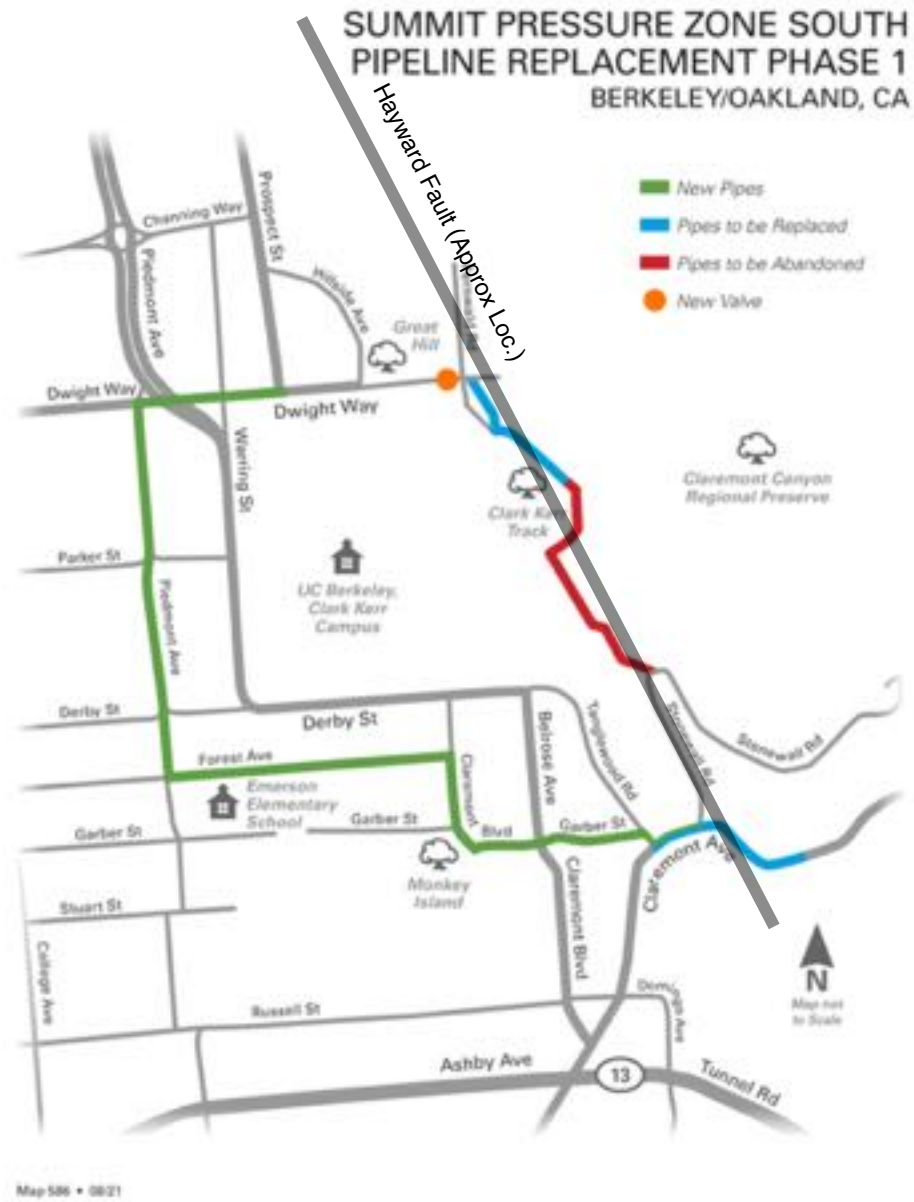
Upgraded in 2021 (Identified in 1991.... 30 years from initial concept to final implementation... still more phases in the future)

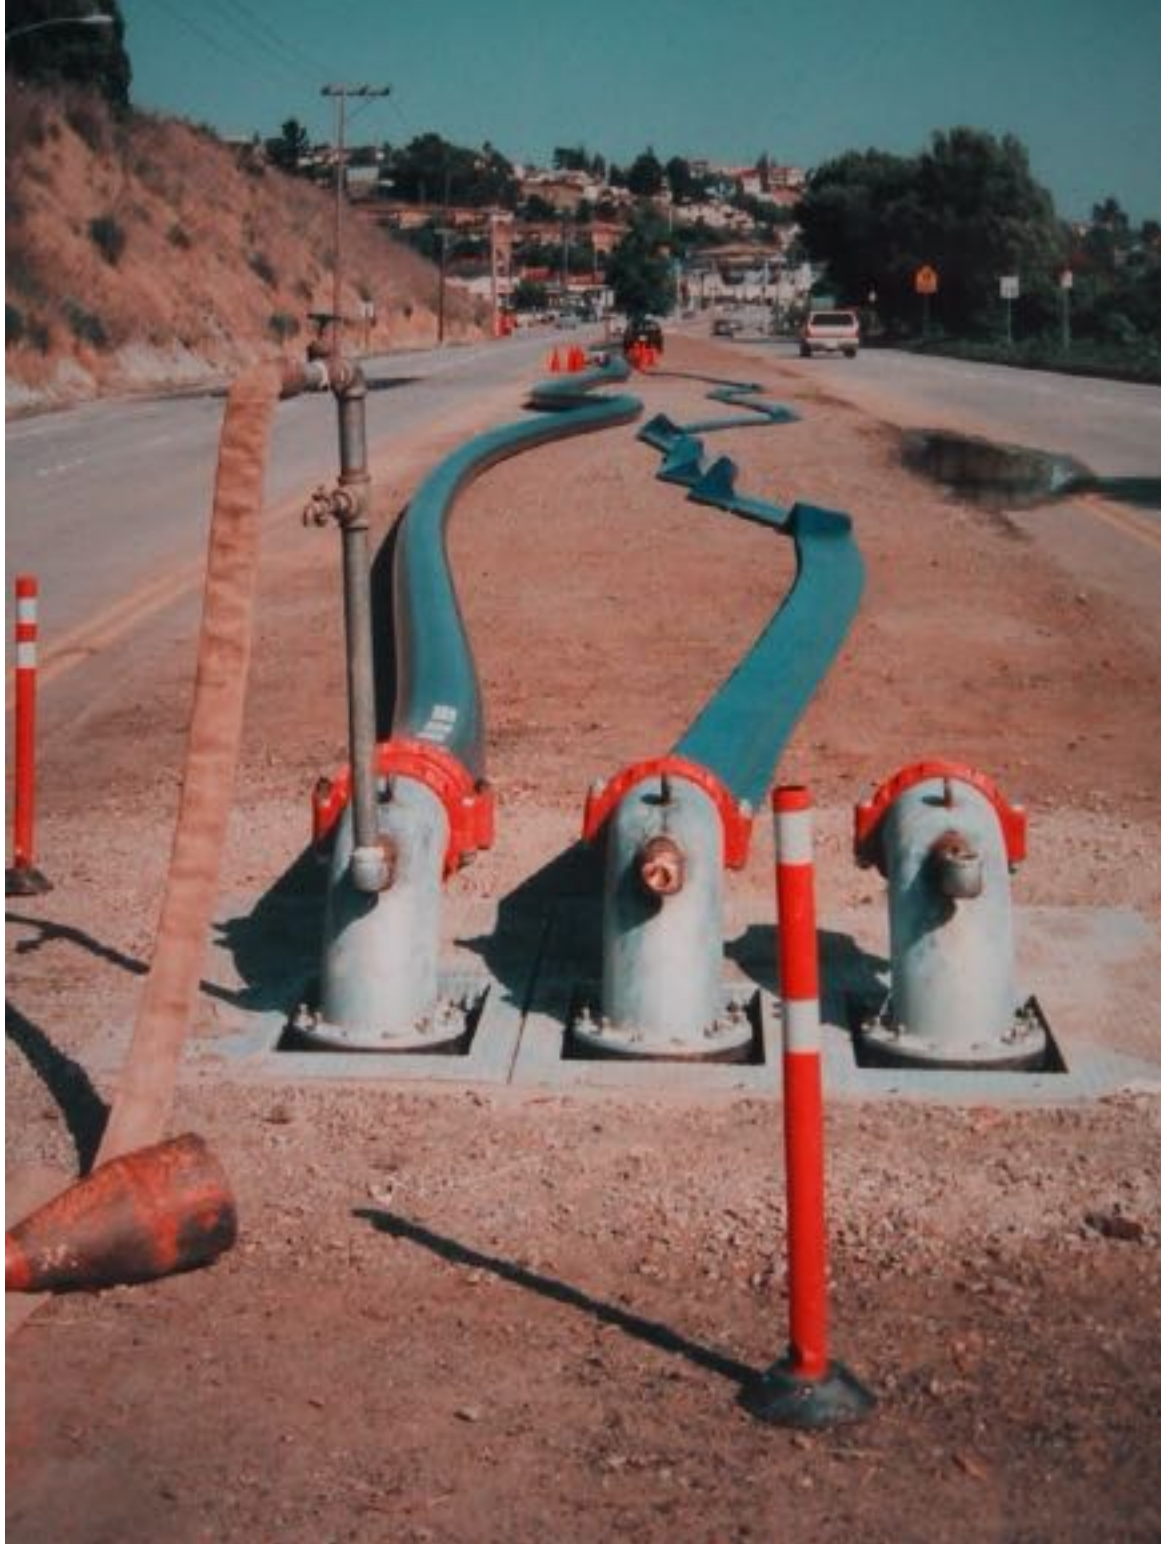
Angus Flex Hose at EBMUD

Fault Crossing

- Original Application
- 3 hoses, 12", 10" and 8" diameter
- Provides parallel capability to a 24" pipe across the Hayward fault, near Castro Valley
- Design features abandoned: above grade elbows, steel elbows, 10" and 8" diameter hose

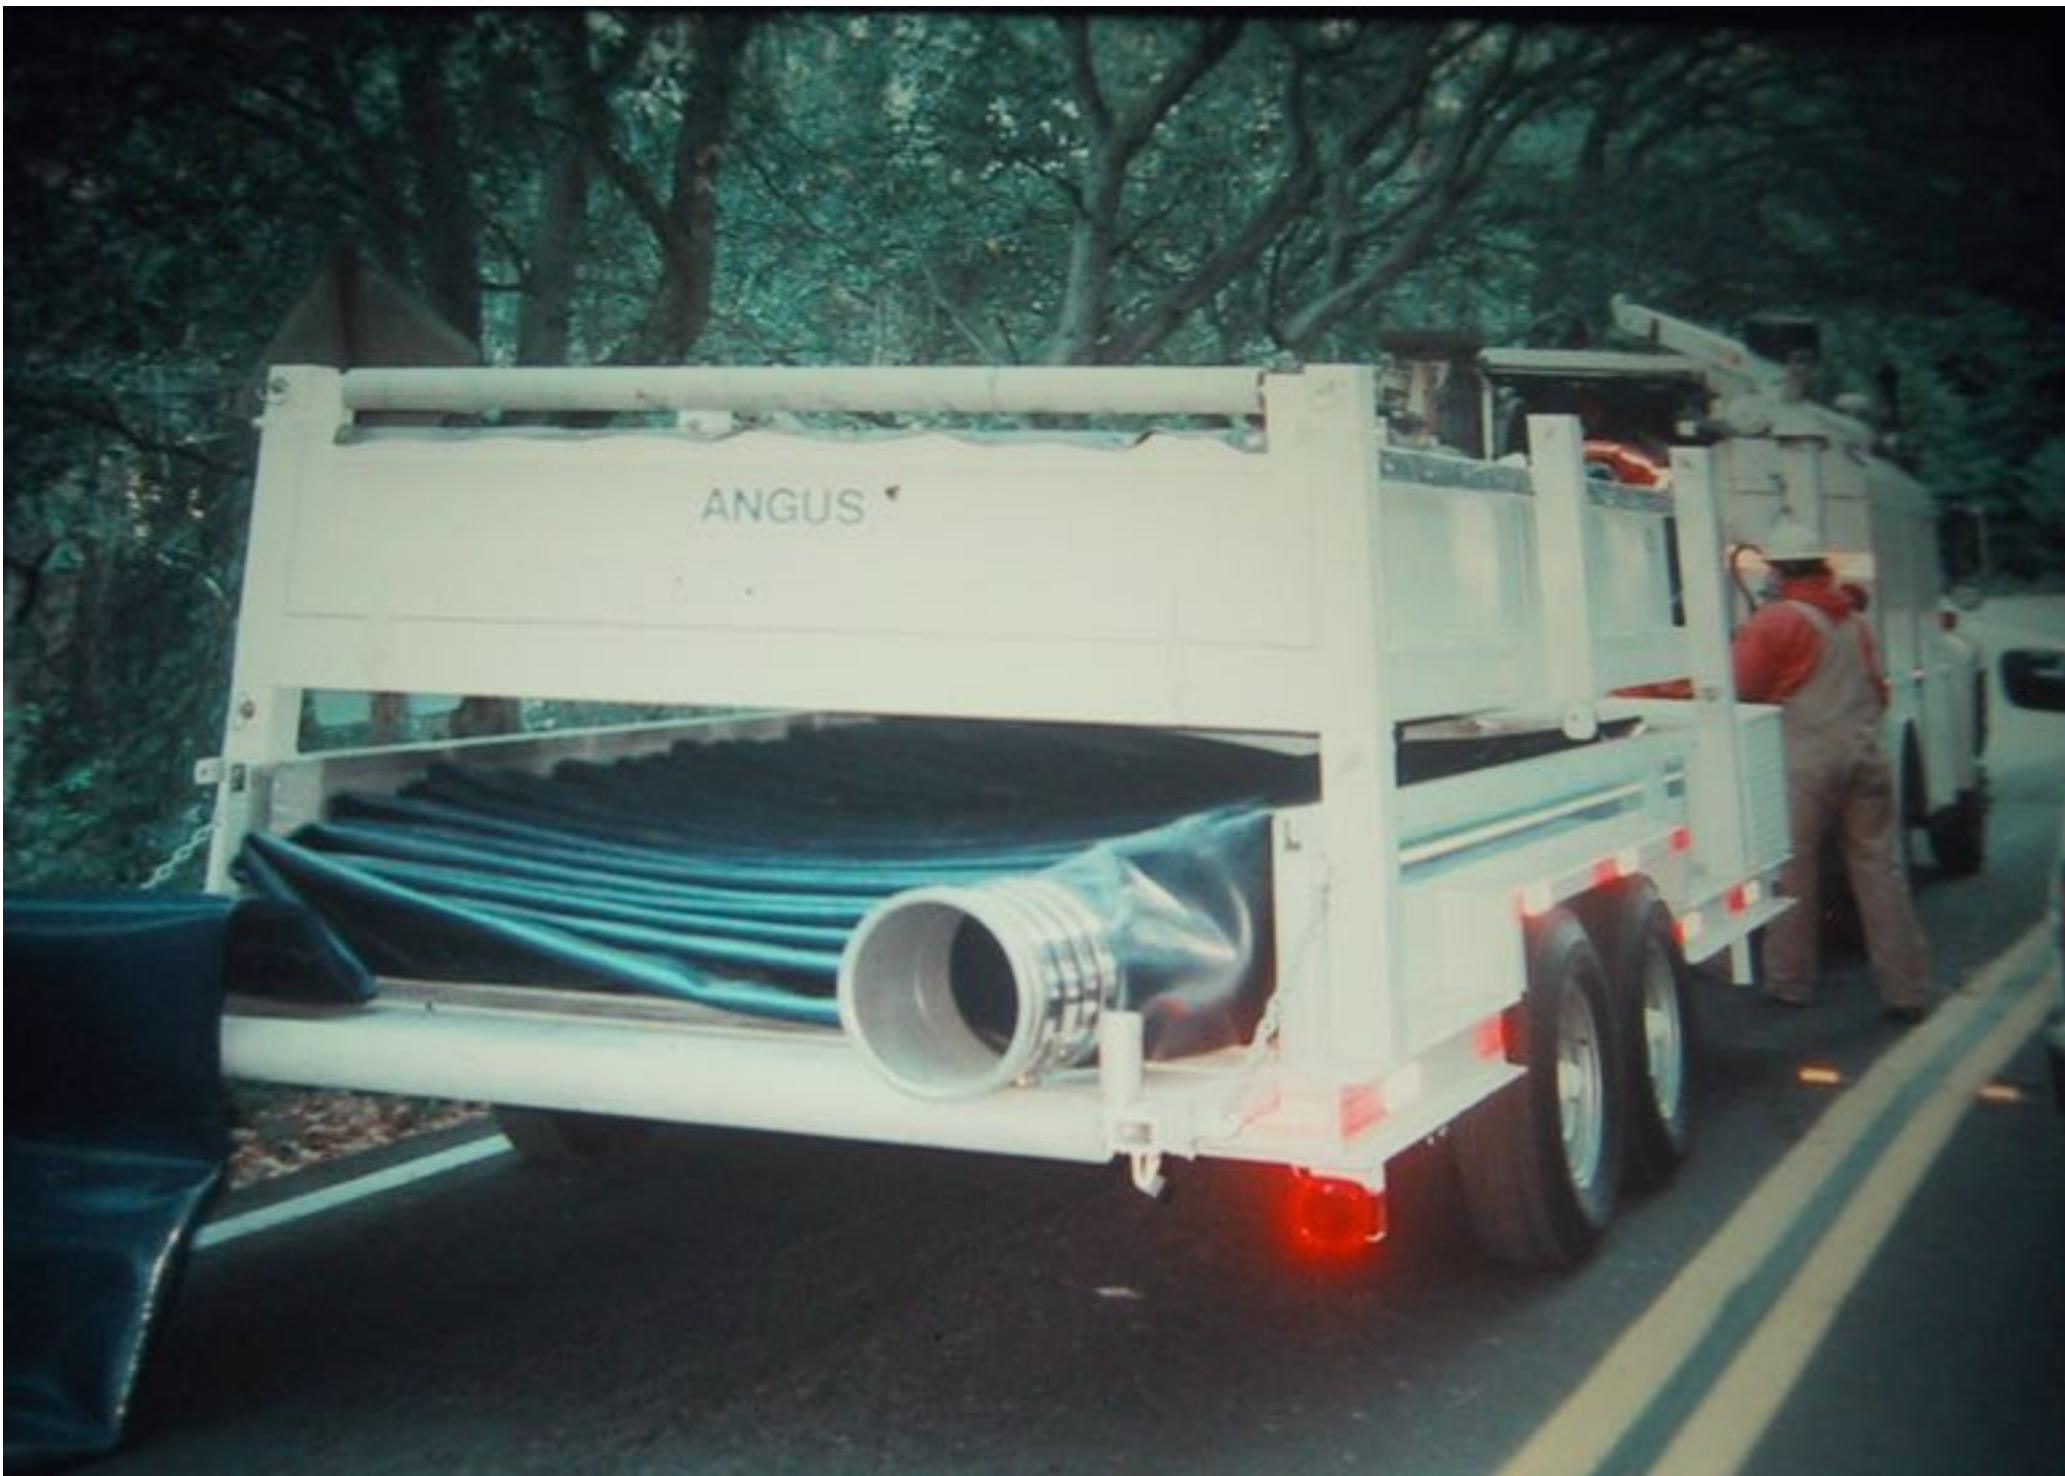
HDPE Application

- Light Weight
- Fused Fittings
- Flanged Fittings
- Can easily accommodate $\pm 10\%$ Strain
