John M. Eidinger *Editor*

May 3, 2004 Revision 11

Abstract

This report is written to provide baseline information for engineers, the fire service, utility managers, the insurance industry and others who may be interested in addressing the fire following earthquake risk that faces our communities.

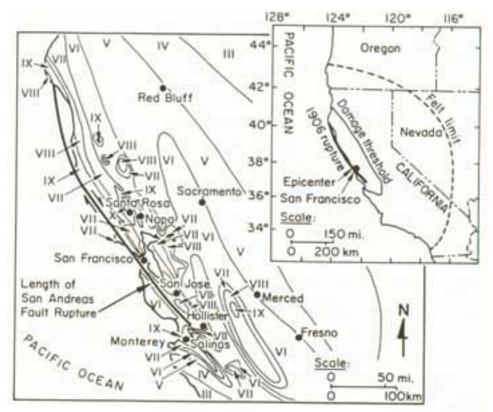
Figure 2-1 MMI map 1906 San Francisco earthquake

This earthquake caused the longest rupture observed in the contiguous United States – from San Juan Bautista to Point Arena, where it passes out to sea, with additional displacement observed farther north at Shelter Cove in Humboldt County – indicating a potential total length of rupture of 430 kilometers. Fault displacements were predominantly right lateral strike-slip, with the largest horizontal displacement - 6.4 meters - occurring near Point Reyes Station in Marin County. The surface of the ground was torn and heaved into furrow-like ridges. Roads crossing the fault were impassable, and pipelines were broken. The region of destructive intensity extended over a distance of 600 kilometers with strong shaking over a wide area, Figure 2-1.

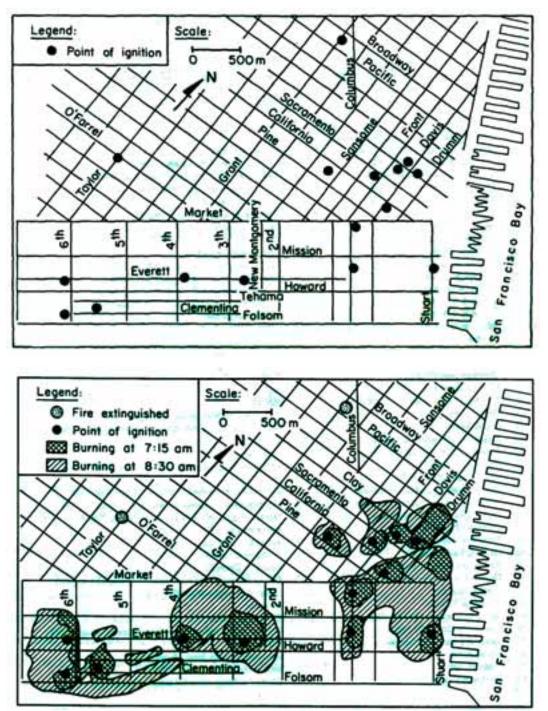
Figure 2-2 San Francisco 1906 Fire – Ignitions at 6:00 am (top) and Spread at 7:15 am and 8:30 am (bottom), Central Business District

Figure 2-2 shows some of the ignitions in the Central Business District, around the foot of Market and Mission Sts., and their spread during the first day, while Figure 2-3 shows the final extent of the burnt area. Figure 2-4 to Figure 2-6 show scenes during and after the fire.

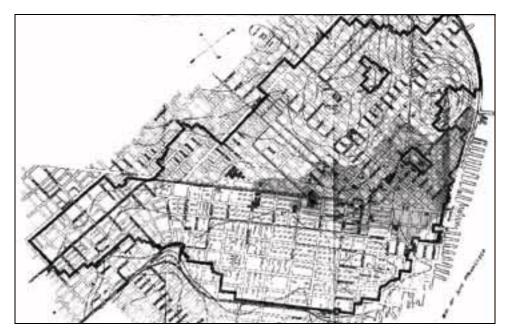
Figure 2-3 San Francisco 1906 Fire – final extents in solid line; many collapsed masonry buildings in shaded area.

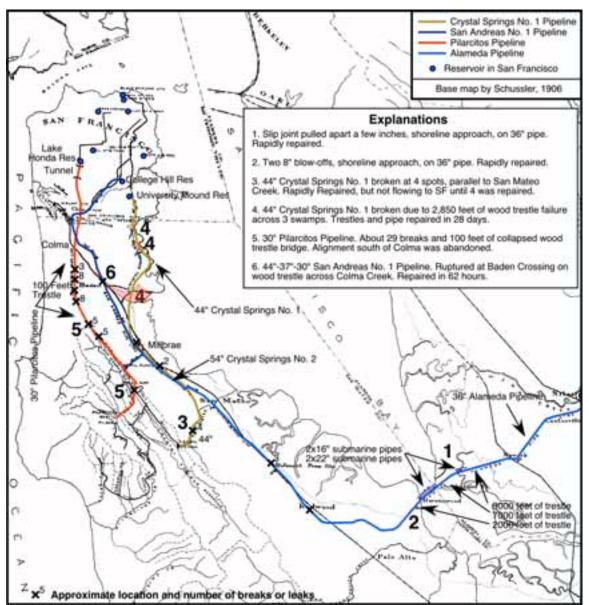
Figure 2-7 Damage to the Transmission Pipelines Serving San Francisco, 1906

Figure 2-7 presents a map of the damage to the 1906 San Francisco water supply. At the time of the earthquake, there was a combined volume of 88.7 billion liters in the San Andreas, Crystal Springs, and Pilarcitos Reservoirs. These reservoirs, coupled with the Alameda watershed on the east side of the San Francisco Bay, supplied all water for the city of San Francisco in 1906. Transmission pipelines conveying water from the southern reservoirs were built mainly of riveted wrought iron. Within the city limits, there were approximately 711 km of distribution piping at the time of the earthquake, of which roughly 18.5 and 66.5 km were wrought and cast iron trunk lines, respectively. These lines were larger than or equal to 400 mm in diameter. The bulk of the system had been constructed during the years of 1870 to 1906.

Superimposed on Figure 2-7 are the approximate locations of transmission pipeline damage caused by the earthquake. Flow from all transmission pipelines stopped shortly after the earthquake. Because telephone service was out, emergency control information had to be obtained by dispatching personnel into the field where maintenance crews reported on the damage. Right lateral strike-slip movement along the San Andreas Fault ruptured a 750 mm diameter wrought iron pipeline conveying water from the Pilarcitos to Lake Honda Reservoir, Figure 2-8. Over 29 breaks were reported north of the San Andreas Fault. Fault movement near the San Andreas Reservoir was measured as 3.6 to 5.6 m. Pipeline ruptures were caused by tensile and compressive deformation of the line. Over three months were required to reconstruct the pipeline. Within 16 hours after the earthquake,

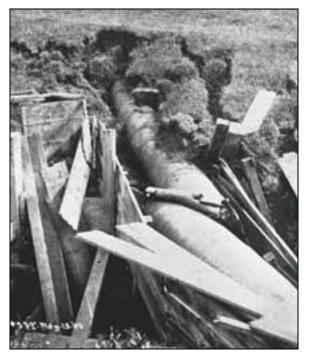
Figure 2-8 Failure of Pilarcitos 30 inch pipeline. Pipe telescoped and was thrown sideways on the wooden bridge crossing Small Frawley Canyon. San Andreas fault crosses pipe diagonally.

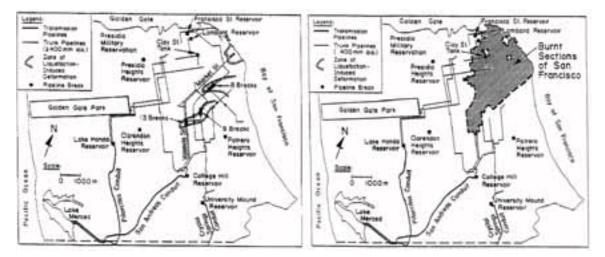
Figure 2-9 (a) map of the 1904 San Francisco water system (b) showing final burnt area

Figure 2-9(a) is a map of the 1904 water supply within the San Francisco City limits. There were nine reservoirs and storage tanks, for a total capacity of 354 million liters. Approximately 92% of this total, or 325 million liters, were contained in the Lake Honda, College Hill, and University Mound Reservoirs. These reservoirs and the pipelines linking them with various parts of the city were the backbone of fire protection. All trunk lines, 400 mm or larger in diameter, are plotted in Figure 2-9(a). Trunk lines are shown connected to the Lake Honda, College Hill, University Mound, Francisco Street, and Clay Street Reservoirs; all other reservoirs were connected to piping 300 mm or less in diameter. Superimposed on Figure 2-9(a) are the zones of lateral spreading caused by soil liquefaction, as delineated by Youd and Hoose (1978). Breaks in the pipeline trunk system crossing these zones are plotted from records provided by Schussler (1906) and Manson (1908). It can be seen that multiple ruptures of the pipeline trunk systems from

the College Hill and University Mound Reservoirs occurred in the zones of large ground deformation, thereby cutting off supply of over 56% of the total stored water to the Mission and downtown districts of San Francisco. Two pipelines, 400 and 500 mm in diameter, were broken by liquefaction induced lateral spreading and settlement across Valencia Street north of the College Hill Reservoir. These broken pipes emptied the reservoir of 53 million liters, thereby depriving fire fighters of water for the burning Mission District of San Francisco. Figure 2-9(b) shows a map of the San Francisco water supply and area burned during the tire. All trunk lines of the College Hill and University Mound Reservoirs downstream of the pipeline ruptures are removed from this figure to show the impact and lack of hydraulic conductivity caused by severing these conduits. With the College Hill and University Mound Reservoirs cut off, only the Clay Street Tank and the Lombard and Francisco Street Reservoirs were within the zone of most intense fire, and therefore capable of providing water directly to fight the blaze. The combined capacity of these reservoirs was only 21 million liters, or 6% of the system capacity. The usefulness of such limited supply was further diminished by breaks in service connections, caused by widespread subsidence, burning and collapsing buildings. Schussler identifies service line breaks as a major source of lost pressure and water. There were roughly 23,200 breaks in service lines, between 15 and 100 mm in diameter. Fallen rubble and collapsed structures often prevented firemen from closing valves on distribution mains to diminish water and pressure losses in areas of broken mains and services. As is evident in Figure 2-9(b), the Lake Honda Reservoir was able to provide a continuous supply of water to the western portion of the city. The fire eventually was stopped along a line roughly parallel to Van Ness Avenue, where water still was available from the Lake Honda Reservoir. Moreover, the southern and southeastern extent of the fire is bounded by areas south and southeast of the trunk system ruptures. It is likely that these unburnt areas had water from the University Mound Reservoir. Recognition of the critical role played by damage to the water system led to the construction of San Francisco's Auxiliary Water Supply System, which is described later in this chapter.

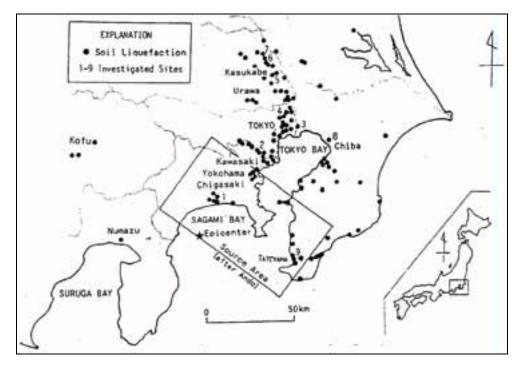
Figure 2-10 Kanto and Chubu Districts showing areas principally affected by liquefaction

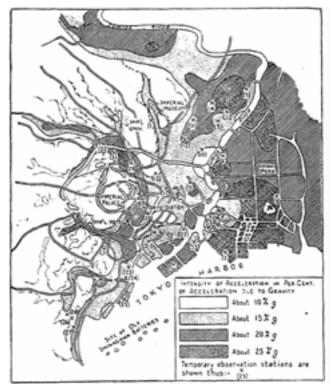
Figure 2-11 Distribution on earthquake intensity in Tokyo

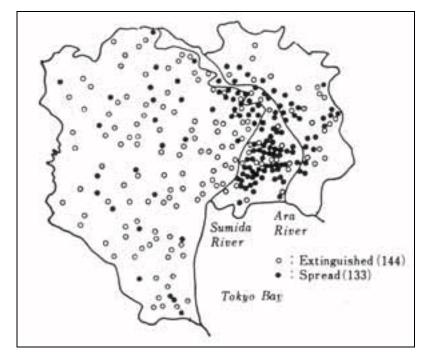
Figure 2-12 Outbreak of fires in the city of Tokyo (Kanto earthquake of 1923)

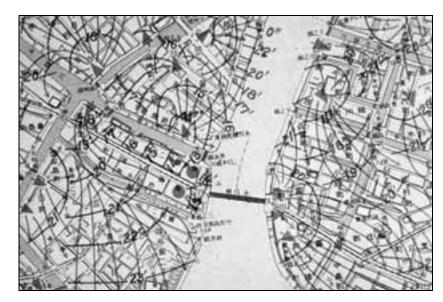
Figure 2-13 Firespread in Central Tokyo, showing direction and hourly progress of flame front

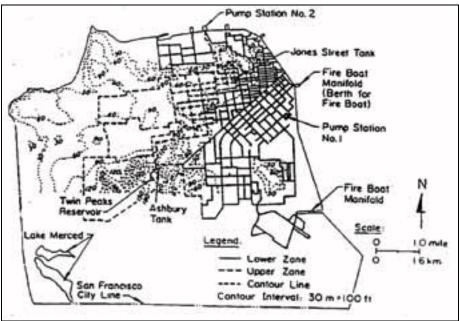
Figure 2-14 San Francisco AWSS Plan

San Francisco possesses three water supply systems, the first of which is typical of water systems in any other city. This system is called the Municipal Water Supply System (MWSS), owned and operated by the San Francisco Water Department (SFWD) and serving both fire fighting and municipal (potable water) uses. The two other systems are specifically dedicated to firefighting use and are owned and operated by the San Francisco Fire Department (SFFD). They were built following, and in direct response to, the 1906 earthquake and fire. These are the Auxiliary Water Supply System (AWSS), first developed following the 1906 earthquake and fire and extended periodically thereafter, Figure 2-14, and the Portable Water Supply System (PWSS), developed in the 1980's and primarily a truck-borne large diameter hose system, Figure 2-15.

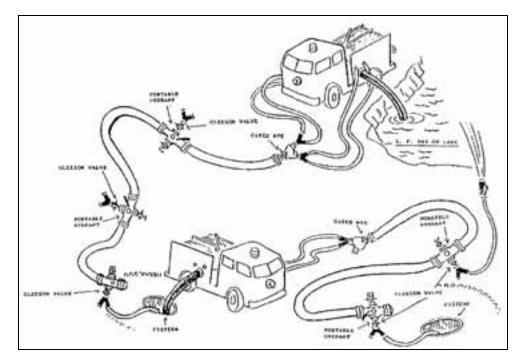
Figure 2-15 San Francisco PWSS

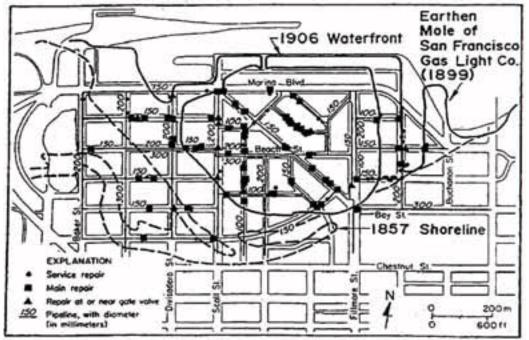
Figure 2-16 MWSS Pipe Breaks, Marina District, 1989 Loma Prieta Earthquake

The greatest damage to the MWSS in the 1989 Loma Prieta consisted of approximately 150 main breaks and service line leaks. Of the 102 main breaks, over 90 percent were in the Marina, Islais Creek and South of Market infirm areas. The significant loss of service

occurred in the Marina area, where 67 main breaks and numerous service line leaks caused loss of pressure, Figure 2-16.

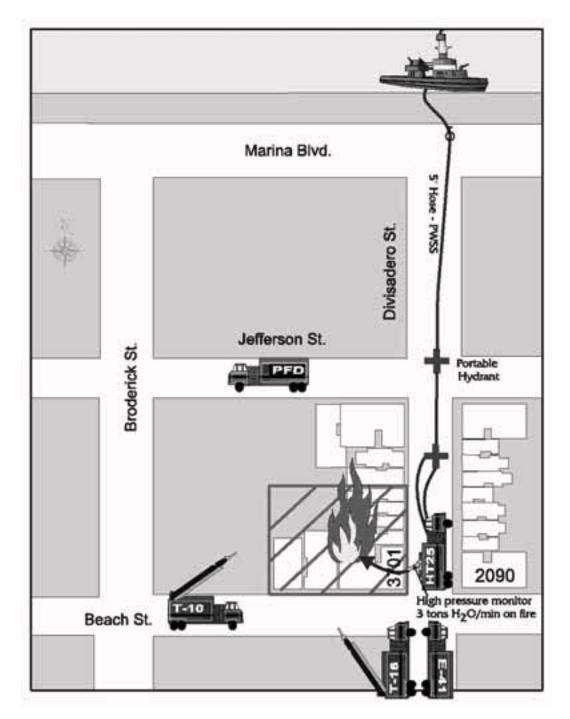
Figure 2-17 1989 Loma Prieta Earthquake, Marina Fire, SFFD deployment

Due to uncertainty as to the number and location of AWSS breaks, valves connecting the Upper Zone to the Lower Zone were not opened. Pump Stations 1 and 2, although available, were not placed in service immediately, but rather at 8 pm following identification and isolation of broken mains. As a result, all pressure in the AWSS Lower Zone was lost for several hours following the earthquake. The pump stations were operated at half capacity so as to fill the AWSS mains slowly, out of concern for entrapped air that was exhausted from the Lower Zone through the Jones Street Tank (air could be heard exhausting through the tank). This operation continued until 10 pm, when full pressure was restored and the Jones Street Tank had been filled with salt water. Figure 2-17 indicates the deployment of various SFFD apparatus, including the fireboat *Phoenix*, at about 6:24 pm.

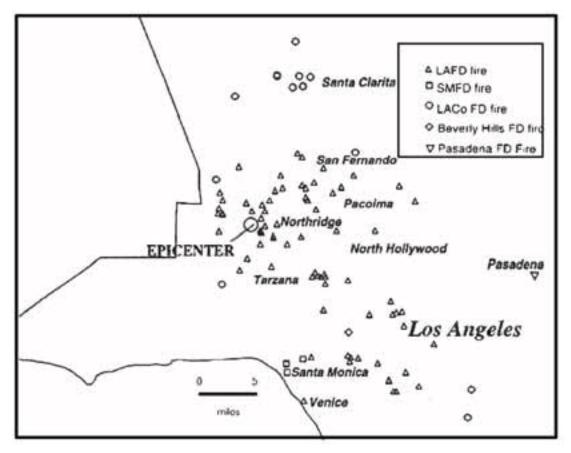
Figure 2-18 Locations Earthquake-related fires, 1994 Northridge Earthquake

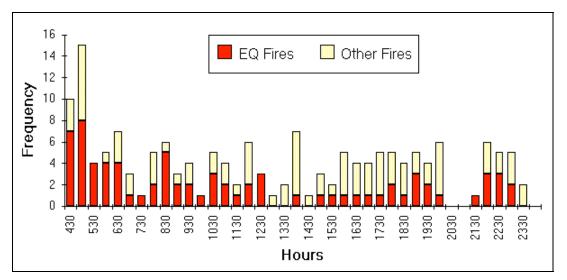
Figure 2-19 LAFD Fires, 4:31 to 24:00 hrs, January 17, 1994

Some data is available on time of fire occurrence relative to the earthquake. Figures 2-19 and 4-8 for example shows data from the 1994 Northridge earthquake, which indicate that about 50% of earthquake-related fires are reported within several hours of the earthquake.

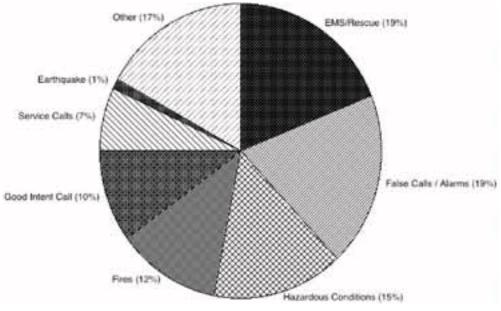
Figure 2-20 LAFD Incident Response Types, 1308 Incidents 4:31 to 24:00 hrs, January 17, 1994

Approximately 110 fires were reported as earthquake-related on January 17, as shown in Figure 2-1 and Table 2-3. The Northridge earthquake reportedly caused or was a contributing factor in 77 fires in the LAFD service area. The 77 fires were among a total of 161 fires that occurred on the day of the earthquake. The time line in Figure 2-19 shows all calls for assistance with fires on the day of the earthquake. Structure fires predominate (86%) the earthquake-related fires. More than 70% (66) of the earthquake-related fires occurred in single- or multiple-family residences, as might be expected from the building stock that is typical in the San Fernando Valley. The major cause of ignition was electric arcing as the result of a short circuit, although gas flame from an appliance is also a recurring source of ignition. The breakdown of the day's calls into dispatches categories is shown in Figure 2-20.

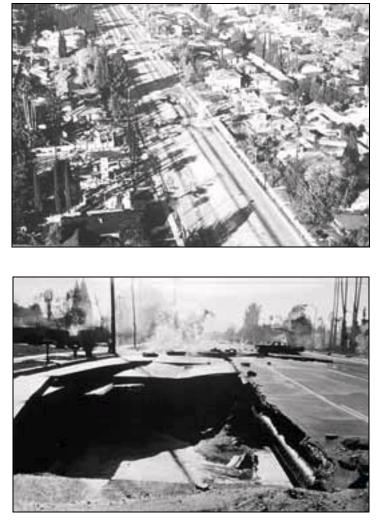
Figure 2-21 North Balboa Blvd. Incident, 1994 Northridge Earthquake (top) Aerial View, (bottom) Surface View

This fire scene is located in the Granada Hills area of the San Fernando Valley. It is a residential area with one- and two-story wood-frame single-family dwellings, many with swimming pools, Figure 2-21 (top). A 48-inch water main under the street was broken, flooding the street and front yards of the homes, Figure 2-21 (bottom).

An aerial photograph of the scene after the structure fires were extinguished is shown in Figure 2-21(b). Note that the ruptured gas main is still burning.

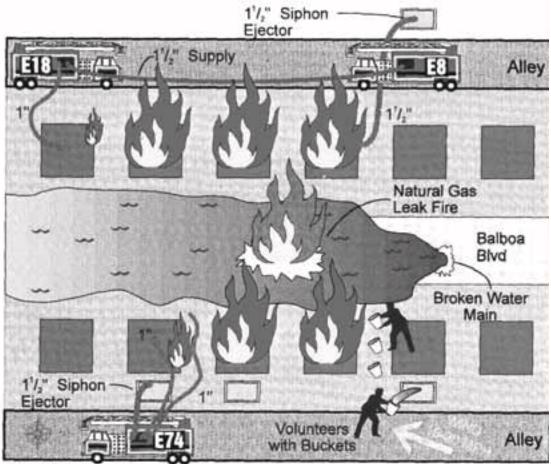
Figure 2-22 LAFD Deployment 5:35 am, No. Balboa Blvd., 1994 Northridge Earthquake

Breaks in the water mains rendered all surrounding fire hydrants inoperative. Fortunately, several homes in the area had swimming pools that were used as water supply sources. Engine 8 and Engine 74 fire fighters used their 1 1/2-inch siphon ejectors to draw water into their tanks. The 1 1/2-inch siphon ejector can supply water at 92 to 115 gpm. The swimming pools provided approximately 70 minutes of water flow. Hose layout as of 5:35 am, and water usage for the incident, are shown in Figure 2-22 and Table 2-4, respectively.

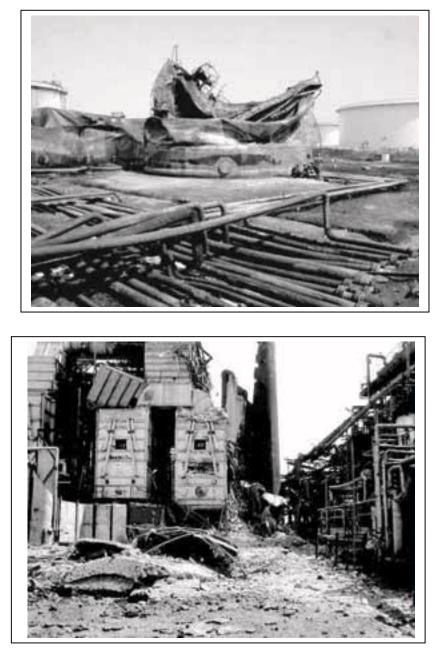
Figure 2-24 Tupras Refinery damage due to fire following earthquake (a) Burnt and collapsed tank; (b) Top of stack collapsed into unit, severely damaging heater unit. Top of stack is in foreground of photo.

One of the pipes broken by the stack collapse was a naphtha line from the original burning naphtha tank in the tank farm. A fire started when the collapse occurred, and although it was extinguished relatively quickly, it flared up several times because of the new fuel from the broken pipe. The supply could not be stopped because the two block valves were at the tank, inaccessible because of the fire, and downstream from the crude unit.

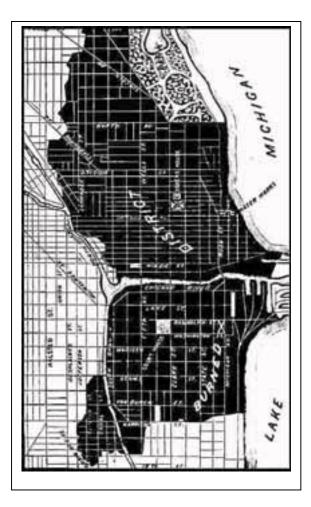
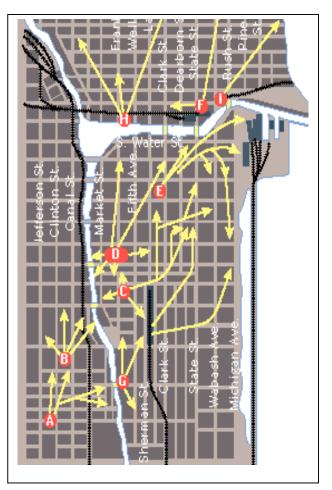
<u>Fire</u>	<u>Time (Oct. 8/9)</u>
A. O'Leary barn	8:30 pm
B. Bateham's Mills	10:00 pm
C. Parmelee's Stables	11:30 pm
D. Gas Works,	12:00 midnight
Conley's Patch	12:20 am
E. Court House	1:30 am
F. Wright's Stables	2:30 am
G. Polk Street	2:30 am
H. Northwestern Elevator	7:00 am
I. Galena Elevator	7:00 am

Figure 3-4 Chicago Fire 1871: (1) Extent of Burnt area; (r) path and time of flamefront arrival

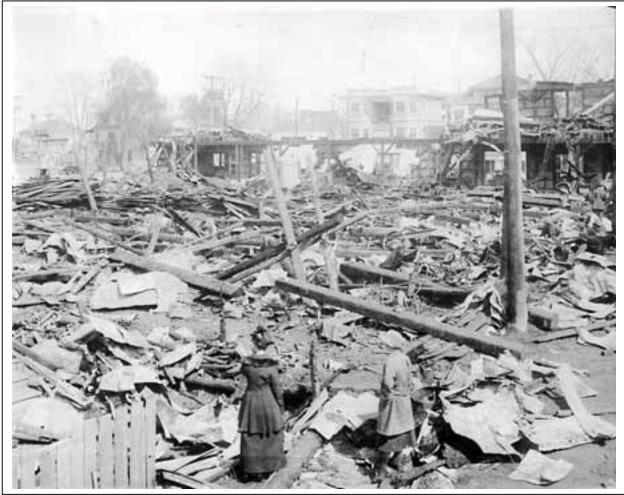
Figure 3-5 Berkeley 1923

A total of 584 buildings were wholly destroyed and about 30 others were seriously damaged, Figure 3-5 and Figure 3-6. Only 7 buildings were masonry, the remaining of wood frame construction. Only about 8% of the buildings had fire retardant roof coverings. Many buildings had close set backs between each other (under 5 feet), although streets were moderately wide (60 feet). The total loss was estimated at \$10,000,000 (\$1923). The fire rendered 4,000 persons homeless. The fire is significant in light of the 1991 East Bay Hills fire, discussed in Section 3.3.4.

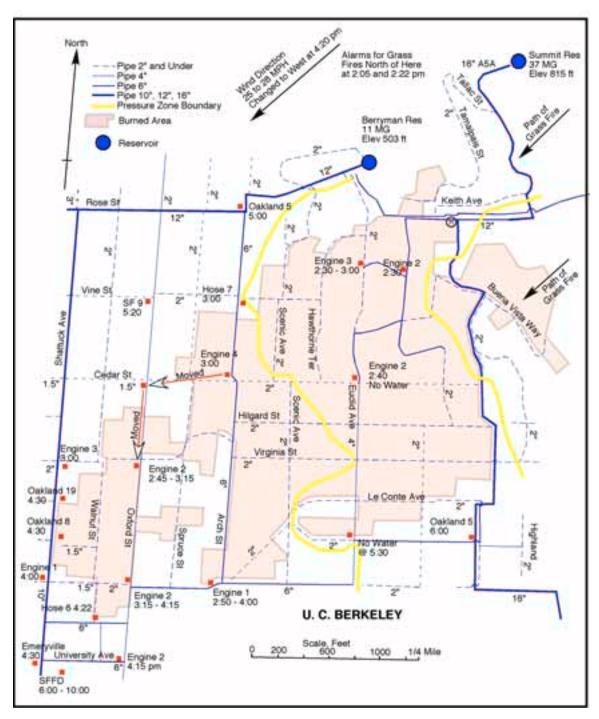
Figure 3-7 Map of 1923 Berkeley Hills Water System, Fire Spread and Response

At the time of the fire, the local water utility had substantial infrastructure in place. Two large local reservoirs had been built in 1884 and 1891; these reservoirs were (at that time) filled from local springs and run-off, although these same reservoirs are now (2003) filled with treated surface water from sources over a hundred miles away. At an elevation higher than the ultimate burned area, there was a 37,000,000-gallon water reservoir that provided water into the "A5A" pressure zone, Figure 3-7. At about mid-elevation in the burn area, there was a 24,000,000-gallon reservoir (since downsized to 15 MG and operated at 11 MG) that provided water into the "A2A" pressure zone. The middle elevation A4B pressure zone got all its water via a pressure regulator from the higher elevation A5A zone. There were water pipelines along every city street that ultimately burned. In an after-incident analysis of why this fire could not be better controlled, several observations were made by the water utility:

- First, the fire spread from uphill (elevation 650 feet) to downhill (elevation 200 feet) locations.
- Second, there was plenty of water in local storage tanks at the time of the fire; these water sources were not depleted in the course of fighting the fire.
- Third, the street layout was fairly regular, with water pipe service on every street.
- Fourth, water distribution pipes in the burn area were commonly 2" diameter cast iron or redwood pipes
- Fifth, immediately adjacent to the burn area the pipes included 10", 12" and 16" diameter pipes.
- Sixth, the fire continued to burn downhill towards the central business district of Berkeley until about 5:00 pm that day, when a combination of factors worked together to halt the fire.

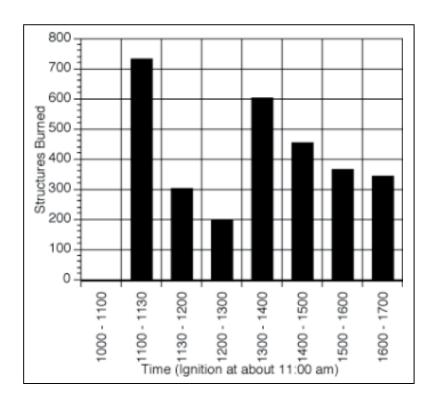
Figure 3-8 Time Line of Structures Burned, 1991 East Bay Hills Fire

Figure 3-8 charts the progression of the fire in terms of structures burned as a function of time after ignition. For the first 30 minutes of the spread, a structure was being burned down at a rate of almost one every three seconds. The apparent slow down of the spread of the fire at about 12 noon to 1 pm reflects that at this time the fire had to traverse the large fire breaks afforded by Highways 24 and 13. Upon examination of the fire department response, there was ample human and equipment resources to control the fire before it spread much beyond the first 2,000 dwelling structures. The lack of good water supply plus lack of coordinated response may have contributed to the loss of the last 1,000 structures.

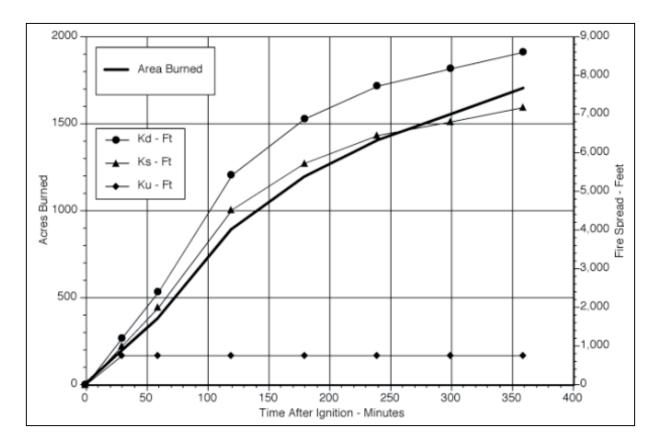
Figure 3-9 Rate of Fire Spread, 1991 East Bay Hills Fire

Figure 3-9 charts the progress of the fire with regards to the area burned. The terms "Kd, Ks and Ku" refer to how fire the fire spread in the downhill, side-hill and up-hill directions, respectively. These terms are used to establish empirical rules that can be used for developing analytical fire spread models such as those presented in Chapter 4.

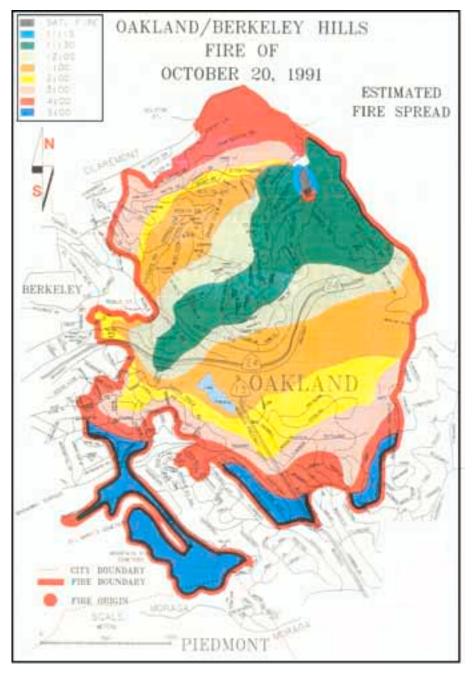
Figure 3-10 Point of Origin and Progress of 1991 East Bay Hills Fire: contours show origin at 11am, and progressive extent of fire at 11:15, 11:30, 12:00, 1:00pm, 2:00 pm, 3:00 pm, 4:00 pm and 5:00 pm

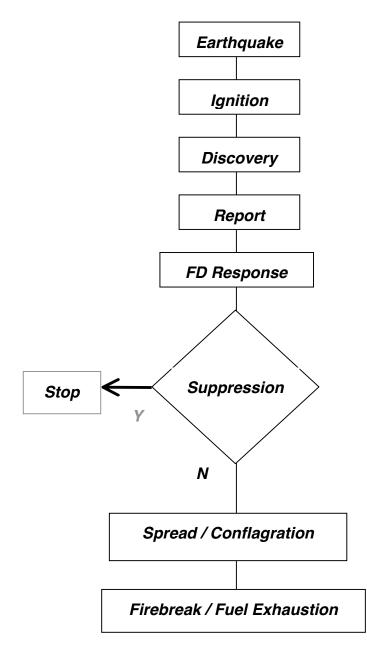
Figure 4-1 Fire following earthquake process

This Chapter presents a methodology for estimating fire losses following earthquake. The basic methodology can be seen in Figure 4-1, the Fire Following Earthquake process, which depicts the main aspects of the fire following earthquake problem. Fire following earthquake is a process, which begins with the occurrence of the earthquake. In summary, the steps in the process are:

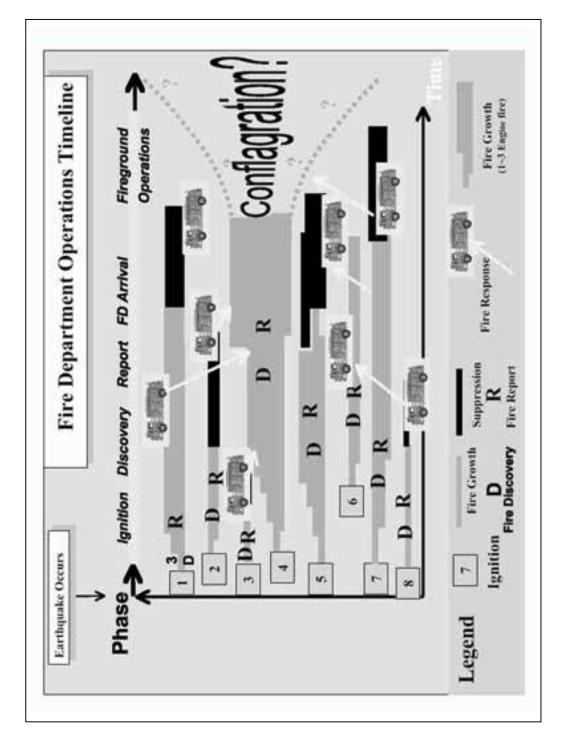
Figure 4-2 Fire department Operations Time Line

This process is also shown in Figure 4-2, which is a Fire Department Operations Time Line. Time is of the essence for the fire following earthquake problem. In this figure, the horizontal axis is Time, beginning at the time of the earthquake, while the vertical axis presents a series of horizontal bars of varying width. Each of these bars depicts the development of one fire, from ignition through growth or increasing size (size is indicated by the width or number of bars).

Beginning at the left of Figure 4-2 (that is, at the time of the earthquake), is the occurrence of various fires or ignitions (denoted by the number of the fire in a square box, see the legend at the bottom of the figure). Some of these fires occur very soon after the earthquake, while others occur sometime later (due for example to restoration of utilities). The mechanism of these ignitions is no different following an earthquake than at other times, although the earthquake can create unusual circumstances for ignition to take place. The primary difference due to the earthquake is the large number of simultaneous ignitions.

Following this ignition, or Fire Initiation, phase there is a period during which the fire is undiscovered but grows. A typical rule of thumb in the fire service is that the rate of growth of an uncombated fire in this phase will double each seven seconds. In Figure 4-2, the size of the fire is denoted by its number of bars. That is, each bar for a particular fire represents one engine required for control and/or suppression. Thus if, with time, a fire in Figure 4-2 proceeds from one bar to two and then three, this denotes that the fire is growing and now requires three Class A fire engines to control the fire (Class A fire engines have approximately 1200 gpm of pumping capacity).

Following receipt of the Fire Report by the fire department, apparatus will respond, if available (in Figure 4-2, arrival of apparatus at the fireground is denoted by the engine number within a circle-note that herein we only track fire engines, since only engines can suppress serious fires). Response may be impeded by blocked streets due to collapsed structures, or by traffic jams. Upon arrival, the fire may be combated per normal procedures or, if the general situation is sufficiently serious, minimal tactics may be all that is possible. Minimal tactics may constitute:

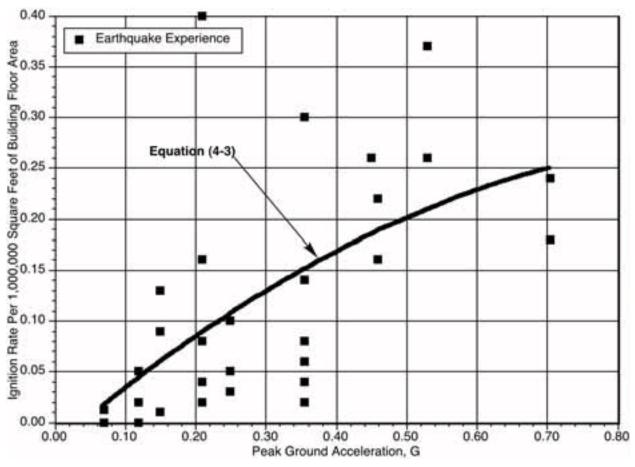
Figure 4-3 Ignition Model for Equation (3)

Post-earthquake ignitions for a particular locality can thus be calculated as a random Poisson process with mean probability determined as a function of PGA and building inventory.

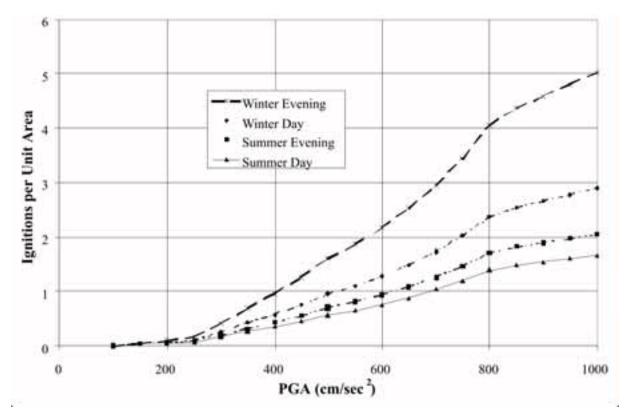
Figure 4-4. Fire Ignition rate as a Function of Season and Time of Day

The four ignition curves in Figure 4-4 represent the variation in the number of ignitions for earthquakes occurring at different times of day and different seasons. The four ignition curves correspond to earthquakes occurring in summer day time, summer evening time, winter day time, and winter evening time. Summer, winter, day, and evening are all considered as fuzzy variables with fuzzy weights shown in Figures 4-5 and 4-6. Combining the membership functions in these figures, the membership surfaces for summer day, summer evening, winter day and winter evening is derived. Typical summer evening fuzzy weights are shown in Figure 4-7.

The Tokyo Fire Department in Japan has developed a set of curves considering the above characteristics (Tokyo Fire Department, 1997). A typical set of curves is presented in Figure 4-4. Six similar sets of curves can be used to estimate the number of ignitions as a function of the following occupancies and building materials: residential wood and non-wood buildings, commercial wood and non-wood buildings and industrial wood and non-wood buildings. After

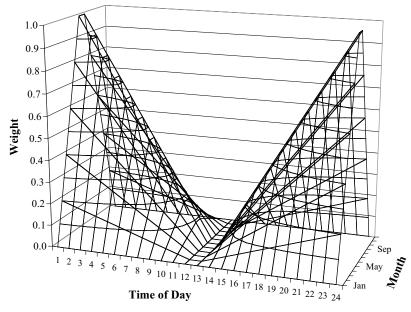
Figure 4-7. Ignition Rates – Summer Evening Fuzzy Weights

The number of ignitions for an earthquake occurring on a certain date and time of day is obtained by first calculating the membership value of the time and season of the earthquake from each of the summer day, summer evening (Figure 4-7), winter day, and winter evening surfaces. These four weights are used to obtain a weighted average of the number of ignitions from the four curves corresponding to the occupancy and structure type of the building.

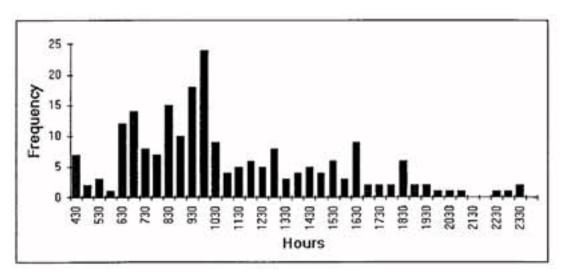
Figure 4-8 Santa Monica Fire Department Incident Reports January 17, 1994 Northridge Earthquake, 0431-2400

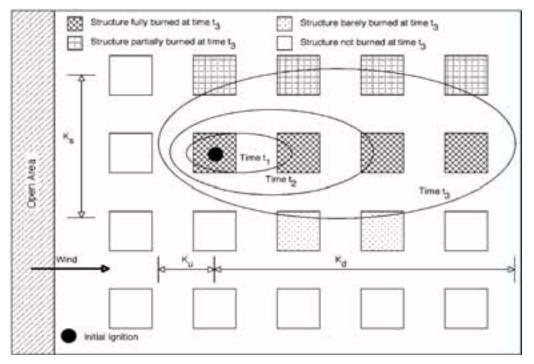
Figure 4-9 shows fire spread as an irregular oval, which is typical of fires burning through a relatively uniformly distributed fuel load, with constant wind velocity. In actual urban conflagrations, patterns of fire spreading are more variable, and are a function of wind speed and

changes in direction, varying fuel availability in differing directions, and of fire suppression tactics. Burnt area is approximately $(K_d + K_u) * (K_s)$.

Figure 4-9 Typical Fire Spread

K_d = length of fire in downwind direction (see Figure 4-9), from the initial ignition location, in meters, defined in Eq-4-3:

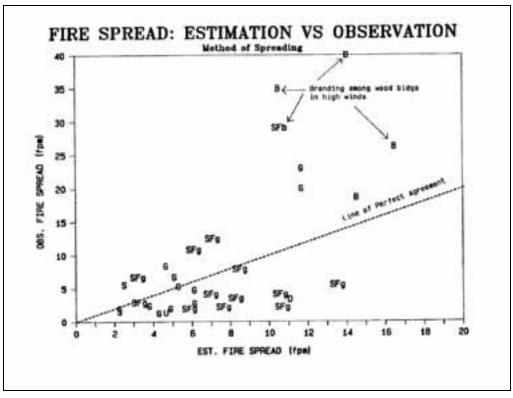
In order to explore the question of utility of these equations in the U.S. context, observed fire spread in various U.S. twentieth century fires was compared with the fire spread predicted using these equations (AIRAC, 1987), Figure 4-10, finding that, with the exception of spread by branding among wood buildings under high winds, estimation using the Hamada equations agreed well with observation.

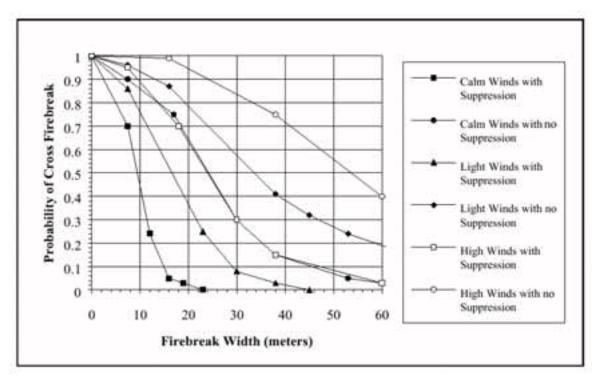
The estimates of both the Hamada and TOSHO (next Section) models are for fire spread within one city block or a built-up district, and do not account for fire spread across firebreaks, such as streets. World War II and other data were reviewed (Bond, 1946), to develop estimates of the probability of a typical fully developed building fire crossing a firebreak, under various wind speeds and with and without active fire suppression efforts (Figure 4-11). Fire growth and spread then is modeled using these equations, taking into account probability of crossing a firebreak (with or without active fire suppression capability being present). Fires are tracked and merged where they meet (i.e., areas are not "burnt twice").

Figure 4-11. Probability of Crossing Firebreak

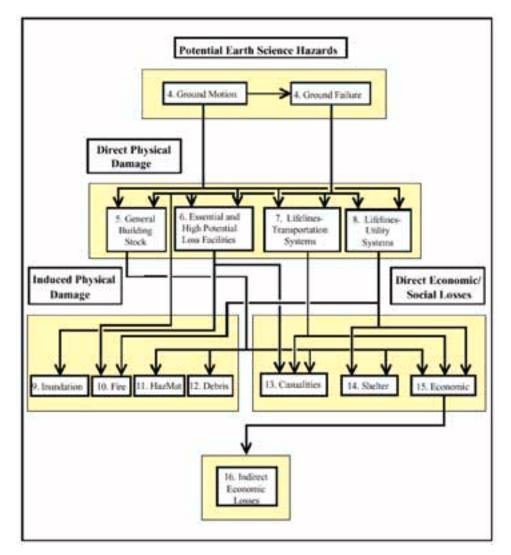
Figure 4-12. Flowchart of the HAZUS Earthquake Loss Estimation Methodology

HAZUS is designed to produce loss estimates for use by federal, state, regional and local governments in planning for earthquake risk mitigation, emergency preparedness, response and recovery. The methodology deals with nearly all aspects of the built environment, and a wide range of different types of losses. Extensive national databases are embedded within HAZUS, containing information such as demographic aspects of the population in a study region, square footage for different occupancies of buildings, and numbers and locations of bridges. Embedded parameters have been included as needed. Using this information, users can carry out general loss estimates for a region. The HAZUS methodology and software are flexible enough so that locally developed inventories and other data that more accurately reflect the local environment can be substituted, resulting in increased accuracy (Figure 4-12).

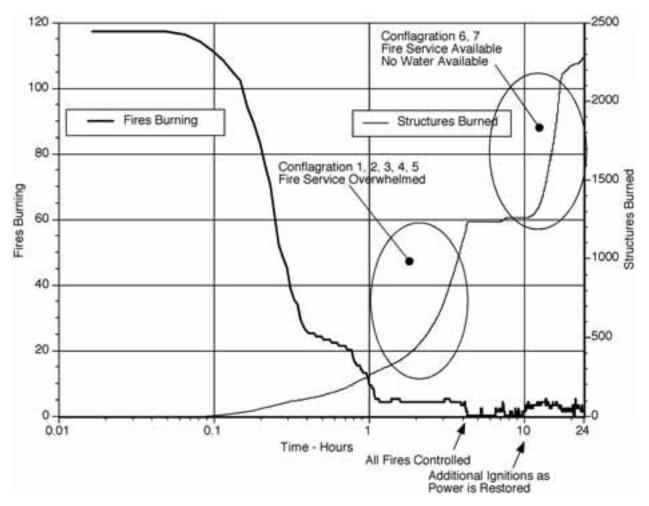
Figure 4-13. Fire Following Earthquake Time History Analysis - EBMUD

- The left axis (fires Burning) shows the number of fires ongoing after the earthquake. For example, at 1 minute after the earthquake, there are 117 fire ignitions. The thick line shows that none of these initial 117 fires come under control for the first few minutes (the curve is flat). There are a total of 169 ignitions in the first 24 hours for the simulation presented in Figure 4-13.

It is useful to examine the time history of the fire spread process using the SERA model. Figure 4-13 provides the results for one simulation of the Hayward M 7 earthquake, assuming light winds and for the water system in its "as-is" condition:

In running the SERA Fire module for many simulations, a pattern is observed that suggests that a significant percentage of all fire losses (perhaps 1/3 to 1/2) would occur at a time after all the initial ignitions were controlled, but after the time that hillside reservoirs were emptied (mostly due to leaking pipes). Thus, one of the mitigation strategies for water utilities to consider is to ensure that there is at least some water in all hillside pumped zone areas subject to high risk of fire, at least for about 18 hours (preferably 24 hours) after a large earthquake. Another trend seen in the analyses was that for simulations of a single earthquake with only about 120 ignitions (50 fewer than in Figure 4-13), the fire service performed quite well, with each initial ignition generally leading to just 1 or 2 burned structures, and low chance of conflagration beyond 10 structures. However, if the earthquake caused 220 ignitions (50 more than in Figure 4-13), then many conflagrations would likely occur, and total structures burned could be easily 4 times worse than in Figure 4-13.

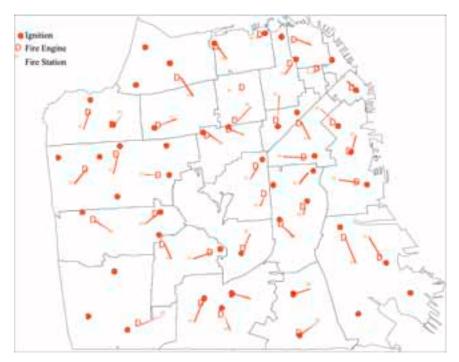
Figure 4-14. Ignitions and deployment of fire engines for San Francisco - RiskLink Simulation

Figure 4-14 presents the simulation status some time after the occurrence of a repeat of the 1906 earthquake in San Francisco. The small buildings indicate the location of the fire stations, the dots are the locations of the fires, and the lines with the truck show how the fire engines have been dispatched from the station to the fire. It can be noted that the engines move in a straight line from the station to the fires (city streets are not modeled to calculate engines travel time). The wind speed is constant over the duration of the simulation and is 10 km/h in this simulation. Figure 4-15 presents the status of the fires at the same simulation time as Figure 4-16. The ellipses indicate the burnt area, the gray ellipses represent fires that have been brought under control while the black ones are still burning uncontrolled. The simulation ends when all the fires are either brought under control or are stopped by firebreaks and run out of fuel. Figure 4-16 presents a measure of the ground shaking for a repeat of the 1906 event. A grid has been overlaid over the city and all the parameters are assumed constant within a cell. For this study the size of the cell is 0.01 x 0.01 degree (about 1km x 1km). The level of shaking is quantified in terms of peak ground acceleration (gals or cm/sec^2). The PGA does not always show a uniform decay as the distance from the fault increases because the acceleration is affected by the local soil condition. Figure 4-17 presents the mean burnt area within each cell at the end of a large number of simulations. By overlaying the exposure in each cell with the burned area one can determine the expected fire loss in each cell and for the whole area.

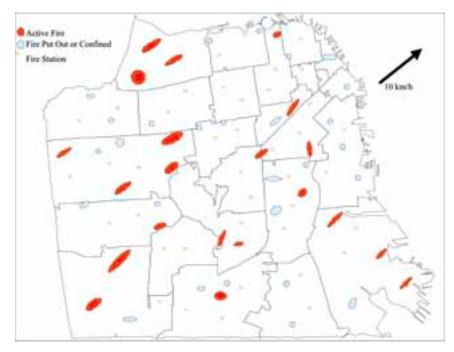
Figure 4-15. Active and controlled fires for San Francisco - RiskLink Simulation

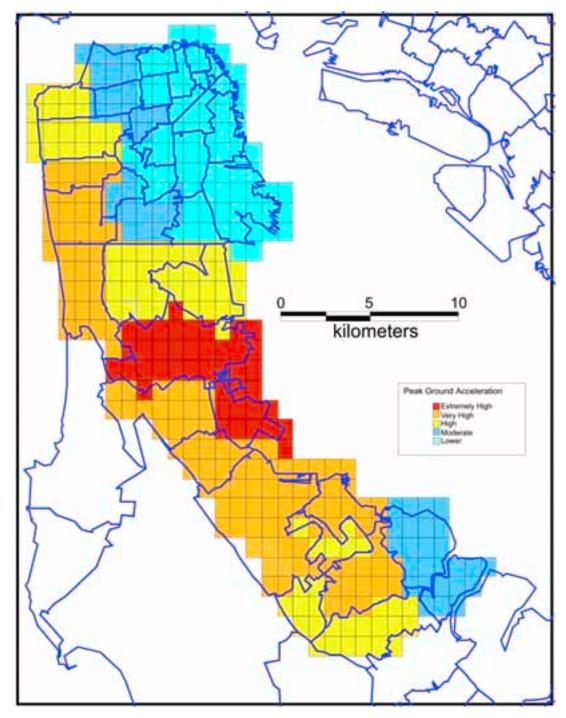
Figure 4-16. Geographical Distribution of Peak Ground Acceleration for the 1906 San Francisco Earthquake (RiskLink Simulation)

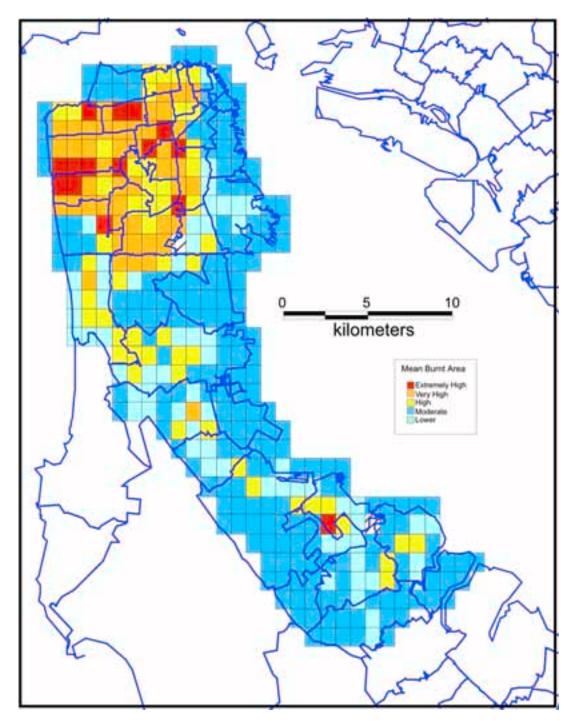
Figure 4-17. Geographical Distribution of Mean Burnt Area for the 1906 San Francisco Earthquake (RiskLink Simulation)

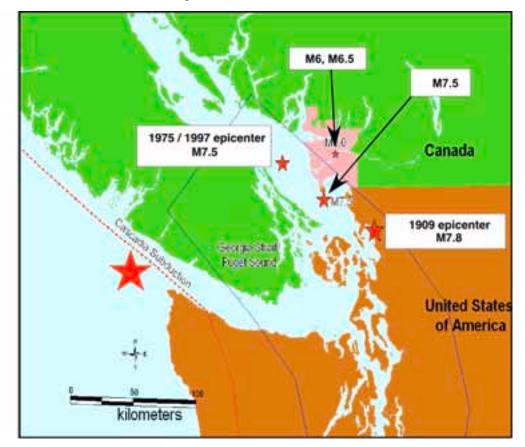
Figure 4-18. Scenario Earthquake Events, Analysis of Fire Following Earthquake, Lower Mainland, British Columbia

The analysis of potential property loss due to post-earthquake fires in the urbanized portions of the Lower Mainland of British Columbia, included the municipalities and districts of Burnaby, Coquitlam, Delta, New Westminster, City of North Vancouver, District of North Vancouver, Port Coquitlam, Port Moody, Richmond, Surrey, Vancouver, and West Vancouver, which have a total population of 1.76 million, representing 96% of the Greater Vancouver Regional District (GVRD). The Lower Mainland of British Columbia is one of the highest earthquake risk regions in Canada. Seismological research indicates that there are several active seismic sources in the region that have caused destructive earthquakes in the past and are potential sources of future destructive shocks. The region is most affected by earthquakes originating (1) in the shallow crust, (2) on the Cascadia subduction zone, and (3) at depth under Vancouver Island and the Strait of Georgia. Based on the seismotectonics of the region, several *scenario earthquakes* were analyzed, Figure 4-18, including:

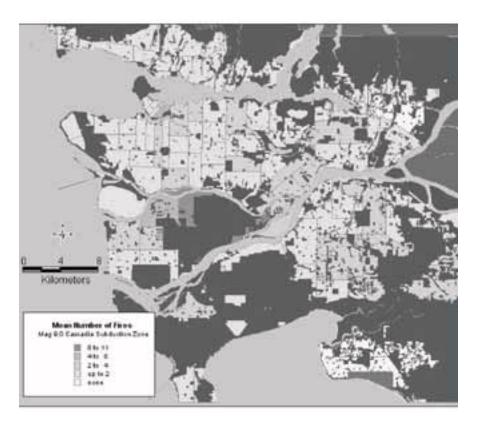
Figure 4-19. Mean number of ignitions, M 9.0 Subduction zone event

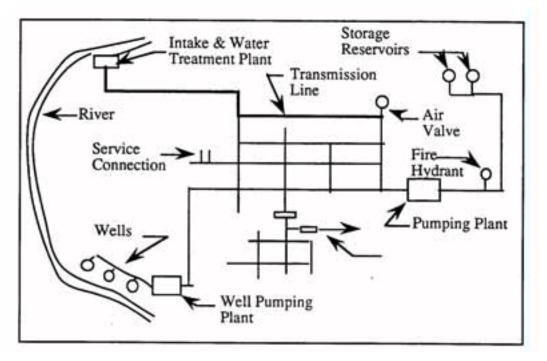
Figure 6-1 shows a schematic diagram of a typical water distribution system.

Figure 6-1. Schematic Diagram of a Typical Water System

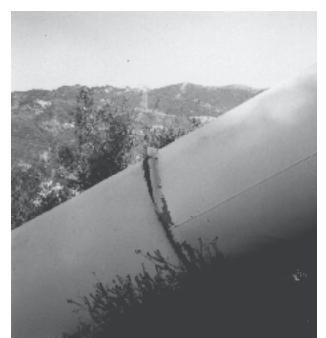
Figure 6-2. Wrinkled Los Angeles Aqueduct. This pipe remained in service A collocation of nine lifelines occurred on Balboa Boulevard, north of Rinaldi Street, in Granada Hills, an apparent tension and compression zone. Located within the street were 3 gas, 3 water, 2 sewer and 1 oil underground lines; 34.5 kV and 4.8 kV power, telephone, and cable TV overhead lines; and ornamental street lighting. Ground movement caused the breakage of some of the underground pipelines, a fire occurred in the street which ultimately burned the overhead lines and five homes.

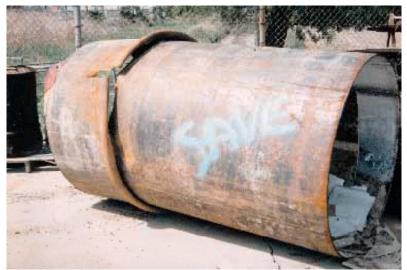
At this location there was a lateral spread on Balboa Boulevard south of Lorillard Street of approximately 9 to 12 inches. Figure 6-3 shows the compression wrinkling and tear to the 48-inch diameter welded steel water pipe that traversed this lateral spread.

Figure 6-3. Wrinkled 48" Balboa Boulevard Pipeline. This pipe leaked

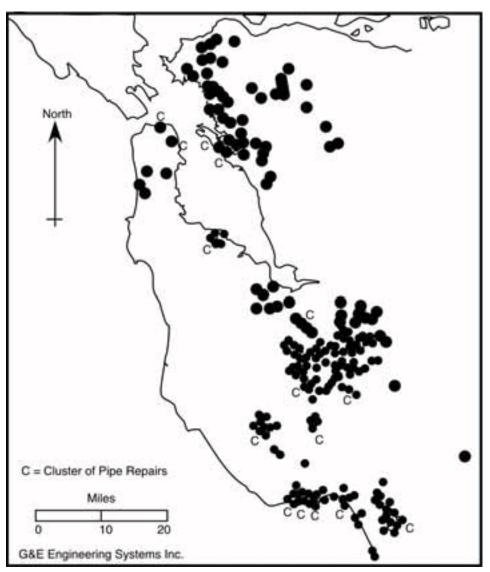
Figure 6-4 shows a map with damage to buried pipelines in the San Francisco Bay Area due to the 1989 Loma Prieta earthquake. This map shows damage at 916 locations for water (including a few wastewater) utilities.

Figure 6-4. Buried Pipeline Damage in the San Francisco Bay Area, 1989 Loma Prieta Earthquake

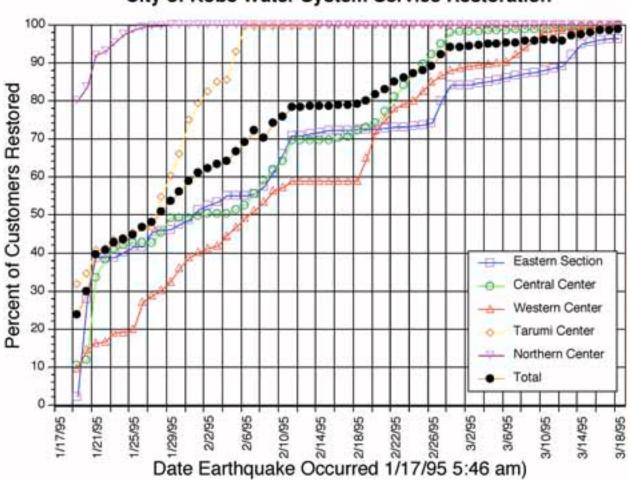
City of Kobe Water System Service Restoration

Figure 6-5.City of Kobe Customer Water Service Restoration Time

The City of Kobe's water system suffered 1,757 pipe repairs to mains. The repairs could be classified into one of three types: damage to the main pipe barrel (splitting open); damage to the pipe joint (separated); damage to air valves and hydrants; the damage rate was divided about 20% - 60% - 20% for these three types of repairs, respectively. Figure 6-5 shows the time needed to restore service to various districts in Kobe (called sections or centers in the figure). It took 90 days to restore the last customer. Figure 6-6 shows damaged pipeline being repaired.

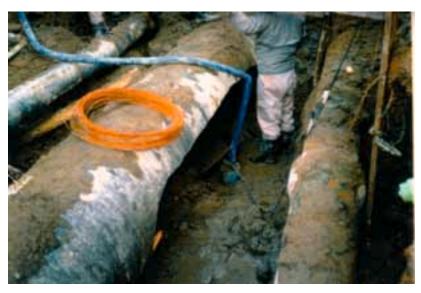
Figure 6-6. Damaged Pipeline, Kobe 1995

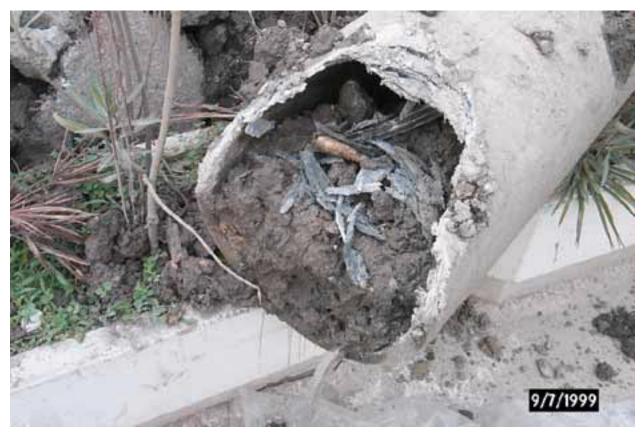
Figure 6-7. Damaged AC Pipeline, Adapazari, Turkey 1999

A population of about 1.8 million people lived within the zone of strong shaking caused by this earthquake. While there was just slight to modest damage to the three water treatment plants in the area (all had been designed, more or less, to the equivalent of California seismic Zone 4), there was widespread and major damage to transmission and distribution pipelines. Damage to a 2.2 m diameter butt-welded steel transmission pipeline where it crossed the Anatolian fault is documented in Eidinger (2002). At other locations, there were multiple failure of an older transmission pipeline subjected to permanent ground deformations (faulting and/or lateral spreads). But the most significant damage was to distribution pipelines, largely due to liquefaction settlements and strong ground shaking. Figure 6-7 shows damage to a 12" diameter asbestos cement pipe, the most common type used in the region.

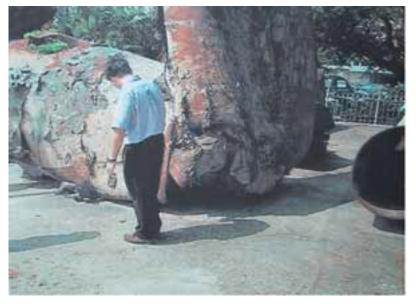
largely due to damage to buried pipelines. Figure 6-8 shows damage to a 2-meter diameter pipeline that was bent due to fault offset (the thrust up side was on the right side of this pipe).

Figure 6-8. Damaged Steel Transmission Pipe, Chi-Chi Earthquake 1999

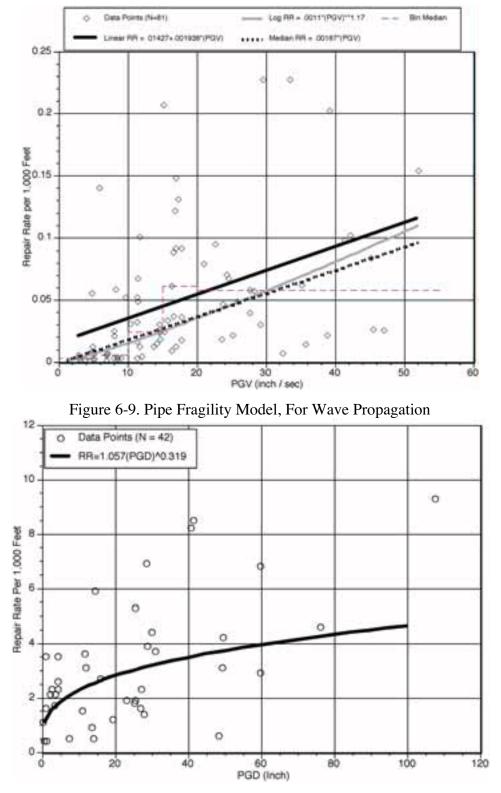
Statistical analysis of the empirical data was carried out in a similar way as that described above for the wave propagation data. The dataset and regression curve are shown in Figure 6-10. The repair rates are about two orders of magnitude greater than those for wave propagation thus indicating the extreme hazard that PGD poses for buried pipe. Portions of water systems that experience ground failure are likely to be mostly inoperable immediately after the earthquake.

Figure 6-10. Pipe Fragility Model, For Permanent Ground Deformations
