John M. Eidinger *Editor*

May 3, 2004 Revision 11

Abstract

This report is written to provide baseline information for engineers, the fire service, utility managers, the insurance industry and others who may be interested in addressing the fire following earthquake risk that faces our communities.

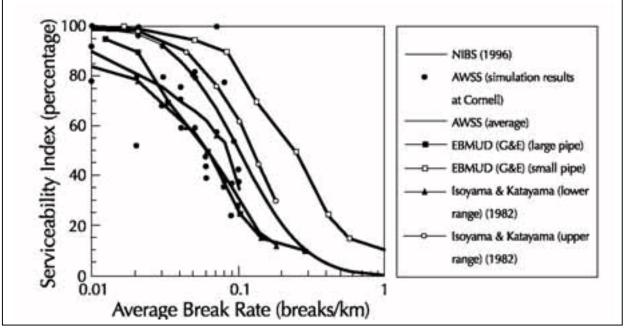
In-lieu of performing these sometimes complex hydraulic analyses, a number of researches have developed simplified models to forecast the serviceability of pipeline networks under various amounts of pipe damage. Figure 6-11 shows the results. In applying Figure 6-11, it should be recognized that the horizontal axis represents pipe breaks (leaks have much less impact), and that the extent of the grid (number of pipe loops) also plays an important role. For example, a single break in a long transmission pipeline would put the entire pipe out of service (Index = 0%), whereas a single break in a equally long length of pipe in a small well-looped network would possibly result in an Index near 100%.

Figure 6-11. Serviceability Index vs. average break rate

The model shown in Figure 6-11 can be used to establish the capability for fire suppression, assuming that suitable fire department resources are at the fire scene. For example, an Serviceability Index over 90% would relate to a "good" water system, and an index below 20% would relate to a "poor" water system.

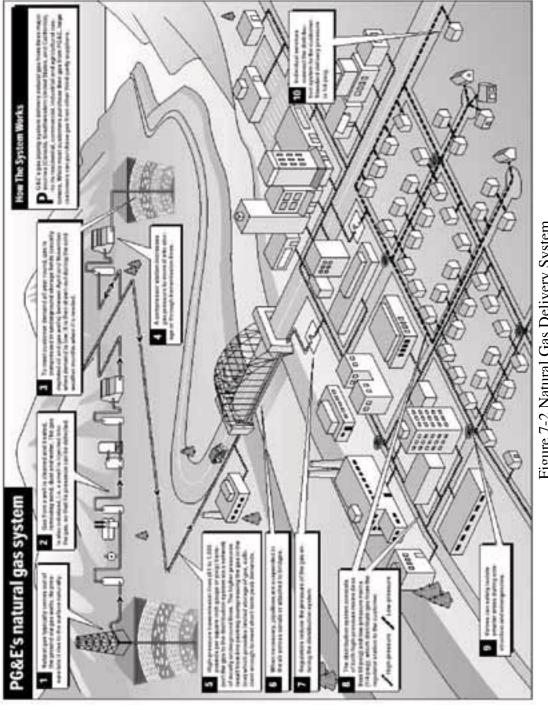
Figure 7-2 Natural Gas Delivery System (provided by Pacific Gas & Electric Company)

Gas utilities install and operate a network of mostly underground pipelines to deliver natural gas from the gas well to residential, commercial, industrial and agricultural customers, as shown in Figure 7-2. The pipelines operate at various pressures throughout the system. Gasses are compressed higher when entering transmission pipelines and regulated (pressure control) lower when entering distribution pipelines and supplying customers. Depending on the operating pressure, size of the pipe, year of installation and other factors, pipe material can be steel, plastic, cast iron or copper.

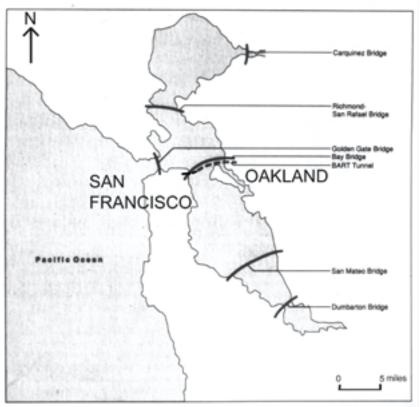
Figure 10-1 Bridges and Tunnels Across San Francisco Bay

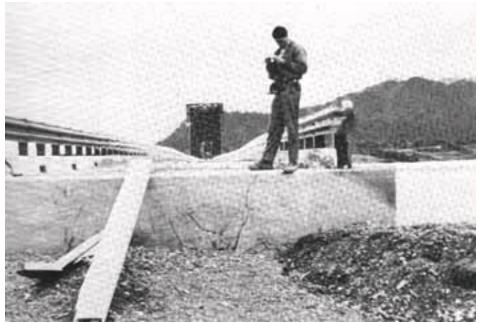
Figure 10-2 The Copper River Bridge #2 was closed after the 1964 Great Alaska earthquake due to approach settlement and shifted truss spans (NAS, 1973).

Figure 10-2. Although it is usually not severe and can be repaired relatively quickly, the settlement of embankments can hinder accessibility to damage areas and to fires following earthquakes.

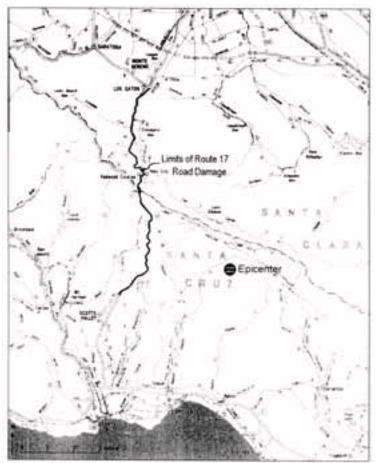
Figure 10-3 Map of Damage to Route 17 after the Loma Prieta Earthquake. trucks out of the firehouse due to racking of the doors. They radioed for mutual aid from the nearest California Division of Forestry fire station 34 minutes away in Ferndale. However, landslides on the steep, mountain road delayed them by more than an hour, by which time the building was a smoldering ruin (Turner, 1999).

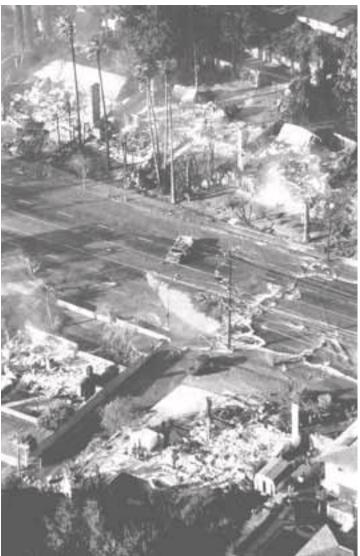
Figure 10-4 Ignition of gas line under Balboa Blvd (after the 1994 Northridge earthquake) resulted in several homes burning down (L.A. Times photo).

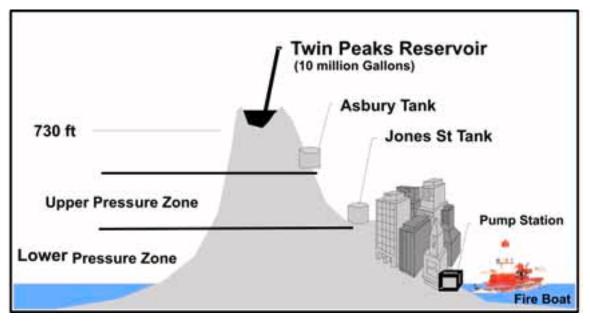
Figure 12-1 Schematic AWSS and Sources of Supply: Twin Peaks Reservoir, Cisterns, Pump Station and Fireboat(s)

(*Phoenix*, and *Guardian*) can pump 9,600 and 24,000 gpm respectively, from San Francisco Bay, as well as thirty-six water suction connections distributed along the City's waterfront to allow fire engines to draft saltwater from the Bay of San Francisco. Thus, there are multiple redundant sources of supply. The Twin Peaks reservoir is intended for large non-earthquake fires, while the pump stations and fireboat manifolds represent an unlimited supply of water.

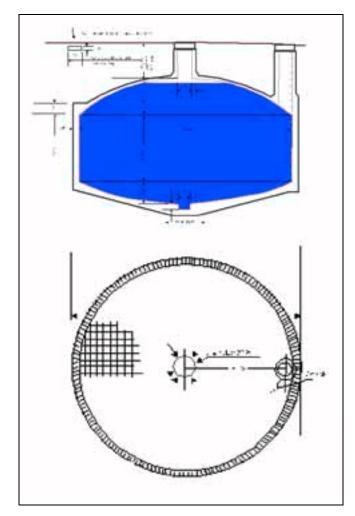
Figure 12-2 San Francisco Cistern – Elevation (top) and Plan (bottom)

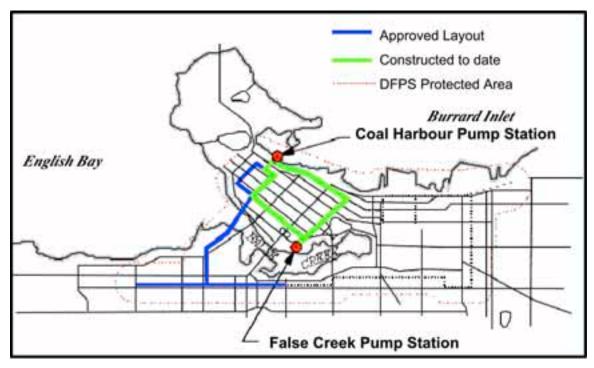
Figure 12-3 Dedicated Fire Protection System (DFPS), City of Vancouver, B.C.

The DFPS is a major asset for protection of the high-value district of Vancouver, and consists of two seismically reliable pump stations (at Coal Harbor, and at False Creek) each capable of 10,000 gpm, Figure 12-3. Due to the large tide range in Vancouver, the pump stations required a deep wet well, with vertical axis turbine pumps, which are powered by direct-drive diesel engines via a right angle gear drive, Figure 12-4.

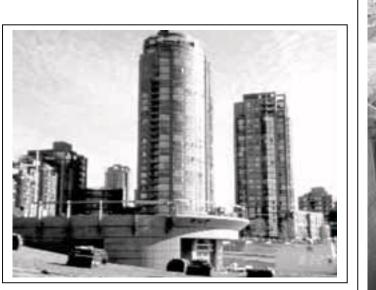
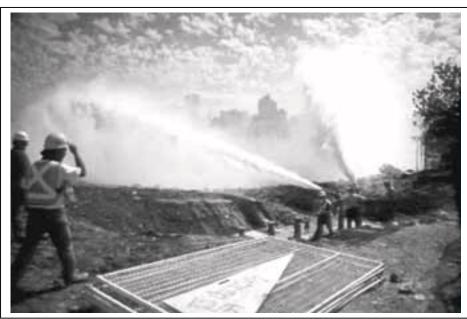
Figure 12-5 Vancouver, B.C. DFPS (a) False Creek pump station (foreground, nearing completion in 1995); (b) welded steel pipe under construction, 1995; (c) False Creek station proof test, 1995.

The two stations are connected by a loop around the CBD of 20 inch diameter welded steel pipe, Figure 12-5(b).Special large diameter hydrants connect to this loop, from which firefighters can receive high volume high pressure flows. VFR is acquiring special large diameter hose which, together with the DFPS, can be used to protect a 1000 ft. radius from any hydrant off of this loop, thus 'blanketing' the CBD.

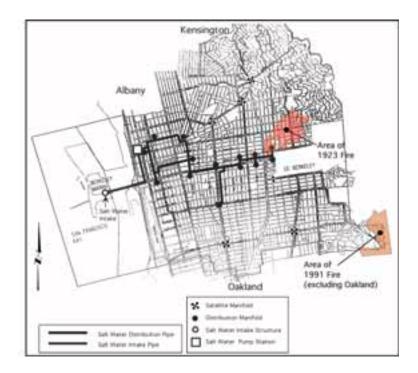
Figure 12-6. City of Berkeley Proposed Salt Water Fire System A total of 14 manifold outlets are provided in the system, to allow the fire department to choose between several different outlet points from the steel pipe system for hose deployment to a particular fire location. For any location served by the SFS, there are an average of 7 different manifold outlets that could be used. This provides flexibility in laying the ULDH along streets.

The layout of the SFS has the following main features (see Figure 12-6).

- 13 manifold System. This analysis considers what is "lost" by saving the cost of one manifold.
- 14 manifold system. This is the baseline system, shown in Figure 12-6.
- 19 manifold system. This adds 5 manifolds to the baseline system.
- 21 manifold system. This adds 7 manifolds to the baseline system.
- 23 manifold system. This adds 9 manifolds to the baseline system.

There would be many "T" and 90-degree turns of the main SFS pipeline in the configuration shown in Figure 12-6. Each "T" connection or 90 degree turn would effectively create an anchor in the pipeline. To limit the effects of these anchors, particularly in the soils susceptible to liquefaction, the next "anchor" placed in the pipeline would be located preferably at least 150 pipe diameters away. The anchor spacing criteria is based on the pipe length required to distribute accumulated axial strains due to pipe settlement.

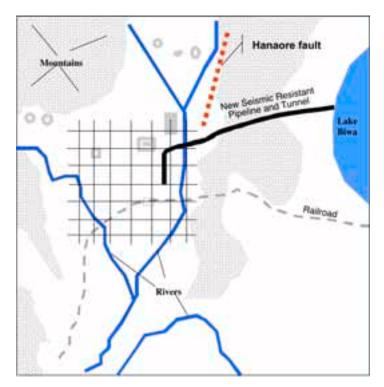
Figure 12-9 Kyoto. Upgrade option using new transmission and local grid pipeline network

One option to provide an alternative water supply would be to construct a high volume seismically resistant pipeline / tunnel from Lake Biwa, to feed a distribution system (shown in Figure 12-9 as a gridwork). This solution would be relatively expensive, especially constructing an underground network in the highly congested portions of Kyoto.

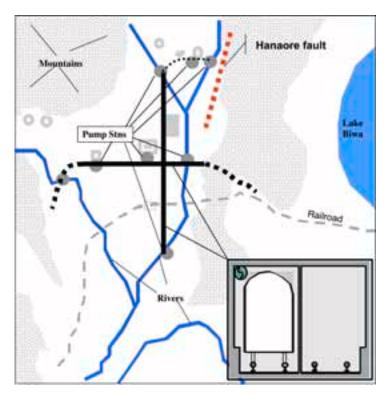
Figure 12-10 Kyoto. Upgrade option using new pipeline in subway, with pump stations drawing water from local water supplies

However, scattered throughout the city are a number of natural and manmade ponds and other bodies of water. This provides the basis for an alternative water supply system, which would be to utilize a recently constructed subway system, shown in Figure 12-10 as the heavy black line, running north-south and east-west, with planned extensions shown as heavy dashed lines. This subway line was only recently constructed, to high seismic standards, and is highly likely to withstand any earthquake without significant damage. The existing route of the subway intersects or is very close to a number of water supplies, such as the rivers and various ponds. A welded steel or other pipe could be placed within the existing subway tunnel, and fed via short connectors linked to selfcontained modularized pump stations installed at the rivers and various ponds, to provide alternative water supplies. Similar to other high pressure systems, the proposed system could feed handlines (or perhaps ultra large flex hoses connected to handlines) wielded by firefighters over perhaps as much as a 1,000 m radius, Figure 12-11, without need of fire engines. The proposed system utilizing the existing earthquake-resistant Kyoto subway structure, in combination with handlines feeding off the high-pressure system, would provide protection to a large part of the urbanized part of Kyoto, Figure 12-12.

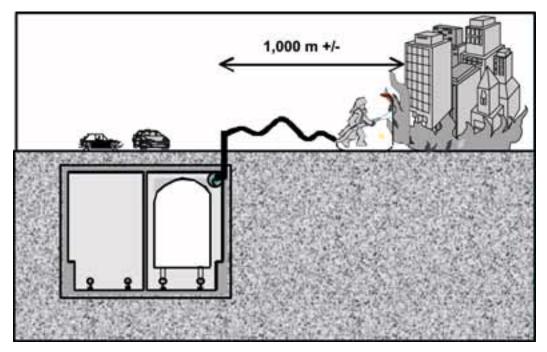
Figure 12-11 Kyoto. The proposed system could feed handlines wielded by firefighters over perhaps as much as a 1,000 m radius, without need of fire engines

Two options for accessing alternative water supplies are highlighted in Figures 12-9 through 12-12.

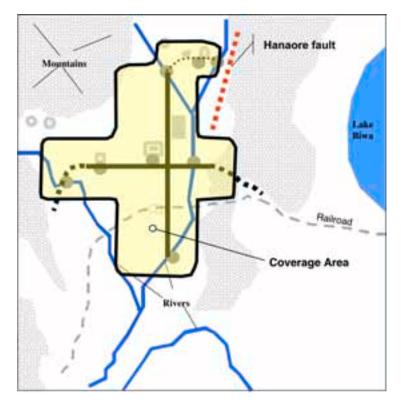
Figure 12-12 Koto. Fire coverage area by new redundant water system

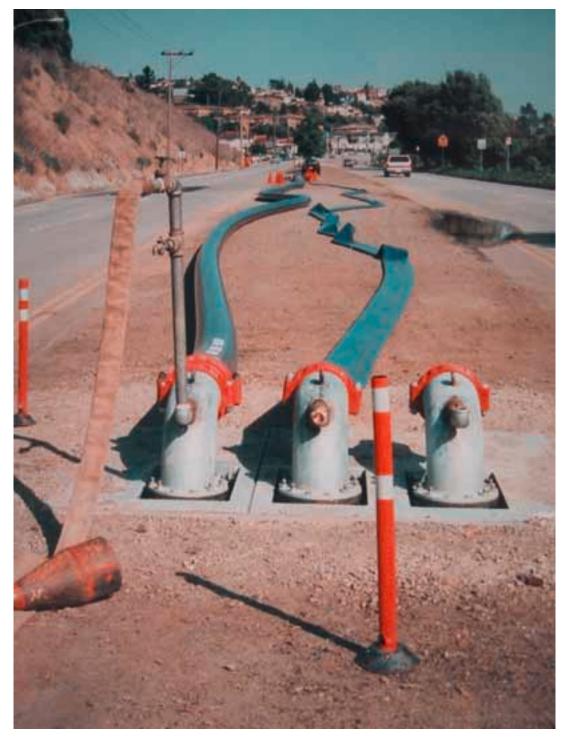
Figure 13-1 shows the actual deployment of above ground flexible hoses uses to bypass a 24" diameter pipeline that crosses the Hayward fault. In the foreground of this figure are three pipe elbows. Attached to the elbow on the left is a 12" diameter blue-colored "super aqueduct" hose manufactured by Angus. We call this 12" ultra large diameter hose, ULDH, in distinction to 5" large diameter hose, LDH, commonly used by fire departments. Attached to the middle elbow is another hose, but unpressurized. The third elbow is currently shown with no attached hose. The original 24" diameter steel pipeline is located in the road to the left of the hoses. The Hayward fault traverses across this street, a few hundred feet away from the elbows seen in the foreground. A similar set of three elbows is located at the other side of the fault, about 900 feet from the elbows seen in the foreground.

Figure 13-1. Flex Hose Deployment in EBMUD System

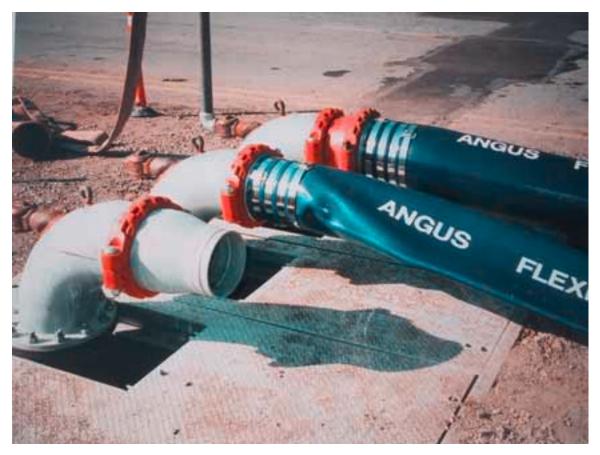
Figure 13-2 shows the same three elbows seen in the foreground of Figure 13-1, from a side view. The hose is attached to the elbows using victaulic couplings. The three elbows are in turn connected to a buried 12" diameter pipe which laterals off the main 24" diameter transmission backbone pipe. The street repair (new pavement) seen in Figure 13-2 shows where the new 12" lateral has been installed.

Figure 13-2. Flex Hose Deployment in EBMUD System In actual practice, the flex hose can be deployed by a minimum of 2 men, and connected up in about 1 hour. In a post-earthquake environment, this might take longer, but with a reasonable emergency response plan, a crew of 8 people could reasonably deploy about 6 such installations in 8 hours. It would take these same 8 people about 15 to 20 days to repair the same damaged pipes. In this way, restoration of water service is spec up from 15 to 20 days, to perhaps 8 hours.

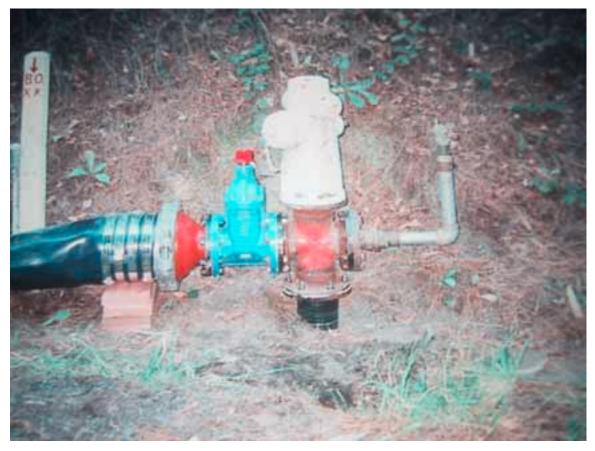
Large diameter flex hoses can also be hooked up to fire hydrants, as for example in Figure 13-3. The hose is attached to a special fitting placed under the hydrant, in order to accommodate the change in diameter. A different fitting could be used to attach the hose directly to the screwed 4.5" diameter pumper outlet fitting on the hydrant. The small pipe outlets seen in Figure 13-1 to Figure 13-3 provide an easy way to empty water from the large diameter flex hose when it is time to roll it up; and also to flush the hose should that be necessary.

Figure 13-3. Flex Hose Attachment To Fire Hydrant

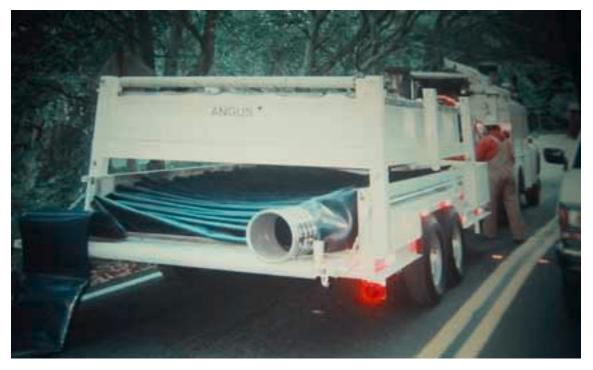
Figure 13-4 shows a "flaking" truck being hauled by a heavy pickup truck. The large diameter hose (up to 600 foot length) is stored in the flaking box, and then driven to the site, and then deployed. Figure 13-5 shows a "hose reel" as an alternative way to store and deploy large diameter hose (in practice, the storage of hose in flaking boxes, Figure 13-4, might be most cost effective).

Figure 13-4. Deployment of Flex Hose

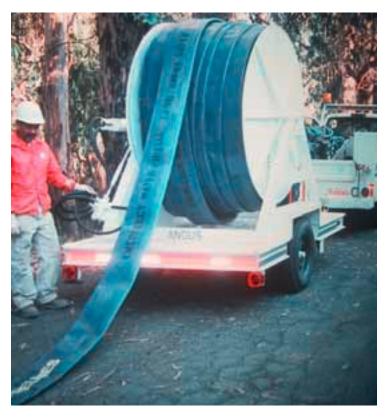
Figure 13-5. Alternate Deployment of Flex Hose

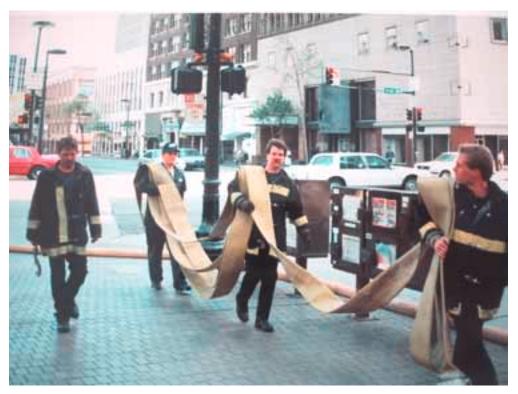
Depending upon the length of hazard to be bypassed, and the required flow rates, it will sometimes be feasible to use large diameter (5" to 6") above ground flex hose (LDH) to do, more-or-less, the same function as the 12" ultra large diameter flex hose. Fire departments are well versed with the use of large diameter flex hose. Figure 13-7 shows just one such deployment.

Figure 13-7. Deployment of Medium Diameter Flex Hose

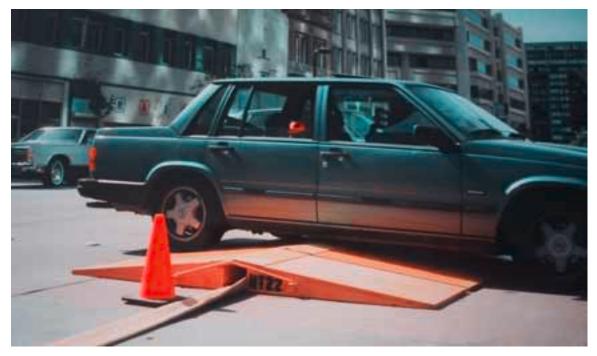
When using 5" diameter flex hose, it might be feasible to also install ramps to allow traffic to go over the hose. One such example is seen in Figure 13-8. These ramps will require additional time / manpower to set up the hose. Even with these ramps, there is no guarantee that vehicles will use them – as was evidenced when a taxicab got stuck on a 5" hose.

Figure 13-8. Use of Ramp Over A 5" Diameter Flex Hose

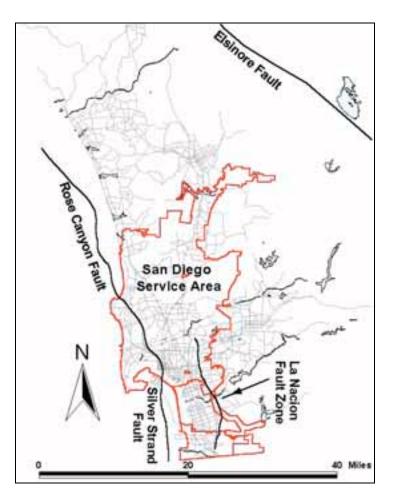
Figure 14-1. San Diego Water System and Nearby Earthquake Faults

The procedure to develop benefit cost analyses presented in Sections 14.2 to 14.7 was applied to the City of San Diego water system (Eidinger, 2000). The San Diego water system serves a population of about 1,200,000 people. Figure 14-1 shows the major faults surrounding the City of San Diego. Using the ignition models presented in chapter 4 of this report, coupled with suitable attenuation models and scenario earthquakes suitable for planning purposes for San Diego, Table 14-10 shows the forecasted median number of fire ignitions for the City of San Diego.

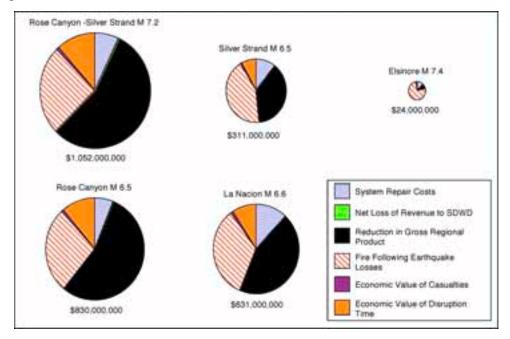
Figure 14-2 summarizes the losses to San Diego assuming the water system in its year 2000 configuration (i.e., before any seismic retrofit). For example, a Magnitude 7.2 earthquake on the combined Rose Canyon – Silver Strand faults would generate about a \$1.052 billion loss in San Diego. Losses due to fires would be about 25% of the total loss. As can be seen in Figure 14-2, the only type of loss greater than from fire is due to the reduction in gross regional product due to loss of water supply. (All data in Figure 14-2 and Figure 14-3 are in \$2000).

Figure 14-2. Scenario Losses to San Diego – As Is Water System A series of capital improvements to the San Diego water system was proposed. Four possible levels of seismic retrofit were considered, ranging from \$0.7 million to \$90 million. Seismic evaluations of the water system were re-run assuming each level of capital upgrade was installed, for the five scenario earthquakes identified in Table 14-10, as well as for many other causative faults and varying magnitudes. Table 14-11 provides some of the results, in terms of forecasted numbers of structures burned, for the water system in its "as-is" and with "recommended" seismic retrofits. The data in Table 14-11 were calculated using models similar to those described in Chapter 4 of this report.

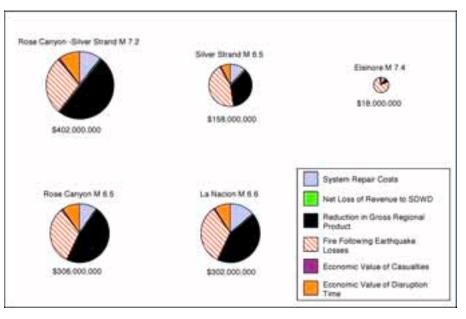
Figure 14-3 shows the scenario losses for the same five scenario earthquakes listed in Figure 14-2, with the assumption of a \$62 million seismic upgrade. As can be seen there is about a 60 to 70% reduction in total losses. The full benefit cost model described previously in Chapter 14 was applied, and the results are listed in Table 14-12. The key points are as follows:

Figure 14-3. Scenario Losses to San Diego – Upgraded Water System
