Paper No. 3268

Fire Following Earthquake – Flex Hose

Summary

This paper describes the use of Flex Hose for use by water and fire departments to address the Fire Following Earthquake issue.

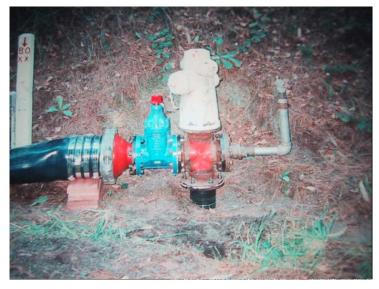
Figure 4. Flex Hose Attachment To Fire Hydrant

Large diameter flex hoses can also be hooked up to fire hydrants, as for example in Figure 4. The hose is attached to a special fitting placed under the hydrant, in order to accommodate the change in diameter. A different fitting could be used to attach the hose

directly to the screwed 4.5" diameter pumper outlet fitting on the hydrant. The small pipe outlets seen in Figures 2 to 4 provide an easy way to empty water from the large diameter flex hose when it is time to roll it up; and also to flush the hose should that be necessary.

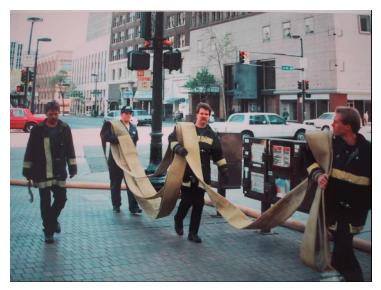
Figure 7. Deployment of Large Diameter Flex Hose

Depending upon the length of hazard to be bypassed, and the required flow rates, it will sometimes be feasible to use large diameter (5" to 6") above ground flex hose to do, more-or-less, the same function as the 12" ultra large diameter flex hose. Fire departments are well versed with the use of large diameter flex hose. Figure 7 shows just one such deployment.

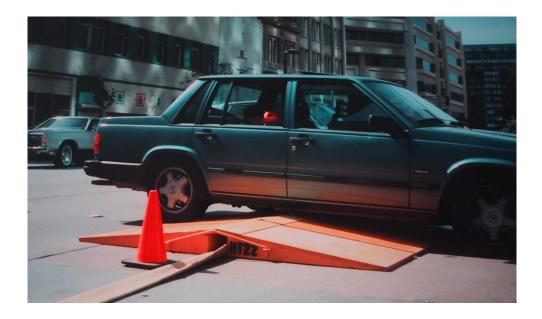
Figure 8. Use of Ramp Over A 5" Diameter Flex Hose

When using 5" diameter flex hose, it might be feasible to also install ramps to allow traffic to go over the hose. One such example is seen in Figure 8. These ramps will require additional time / manpower to set up the hose. Even with these ramps, there is no guarantee that vehicles will use them – as was evidenced when a taxicab got stuck on a 5" hose.
