Seismic Upgrade of Pipes Across the Hayward Fault

by
John Eidinger¹

ABSTRACT

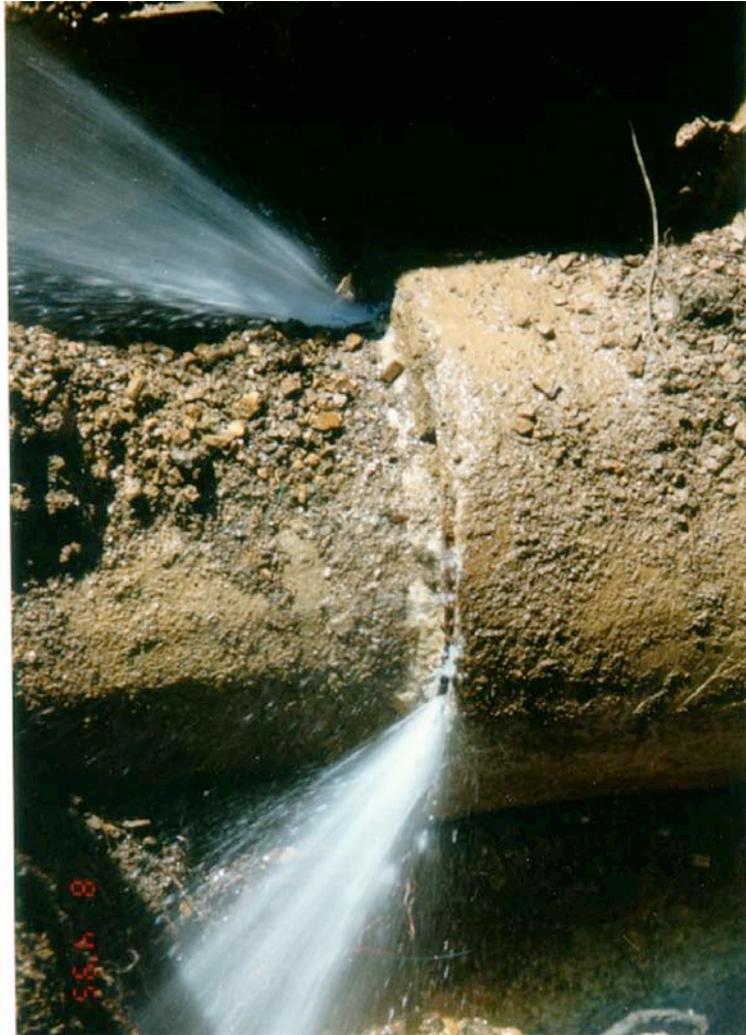
Figure 1 shows a 30-inch diameter EBMUD water pipe leaking where it crosses the Hayward fault near the Oakland Zoo. The water jetting out of the pipe is at a location where this same pipe had been previously repaired. When this pipe last failed, it was repaired quickly to restore water service, but the repair did not make the pipe "fault tolerant".

Figure 1. Leaking 30-inch diameter water pipe, damaged due to fault creep on the Hayward fault

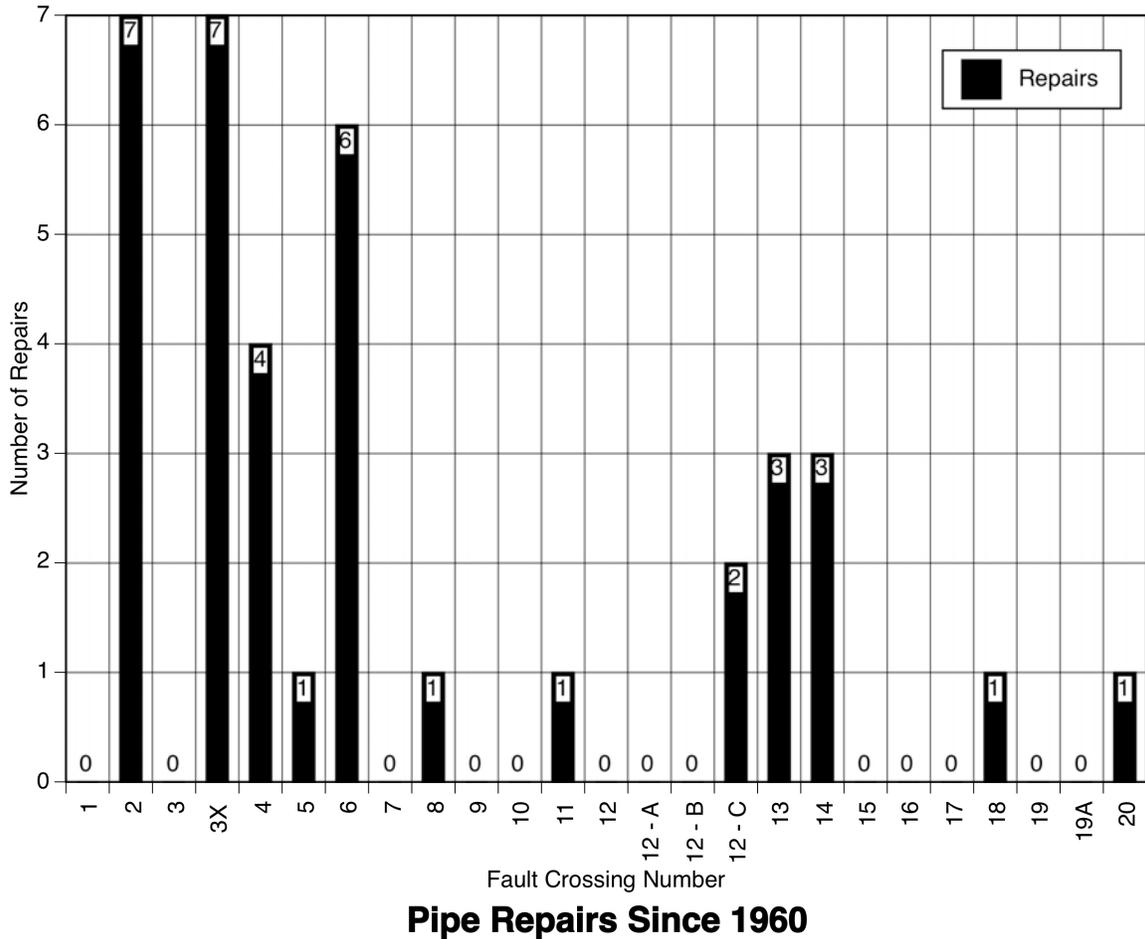
Over the past 50+ years, EBMUD has maintained a record of every leak to their pipes, and there have been dozens of pipe failures (for pipes 20-inch and larger) due to ongoing fault creep. Figure 2 shows the number of times that EBMUD has repaired its 25 largest diameter water pipes where they cross the Hayward fault. All these pipes are welded steel, designed to AWWA M11 (or similar). The historical failure rate for these 25 pipes is about 1 to 2 per year due to fault creep. Figure 2 shows that some pipes fail much more often than others, and this depends largely on the local creep rate; the orientation of the pipe to the fault angle; the presence of nearby pipe appurtenances (like valves); and other factors.

Figure 2. Leak history for twenty-five 20-inch and larger water pipes (EBMUD) due to ongoing Hayward fault creep, 1960-1990

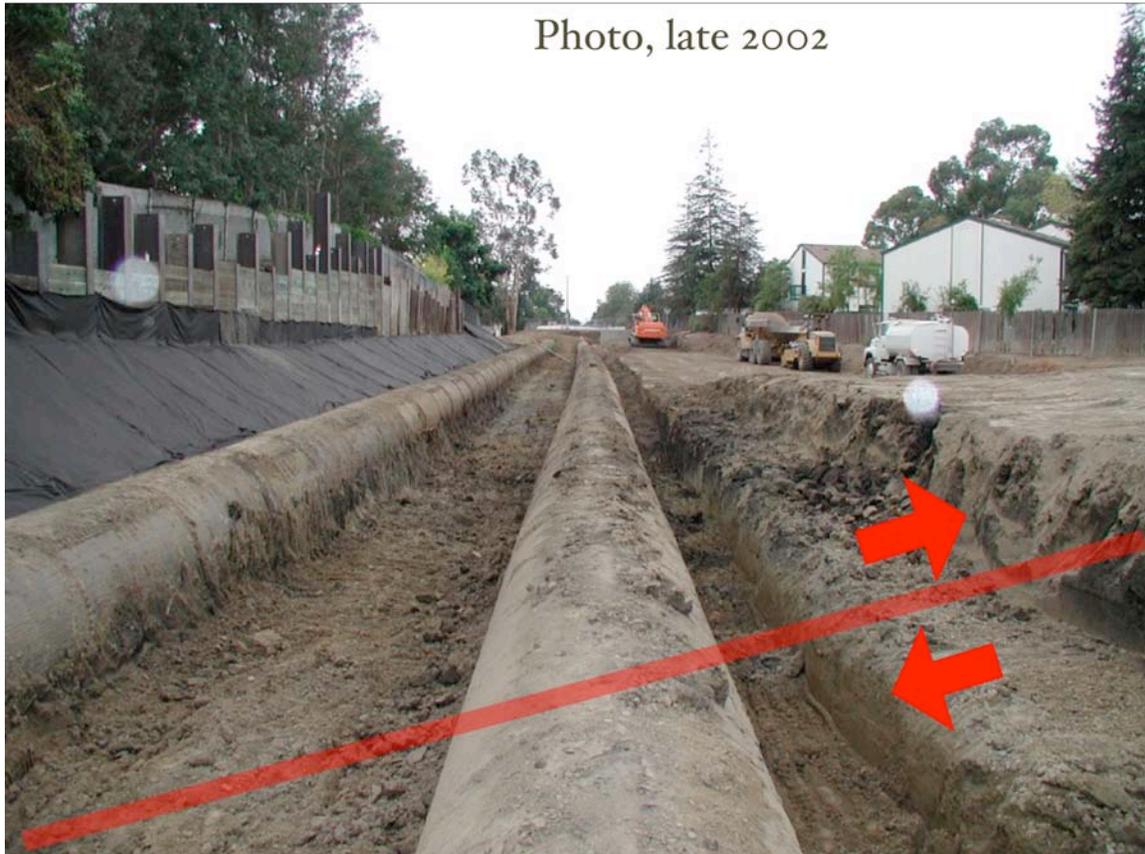
Figure 3 shows SFPUC's Bay Division Pipelines (BDPL) 1 and 2 pipes (original construction) where they cross the Hayward fault in Fremont. BDPL 1 was built in 1923; BDPL 2 in 1933. These pipes were replaced in late 2002/early 2003 with new fault-tolerant pipes. The location of the creeping trace is shown in red. The effect of cumulative fault creep is clearly observed by the observed bend in the BDPL 2 (center of photo). Note that the bend in BDPL 2 is *not* at the fault location (the fault location shown is based on a trench dug 20 feet to the right); this is as expected given the strength of the pipe and the type of soil it is buried in.

Figure 3. SFPUC BDPL 1 (left) and 2 (right) Pipes

The SFPUC has seismically upgraded BDPL 1 (60-inch) and BDPL 2 (66-inch) diameter water pipes by replacing them with new pipes that are designed to accommodate 5 feet of fault offset (constructed in 2003). At this location (see Figure 3), SFPUC also installed valves and bypass manifolds to allow the installation of six flex hoses to bypass the new 60-inch and 66-inch pipes should they unexpectedly fail. The SFPUC is currently designing upgrades for two other existing pipes (BDPL 3, 78-inch and BDPL 4, 96-inch), and construction of the first phase was completed in 2008 (isolation valves). Construction of a new BDPL 5 (72-inch) pipe that is designed to accommodate 5.5 feet of fault offset should begin in late 2009.
