SEISMIC AND WIND DESIGN FOR SOLAR PANELS

J. M. Eiding¹ D. Pratt² F. Nikman³

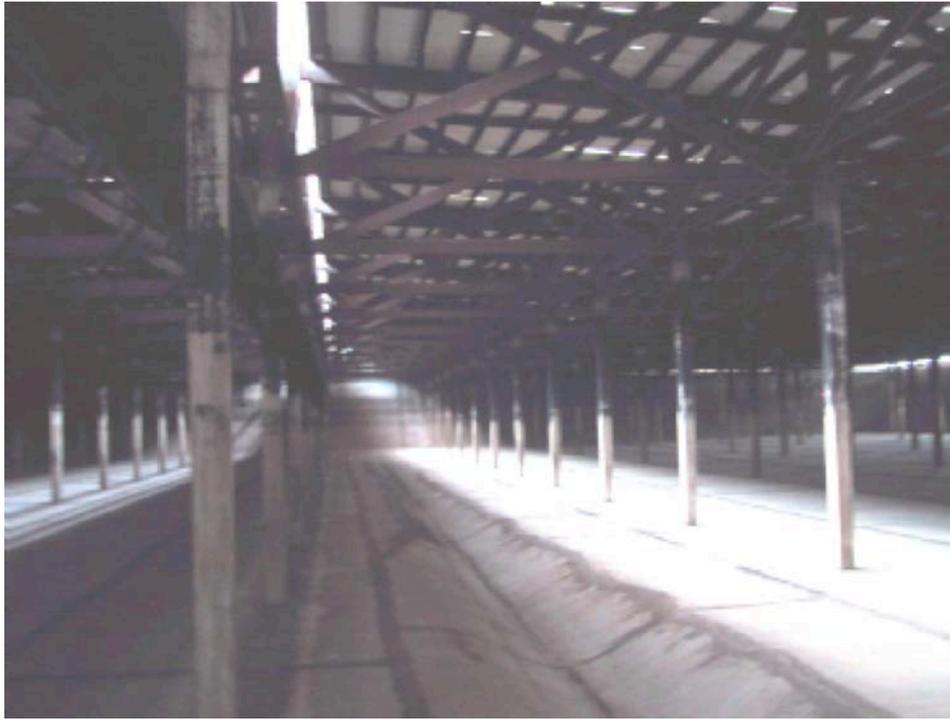
Figure 1. Interior View of Empty Water Reservoir

We examine the practical issues and economics of installing solar panels for a reservoir with light wood roof in Pasadena (10 miles from Los Angeles). Figures 1 and 2 show the existing condition of the reservoir in Pasadena. The roof sheathing is corrugated steel, the roof structure is redwood rafters atop redwood beams atop redwood columns, the liner is light reinforced concrete. The columns rest on the liner without positive attachment. Roof dead weight is about 8 psf. The roof was built in 1950, for an original seismic horizontal load of 10% times dead weight. The existing lateral load system is provided by lateral resistance of the roof beams and rafters being resisted by exterior concrete anchors. The current (2008) seismic design criteria is for an earthquake with $PGA = 0.60g$ (475 year return period). Seismic analysis of the roof shows that the interior connections between wood members are undersized for the seismic loads (seismic upgrade by modifying most bolted connections) and the exterior concrete anchor blocks are too small (seismic upgrade with new drilled piers). Accumulated corrosion, repair of the leaking liner and other maintenance items results in a seismic upgrade cost of \$32 per square foot (excluding solar panels).

We next looked for evidence of wind-damage for existing reservoirs. In Pasadena, one of eight reservoirs had its roof peeled off / damaged (moderate repair costs) in a prior wind event. In Fremont, one of six reservoirs (all similar to the one in Figures 1 and 2) had its roof peeled off (very high repair costs) in a recent winter storm. Both these reservoirs were located at or near the base of large mountains (1,500 to 4,000 feet higher than the roof) in exposure C type environments. It is readily apparent that the 50-year return wind speeds in the California code should not be considered "never to exceed" and in fact can be expected to be exceeded one or more times at reservoirs within a 50 year time frame. If the reservoir is strictly used for water retention purposes, then perhaps a \$2 to \$10 per square foot repair bill, due to high winds once every 50 years is acceptable. However, once a new solar panel array is installed, the repair bill would increase to perhaps \$35 to \$60 per square foot, and the loss of the power generated might become material to the community if solar power become a material portion of the total base load power generation.

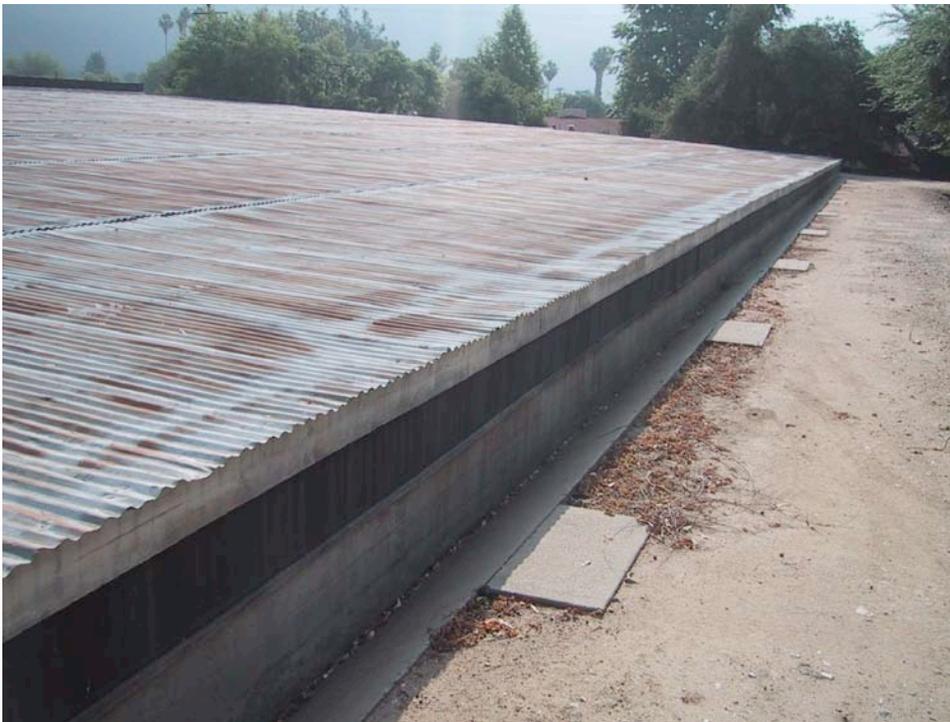
Figure 2. Exterior View of Water Reservoir Roof
