Seismic Fragility Formulations for Water Systems

*Web Site Report
Appendices*

*Prepared by:
G&E Engineering Systems Inc.*

*G&E Report 47.01.02, Revision 1
July 12, 2001*

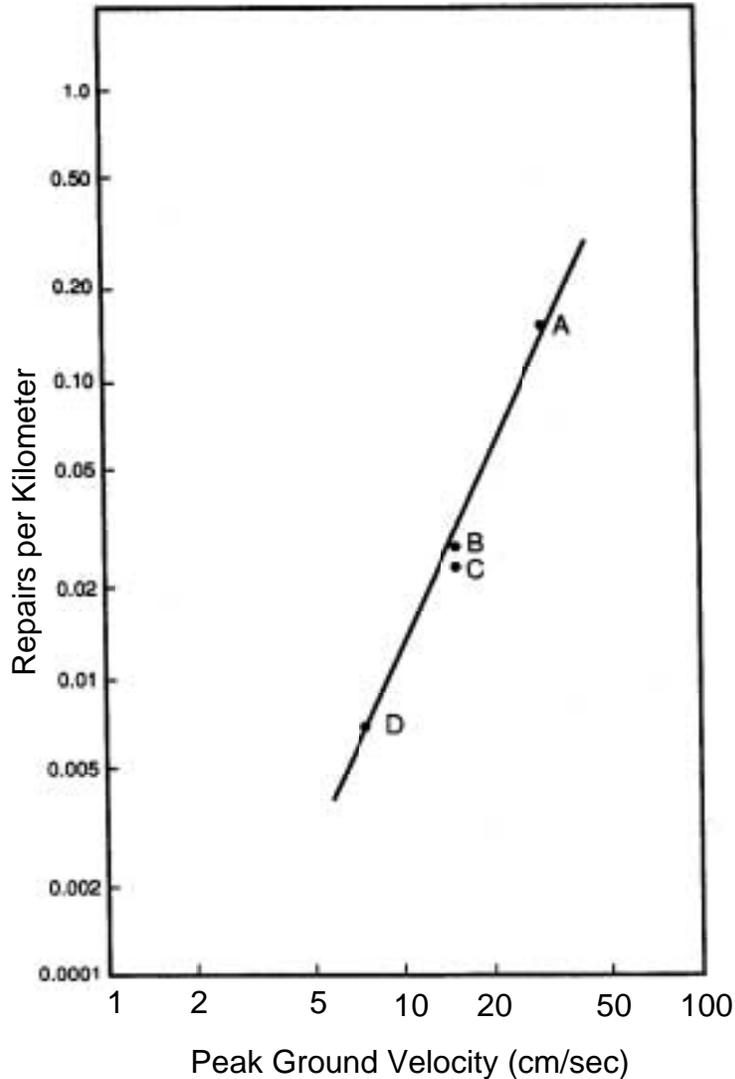
Figure A-1. Wave Propagation Damage to Cast Iron Pipe [from Barenberg, 1988]

A. 1971 San Fernando. Most common - 3 to 6 inch diameter pipes. PGV = 30 cm/sec.
Observed repair rate = 0.155 repairs / km

B. 1969 Santa Rosa. Most common - 3 to 6 inch diameter pipes. PGV = 15 cm/sec.
Observed repair rate = 0.028 repairs / km

C. 1971 San Fernando. Most common - 3 to 6 inch diameter pipes. PGV = 15 cm/sec.
Observed repair rate = 0.024 repairs / km

D. 1965 Puget Sound. Most common - 8 to 10 inch diameter pipes. PGV = 7.5 cm/sec.
Observed repair rate = 0.007 repairs / km

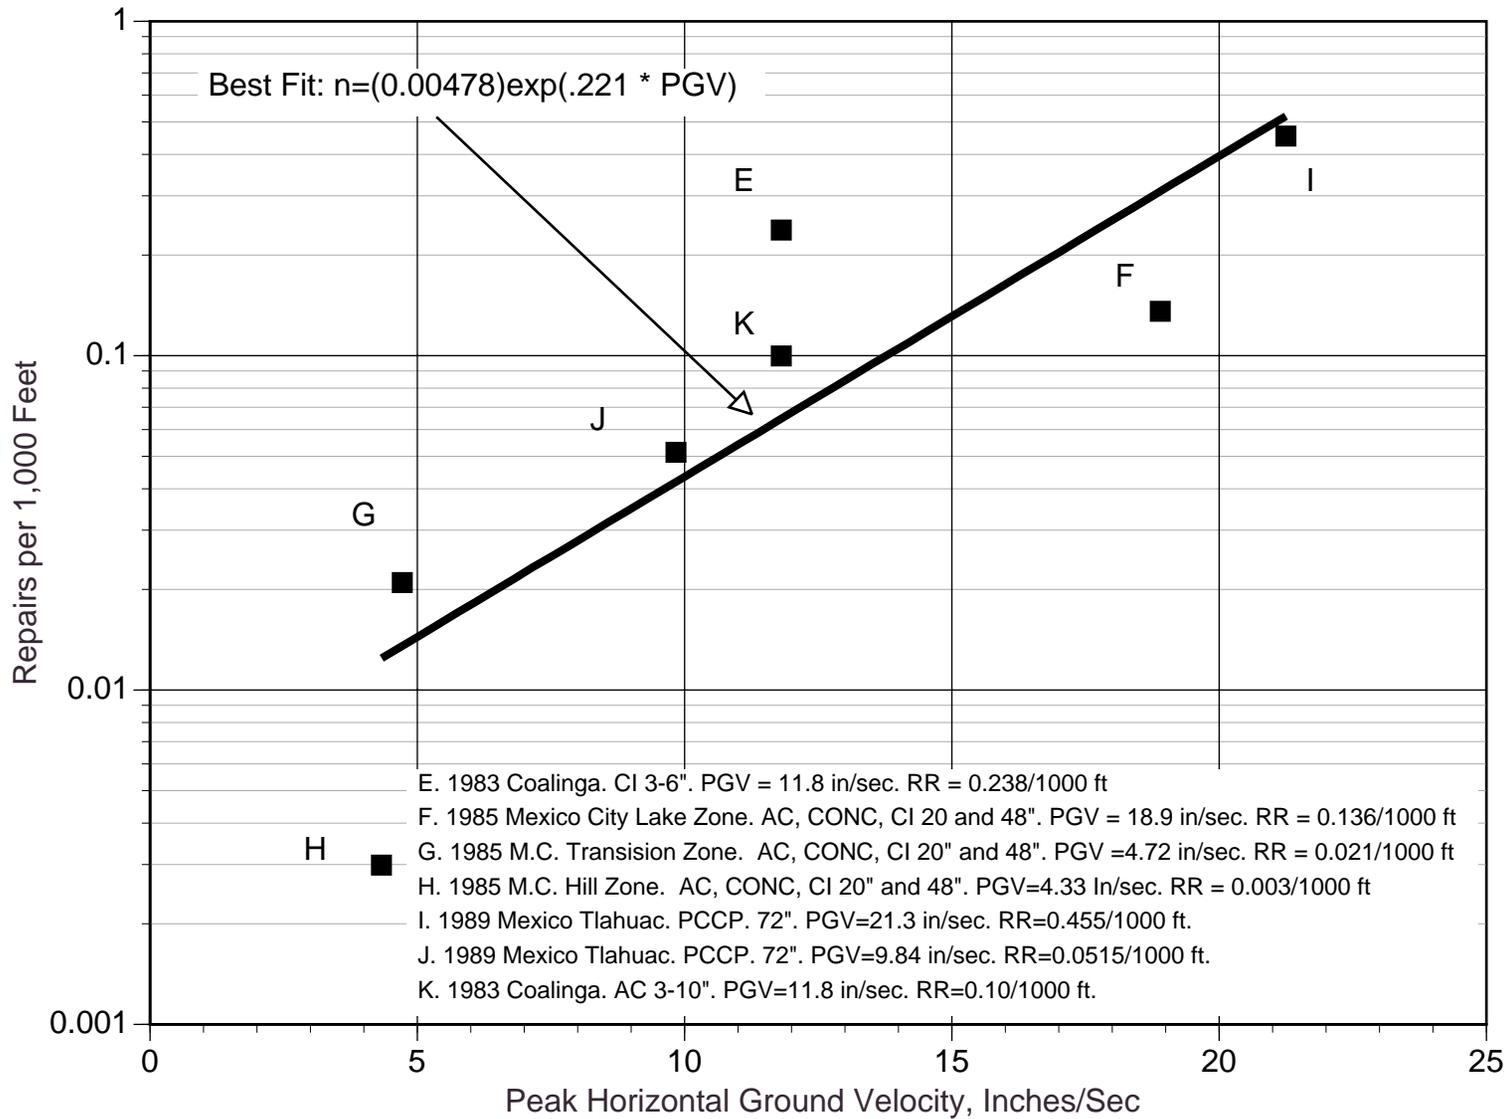
**Figure A-2. Pipe Damage - Wave Propagation
[from O'Rourke and Ayala, 1994]**

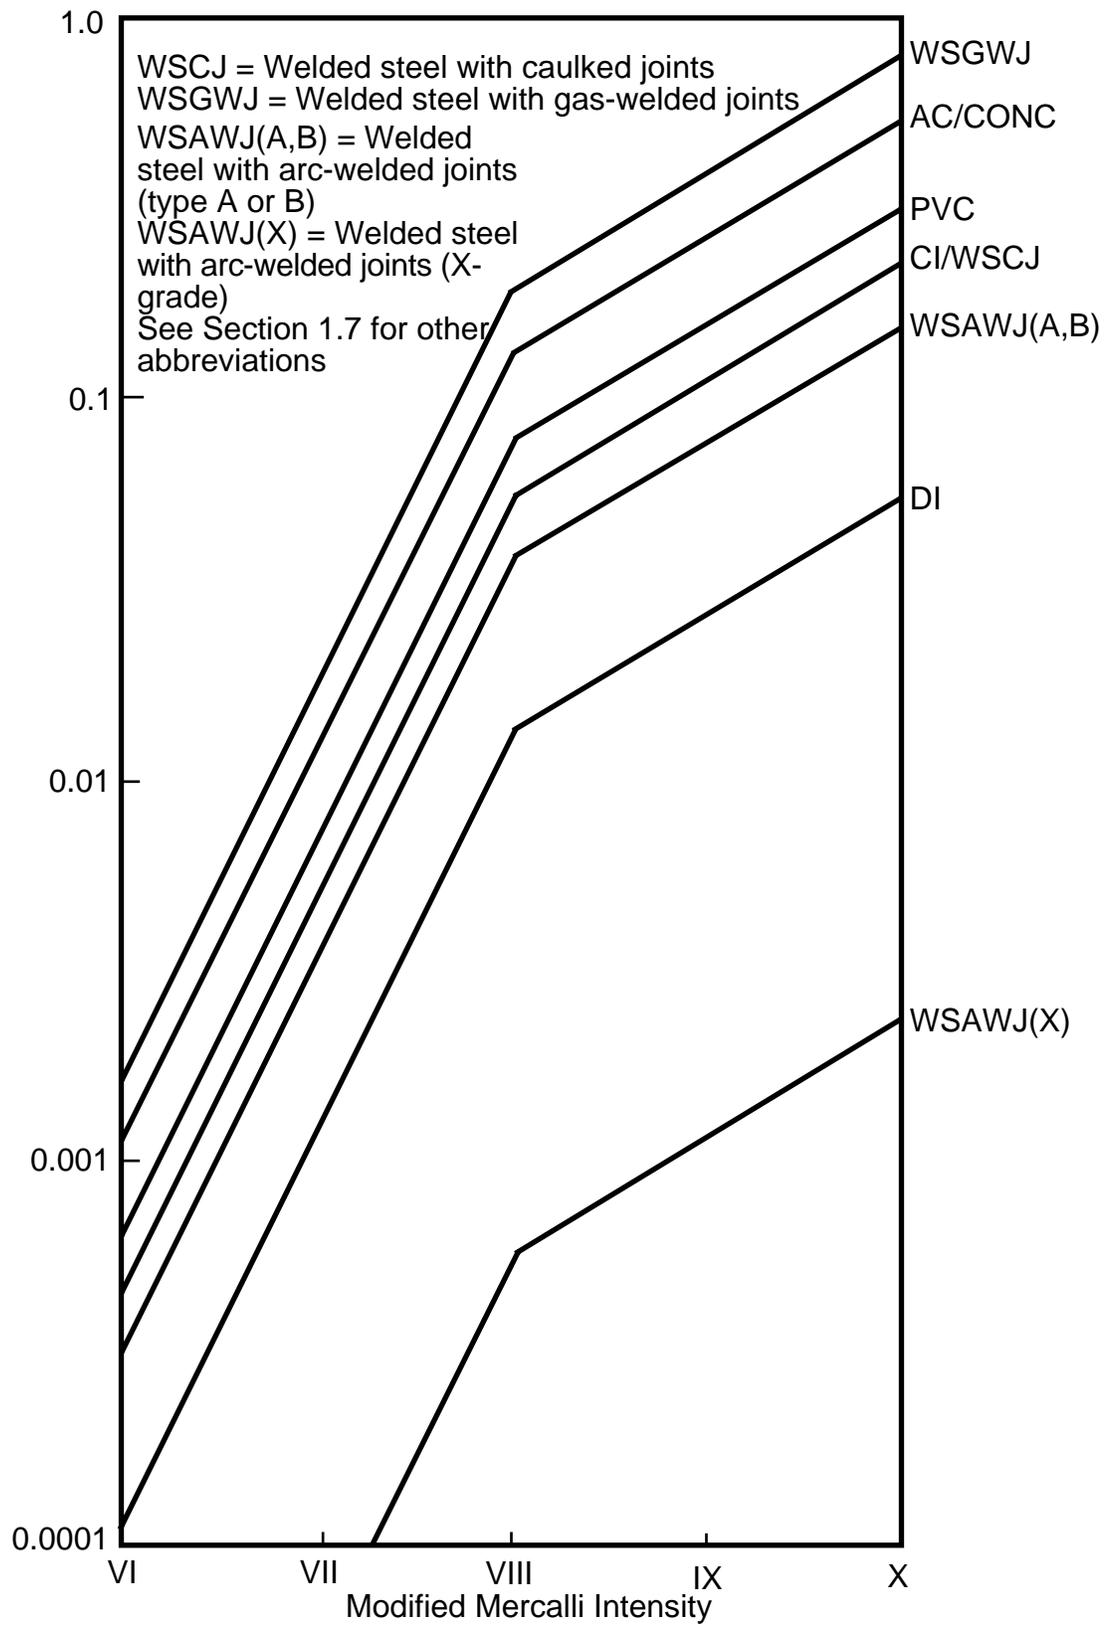
Figure A-3. Pipe Fragility Curves for Ground Shaking Hazard Only [From Ballantyne et al]

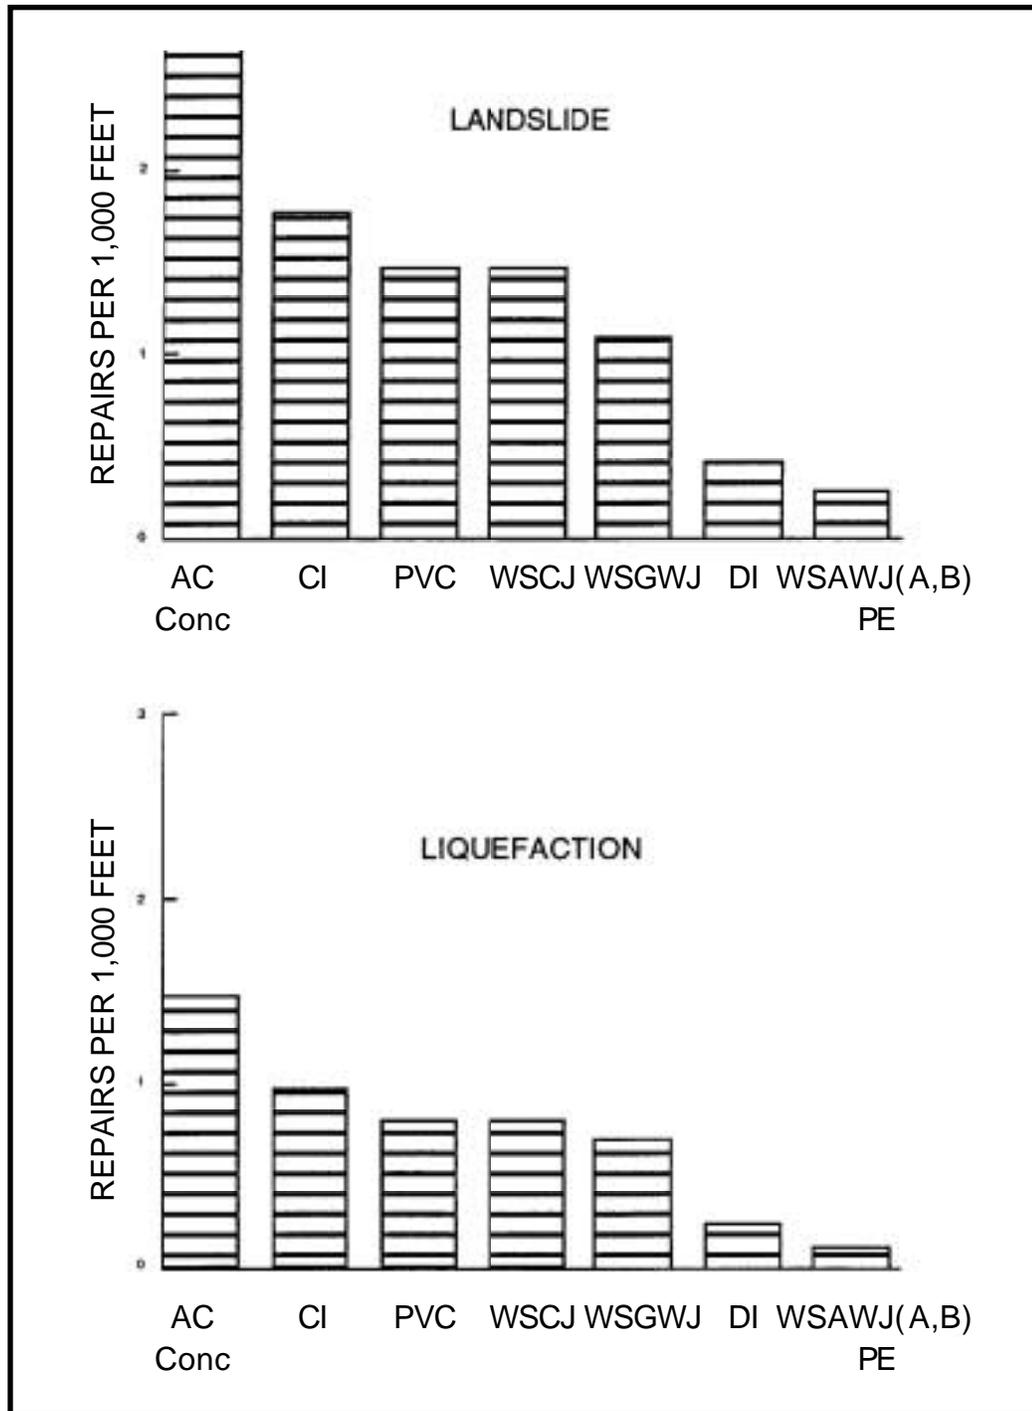
Figure A-4. Earthquake Vulnerability Models for Buried Pipes for Landslide and Liquefaction

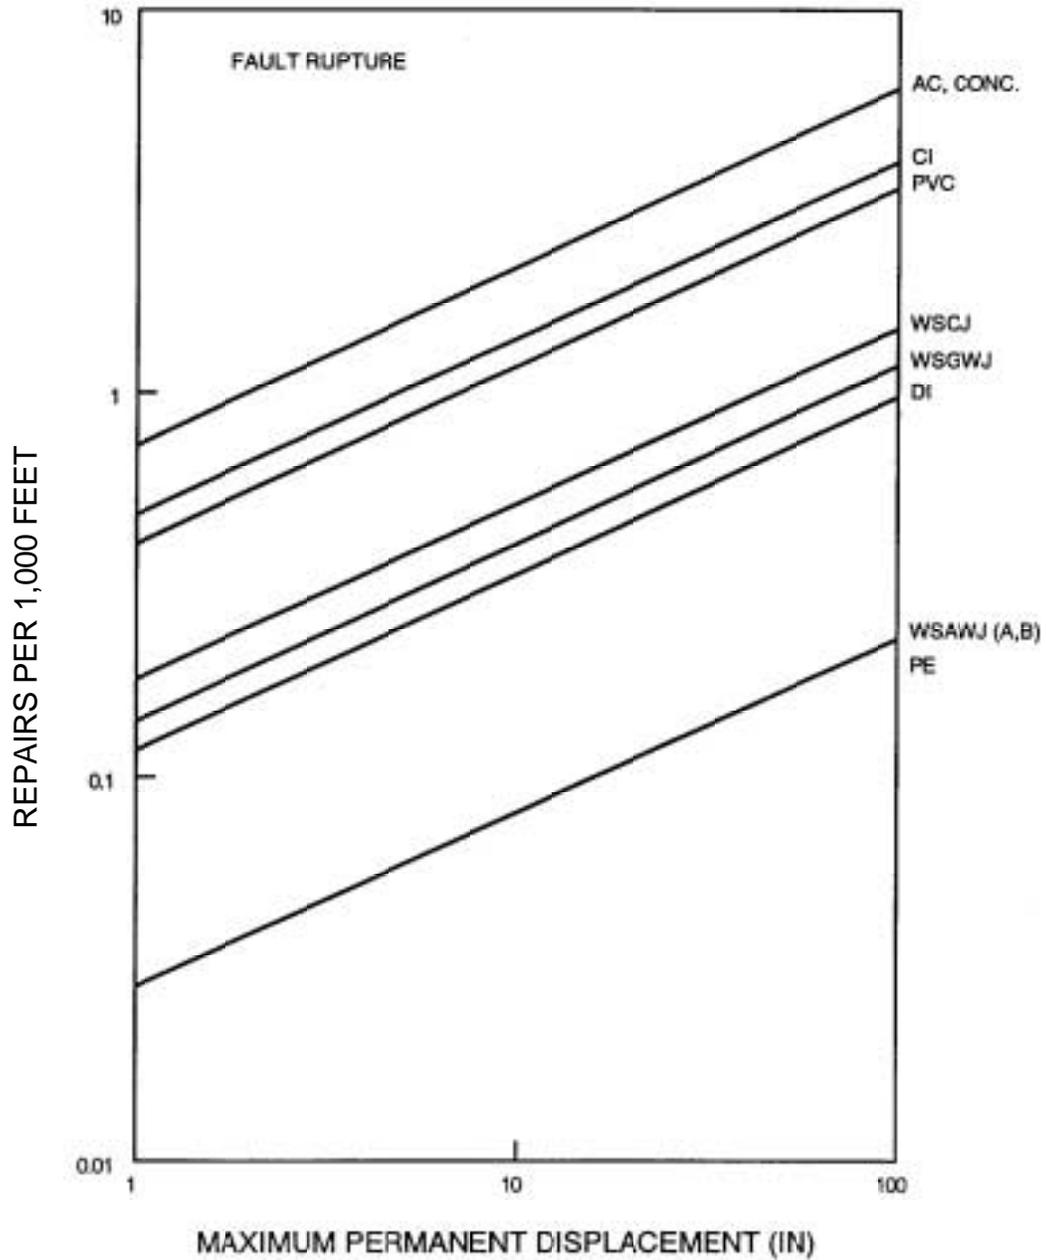
Figure A-5. Earthquake Vulnerability Models for Buried Pipes for Fault Offset

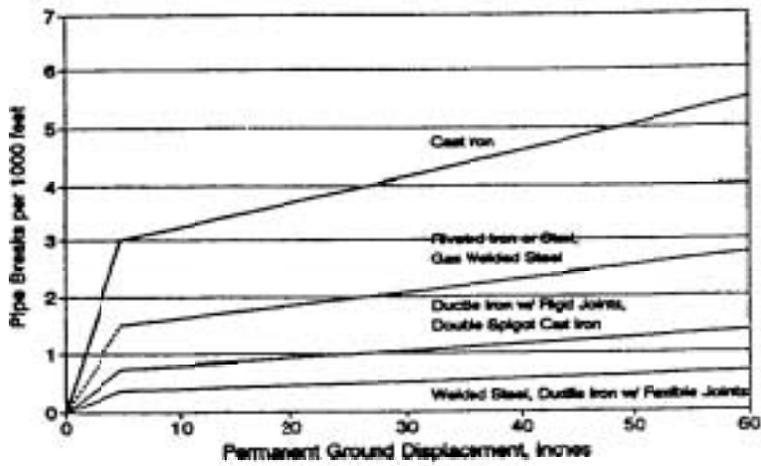
Figure A-6. PGD Damage Algorithm [from Harding and Lawson, 1991]

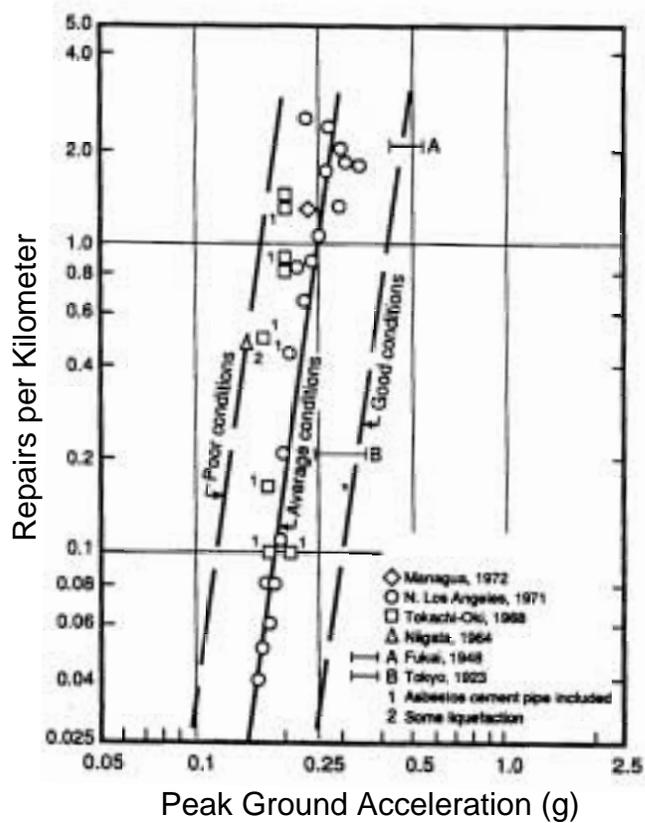
Figure A-7. Pipe Damage [from Katayama et al, 1975]

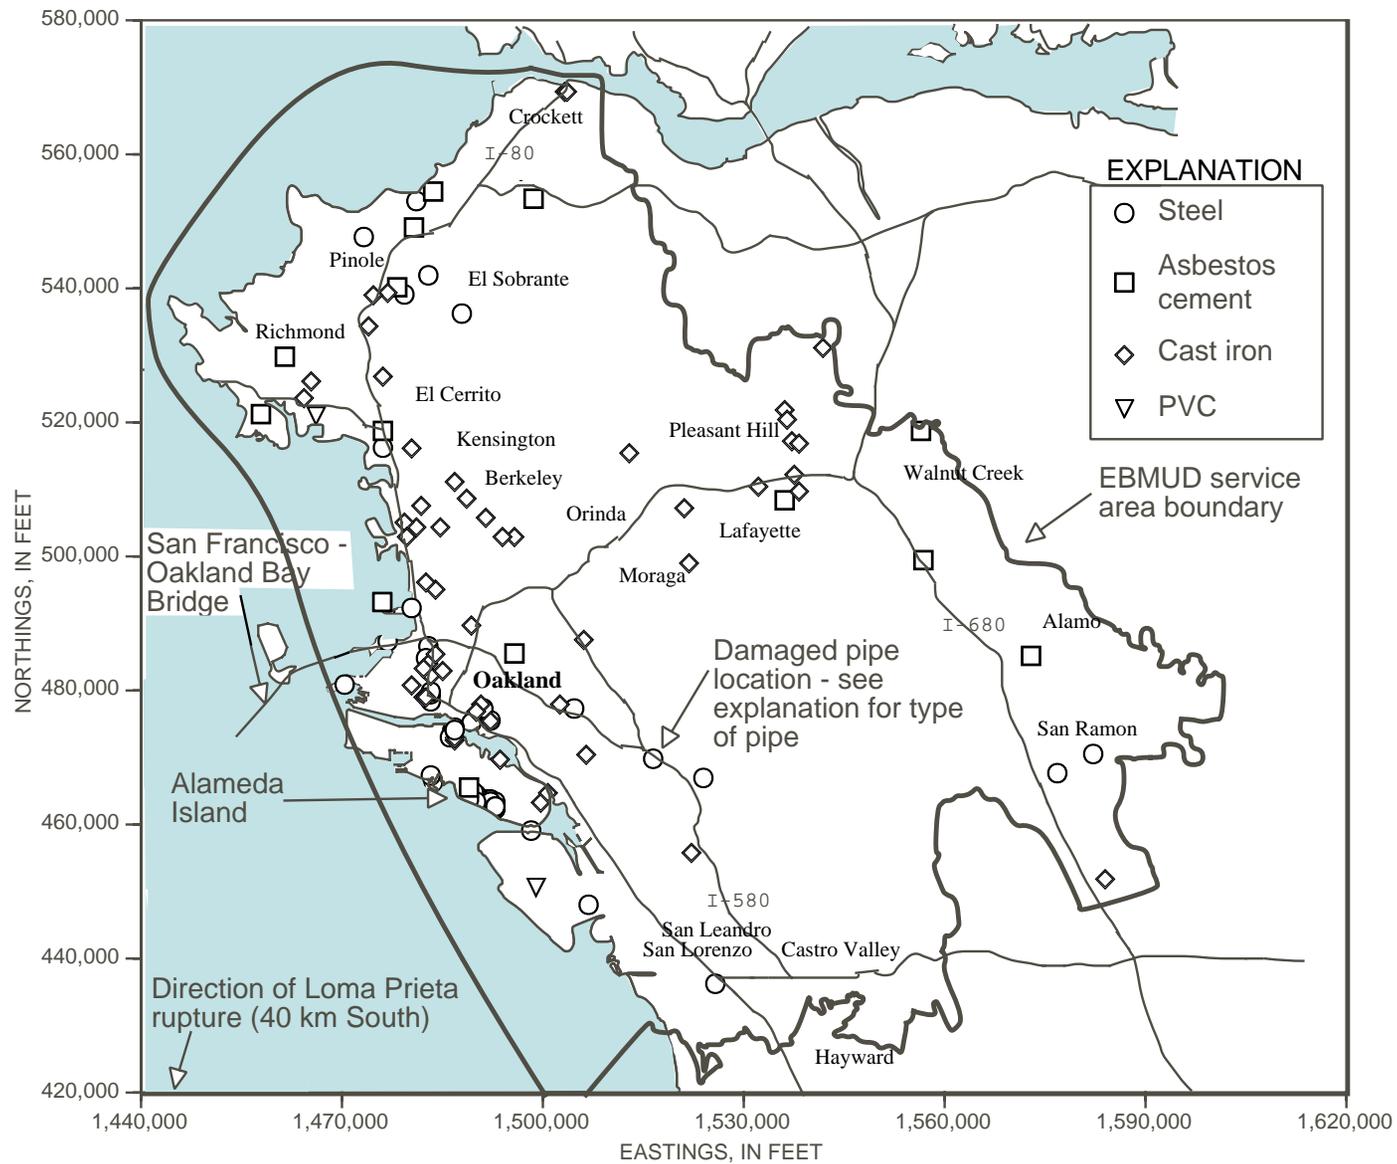
Figure A-8. Location of Pipe Repairs in EBMUD System, 1989 Loma Prieta Earthquake [after Eidinger, 1998]

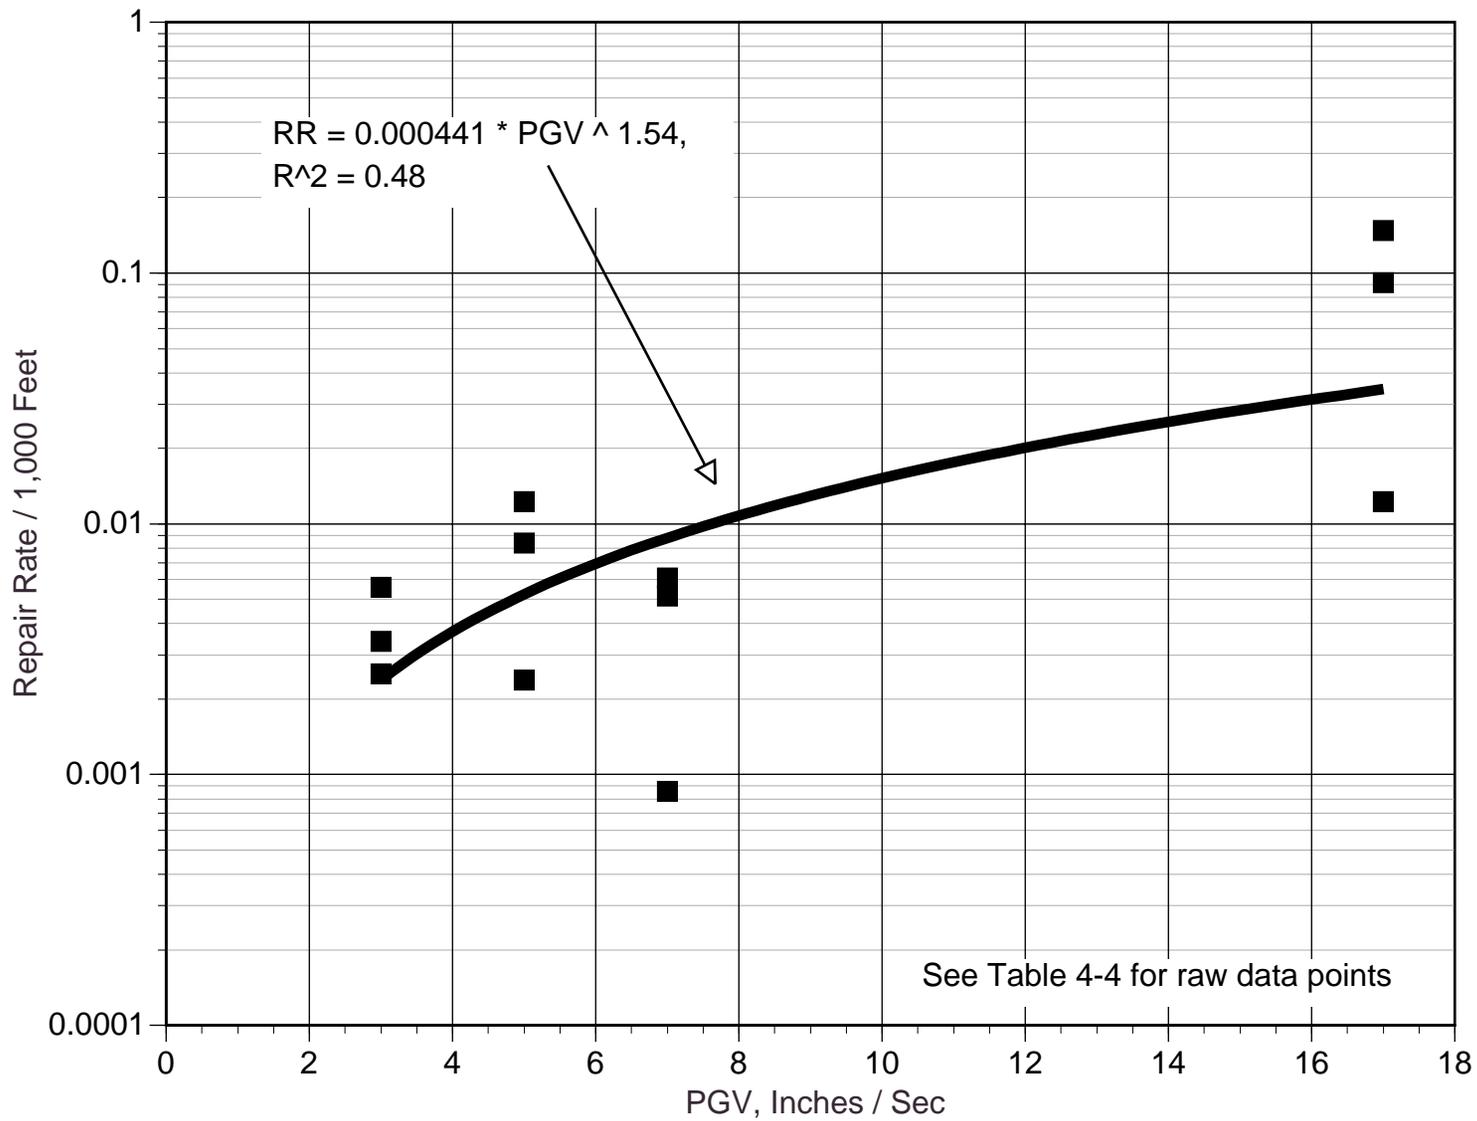
**Figure A-9. Repair Rate, Loma Prieta (EBMUD),
Ground Shaking, All Materials (CI + AC + WS)**

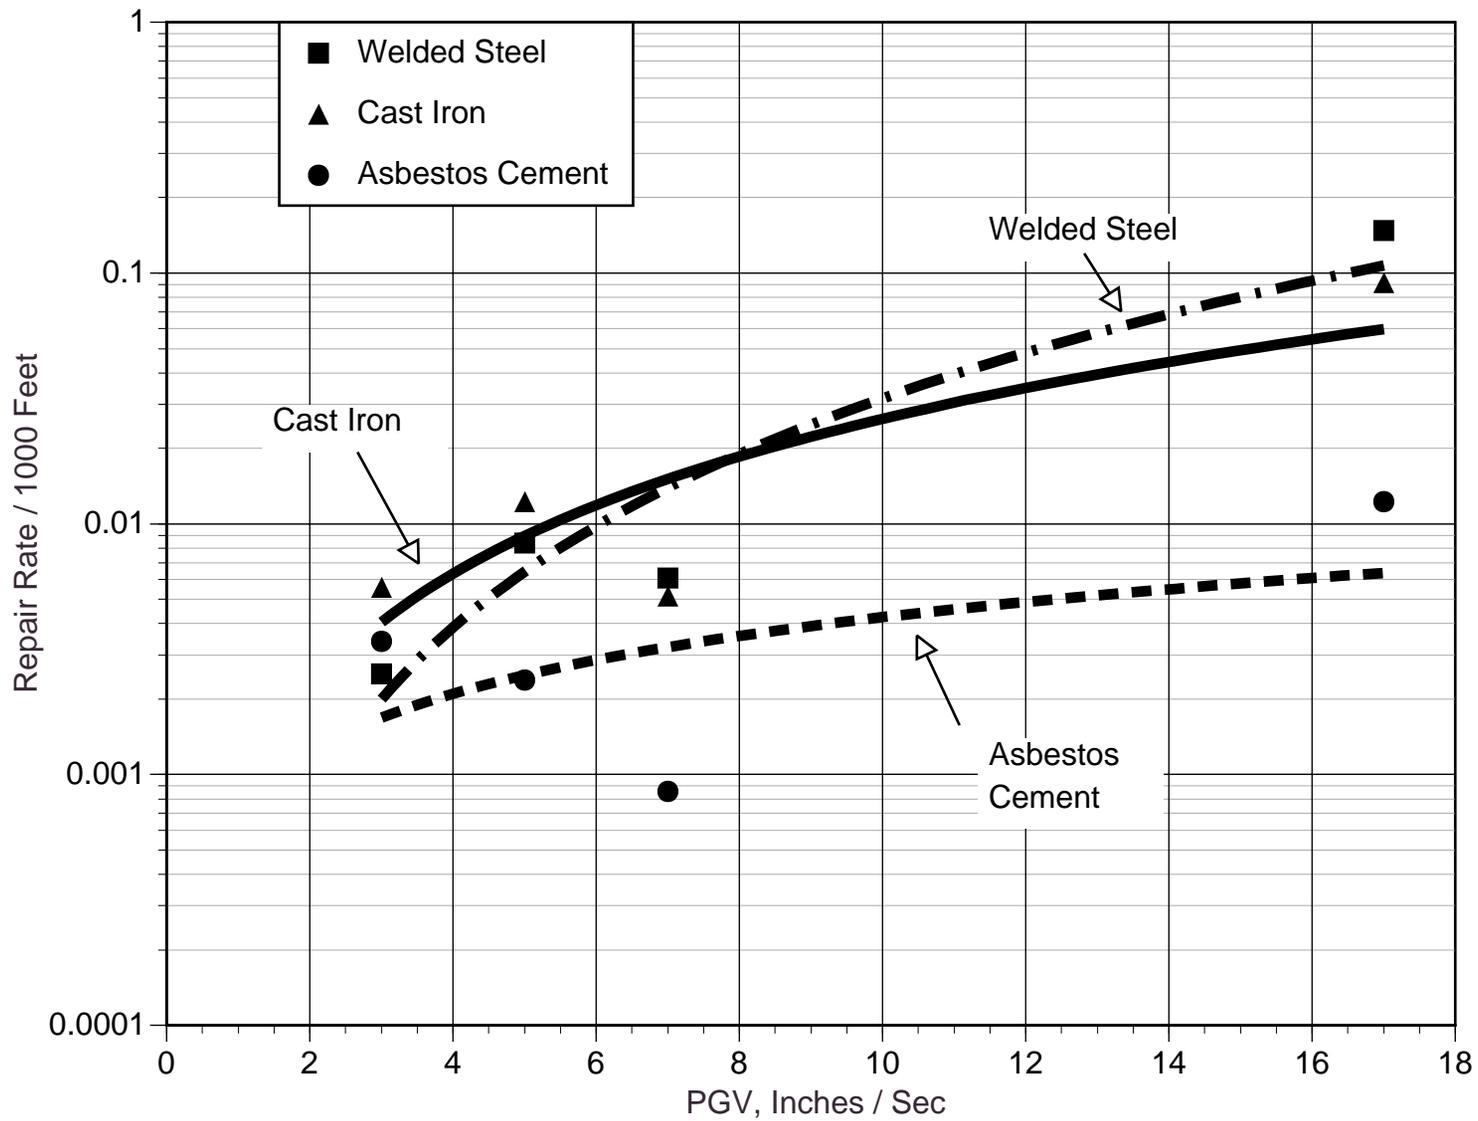
**Figure A-10. Repair Rate, Loma Prieta (EBMUD),
Ground Shaking, By Material (CI + AC + WS)**

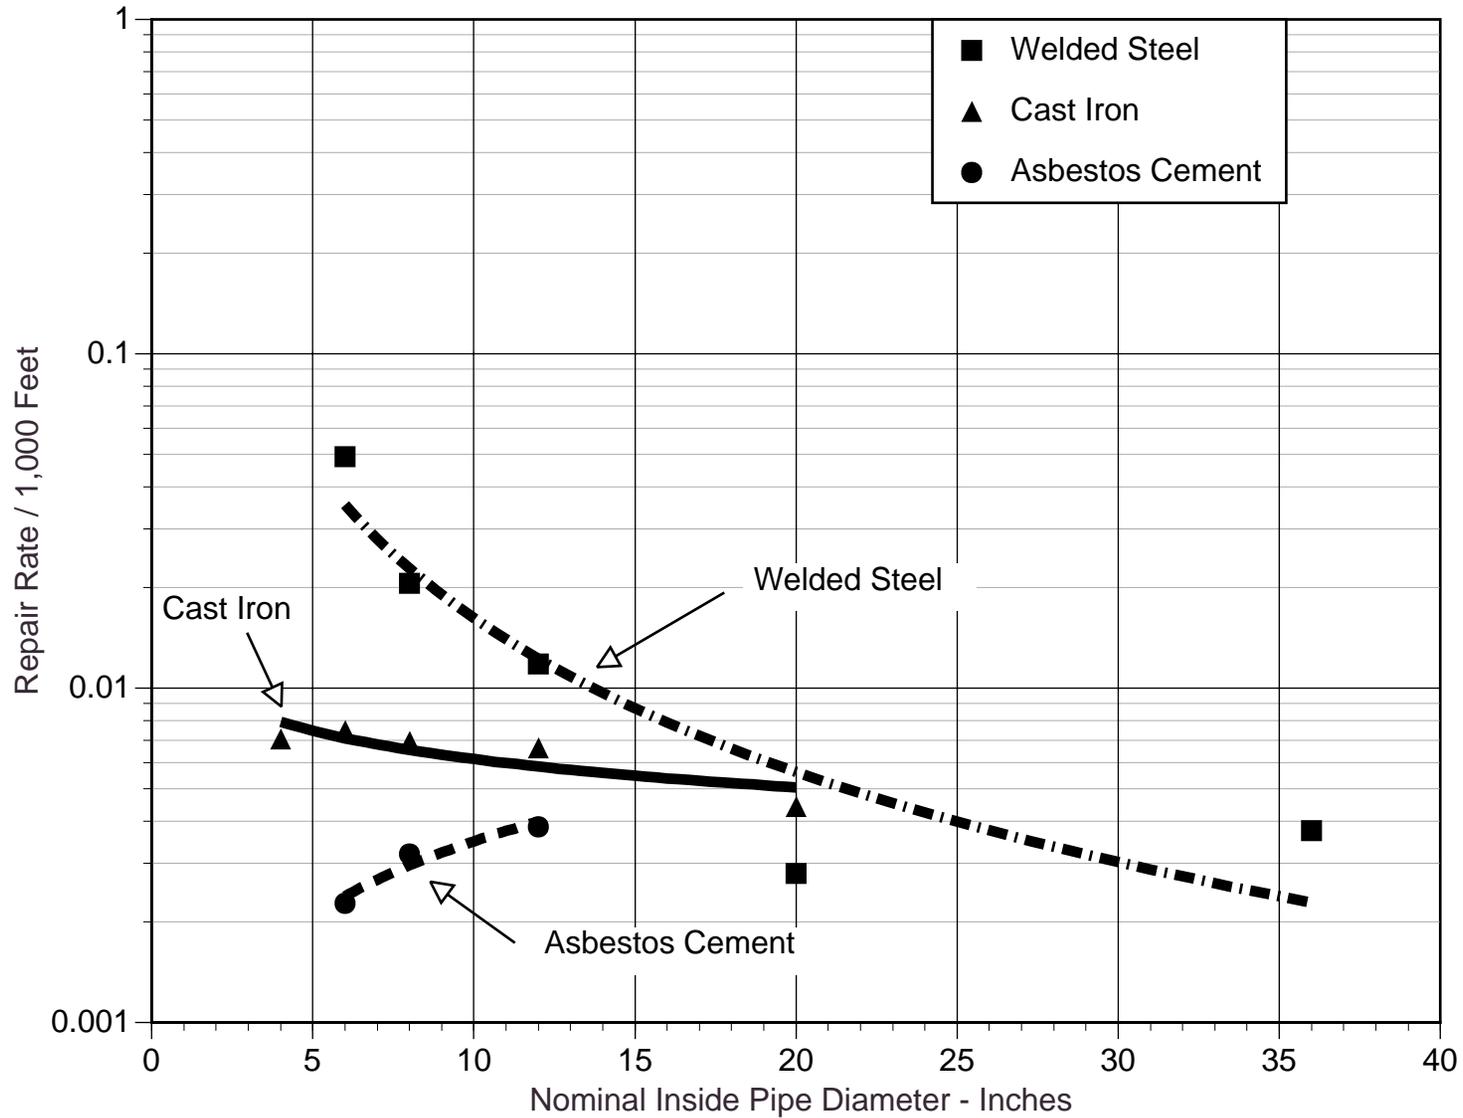
Figure A-11. Repair Rate - As a Function of Pipe Diameter, Loma Prieta - EBMUD Data

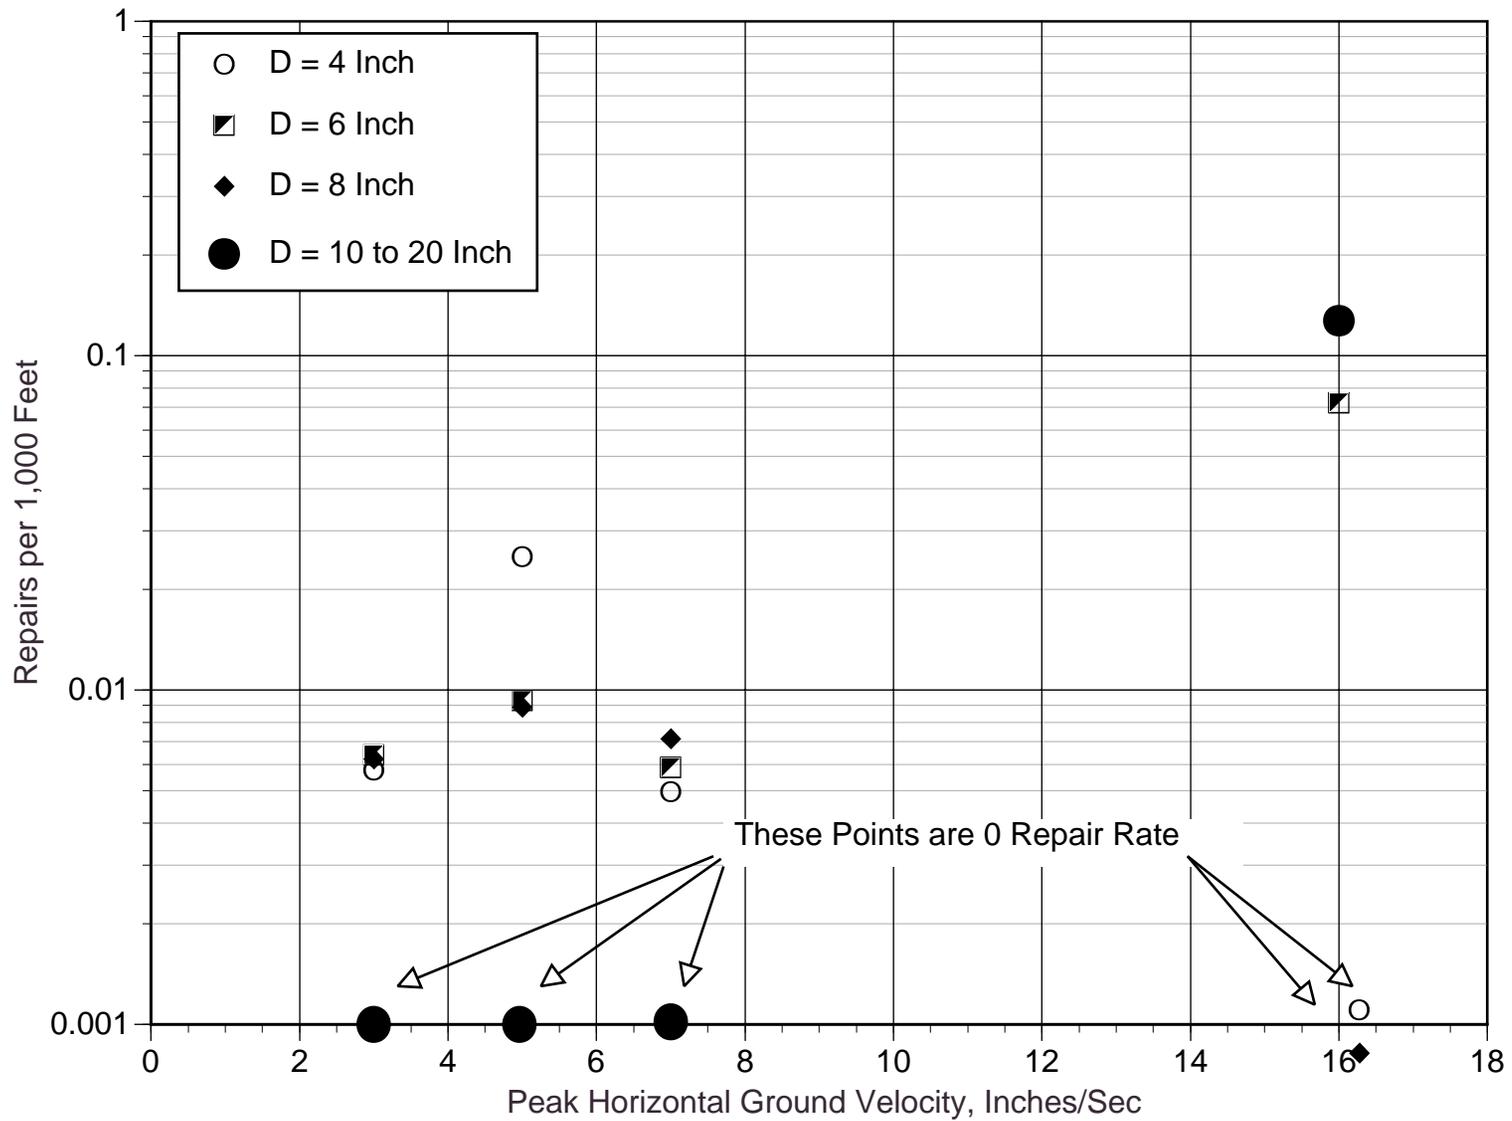
Figure A-12. Pipe Damage - Wave Propagation - Cast Iron - Loma Prieta - By Diameter

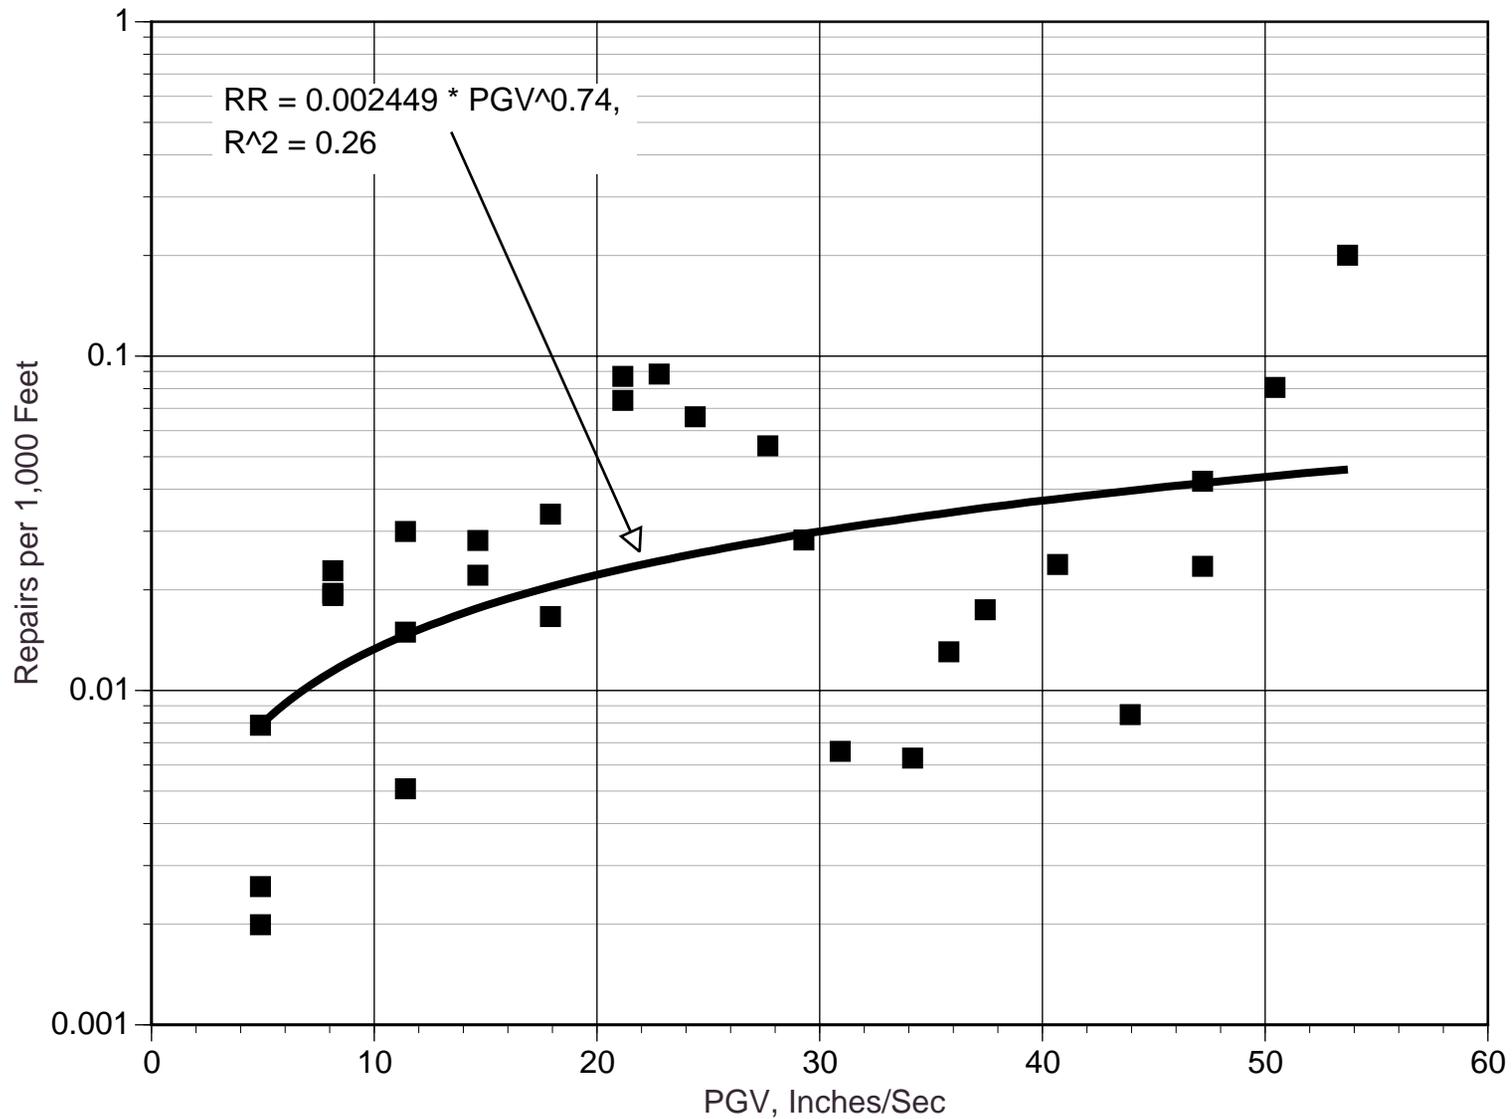
Figure A-13. Repair Rate, Northridge (LADWP), All Materials, Ground Shaking

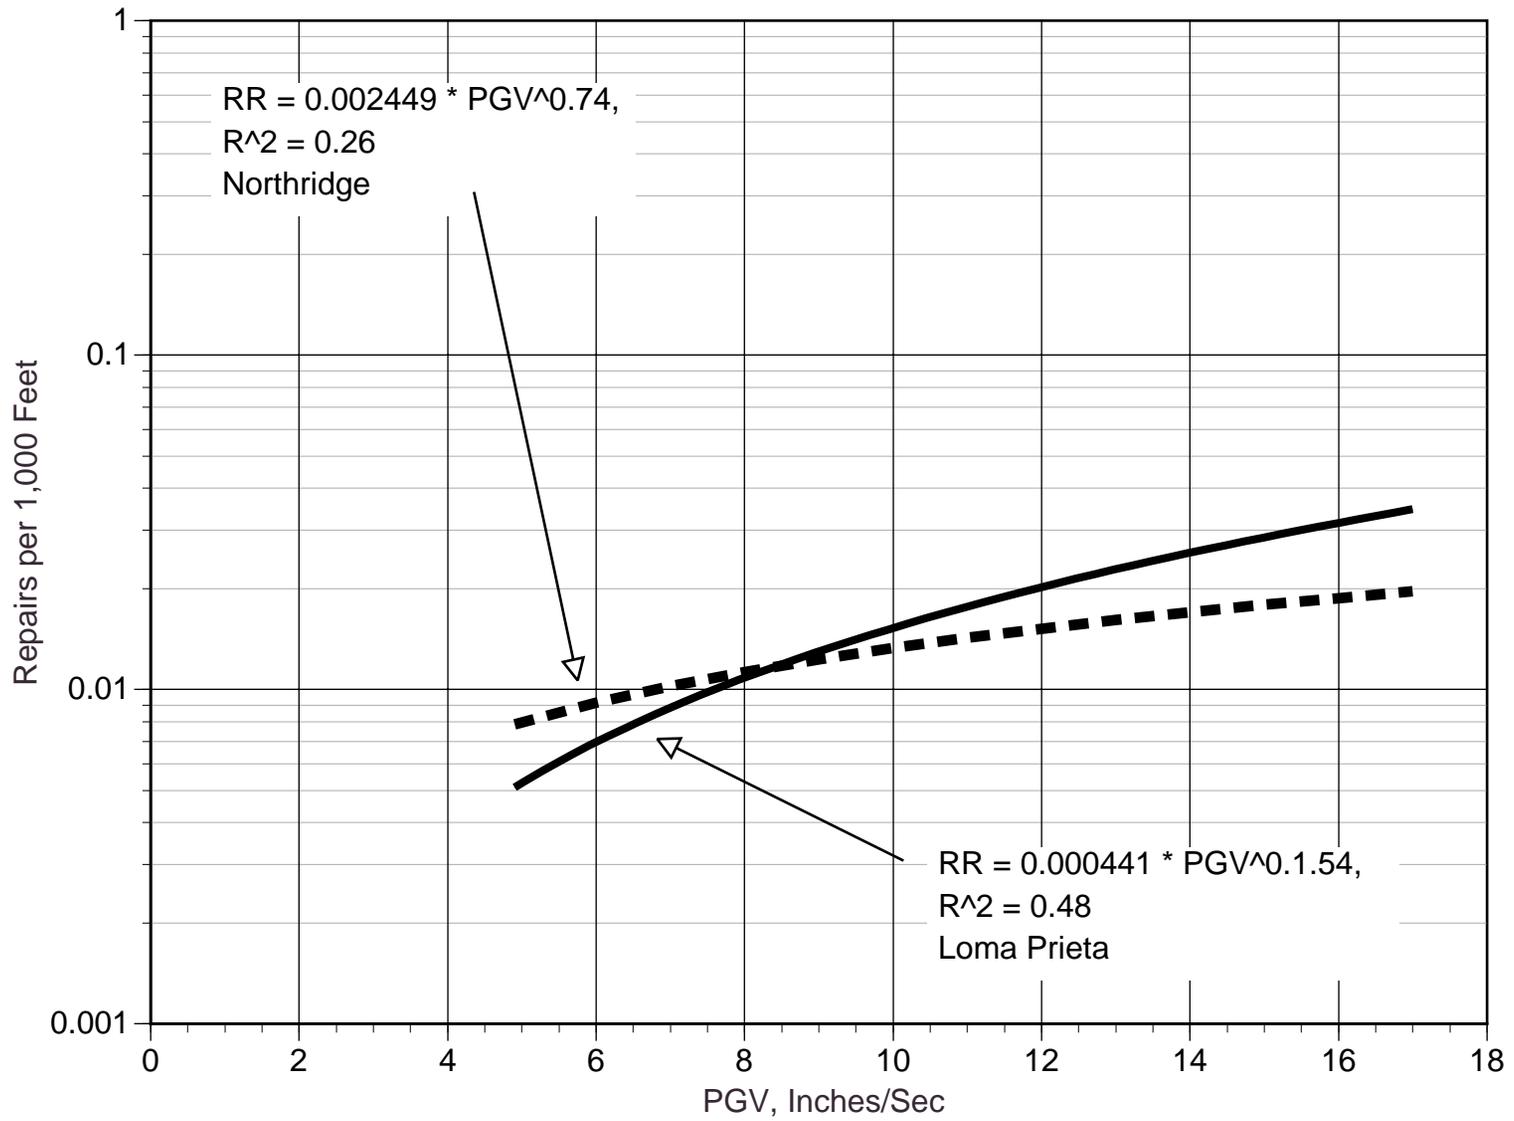
Figure A-14. Repair Rate, Northridge (LADWP) vs. Loma Prieta (EBMUD), all data

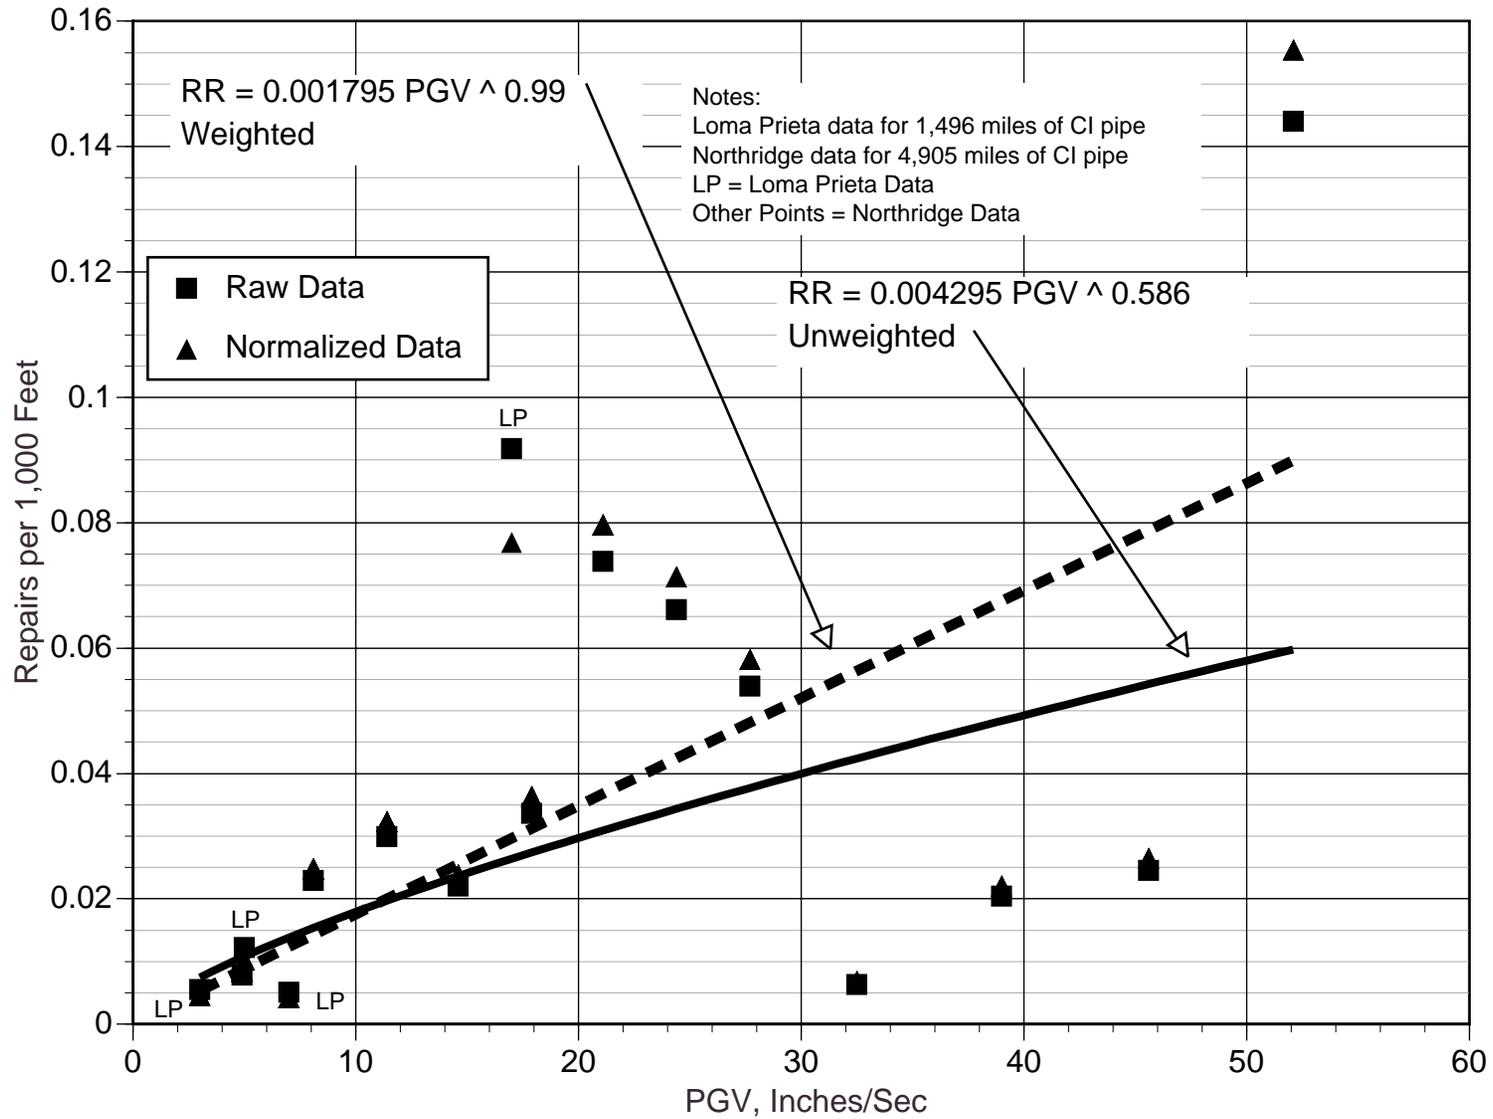
Figure A-15. Repair Rate, Northridge (LADWP) and Loma Prieta (EBMUD), Cast Iron Pipe Only

Raw data: Loma Prieta data includes service repairs, Northridge does not

Raw data: Northridge data excludes certain main repairs due to insufficient attributes

Normalized data: LP data reduced for service repairs, Northridge data increased for missing main repairs
