Seismic Fragility Formulations for Water Systems

*Web Site Report
Appendices*

*Prepared by:
G&E Engineering Systems Inc.*

*G&E Report 47.01.02, Revision 1
July 12, 2001*

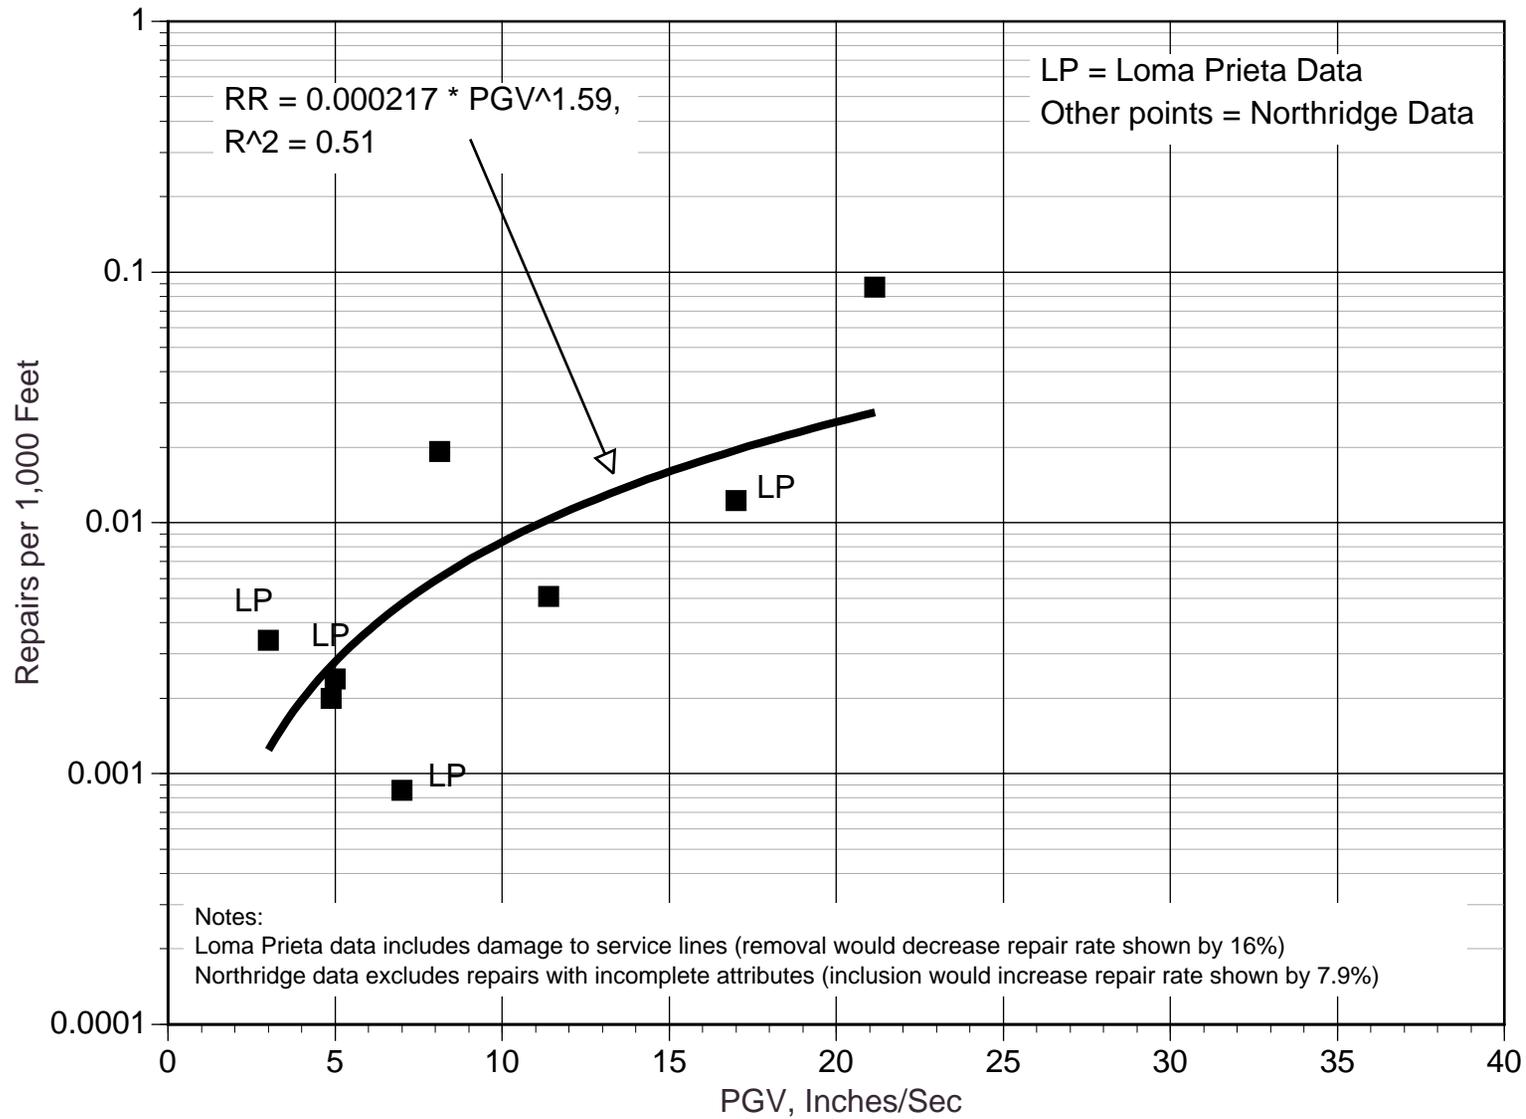
Figure A-16. Repair Rate, Northridge (LADWP) and Loma Prieta (EBMUD), Asbestos Cement Pipe Only

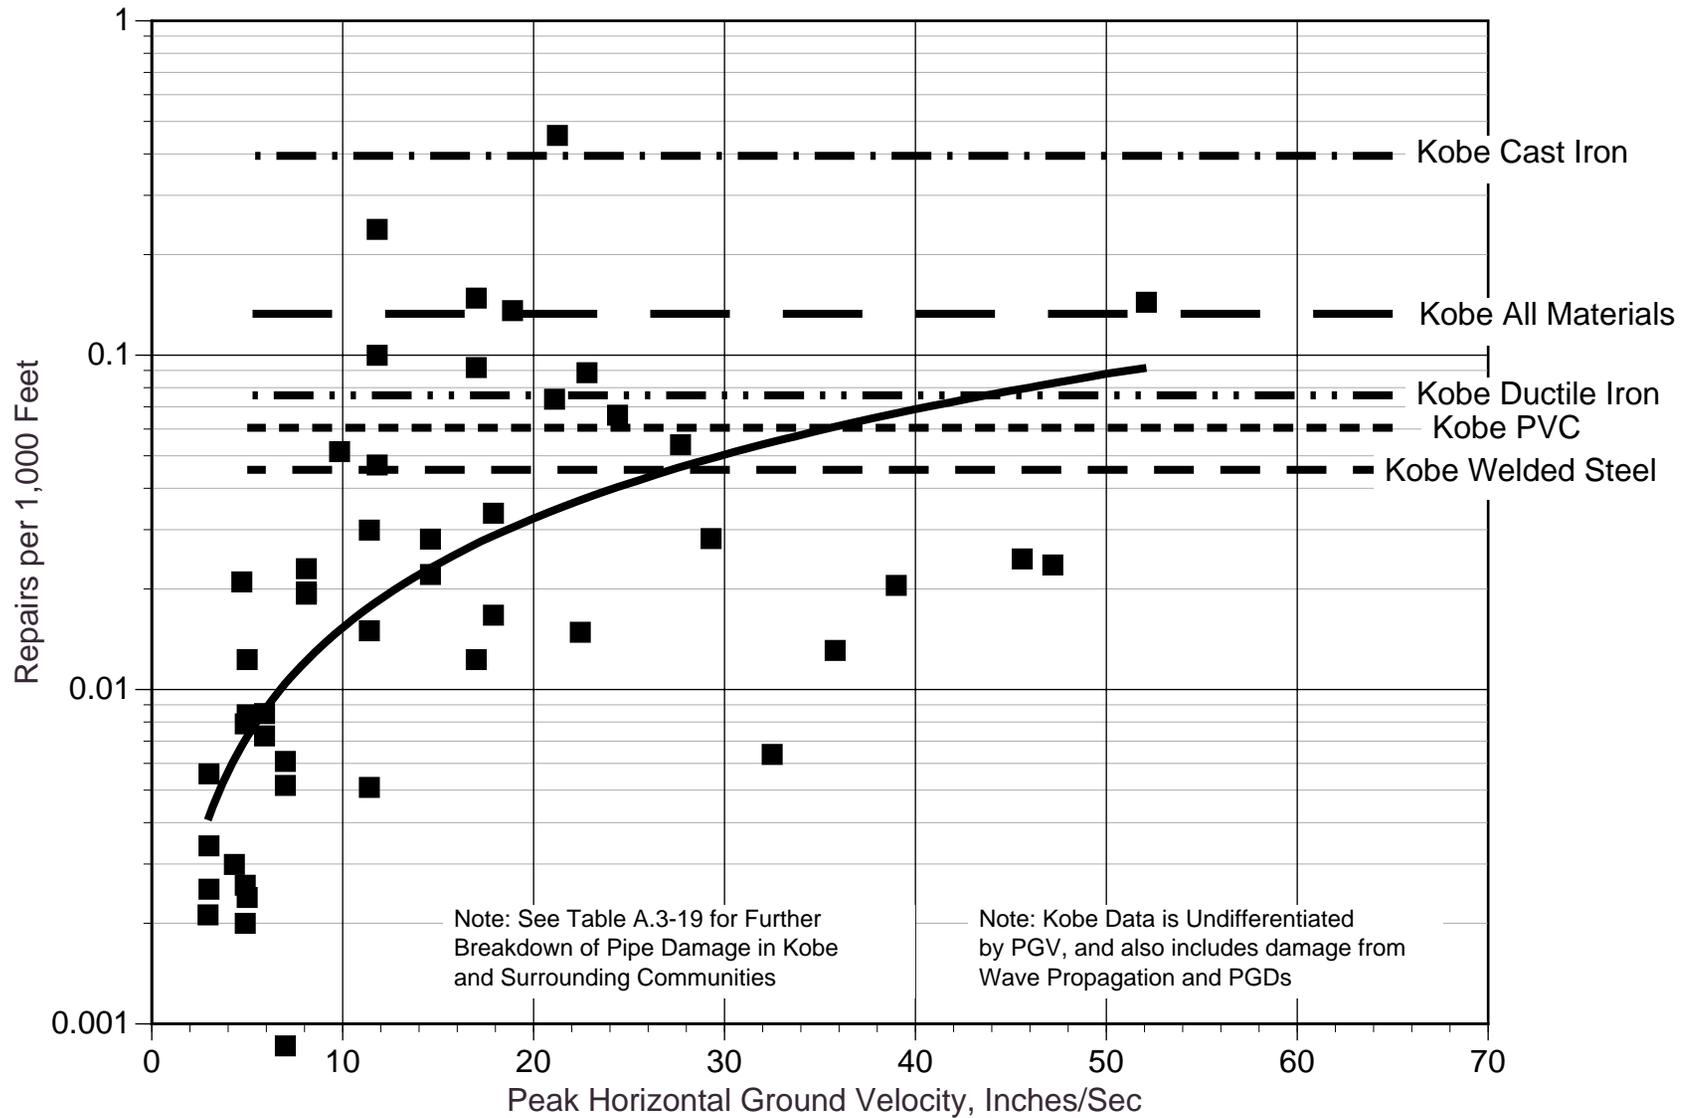
Figure A-17. Pipe Damage - Ground Shaking Data in Tables A.3-4, A.3-14, A.3-15, A.3-16, Figures A-1 and A-2, plus All Data (PGV and PGD) from Kobe, 1995

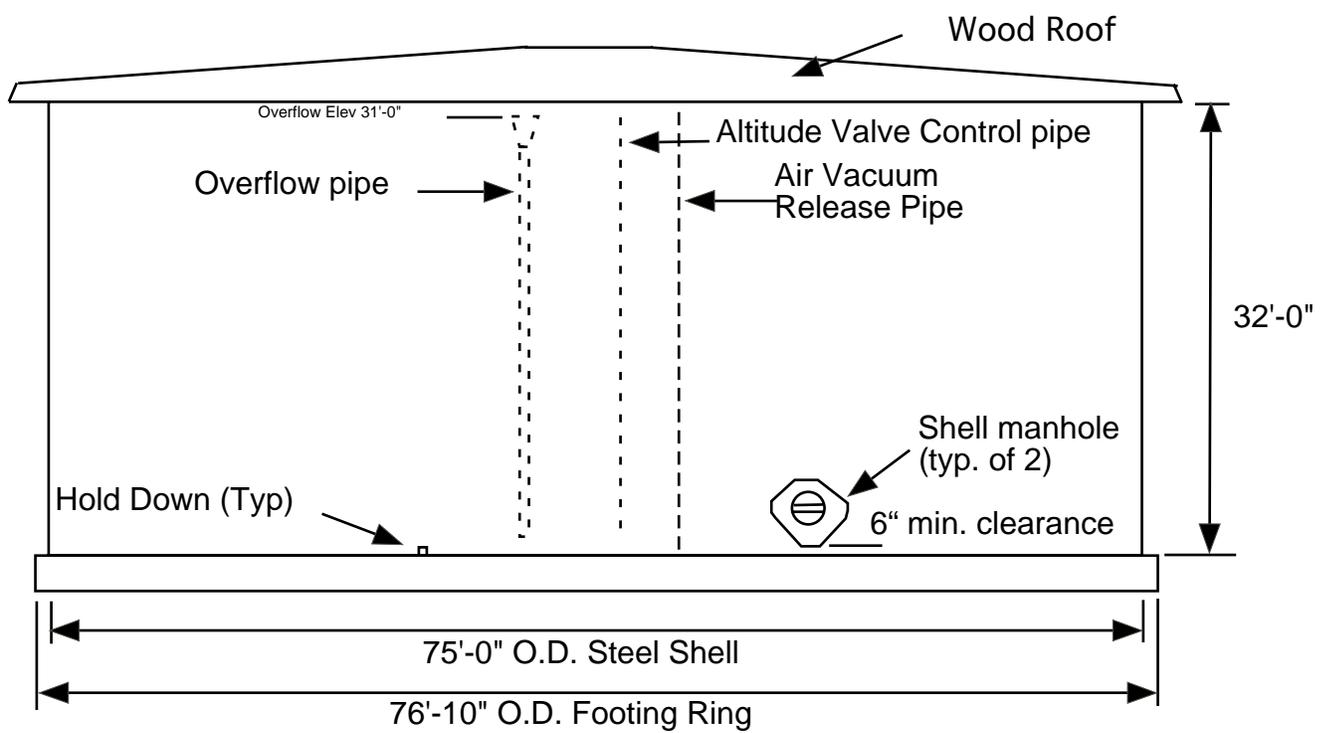
Figure B-1. Elevation of Example Tank

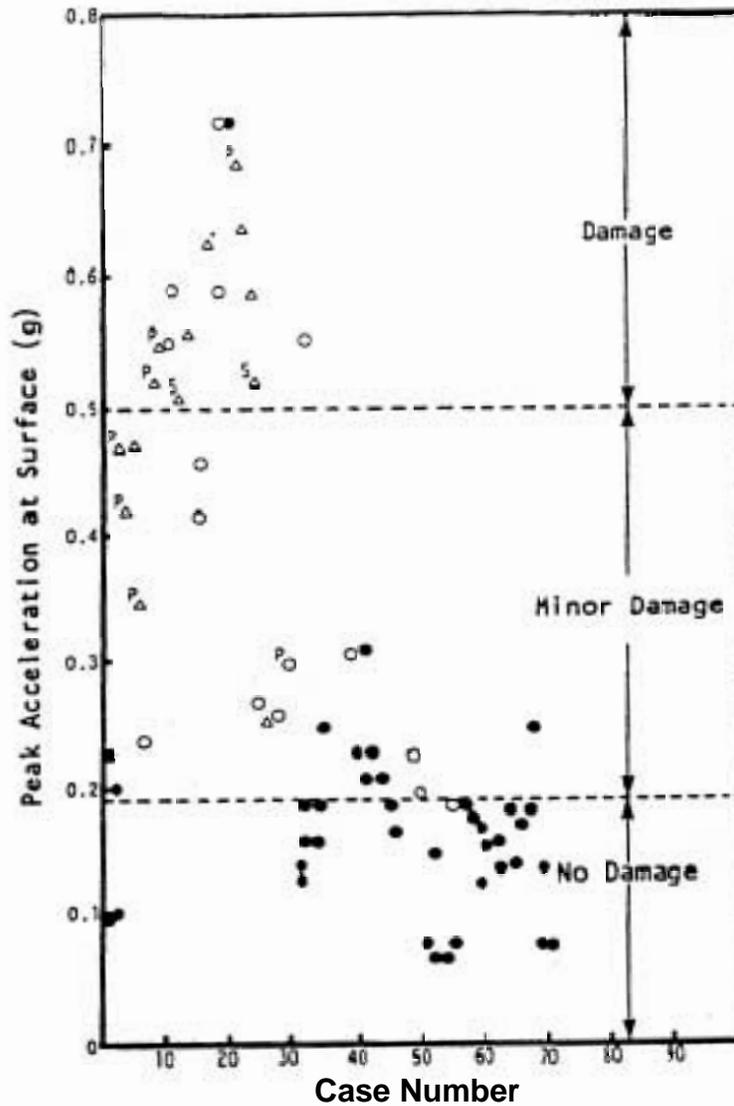
- No damage
- Minor damage, due to shaking
- △ Damage from shaking
- P_△ Near portal
- S_△ Shallow cover

Figure C-1. Peak Surface Acceleration and Associated damage observations for earthquakes (from Dowding and Rozen, 1978)

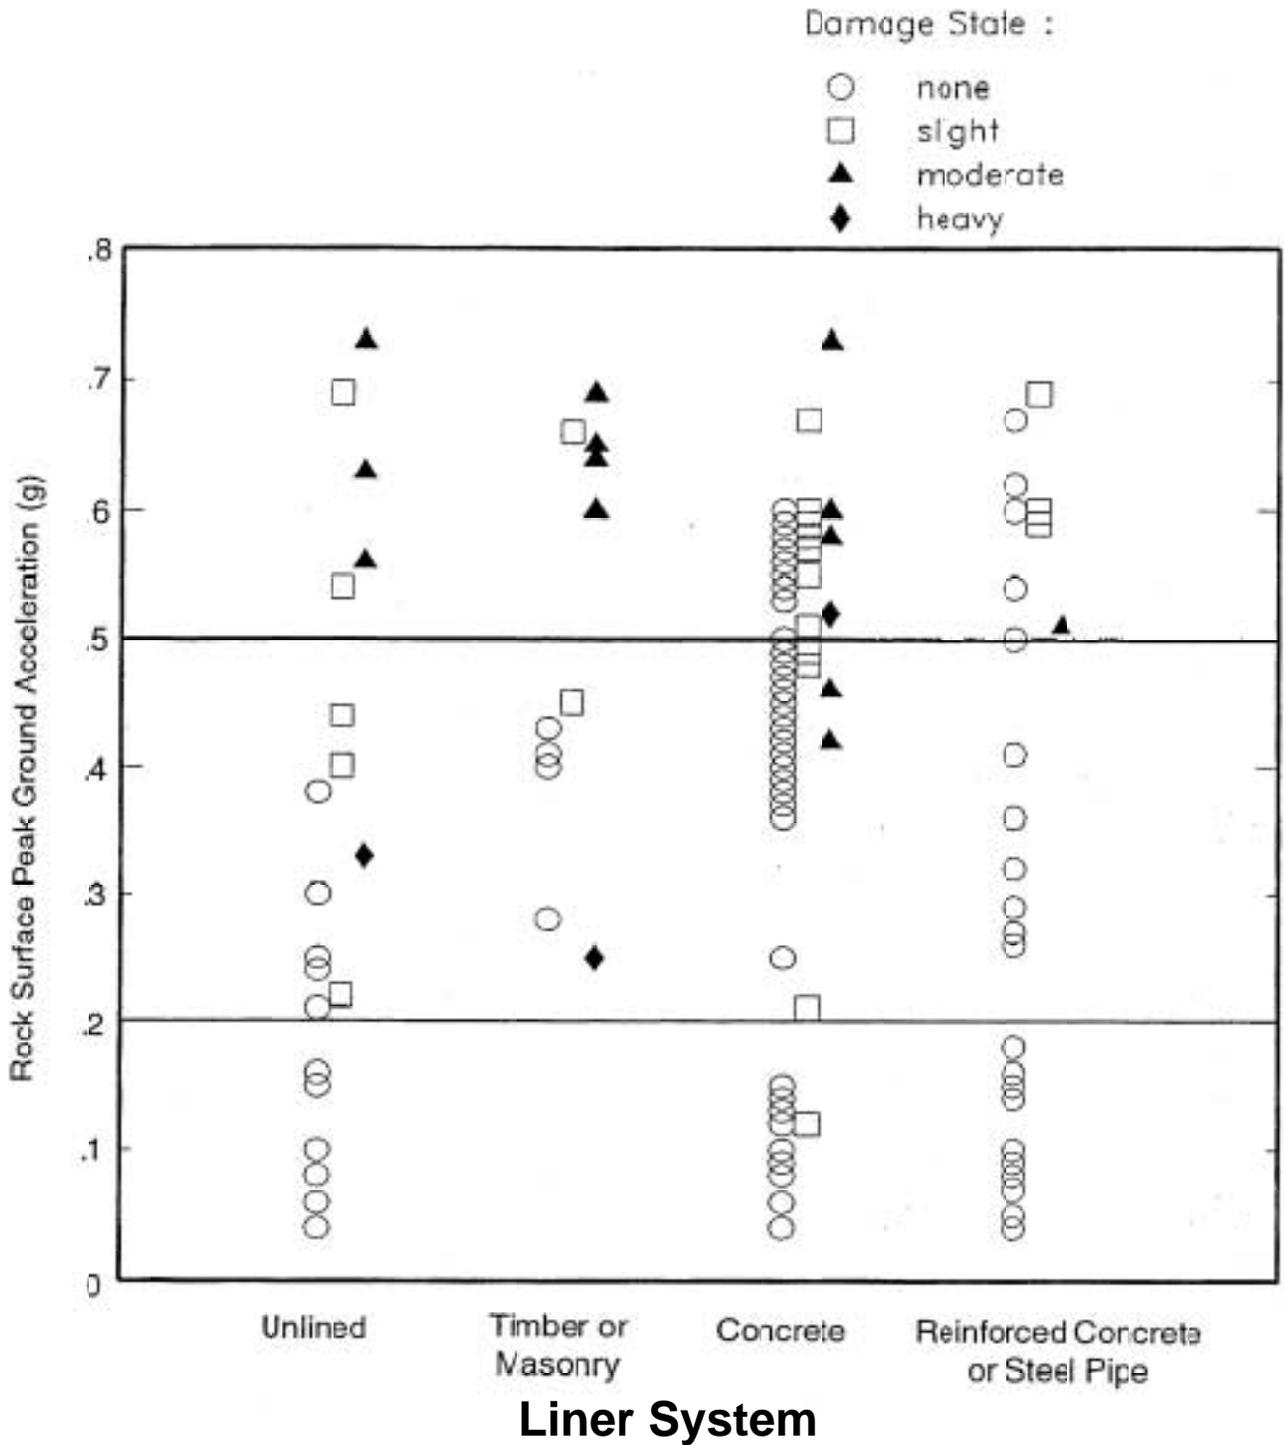
Figure C-2. Summary of empirical observations of seismic ground shaking-induced damage for 204 bored tunnels [after Power et al, 1998]

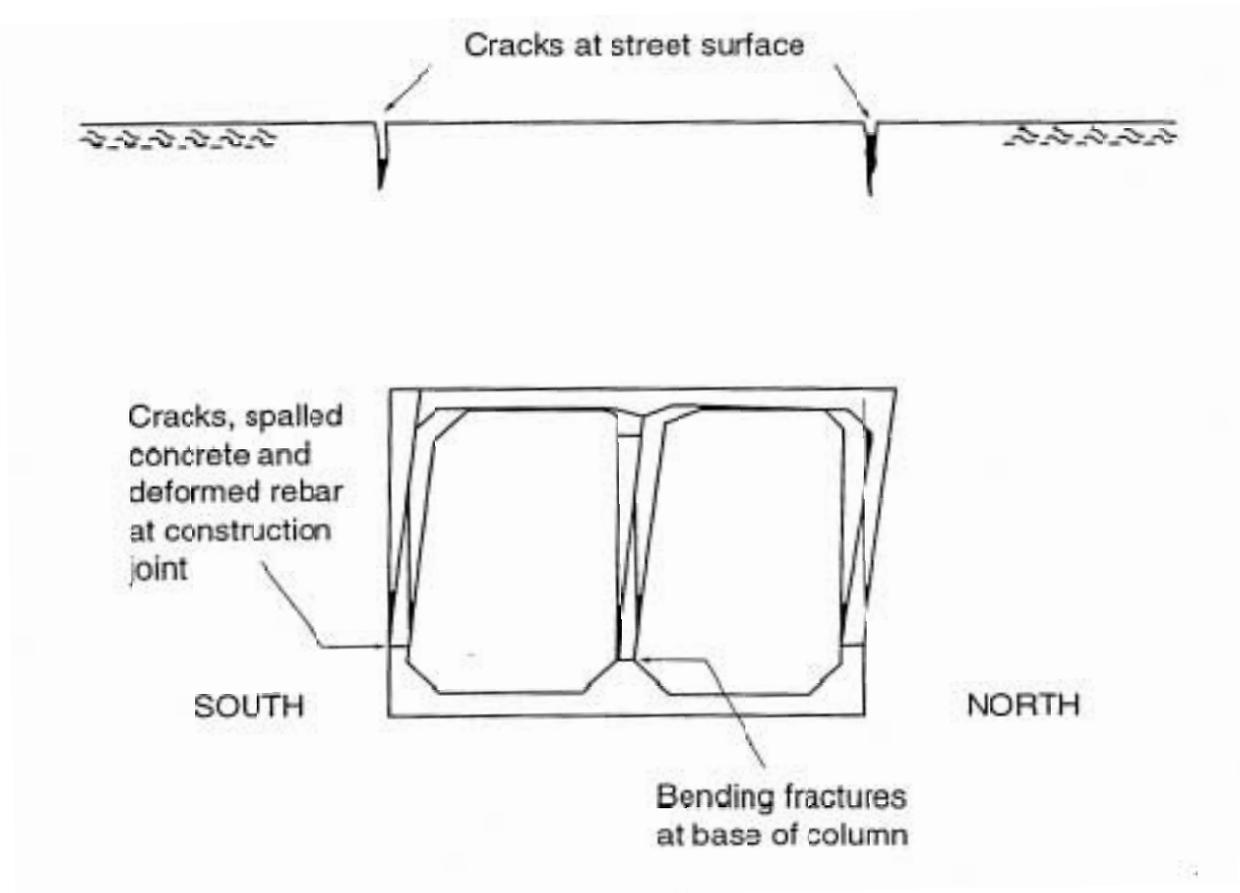
Figure C-4. Deformations of cut and cover tunnel (exaggerated scale) for tunnel of Kobe Rapid Transit Railway between Daikai and Nagata stations [after O'Rourke and Shiba, 1997]

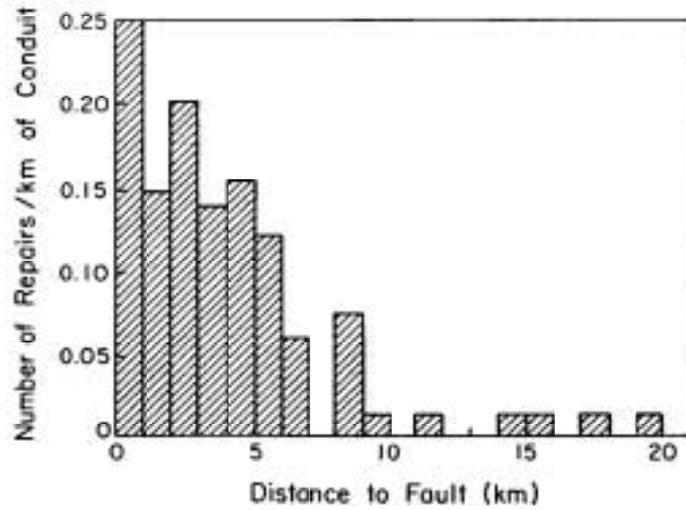
D-1a. Repair Rate versus Distance to Nearest Fault

Figure D-1. Canal and Ditch Repair Rates, 1979 Imperial Valley Earthquake [after Dobry et al]

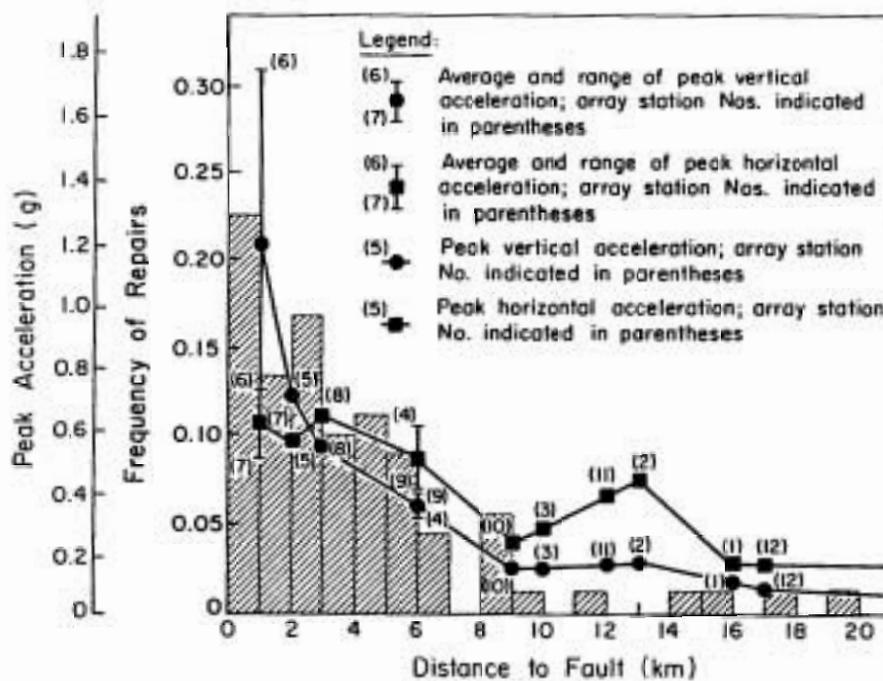
D-1b. Repair Rate versus PGAs Recorded at Similar Distances to the Nearest Fault

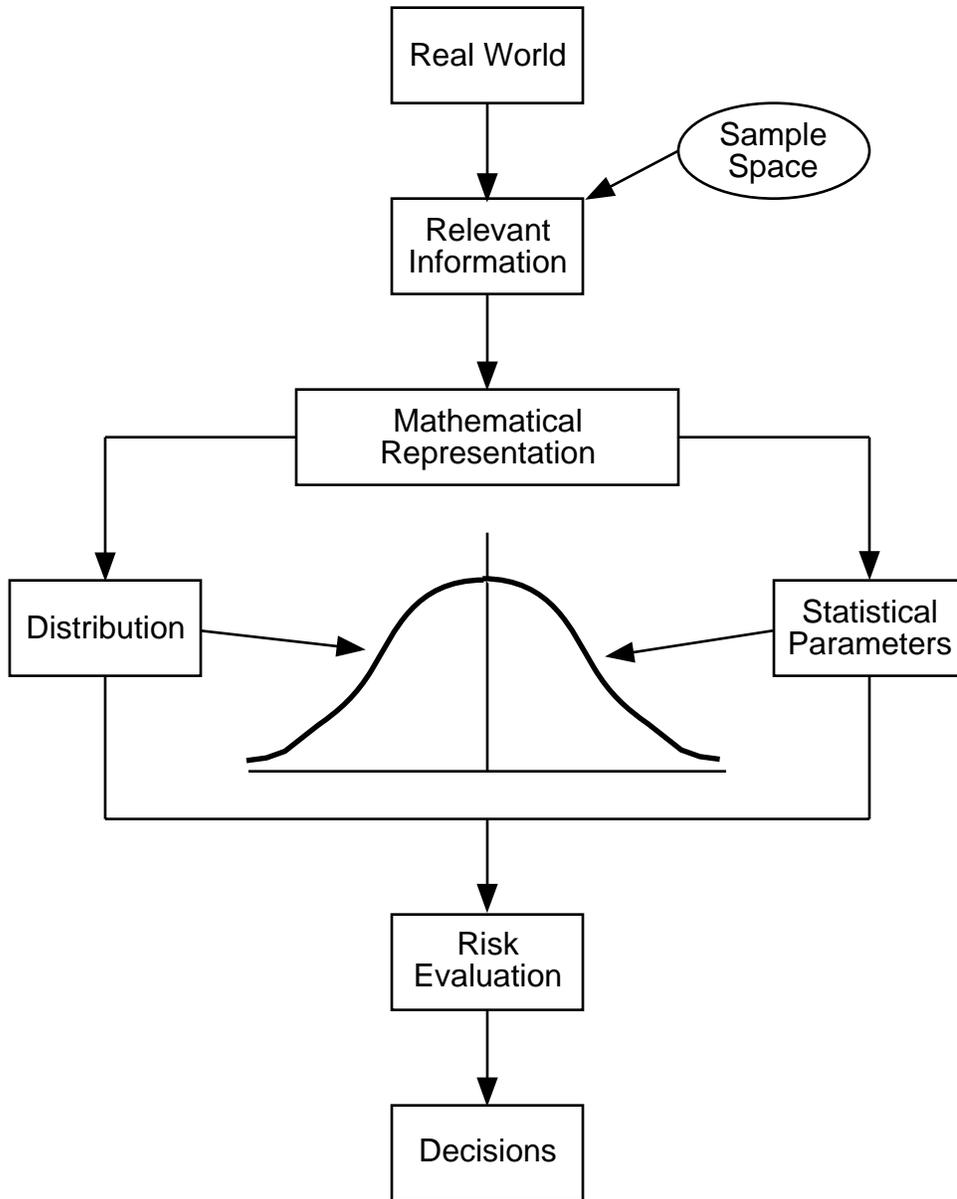
Figure E-1. Steps in a Probabilistic Study

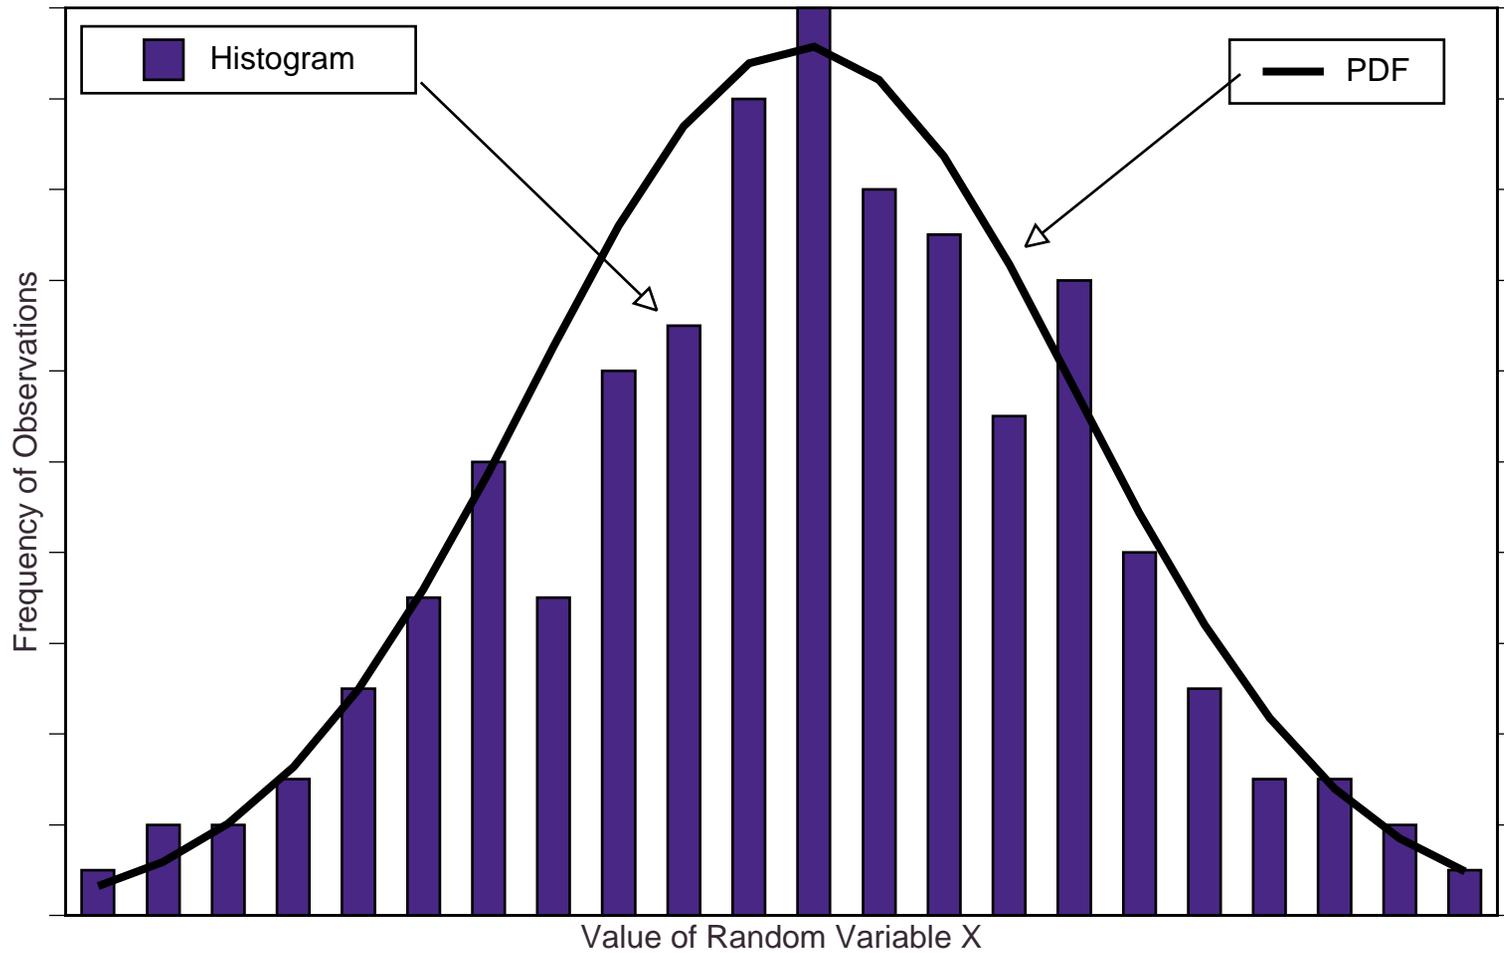
Figure E-2. Typical Histogram or Frequency Diagram

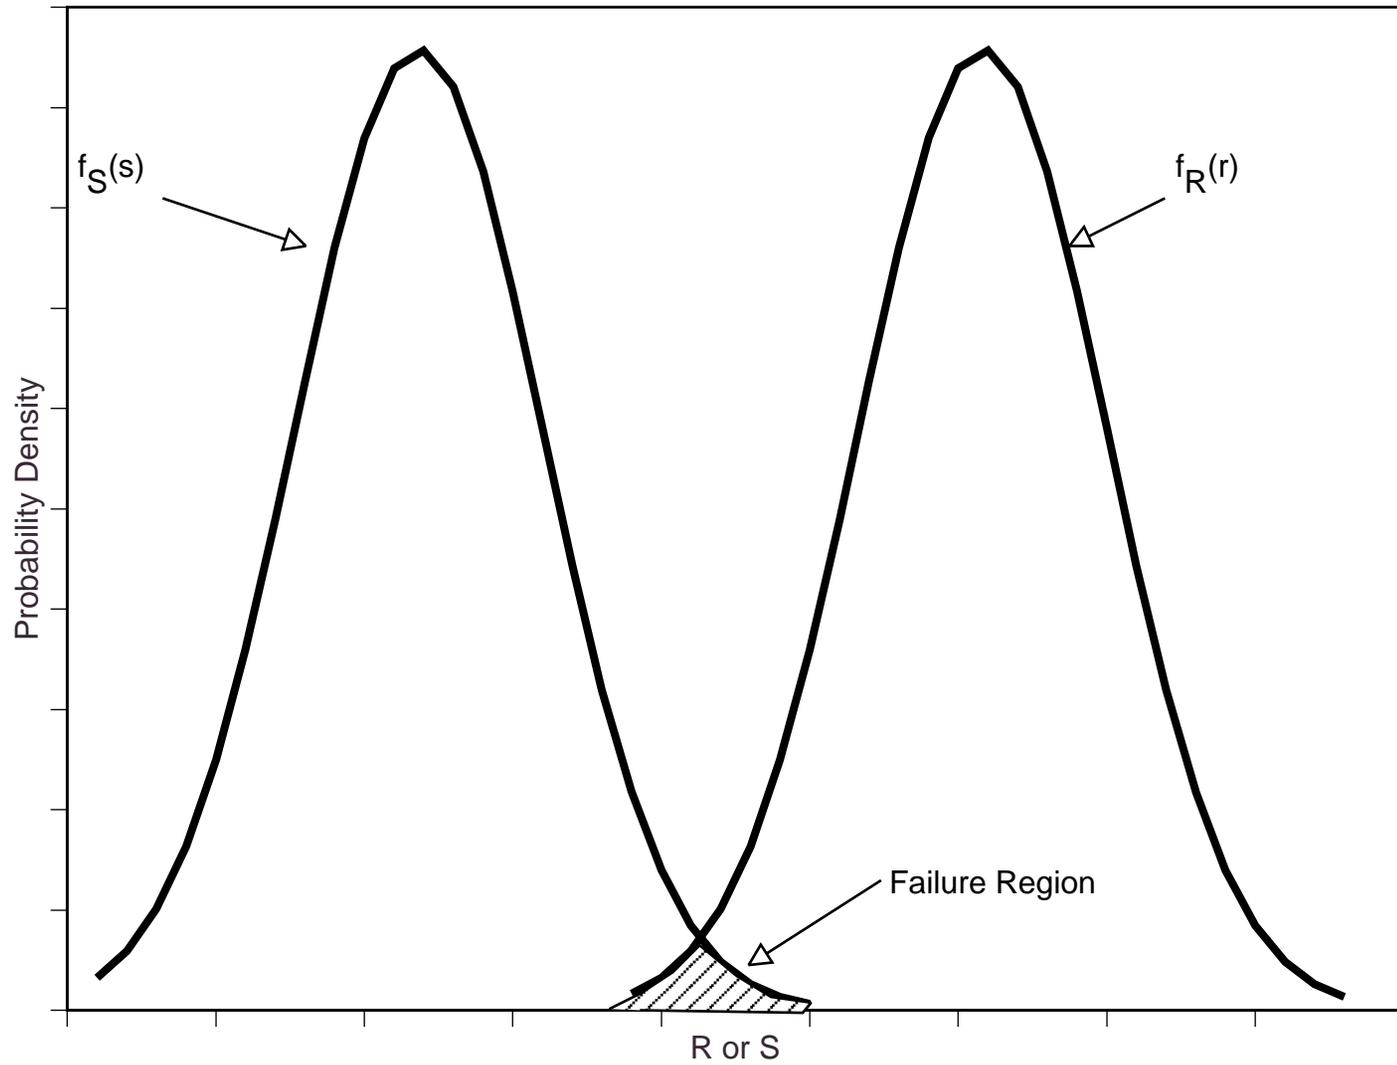
Figure E-3. Risk Evaluation

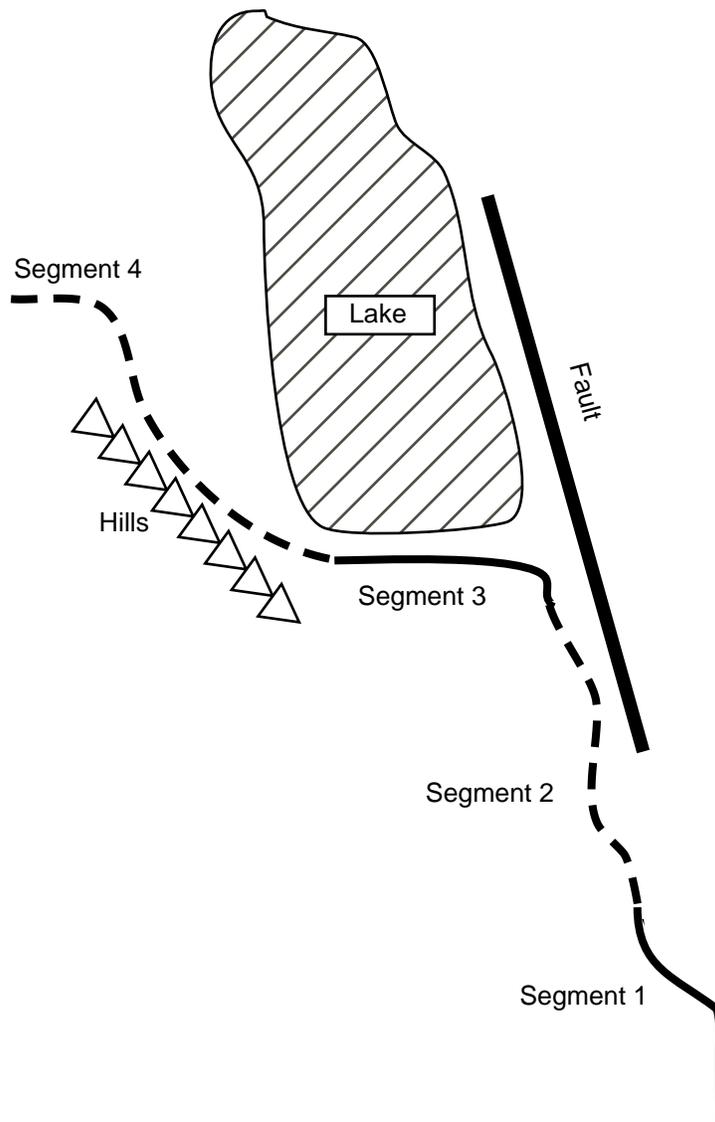
Figure F-1. Example Water Transmission System

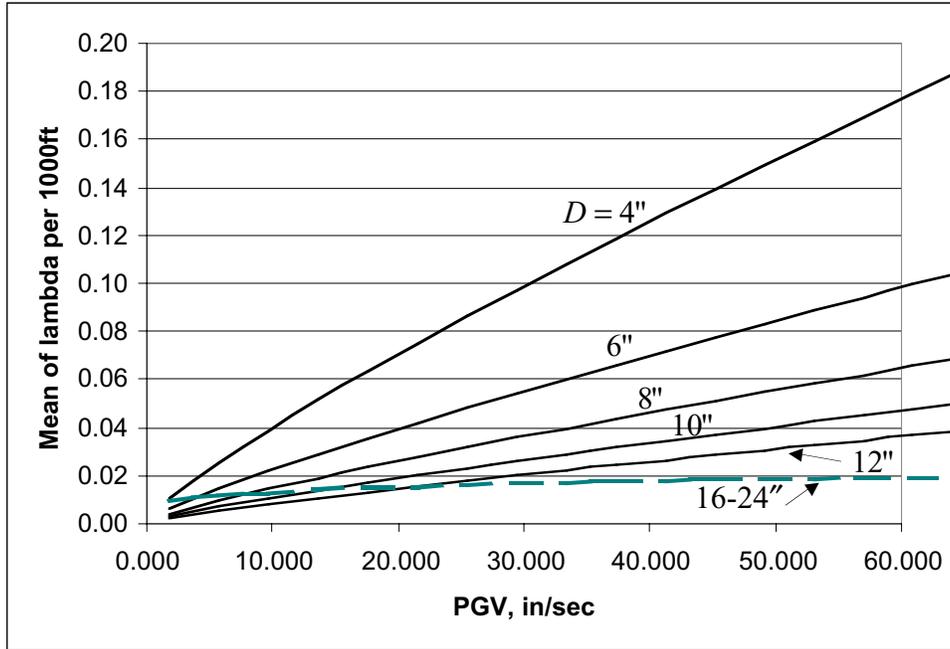
Figure G-1. Mean of λ for Cast Iron Pipes: 3-parameter formula for pipes with 4-12" diameter; 2-parameter formula for pipes with 16-24" diameter.

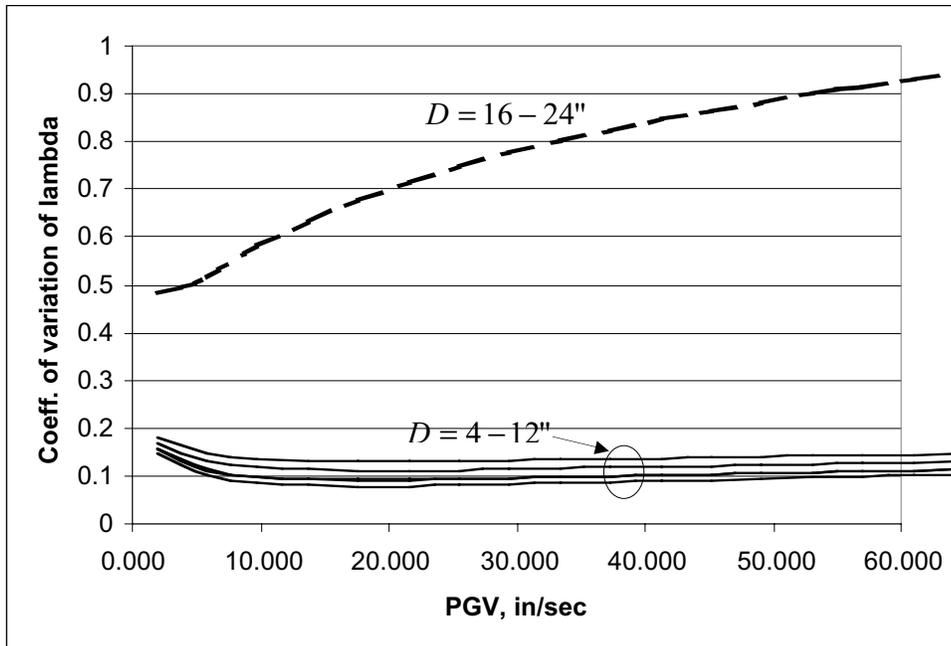
Figure G-2. Coefficient of variation of λ for Cast Iron Pipes: 3-parameter formula for pipes with 4-12" diameter; 2-parameter formula for pipes with 16-24" diameter.

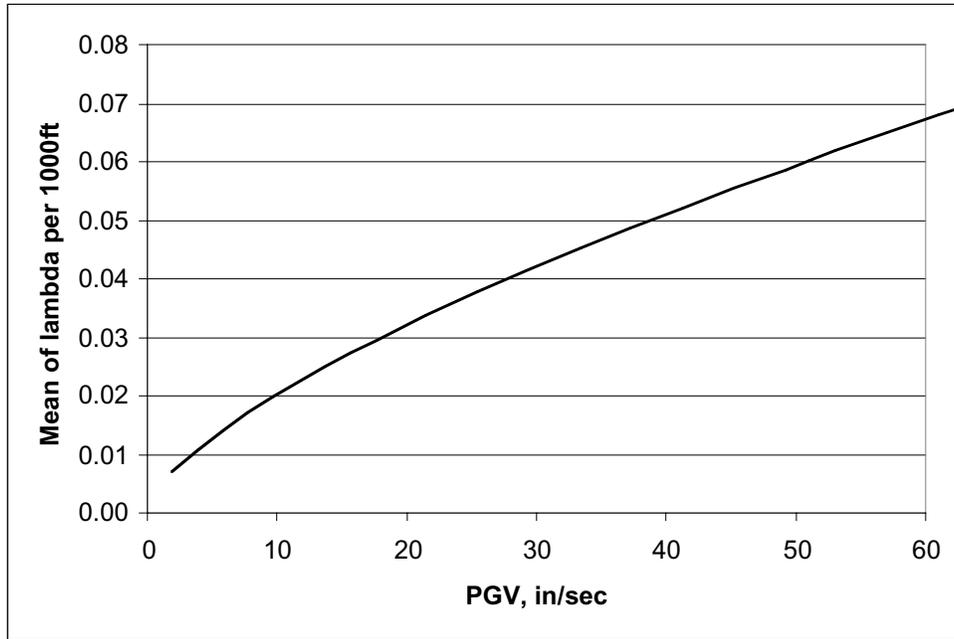
Figure G-3. Mean of λ for Ductile Iron pipes with 4-20" Diameter.

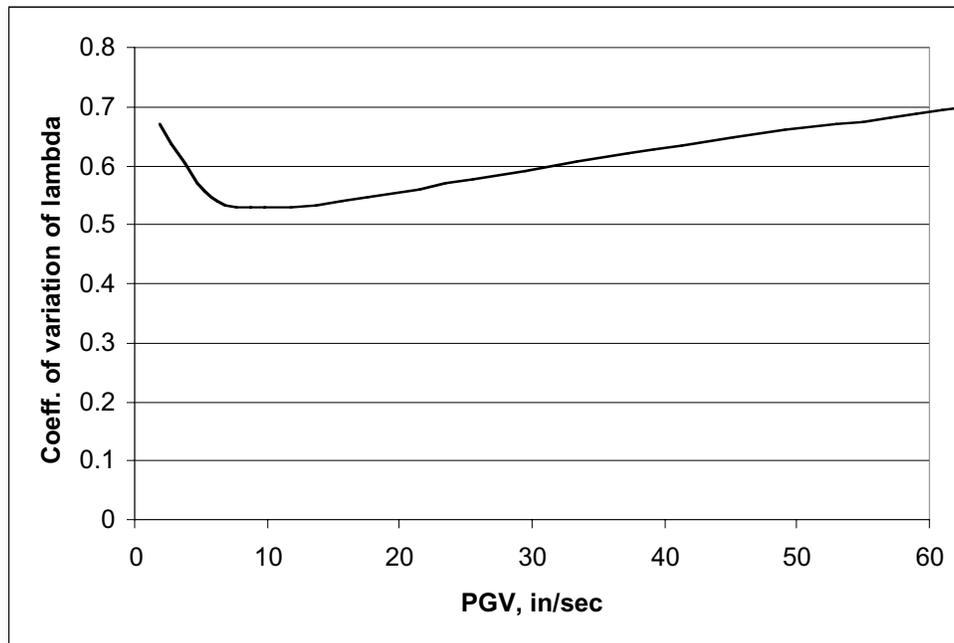
Figure G-4. Coefficient of Variation of λ for Ductile Iron Pipes with 4-20" Diameter.

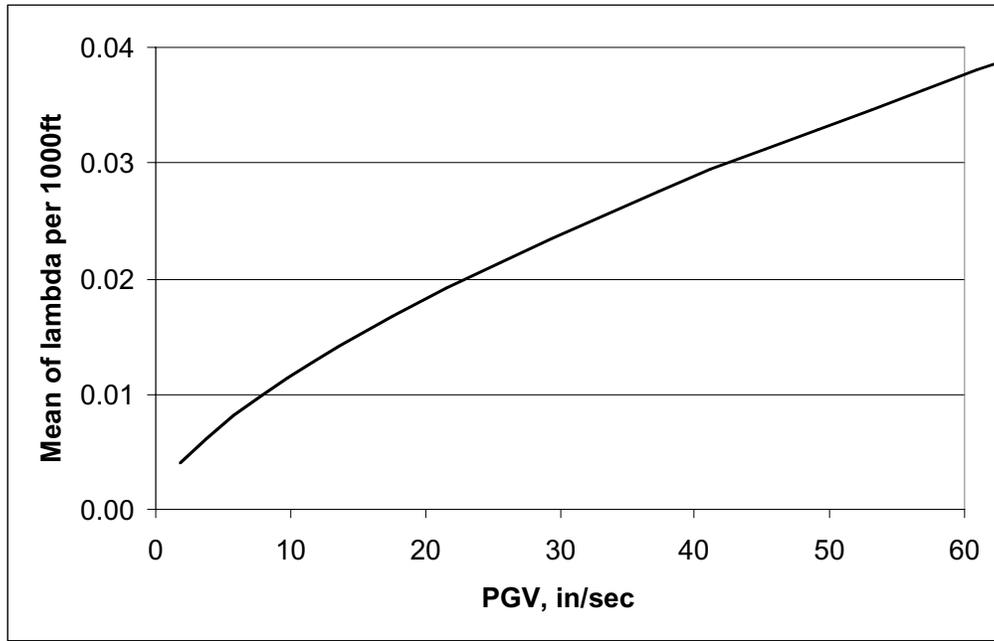
Figure G-5. Mean of λ for Asbestos Cement pipes with 4-12" Diameter.

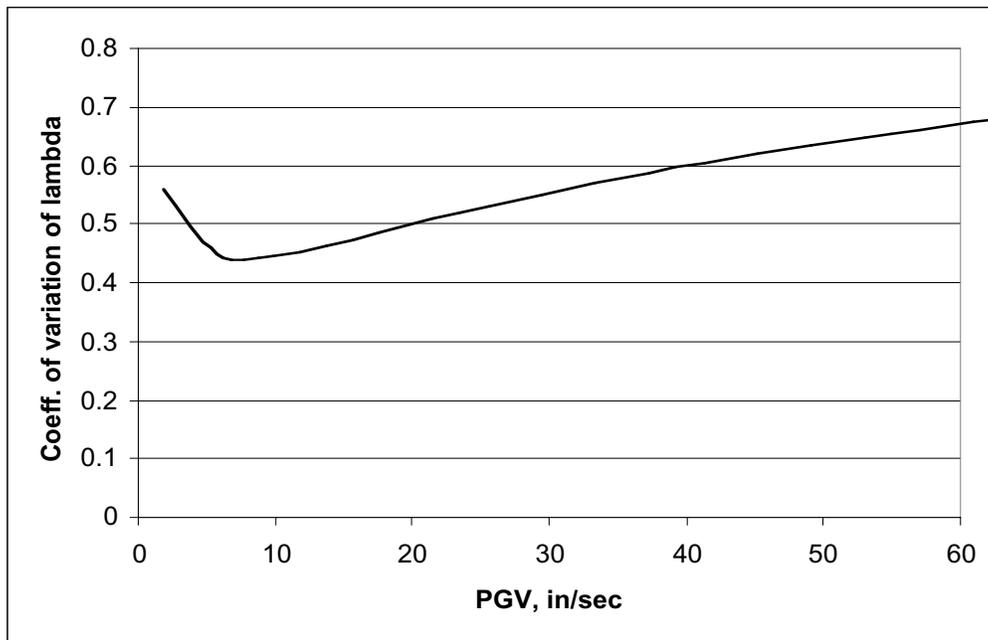
Figure G-6. Coefficient of Variation of λ for AC Pipes with 4-12" Diameter.

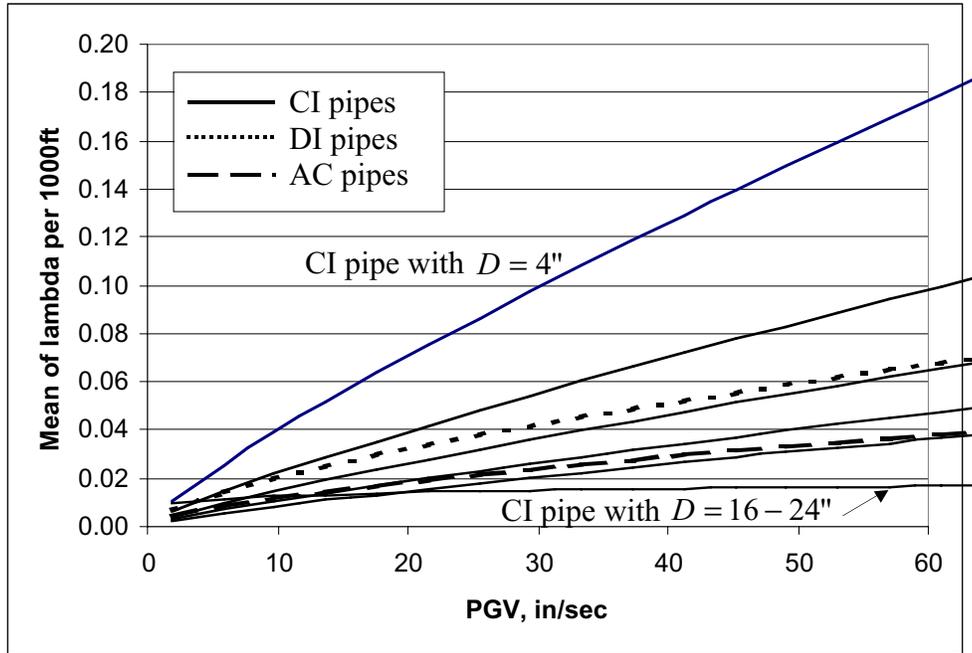
Figure G-7. Comparison of Mean of λ for Pipes of Different Material and Diameter.

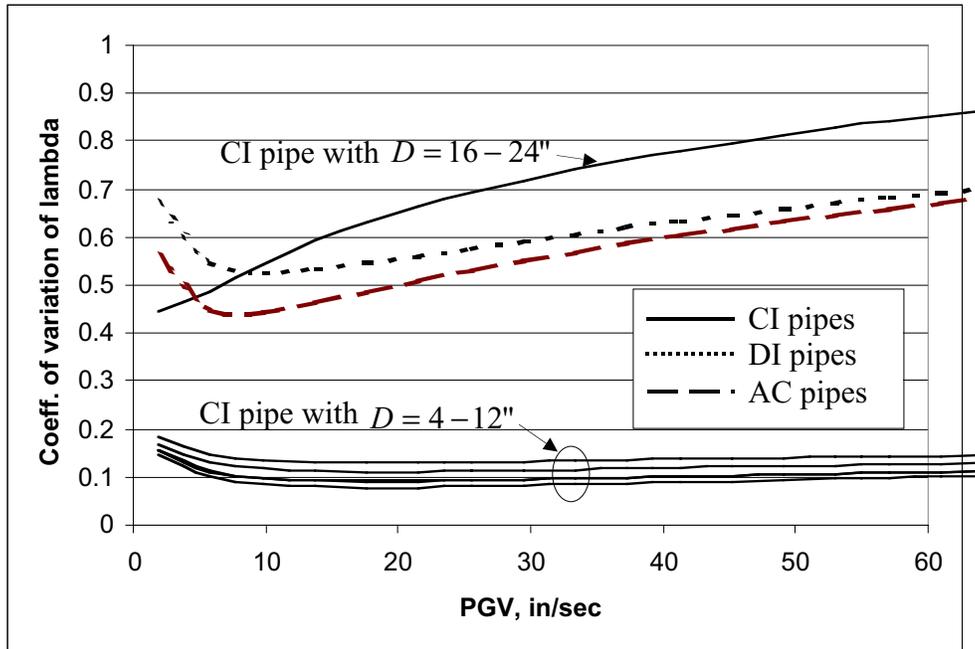
Figure G-8. Comparison of C.O.V. of λ for Pipes of Different Material and Diameter.
