# Seismic Performance of Buried Cables and Pot Heads

John Eiding

G&E Engineering Systems Inc.

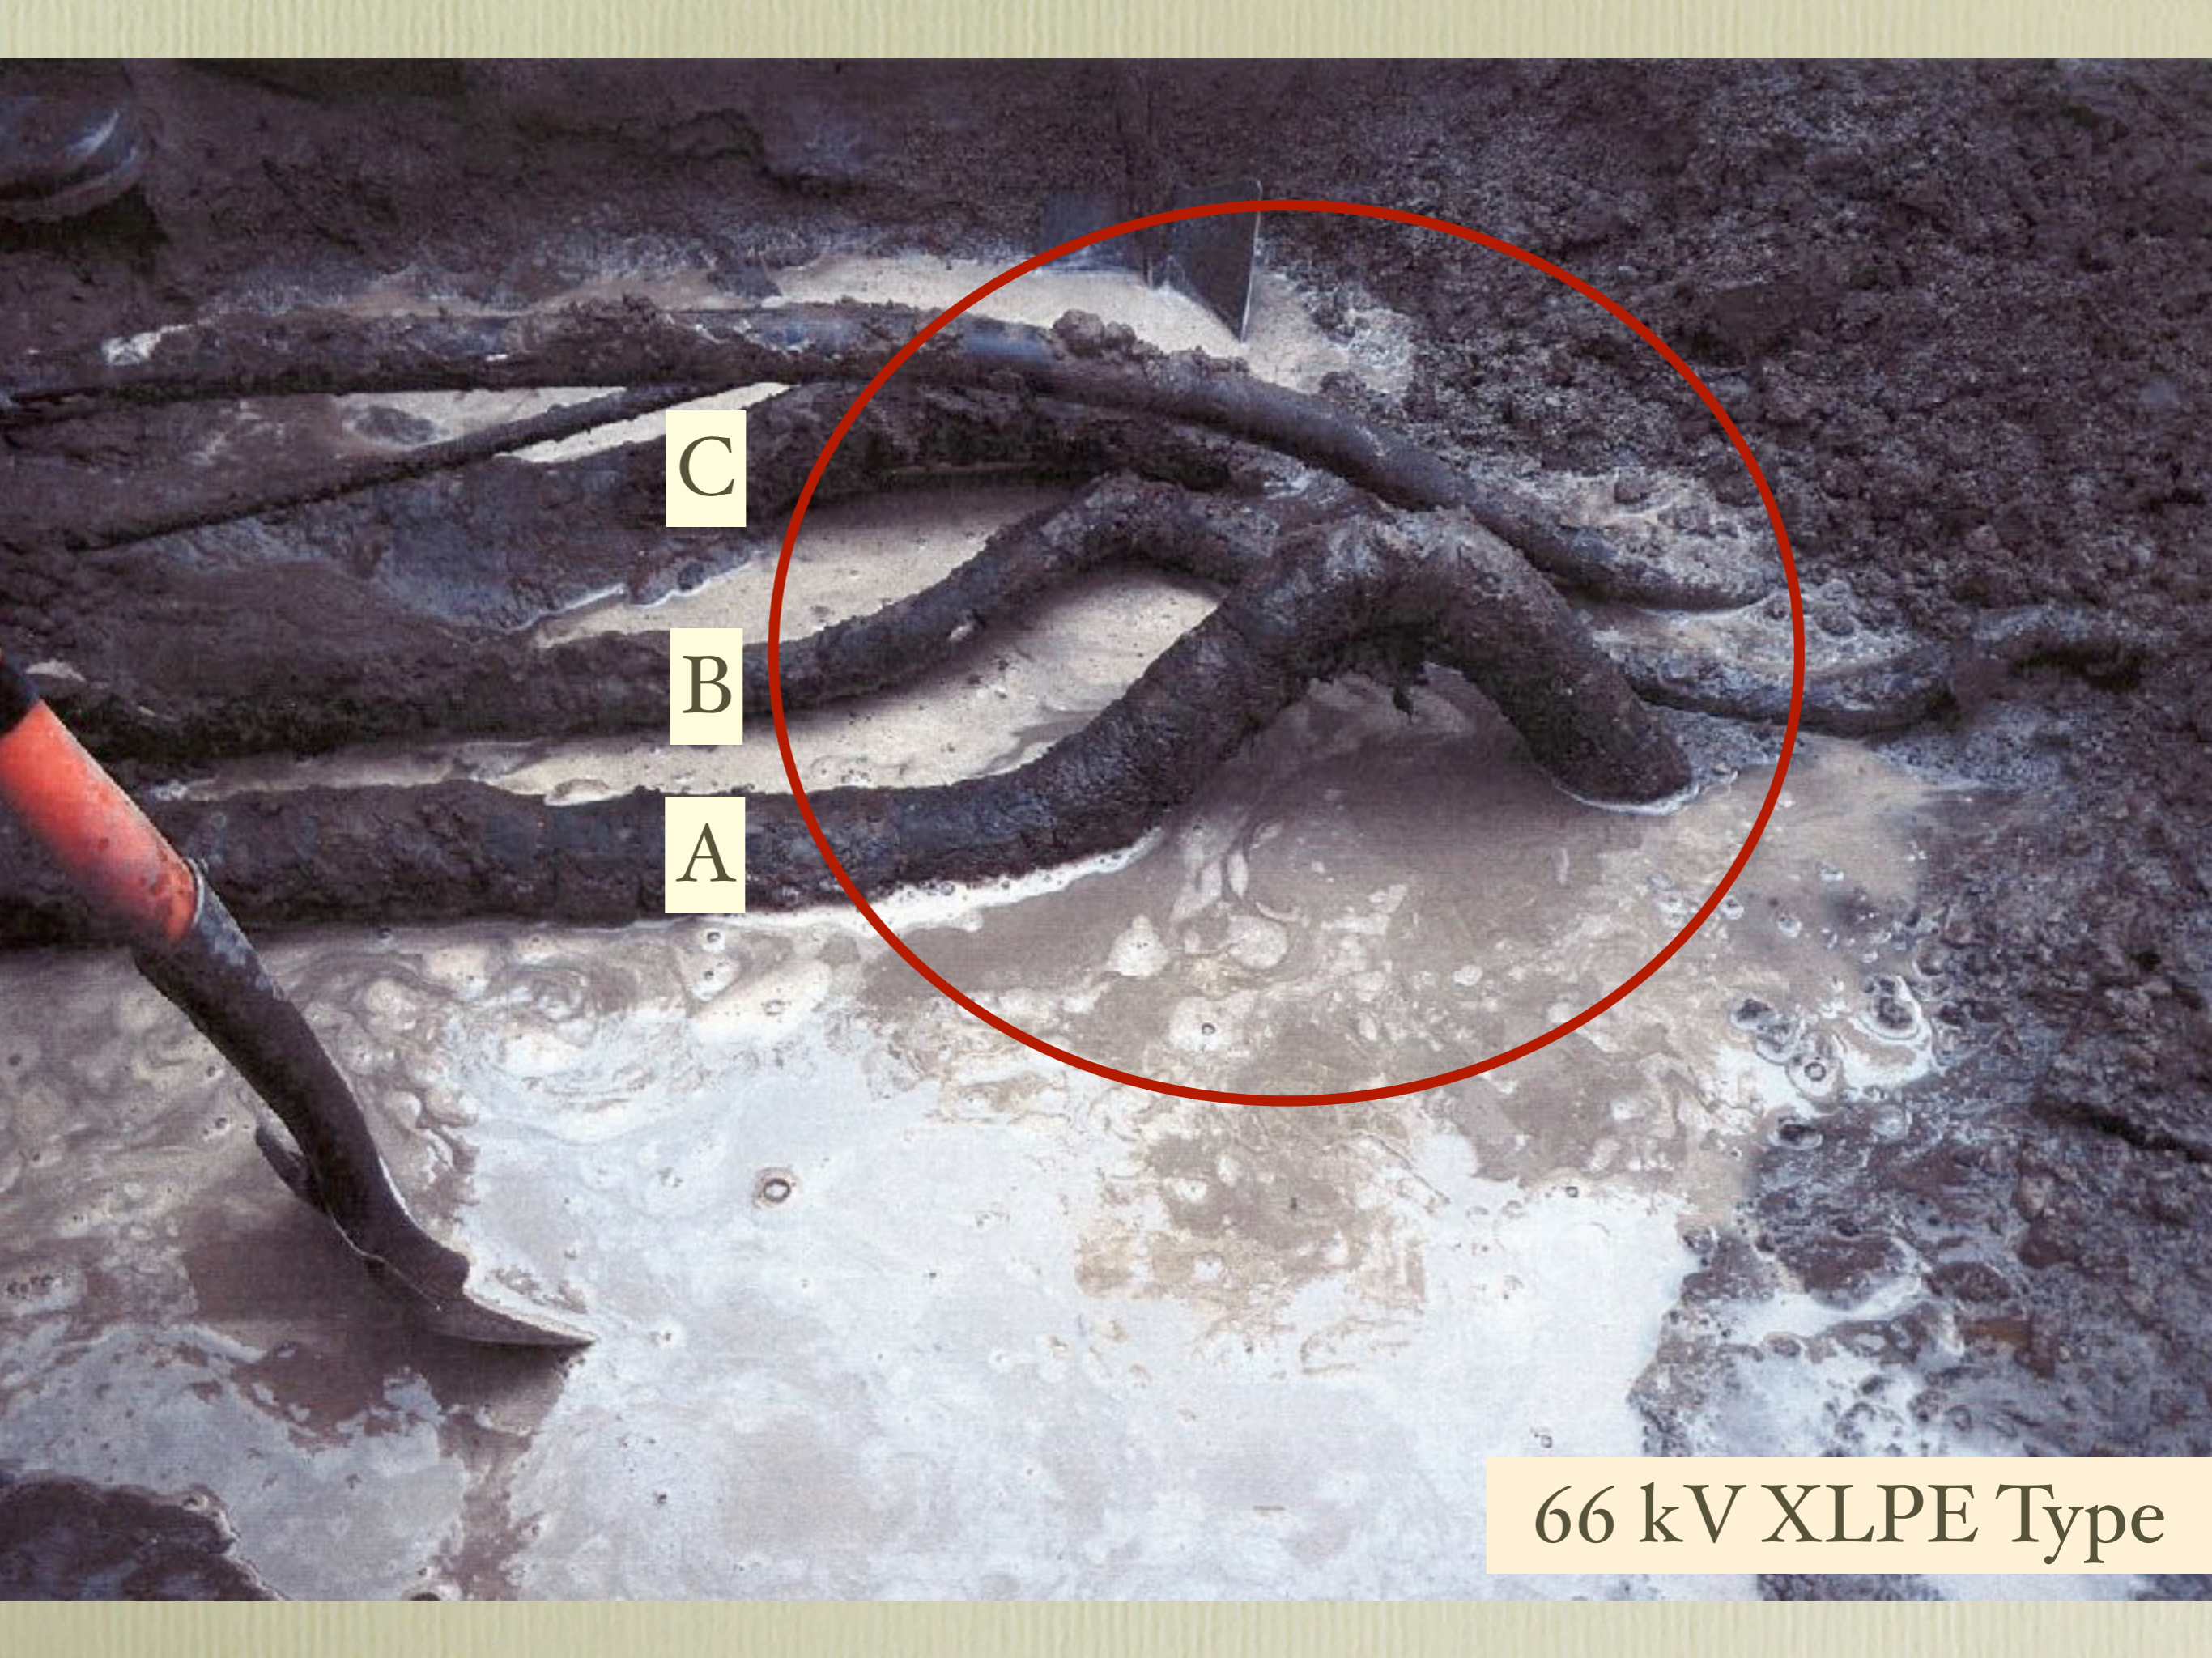
66 kV XLPE Type

Several buckled cables

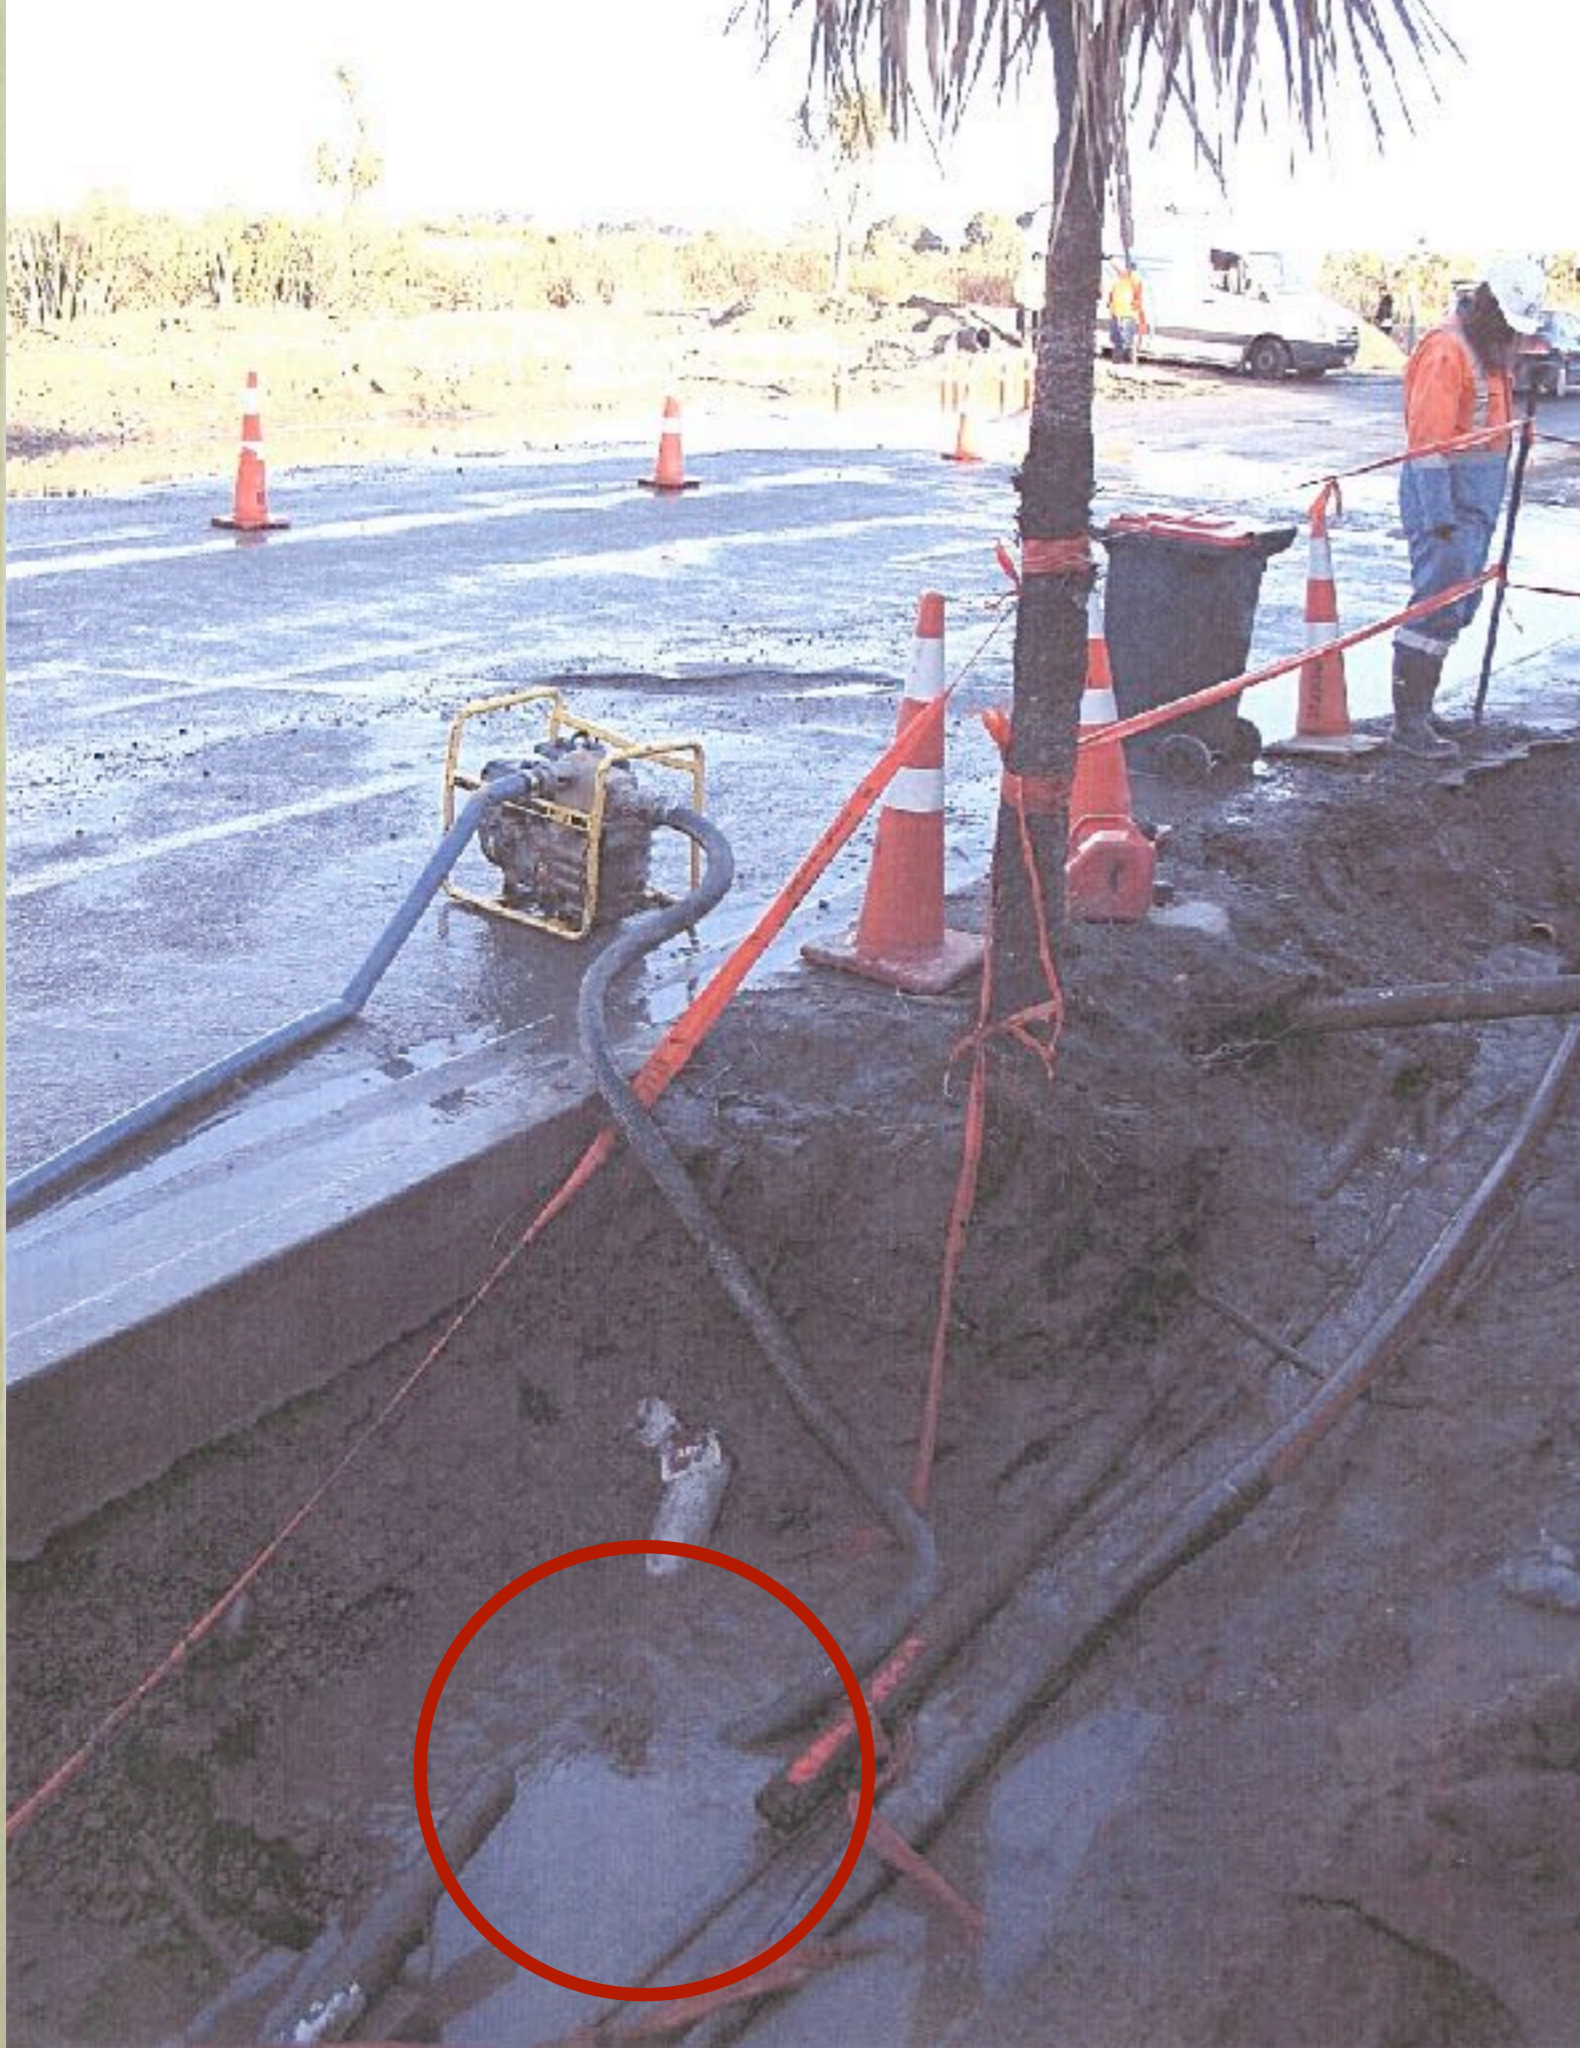
Two 66 kV Oil  
Filled Pipe-Type  
Cables

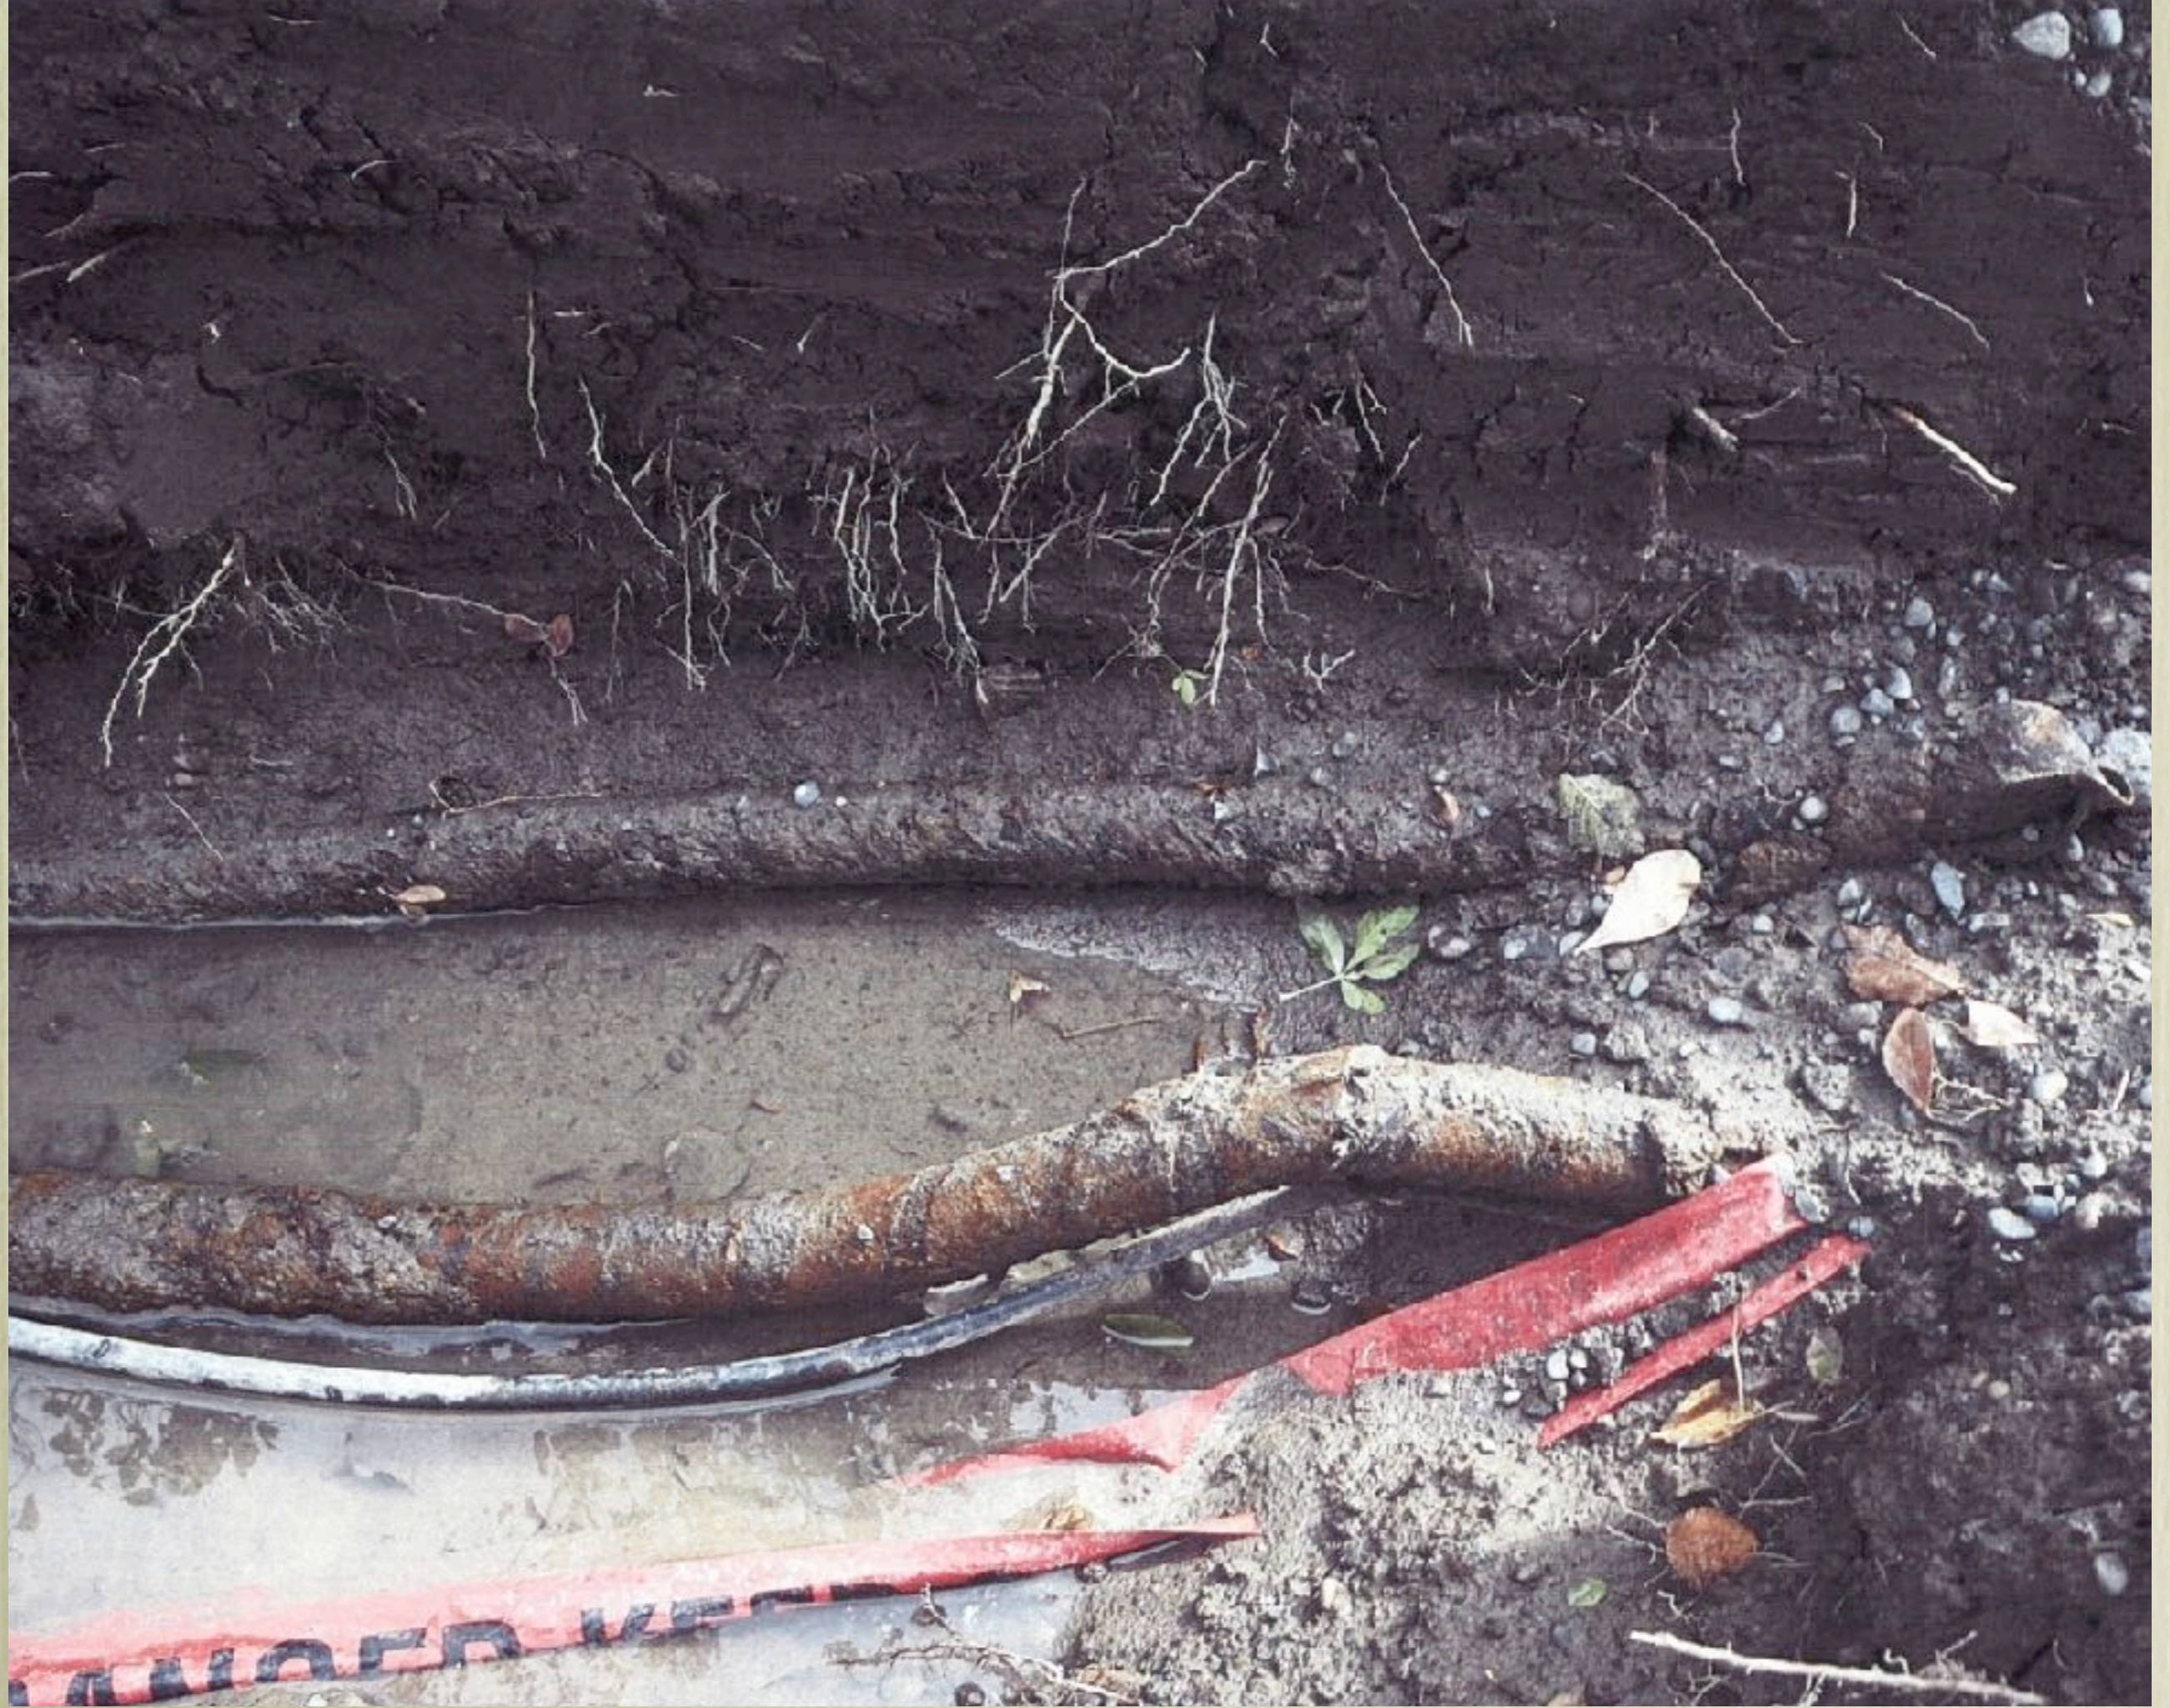
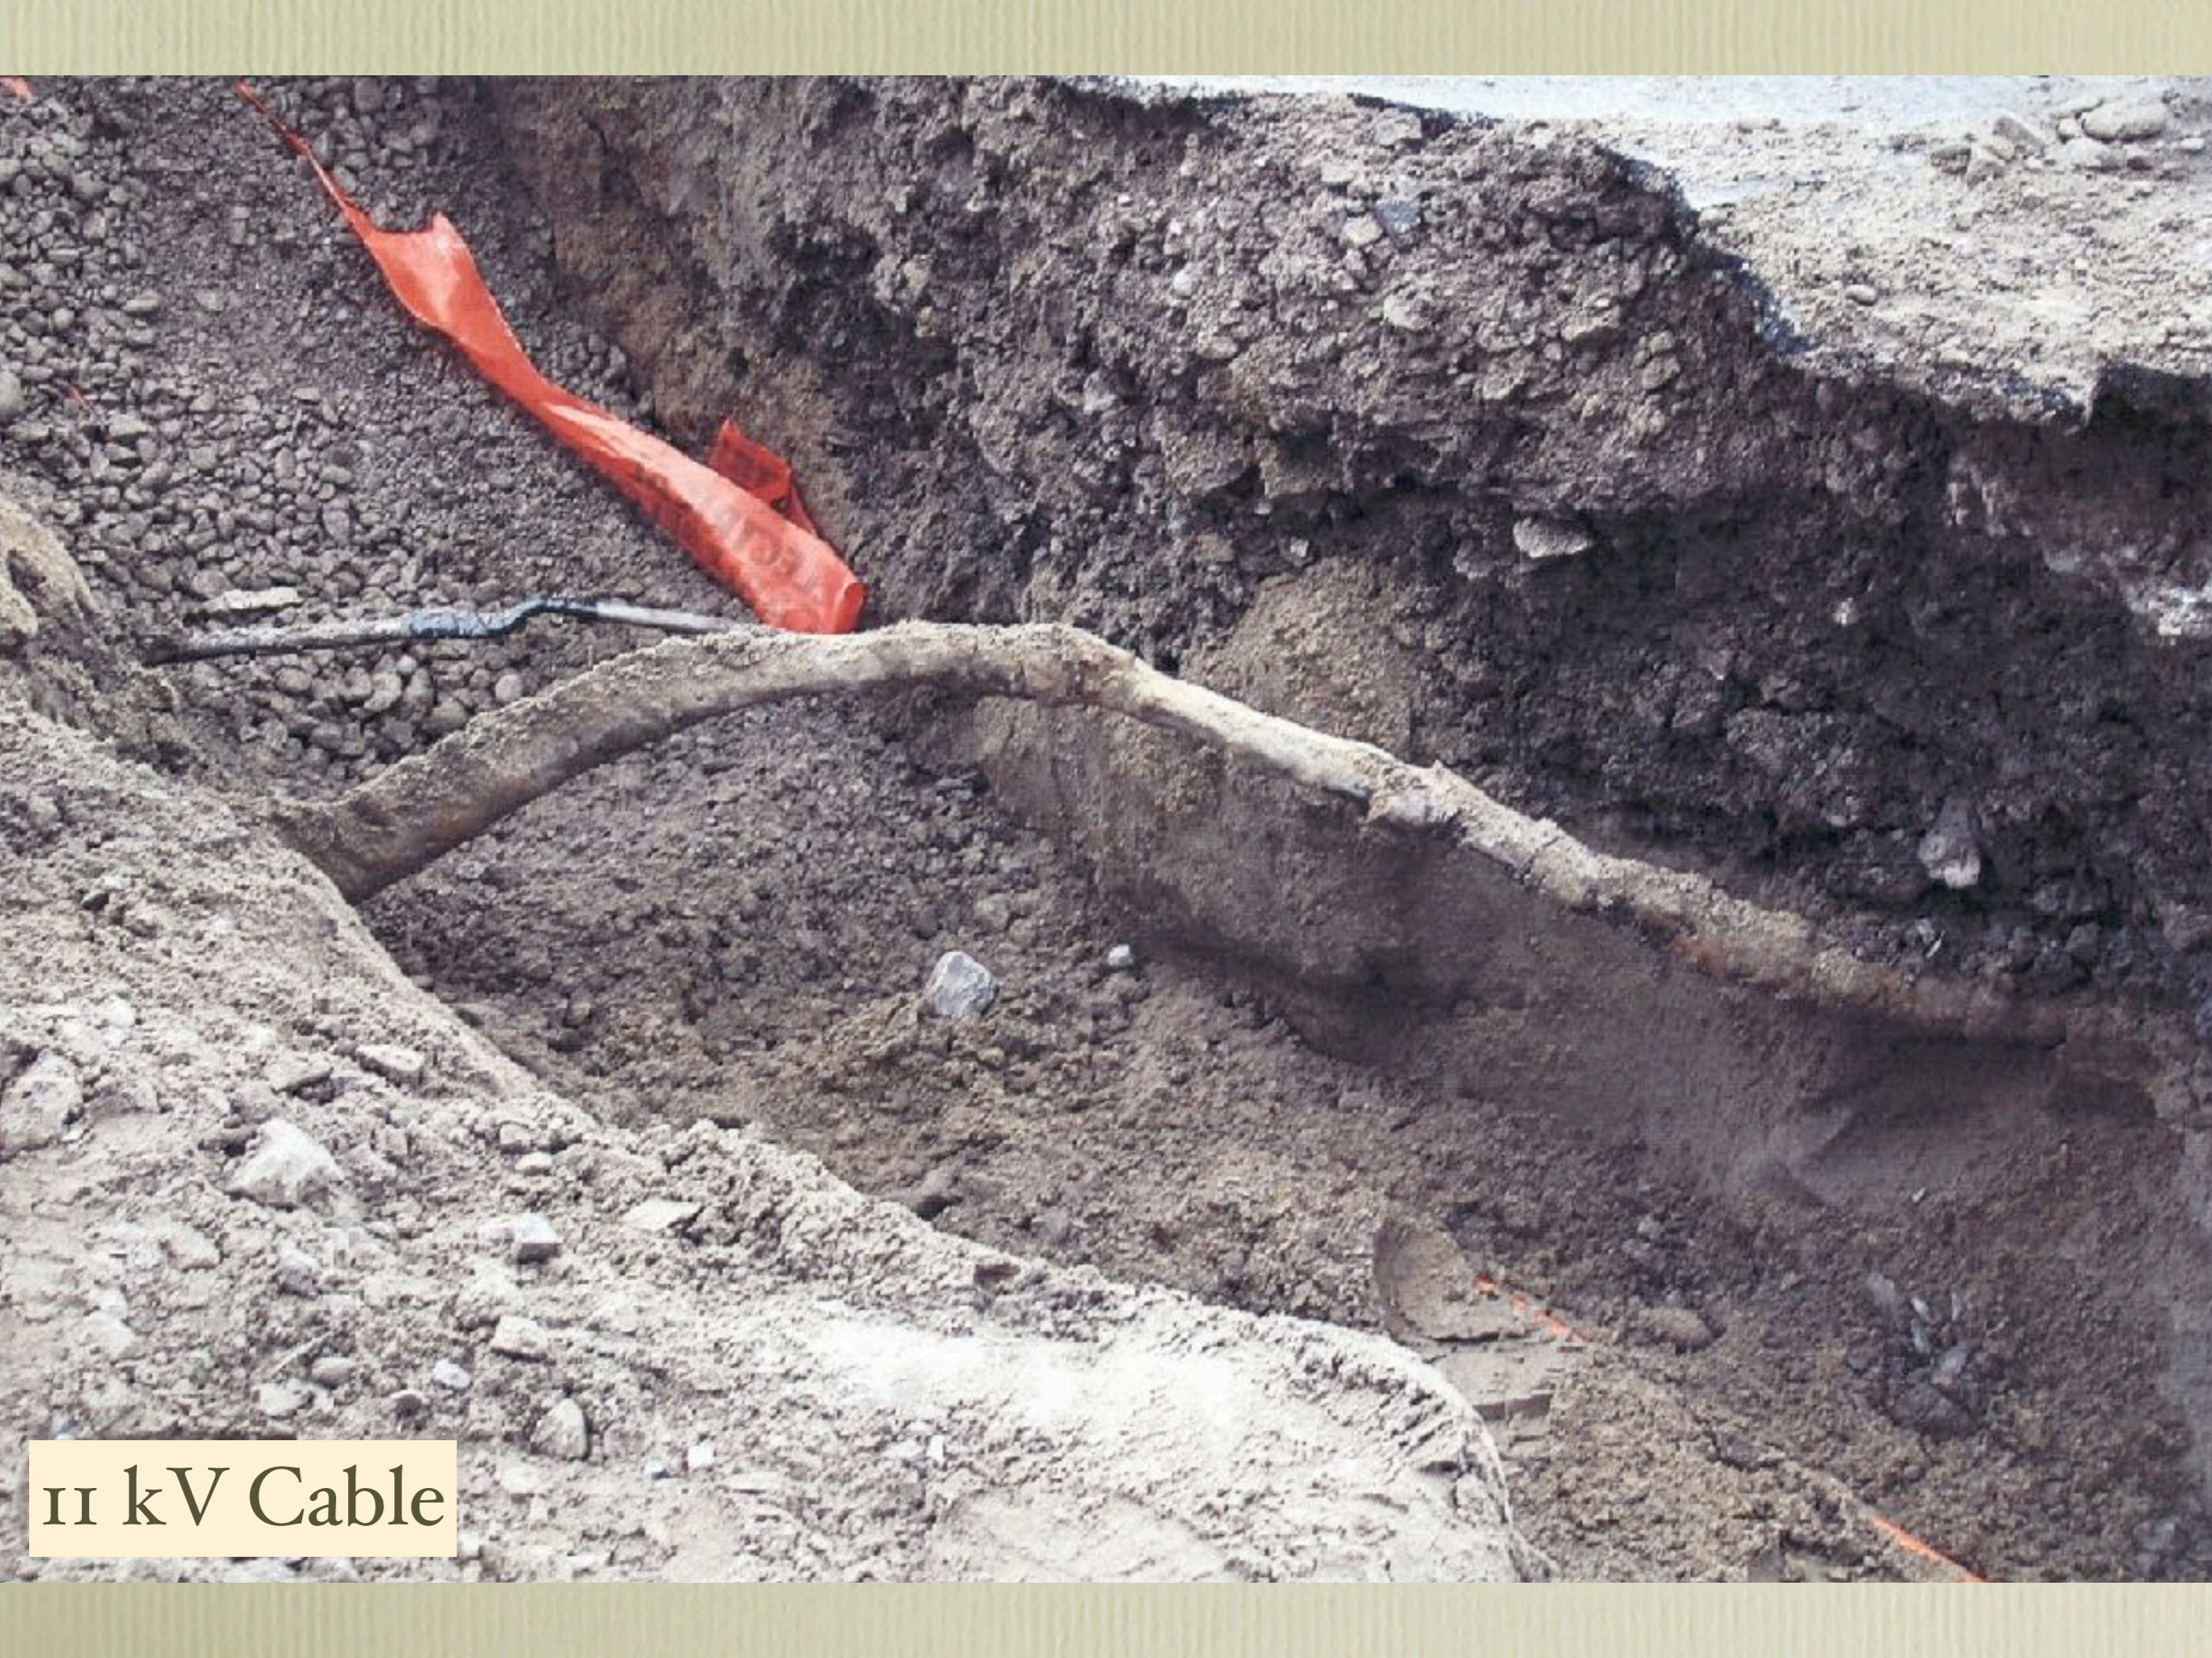
11 kV Cable

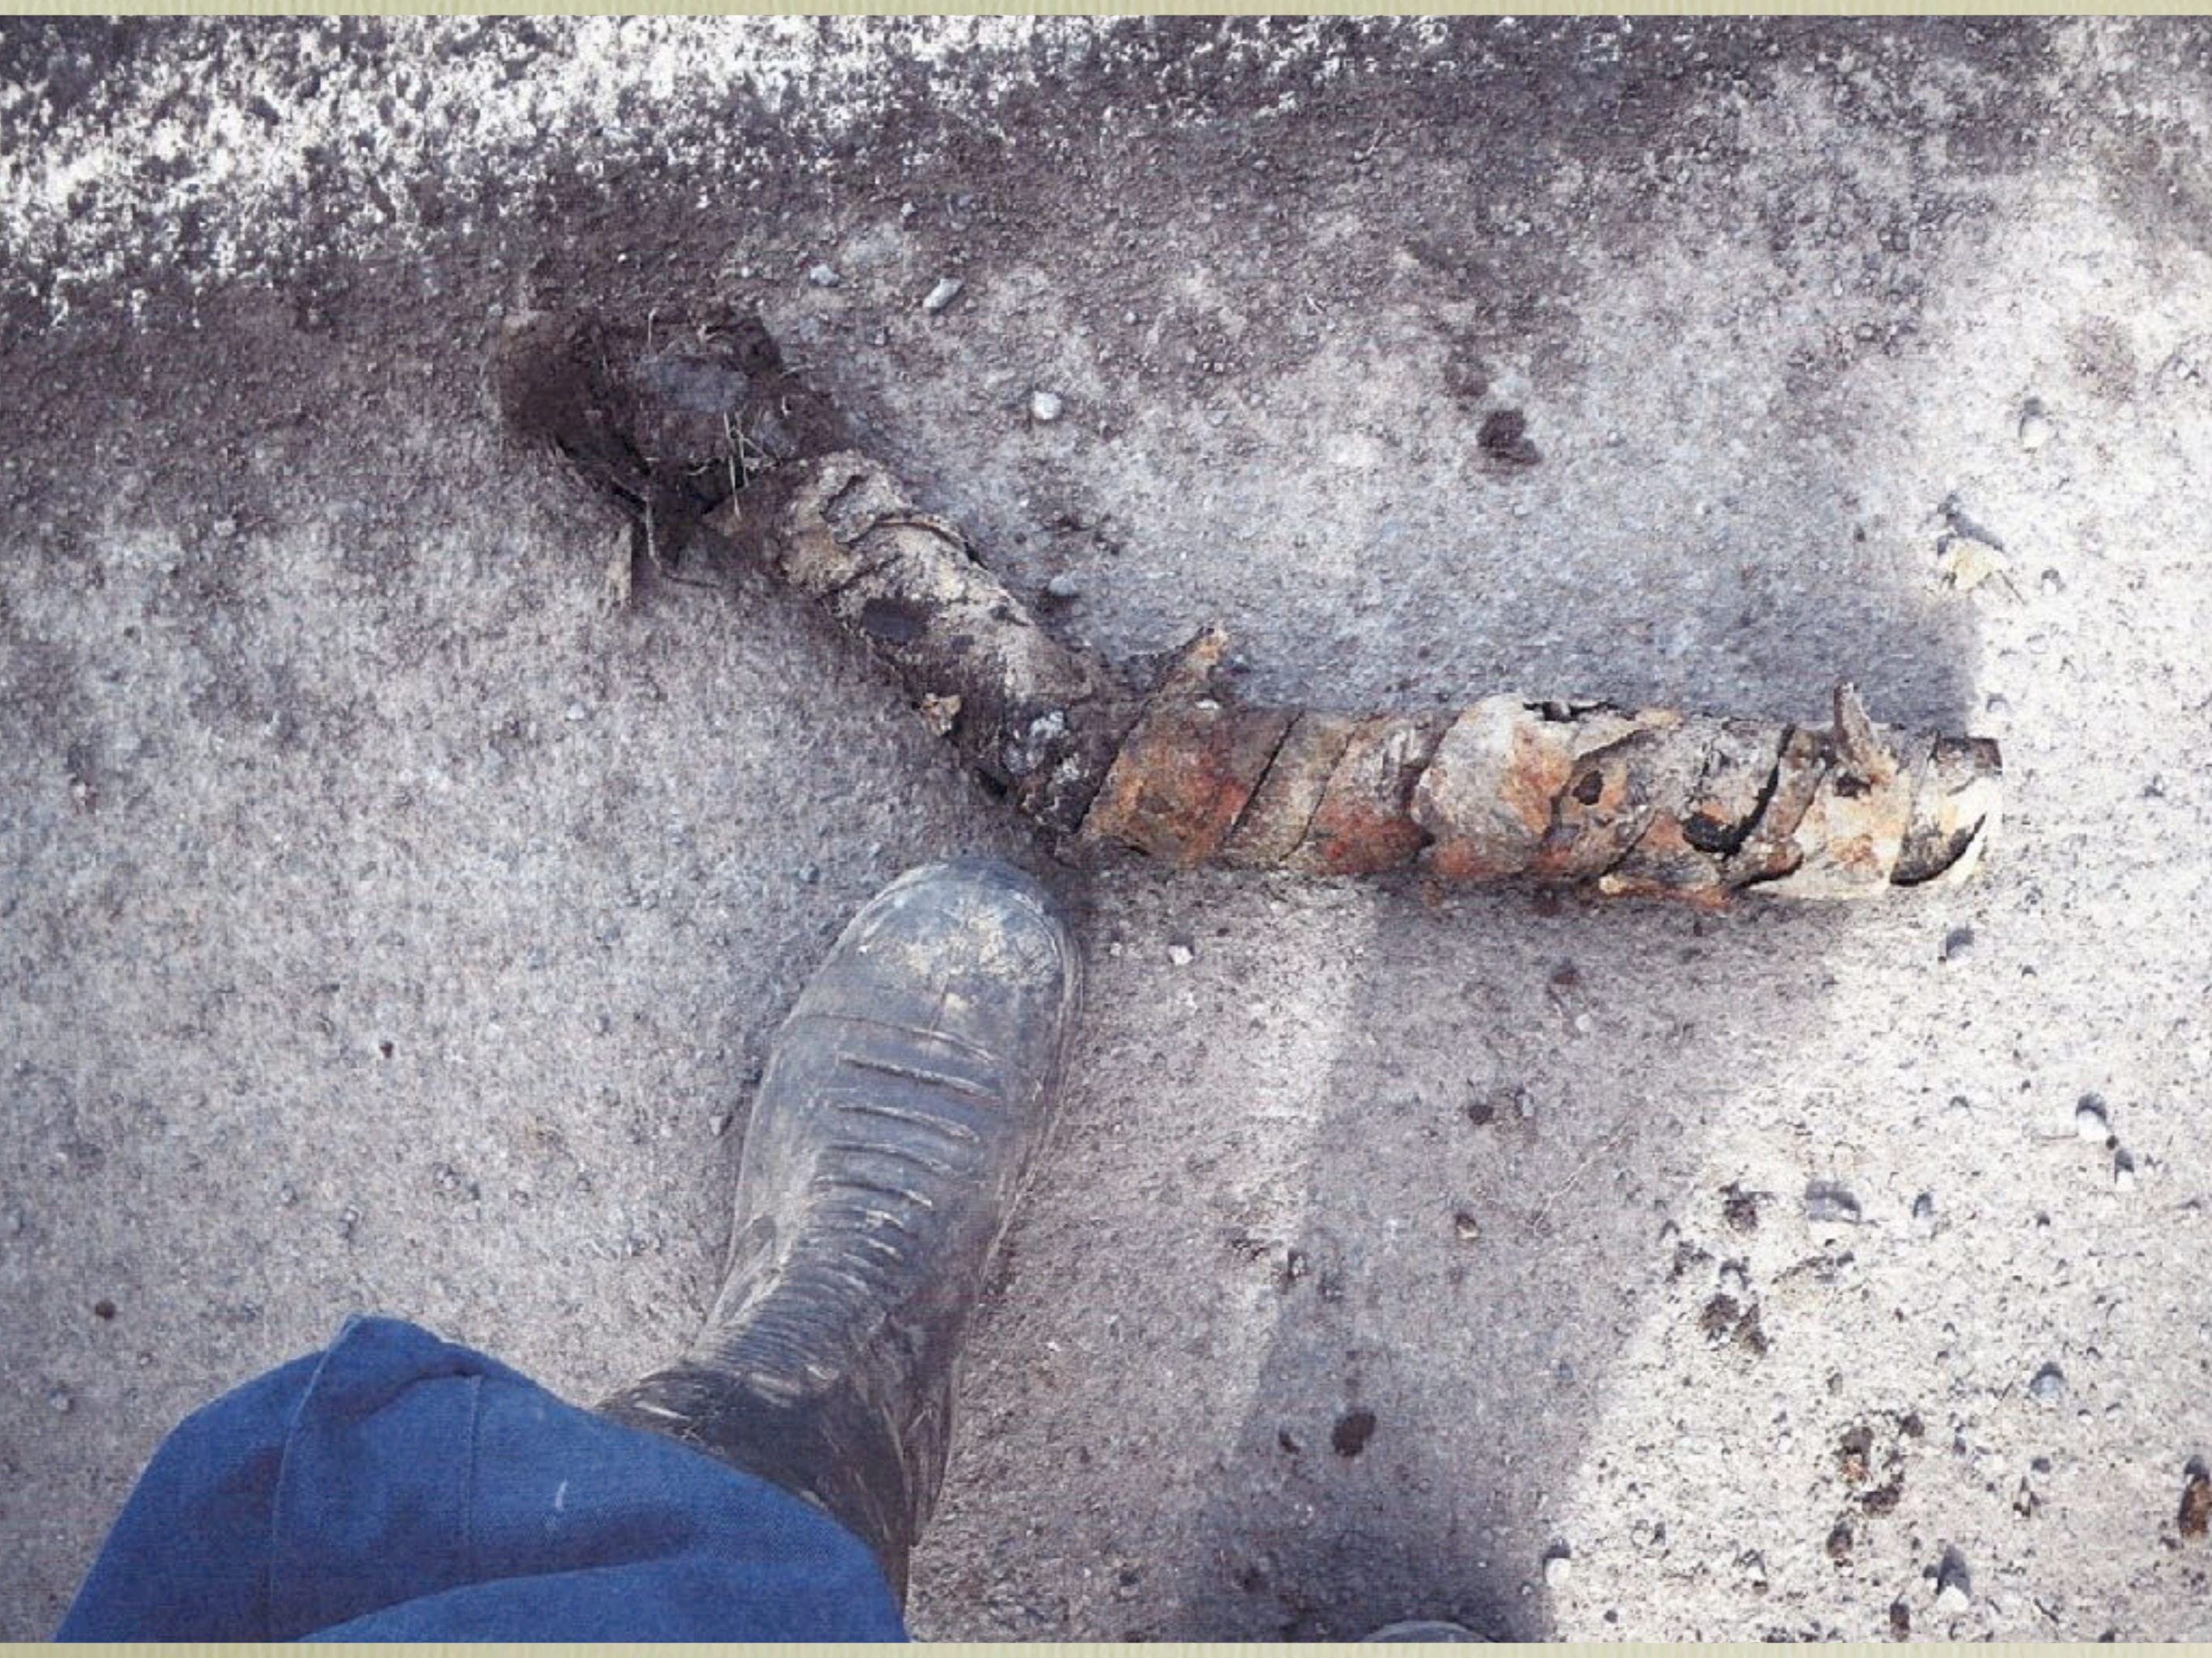
11 kV Cable

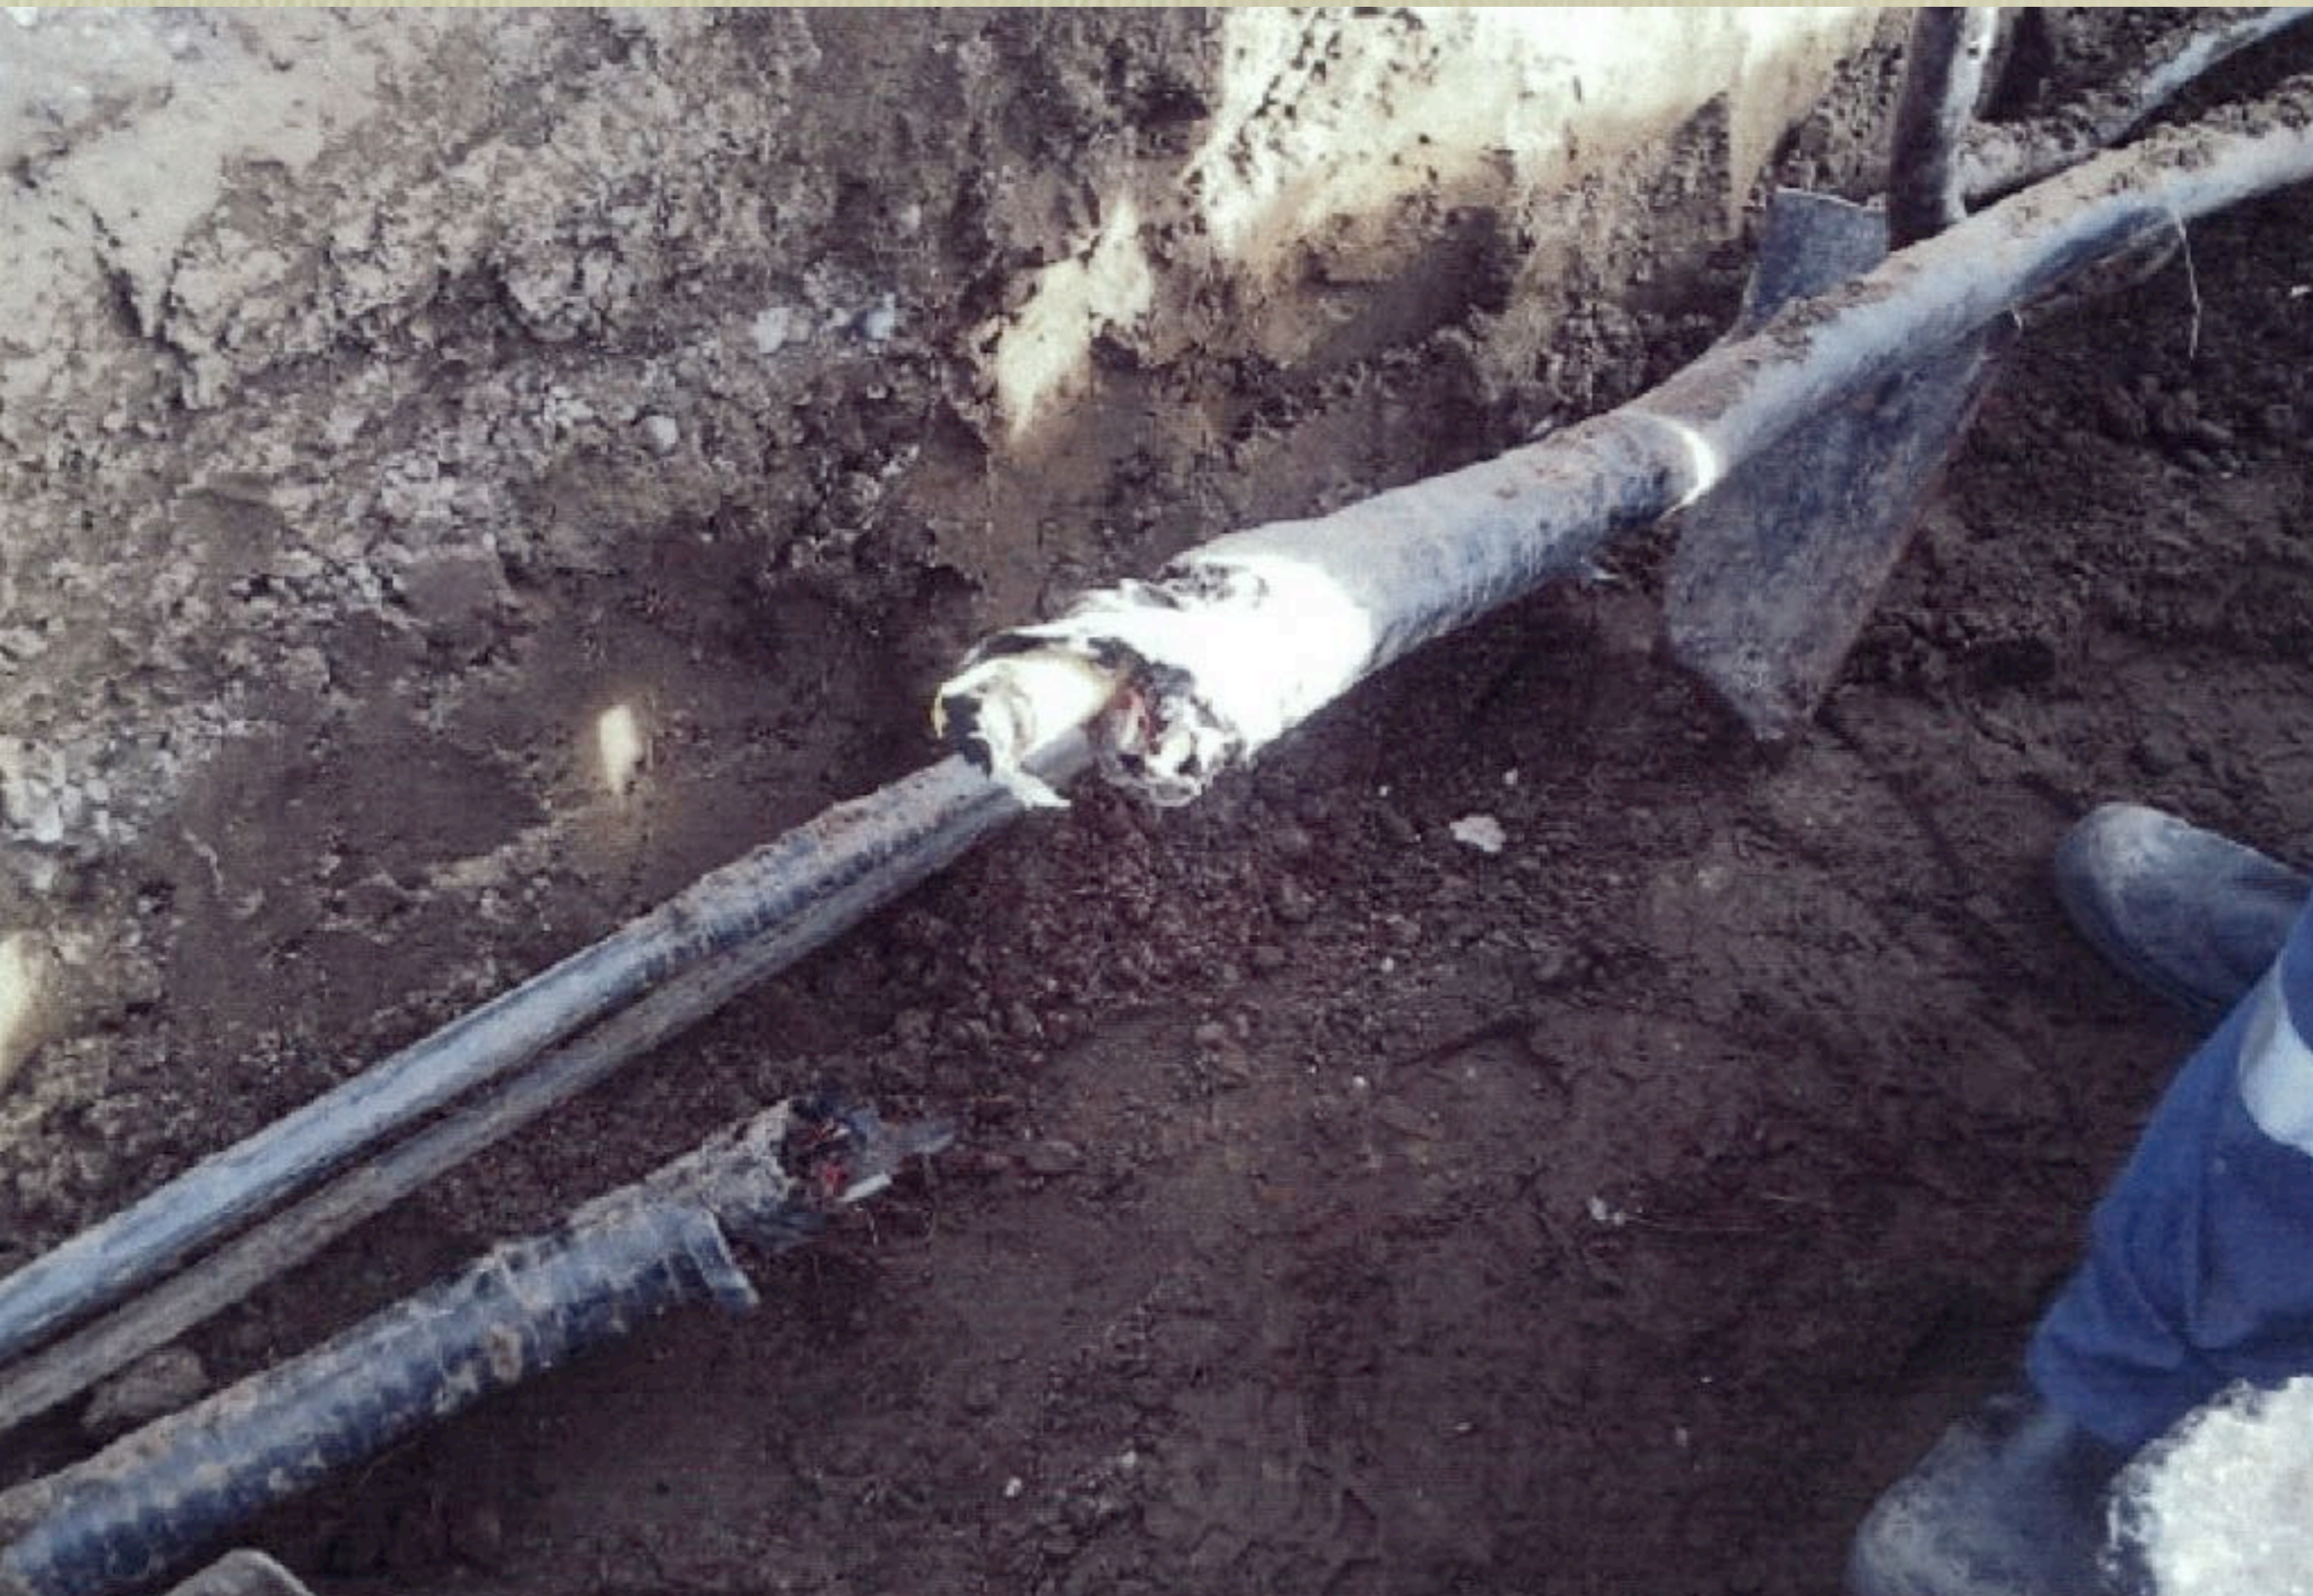
11 kV
