# Seismic Performance of Buried Cables and Pot Heads

John Eiding

G&E Engineering Systems Inc.

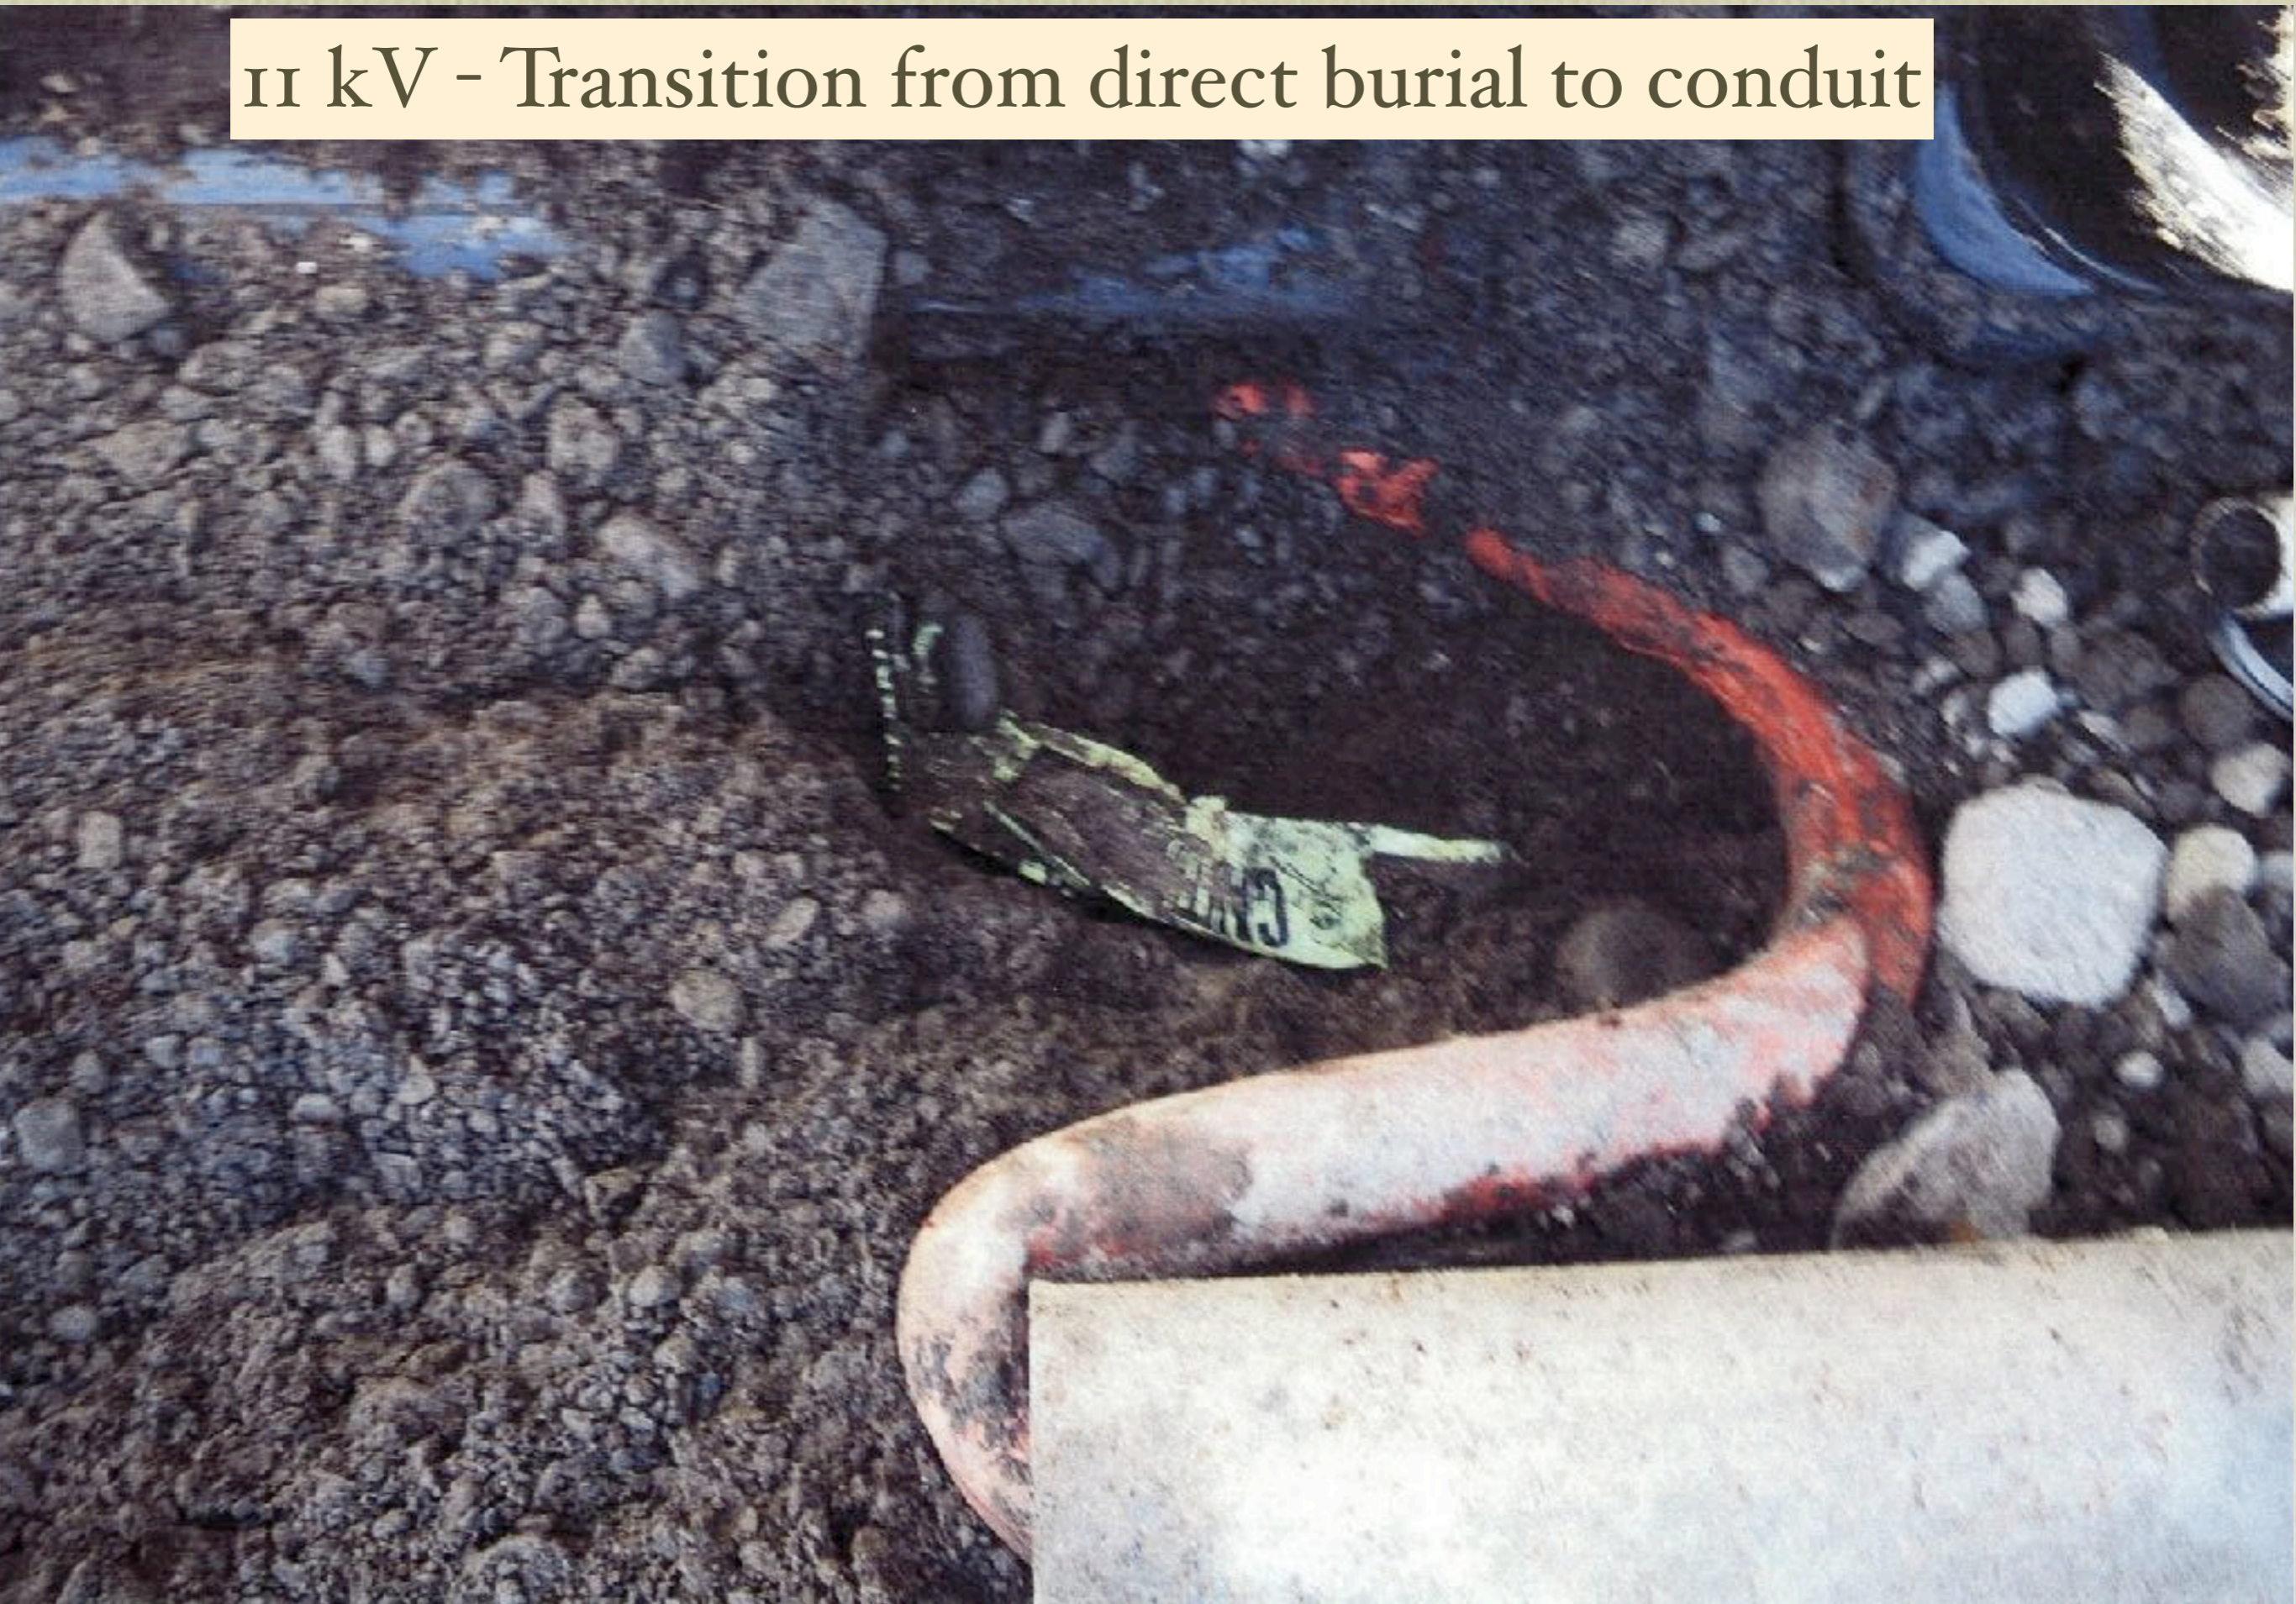
11 kV - Transition from direct burial to conduit

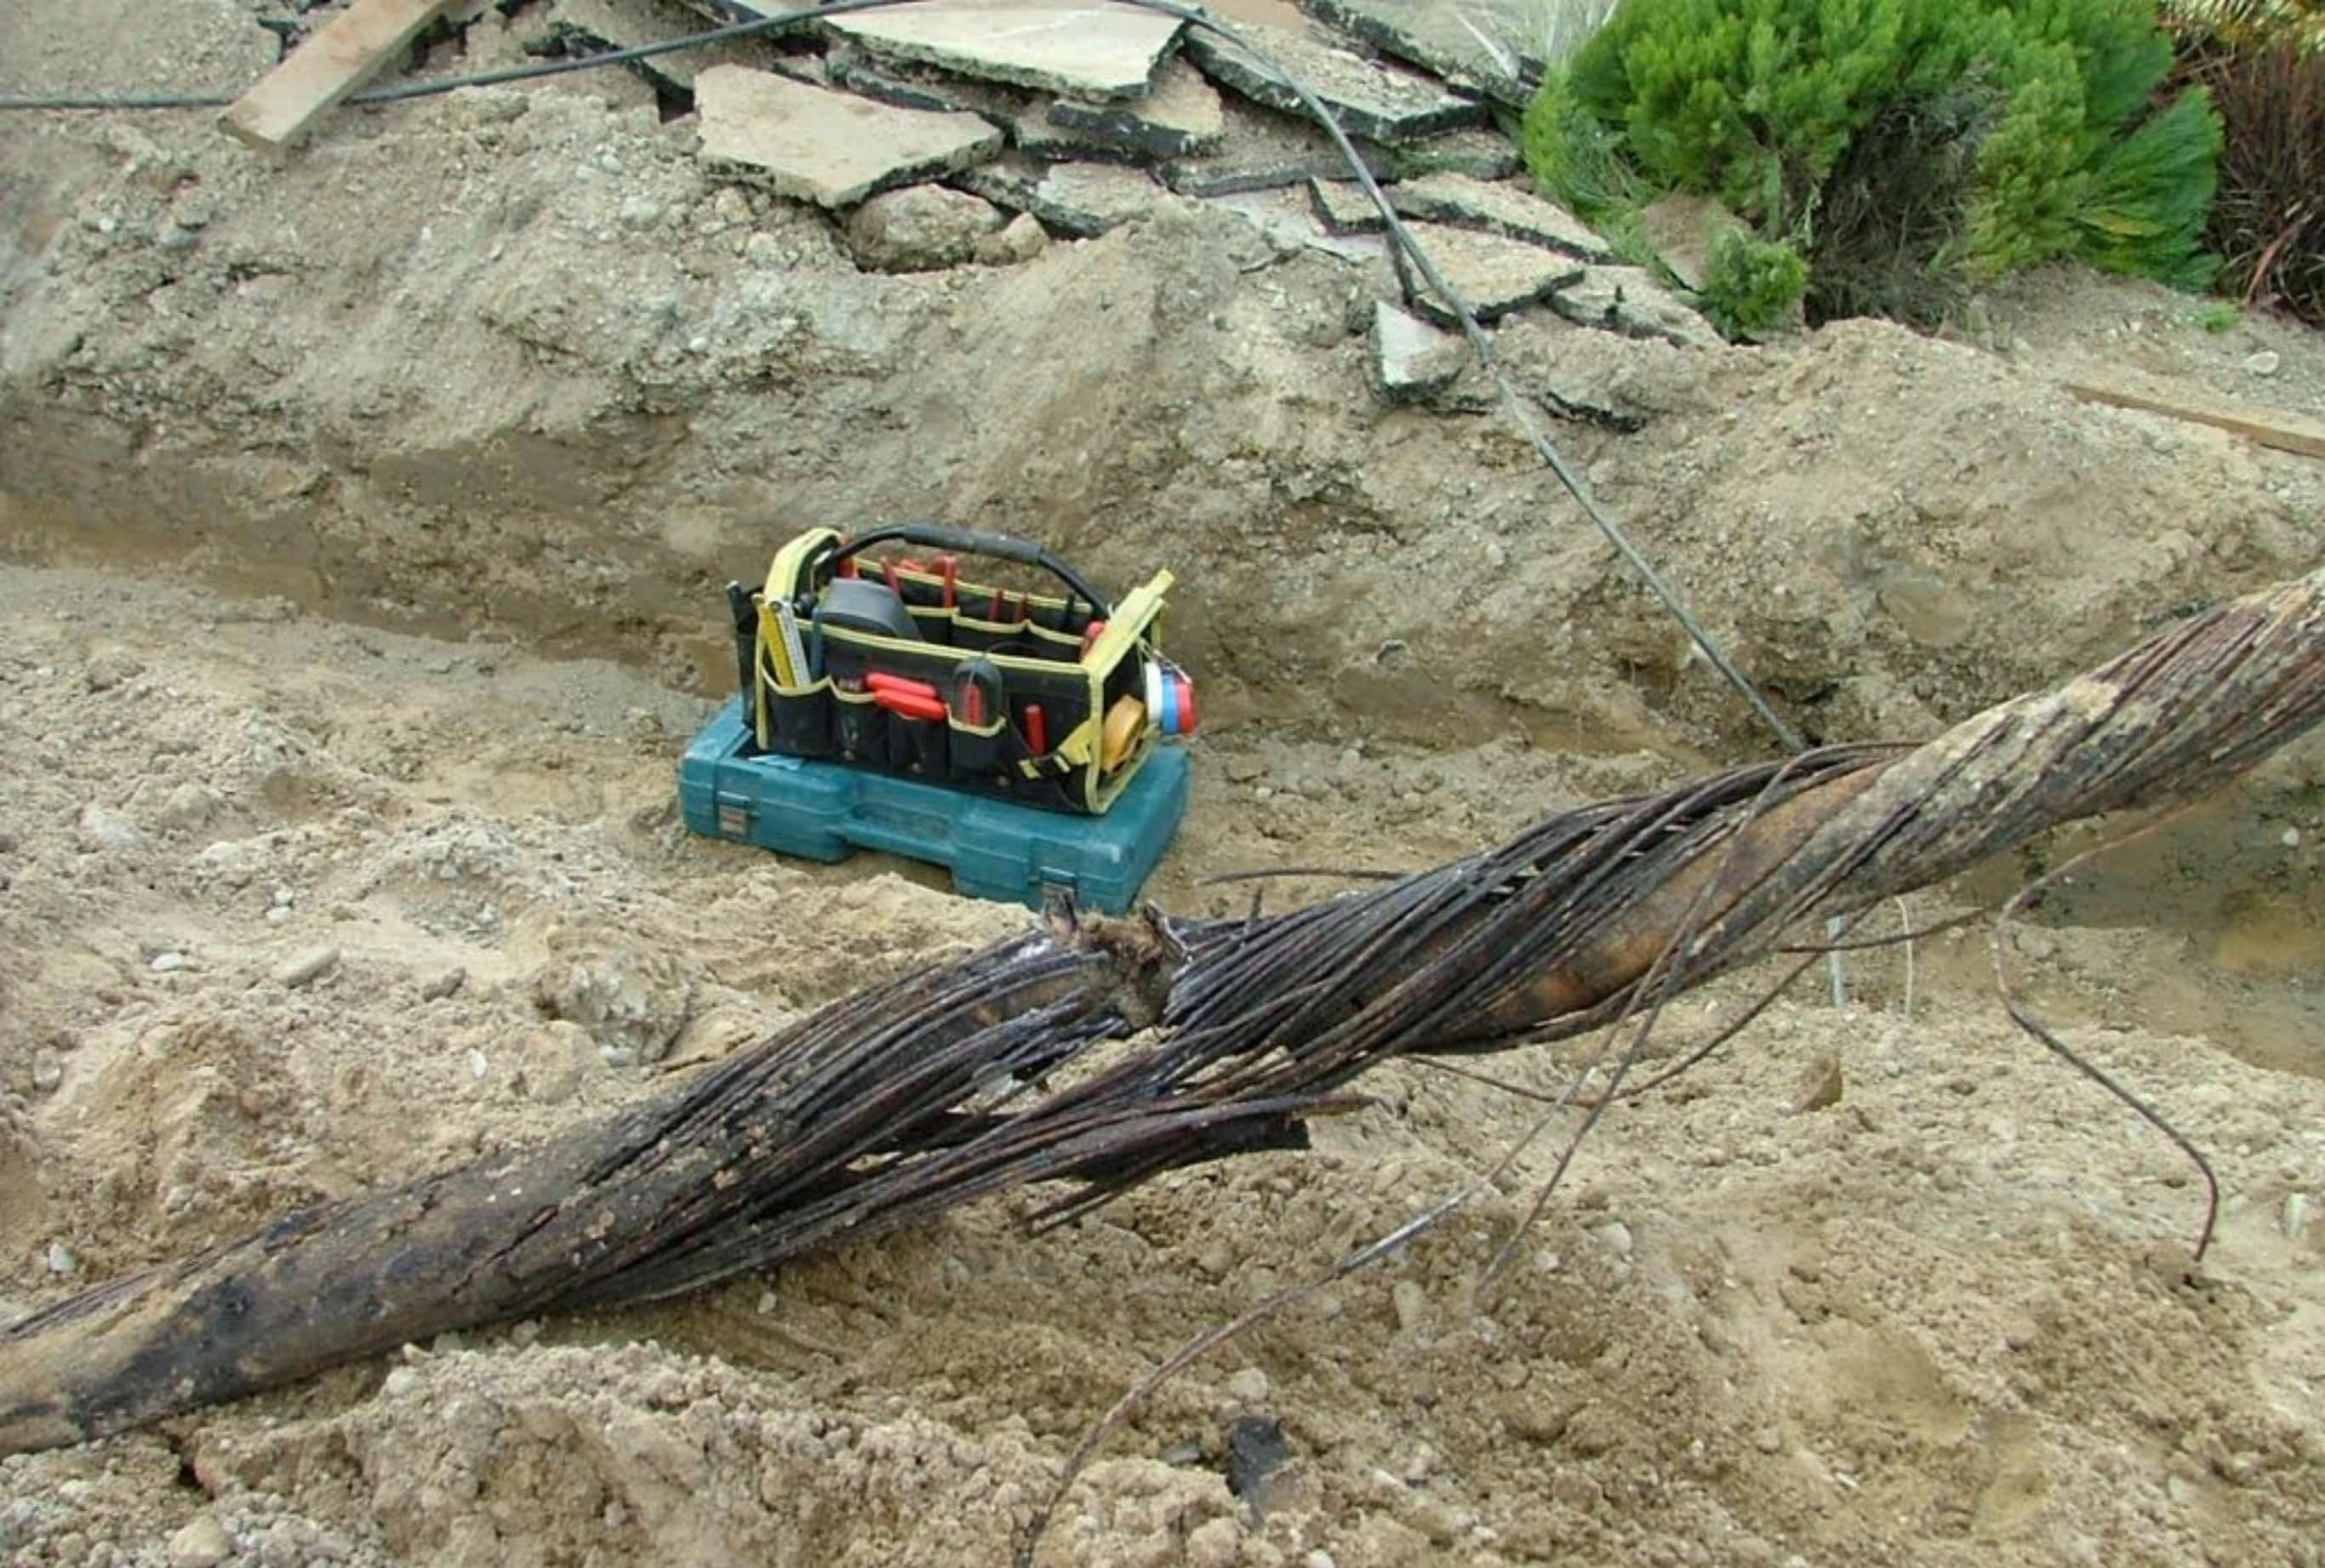
Electric line is direct burial (440 V, 40 m typ)

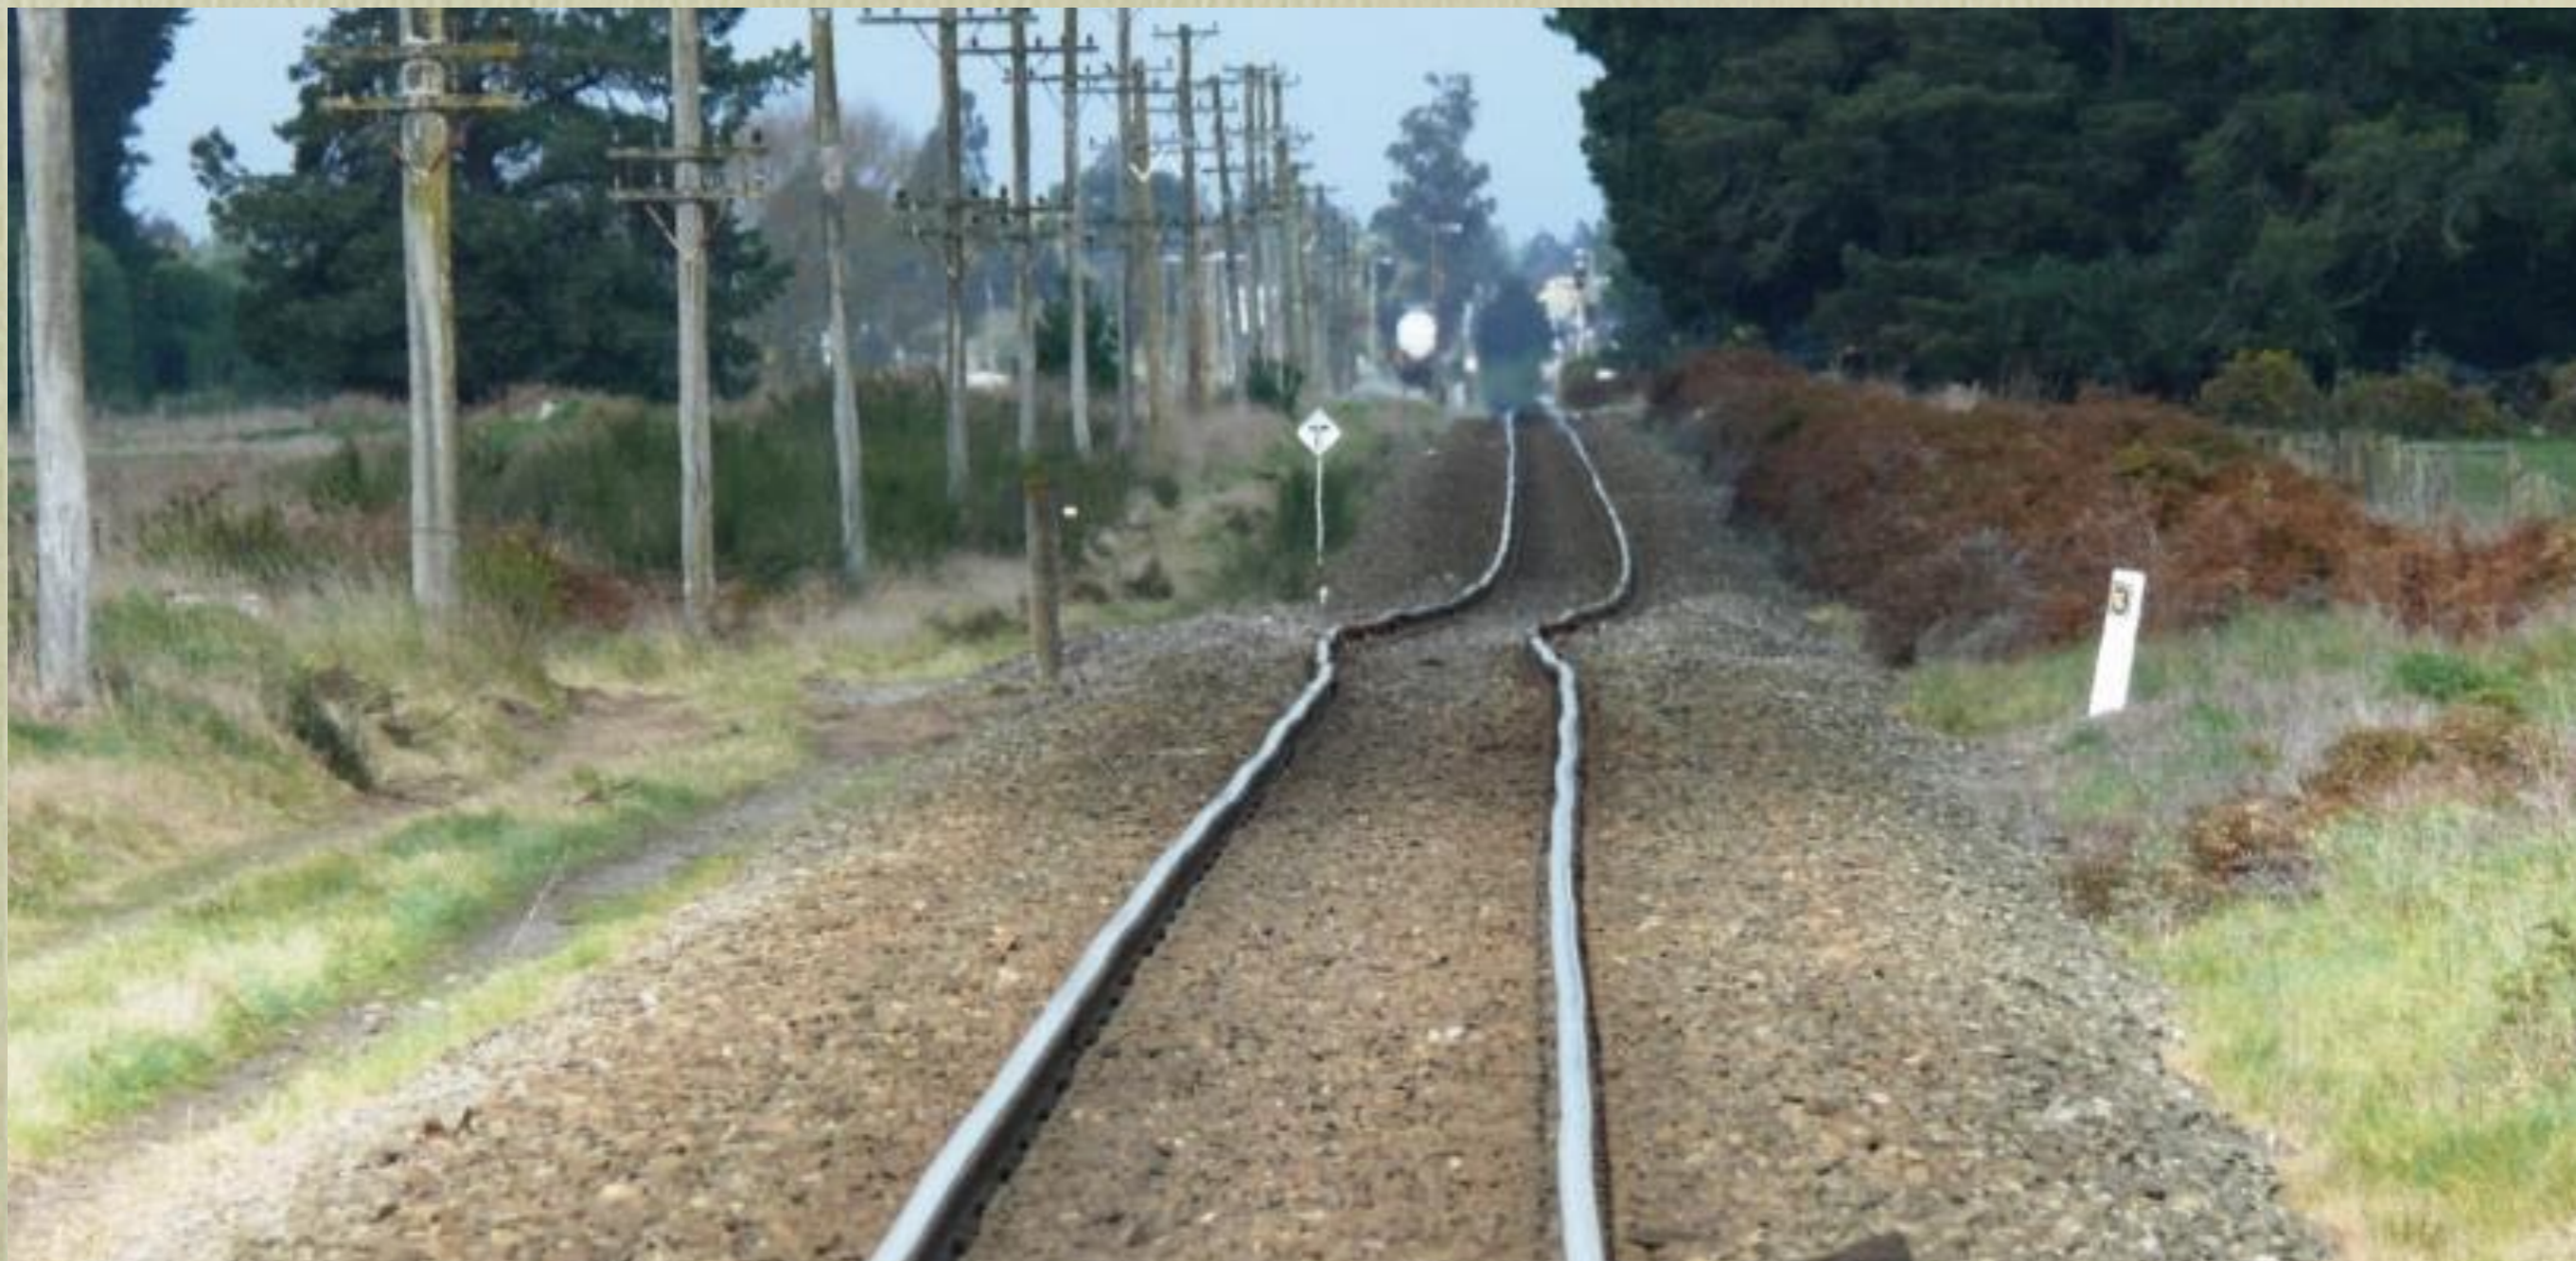
Fault Crossing - Post Earthquake

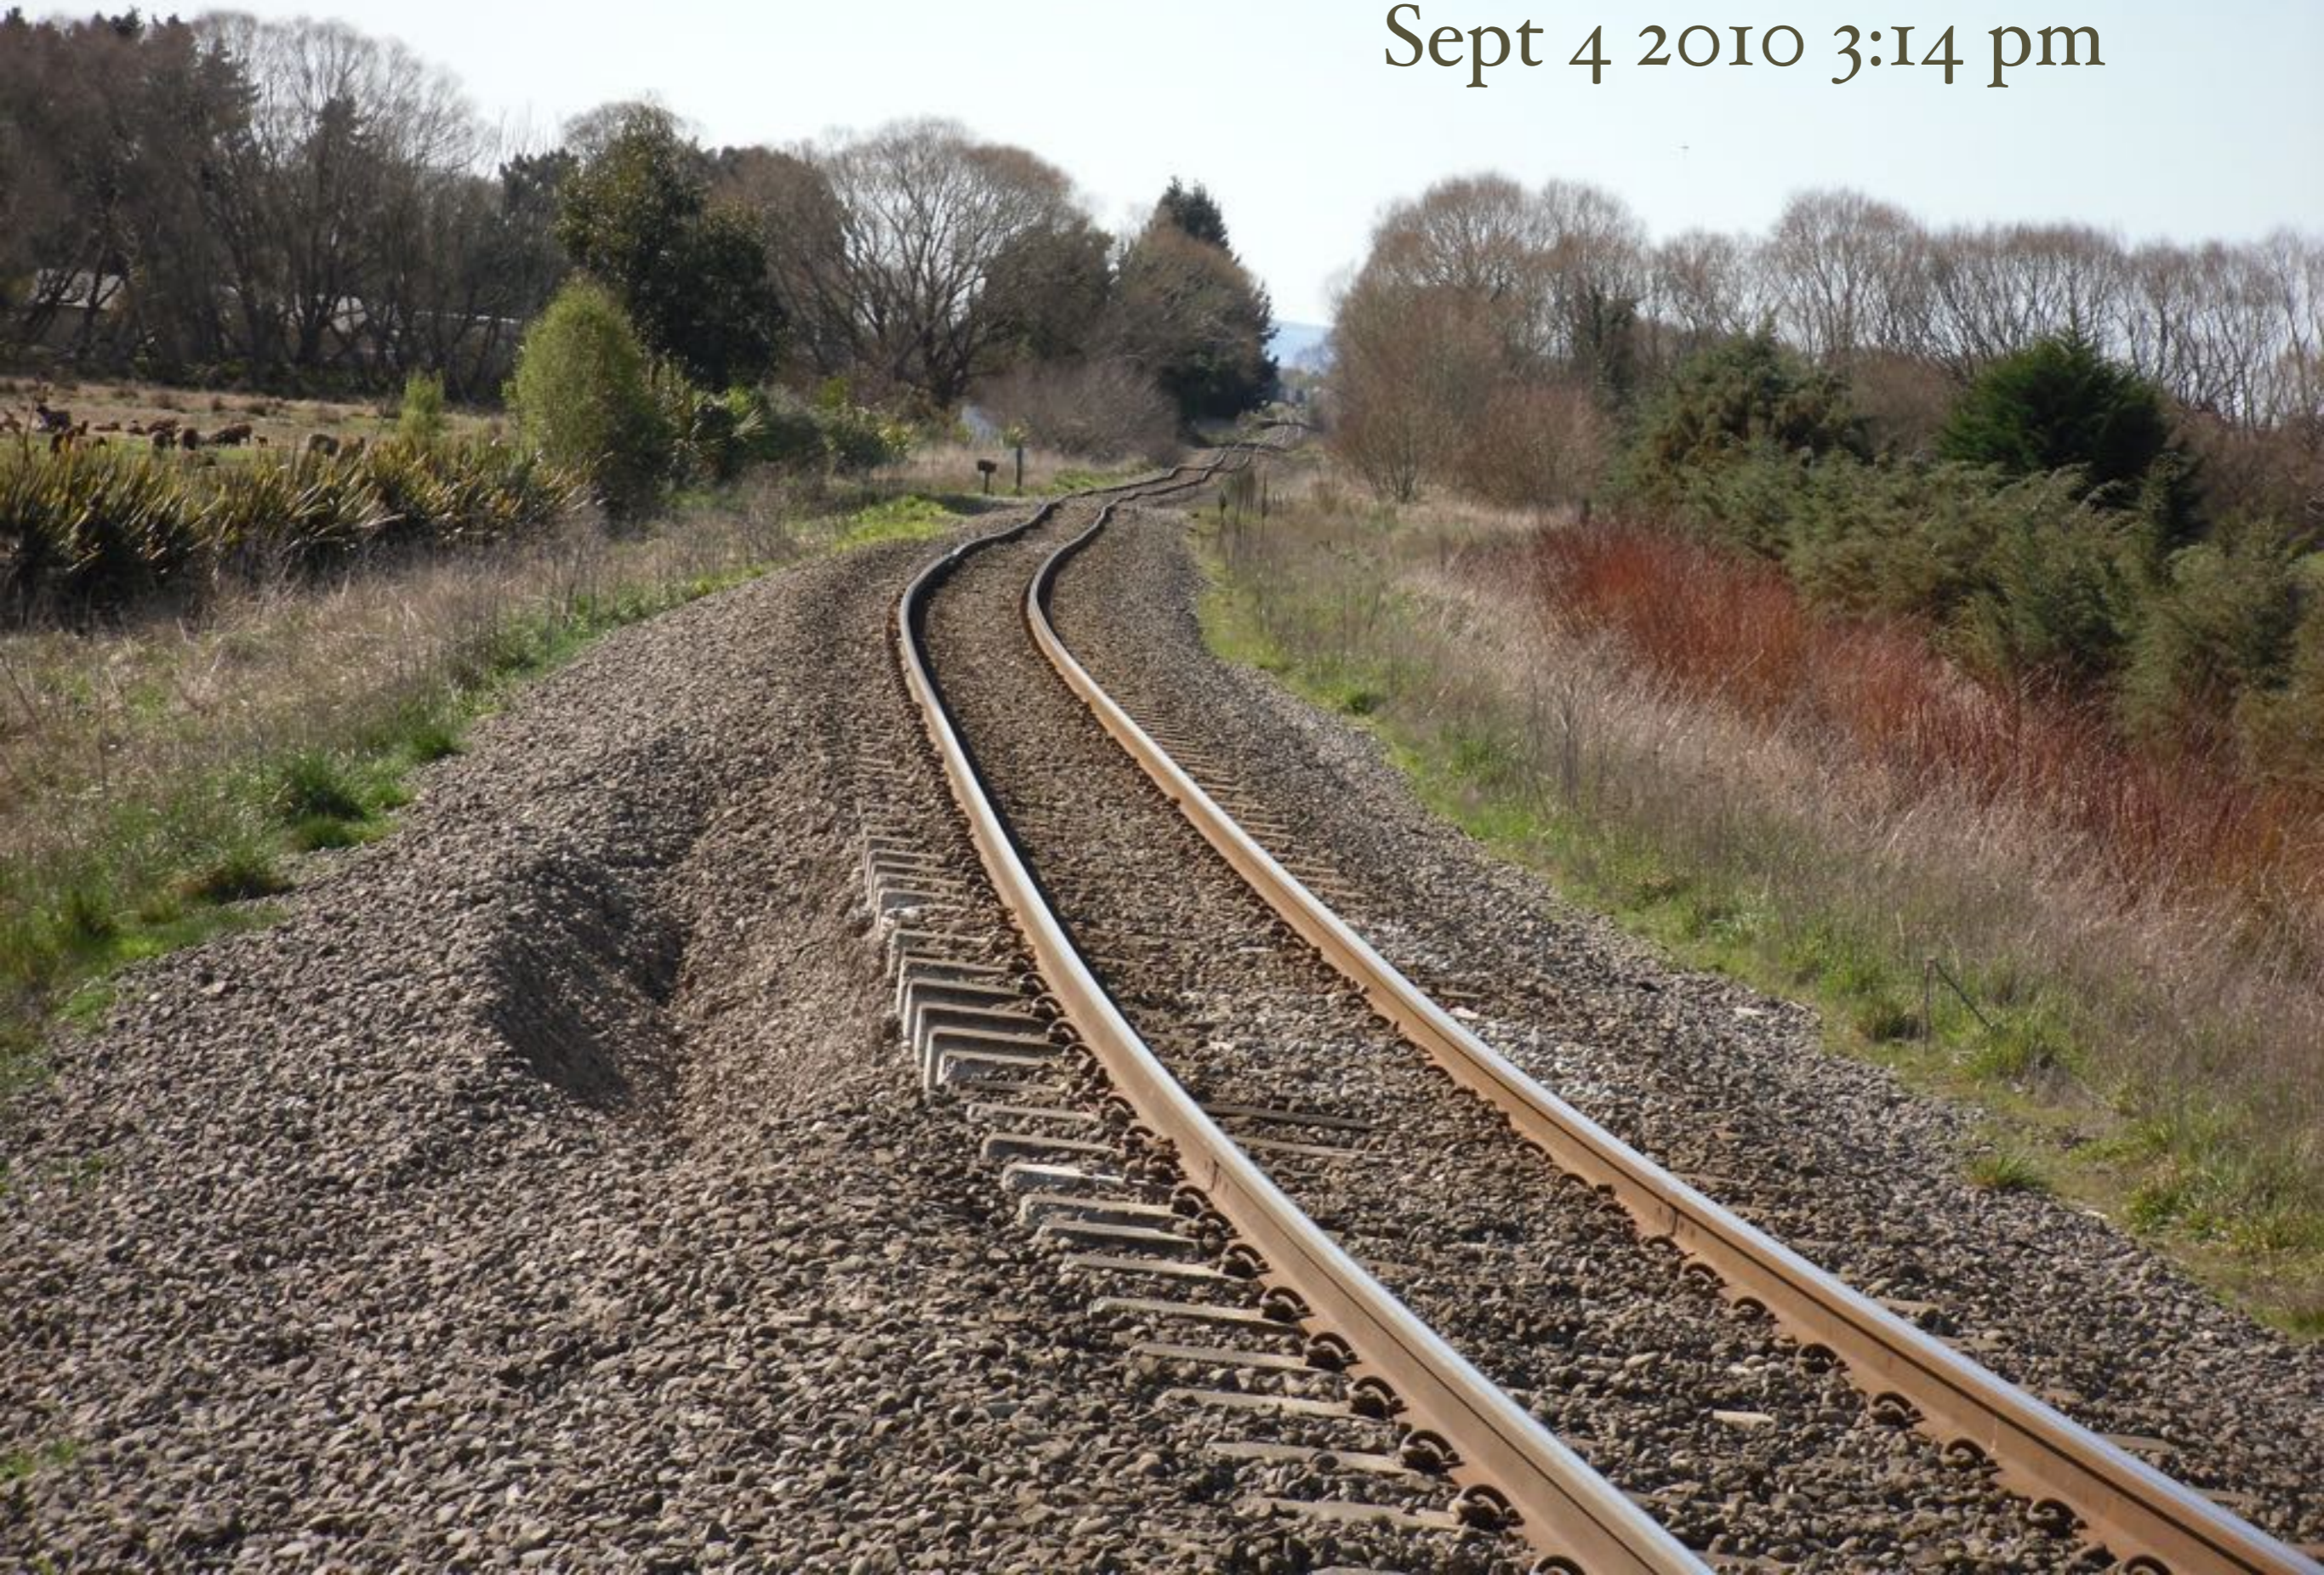
# Liquefaction along the Main North Line

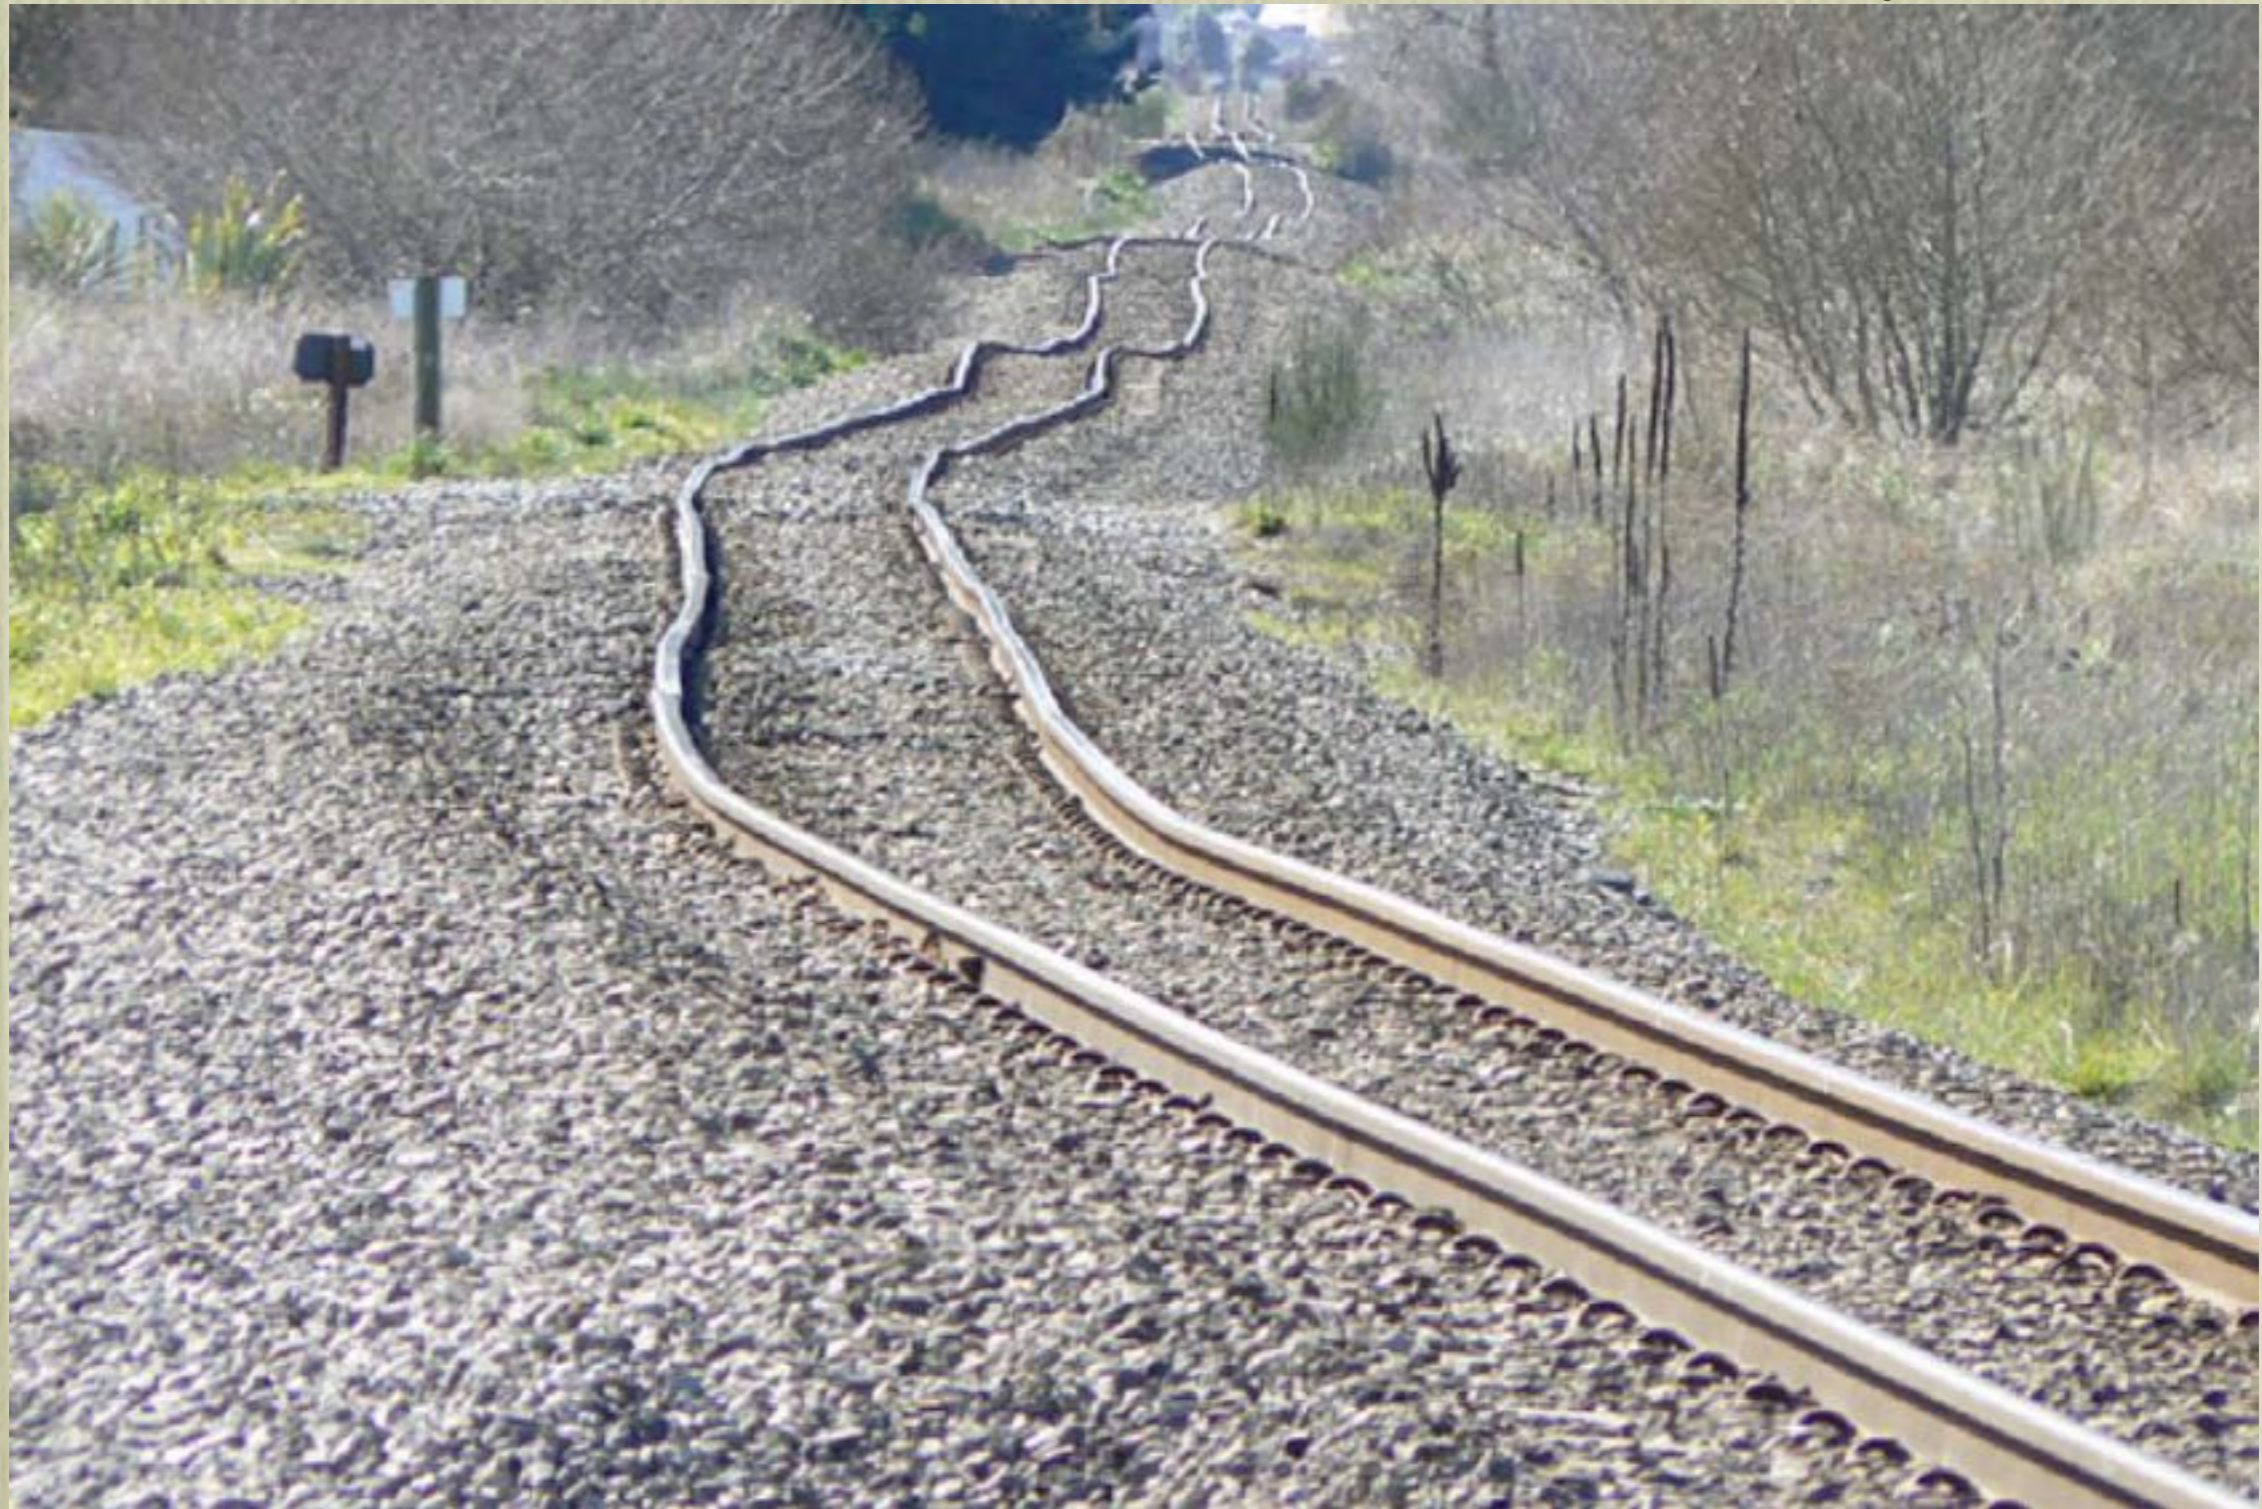
# Liquefaction along the Main North Line Several days later
