# Seismic Performance of Buried Cables and Pot Heads

John Eiding

G&E Engineering Systems Inc.

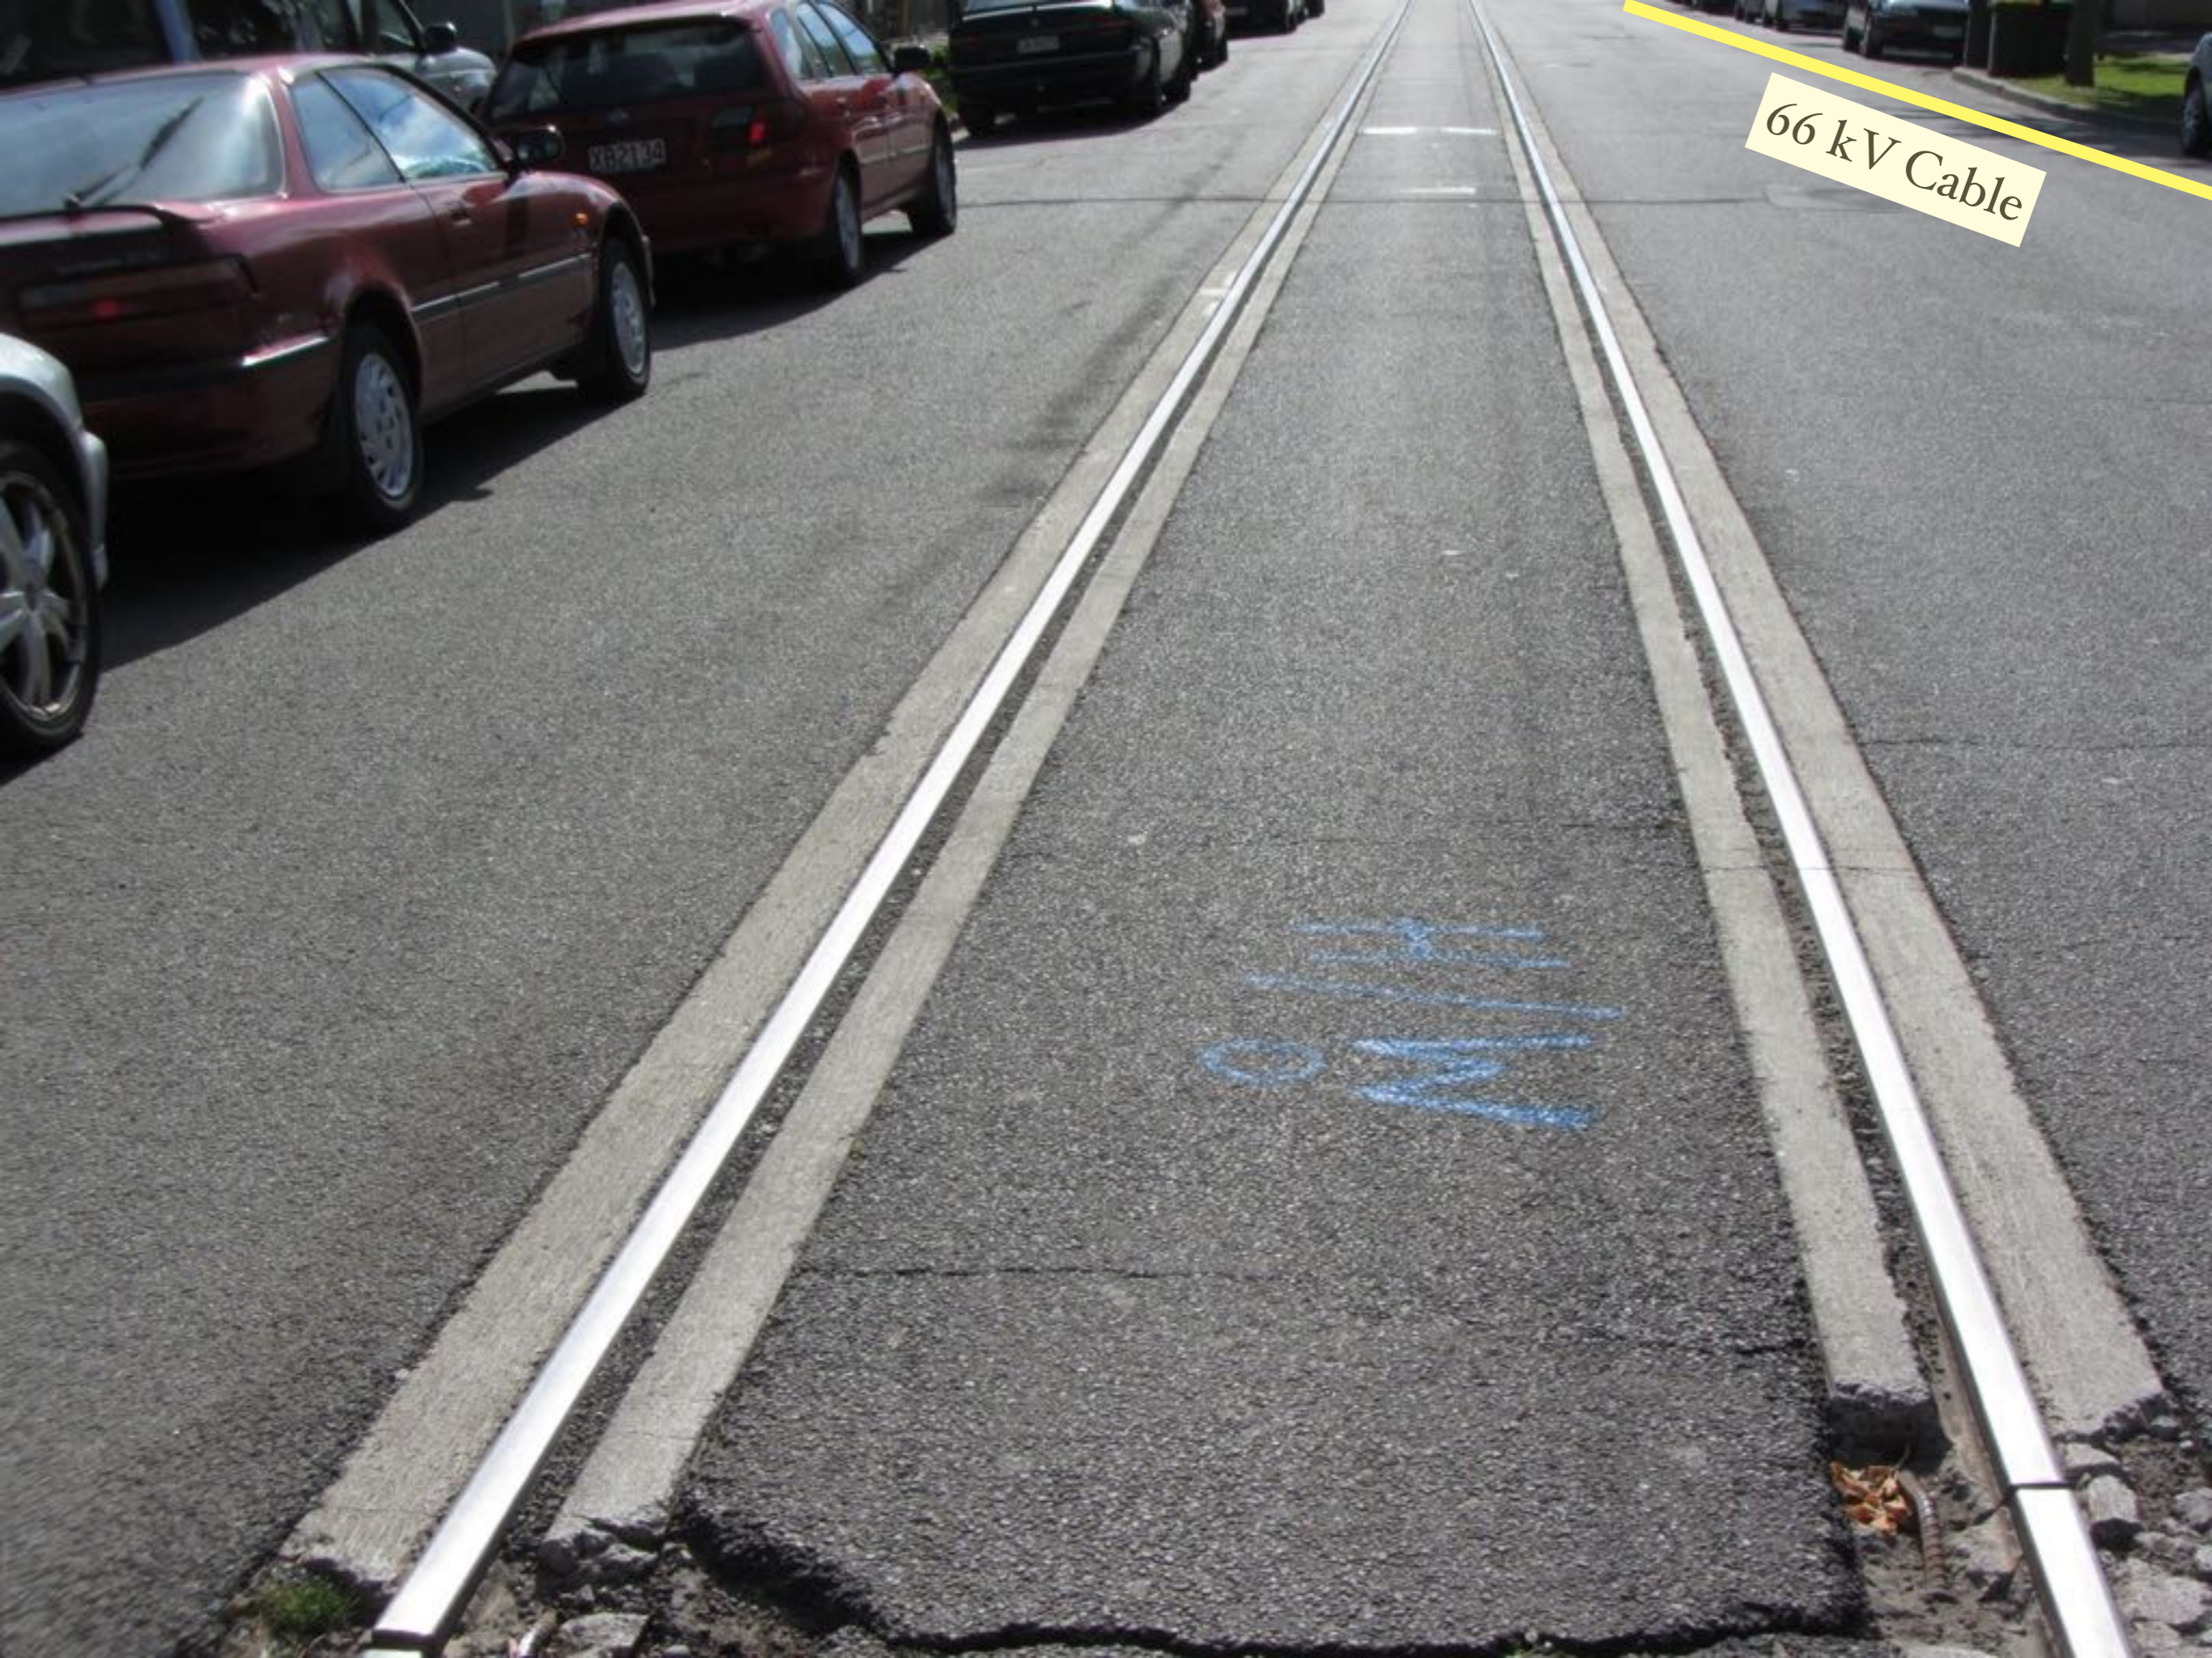
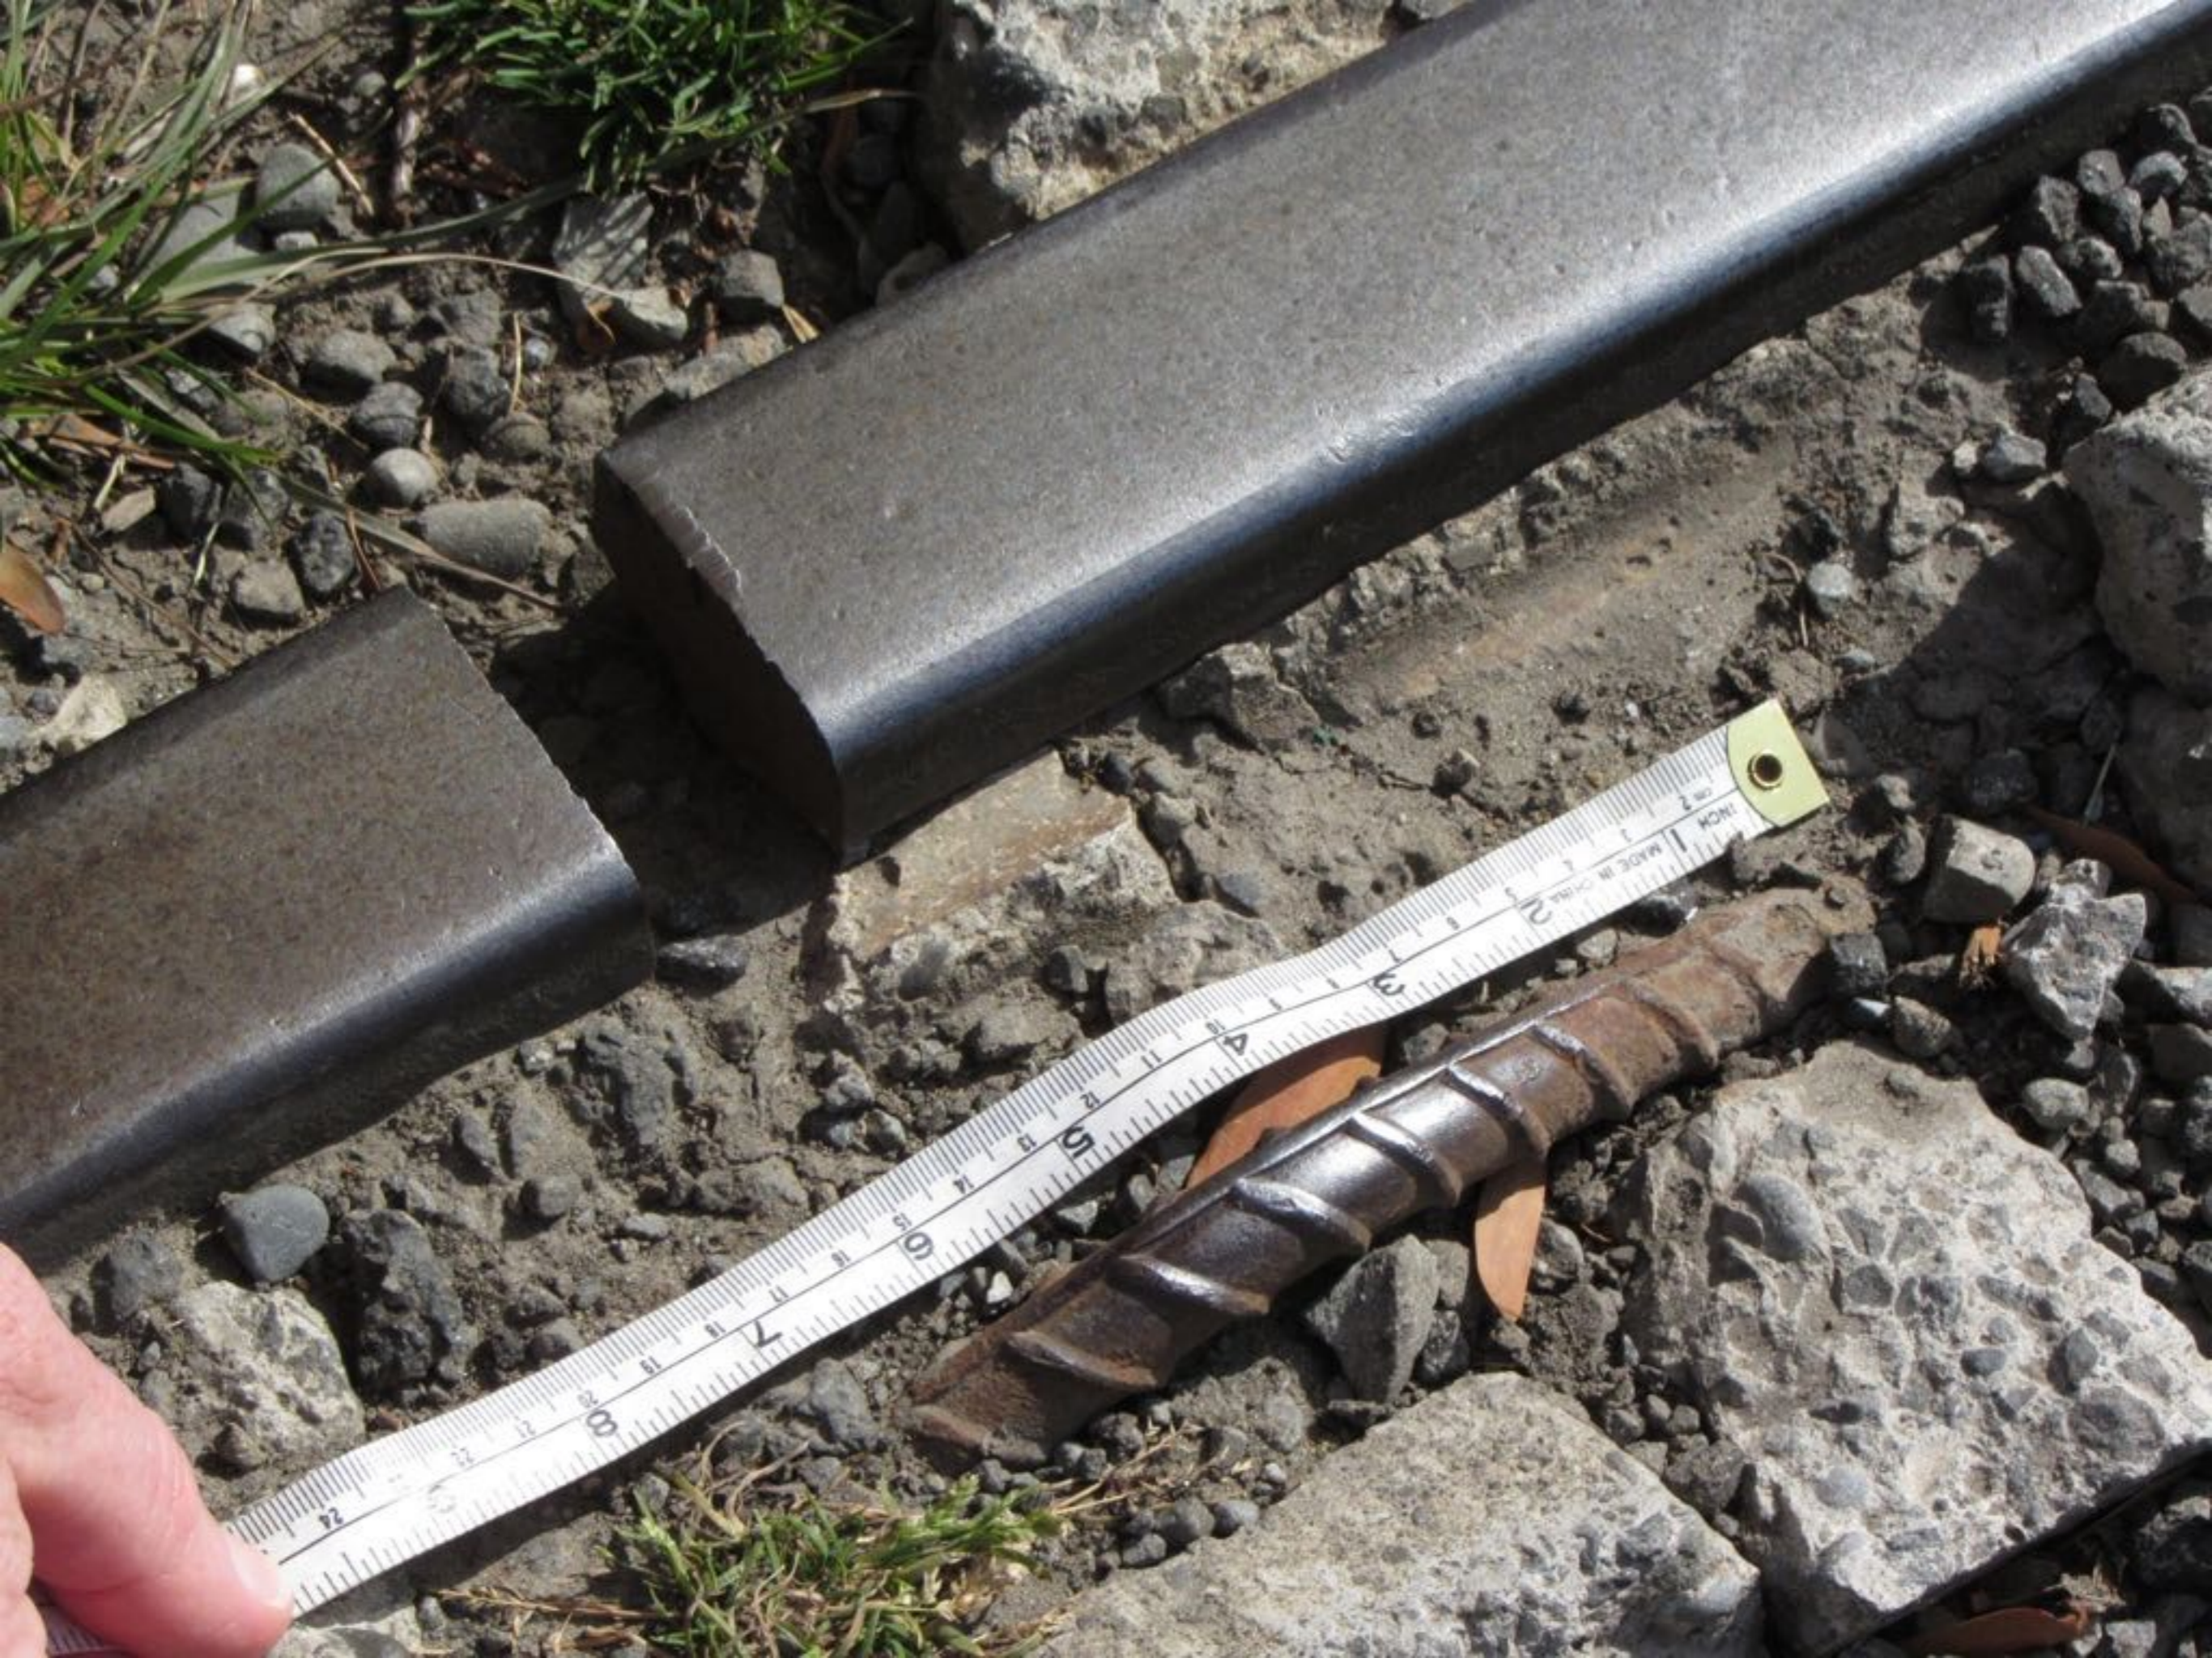
66 kV Cable

Cable Compresses, High Curvature, Buckles and Fails

- Never use direct burial cables in thermal concrete in liquefaction zones.
- Use overhead (if possible)
- User buried cables in PVC or HDPE conduits within reinforced thermal concrete duct banks

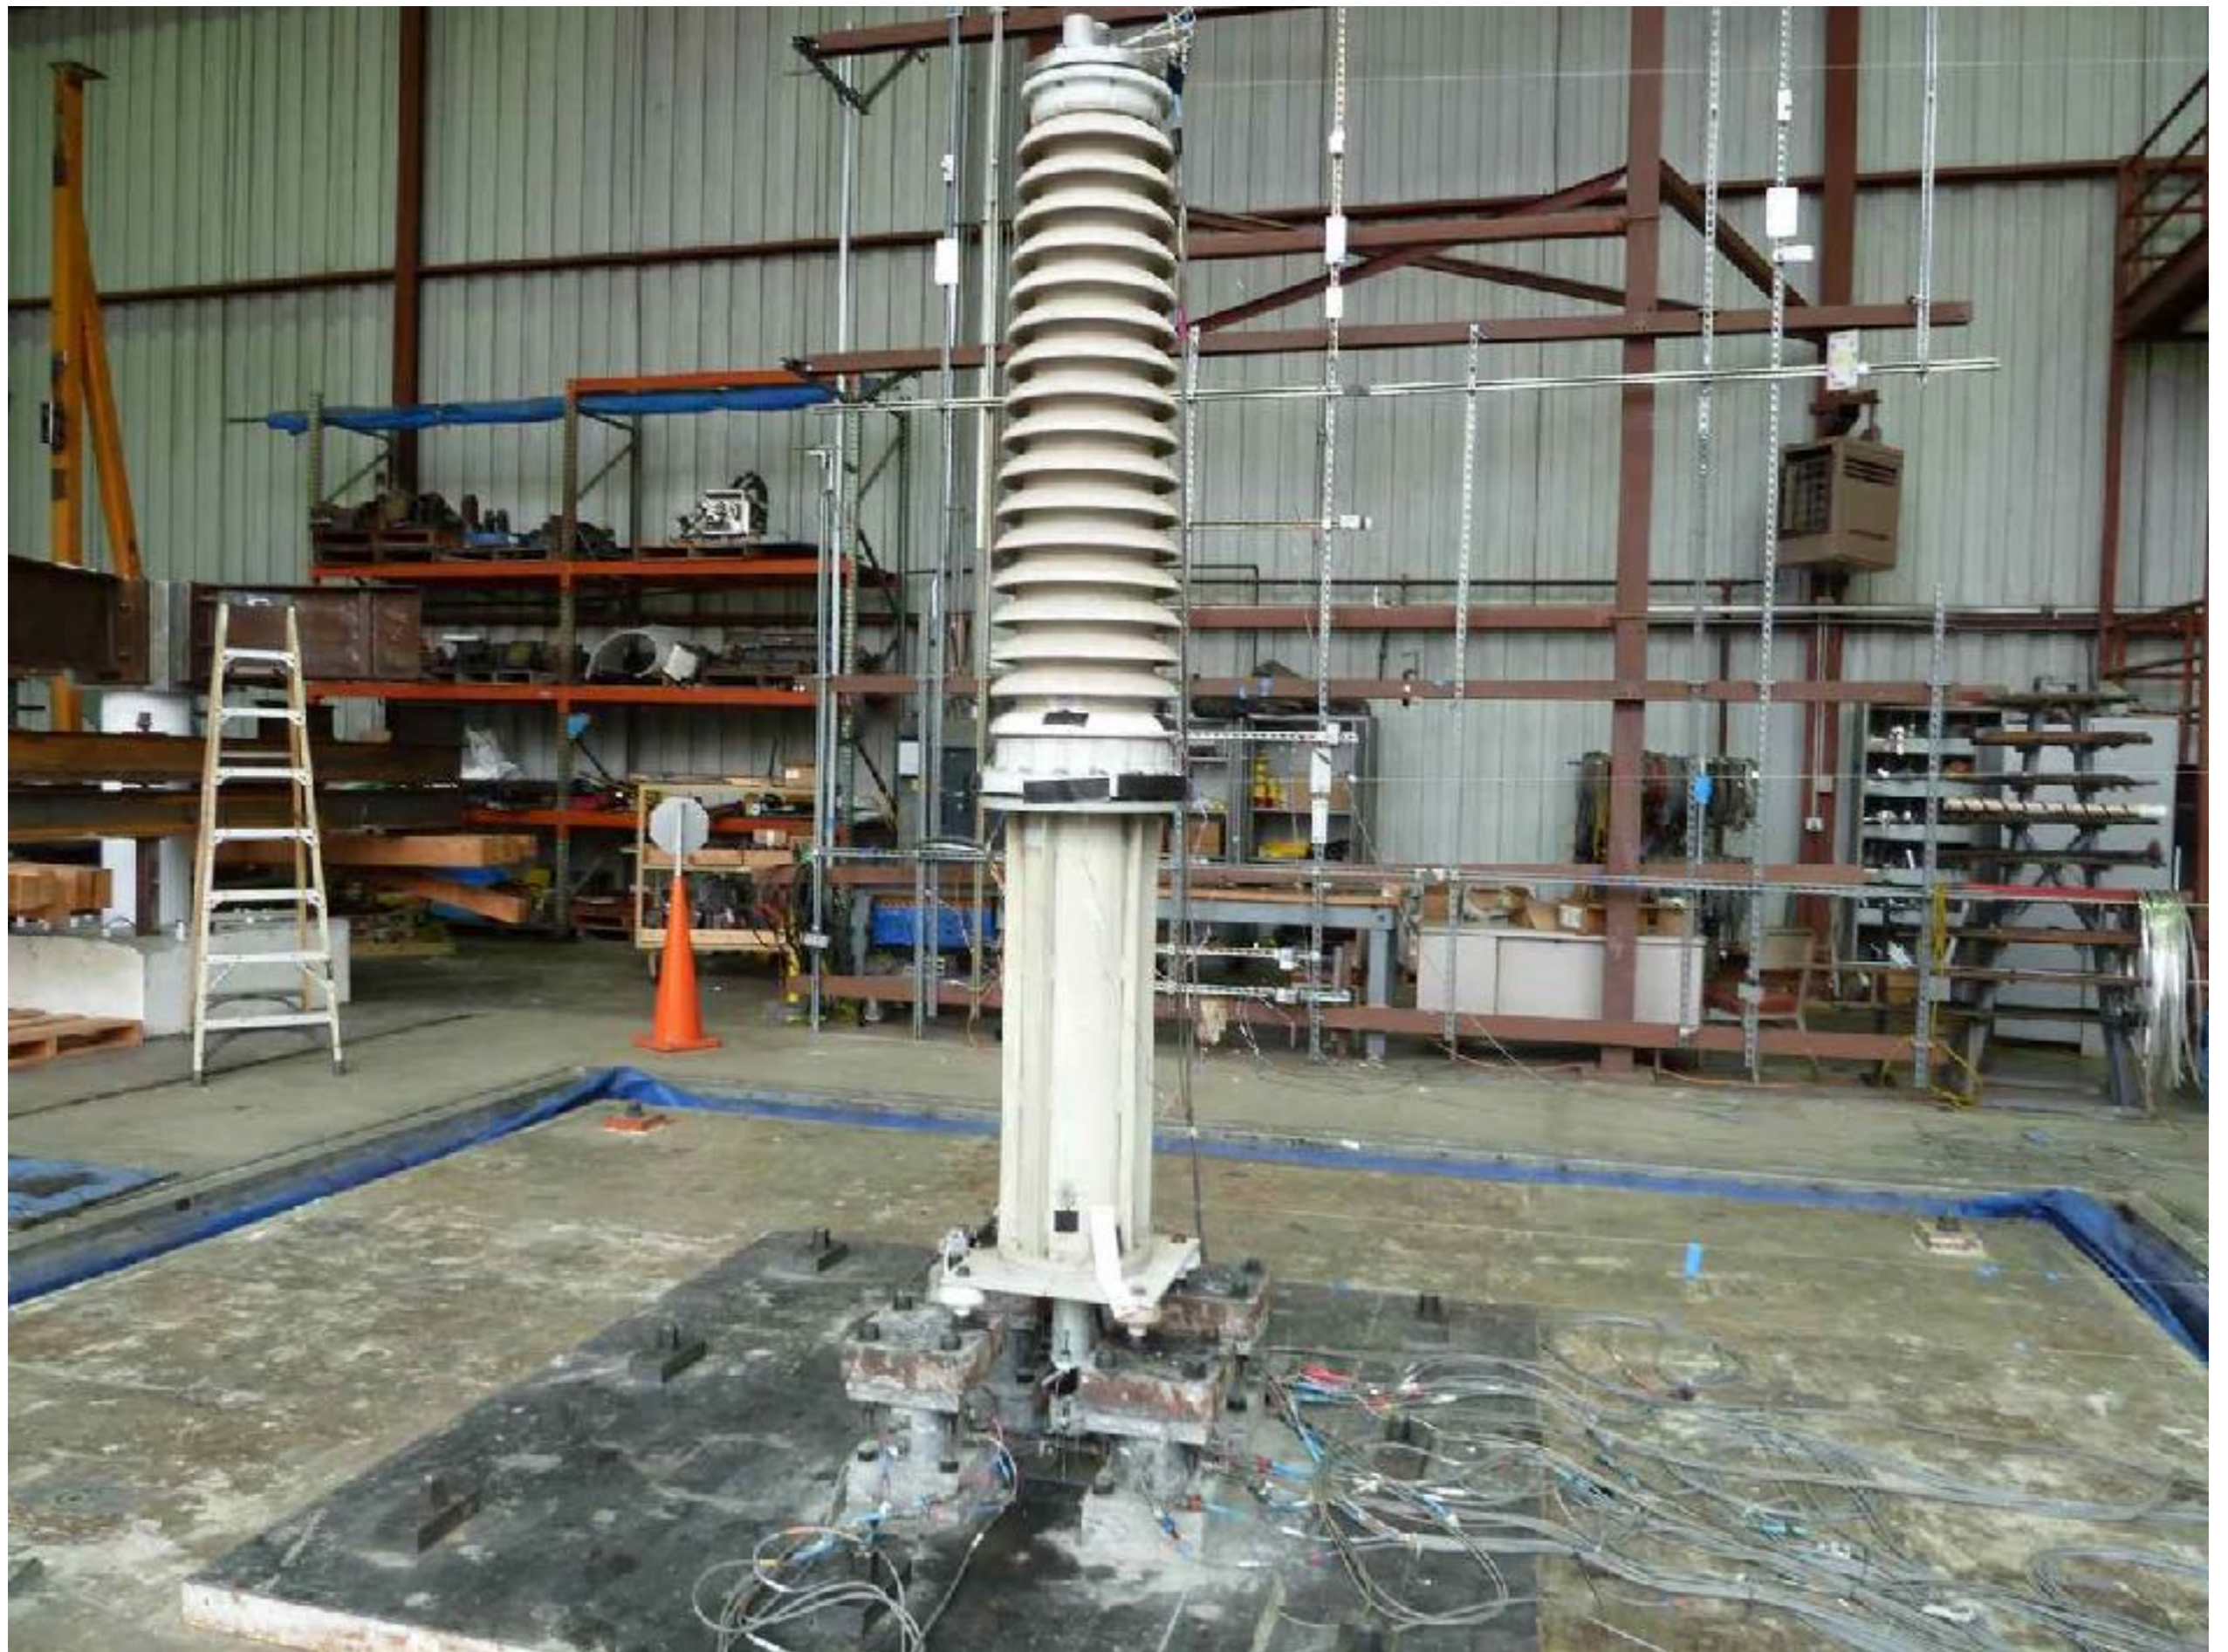
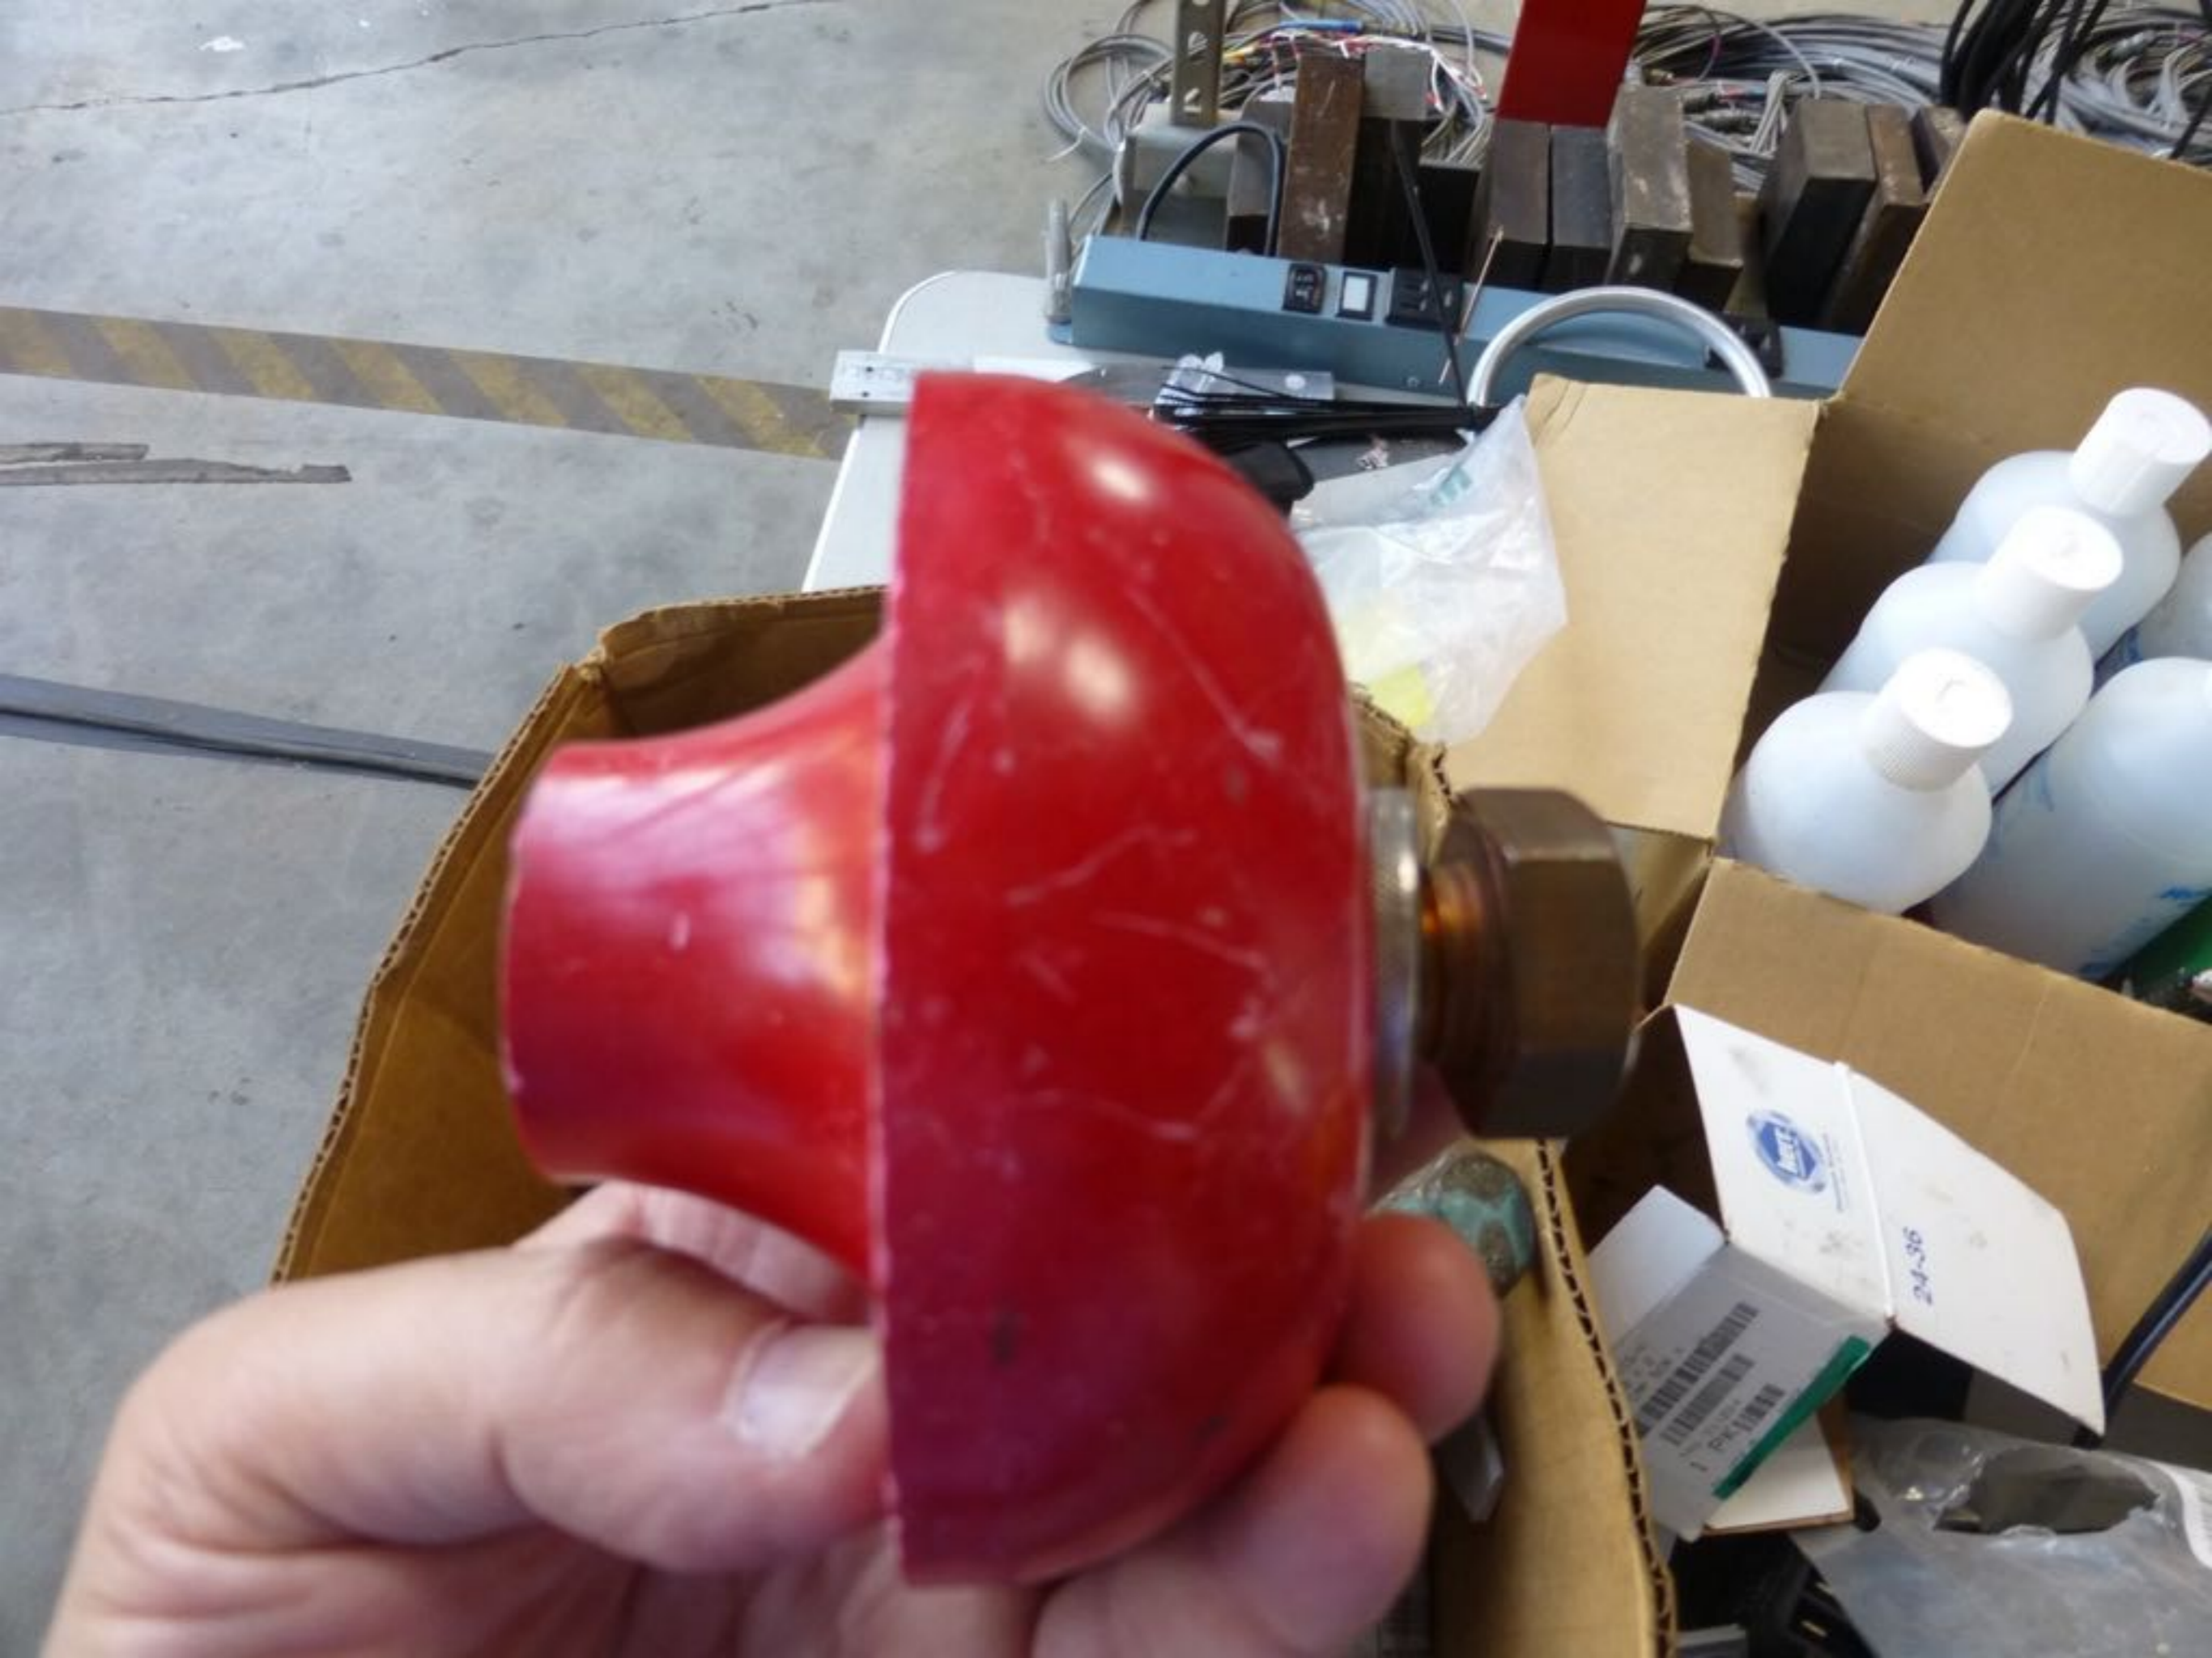
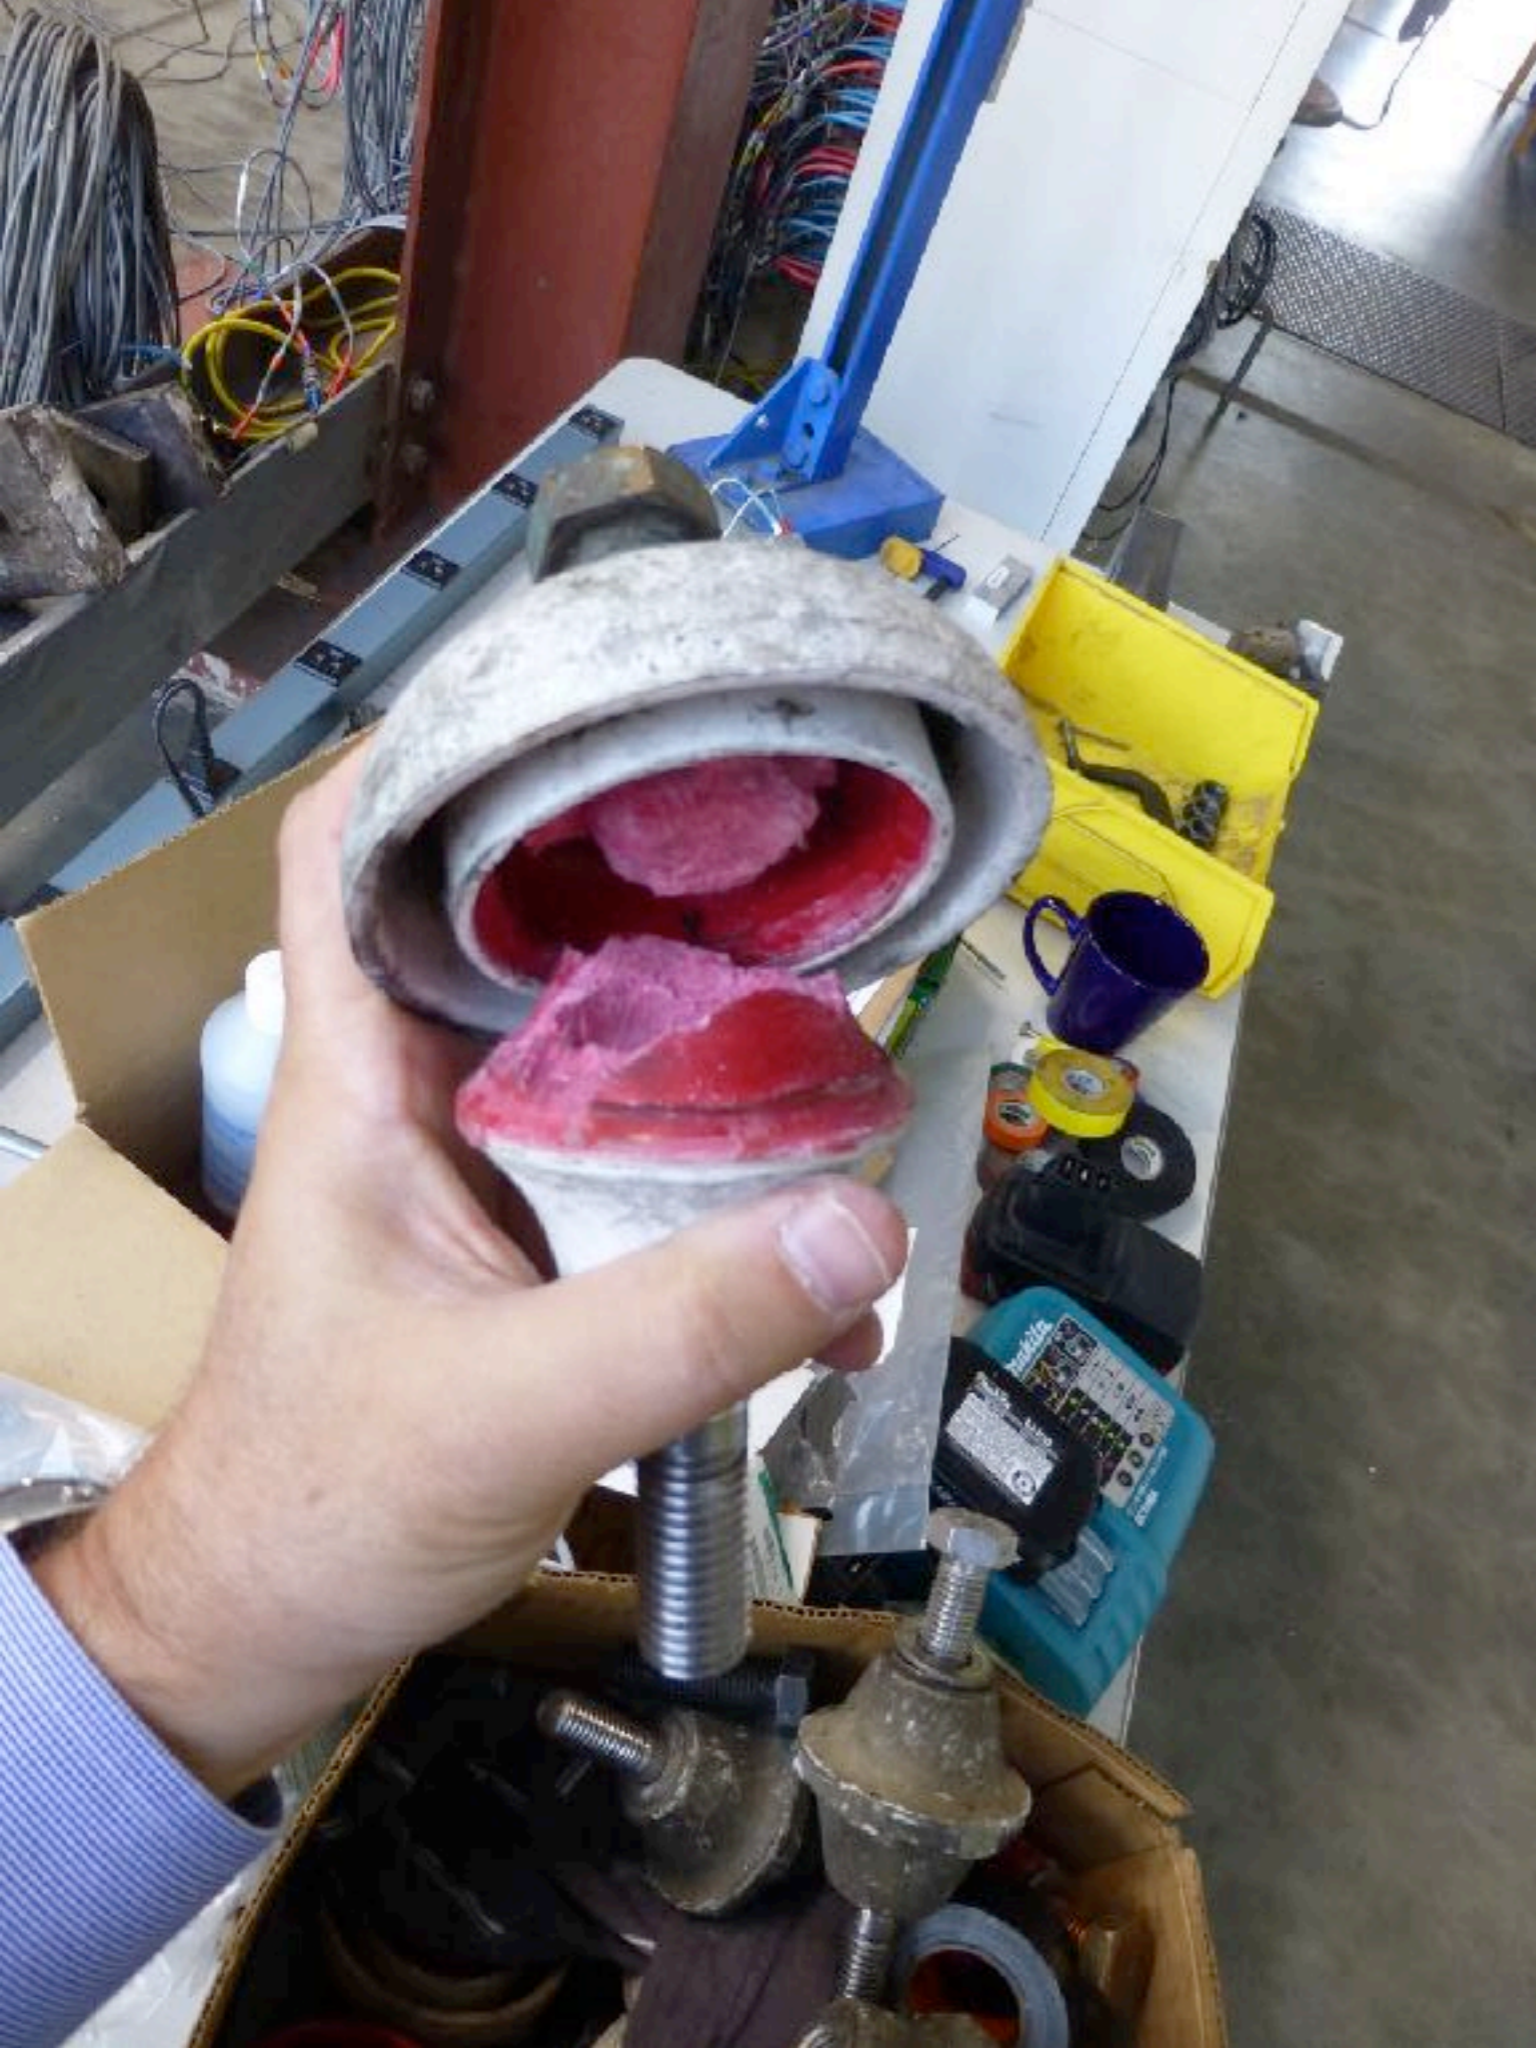
Pot Heads  
with Weak  
Standoffs  
(fail at PGA  
0.25-0.5g)
